DEPARTMENT OF THE NAVY

SUBJECT: ADMINISTRATIVE ORDER ON CONSENT (AOC) STATEMENT OF WORK (SOW) SECTION 5 CORROSION AND METAL FATIGUE PRACTICES, DESTRUCTIVE TESTING RESULTS REPORT, RED HILL BULK FUEL STORAGE FACILITY (RED HILL), JOINT BASE PEARL HARBOR-HICKAM, OAHU, HAWAII

In 2018, ten coupons were removed from Tank 14, so that a metallurgical and corrosion analysis of the coupons could be undertaken, with the primary aim of validating non-destructive examination (NDE) results. The steel coupons, concrete powder samples, and corrosion product were submitted to a certified third-party laboratory to perform this analysis.

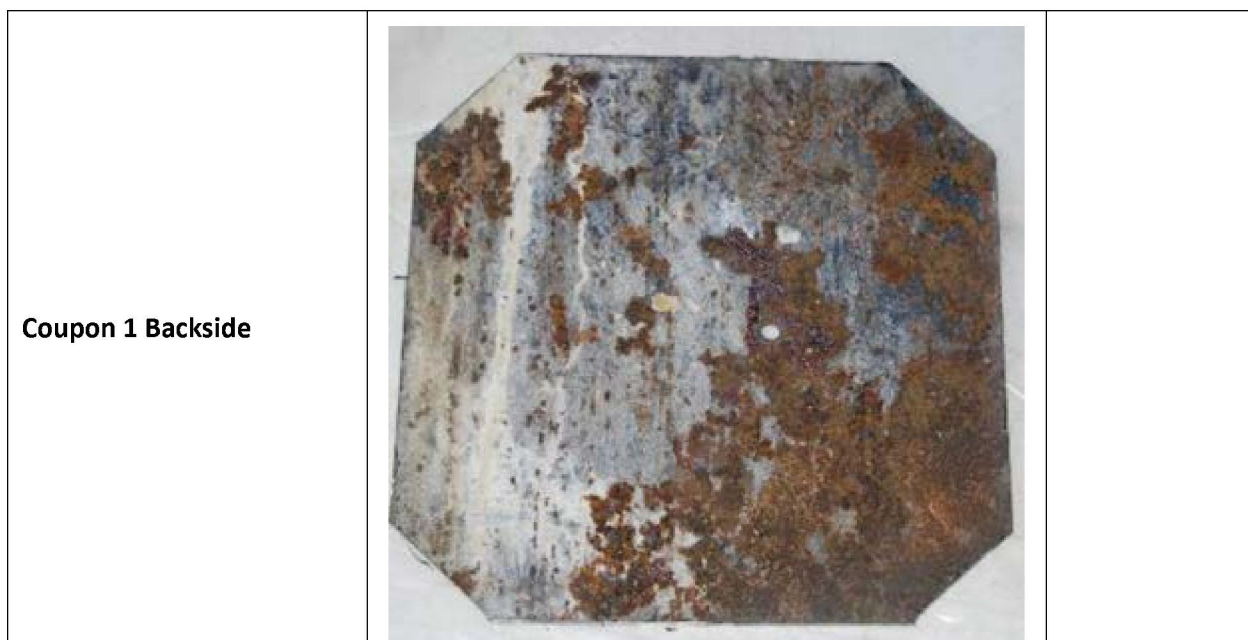
Wed, 20 Jun 2018, 01:33 PM		
COUPON SPECIFICS		
Coupon ID	1	1
Coupon Location	14-UD-A-42-45-107	
Coupon Dimensions	12" × 12"	
Coupon Thickness	¼" (NDE: minimum 0.147")	Prove-up: minimum 0.112"
Locations of Welds	None	
ON SITE VISUAL EXAMINATION		
Checks	Observations	
	Exterior	Interior
Deposits, Coatings, Debris	Deposits	Standard coating with paint
Scale	None	None
Observed Biological Material	None	None
Wet or Dry	Wet	Dry
Smell	Damp, burnt	Burnt
Presence of petroleum product between steel and concrete surface	No	No
Presence of corrosion	Yes	No
Isolated pitting	No	No
Isolated pitting within areas of general corrosion	No	No
Linked pitting within areas of general corrosion	No	No
Identify color of corrosion products	Brown	N/A
Identify if selected attack at welds	N/A	N/A

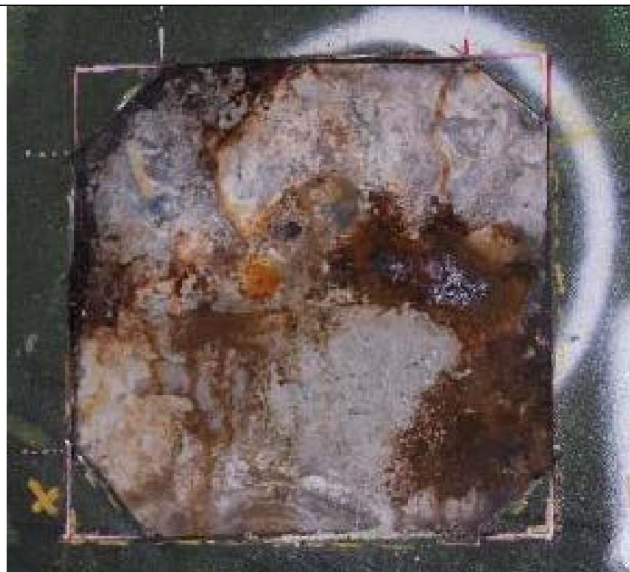
6/19/2018: 0930		
CONCRETE SAMPLE SPECIFICS		
Sample ID	2	2
Sample Location	14-ER-E3-12-33-40	
Sample Dimensions	12" × 12"	
ON SITE VISUAL EXAMINATION		
Checks	Observations	
	Exterior	Units
Void space between concrete and liner (if any)	1/8" void at upper left side. Otherwise no voids.	
Biological Materials	None	
Wet or Dry	Slightly damp	
Smell	Musty, no fuel	
Temperature	80.0	Degrees F
Surface pH	10-11 corroded area 11-12 non-corroded area	
Structure to Electrolyte	-0.380	Volts/CSE
Concrete Resistivity	19.0 Horizontal 17.5 Vertical	k-ohm-cm k-ohm-cm
General Condition	Good sound condition with some minor spalling and corrosion product. Coupon took some hammering to remove.	
Concrete behind Coupon 2

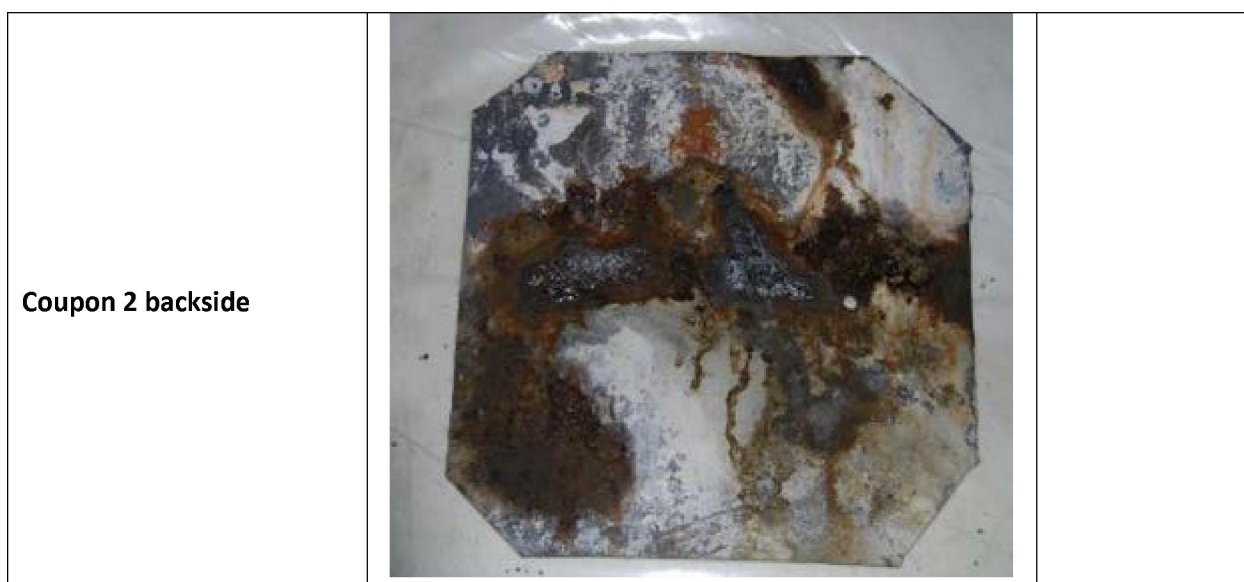
Tue, 19 Jun 2018, 10:46 AM		
COUPON SPECIFICS		
Coupon ID	2	2
Coupon Location	14-ER-E3-12-33-40	
Coupon Dimensions	12" × 12"	
Coupon Thickness	¼" (NDE: minimum 0.157")	Prove-up: minimum 0.150"
Locations of Welds	None	
ON SITE VISUAL EXAMINATION		
Checks	Observations	
	Exterior	Interior
Deposits, Coatings, Debris	Lots of deposits and concrete	Regular coating
Scale	None	None
Observed Biological Material	None	None
Wet or Dry	damp	Dry
Smell	burnt, musty, muddy	Burnt but less intense than exterior
Presence of petroleum product between steel and concrete surface.	No	No
Presence of corrosion	Yes	Yes
Isolated pitting	Yes	Yes
Isolated pitting within areas of general corrosion	Yes	No
Linked pitting within areas of general corrosion	No	No
Identify color of corrosion products	Brown, black, gray	Brown
Identify if selected attack at welds	N/A	N/A

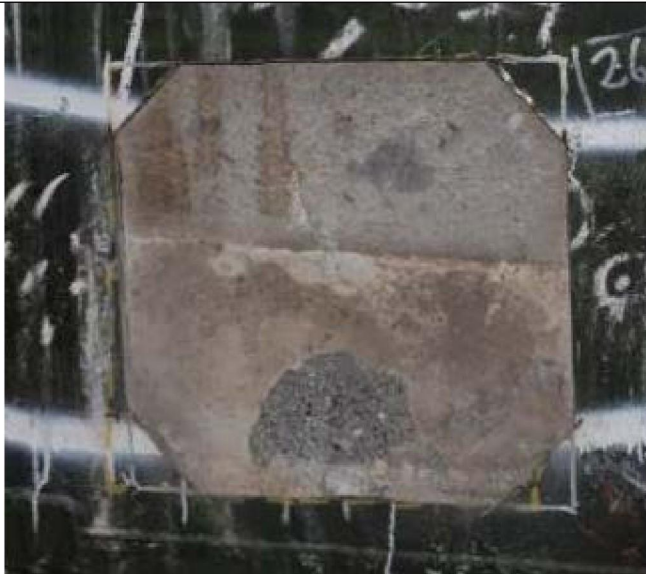
6/20/2018: 0800		
CONCRETE SAMPLE SPECIFICS		
Sample ID	5	5
Sample Location	14-BA-26-15-15-8	
Sample Dimensions	12" × 12"	
ON SITE VISUAL EXAMINATION		
Checks	Observations	
	Exterior	Units
Void space between concrete and liner (if any)	1/16" Void on top right side, no voids in all other areas	
Biological Materials	None	
Wet or Dry	Dry	
Smell	None	
Temperature	78.5	F
Surface pH	11-12	
Structure to Electrolyte	-0.220	Volts/CSE
Concrete Resistivity	19.1 Horizontal 22.0 Vertical	k-ohm-cm k-ohm-cm
General Condition	Excellent, sound concrete	
Concrete behind Coupon 5

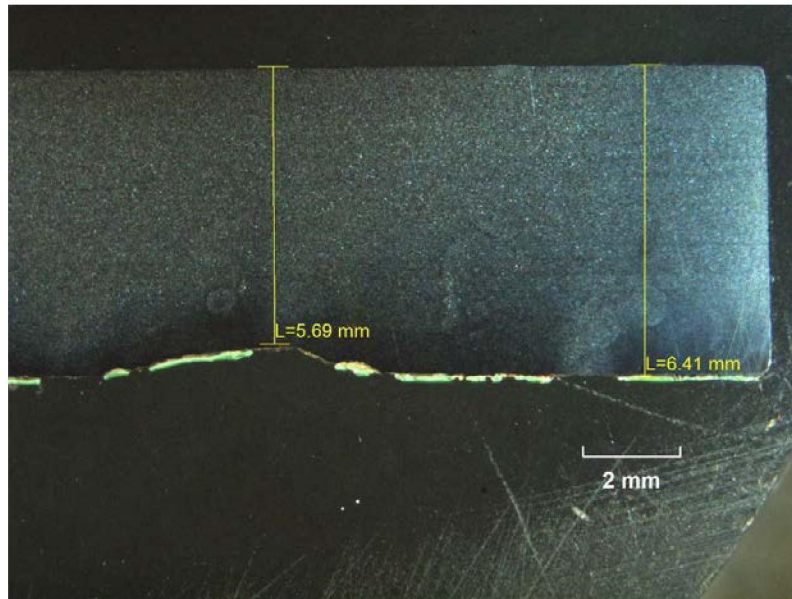
Figure 3-5 Cross Section of Coupon 5 at Area of Maximum Wall Loss

- Detailed results of the Destructive Testing Laboratory analysis of Coupon 5 are contained in Appendix A.
- The thinnest measured location was 224.0 mils (5.69 mm).
- Assuming a nominal wall thickness of 250 mils, the remaining wall thickness at the thinnest location was 89.6%.
- A cross-section view of Coupon 5 is shown in Figure 3-5.

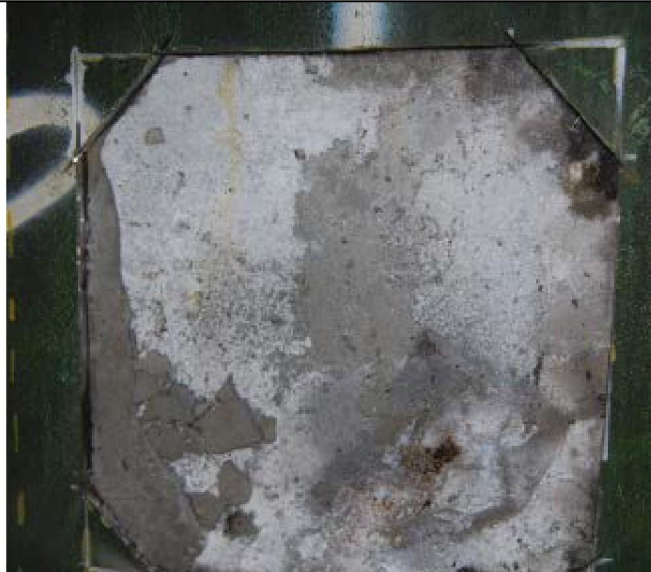
6/21/2018: 1100		
CONCRETE SAMPLE SPECIFICS		
Sample ID	6	6
Sample Location	14-BA-24-8-36-30	
Sample Dimensions	12" × 12"	
ON SITE VISUAL EXAMINATION		
Checks	Observations	
	Exterior	Units
Void space between concrete and liner (if any)	None, however some loose adhering grout present	
Biological Materials	None	
Wet or Dry	Dry	
Smell	None	
Temperature	77.4	F
Surface pH	12.5	
Structure to Electrolyte	-0.387	Volts/CSE
Concrete Resistivity	Horizontal = 10.1 Vertical = 18.2	k-ohm-cm k-ohm-cm
General Condition	Concrete is sound, no delamination. There is loose adhering grout on left side and middle	
Concrete behind Coupon 6

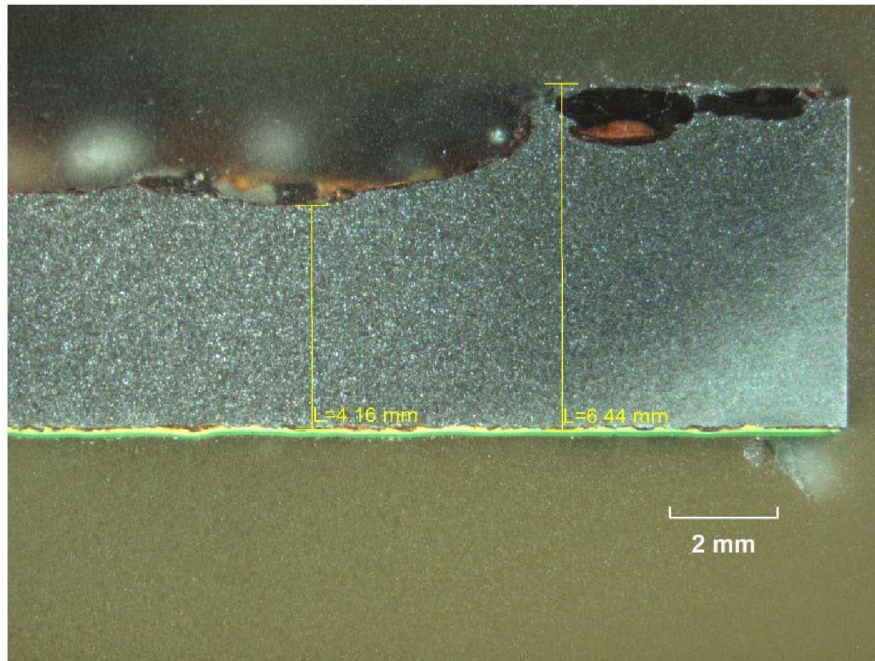
Figure 3-7 Cross Section of Coupon 7 at Area of Maximum Wall Loss

- Detailed results of the Destructive Testing Laboratory analysis of Coupon 7 are contained in Appendix A.
- The thinnest measured location was 163.8 mils (4.16 mm).
- Assuming a nominal wall thickness of 250 mils, the remaining wall thickness at the thinnest location was 66.5%.
- A cross-section view of Coupon 7 is shown in Figure 3-7.

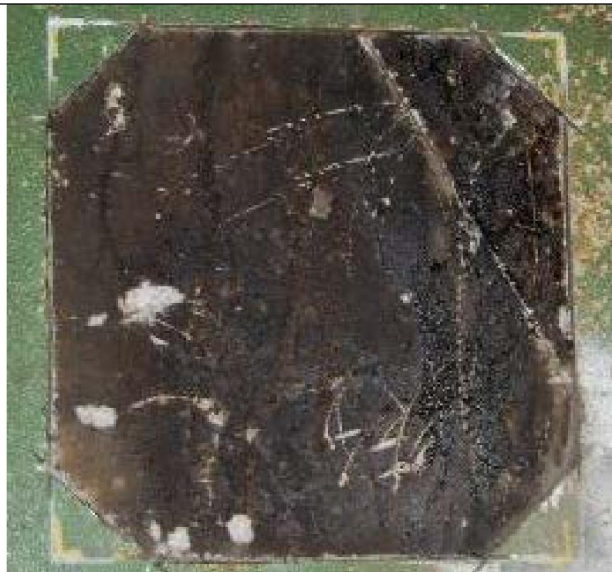
6/21/2018: 0930		
CONCRETE SAMPLE SPECIFICS		
Sample ID	10	10
Sample Location	14-LD-3-9-24-215	
Sample Dimensions	12" × 12"	
ON SITE VISUAL EXAMINATION		
Checks	Observations	
	Exterior	Units
Void space between concrete and liner (if any)	None	
Biological Materials	None	
Wet or Dry	Dry	
Smell	like coal tar	
Temperature	77.6	F
Surface pH	12-12.5	
Structure to Electrolyte	-0.181	Volts/CSE
Concrete Resistivity	27.3 Horizontal 38.1 Vertical	k-ohm-cm k-ohm-cm
General Condition	Excellent, sound concrete with no cracks or delamination. Coupon had to be cut into two pieces to remove. What appears to be coal tar coating present on backside of coupon and concrete.	
Concrete behind Coupon 10

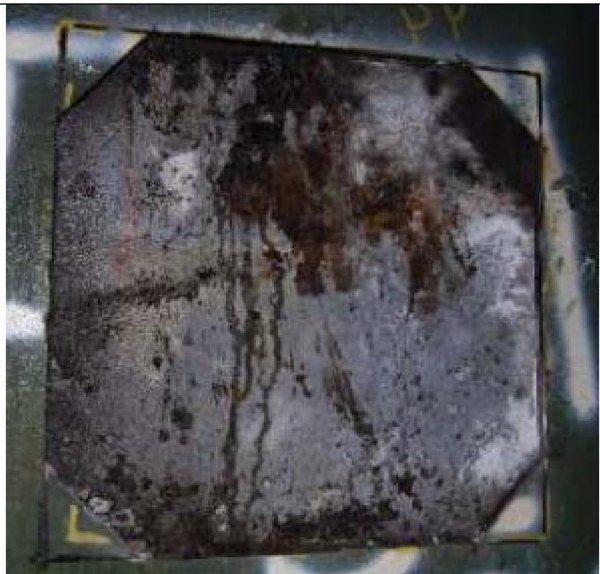
Backside of Coupon A1	 	
-----------------------	--	--

6/20/2018: 1100		
CONCRETE SAMPLE SPECIFICS		
Sample ID	A1	A1
Sample Location	14-BA-23-9-95-50	
Sample Dimensions	12" x 12"	
ON SITE VISUAL EXAMINATION		
Checks	Observations	
	Exterior	Units
Void space between concrete and liner (if any)	1/8" Void on left side, no voids in all other areas	
Biological Materials	None	
Wet or Dry	Mostly dry with damp areas around corrosion product	
Smell	None	
Temperature	77.5	Degrees F
Surface pH	11-12 in dry areas, 7-8 in corroded area	
Structure to Electrolyte	-0.448 (dry area) -0.432 (damp area w. corrosion products)	Volts/CSE
Concrete Resistivity	32.9 Horizontal 37.0 Vertical	k-ohm-cm
General Condition	Good condition with sound concrete, no cracks or delamination. Corrosion products are present on concrete.	
Concrete behind Coupon A1

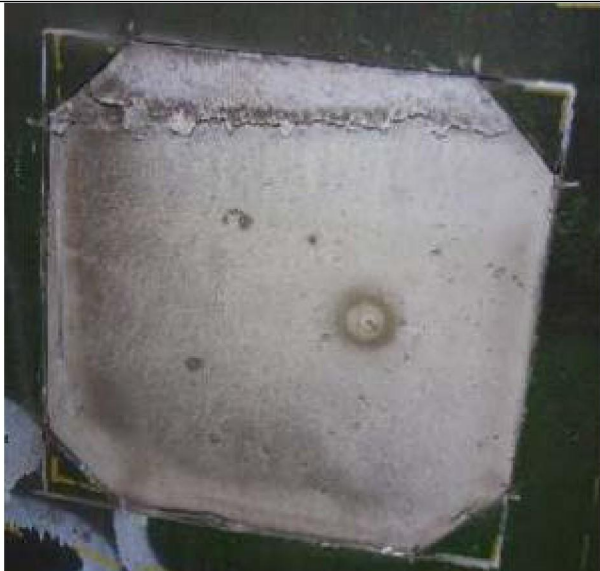
The concrete behind Coupon A2 was sound concrete with no cracks or delaminations. Table 3-10 contains the on-site concrete observations and test results.

6/20/2018: 1530		
CONCRETE SAMPLE SPECIFICS		
Sample ID	A2	A2
Sample Location	14-BA-11-4-226-50	
Sample Dimensions	12" x 12"	
ON SITE VISUAL EXAMINATION		
Checks	Observations	
	Exterior	Units
Void space between concrete and liner (if any)	1/2" Void on left and bottom side. ¼" void on the right side	
Biological Materials	None	
Wet or Dry	Dry	
Smell	None	
Temperature	78.4	Degrees F
Surface pH	11-12	
Structure to Electrolyte	-0.226 (middle) -0.230 (right side)	Volts/CSE
Concrete Resistivity	35.8 Horizontal 36.1 Vertical	k-ohm-cm
General Condition	Good condition with sound concrete, no cracks or delamination. There is a layer of concrete that appears to have come off. Below that layer is sound concrete.	
Concrete behind Coupon A2

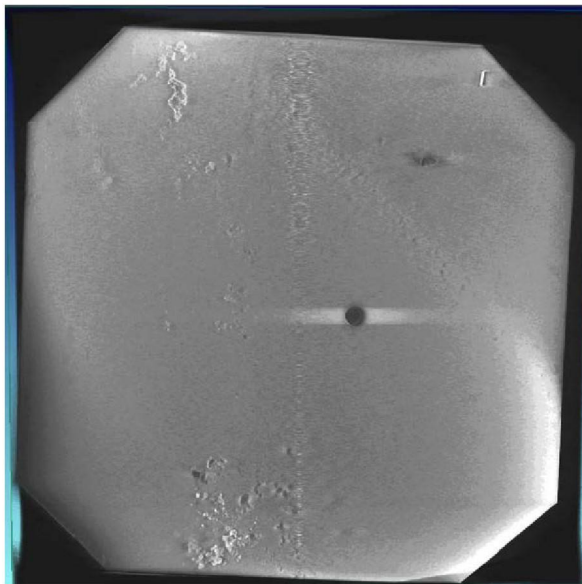
Figure 4-2 CT Scan Image from Destructive Testing Lab Report, Coupon 1

The LFET minimum screening thickness found was 0.112 inch. Therefore, a repair was specified in this area. Backside pitting corrosion expected. Later prove-up with PAUT indicated an expected minimum remaining wall thickness of 0.112 inch.

Destructive testing found pitting and minimum wall thickness of 0.208 inch. Remaining wall thickness greater than expected (208 mils vs. 112 mils). This deviation exceeded the 20 mils accuracy range for pitting.

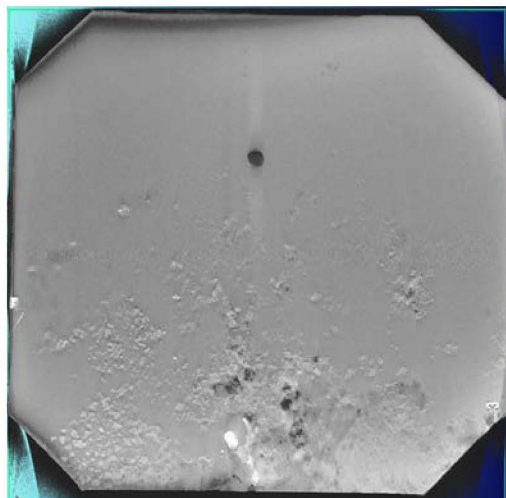
Figure 4-6 CT Scan Image from Destructive Testing Lab Report, Coupon 3

Destructive testing found pitting and minimum wall thickness of 0.132 inch. The remaining wall thickness, 132 mils, was less than expected (greater than 200 mils). The LFET value did not fall within the 20-mil accuracy range for pitting.

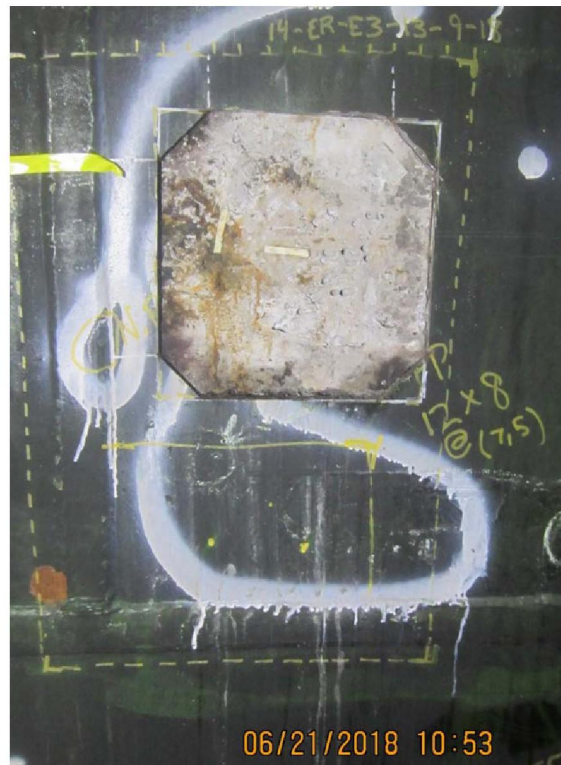
Figure 4-8 Location of Coupon 3 after Removal

was prevented from finishing the NDE process by being unable to layout the repair at Indication B. Instead of performing a layout at Indication B, the contractor was asked to layout repairs for Coupon 3 (Indication A). Figure 4-8 depicts the location after the coupon was removed.

Inner square indicates boundary of Coupon 3. Outer rectangle indicates boundary of patch plate for repair.

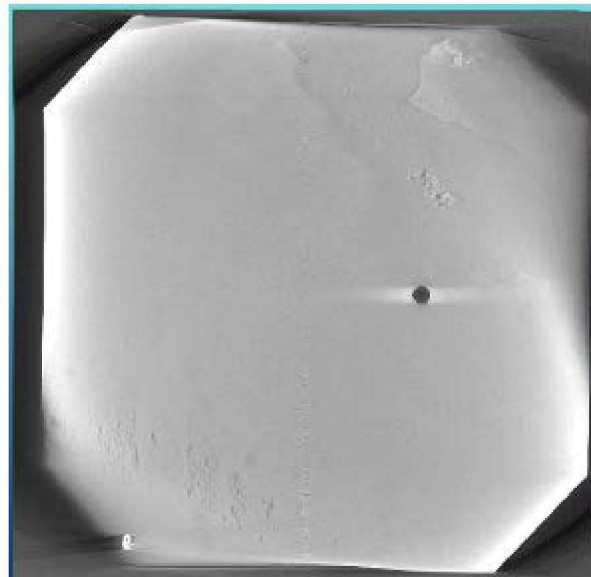
Figure 4-12 CT Scan Image from Destructive Testing Lab Report, Coupon 6

Destructive testing found pitting and minimum wall thickness of 0.158 inch. The remaining wall thickness was thinner than expected in the isolated pit.

LFET does not always detect metal loss of very small volume with narrow and non-uniform characteristics. The likelihood this single small pit, smaller than what the equipment could detect with more than 64% metal thickness remaining after 75 years in service, would form into a thru-hole before the next inspection, is extremely low. Given the steel plate's original thickness of 250 mils and the metal thickness of 158 mils upon removal (a loss of 92 mils), and assuming a constant rate of corrosion between the tank's construction in 1943 and coupon removal in 2018 (75 years),

the maximum corrosion rate at Coupon 6 is 1.23 mils per year (mpy). No conditions were evident that would support accelerated corrosion at Coupon 6.

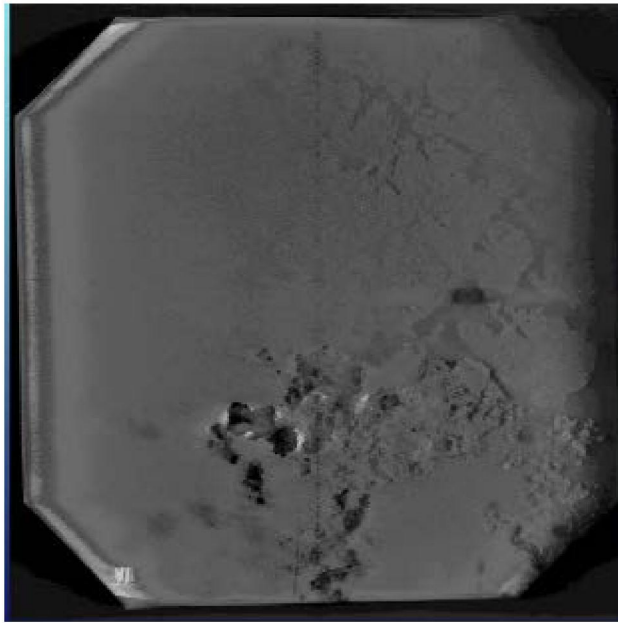
Figure 4-20 CT Scan Image from Destructive Testing Lab Report, Coupon A1

Destructive testing found pitting and minimum wall thickness of 0.122 inch. The remaining wall thickness was as expected. The LFET thickness fell within the 20-mil accuracy range.

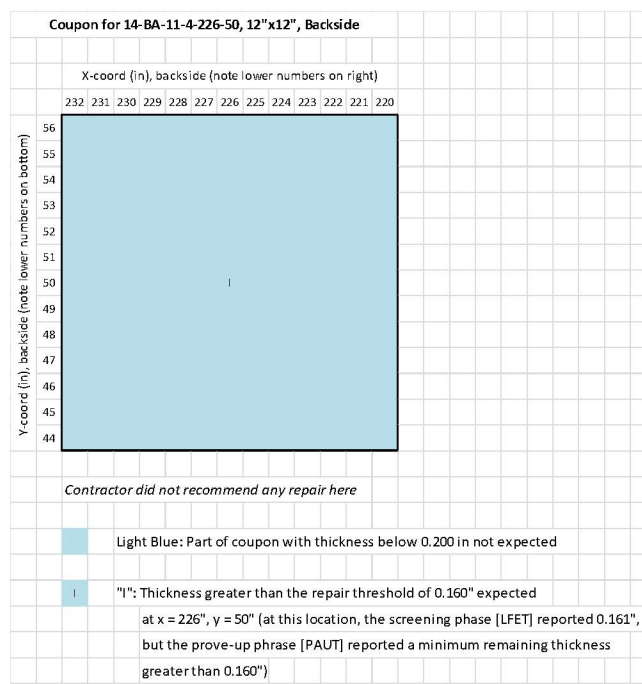
Figure 4-21 Expected Results from NDE Spreadsheet Data, Coupon A2

The LFET screening found no indications. Therefore, no repair was specified in this area.

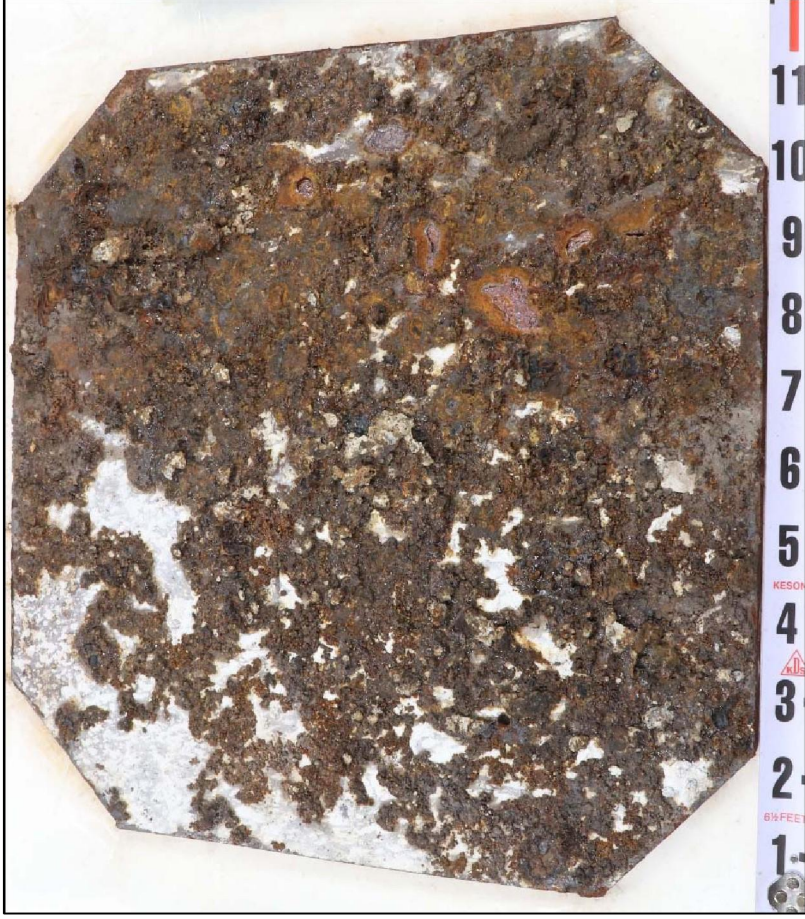
Figure 16. An image of the interior surface of Coupon 7 in the as-received condition.

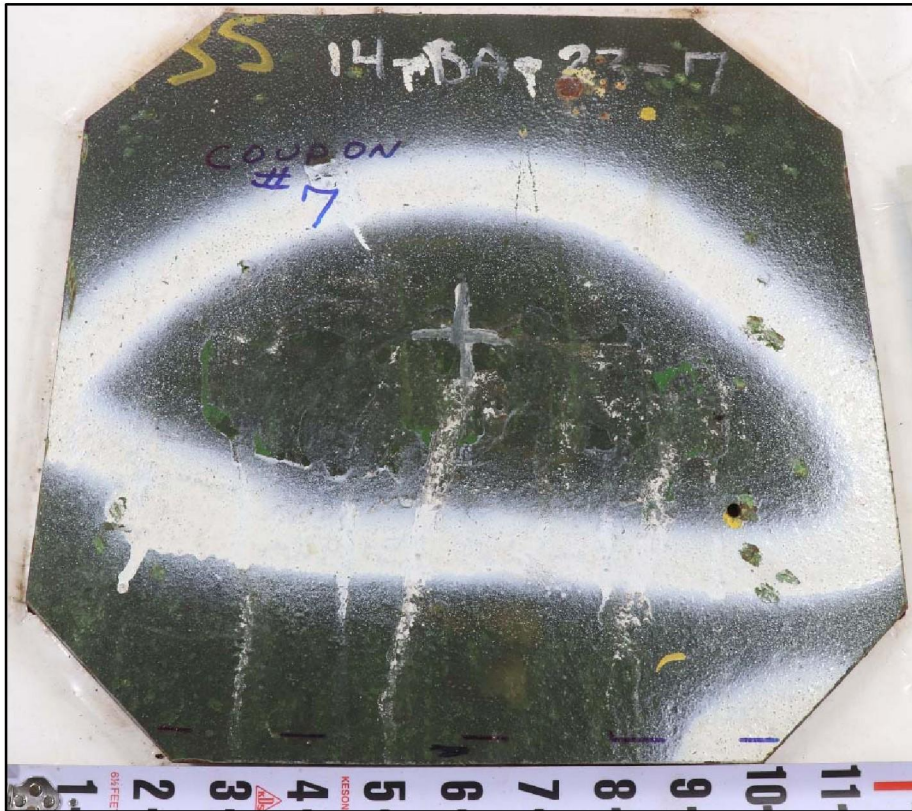
Figure 17. An image of the exterior surface of Coupon 7 in the as-received condition.

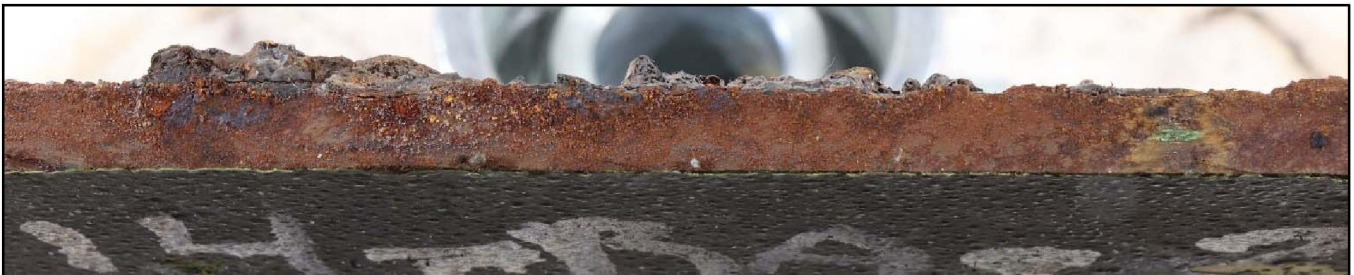
Figure 18. An image of a representative edge of Coupon 7 in the as-received condition.

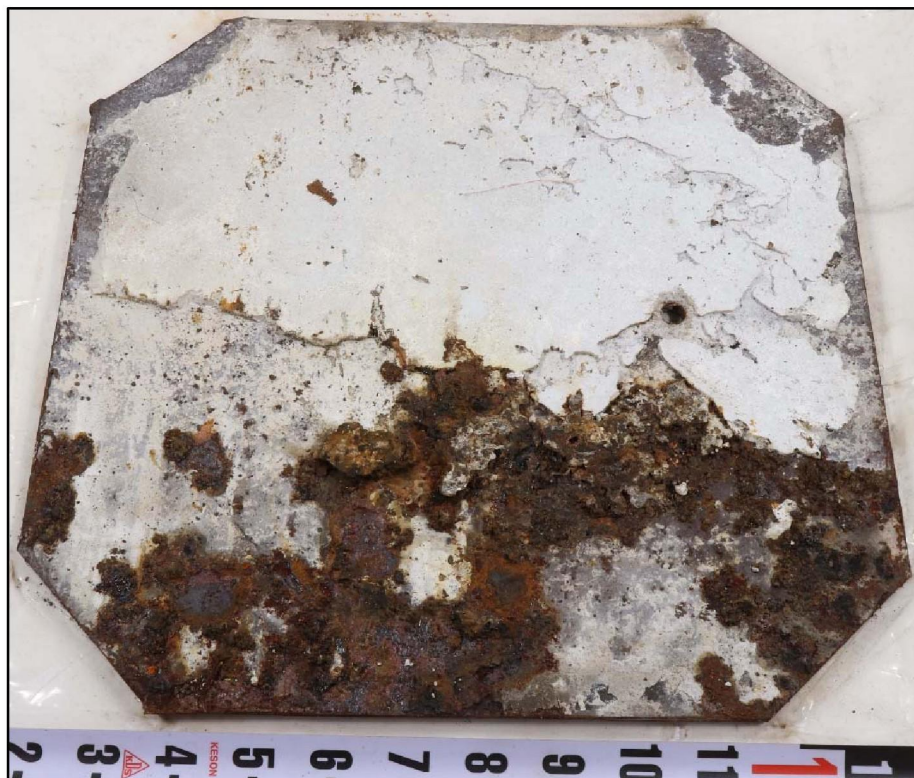
Figure 25. An image of the interior surface of Coupon A1 in the as-received condition.

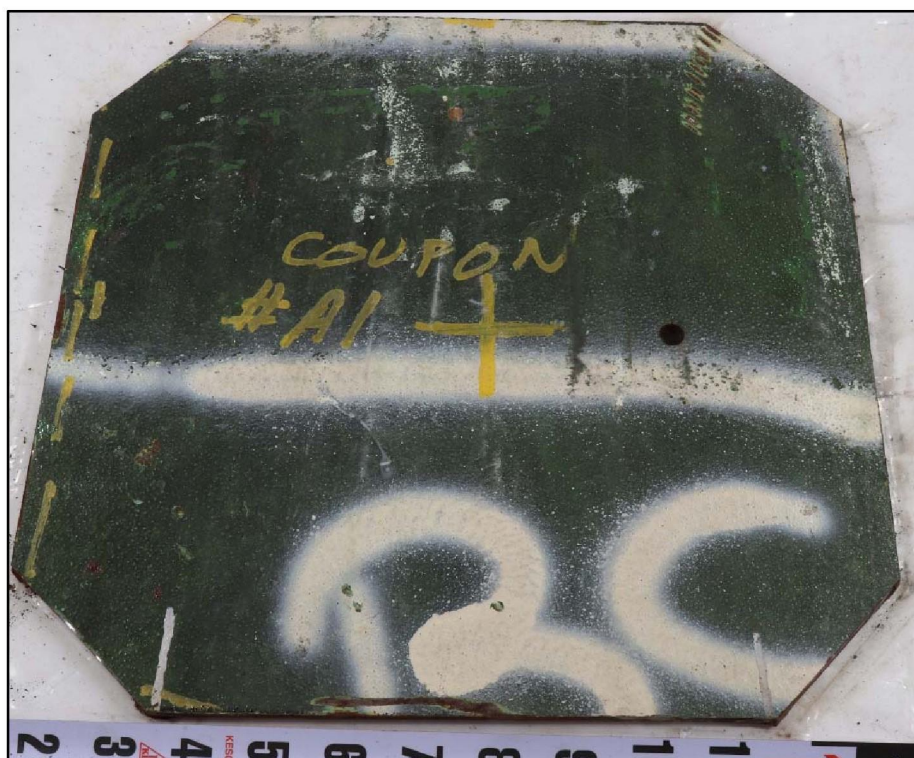
Figure 26. An image of the exterior surface of Coupon A1 in the as-received condition.

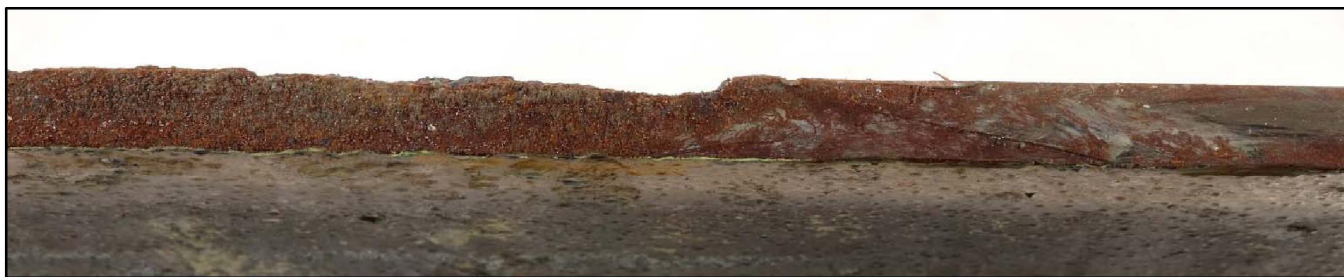
Figure 27. An image of a representative edge of Coupon A1 in the as-received condition.

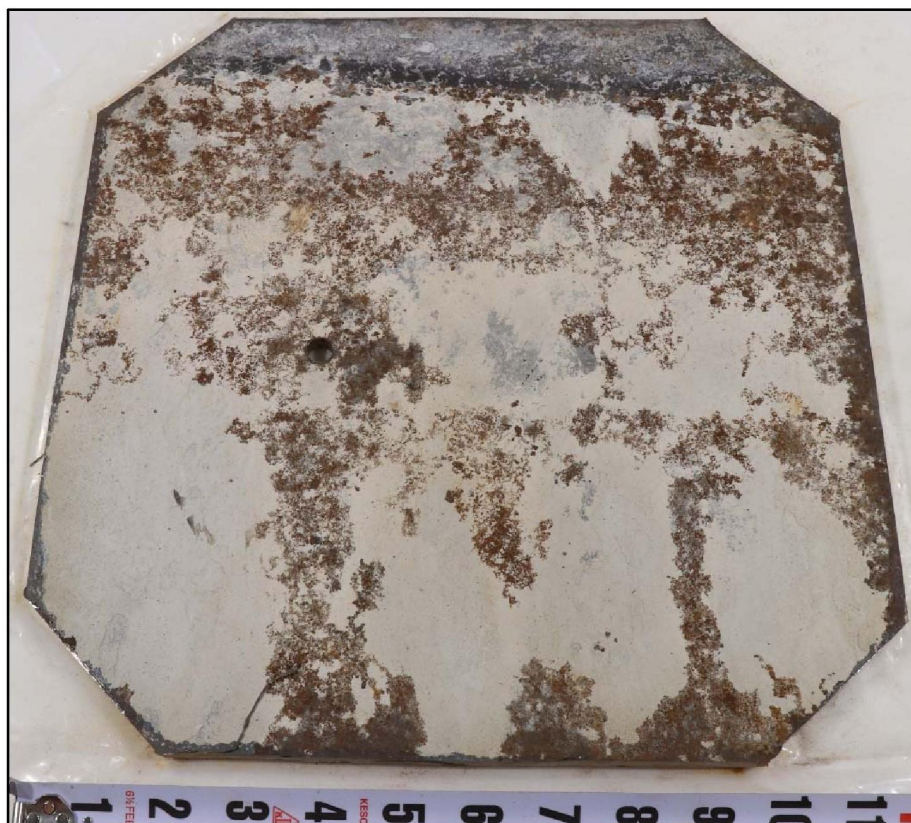
Figure 28. An image of the interior surface of Coupon A2 in the as-received condition.

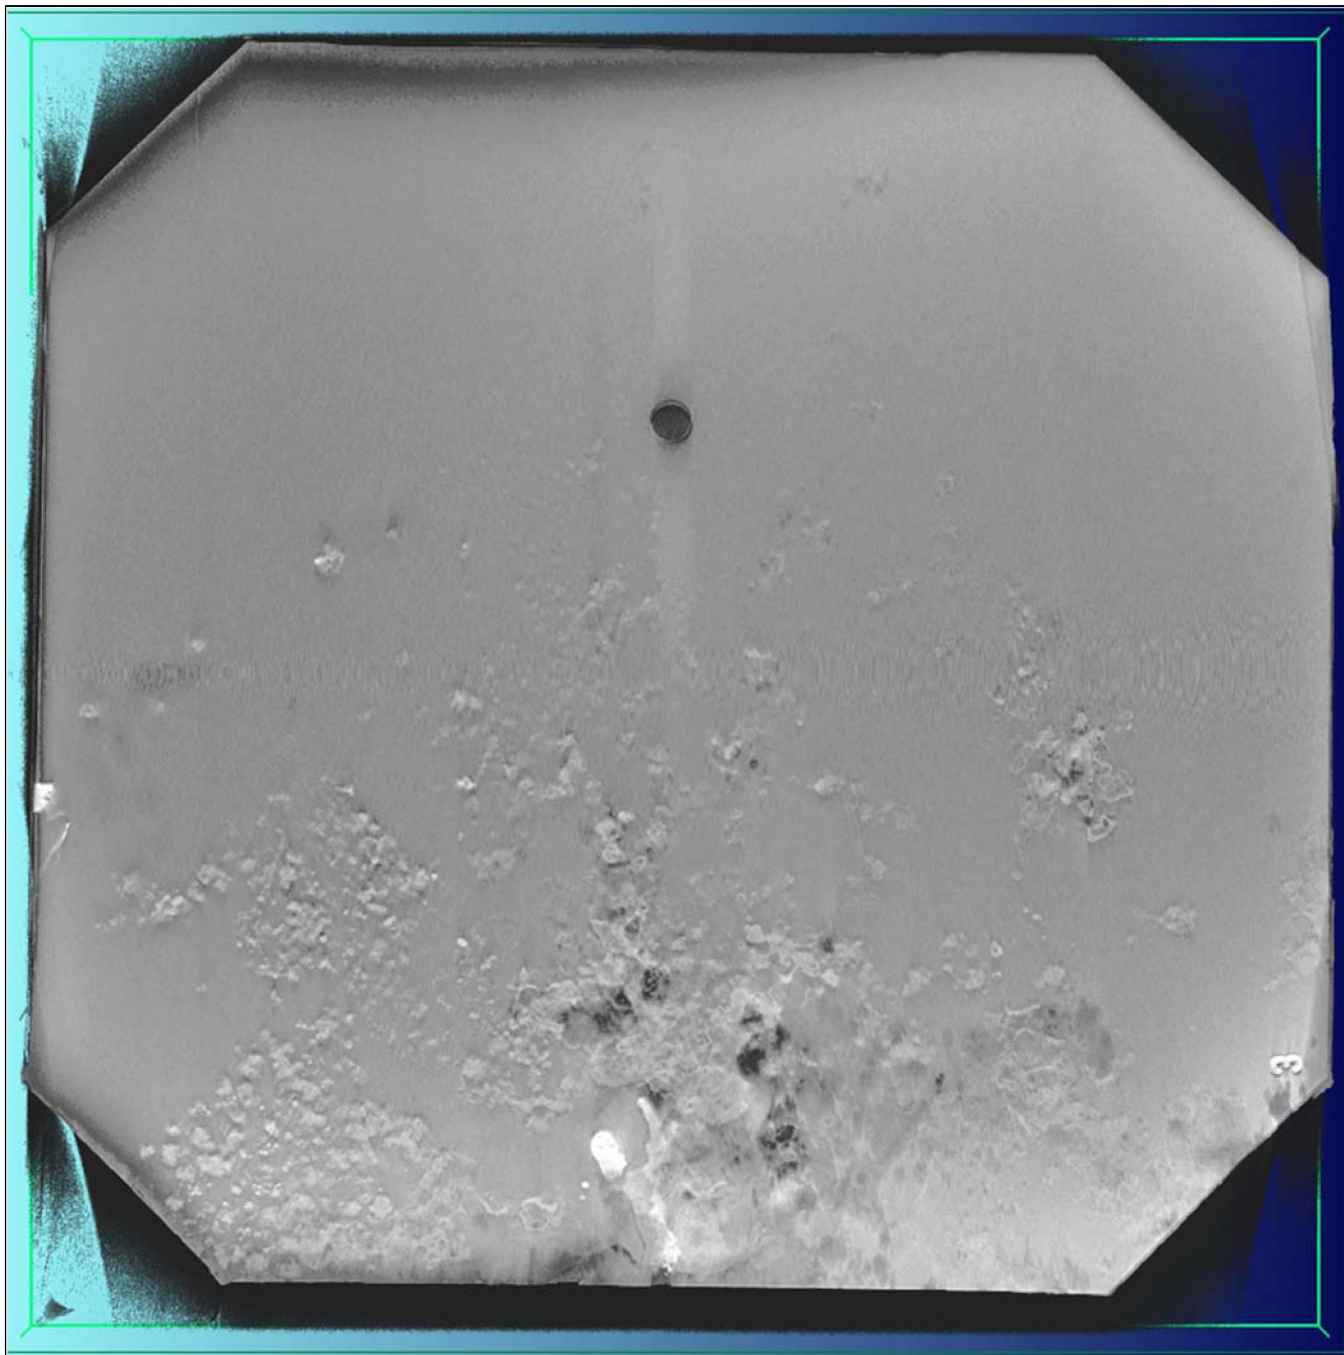
Figure 33. A representative screenshot of the CT scan performed on Coupon 3.

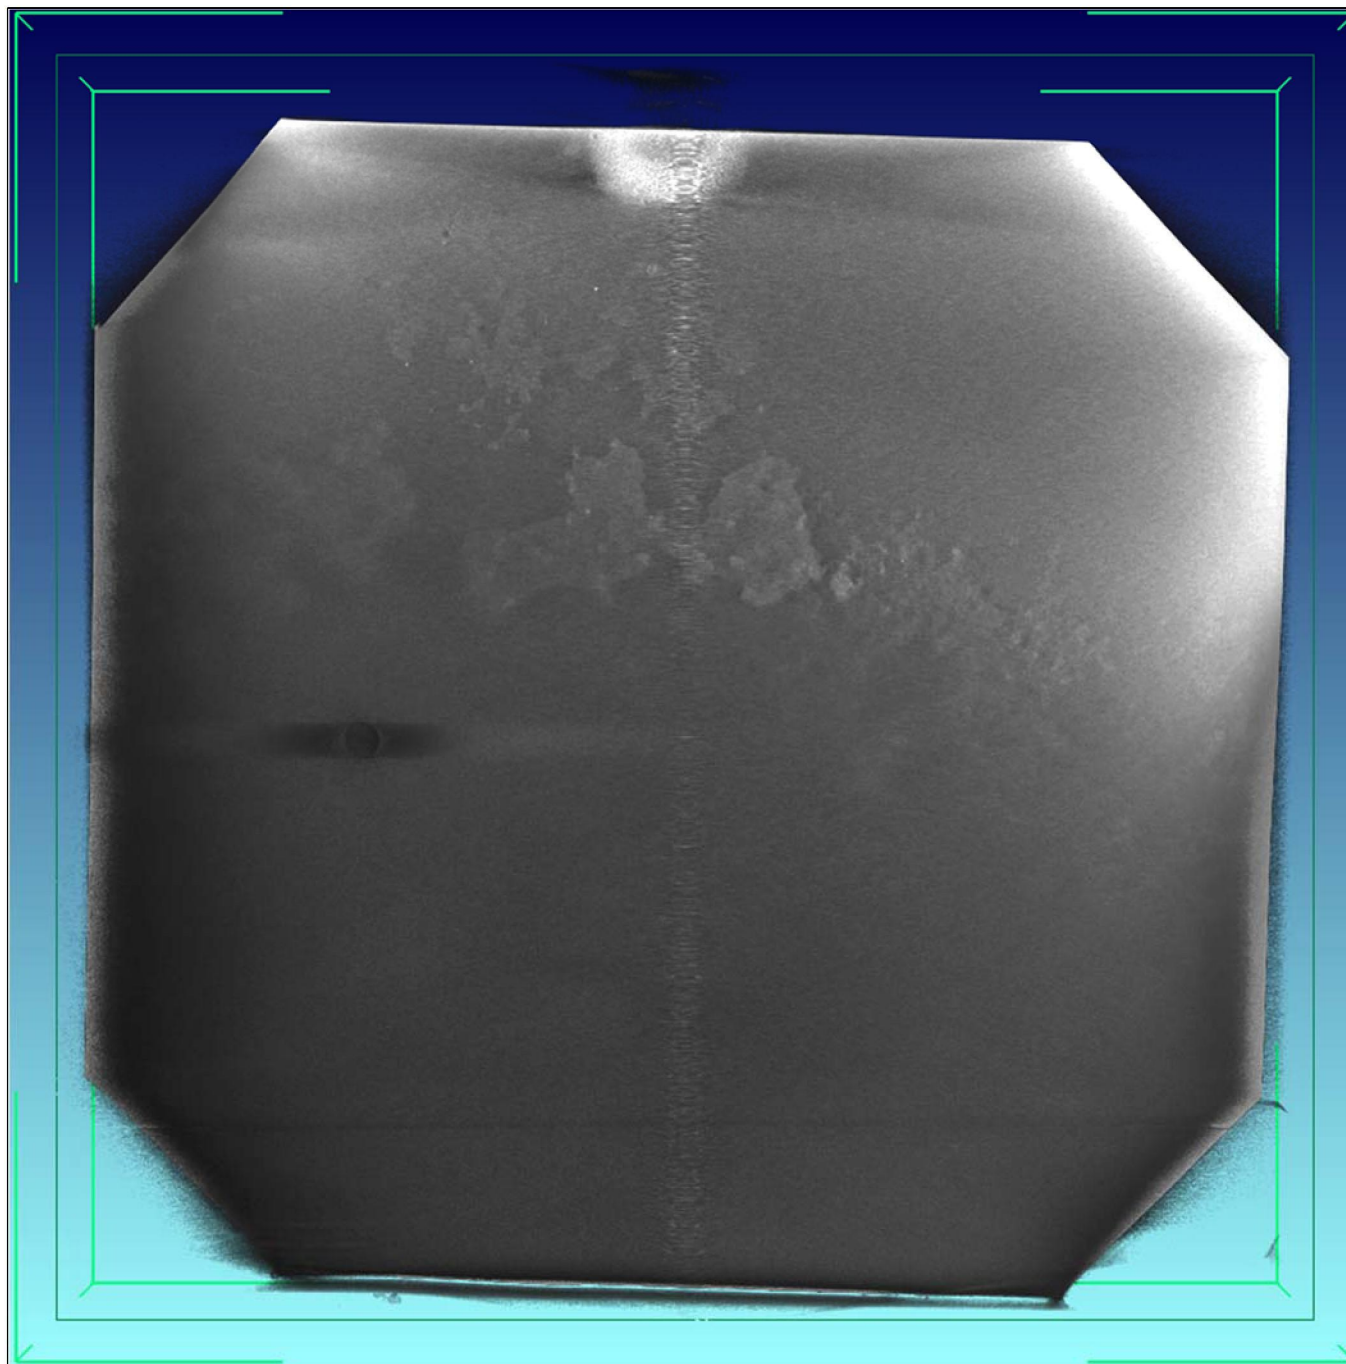
③ Suspected NDT inspection indication was a depression on the painted face of Sample 5-4. No pits observed.

Figure 34. A representative screenshot of the CT scan performed on Coupon 5.

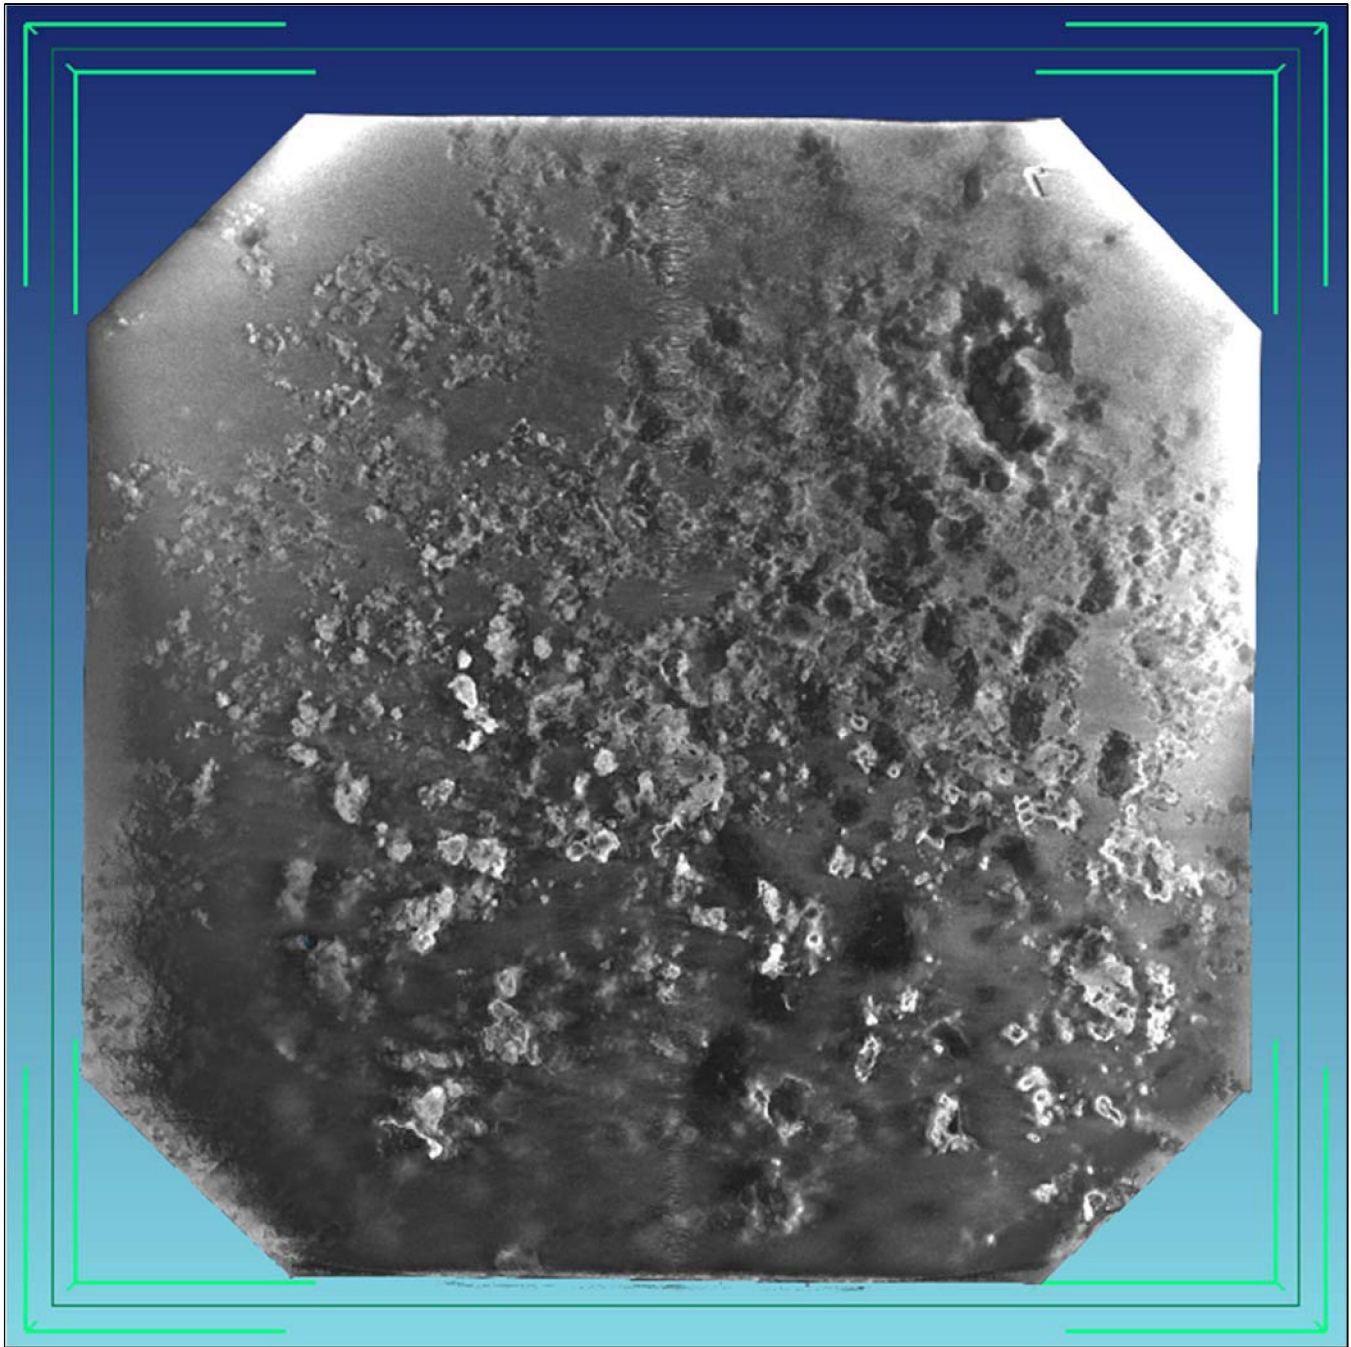
Figure 36. A representative screenshot of the CT scan performed on Coupon 7.

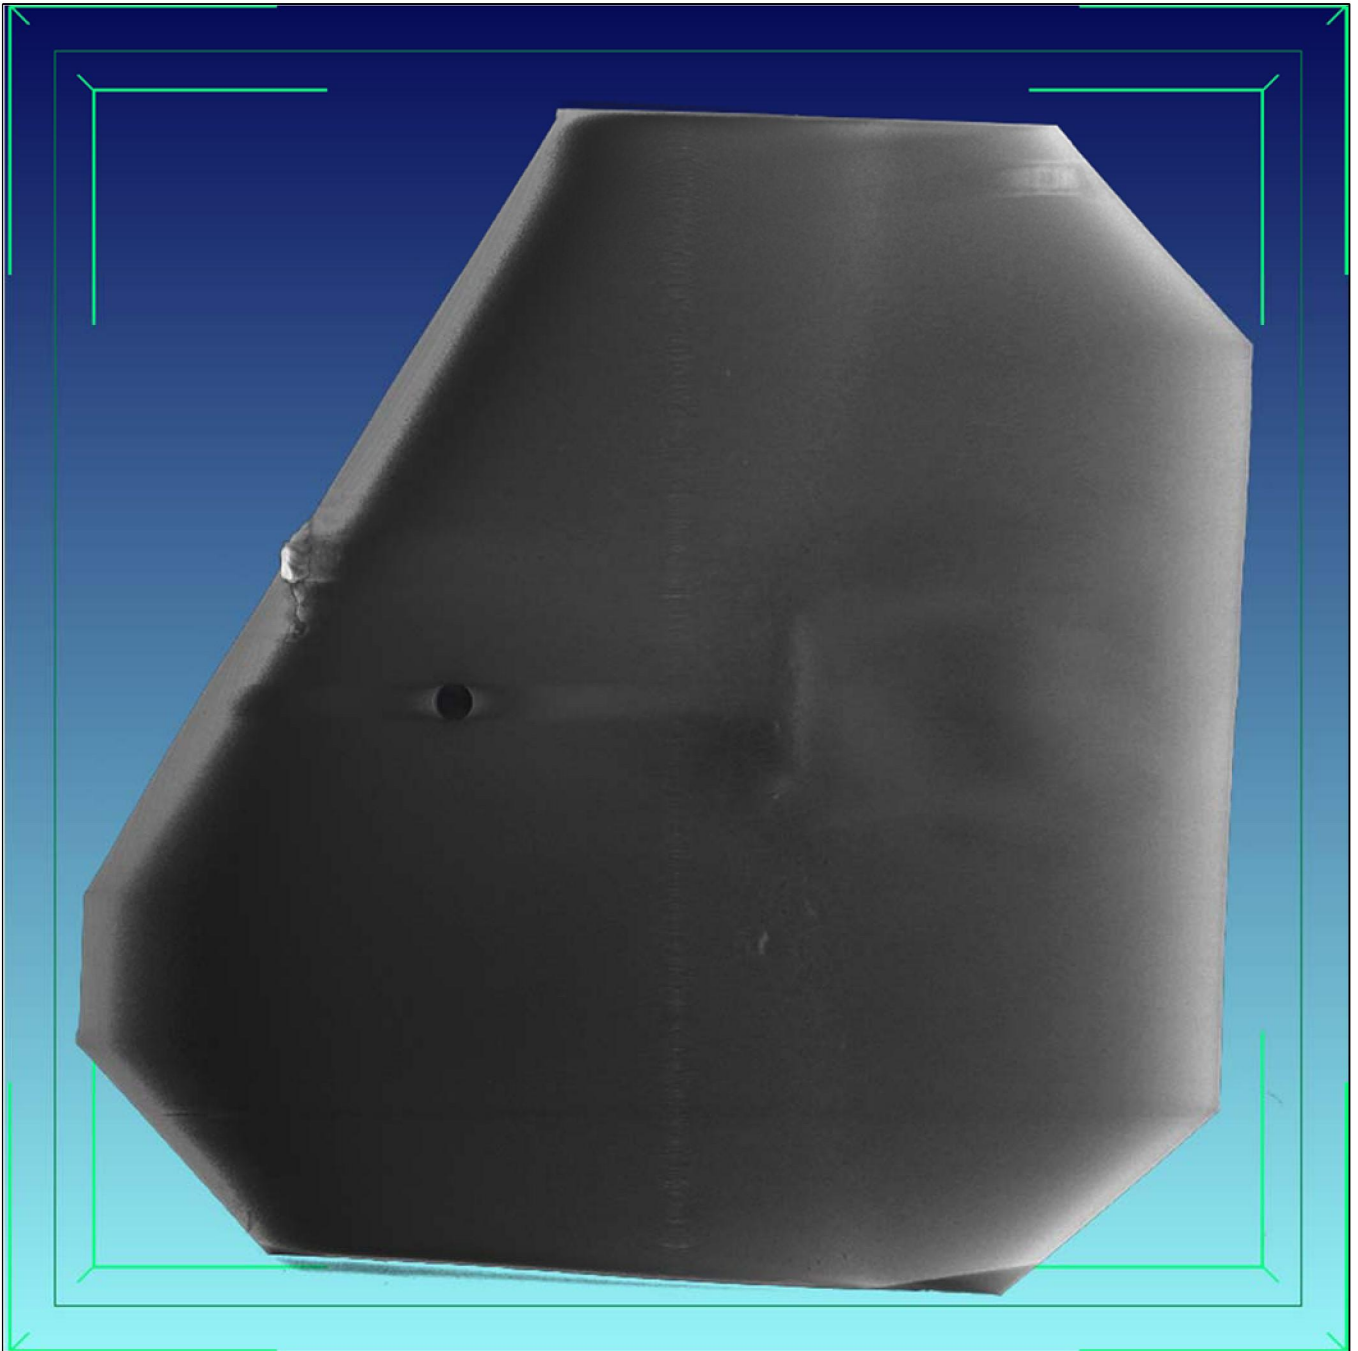
⑤ No pits observed. Suspected NDT inspection indication was a weld nugget on the interior surface of the coupon (thick area) on Sample 10-4.

Figure 38. A representative screenshot of the CT scan performed on Coupon 10.
