DEPARTMENT OF THE NAVY

SUBJECT: ADMINISTRATIVE ORDER ON CONSENT (AOC) STATEMENT OF WORK (SOW) SECTION 5 CORROSION AND METAL FATIGUE PRACTICES, DESTRUCTIVE TESTING RESULTS REPORT, RED HILL BULK FUEL STORAGE FACILITY (RED HILL), JOINT BASE PEARL HARBOR-HICKAM, OAHU, HAWAII

In 2018, ten coupons were removed from Tank 14, so that a metallurgical and corrosion analysis of the coupons could be undertaken, with the primary aim of validating non-destructive examination (NDE) results. The steel coupons, concrete powder samples, and corrosion product were submitted to a certified third-party laboratory to perform this analysis.

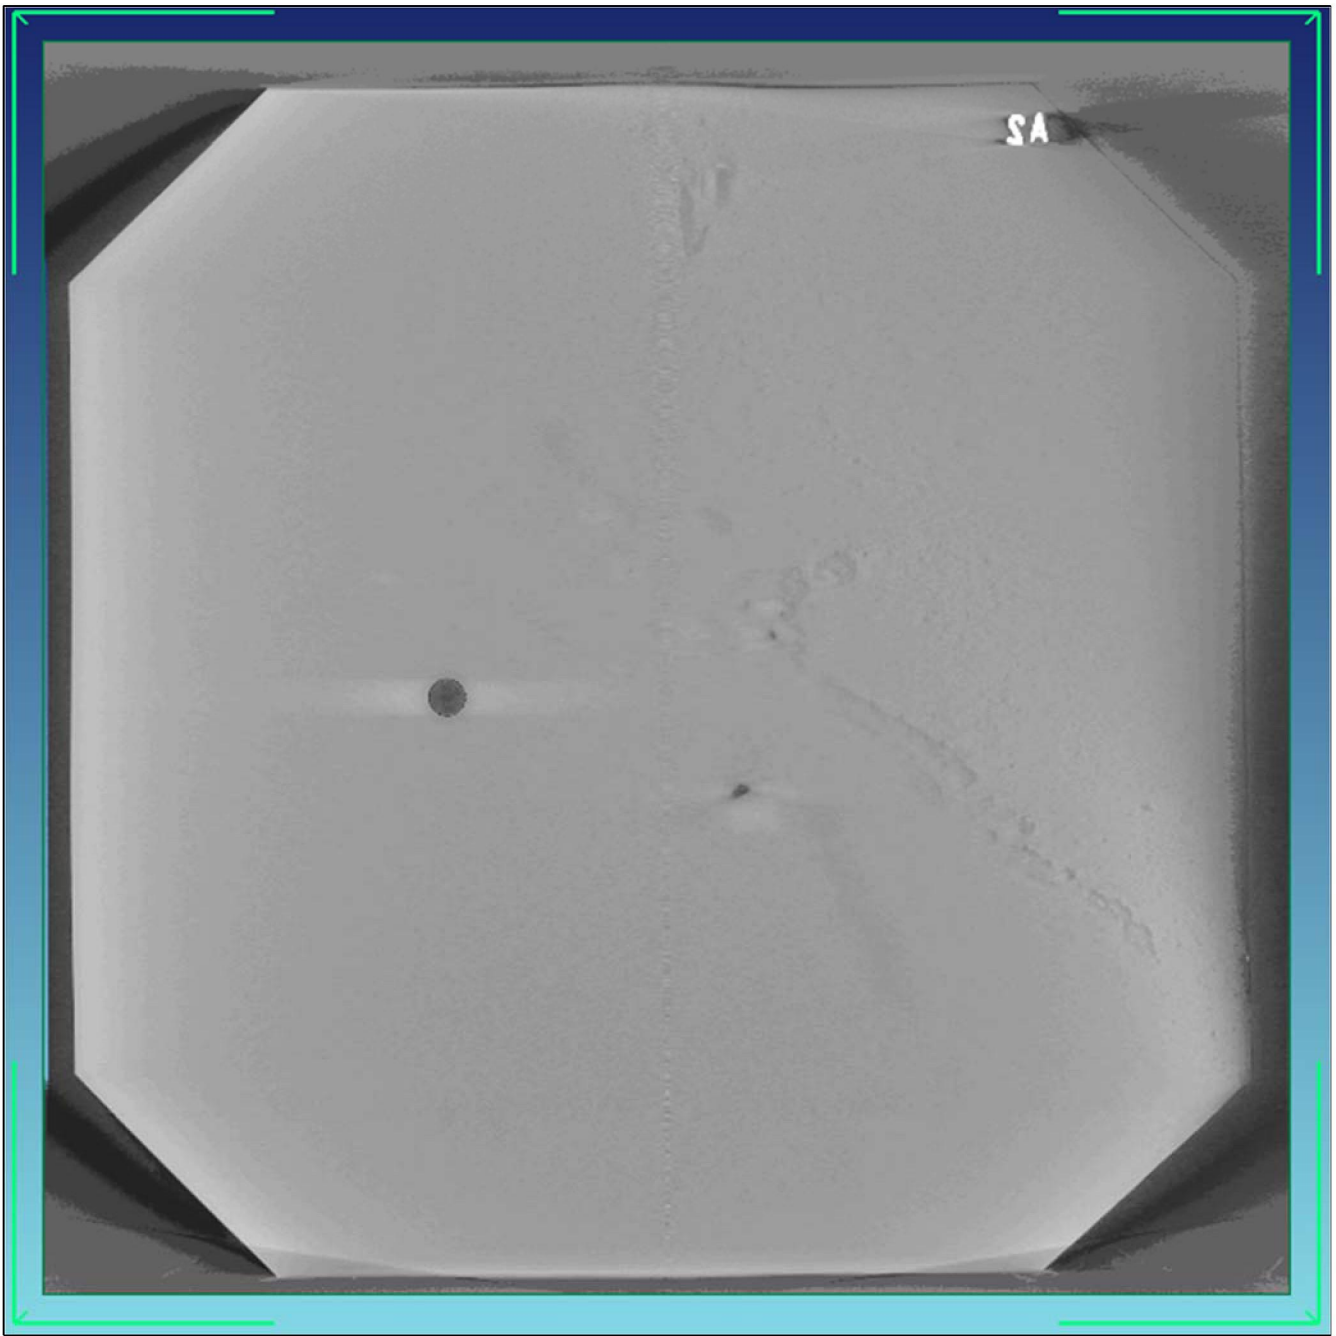
⑥ No pits observed. Suspected NDT inspection indications are areas of melting on the painted face, underneath the paint on Sample A2-4. Therefore, only 2 samples examined in cross-section.

Figure 40. A representative screenshot of the CT scan performed on Coupon A2.

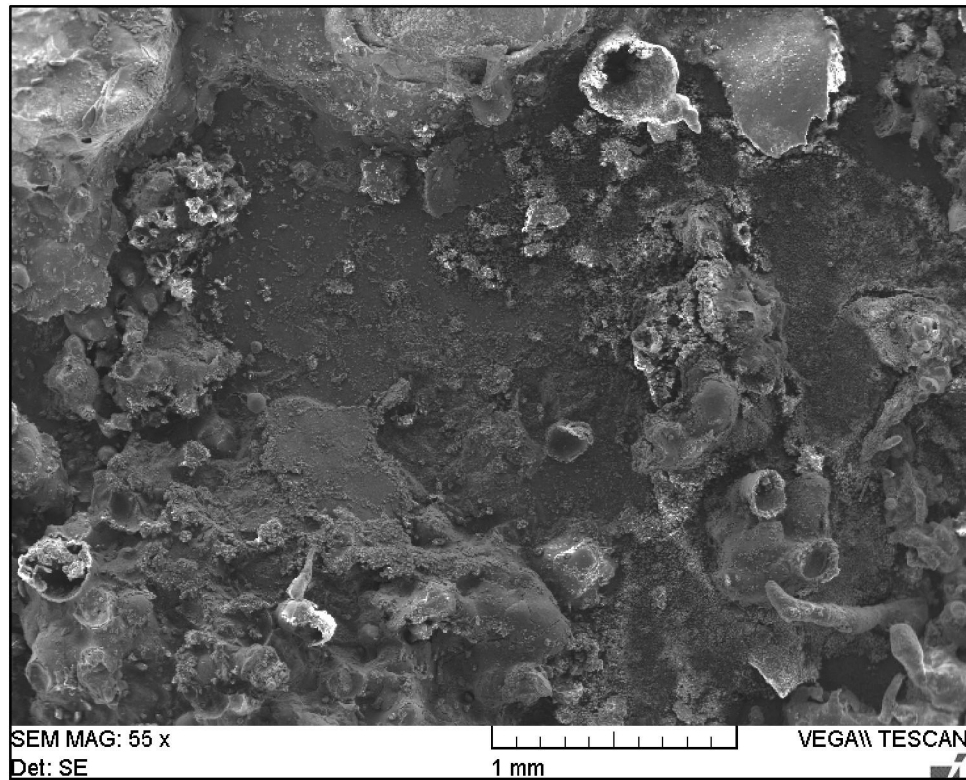
Figure 43. A representative SEM image of a pit on a specimen excised from Coupon 1 labeled as 1-3, prior to cleaning. (SEM, 32X)

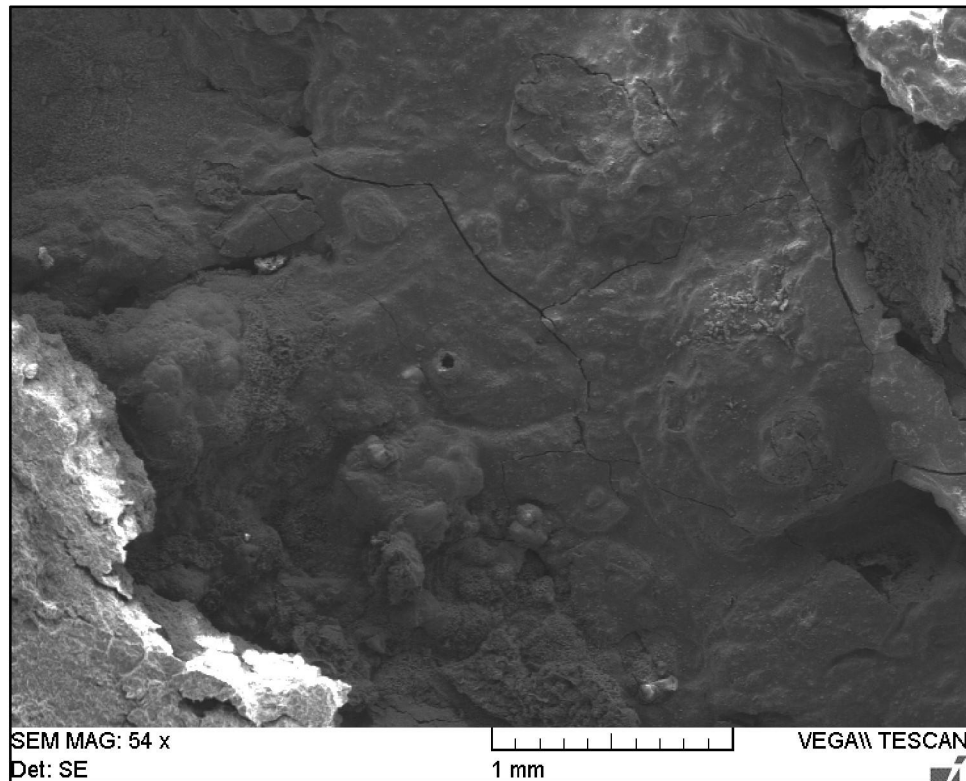
Figure 44. A representative SEM image of a pit on a specimen excised from Coupon 2 labeled as 2-1, prior to cleaning. (SEM, 32X)

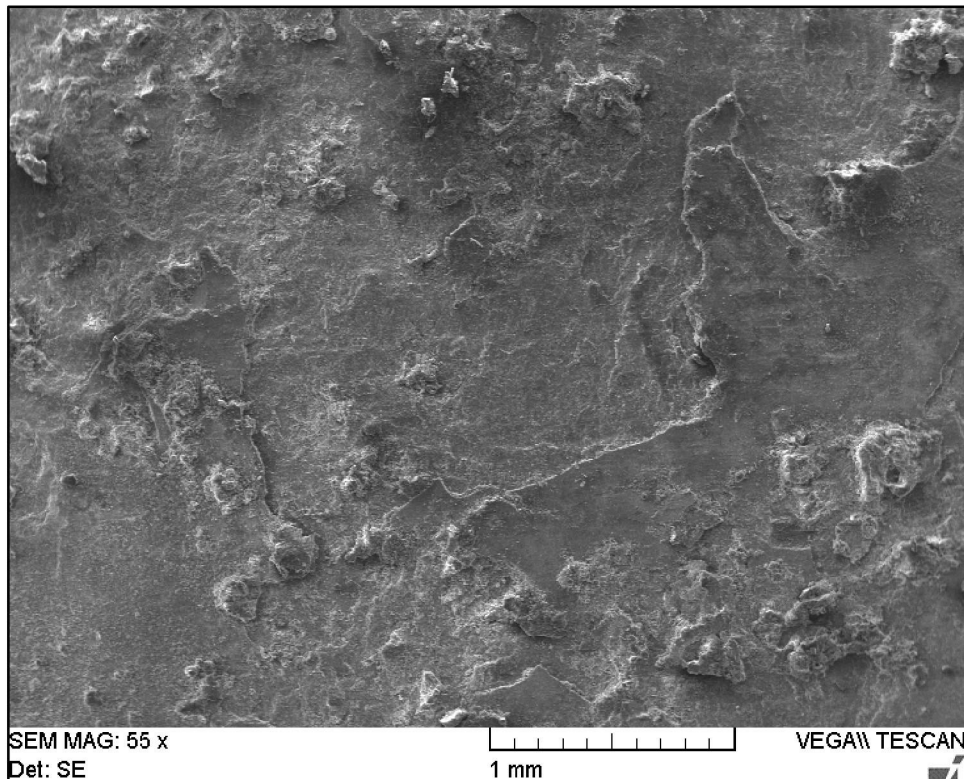
Figure 60. A representative SEM image of a pit on a specimen excised from Coupon 8 labeled as 8-2, prior to cleaning. (SEM, 33X)

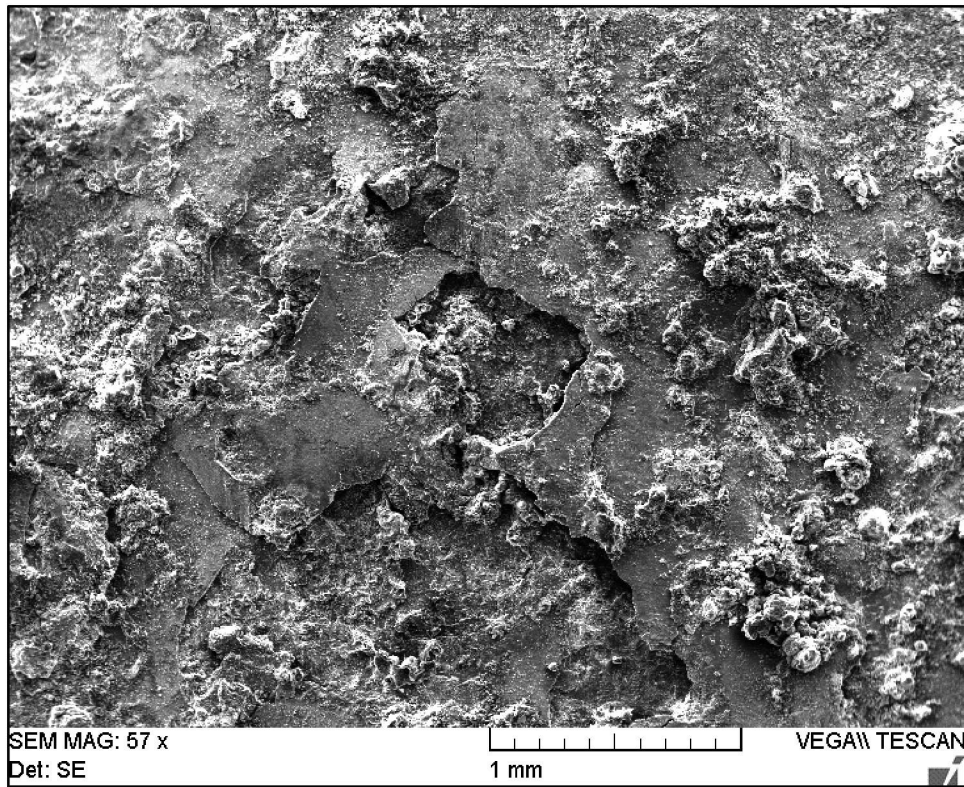
Figure 69. A representative SEM image of a possible pit on a specimen excised from Coupon A-2 labeled as A2-2, prior to cleaning. (SEM, 33X)

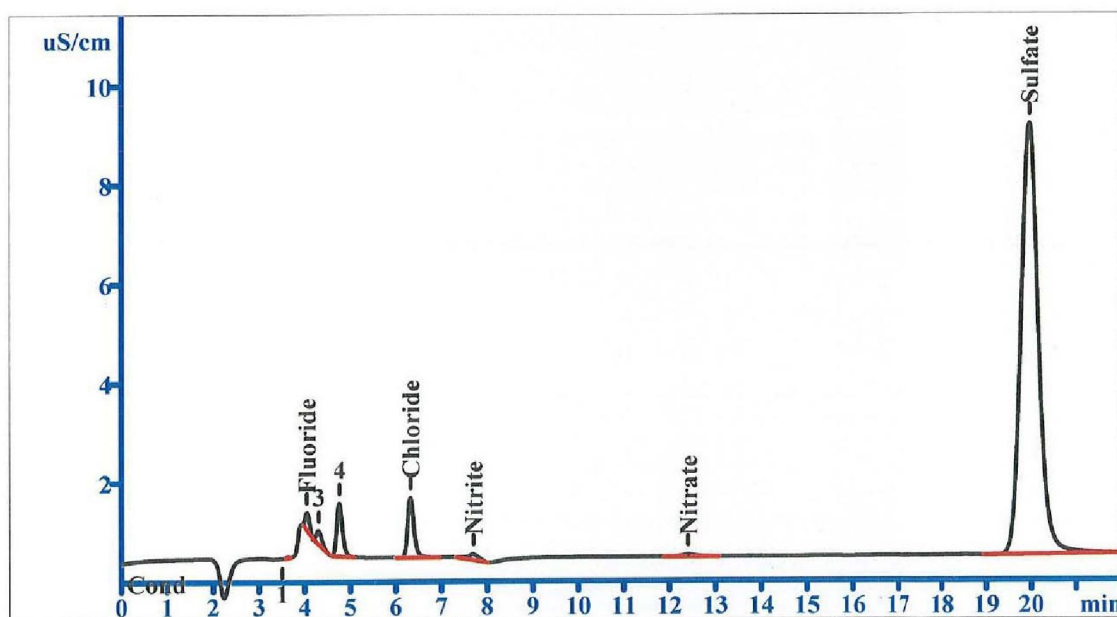
Figure 104. The ion chromatogram generated from a concrete sample removed from Coupon 5.

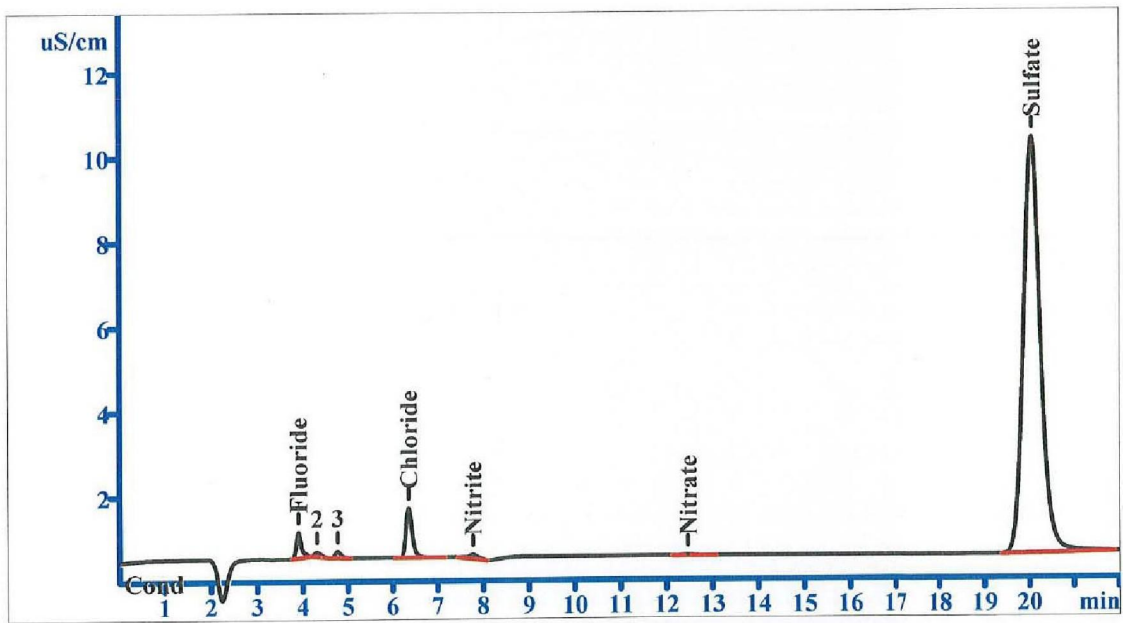
Figure 106. The ion chromatogram generated from a concrete sample removed from Coupon 7.

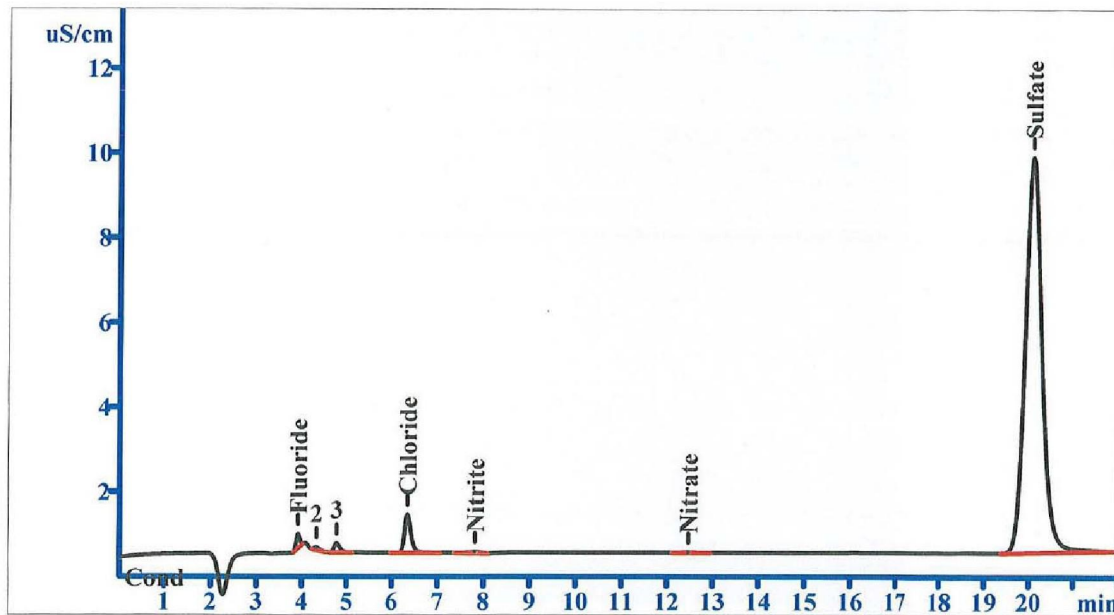
Figure 108. The ion chromatogram generated from a concrete sample removed from Coupon 10.

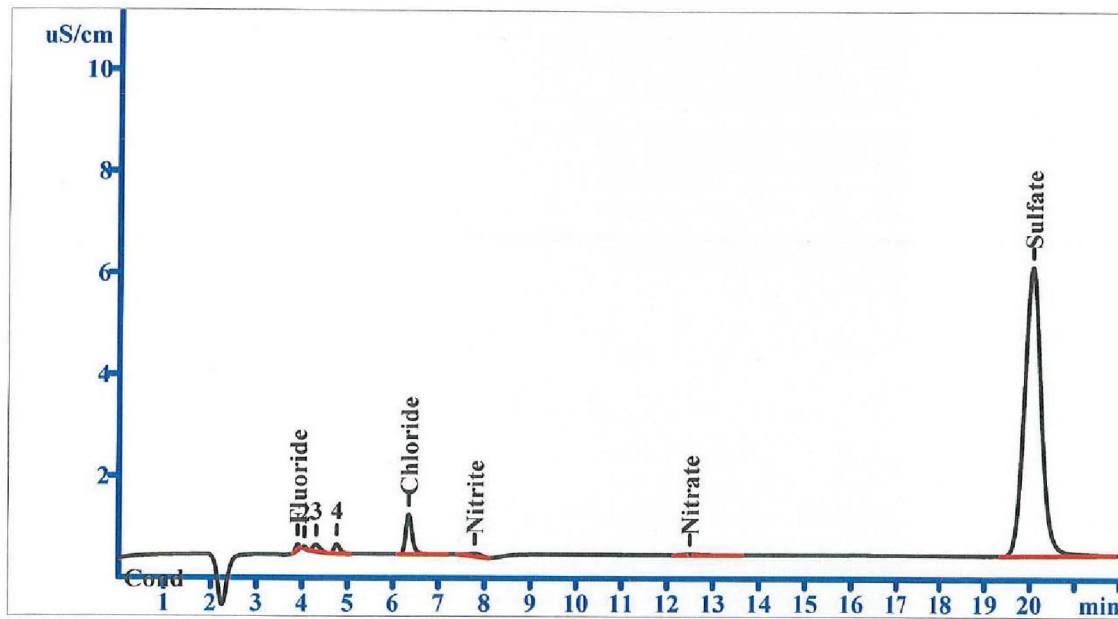
Figure 109. The ion chromatogram generated from a concrete sample removed from Coupon A1.

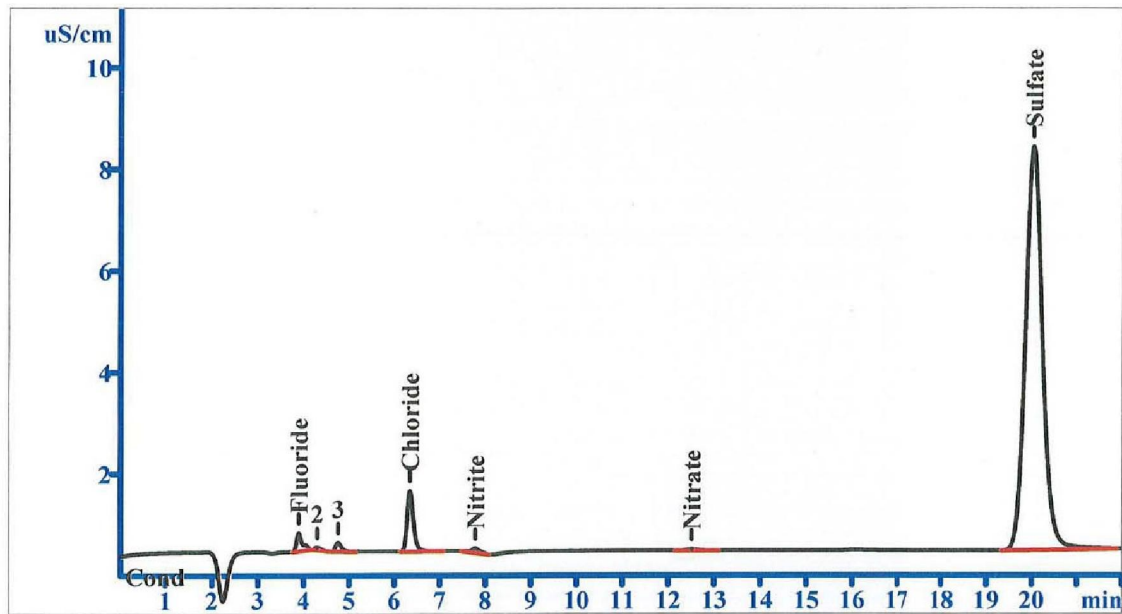
Figure 110. The ion chromatogram generated from a concrete sample removed from Coupon A2.

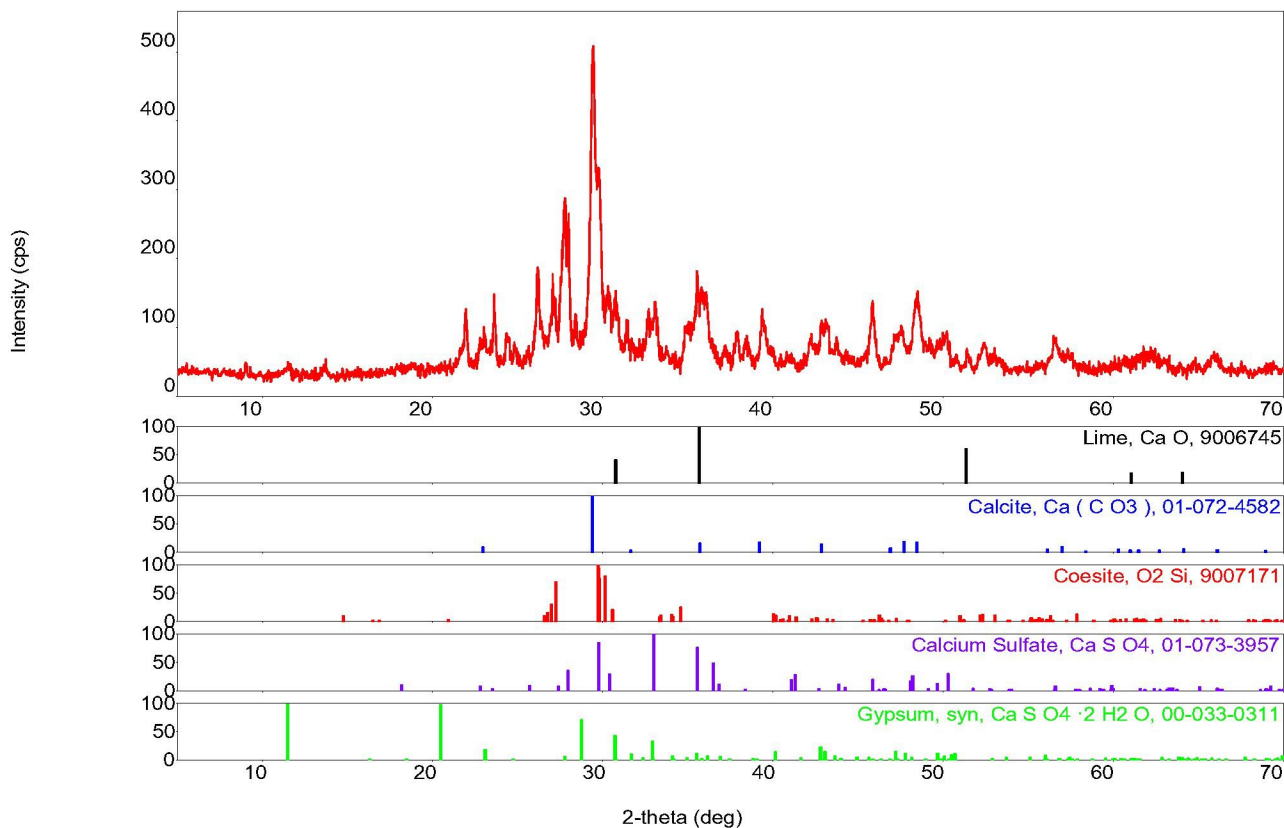
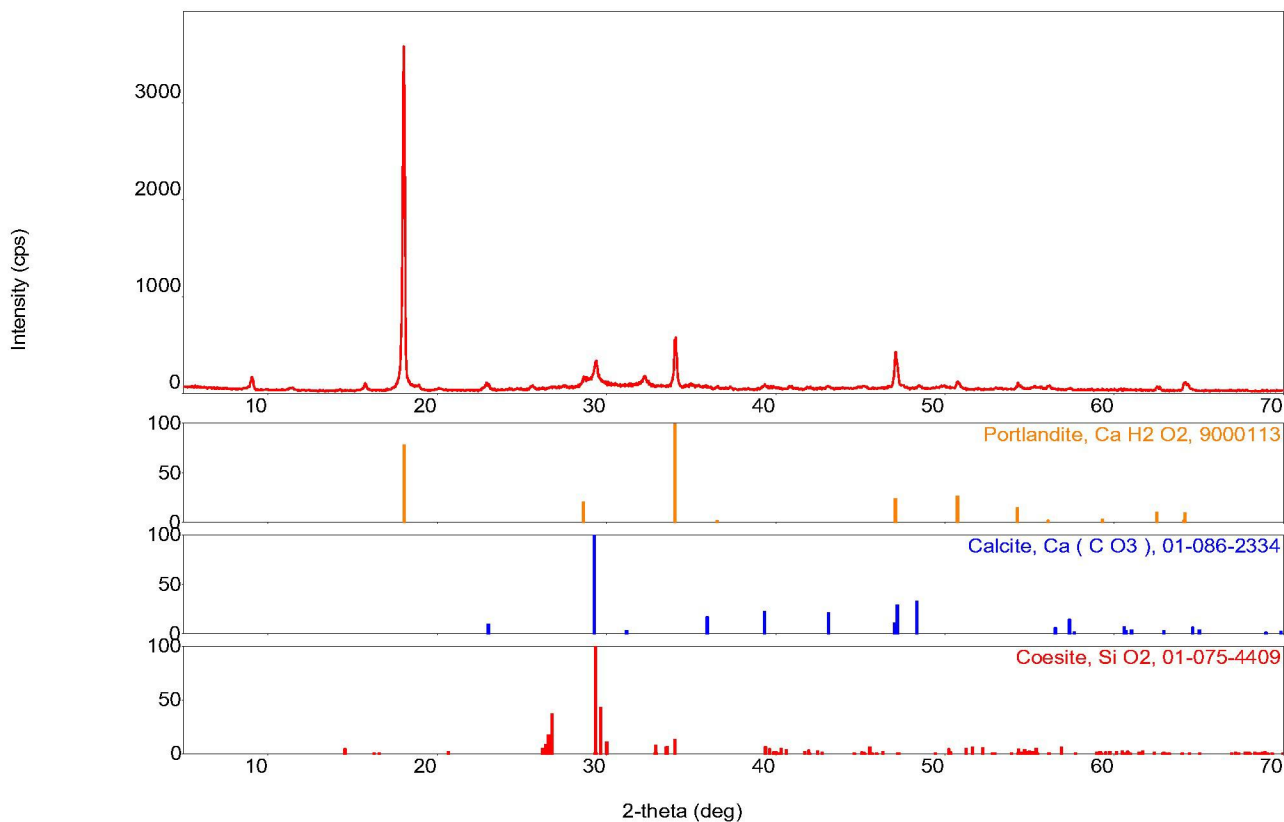
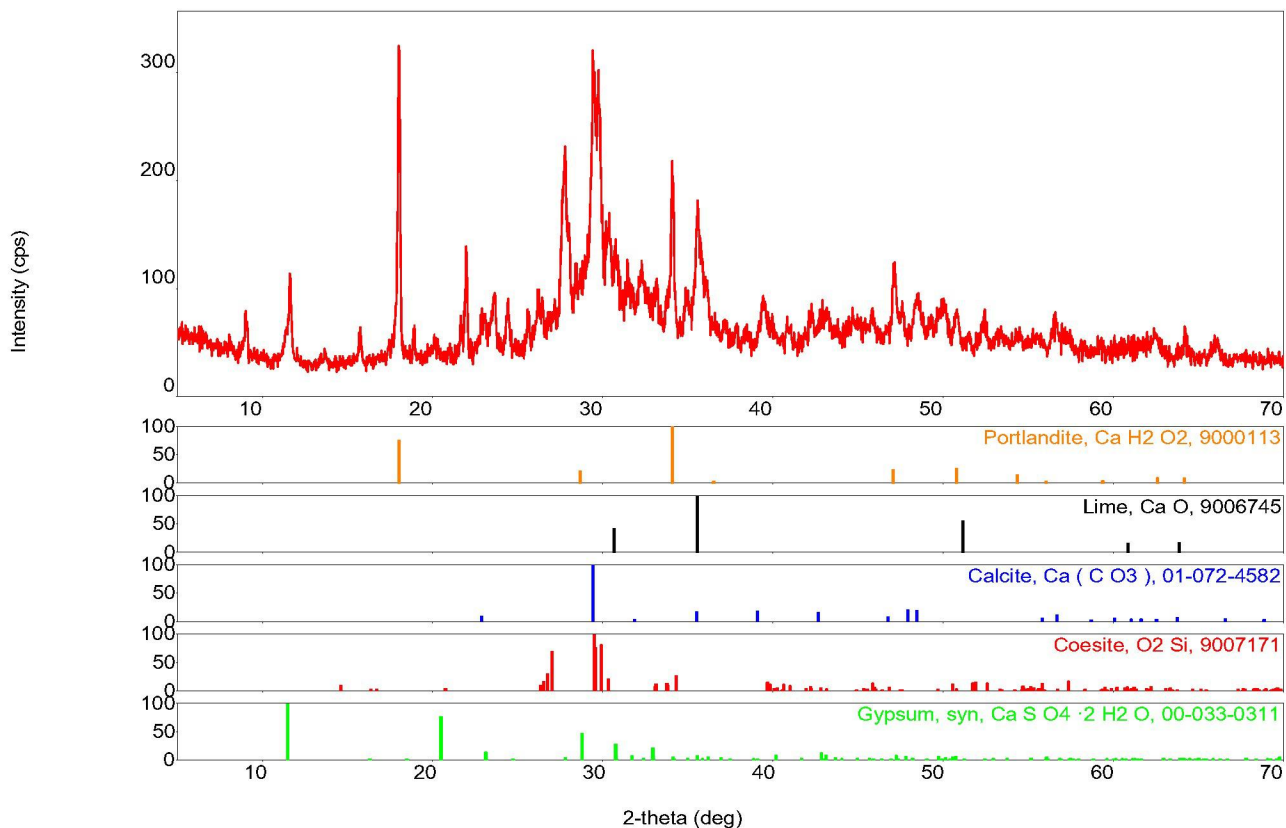
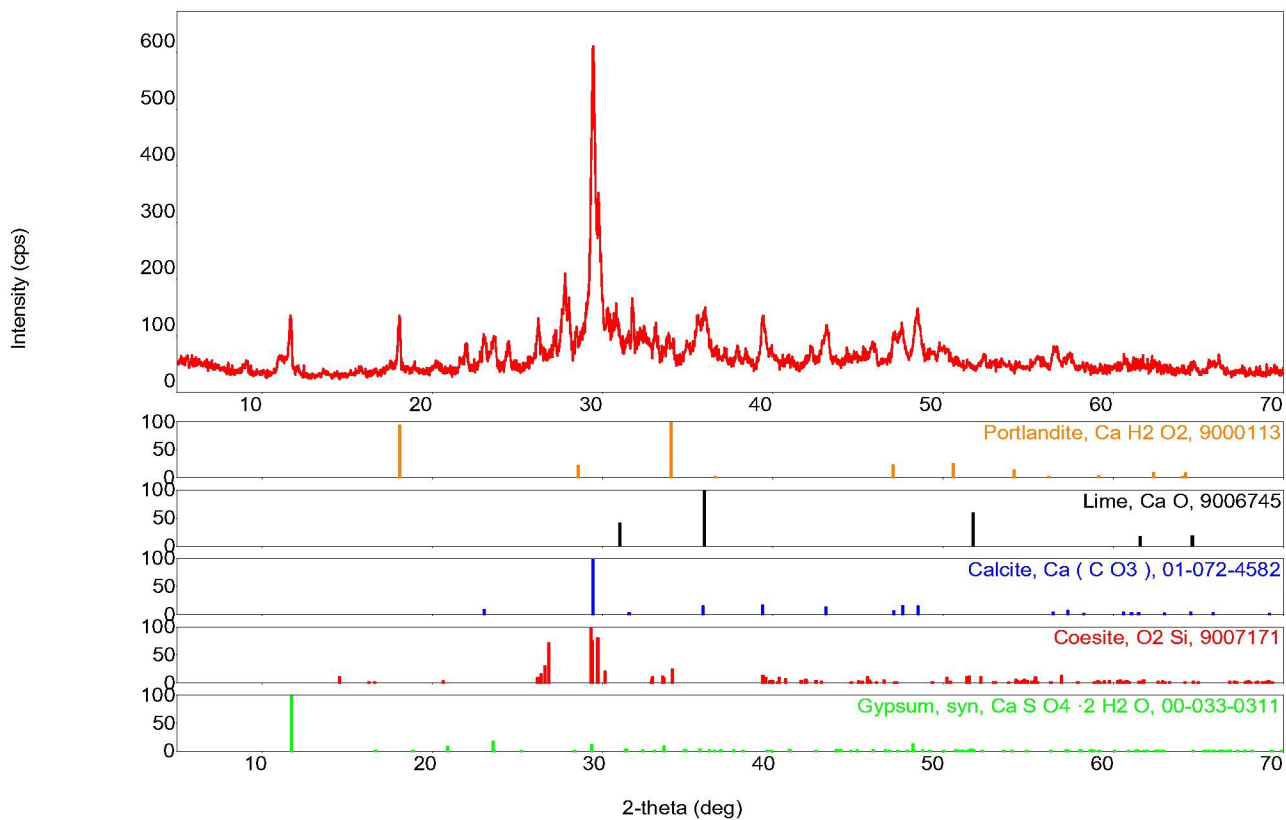
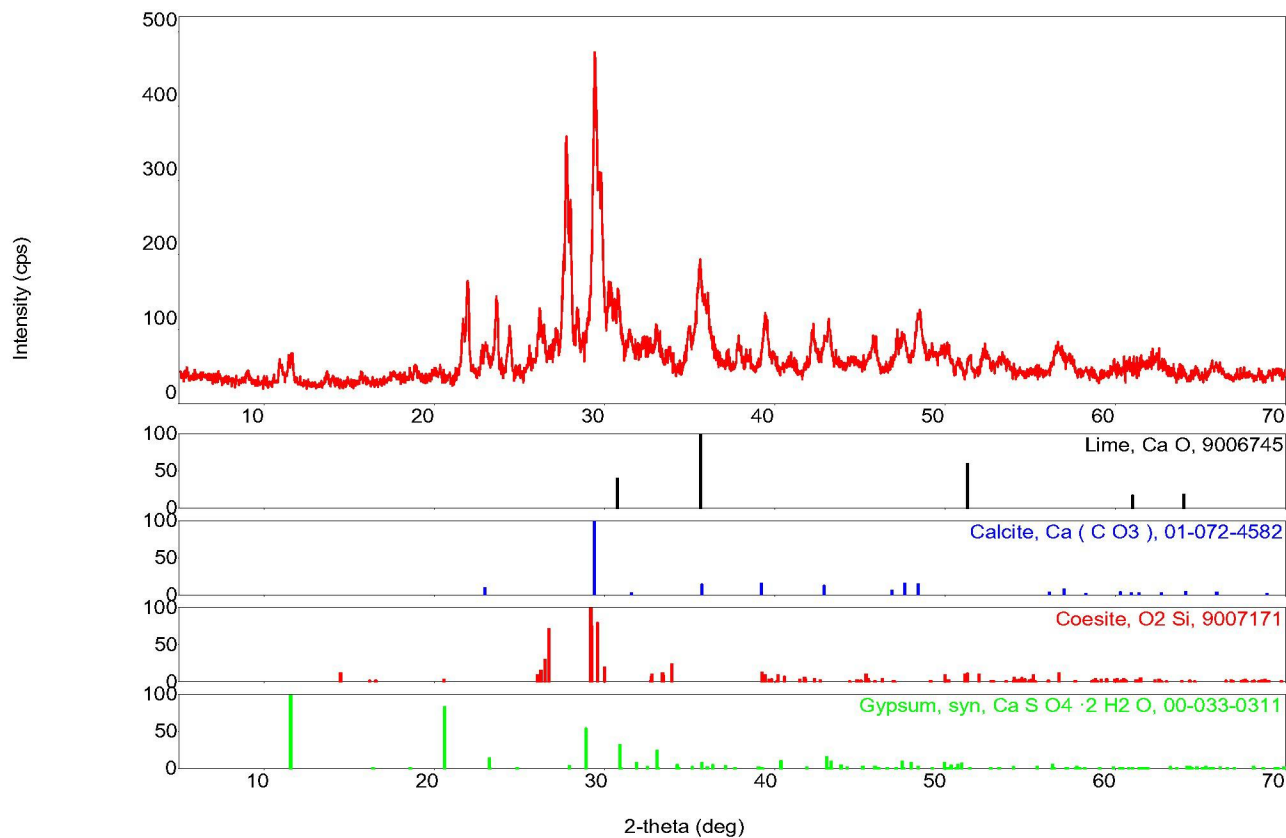
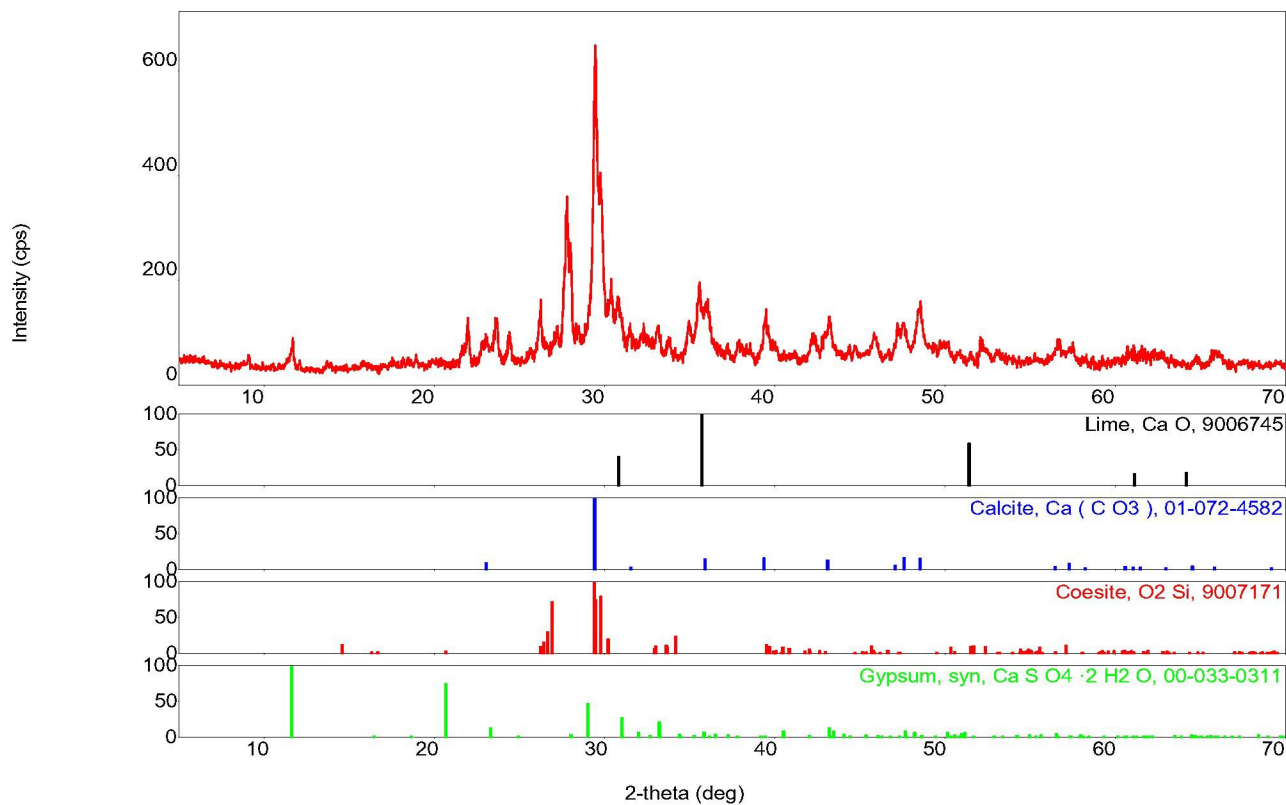
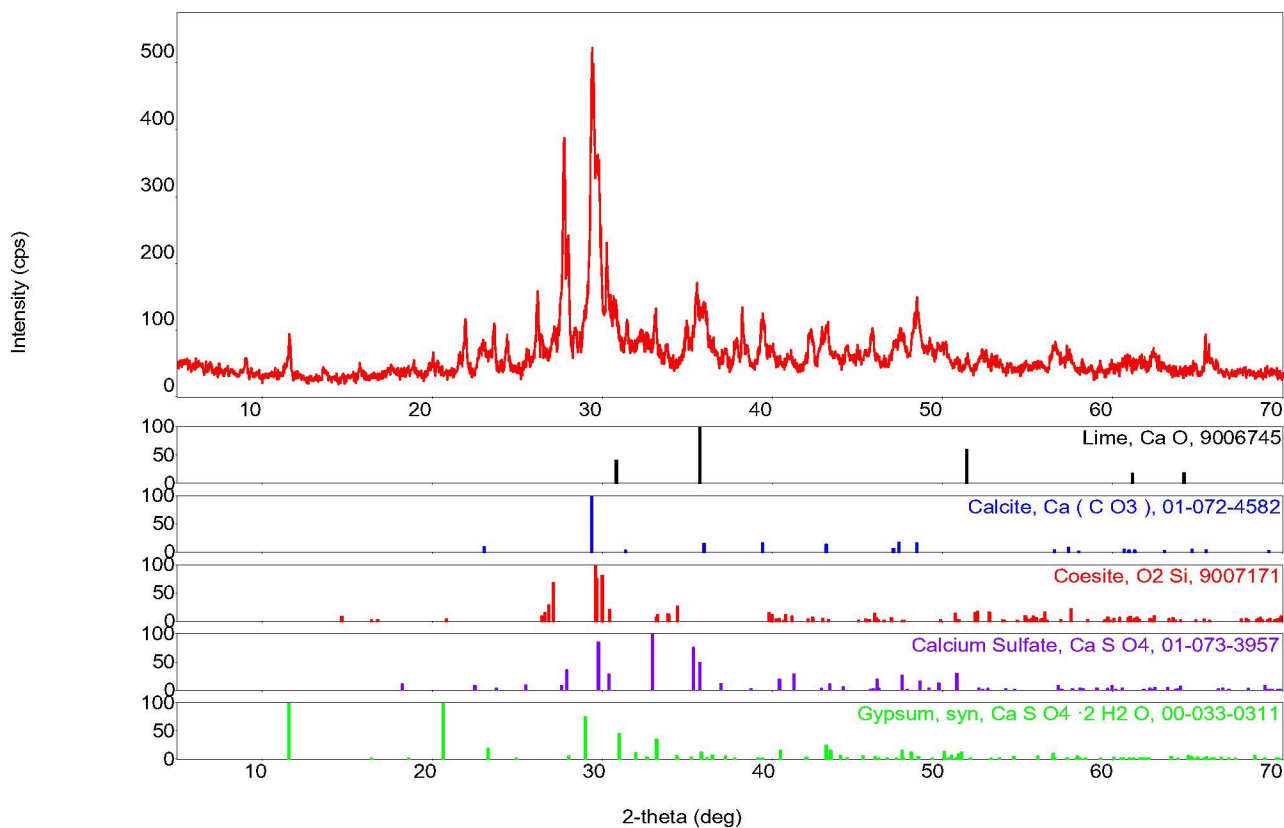
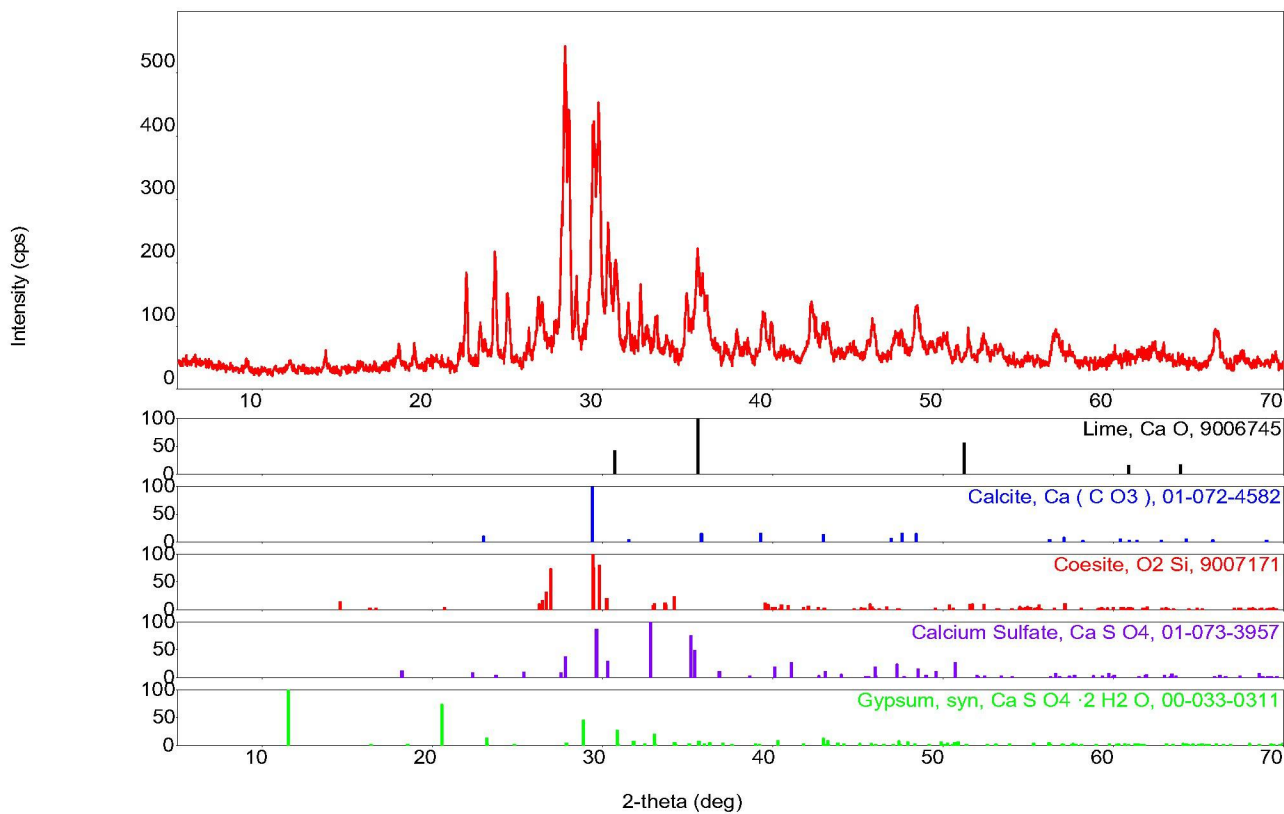
X-Ray Diffraction Spectroscopy (XRD) analysis of the concrete samples revealed the presence of the following crystalline phases: calcium oxide (lime); calcium carbonate (calcite); silicon dioxide (coesite); calcium sulfate; calcium sulfate hydrated (gypsum) and calcium hydroxide (portlandite). The results are summarized in Tables 17 and 18. The XRD diffractograms for the concrete samples are provided as Figures 113 through 122.
