DEPARTMENT OF THE NAVY

SUBJECT: ADMINISTRATIVE ORDER ON CONSENT (AOC) STATEMENT OF WORK (SOW) SECTION 5 CORROSION AND METAL FATIGUE PRACTICES, DESTRUCTIVE TESTING RESULTS REPORT, RED HILL BULK FUEL STORAGE FACILITY (RED HILL), JOINT BASE PEARL HARBOR-HICKAM, OAHU, HAWAII

In 2018, ten coupons were removed from Tank 14, so that a metallurgical and corrosion analysis of the coupons could be undertaken, with the primary aim of validating non-destructive examination (NDE) results. The steel coupons, concrete powder samples, and corrosion product were submitted to a certified third-party laboratory to perform this analysis.

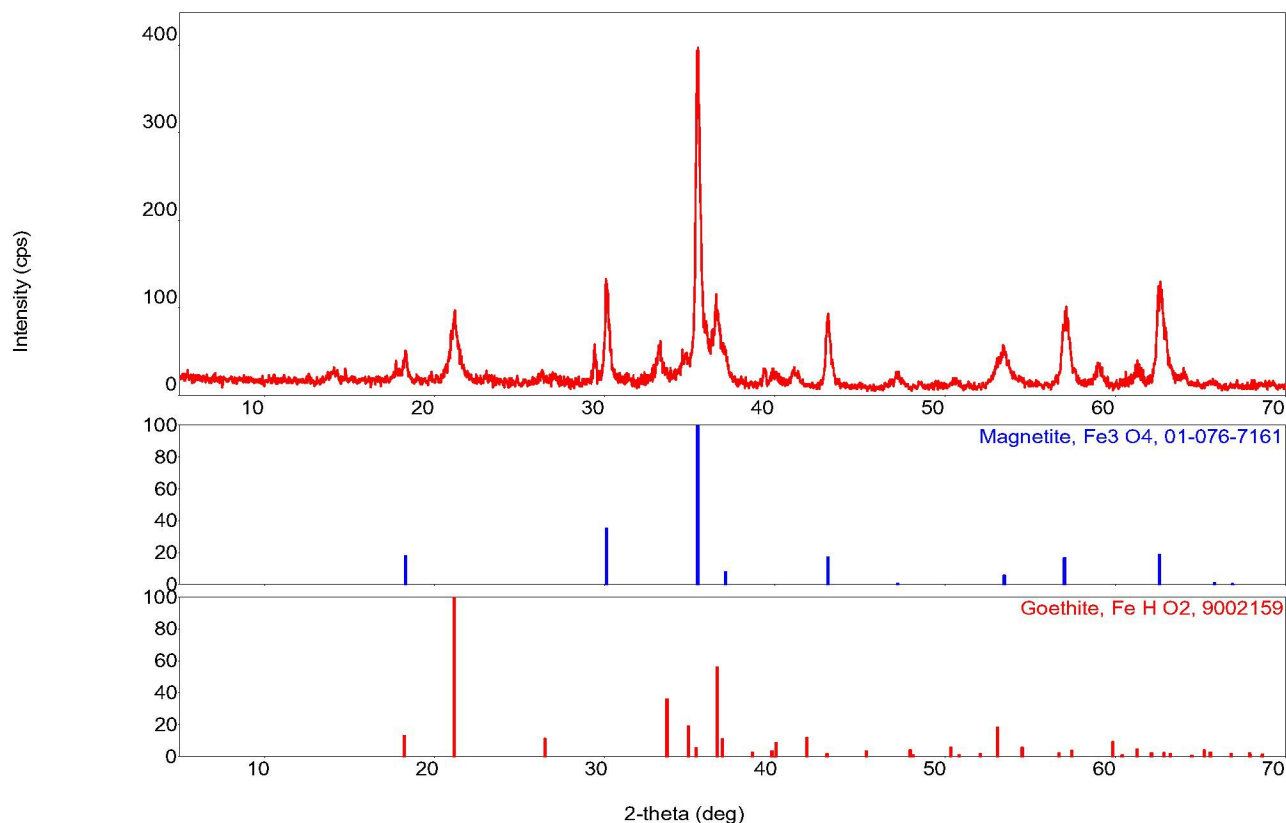
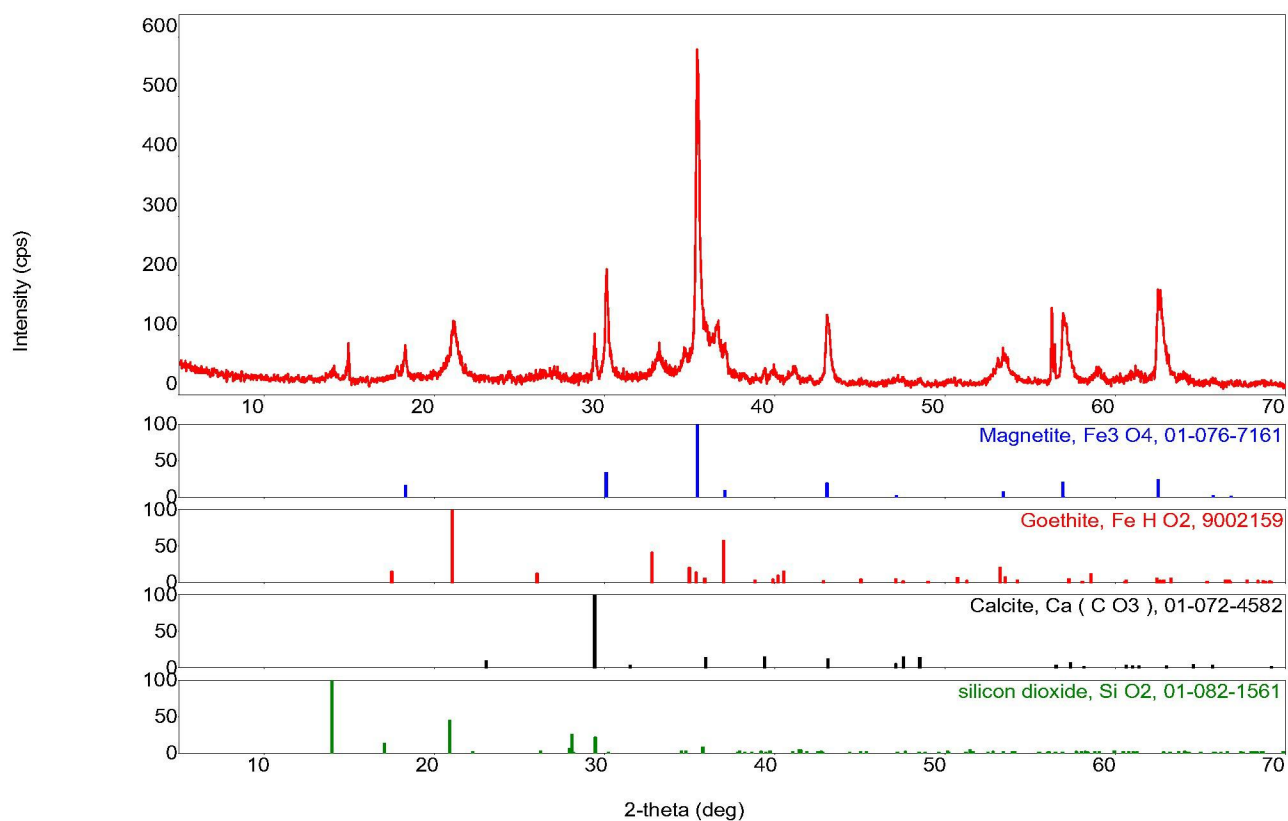
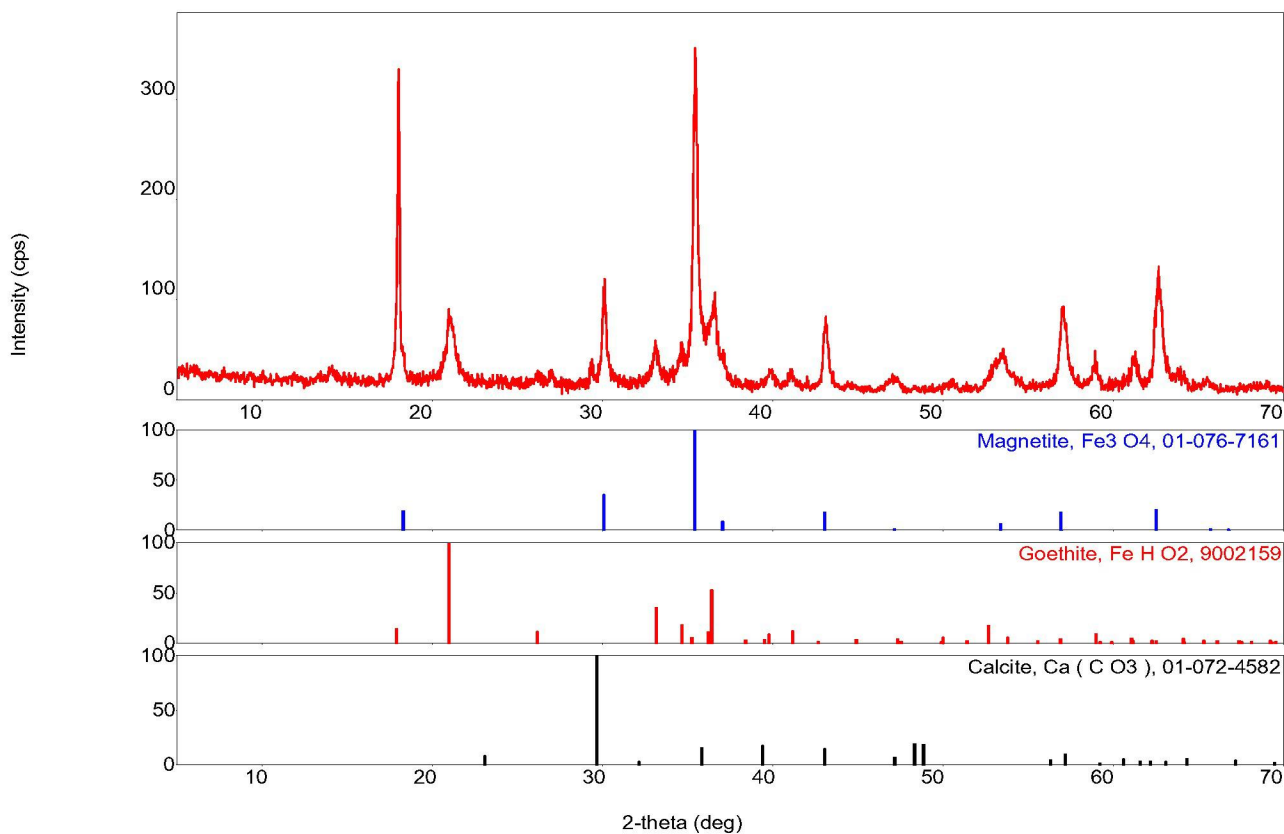
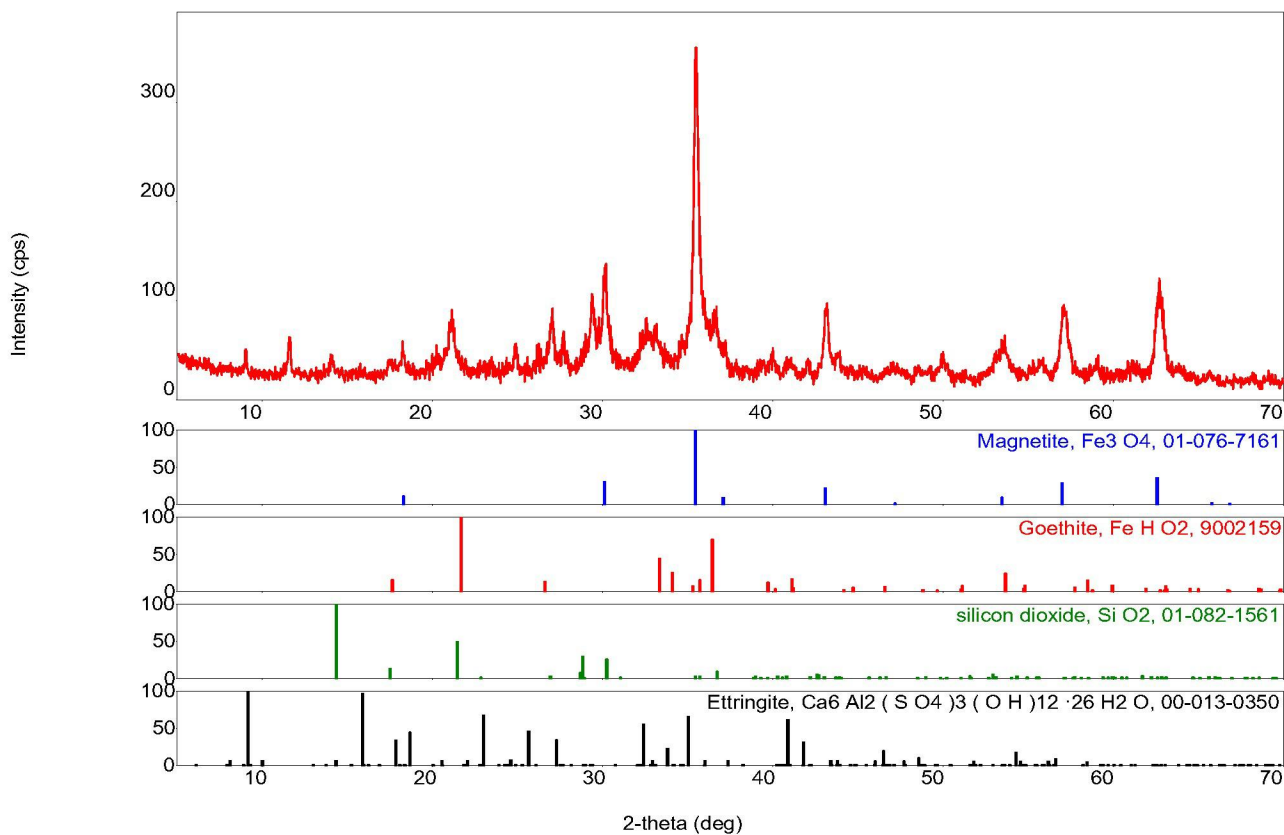
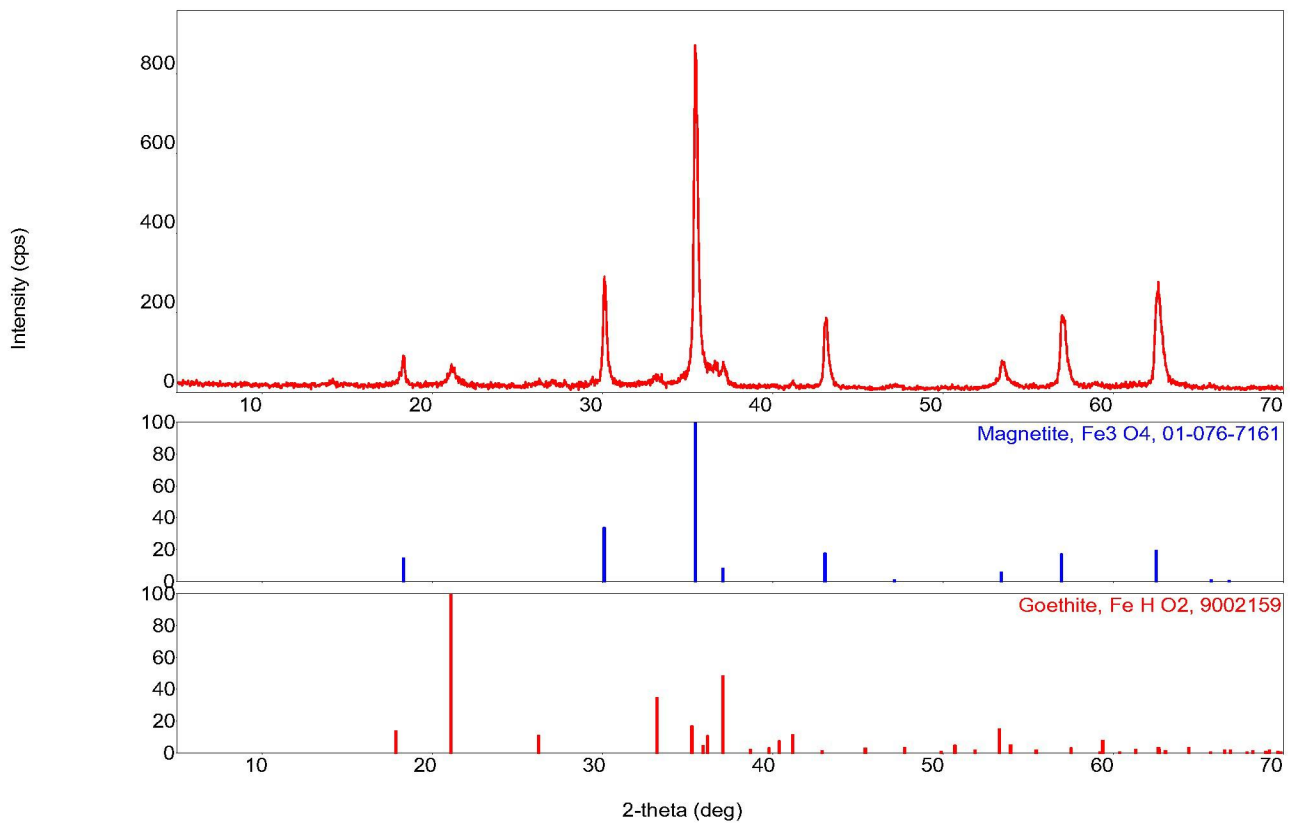
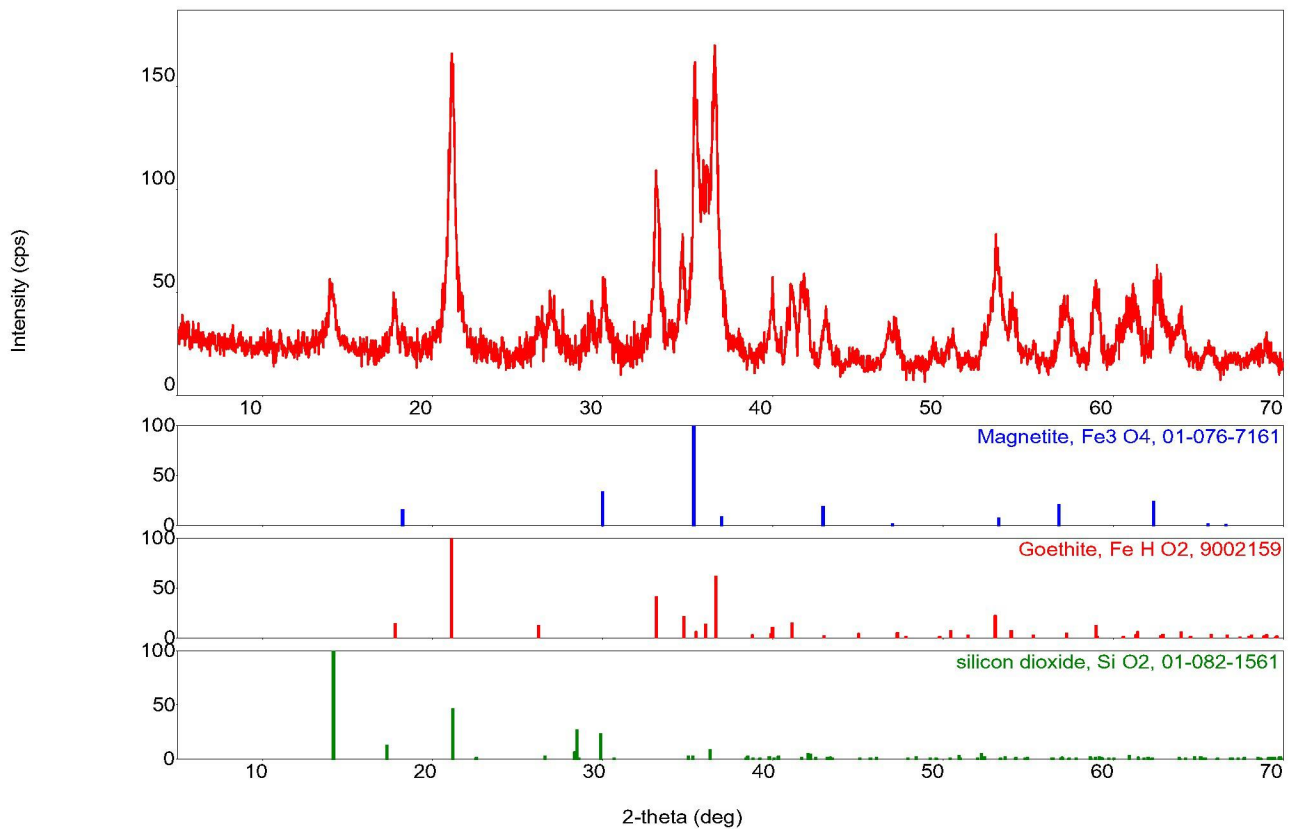
X-Ray Diffraction Spectroscopy (XRD) analysis of the corrosion product from the metal panels revealed the presence of the following crystalline phases: iron oxide (magnetite); iron hydroxide (goethite); calcium carbonate (calcite); silicon dioxide and hydrous calcium aluminum sulfate (ettringite). The results are summarized in Tables 19 and 20. The XRD diffractograms for the corrosion samples are provided as Figures 123 through 128.

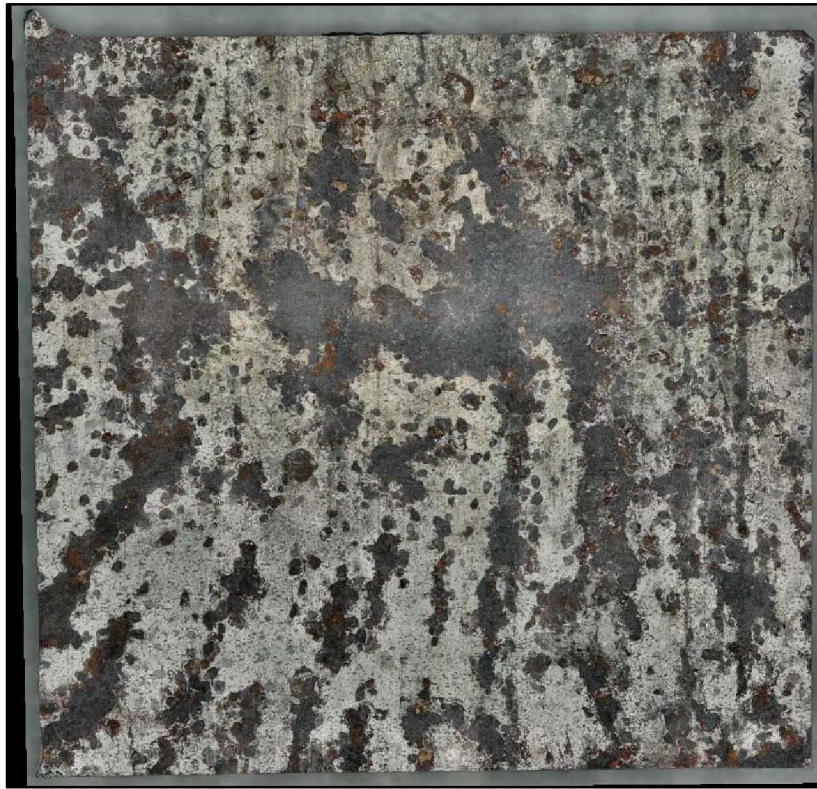
Figure 149. A screenshot of the 3D digital image of a specimen excised from Coupon 1 labeled as 1-1, after CO₂ blast cleaning

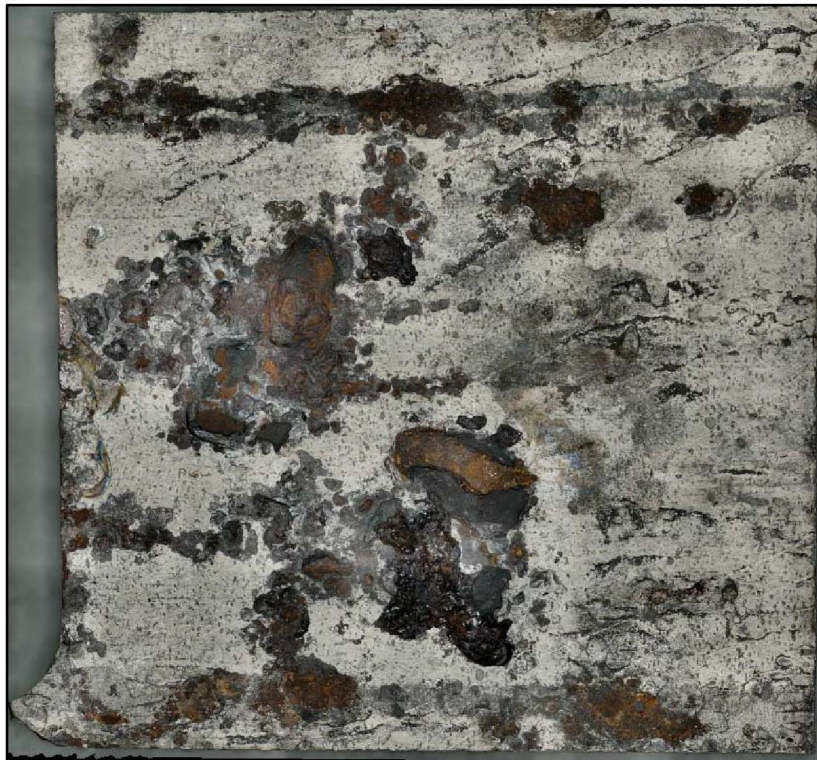
Figure 150. A screenshot of the 3D digital image of a specimen excised from Coupon 1 labeled as 1-2, after CO₂ blast cleaning

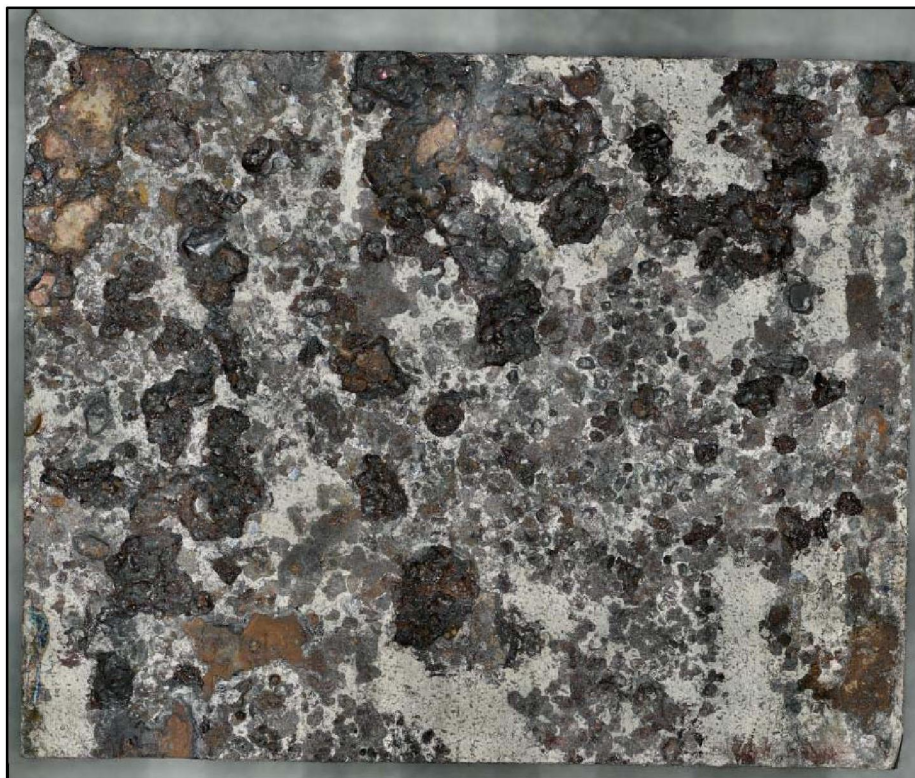
Figure 151. A screenshot of the 3D digital image of a specimen excised from Coupon 1 labeled as 1-3, after CO₂ blast cleaning

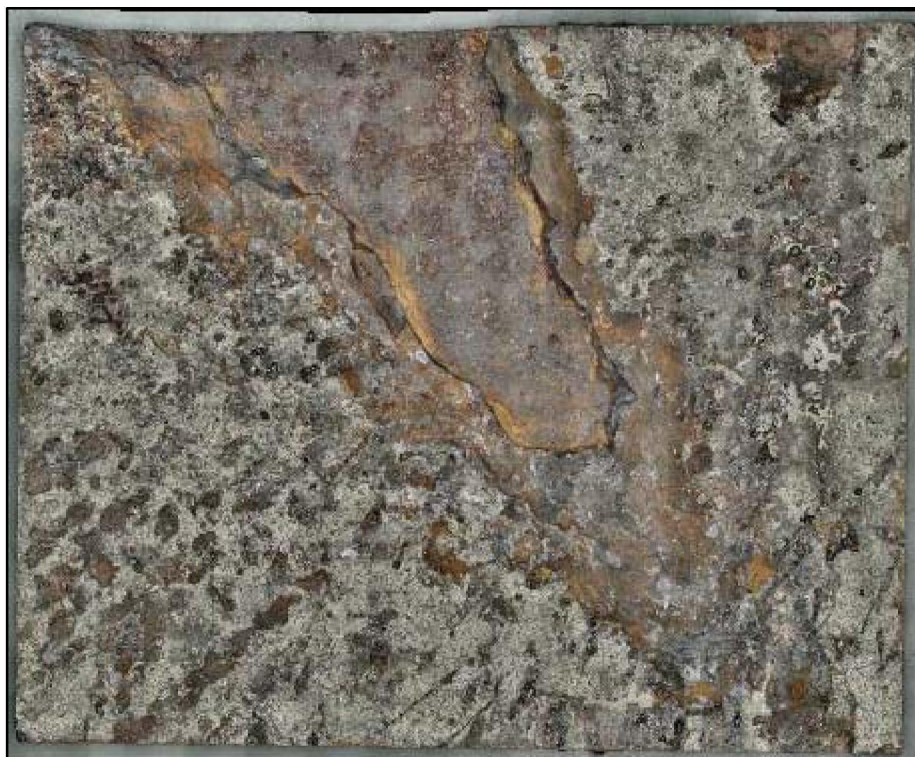
Figure 152. A screenshot of the 3D digital image of a specimen excised from Coupon 2 labeled as 2-1, after CO₂ blast cleaning

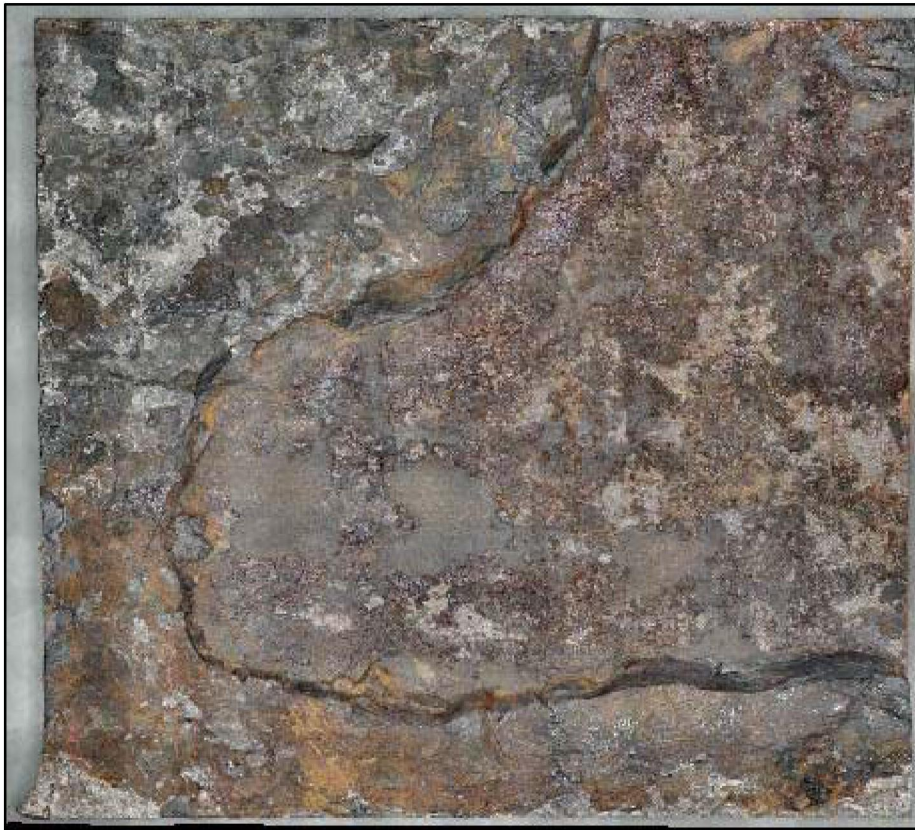
Figure 153. A screenshot of the 3D digital image of a specimen excised from Coupon 2 labeled as 2-2, after CO₂ blast cleaning

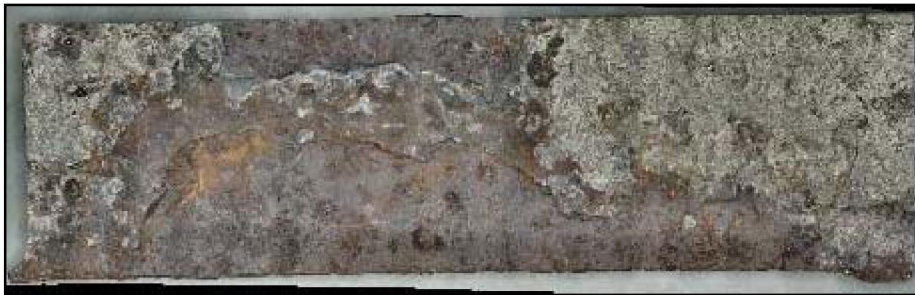
Figure 154. A screenshot of the 3D digital image of a specimen excised from Coupon 2 labeled as 2-3, after CO₂ blast cleaning

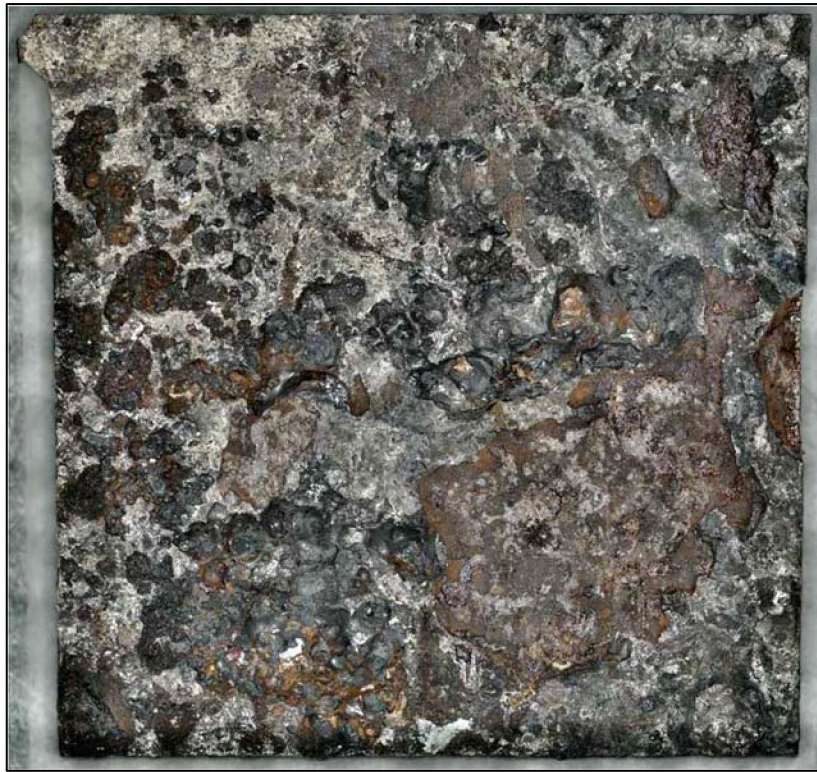
Figure 155. A screenshot of the 3D digital image of a specimen excised from Coupon 3 labeled as 3-1, after CO₂ blast cleaning

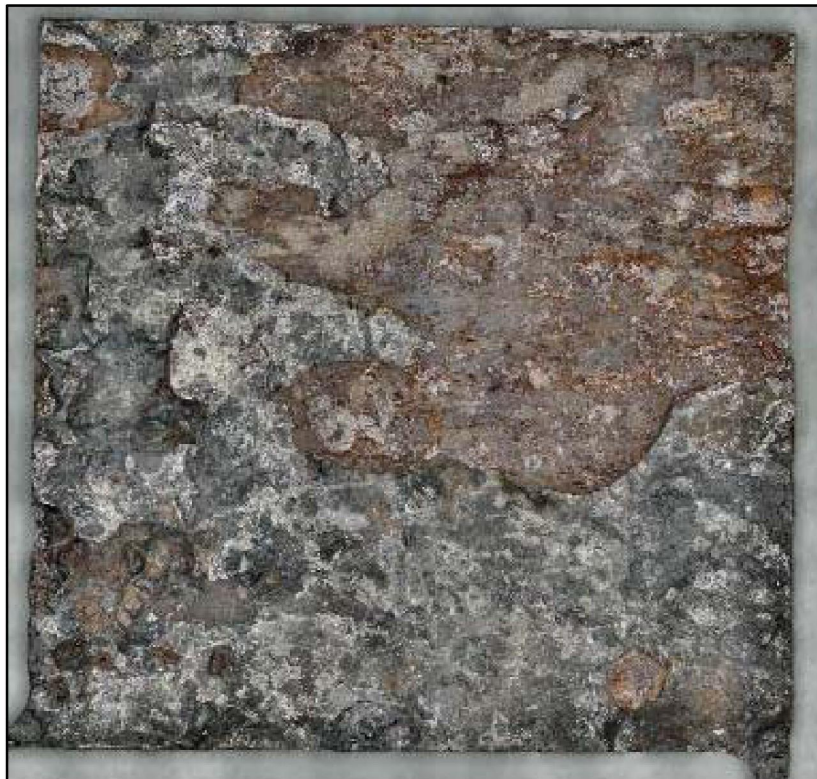
Figure 156. A screenshot of the 3D digital image of a specimen excised from Coupon 3 labeled as 3-2, after CO₂ blast cleaning

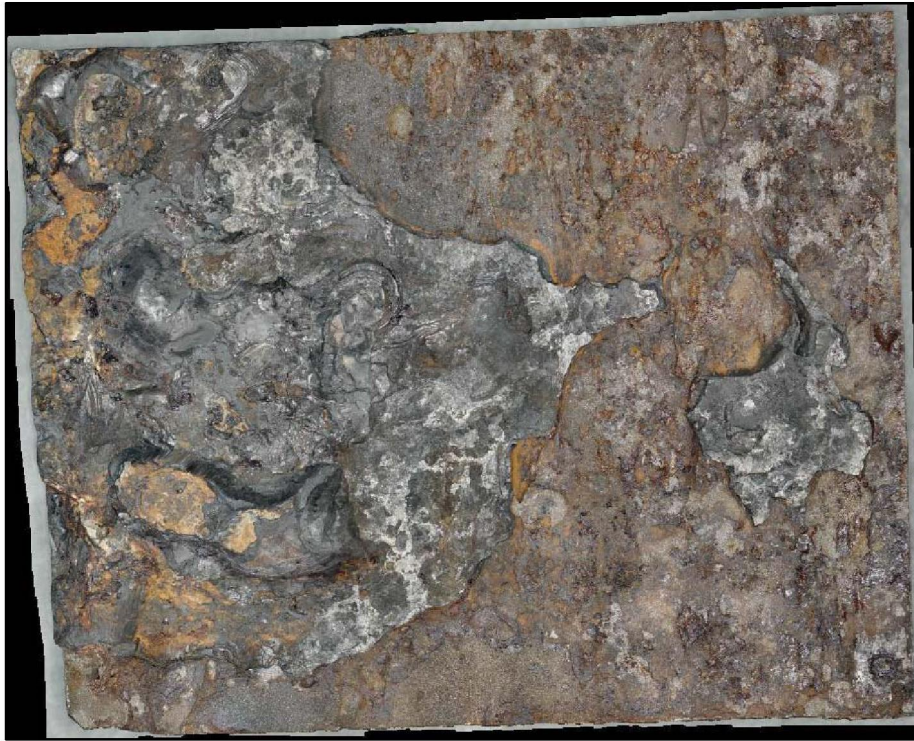
Figure 157. A screenshot of the 3D digital image of a specimen excised from Coupon 3 labeled as 3-3, after CO₂ blast cleaning

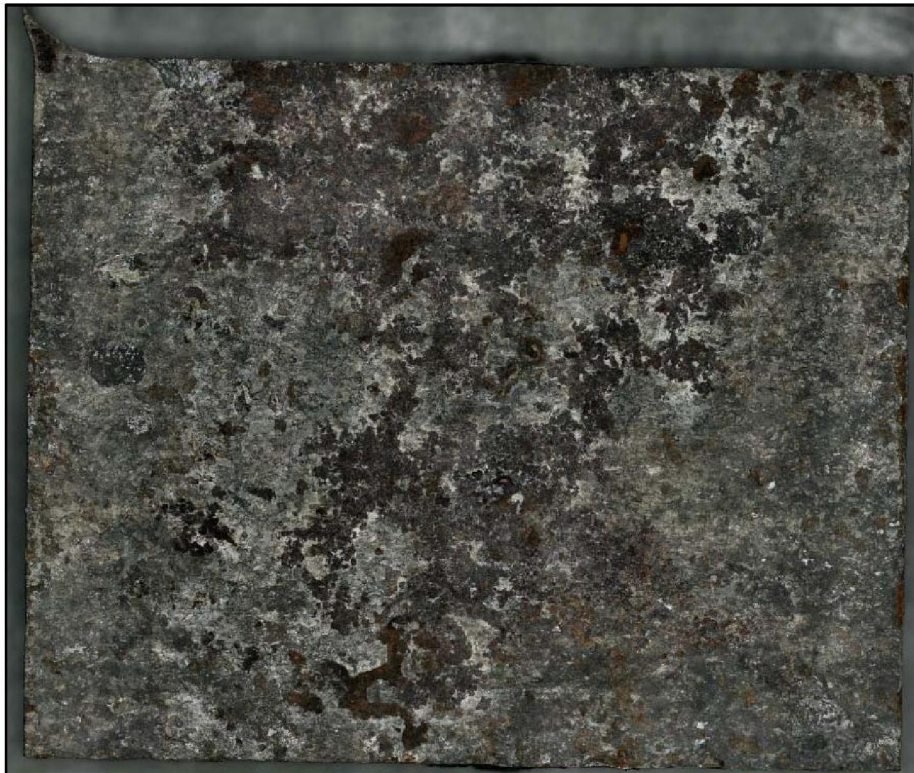
Figure 158. A screenshot of the 3D digital image of a specimen excised from Coupon 5 labeled as 5-1, after CO₂ blast cleaning

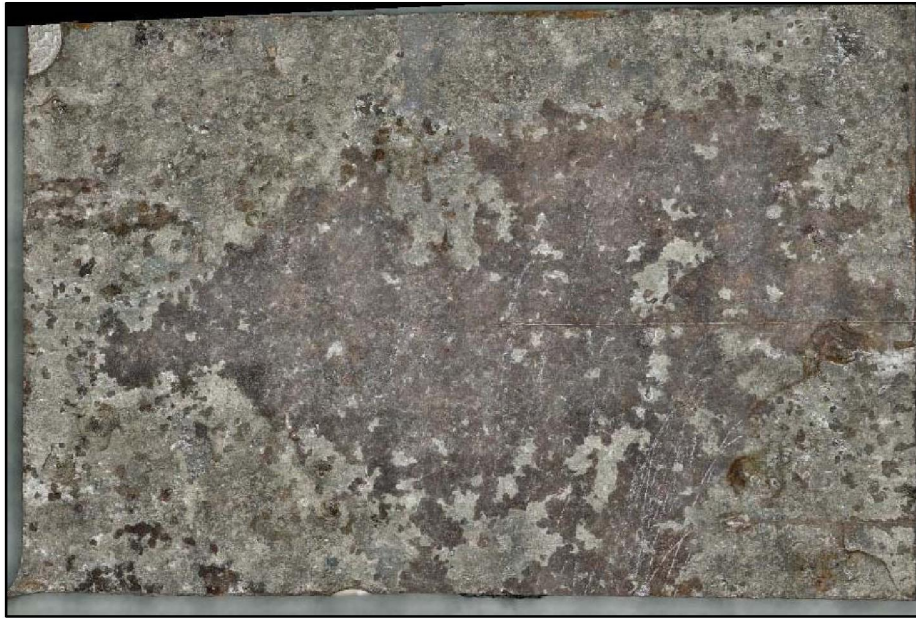
Figure 159. A screenshot of the 3D digital image of a specimen excised from Coupon 5 labeled as 5-2, after CO₂ blast cleaning

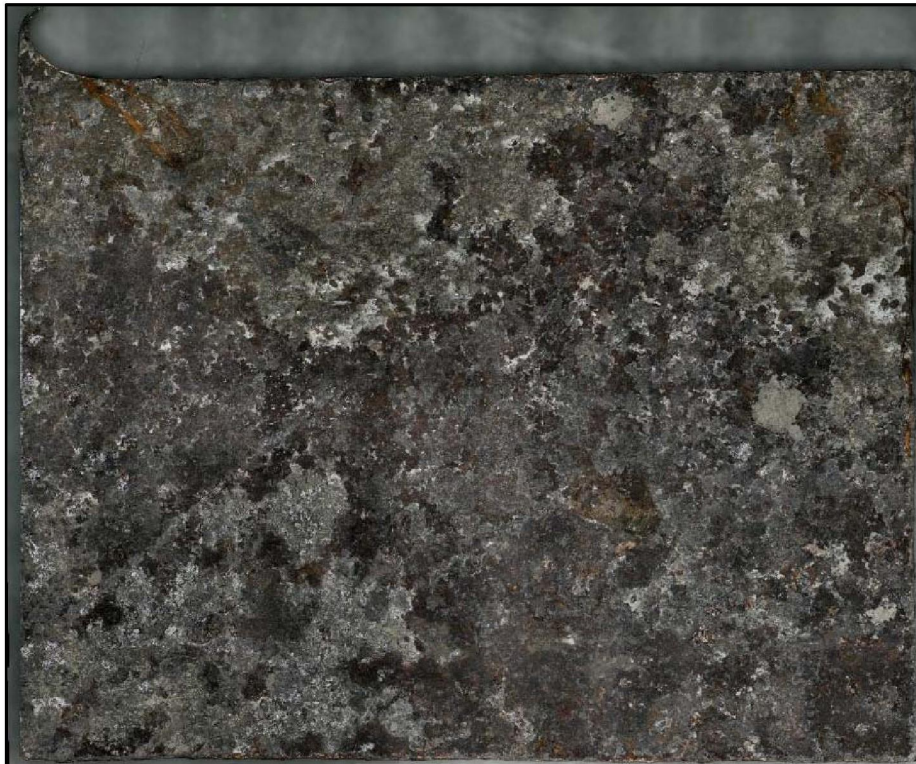
Figure 160. A screenshot of the 3D digital image of a specimen excised from Coupon 5 labeled as 5-3, after CO₂ blast cleaning

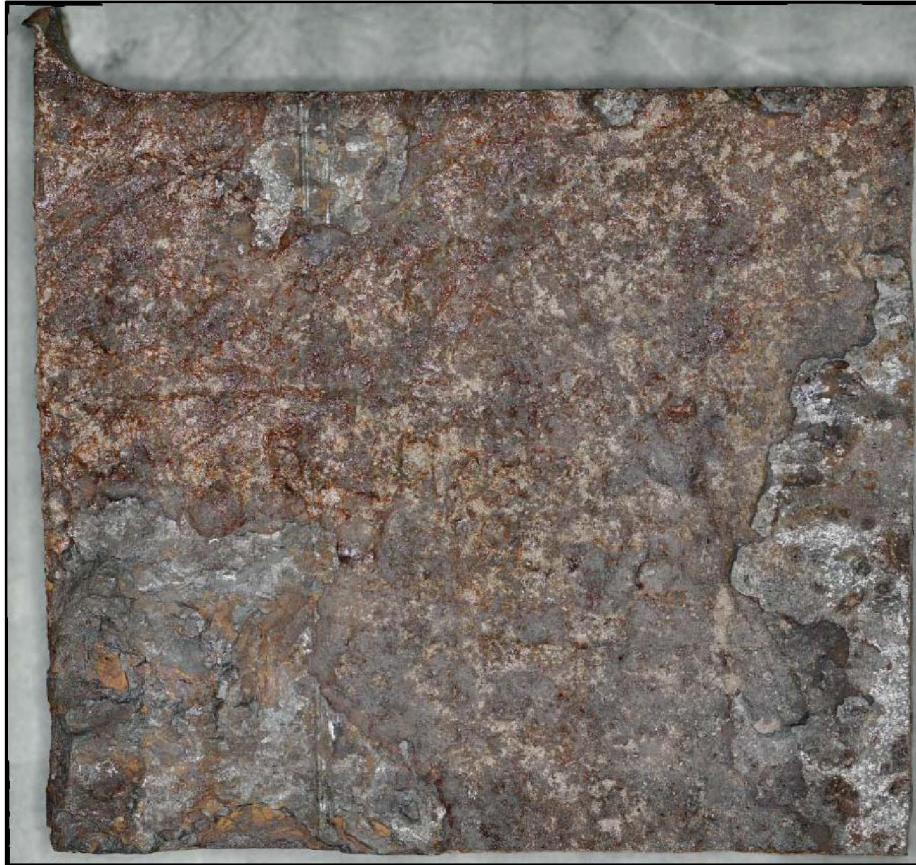
Figure 161. A screenshot of the 3D digital image of a specimen excised from Coupon 6 labeled as 6-1, after CO₂ blast cleaning

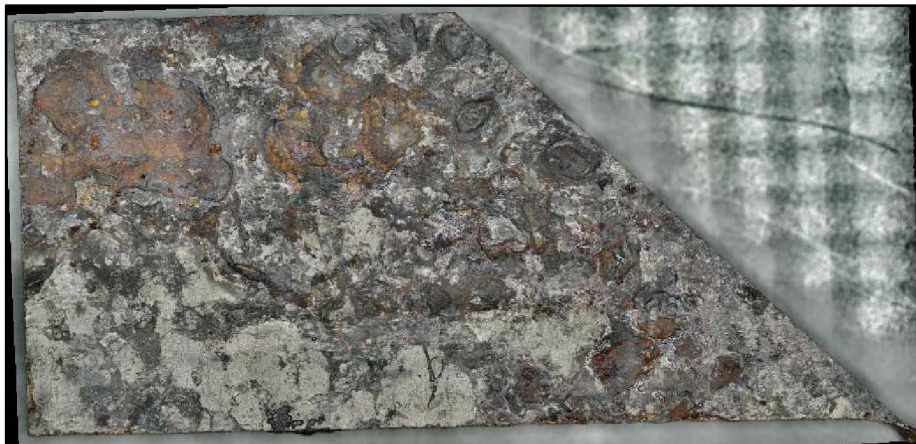
Figure 162. A screenshot of the 3D digital image of a specimen excised from Coupon 6 labeled as 6-2, after CO₂ blast cleaning

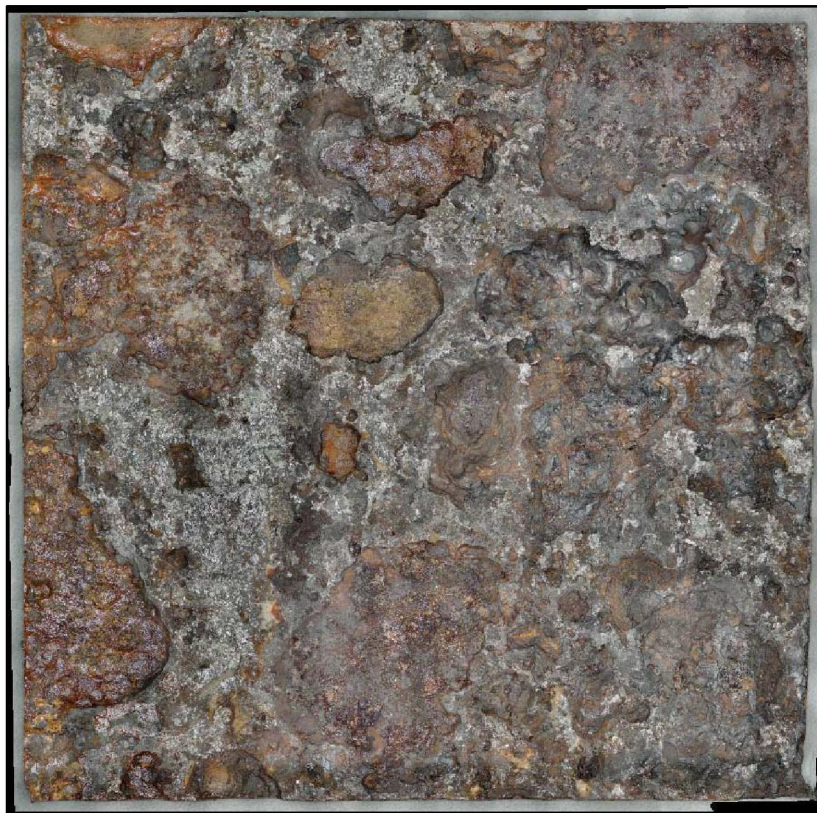
Figure 165. A screenshot of the 3D digital image of a specimen excised from Coupon 7 labeled as 7-2, after CO₂ blast cleaning.

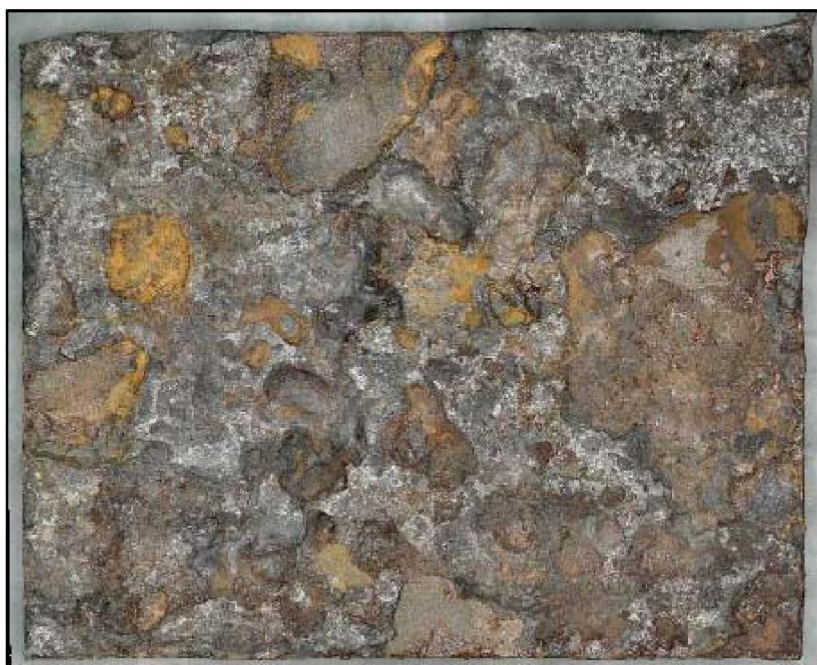
Figure 166. A screenshot of the 3D digital image of a specimen excised from Coupon 7 labeled as 7-3, after CO₂ blast cleaning

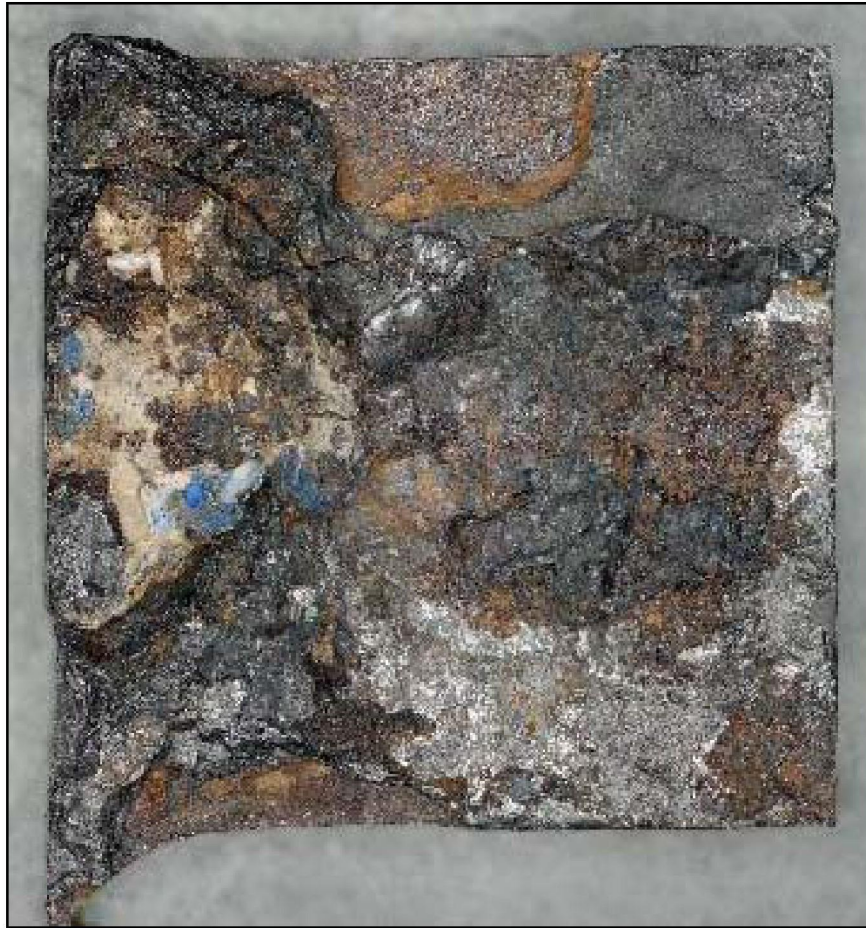
Figure 167. A screenshot of the 3D digital image of a specimen excised from Coupon 7 labeled as 7-4, after CO₂ blast cleaning

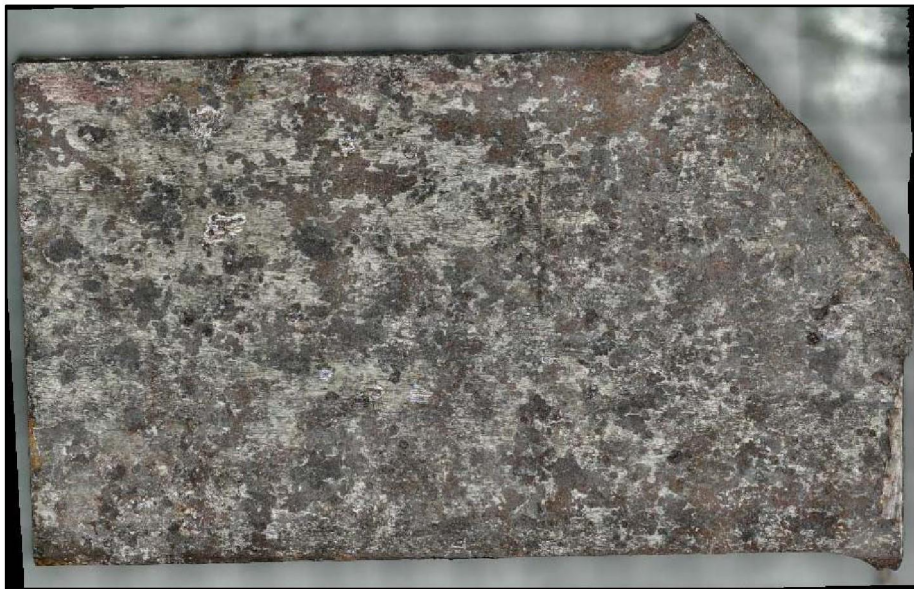
Figure 168. A screenshot of the 3D digital image of a specimen excised from Coupon 8 labeled as 8-1, after CO₂ blast cleaning

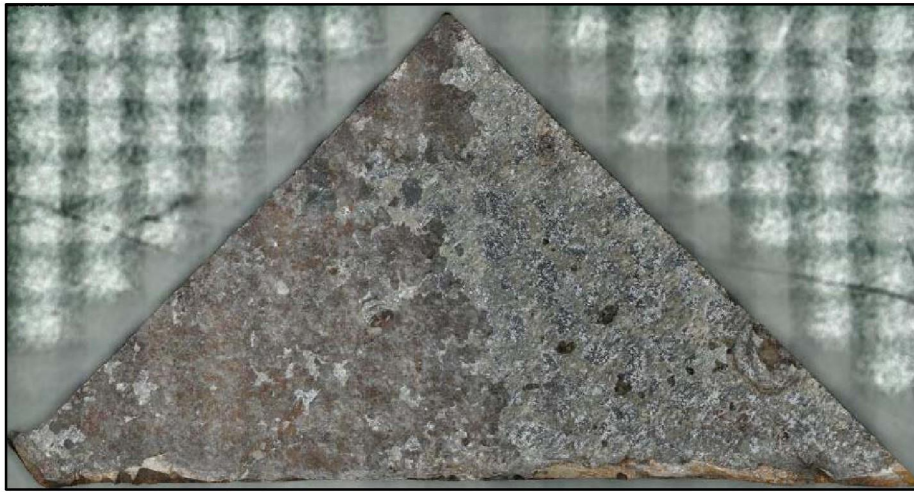
Figure 169. A screenshot of the 3D digital image of a specimen excised from Coupon 8 labeled as 8-2, after CO₂ blast cleaning

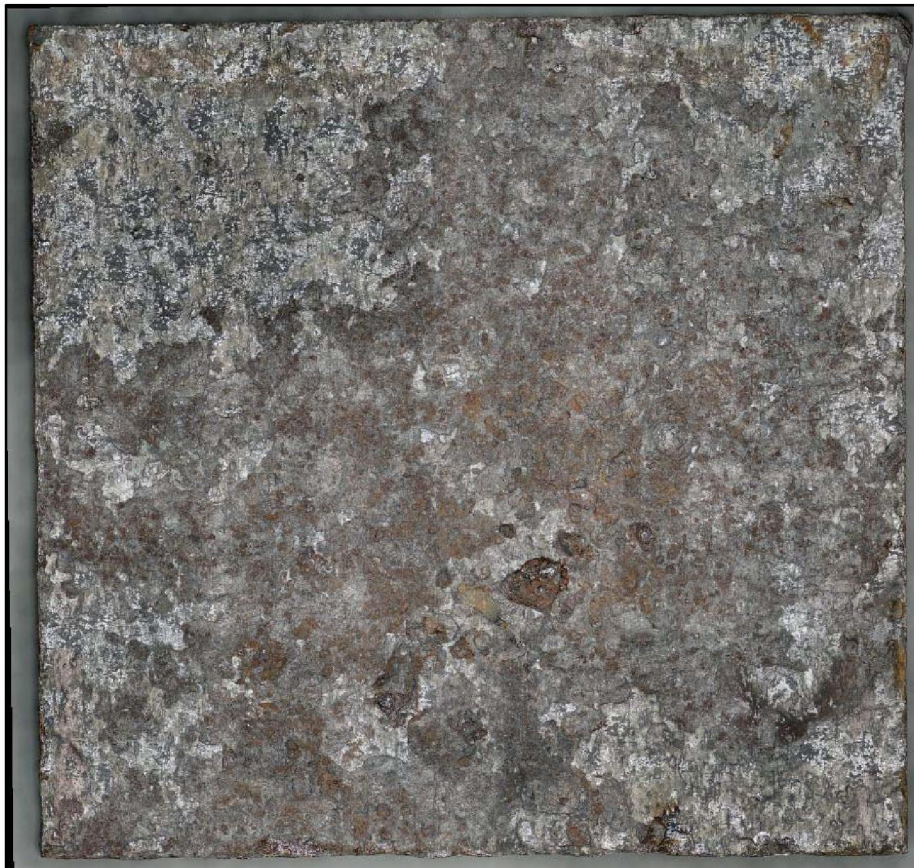
Figure 170. A screenshot of the 3D digital image of a specimen excised from Coupon 8 labeled as 8-3, after CO₂ blast cleaning

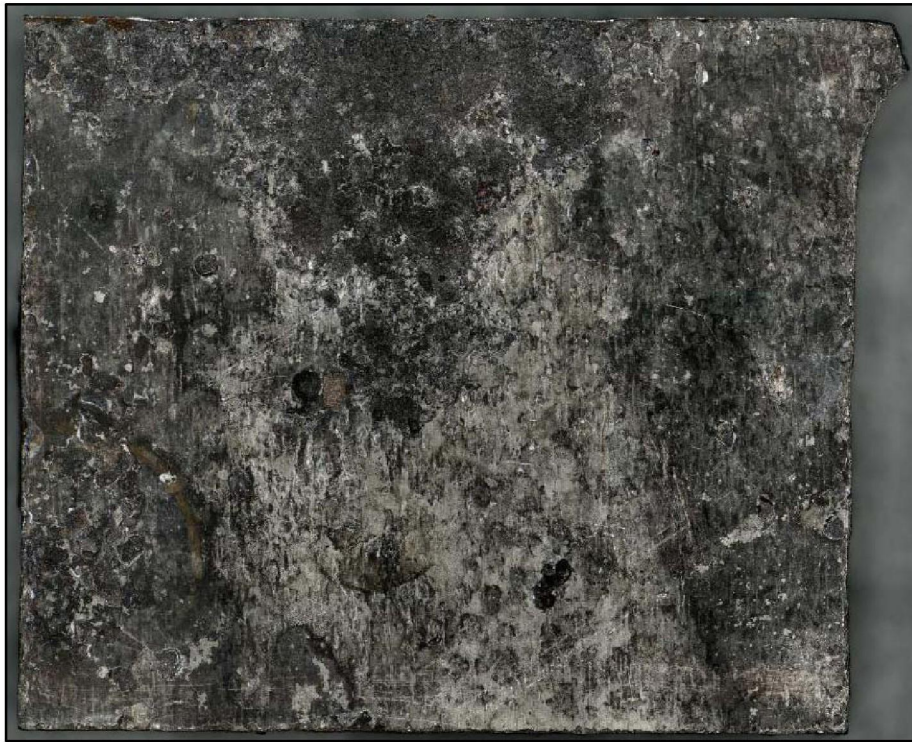
Figure 171. A screenshot of the 3D digital image of a specimen excised from Coupon 10 labeled as 10-1, after CO₂ blast cleaning

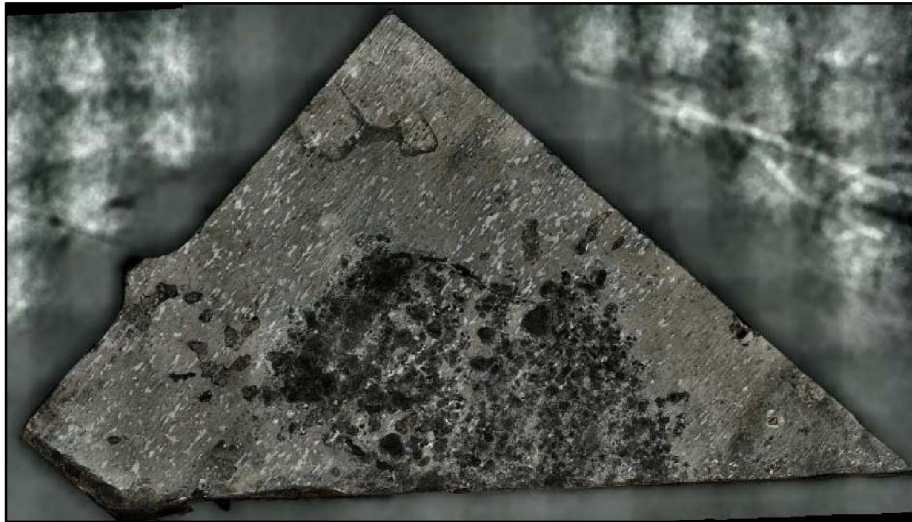
Figure 172. A screenshot of the 3D digital image of a specimen excised from Coupon 10 labeled as 10-2, after CO₂ blast cleaning

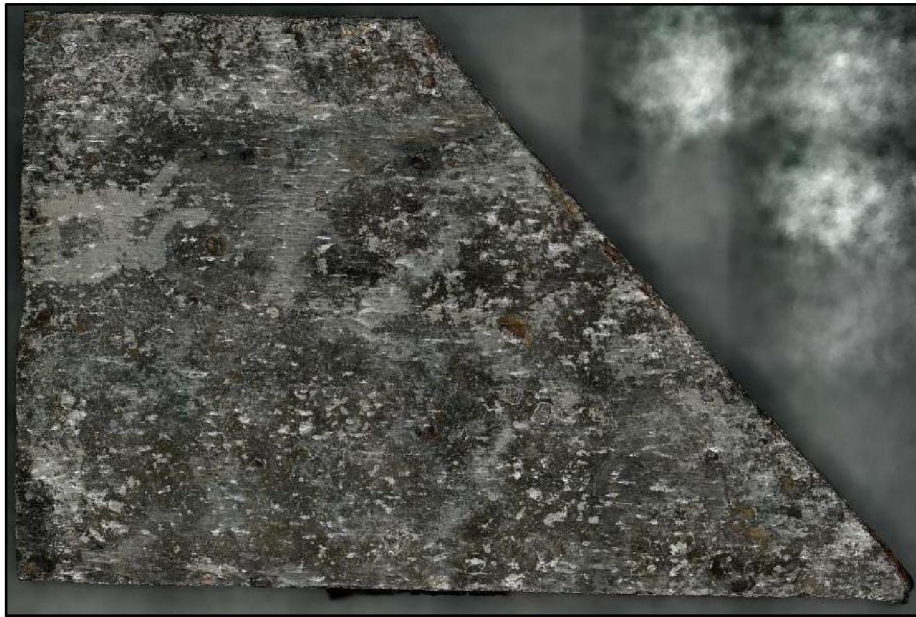
Figure 173. A screenshot of the 3D digital image of a specimen excised from Coupon 10 labeled as 10-3, after CO₂ blast cleaning

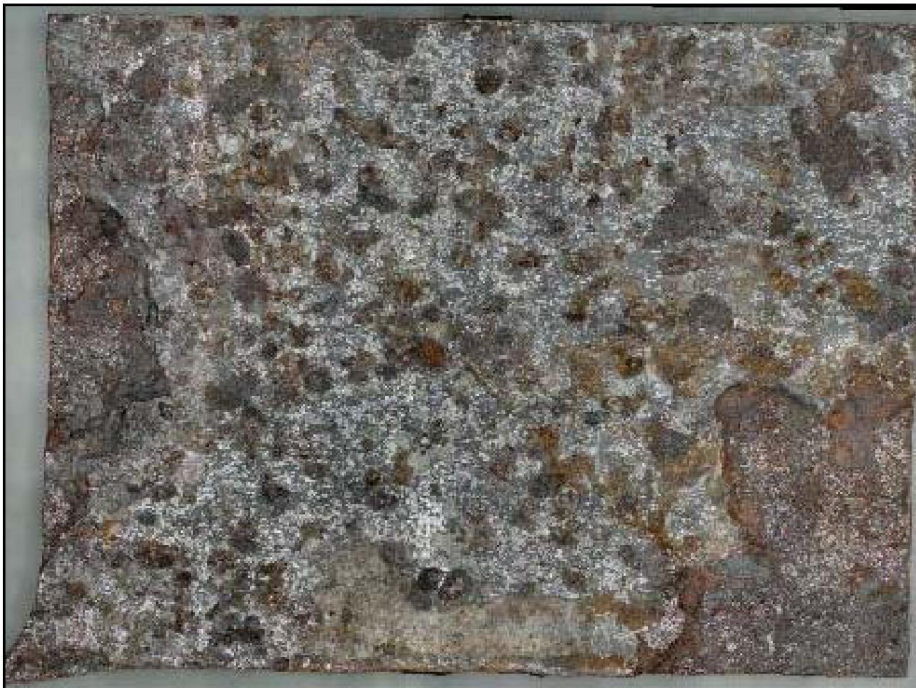
Figure 174. A screenshot of the 3D digital image of a specimen excised from Coupon A-1 labeled as A1-1, after CO₂ blast cleaning

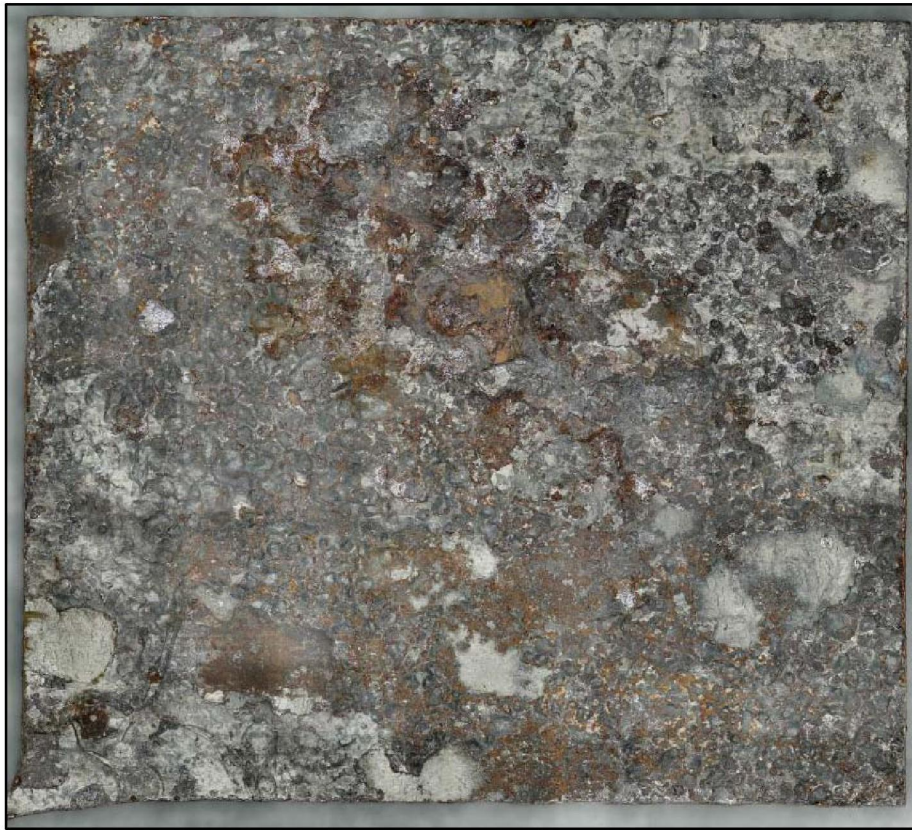
Figure 175. A screenshot of the 3D digital image of a specimen excised from Coupon A-1 labeled as A1-2, after CO₂ blast cleaning
