DEPARTMENT OF THE NAVY

SUBJECT: ADMINISTRATIVE ORDER ON CONSENT (AOC) STATEMENT OF WORK (SOW) SECTION 5 CORROSION AND METAL FATIGUE PRACTICES, DESTRUCTIVE TESTING RESULTS REPORT, RED HILL BULK FUEL STORAGE FACILITY (RED HILL), JOINT BASE PEARL HARBOR-HICKAM, OAHU, HAWAII

In 2018, ten coupons were removed from Tank 14, so that a metallurgical and corrosion analysis of the coupons could be undertaken, with the primary aim of validating non-destructive examination (NDE) results. The steel coupons, concrete powder samples, and corrosion product were submitted to a certified third-party laboratory to perform this analysis.

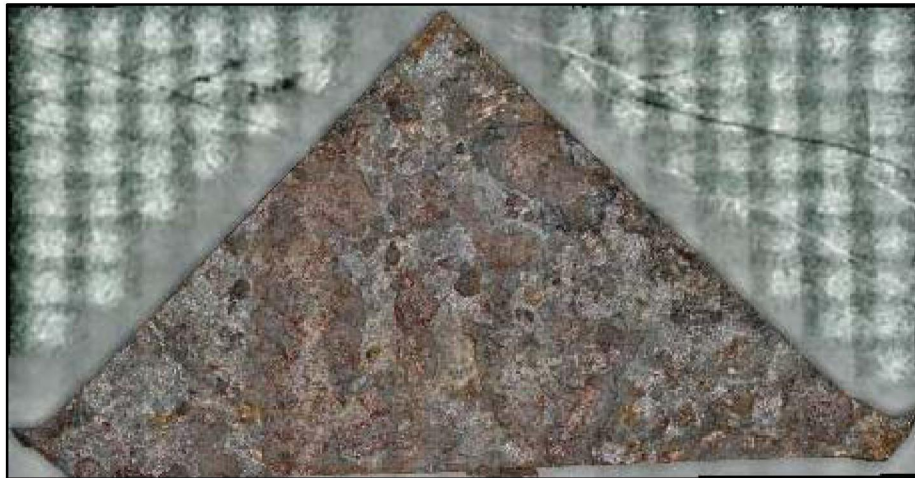
Figure 176. A screenshot of the 3D digital image of a specimen excised from Coupon A-1 labeled as A1-3, after CO₂ blast cleaning

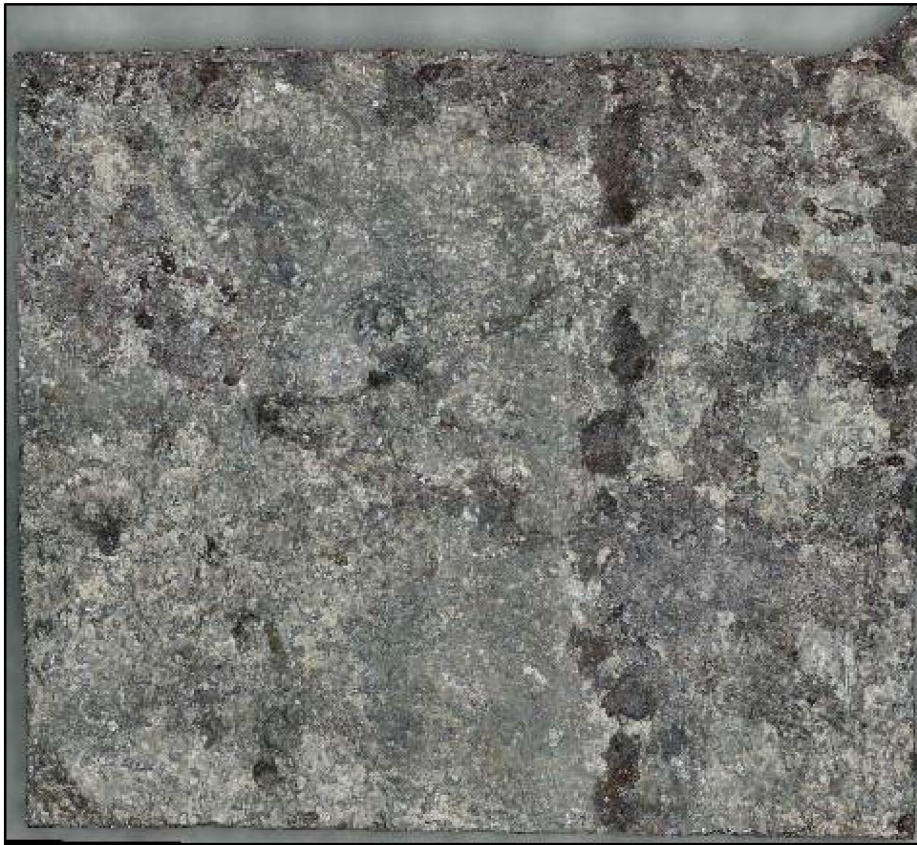
Figure 177. A screenshot of the 3D digital image of a specimen excised from Coupon A-2 labeled as A2-1, after CO₂ blast cleaning

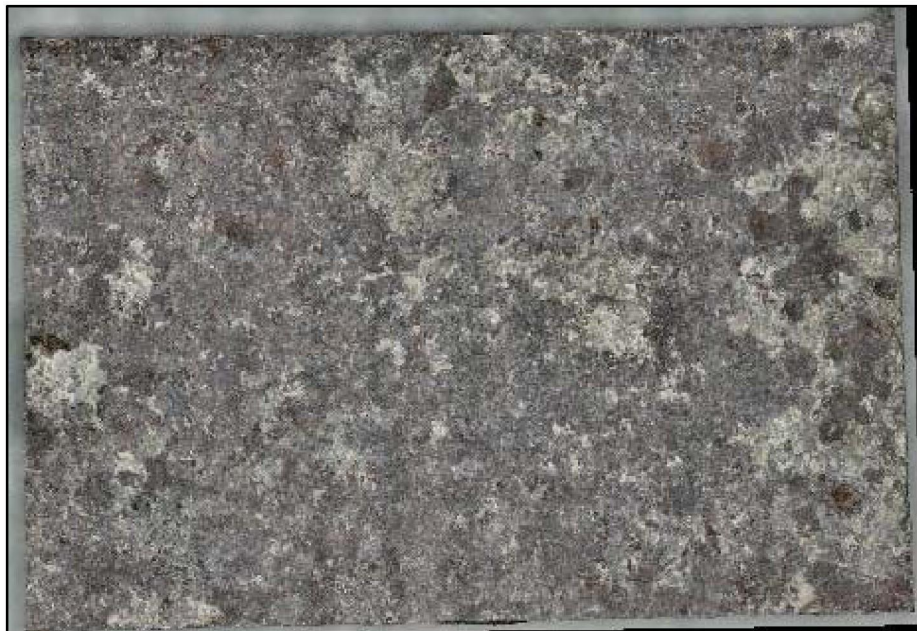
Figure 178. A screenshot of the 3D digital image of a specimen excised from Coupon A-2 labeled as A2-2, after CO₂ blast cleaning

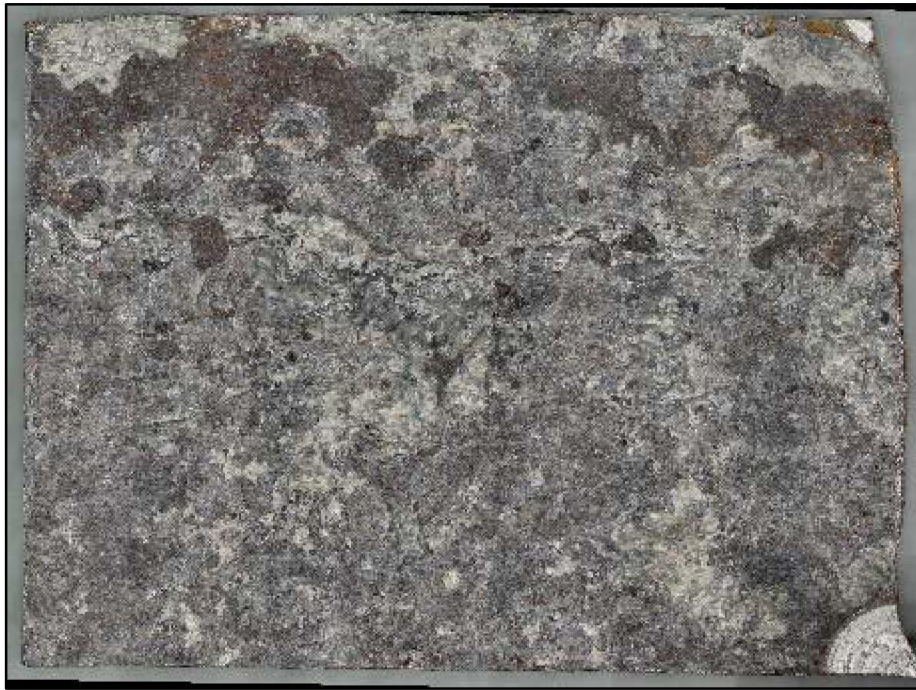
Figure 179. A screenshot of the 3D digital image of a specimen excised from Coupon A-2 labeled as A2-3, after CO₂ blast cleaning

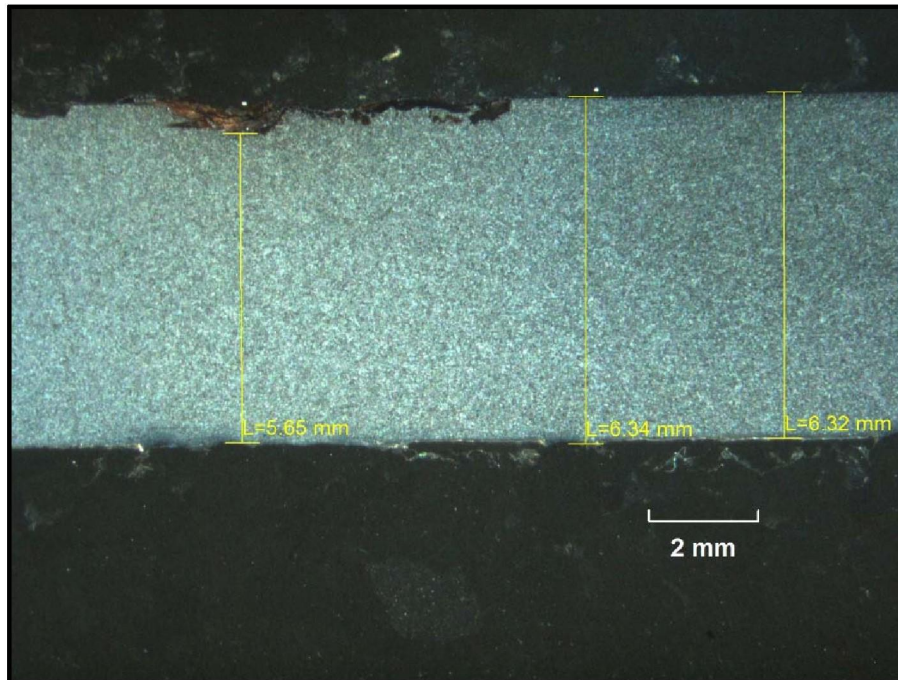
Figure 180. The prepared metallographic cross-section from Sample 1-2 is shown during examination with a stereomicroscope. The thickest location(s) are shown, as well as the thickness remaining underneath the deepest observed pit. (7X)

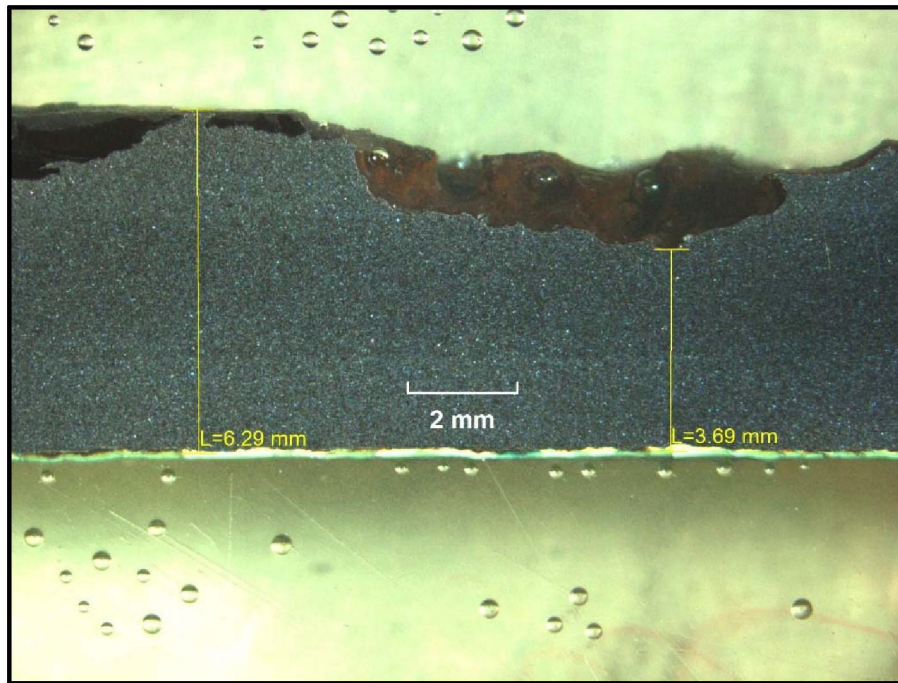
Figure 187. The prepared metallographic cross-section from Sample 3-2 is shown during examination with a stereomicroscope. The thickest location(s) are shown, as well as the thickness remaining underneath the deepest observed pit. (7X)

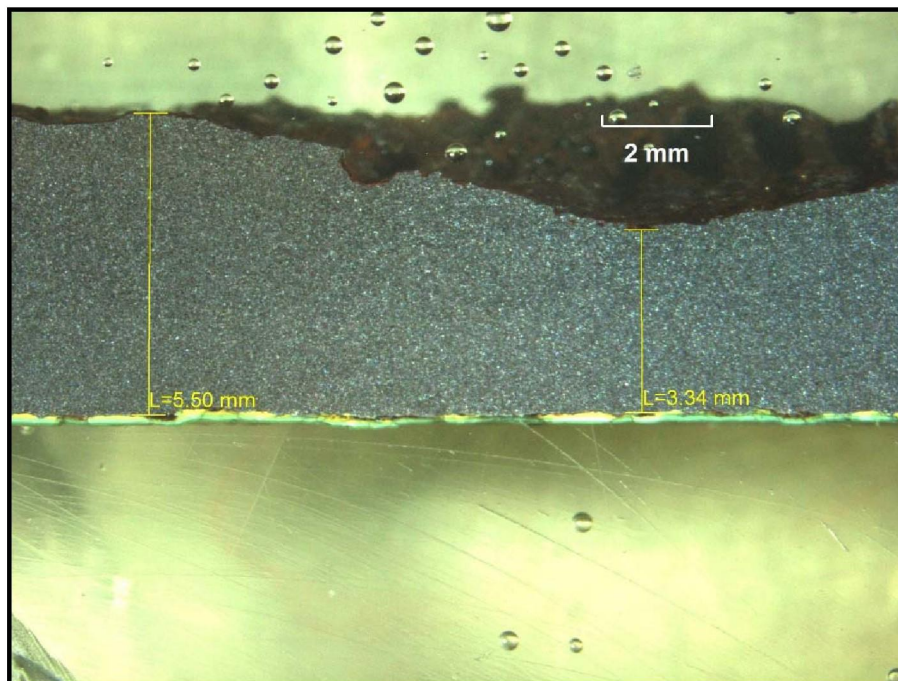
Figure 188. The prepared metallographic cross-section from Sample 3-3 is shown during examination with a stereomicroscope. The thickest location(s) are shown, as well as the thickness remaining underneath the deepest observed pit. (7X)

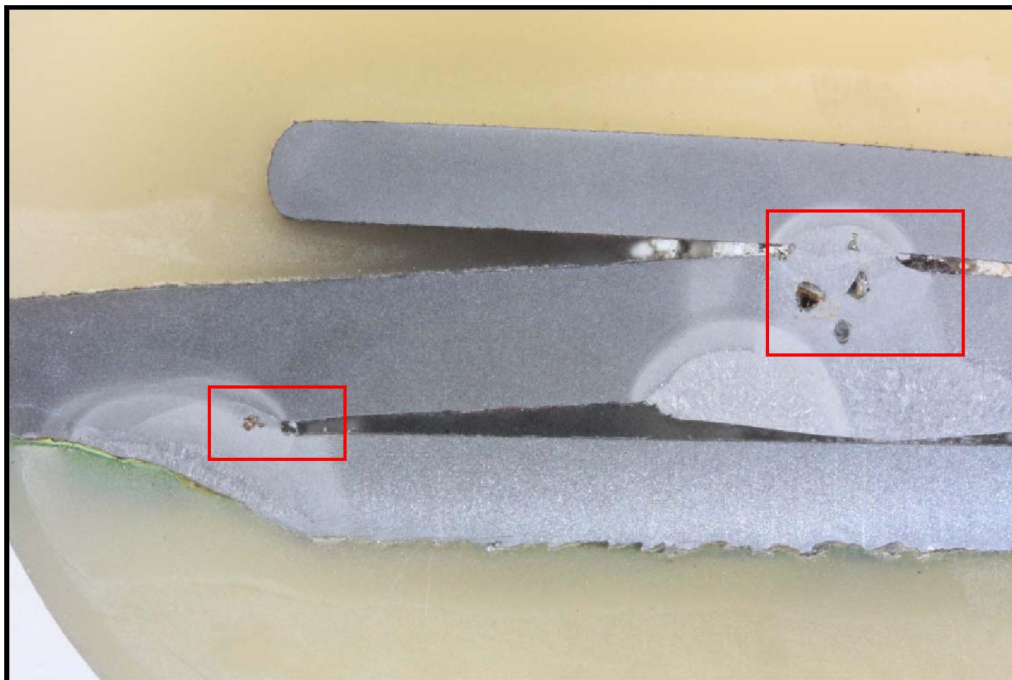
Figure 210. The prepared metallographic cross-section through welded sample 8-4 is shown in an overall view. The painted exterior surface is along the bottom section. The areas identified by the red boxes are shown in the next two figures at higher magnification.

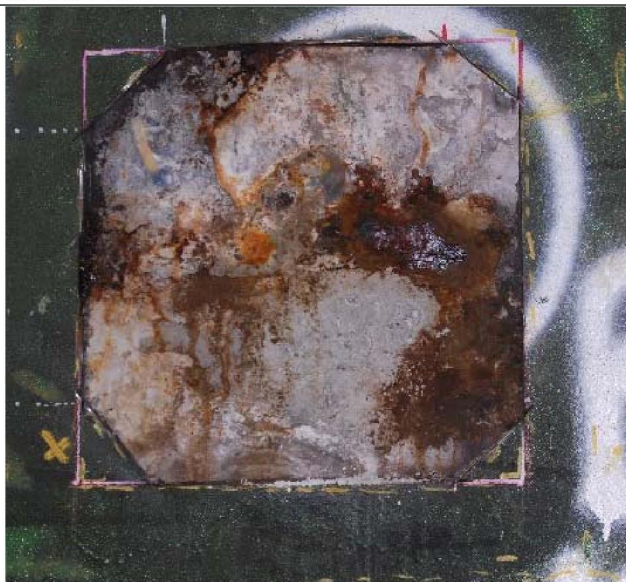
6/19/2018: 14:00		
CONCRETE SAMPLE SPECIFICS		
Sample ID	3	3
Sample Location	14-ER-E3-13-7-18	
Sample Dimensions	12X12 INCHES	
ON SITE VISUAL EXAMINATION		
Checks	Observations	
	Exterior	Units
Void space between concrete and liner (if any)	On left side, uneven corrosion product and a 1/16-inch void. Otherwise, no voids.	
Biological Materials	None	
Wet or Dry	Mostly dry, with some damp spots	
Smell	None	
Temperature	79.3	F
Surface pH	11-12 dry areas, 7-8 in areas with corrosion product	
Structure to Electrolyte	-0.488	Volts/CSE
Concrete Resistivity	27.8 Horizontal 31.2 Vertical	K-Ohm-cm
General Condition	Good, with some corrosion products. Corrosion product was black on the left side, and brown in some other areas. Concrete was hard and difficult to drill for powder samples. Coupons required some hammering and prying to remove after cutting.

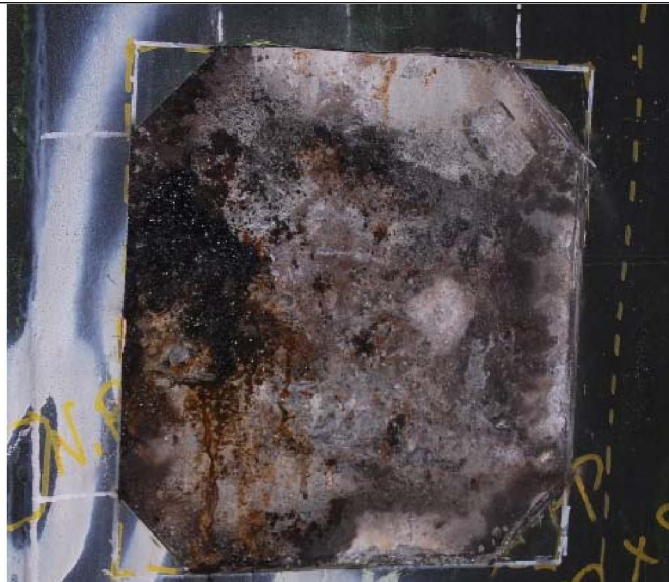
6/20/2018: 0800		
CONCRETE SAMPLE SPECIFICS		
Sample ID	5	5
Sample Location	14-DA-26-15-15-8	
Sample Dimensions	12X12 INCHES	
ON SITE VISUAL EXAMINATION		
Checks	Observations	
	Exterior	Units
Void space between concrete and liner (if any)	1/16" Void on top right side, no voids in all other areas	
Biological Materials	None	
Wet or Dry	Dry	
Smell	None	
Temperature	78.5	F
Surface pH	11-12	
Structure to Electrolyte	-0.220	Volts/CSE
Concrete Resistivity	19.1 Horizontal 22.0 Vertical	k-ohm-cm k-ohm-cm
General Condition	Excellent, sound concrete

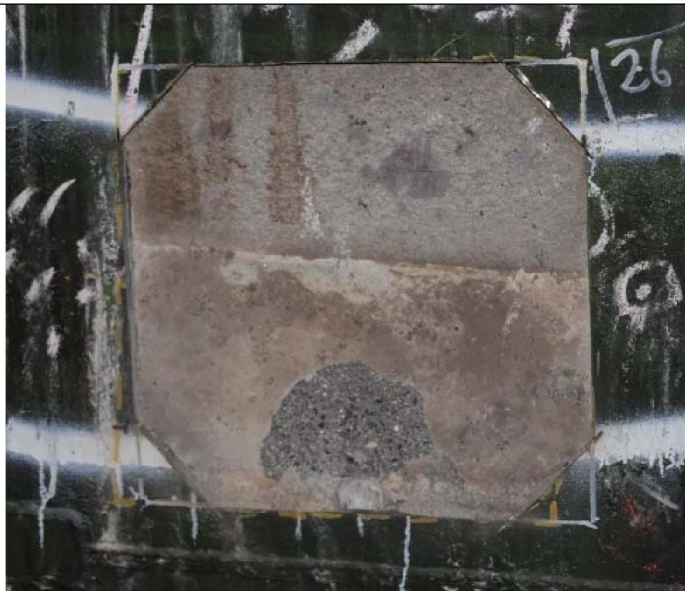
6/21/2018: 1100		
CONCRETE SAMPLE SPECIFICS		
Sample ID	6	6
Sample Location	14-BA-24-8-36-30	
Sample Dimensions	12X12 INCHES	
ON SITE VISUAL EXAMINATION		
Checks	Observations	
	Exterior	Units
Void space between concrete and liner (if any)	None, however some loose adhering grout present	
Biological Materials	None	
Wet or Dry	Dry	
Smell	None	
Temperature	77.4F	F
Surface pH	12.5	
Structure to Electrolyte	-0.387	Volts/CSE
Concrete Resistivity	Horizontal = 387 Vertical = 359	k-ohm-cm k-ohm-cm
General Condition	Concrete is sound, no delamination. There is loose adhering grout on left side and middle

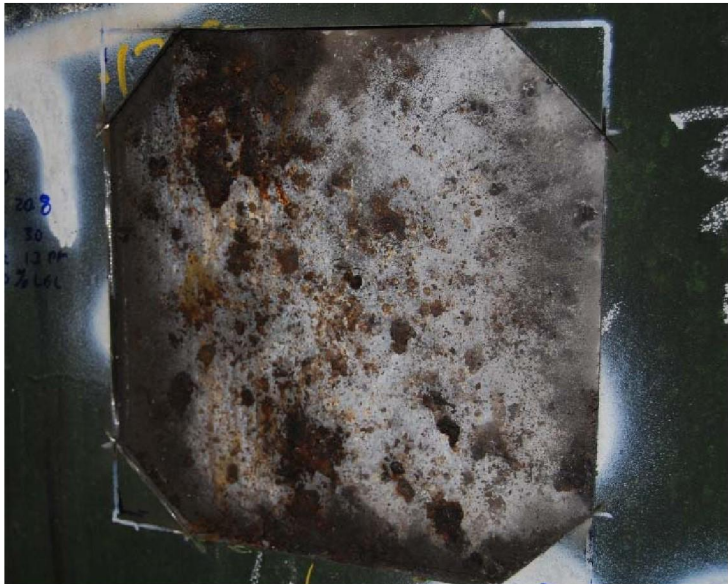
6/20/2018: 1400		
CONCRETE SAMPLE SPECIFICS		
Sample ID	8	8
Sample Location	14-BA-20-13-23-4	
Sample Dimensions	12X12 INCHES	
ON SITE VISUAL EXAMINATION		
Checks	Observations	
	Exterior	Units
Void space between concrete and liner (if any)	1/16" Void on left side, no voids in all other areas	
Biological Materials	None	
Wet or Dry	Dry	
Smell	None	
Temperature	80.0	F
Surface pH	11-12	
Structure to Electrolyte	-0.248	Volts/CSE
Concrete Resistivity	30.9 Horizontal 27.5 Vertical	k-ohm-cm k-ohm-cm
General Condition	Excellent, sound concrete with no cracks or delamination. Coupon had steel backing plate

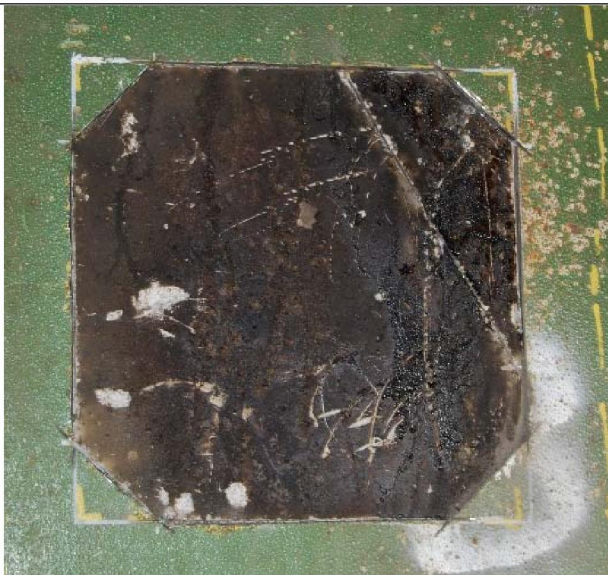
6/20/2018: 1100		
CONCRETE SAMPLE SPECIFICS		
Sample ID	A1	A1
Sample Location	14-BA-23-9-95-50	
Sample Dimensions	12X12 INCHES	
ON SITE VISUAL EXAMINATION		
Checks	Observations	
	Exterior	Units
Void space between concrete and liner (if any)	1/8" Void on left side, no voids in all other areas	
Biological Materials	None	
Wet or Dry	Mostly dry with damp areas around corrosion product	
Smell	None	
Temperature	77.5	F
Surface pH	11-12 in dry areas, 7-8 in corroded area	
Structure to Electrolyte	-0.448 (dry area) -0.432 (damp area w. corrosion products)	Volts/CSE
Concrete Resistivity	32.9 Horizontal 37.0 Vertical	k-ohm-cm
General Condition	Good condition with sound concrete, no cracks or delamination. Corrosion products are present on concrete.

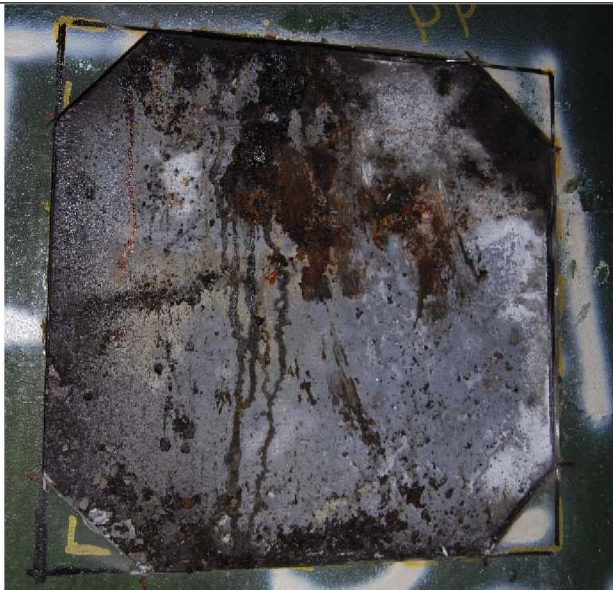
6/20/2018: 1530		
CONCRETE SAMPLE SPECIFICS		
Sample ID	A2	A2
Sample Location	14-BA-11-4-226-50	
Sample Dimensions	12X12 INCHES	
ON SITE VISUAL EXAMINATION		
Checks	Observations	
	Exterior	Units
Void space between concrete and liner (if any)	1/2" Void on left and bottom side. ¼"void on the right side	
Biological Materials	None	
Wet or Dry	Dry	
Smell	None	
Temperature	78.4	F
Surface pH	11-12	
Structure to Electrolyte	-0.226 (middle) -0.230 (right side)	Volts/CSE
Concrete Resistivity	35.8 Horizontal 36.1 Vertical	k-ohm-cm
General Condition	Good condition with sound concrete, no cracks or delamination. There is a layer of concrete which appears to have come off. Below that layer is sound concrete.	
Provide photo documentation with a minimum resolution of 2560 x 1920 of the coupon, front and back.
