**SUBJECT: DESTRUCTIVE ANALYSIS OF 10 STEEL COUPONS REMOVED FROM
RED HILL FUEL STORAGE TANK NO. 14, PURSUANT TO SECTION 5.3
OF THE ADMINISTRATIVE ORDER ON CONSENT STATEMENT OF
WORK, RED HILL BULK FUEL STORAGE FACILITY, JOINT BASE PEARL
HARBOR-HICKAM, OAHU, HAWAII**

Destructive Analysis of 10 Steel Coupons Removed from Red Hill Fuel Storage Tank #14

REPORT No. 201801967

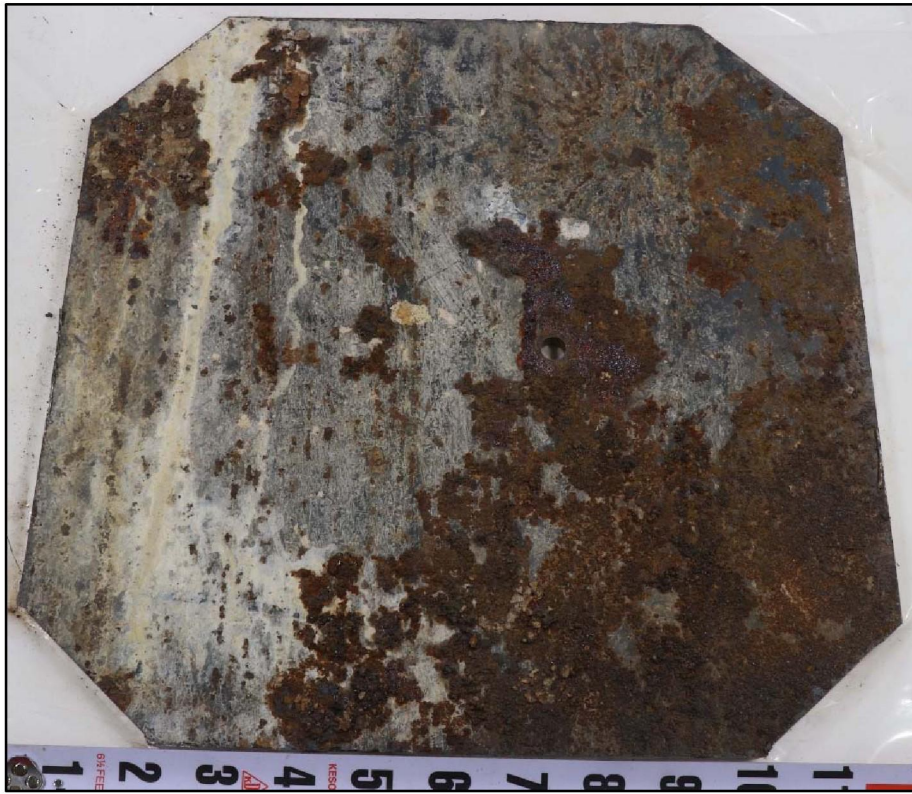
Figure 1. An image of the interior surface of Coupon 1 in the as-received condition.

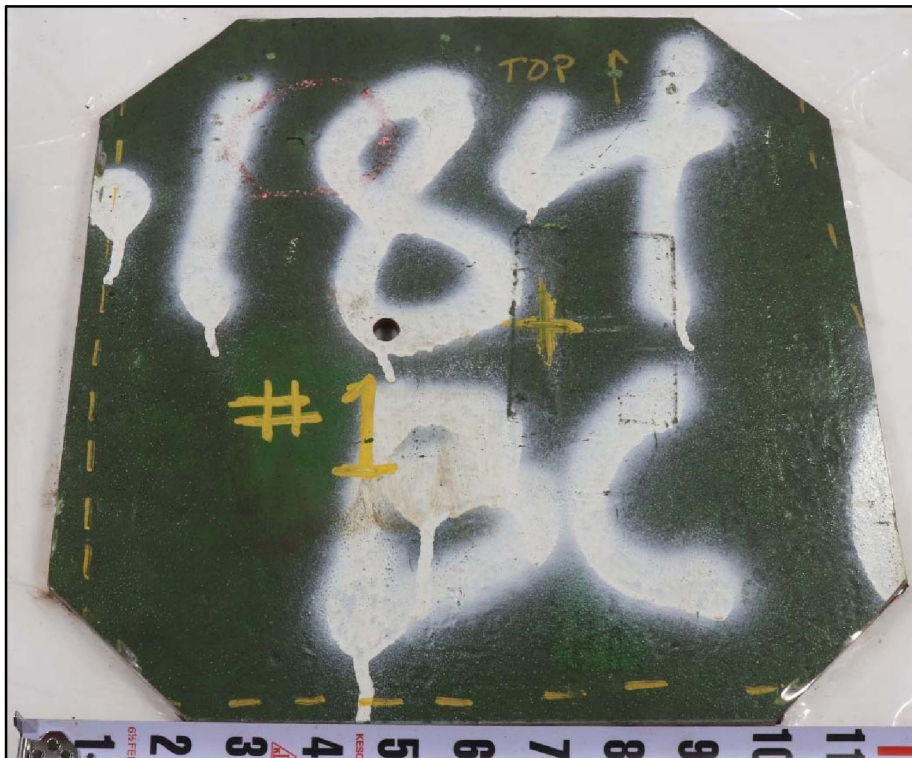
Figure 2. An image of the exterior surface of Coupon 1 in the as-received condition.

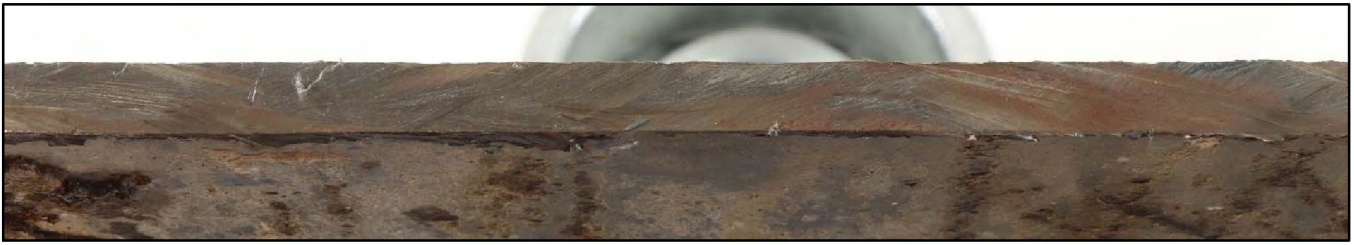
Figure 3. An image of a representative edge of Coupon 1 in the as-received condition.

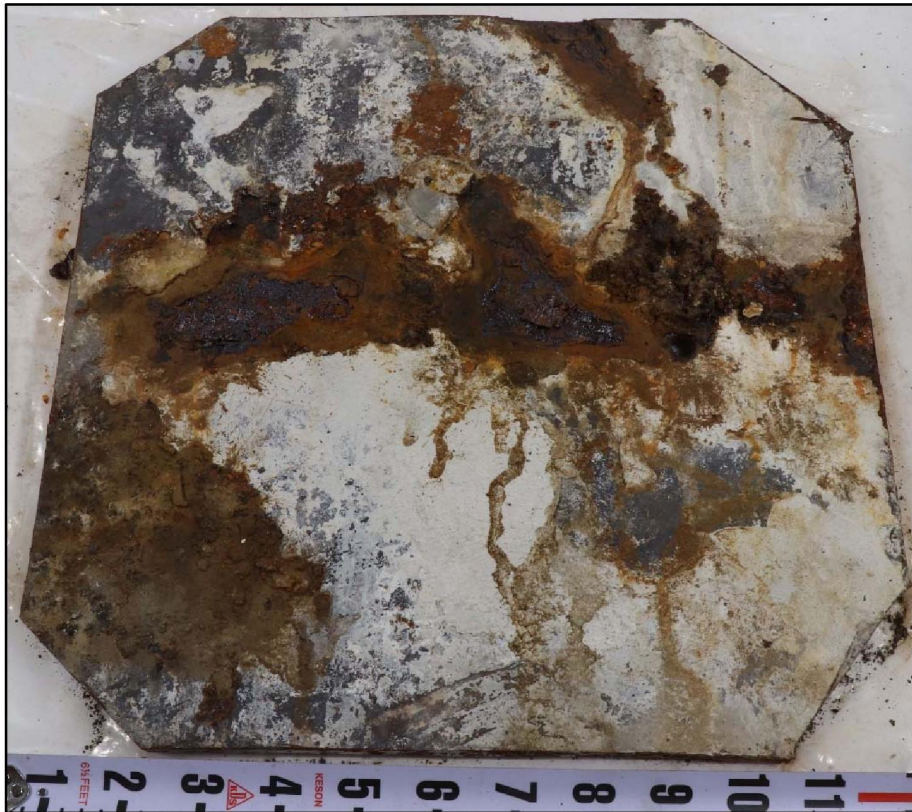
Figure 4. An image of the interior surface of Coupon 2 in the as-received condition.

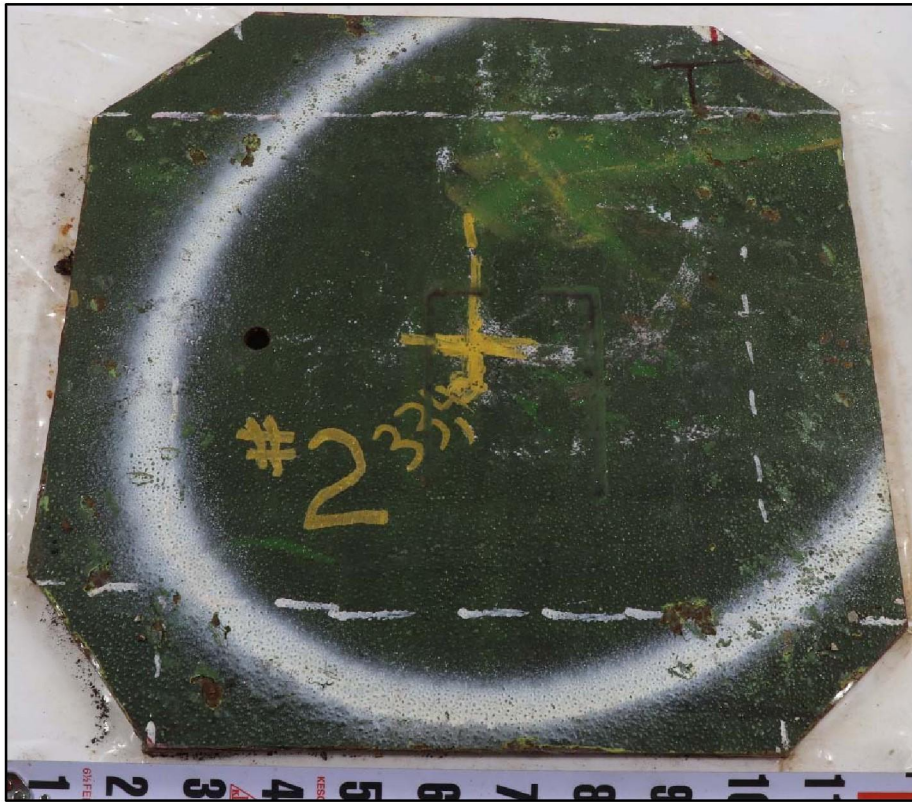
Figure 5. An image of the exterior surface of Coupon 2 in the as-received condition.

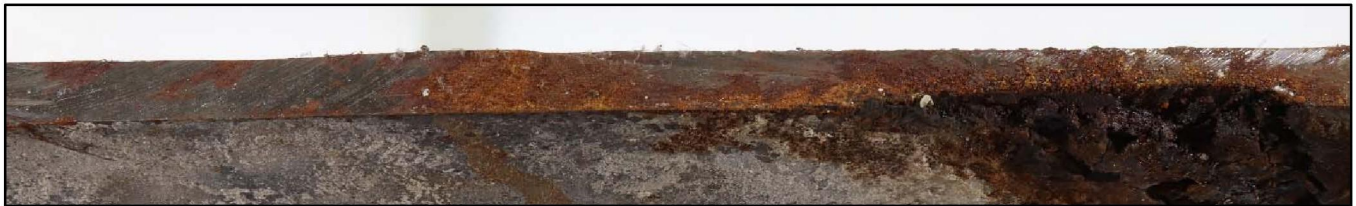
Figure 6. An image of a representative edge of Coupon 2 in the as-received condition.

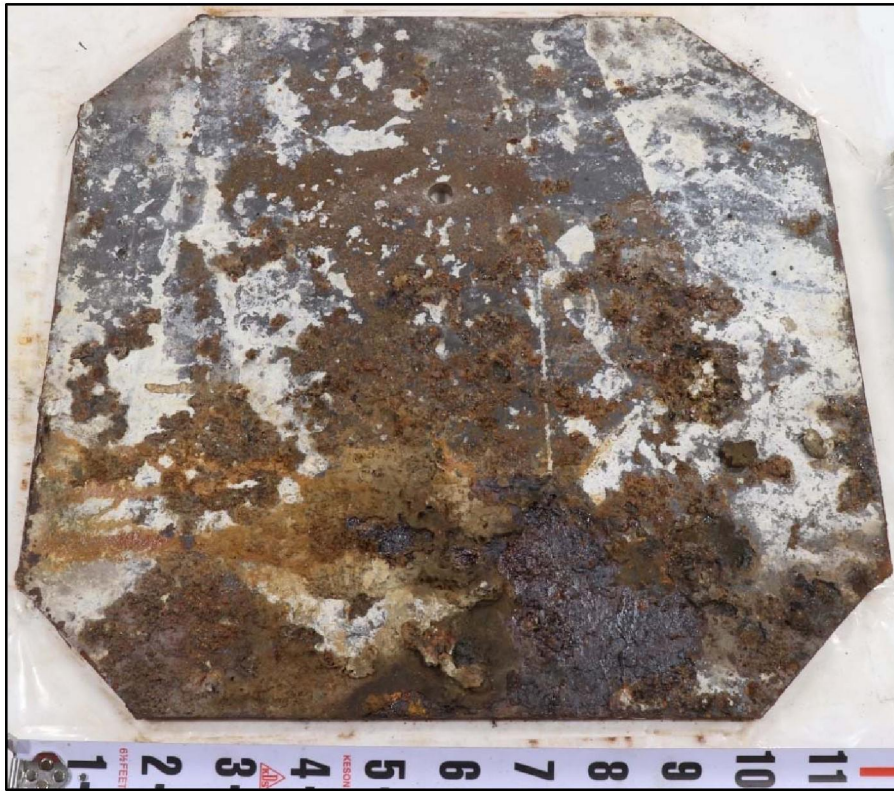
Figure 7. An image of the interior surface of Coupon 3 in the as-received condition.

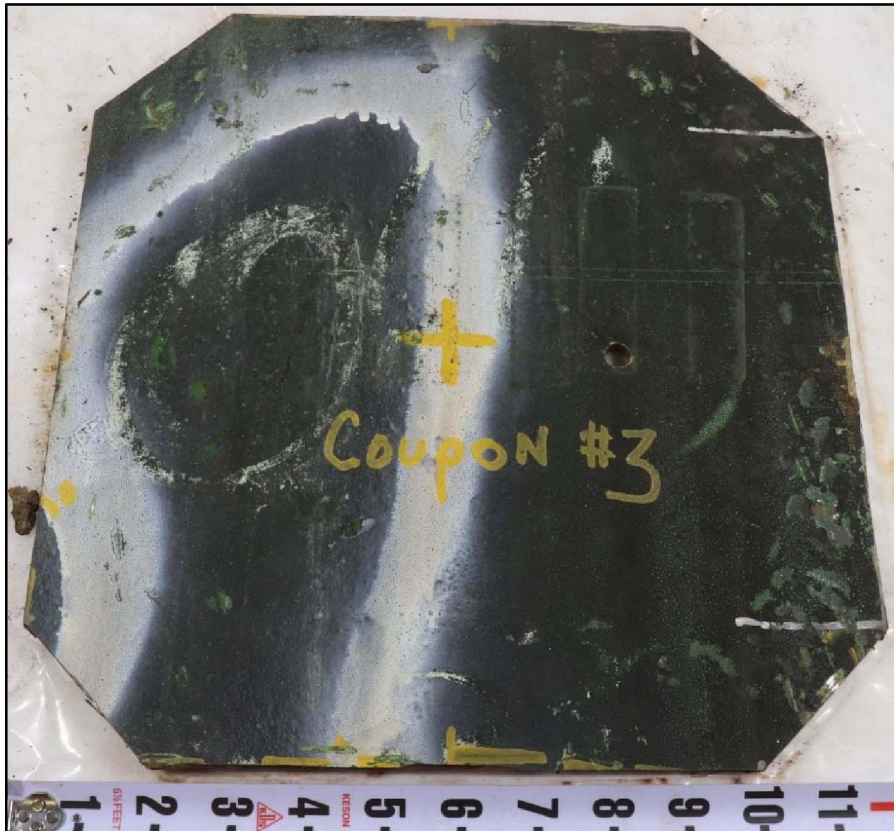
Figure 8. An image of the exterior surface of Coupon 3 in the as-received condition.

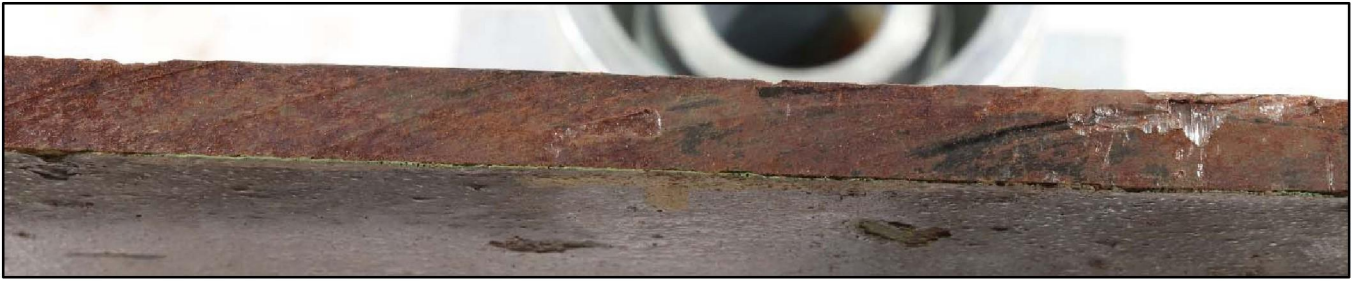
Figure 9. An image of a representative edge of Coupon 3 in the as-received condition.

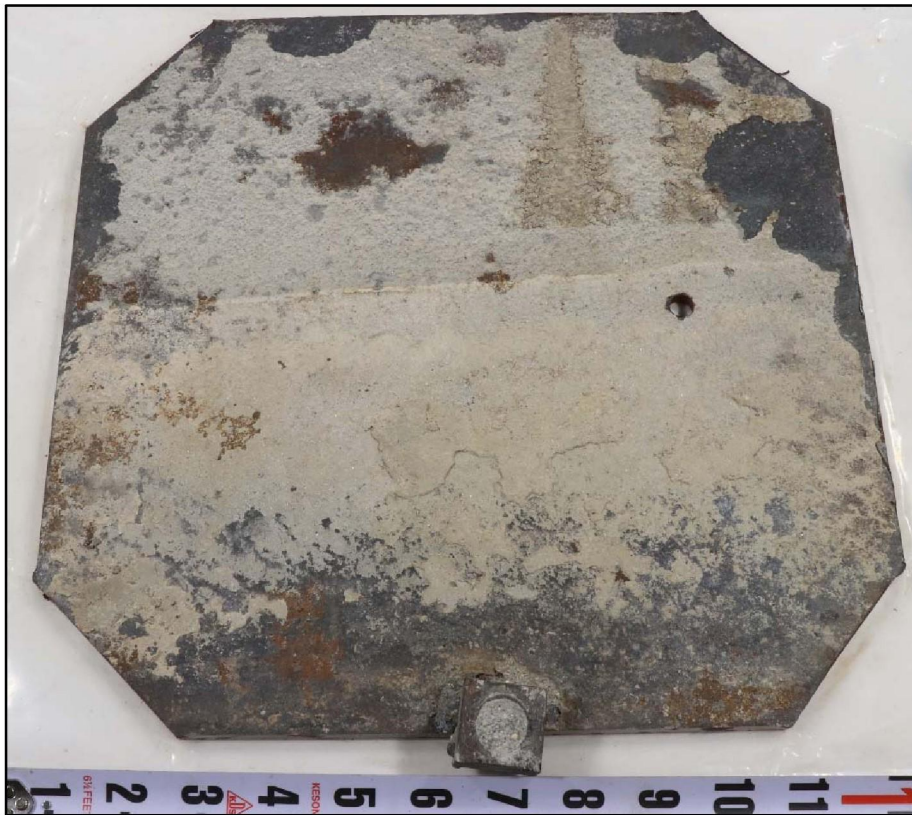
Figure 10. An image of the interior surface of Coupon 5 in the as-received condition.

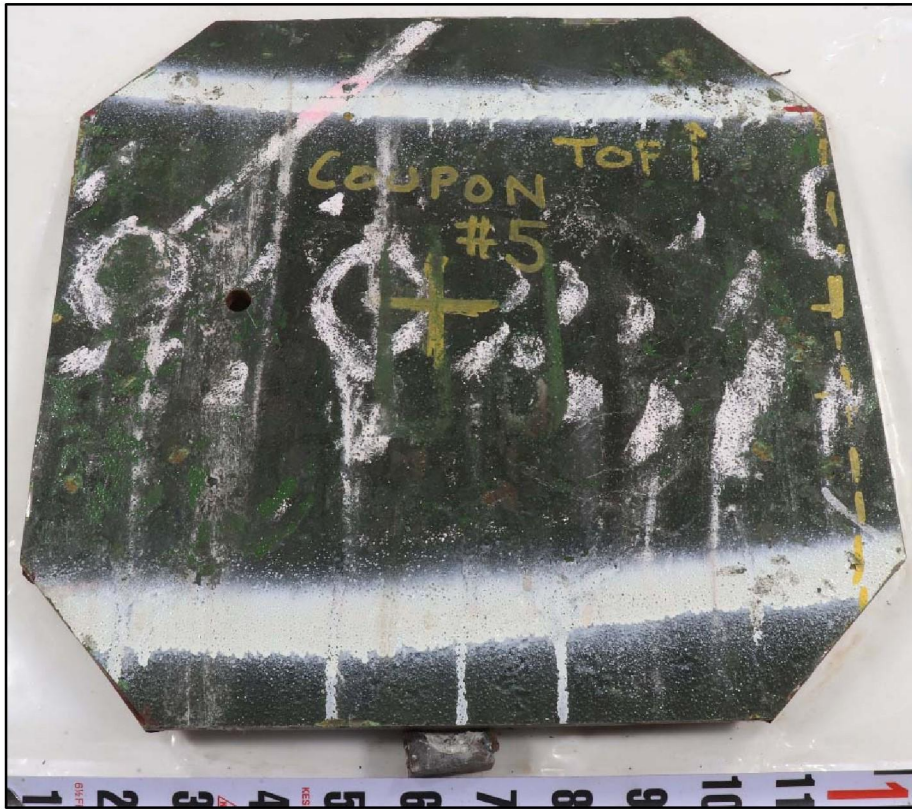
Figure 11. An image of the exterior surface of Coupon 5 in the as-received condition.

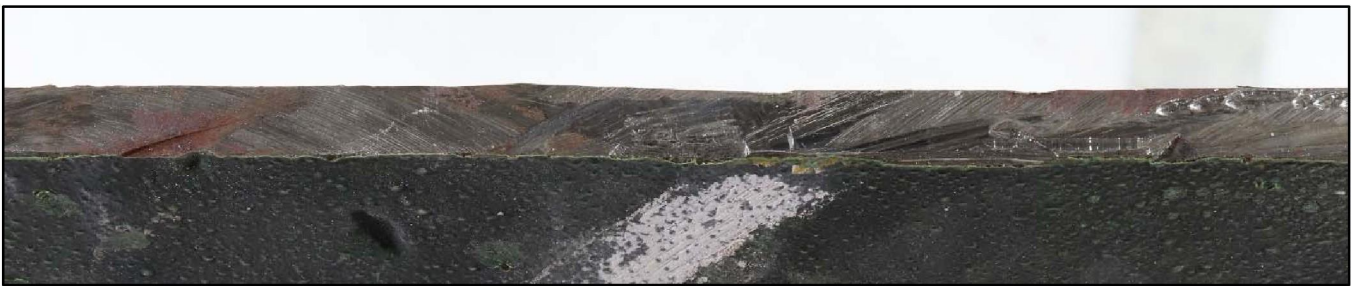
Figure 12. An image of a representative edge of Coupon 5 in the as-received condition.

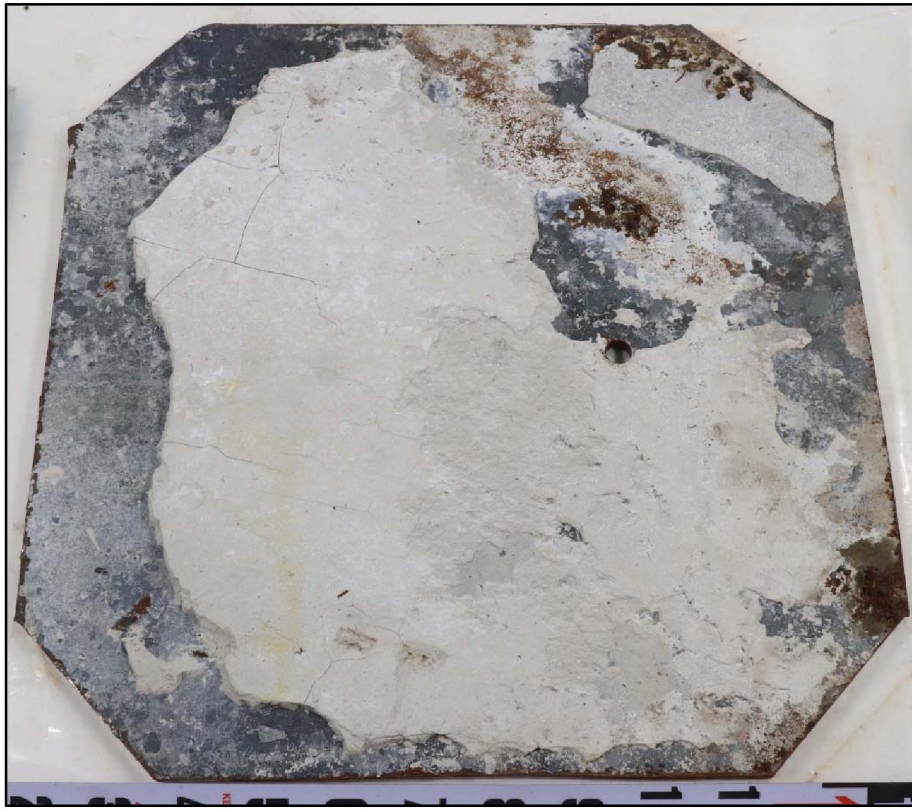
Figure 13. An image of the interior surface of Coupon 6 in the as-received condition.

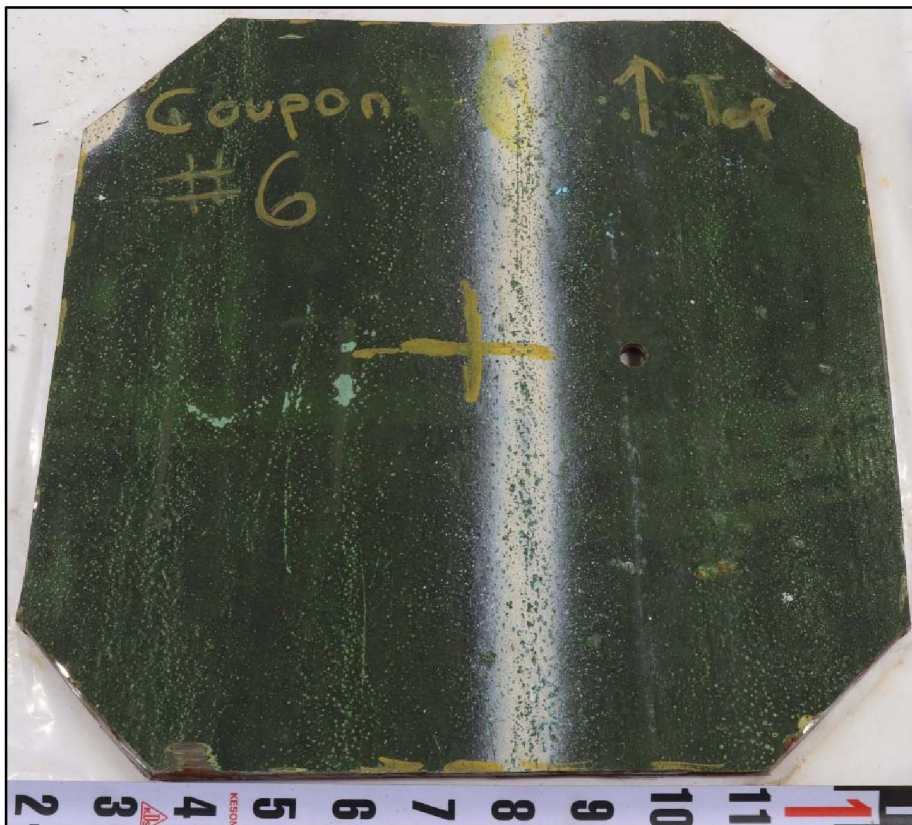
Figure 14. An image of the exterior surface of Coupon 6 in the as-received condition.

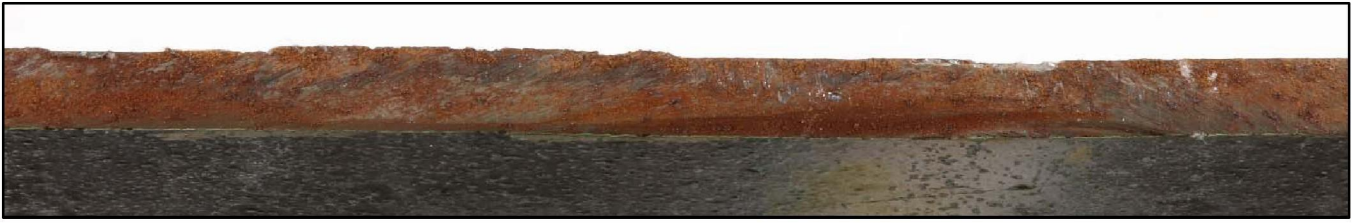
Figure 15. An image of a representative edge of Coupon 6 in the as-received condition.

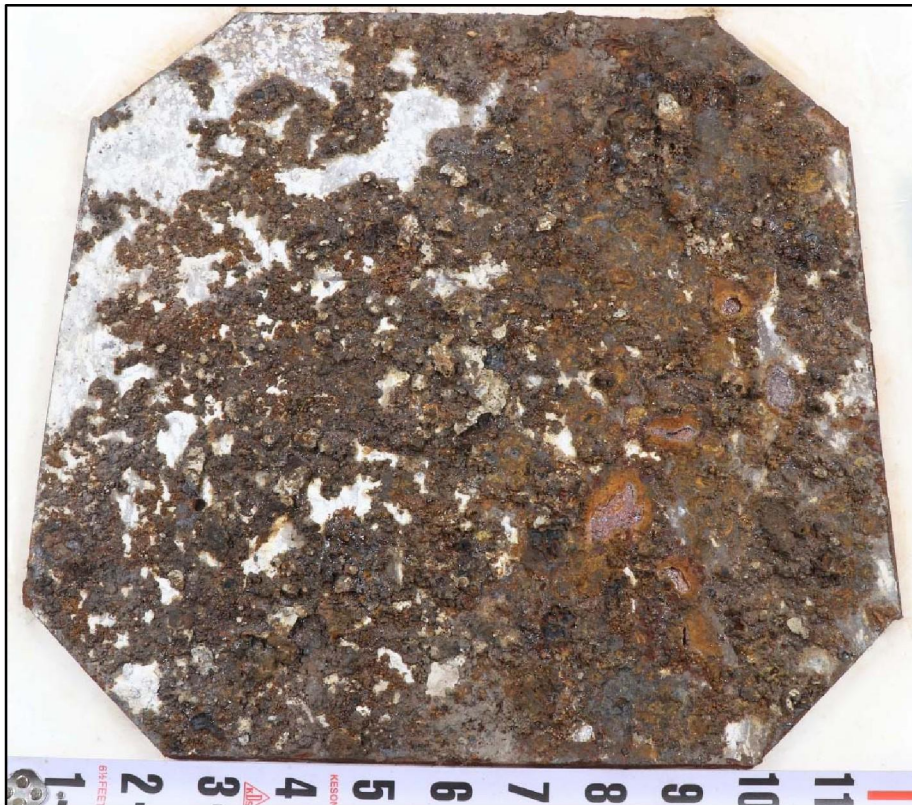
Figure 16. An image of the interior surface of Coupon 7 in the as-received condition.

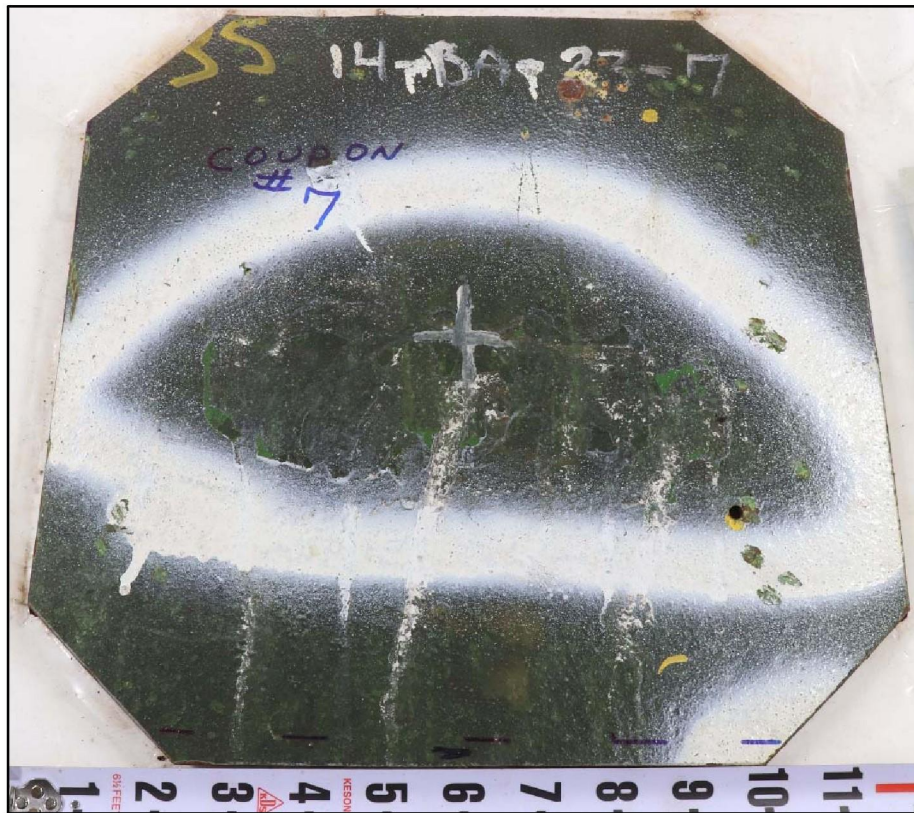
Figure 17. An image of the exterior surface of Coupon 7 in the as-received condition.

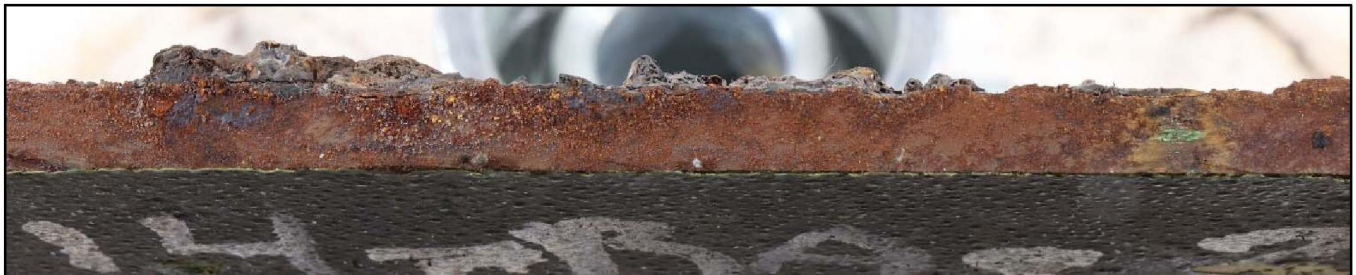
Figure 18. An image of a representative edge of Coupon 7 in the as-received condition.

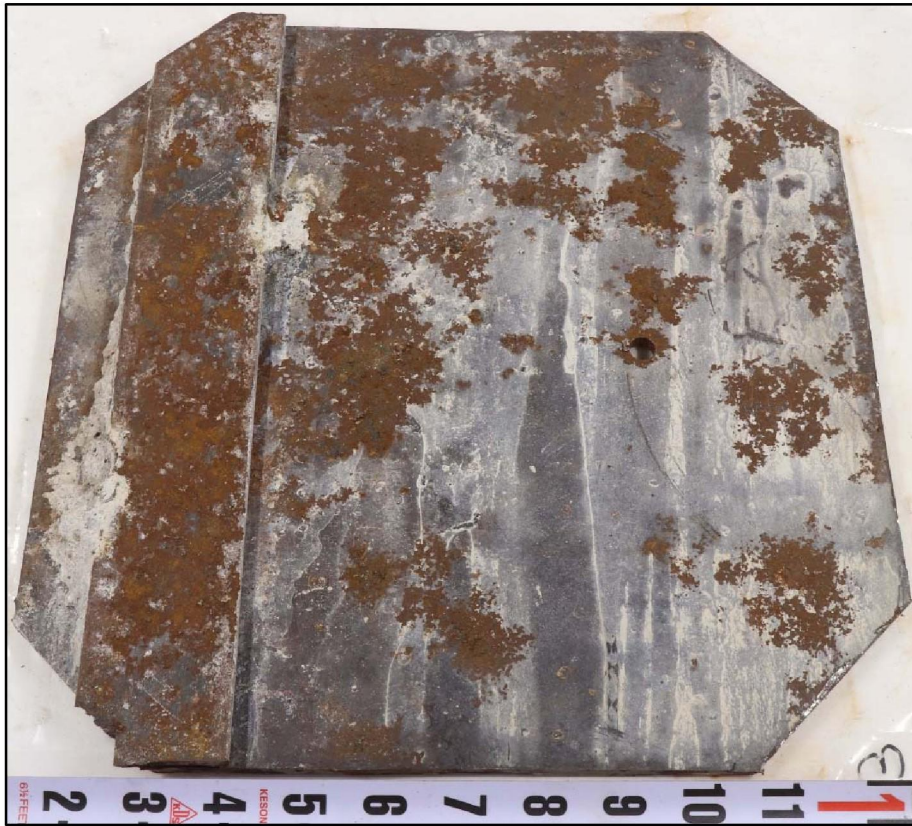
Coupon 8 exhibited what is presumed to be a prior weld repair and/or addition of a backing plate, where a patch was made on the tank wall. Representative images of the welds are presented as Figures 208 through 213. A full weld evaluation is outside the scope of this effort. The results are thus provided for information only.

Figure 19. An image of the interior surface of Coupon 8 in the as-received condition.

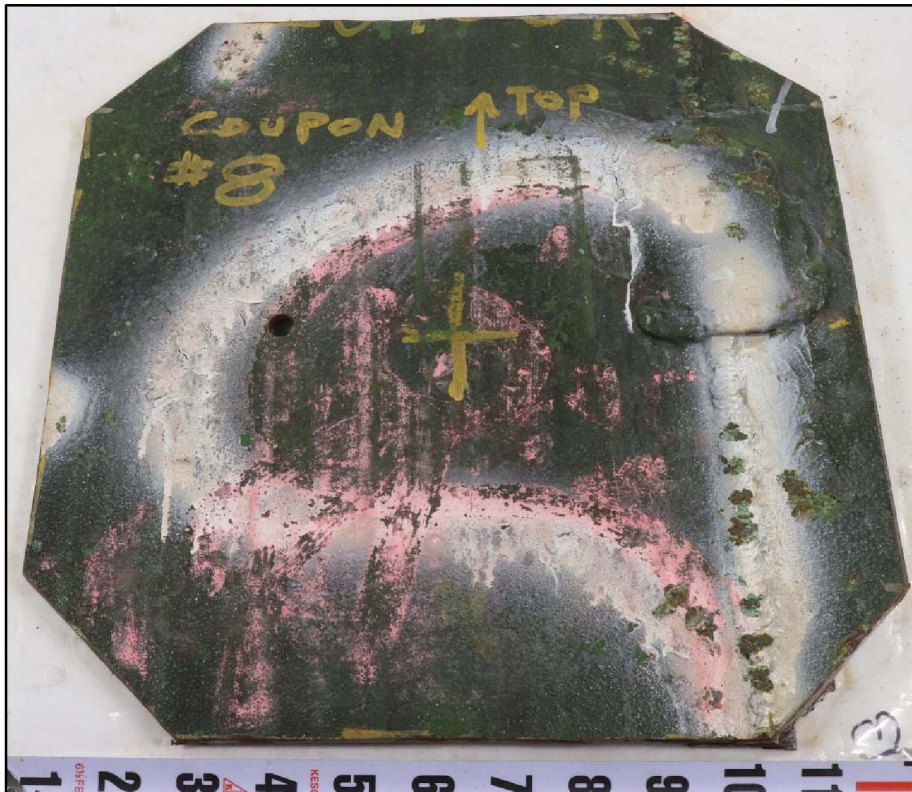
Figure 20. An image of the exterior surface of Coupon 8 in the as-received condition.

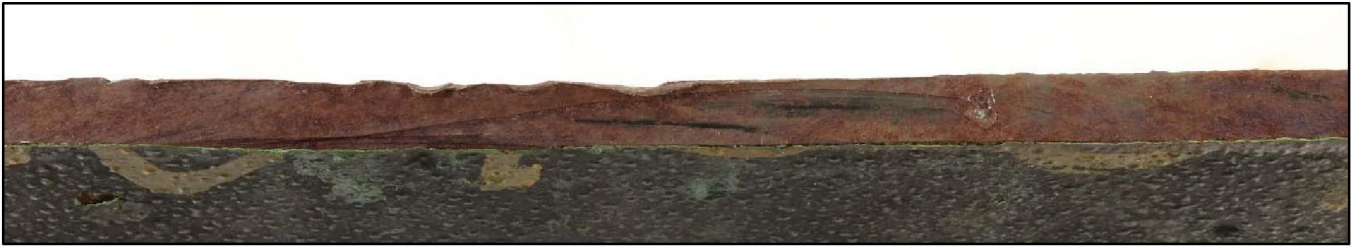
Figure 21. An image of a representative edge of Coupon 8 in the as-received condition.

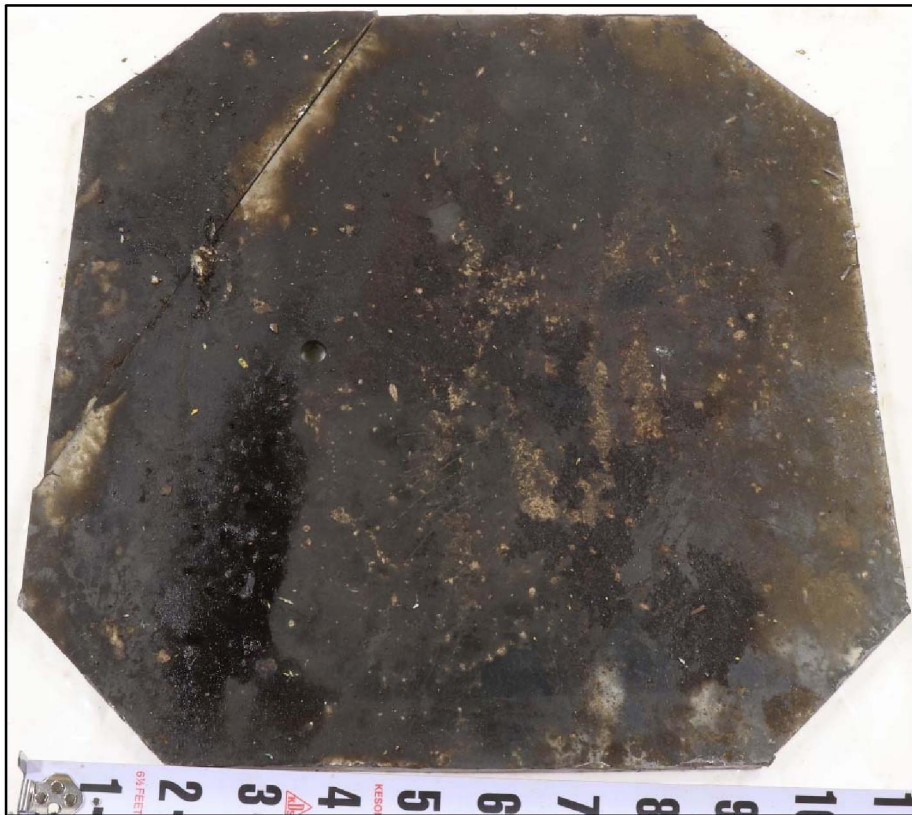
Figure 22. An image of the interior surface of Coupon 10 in the as-received condition.

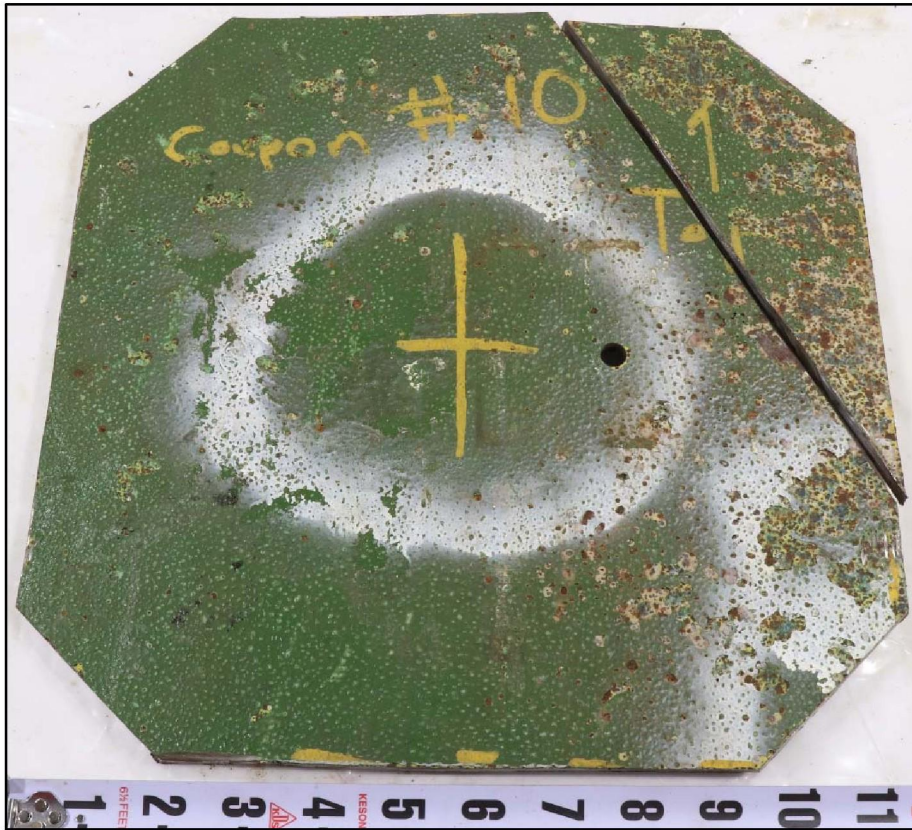
Figure 23. An image of the exterior surface of Coupon 10 in the as-received condition.

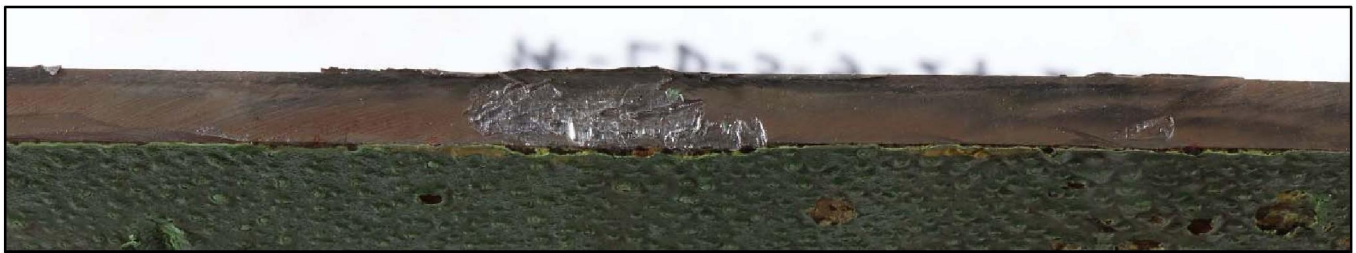
Figure 24. An image of a representative edge of Coupon 10 in the as-received condition.

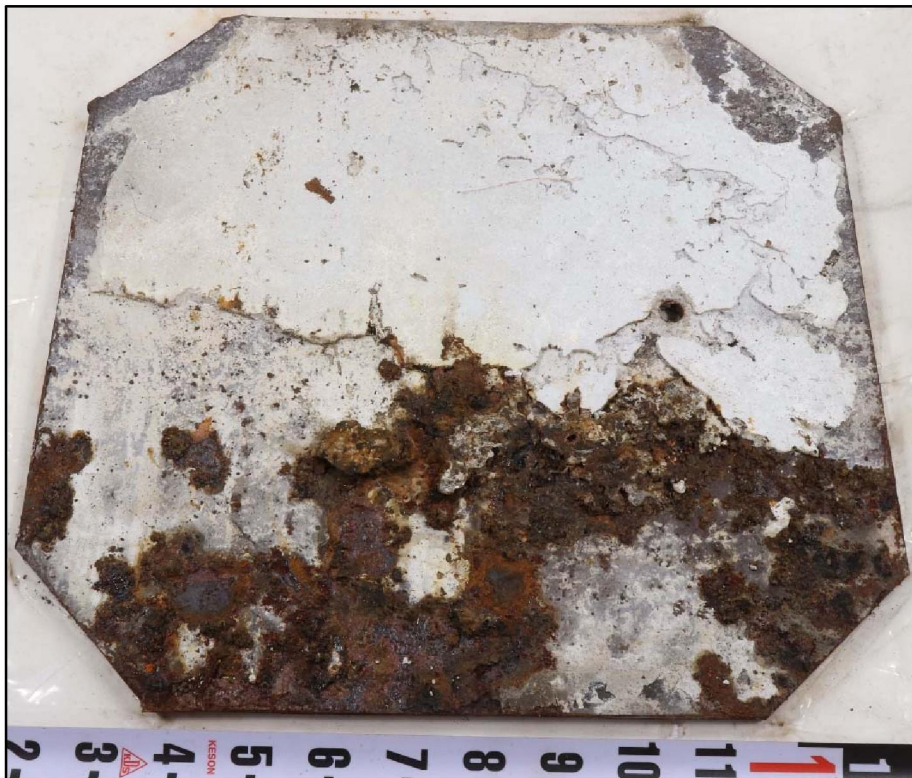
Figure 25. An image of the interior surface of Coupon A1 in the as-received condition.

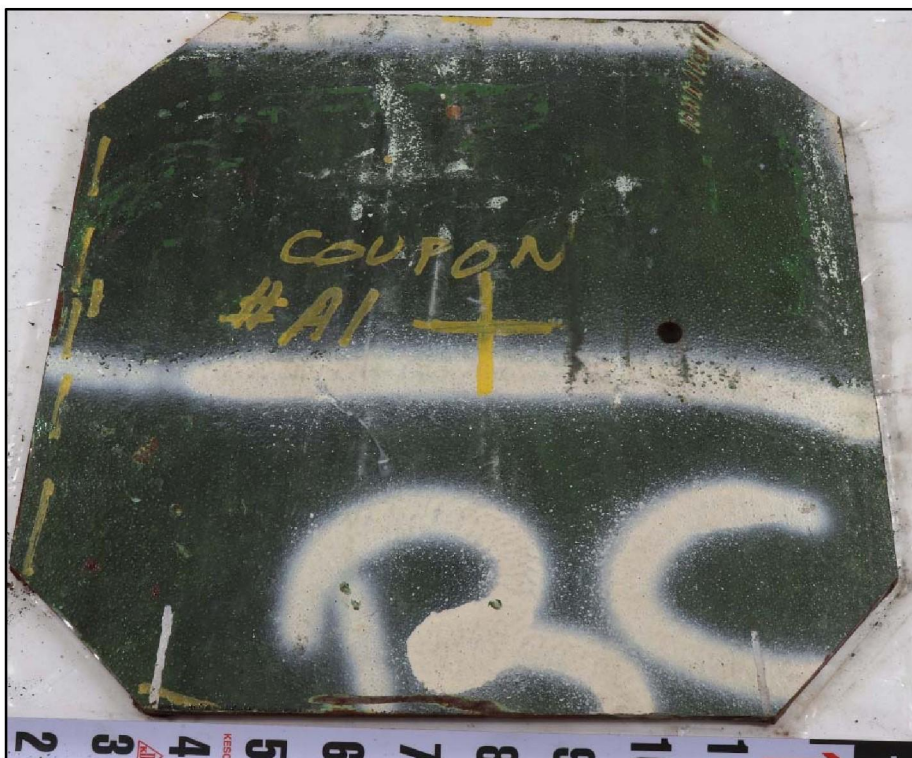
Figure 26. An image of the exterior surface of Coupon A1 in the as-received condition.

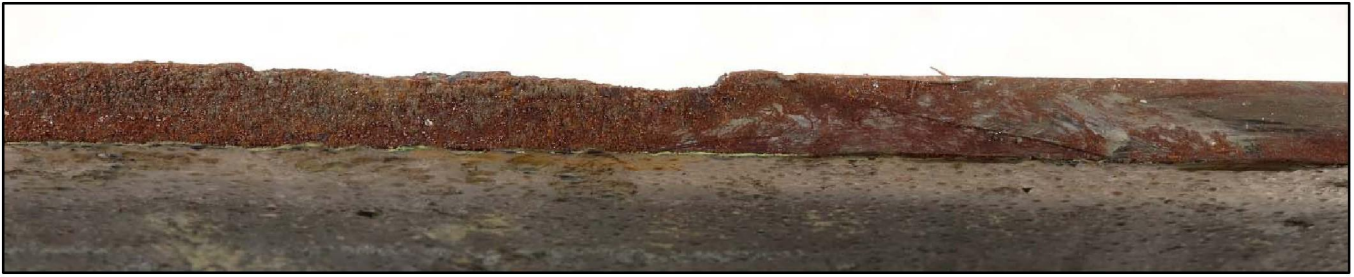
Figure 27. An image of a representative edge of Coupon A1 in the as-received condition.

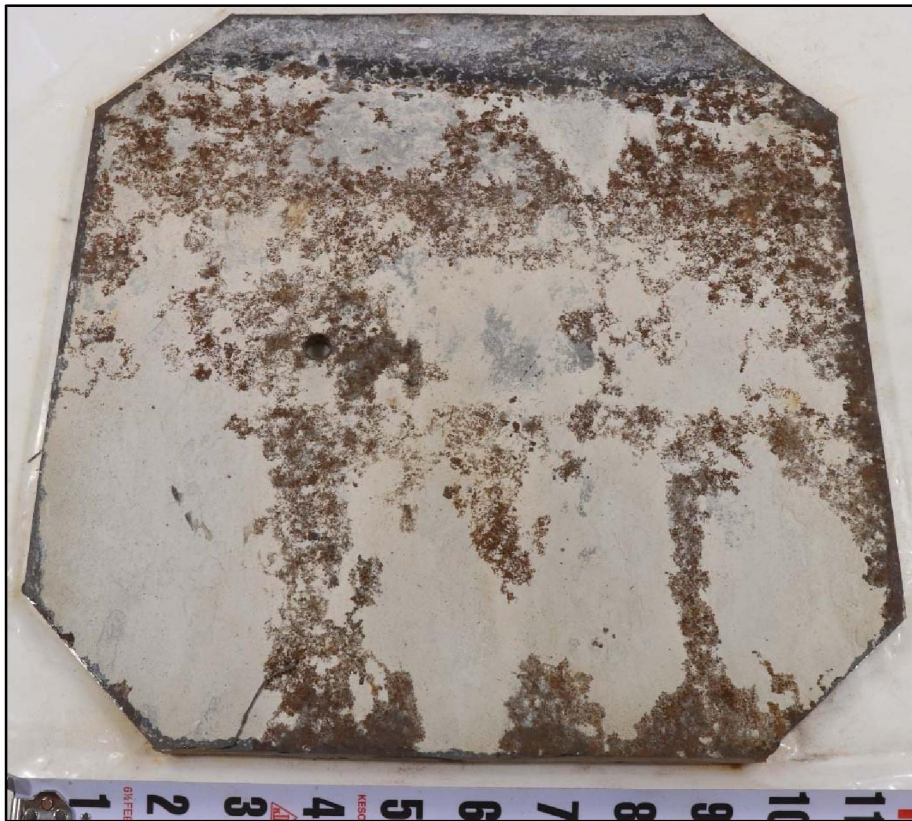
Figure 28. An image of the interior surface of Coupon A2 in the as-received condition.

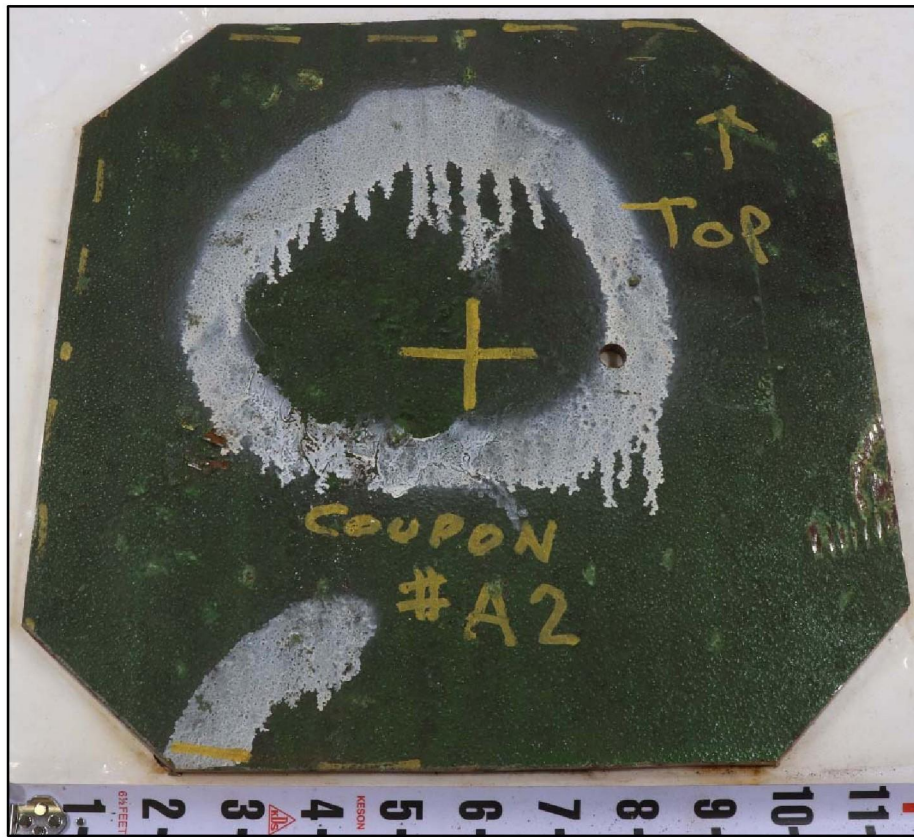
Figure 29. An image of the exterior surface of Coupon A2 in the as-received condition.

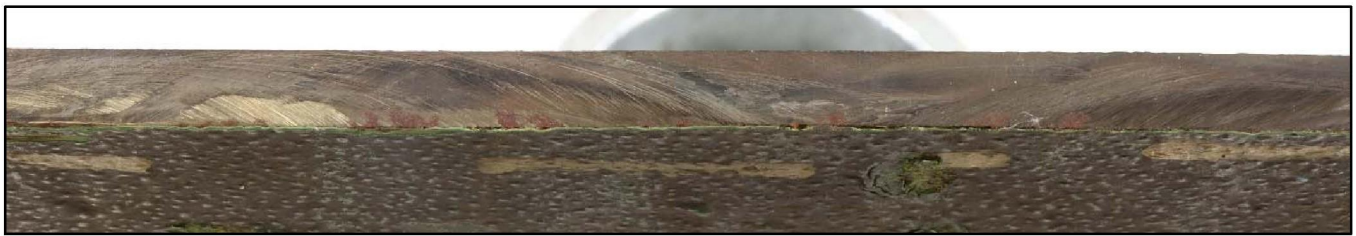
Figure 30. An image of a representative edge of Coupon A2 in the as-received condition.
