**SUBJECT: DESTRUCTIVE ANALYSIS OF 10 STEEL COUPONS REMOVED FROM
RED HILL FUEL STORAGE TANK NO. 14, PURSUANT TO SECTION 5.3
OF THE ADMINISTRATIVE ORDER ON CONSENT STATEMENT OF
WORK, RED HILL BULK FUEL STORAGE FACILITY, JOINT BASE PEARL
HARBOR-HICKAM, OAHU, HAWAII**

Destructive Analysis of 10 Steel Coupons Removed from Red Hill Fuel Storage Tank #14

REPORT No. 201801967

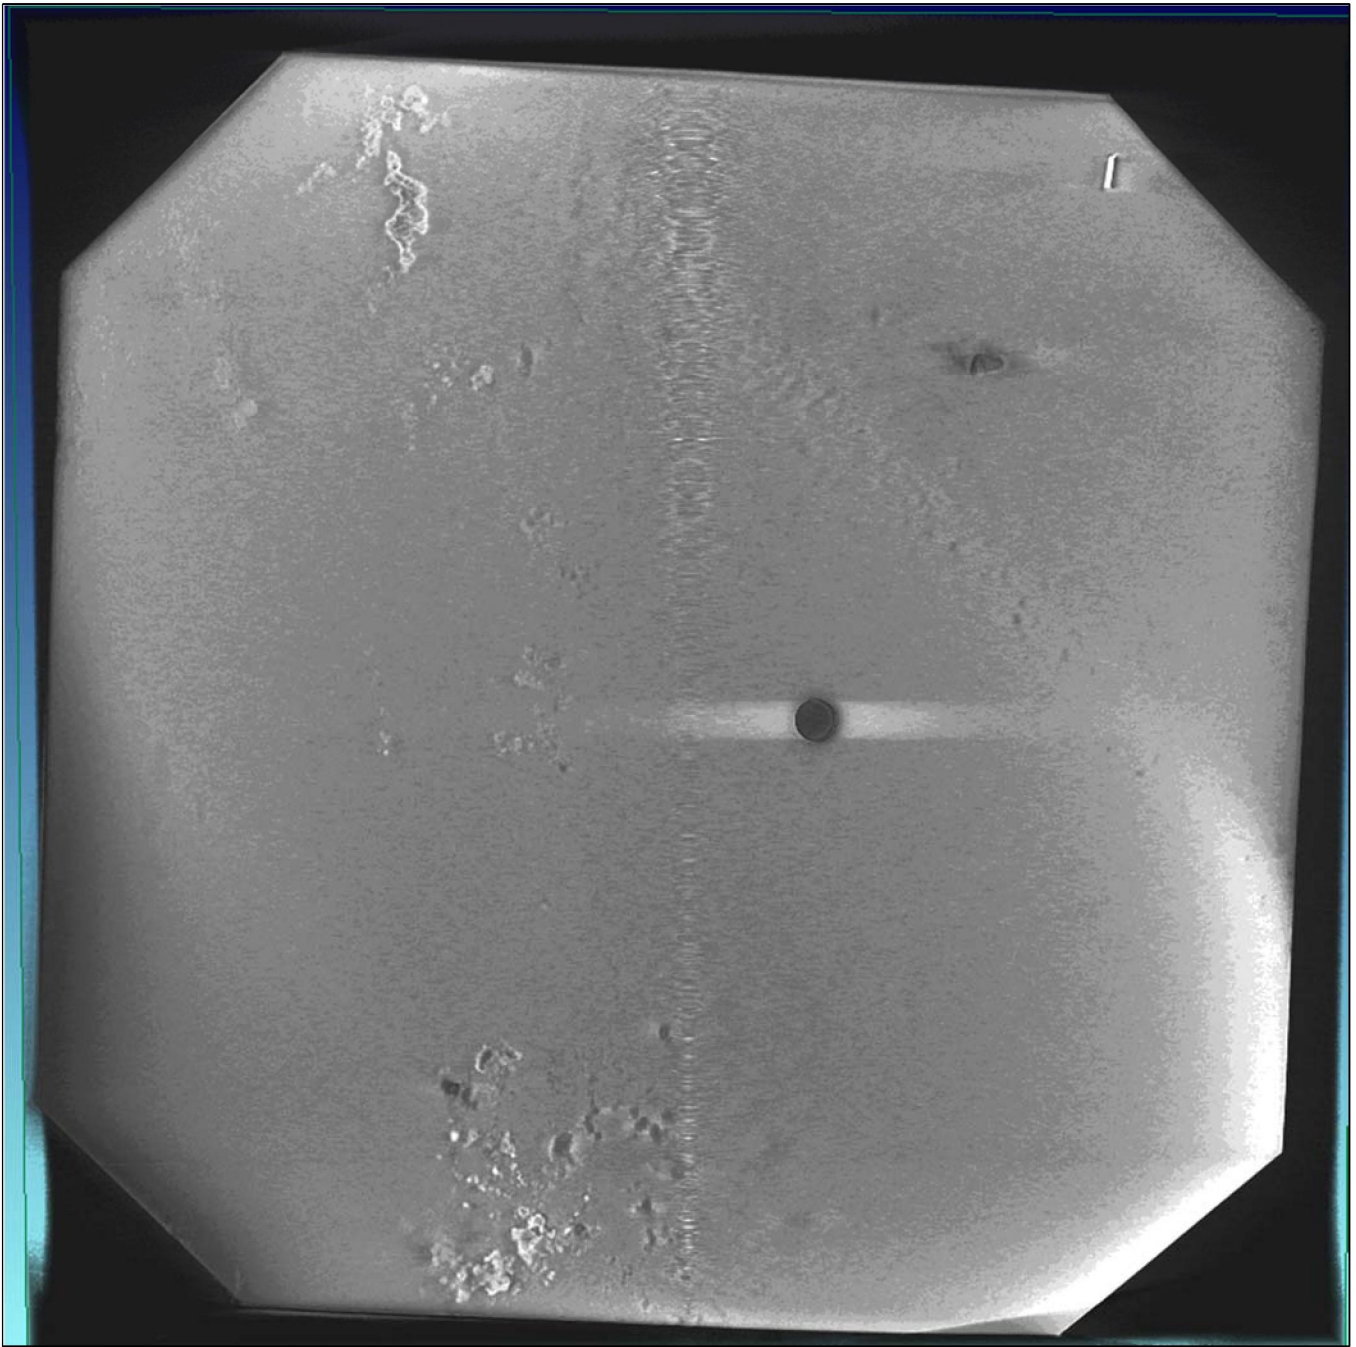
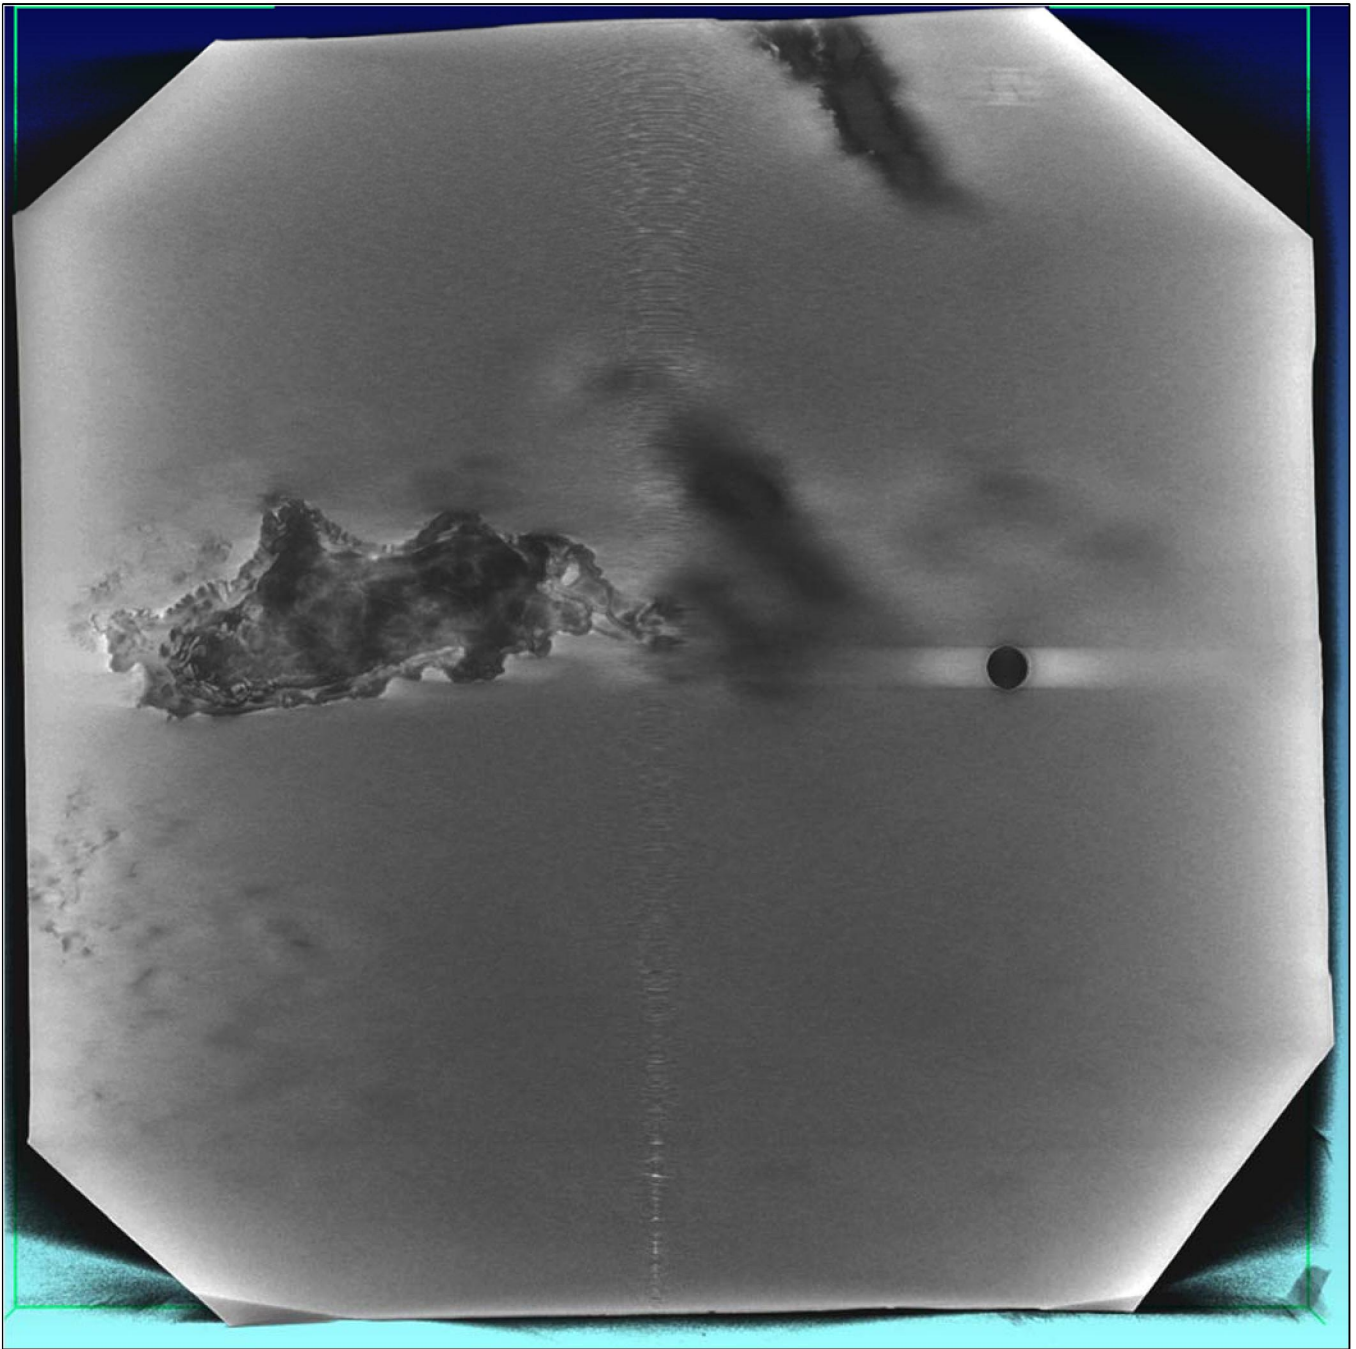
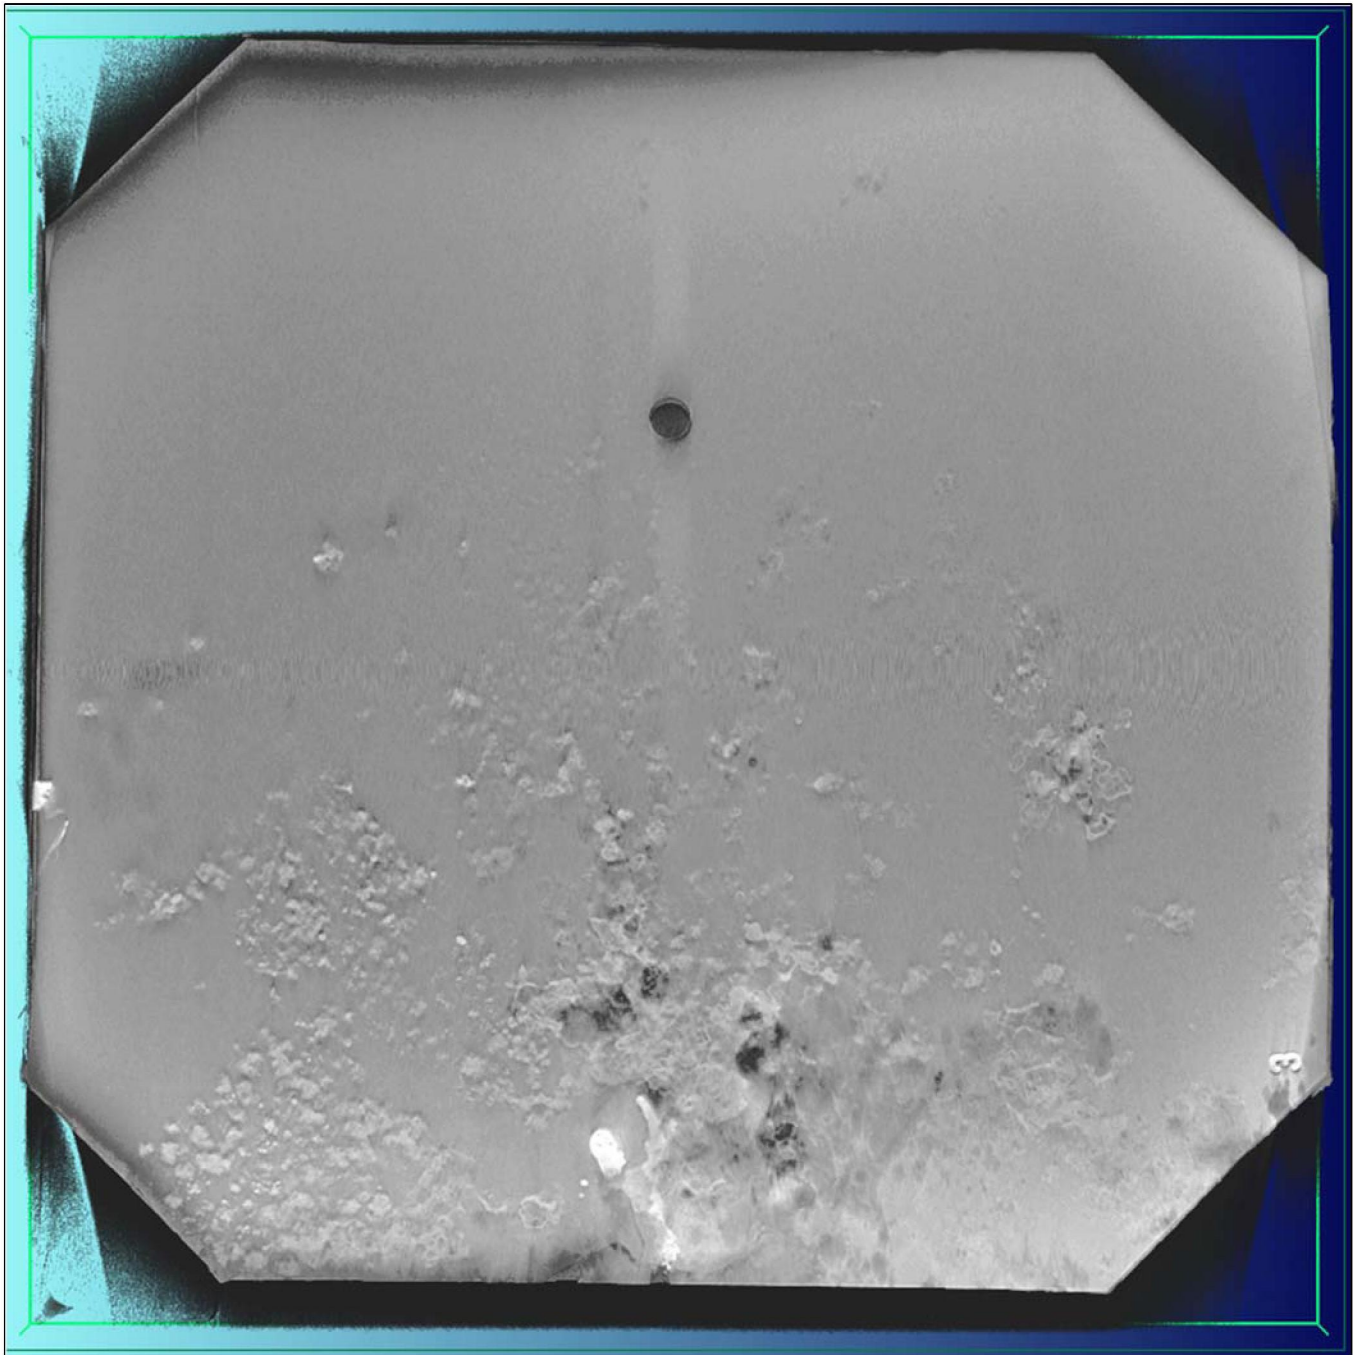
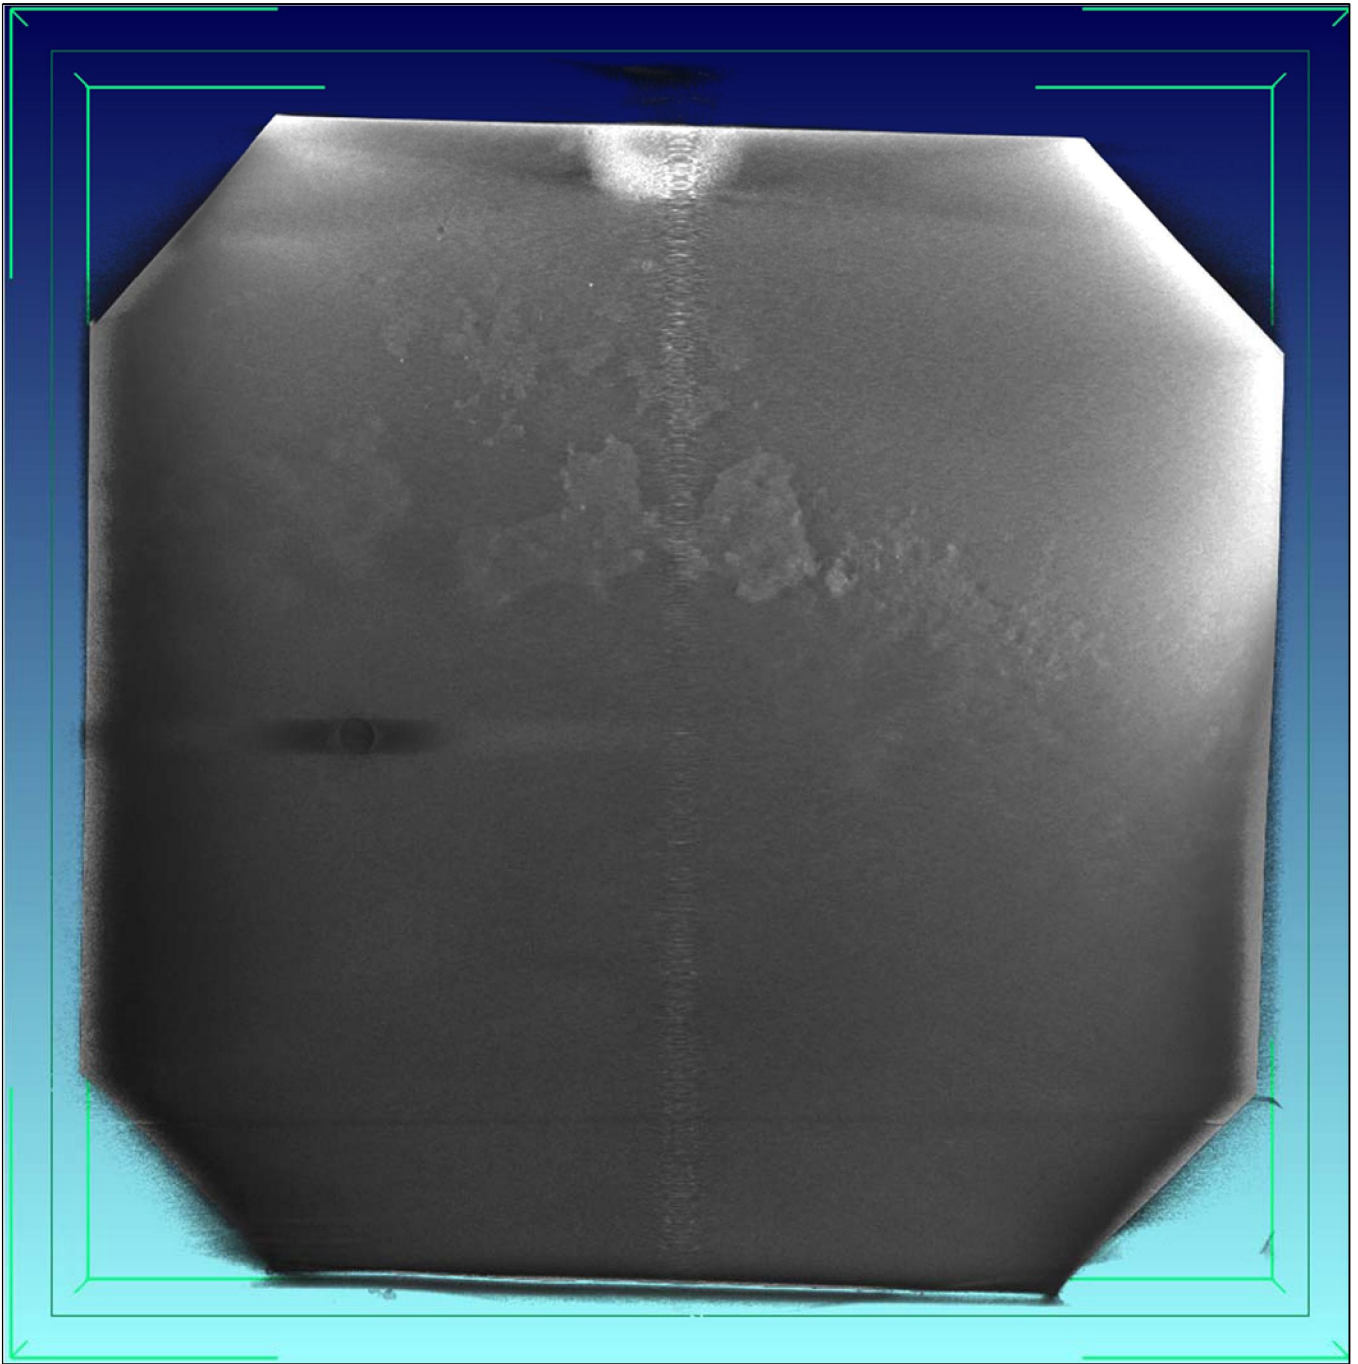
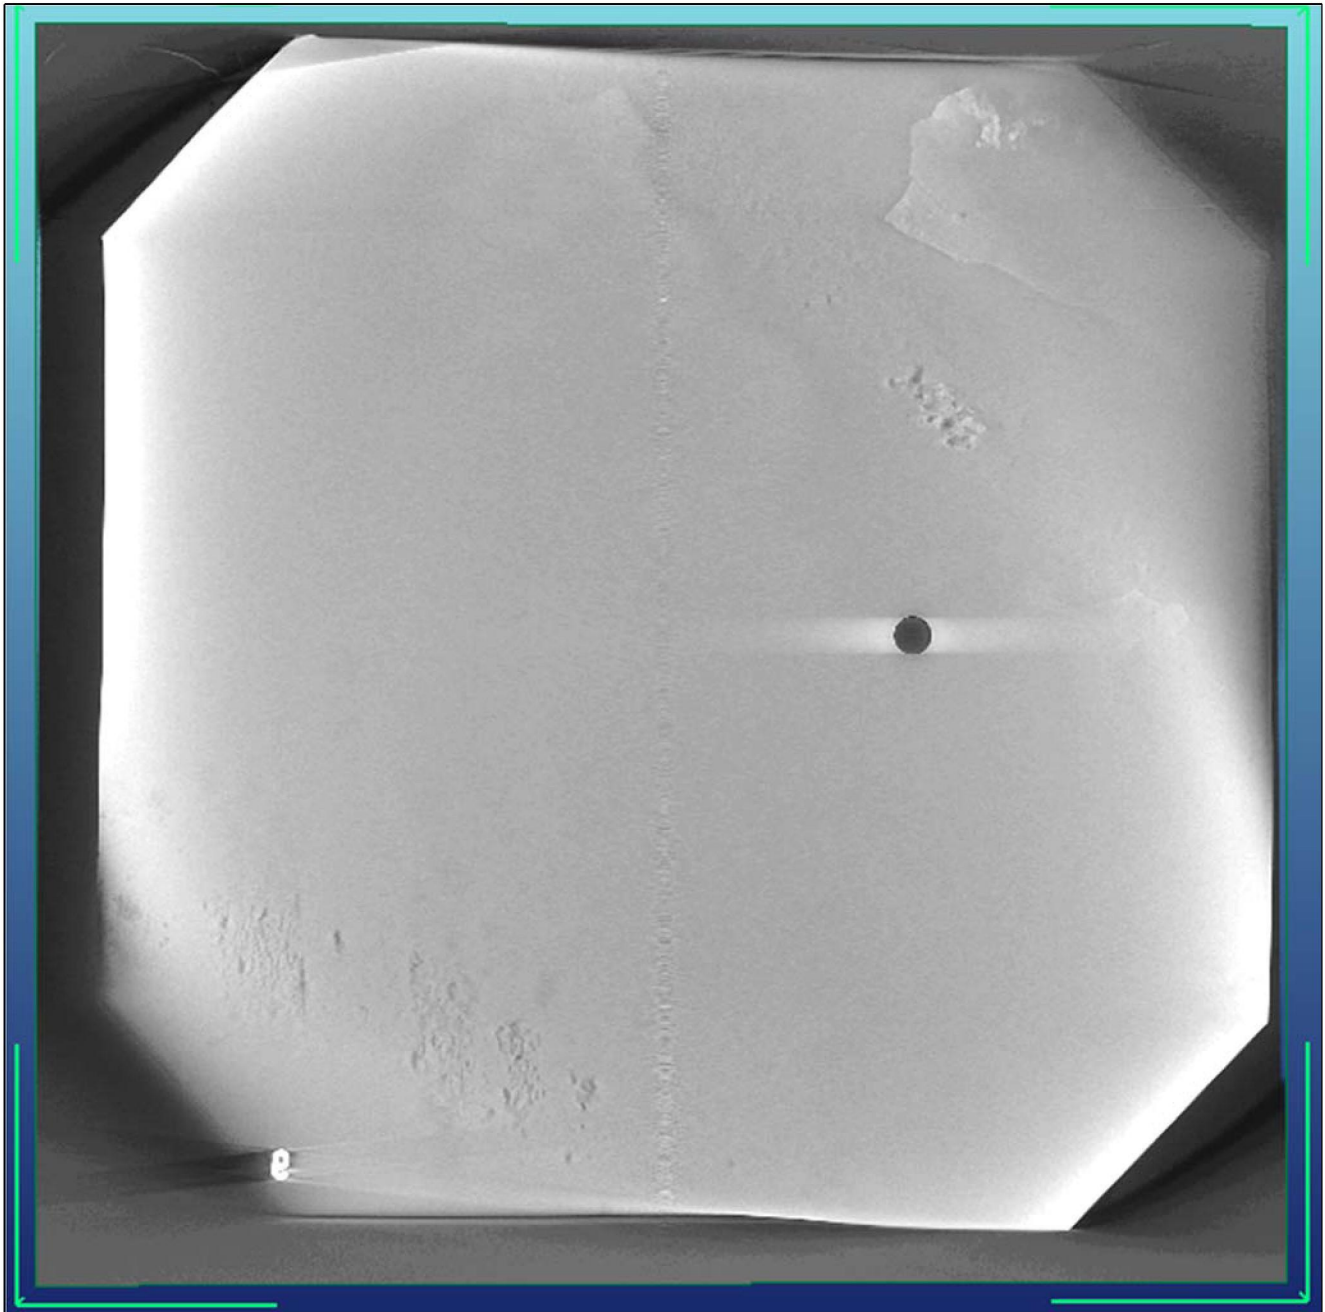
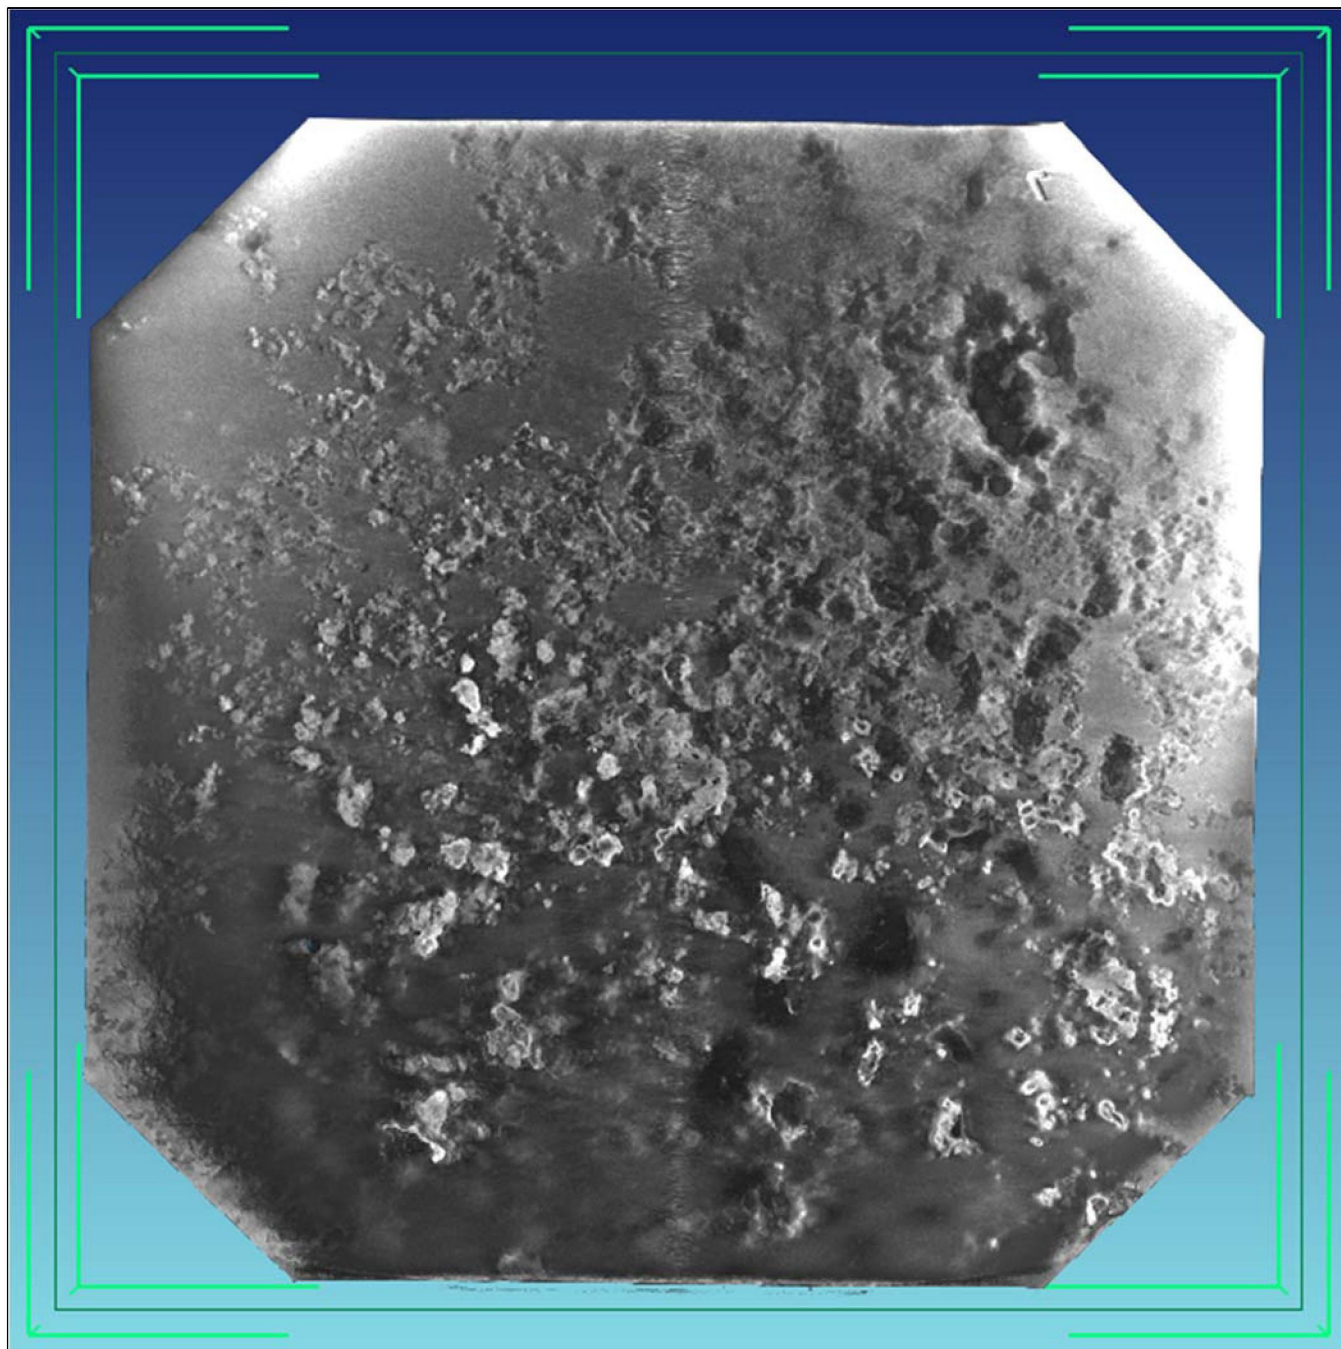
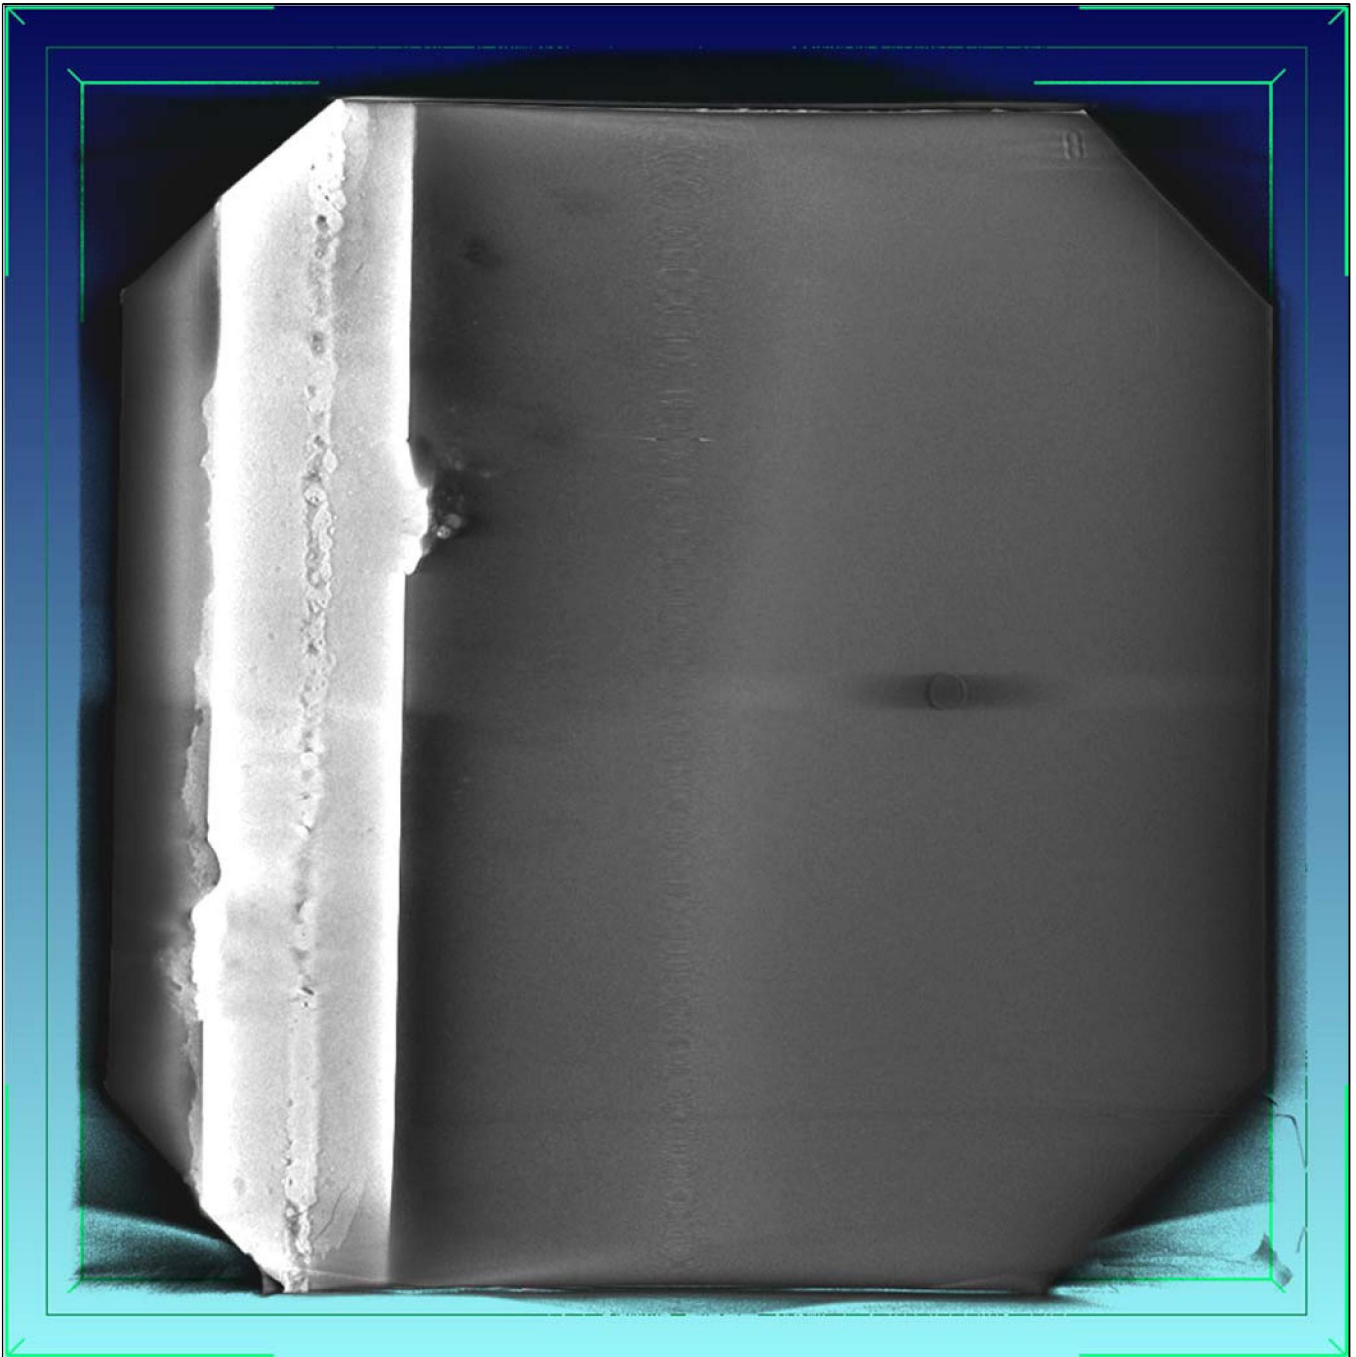
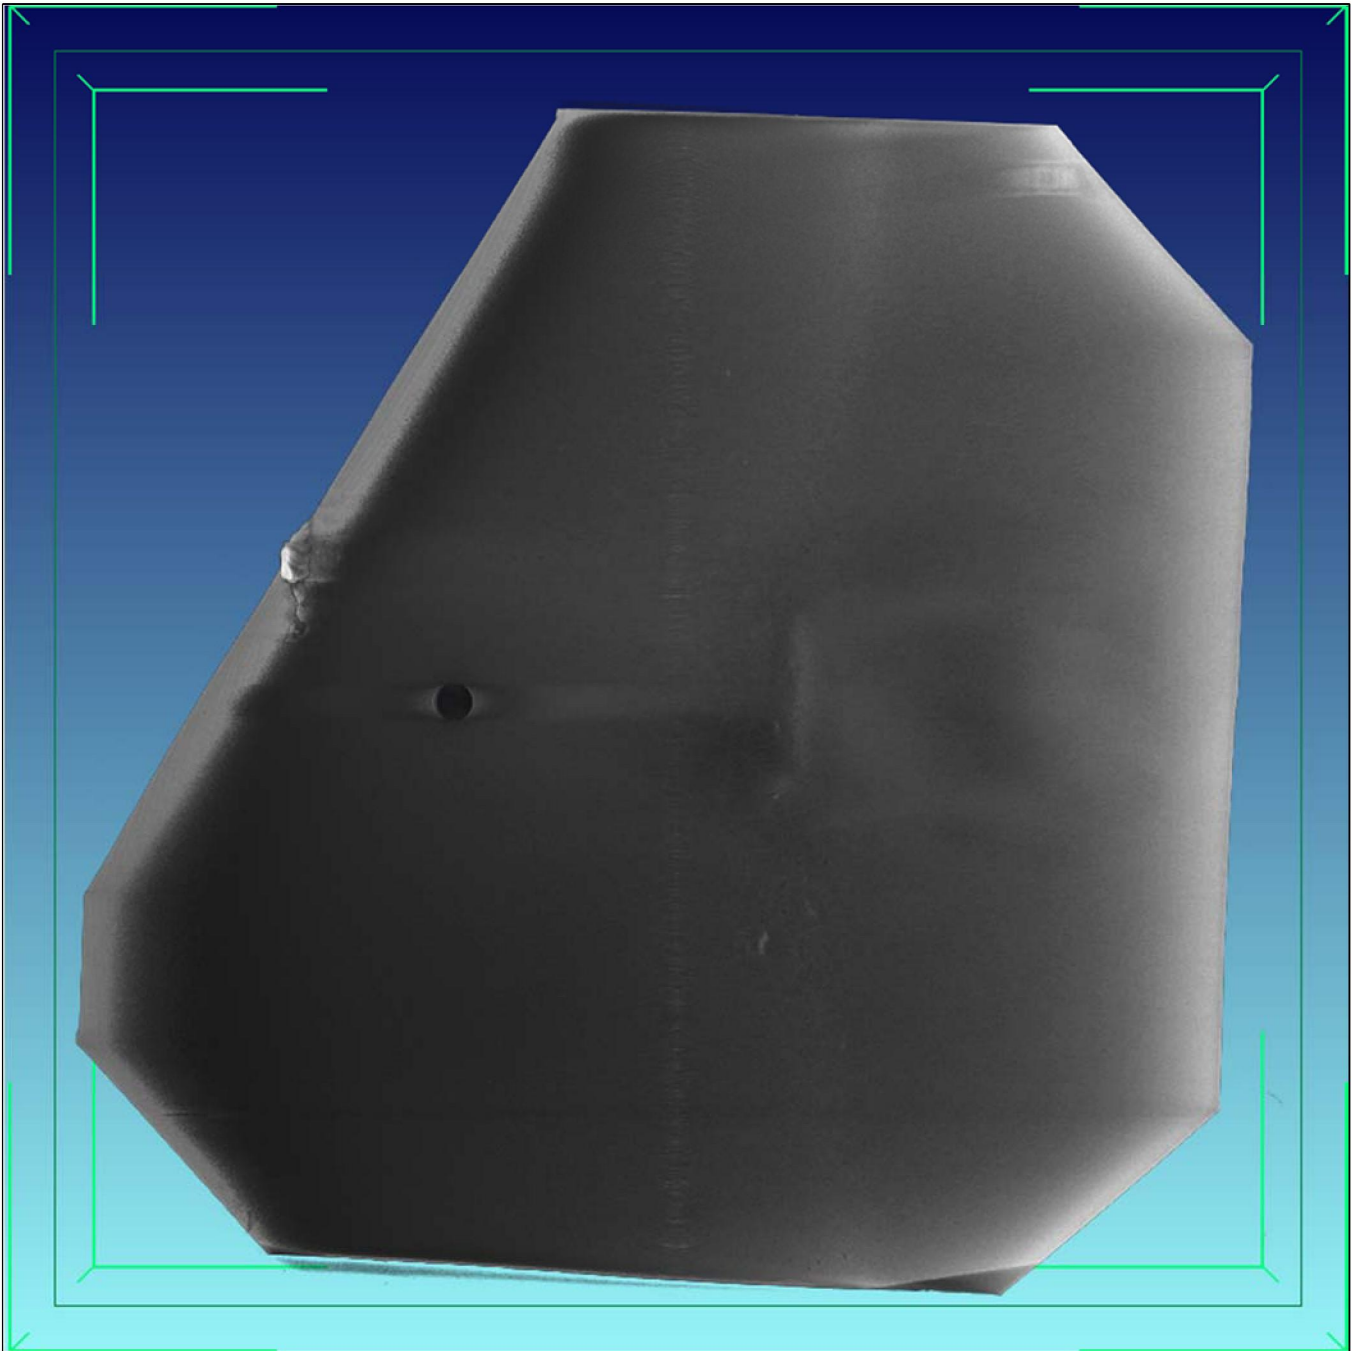
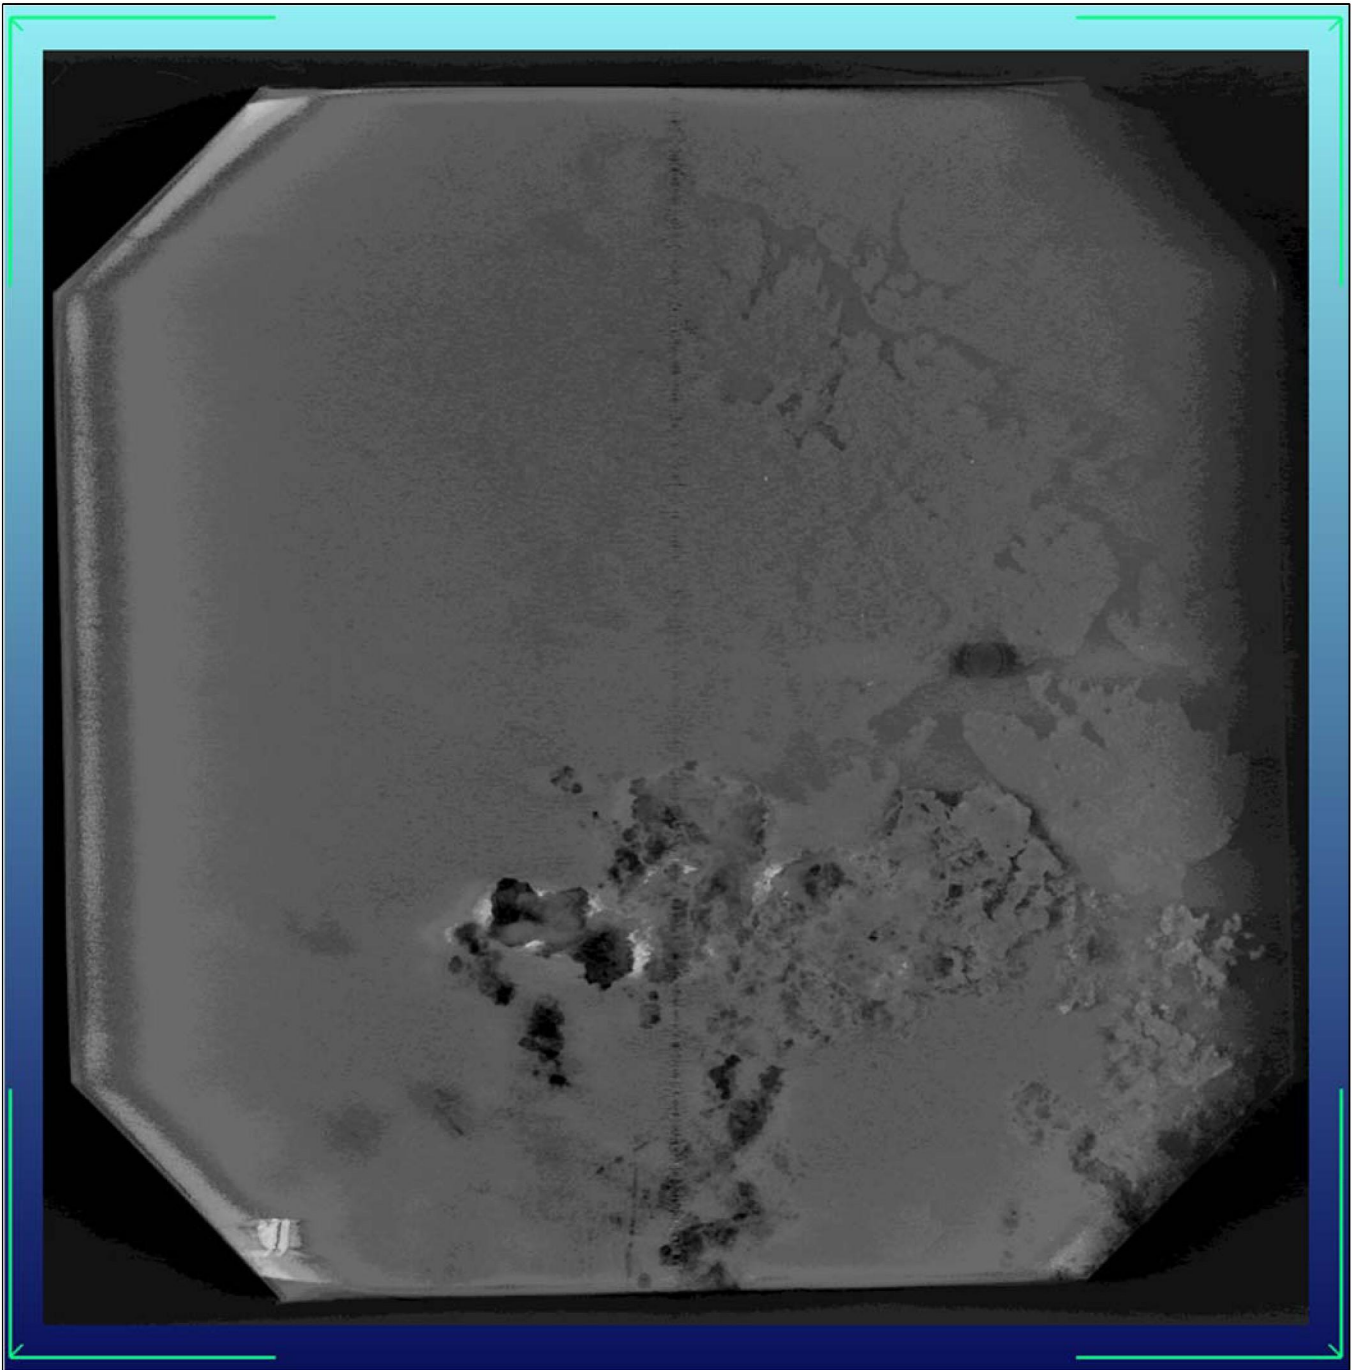
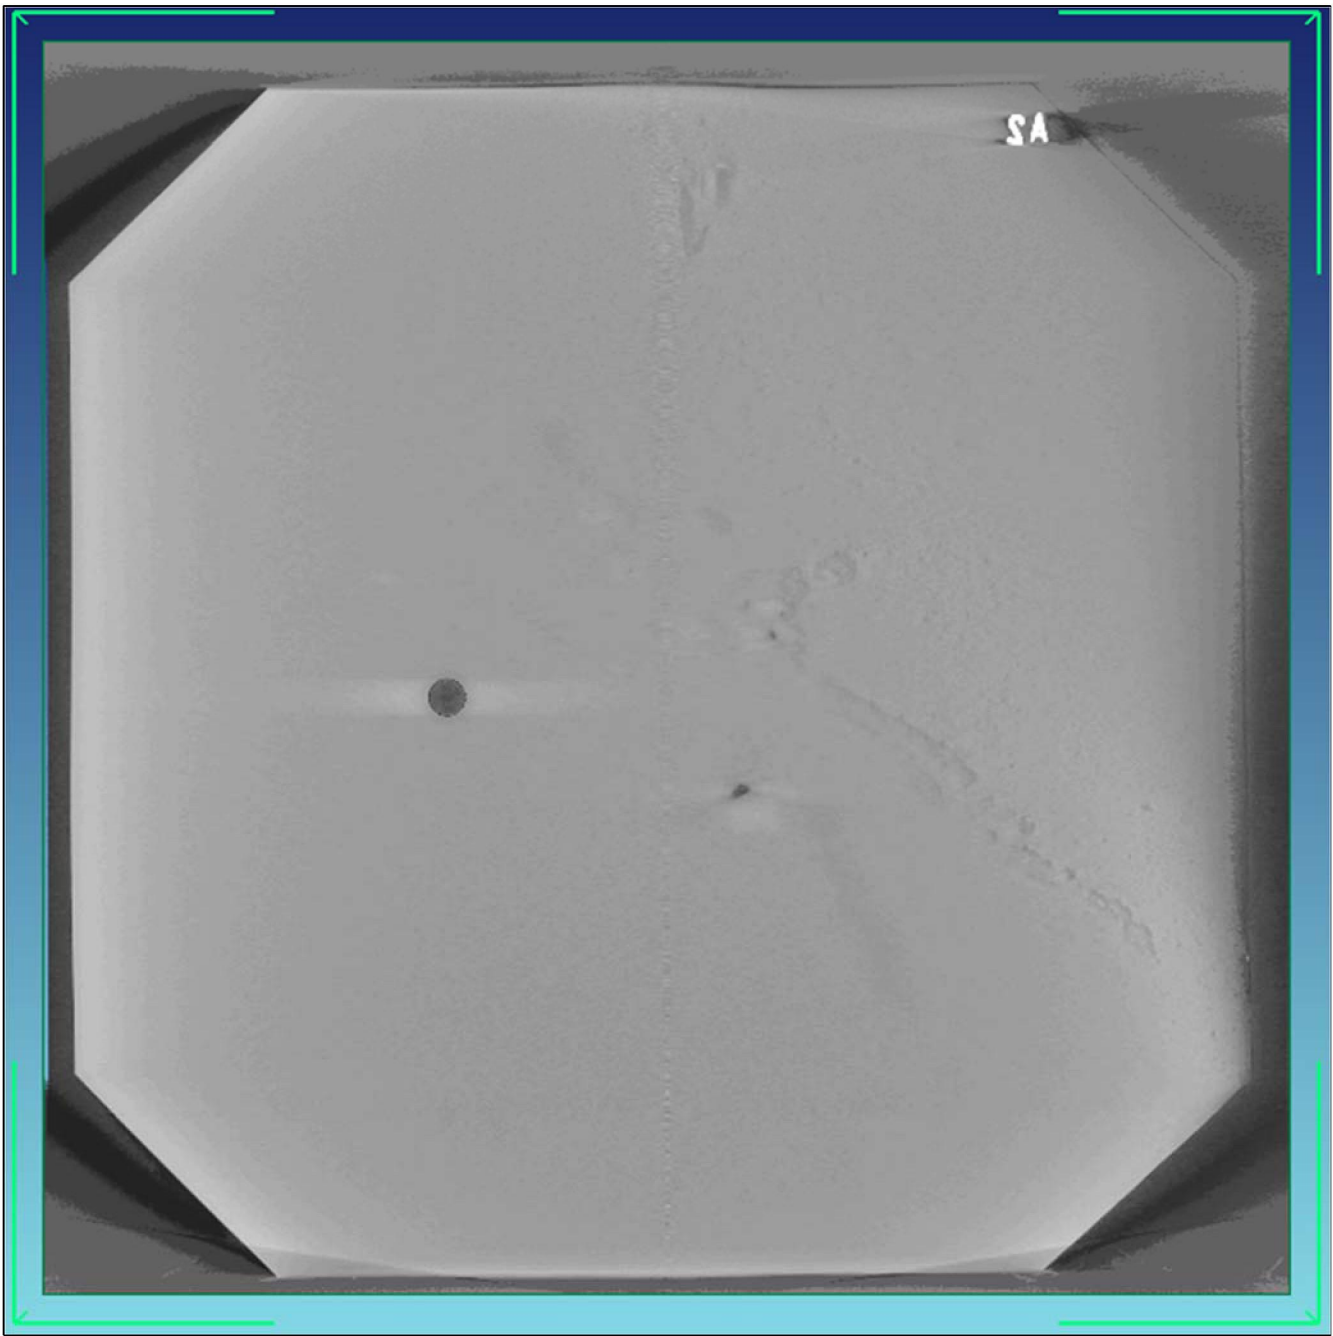
Computer Tomography (CT) scans were performed on each of the submitted coupons prior to cleaning or sectioning. This task was subcontracted to an accredited partner laboratory. Representative screenshots of the scans are provided in Figures 31 through 40. The full CT scan files and appropriate software will be provided to the customer on a separate disk. The CT scans were used to identify three regions on each coupon that exhibited the most severe wall thinning or any other density-based anomaly. The three regions of severe wall thinning identified were excised from the coupons for further analysis.

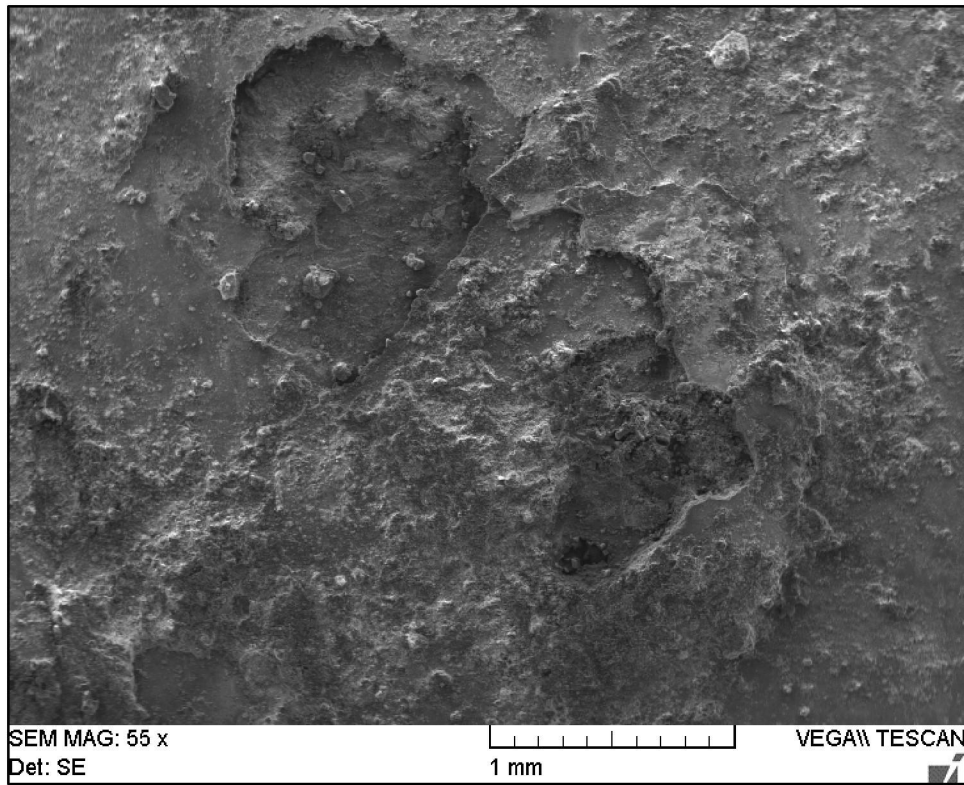
Figure 41. A representative SEM image of a pit on a specimen excised from Coupon 1 labeled as 1-1, prior to cleaning. (SEM, 32X)

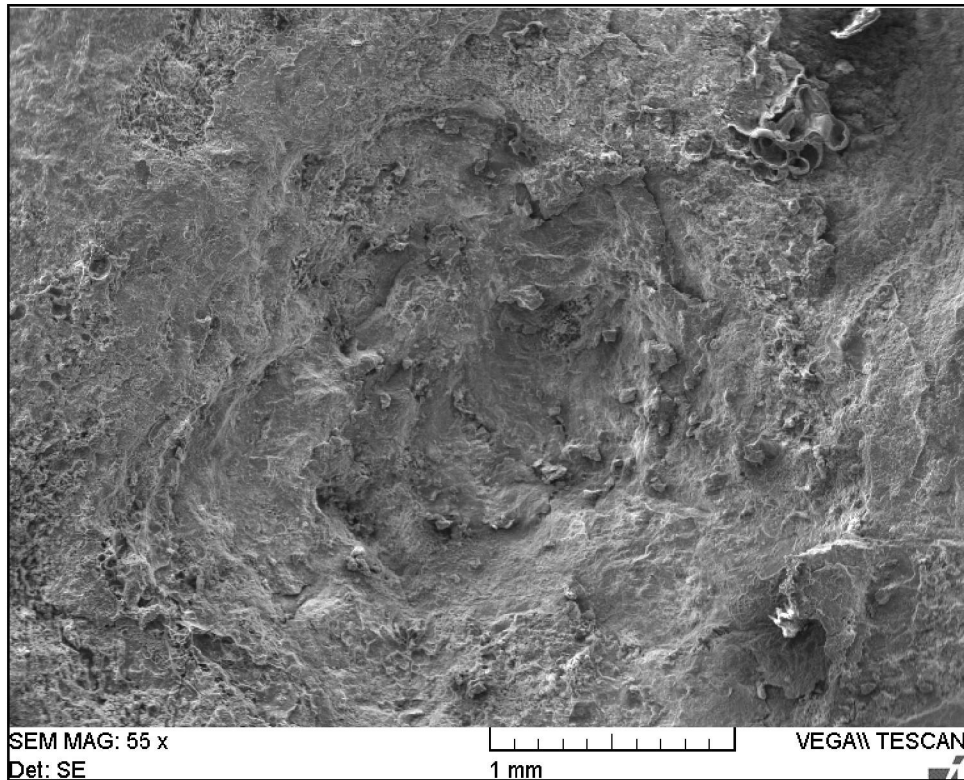
Figure 42. A representative SEM image of a pit on a specimen excised from Coupon 1 labeled as 1-2, prior to cleaning. (SEM, 32X)

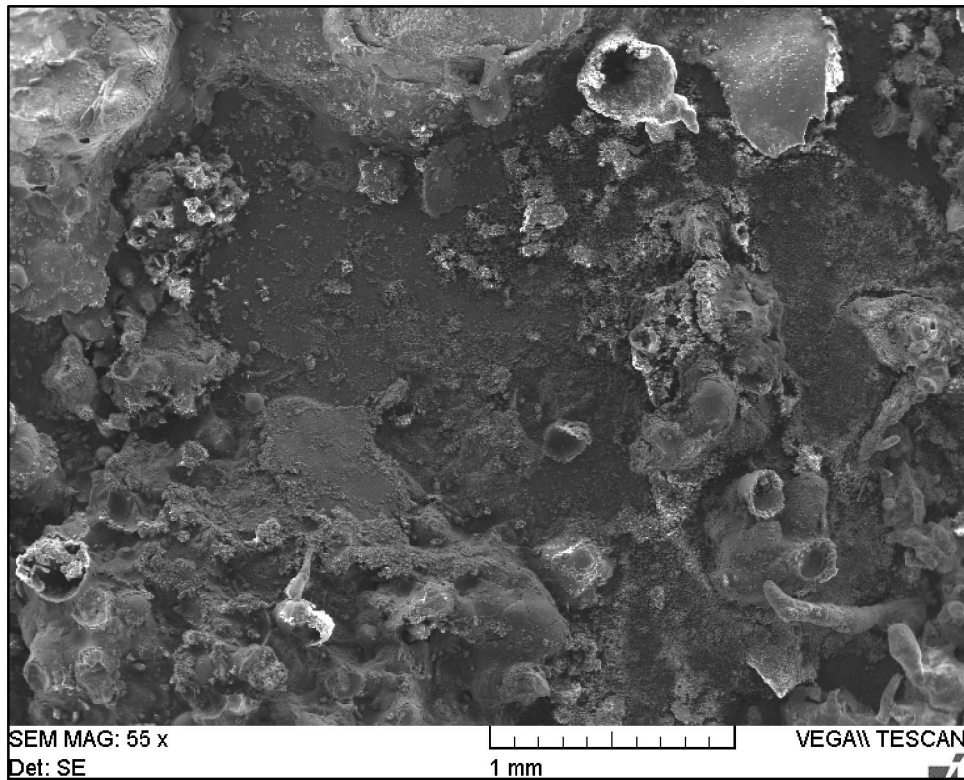
Figure 43. A representative SEM image of a pit on a specimen excised from Coupon 1 labeled as 1-3, prior to cleaning. (SEM, 32X)

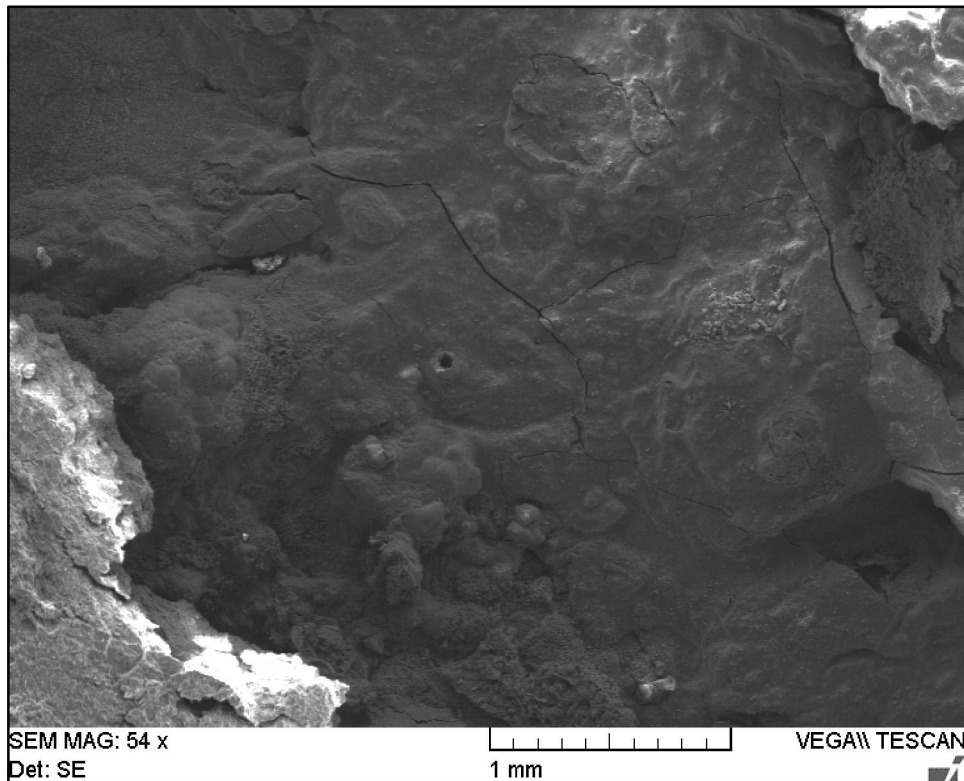
Figure 44. A representative SEM image of a pit on a specimen excised from Coupon 2 labeled as 2-1, prior to cleaning. (SEM, 32X)

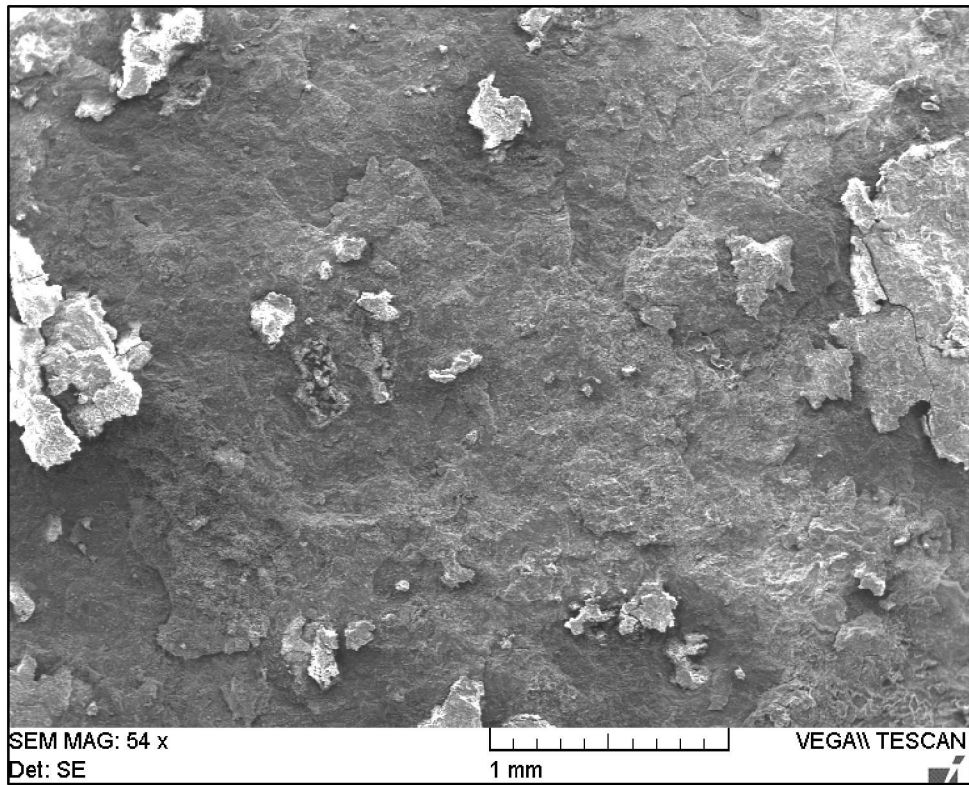
Figure 45. A representative SEM image of a pit on a specimen excised from Coupon 2 labeled as 2-2, prior to cleaning. (SEM, 32X)

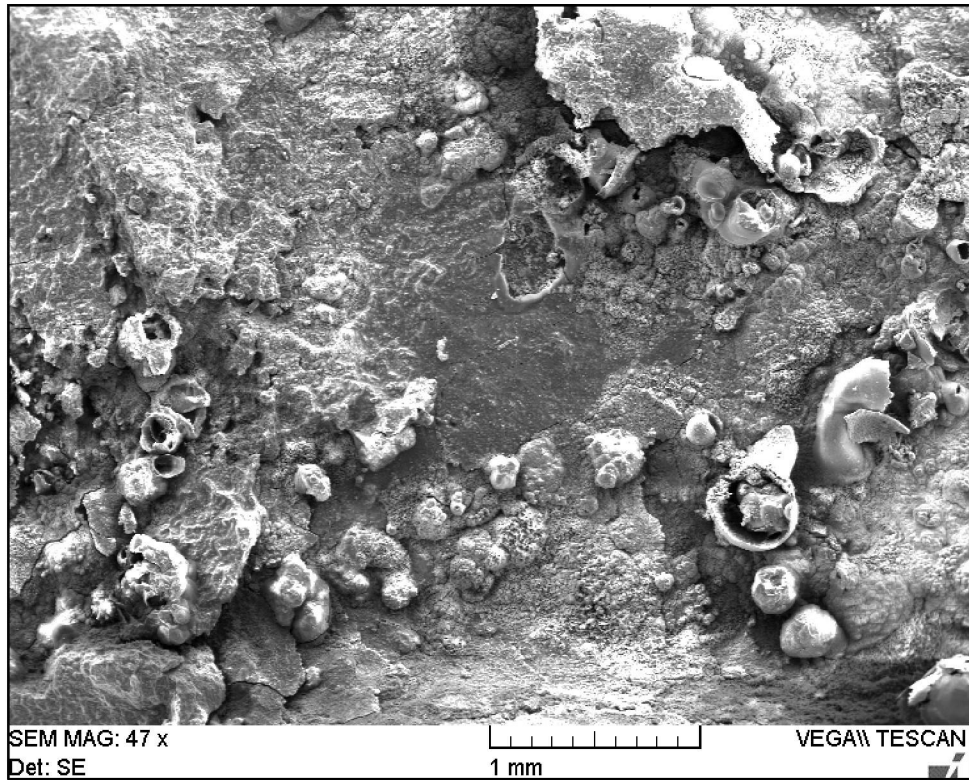
Figure 46. A representative SEM image of a pit on a specimen excised from Coupon 2 labeled as 2-3, prior to cleaning. (SEM, 28X)
