**SUBJECT: DESTRUCTIVE ANALYSIS OF 10 STEEL COUPONS REMOVED FROM
RED HILL FUEL STORAGE TANK NO. 14, PURSUANT TO SECTION 5.3
OF THE ADMINISTRATIVE ORDER ON CONSENT STATEMENT OF
WORK, RED HILL BULK FUEL STORAGE FACILITY, JOINT BASE PEARL
HARBOR-HICKAM, OAHU, HAWAII**

Destructive Analysis of 10 Steel Coupons Removed from Red Hill Fuel Storage Tank #14

REPORT No. 201801967

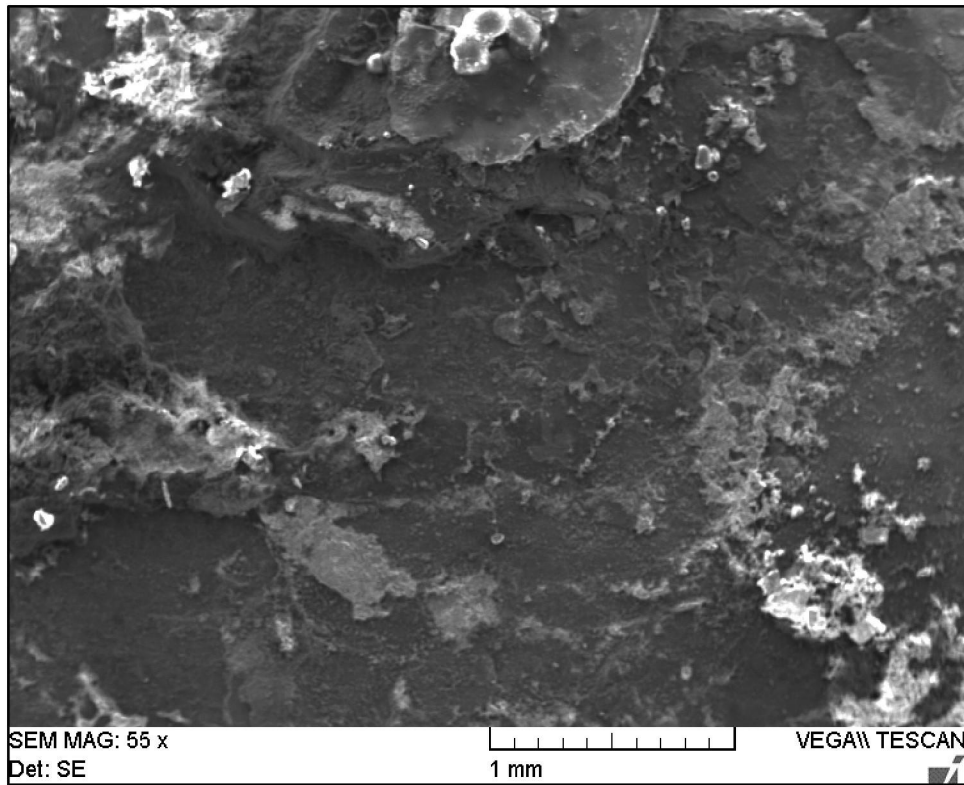
Figure 47. A representative SEM image of a pit on a specimen excised from Coupon 3 labeled as 3-1, prior to cleaning. (SEM, 32X)

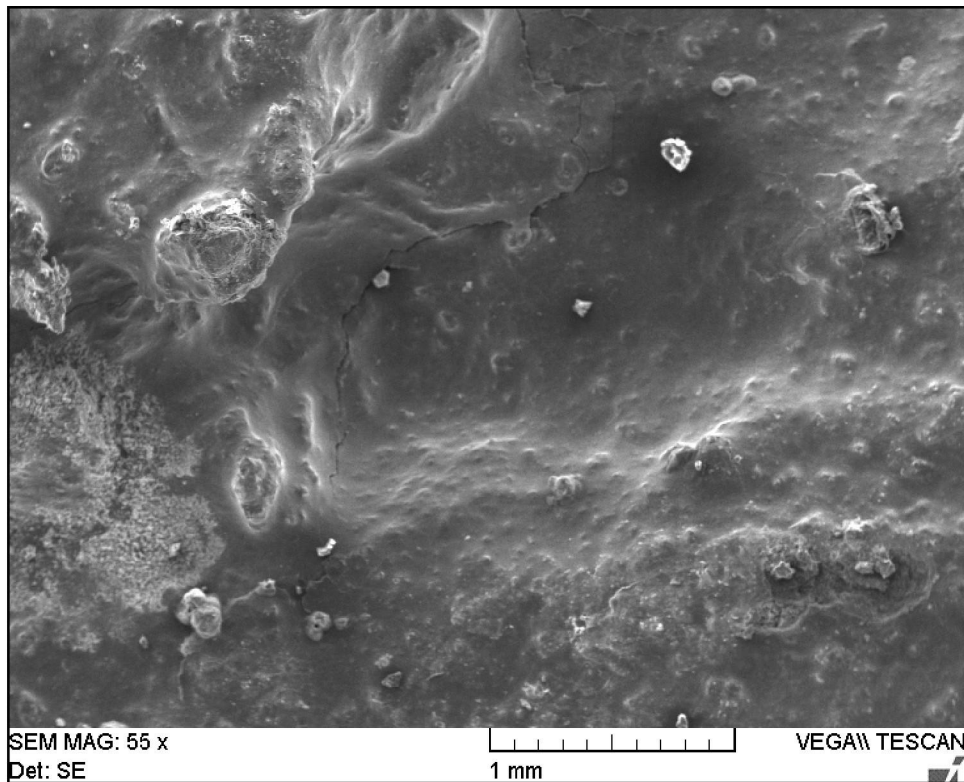
Figure 48. A representative SEM image of a pit on a specimen excised from Coupon 3 labeled as 3-2, prior to cleaning. (SEM, 32X)

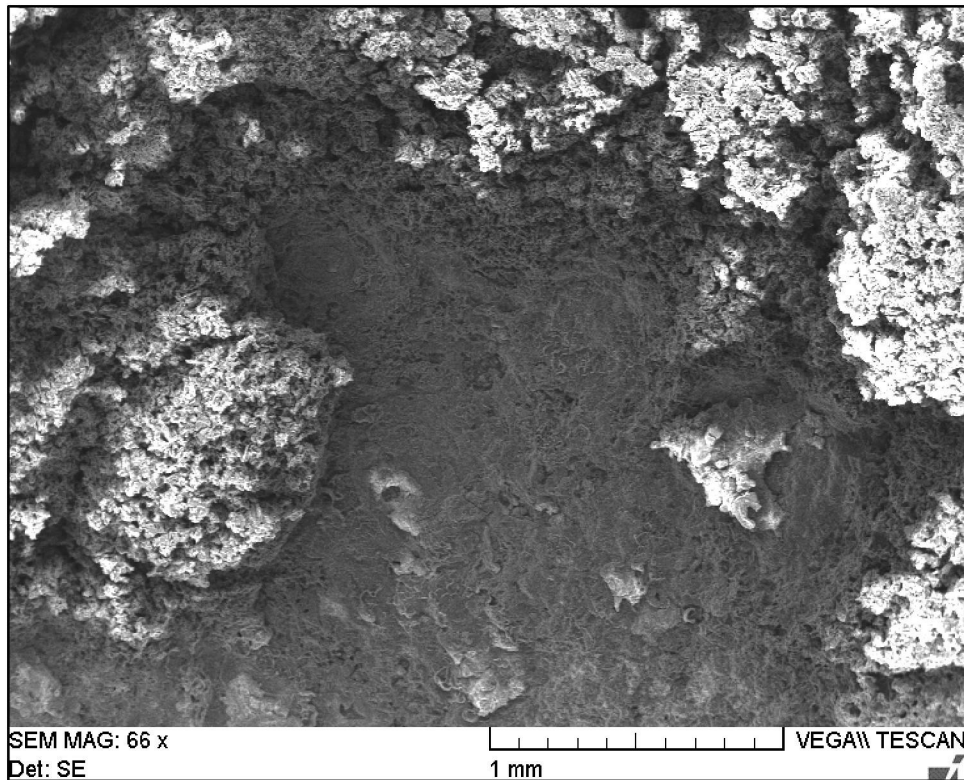
Figure 49. A representative SEM image of a pit on a specimen excised from Coupon 3 labeled as 3-3, prior to cleaning. (SEM, 39X)

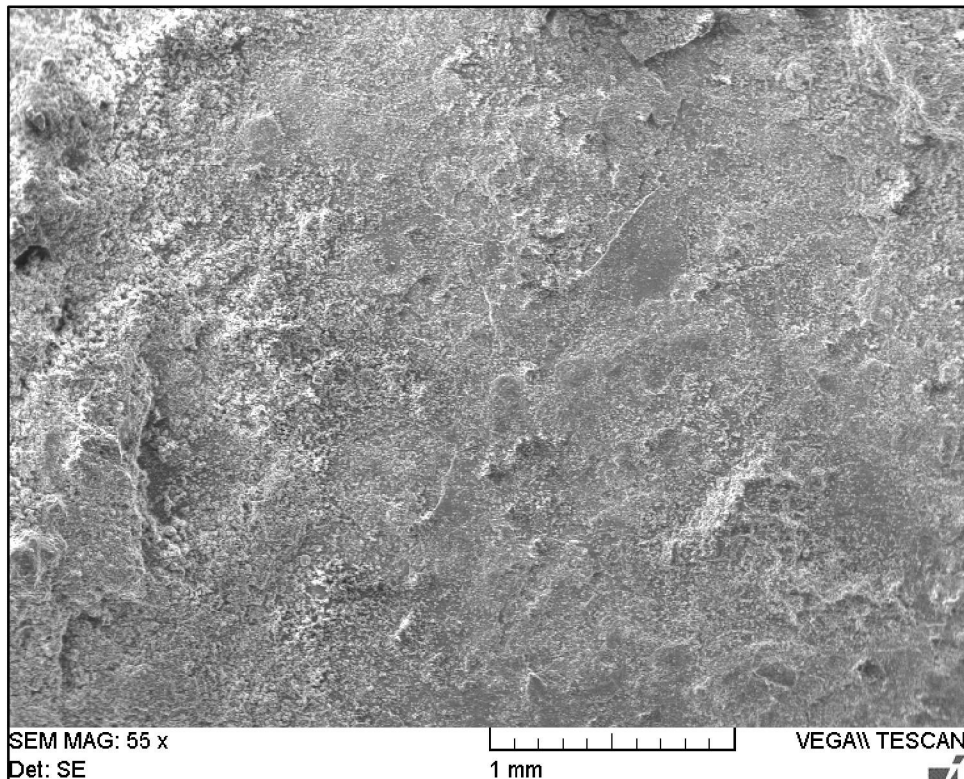
Figure 52. A representative SEM image of a pit on a specimen excised from Coupon 5 labeled as 5-3, prior to cleaning. (SEM, 32X)

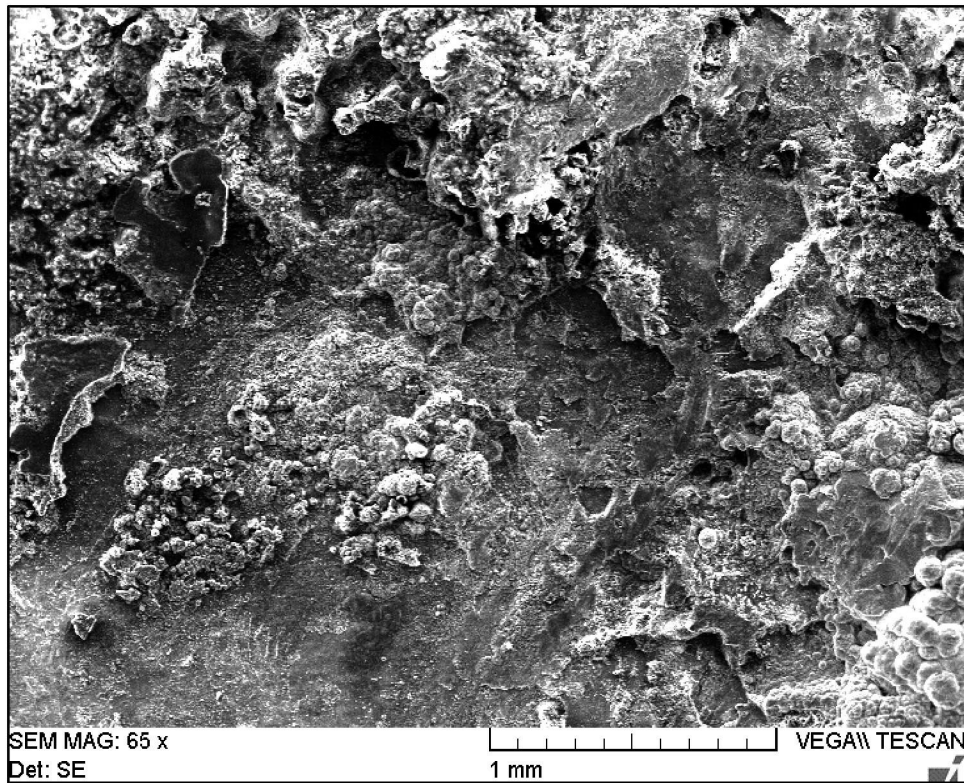
Figure 53. A representative SEM image of a pit on a specimen excised from Coupon 6 labeled as 6-1, prior to cleaning. (SEM, 38X)

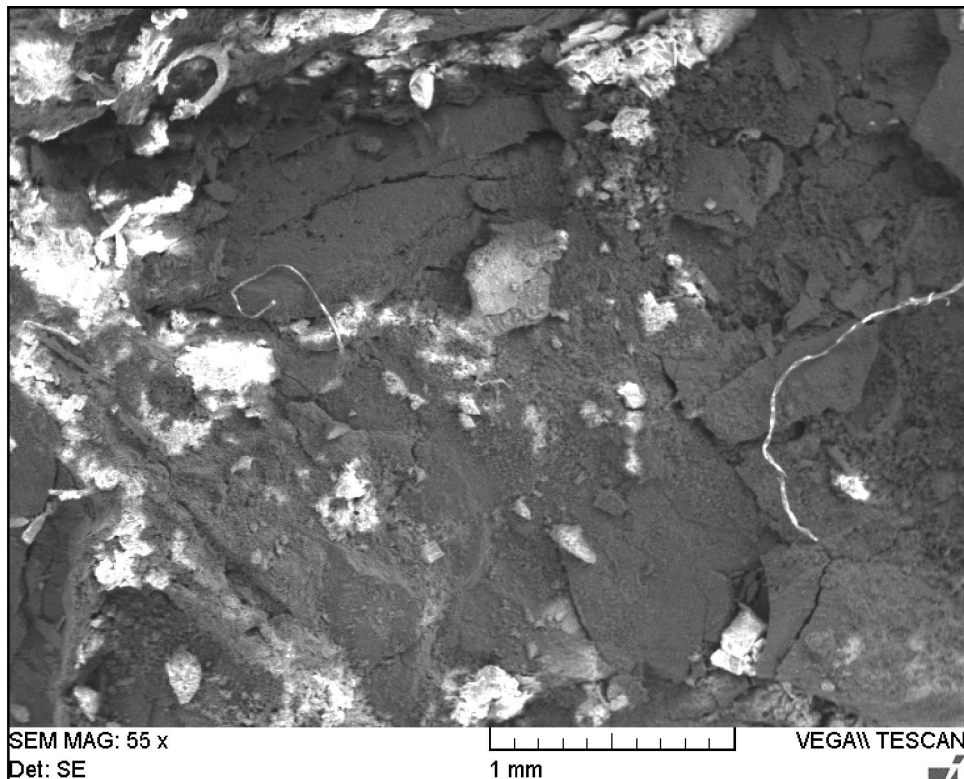
Figure 56. A representative SEM image of a pit on a specimen excised from Coupon 7 labeled as 7-1, prior to cleaning. (SEM, 32X)

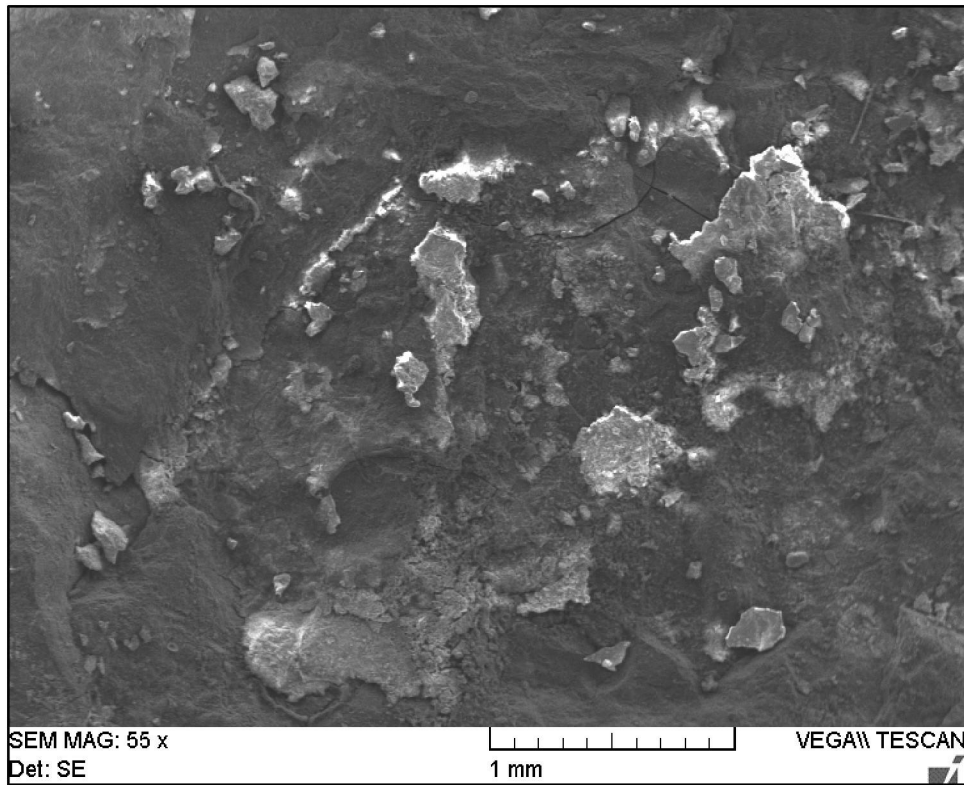
Figure 57. A representative SEM image of a pit on a specimen excised from Coupon 7 labeled as 7-2, prior to cleaning. (SEM, 32X)

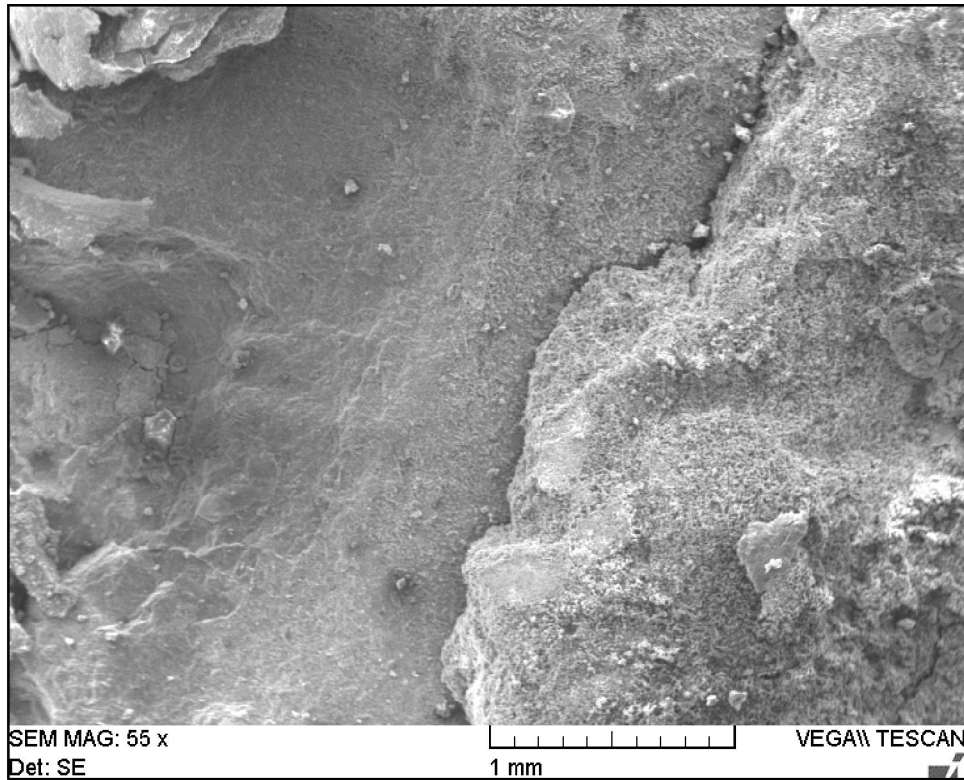
Figure 58. A representative SEM image of a pit on a specimen excised from Coupon 7 labeled as 7-3, prior to cleaning. (SEM, 32X)

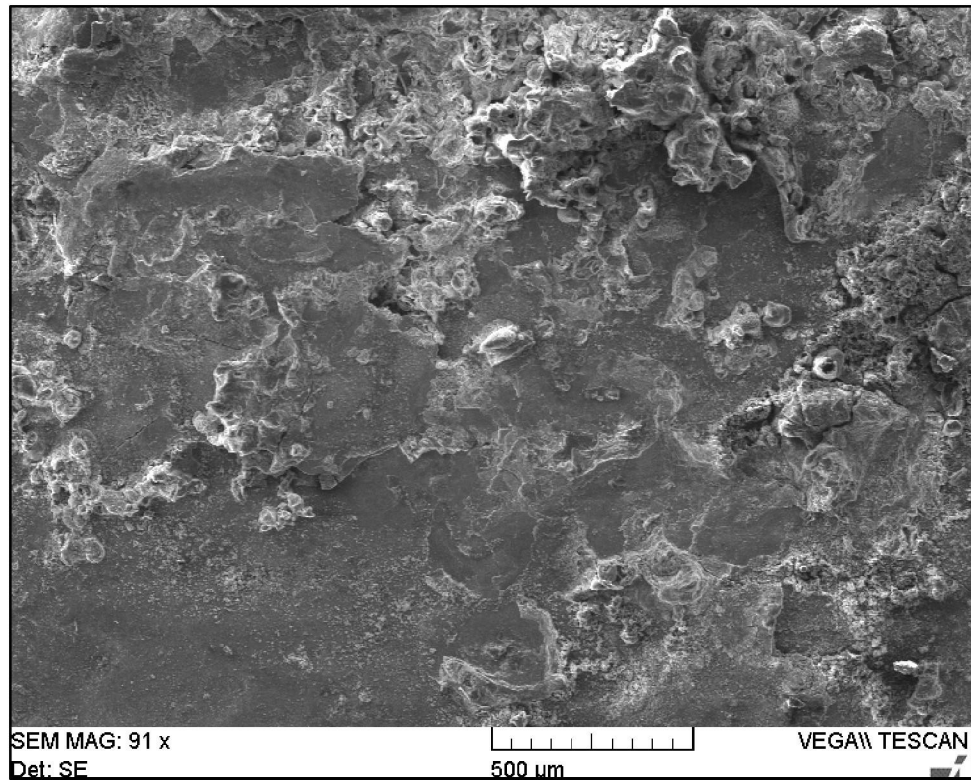
Figure 59. A representative SEM image of a pit on a specimen excised from Coupon 8 labeled as 8-1, prior to cleaning. (SEM, 53X)

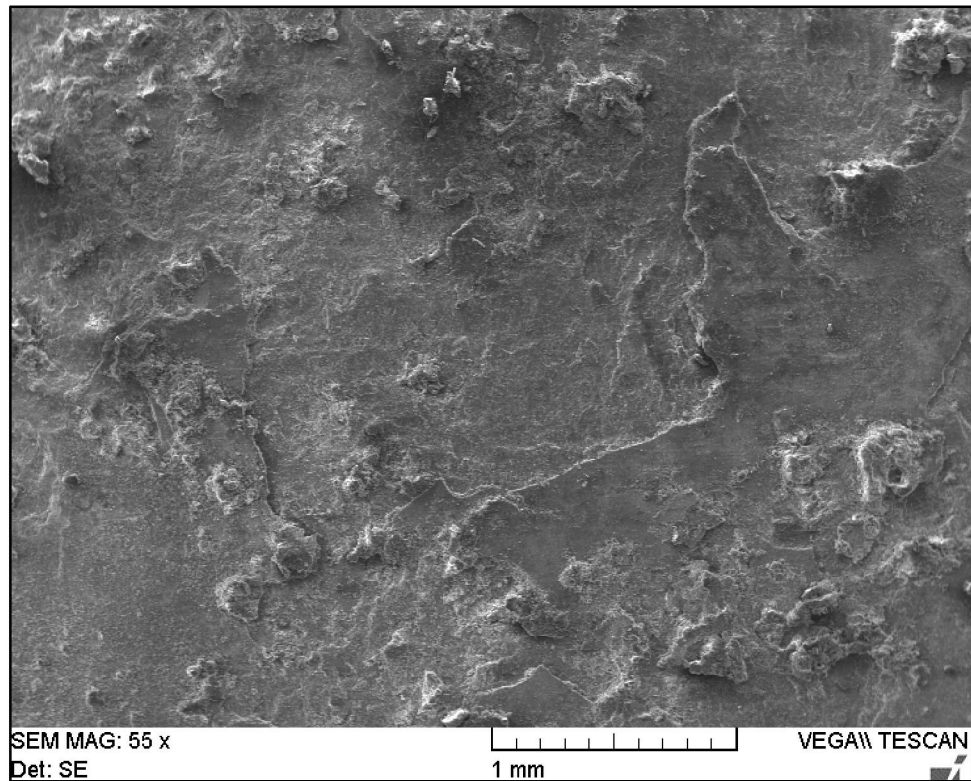
Figure 60. A representative SEM image of a pit on a specimen excised from Coupon 8 labeled as 8-2, prior to cleaning. (SEM, 33X)

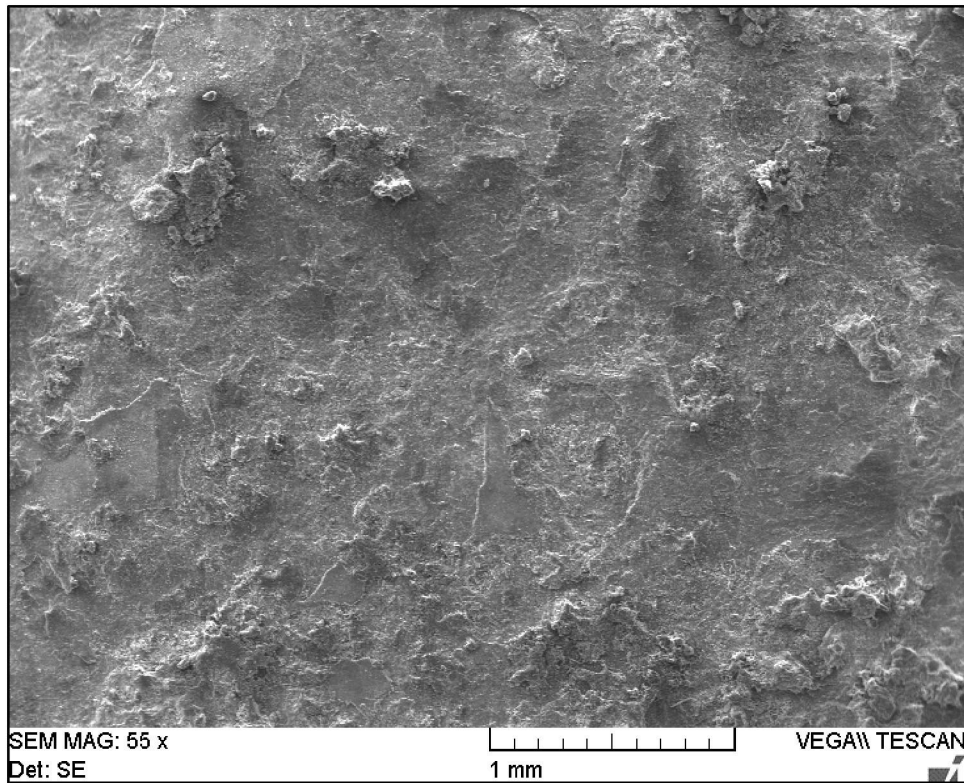
④ This is the weld-repaired plate section. Sample 8-3 exhibited a depression or pit on the painted surface.

Figure 61. A representative SEM image of a pit on a specimen excised from Coupon 8 labeled as 8-3, prior to cleaning. (SEM, 33X)

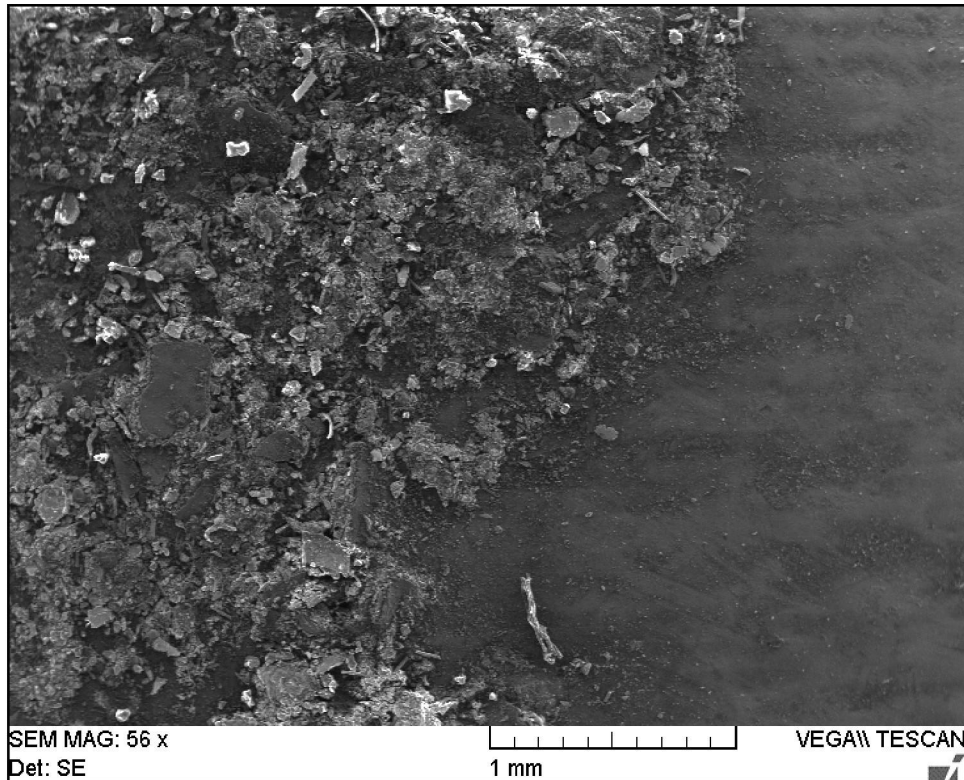
Figure 62. A representative SEM image of the surface of a specimen excised from Coupon 10 labeled as 10-1, prior to cleaning. No pit was observed in this location. (SEM, 33X)

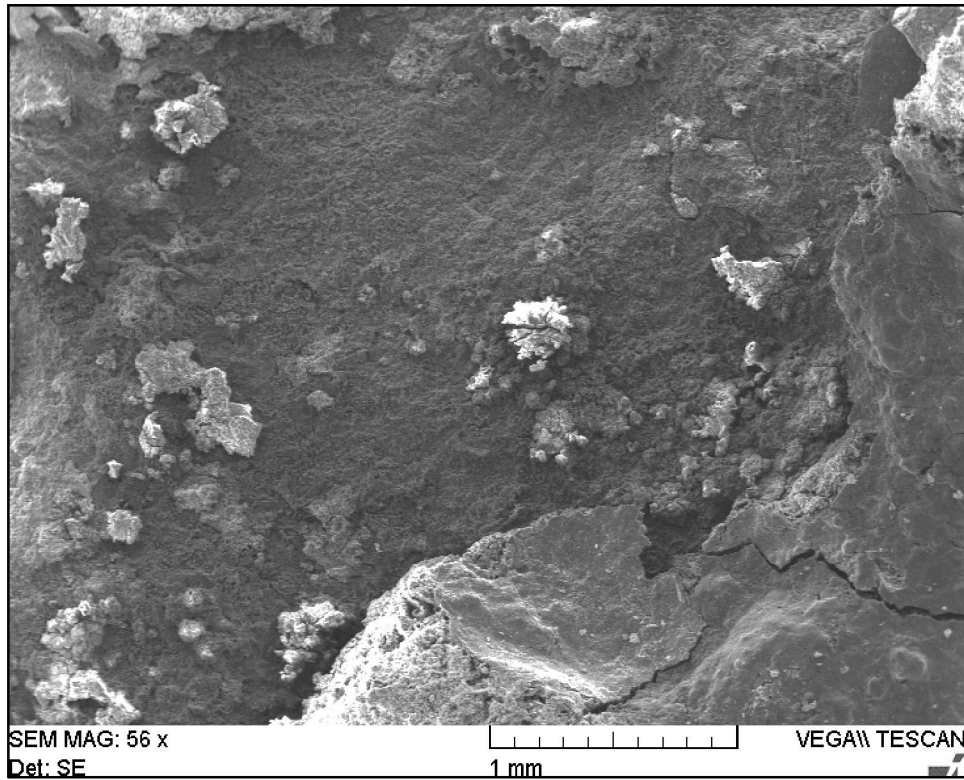
Figure 66. A representative SEM image of a pit on a specimen excised from Coupon A-1 labeled as A1-2, prior to cleaning. (SEM, 33X)

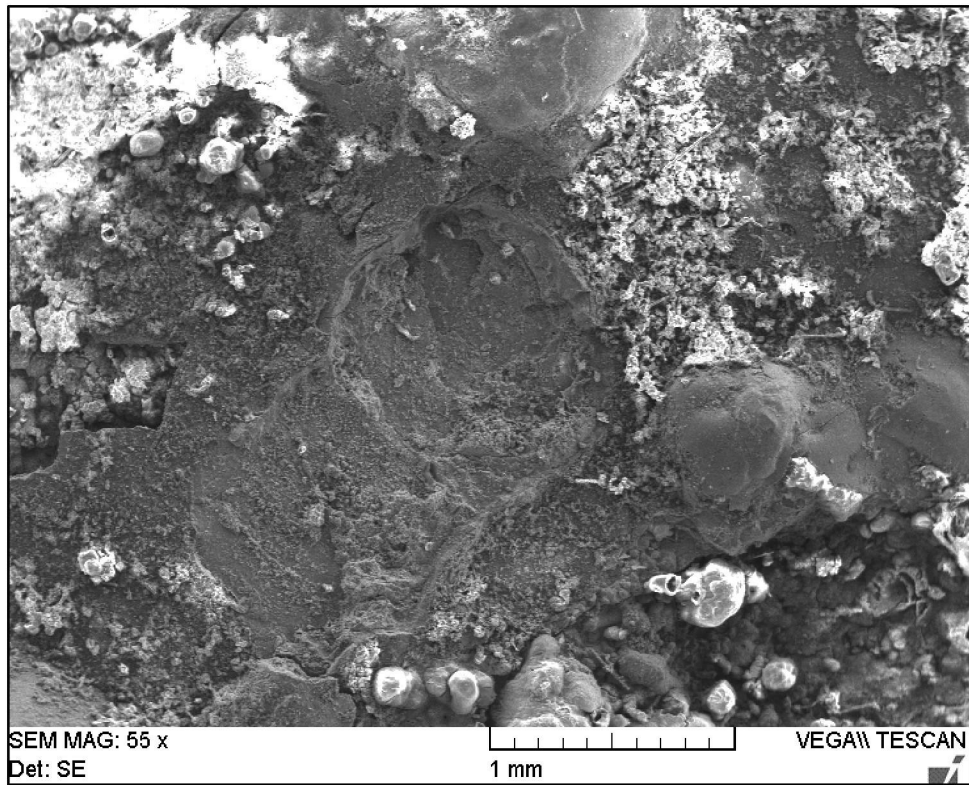
Figure 67. A representative SEM image of a pit on a specimen excised from Coupon A-1 labeled as A1-3, prior to cleaning. (SEM, 32X)

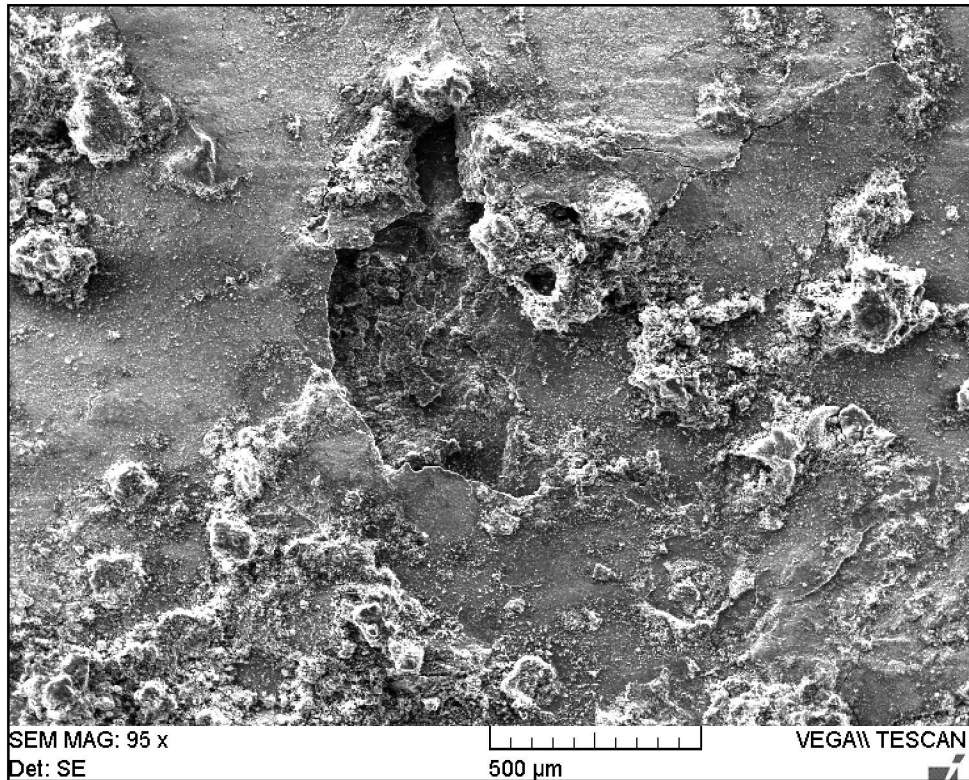
Figure 68. A representative SEM image of a pit on a specimen excised from Coupon A-2 labeled as A2-1, prior to cleaning. (SEM, 56X)

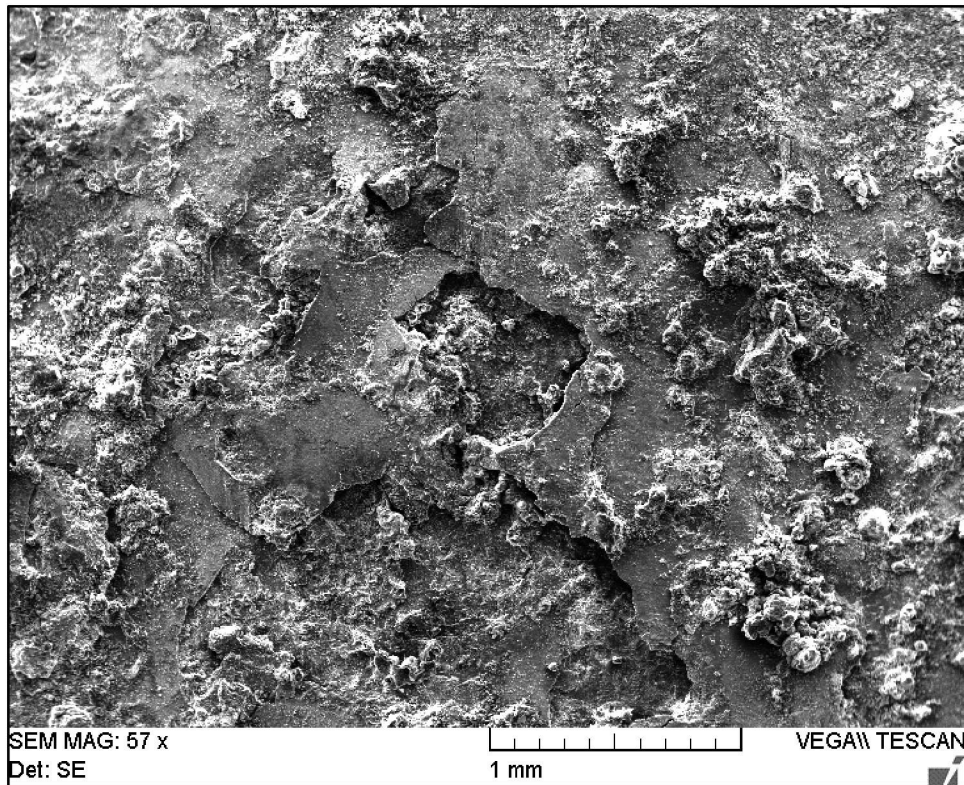
Figure 69. A representative SEM image of a possible pit on a specimen excised from Coupon A-2 labeled as A2-2, prior to cleaning. (SEM, 33X)

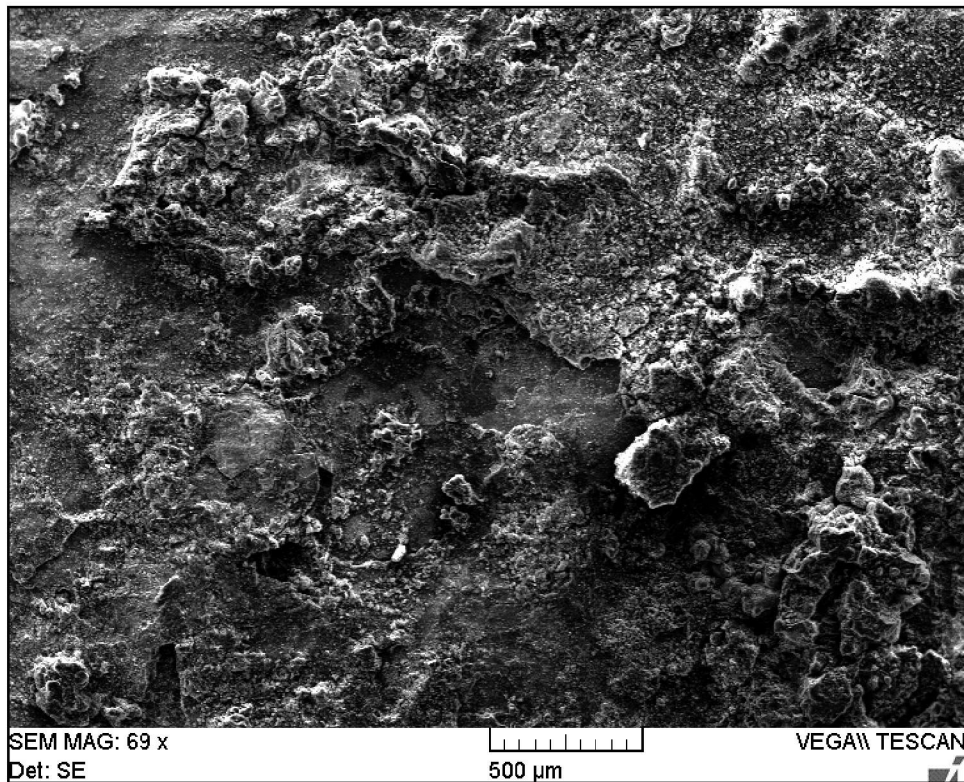
Figure 70. A representative SEM image of a possible pit on a specimen excised from Coupon A-2 labeled as A2-3, prior to cleaning. (SEM, 40X)

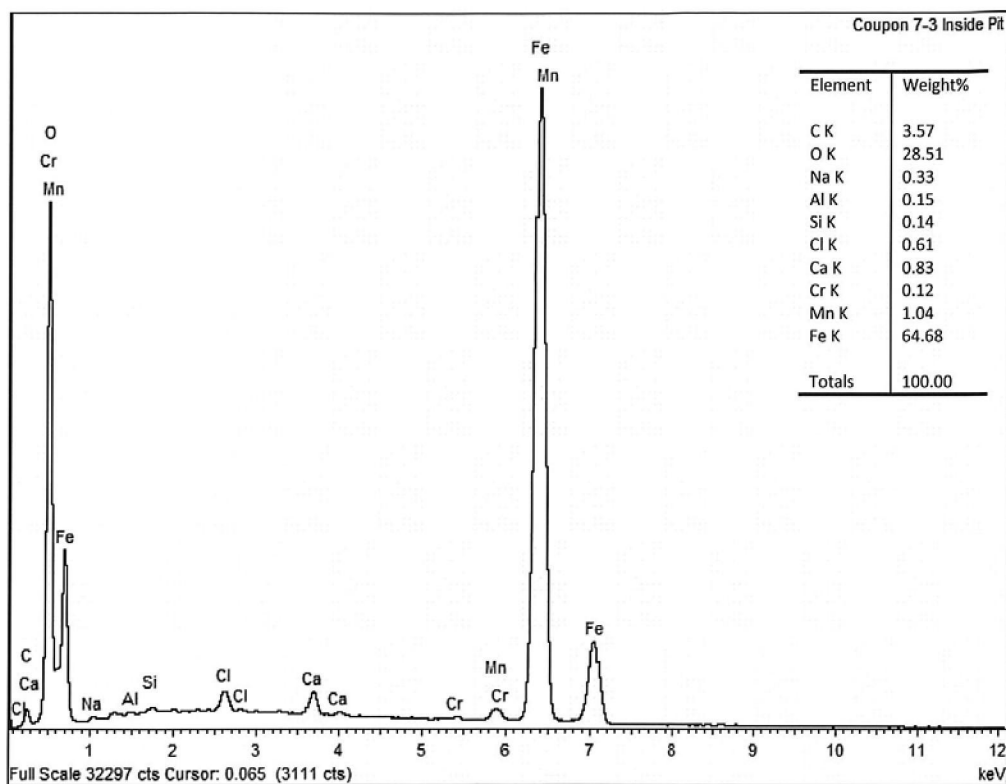
Figure 88. A representative EDS spectrum generated from of a pit on a specimen excised from Coupon 7 labeled as 7-3, prior to cleaning.

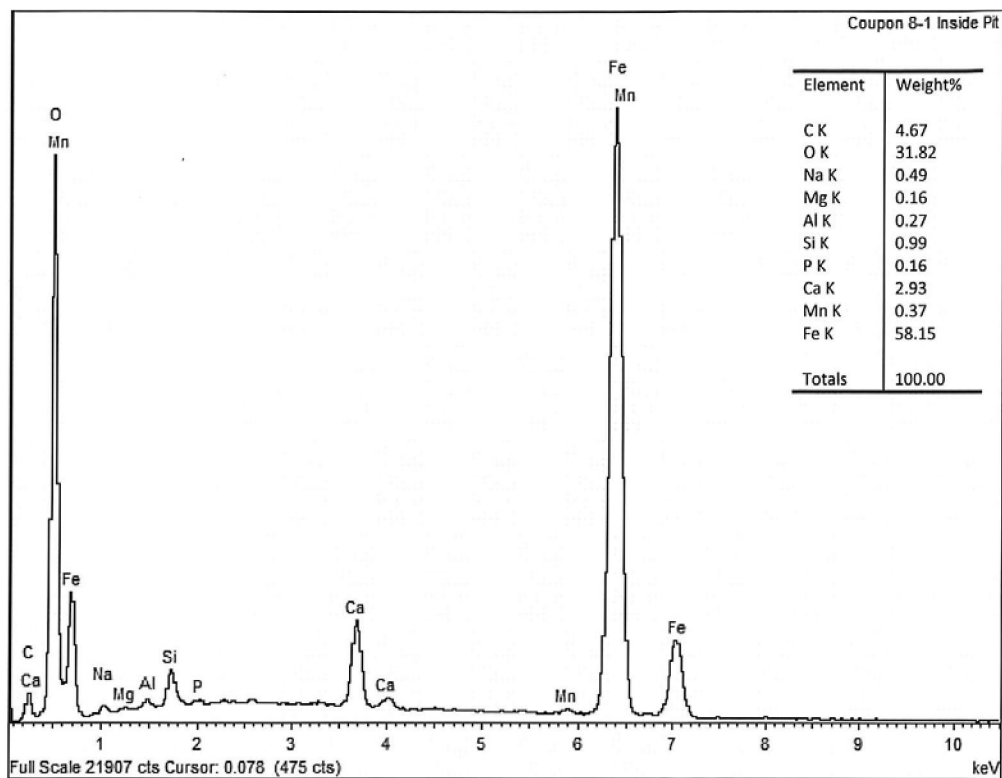
Figure 89. A representative EDS spectrum generated from of a pit on a specimen excised from Coupon 8 labeled as 8-1, prior to cleaning.

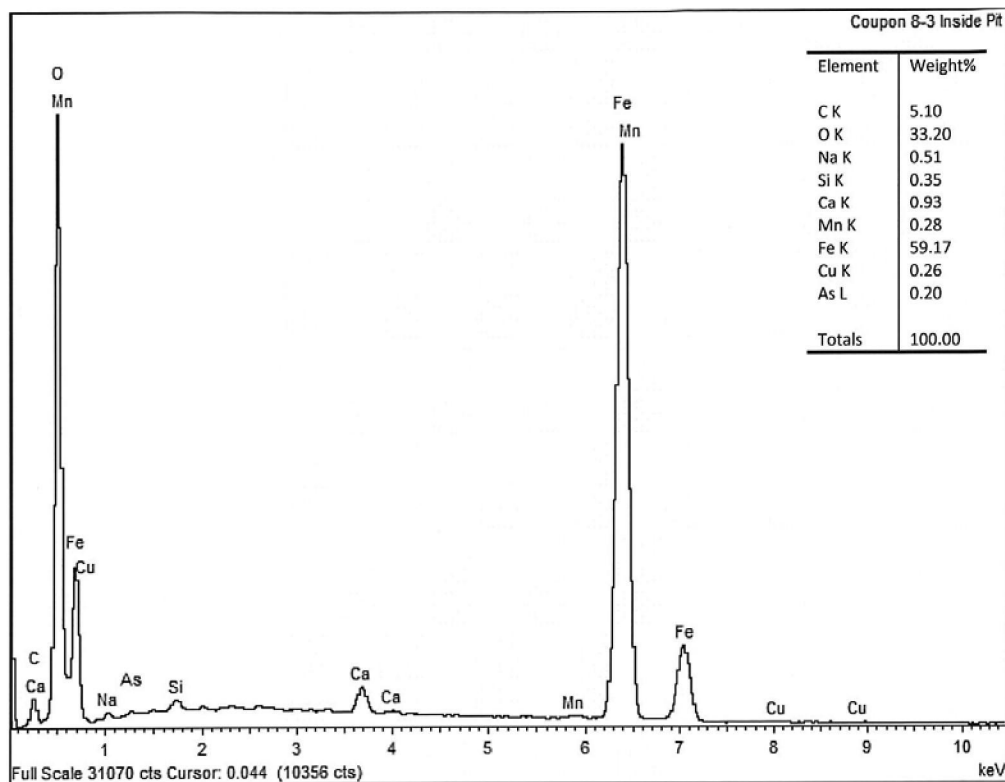
Figure 91. A representative EDS spectrum generated from of a pit on a specimen excised from Coupon 8 labeled as 8-3, prior to cleaning.

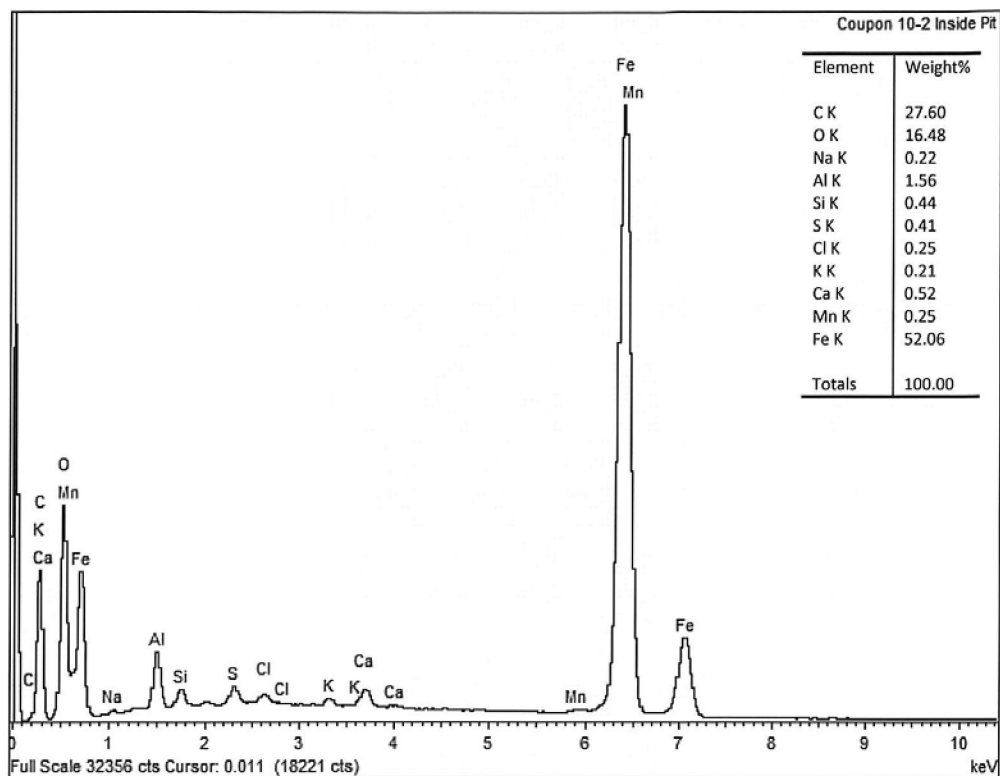
Figure 93. A representative EDS spectrum generated from of a pit on a specimen excised from Coupon 10 labeled as 10-2, prior to cleaning.

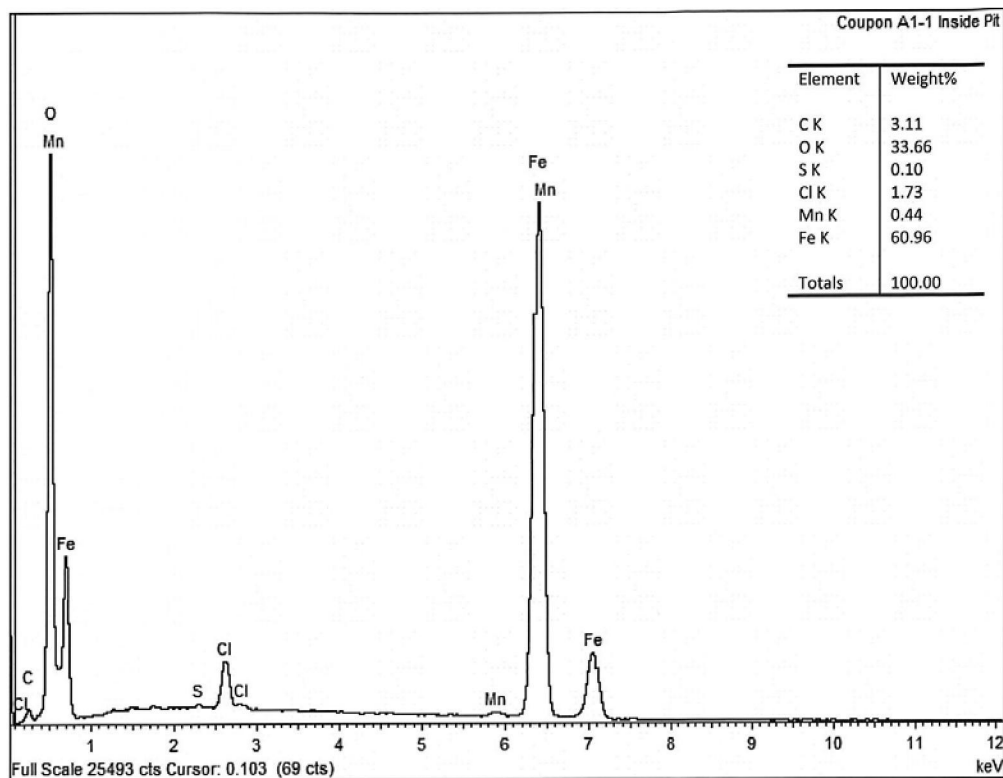
Figure 95. A representative EDS spectrum generated from of a pit on a specimen excised from Coupon A1 labeled as A1-1, prior to cleaning.

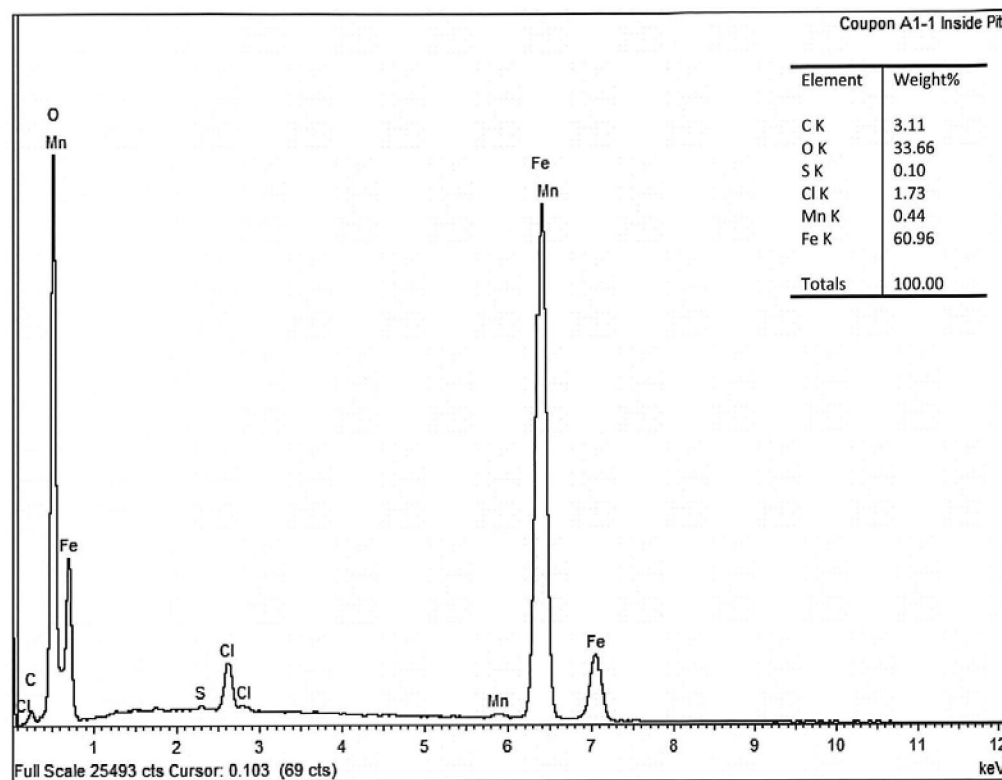
Figure 96. A representative EDS spectrum generated from of a pit on a specimen excised from Coupon A1 labeled as A1-2, prior to cleaning.

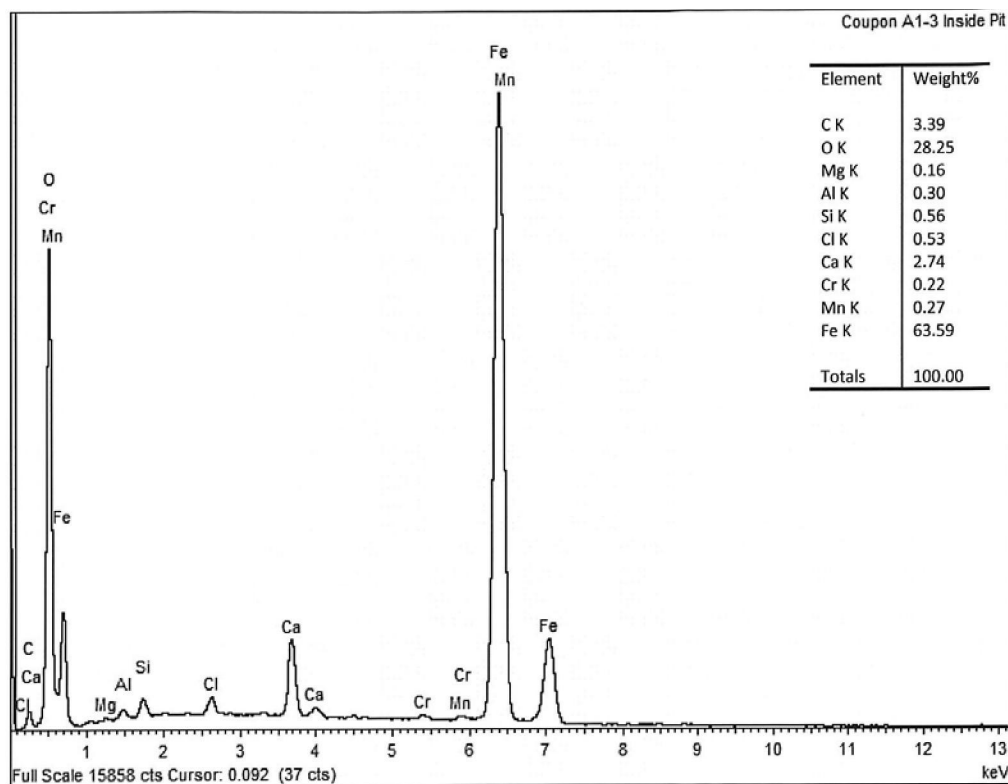
Figure 97. A representative EDS spectrum generated from of a pit on a specimen excised from Coupon A1 labeled as A1-3, prior to cleaning.

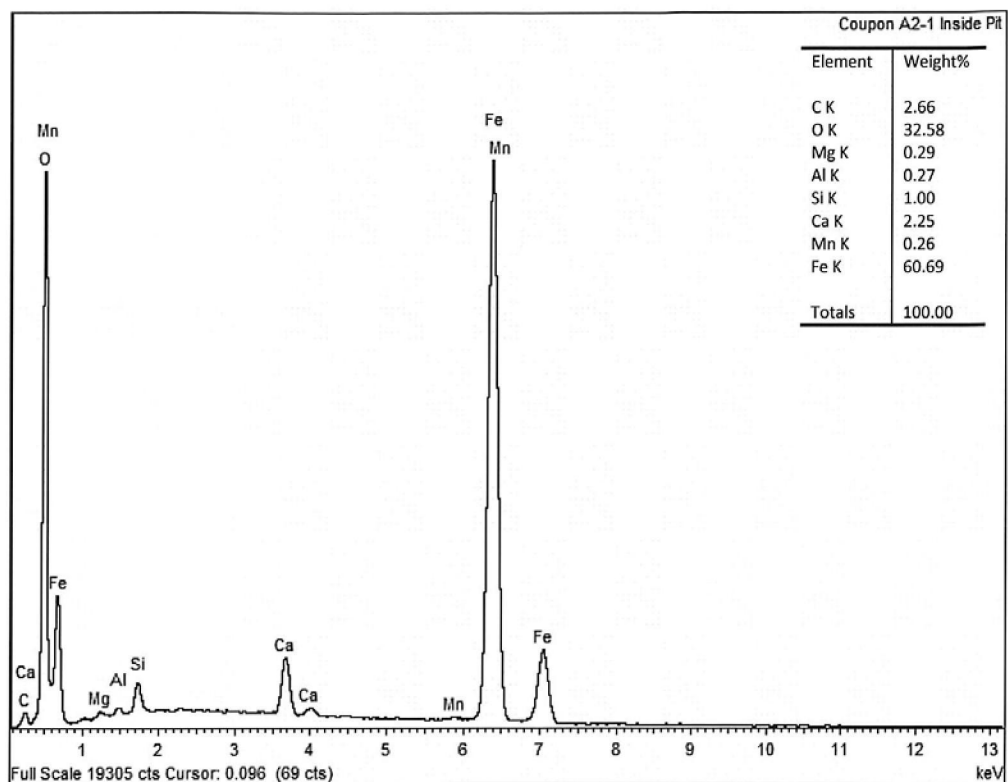
Figure 98. A representative EDS spectrum generated from of a pit on a specimen excised from Coupon A2 labeled as A2-1, prior to cleaning.

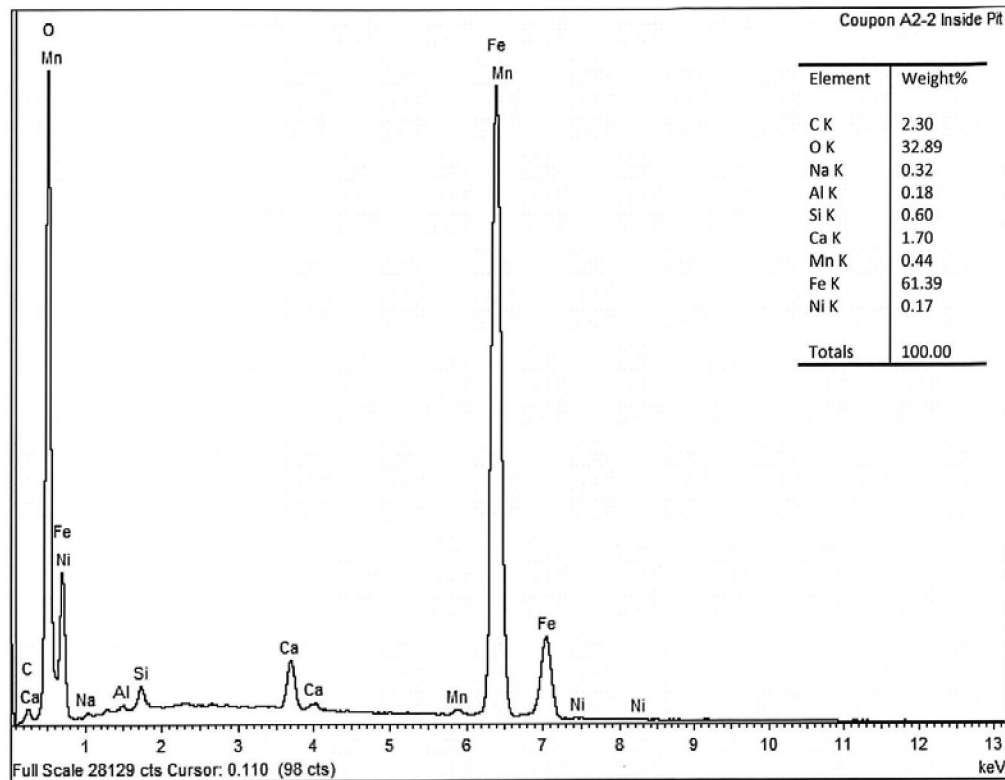
Figure 99. A representative EDS spectrum generated from of a pit on a specimen excised from Coupon A2 labeled as A2-2, prior to cleaning.

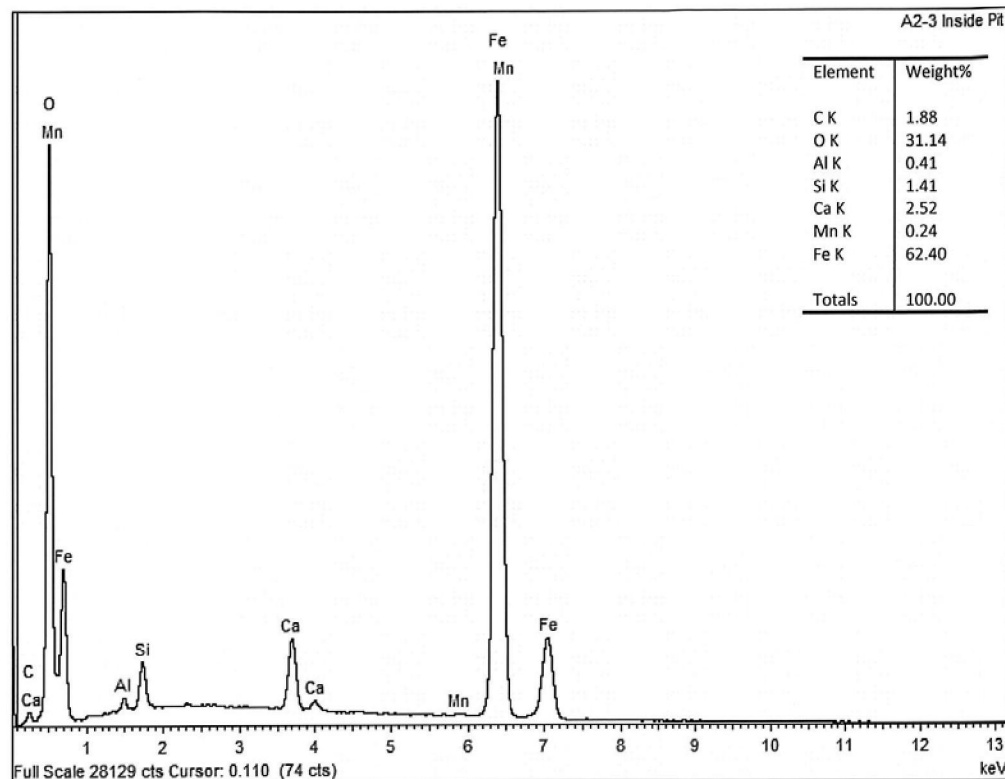
Figure 100. A representative EDS spectrum generated from of a pit on a specimen excised from Coupon A2 labeled as A2-3, prior to cleaning.
