**SUBJECT: DESTRUCTIVE ANALYSIS OF 10 STEEL COUPONS REMOVED FROM
RED HILL FUEL STORAGE TANK NO. 14, PURSUANT TO SECTION 5.3
OF THE ADMINISTRATIVE ORDER ON CONSENT STATEMENT OF
WORK, RED HILL BULK FUEL STORAGE FACILITY, JOINT BASE PEARL
HARBOR-HICKAM, OAHU, HAWAII**

Destructive Analysis of 10 Steel Coupons Removed from Red Hill Fuel Storage Tank #14

REPORT No. 201801967

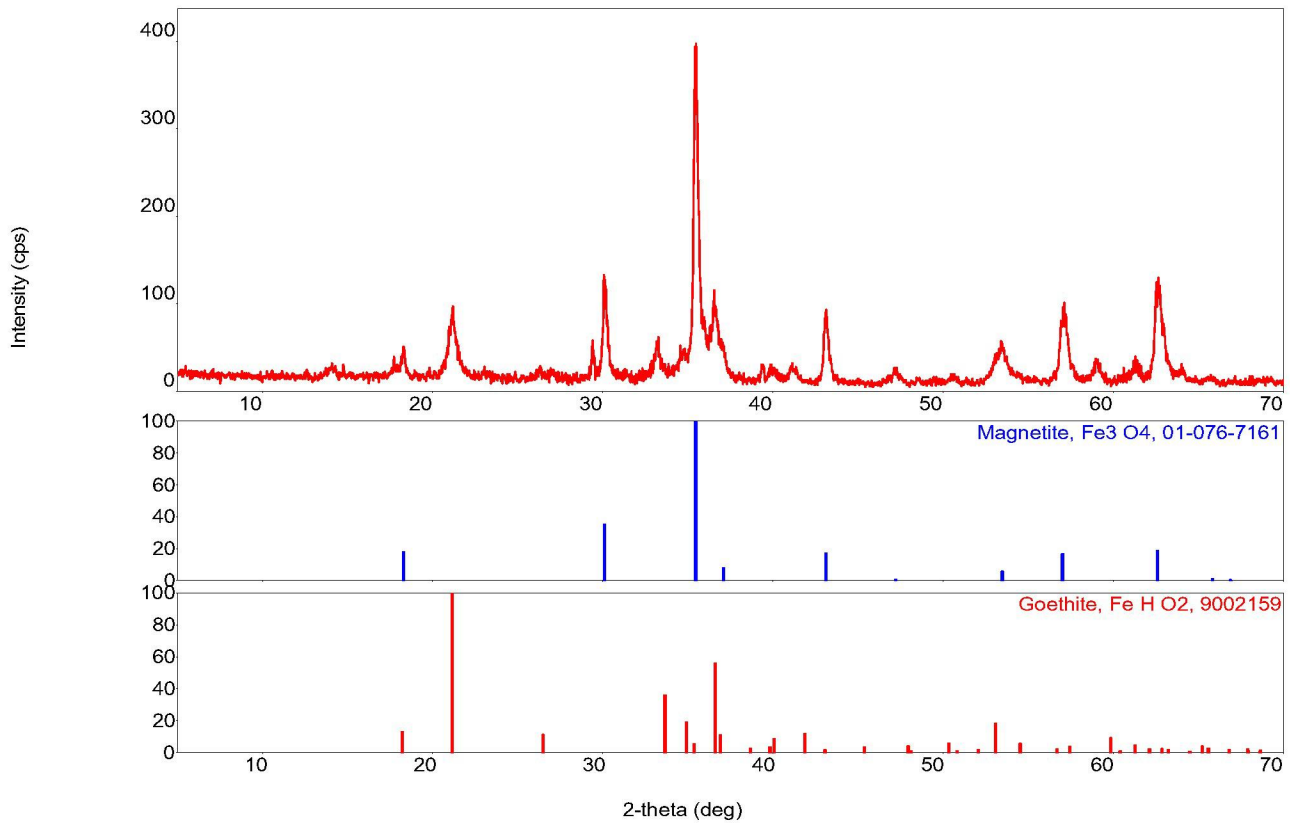
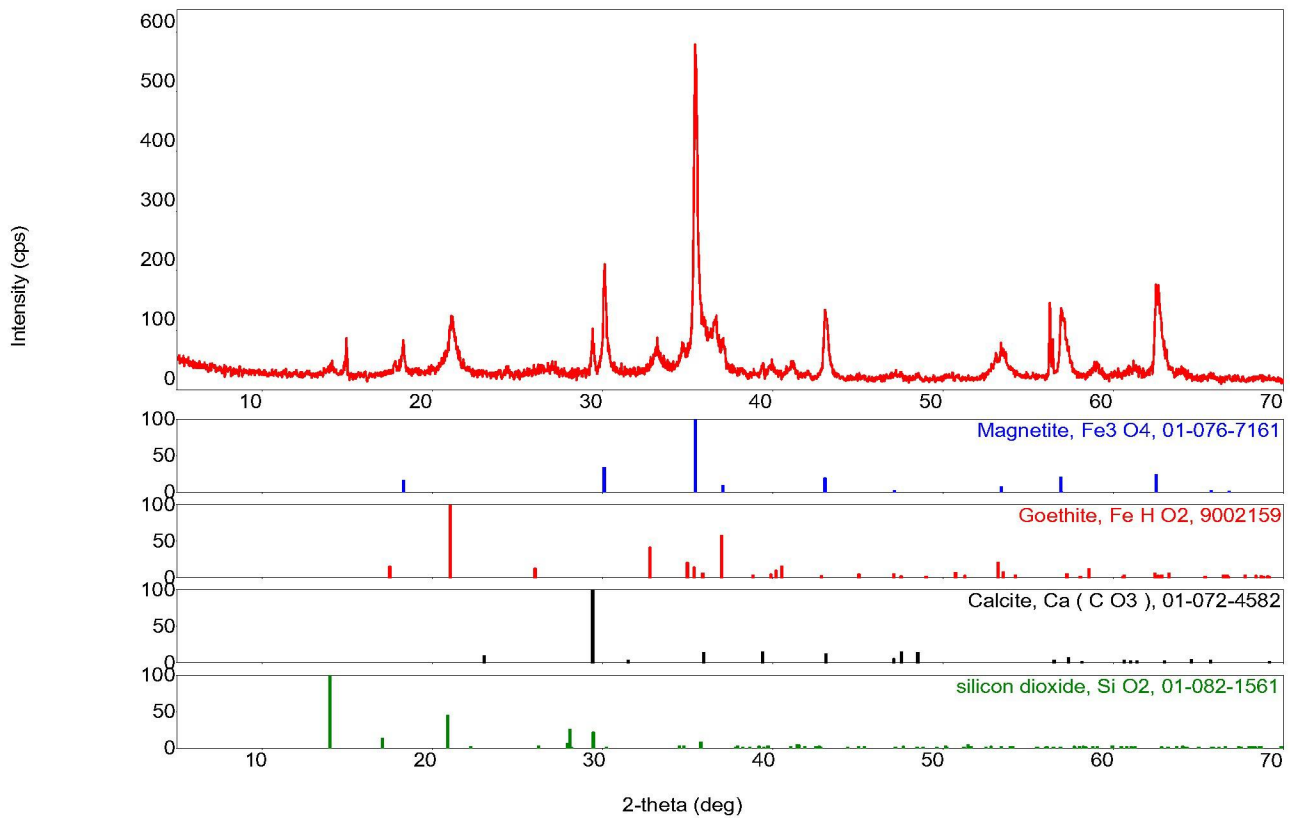
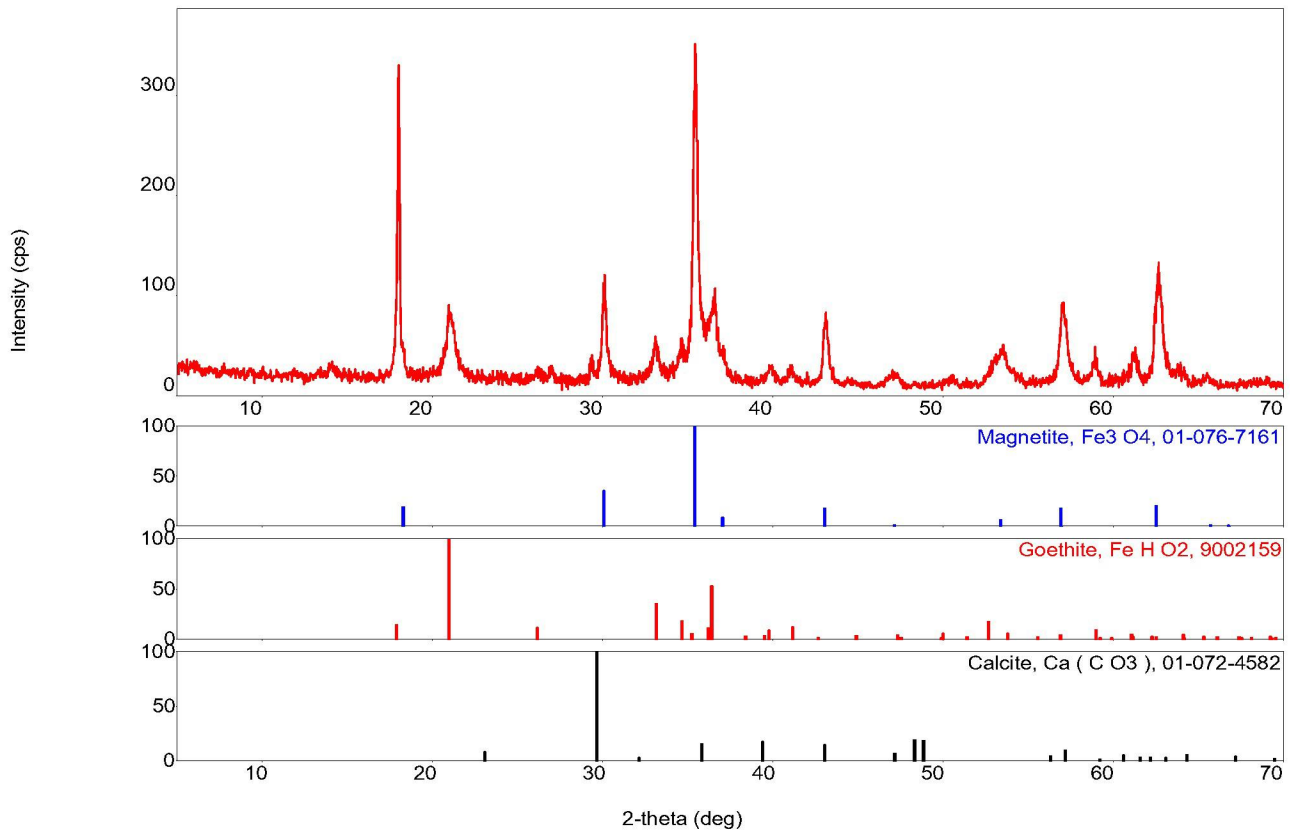
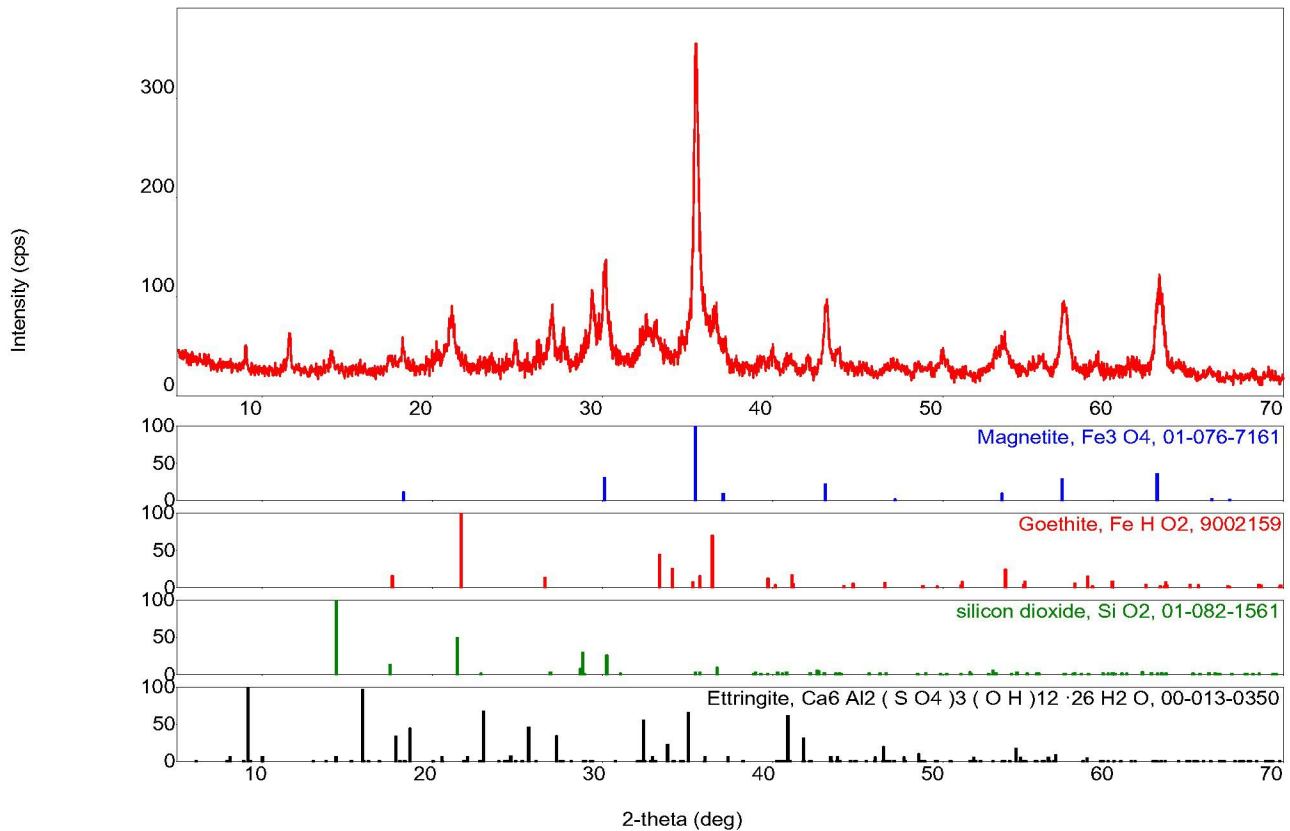
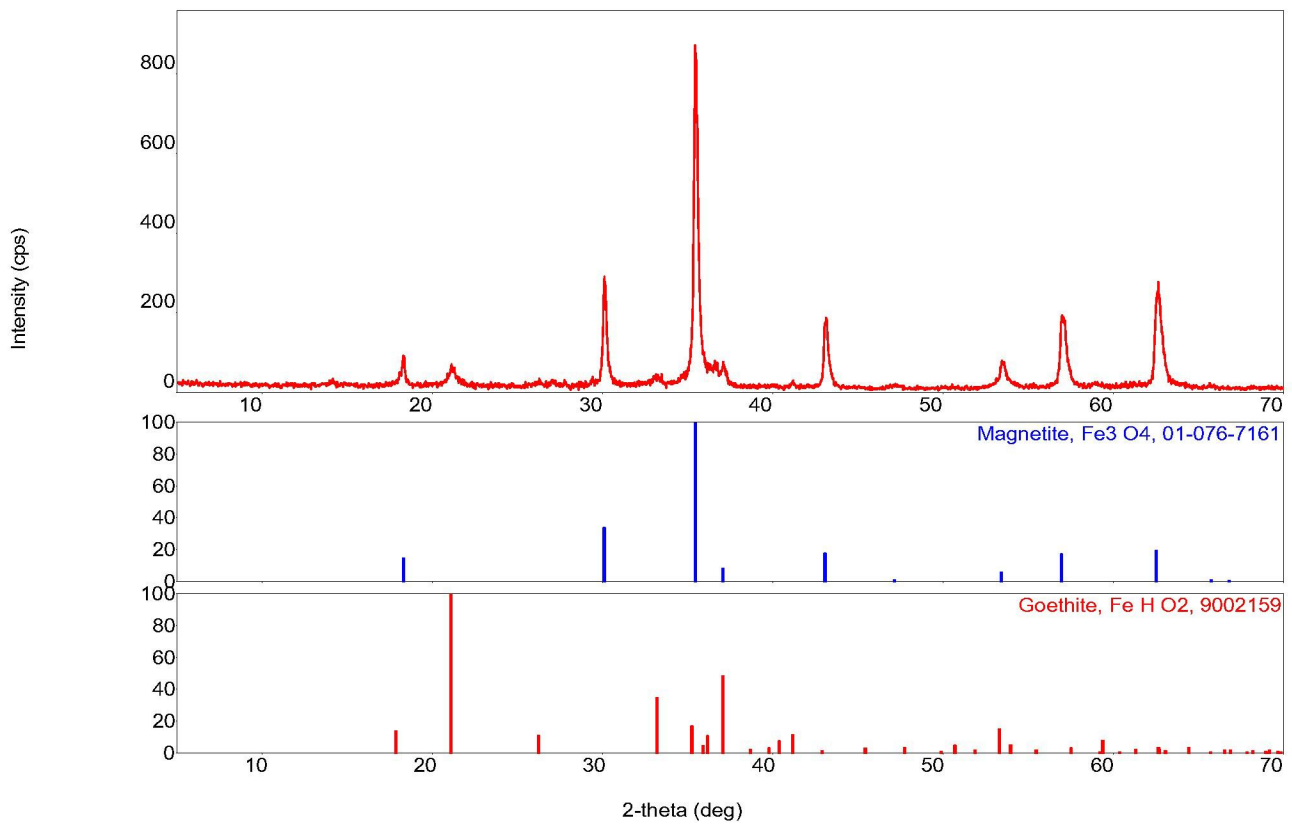
X-Ray Diffraction Spectroscopy (XRD) analysis of the corrosion product from the metal panels revealed the presence of the following crystalline phases: iron oxide (magnetite); iron hydroxide (goethite); calcium carbonate (calcite); silicon dioxide and hydrous calcium aluminum sulfate (ettringite). The results are summarized in Tables 19 and 20. The XRD diffractograms for the corrosion samples are provided as Figures 123 through 128.

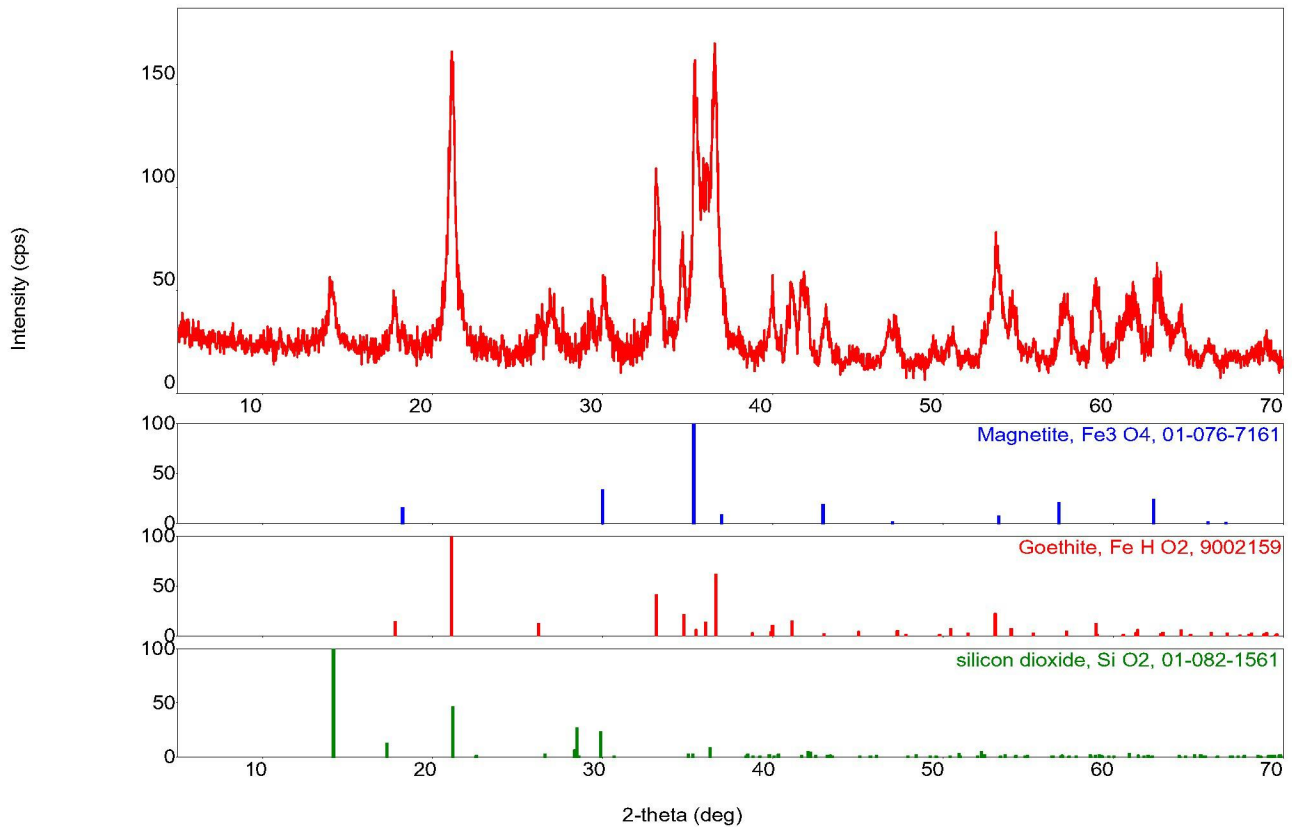
Figure 128. The XRD diffractogram generated from corrosion product removed Coupon 8.

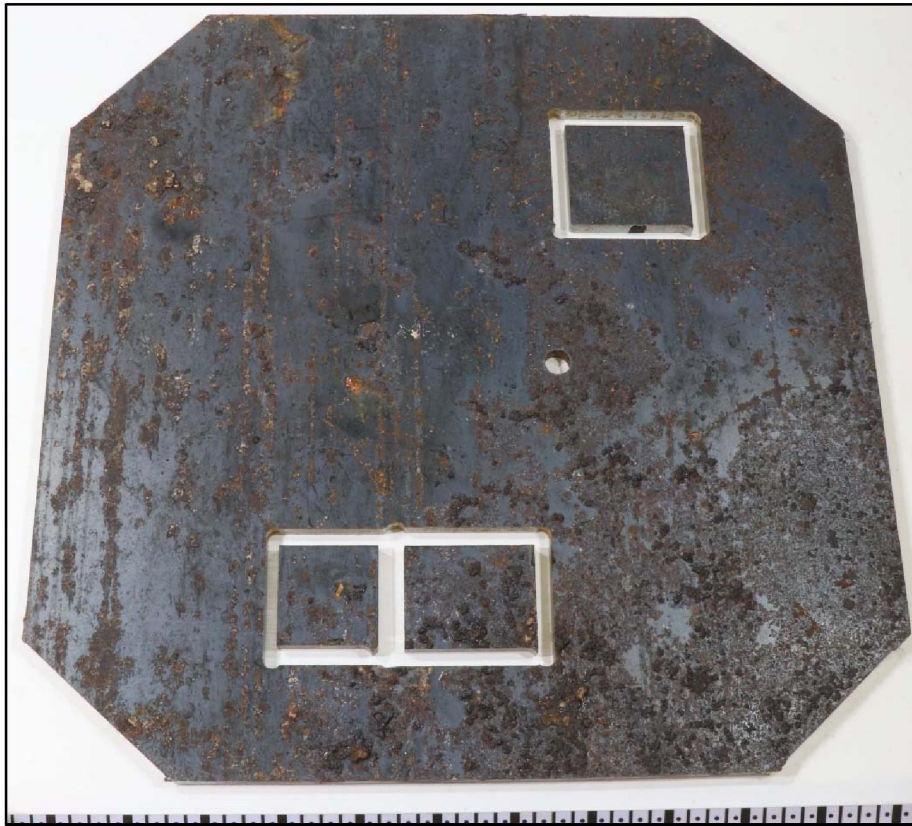
Figure 129. An image of the interior surface of Coupon 1 after CO₂ blast cleaning.

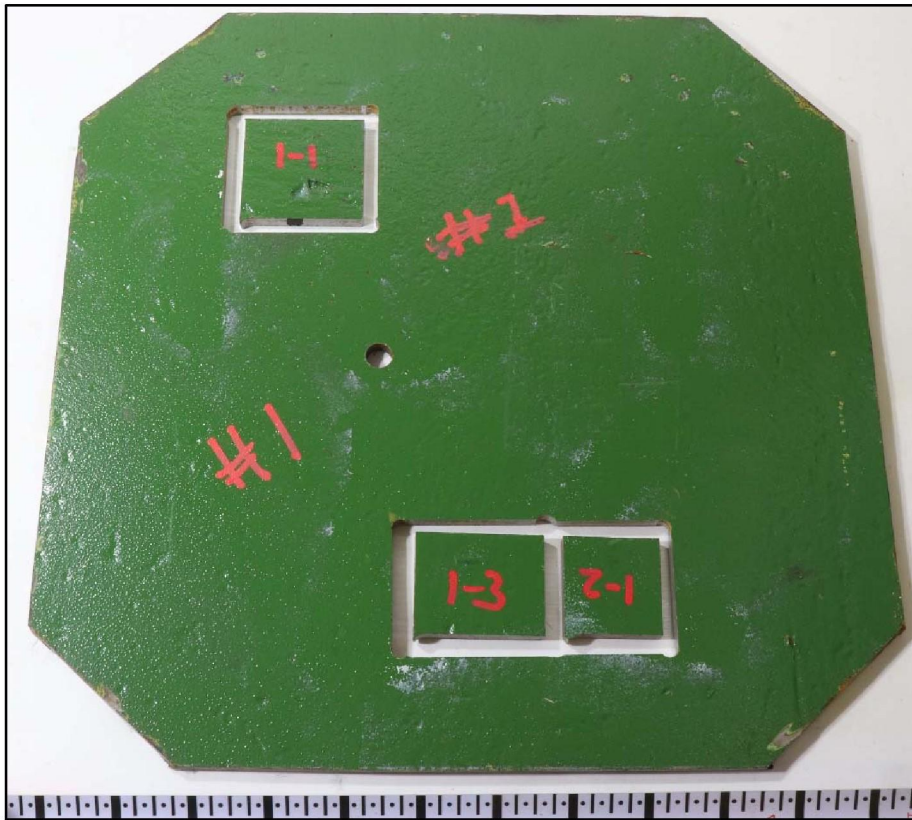
Figure 130. An image of the exterior surface of Coupon 1 after CO₂ blast cleaning.

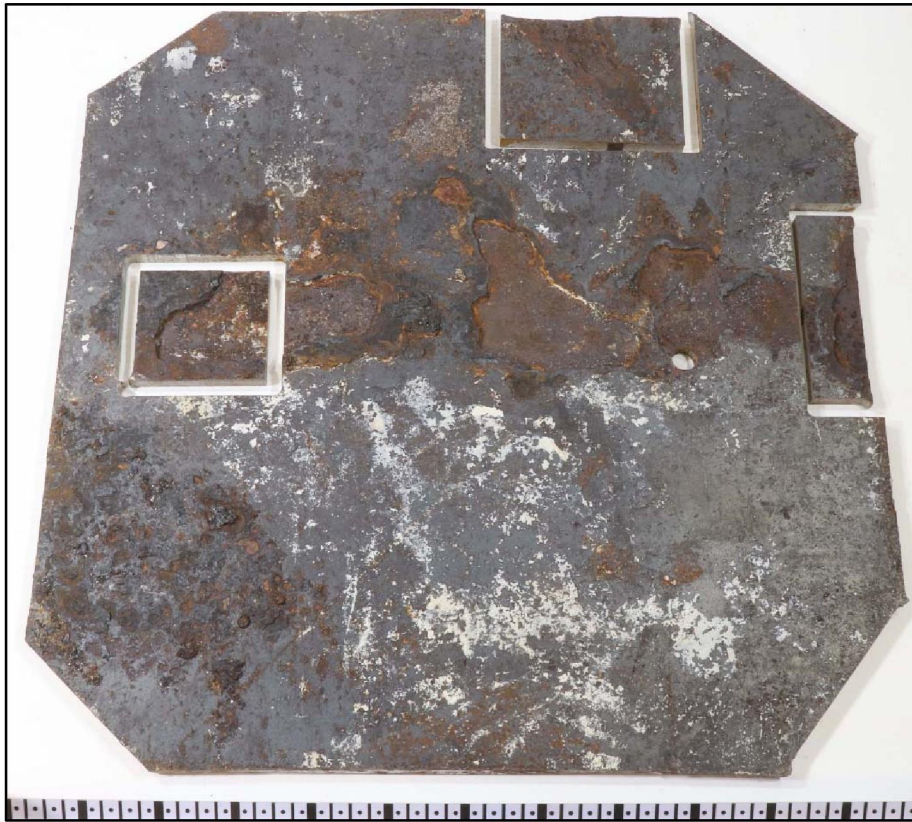
Figure 131. An image of the interior surface of Coupon 2 after CO₂ blast cleaning.

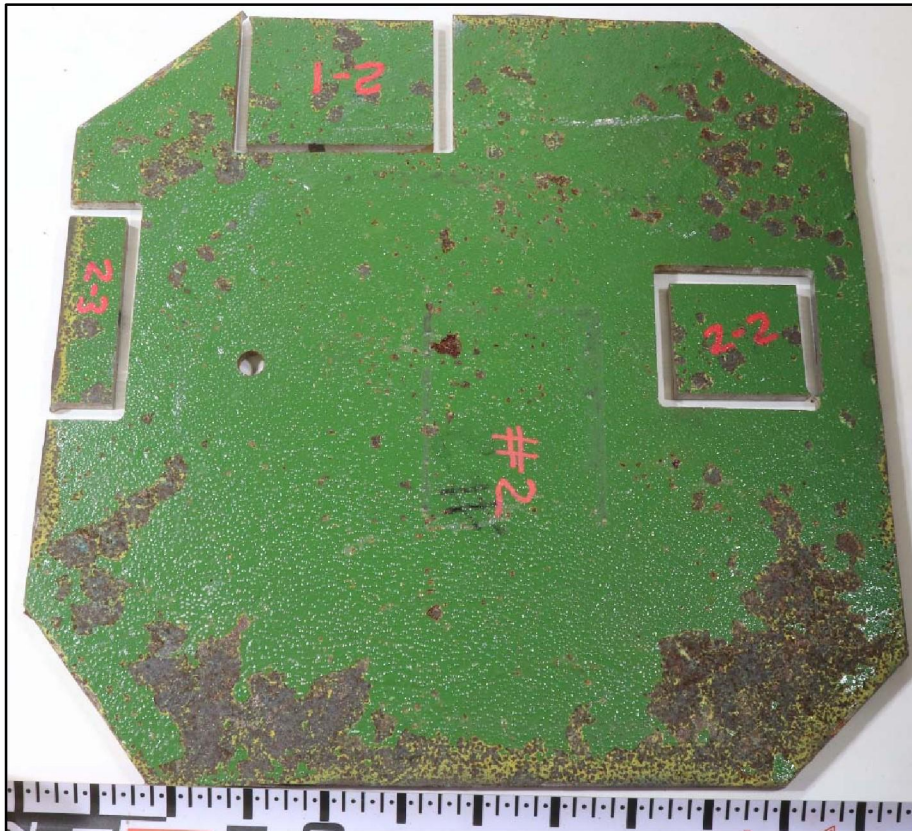
Figure 132. An image of the exterior surface of Coupon 2 after CO₂ blast cleaning.

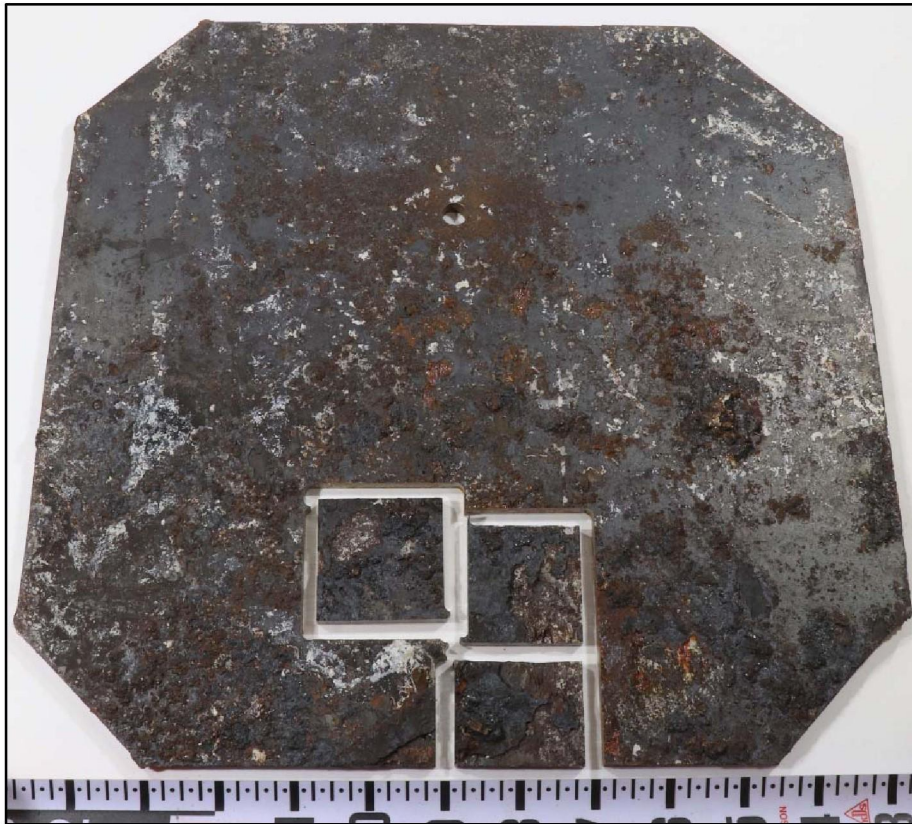
Figure 133. An image of the interior surface of Coupon 3 after CO₂ blast cleaning.

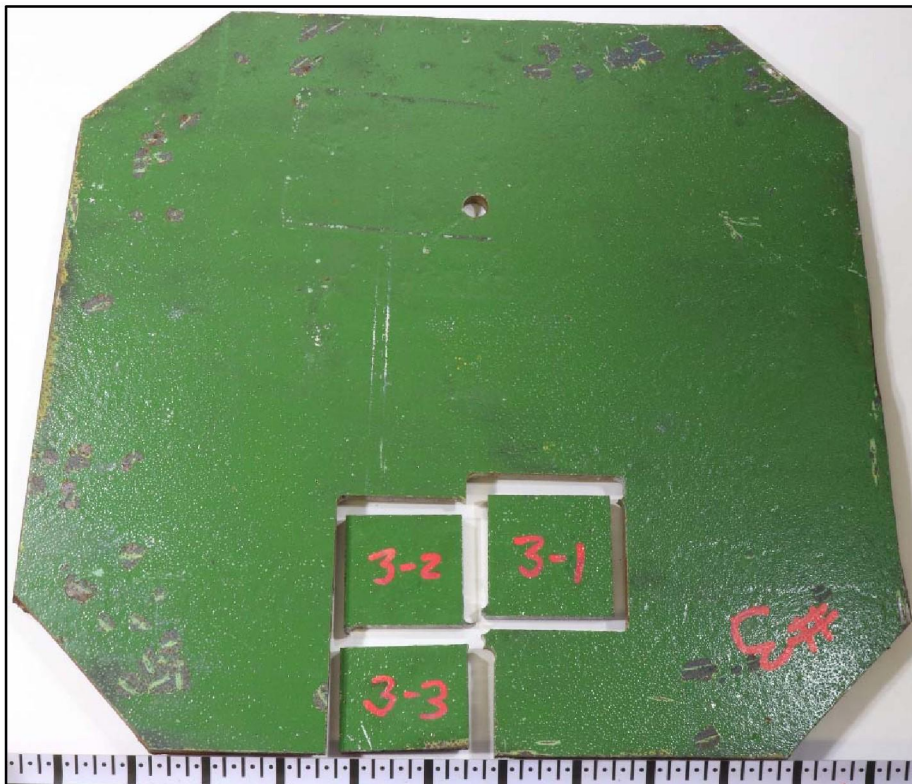
Figure 134. An image of the exterior surface of Coupon 3 after CO₂ blast cleaning.

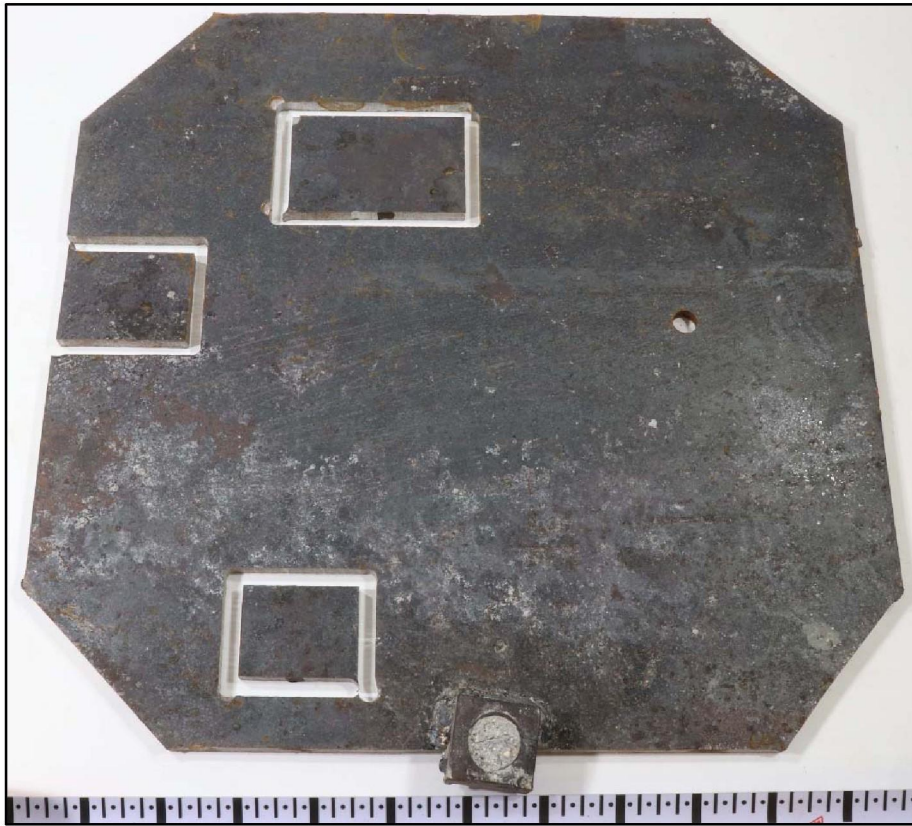
Figure 135. An image of the interior surface of Coupon 5 after CO₂ blast cleaning.

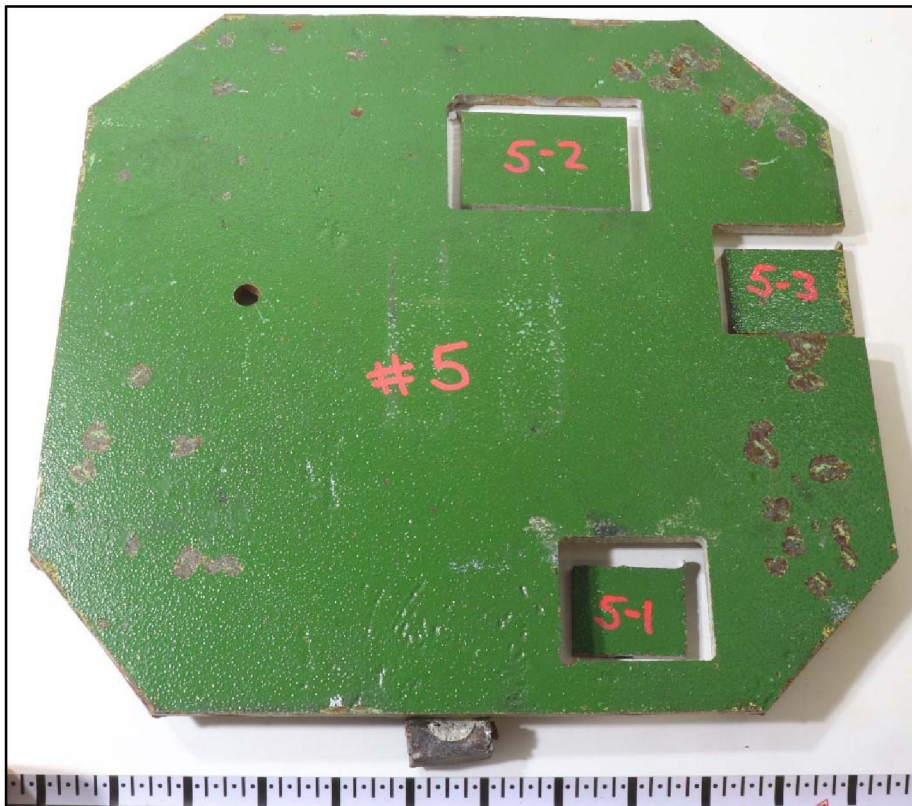
Figure 136. An image of the exterior surface of Coupon 5 after CO₂ blast cleaning.

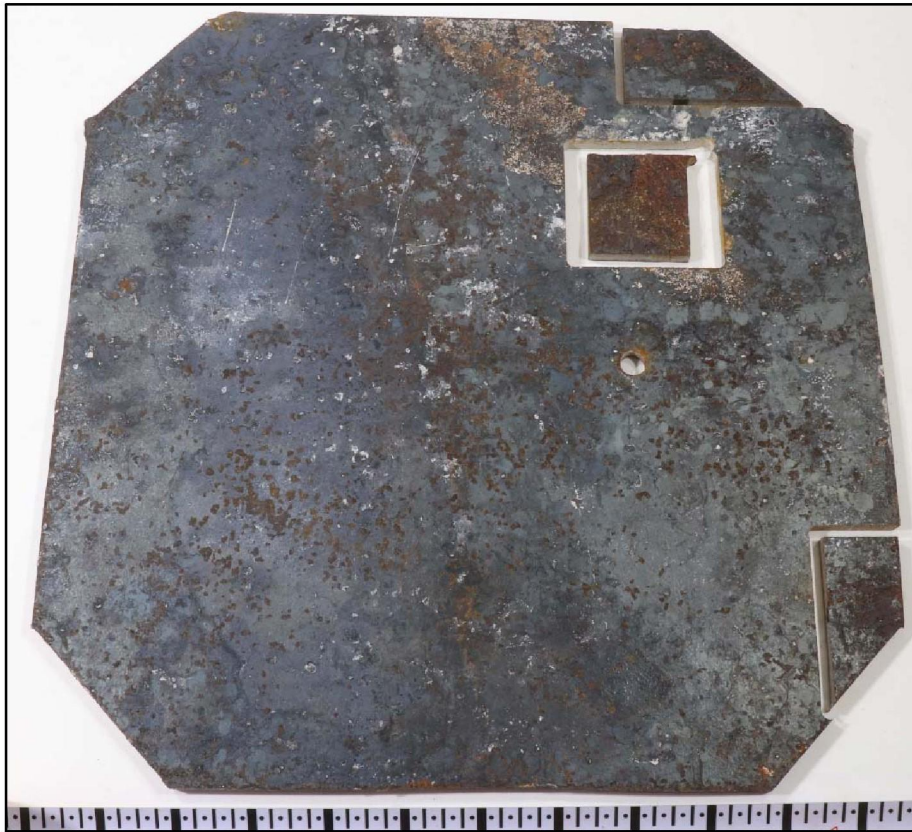
Figure 137. An image of the interior surface of Coupon 6 after CO₂ blast cleaning.

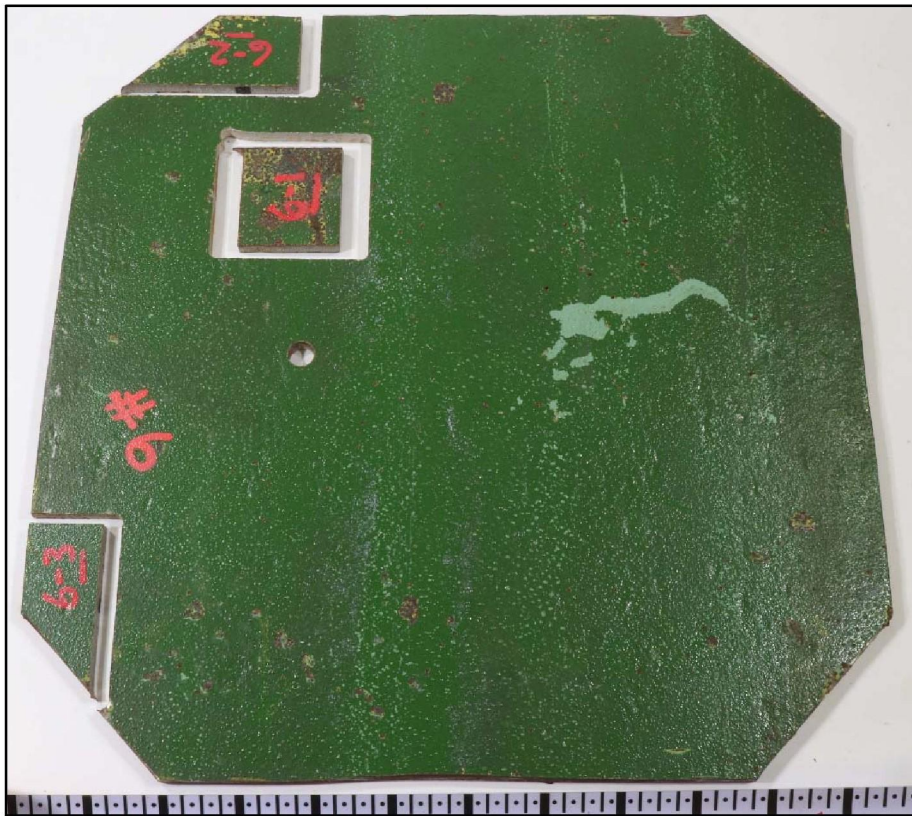
Figure 138. An image of the exterior surface of Coupon 6 after CO₂ blast cleaning.

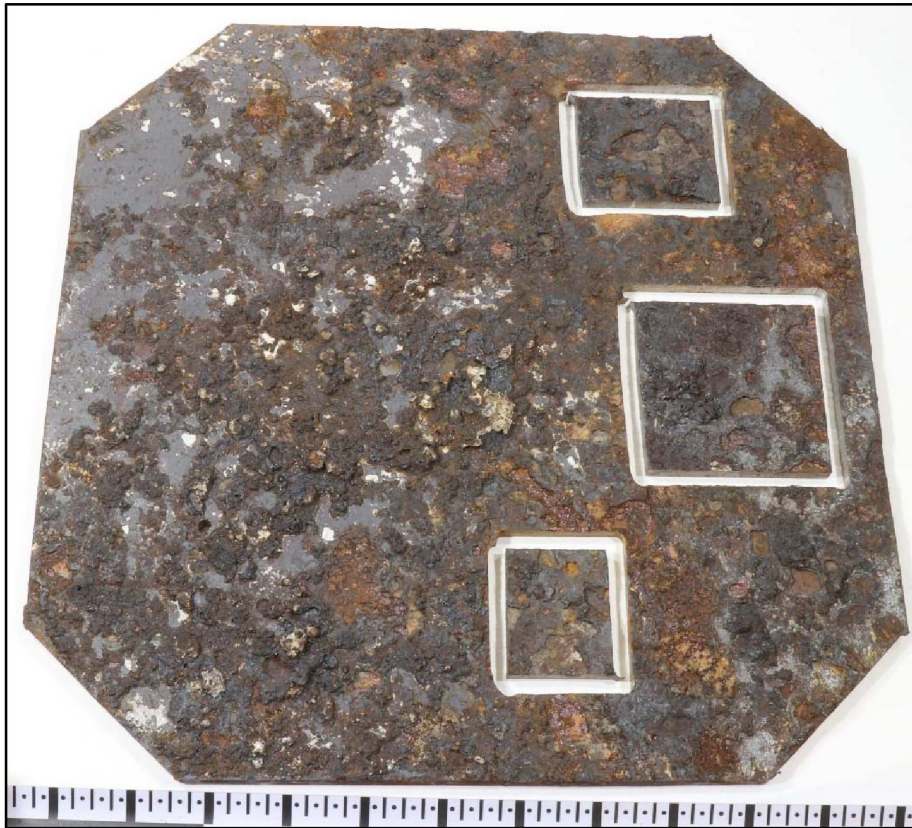
Figure 139. An image of the interior surface of Coupon 7 after CO₂ blast cleaning.

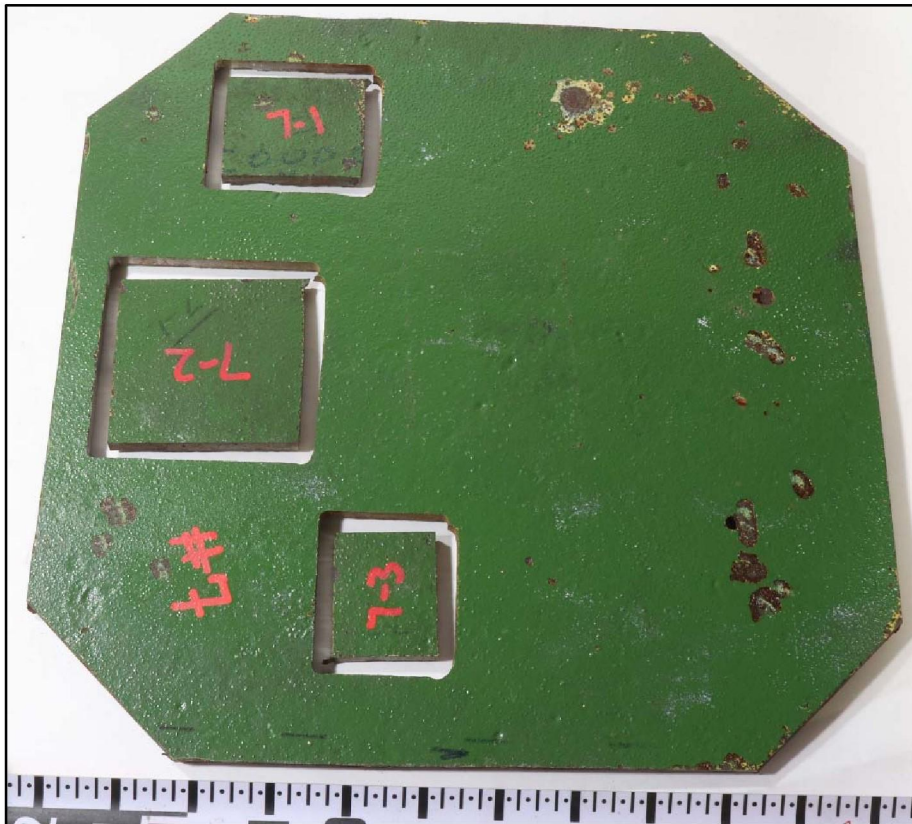
Figure 140. An image of the exterior surface of Coupon 7 after CO₂ blast cleaning.

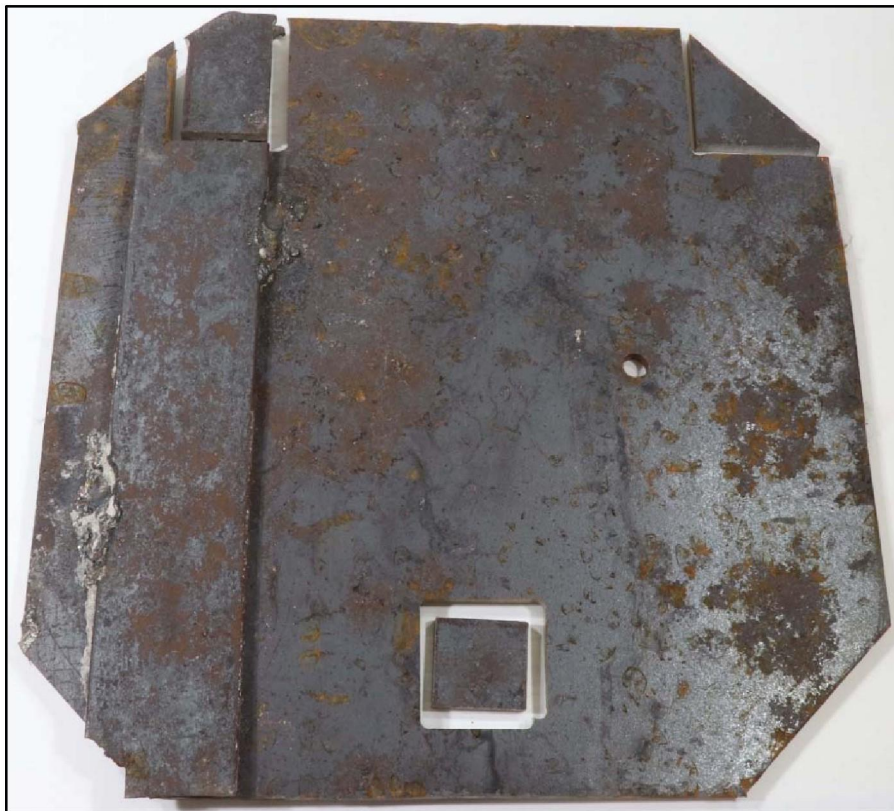
Figure 141. An image of the interior surface of Coupon 8 after CO₂ blast cleaning.

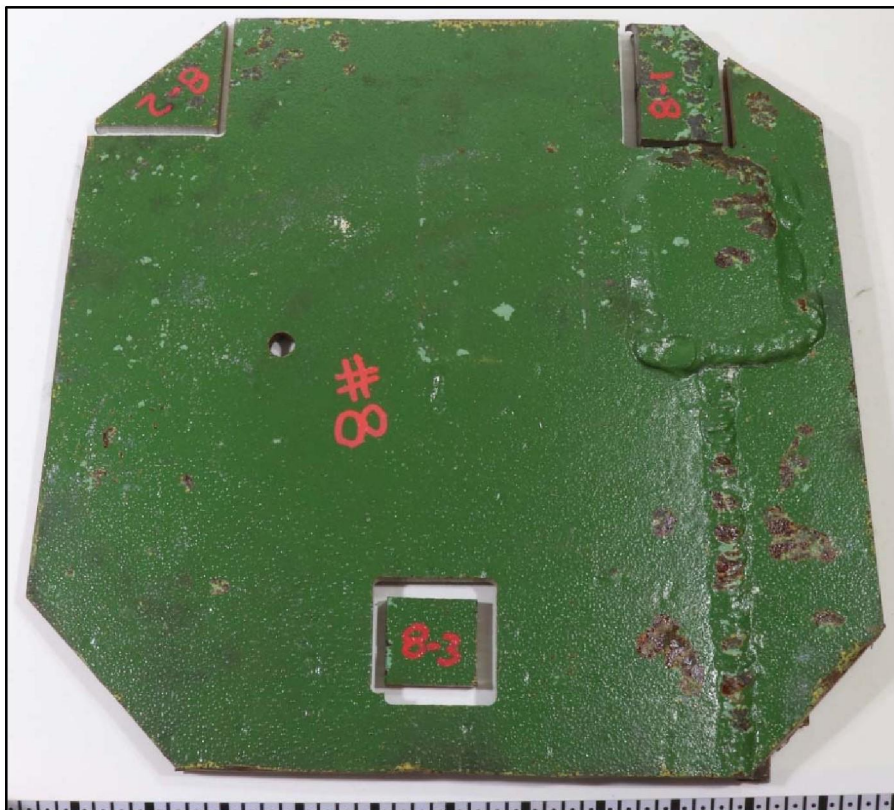
Figure 142. An image of the exterior surface of Coupon 8 after CO₂ blast cleaning.

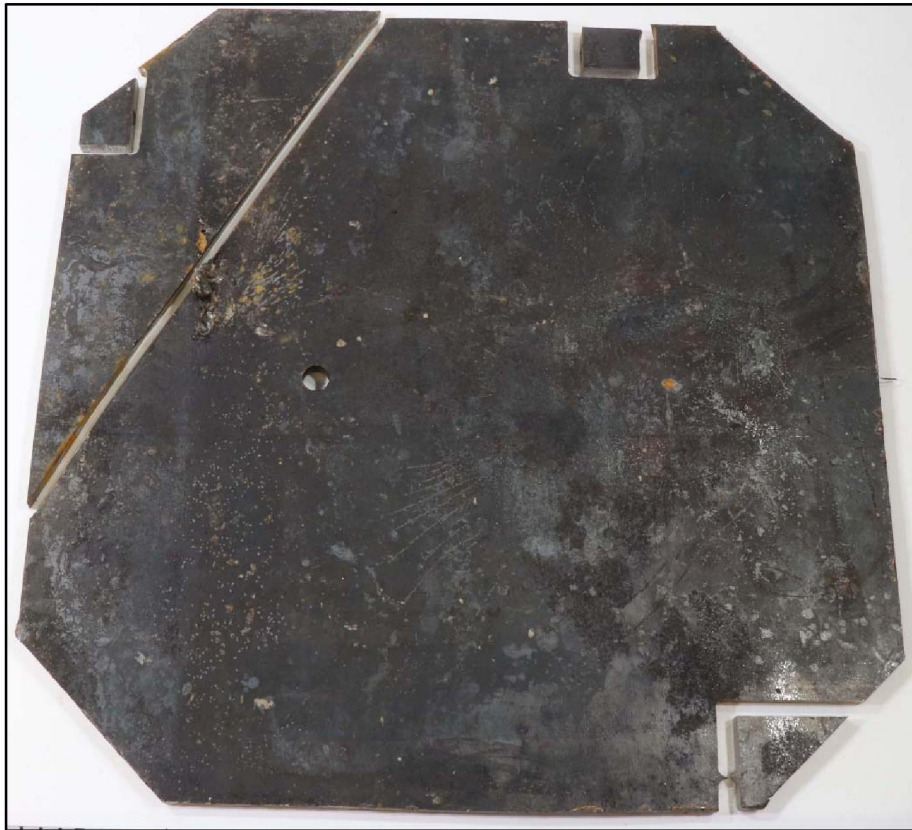
Figure 143. An image of the interior surface of Coupon 10 after CO₂ blast cleaning.

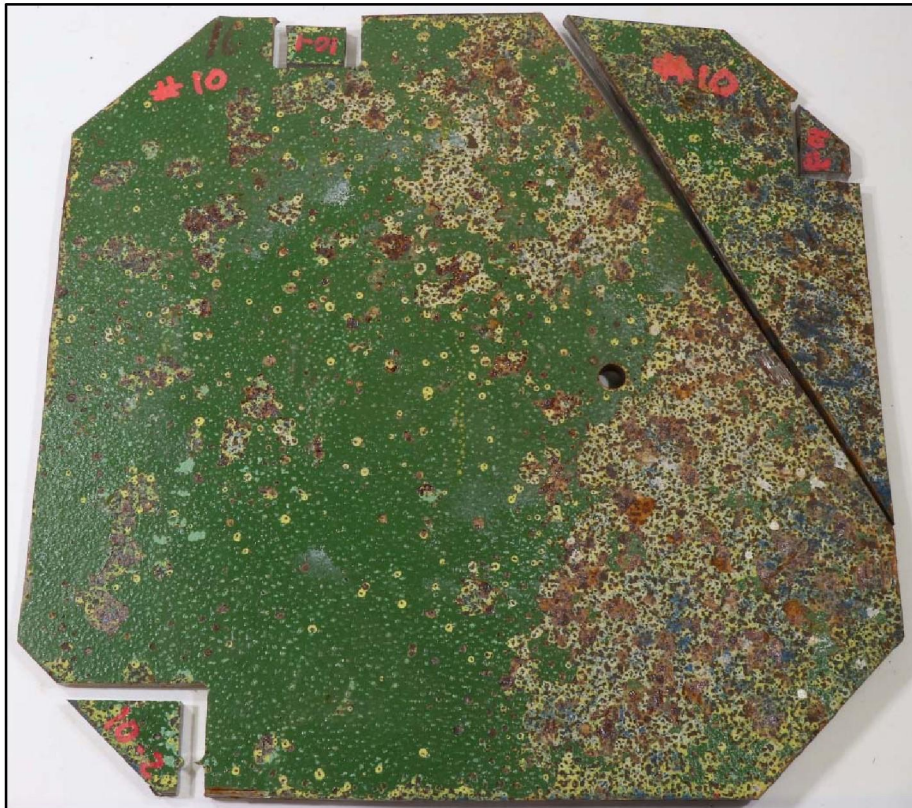
Figure 144. An image of the exterior surface of Coupon 10 after CO₂ blast cleaning.

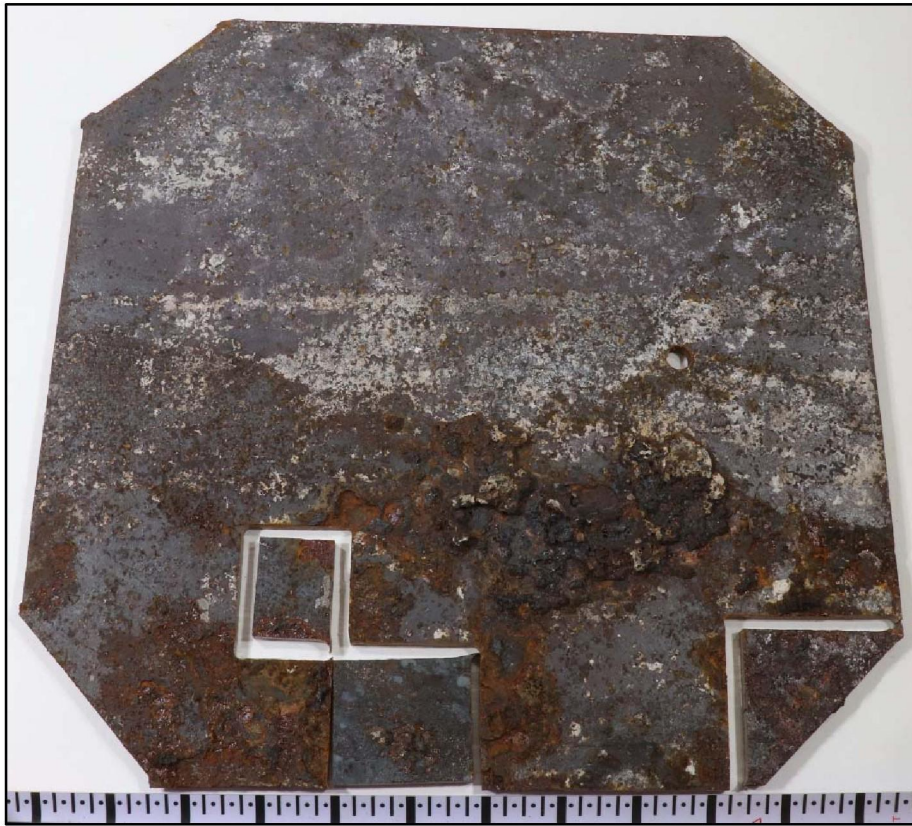
Figure 145. An image of the interior surface of Coupon A1 after CO₂ blast cleaning.

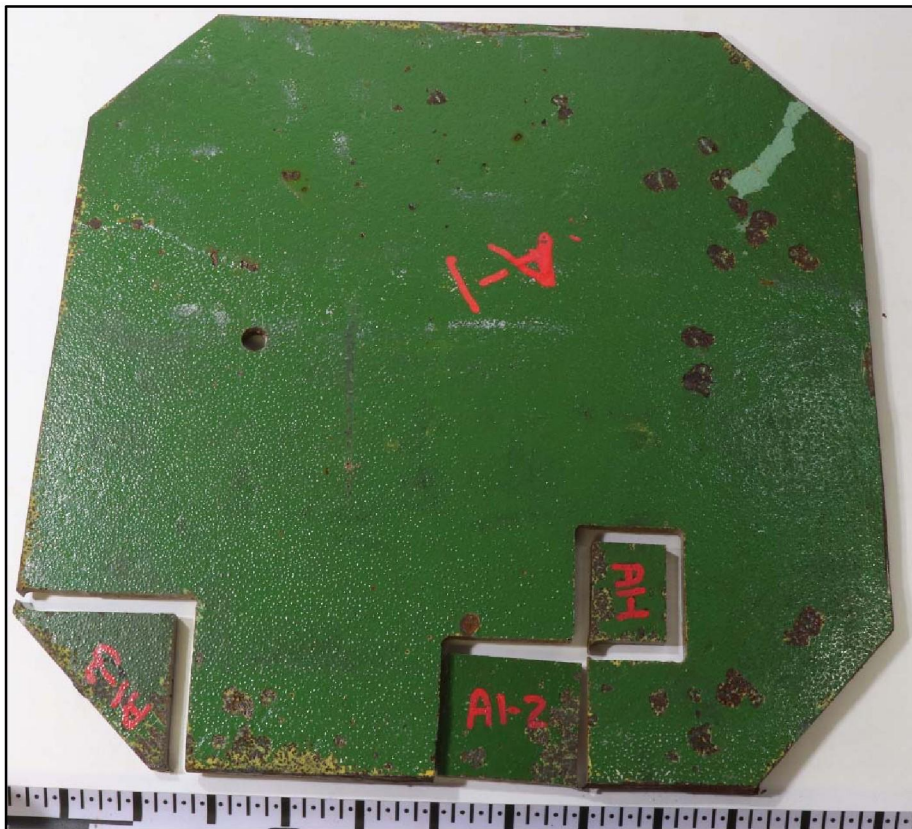
Figure 146. An image of the exterior surface of Coupon A1 after CO₂ blast cleaning.

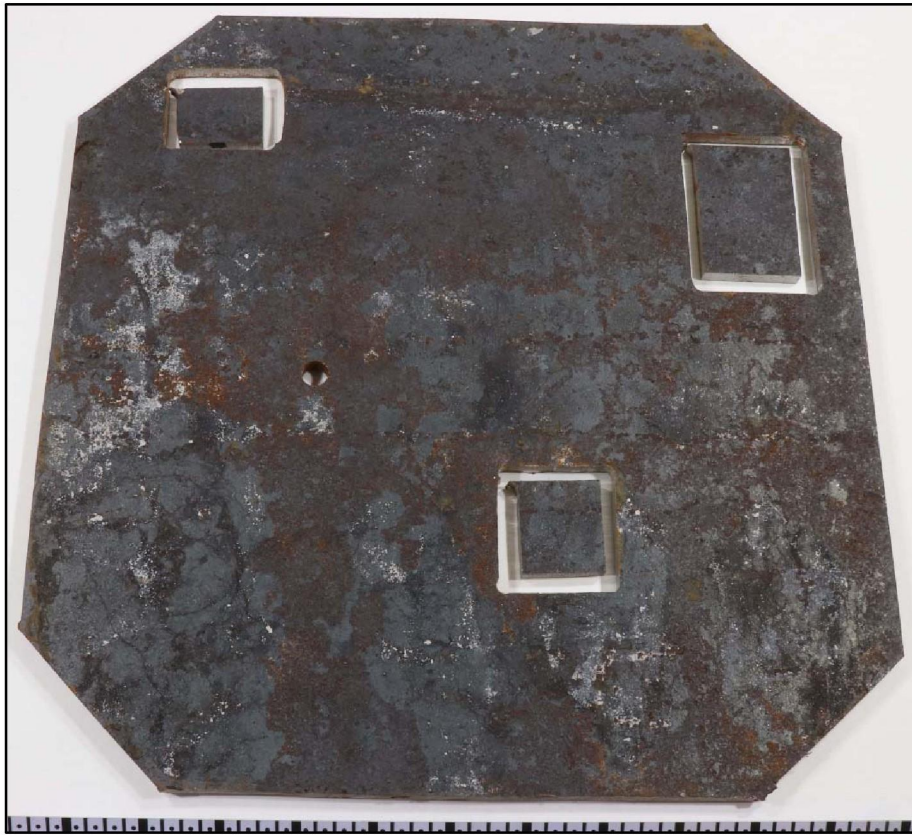
Figure 147. An image of the interior surface of Coupon A2 after CO₂ blast cleaning.

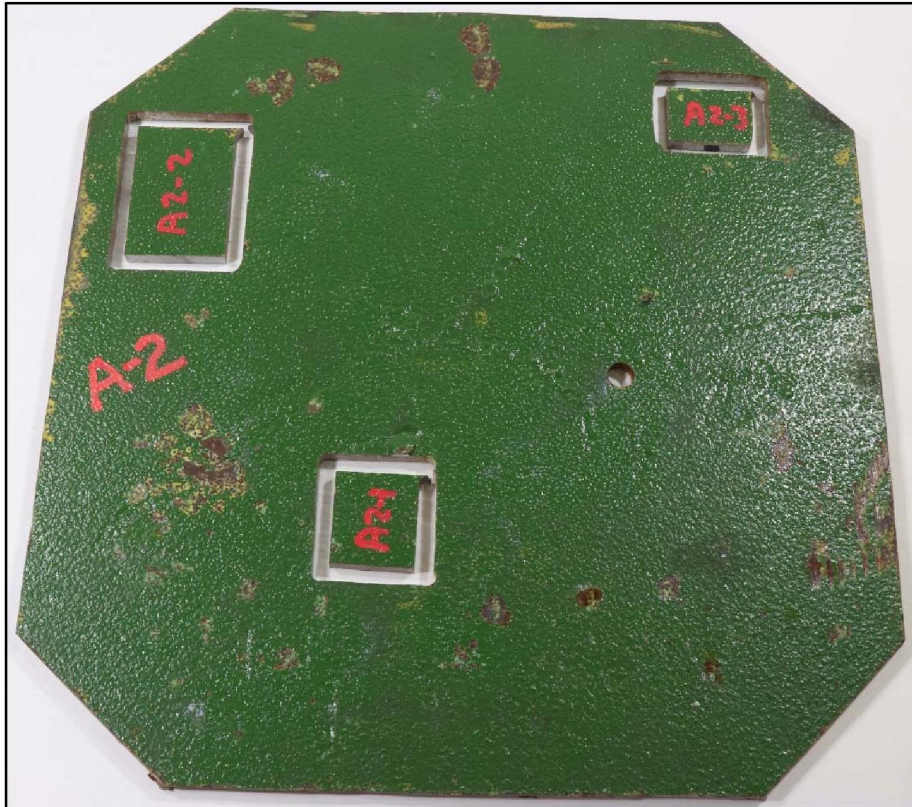
Figure 148. An image of the exterior surface of Coupon A2 after CO₂ blast cleaning.

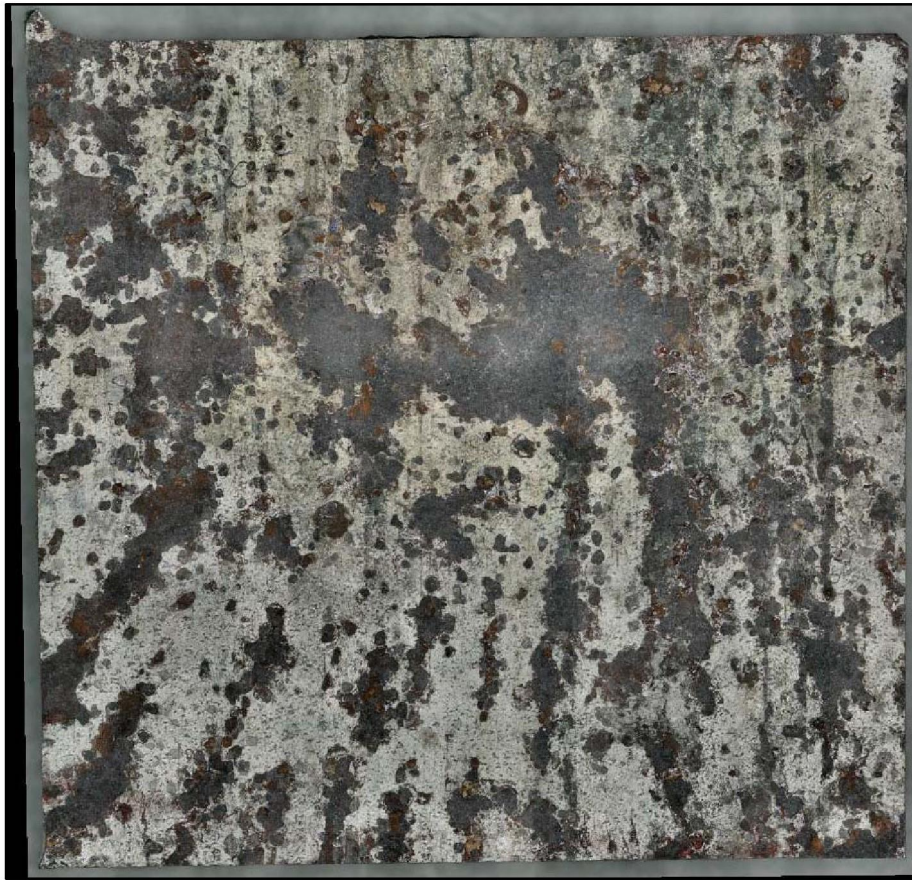
Figure 149. A screenshot of the 3D digital image of a specimen excised from Coupon 1 labeled as 1-1, after CO₂ blast cleaning
