**SUBJECT: DESTRUCTIVE ANALYSIS OF 10 STEEL COUPONS REMOVED FROM
RED HILL FUEL STORAGE TANK NO. 14, PURSUANT TO SECTION 5.3
OF THE ADMINISTRATIVE ORDER ON CONSENT STATEMENT OF
WORK, RED HILL BULK FUEL STORAGE FACILITY, JOINT BASE PEARL
HARBOR-HICKAM, OAHU, HAWAII**

Destructive Analysis of 10 Steel Coupons Removed from Red Hill Fuel Storage Tank #14

REPORT No. 201801967

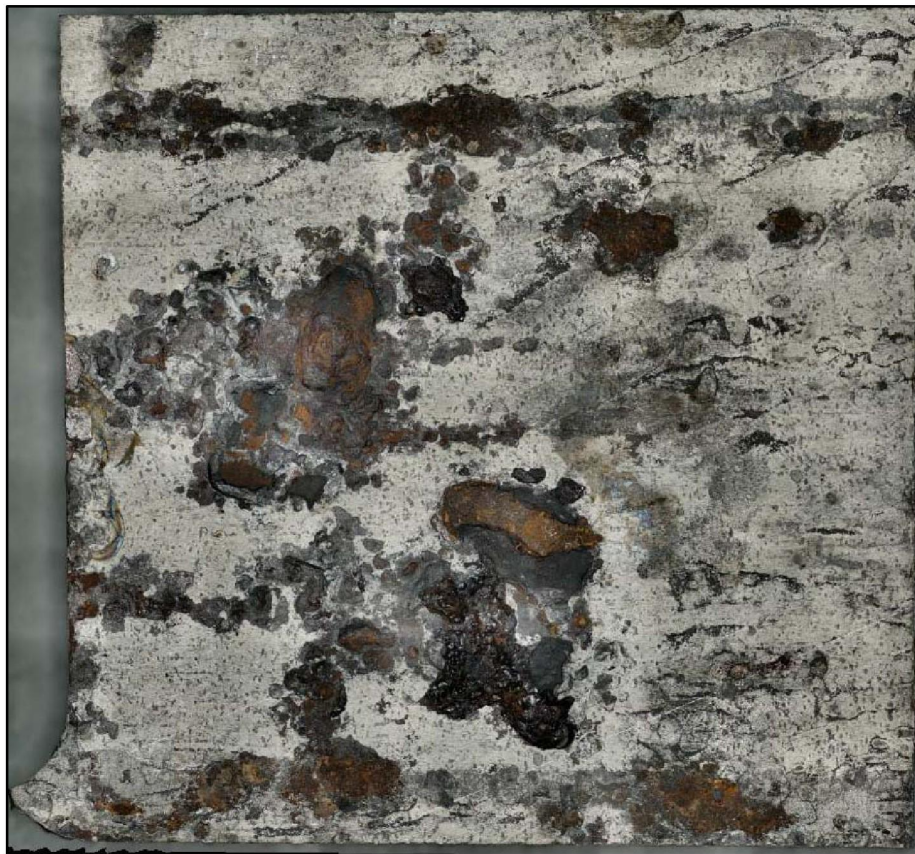
Figure 150. A screenshot of the 3D digital image of a specimen excised from Coupon 1 labeled as 1-2, after CO₂ blast cleaning

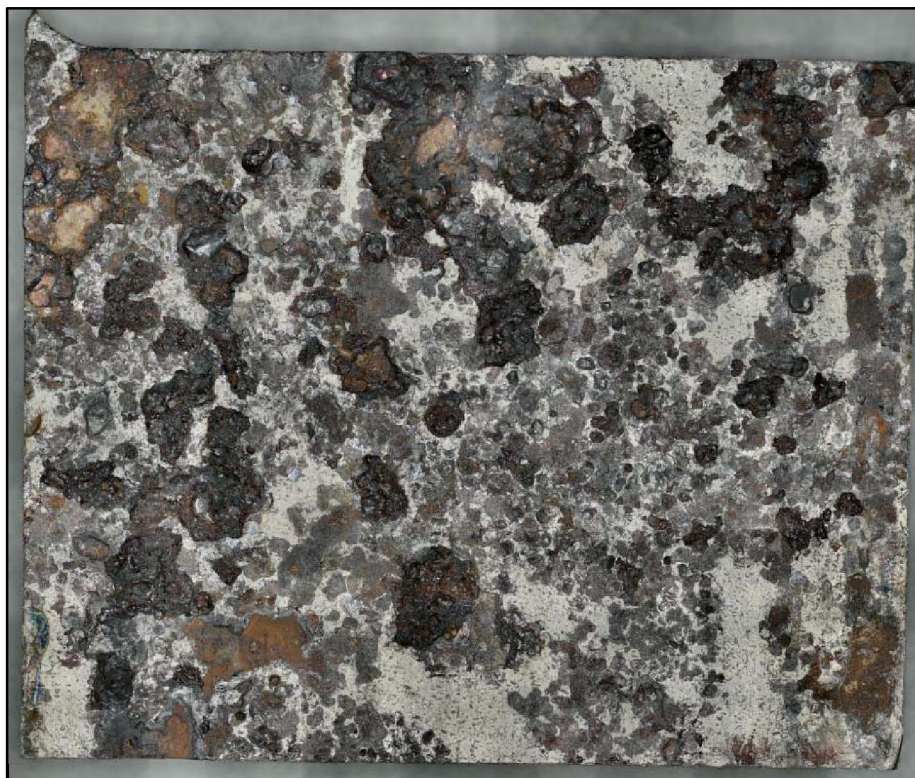
Figure 151. A screenshot of the 3D digital image of a specimen excised from Coupon 1 labeled as 1-3, after CO₂ blast cleaning

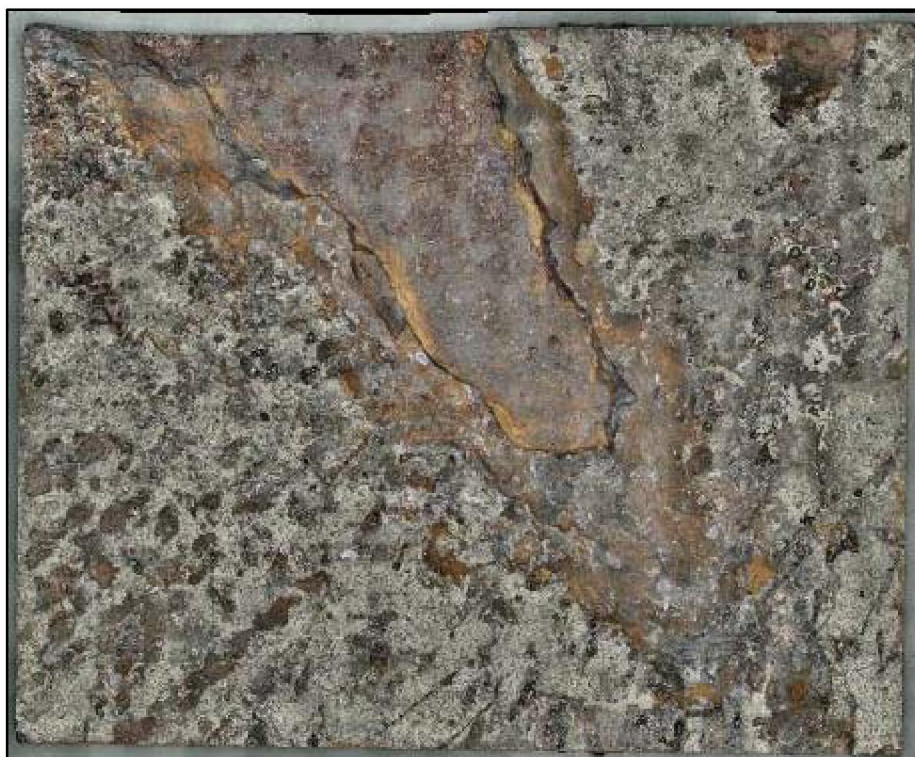
Figure 152. A screenshot of the 3D digital image of a specimen excised from Coupon 2 labeled as 2-1, after CO₂ blast cleaning

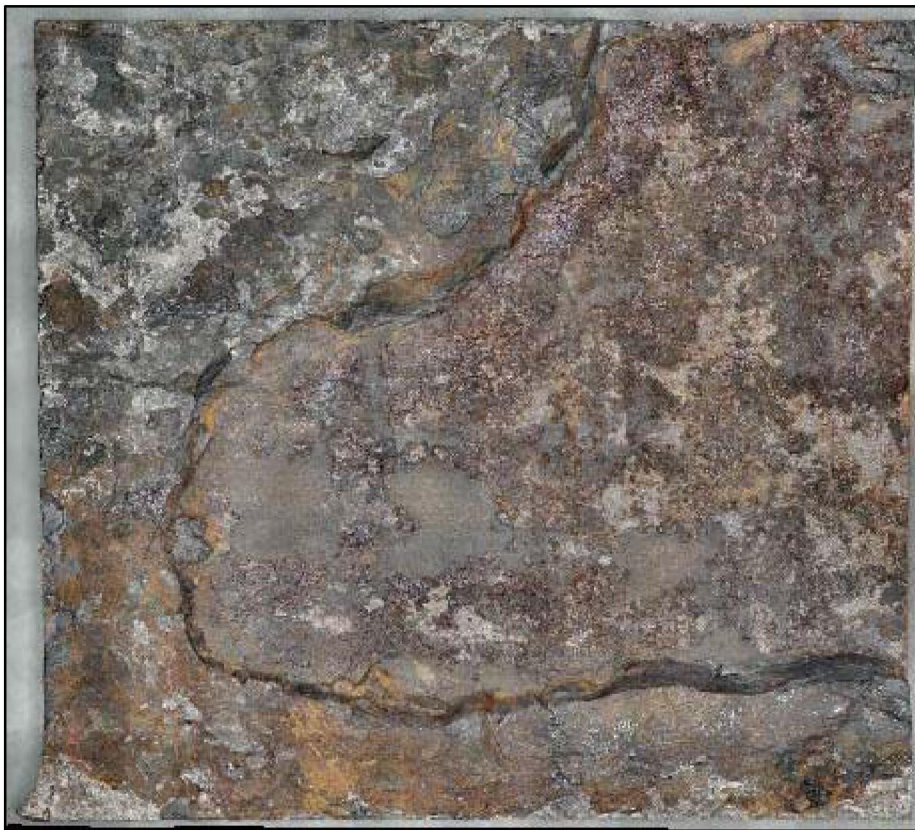
Figure 153. A screenshot of the 3D digital image of a specimen excised from Coupon 2 labeled as 2-2, after CO₂ blast cleaning

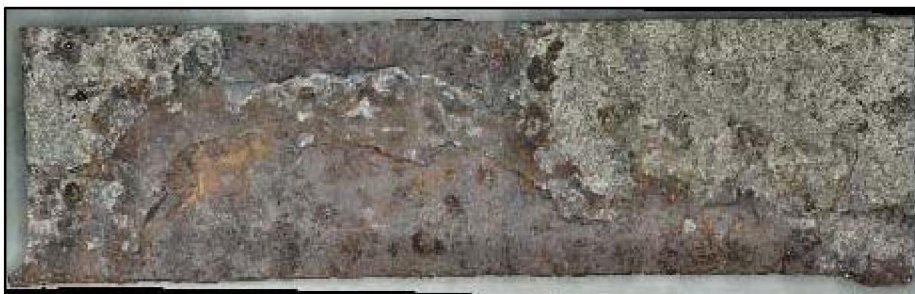
Figure 154. A screenshot of the 3D digital image of a specimen excised from Coupon 2 labeled as 2-3, after CO₂ blast cleaning

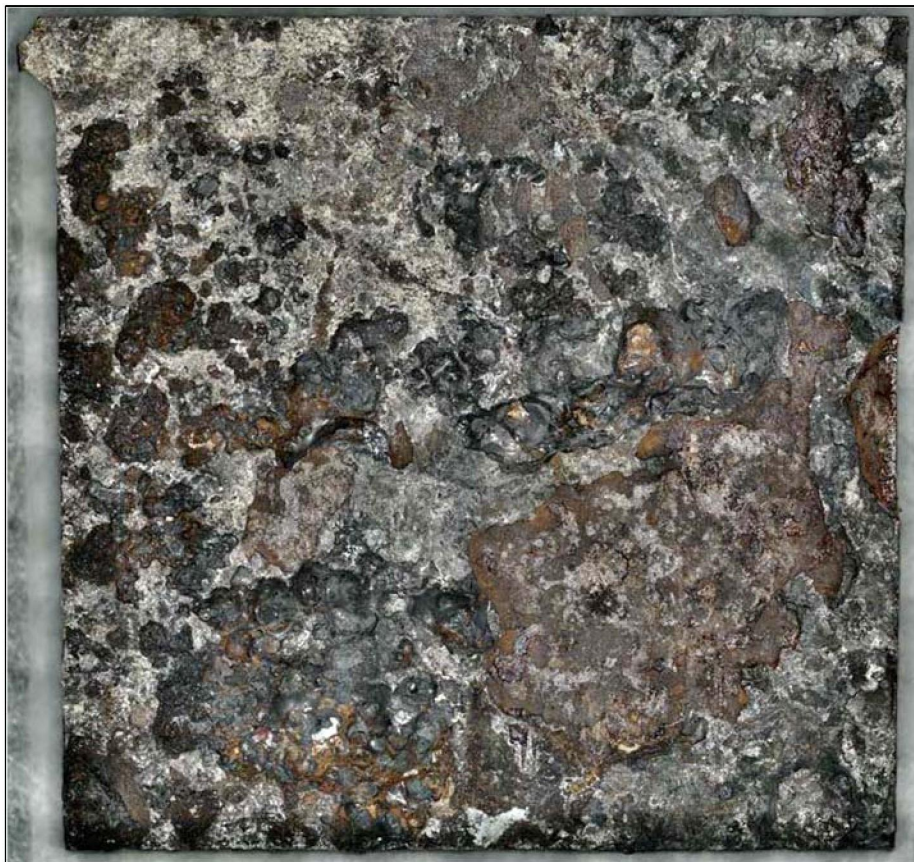
Figure 155. A screenshot of the 3D digital image of a specimen excised from Coupon 3 labeled as 3-1, after CO₂ blast cleaning

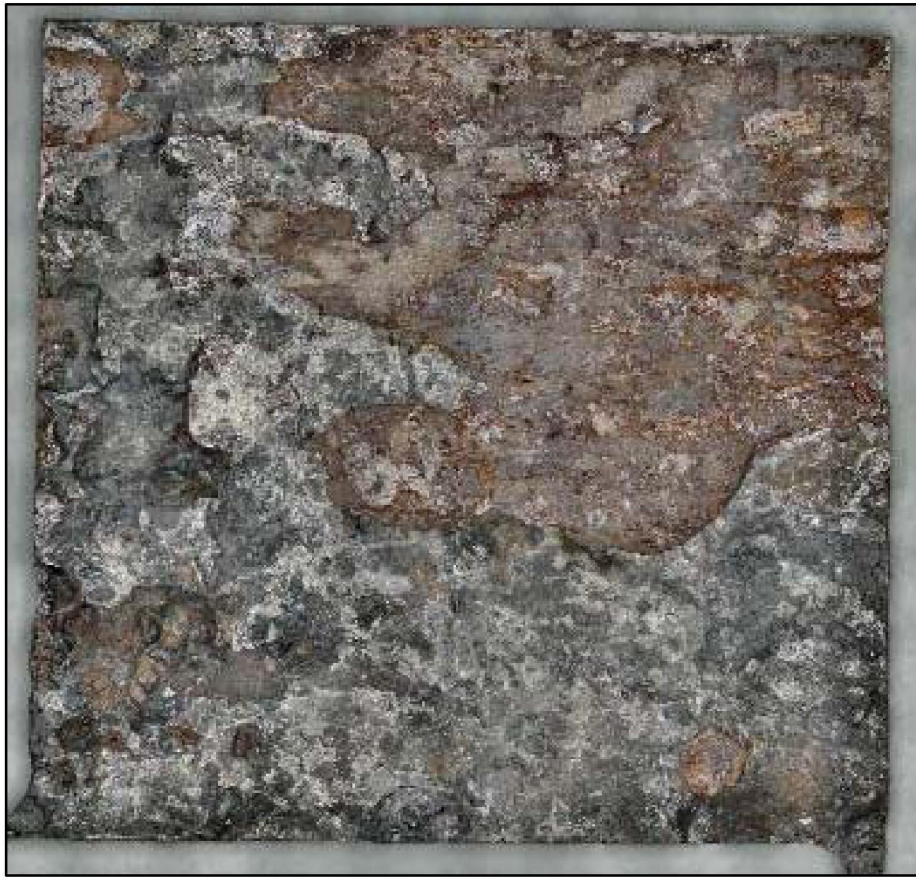
Figure 156. A screenshot of the 3D digital image of a specimen excised from Coupon 3 labeled as 3-2, after CO₂ blast cleaning

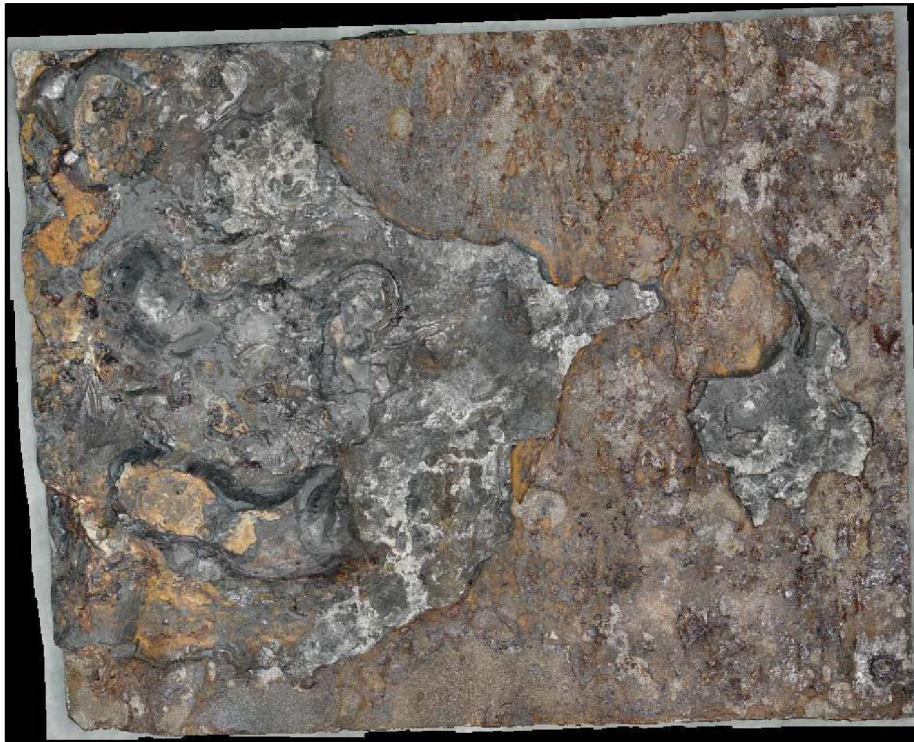
Figure 157. A screenshot of the 3D digital image of a specimen excised from Coupon 3 labeled as 3-3, after CO₂ blast cleaning

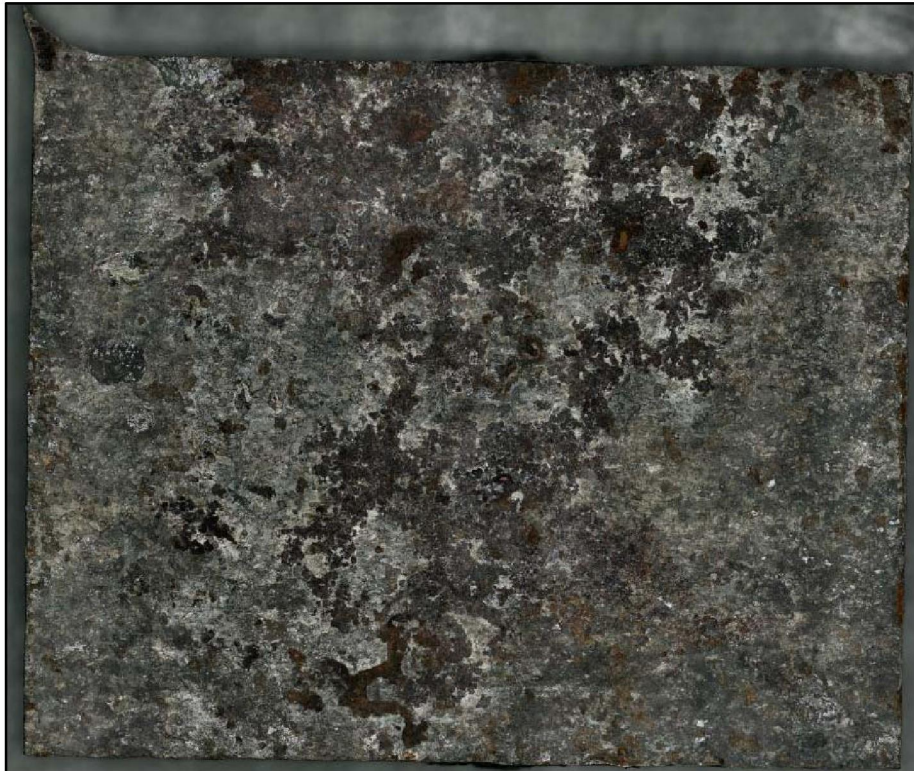
Figure 158. A screenshot of the 3D digital image of a specimen excised from Coupon 5 labeled as 5-1, after CO₂ blast cleaning

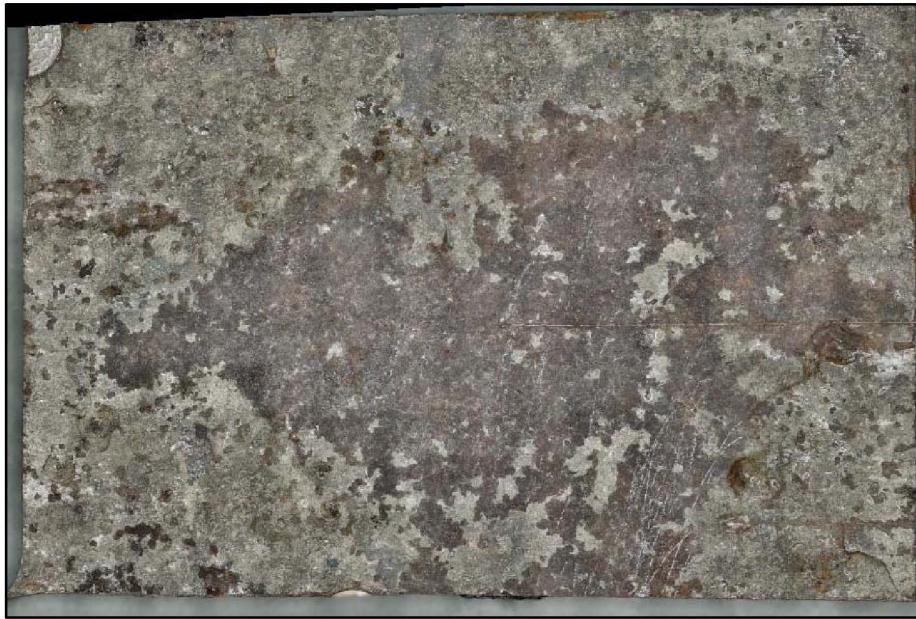
Figure 159. A screenshot of the 3D digital image of a specimen excised from Coupon 5 labeled as 5-2, after CO₂ blast cleaning

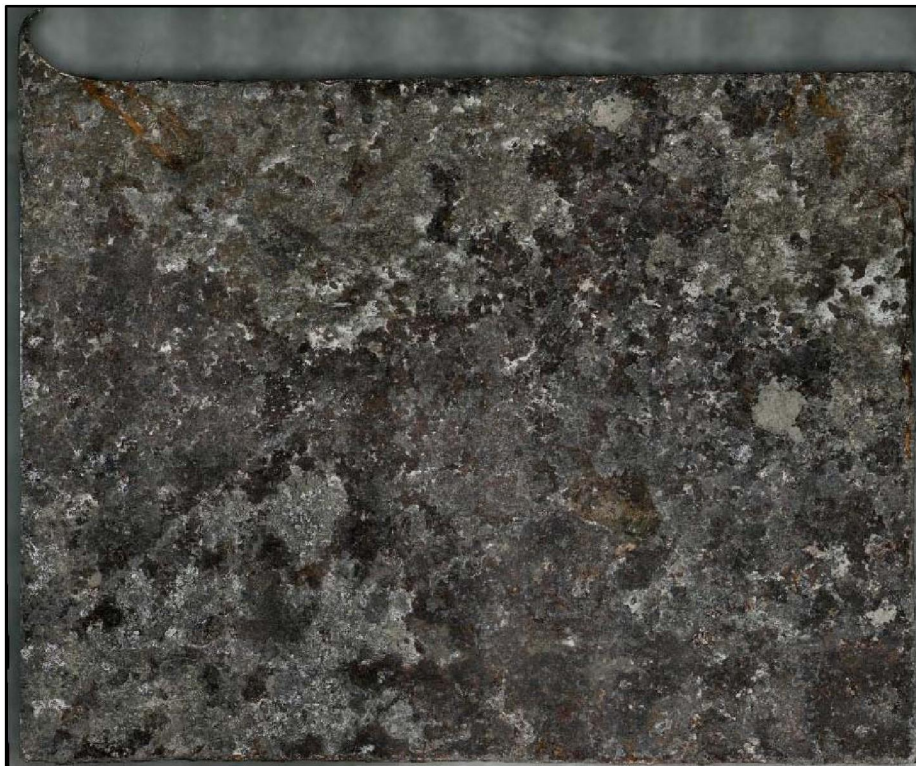
Figure 160. A screenshot of the 3D digital image of a specimen excised from Coupon 5 labeled as 5-3, after CO₂ blast cleaning

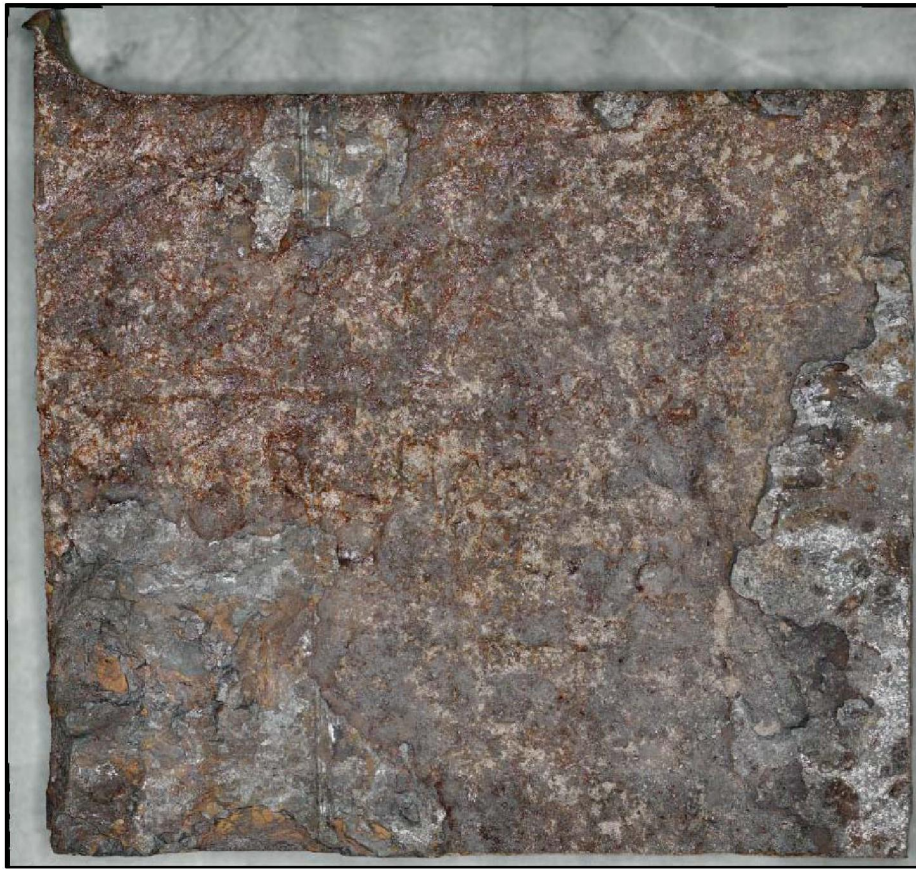
Figure 161. A screenshot of the 3D digital image of a specimen excised from Coupon 6 labeled as 6-1, after CO₂ blast cleaning

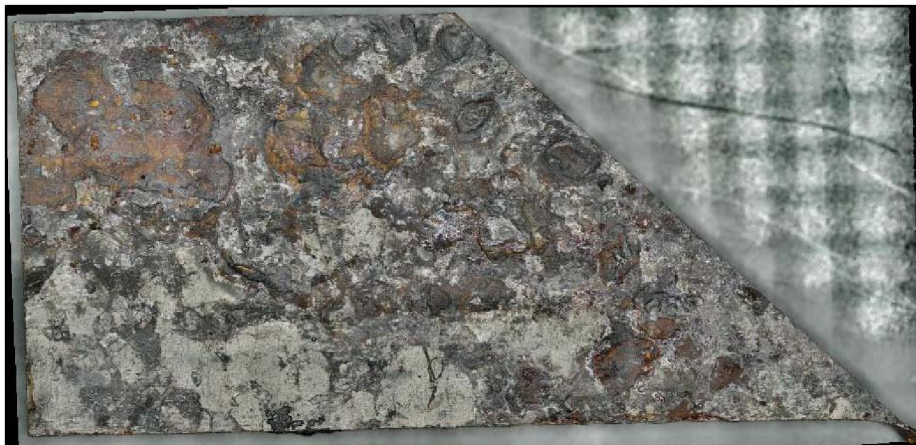
Figure 162. A screenshot of the 3D digital image of a specimen excised from Coupon 6 labeled as 6-2, after CO₂ blast cleaning

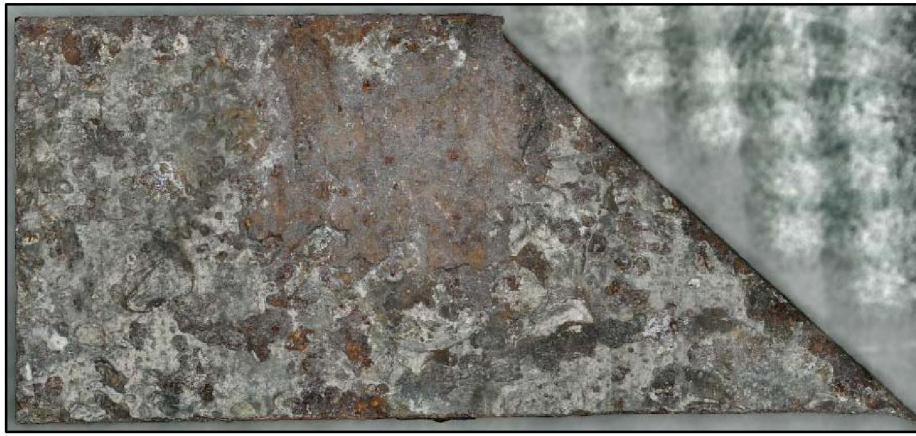
Figure 163. A screenshot of the 3D digital image of a specimen excised from Coupon 6 labeled as 6-3, after CO₂ blast cleaning

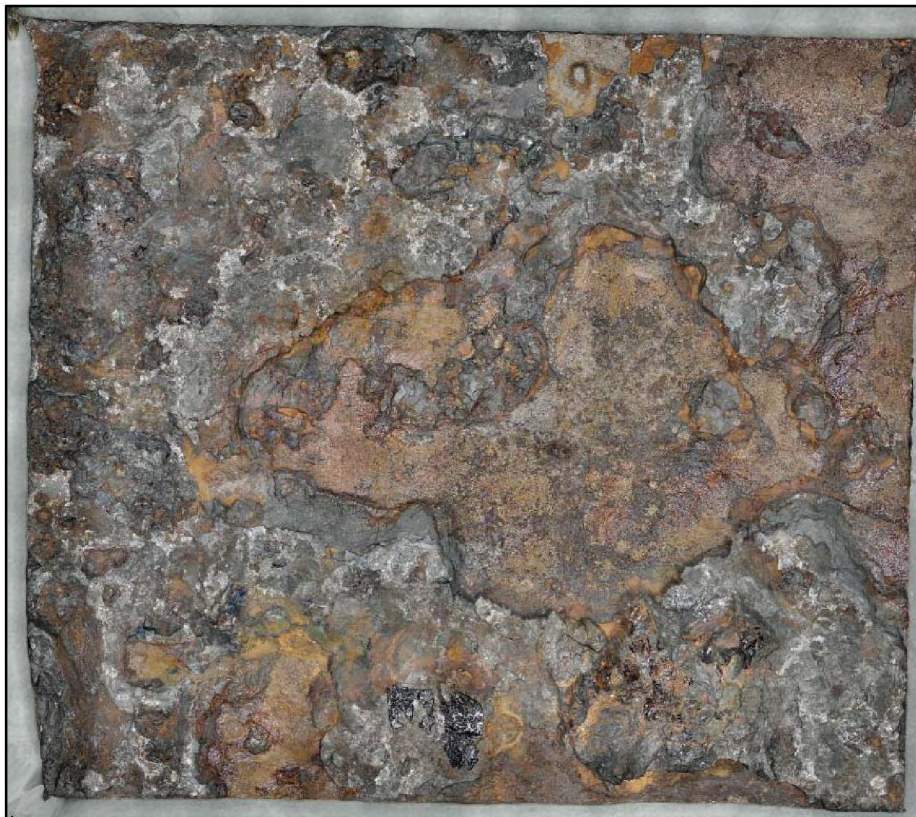
Figure 164. A screenshot of the 3D digital image of a specimen excised from Coupon 7 labeled as 7-1, after CO₂ blast cleaning

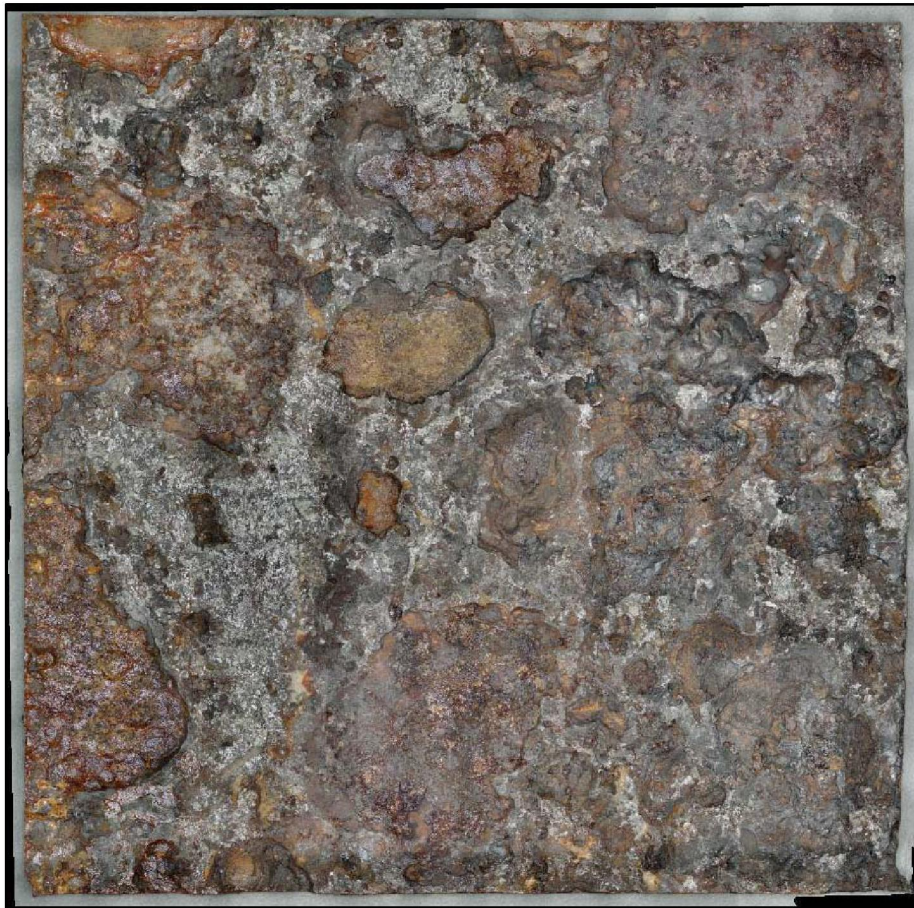
Figure 165. A screenshot of the 3D digital image of a specimen excised from Coupon 7 labeled as 7-2, after CO₂ blast cleaning.

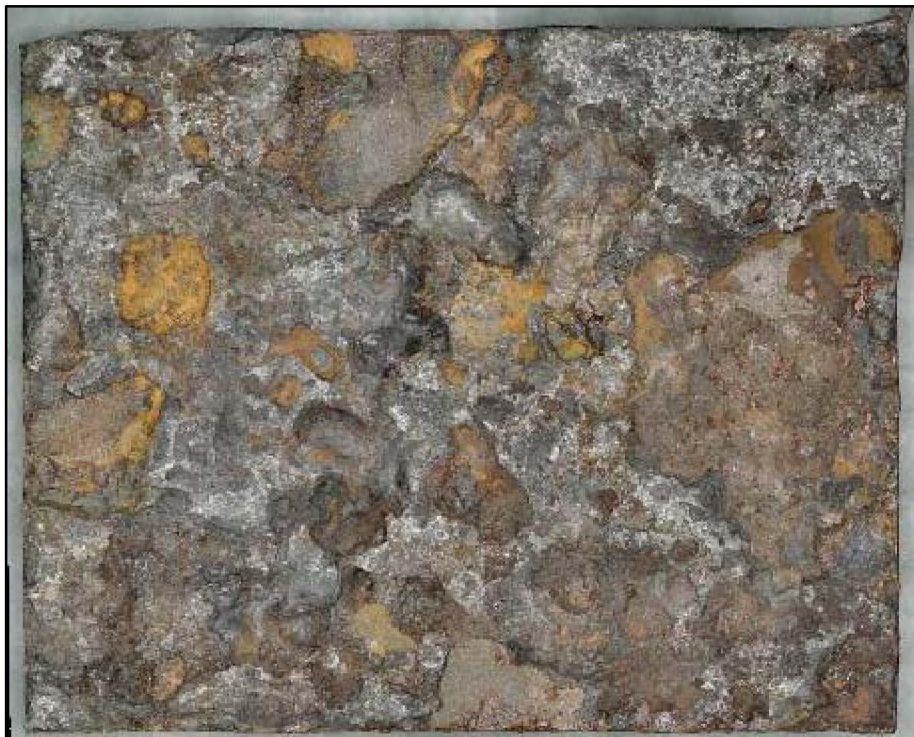
Figure 166. A screenshot of the 3D digital image of a specimen excised from Coupon 7 labeled as 7-3, after CO₂ blast cleaning

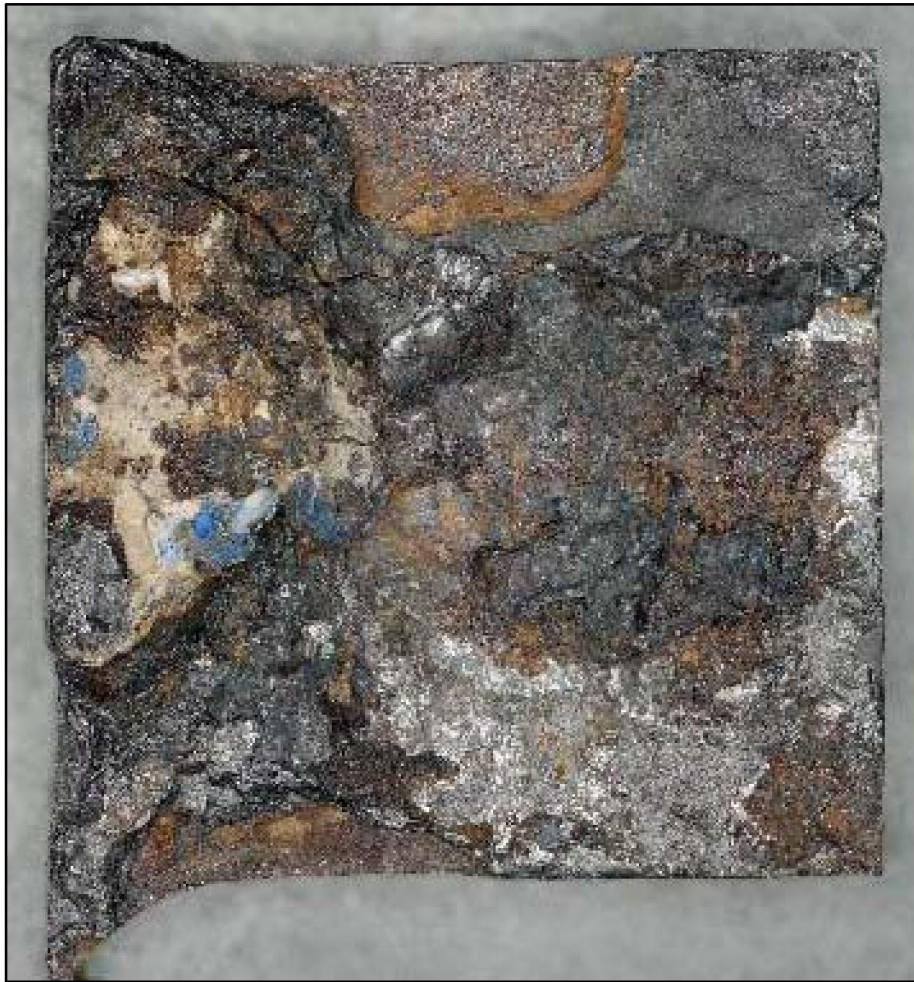
Figure 167. A screenshot of the 3D digital image of a specimen excised from Coupon 7 labeled as 7-4, after CO₂ blast cleaning

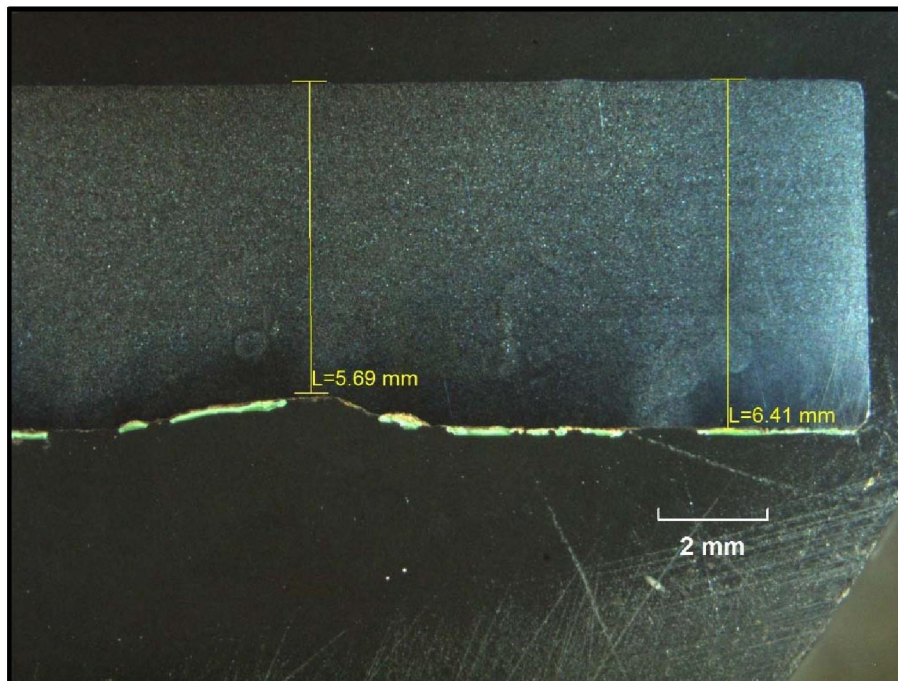
Figure 192. The prepared metallographic cross-section from Sample 5-5 is shown during examination with a stereomicroscope. The thickest remaining wall is shown. Note that the reduction in wall thickness was due to a depression on the painted face of the specimen. (7X)

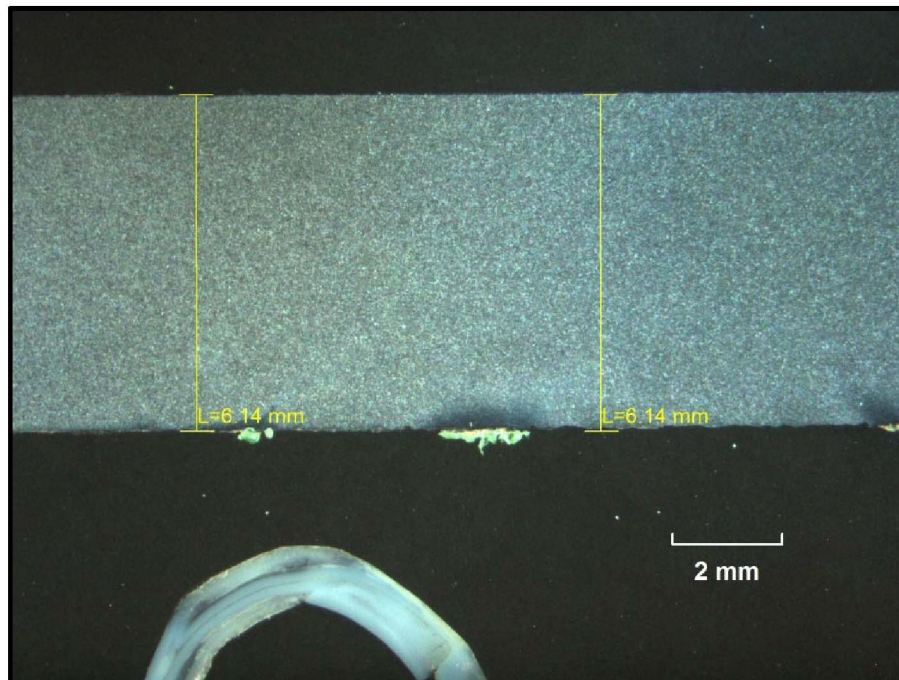
Figure 200. The prepared metallographic cross-section from Sample 10-1 is shown during examination with a stereomicroscope. The thickest location(s) are shown. No pitting was observed. (7X)

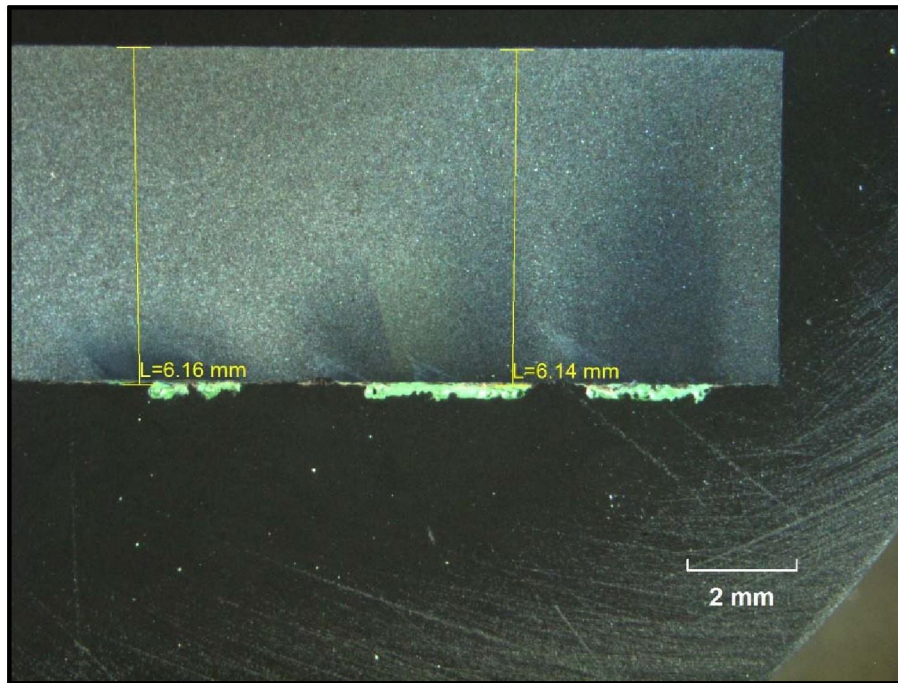
Figure 201. The prepared metallographic cross-section from Sample 10-2 is shown during examination with a stereomicroscope. The thickest location(s) are shown. No pitting was observed. (7X)

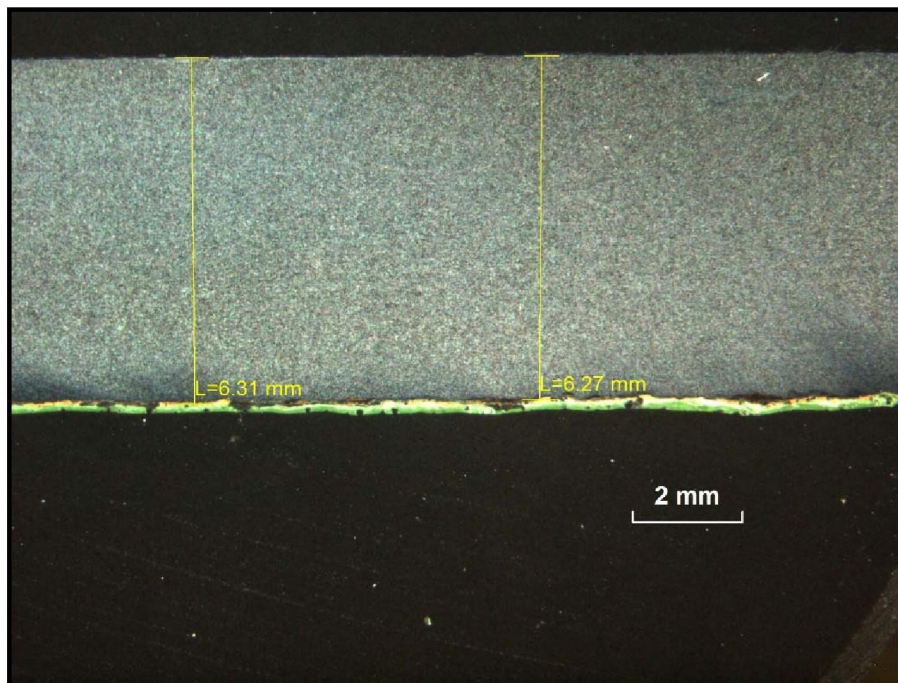
Figure 206. The prepared metallographic cross-section from Sample A2-3 is shown during examination with a stereomicroscope. No pitting was observed. (7X)

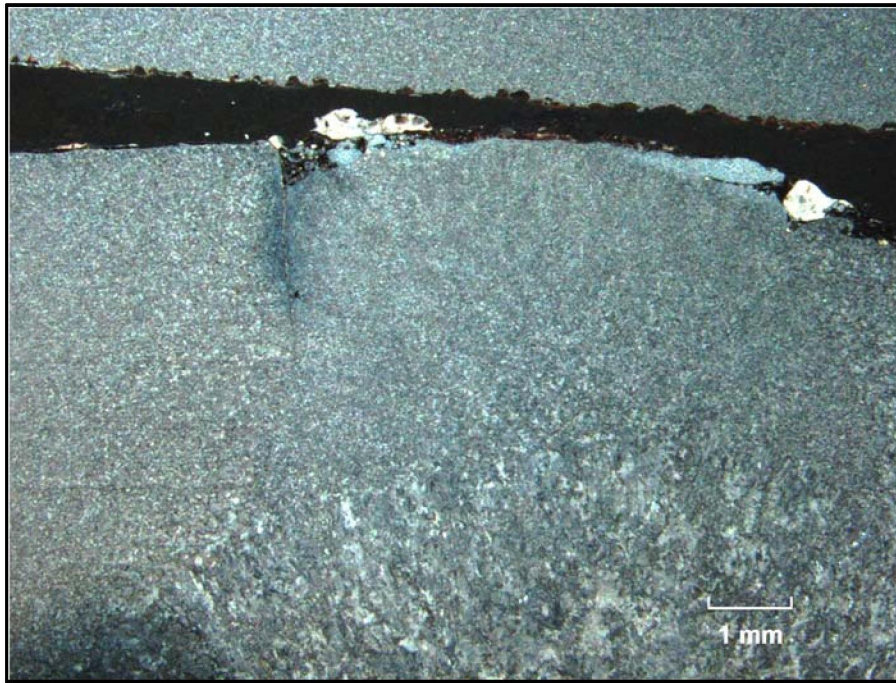
Coupon 8 exhibited what is presumed to be a prior weld repair and/or addition of a backing plate, where a patch was made on the tank wall. Representative images of the welds are presented as Figures 208 through 213. A full weld evaluation is outside the scope of this effort. The results are thus provided for information only.

Figure 209. The location identified in the previous figure is shown at higher magnification. The weld indication (arrow) appeared to be an area of incomplete fusion.

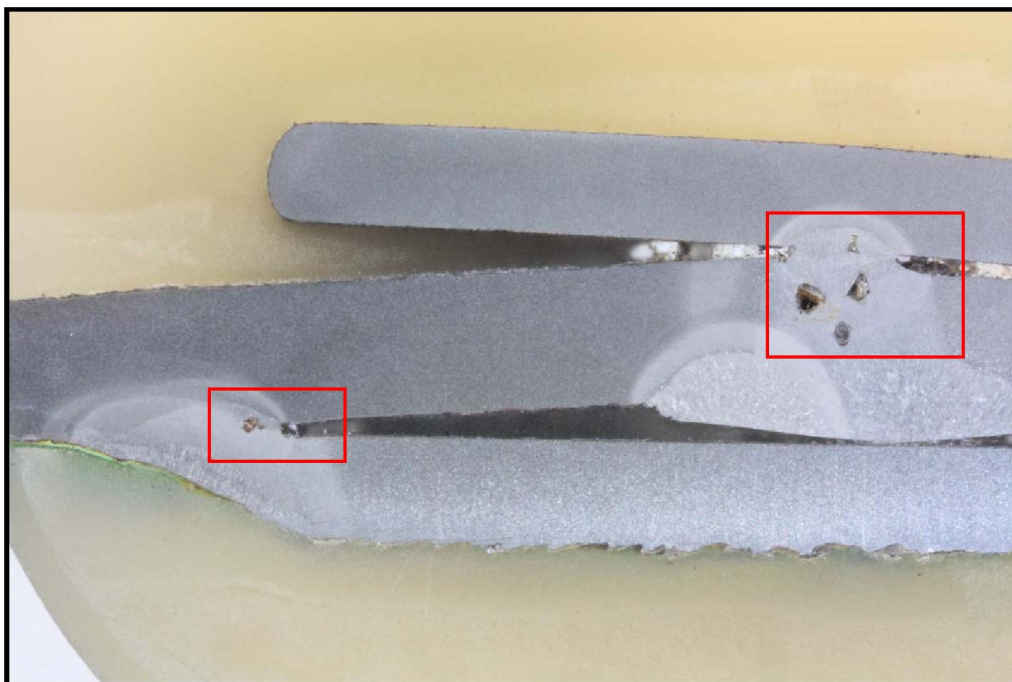
Figure 210. The prepared metallographic cross-section through welded sample 8-4 is shown in an overall view. The painted exterior surface is along the bottom section. The areas identified by the red boxes are shown in the next two figures at higher magnification.

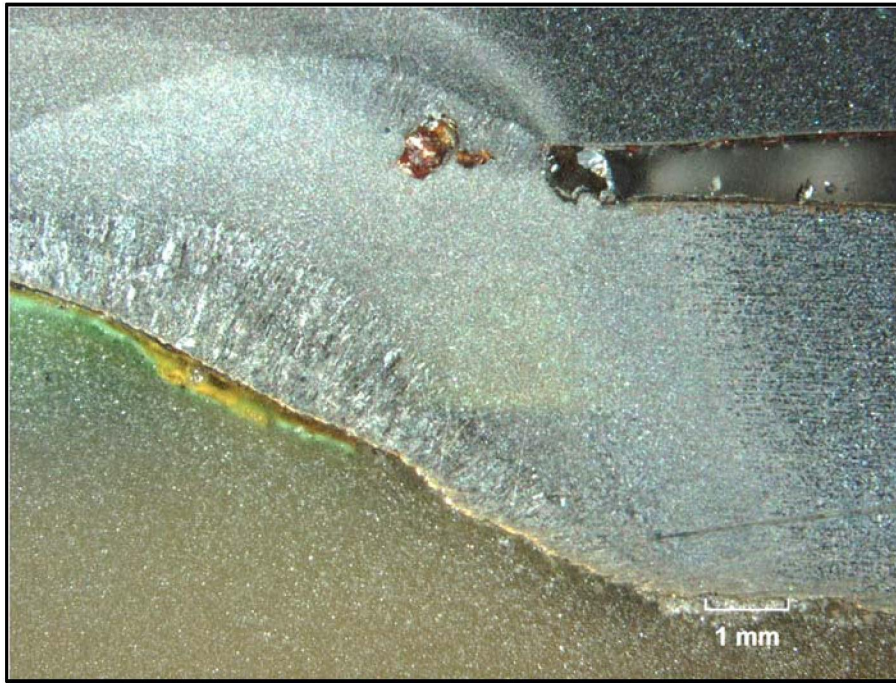
Figure 211. The left-hand feature in Figure 210 is shown at higher magnification. The weld indication (arrow) appeared to be an area of porosity.

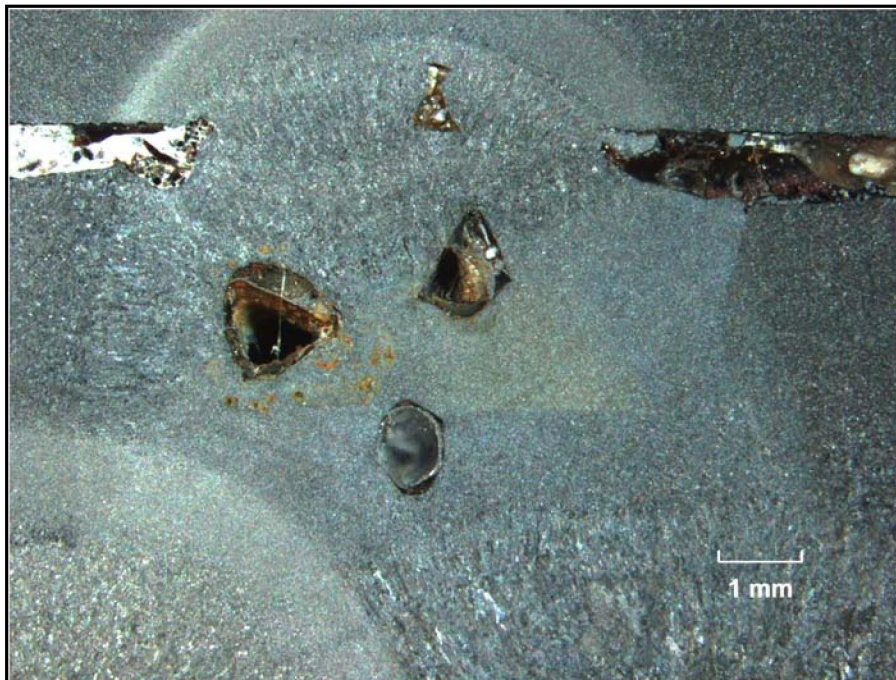
Figure 212. The right-hand feature in Figure 210 is shown at higher magnification. The weld indications appeared to be porosity.

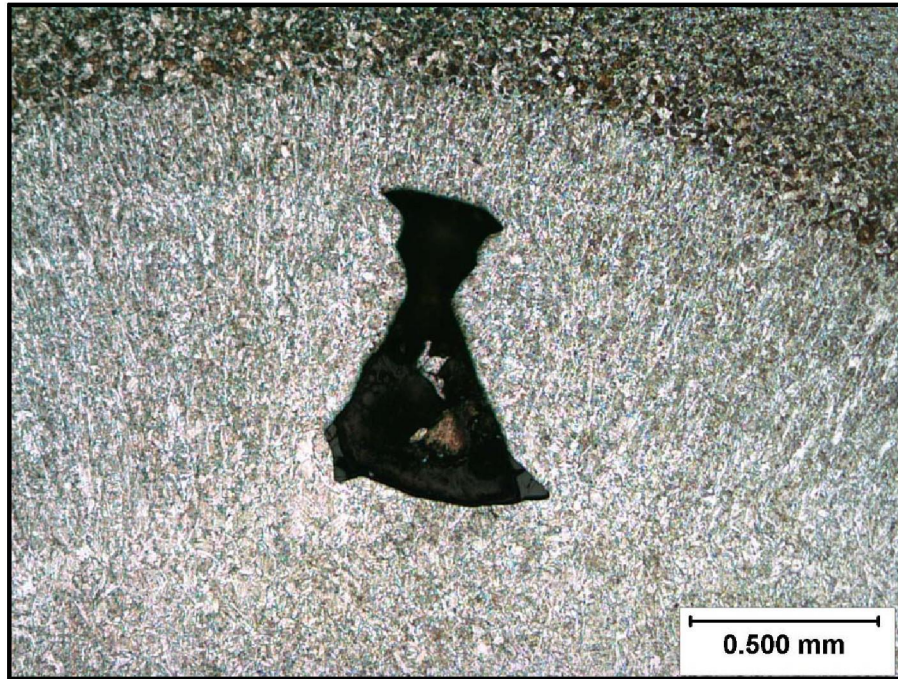
Figure 213. The one of the voids is shown at higher magnification. (2% Nital Etch, 50X)

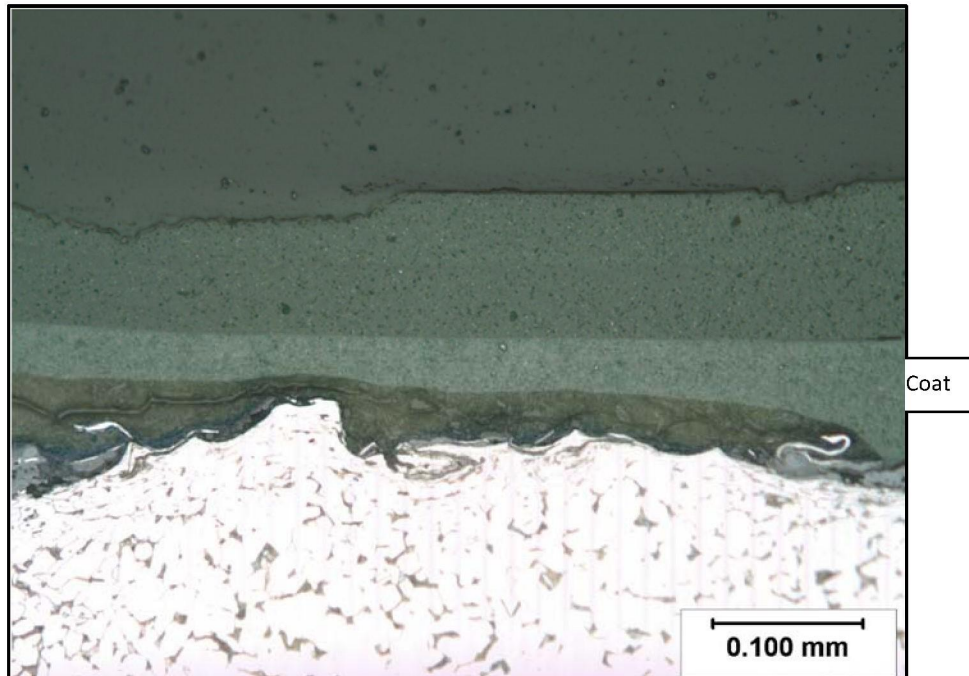
A typical paint layer was examined microscopically and was determined to consist of two layers, as shown in Figure 214. This indicates that the exterior tank wall exhibits a primer layer with a top coat. The scraped paint samples that were excised from each coupon previously for FTIR analysis would likely have captured some of both layers. The FTIR results presented previously were a good match for polyurethane, with no observable secondary component. Although this indicates that both the primer and top coat were polyurethane-based, it cannot be ruled out that the primer exhibited a different composition.

Figure 214. A typical paint layer is shown in cross-section, with key characteristics identified. (2% Nital Etch, 200X)
