SUBJECT: ADMINISTRATIVE ORDER ON CONSENT (AOC) STATEMENT OF WORK (SOW) SECTION 5 CORROSION AND METAL FATIGUE PRACTICES, DESTRUCTIVE TESTING RESULTS REPORT, RED HILL BULK FUEL STORAGE FACILITY (RED HILL), JOINT BASE PEARL HARBOR-HICKAM, OAHU, HAWAII

In 2018, ten coupons were removed from Tank 14, so that a metallurgical and corrosion analysis of the coupons could be undertaken, with the primary aim of validating non-destructive examination (NDE) results. The steel coupons, concrete powder samples, and corrosion product were submitted to a certified third-party laboratory to perform this analysis.

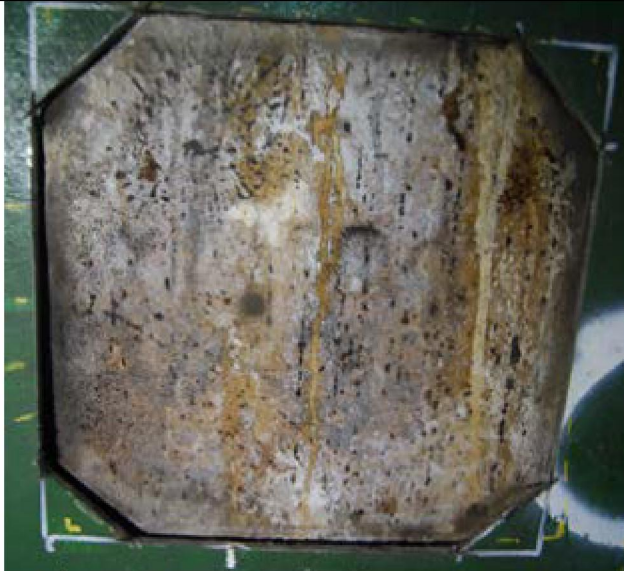
The concrete behind Coupon 1 was sound concrete with no cracks or delaminations. Table 3-1 contains the on-site concrete observations and test results.

6/20/2018: 1400		
CONCRETE SAMPLE SPECIFICS		
Sample ID	1	1
Sample Location	14-UD-A-42-45-107	
Sample Dimensions	12" × 12"	
ON SITE VISUAL EXAMINATION		
Checks	Observations	
	Exterior	Units
Void space between concrete and liner (if any)	1/8" Void on left side, no voids in all other areas	
Biological Materials	None	
Wet or Dry	Dry	
Smell	None	
Temperature	76.9	Degrees F
Surface pH	9 to 9.5	
Structure to Electrolyte	-0.252	Volts/CSE
Concrete Resistivity	26.4 Horizontal 31.1 Vertical	k-ohm-cm k-ohm-cm
General Condition	Excellent, sound concrete with some discoloration and no cracks and no delamination	
Concrete behind Coupon 1

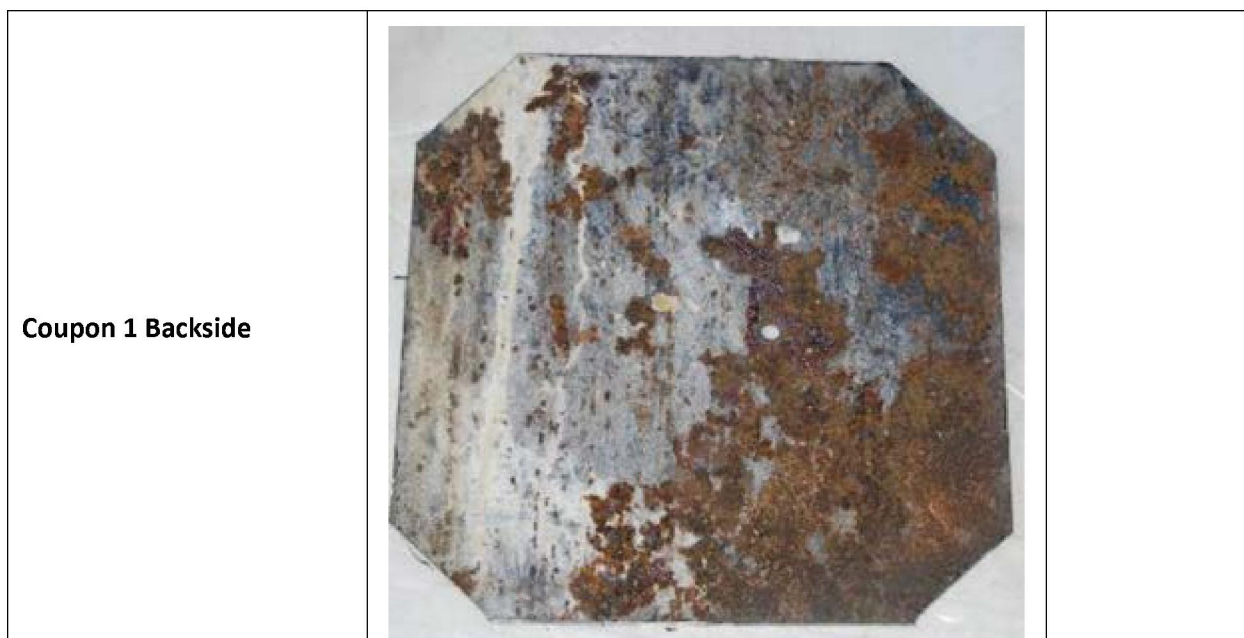
Wed, 20 Jun 2018, 01:33 PM		
COUPON SPECIFICS		
Coupon ID	1	1
Coupon Location	14-UD-A-42-45-107	
Coupon Dimensions	12" × 12"	
Coupon Thickness	¼" (NDE: minimum 0.147")	Prove-up: minimum 0.112"
Locations of Welds	None	
ON SITE VISUAL EXAMINATION		
Checks	Observations	
	Exterior	Interior
Deposits, Coatings, Debris	Deposits	Standard coating with paint
Scale	None	None
Observed Biological Material	None	None
Wet or Dry	Wet	Dry
Smell	Damp, burnt	Burnt
Presence of petroleum product between steel and concrete surface	No	No
Presence of corrosion	Yes	No
Isolated pitting	No	No
Isolated pitting within areas of general corrosion	No	No
Linked pitting within areas of general corrosion	No	No
Identify color of corrosion products	Brown	N/A
Identify if selected attack at welds	N/A	N/A

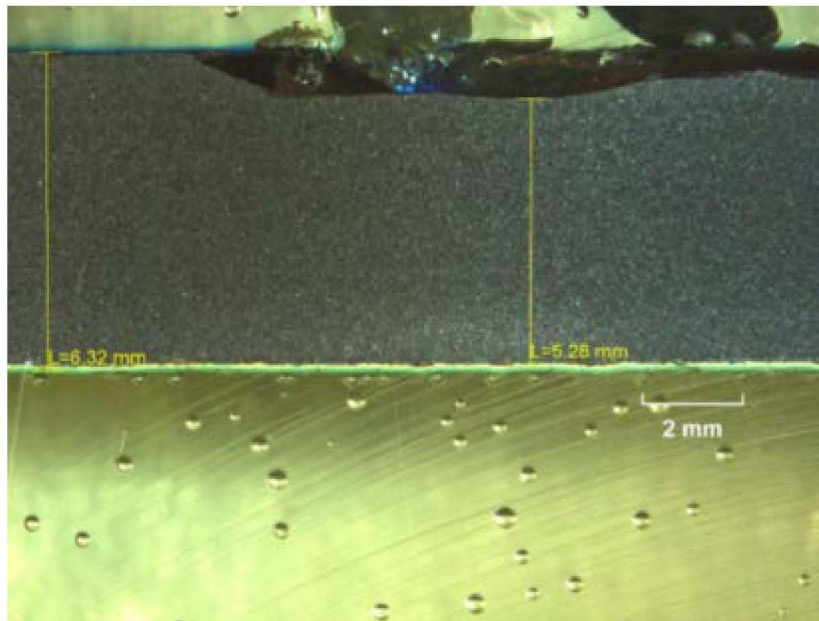
Figure 3-2 Cross Section of Coupon 1 at Area of Maximum Wall Loss

Coupon 1 was found to have significantly less metal loss than what was identified by the NDE. Coupon 7 had less metal loss than what was predicted by NDE. Coupons 2, 5, 8, 10, A1 and A2 all had measured thicknesses consistent to what was found with the NDE. Coupon 3 destructive testing showed actionable metal loss whereas the NDE did not identify any in this exact location. An actionable indication was found adjacent to where Coupon 3 was cut out. During the follow-on repair process, however, the metal loss at the Coupon 3 location would have been detected. Coupon 6 showed more metal loss than was predicted by the NDE and was just below the repair threshold. The destructive testing identified this to be a pit of very small volume. The NDE method used, Low-Frequency Electromagnetic Technique (LFET), does not always detect metal losses of very small volume.

- Detailed results of the Destructive Testing Laboratory analysis of Coupon 1 are contained in Appendix A.
- The thinnest measured location was 207.9 mils (5.28 mm).
- Assuming a nominal wall thickness of 250 mils, the remaining wall thickness at the thinnest location was 83.1%.
- Coupon 1 exhibited backside corrosion as was predicted.
- A cross-section view of Coupon 1 is shown in Figure 3-2.

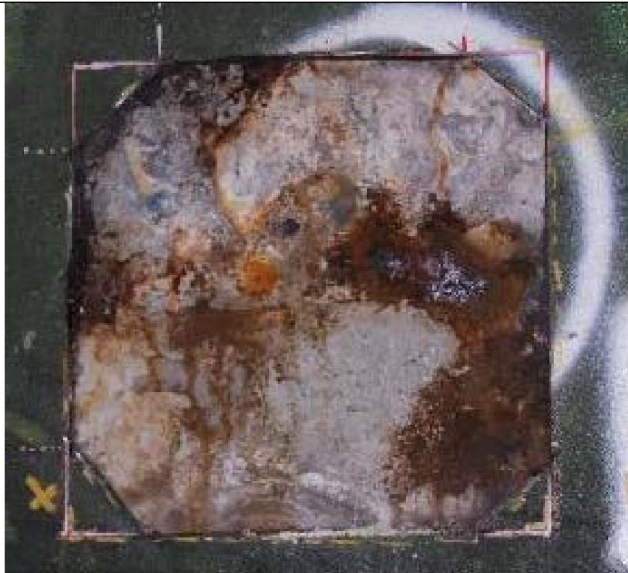
6/19/2018: 0930		
CONCRETE SAMPLE SPECIFICS		
Sample ID	2	2
Sample Location	14-ER-E3-12-33-40	
Sample Dimensions	12" × 12"	
ON SITE VISUAL EXAMINATION		
Checks	Observations	
	Exterior	Units
Void space between concrete and liner (if any)	1/8" void at upper left side. Otherwise no voids.	
Biological Materials	None	
Wet or Dry	Slightly damp	
Smell	Musty, no fuel	
Temperature	80.0	Degrees F
Surface pH	10-11 corroded area 11-12 non-corroded area	
Structure to Electrolyte	-0.380	Volts/CSE
Concrete Resistivity	19.0 Horizontal 17.5 Vertical	k-ohm-cm k-ohm-cm
General Condition	Good sound condition with some minor spalling and corrosion product. Coupon took some hammering to remove.	
Concrete behind Coupon 2

<p>Coupon 2 backside</p>	 	
---------------------------------	--	--

Tue, 19 Jun 2018, 10:46 AM		
COUPON SPECIFICS		
Coupon ID	2	2
Coupon Location	14-ER-E3-12-33-40	
Coupon Dimensions	12" × 12"	
Coupon Thickness	¼" (NDE: minimum 0.157")	Prove-up: minimum 0.150"
Locations of Welds	None	
ON SITE VISUAL EXAMINATION		
Checks	Observations	
	Exterior	Interior
Deposits, Coatings, Debris	Lots of deposits and concrete	Regular coating
Scale	None	None
Observed Biological Material	None	None
Wet or Dry	damp	Dry
Smell	burnt, musty, muddy	Burnt but less intense than exterior
Presence of petroleum product between steel and concrete surface.	No	No
Presence of corrosion	Yes	Yes
Isolated pitting	Yes	Yes
Isolated pitting within areas of general corrosion	Yes	No
Linked pitting within areas of general corrosion	No	No
Identify color of corrosion products	Brown, black, gray	Brown
Identify if selected attack at welds	N/A	N/A

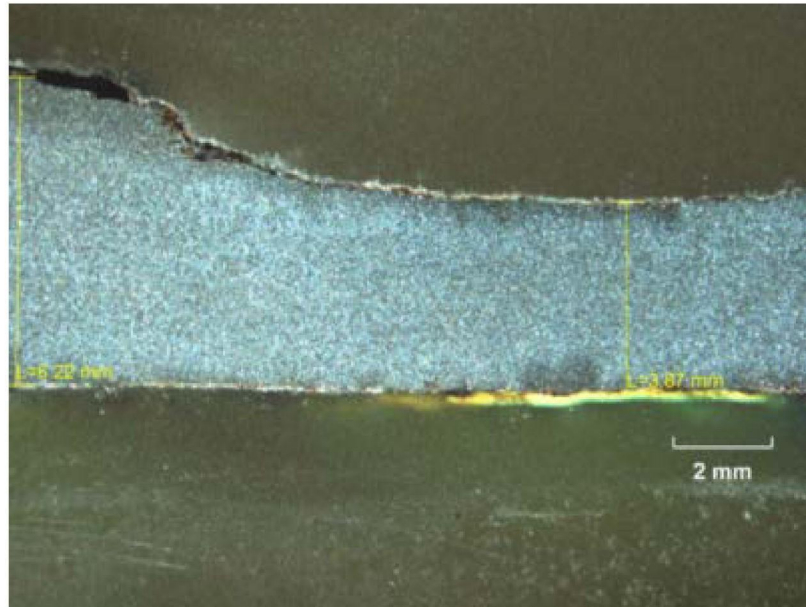
Figure 3-3 Cross Section of Coupon 2 at area of Maximum Wall Loss

- Detailed results of the Destructive Testing Laboratory analysis of Coupon 2 are contained in Appendix A.
- The thinnest measured location was 152.4 mils (3.87 mm).
- Assuming a nominal wall thickness of 250 mils, the remaining wall thickness at the thinnest location was 60.9%.

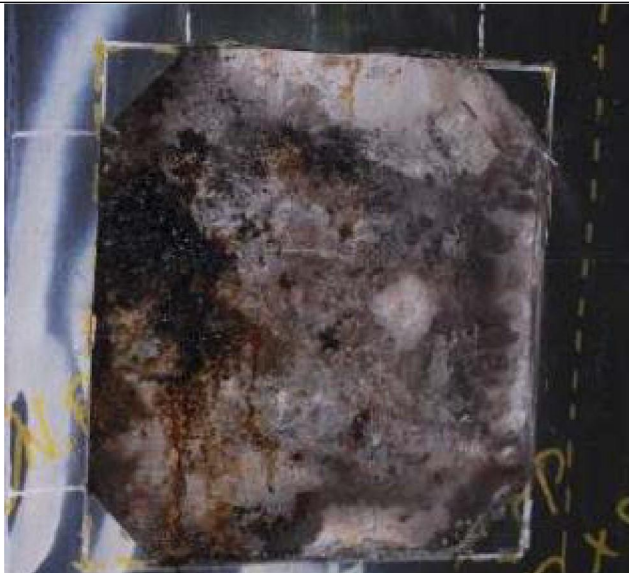
6/19/2018: 14:00		
CONCRETE SAMPLE SPECIFICS		
Sample ID	3	3
Sample Location	14-ER-E3-13-7-18	
Sample Dimensions	12" x 12"	
ON SITE VISUAL EXAMINATION		
Checks	Observations	
	Exterior	Units
Void space between concrete and liner (if any)	On left side, uneven corrosion product and a 1/16-inch void. Otherwise, no voids.	
Biological Materials	None	
Wet or Dry	Mostly dry, with some damp spots	
Smell	None	
Temperature	79.3	F
Surface pH	11-12 dry areas, 7-8 in areas with corrosion product	
Structure to Electrolyte	-0.488	Volts/CSE
Concrete Resistivity	27.8 Horizontal 31.2 Vertical	K-Ohm-cm
General Condition	Good, with some corrosion products. Corrosion product was black on the left side, and brown in some other areas. Concrete was hard and difficult to drill for powder samples. Coupons required some hammering and prying to remove after cutting.	
Concrete behind Coupon 3

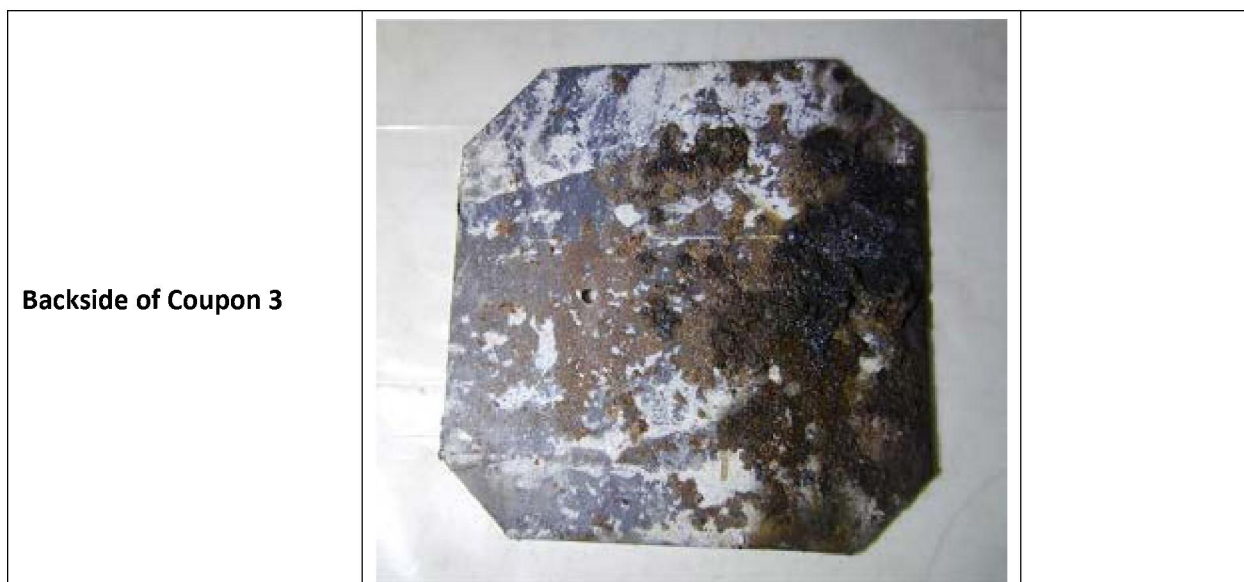
Tue, 19 Jun 2018, 3:00 PM		
COUPON SPECIFICS		
Coupon ID	3	3
Coupon Location	14-ER-E3-13-9-18	
Coupon Dimensions	12" × 12"	
Coupon Thickness	¼" (NDE: minimum 0.033")	(No prove-up-phase thickness)
Locations of Welds	None	
ON SITE VISUAL EXAMINATION		
Checks	Observations	
	Exterior	Interior
Deposits, Coatings, Debris	Thick, brown, grey deposits	Standard coating with paint
Scale	None	None
Observed Biological Material	None	None
Wet or Dry	Wet	Dry
Smell	Burnt, like wax	None
Presence of petroleum product between steel and concrete surface	Yes	No
Presence of corrosion	Yes	Yes
Isolated pitting	Yes	Yes
Isolated pitting within areas of general corrosion	Yes	No
Linked pitting within areas of general corrosion	No	No
Identify color of corrosion products	White, brown	Brown
Identify if selected attack at welds	N/A	N/A

Coupon 3 exhibited backside corrosion that was not predicted. However, it must be noted that layout work to finalize sizing and location of a repair adjacent to Coupon 3 had not taken place prior to removal of the coupon. This corrosion was noted on the Spreadsheet that was reviewed by the Regulators, and one of the reasons why this coupon location was selected.

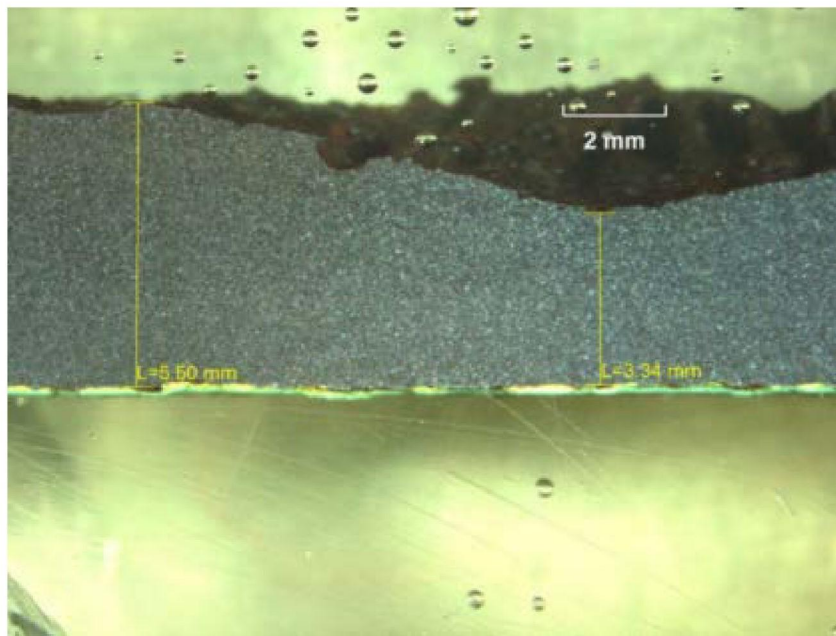
Figure 3-4 Cross Section of Coupon 3 at Area of Maximum Wall Loss

- Detailed results of the Destructive Testing Laboratory analysis of Coupon 3 are contained in Appendix A.
- The thinnest measured location was 131.5 mils (3.34 mm).
- Assuming a nominal wall thickness of 250 mils, the remaining wall thickness at the thinnest location was 52.6%.
- A cross-section view of Coupon 3 is shown in Figure 3-4.

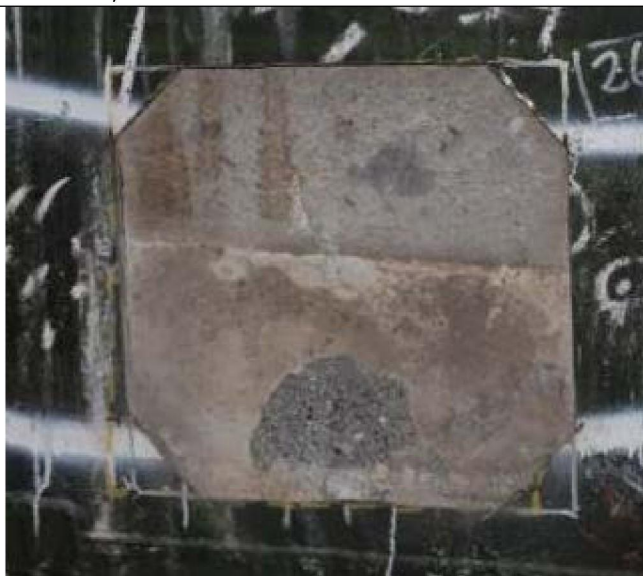
6/20/2018: 0800		
CONCRETE SAMPLE SPECIFICS		
Sample ID	5	5
Sample Location	14-BA-26-15-15-8	
Sample Dimensions	12" × 12"	
ON SITE VISUAL EXAMINATION		
Checks	Observations	
	Exterior	Units
Void space between concrete and liner (if any)	1/16" Void on top right side, no voids in all other areas	
Biological Materials	None	
Wet or Dry	Dry	
Smell	None	
Temperature	78.5	F
Surface pH	11-12	
Structure to Electrolyte	-0.220	Volts/CSE
Concrete Resistivity	19.1 Horizontal 22.0 Vertical	k-ohm-cm k-ohm-cm
General Condition	Excellent, sound concrete	
Concrete behind Coupon 5

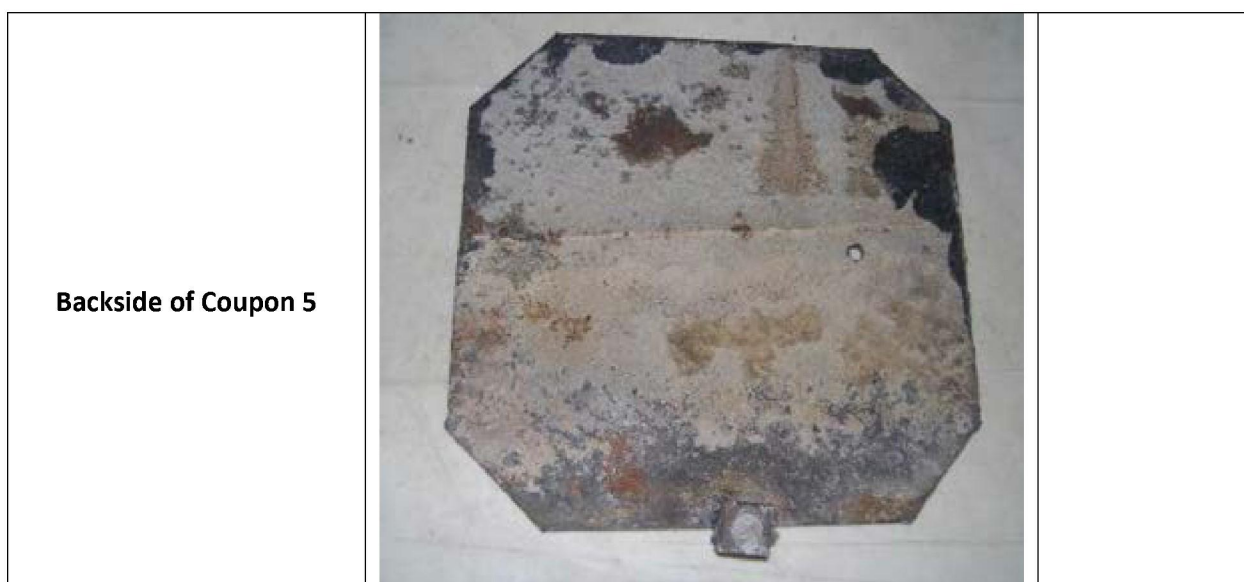
Wed, 20 Jun 2018, 08:20 AM		
COUPON SPECIFICS		
Coupon ID	5	5
Coupon Location	14-BA-26-15-15-8	
Coupon Dimensions	12" x 12"	
Coupon Thickness	¼" (NDE: minimum 0.047")	
Locations of Welds	None	(No prove-up-phase thickness)
ON SITE VISUAL EXAMINATION		
Checks	Observations	
	Exterior	Interior
Deposits, Coatings, Debris	Concrete layer, thin	Standard coating
Scale	None	None
Observed Biological Material	None	None
Wet or Dry	Dry	Dry
Smell	Burnt	Burnt
Presence of petroleum product between steel and concrete surface	No	No
Presence of corrosion	Yes	No
Isolated pitting	No	No
Isolated pitting within areas of general corrosion	No	No
Linked pitting within areas of general corrosion	No	No
Identify color of corrosion products	Brown	N/A
Identify if selected attack at welds	N/A	N/A

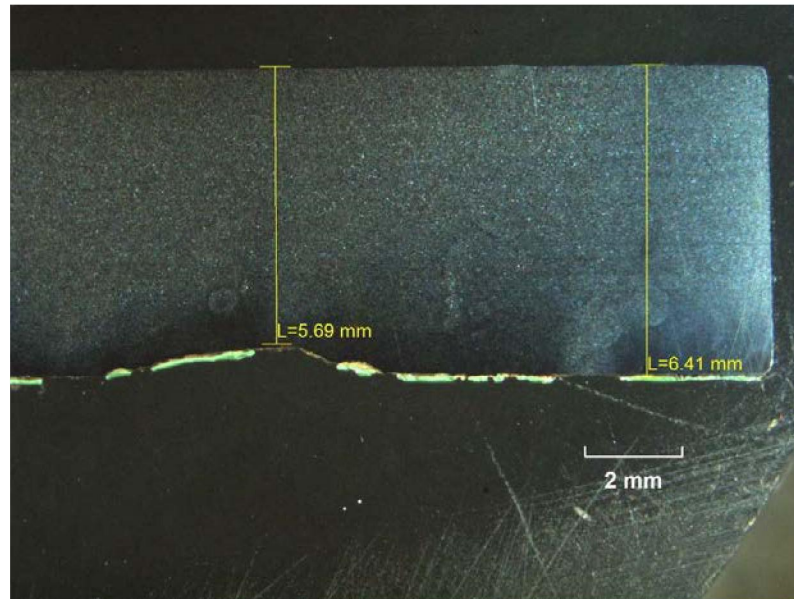
Figure 3-5 Cross Section of Coupon 5 at Area of Maximum Wall Loss

- Detailed results of the Destructive Testing Laboratory analysis of Coupon 5 are contained in Appendix A.
- The thinnest measured location was 224.0 mils (5.69 mm).
- Assuming a nominal wall thickness of 250 mils, the remaining wall thickness at the thinnest location was 89.6%.
- A cross-section view of Coupon 5 is shown in Figure 3-5.

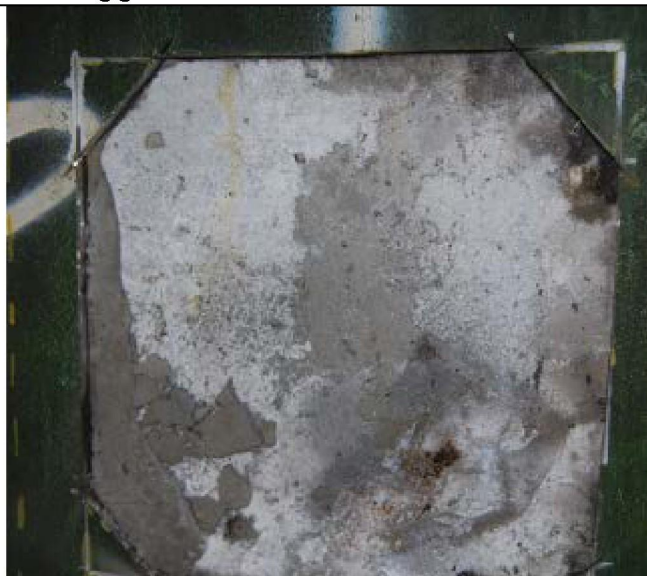
6/21/2018: 1100		
CONCRETE SAMPLE SPECIFICS		
Sample ID	6	6
Sample Location	14-BA-24-8-36-30	
Sample Dimensions	12" × 12"	
ON SITE VISUAL EXAMINATION		
Checks	Observations	
	Exterior	Units
Void space between concrete and liner (if any)	None, however some loose adhering grout present	
Biological Materials	None	
Wet or Dry	Dry	
Smell	None	
Temperature	77.4	F
Surface pH	12.5	
Structure to Electrolyte	-0.387	Volts/CSE
Concrete Resistivity	Horizontal = 10.1 Vertical = 18.2	k-ohm-cm k-ohm-cm
General Condition	Concrete is sound, no delamination. There is loose adhering grout on left side and middle	
Concrete behind Coupon 6

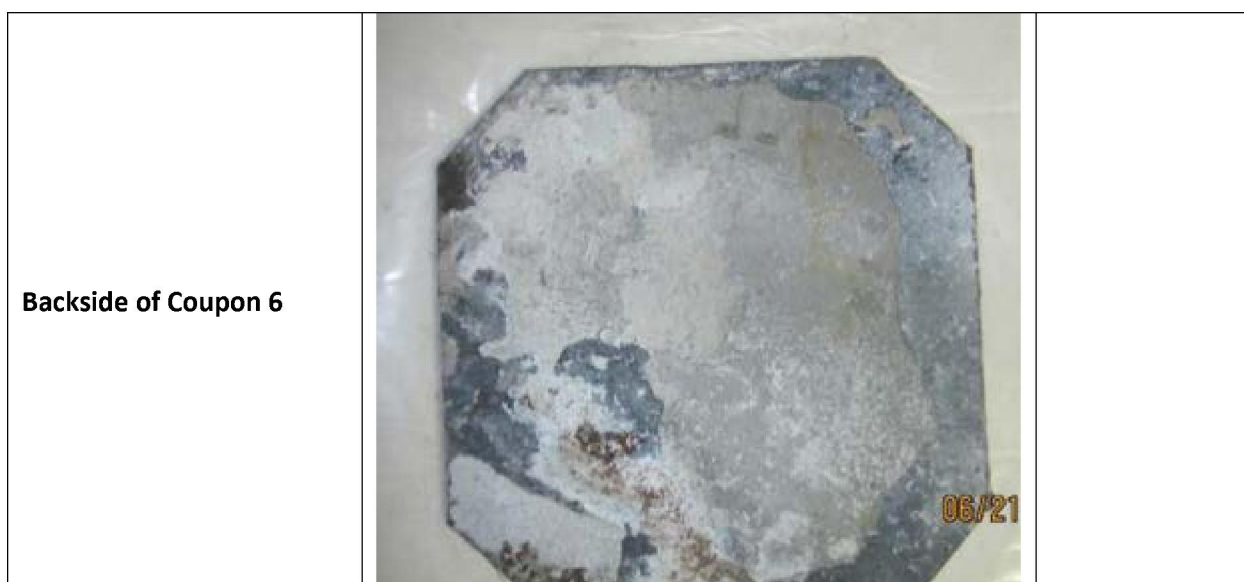
Thu, 21 Jun 2018, 11:05 AM		
COUPON SPECIFICS		
Coupon ID	6	6
Coupon Location	14-BA-24-8-36-30	
Coupon Dimensions	12" × 12"	
Coupon Thickness	¼" (NDE: No reported thickness; greater than 0.200")	(No prove-up-phase thickness)
Locations of Welds	None	
ON SITE VISUAL EXAMINATION		
Checks	Observations	
	Exterior	Interior
Deposits, Coatings, Debris	Scrapes	Standard coating
Scale	Concrete	None
Observed Biological Material	None	None
Wet or Dry	Dry	Dry
Smell	Burnt	Burnt
Presence of petroleum product between steel and concrete surface	No	No
Presence of corrosion	Yes, small	Yes, tiny
Isolated pitting	No	No
Isolated pitting within areas of general corrosion	No	No
Linked pitting within areas of general corrosion	No	No
Identify color of corrosion products	Brown	Brown
Identify if selected attack at welds	N/A	N/A

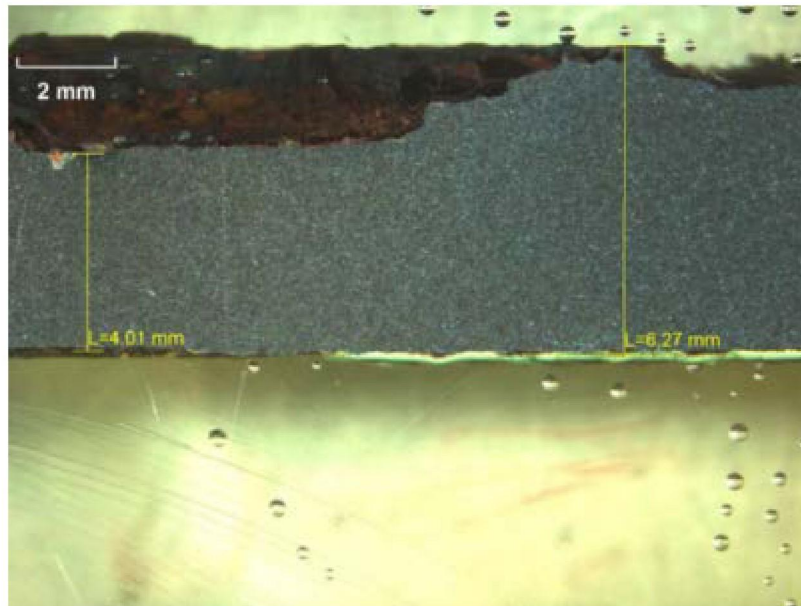
Figure 3-6 Cross Section of Coupon 6 at Area of Maximum Wall Loss

- Detailed results of the Destructive Testing Laboratory analysis of Coupon 6 are contained in Appendix A.
- The thinnest measured location was 157.9 mils (4.01 mm).
- Assuming a nominal wall thickness of 250 mils, the remaining wall thickness at the thinnest location was 63.1%.
- A cross-section view of Coupon 6 is shown in Figure 3-6.

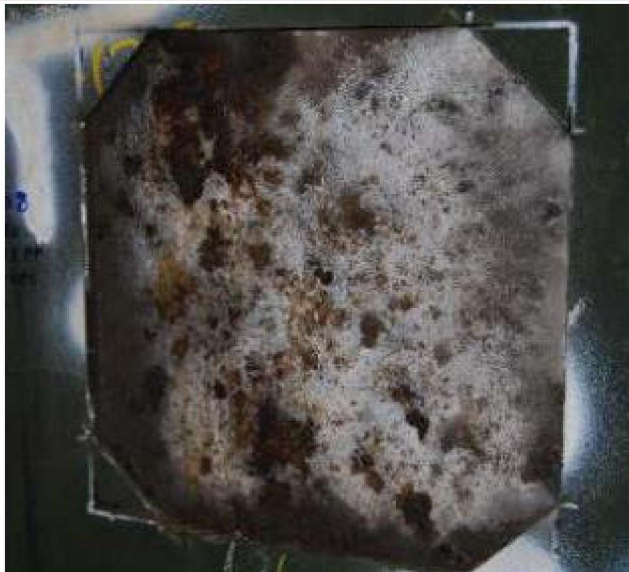
6/21/2018: 1030		
CONCRETE SAMPLE SPECIFICS		
Sample ID	7	7
Sample Location	14-BA-23-7-38-49	
Sample Dimensions	12" × 12"	
ON SITE VISUAL EXAMINATION		
Checks	Observations	
	Exterior	Units
Void space between concrete and liner (if any)	3/8" void on left side. 1/16" void on top right otherwise no voids	
Biological Materials	None	
Wet or Dry		
Smell	none	
Temperature	77.5	F
Surface pH	9-10	
Structure to Electrolyte	-0.276	Volts/CSE
Concrete Resistivity	Horizontal = 39.3 Vertical = 42.4	k-ohm-cm k-ohm-cm
General Condition	Concrete is sound with no delamination or cracks. Some brown and black corrosion products on concrete	
Concrete behind Coupon 7

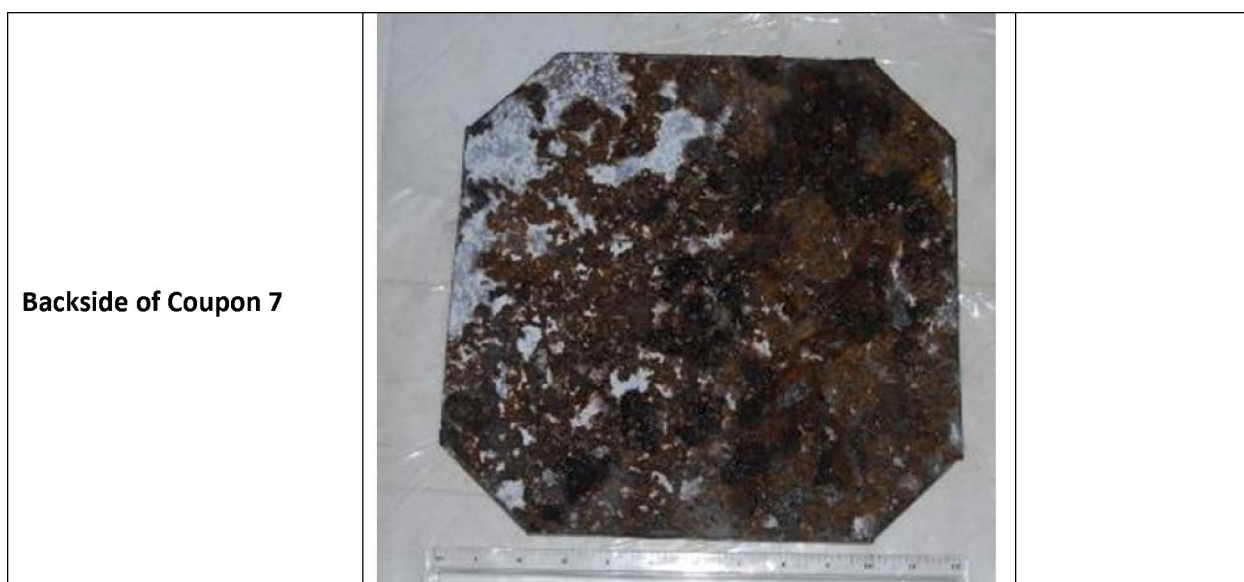
Thu, 21 Jun 2018, 10:35 AM		
COUPON SPECIFICS		
Coupon ID	7	7
Coupon Location	14-BA-23-7-38-49	
Coupon Dimensions	12" × 12"	
Coupon Thickness	¼" (NDE: minimum 0.157")	Prove-up: minimum 0.135"
Locations of Welds	None	
ON SITE VISUAL EXAMINATION		
Checks	Observations	
	Exterior	Interior
Deposits, Coatings, Debris	Lots of general corrosion	Standard coating
Scale	Yes, thick, varied	None
Observed Biological Material	None	None
Wet or Dry	Wet	Dry
Smell	Burnt, damp	Burnt
Presence of petroleum product between steel and concrete surface,	No	No
Presence of corrosion	Yes	Yes
Isolated pitting	Yes	No
Isolated pitting within areas of general corrosion	Yes	No
Linked pitting within areas of general corrosion	No	No
Identify color of corrosion products	Brown, black	Brown
Identify if selected attack at welds	N/A	N/A

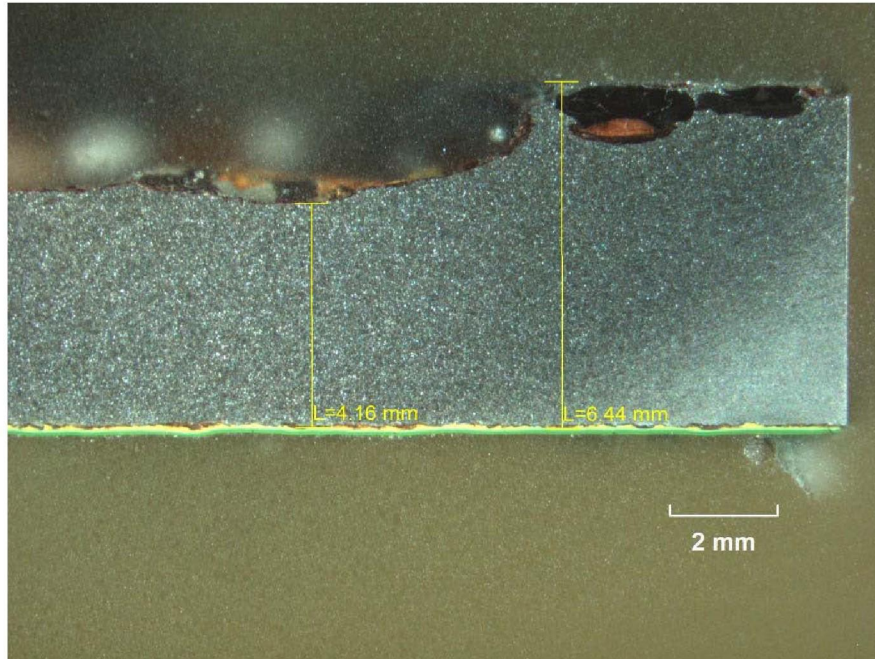
Figure 3-7 Cross Section of Coupon 7 at Area of Maximum Wall Loss

- Detailed results of the Destructive Testing Laboratory analysis of Coupon 7 are contained in Appendix A.
- The thinnest measured location was 163.8 mils (4.16 mm).
- Assuming a nominal wall thickness of 250 mils, the remaining wall thickness at the thinnest location was 66.5%.
- A cross-section view of Coupon 7 is shown in Figure 3-7.

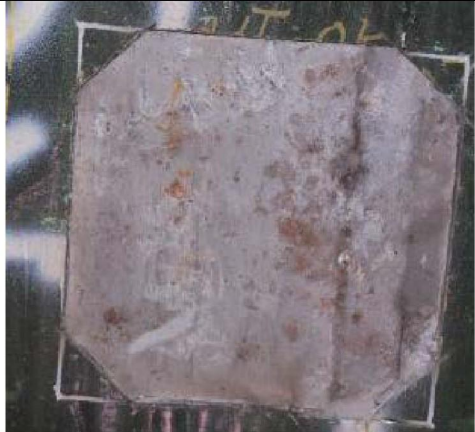
6/20/2018: 1400		
CONCRETE SAMPLE SPECIFICS		
Sample ID	8	8
Sample Location	14-BA-20-13-236-43	
Sample Dimensions	12" × 12"	
ON SITE VISUAL EXAMINATION		
Checks	Observations	
	Exterior	Units
Void space between concrete and liner (if any)	1/16" Void on left side, no voids in all other areas	
Biological Materials	None	
Wet or Dry	Dry	
Smell	None	
Temperature	80.0	F
Surface pH	11-12	
Structure to Electrolyte	-0.248	Volts/CSE
Concrete Resistivity	30.9 Horizontal 27.5 Vertical	k-ohm-cm k-ohm-cm
General Condition	Excellent, sound concrete with no cracks or delamination. Coupon had steel backing plate	
Concrete behind Coupon 8

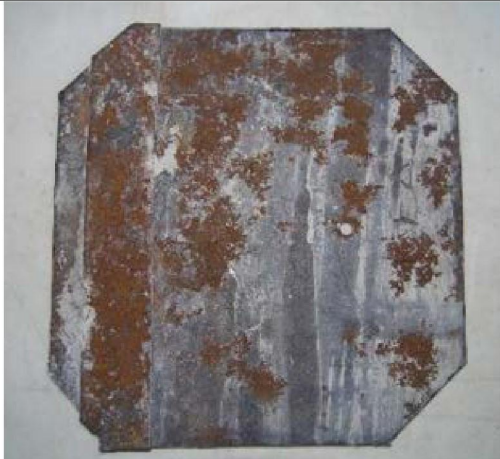
Backside of Coupon 8

Wed, 20 Jun 2018, 09:40 AM		
COUPON SPECIFICS		
Coupon ID	8	8
Coupon Location	14-BA-20-13-236-43	
Coupon Dimensions	12" × 12"	
Coupon Thickness	¼" (NDE: minimum 0.069")	Prove-up: minimum 0.200"
Locations of Welds	About 2" from right edge of front face (exterior face)	
ON SITE VISUAL EXAMINATION		
Checks	Observations	
	Exterior	Interior
Deposits, Coatings, Debris	White coating	Standard coating with pink, white paint
Scale	None	None
Observed Biological Material	None	None
Wet or Dry	Dry	Dry
Smell	Burnt metal	Fuel-like
Presence of petroleum product between steel and concrete surface	No	No
Presence of corrosion	Yes	No
Isolated pitting	Yes (Pit 1: 5" from left, 2" from top) (Pit 2: 7" from left, 5" from top)	No
Isolated pitting within areas of general corrosion	Yes	No
Linked pitting within areas of general corrosion	No	No
Identify color of corrosion products	Brown	No
Identify if selected attack at welds	Yes	N/A

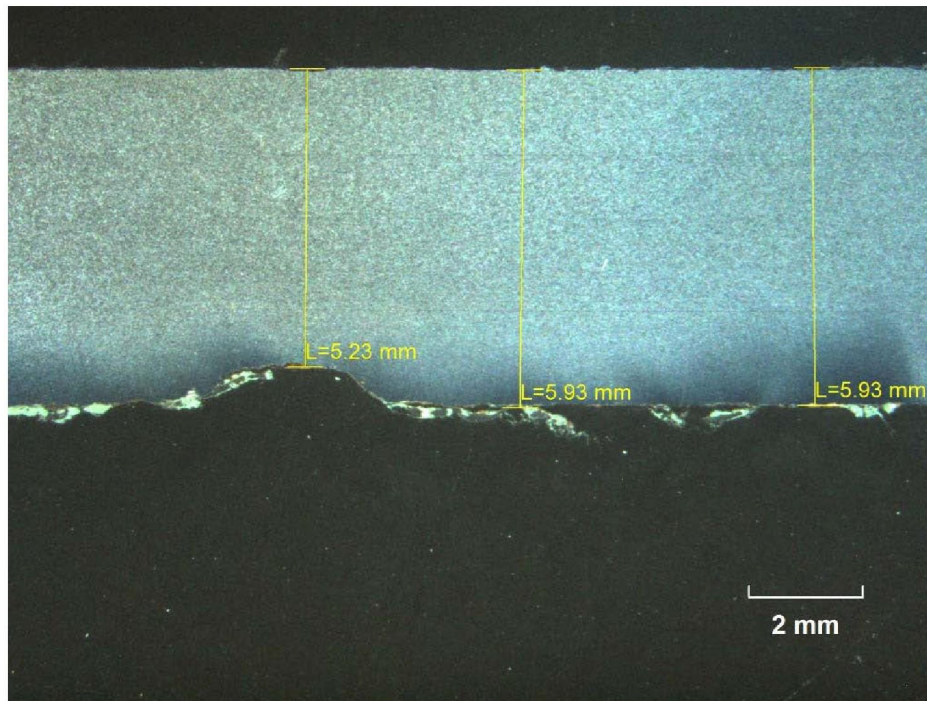
Figure 3-8 Cross Section of Coupon 8 at Area of Maximum Wall Loss

- Detailed results of the Destructive Testing Laboratory analysis of Coupon 8 are contained in Appendix A.
- The thinnest measured location was 205.9 mils (5.23 mm).
- Assuming a nominal wall thickness of 250 mils, the remaining wall thickness at the thinnest location was 82.4%.
- A cross-section view of Coupon 8 is shown in Figure 3-8.

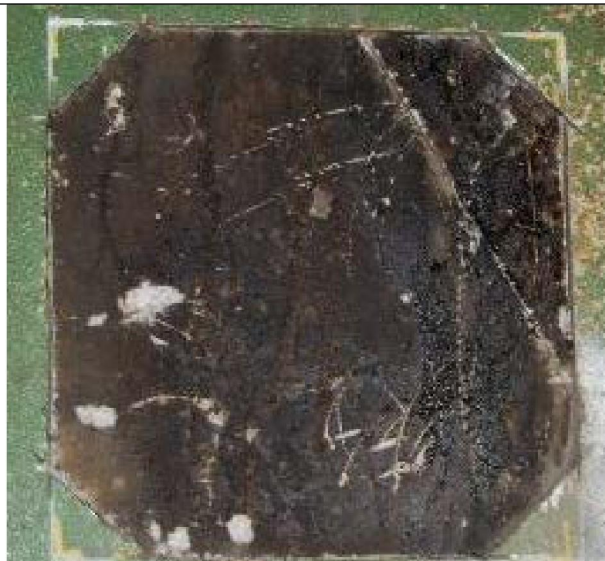
6/21/2018: 0930		
CONCRETE SAMPLE SPECIFICS		
Sample ID	10	10
Sample Location	14-LD-3-9-24-215	
Sample Dimensions	12" × 12"	
ON SITE VISUAL EXAMINATION		
Checks	Observations	
	Exterior	Units
Void space between concrete and liner (if any)	None	
Biological Materials	None	
Wet or Dry	Dry	
Smell	like coal tar	
Temperature	77.6	F
Surface pH	12-12.5	
Structure to Electrolyte	-0.181	Volts/CSE
Concrete Resistivity	27.3 Horizontal 38.1 Vertical	k-ohm-cm k-ohm-cm
General Condition	Excellent, sound concrete with no cracks or delamination. Coupon had to be cut into two pieces to remove. What appears to be coal tar coating present on backside of coupon and concrete.	
Concrete behind Coupon 10

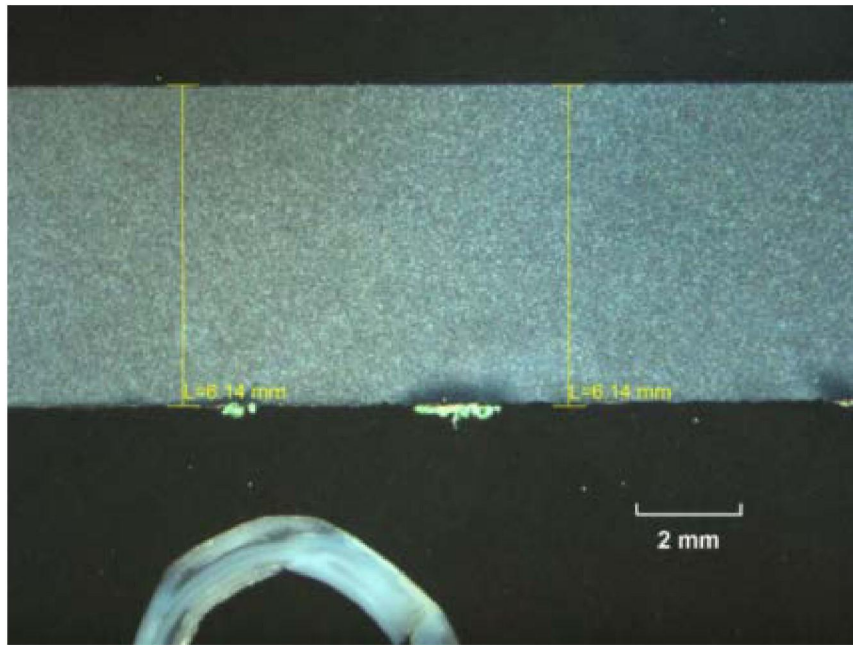
Figure 3-9 Cross Section of Coupon 10 at Area of Maximum Wall Loss

- Detailed results of the Destructive Testing Laboratory analysis of Coupon 10 are contained in Appendix A.
- The thinnest measured location was 241.7 mils (6.14 mm).
- Assuming a nominal wall thickness of 250 mils, the remaining wall thickness at the thinnest location was 96.7%.
- A cross-section view of Coupon 10 is shown in Figure 3-9.

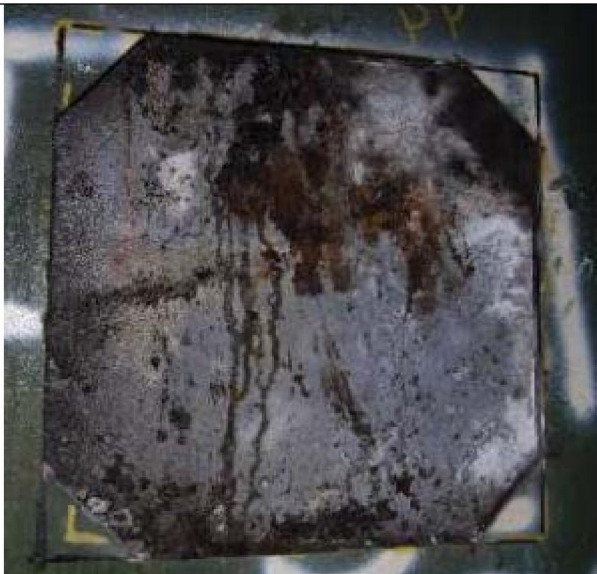
Backside of Coupon A1	 	
-----------------------	--	--

6/20/2018: 1100		
CONCRETE SAMPLE SPECIFICS		
Sample ID	A1	A1
Sample Location	14-BA-23-9-95-50	
Sample Dimensions	12" × 12"	
ON SITE VISUAL EXAMINATION		
Checks	Observations	
	Exterior	Units
Void space between concrete and liner (if any)	1/8" Void on left side, no voids in all other areas	
Biological Materials	None	
Wet or Dry	Mostly dry with damp areas around corrosion product	
Smell	None	
Temperature	77.5	Degrees F
Surface pH	11-12 in dry areas, 7-8 in corroded area	
Structure to Electrolyte	-0.448 (dry area) -0.432 (damp area w. corrosion products)	Volts/CSE
Concrete Resistivity	32.9 Horizontal 37.0 Vertical	k-ohm-cm
General Condition	Good condition with sound concrete, no cracks or delamination. Corrosion products are present on concrete.	
Concrete behind Coupon A1

Wed, 20 Jun 2018, 10:55 AM		
COUPON SPECIFICS		
Coupon ID	A1	A1
Coupon Location	14-BA-23-9-95-50	
Coupon Dimensions	12" × 12"	
Coupon Thickness	¼" (NDE: minimum 0.134")	(no prove-up-phase thickness)
Locations of Welds	None	
ON SITE VISUAL EXAMINATION		
Checks	Observations	
	Exterior	Interior
Deposits, Coatings, Debris	Abundant corrosion product	Standard coating
Scale	None	None
Observed Biological Material	None	None
Wet or Dry	Dry	Dry
Smell	Burnt, musty	Burnt
Presence of petroleum product between steel and concrete surface, and on or above the leg of the angle backer bar embedded in the concrete	No	No
Presence of corrosion	Yes	Yes
Isolated pitting	Yes (Pit: 7.5" from left, 2.5" from top)	No
Isolated pitting within areas of general corrosion	Yes	No
Linked pitting within areas of general corrosion	Yes	No
Identify color of corrosion products	Dark brown	Brown
Identify if selected attack at welds	Yes	N/A

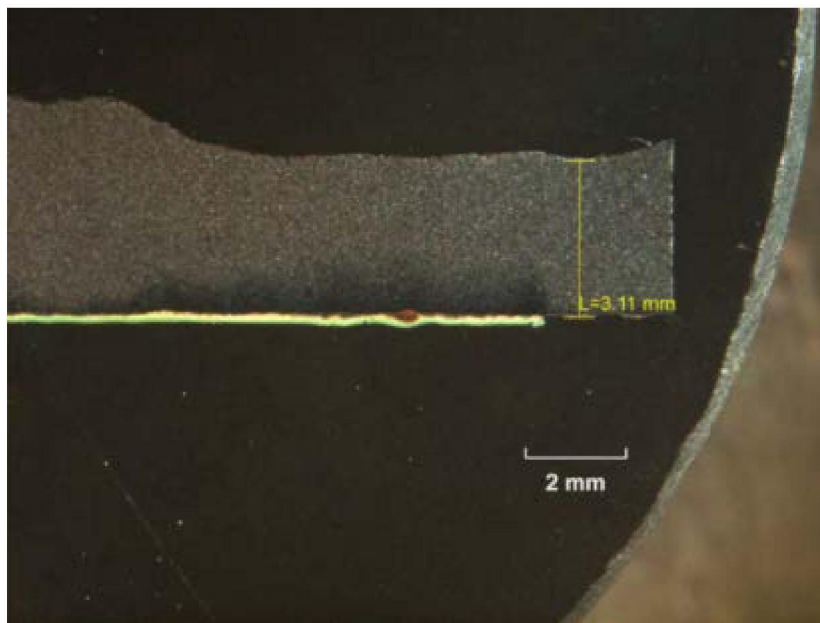
Figure 3-10 Cross Section of Coupon A1 at Area of Maximum Wall Loss

- Detailed results of the Destructive Testing Laboratory analysis of Coupon A1 are contained in Appendix A.
- The thinnest measured location 122.4 mils (3.11 mm).
- Assuming a nominal wall thickness of 250 mils, the remaining wall thickness at the thinnest location was 48.5%.
- A cross-section view of Coupon A1 is shown in Figure 3-10.

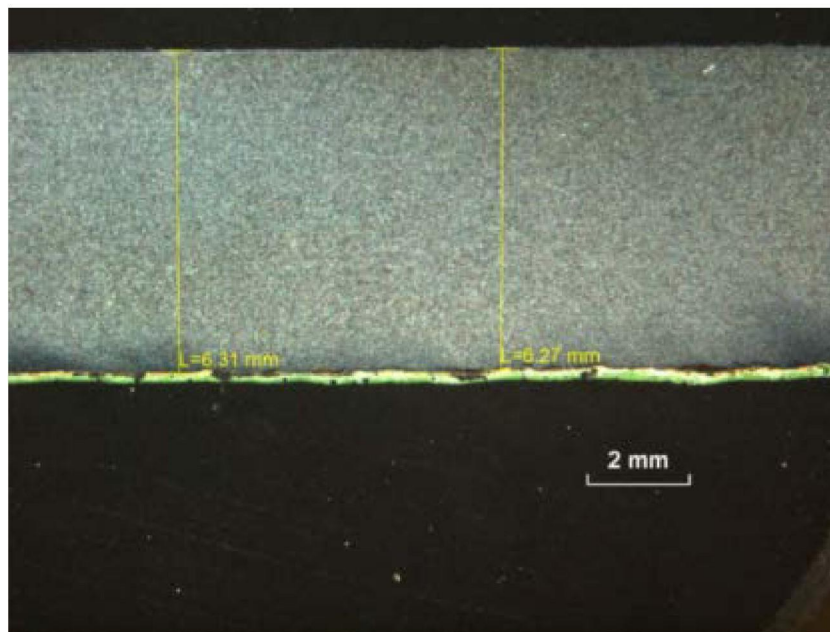
Figure 3-11 Cross Section of Coupon A2 at Area of Maximum Wall Loss

- Detailed results of the Destructive Testing Laboratory analysis of Coupon A2 are contained in Appendix A.
- The thinnest measured location was 247.6 mils (6.29 mm).
- Assuming a nominal wall thickness of 250 mils, the remaining wall thickness at the thinnest location was 97.5%.
- A cross-section view of Coupon A2 is shown in Figure 3-11.

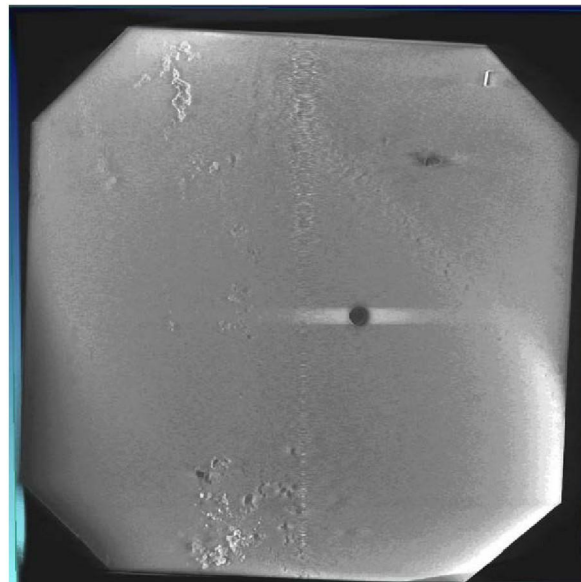
Figure 4-2 CT Scan Image from Destructive Testing Lab Report, Coupon 1

The LFET minimum screening thickness found was 0.112 inch. Therefore, a repair was specified in this area. Backside pitting corrosion expected. Later prove-up with PAUT indicated an expected minimum remaining wall thickness of 0.112 inch.

Destructive testing found pitting and minimum wall thickness of 0.208 inch. Remaining wall thickness greater than expected (208 mils vs. 112 mils). This deviation exceeded the 20 mils accuracy range for pitting.

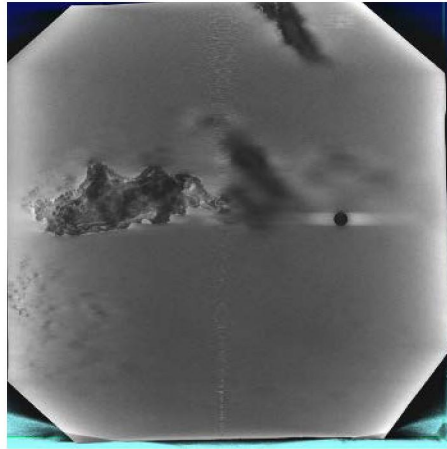
Figure 4-4 CT Scan Image from Destructive Testing Lab Report, Coupon 2

The LFET minimum screening thickness found was 0.157 inch. Therefore, a repair was specified in this area. Backside pitting corrosion expected. Later prove-up with PAUT indicated an expected minimum remaining wall thickness of 0.150 inch.

Destructive testing found pitting and minimum wall thickness of 0.152 inch.

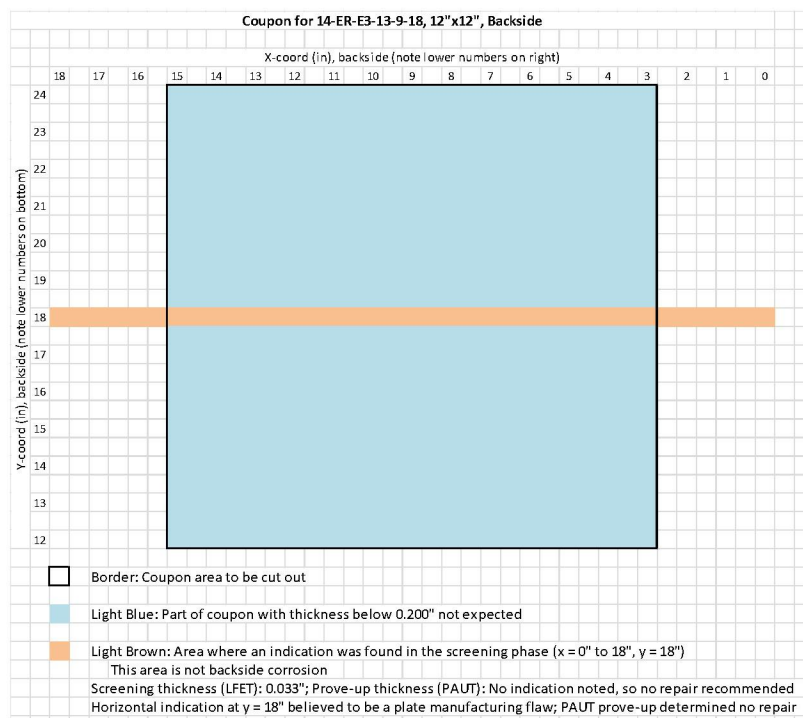
Figure 4-5 Expected Results from NDE Spreadsheet Data, Coupon 3

The LFET minimum screening thickness was 0.033 inch. During the PAUT prove-up, the 33-mil thickness was identified not to be metal loss but instead was a non-actionable lamination. Therefore, a repair was not initially specified in this area. Backside corrosion was not expected.

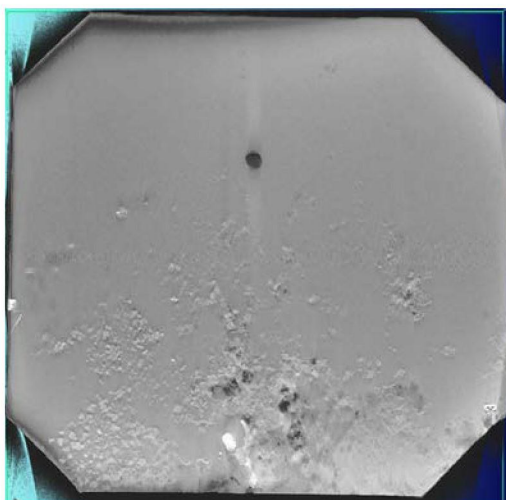
Figure 4-6 CT Scan Image from Destructive Testing Lab Report, Coupon 3

Destructive testing found pitting and minimum wall thickness of 0.132 inch. The remaining wall thickness, 132 mils, was less than expected (greater than 200 mils). The LFET value did not fall within the 20-mil accuracy range for pitting.

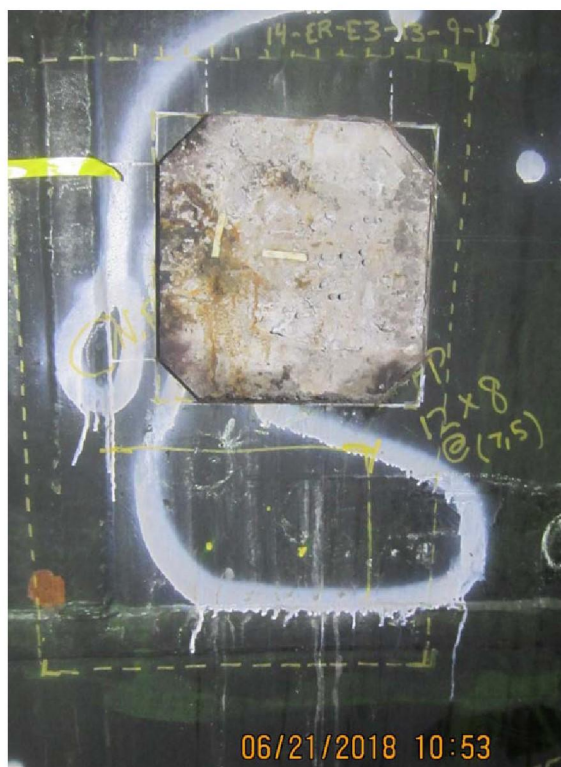
Figure 4-8 Location of Coupon 3 after Removal

was prevented from finishing the NDE process by being unable to layout the repair at Indication B. Instead of performing a layout at Indication B, the contractor was asked to layout repairs for Coupon 3 (Indication A). Figure 4-8 depicts the location after the coupon was removed.

Inner square indicates boundary of Coupon 3. Outer rectangle indicates boundary of patch plate for repair.

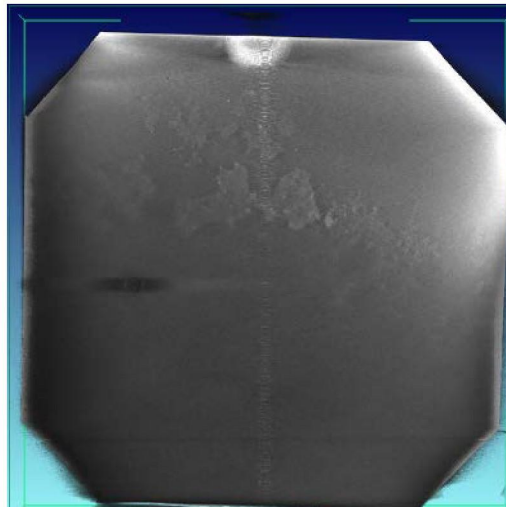
Figure 4-10 CT Scan Image from Destructive Testing Lab Report, Coupon 5

The LFET minimum screening thickness was 0.047 inch. A prove-up thickness greater than 0.160 inch was expected. Therefore, a repair was not specified in this area. A flaw, not backside corrosion, was expected.

Destructive testing found pitting and minimum wall thickness of 0.224 inch. The remaining wall thickness was as expected.

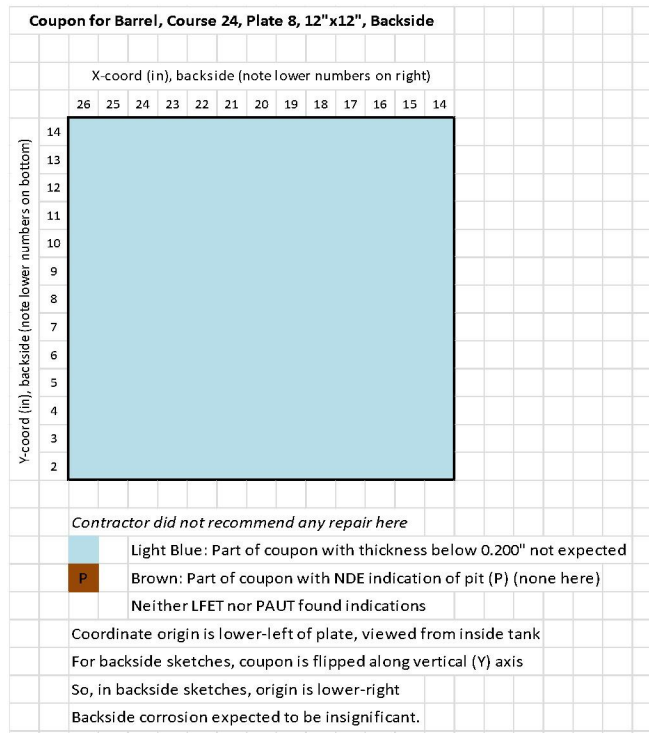
Figure 4-11 Expected Results from NDE Spreadsheet Data, Coupon 6

The LFET screening found no indications. Therefore, a repair was not specified in this area.

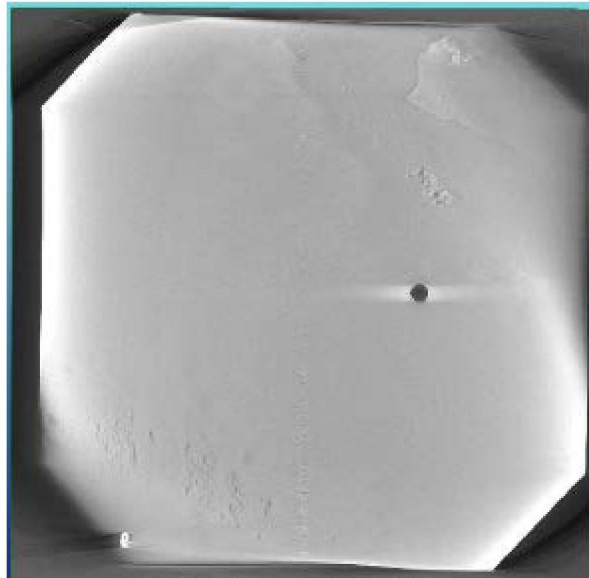
Figure 4-12 CT Scan Image from Destructive Testing Lab Report, Coupon 6

Destructive testing found pitting and minimum wall thickness of 0.158 inch. The remaining wall thickness was thinner than expected in the isolated pit.

LFET does not always detect metal loss of very small volume with narrow and non-uniform characteristics. The likelihood this single small pit, smaller than what the equipment could detect with more than 64% metal thickness remaining after 75 years in service, would form into a thru-hole before the next inspection, is extremely low. Given the steel plate's original thickness of 250 mils and the metal thickness of 158 mils upon removal (a loss of 92 mils), and assuming a constant rate of corrosion between the tank's construction in 1943 and coupon removal in 2018 (75 years),

the maximum corrosion rate at Coupon 6 is 1.23 mils per year (mpy). No conditions were evident that would support accelerated corrosion at Coupon 6.

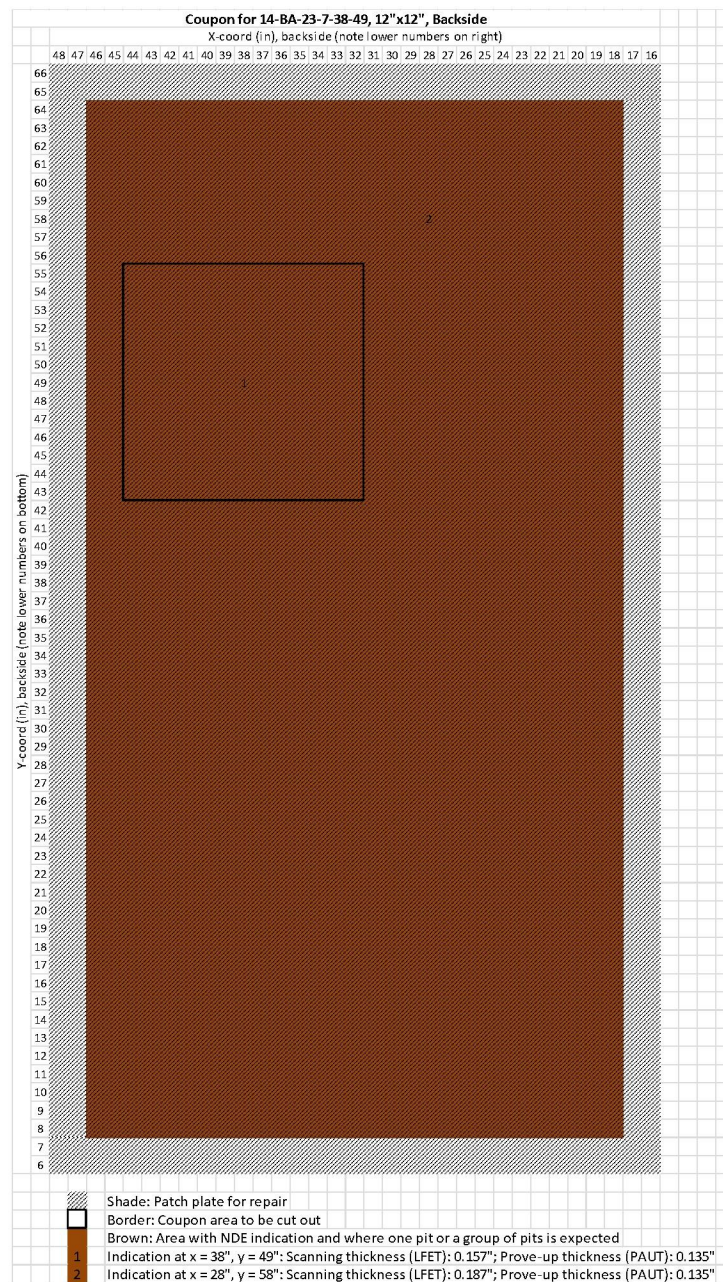
Figure 4-13 Expected Results from NDE Spreadsheet Data, Coupon 7

The LFET minimum screening thickness was 0.157 inch. The prove-up thickness was 0.135 inch. Therefore, a repair was specified in this area.
