SUBJECT: ADMINISTRATIVE ORDER ON CONSENT (AOC) STATEMENT OF WORK (SOW) SECTION 5 CORROSION AND METAL FATIGUE PRACTICES, DESTRUCTIVE TESTING RESULTS REPORT, RED HILL BULK FUEL STORAGE FACILITY (RED HILL), JOINT BASE PEARL HARBOR-HICKAM, OAHU, HAWAII

In 2018, ten coupons were removed from Tank 14, so that a metallurgical and corrosion analysis of the coupons could be undertaken, with the primary aim of validating non-destructive examination (NDE) results. The steel coupons, concrete powder samples, and corrosion product were submitted to a certified third-party laboratory to perform this analysis.

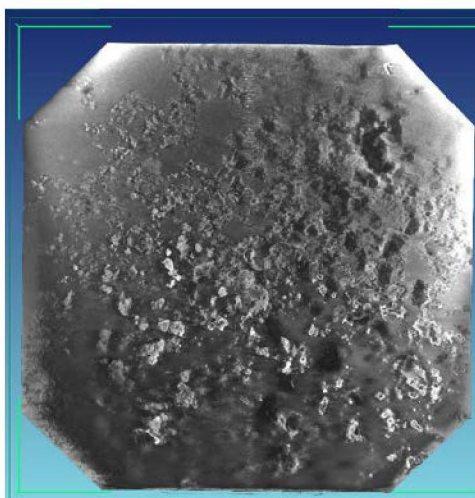
Figure 4-14 CT Scan Image from Destructive Testing Lab Report, Coupon 7

Destructive testing found pitting and a minimum wall thickness of 0.164 inch. The remaining wall thickness was within the 20-mil range for pitting but thicker than expected for the prove-up testing (164 mils vs. 135 mils).

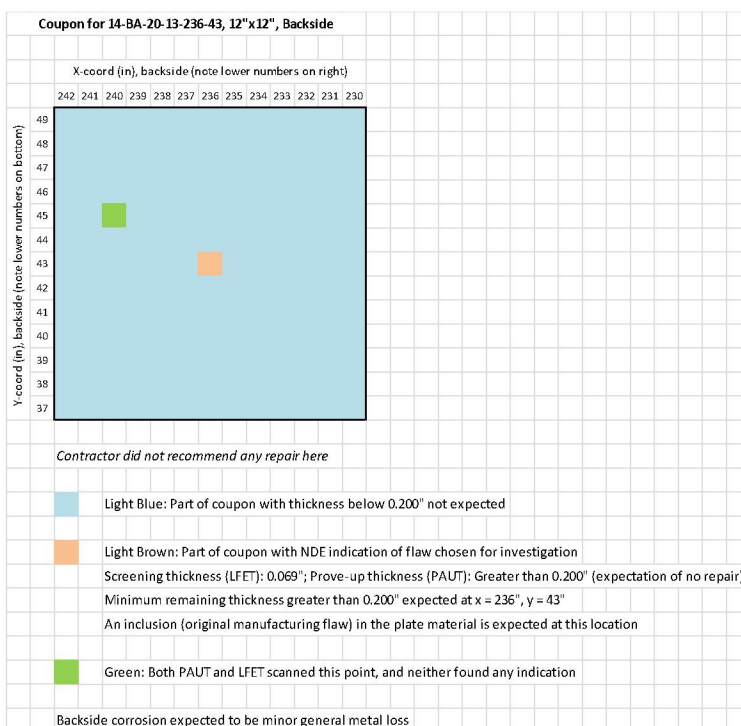
Figure 4-15 Expected Results from NDE Spreadsheet Data, Coupon 8

The LFET minimum screening thickness was 0.069 inch. The prove-up thickness was greater than 0.200 inch. Therefore, no repair was specified in this area.

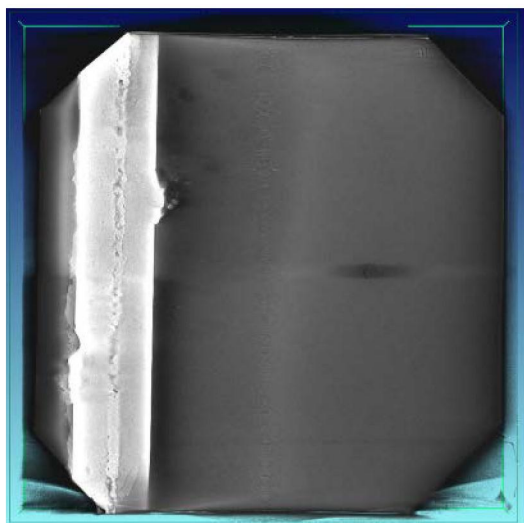
Figure 4-16 CT Scan Image from Destructive Testing Lab Report, Coupon 8

Destructive testing found pitting and minimum wall thickness of 0.206 inch. Remaining wall thickness was as expected.

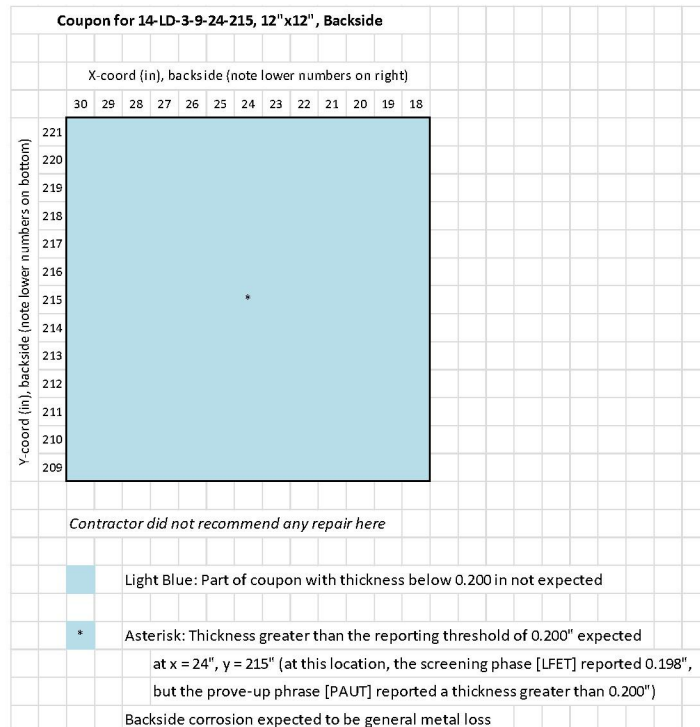
Figure 4-17 Expected Results From NDE Spreadsheet Data, Coupon 10

The LFET screening found no indications. Therefore, no repair was specified in this area.

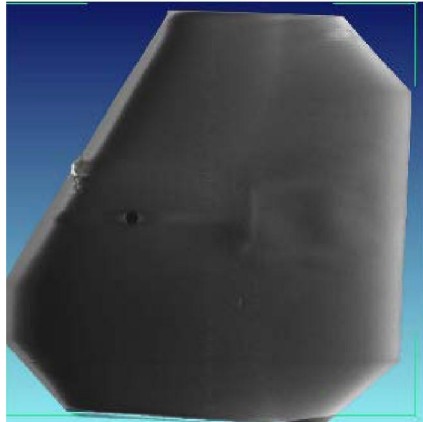
Figure 4-18 CT Scan Image from Destructive Testing Lab Report, Coupon 10

Destructive testing found a minimum wall thickness of 0.242 inch. Remaining wall thickness was as expected.

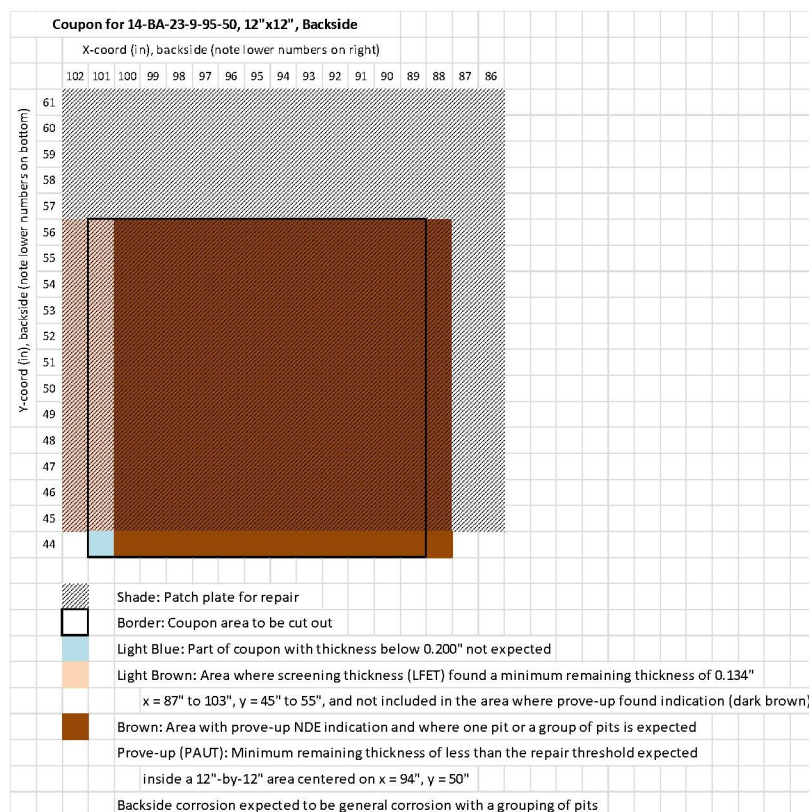
Figure 4-19 Expected Results from NDE Spreadsheet Data, Coupon A1

The LFET minimum screening thickness was 0.134 inch. No prove-up measurements were done in this location because a weld repair was indicated. A repair was specified in this area.

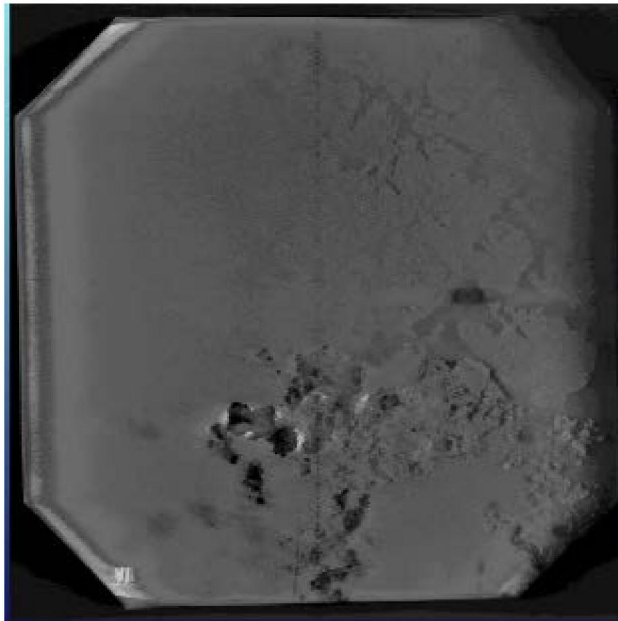
Figure 4-20 CT Scan Image from Destructive Testing Lab Report, Coupon A1

Destructive testing found pitting and minimum wall thickness of 0.122 inch. The remaining wall thickness was as expected. The LFET thickness fell within the 20-mil accuracy range.

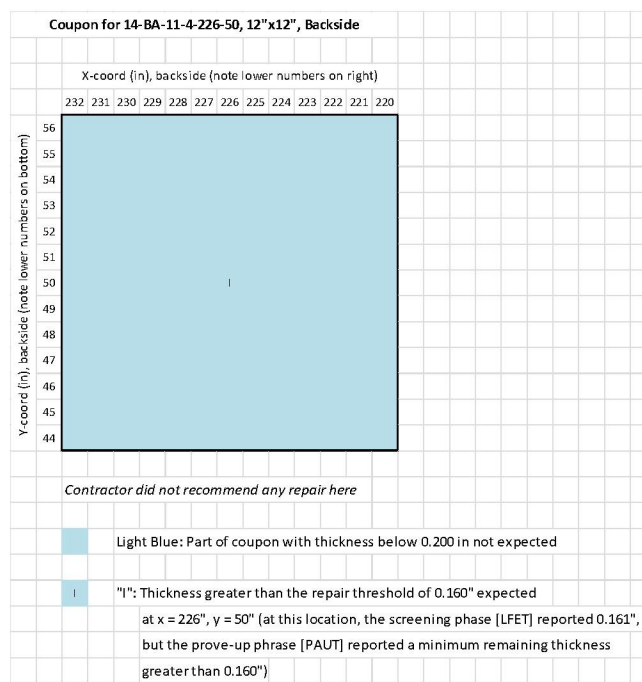
Figure 4-21 Expected Results from NDE Spreadsheet Data, Coupon A2

The LFET screening found no indications. Therefore, no repair was specified in this area.

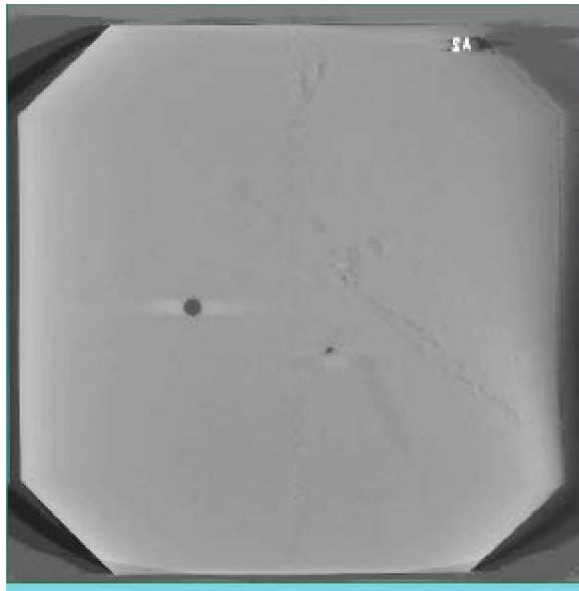
Figure 4-22 CT Scan Image from Destructive Testing Lab Report, Coupon A2

Destructive testing found a minimum wall thickness of 0.248 inch. The remaining wall thickness was as expected.

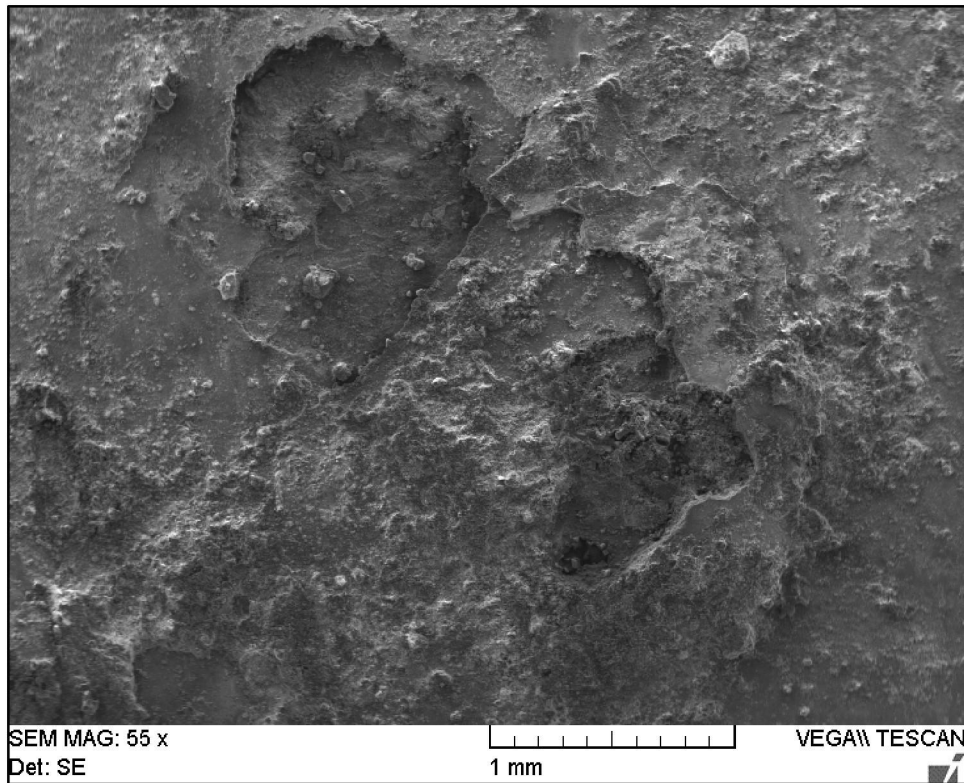
Figure 41. A representative SEM image of a pit on a specimen excised from Coupon 1 labeled as 1-1, prior to cleaning. (SEM, 32X)

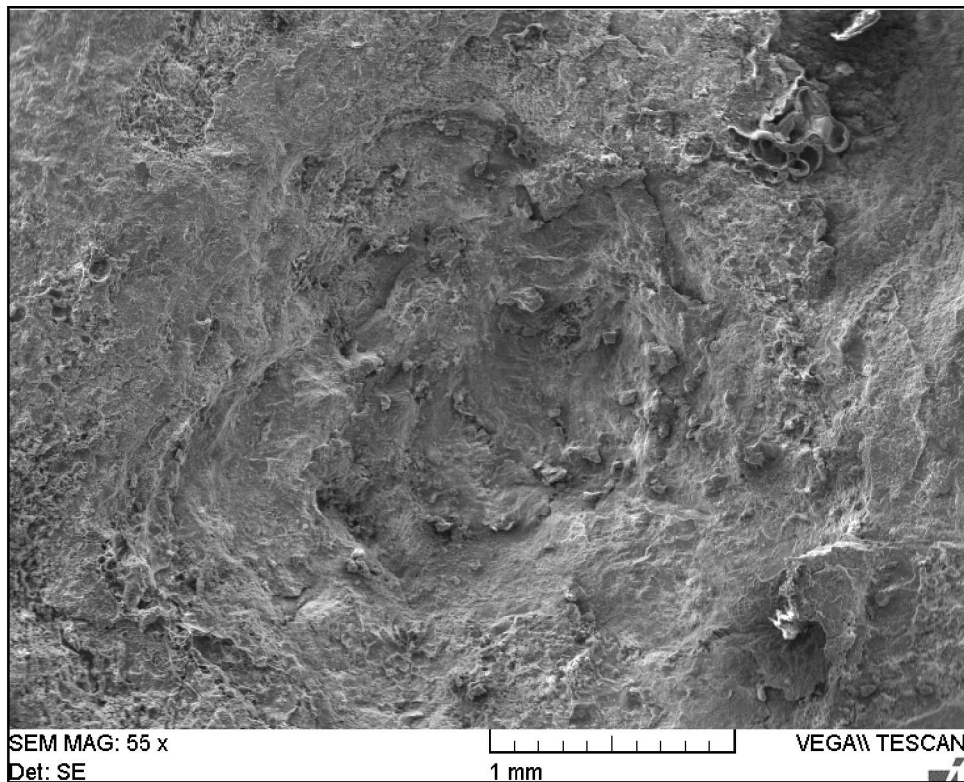
Figure 42. A representative SEM image of a pit on a specimen excised from Coupon 1 labeled as 1-2, prior to cleaning. (SEM, 32X)

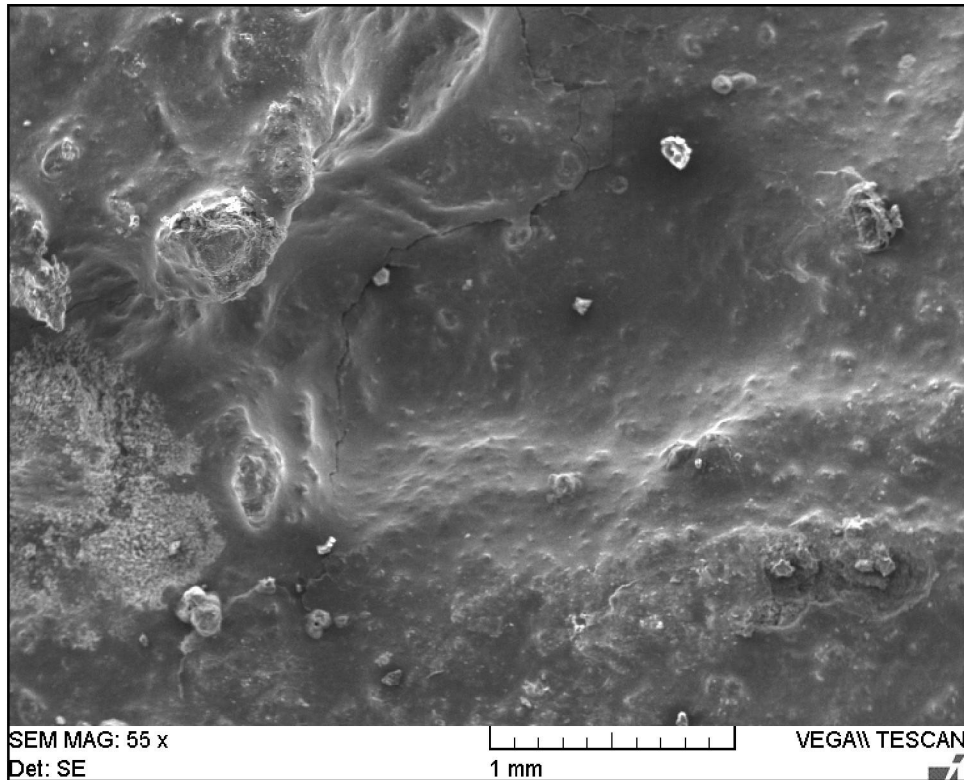
Figure 48. A representative SEM image of a pit on a specimen excised from Coupon 3 labeled as 3-2, prior to cleaning. (SEM, 32X)

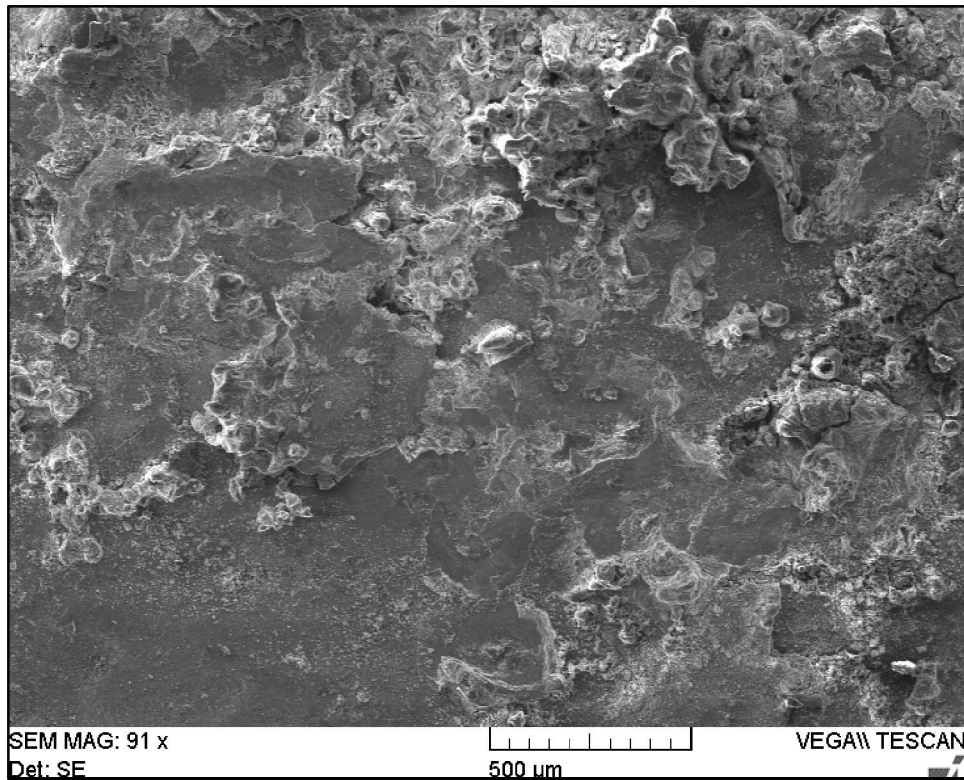
Figure 59. A representative SEM image of a pit on a specimen excised from Coupon 8 labeled as 8-1, prior to cleaning. (SEM, 53X)

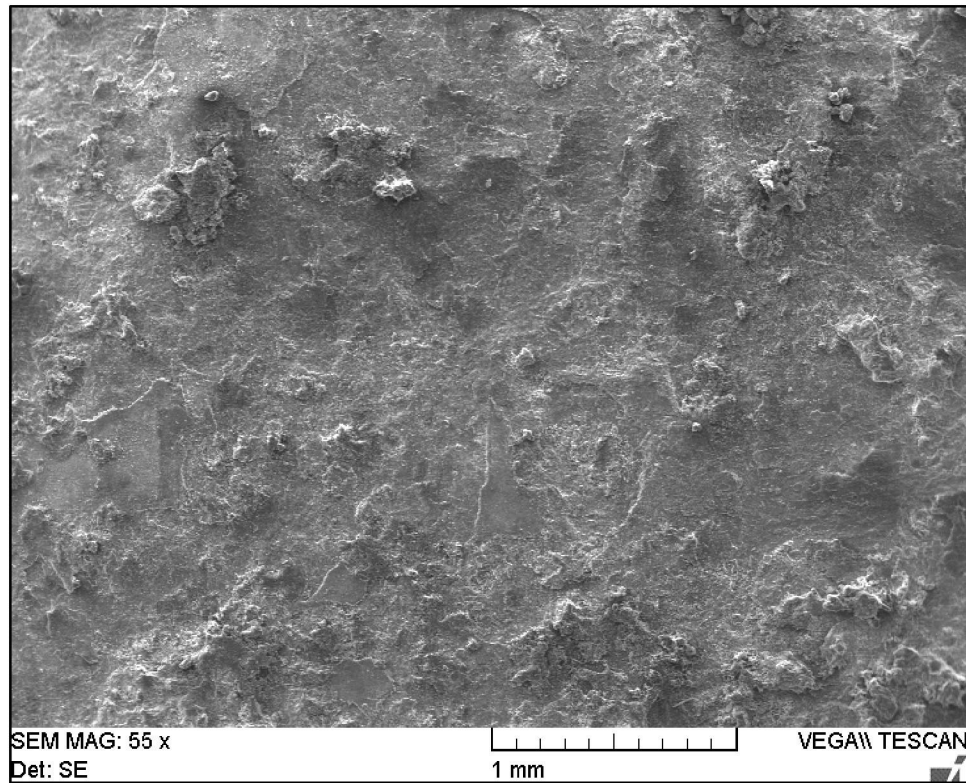
Figure 60. A representative SEM image of a pit on a specimen excised from Coupon 8 labeled as 8-2, prior to cleaning. (SEM, 33X)

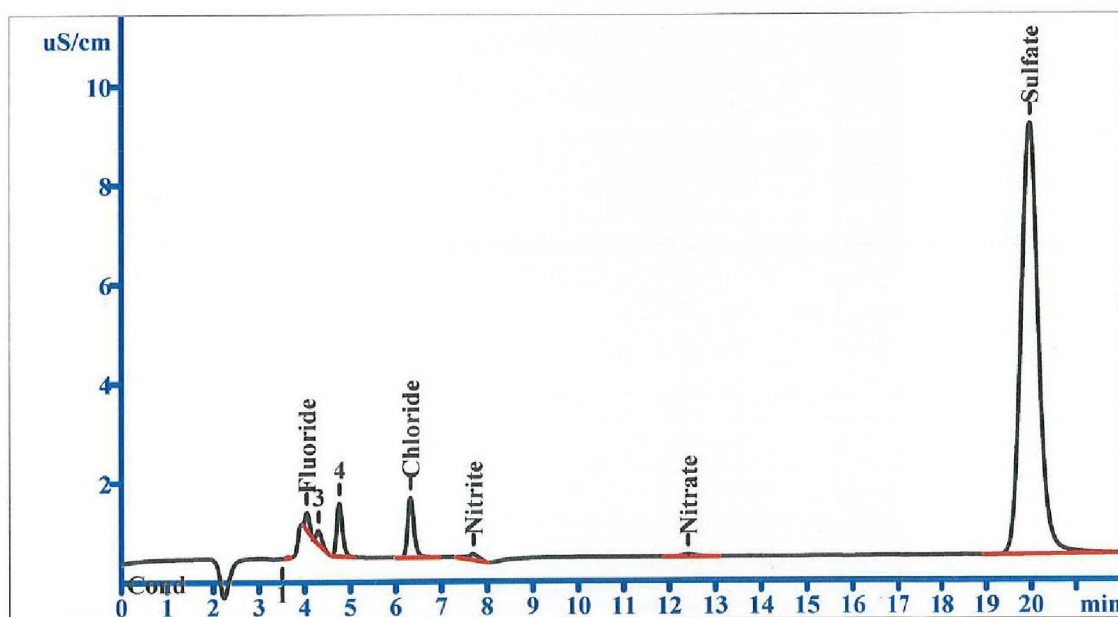
Figure 104. The ion chromatogram generated from a concrete sample removed from Coupon 5.

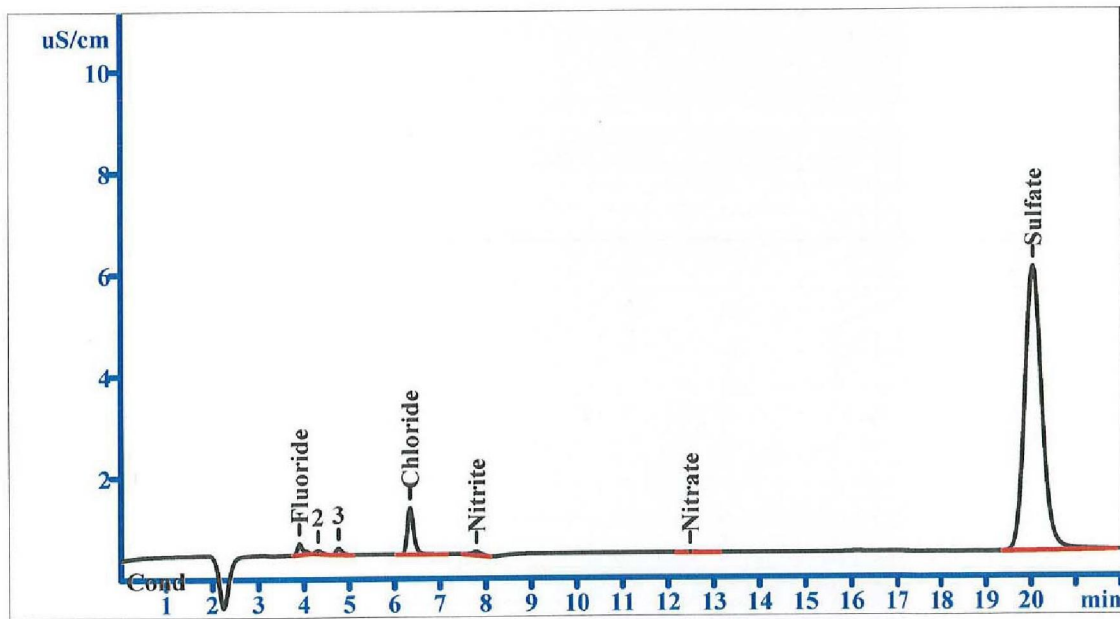
Figure 105. The ion chromatogram generated from a concrete sample removed from Coupon 6.

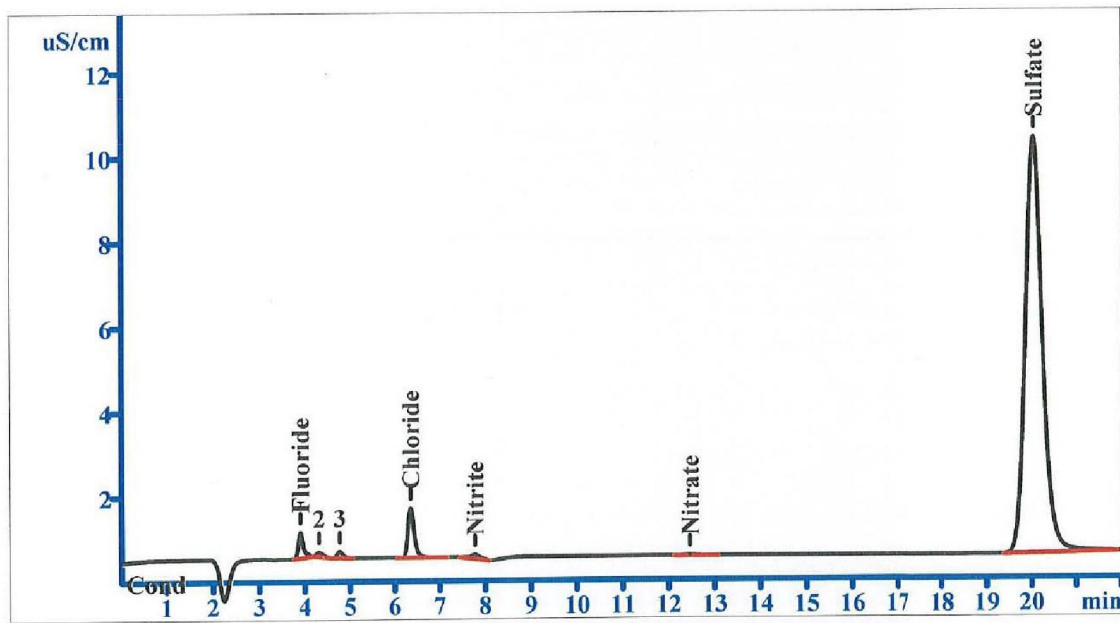
Figure 106. The ion chromatogram generated from a concrete sample removed from Coupon 7.

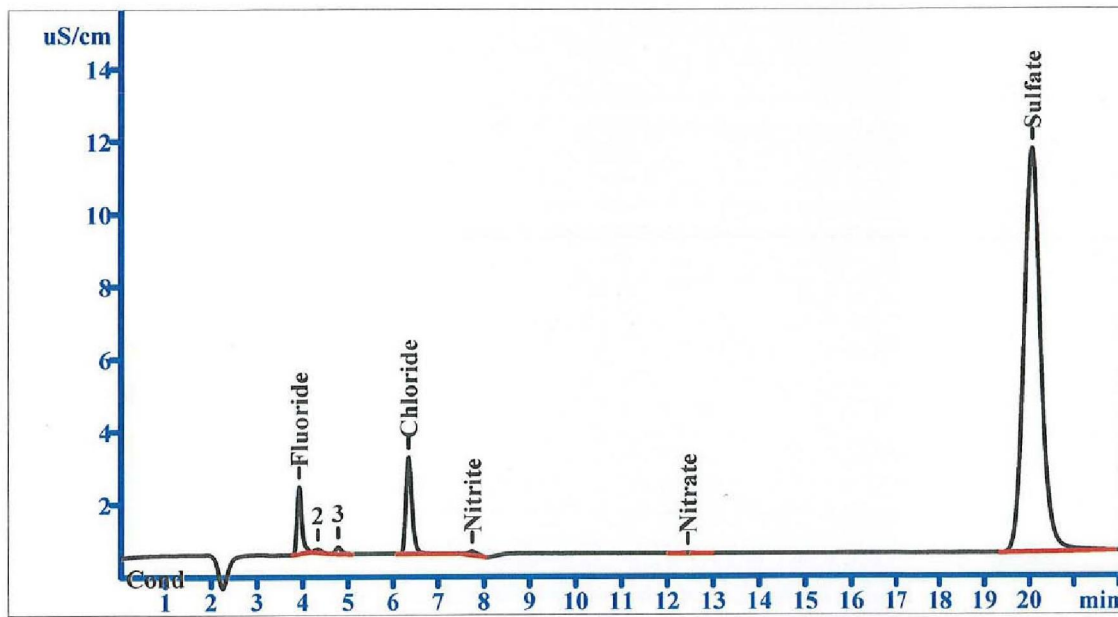
Figure 107. The ion chromatogram generated from a concrete sample removed from Coupon 8.

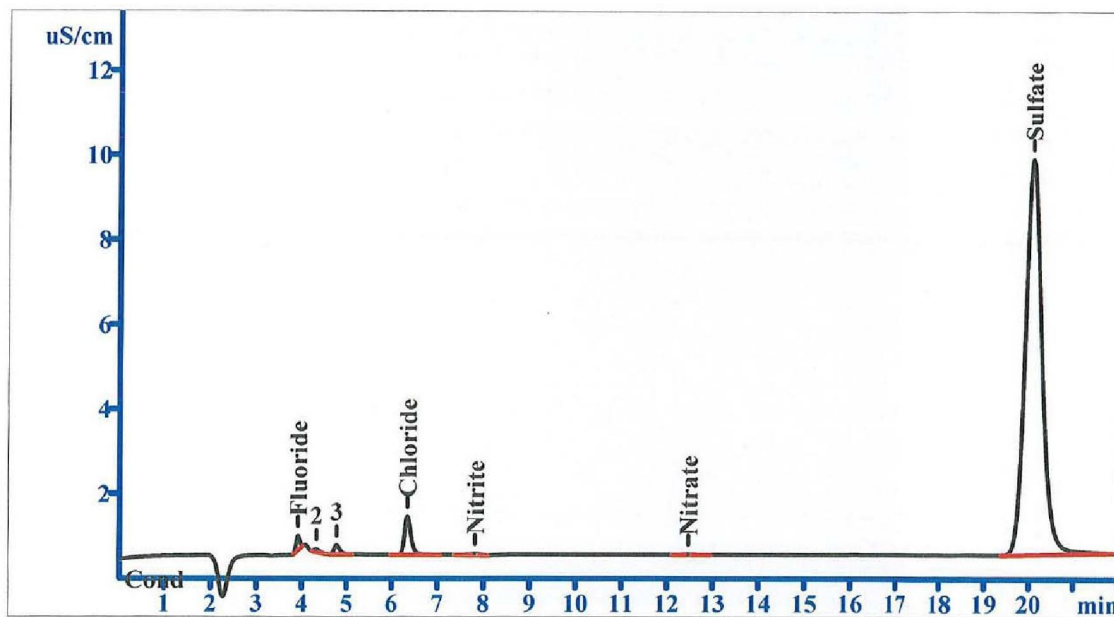
Figure 108. The ion chromatogram generated from a concrete sample removed from Coupon 10.

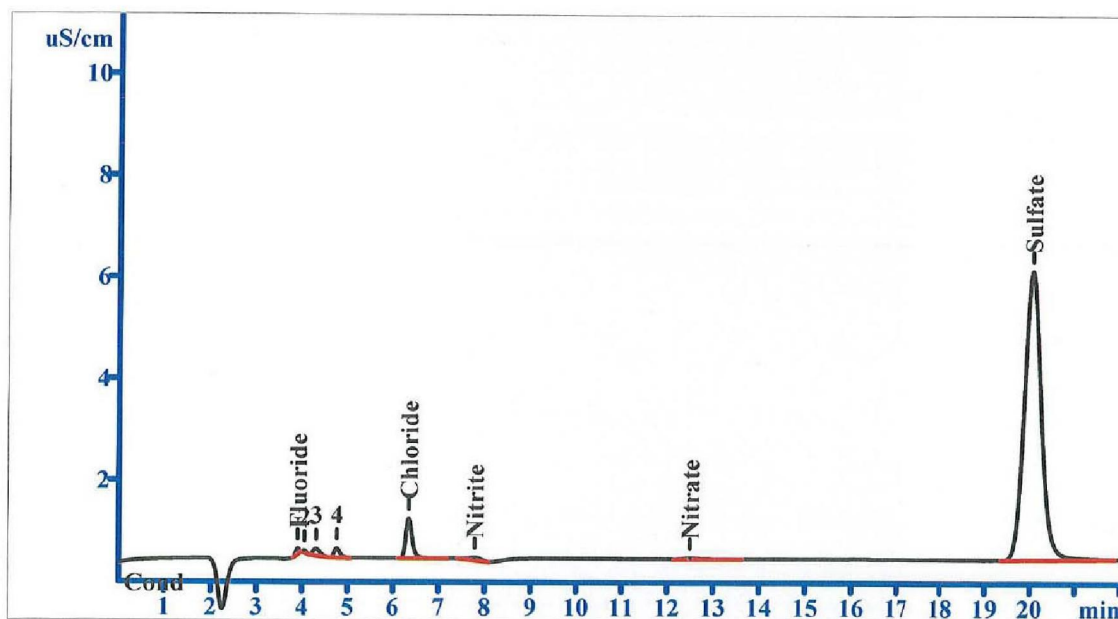
Figure 109. The ion chromatogram generated from a concrete sample removed from Coupon A1.

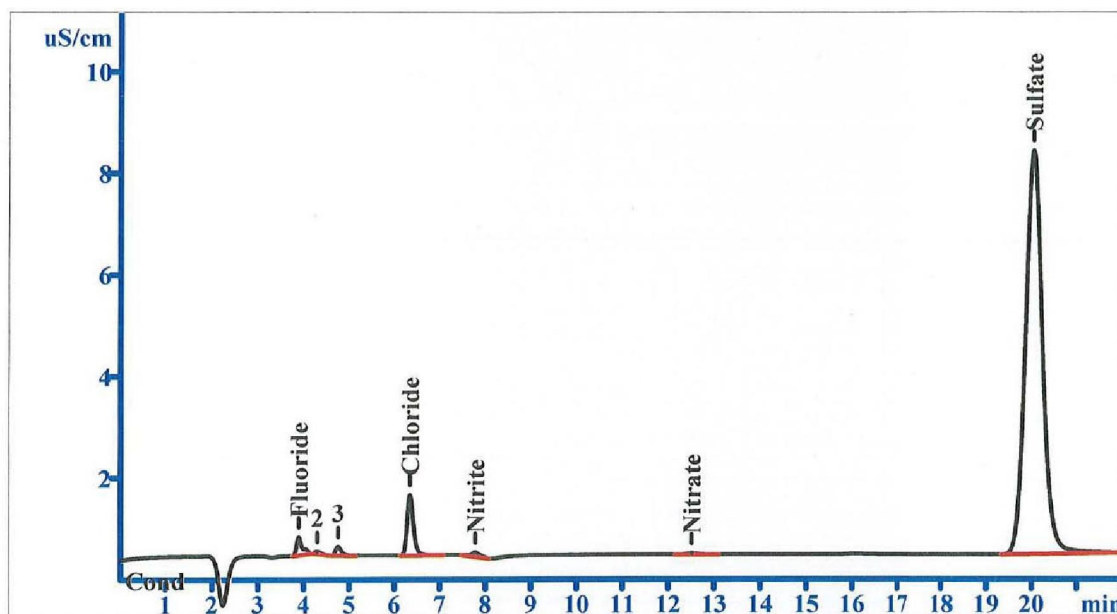
Figure 110. The ion chromatogram generated from a concrete sample removed from Coupon A2.

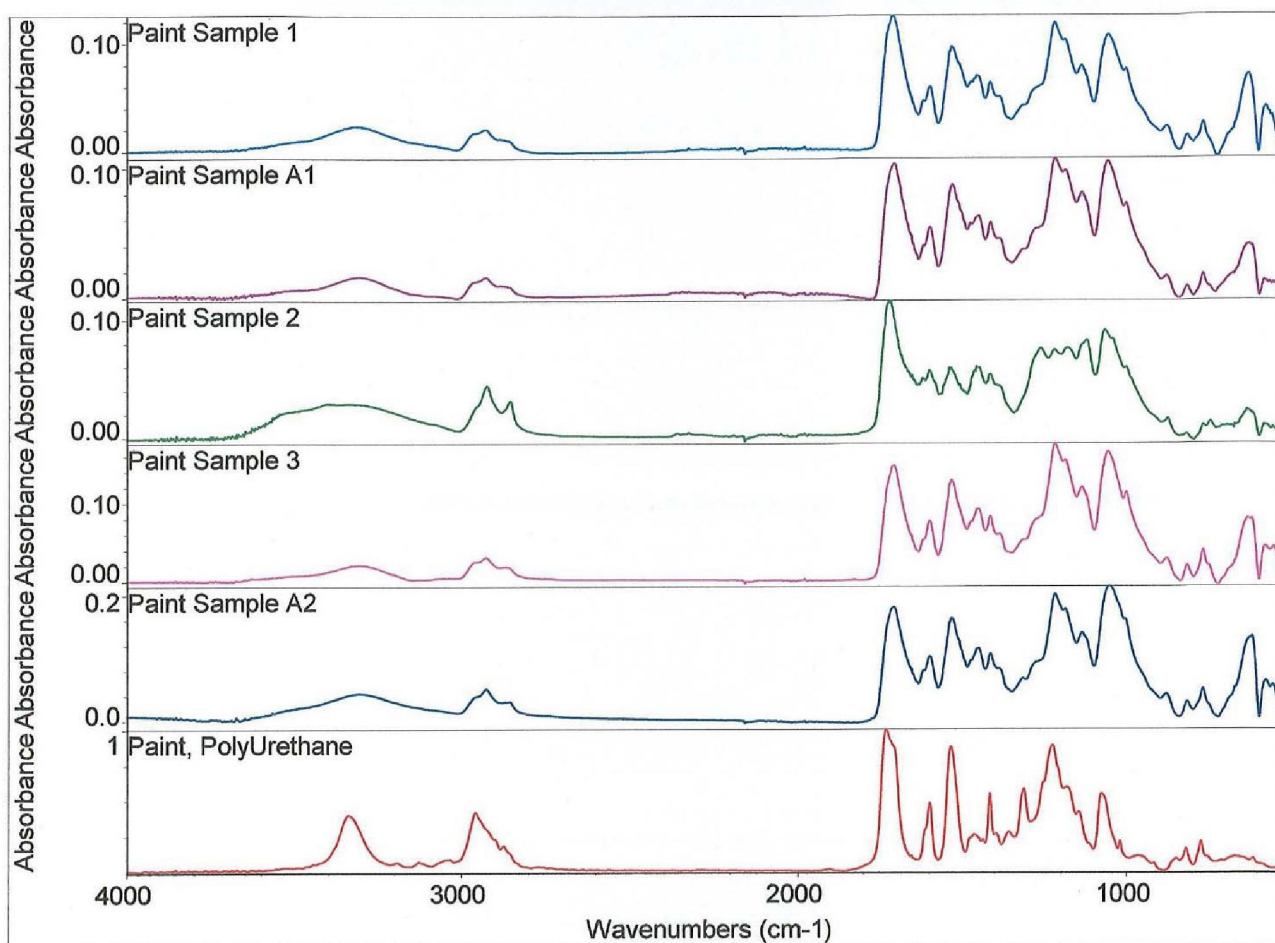
Fourier transform infrared (FTIR) spectroscopy was performed on paint samples removed from each coupon using Attenuated Total Reflectance (ATR) with a diamond crystal. All paint samples were identified as polyurethane enamel. The resulting FTIR spectra of the samples and the best matches from the spectral FTIR library of standards for polyurethane enamel are provided as Figures 111 and 112.

Figure 111. The FTIR spectra generated from a paint samples removed from the exterior surfaces of Coupons 1, A1, 2, A2 and 3 the best matches from the spectral FTIR library of standards for polyurethane enamel.

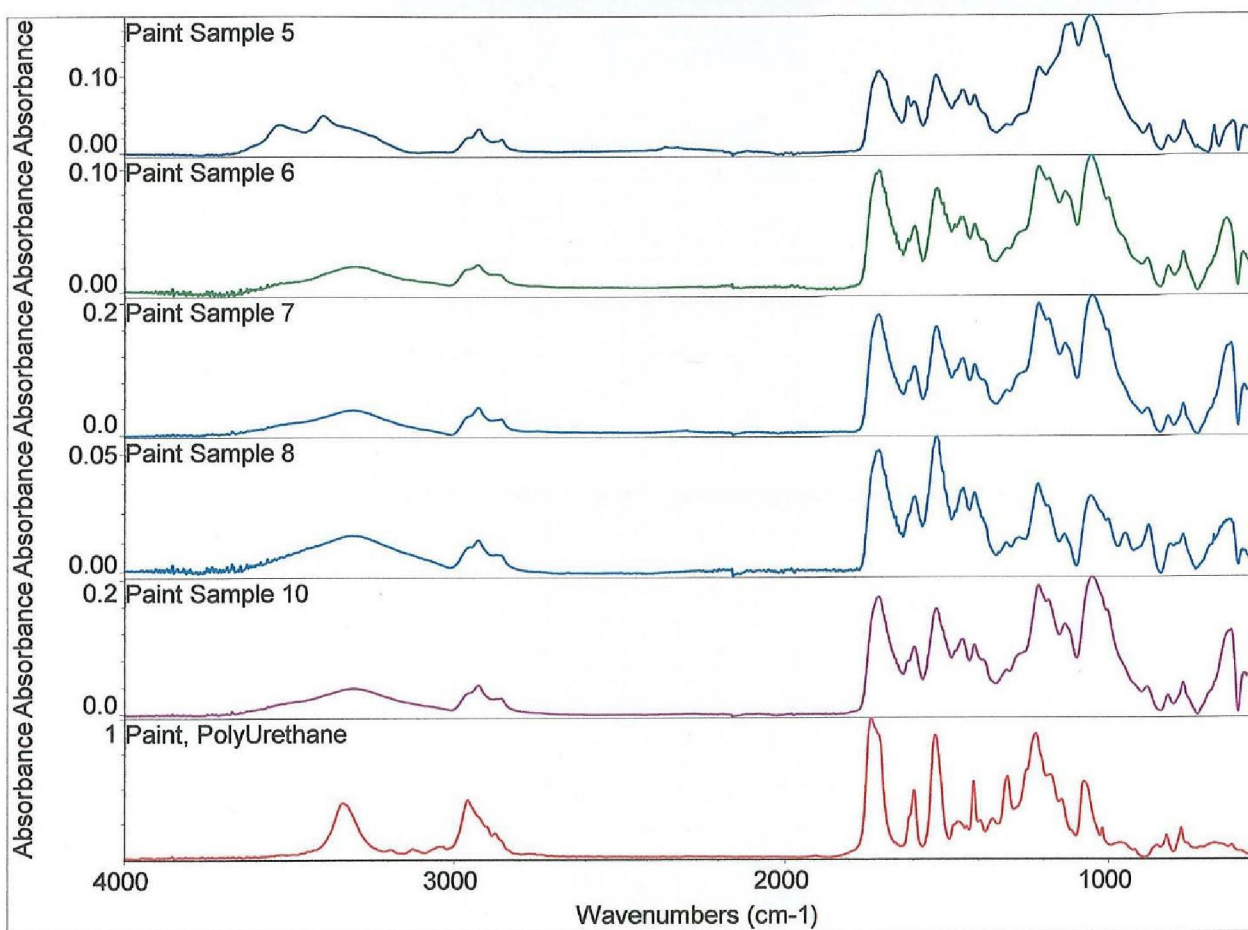
Figure 112. The FTIR spectra generated from a paint samples removed from the exterior surfaces of Coupons 5, 6, 7, 8 and 10 the best matches from the spectral FTIR library of standards for polyurethane enamel.
