SUBJECT: ADMINISTRATIVE ORDER ON CONSENT (AOC) STATEMENT OF WORK (SOW) SECTION 5 CORROSION AND METAL FATIGUE PRACTICES, DESTRUCTIVE TESTING RESULTS REPORT, RED HILL BULK FUEL STORAGE FACILITY (RED HILL), JOINT BASE PEARL HARBOR-HICKAM, OAHU, HAWAII

In 2018, ten coupons were removed from Tank 14, so that a metallurgical and corrosion analysis of the coupons could be undertaken, with the primary aim of validating non-destructive examination (NDE) results. The steel coupons, concrete powder samples, and corrosion product were submitted to a certified third-party laboratory to perform this analysis.

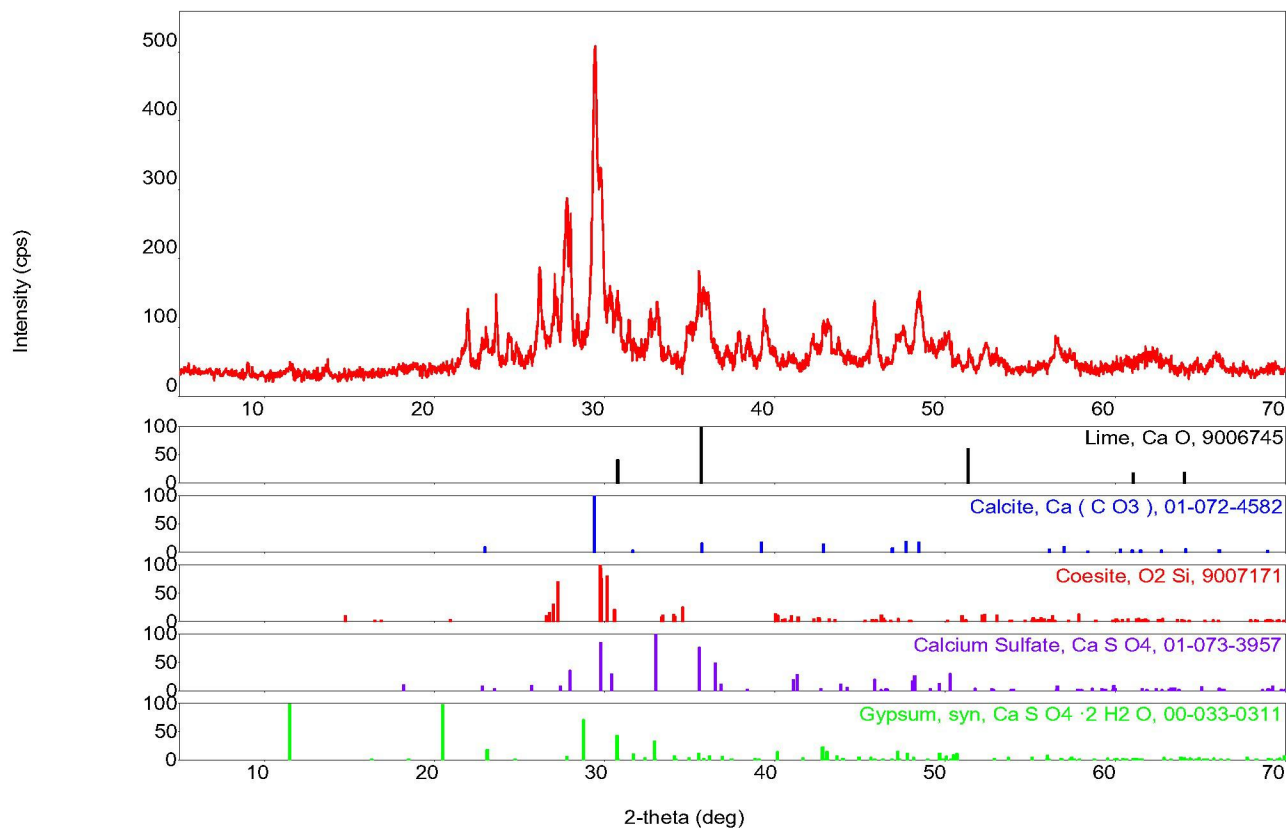
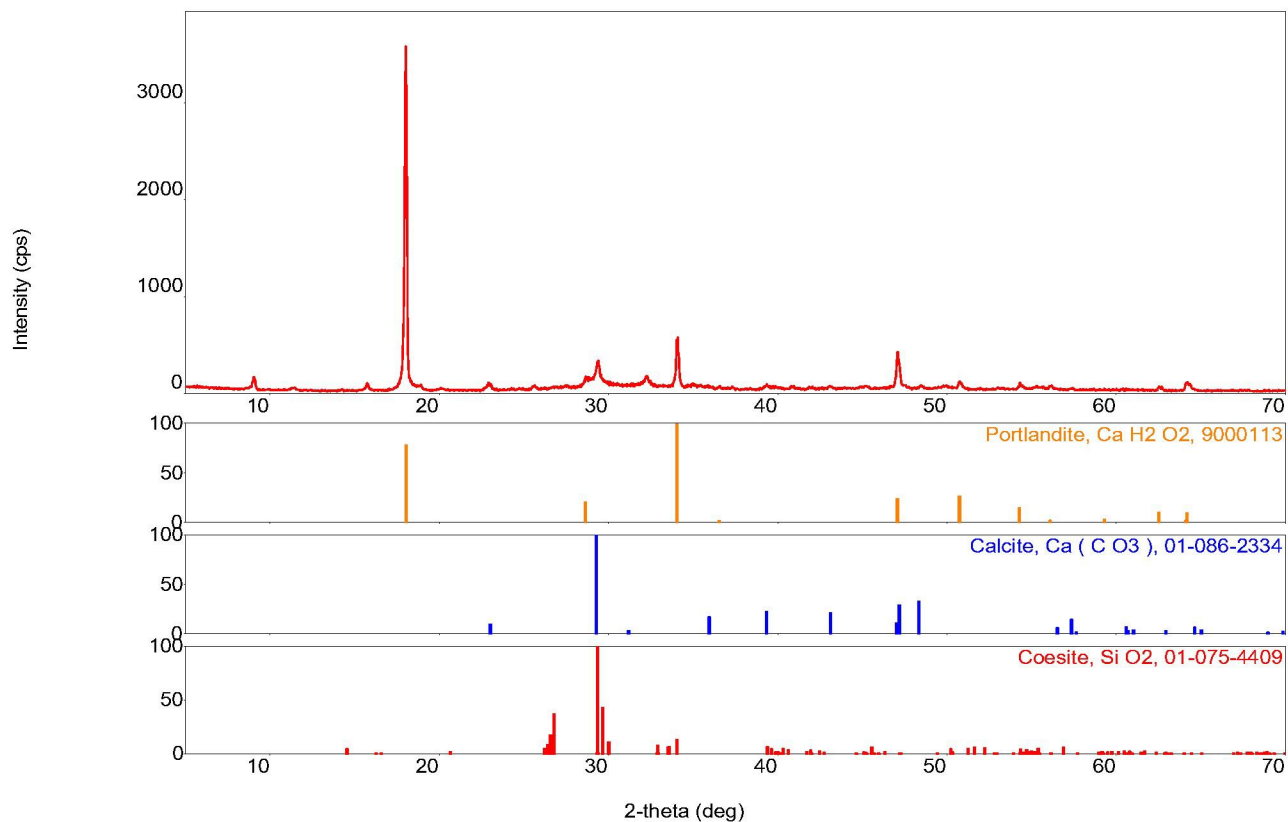
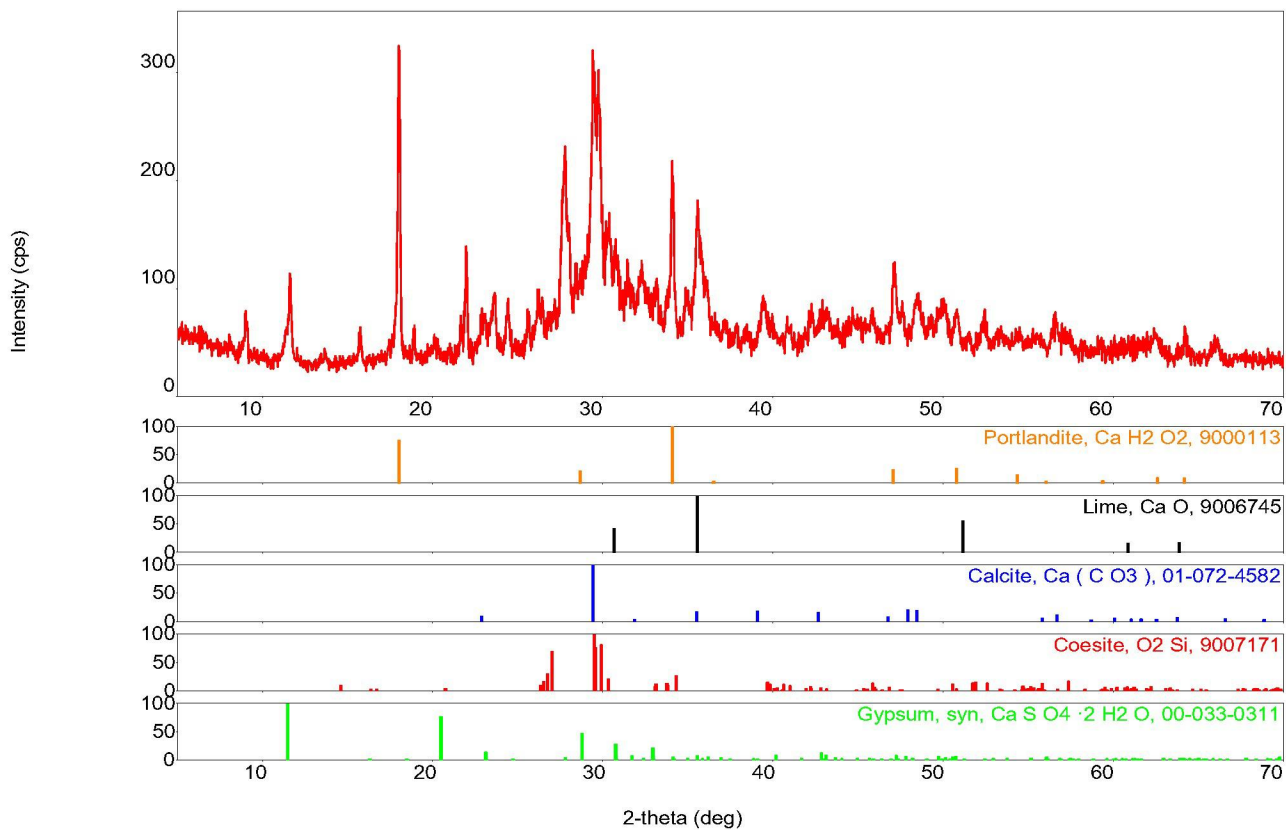
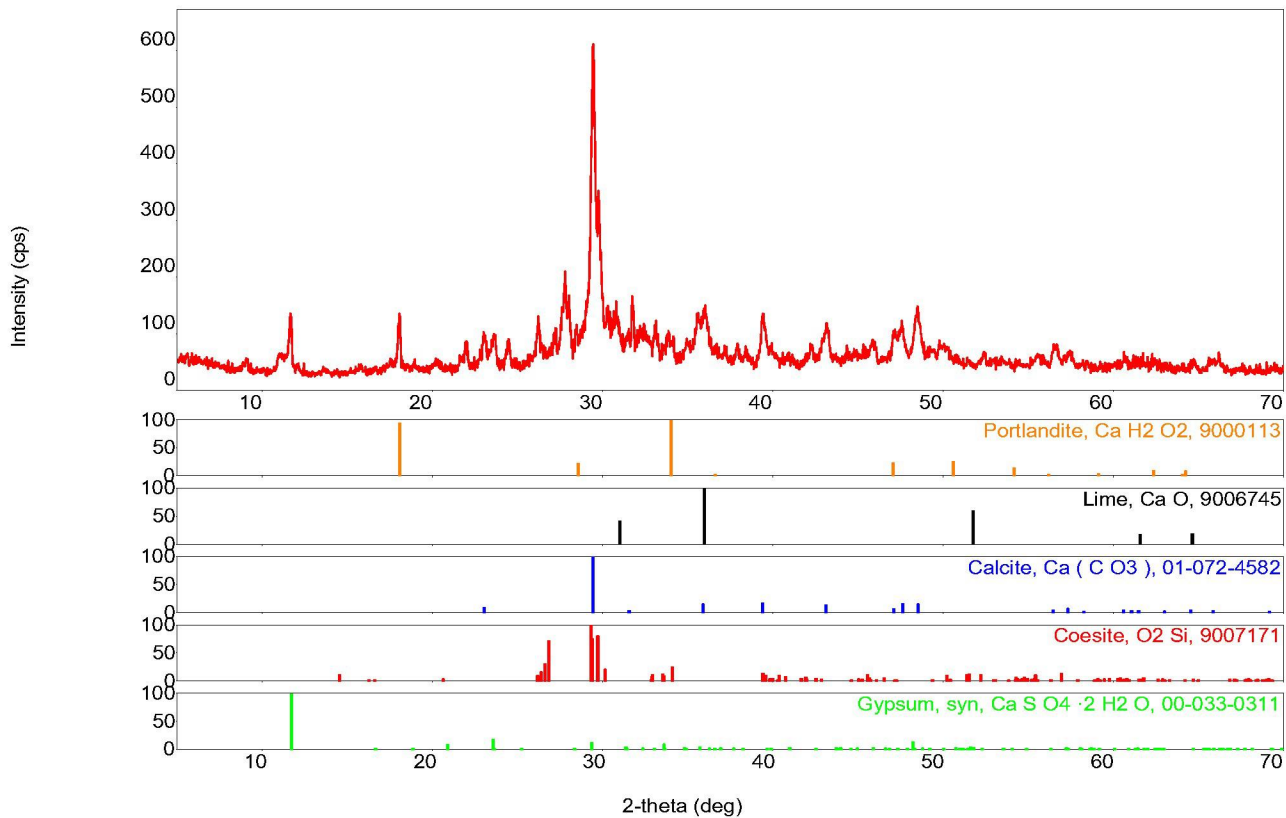
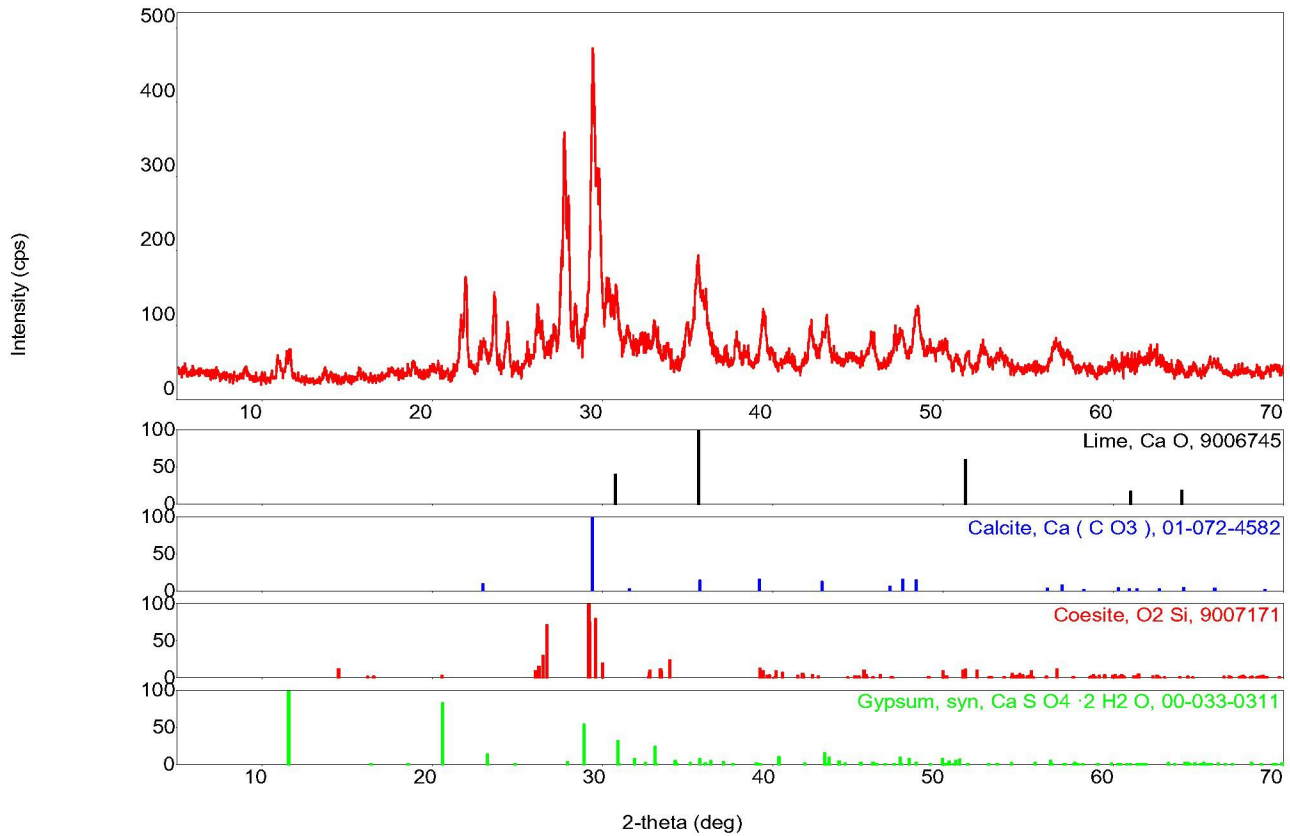
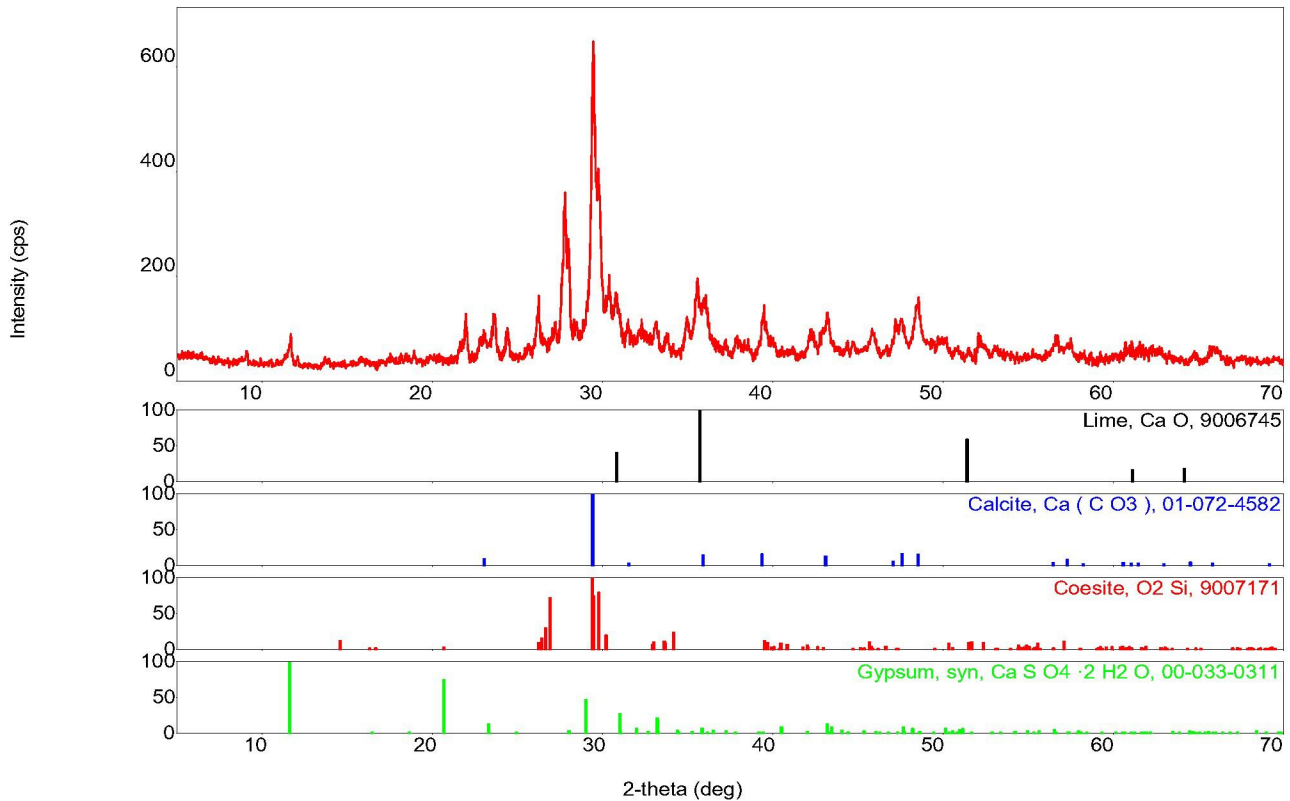
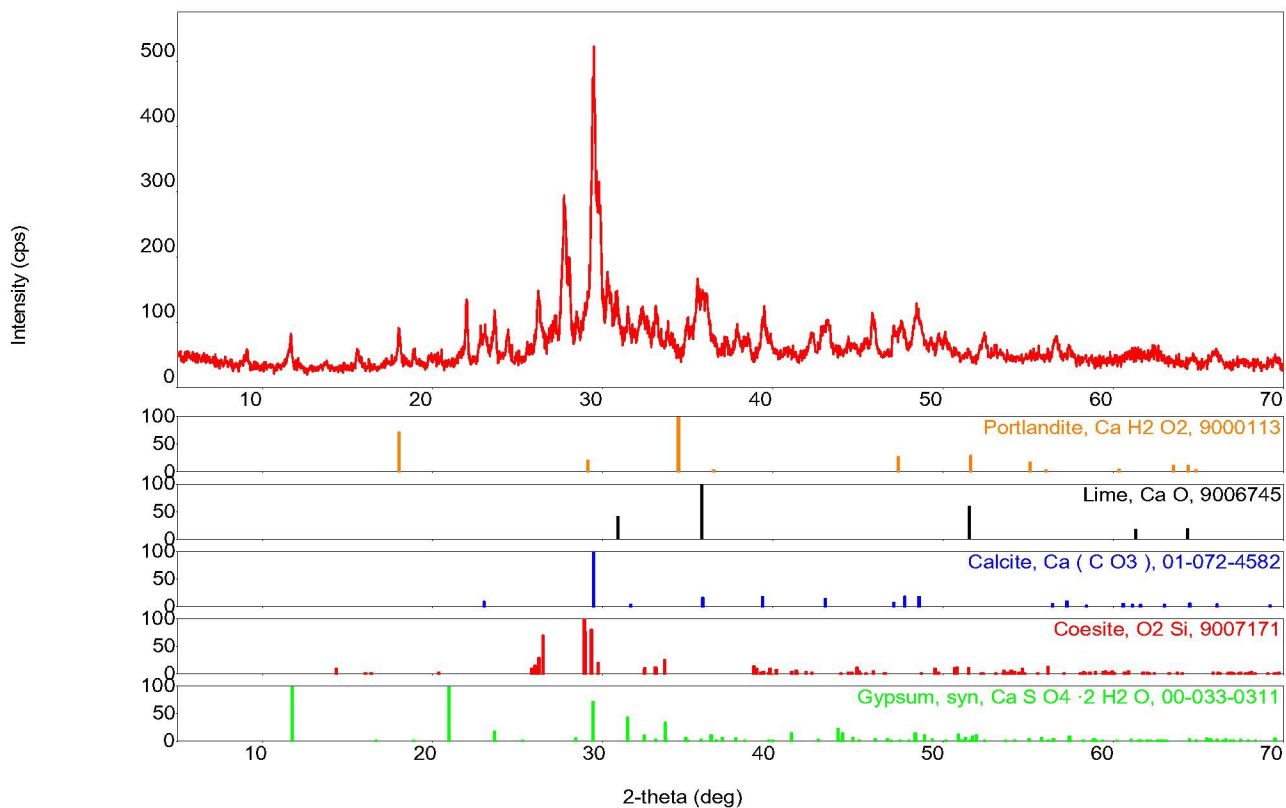
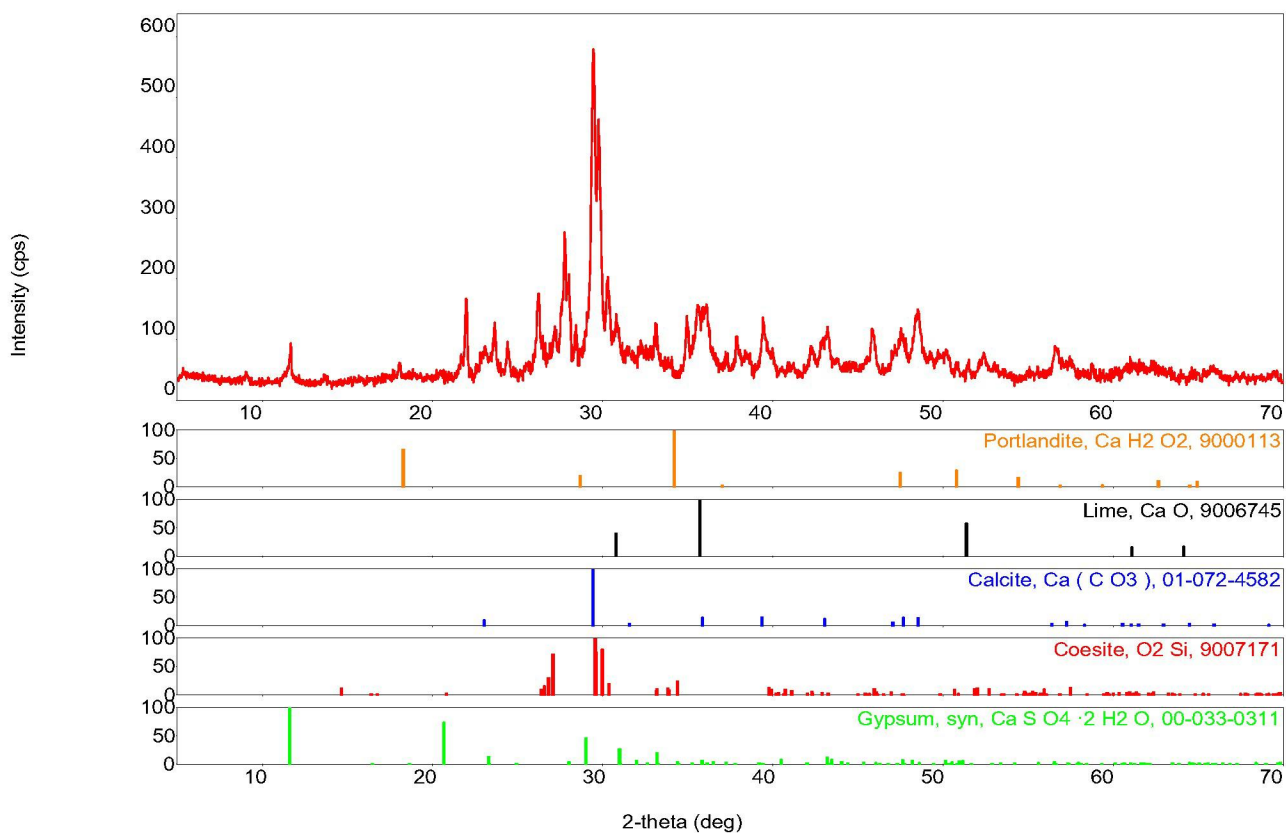
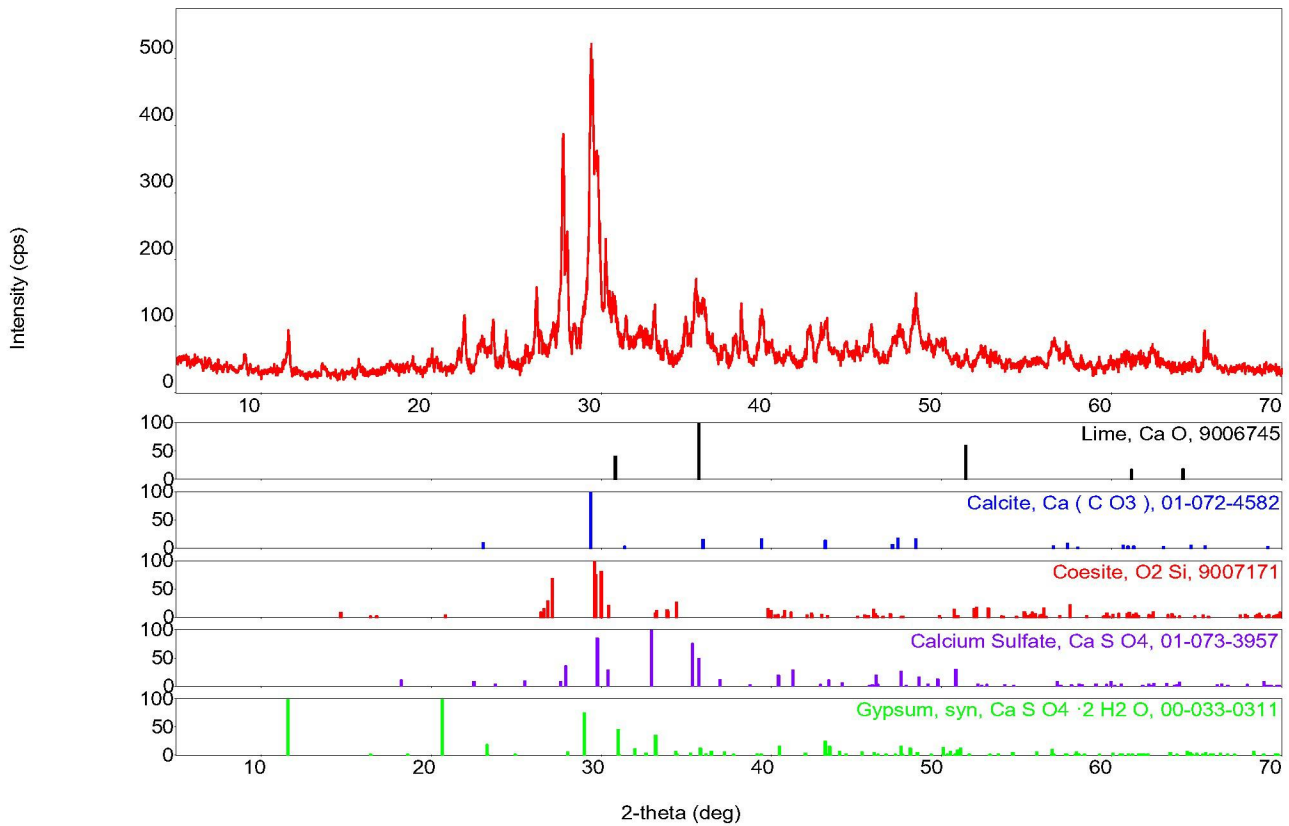
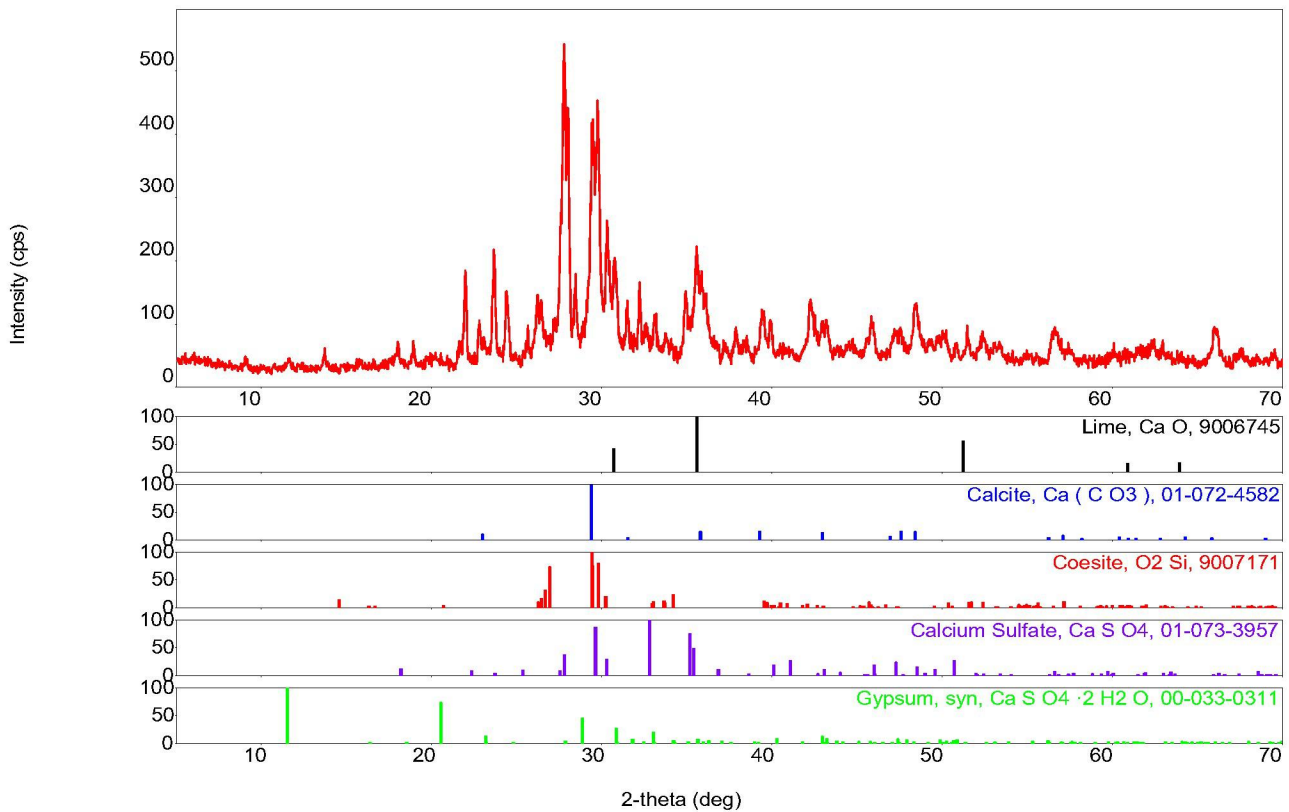
X-Ray Diffraction Spectroscopy (XRD) analysis of the concrete samples revealed the presence of the following crystalline phases: calcium oxide (lime); calcium carbonate (calcite); silicon dioxide (coesite); calcium sulfate; calcium sulfate hydrated (gypsum) and calcium hydroxide (portlandite). The results are summarized in Tables 17 and 18. The XRD diffractograms for the concrete samples are provided as Figures 113 through 122.

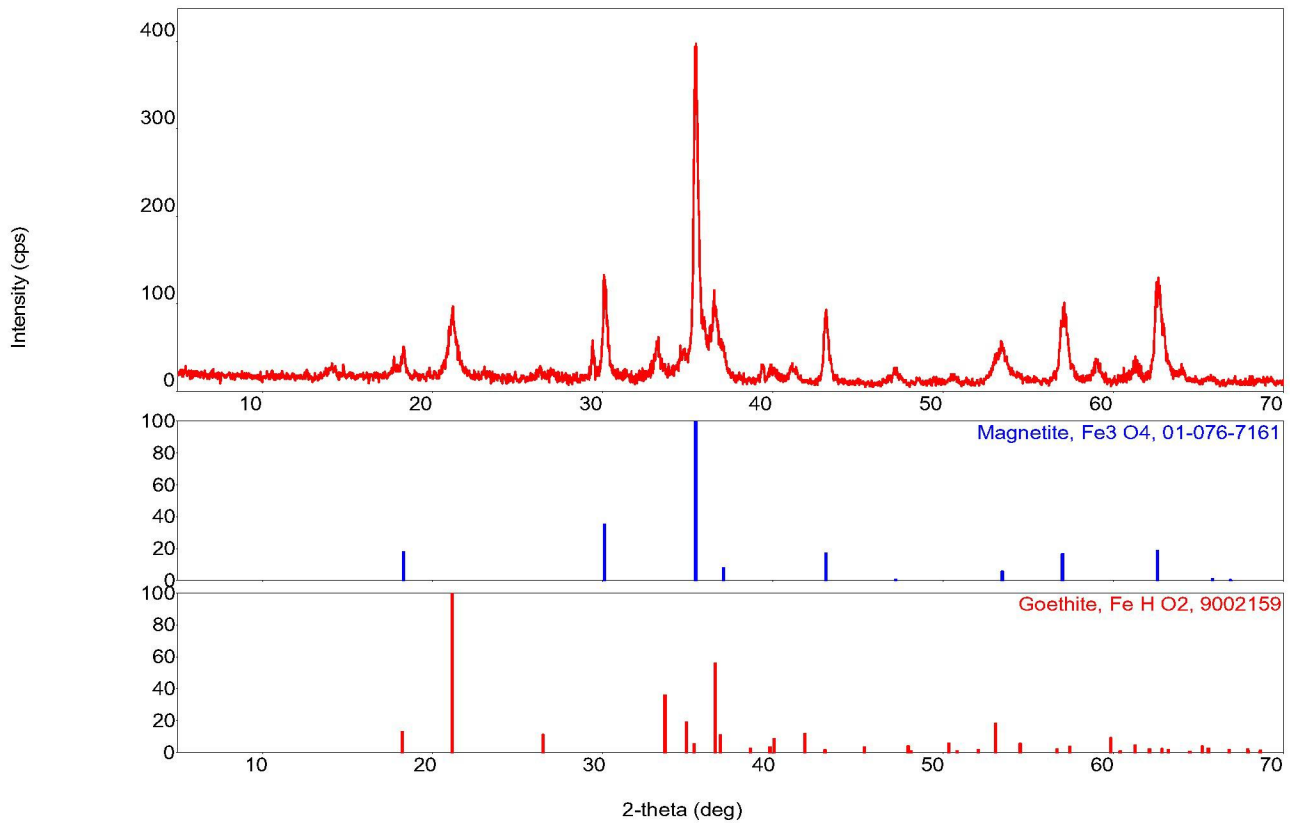
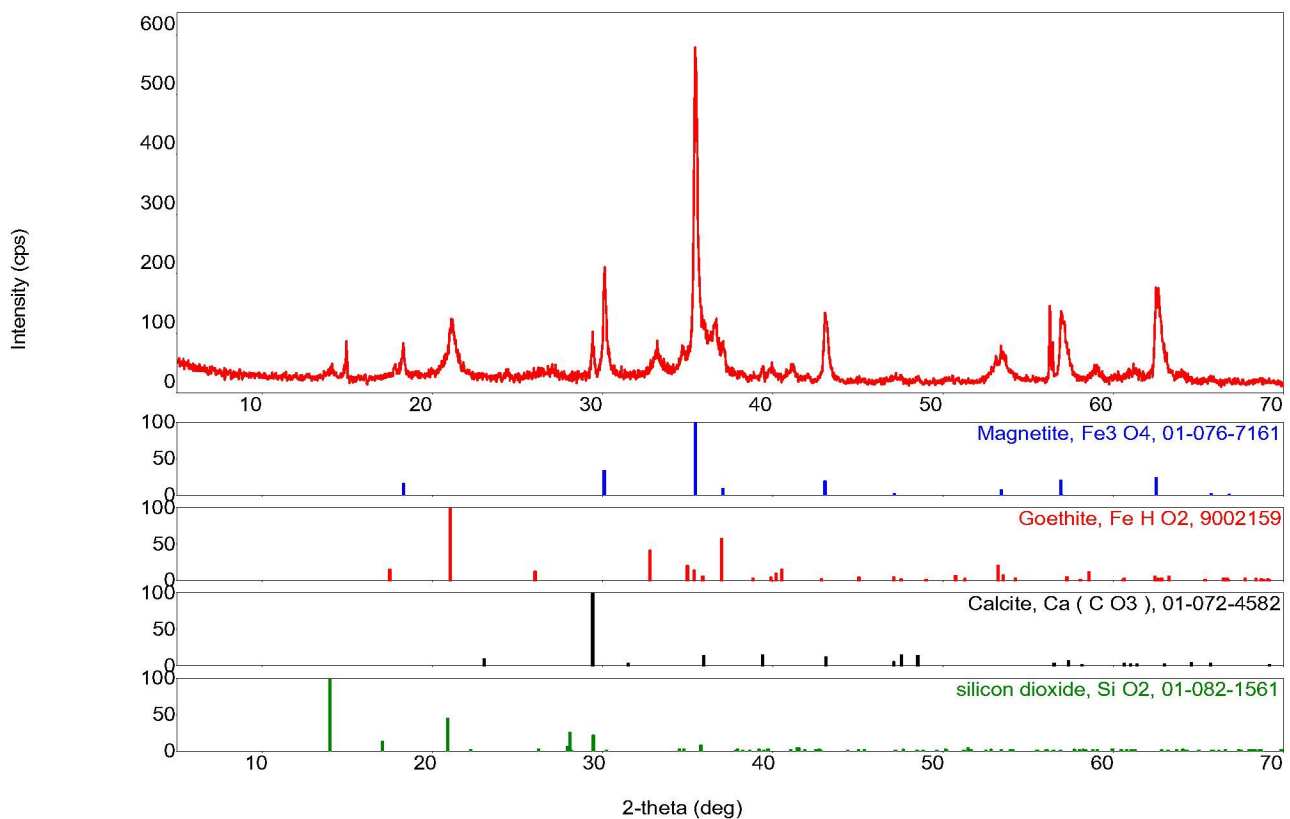
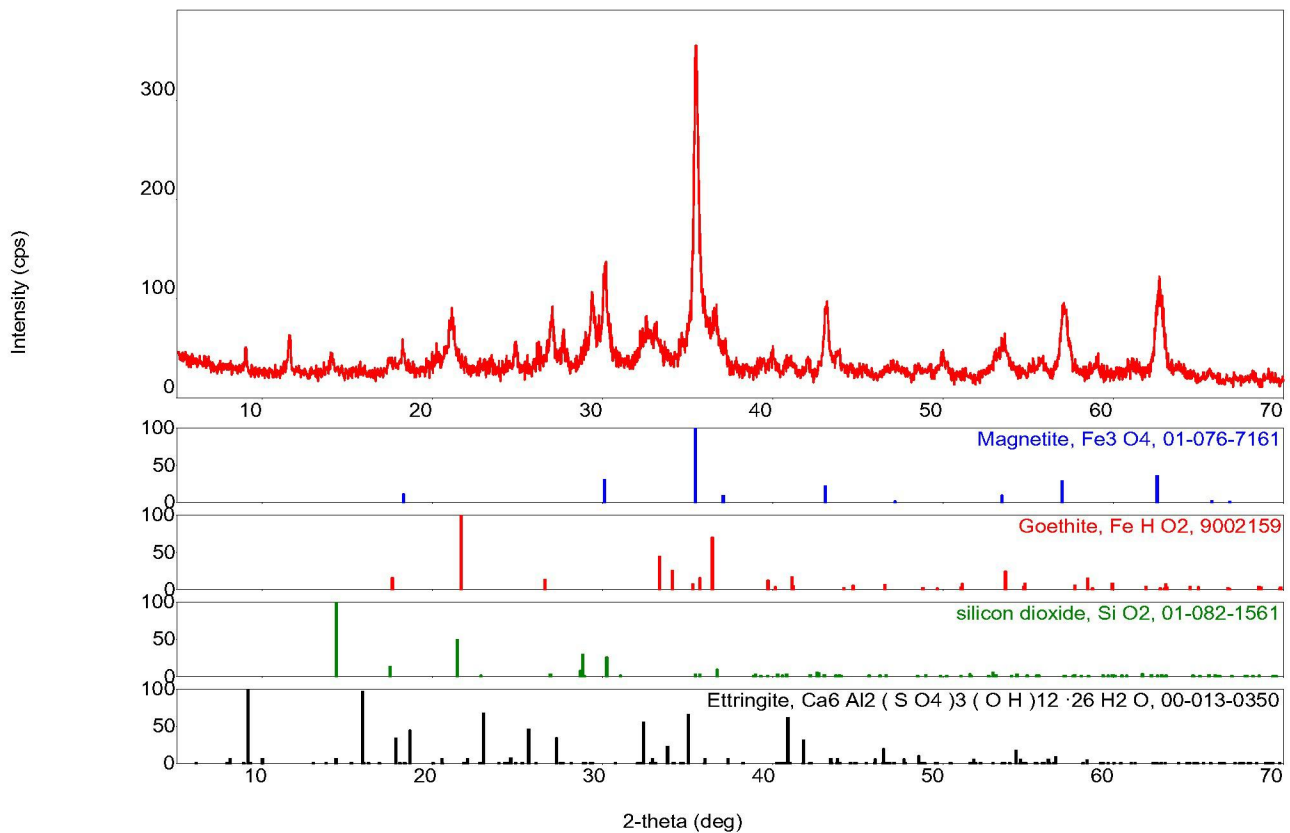
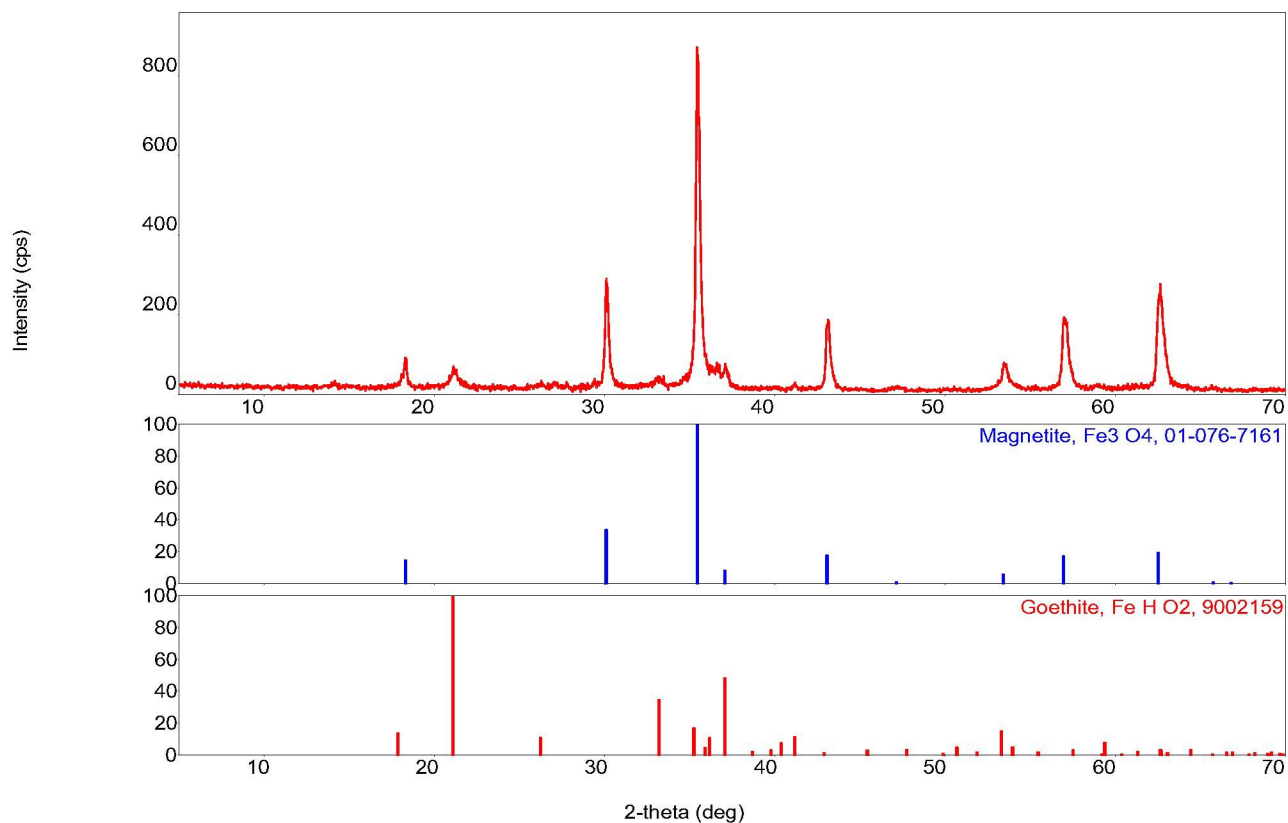
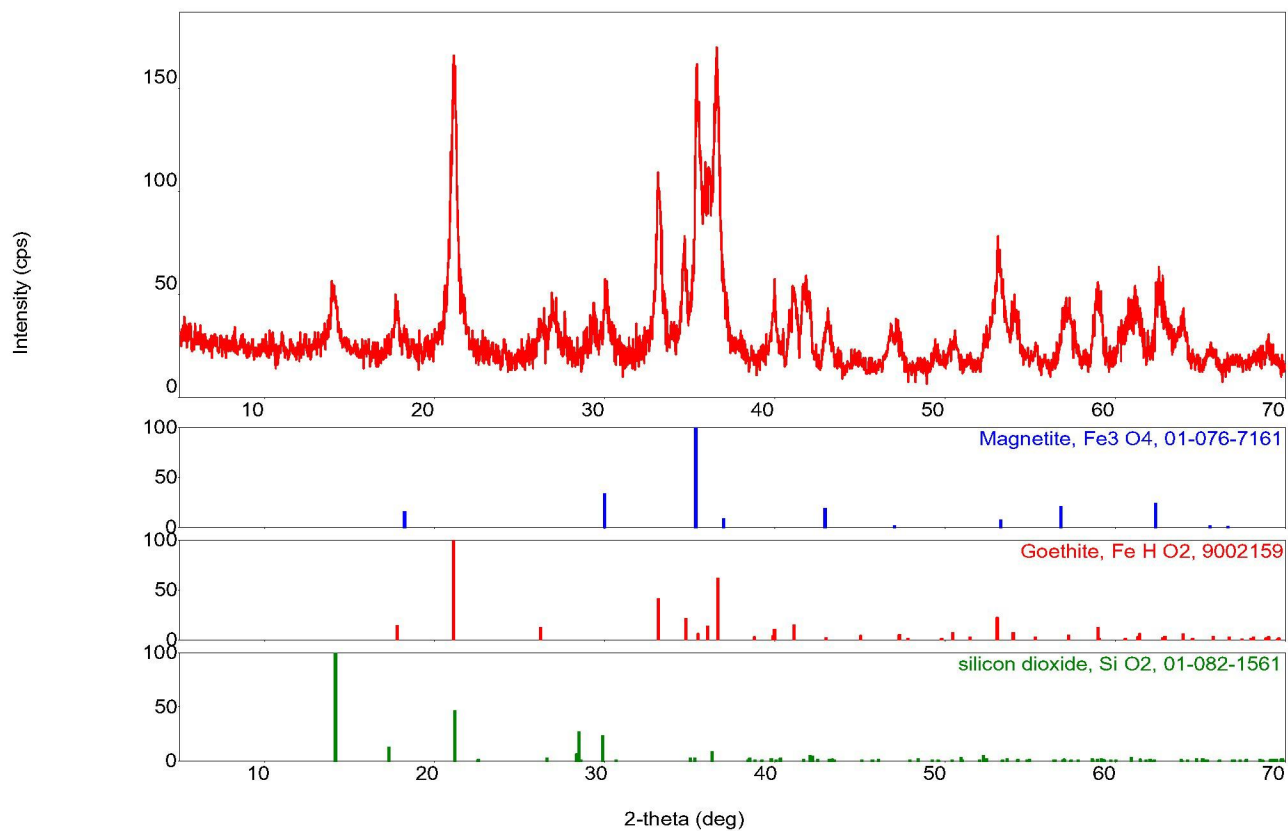
X-Ray Diffraction Spectroscopy (XRD) analysis of the corrosion product from the metal panels revealed the presence of the following crystalline phases: iron oxide (magnetite); iron hydroxide (goethite); calcium carbonate (calcite); silicon dioxide and hydrous calcium aluminum sulfate (ettringite). The results are summarized in Tables 19 and 20. The XRD diffractograms for the corrosion samples are provided as Figures 123 through 128.

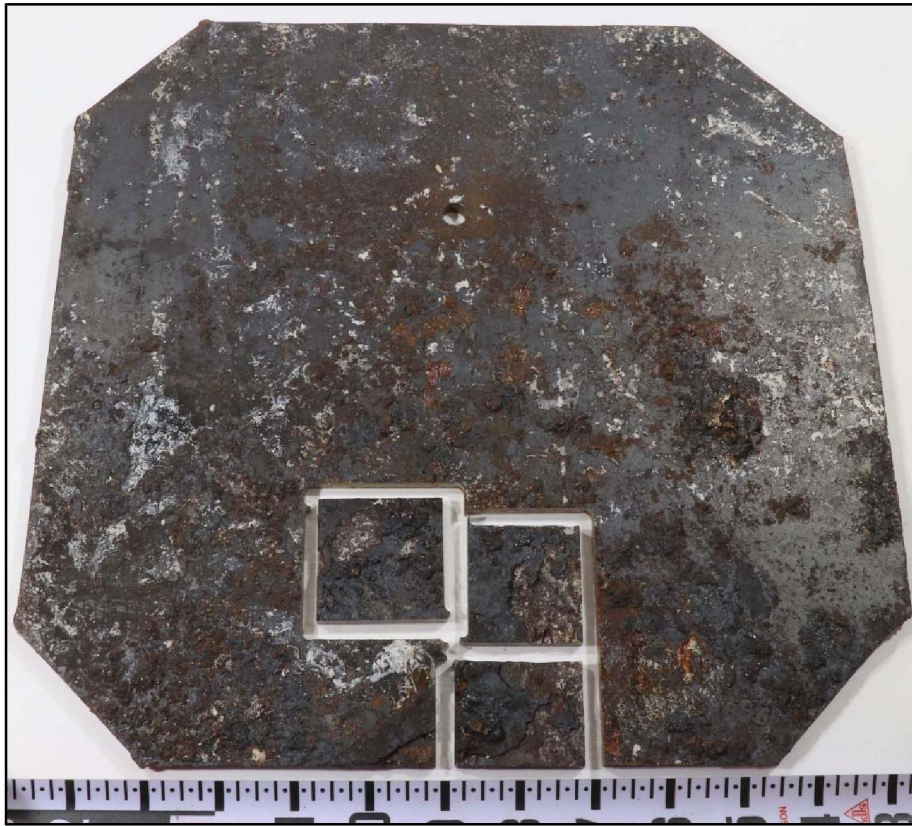
Figure 133. An image of the interior surface of Coupon 3 after CO₂ blast cleaning.

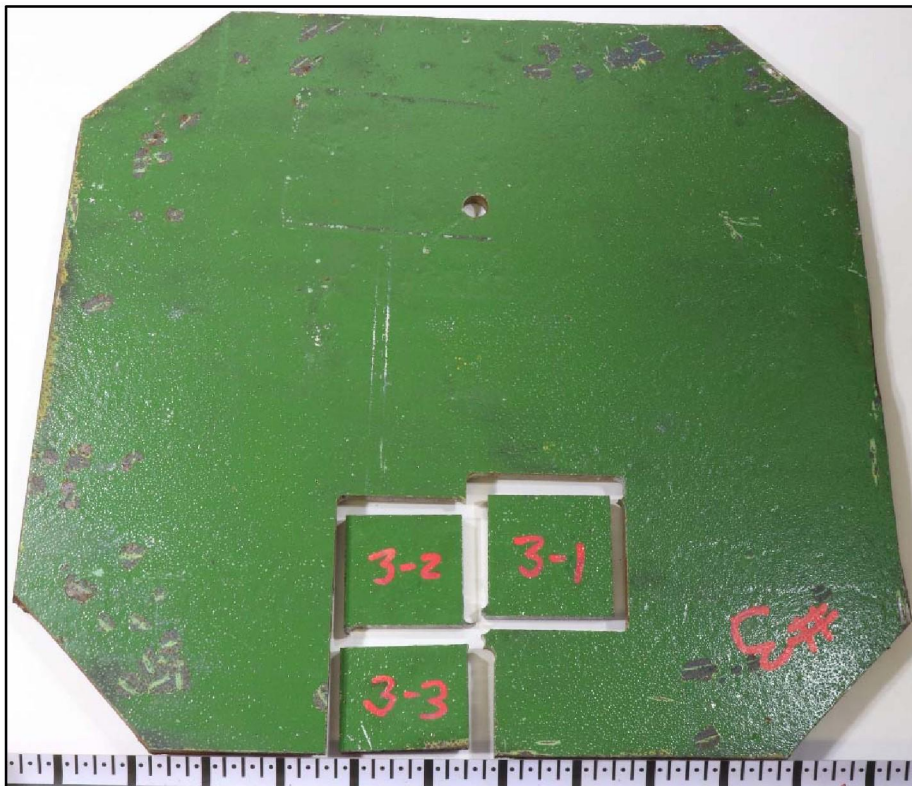
Figure 134. An image of the exterior surface of Coupon 3 after CO₂ blast cleaning.

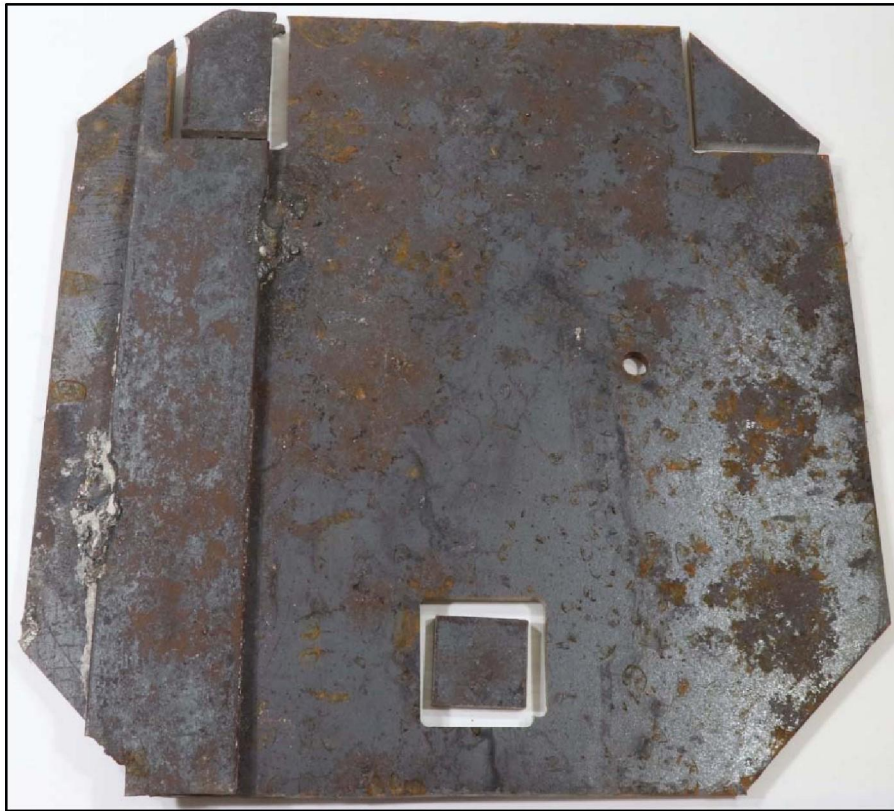
Figure 141. An image of the interior surface of Coupon 8 after CO₂ blast cleaning.

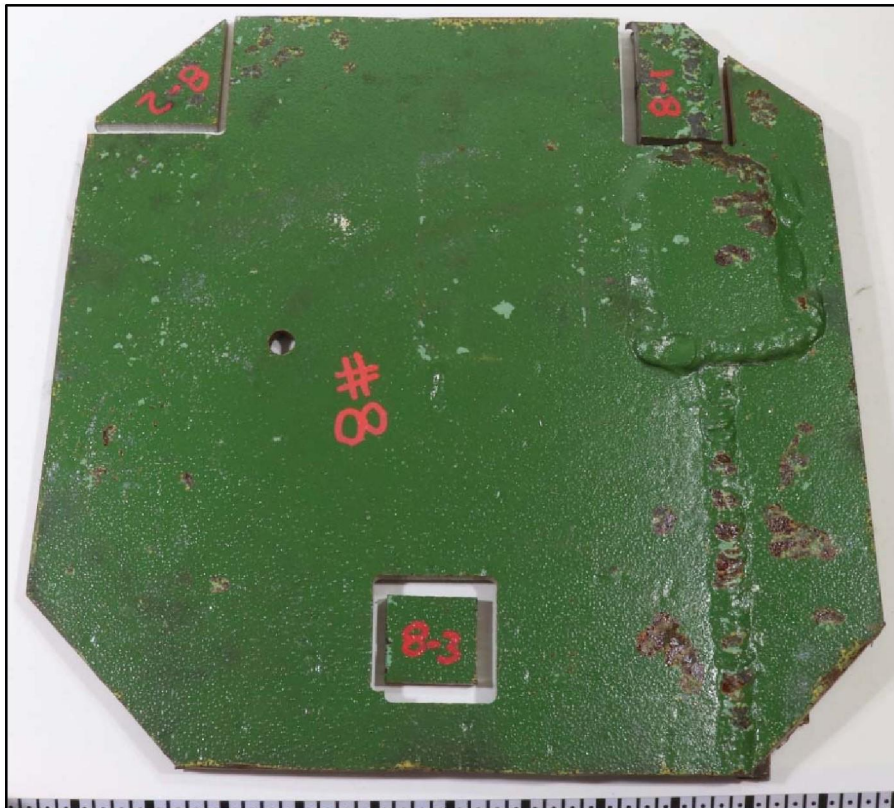
Figure 142. An image of the exterior surface of Coupon 8 after CO₂ blast cleaning.

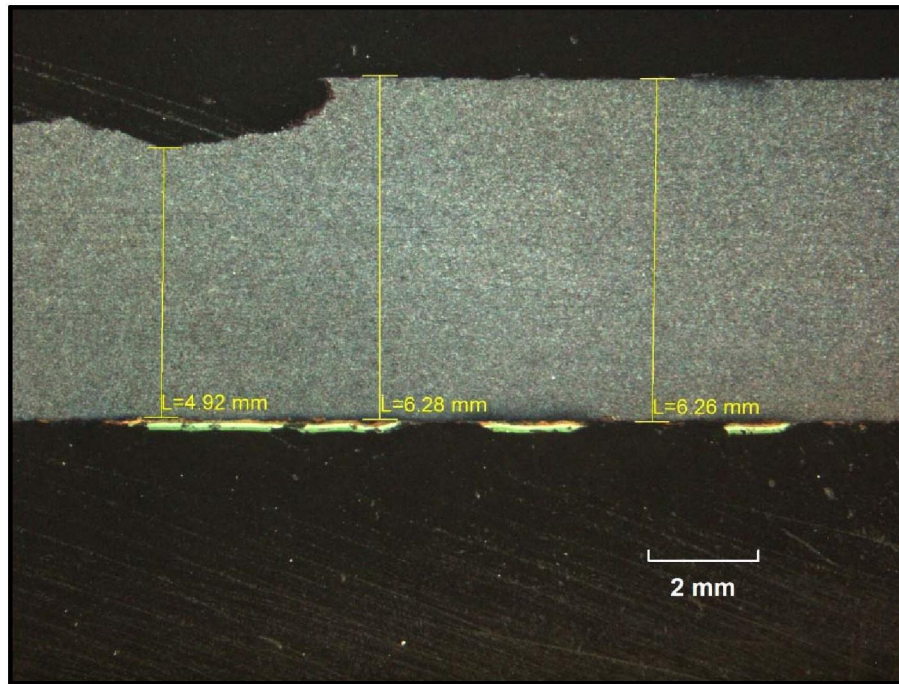
Figure 203. The prepared metallographic cross-section from Sample A1-1 is shown during examination with a stereomicroscope. The thickest location(s) are shown, as well as the thickness remaining underneath the deepest observed pit. (7X)

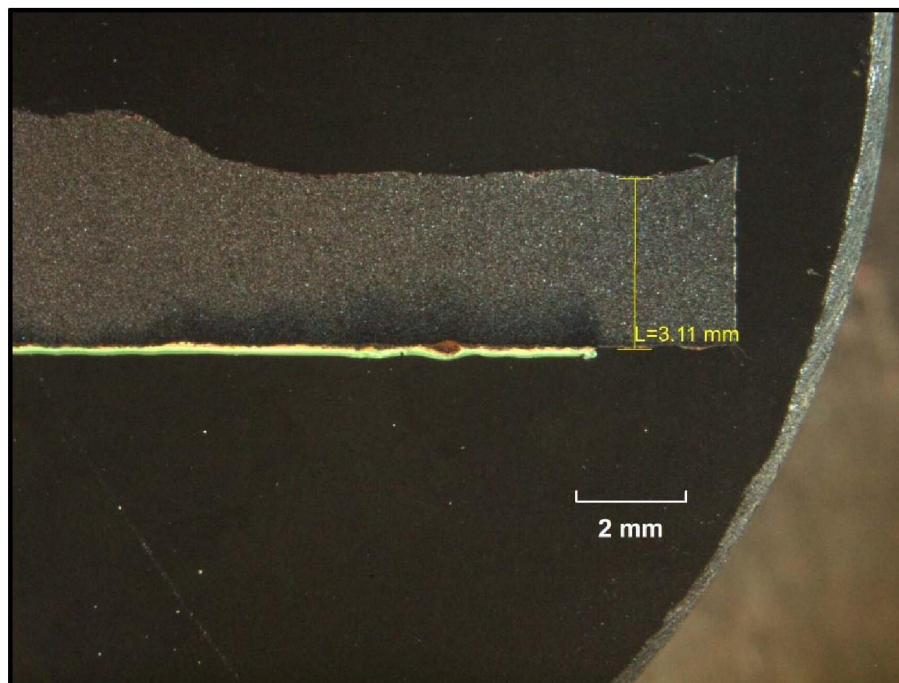
Figure 204. The prepared metallographic cross-section from Sample A1-4 is shown during examination with a stereomicroscope. The thickness remaining underneath the deepest observed pit is shown. (7X)

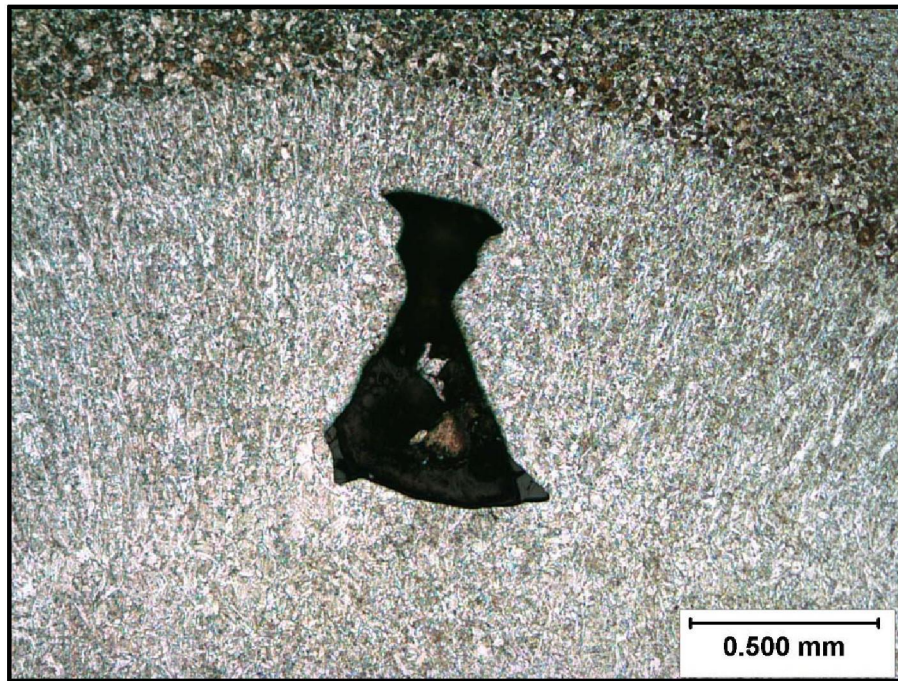
Figure 213. The one of the voids is shown at higher magnification. (2% Nital Etch, 50X)

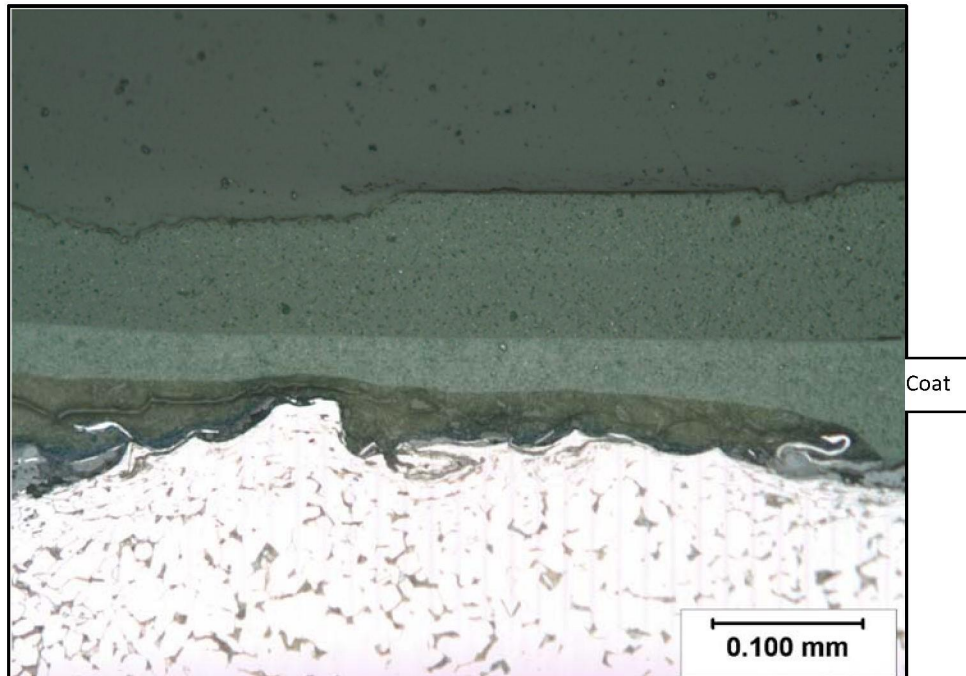
A typical paint layer was examined microscopically and was determined to consist of two layers, as shown in Figure 214. This indicates that the exterior tank wall exhibits a primer layer with a top coat. The scraped paint samples that were excised from each coupon previously for FTIR analysis would likely have captured some of both layers. The FTIR results presented previously were a good match for polyurethane, with no observable secondary component. Although this indicates that both the primer and top coat were polyurethane-based, it cannot be ruled out that the primer exhibited a different composition.

Figure 214. A typical paint layer is shown in cross-section, with key characteristics identified. (2% Nital Etch, 200X)

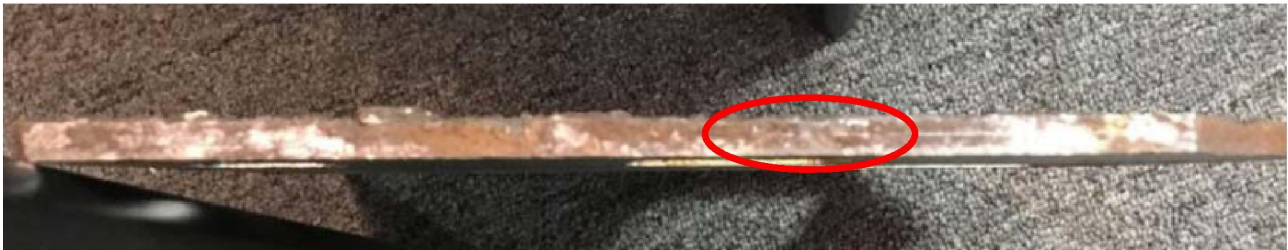
Figure A-2. The same edge of Coupon #7 is shown on 3/20/19 after laboratory testing by IMR and subsequent storage. The red circle corresponds to the same area shown in Figure A-1. Note that the left ~1/4 of the coupon was consumed for mechanical testing, etc., but the area-of-concern remained intact.

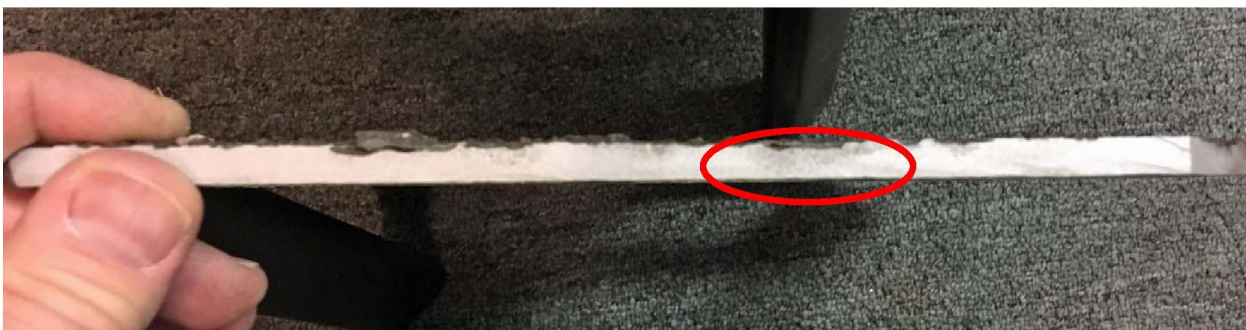
Figure A-3. The same area is shown after sandblasting on 3/20/19. A slight shadowing was observed in the area-of-concern, but no corrosion product was noted.
