SUBJECT: ADMINISTRATIVE ORDER ON CONSENT (AOC) STATEMENT OF WORK (SOW) SECTION 5 CORROSION AND METAL FATIGUE PRACTICES, DESTRUCTIVE TESTING RESULTS REPORT, RED HILL BULK FUEL STORAGE FACILITY (RED HILL), JOINT BASE PEARL HARBOR-HICKAM, OAHU, HAWAII

In 2018, ten coupons were removed from Tank 14, so that a metallurgical and corrosion analysis of the coupons could be undertaken, with the primary aim of validating non-destructive examination (NDE) results. The steel coupons, concrete powder samples, and corrosion product were submitted to a certified third-party laboratory to perform this analysis.

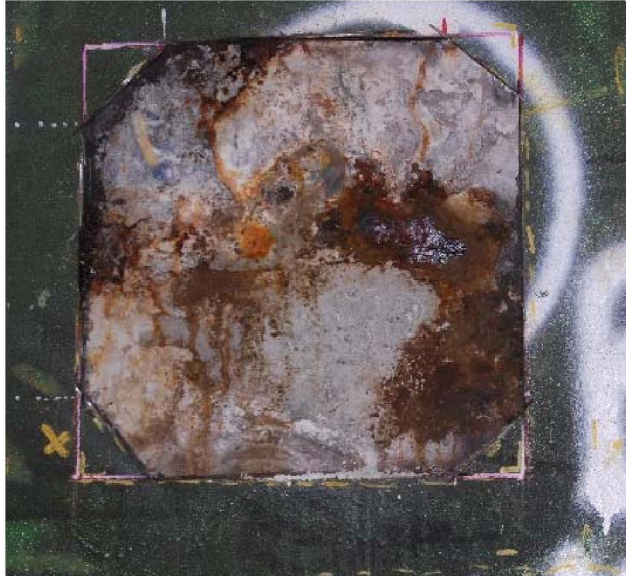
Checks	Observations	
	Exterior	Units
Void space between concrete and liner (if any)	On left side, uneven corrosion product and a 1/16-inch void. Otherwise, no voids.	
Biological Materials	None	
Wet or Dry	Mostly dry, with some damp spots	
Smell	None	
Temperature	79.3	F
Surface pH	11-12 dry areas, 7-8 in areas with corrosion product	
Structure to Electrolyte	-0.488	Volts/CSE
Concrete Resistivity	27.8 Horizontal 31.2 Vertical	K-Ohm-cm
General Condition	Good, with some corrosion products. Corrosion product was black on the left side, and brown in some other areas. Concrete was hard and difficult to drill for powder samples. Coupons required some hammering and prying to remove after cutting.

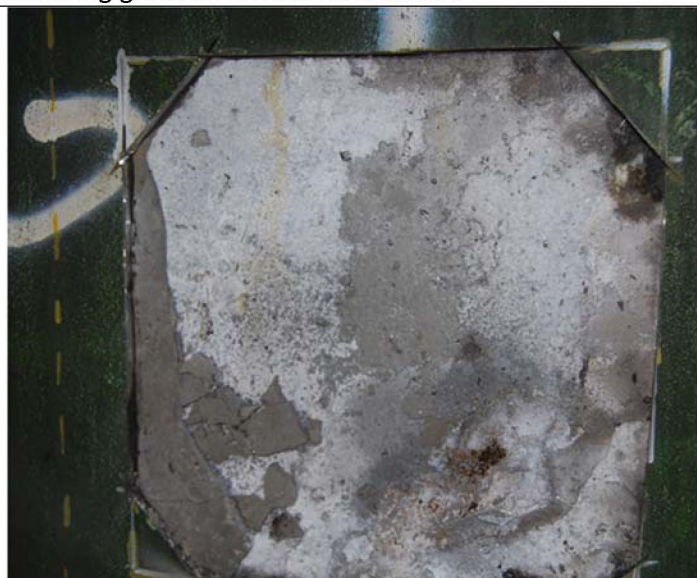
6/21/2018: 1030		
CONCRETE SAMPLE SPECIFICS		
Sample ID	7	7
Sample Location	14-BA-23-7-38-49	
Sample Dimensions	12X12 INCHES	
ON SITE VISUAL EXAMINATION		
Checks	Observations	
	Exterior	Units
Void space between concrete and liner (if any)	3/8" void on left side. 1/16" void on top right otherwise no voids	
Biological Materials	None	
Wet or Dry		
Smell	none	
Temperature	77.5F	F
Surface pH	9- 10	
Structure to Electrolyte		Volts/CSE
Concrete Resistivity	Horizontal = 39.3 Vertical = 42.4	k-ohm-cm k-ohm-cm
General Condition	Concrete is sound with no delamination or cracks. Some brown and black corrosion products on concrete

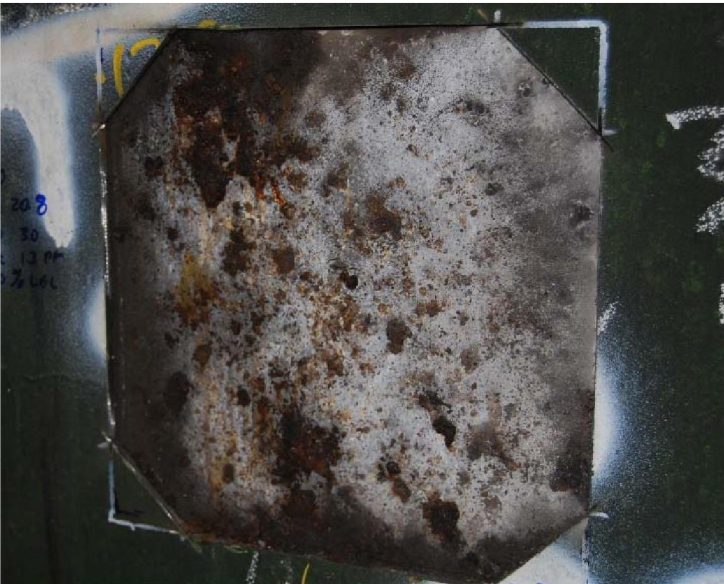
6/20/2018: 1400		
CONCRETE SAMPLE SPECIFICS		
Sample ID	8	8
Sample Location	14-BA-20-13-23-4	
Sample Dimensions	12X12 INCHES	
ON SITE VISUAL EXAMINATION		
Checks	Observations	
	Exterior	Units
Void space between concrete and liner (if any)	1/16" Void on left side, no voids in all other areas	
Biological Materials	None	
Wet or Dry	Dry	
Smell	None	
Temperature	80.0	F
Surface pH	11-12	
Structure to Electrolyte	-0.248	Volts/CSE
Concrete Resistivity	30.9 Horizontal 27.5 Vertical	k-ohm-cm k-ohm-cm
General Condition	Excellent, sound concrete with no cracks or delamination. Coupon had steel backing plate

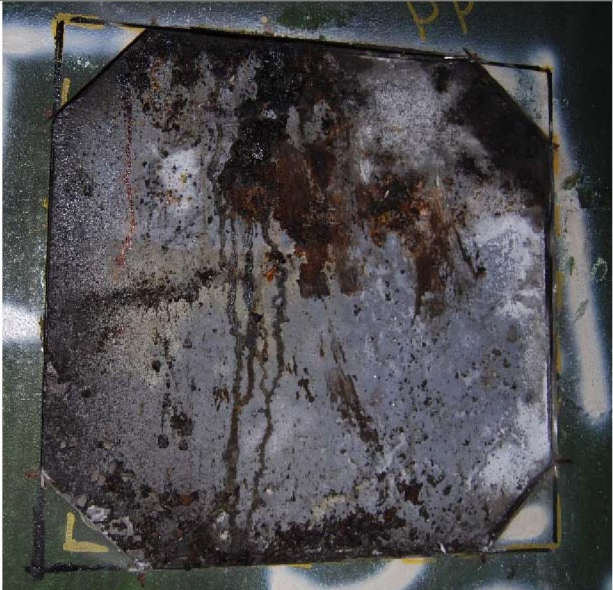
6/20/2018: 1530		
CONCRETE SAMPLE SPECIFICS		
Sample ID	A2	A2
Sample Location	14-BA-11-4-226-50	
Sample Dimensions	12X12 INCHES	
ON SITE VISUAL EXAMINATION		
Checks	Observations	
	Exterior	Units
Void space between concrete and liner (if any)	1/2" Void on left and bottom side. 1/4"void on the right side	
Biological Materials	None	
Wet or Dry	Dry	
Smell	None	
Temperature	78.4	F
Surface pH	11-12	
Structure to Electrolyte	-0.226 (middle) -0.230 (right side)	Volts/CSE
Concrete Resistivity	35.8 Horizontal 36.1 Vertical	k-ohm-cm
General Condition	Good condition with sound concrete, no cracks or delamination. There is a layer of concrete which appears to have come off. Below that layer is sound concrete.	
Provide photo documentation with a minimum resolution of 2560 x 1920 of the coupon, front and back.
