**SUBJECT: DESTRUCTIVE ANALYSIS OF 10 STEEL COUPONS REMOVED FROM  
RED HILL FUEL STORAGE TANK NO. 14, PURSUANT TO SECTION 5.3  
OF THE ADMINISTRATIVE ORDER ON CONSENT STATEMENT OF  
WORK, RED HILL BULK FUEL STORAGE FACILITY, JOINT BASE PEARL  
HARBOR-HICKAM, OAHU, HAWAII**

## **Destructive Analysis of 10 Steel Coupons Removed from Red Hill Fuel Storage Tank #14**

**REPORT No. 201801967**

December 17, 2018

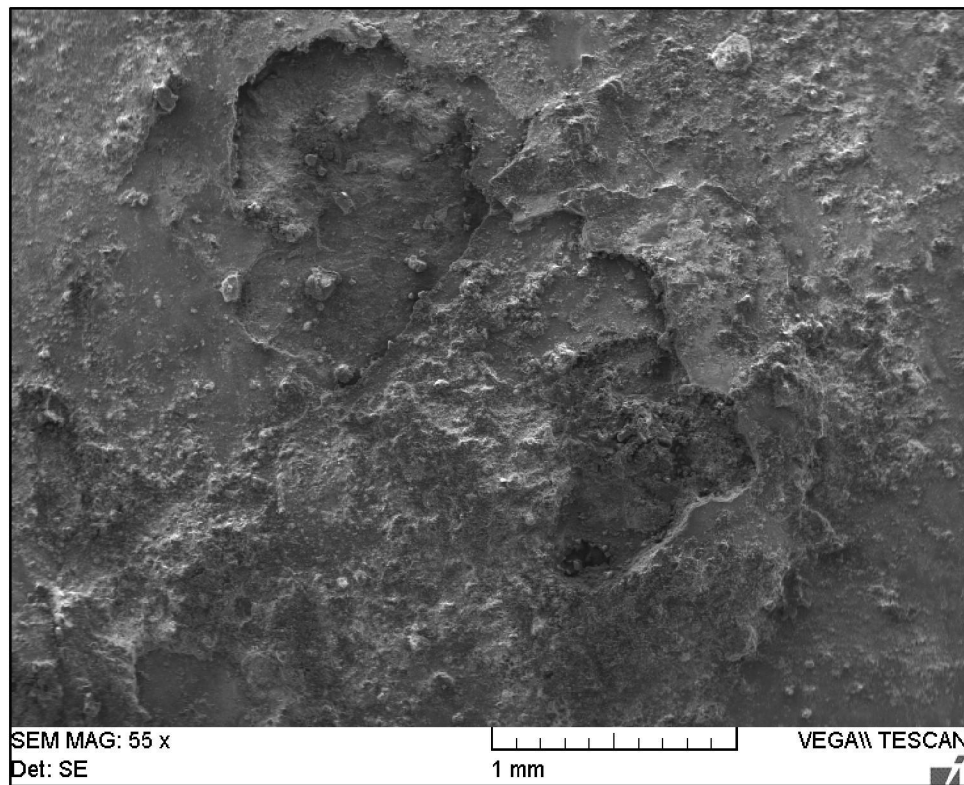
**Figure 41.** A representative SEM image of a pit on a specimen excised from Coupon 1 labeled as 1-1, prior to cleaning. (SEM, 32X)

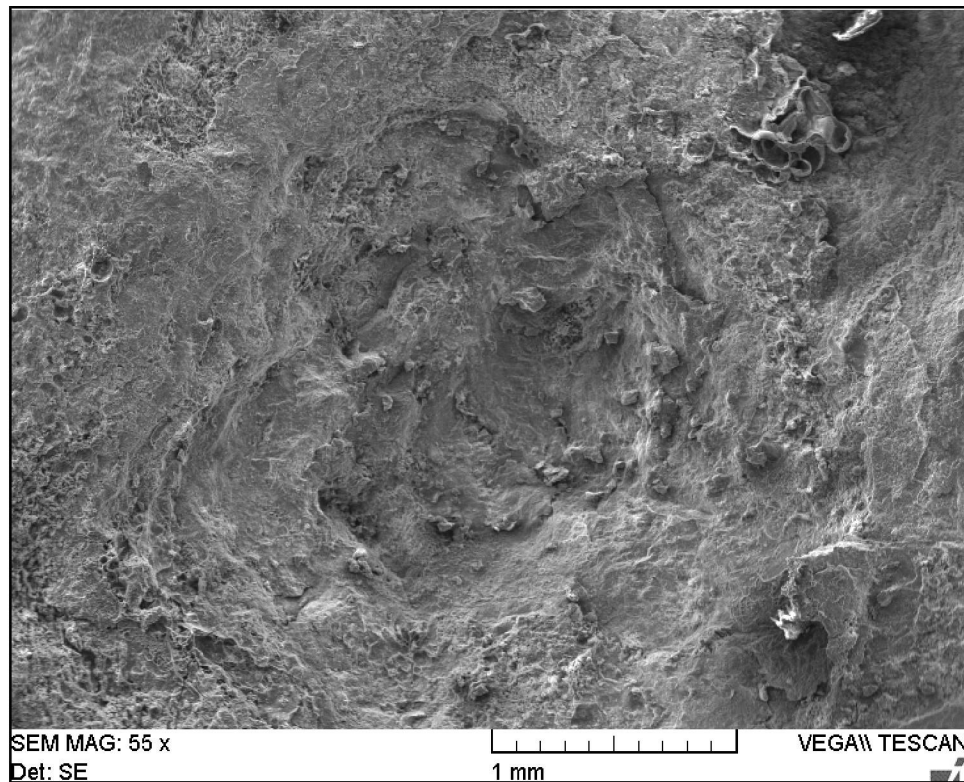
**Figure 42.** A representative SEM image of a pit on a specimen excised from Coupon 1 labeled as 1-2, prior to cleaning. (SEM, 32X)

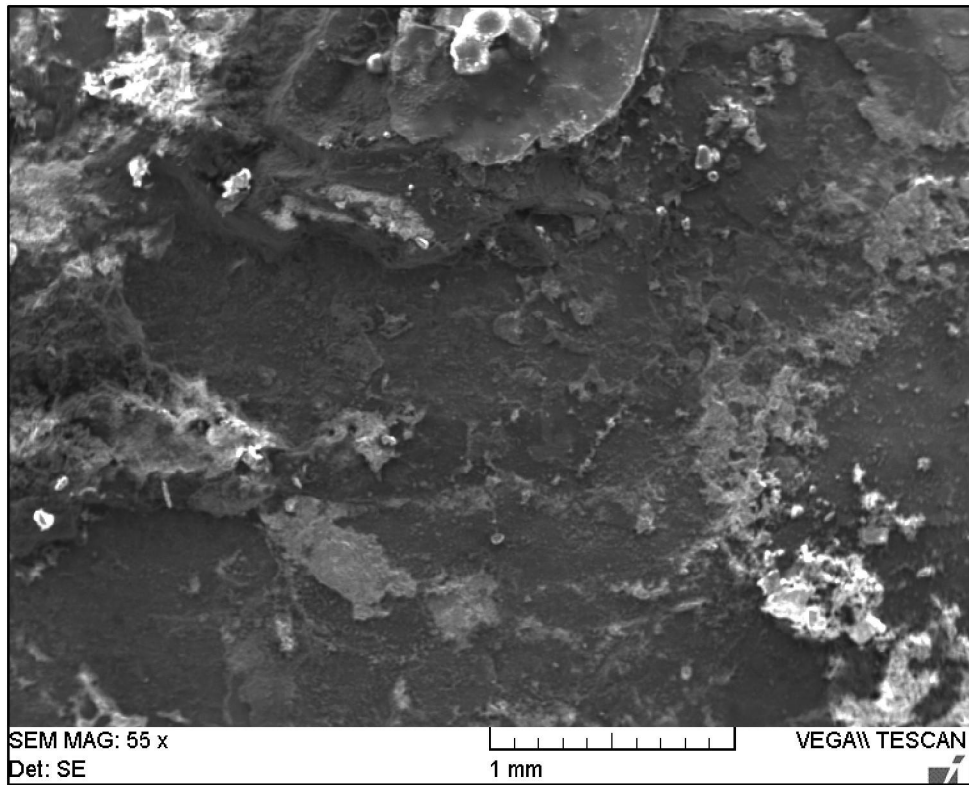
**Figure 47.** A representative SEM image of a pit on a specimen excised from Coupon 3 labeled as 3-1, prior to cleaning. (SEM, 32X)

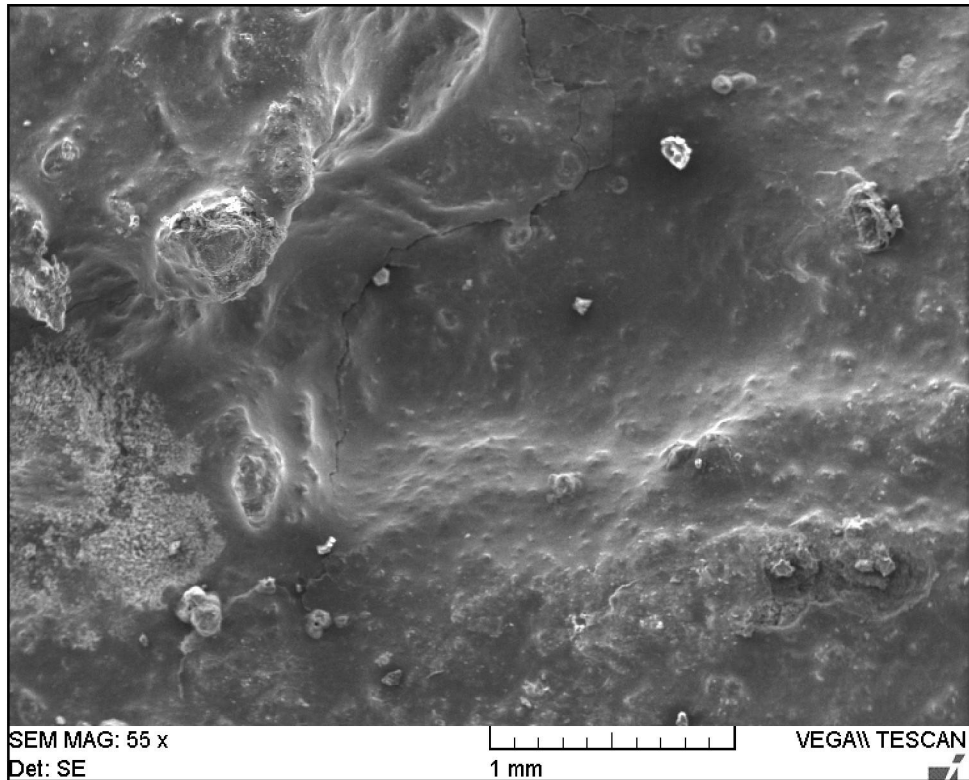
**Figure 48.** A representative SEM image of a pit on a specimen excised from Coupon 3 labeled as 3-2, prior to cleaning. (SEM, 32X)

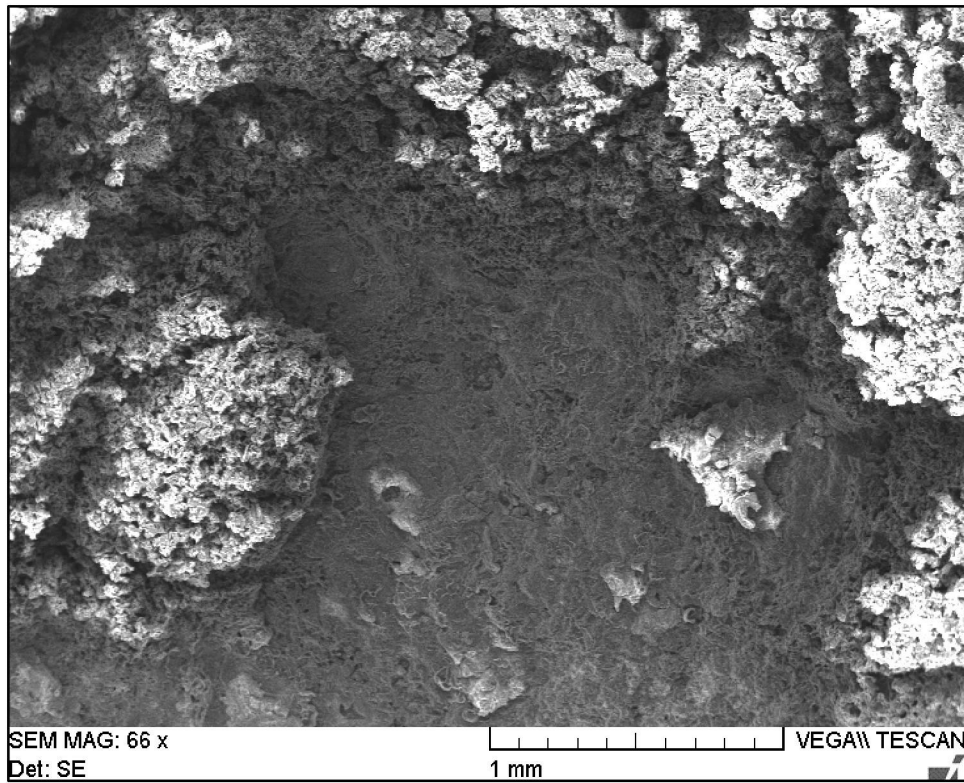
**Figure 49.** A representative SEM image of a pit on a specimen excised from Coupon 3 labeled as 3-3, prior to cleaning. (SEM, 39X)

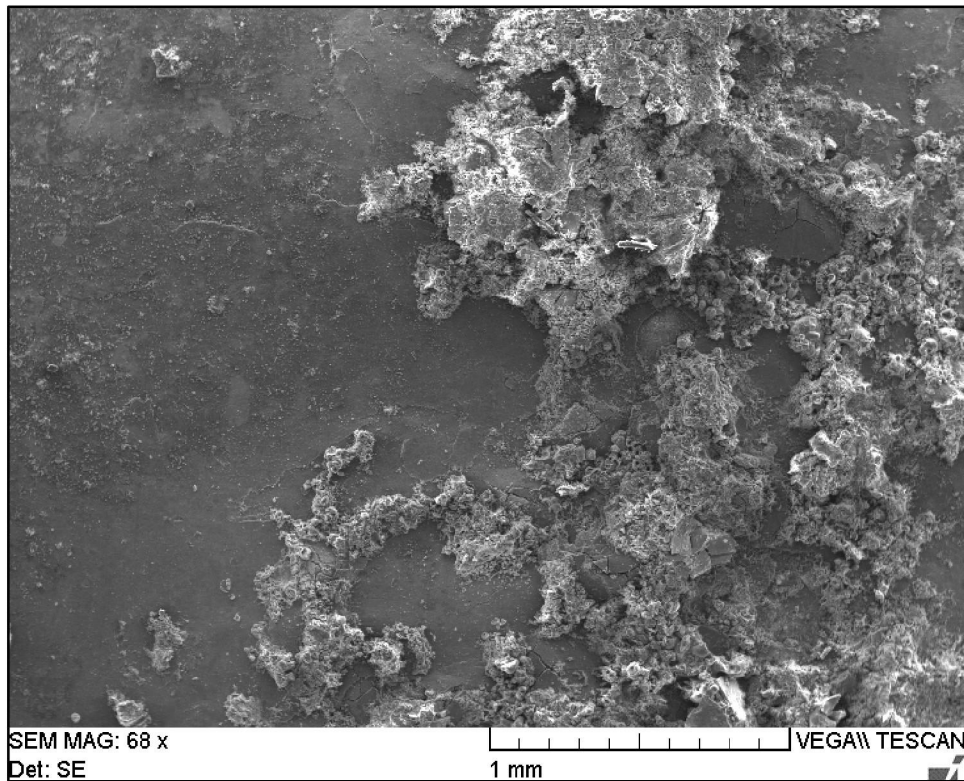
**Figure 50.** A representative SEM image of the specimen excised from Coupon 5 labeled as 5-1, prior to cleaning. No pits observed. (SEM, 40X)

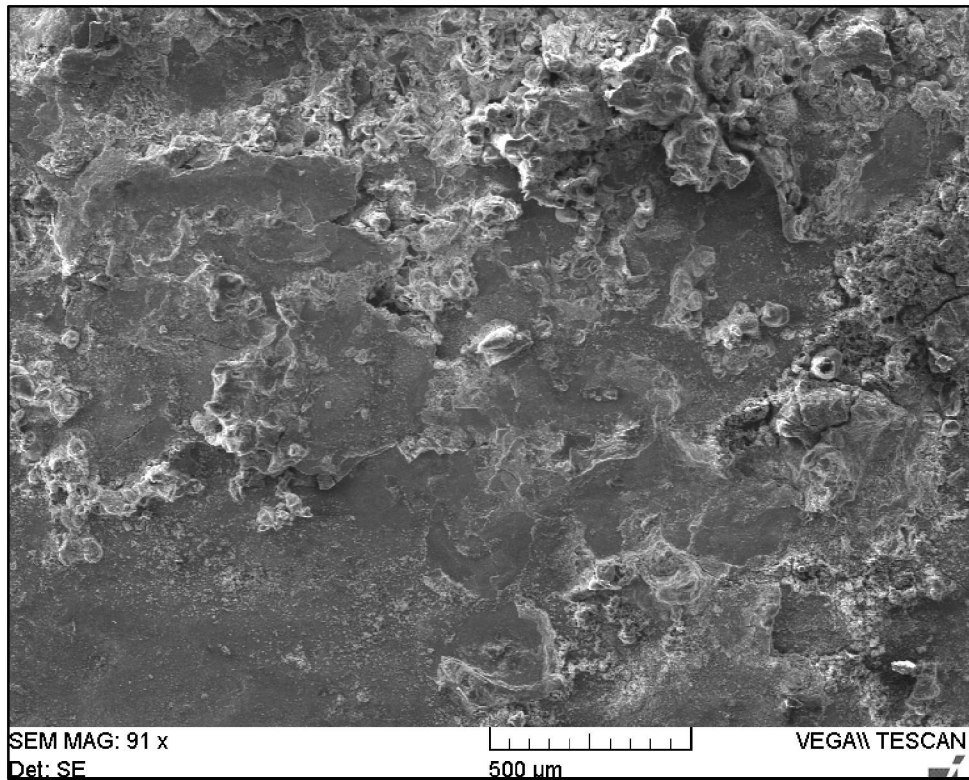
**Figure 59.** A representative SEM image of a pit on a specimen excised from Coupon 8 labeled as 8-1, prior to cleaning. (SEM, 53X)

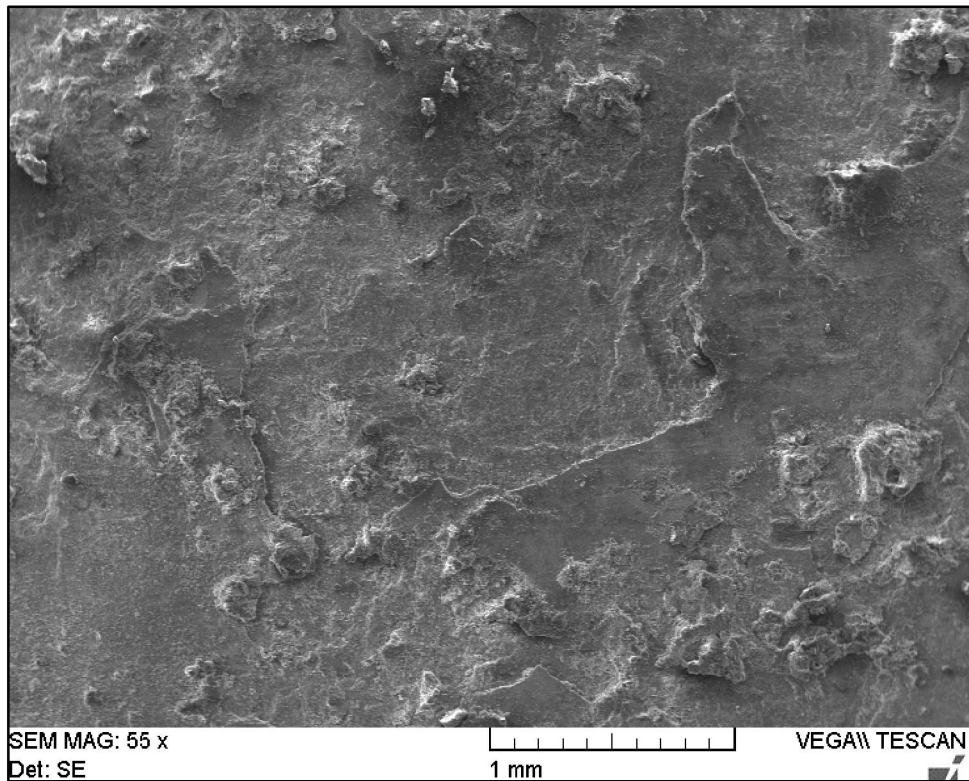
**Figure 60.** A representative SEM image of a pit on a specimen excised from Coupon 8 labeled as 8-2, prior to cleaning. (SEM, 33X)

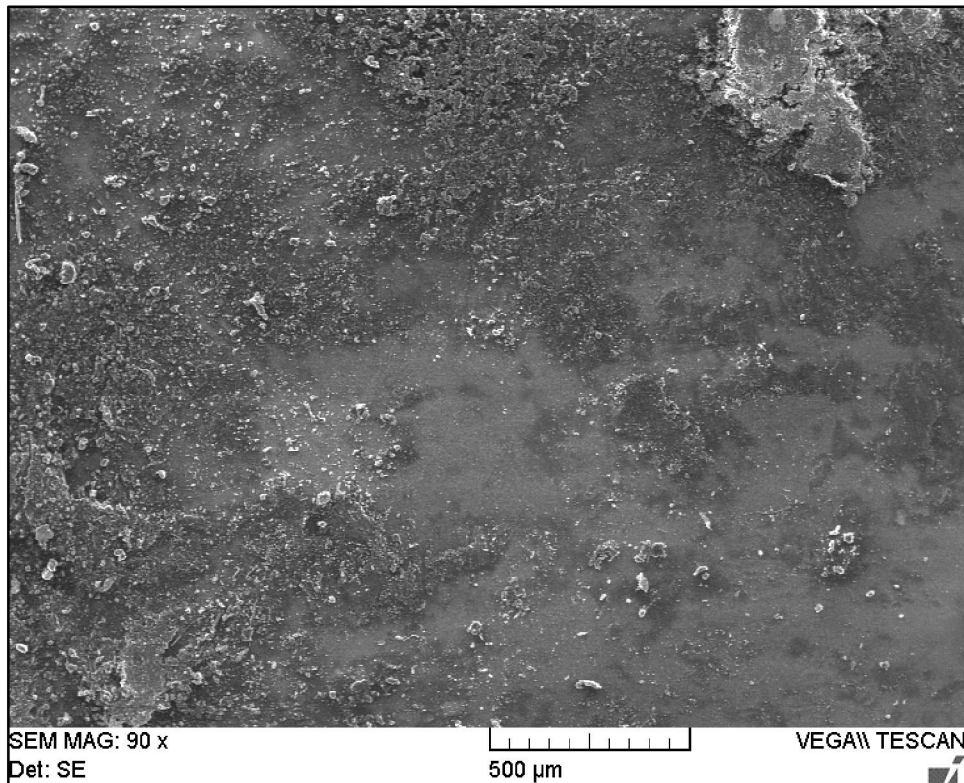
⑤ No pits observed. Suspected NDT inspection indication was a weld nugget on the interior surface of the coupon (thick area) on Sample 10-4.

**Figure 64.** A representative SEM image of the surface on a specimen excised from Coupon 10 labeled as 10-3, prior to cleaning. No pit was observed in this location. (SEM, 53X)

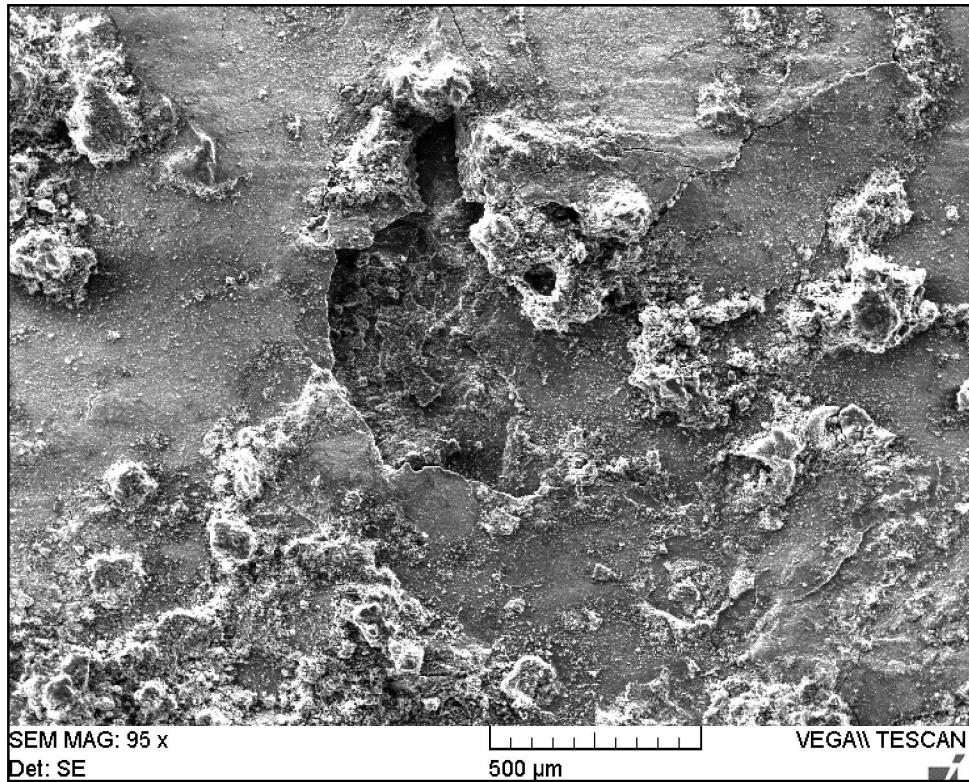
**Figure 68.** A representative SEM image of a pit on a specimen excised from Coupon A-2 labeled as A2-1, prior to cleaning. (SEM, 56X)

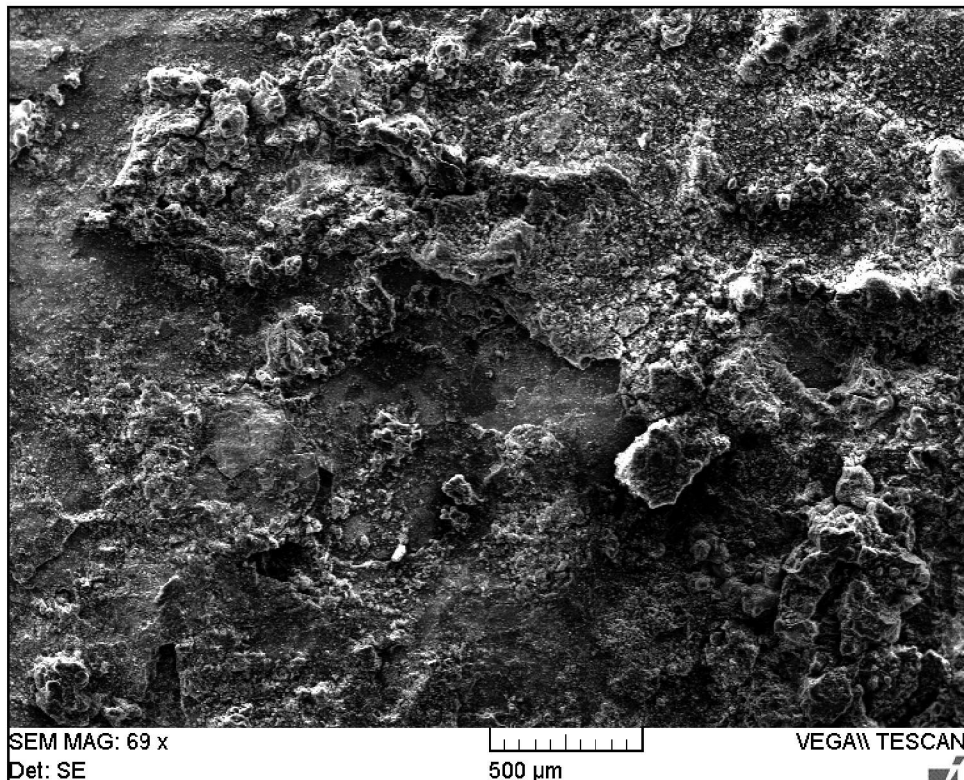
**Figure 70.** A representative SEM image of a possible pit on a specimen excised from Coupon A-2 labeled as A2-3, prior to cleaning. (SEM, 40X)

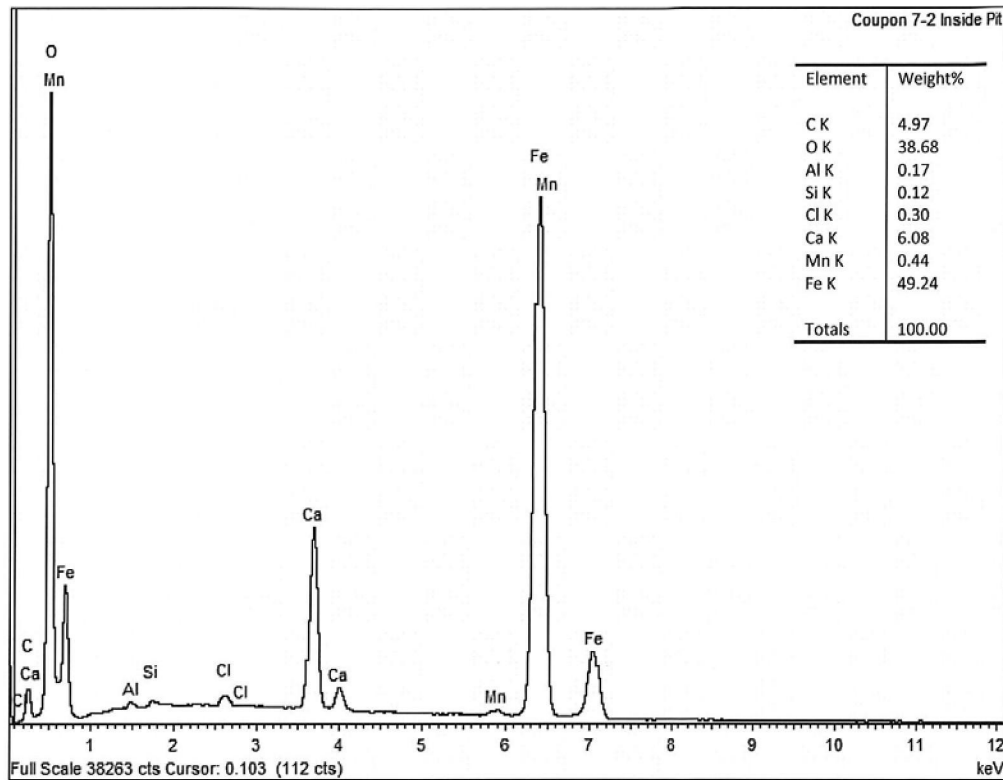
**Figure 87.** A representative EDS spectrum generated from of a pit on a specimen excised from Coupon 7 labeled as 7-2, prior to cleaning.

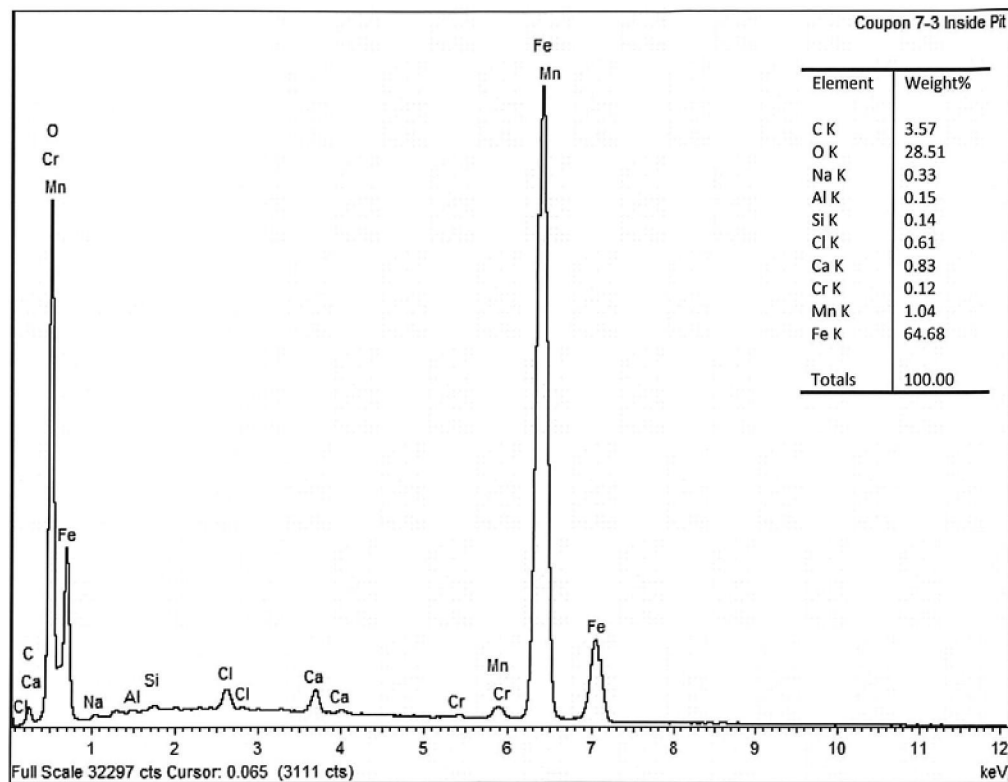
**Figure 88.** A representative EDS spectrum generated from of a pit on a specimen excised from Coupon 7 labeled as 7-3, prior to cleaning.

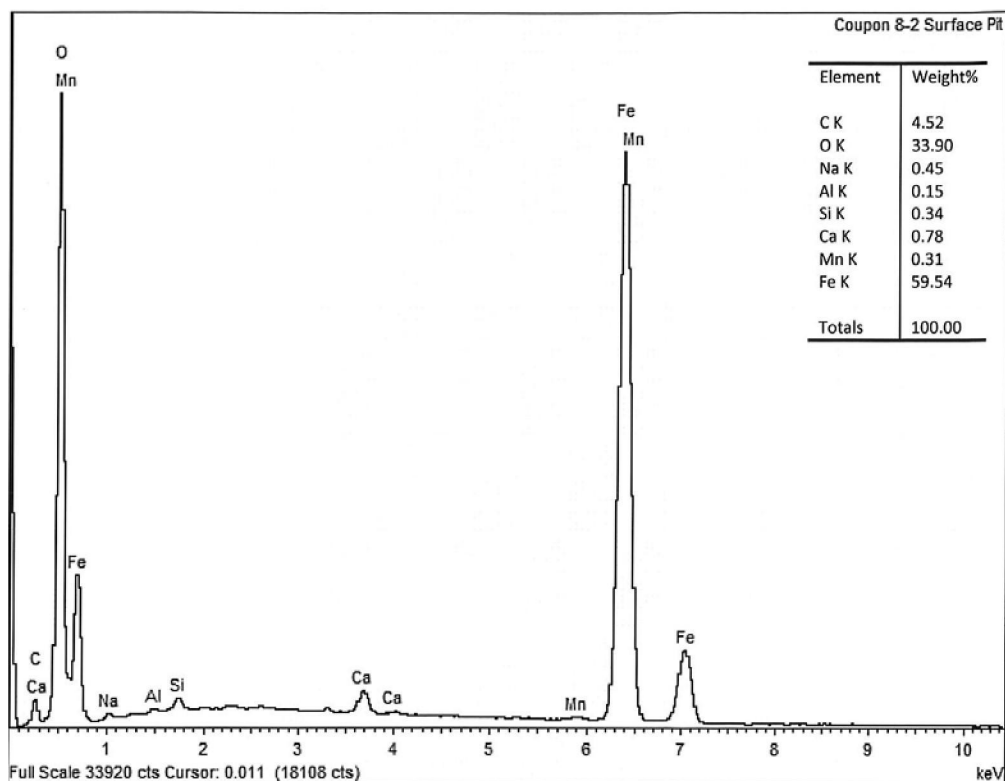
**Figure 90.** A representative EDS spectrum generated from the surface of a specimen excised from Coupon 8 labeled as 8-2, prior to cleaning.

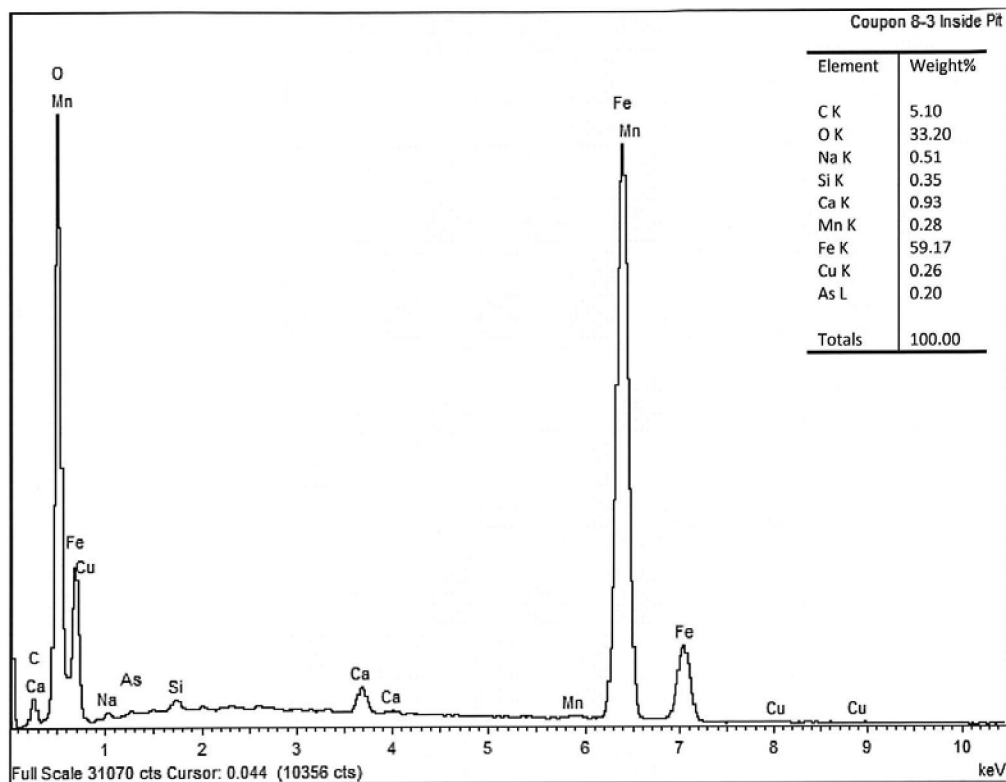
**Figure 91.** A representative EDS spectrum generated from of a pit on a specimen excised from Coupon 8 labeled as 8-3, prior to cleaning.

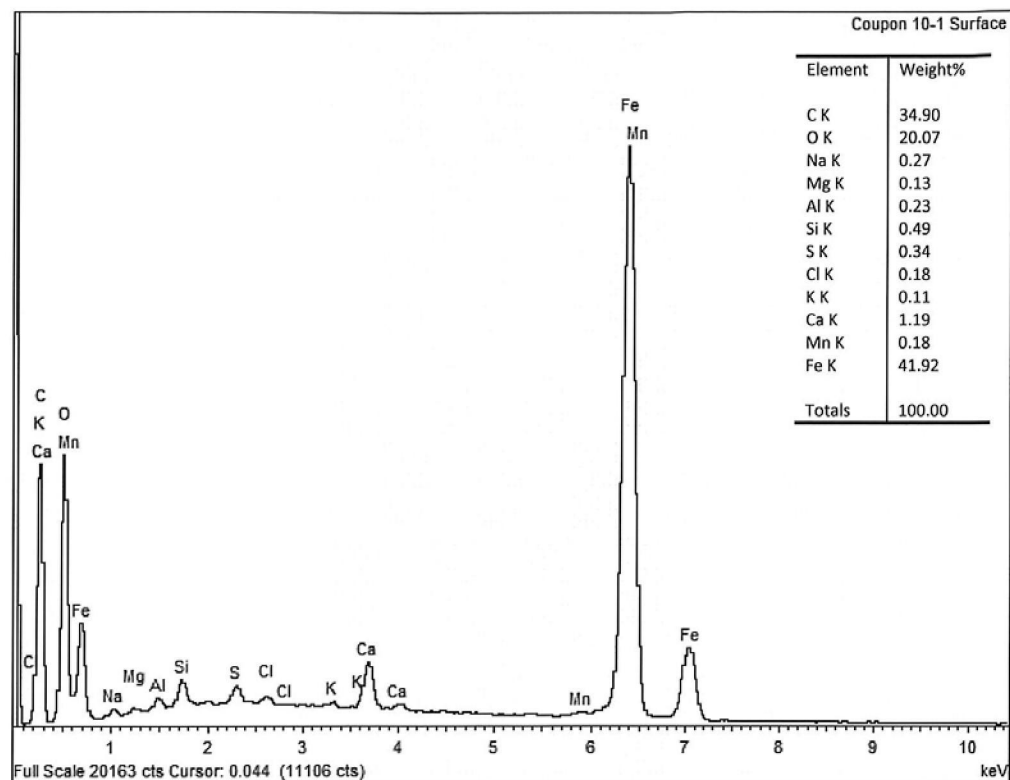
**Figure 92.** A representative EDS spectrum generated from the surface of a specimen excised from Coupon 10 labeled as 10-1, prior to cleaning.

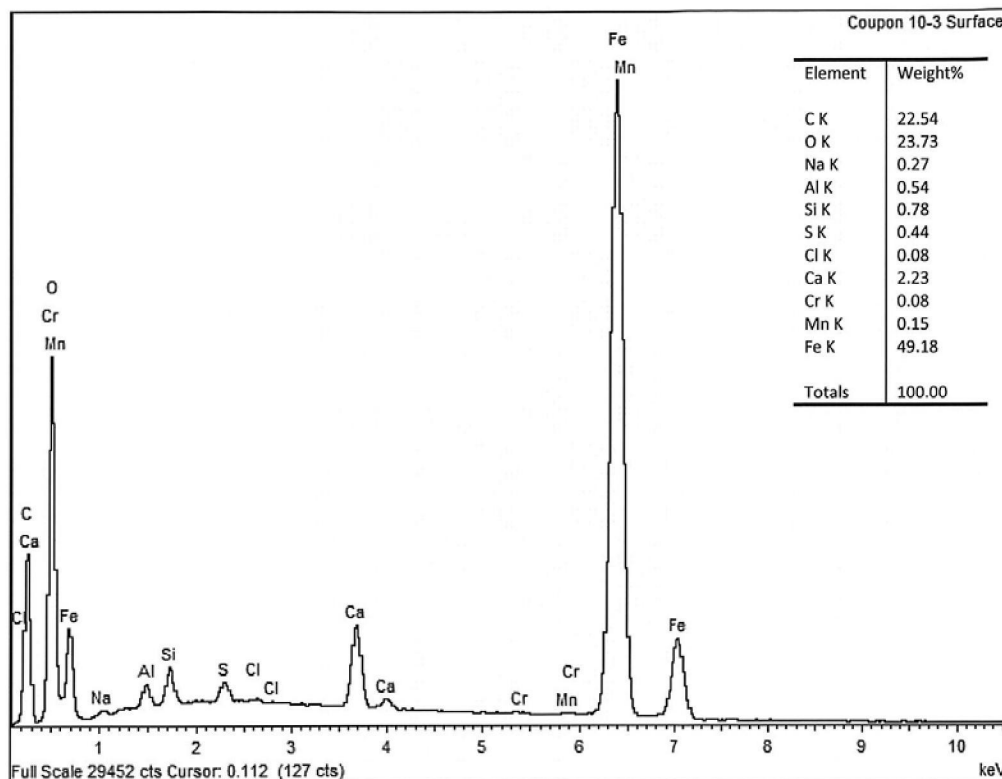
**Figure 94.** A representative EDS spectrum generated from the surface of a specimen excised from Coupon 10 labeled as 10-3, prior to cleaning.

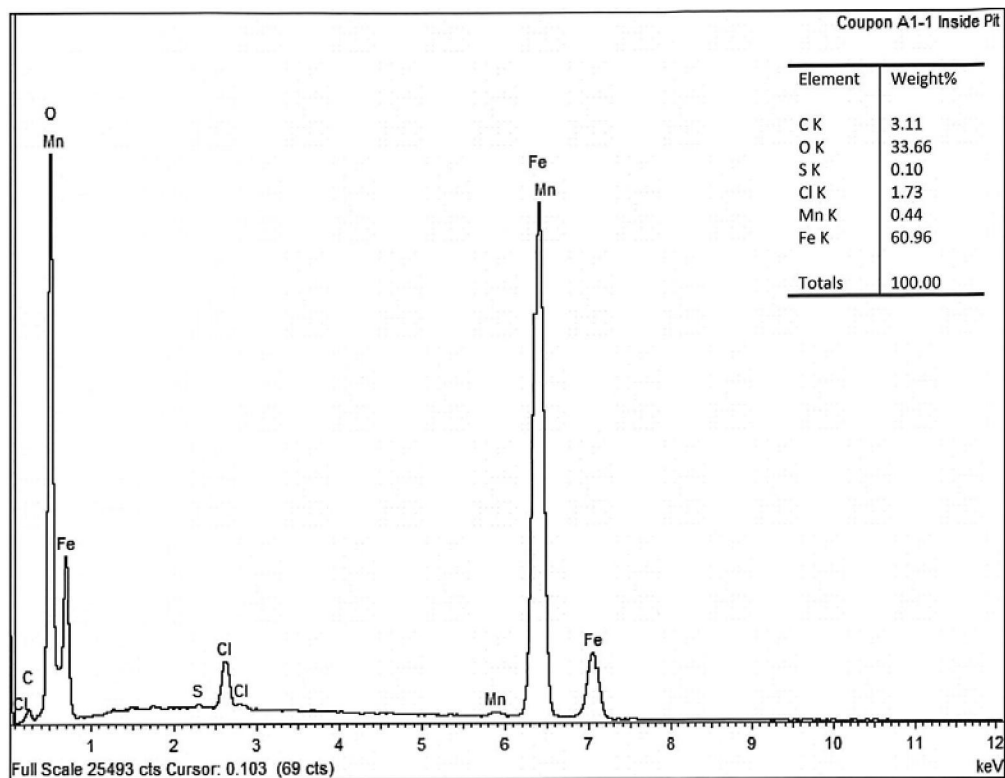
**Figure 95.** A representative EDS spectrum generated from of a pit on a specimen excised from Coupon A1 labeled as A1-1, prior to cleaning.

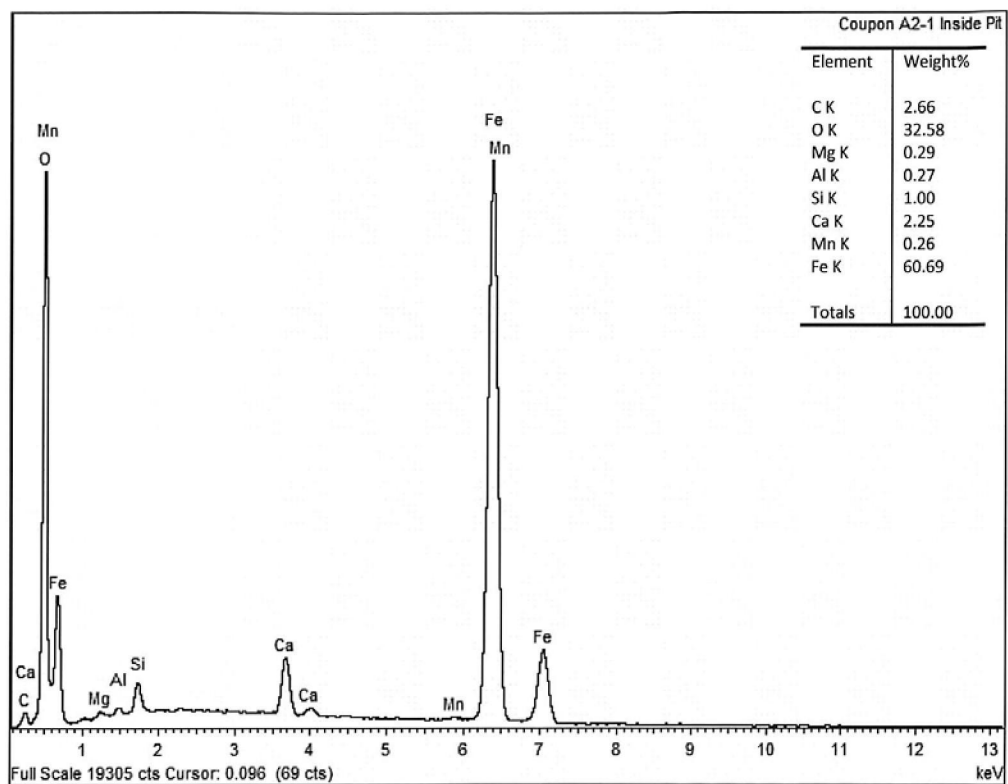
**Figure 98.** A representative EDS spectrum generated from of a pit on a specimen excised from Coupon A2 labeled as A2-1, prior to cleaning.

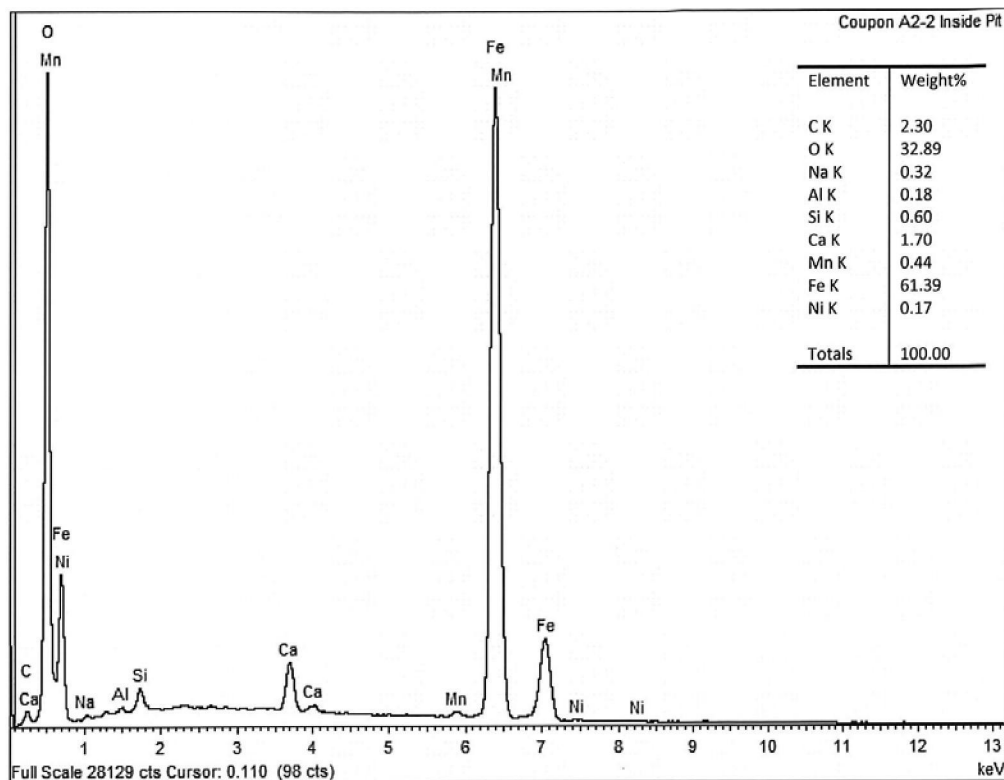
**Figure 99.** A representative EDS spectrum generated from of a pit on a specimen excised from Coupon A2 labeled as A2-2, prior to cleaning.

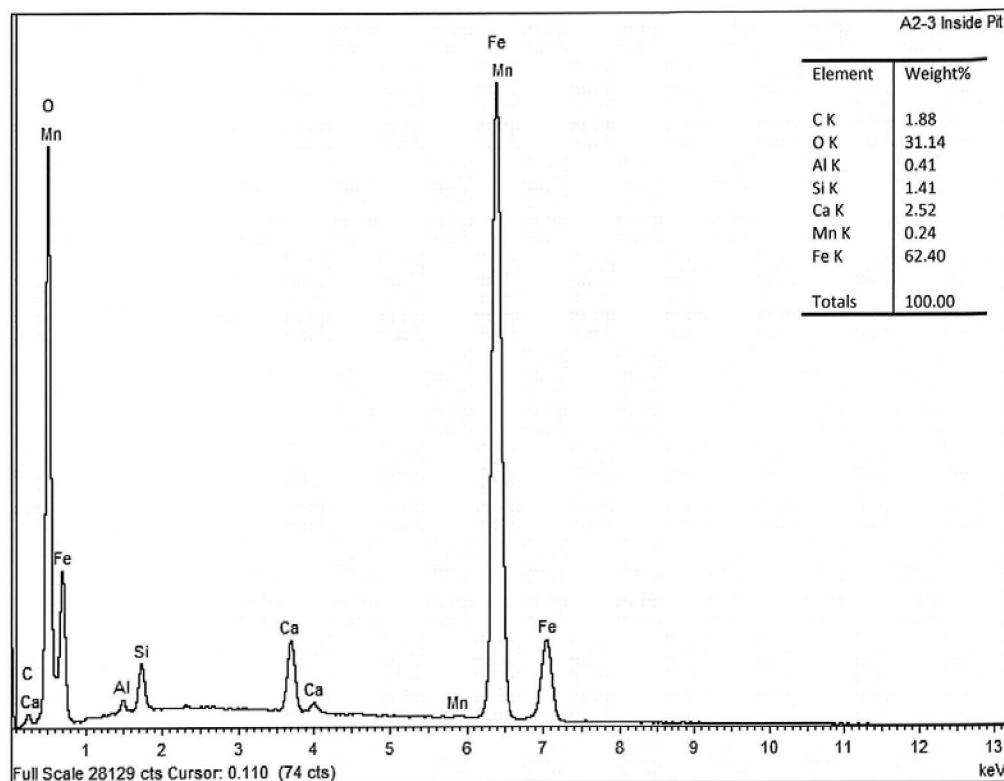
**Figure 100.** A representative EDS spectrum generated from of a pit on a specimen excised from Coupon A2 labeled as A2-3, prior to cleaning.

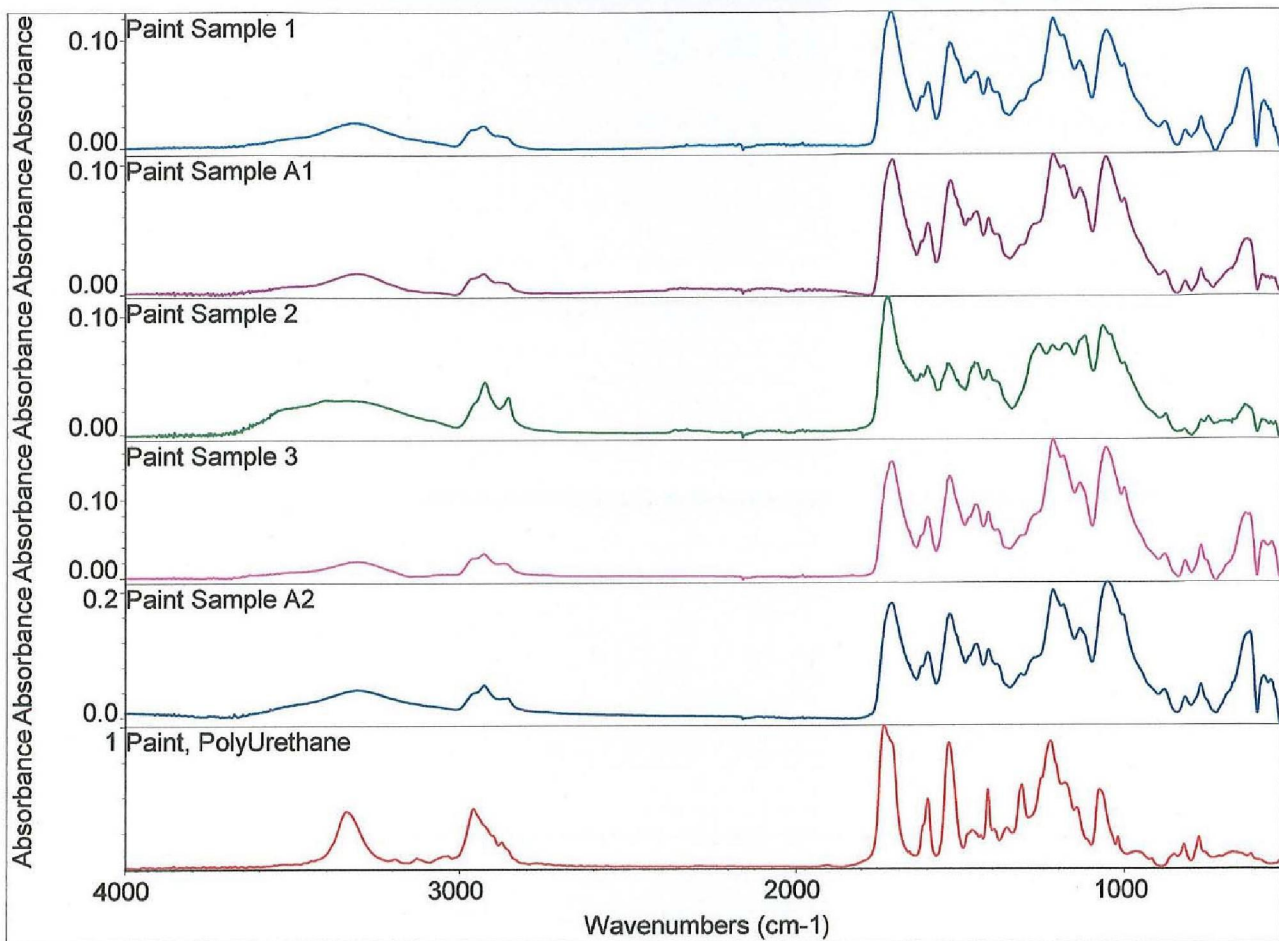
Fourier transform infrared (FTIR) spectroscopy was performed on paint samples removed from each coupon using Attenuated Total Reflectance (ATR) with a diamond crystal. All paint samples were identified as polyurethane enamel. The resulting FTIR spectra of the samples and the best matches from the spectral FTIR library of standards for polyurethane enamel are provided as Figures 111 and 112.

**Figure 111.** The FTIR spectra generated from a paint samples removed from the exterior surfaces of Coupons 1, A1, 2, A2 and 3 the best matches from the spectral FTIR library of standards for polyurethane enamel.

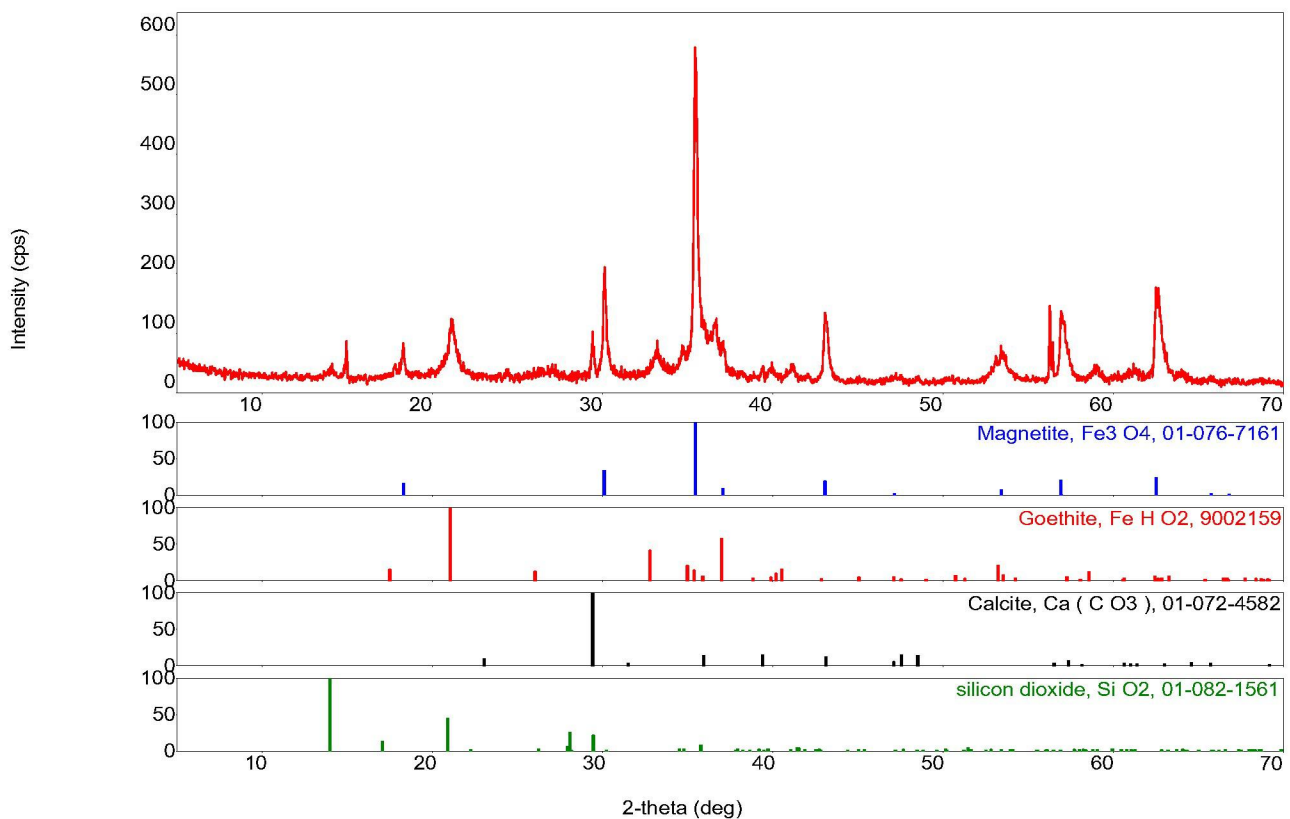
X-Ray Diffraction Spectroscopy (XRD) analysis of the corrosion product from the metal panels revealed the presence of the following crystalline phases: iron oxide (magnetite); iron hydroxide (goethite); calcium carbonate (calcite); silicon dioxide and hydrous calcium aluminum sulfate (ettringite). The results are summarized in Tables 19 and 20. The XRD diffractograms for the corrosion samples are provided as Figures 123 through 128.

**Figure 124.** The XRD diffractogram generated from corrosion product removed Coupon 2.

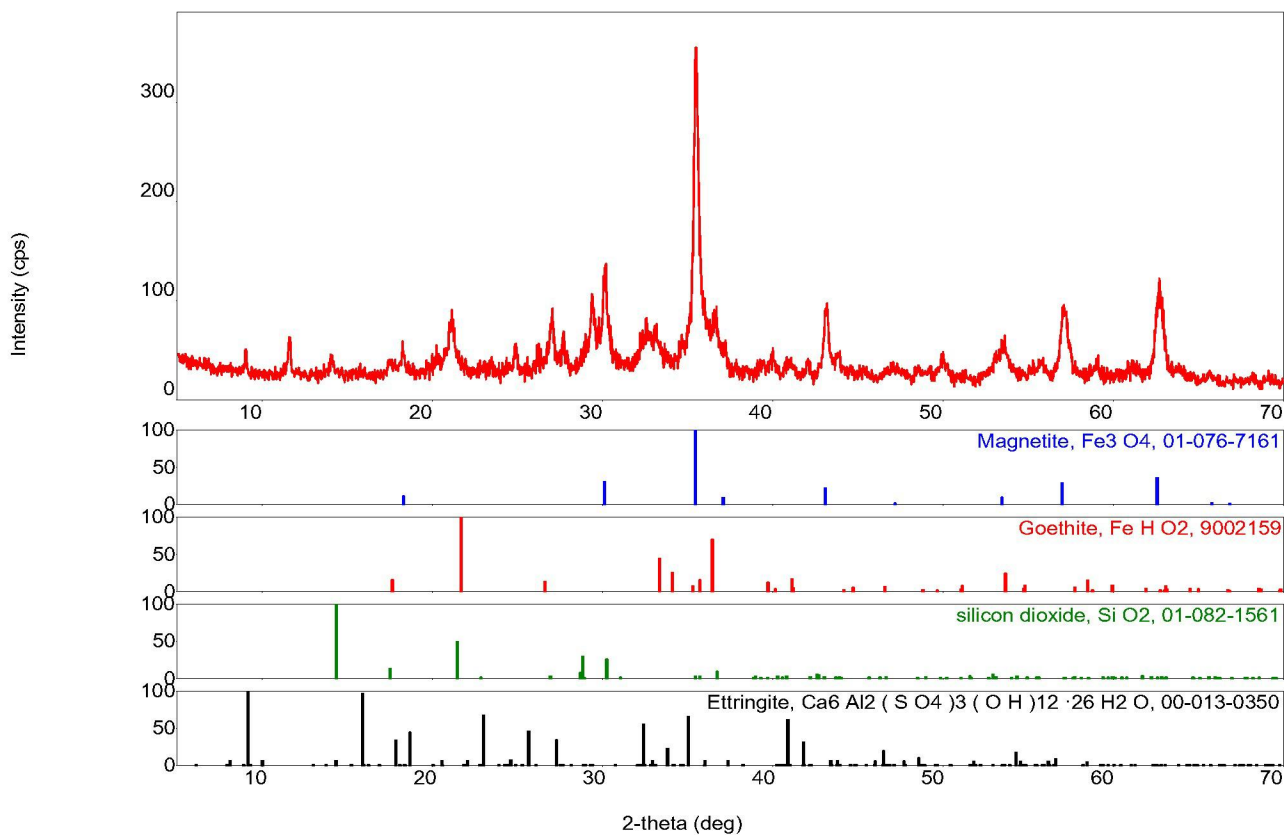
**Figure 126.** The XRD diffractogram generated from corrosion product removed Coupon 6.

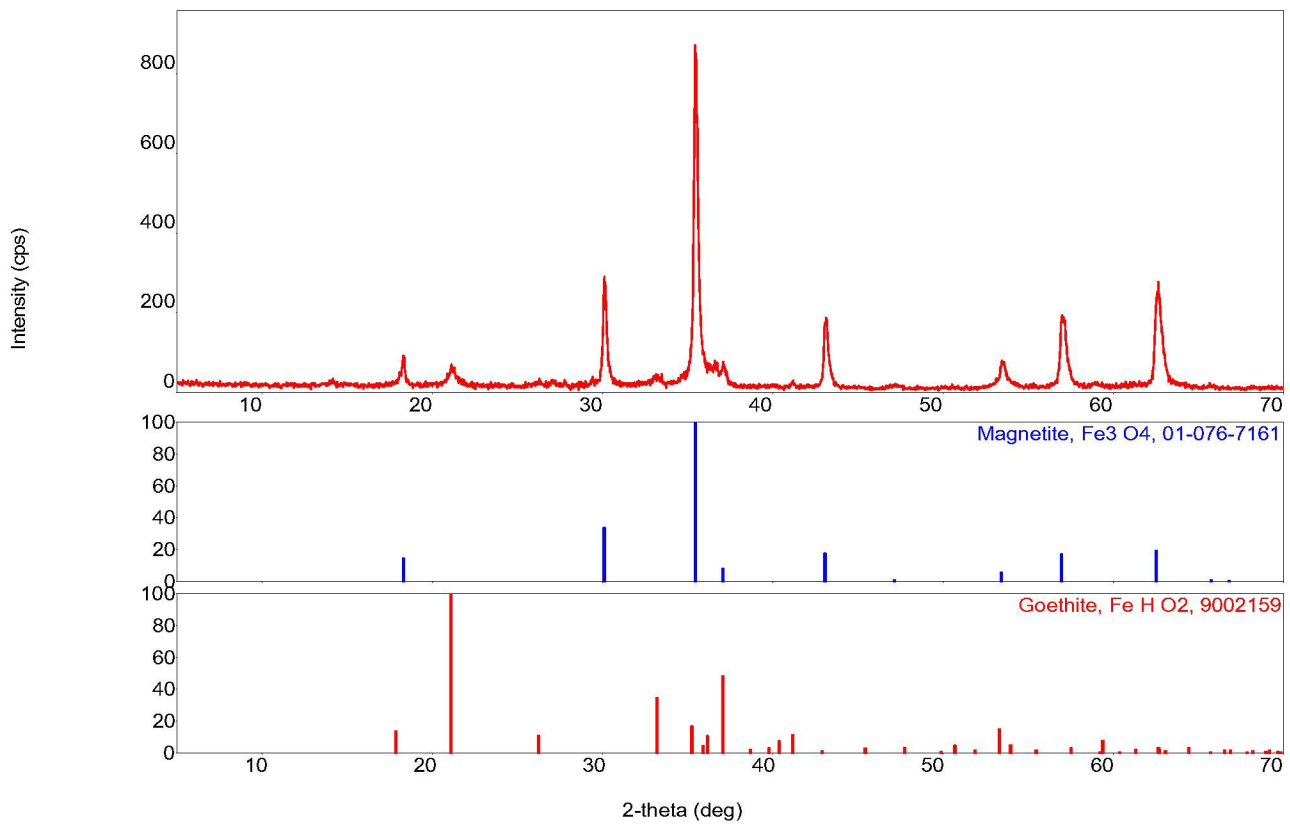
**Figure 127.** The XRD diffractogram generated from corrosion product removed Coupon 7.

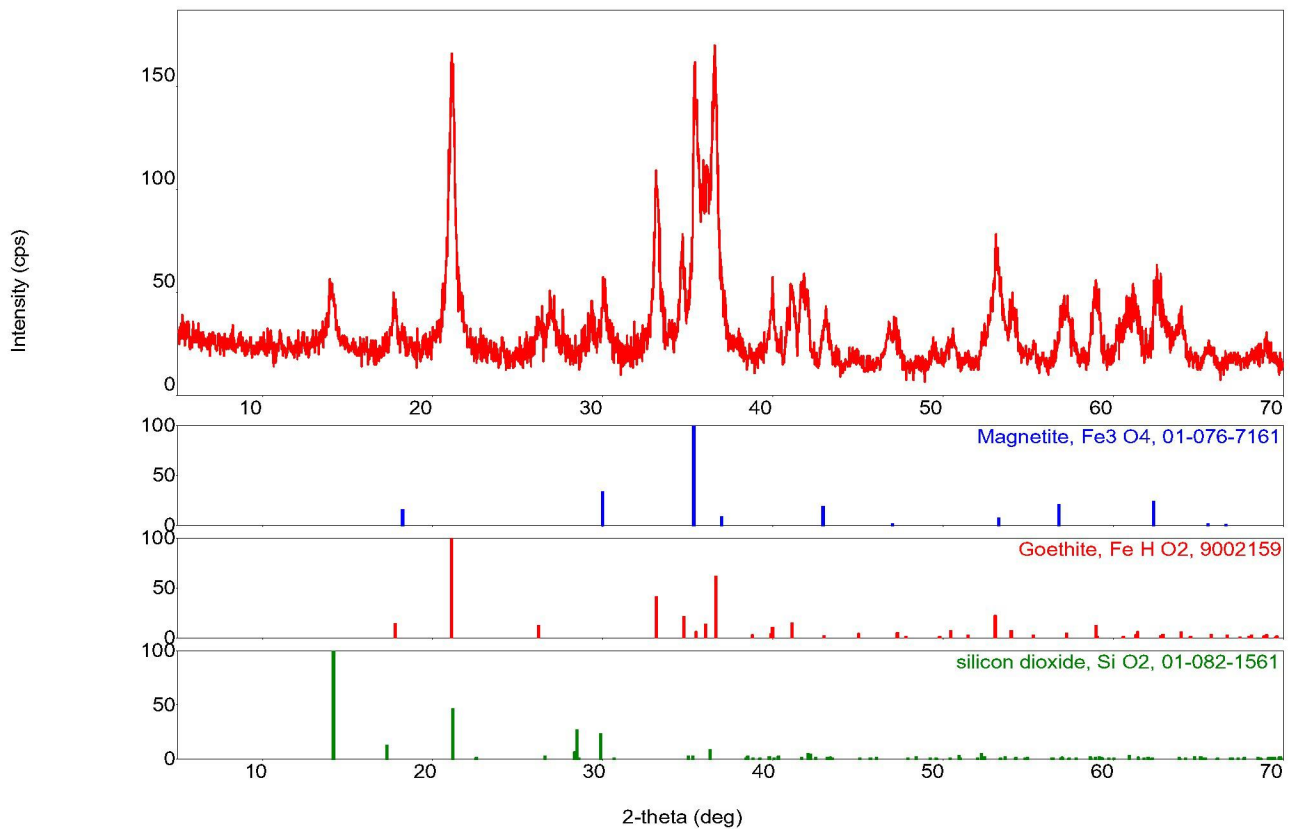
**Figure 128.** The XRD diffractogram generated from corrosion product removed Coupon 8.
