**SUBJECT: DESTRUCTIVE ANALYSIS OF 10 STEEL COUPONS REMOVED FROM  
RED HILL FUEL STORAGE TANK NO. 14, PURSUANT TO SECTION 5.3  
OF THE ADMINISTRATIVE ORDER ON CONSENT STATEMENT OF  
WORK, RED HILL BULK FUEL STORAGE FACILITY, JOINT BASE PEARL  
HARBOR-HICKAM, OAHU, HAWAII**

## **Destructive Analysis of 10 Steel Coupons Removed from Red Hill Fuel Storage Tank #14**

**REPORT No. 201801967**

December 17, 2018

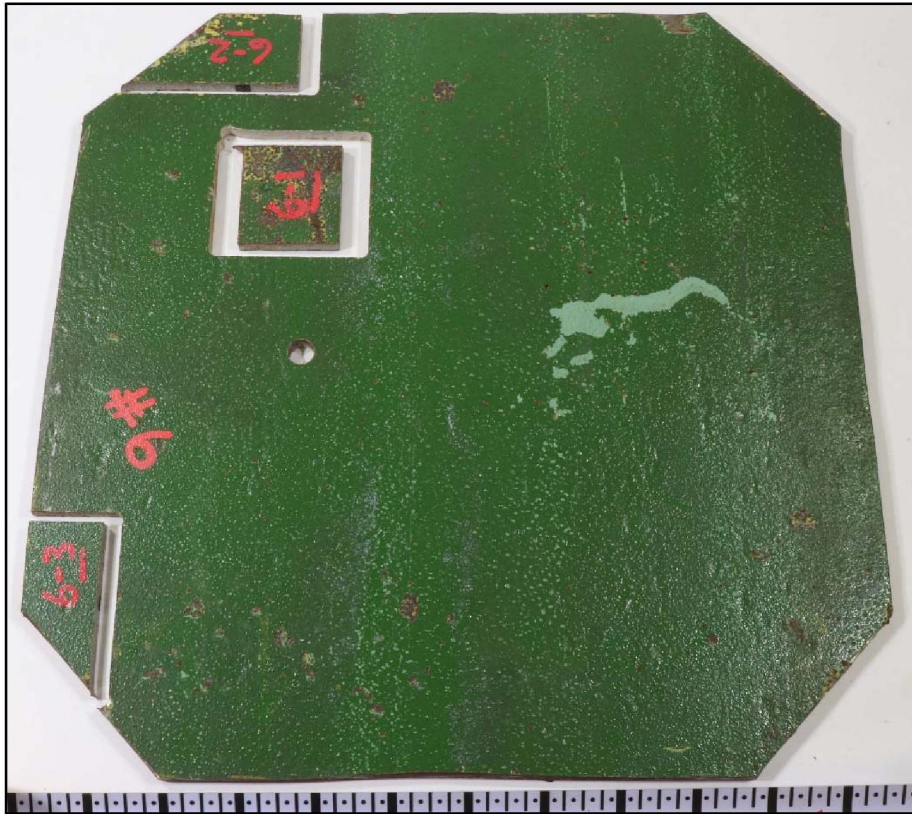
**Figure 138.** An image of the exterior surface of Coupon 6 after CO<sub>2</sub> blast cleaning.

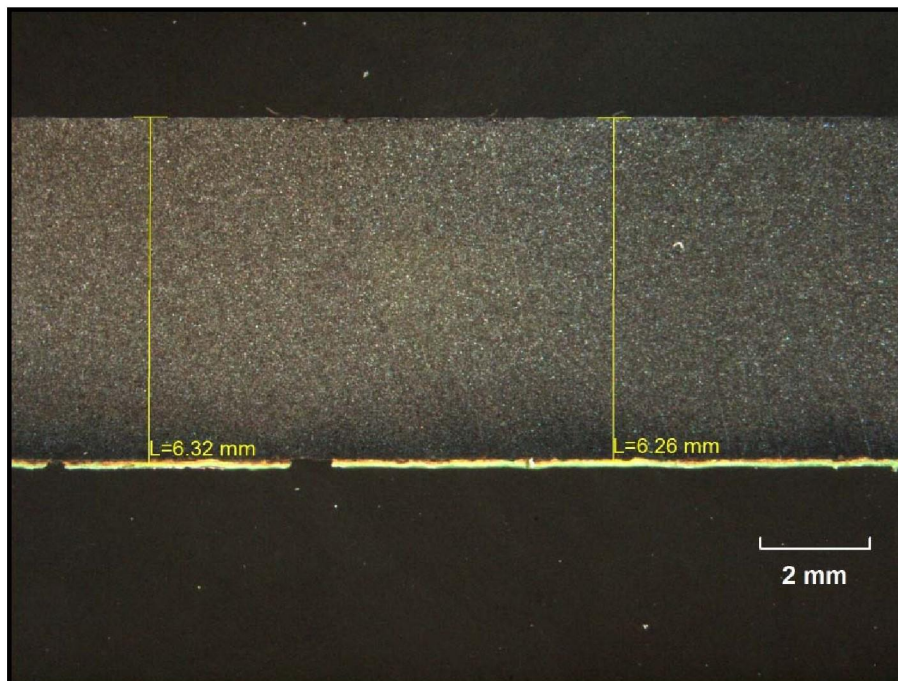
**Figure 190.** The prepared metallographic cross-section from Sample 5-1 is shown during examination with a stereomicroscope. No significant corrosion was observed. (7X)
