2.1 Mid Atlantic Environmental, Inc. conducted an inspection on Tank #8 at the Red Hill Underground Storage Facility, Pearl Harbor, Hawaii. This inspection was conducted in accordance with the scope of work identified by Contract Number N00604-97-R-0013, PRL 96-21, titled "Emergency Repair for Red Hill Tanks."

RED HILL TANK NO. 8  
PRODUCT: DFM

OI		TK	
LTR	DESCRIPTION	BY	DATE
REVISIONS			
MID ATLANTIC ENVIRONMENTAL			
EMERGENCY REPAIRS FOR RED HILL TANKS			
Tank #8			
Floor Layout		File #8fll0	
Tank bottom			
Drawn By: T. Kitchen		Date: 7/20/98

**Bottom Layout with Pit Indications**

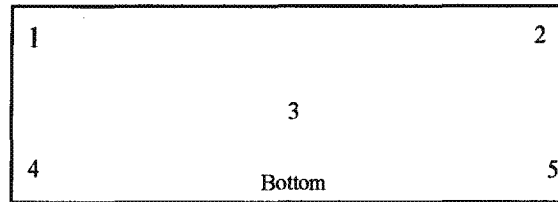
Lower Dome

Plate Number	Thickness Measurements (in inches)					Plate Type
	Point Numbers					
	1	2	3	4	5	
1	0.260	0.286	0.250	0.256	0.255	E
2	0.268	0.266	0.255	0.262	0.267	E
3	0.252	0.254	0.259	0.271	0.255	E
4	0.255	0.256	0.248	0.251	0.251	E
5	0.255	0.255	0.256	0.261	0.271	E
6	0.261	0.256	0.261	0.263	0.256	E
7	0.258	0.256	0.260	0.261	0.264	E
8	0.251	0.253	0.253	0.249	0.252	E
9	0.248	0.254	0.244	0.258	0.253	E
10	0.253	0.245	0.246	0.255	0.247	E
11	0.261	0.259	0.256	0.260	0.261	E
12	0.259	0.251	0.251	0.278	0.287	E
13	0.247	0.246	0.255	0.253	0.264	E
14	0.251	0.251	0.250	0.260	0.266	E
15	0.262	0.255	0.247	0.261	0.273	E
16	0.256	0.254	0.251	0.261	0.250	E
17	0.252	0.249	0.251	0.252	0.248	E
18	0.246	0.251	0.246	0.251	0.256	E
19	0.249	0.250	0.274	0.251	0.256	E
20	0.254	0.252	0.251	0.274	0.258	E
21	0.262	0.261	0.254	0.268	0.271	E
22	0.278	0.258	0.260	0.261	0.269	E
