**Section 9**  
**RECOMMENDED REPAIRS**

MID ATLANTIC ENVIRONMENTAL	
EMERGENCY REPAIRS FOR RED HILL TANKS	
Tank #8 AS BUILT DRAWINGS	
Repair No.: 001	File: 8R001
UPPER DOME	Quadrant: D
Course: EXTENSION	PLATE: 22
Drawn by: Tom Kitchen	Date: 5/4/98

**Dames & Moore**  
Emergency Repairs For Red Hill Tanks at the Fleet Industrial & Supply Center  
Contract No. N62742-96-C-1356

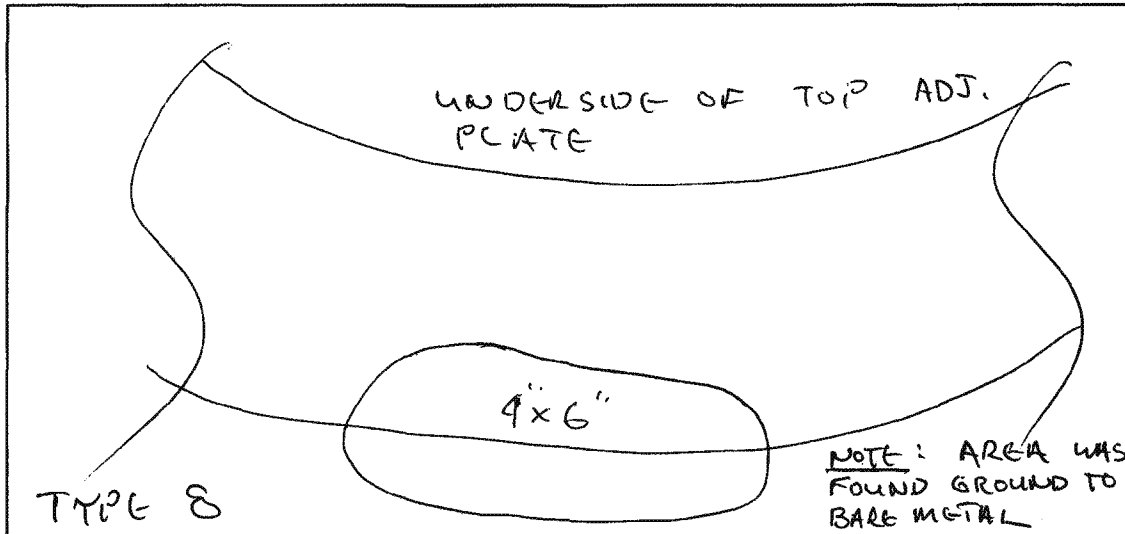
Tank No.: 8 Repair No.: 001 Type: 8 Location: D

NOTE: AREA EAS FOUND TO BE GROUND TO BARE METAL

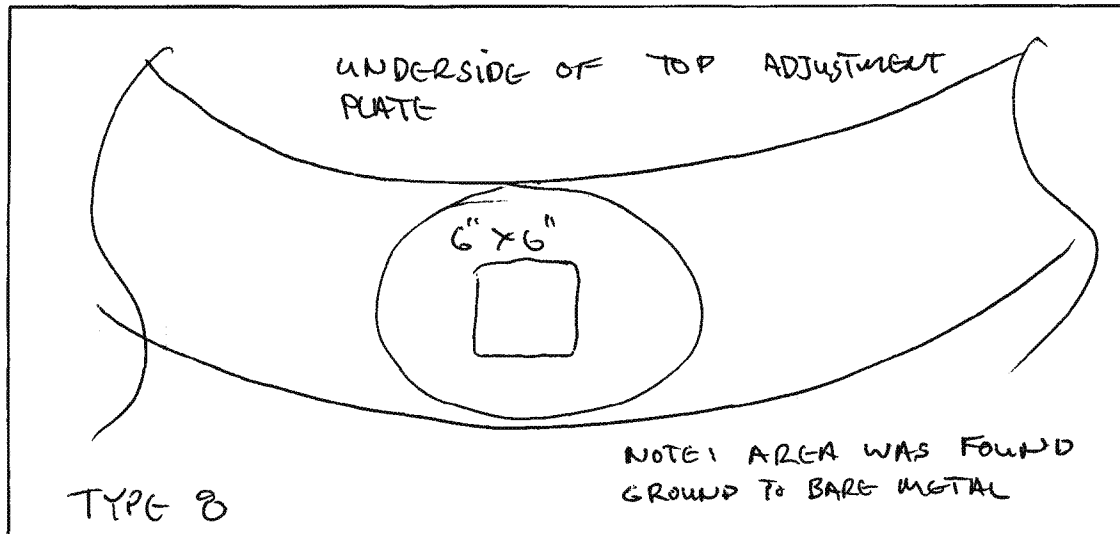
Tank No.: 8 Repair No.: 002 Type: 8 Location: C

MID ATLANTIC ENVIRONMENTAL	
EMERGENCY REPAIRS FOR RED HILL TANKS	
Tank #8 AS BUILT DRAWINGS	
Repair No.: 002	File: 8R001
UPPER DOME	Quadrant: C
Course: EXTENSION	PLATE: 14
Drawn by: Tom Kitchen	Date: 5/4/98

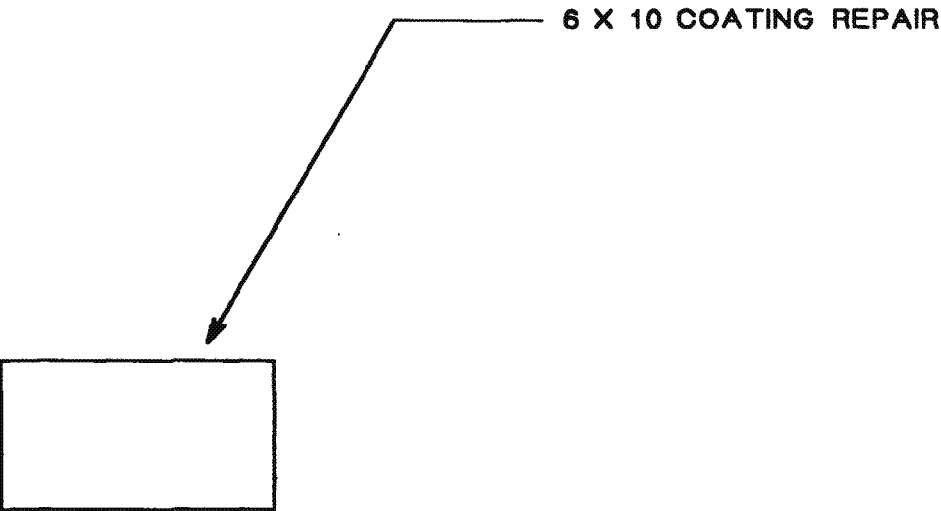
TYPE 8 REPAIR

MID ATLANTIC ENVIRONMENTAL	
EMERGENCY REPAIRS FOR RED HILL TANKS	
Tank #8 AS BUILT DRAWING	
Repair No.: 003	File #: 003
CYLINDER	Quadrant: D
Course: 19	PLATE: 21
Drawn by: Tom Kitchen	Date: 5/4/98

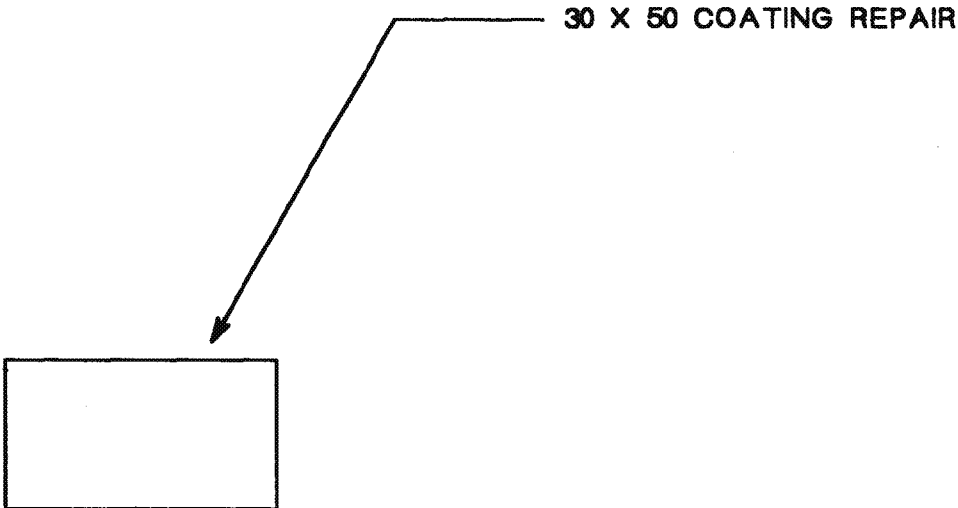
TYPE 8 REPAIR

MID ATLANTIC ENVIRONMENTAL	
EMERGENCY REPAIRS FOR RED HILL TANKS	
Tank #8 AS BUILT DRAWING	
Repair No. 006	File # 8r006
LOWER DOME	Quadrant C
Course 2	PLATE 14
Drawn by Tom Kitchen	Date 5/4/98

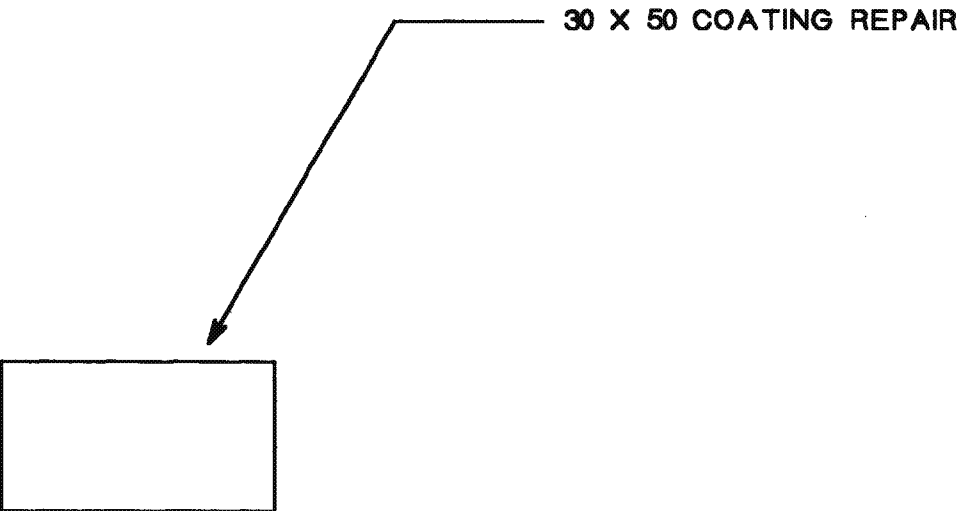
TYPE 8 REPAIR

MID ATLANTIC ENVIRONMENTAL	
EMERGENCY REPAIRS FOR RED HILL TANKS	
Tank #8 AS BUILT DRAWING	
Repair No.: 007	File #: 007
LOWER DOME	Quadrant: C
Course: 2	PLATE: 14
Drawn by: Tom Kitchen	Date: 5/4/98

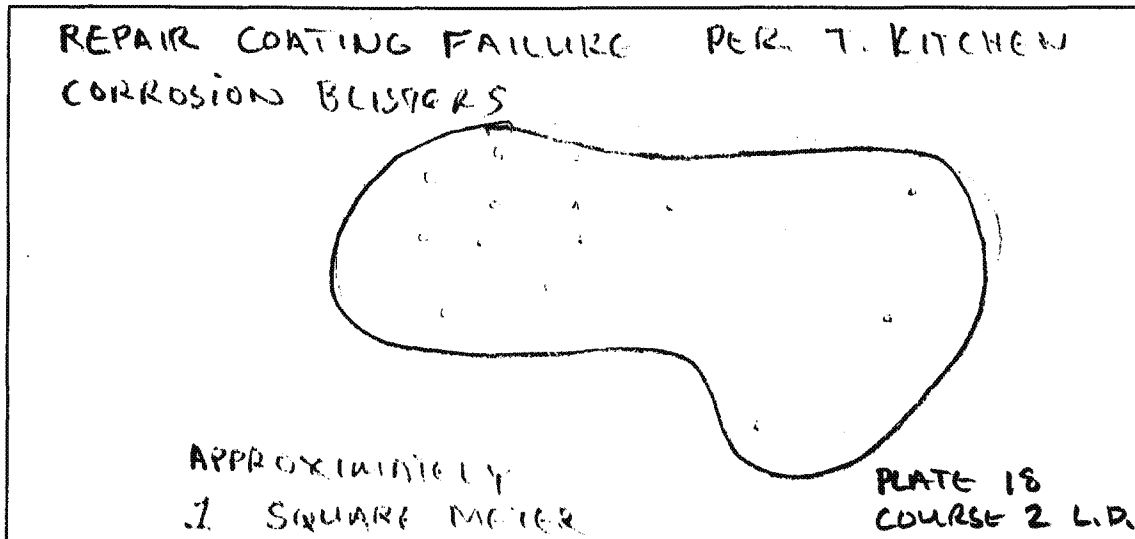
Tank No.: 8 Repair No.: 007 Type: 8 Location: D

DEFECT INSPECTED BY TK & JF 3/25/98

30 X 50 COATING REPAIR

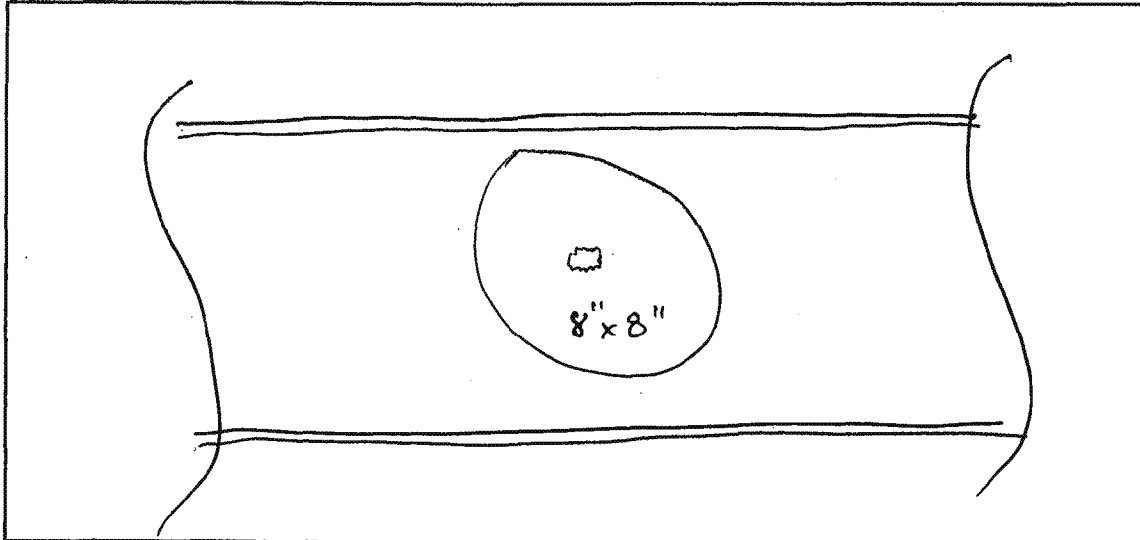
Tank No.: 8 Repair No.: 009 Type: 8 Location: B11-EXT

MID ATLANTIC ENVIRONMENTAL	
EMERGENCY REPAIRS FOR RED HILL TANKS	
Tank #8 AS BUILT DRAWING	
Repair No.: 009	File: 8r009
UPPER DOME	Quadrant: B
Course: EXTENSION	PLATE: 11
Drawn by: Tom Kitchen	Date: 5/4/98

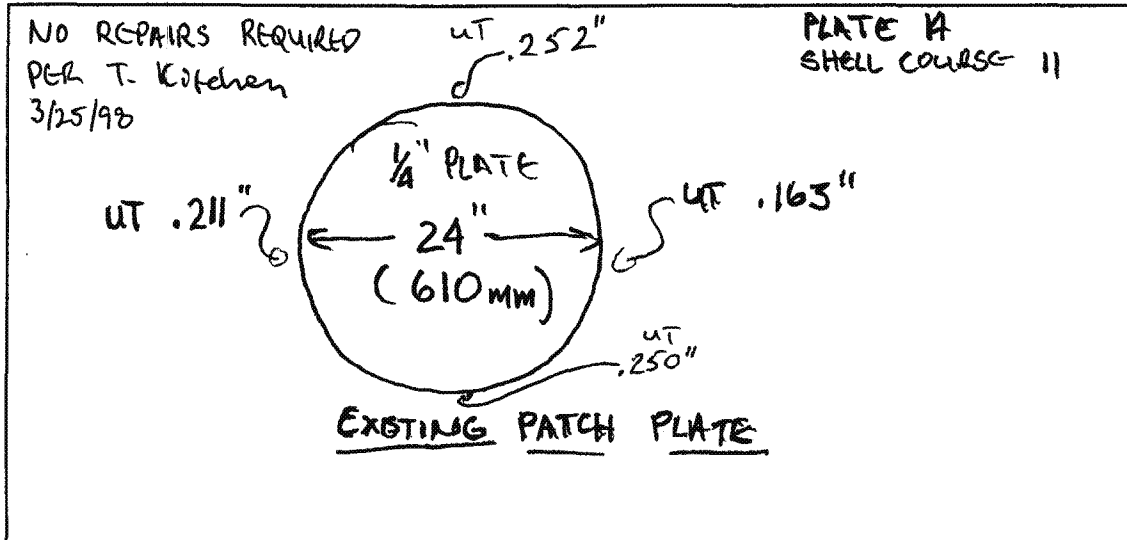
Tank No.: 8 Repair No.: 010 Type: N/A Location: C

UT READINGS AT EDGE OF PLATE INDICATE GOOD METAL  
NO REPAIR NECESSARY

MID ATLANTIC ENVIRONMENTAL	
EMERGENCY REPAIRS FOR RED HILL TANKS	
Tank #8 AS BUILT DRAWING	
Repair No. 010	File # 8010
CYLINDER	Quadrant C
Course 11	PLATE 14
Drawn by Tom Kitchen	Date 5/4/98

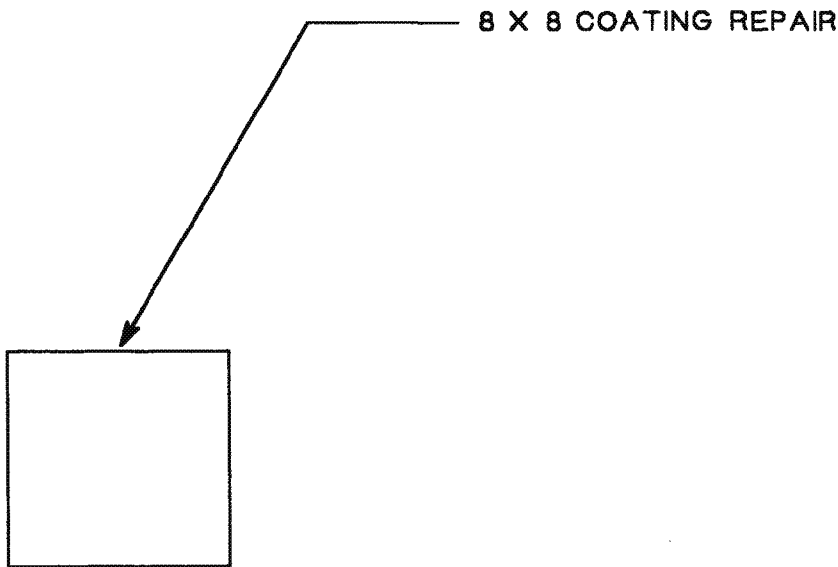
TYPE 8 REPAIR

MID ATLANTIC ENVIRONMENTAL	
EMERGENCY REPAIRS FOR RED HILL TANKS	
Tank #8 RECOMMENDED REPAIR DRAWING	
Repair No. 011	File #8r011
LOWER DOME	Quadrant A
Course 2	PLATE 8
Drawn by Tom Kitchen	Date 5/4/98

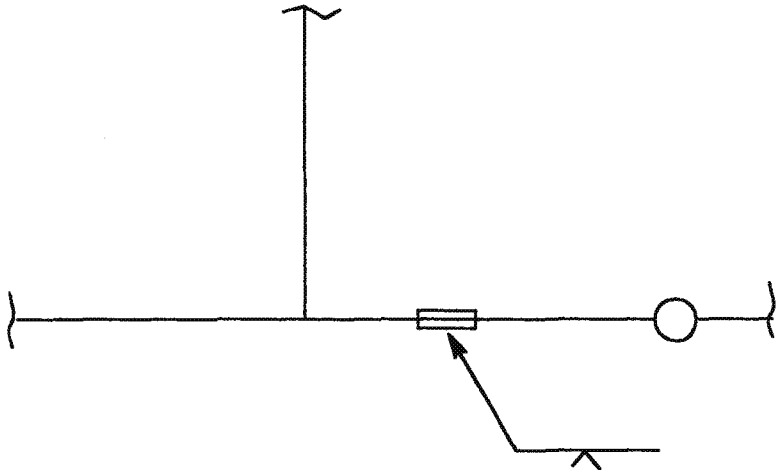
TYPE 9 REPAIR

MID ATLANTIC ENVIRONMENTAL	
EMERGENCY REPAIRS FOR RED HILL TANKS	
Tank #8 RECOMMENDED REPAIR DRAWING	
Repair No.: 012	File: 8r012
CYLINDER	Quadrant: B
Course: 9	PLATE: 17
Drawn by: Tom Kitchen	Date: 5/4/98

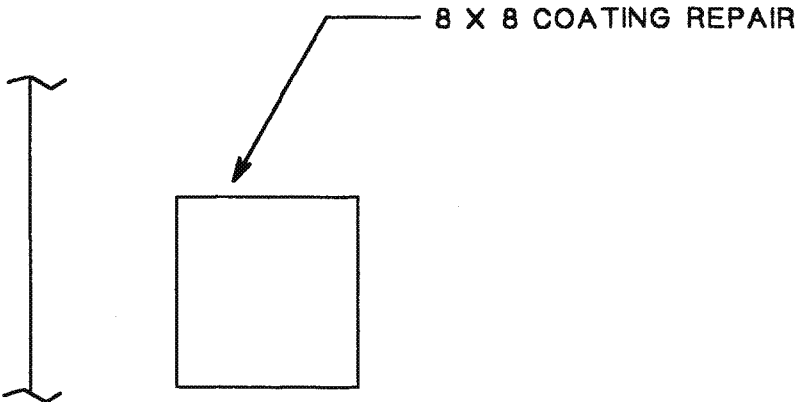
TYPE 9 REPAIR

MID ATLANTIC ENVIRONMENTAL	
EMERGENCY REPAIRS FOR RED HILL TANKS	
Tank #8 RECOMMENDED REPAIR DRAWING	
Repair No.: 013	File: 8r013
LOWER DOME	Quadrant: B
Course: 3	PLATE: 11
Drawn by: Tom Kitchen	Date: 5/4/98
