**Dames & Moore**  
Emergency Repairs For Red Hill Tanks at the Fleet Industrial & Supply Center  
Contract No. N62742-96-C-1356

Repair Record

MID ATLANTIC ENVIRONMENTAL	
EMERGENCY REPAIRS FOR RED HILL TANKS	
Tank #8 RECOMMENDED REPAIR DRAWING	
Repair No.: 014	File: 8r014
LOWER DOME	Quadrant: B
Course: 3	PLATE: 10
Drawn by: Tom Kitchen	Date: 5/4/98

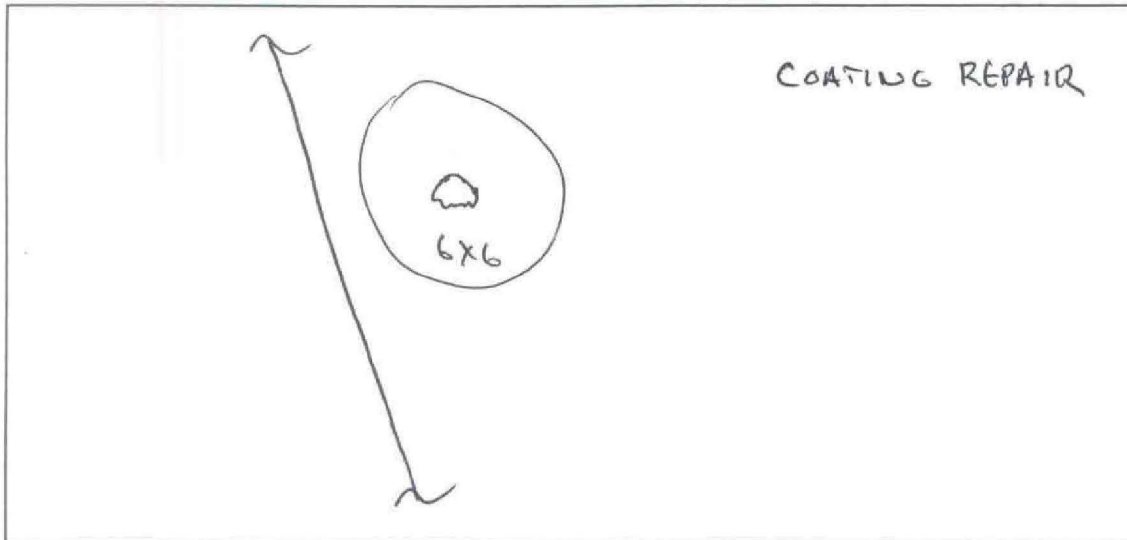
Tank No.: 8 Repair No.: ADD 016 Type: 8 Location: B9-3

6 X 8 COATING REPAIR

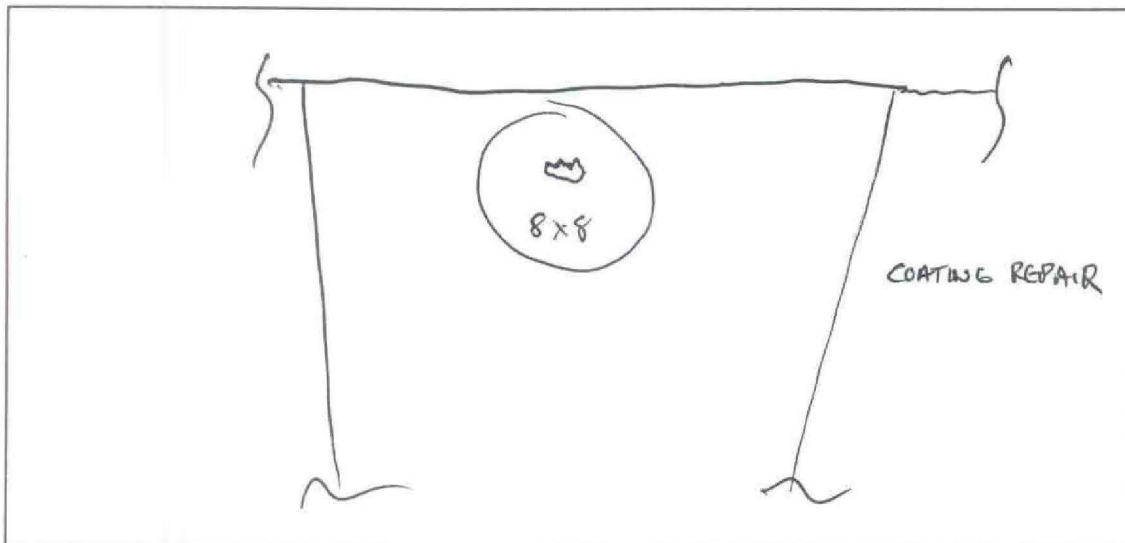
Tank No.: 8 Repair No.: ADD 018 Type: 8 Location: B10-2

SCATTERED BLISTERS APPROXIMATE AREA OF COATING  
REPAIR EQUAL 2 SQUARE METERS
