MID ATLANTIC ENVIRONMENTAL	
EMERGENCY REPAIRS FOR RED HILL TANKS	
Tank #7 RECOMMENDED REPAIR DRAWING	
Repair No. 031	File 7R031
cylinder	Quadrant C
Course 24	Plate 15
Drawn by Tom Kitchen	Date 5/4/98

Dames & Moore
Emergency Repairs For Red Hill Tanks at the Fleet Industrial & Supply Center
Contract No. N62742-96-C-1356

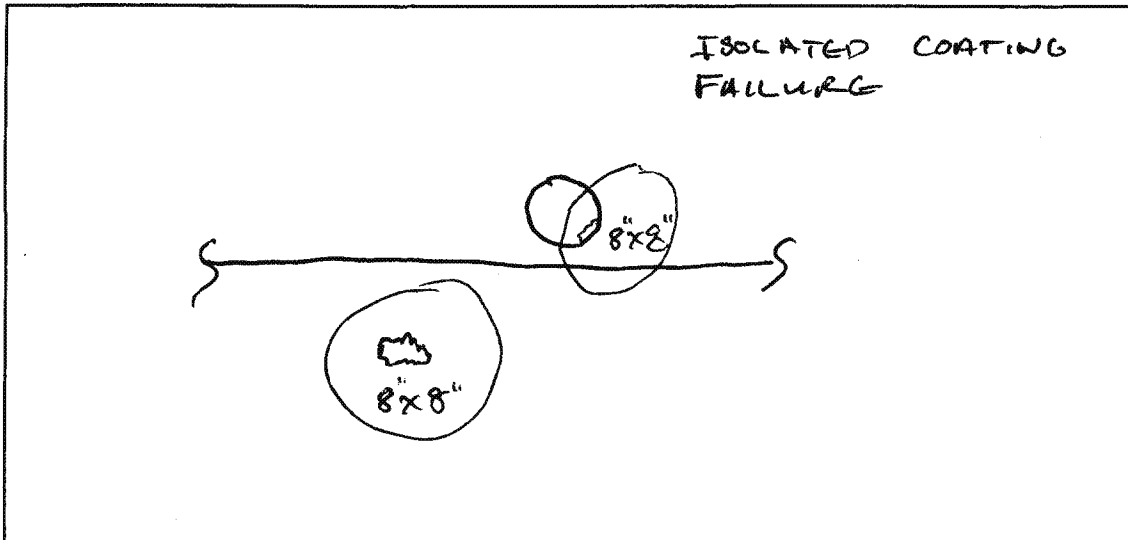
Tank No.: 7 Repair No.: 031 Type: 8 Location: C15-24

TYPE 8 REPAIR

Coating Type: Epoxy

Surface Preparation: ☒ Primer Coat: ☒ Intermediate Coat: ☒ Final Coat: ☒

NDT Performed: Visual: ☒ DFT: ☒ Average DFT: 8-15 mils

Repair Acceptable: John Zschell Date Accepted: 4-3-98

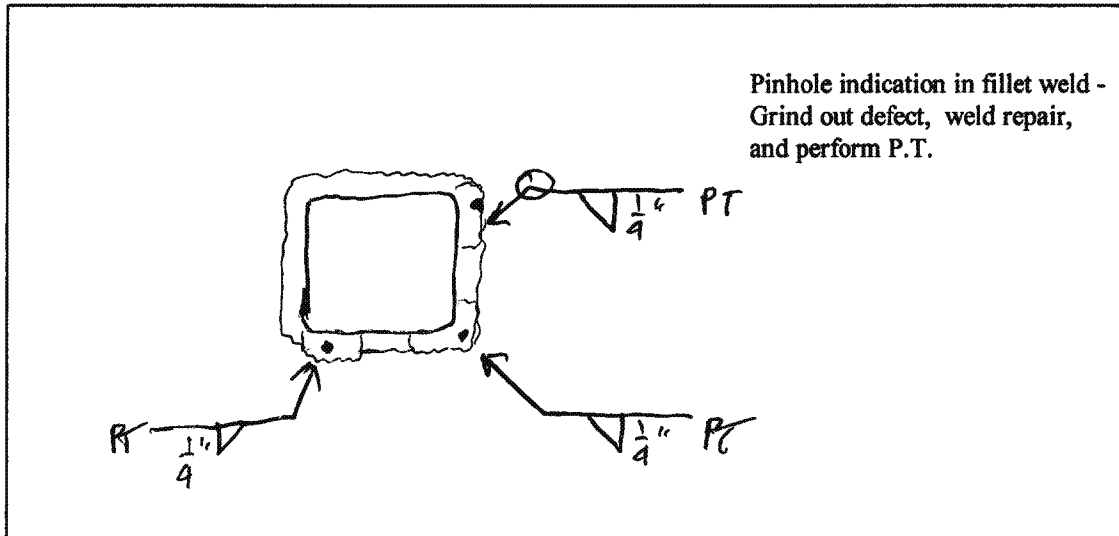
Tank No.: 7 Repair No.: 032 Type: 10 Location: C18-28

TYPE 10 REPAIR

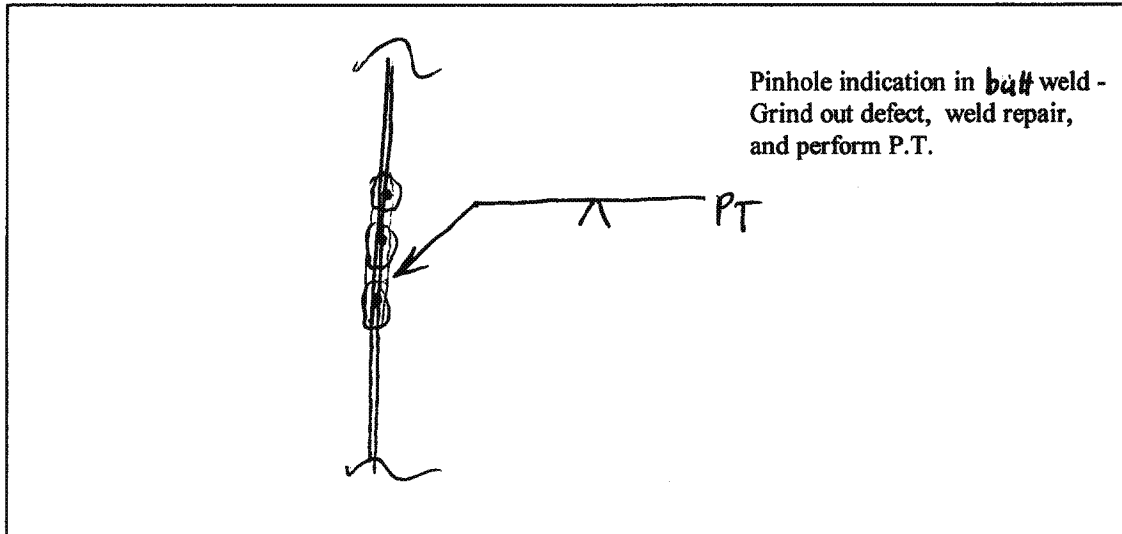
Tank No.: 7 Repair No.: 033 Type: 9 Location: D21-3

TYPE 10 REPAIR

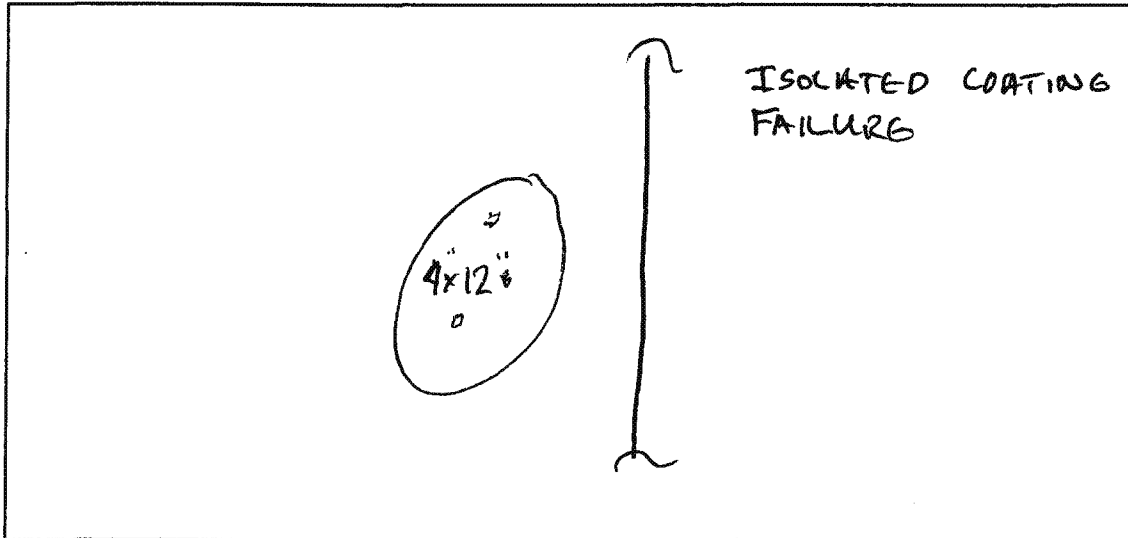
Tank No.: 7 Repair No.: 034 Type: 8 Location: C17-3

TYPE 8 REPAIR

8 X 12 COATING REPAIR

Repair Acceptable: John Zachell Date Accepted: 4-3-98

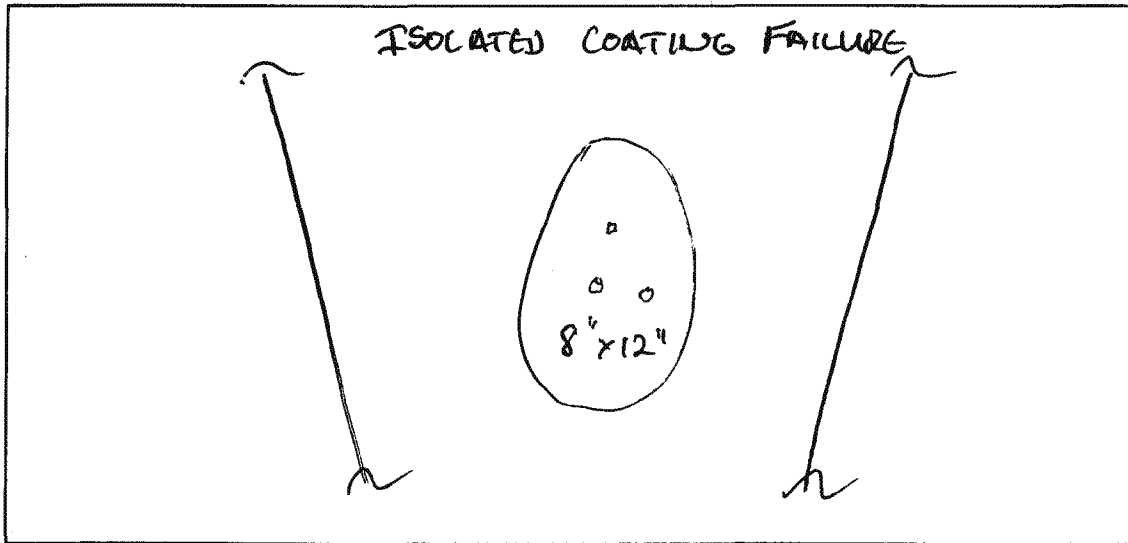
Tank No.: 7 Repair No.: 035 Type: 8 Location: C16-3

TYPE 8 REPAIR

Repair Acceptable: John Zuhel Date Accepted: 4-3-98

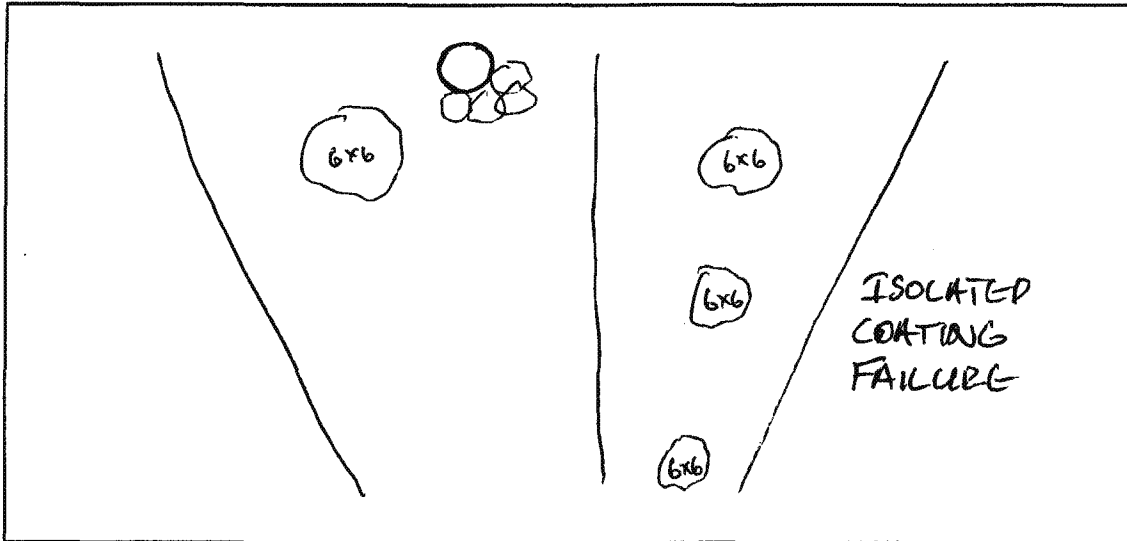
Tank No.: 7 Repair No.: 036 Type: 8 Location: C18-2

TYPE 8 REPAIR

Repair Acceptable: John Zdrull Date Accepted: 4-3-98

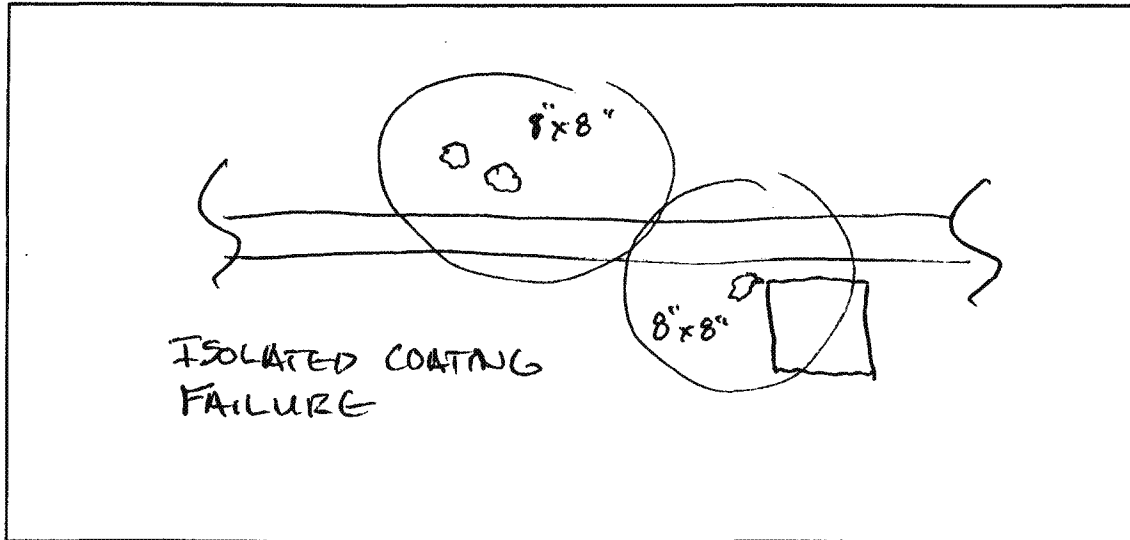
Tank No.: 7 Repair No.: 037 Type: 8 Location: C15-2

TYPE 8 REPAIR

Repair Acceptable: John Zedell Date Accepted: 4-3-98

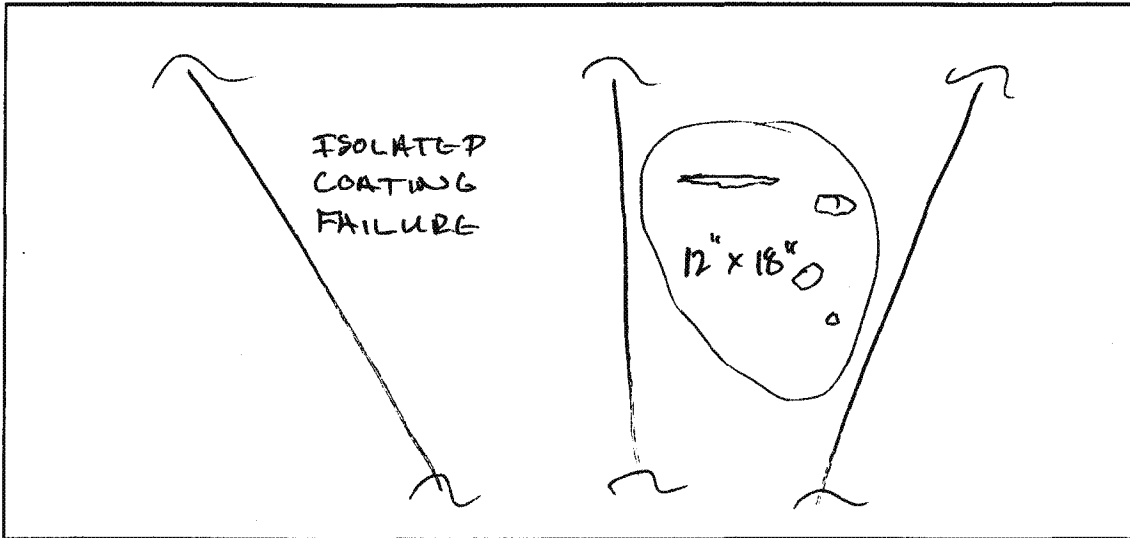
Tank No.: 7 Repair No.: 038 Type: 8 Location: D21-2

TYPE 8 REPAIR

Repair Acceptable: John Zedell Date Accepted: 4-3-98

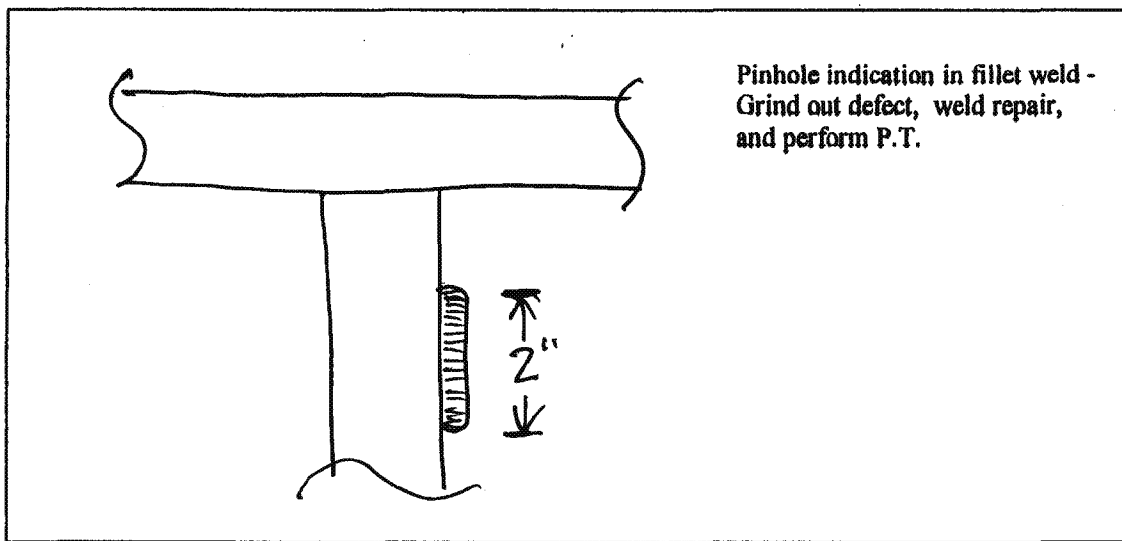
Tank No.: 7 Repair No.: 040 Type: 10 Location: B9-A

TYPE 10 REPAIR
