MID ATLANTIC ENVIRONMENTAL	
EMERGENCY REPAIRS FOR RED HILL TANKS	
Tank #7 RECOMMENDED REPAIR DRAWINGS	
Repair No. : 046	File: 7r046
Upper Dome	Quadrant: B
Course: A	Plate: 10
Drawn by: Tom Kitchen	Date: 5/4/98

Dames & Moore
Emergency Repairs For Red Hill Tanks at the Fleet Industrial & Supply Center
Contract No. N62742-96-C-1356

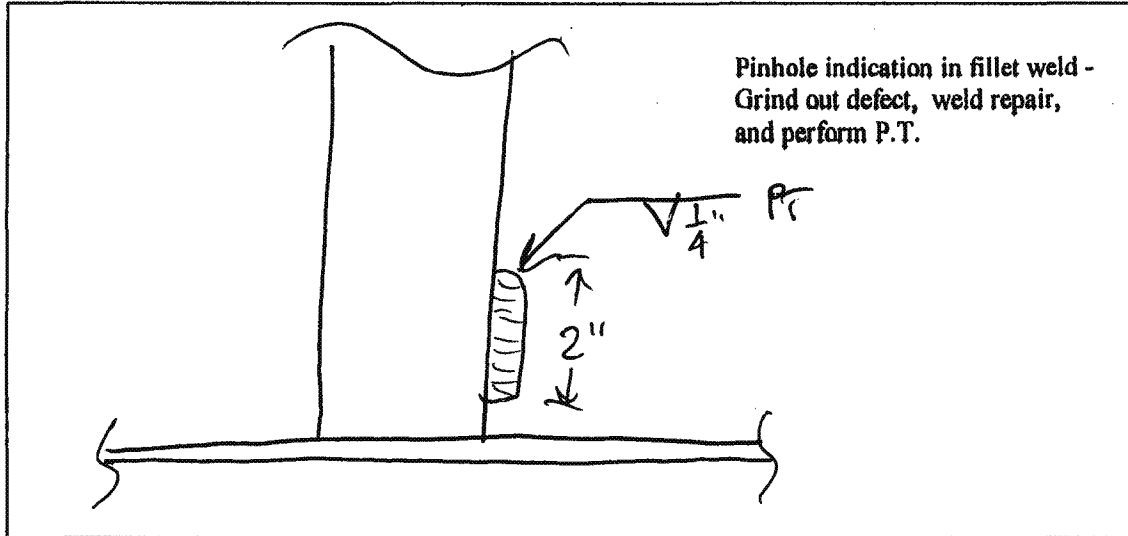
Sketch of Repair Area

Tank No.: 7 Repair No.: 046 Type: 10 Location: B10-A

Weld Repair

WPS No.: SM1.1-1

NDT Performed: Visual ☒ Vacuum Box ☐ Dye Penetrant ☒

Repair Acceptable: John Zachell Date Accepted: 4-15-98

Coating Repair

Coating Type: EPOXY

NDT Performed: Visual: ☒ DFT: ☒ Average DFT: 8-15 mils

Repair Acceptable: John Zachell Date Accepted: 4-17-98

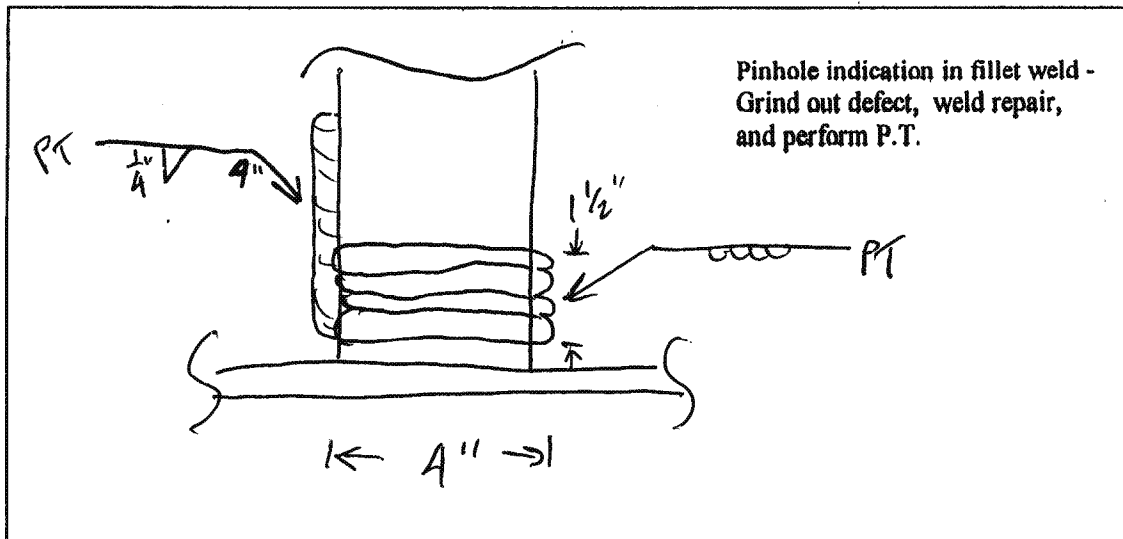
Sketch of Repair Area

Tank No.: 7 Repair No.: 047 Type: 10 Location: B11-A

Weld Repair

Repair Acceptable: John Zurell

Coating Repair

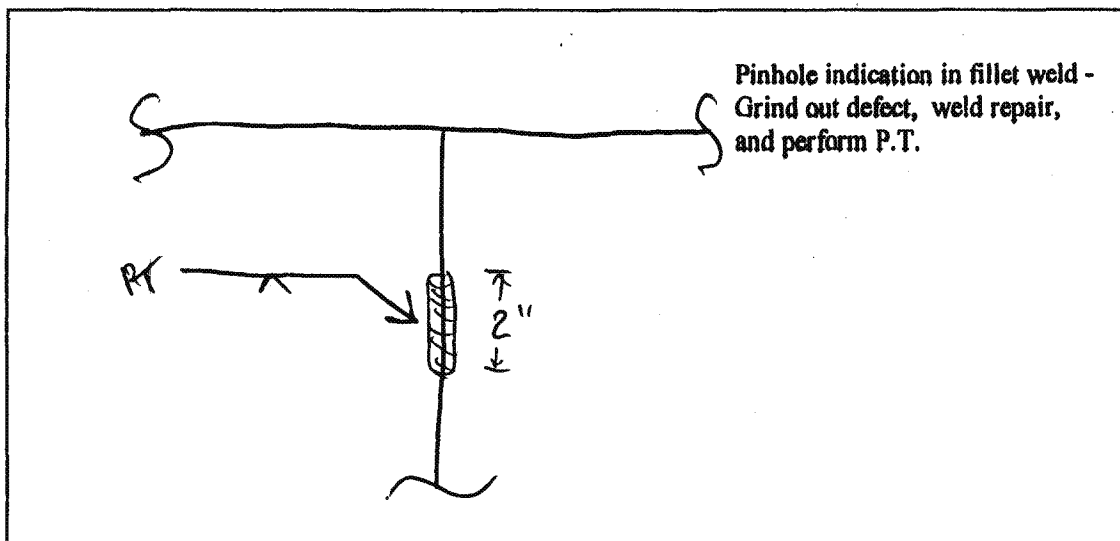
Sketch of Repair Area

Tank No.: 7 Repair No.: 048 Type: 9 Location: B11-8

Weld Repair

Repair Acceptable: John Zehnell Date Accepted: 4-15-98

Coating Repair

Repair Acceptable: John Zehnell Date Accepted: 4-17-98

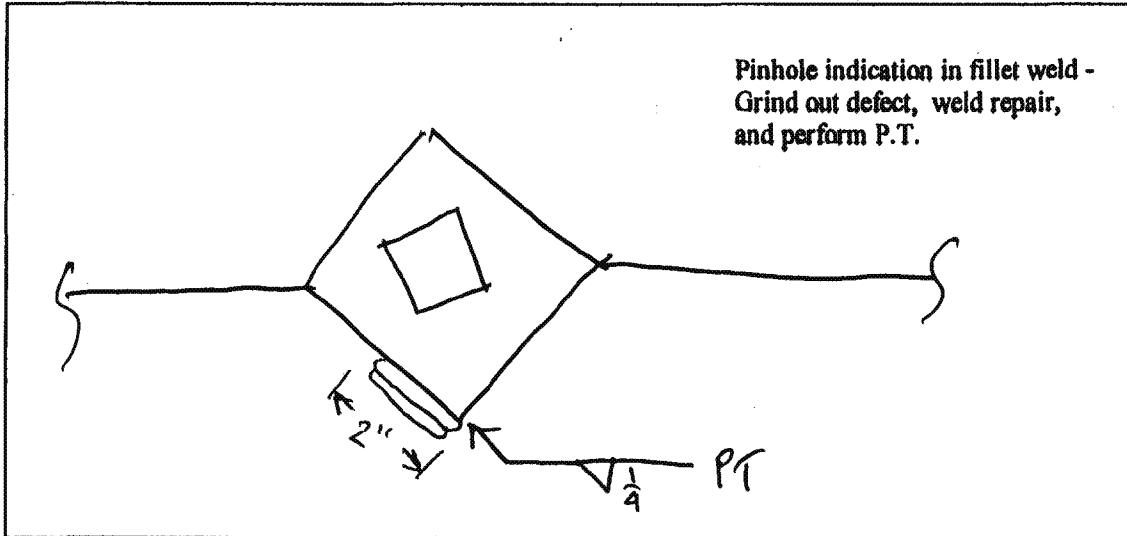
Sketch of Repair Area

Tank No.: 7 Repair No.: 049 Type: 10 Location: B9-15

Weld Repair

Repair Acceptable: John Zschell

Coating Repair

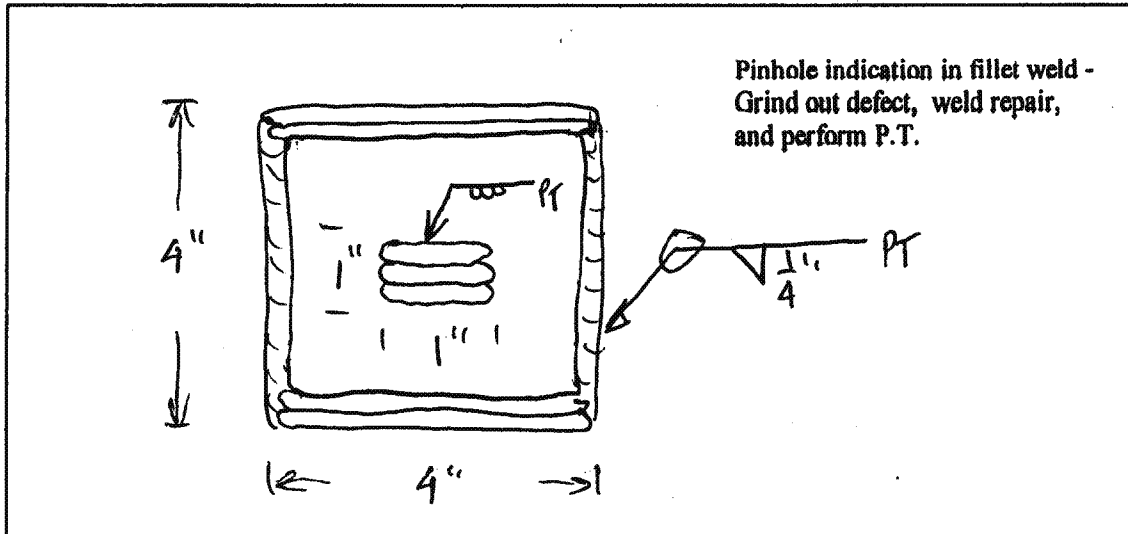
Sketch of Repair Area

Tank No.: 7 Repair No.: 050 Type: 10 Location: B11-28

Weld Repair

Repair Acceptable: John Zischell Date Accepted: 4-15-98

Coating Repair

Repair Acceptable: John Zischell Date Accepted: 4-17-98

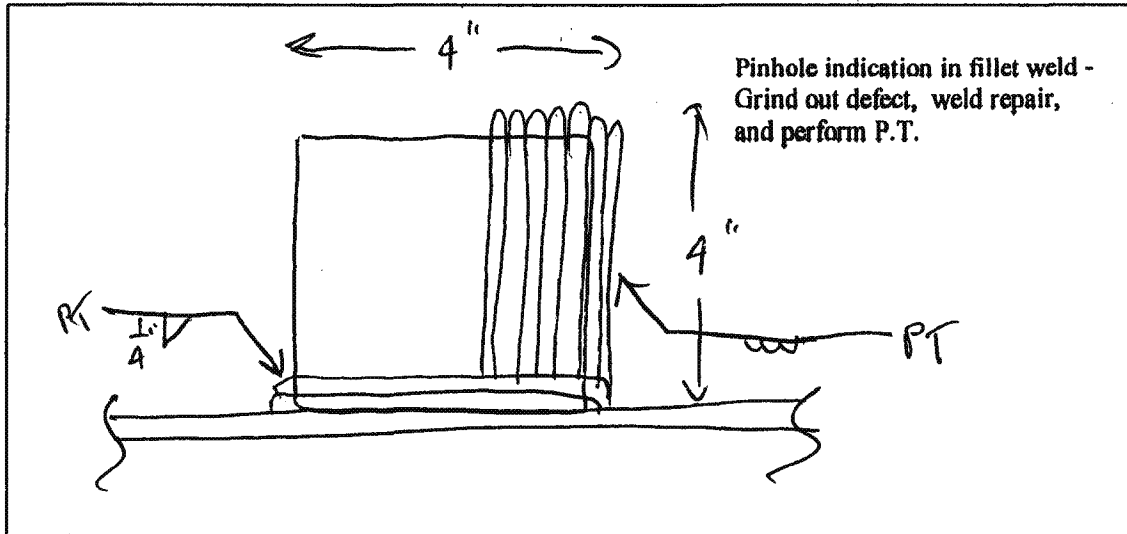
Sketch of Repair Area

Tank No.: 7 Repair No.: 051 Type: 10 Location: B8-28

Weld Repair

Repair Acceptable: John Zschell

Coating Repair

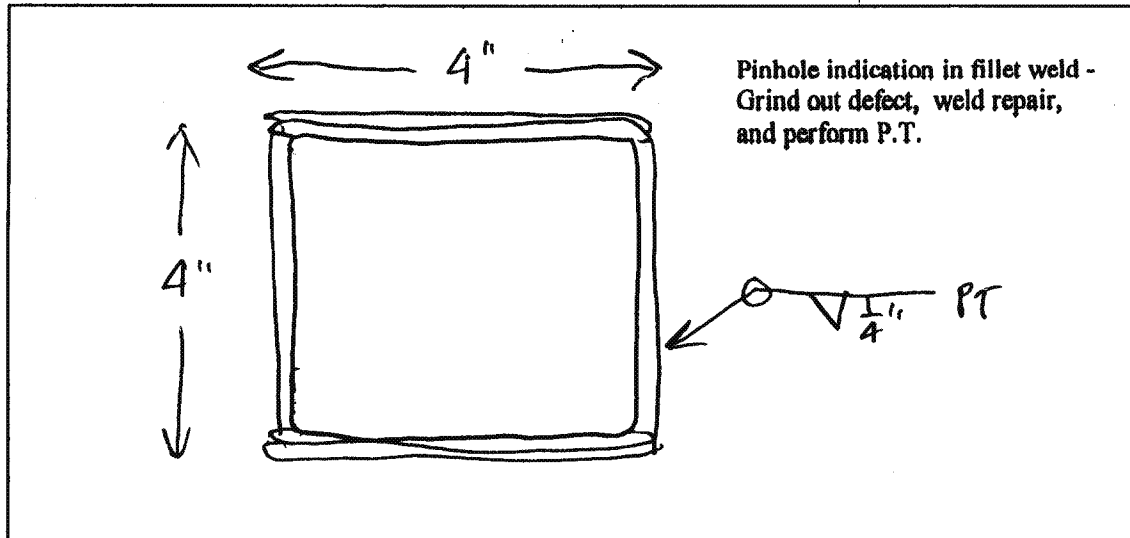
Sketch of Repair Area

Tank No.: 7 Repair No.: 052 Type: 10 Location: B7-28

Weld Repair

Repair Acceptable: John Zschell

Coating Repair

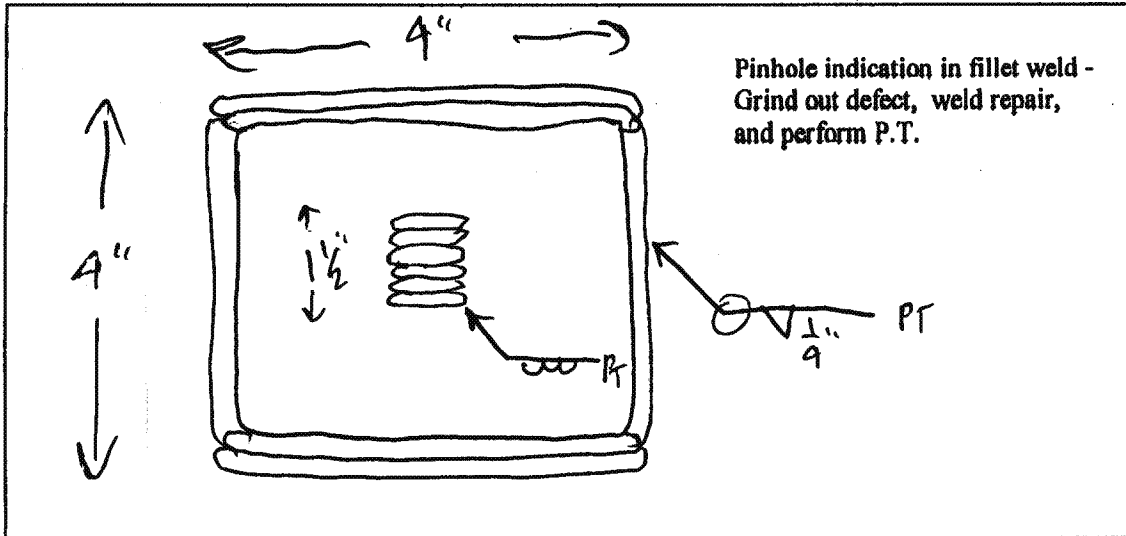
Sketch of Repair Area

Tank No.: 7 Repair No.: 053 Type: 10 Location: B6-28

Weld Repair

Repair Acceptable: John Zichell

Coating Repair

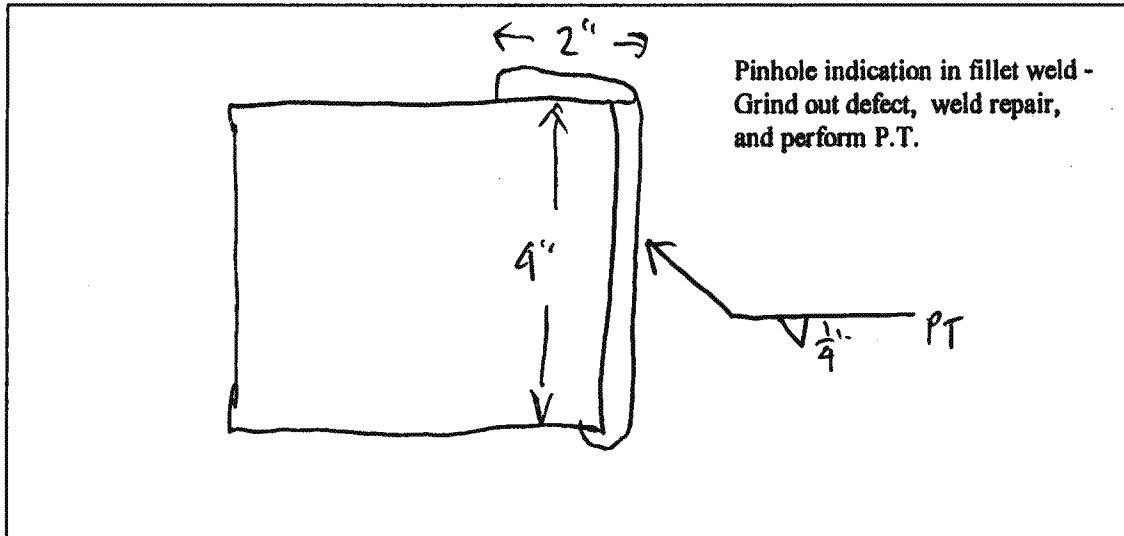
Sketch of Repair Area

Tank No.: 7 Repair No.: 054 Type: 10 Location: B5-28

Weld Repair

Repair Acceptable: John Zichell

Coating Repair

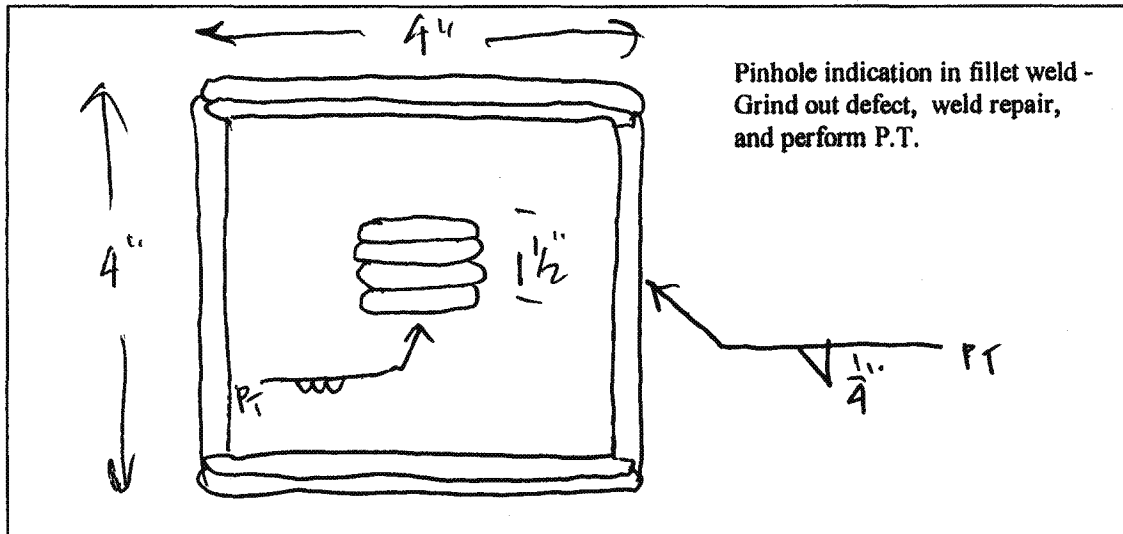
Sketch of Repair Area

Tank No.: 7 Repair No.: 055 Type: 10 Location: B4-28

Weld Repair

Repair Acceptable: John Zurell

Coating Repair

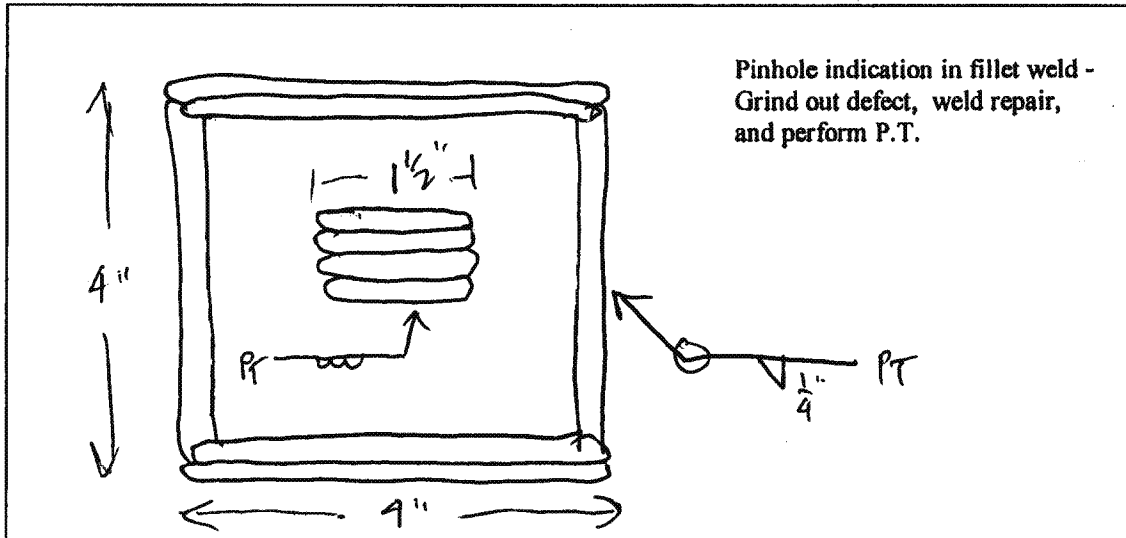
Sketch of Repair Area

Tank No.: 7 Repair No.: 056 Type: 10 Location: B2-28

Weld Repair

Repair Acceptable: John Zedell Date Accepted: 4-15-98

Coating Repair

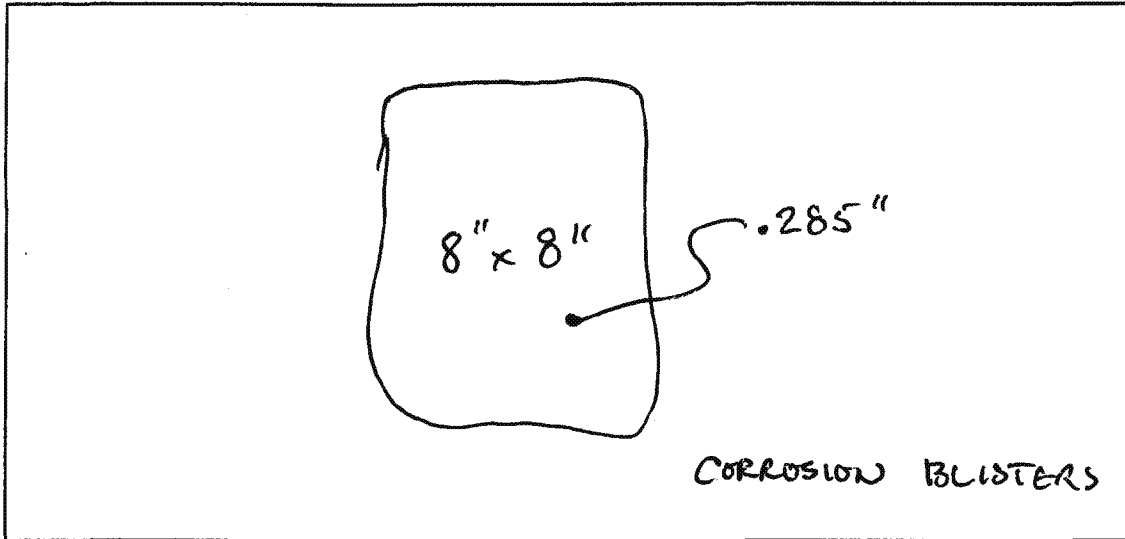
Sketch of Repair Area

Tank No.: 7 Repair No.: 057 Type: 8 Location: B11-3

Weld Repair

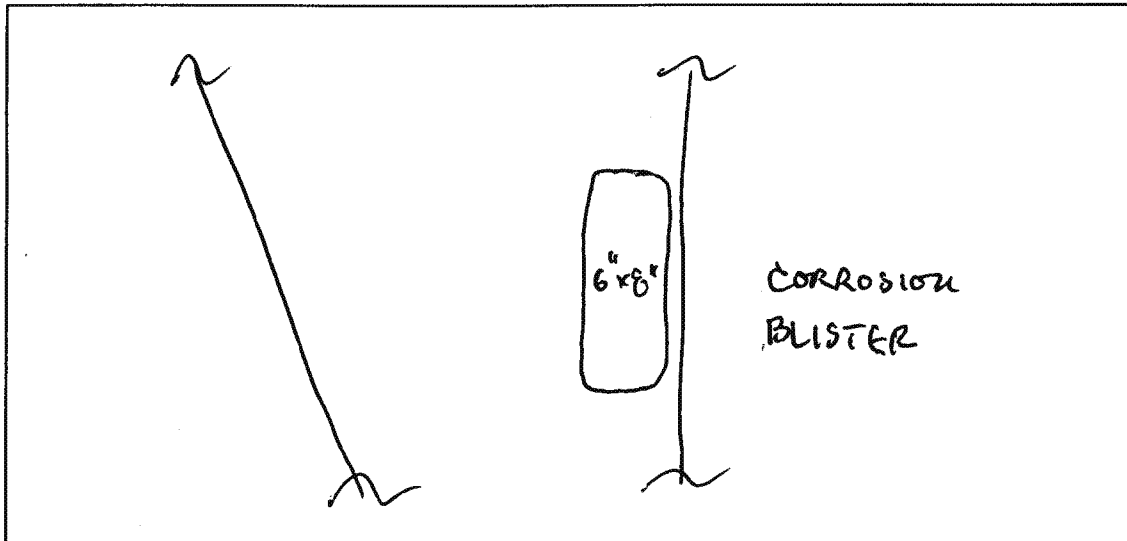
Sketch of Repair Area

Tank No.: 7 Repair No.: 058 Type: 8 Location: B11-3

Weld Repair N/A

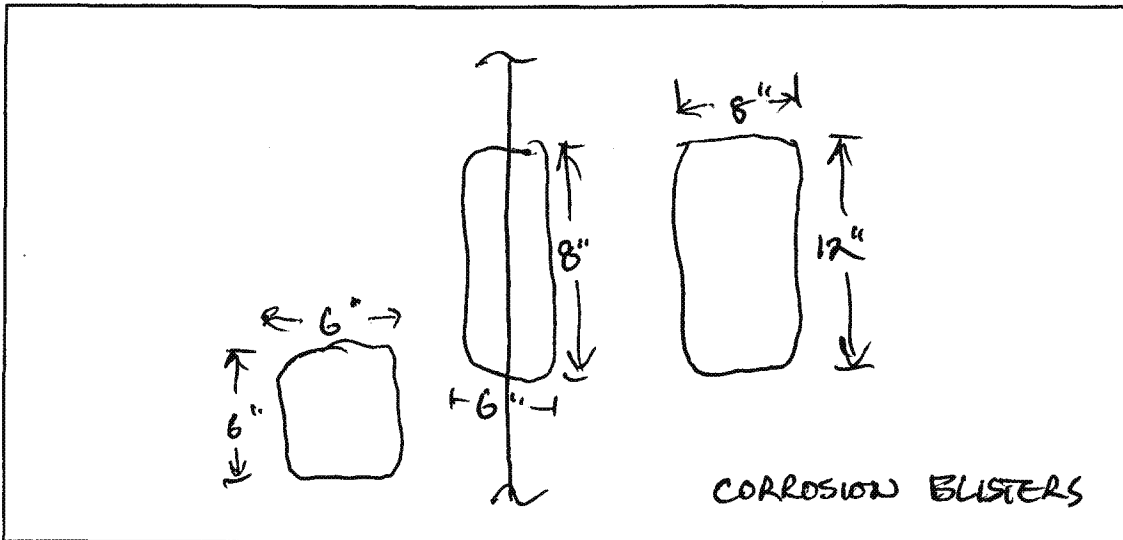
Sketch of Repair Area

Tank No.: 7 Repair No.: 059 Type: 8 Location: A3-3

Weld Repair N/A

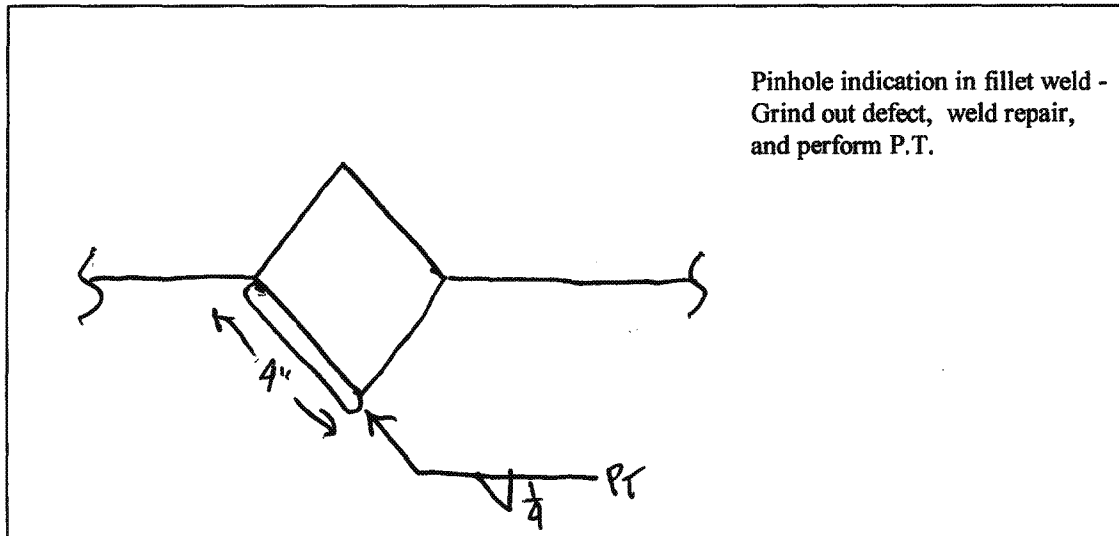
Sketch of Repair Area

Tank No.: 7 Repair No.: 060 Type: 10 Location: A1-17

Weld Repair
