2.1 Mid Atlantic Environmental, Inc. conducted an inspection on Tank #6 at the Red Hill Underground Storage Facility, Pearl Harbor, Hawaii. This inspection was conducted in accordance with the scope of work identified by Contract Number N00604-97-R-0013, PRL 96-21, titled "Emergency Repair for Red Hill Tanks."

RED HILL TANK NO. 6  
PRODUCT: JP-5

MID ATLANTIC ENVIRONMENTAL	
EMERGENCY REPAIRS FOR RED HILL TANKS	
Tank #6 RECOMMENDED REPAIR DRAWING	
Repair No.: 001	File# 001
UPPER DOME	Quadrant: D
Course: A	PLATE: 20
Drawn by: Tom Kitchen	Date: 7/1/98

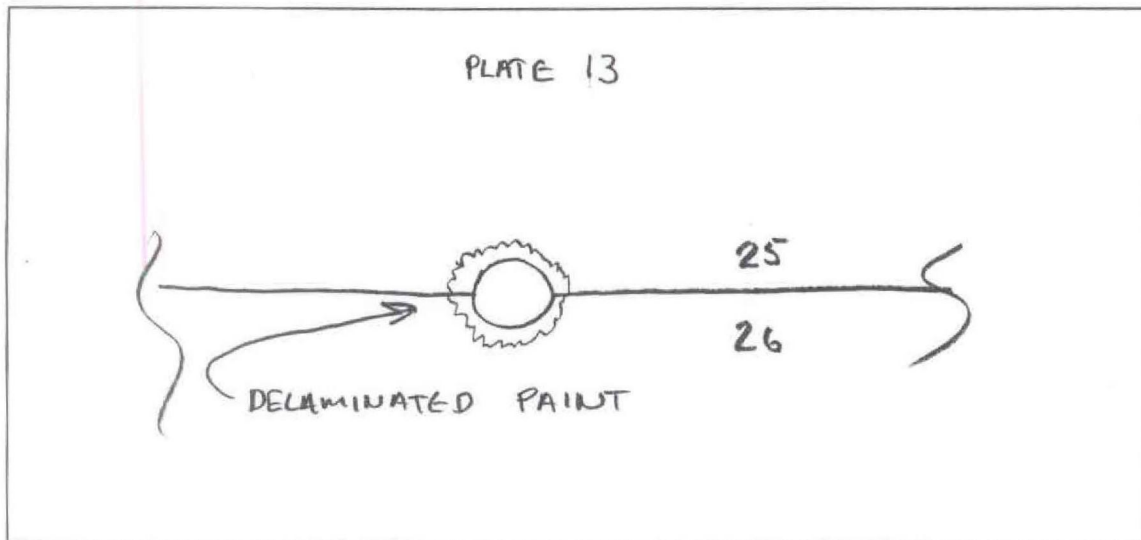
Tank No.: 6 Repair No.: 005 Type: 8 Location: C 13 25/26

DEFECT INSPECTED BY TK & JF 7/1/98

TYPE 8 REPAIR

MID ATLANTIC ENVIRONMENTAL	
EMERGENCY REPAIRS FOR RED HILL TANKS	
Tank #6 RECOMMENDED REPAIR DRAWING	
Repair No.: 005	File: 6R005
CYLINDER	Quadrant: C
Course: 25 & 26	PLATE: 13
Drawn by: Tom Kitchen	Date: 7/1/98
