TANK #2 - QUADRANT D

**3.0 TANK MAPS**  
Dunkin & Bush, Inc.  
Honolulu, HI  
Tank #2 - Quadrant C

### 3.0 TANK MAPS

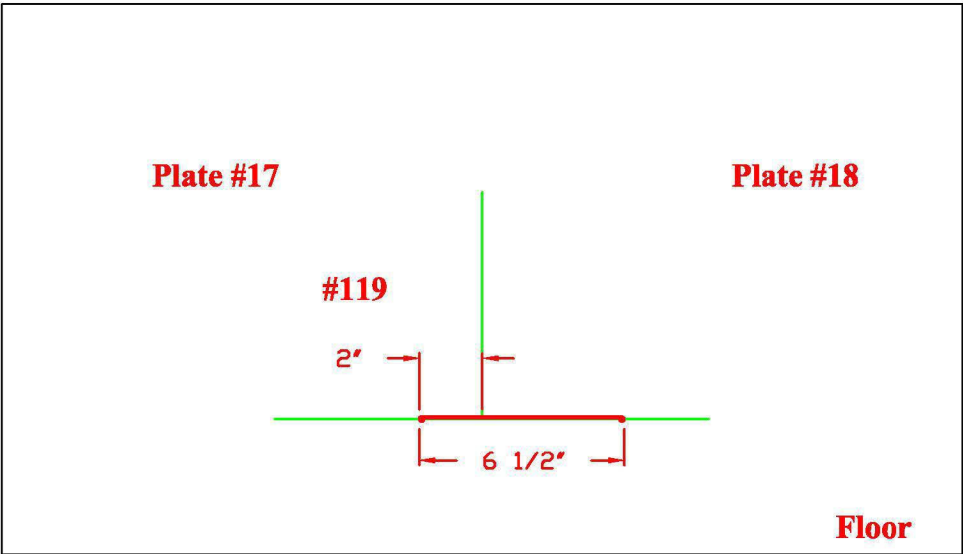
Tank Section: Floor/Shell  
Quadrant: D  
Course:  
Plate: # 17 - 18

Flaw #119 - Lack of fusion  
.211" depth 6 1/2" long (top)

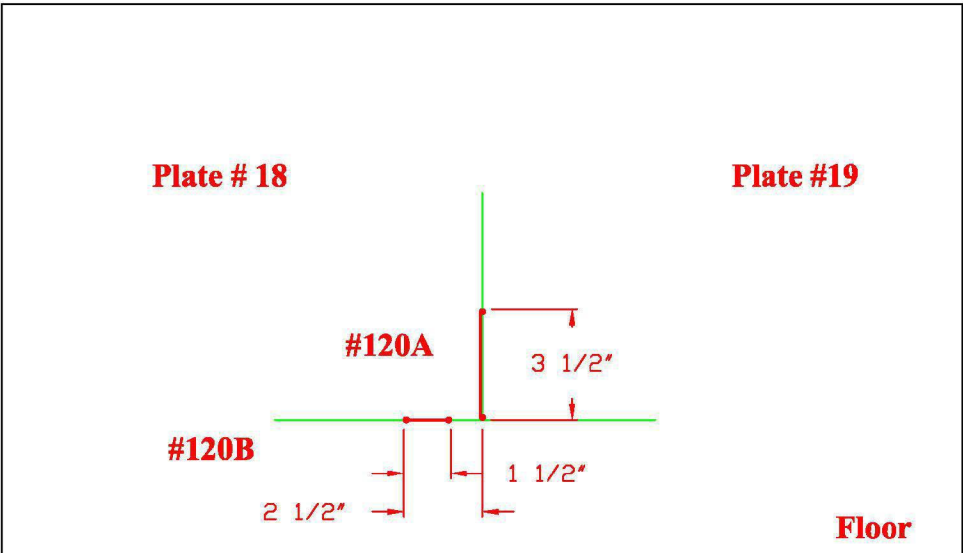
Tank Section: Floor/Shell  
Quadrant: D  
Course:  
Plate: # 18 - 19

Flaw #120A - Lack of fusion  
.088" depth 3 1/2" long (left)  
Flaw #120B - Incomplete pen.  
.228" depth 1 1/2" long (center)

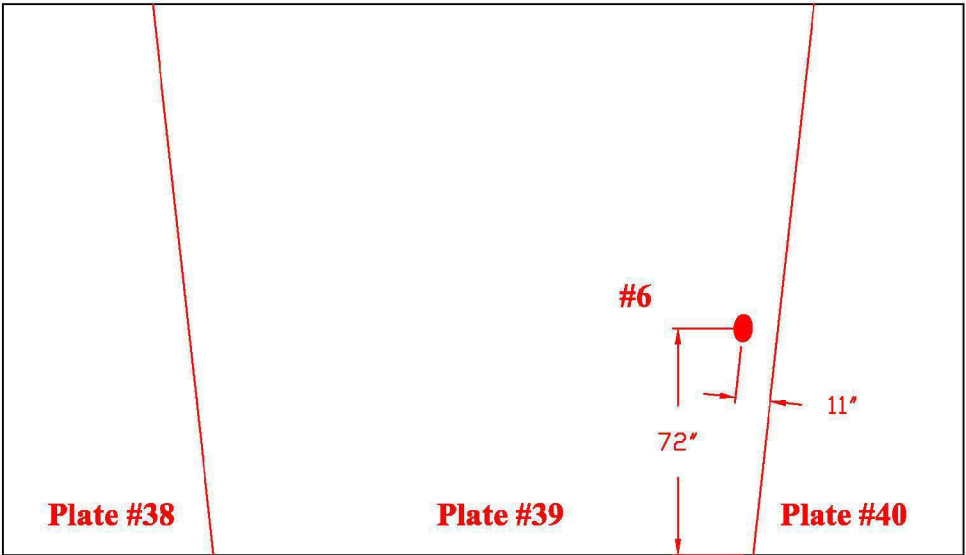
Tank Section: Lower dome  
Quadrant: C  
Course: 2  
Plate: # 39

Flaw # 6 - Dent  
N.S.W.L.

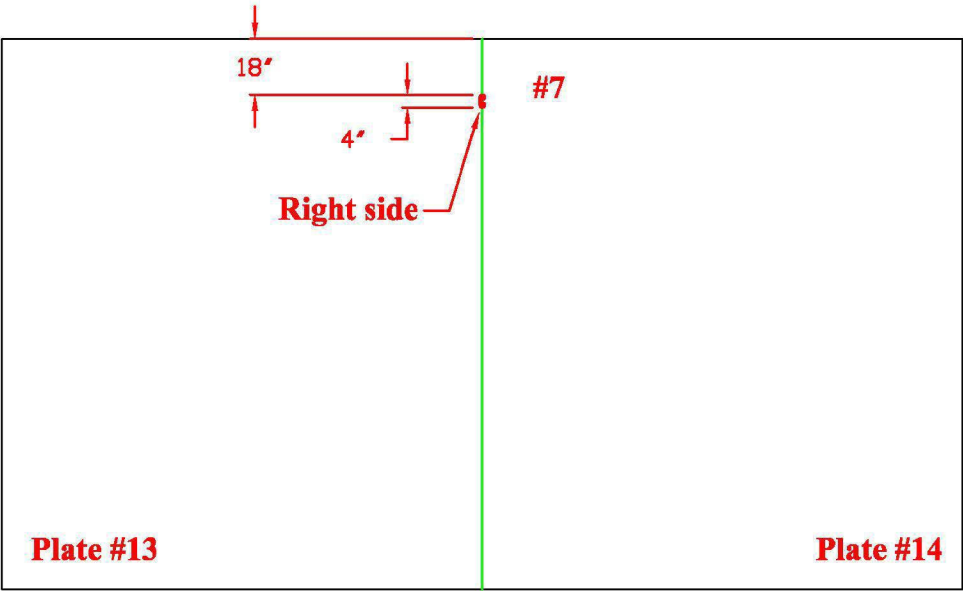
Tank Section: Lower dome  
Quadrant: A  
Course: 3  
Plate: #13 - 14

Flaw #7 - Lack of fusion  
.195" depth 4" long  
(right side)

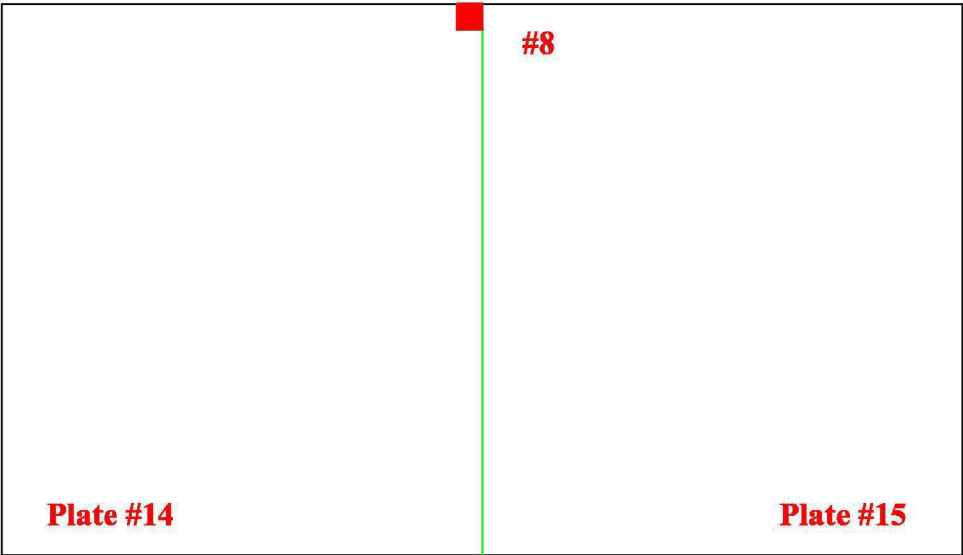
Tank Section: Lower dome  
Quadrant: A  
Course: 3  
Plate: #14 - 15

Flaw #8 - W.L.  
.223" Remaining

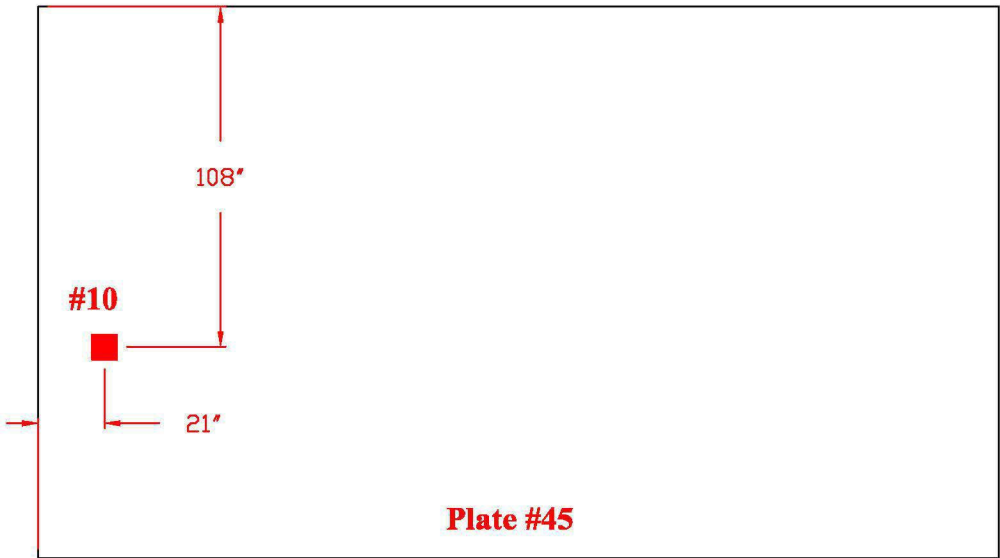
Tank Section: Lower dome  
Quadrant: C  
Course: 3  
Plate: #45

Flaw #10 - W.L./Pit  
.219 Remaining

**Flaw # 10:** The waveform above depicts underside corrosion exhibiting 0.219" wall remaining.

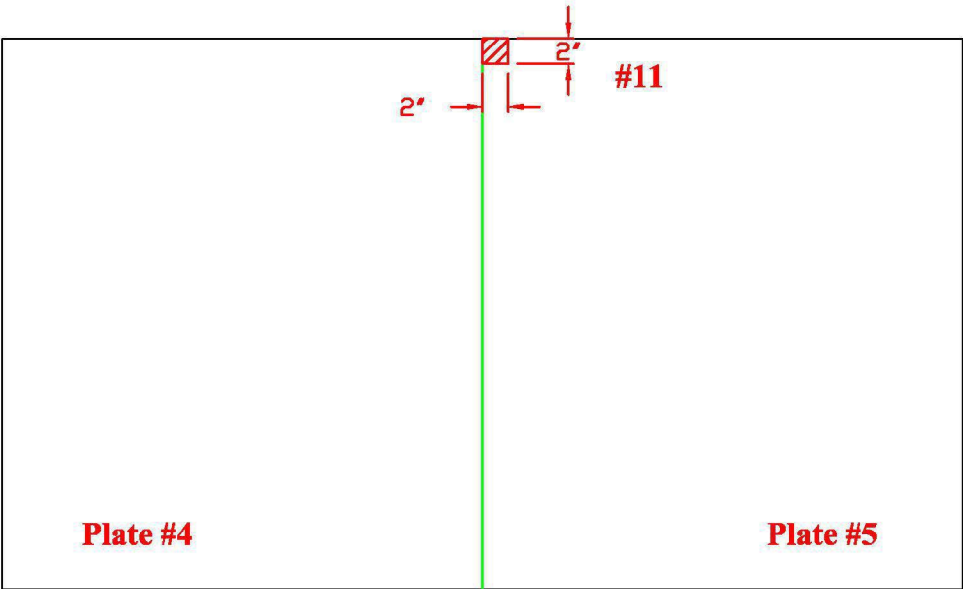
Tank Section: Lower dome  
Quadrant: A  
Course: 3  
Plate: # 5

Flaw #11 - W.L.  
.226" Remaining

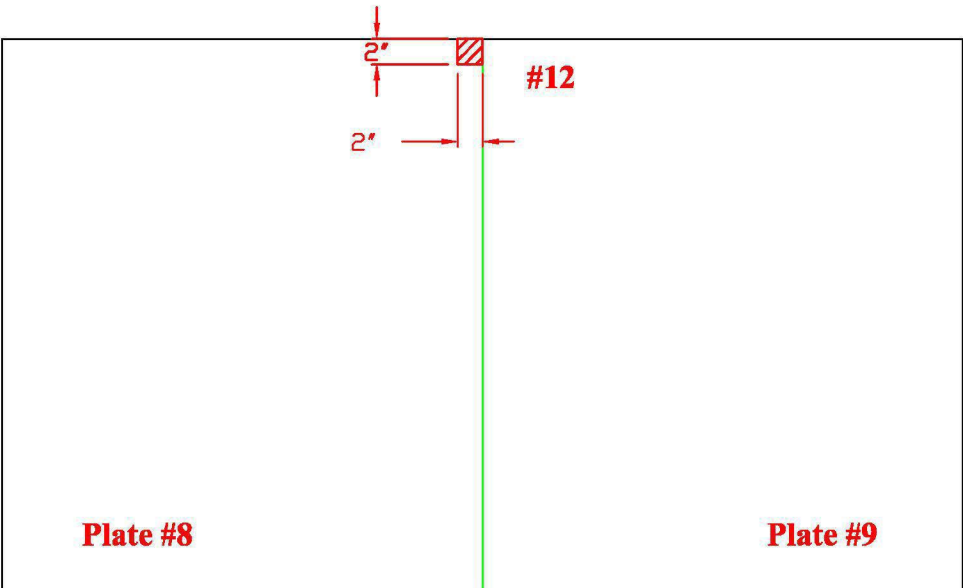
Tank Section: Lower dome  
Quadrant: A  
Course: 3  
Plate: # 8

Flaw #12 - W.L.  
.233" Remaining

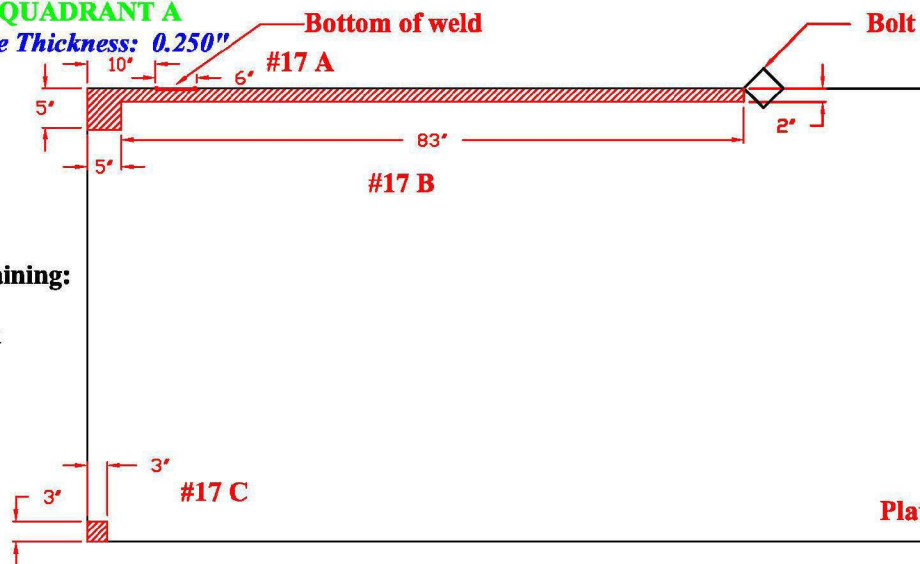
**Course: 21**  
**Plate #: 3**

#17A - Lack of fusion  
.173" depth 6" long  
(bottom of weld)

#17B - W.L. - .224"

#17C - W.L. - .234"

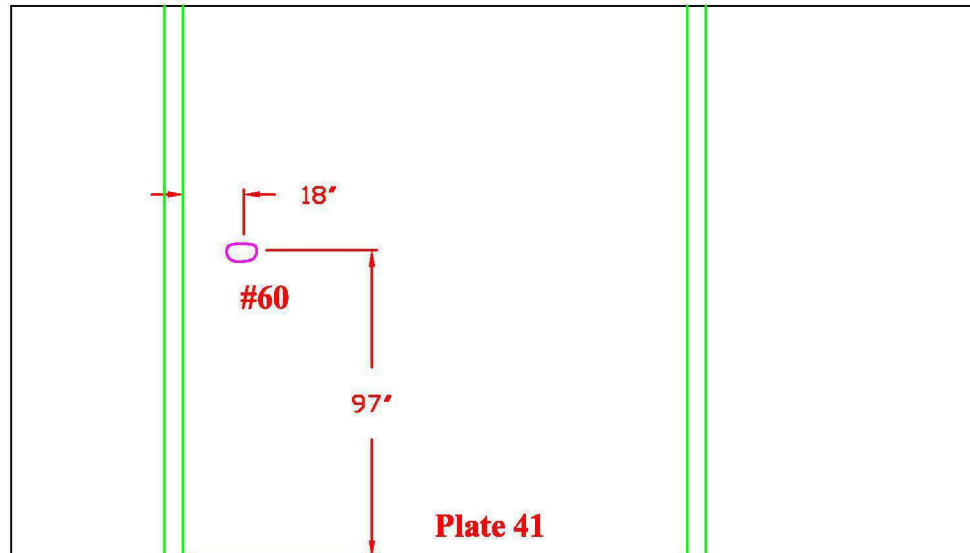
**Tank Section: Upper dome**  
**Quadrant: C**  
**Course: A**  
**Plate: # 41**

**Flaw # 60 - Dent**  
**.165 deep 1½" dia N.S.W.L.**

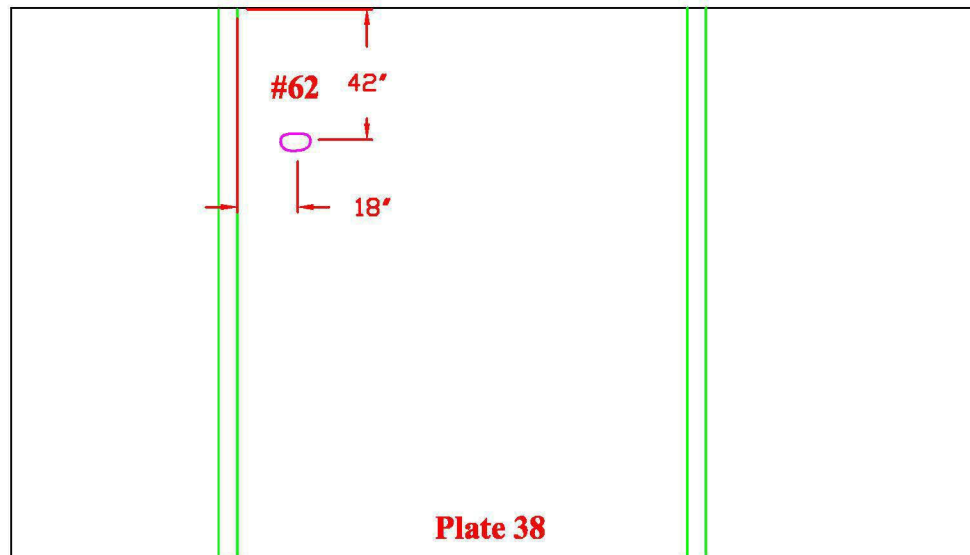
**Tank Section: Upper dome**  
**Quadrant: C**  
**Course: A**  
**Plate: # 38**

**Flaw # 62 - Dent**  
**.480 deep 2" dia N.S.W.L.**

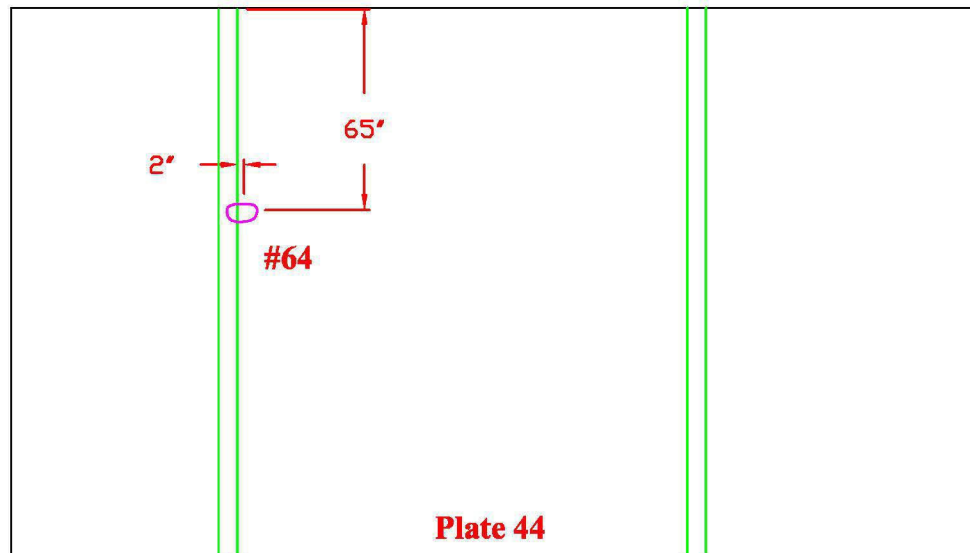
**Tank Section: Upper dome**  
**Quadrant: C**  
**Course: A**  
**Plate: # 44**

**Flaw # 64 - Dent**  
**.115 deep 2" dia N.S.W.L.**

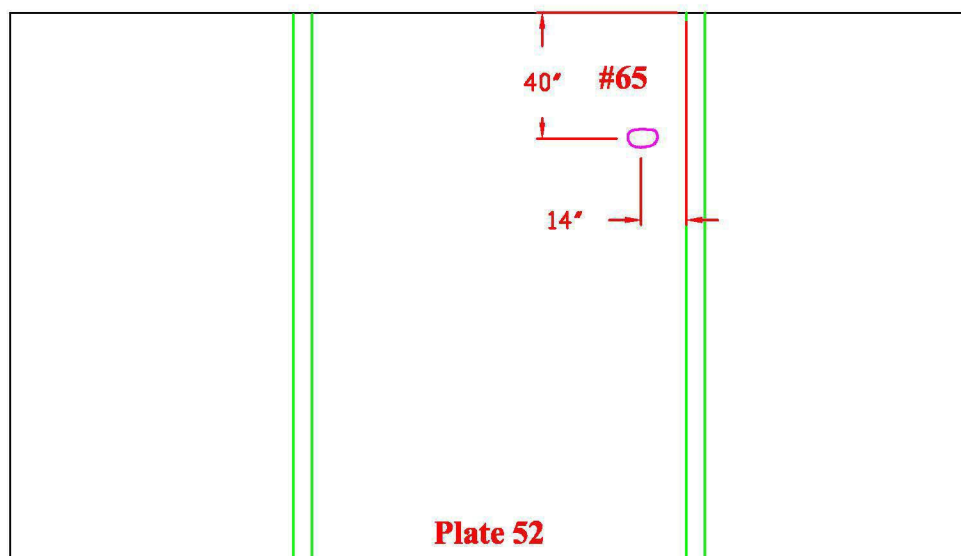
**Tank Section: Upper dome**  
**Quadrant: C**  
**Course: A**  
**Plate: # 52**

**Flaw # 65 - Dent**  
**.085 deep 1 1/2" dia N.S.W.L.**

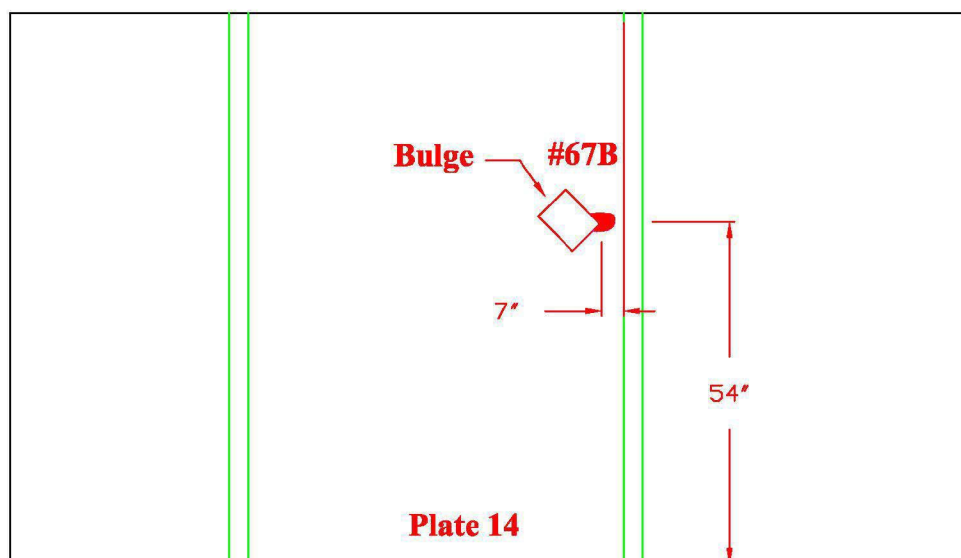
**Tank Section: Upper dome**  
**Quadrant: B**  
**Course: C**  
**Plate: # 14**

**Flaw # 67A - Patch**  
**.141 Remaining**

**Flaw # 67B - W.L.**  
**.185 Remaining**

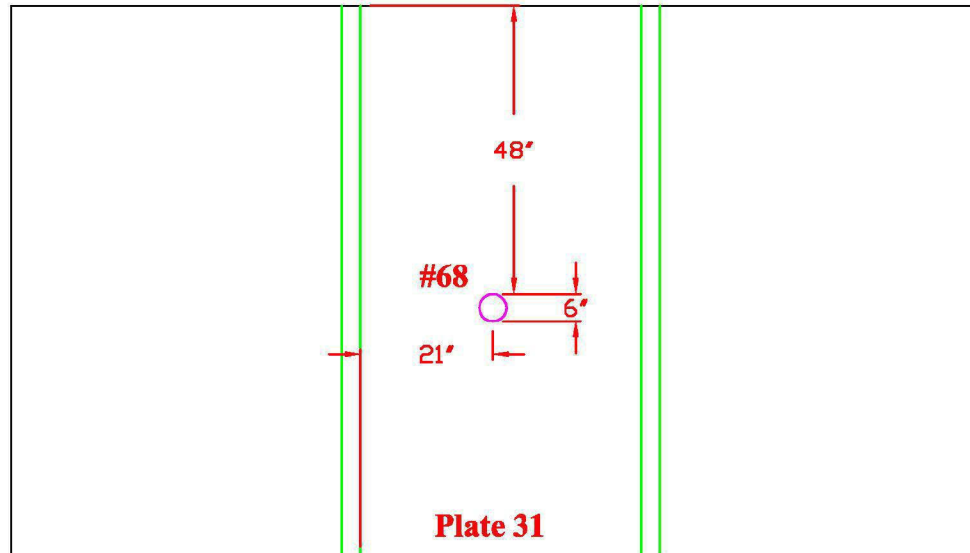
**Tank Section: Upper dome**  
**Quadrant: B**  
**Course: B**  
**Plate: # 31**

**Flaw # 68 - Dent**  
**.300 deep 6" dia N.S.W.L.**

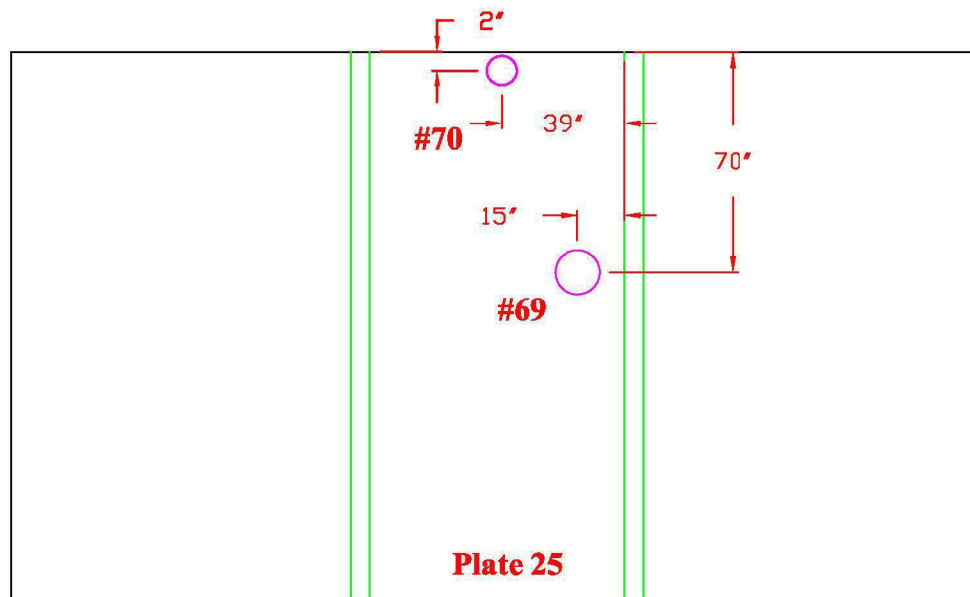
**Tank Section: Upper dome**  
**Quadrant: B**  
**Course: A**  
**Plate: # 25**

**Flaw # 69 - Patch**  
**.120 deep 1 ½" dia N.S.W.L.**

**Flaw # 70 - Dent**  
**.200 deep 2 ½" dia N.S.W.L.**

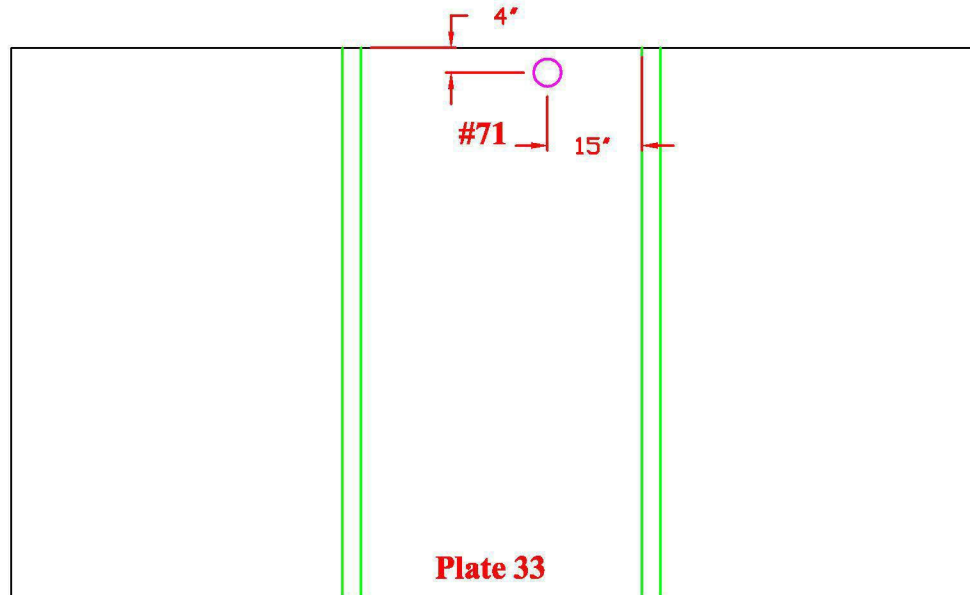
**Tank Section: Upper dome**  
**Quadrant: B**  
**Course: A**  
**Plate: # 33**

**Flaw # 71 - Dent**  
**.320 deep 3" dia N.S.W.L.**

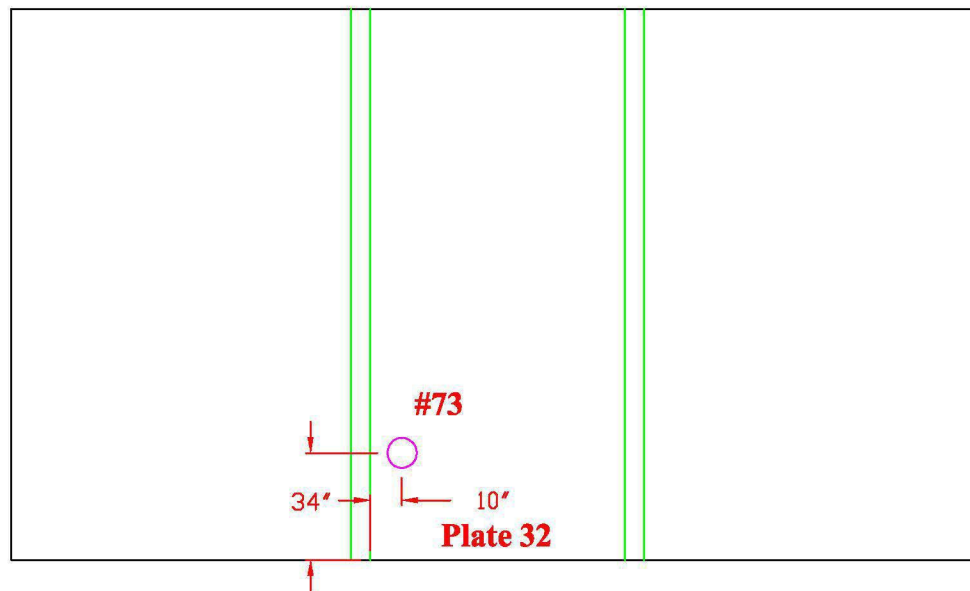
**Tank Section: Upper dome**  
**Quadrant: B**  
**Course: A**  
**Plate: # 32**

**Flaw # 73 - Dent**  
**.170 deep 2" dia N.S.W.L.**

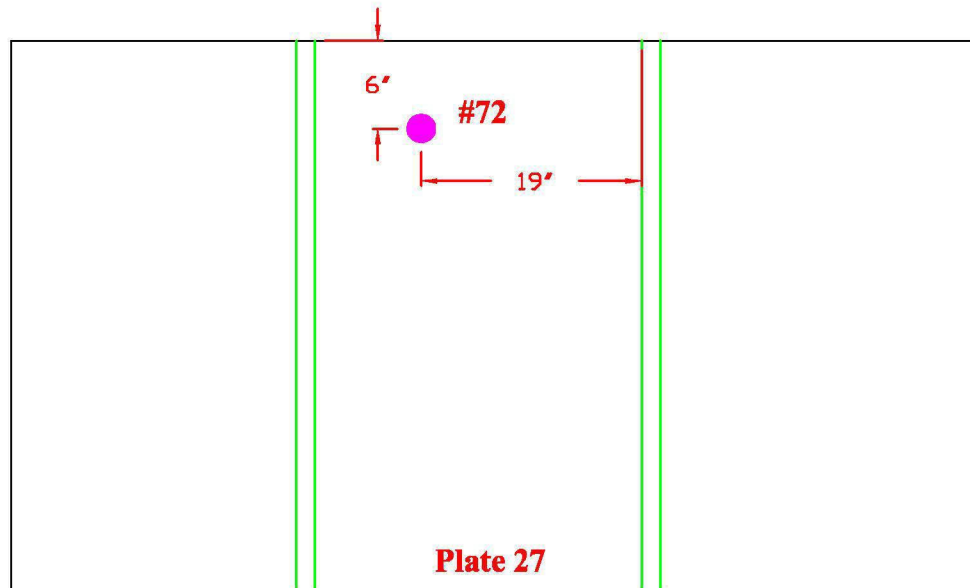
**Tank Section: Upper dome**  
**Quadrant: B**  
**Course: A**  
**Plate: # 27**

**Flaw # 72 - T.S. Pit**  
**.210" Remaining**

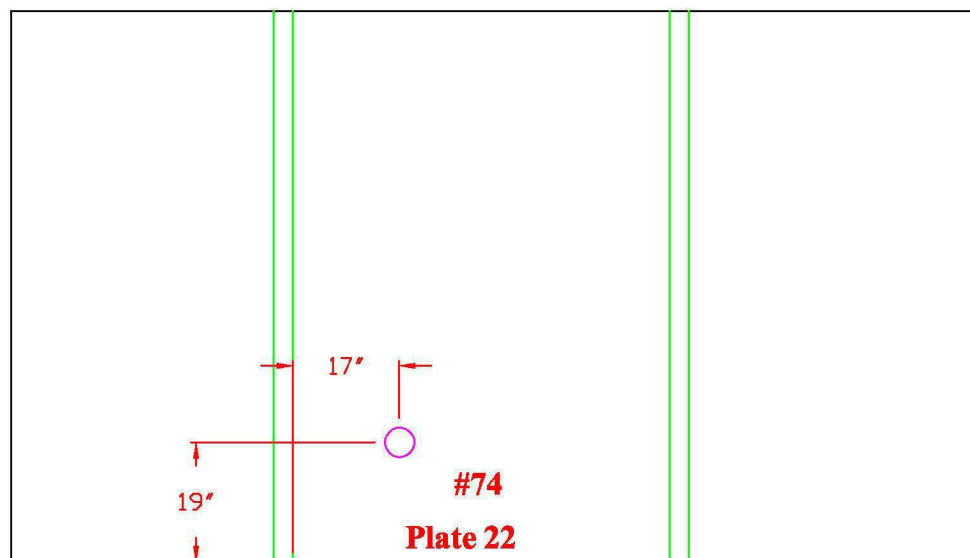
**Tank Section: Upper dome**  
**Quadrant: B**  
**Course: B**  
**Plate: # 22**

**Flaw # 74 - Dent**  
**.260 deep 3" dia N.S.W.L.**

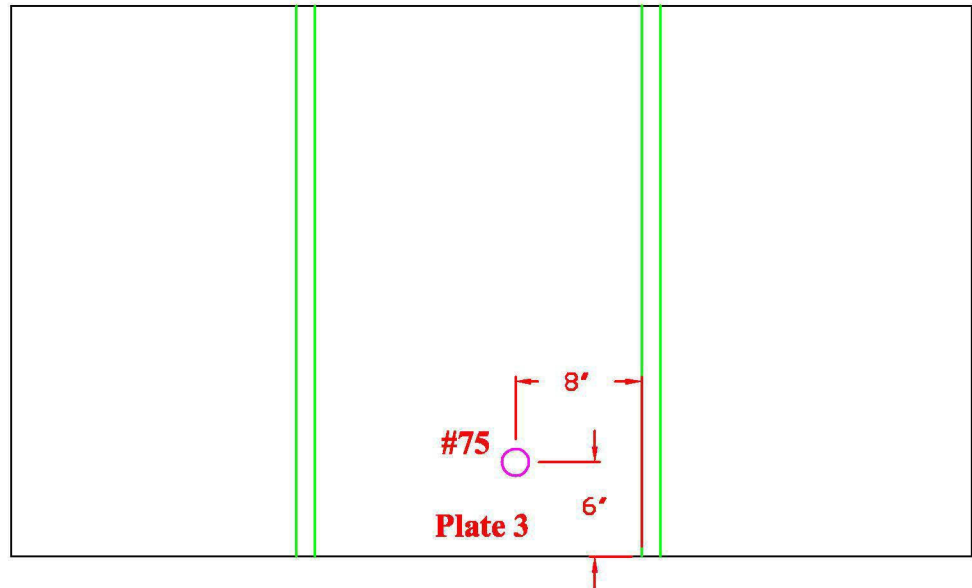
**Tank Section: Upper dome**  
**Quadrant: A**  
**Course: B**  
**Plate: # 3**

**Flaw # 75 - Dent**  
**.250" deep 1½"-2" dia**  
**N.S.W.L.**

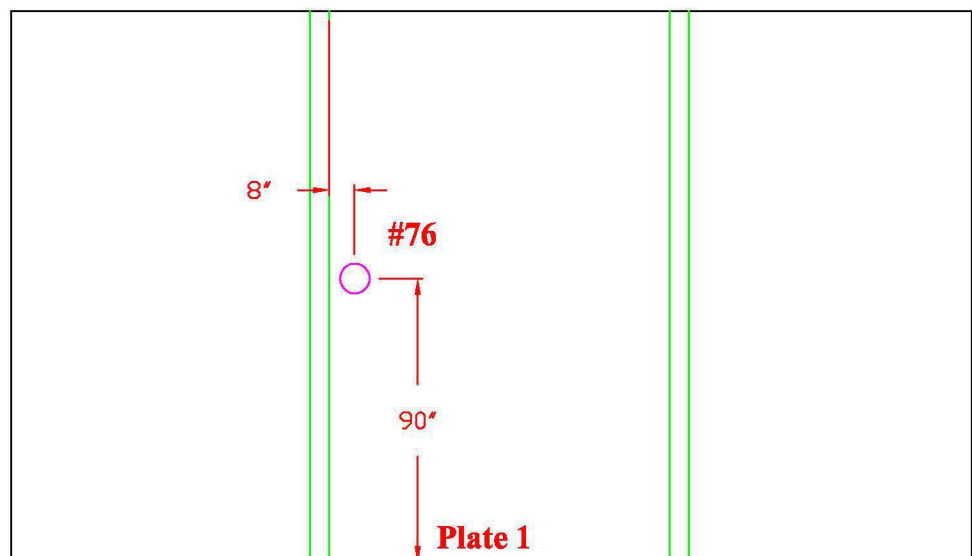
**Tank Section: Upper dome**  
**Quadrant: A**  
**Course: B**  
**Plate: # 1**

**Flaw # 76 - Thru Wall Pit**  
**.232 depth 3/16" dia**

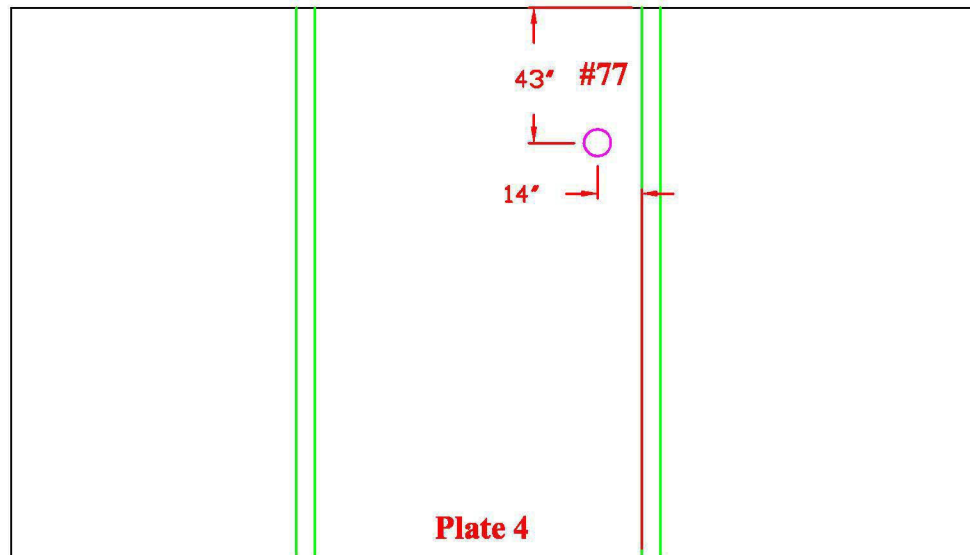
**Tank Section: Upper dome**  
**Quadrant: A**  
**Course: A**  
**Plate: # 4**

**Flaw # 77 - Dent**  
**.165" deep 3" dia**  
**N.S.W.L.**

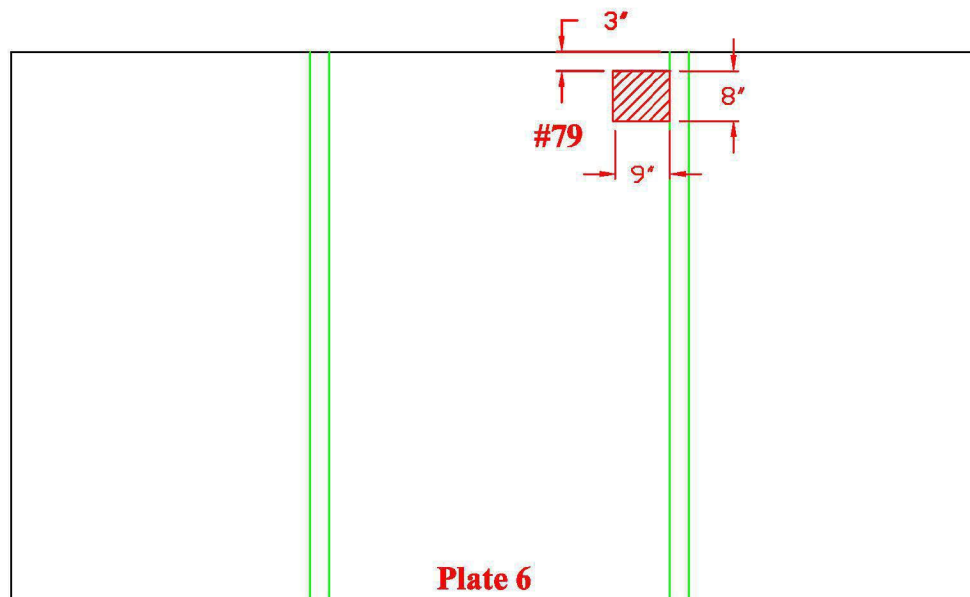
**Tank Section: Upper dome**  
**Quadrant: A**  
**Course: C**  
**Plate: # 6**

**Flaw # 79 - W.L.**  
**.210 Remaining**

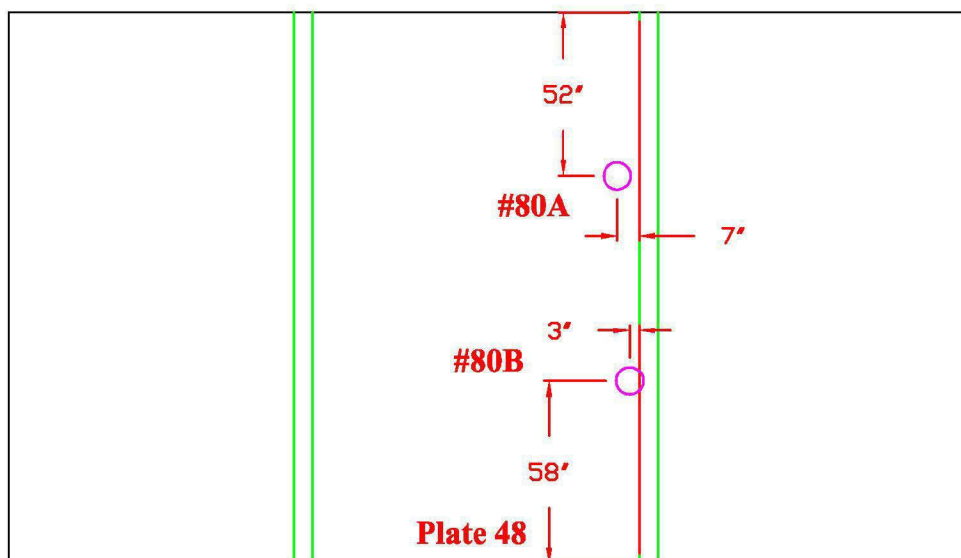
**Flaw # 80A - Dent**  
.255" deep 1 1/2" - 2" dia  
N.S.W.L.

**Flaw # 80B - Dent**  
.140" deep 1 1/2" - 2" dia  
N.S.W.L.

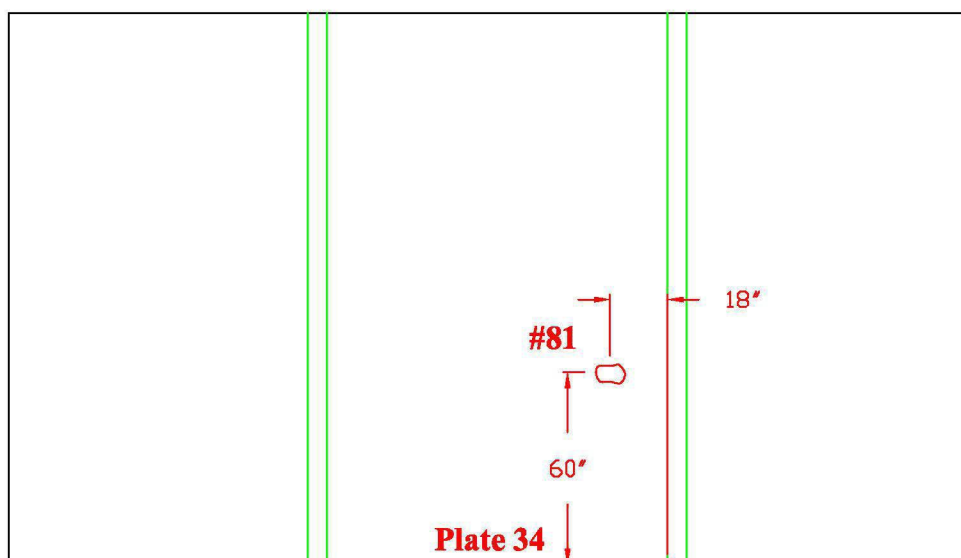
**Tank Section: Upper dome**  
**Quadrant: C**  
**Course: C**  
**Plate: # 34**

**Flaw # 81 - T.S. Pit**  
.055 deep

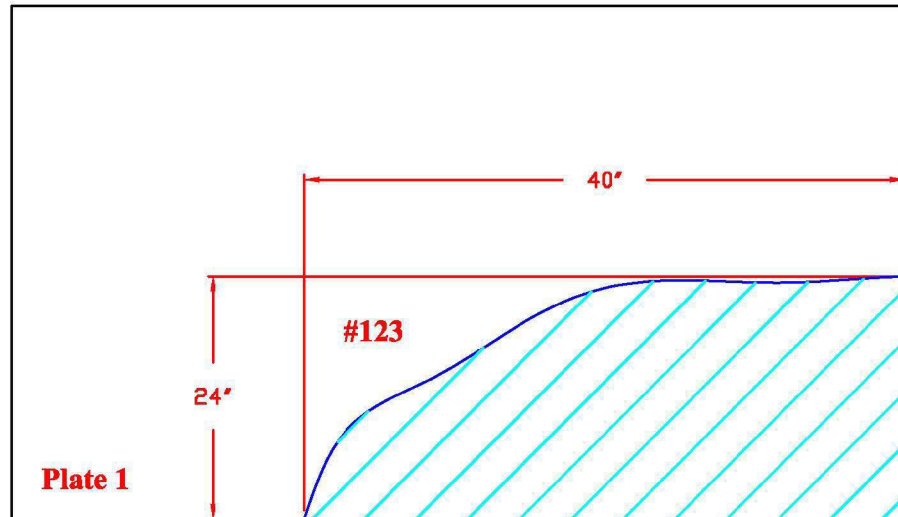
**Plate: # 1**

**Flaw # 123 - Bulge - N.S.W.L.**

Shear wave technique was performed on all welds in bulge area.

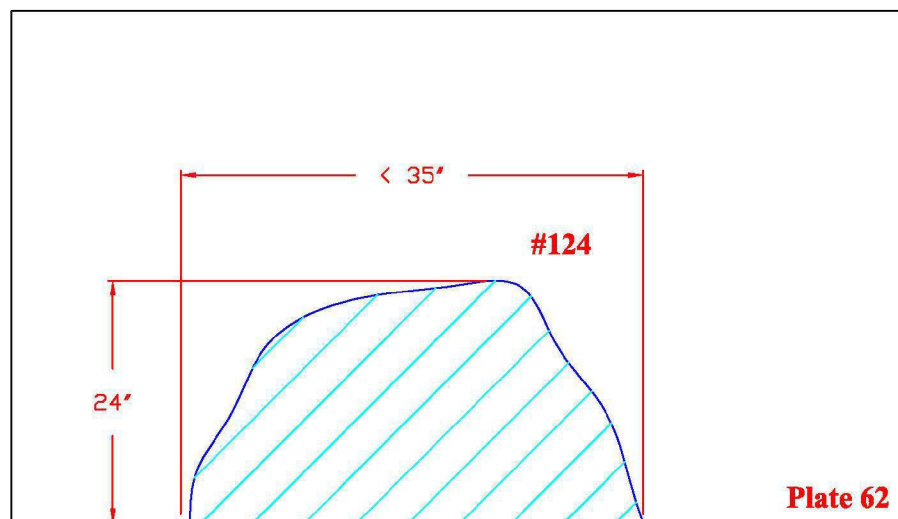
**Flaw # 124 - Bulge - N.S.W.L.**

Shear wave technique was performed on all welds in bulge area.

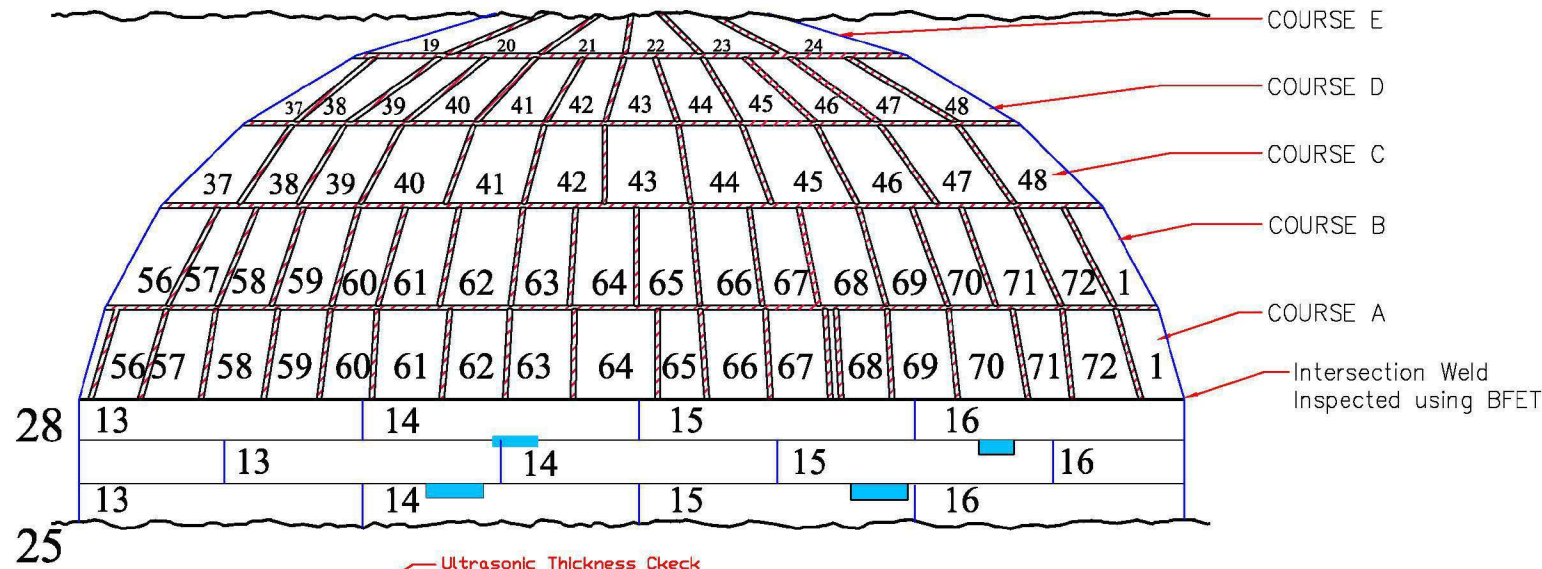
TANK # 2 - QUADRANT - D UPPER DOME (SECTIONS)

U.T. Range for All Channels tested: 0.135 - 0.150

Ultrasonic Thickness Check  
Point Pattern carried out on  
all channels in Tank # 2 at every 6"

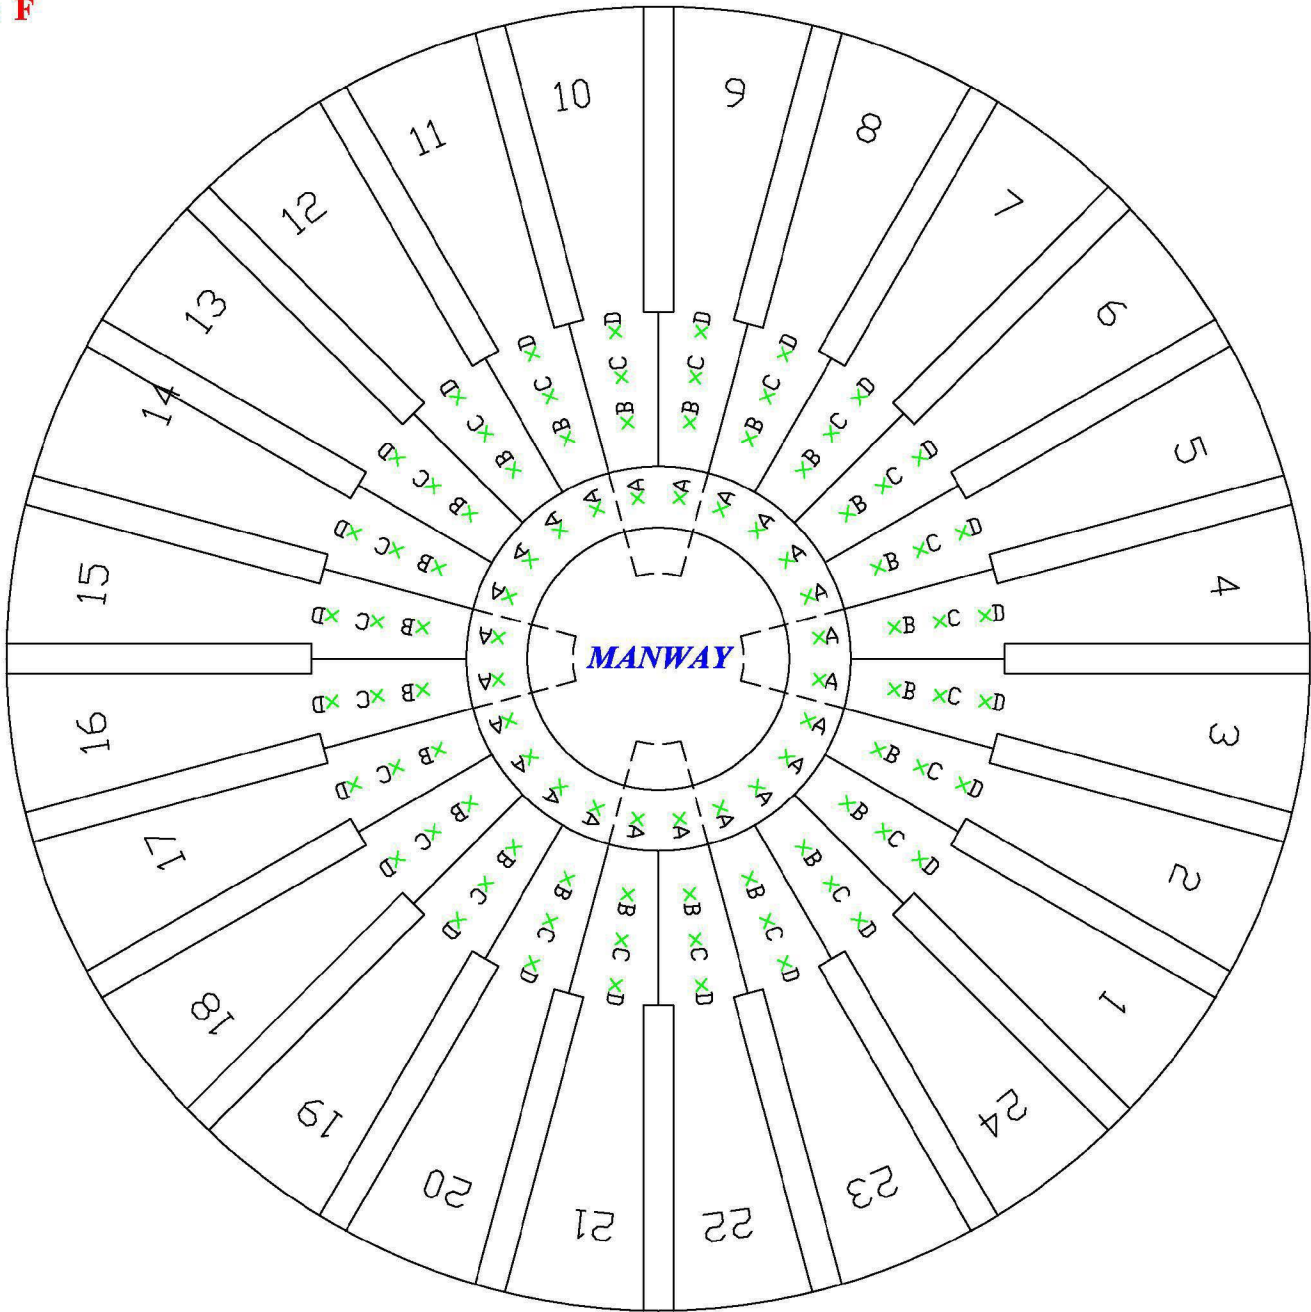
TANK #2 - Upper Dome Course F (U.T. Survey)  
\*Nominal Plate Thickness: 0.250"

#### U.T. Thickness Measurements of Upper Dome Course F

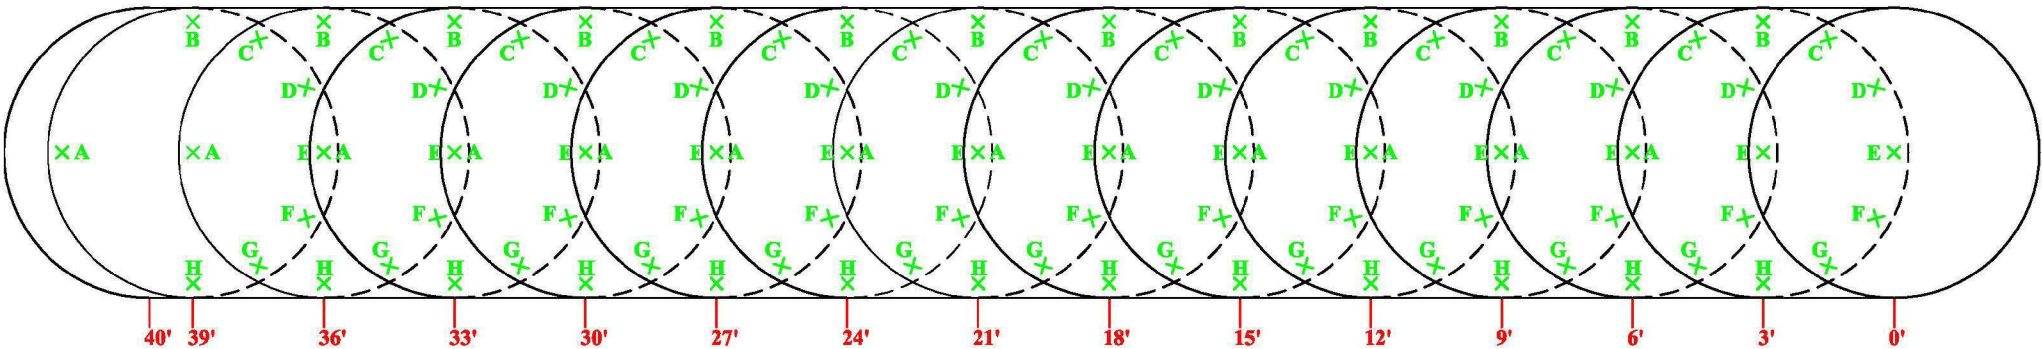
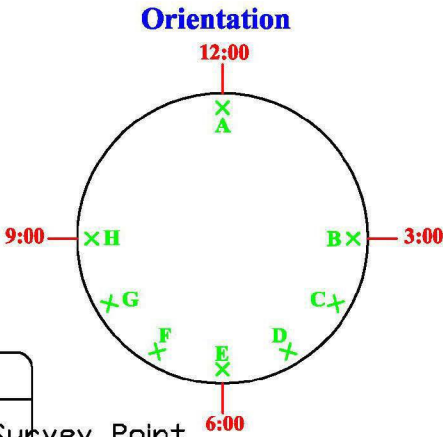
TANK #2 - 32" FUEL PIPE NOZZLE (U.T. Survey)

U.T. Thickness Measurements

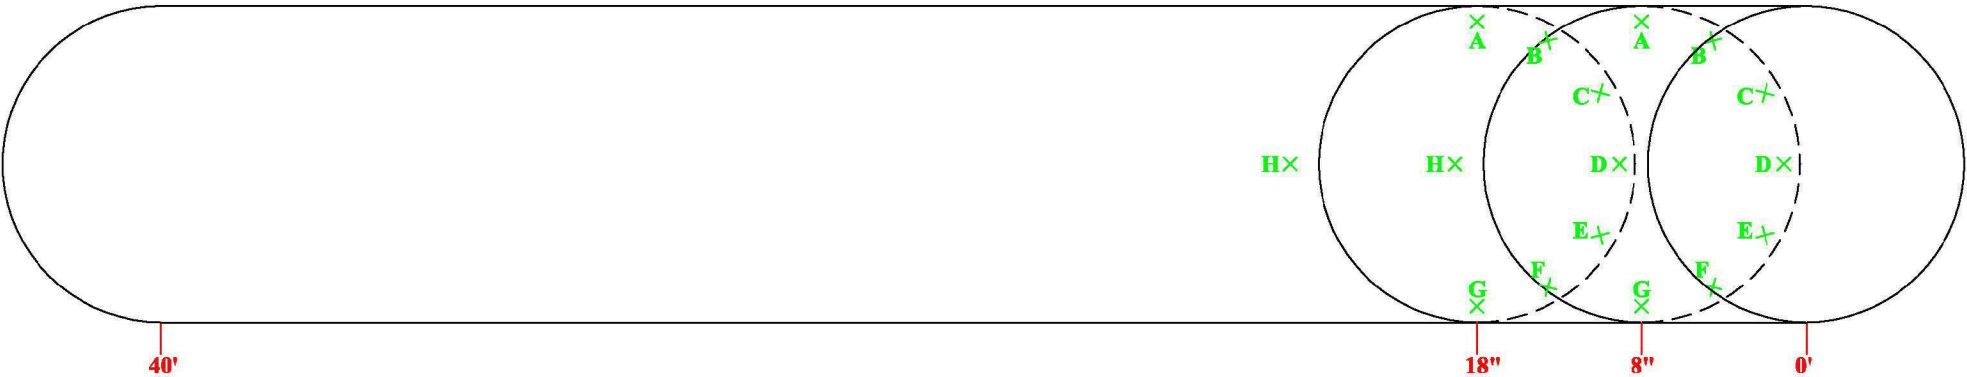
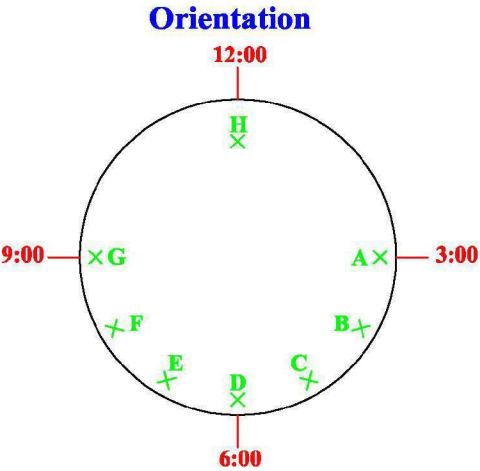
TANK #2 - 18" FUEL PIPE NOZZLE (U.T. Survey)

U.T. Thickness Measurements

| | A | B | C | D | E | F | G | H |
|---|---|---|---|---|---|---|---|---|
| 8" | 0.380" | 0.387" | 0.390" | 0.400" | 0.386" | 0.389" | 0.380" | 0.384" |
| 18" | 0.416" | 0.402" | 0.412" | 0.380" | 0.408" | 0.390" | 0.379" | 0.388" |

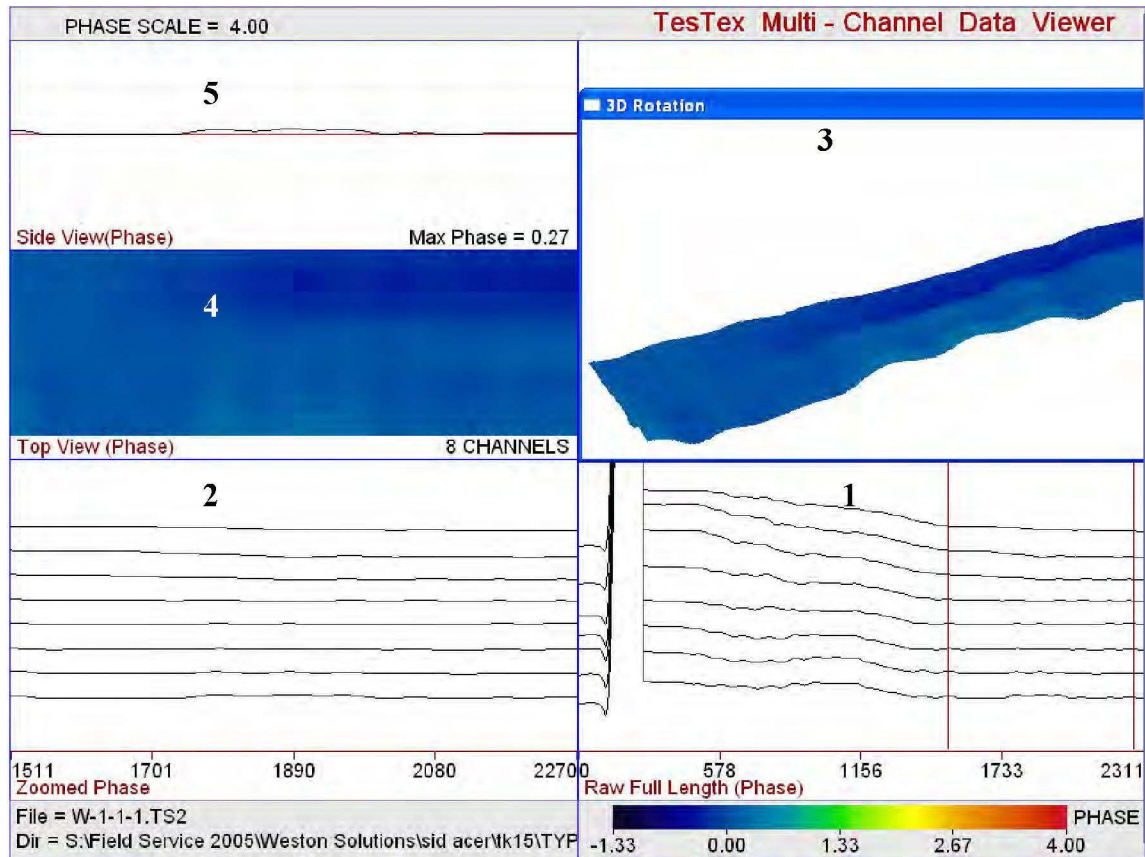
Tank #15

Shown above is a typical **TS-2000** waveform collected from the Barrel of Tank #15. This particular plate exhibits nominal wall thickness.
