Underground Storage Tank System Evaluation Final Report

Red Hill Bulk Fuel Storage Facility Joint Base Pearl Harbor-Hickam

June 2017

Date of Report: June 13, 2017

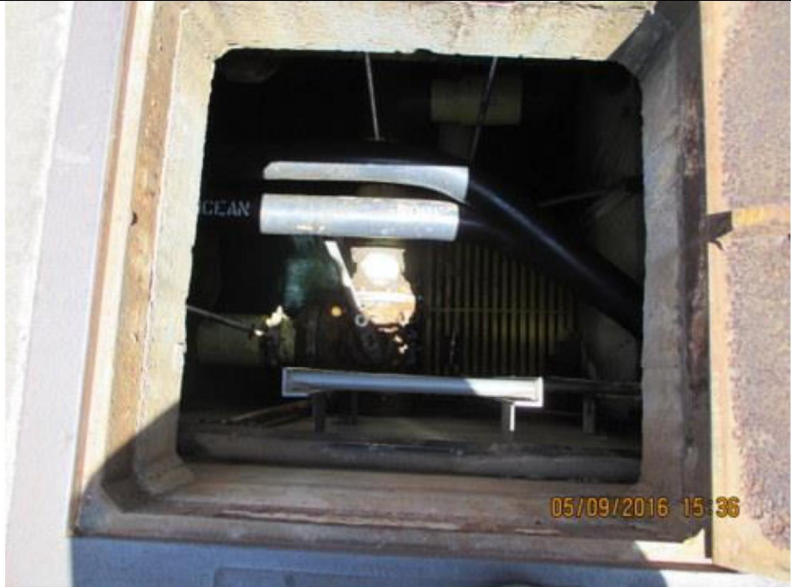
DATE TAKEN: 5/9/2016	
TAKEN BY: Chris Krejci	SITE LOCATION: Red Hill Facility
PHOTO #: 23	
COMMENTS: Diversion valve for Hotel Pier storm water drainage system

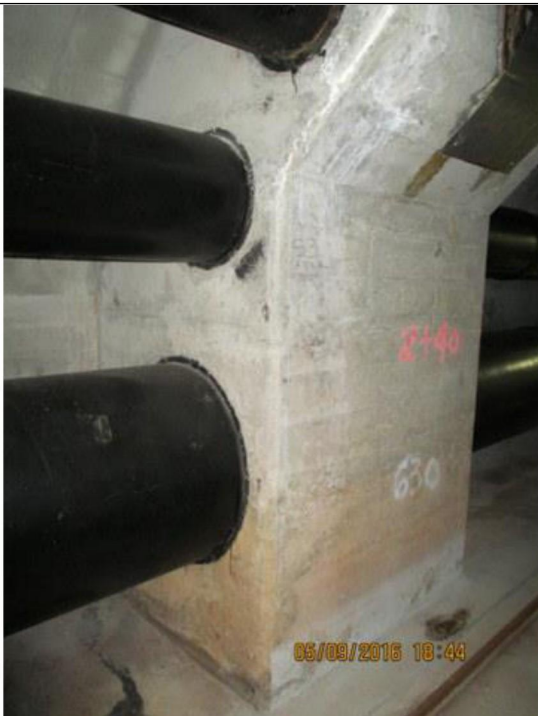
DATE TAKEN: 5/9/2016	
TAKEN BY: Chris Krejci	SITE LOCATION: Red Hill Facility
PHOTO #: 32	
COMMENTS: Pipelines supported by concrete wall in tunnel

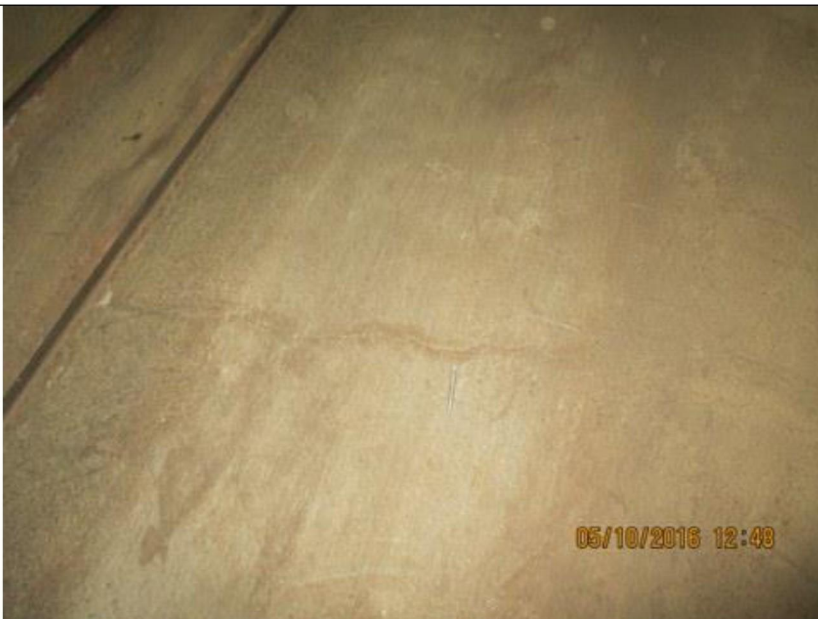
DATE TAKEN: 5/10/2016	
TAKEN BY: Chris Krejci	SITE LOCATION: Red Hill Facility
PHOTO #: 34	
COMMENTS: Minor cracking in tunnel floor

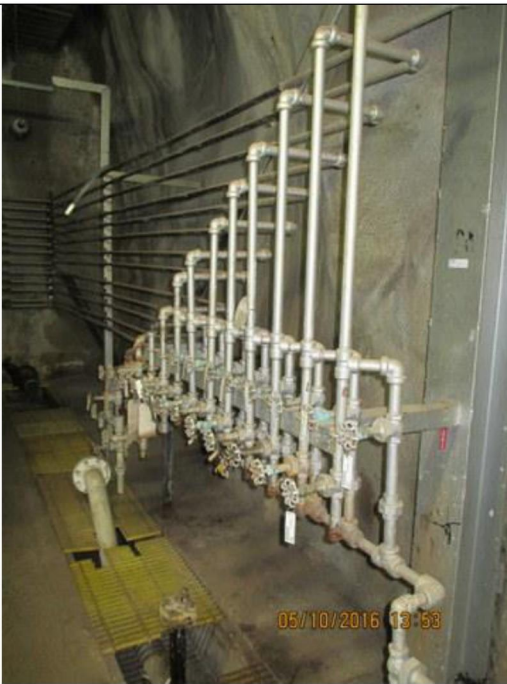
DATE TAKEN: 5/10/2016	
TAKEN BY: Chris Krejci	SITE LOCATION: Red Hill Facility
PHOTO #: 39	
COMMENTS: Tell-tale system on Tank 19 (Tank 19 has been permanently removed from service and the tell-tale system has been decommissioned).

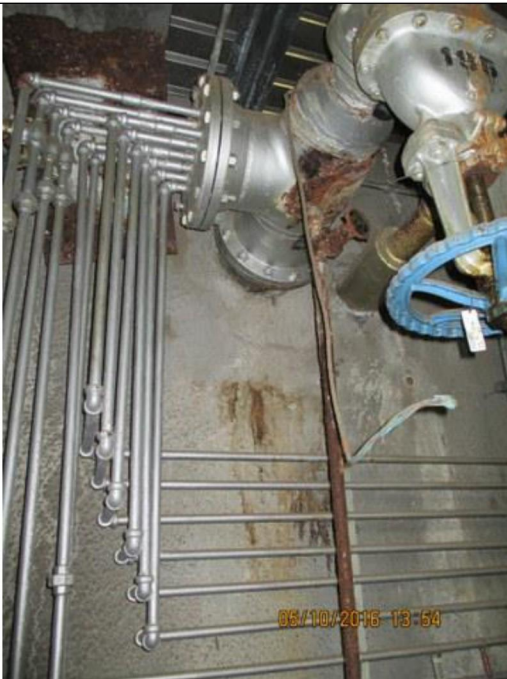
DATE TAKEN: 5/10/2016	
TAKEN BY: Chris Krejci	SITE LOCATION: Red Hill Facility
PHOTO #: 40	
COMMENTS: Tell-tale system on Tank 19 (Tank 19 has been permanently removed from service and the tell-tale system has been decommissioned).

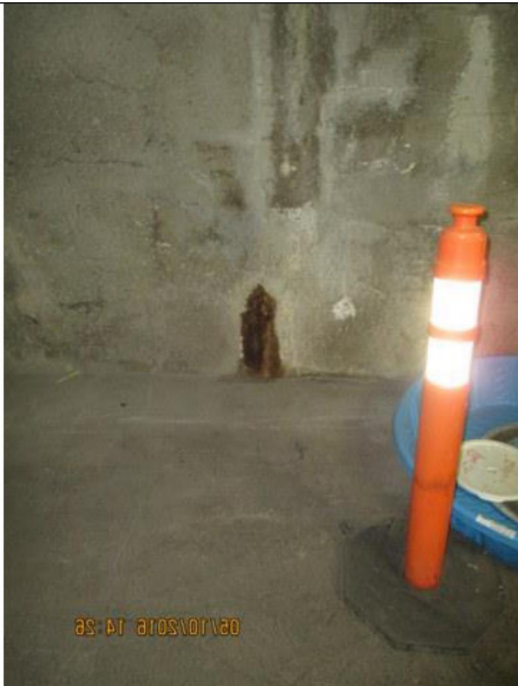
DATE TAKEN: 5/10/2016	
TAKEN BY: Chris Krejci	SITE LOCATION: Red Hill Facility
PHOTO #: 46	
COMMENTS: Staining on tunnel wall (appearance similar to bunker oil)

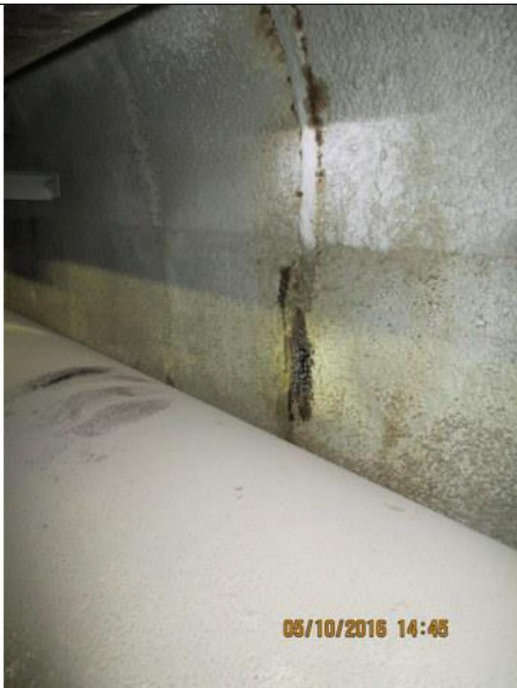
DATE TAKEN: 5/10/2016	
TAKEN BY: Chris Krejci	SITE LOCATION: Red Hill Facility
PHOTO #: 51	
COMMENTS: Flashing lining tunnel walls in some areas

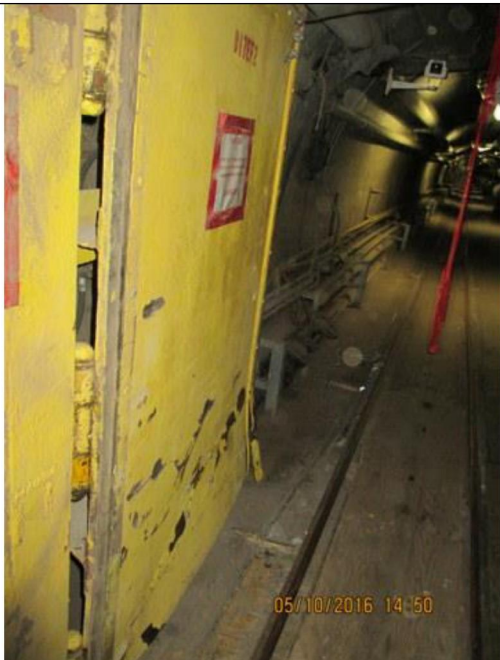
DATE TAKEN: 5/10/2016	
TAKEN BY: Chris Krejci	SITE LOCATION: Red Hill Facility
PHOTO #: 52	
COMMENTS: Oil-tight door

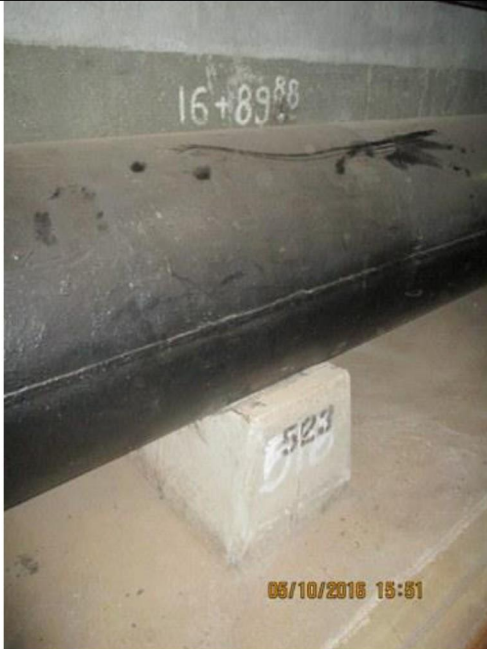
DATE TAKEN: 5/10/2016	
TAKEN BY: Chris Krejci	SITE LOCATION: Red Hill Facility
PHOTO #: 57	
COMMENTS: Pipe support in tunnel
