**UNITED STATES ENVIRONMENTAL
PROTECTION AGENCY
REGION IX
75 Hawthorne Street
San Francisco, CA 94105**

**STATE OF HAWAII
DEPARTMENT OF HEALTH
P. O. BOX 3378
HONOLULU, HI 96801-3378**

Re: Response to Corrosion and Metal Fatigue Practices, Destructive Testing Results Report, Red Hill Bulk Fuel Storage Facility (Red Hill), Joint Base Pearl Harbor-Hickam, Oahu, Hawaii

Corrosion Report on Red Hill Bulk Fuel Storage Facility

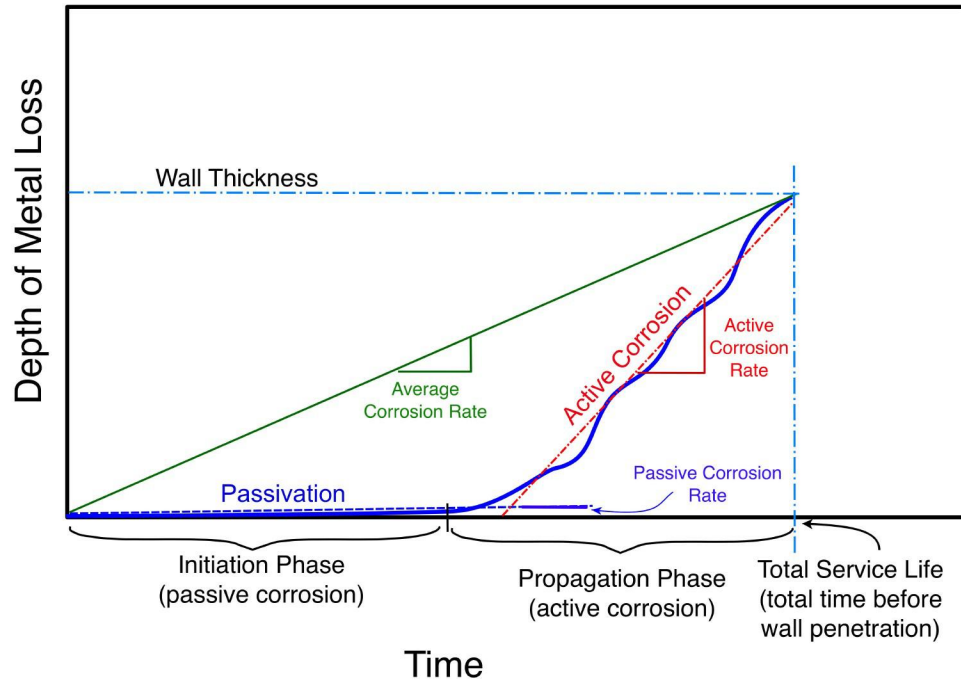
Figure 7: Initiation and propagation phases of steel corrosion in concrete. Modeled after Tuutti [10] in [4].

When steel corrodes in concrete, there is an initiation phase and a propagation phase (Figure 7) [4]. During the initiation phase, the steel is passive and corrodes at a very low rate. When the concrete becomes carbonated or contaminated with chlorides, the steel loses passivity and corrosion rates begin to increase in the propagation phase (Figure 7). In Figure 6, regions of the coupons that were bonded to the concrete or grout and not corroded (e.g., gray regions) were still in the initiation phase (Figure 7) and have a very low passive corrosion rate. Regions that show rust (e.g., red or brown corrosion products) are in the propagation phase and have higher

active corrosion rates. Unfortunately, knowledge of the active corrosion rate cannot be used to determine the total service life or time before penetration as the initiation phase can dominate the service life (Figure 7 and 8a) [10]. However, if the remaining wall thickness and the active corrosion rate are known, the remaining time before wall penetration can be estimated (Figure 8b).

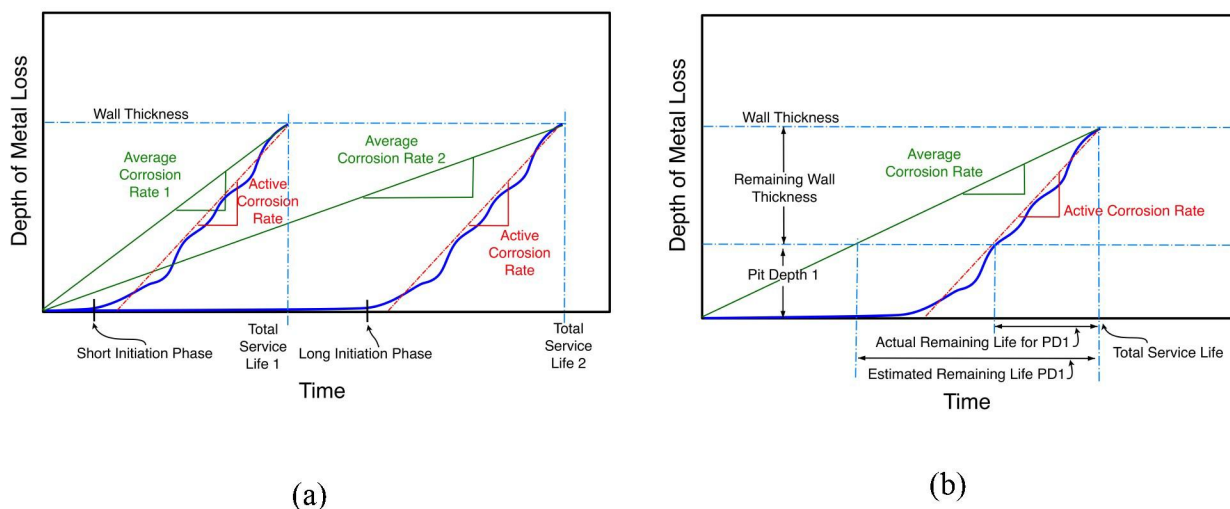
Figure 8: Effect of initiation phase on average corrosion rates (a). Remaining life (b) based on active and average corrosion rates and pit depth 1 (PD1).

The higher historical corrosion rates could be associated with short initiation phases (Figure 8a) from regions where steel lost passivation in the early stages. Regions where the steel remain passivated and have long initiation phases (Figure 8a) will result in low average corrosion rates. Currently, any region of the tank that has back-side corrosion (i.e., rusting and remaining thickness less than the original plate thickness of 0.25") is likely not passivated, and in the propagation stage (Figure 7). To obtain an accurate remaining life before wall penetration, realistic corrosion rates are needed. Therefore, in regions of the tank that are no longer passivated, actual measured active corrosion rates or historical corrosion rate data with a short initiation phases (Figure 8a) are needed to more accurately estimate the remaining life

(Figure 8b). If corrosion rates based on long initiation phases are used, the actual remaining life could be grossly over estimated (Figure 8b).

For moist concrete that is carbonated or contaminated by chlorides, the literature suggests that the corrosion rate can be of the order of 100 $\mu\text{m/yr}$ (4 mils/yr) [4]. The corrosion rate can be less if the moisture level decreases, but can also increase by an order of magnitude with heavy chloride contamination [4]. Since the corrosion rates are difficult to predict, historical corrosion data from all of the Red Hill tanks should be analyzed to help bracket realistic values. Additionally, if possible, active corrosion rates should be determined by measuring changes in the remaining wall thicknesses of known pit sites while tanks are out of service. This could be accomplished using, for example, ultrasonic testing.

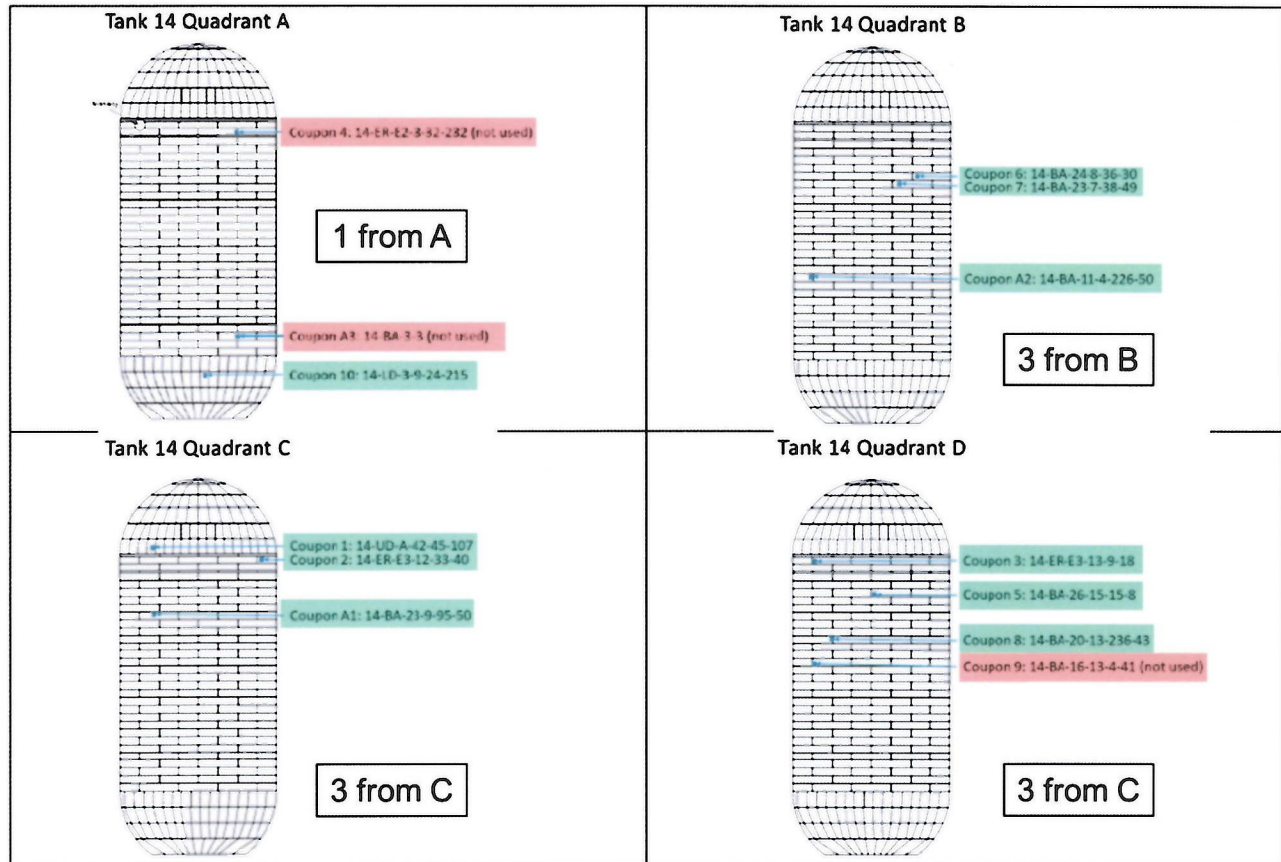
The Navy, however, did not follow its commitment in the DT SOW and instead selected a much less diverse range of coupons that are unlikely to be representative of the potential conditions

within Tank 14 much less the conditions of all the tanks at the RHBFSS. Ultimately, the Navy extracted eight coupons from the tank barrel (i.e., the vertical walls), one from just inside the upper dome, and one from sloped section of the lower dome; shown below for the locations marked in green. The locations marked in red were identified as possible coupon locations but were not extracted. The BWS is not aware of any random locations selected based on the BFET scans specifically to assess the welds. The Navy's description of the NDE result at these coupon locations do not discuss the BFET result at all. Further, the BWS is not aware of any coupons extracted from the lower dome bottom plate.
