SUBJECT: ADMINISTRATIVE ORDER ON CONSENT (AOC) STATEMENT OF WORK (SOW) SECTION 5 CORROSION AND METAL FATIGUE PRACTICES, DESTRUCTIVE TESTING RESULTS REPORT, RED HILL BULK FUEL STORAGE FACILITY (RED HILL), JOINT BASE PEARL HARBOR-HICKAM, OAHU, HAWAII

In 2018, ten coupons were removed from Tank 14, so that a metallurgical and corrosion analysis of the coupons could be undertaken, with the primary aim of validating non-destructive examination (NDE) results. The steel coupons, concrete powder samples, and corrosion product were submitted to a certified third-party laboratory to perform this analysis.

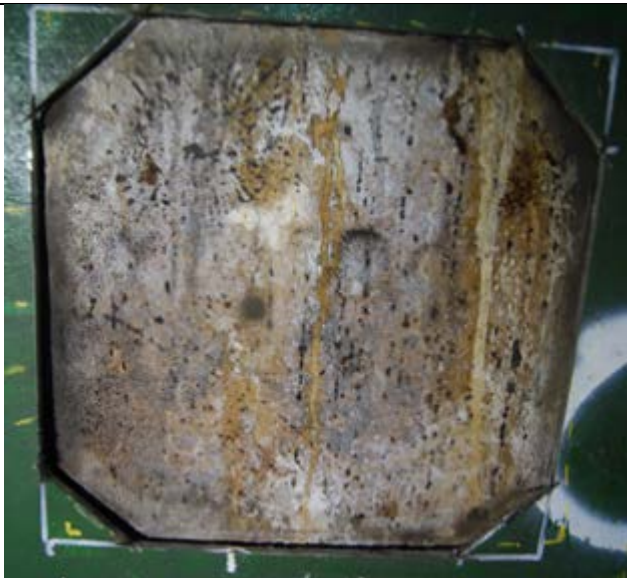
<p><b>Coupon 1 Backside</b></p>	 	
---------------------------------	--	--

6/20/2018: 1400		
CONCRETE SAMPLE SPECIFICS		
Sample ID	1	1
Sample Location	14-UD-A-42-45-107	
Sample Dimensions	12" × 12"	
ON SITE VISUAL EXAMINATION		
Checks	Observations	
	Exterior	Units
Void space between concrete and liner (if any)	1/8" Void on left side, no voids in all other areas	
Biological Materials	None	
Wet or Dry	Dry	
Smell	None	
Temperature	76.9	Degrees F
Surface pH	9 to 9.5	
Structure to Electrolyte	-0.252	Volts/CSE
Concrete Resistivity	26.4 Horizontal 31.1 Vertical	k-ohm-cm k-ohm-cm
General Condition	Excellent, sound concrete with some discoloration and no cracks and no delamination	
Concrete behind Coupon 1

Wed, 20 Jun 2018, 01:33 PM		
COUPON SPECIFICS		
Coupon ID	1	1
Coupon Location	14-UD-A-42-45-107	
Coupon Dimensions	12" × 12"	
Coupon Thickness	¼" (NDE: minimum 0.147")	
Locations of Welds	None	
ON SITE VISUAL EXAMINATION		
Checks	Observations	
	Exterior	Interior
Deposits, Coatings, Debris	Deposits	Standard coating with paint
Scale	None	None
Observed Biological Material	None	None
Wet or Dry	Wet	Dry
Smell	Damp, burnt	Burnt
Presence of petroleum product between steel and concrete surface	No	No
Presence of corrosion	Yes	No
Isolated pitting	No	No
Isolated pitting within areas of general corrosion	No	No
Linked pitting within areas of general corrosion	No	No
Identify color of corrosion products	Brown	N/A
Identify if selected attack at welds	N/A	N/A

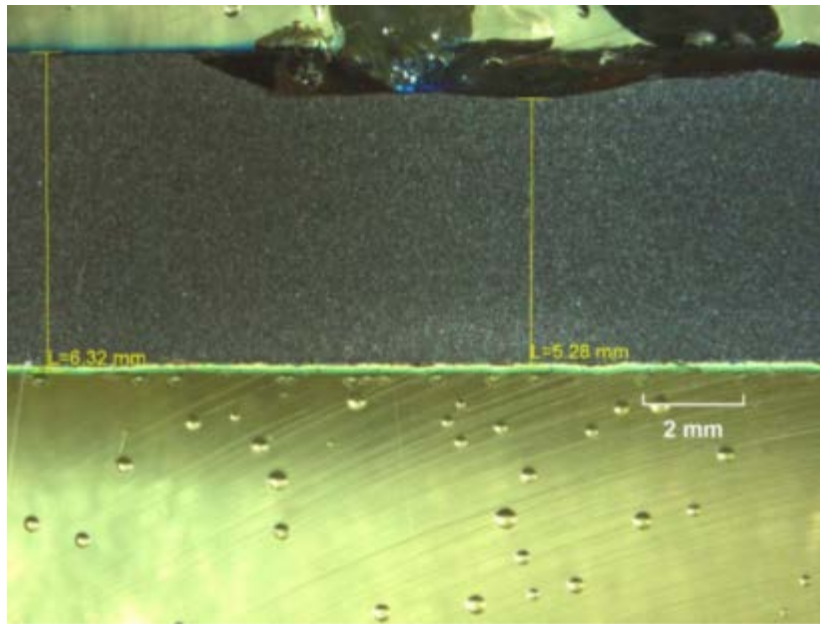
**Figure 3-2 Cross Section of Coupon 1 at Area of Maximum Wall Loss**

- Detailed results of the Destructive Testing Laboratory analysis of Coupon 1 are contained in Appendix A.
- The thinnest measured location was 207.9 mils (5.28 mm).
- Assuming a nominal wall thickness of 250 mils, the remaining wall thickness at the thinnest location was 83.1%.
- Coupon 1 exhibited backside corrosion as was predicted.
- A cross-section view of Coupon 1 is shown in Figure 3-2.

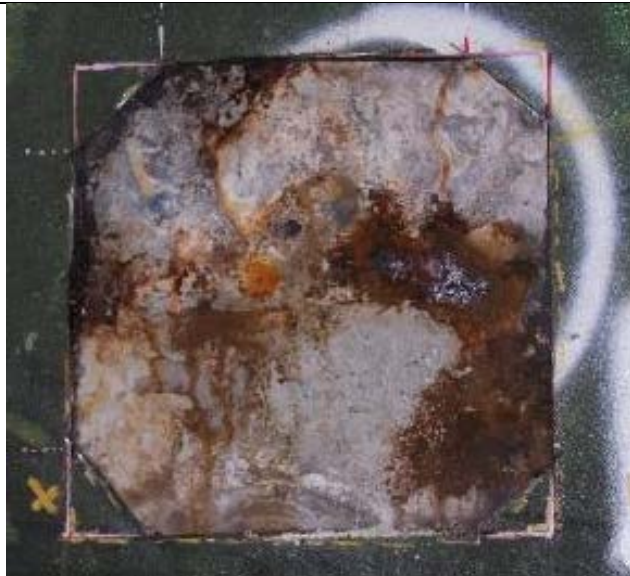
<p><b>Coupon 2 backside</b></p>	 	
---------------------------------	--	--

6/19/2018: 0930		
CONCRETE SAMPLE SPECIFICS		
Sample ID	2	2
Sample Location	14-ER-E3-12-33-40	
Sample Dimensions	12" × 12"	
ON SITE VISUAL EXAMINATION		
Checks	Observations	
	Exterior	Units
Void space between concrete and liner (if any)	1/8" void at upper left side. Otherwise no voids.	
Biological Materials	None	
Wet or Dry	Slightly damp	
Smell	Musty, no fuel	
Temperature	80.0	Degrees F
Surface pH	10-11 corroded area 11-12 non-corroded area	
Structure to Electrolyte	-0.380	Volts/CSE
Concrete Resistivity	19.0 Horizontal 17.5 Vertical	k-ohm-cm k-ohm-cm
General Condition	Good sound condition with some minor spalling and corrosion product. Coupon took some hammering to remove.	
Concrete behind Coupon 2

Tue, 19 Jun 2018, 10:46 AM		
COUPON SPECIFICS		
Coupon ID	2	2
Coupon Location	14-ER-E3-12-33-40	
Coupon Dimensions	12" × 12"	
Coupon Thickness	¼" (NDE: minimum 0.157")	Prove-up: minimum 0.150"
Locations of Welds	None	
ON SITE VISUAL EXAMINATION		
Checks	Observations	
	Exterior	Interior
Deposits, Coatings, Debris	Lots of deposits and concrete	Regular coating
Scale	None	None
Observed Biological Material	None	None
Wet or Dry	damp	Dry
Smell	burnt, musty, muddy	Burnt but less intense than exterior
Presence of petroleum product between steel and concrete surface.	No	No
Presence of corrosion	Yes	Yes
Isolated pitting	Yes	Yes
Isolated pitting within areas of general corrosion	Yes	No
Linked pitting within areas of general corrosion	No	No
Identify color of corrosion products	Brown, black, gray	Brown
Identify if selected attack at welds	N/A	N/A

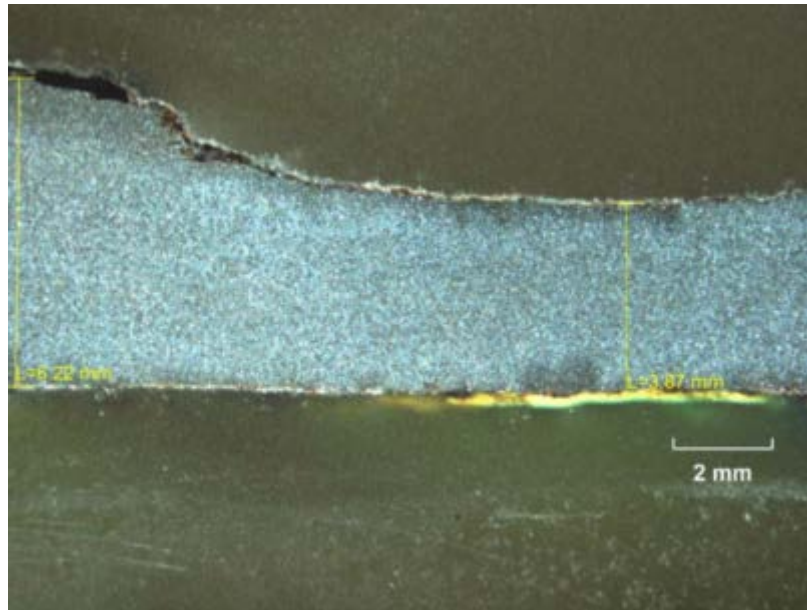
**Figure 3-3 Cross Section of Coupon 2 at area of Maximum Wall Loss**

- Detailed results of the Destructive Testing Laboratory analysis of Coupon 2 are contained in Appendix A.
- The thinnest measured location was 152.4 mils (3.87 mm).
- Assuming a nominal wall thickness of 250 mils, the remaining wall thickness at the thinnest location was 60.9%.

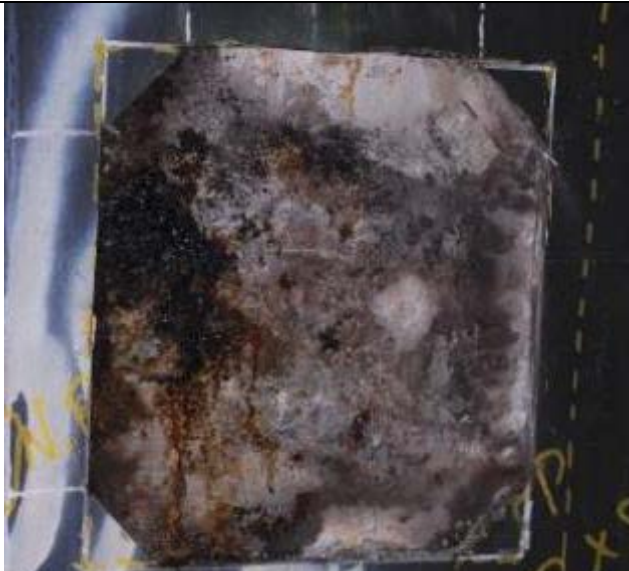
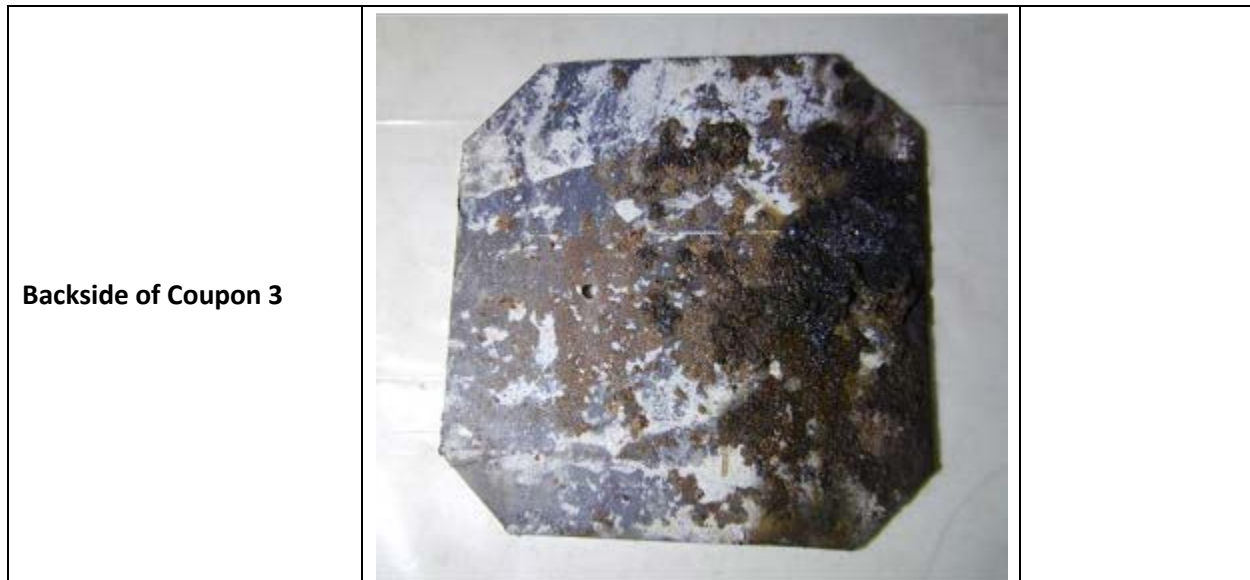
6/19/2018: 14:00		
CONCRETE SAMPLE SPECIFICS		
Sample ID	3	3
Sample Location	14-ER-E3-13-7-18	
Sample Dimensions	12" × 12"	
ON SITE VISUAL EXAMINATION		
Checks	Observations	
	Exterior	Units
Void space between concrete and liner (if any)	On left side, uneven corrosion product and a 1/16-inch void. Otherwise, no voids.	
Biological Materials	None	
Wet or Dry	Mostly dry, with some damp spots	
Smell	None	
Temperature	79.3	F
Surface pH	11-12 dry areas, 7-8 in areas with corrosion product	
Structure to Electrolyte	-0.488	Volts/CSE
Concrete Resistivity	27.8 Horizontal 31.2 Vertical	K-Ohm-cm
General Condition	Good, with some corrosion products. Corrosion product was black on the left side, and brown in some other areas. Concrete was hard and difficult to drill for powder samples. Coupons required some hammering and prying to remove after cutting.	
Concrete behind Coupon 3

Tue, 19 Jun 2018, 3:00 PM		
COUPON SPECIFICS		
Coupon ID	3	3
Coupon Location	14-ER-E3-13-9-18	
Coupon Dimensions	12" × 12"	
Coupon Thickness	¼" (NDE: minimum 0.033")	(No prove-up-phase thickness)
Locations of Welds	None	
ON SITE VISUAL EXAMINATION		
Checks	Observations	
	Exterior	Interior
Deposits, Coatings, Debris	Thick, brown, grey deposits	Standard coating with paint
Scale	None	None
Observed Biological Material	None	None
Wet or Dry	Wet	Dry
Smell	Burnt, like wax	None
Presence of petroleum product between steel and concrete surface	Yes	No
Presence of corrosion	Yes	Yes
Isolated pitting	Yes	Yes
Isolated pitting within areas of general corrosion	Yes	No
Linked pitting within areas of general corrosion	No	No
Identify color of corrosion products	White, brown	Brown
Identify if selected attack at welds	N/A	N/A

Coupon 3 exhibited backside corrosion that was not predicted. However, it must be noted that layout work to finalize sizing and location of a repair adjacent to Coupon 3 had not taken place prior to removal of the coupon. This corrosion was noted on the Spreadsheet that was reviewed by the Regulators, and one of the reasons why this coupon location was selected.

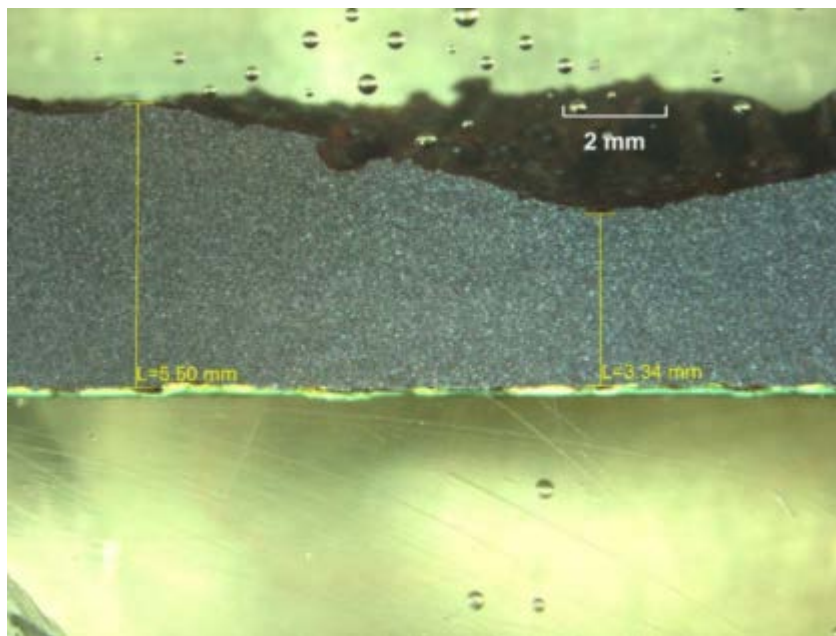
**Figure 3-4 Cross Section of Coupon 3 at Area of Maximum Wall Loss**

- Detailed results of the Destructive Testing Laboratory analysis of Coupon 3 are contained in Appendix A.
- The thinnest measured location was 131.5 mils (3.34 mm).
- Assuming a nominal wall thickness of 250 mils, the remaining wall thickness at the thinnest location was 52.6%.
- A cross-section view of Coupon 3 is shown in Figure 3-4.

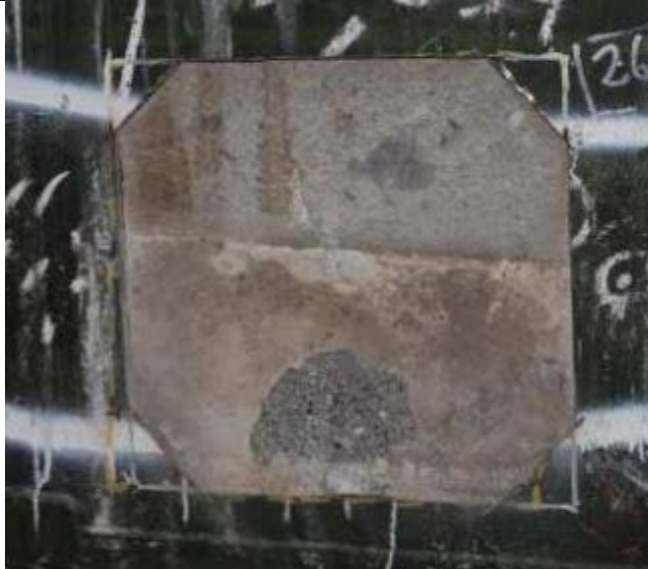
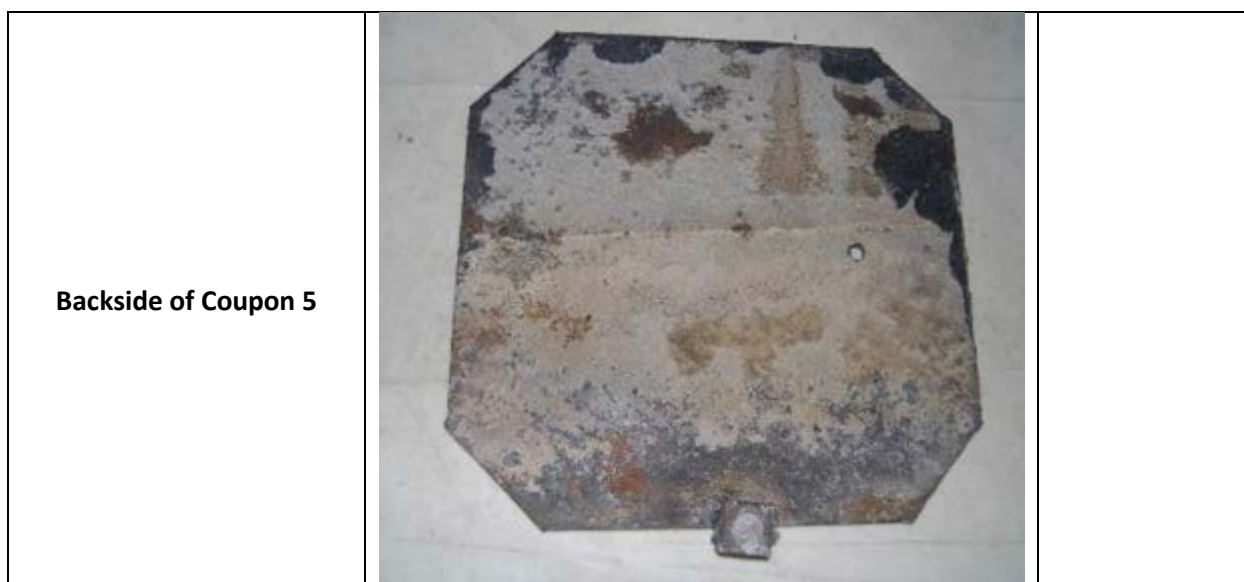
6/20/2018: 0800		
CONCRETE SAMPLE SPECIFICS		
Sample ID	5	5
Sample Location	14-BA-26-15-15-8	
Sample Dimensions	12" × 12"	
ON SITE VISUAL EXAMINATION		
Checks	Observations	
	Exterior	Units
Void space between concrete and liner (if any)	1/16" Void on top right side, no voids in all other areas	
Biological Materials	None	
Wet or Dry	Dry	
Smell	None	
Temperature	78.5	F
Surface pH	11-12	
Structure to Electrolyte	-0.220	Volts/CSE
Concrete Resistivity	19.1 Horizontal 22.0 Vertical	k-ohm-cm k-ohm-cm
General Condition	Excellent, sound concrete	
Concrete behind Coupon 5

Wed, 20 Jun 2018, 08:20 AM		
COUPON SPECIFICS		
Coupon ID	5	5
Coupon Location	14-BA-26-15-15-8	
Coupon Dimensions	12" × 12"	
Coupon Thickness	¼" (NDE: minimum 0.047")	
Locations of Welds	None	(No prove-up-phase thickness)
ON SITE VISUAL EXAMINATION		
Checks	Observations	
	Exterior	Interior
Deposits, Coatings, Debris	Concrete layer, thin	Standard coating
Scale	None	None
Observed Biological Material	None	None
Wet or Dry	Dry	Dry
Smell	Burnt	Burnt
Presence of petroleum product between steel and concrete surface	No	No
Presence of corrosion	Yes	No
Isolated pitting	No	No
Isolated pitting within areas of general corrosion	No	No
Linked pitting within areas of general corrosion	No	No
Identify color of corrosion products	Brown	N/A
Identify if selected attack at welds	N/A	N/A

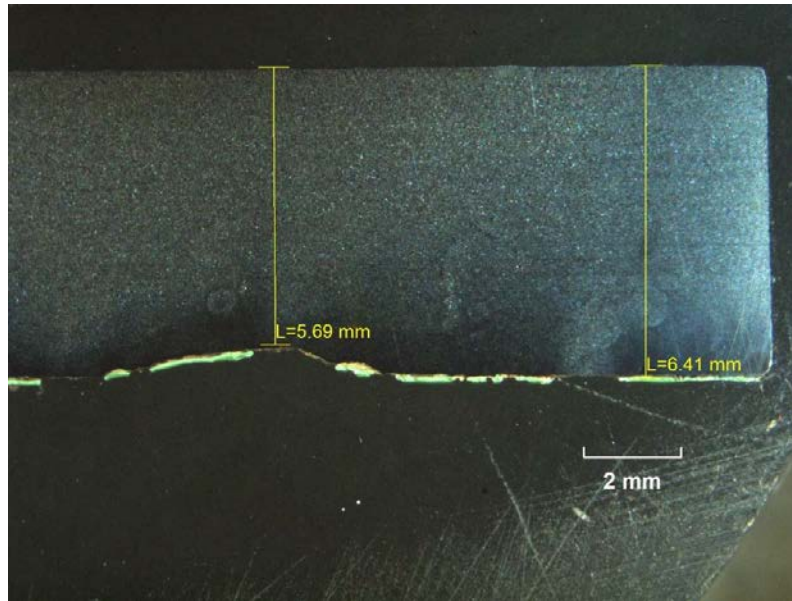
**Figure 3-5 Cross Section of Coupon 5 at Area of Maximum Wall Loss**

- Detailed results of the Destructive Testing Laboratory analysis of Coupon 5 are contained in Appendix A.
- The thinnest measured location was 224.0 mils (5.69 mm).
- Assuming a nominal wall thickness of 250 mils, the remaining wall thickness at the thinnest location was 89.6%.
- A cross-section view of Coupon 5 is shown in Figure 3-5.

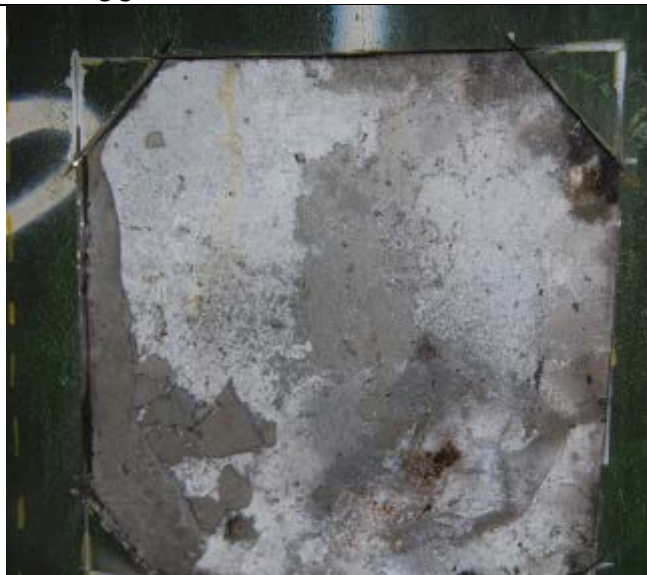
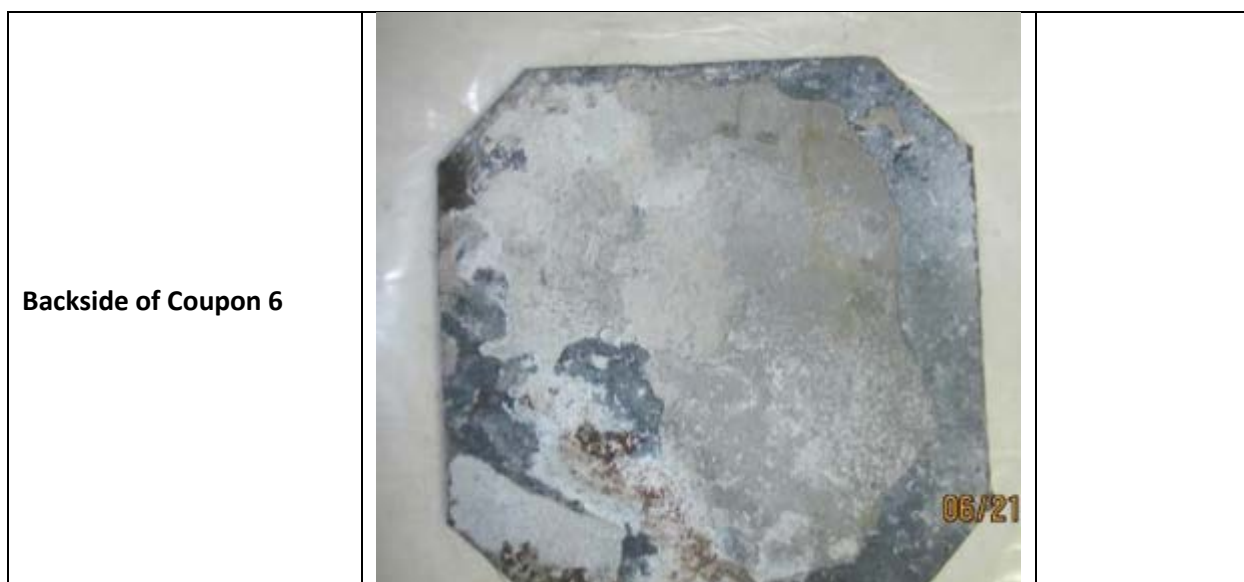
6/21/2018: 1100		
CONCRETE SAMPLE SPECIFICS		
Sample ID	6	6
Sample Location	14-BA-24-8-36-30	
Sample Dimensions	12" × 12"	
ON SITE VISUAL EXAMINATION		
Checks	Observations	
	Exterior	Units
Void space between concrete and liner (if any)	None, however some loose adhering grout present	
Biological Materials	None	
Wet or Dry	Dry	
Smell	None	
Temperature	77.4	F
Surface pH	12.5	
Structure to Electrolyte	-0.387	Volts/CSE
Concrete Resistivity	Horizontal = 10.1 Vertical = 18.2	k-ohm-cm k-ohm-cm
General Condition	Concrete is sound, no delamination. There is loose adhering grout on left side and middle	
Concrete behind Coupon 6

Thu, 21 Jun 2018, 11:05 AM		
COUPON SPECIFICS		
Coupon ID	6	6
Coupon Location	14-BA-24-8-36-30	
Coupon Dimensions	12" × 12"	
Coupon Thickness	¼" (NDE: No reported thickness; greater than 0.200")	(No prove-up-phase thickness)
Locations of Welds	None	
ON SITE VISUAL EXAMINATION		
Checks	Observations	
	Exterior	Interior
Deposits, Coatings, Debris	Scrapes	Standard coating
Scale	Concrete	None
Observed Biological Material	None	None
Wet or Dry	Dry	Dry
Smell	Burnt	Burnt
Presence of petroleum product between steel and concrete surface	No	No
Presence of corrosion	Yes, small	Yes, tiny
Isolated pitting	No	No
Isolated pitting within areas of general corrosion	No	No
Linked pitting within areas of general corrosion	No	No
Identify color of corrosion products	Brown	Brown
Identify if selected attack at welds	N/A	N/A

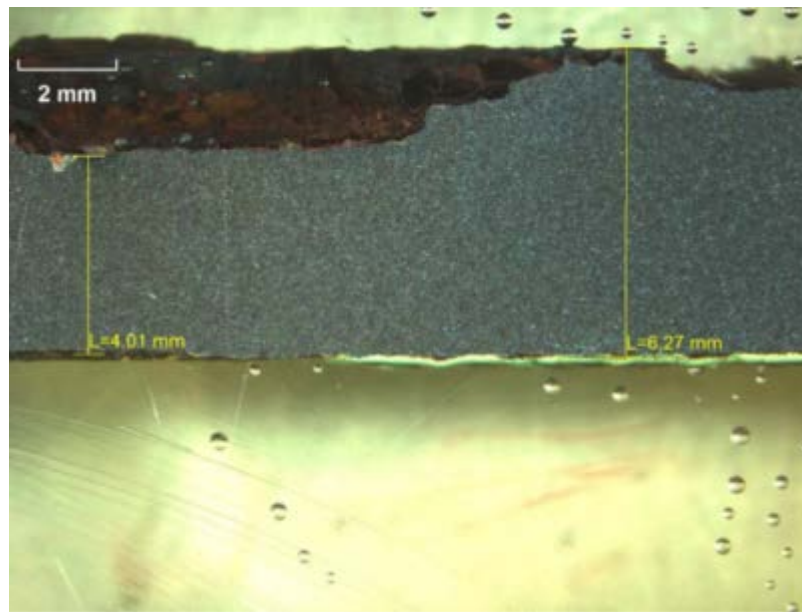
**Figure 3-6 Cross Section of Coupon 6 at Area of Maximum Wall Loss**

- Detailed results of the Destructive Testing Laboratory analysis of Coupon 6 are contained in Appendix A.
- The thinnest measured location was 157.9 mils (4.01 mm).
- Assuming a nominal wall thickness of 250 mils, the remaining wall thickness at the thinnest location was 63.1%.
- A cross-section view of Coupon 6 is shown in Figure 3-6.

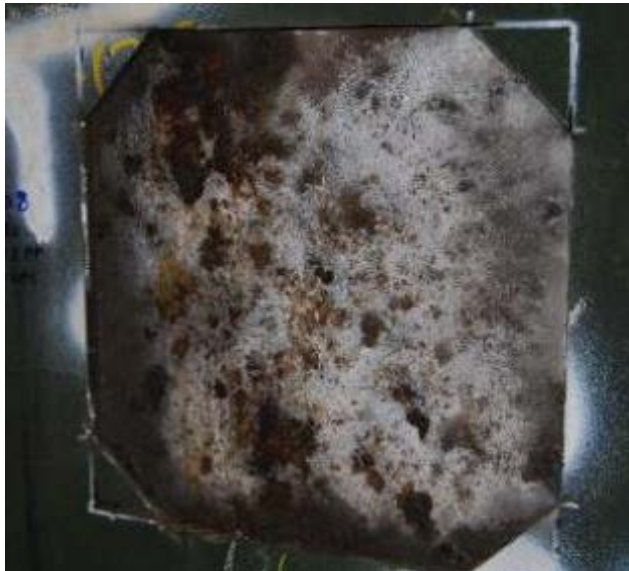
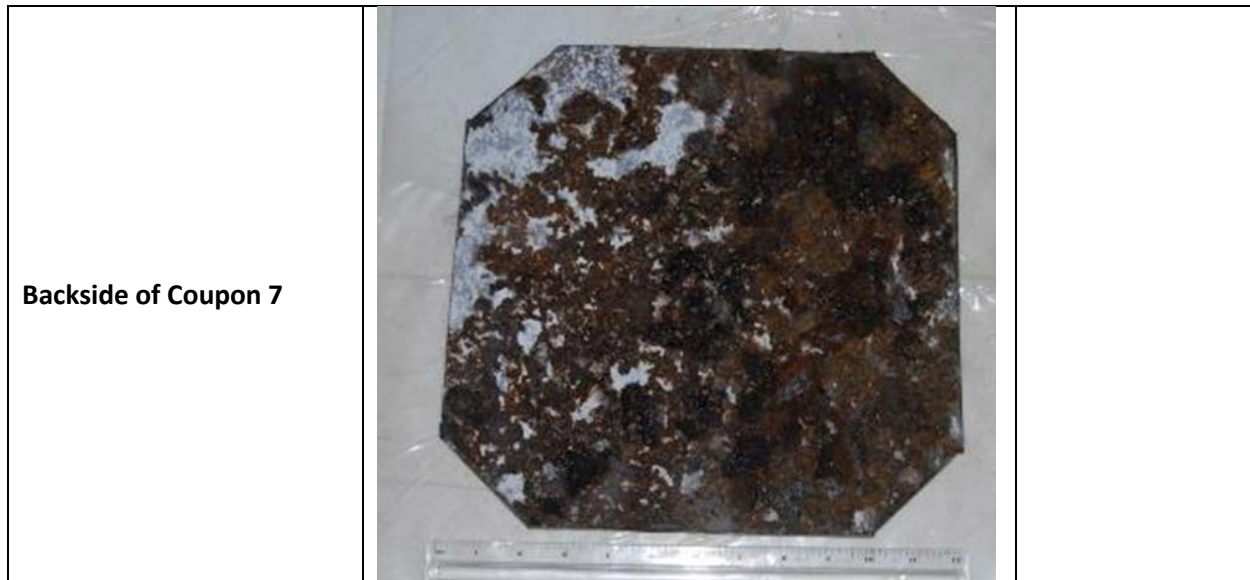
6/21/2018: 1030		
CONCRETE SAMPLE SPECIFICS		
Sample ID	7	7
Sample Location	14-BA-23-7-38-49	
Sample Dimensions	12" × 12"	
ON SITE VISUAL EXAMINATION		
Checks	Observations	
	Exterior	Units
Void space between concrete and liner (if any)	3/8" void on left side. 1/16" void on top right otherwise no voids	
Biological Materials	None	
Wet or Dry		
Smell	none	
Temperature	77.5	F
Surface pH	9-10	
Structure to Electrolyte	-0.276	Volts/CSE
Concrete Resistivity	Horizontal = 39.3 Vertical = 42.4	k-ohm-cm k-ohm-cm
General Condition	Concrete is sound with no delamination or cracks. Some brown and black corrosion products on concrete	
Concrete behind Coupon 7

Thu, 21 Jun 2018, 10:35 AM		
COUPON SPECIFICS		
Coupon ID	7	7
Coupon Location	14-BA-23-7-38-49	
Coupon Dimensions	12" × 12"	
Coupon Thickness	¼" (NDE: minimum 0.157")	Prove-up: minimum 0.135"
Locations of Welds	None	
ON SITE VISUAL EXAMINATION		
Checks	Observations	
	Exterior	Interior
Deposits, Coatings, Debris	Lots of general corrosion	Standard coating
Scale	Yes, thick, varied	None
Observed Biological Material	None	None
Wet or Dry	Wet	Dry
Smell	Burnt, damp	Burnt
Presence of petroleum product between steel and concrete surface,	No	No
Presence of corrosion	Yes	Yes
Isolated pitting	Yes	No
Isolated pitting within areas of general corrosion	Yes	No
Linked pitting within areas of general corrosion	No	No
Identify color of corrosion products	Brown, black	Brown
Identify if selected attack at welds	N/A	N/A

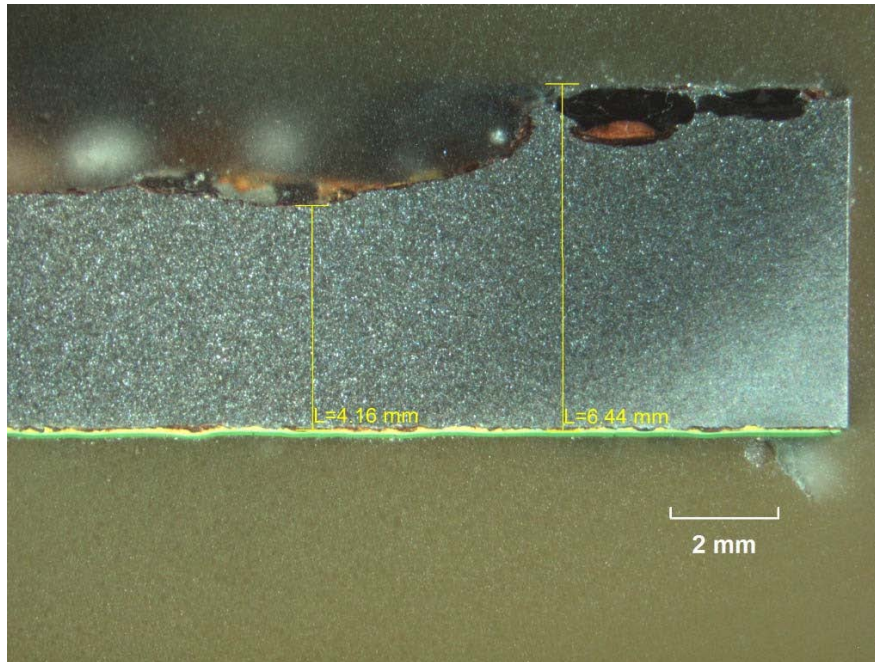
**Figure 3-7 Cross Section of Coupon 7 at Area of Maximum Wall Loss**

- Detailed results of the Destructive Testing Laboratory analysis of Coupon 7 are contained in Appendix A.
- The thinnest measured location was 163.8 mils (4.16 mm).
- Assuming a nominal wall thickness of 250 mils, the remaining wall thickness at the thinnest location was 66.5%.
- A cross-section view of Coupon 7 is shown in Figure 3-7.

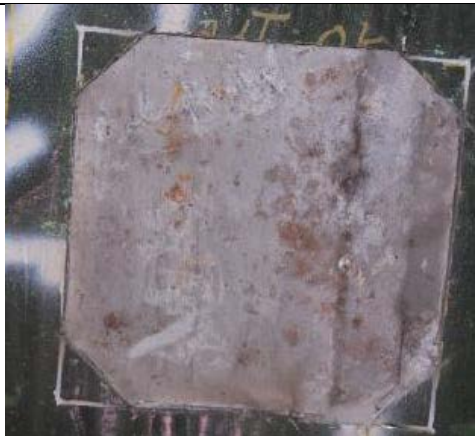
Backside of Coupon 8

6/20/2018: 1400		
CONCRETE SAMPLE SPECIFICS		
Sample ID	8	8
Sample Location	14-BA-20-13-236-43	
Sample Dimensions	12" × 12"	
ON SITE VISUAL EXAMINATION		
Checks	Observations	
	Exterior	Units
Void space between concrete and liner (if any)	1/16" Void on left side, no voids in all other areas	
Biological Materials	None	
Wet or Dry	Dry	
Smell	None	
Temperature	80.0	F
Surface pH	11-12	
Structure to Electrolyte	-0.248	Volts/CSE
Concrete Resistivity	30.9 Horizontal 27.5 Vertical	k-ohm-cm k-ohm-cm
General Condition	Excellent, sound concrete with no cracks or delamination. Coupon had steel backing plate	
Concrete behind Coupon 8

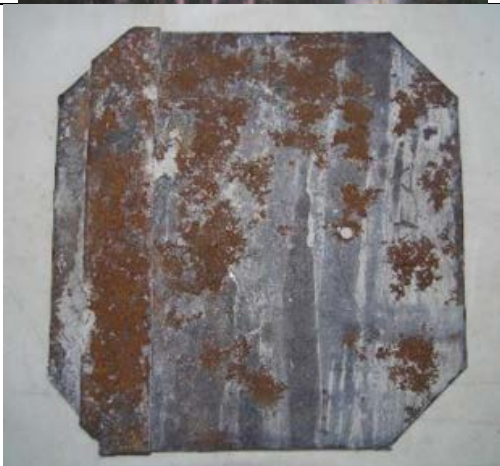
Wed, 20 Jun 2018, 09:40 AM		
COUPON SPECIFICS		
Coupon ID	8	8
Coupon Location	14-BA-20-13-236-43	
Coupon Dimensions	12" × 12"	
Coupon Thickness	¼" (NDE: minimum 0.069")	Prove-up: minimum 0.200"
Locations of Welds	About 2" from right edge of front face (exterior face)	
ON SITE VISUAL EXAMINATION		
Checks	Observations	
	Exterior	Interior
Deposits, Coatings, Debris	White coating	Standard coating with pink, white paint
Scale	None	None
Observed Biological Material	None	None
Wet or Dry	Dry	Dry
Smell	Burnt metal	Fuel-like
Presence of petroleum product between steel and concrete surface	No	No
Presence of corrosion	Yes	No
Isolated pitting	Yes (Pit 1: 5" from left, 2" from top) (Pit 2: 7" from left, 5" from top)	No
Isolated pitting within areas of general corrosion	Yes	No
Linked pitting within areas of general corrosion	No	No
Identify color of corrosion products	Brown	No
Identify if selected attack at welds	Yes	N/A

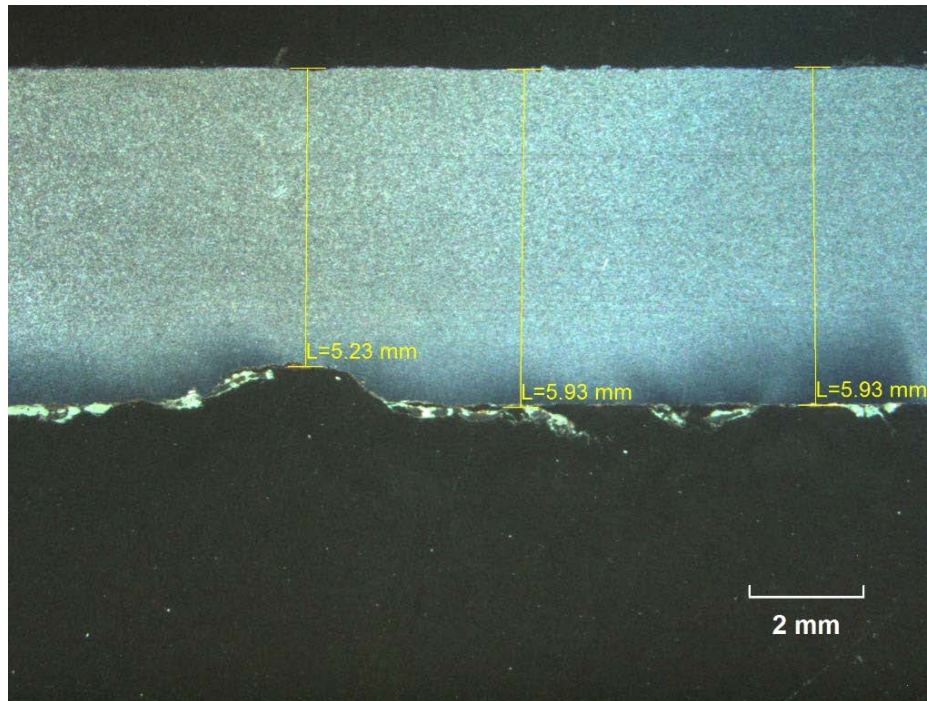
**Figure 3-8 Cross Section of Coupon 8 at Area of Maximum Wall Loss**

- Detailed results of the Destructive Testing Laboratory analysis of Coupon 8 are contained in Appendix A.
- The thinnest measured location was 205.9 mils (5.23 mm).
- Assuming a nominal wall thickness of 250 mils, the remaining wall thickness at the thinnest location was 82.4%.
- A cross-section view of Coupon 8 is shown in Figure 3-8.

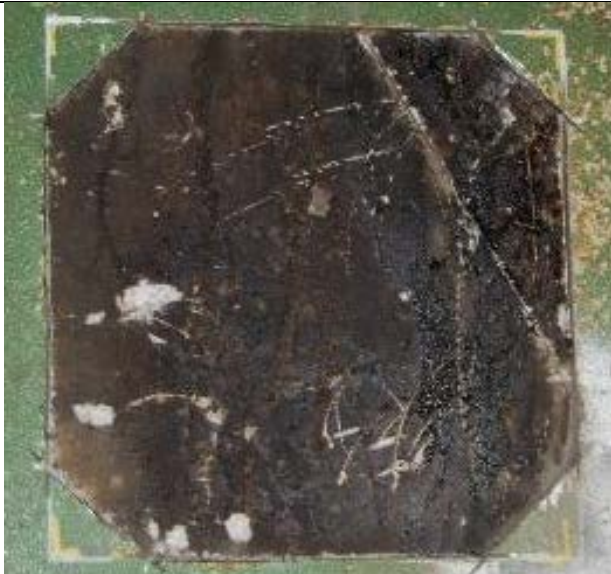
6/21/2018: 0930		
CONCRETE SAMPLE SPECIFICS		
Sample ID	10	10
Sample Location	14-LD-3-9-24-215	
Sample Dimensions	12" × 12"	
ON SITE VISUAL EXAMINATION		
Checks	Observations	
	Exterior	Units
Void space between concrete and liner (if any)	None	
Biological Materials	None	
Wet or Dry	Dry	
Smell	like coal tar	
Temperature	77.6	F
Surface pH	12-12.5	
Structure to Electrolyte	-0.181	Volts/CSE
Concrete Resistivity	27.3 Horizontal 38.1 Vertical	k-ohm-cm k-ohm-cm
General Condition	Excellent, sound concrete with no cracks or delamination. Coupon had to be cut into two pieces to remove. What appears to be coal tar coating present on backside of coupon and concrete.	
Concrete behind Coupon 10

Thu, 21 Jun 2018, 10:30 AM		
COUPON SPECIFICS		
Coupon ID	10	10
Coupon Location	14-LD-3-9-24-215	
Coupon Dimensions	12" x 12"	
Coupon Thickness	¼" (NDE: minimum 0.198")	Prove-up: minimum 0.200"
Locations of Welds	None	
ON SITE VISUAL EXAMINATION		
Checks	Observations	
	Exterior	Interior
Deposits, Coatings, Debris	Coal-tar-like	Lots of surface debris
Scale	None	None
Observed Biological Material	None	None
Wet or Dry	Wet	Dry
Smell	Coal-tar-like	None
Presence of petroleum product between steel and concrete surface	No	No
Presence of corrosion	Yes (small)	Yes
Isolated pitting	No	Yes
Isolated pitting within areas of general corrosion	No	No
Linked pitting within areas of general corrosion	No	No
Identify color of corrosion products	Brown	Brown
Identify if selected attack at welds	N/A	N/A

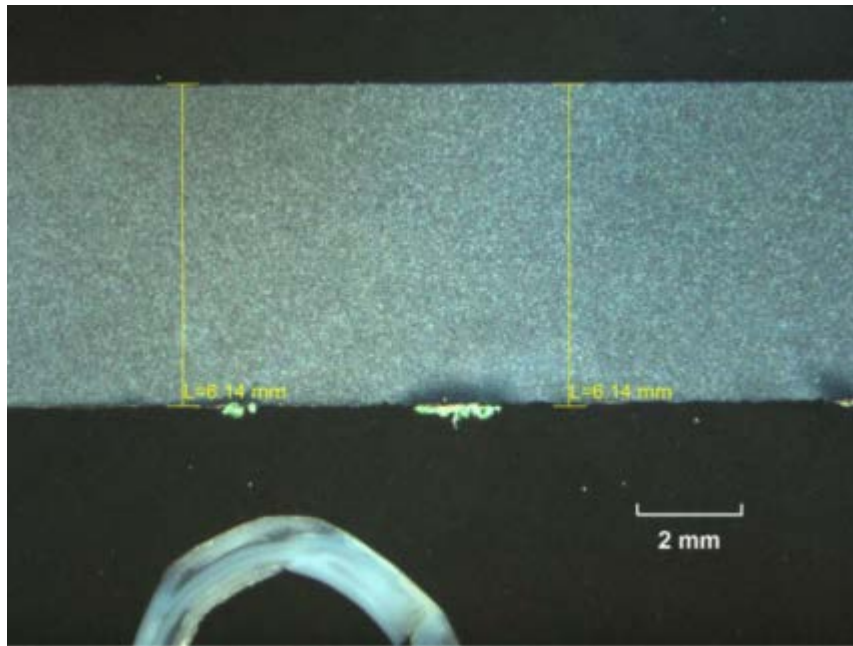
**Figure 3-9 Cross Section of Coupon 10 at Area of Maximum Wall Loss**

- Detailed results of the Destructive Testing Laboratory analysis of Coupon 10 are contained in Appendix A.
- The thinnest measured location was 241.7 mils (6.14 mm).
- Assuming a nominal wall thickness of 250 mils, the remaining wall thickness at the thinnest location was 96.7%.
- A cross-section view of Coupon 10 is shown in Figure 3-9.

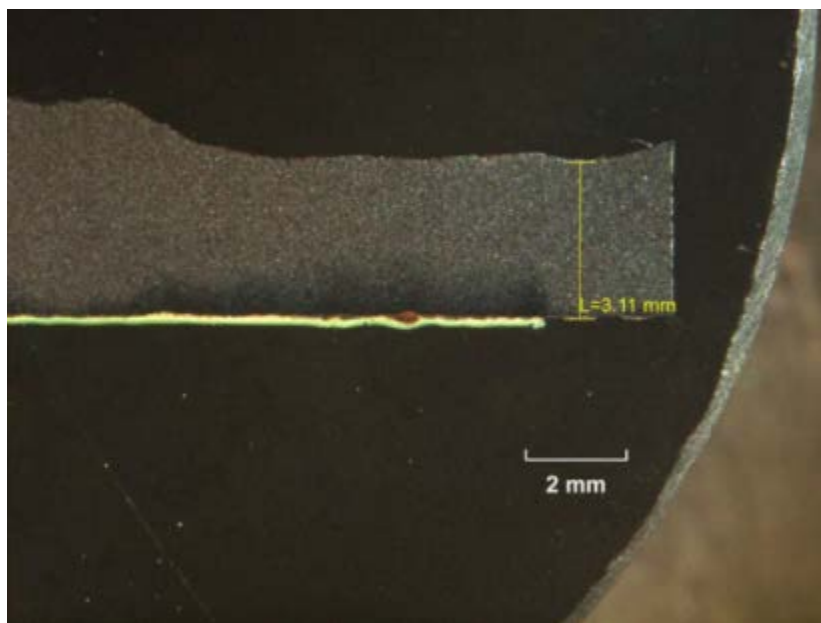
**Figure 3-10 Cross Section of Coupon A1 at Area of Maximum Wall Loss**

- Detailed results of the Destructive Testing Laboratory analysis of Coupon A1 are contained in Appendix A.
- The thinnest measured location 122.4 mils (3.11 mm).
- Assuming a nominal wall thickness of 250 mils, the remaining wall thickness at the thinnest location was 48.5%.
- A cross-section view of Coupon A1 is shown in Figure 3-10.

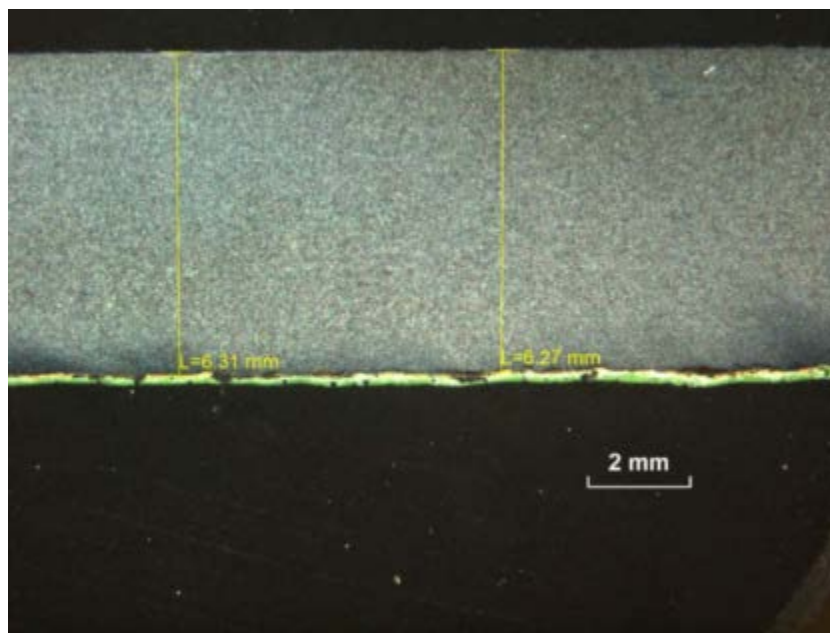
**Figure 3-11 Cross Section of Coupon A2 at Area of Maximum Wall Loss**

- Detailed results of the Destructive Testing Laboratory analysis of Coupon A2 are contained in Appendix A.
- The thinnest measured location was 247.6 mils (6.29 mm).
- Assuming a nominal wall thickness of 250 mils, the remaining wall thickness at the thinnest location was 97.5%.
- A cross-section view of Coupon A2 is shown in Figure 3-11.

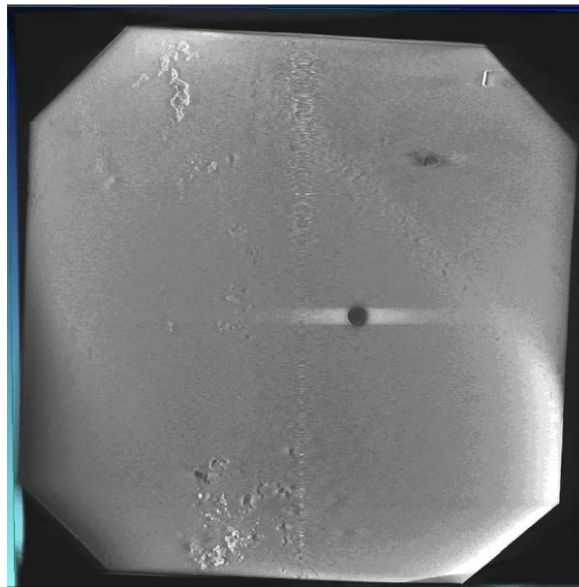
**Figure 4-2 CT Scan Image from Destructive Testing Lab Report, Coupon 1**

The LFET minimum screening thickness found was 0.112 inch. Therefore, a repair was specified in this area. Backside pitting corrosion expected. Later prove-up with PAUT indicated an expected minimum remaining wall thickness of 0.112 inch.

Destructive testing found pitting and minimum wall thickness of 0.208 inch. Remaining wall thickness greater than expected (208 mils vs. 112 mils). This deviation exceeded the 20 mils accuracy range for pitting.

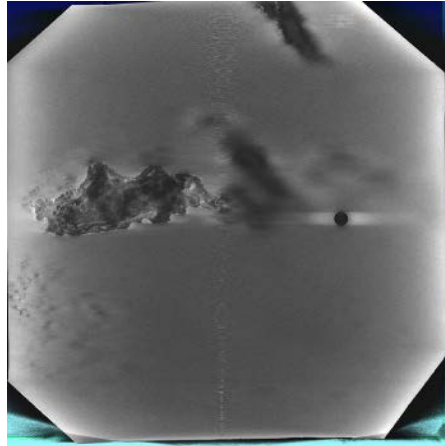
**Figure 4-4 CT Scan Image from Destructive Testing Lab Report, Coupon 2**

The LFET minimum screening thickness found was 0.157 inch. Therefore, a repair was specified in this area. Backside pitting corrosion expected. Later prove-up with PAUT indicated an expected minimum remaining wall thickness of 0.150 inch.

Destructive testing found pitting and minimum wall thickness of 0.152 inch.

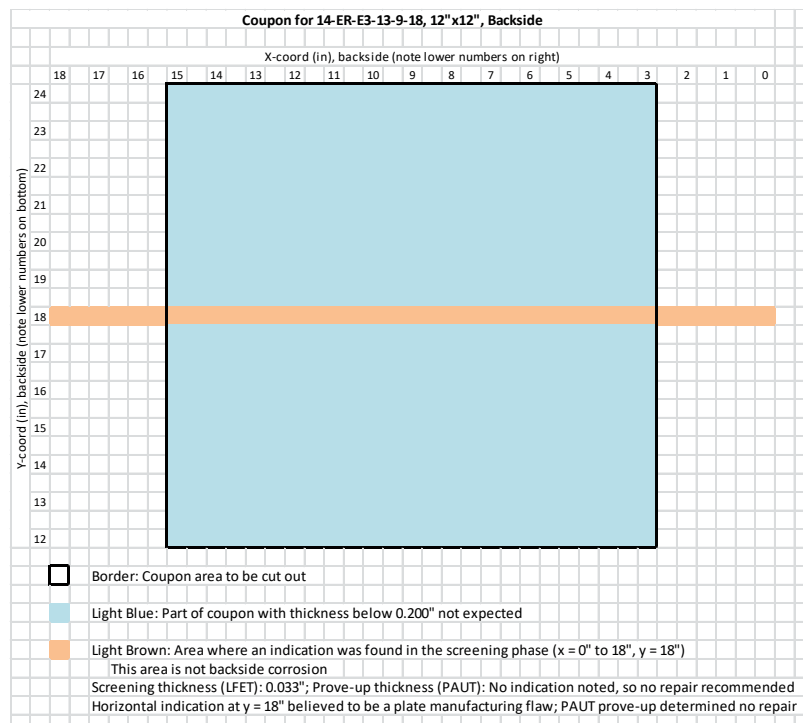
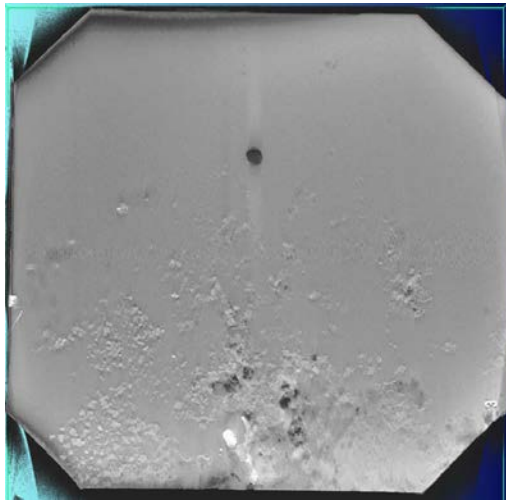
The LFET minimum screening thickness was 0.033 inch. During the PAUT prove-up, the 33-mil thickness was identified not to be metal loss but instead was a non-actionable lamination. Therefore, a repair was not initially specified in this area. Backside corrosion was not expected.

Destructive testing found pitting and minimum wall thickness of 0.132 inch. The remaining wall thickness, 132 mils, was less than expected (greater than 200 mils). The LFET value did not fall within the 20-mil accuracy range for pitting.

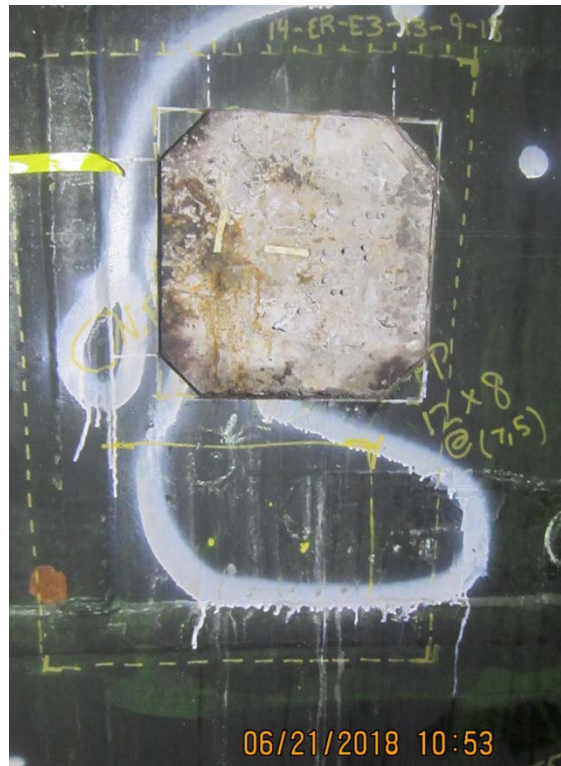
**Figure 4-8 Location of Coupon 3 after Removal**

was prevented from finishing the NDE process by being unable to layout the repair at Indication B. Instead of performing a layout at Indication B, the contractor was asked to layout repairs for Coupon 3 (Indication A). Figure 4-8 depicts the location after the coupon was removed.

Inner square indicates boundary of Coupon 3. Outer rectangle indicates boundary of patch plate for repair.

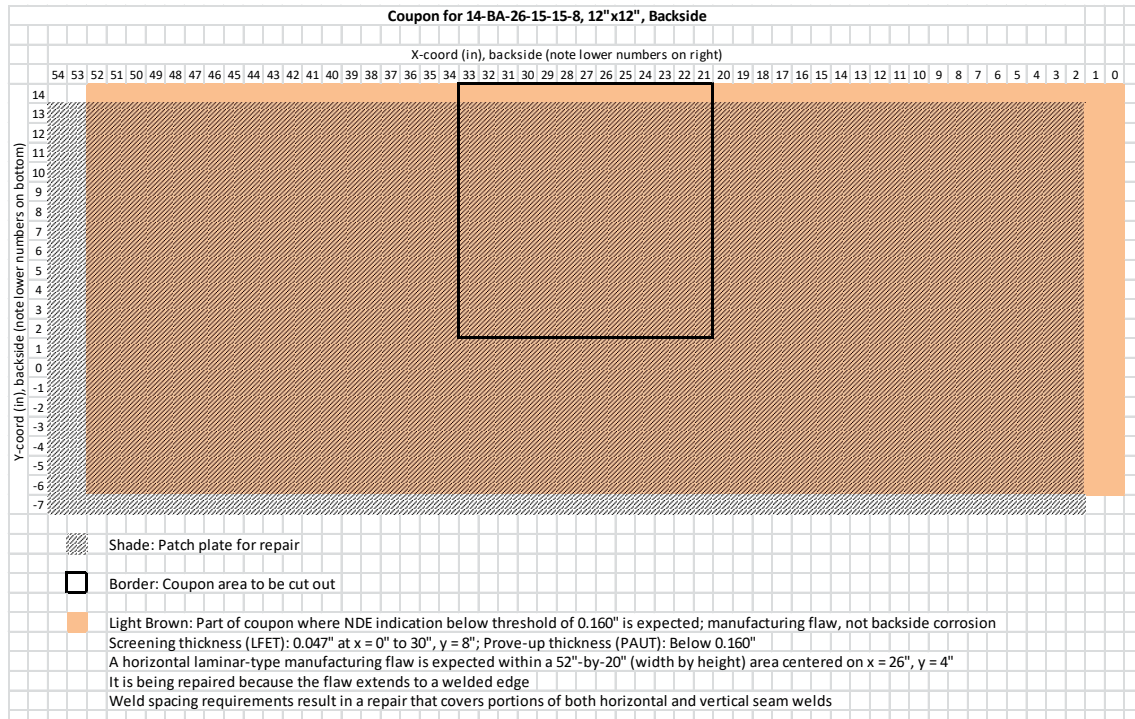
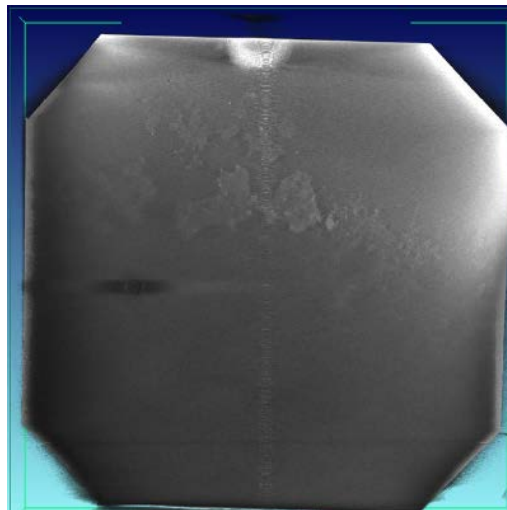
The LFET minimum screening thickness was 0.047 inch. A prove-up thickness greater than 0.160 inch was expected. Therefore, a repair was not specified in this area. A flaw, not backside corrosion, was expected.

Destructive testing found pitting and minimum wall thickness of 0.224 inch. The remaining wall thickness was as expected.

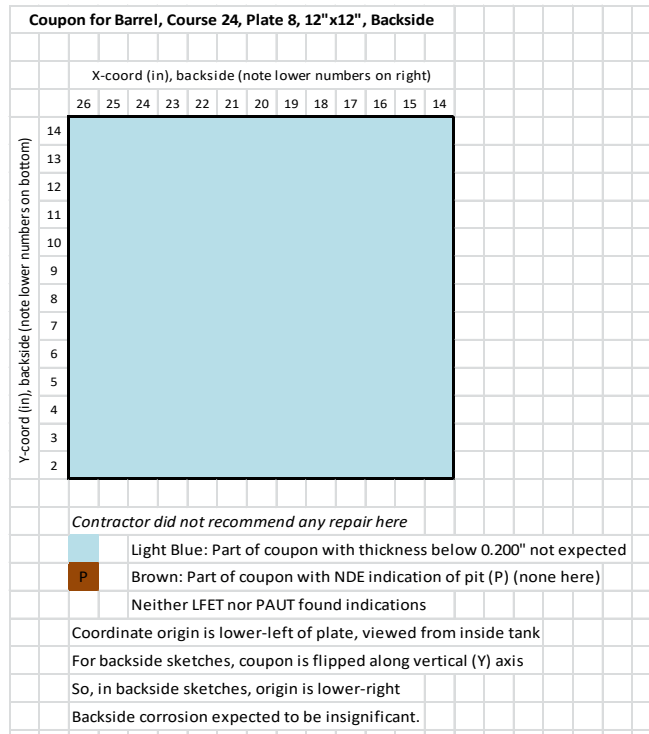
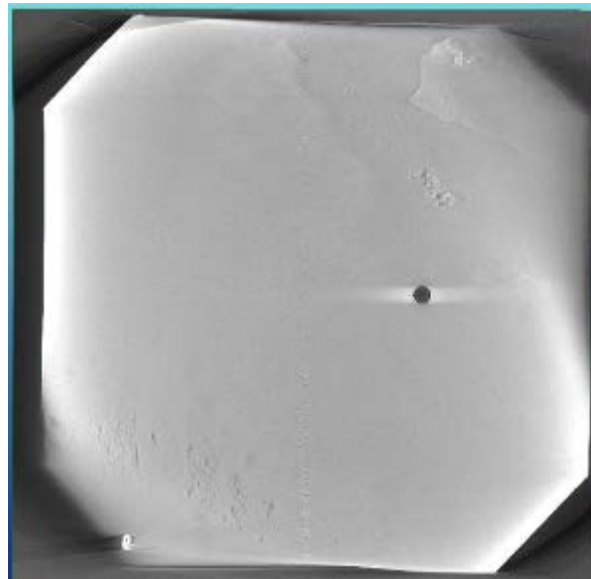
Destructive testing found pitting and minimum wall thickness of 0.158 inch. The remaining wall thickness was thinner than expected in the isolated pit.

LFET does not always detect metal loss of very small volume with narrow and non-uniform characteristics. The likelihood this single small pit, smaller than what the equipment could detect with more than 64% metal thickness remaining after 75 years in service, would form into a thru-hole before the next inspection, is extremely low. Given the steel plate's original thickness of 250 mils and the metal thickness of 158 mils upon removal (a loss of 92 mils), and assuming a constant rate of corrosion between the tank's construction in 1943 and coupon removal in 2018 (75 years),

the maximum corrosion rate at Coupon 6 is 1.23 mils per year (mpy). No conditions were evident that would support accelerated corrosion at Coupon 6.

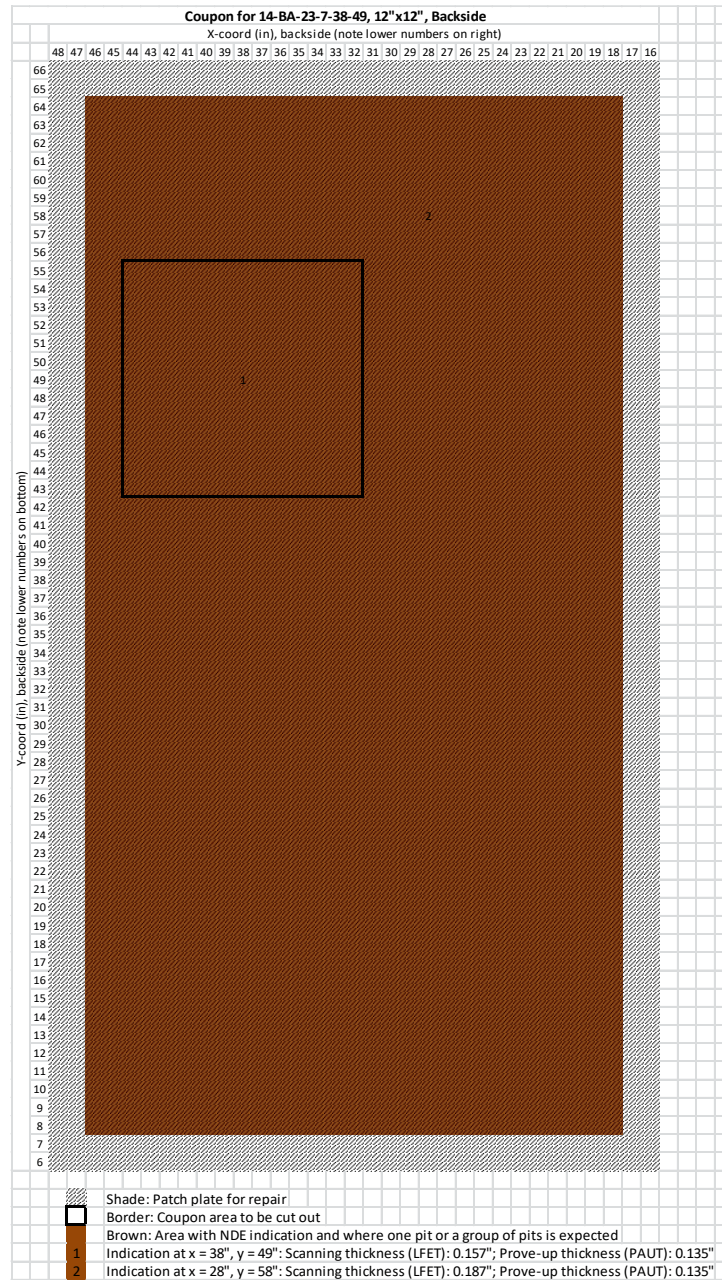
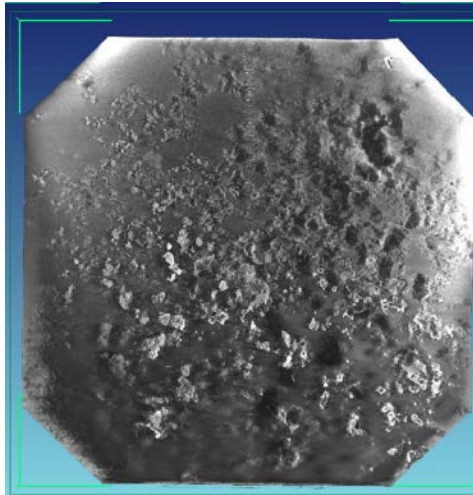
The LFET minimum screening thickness was 0.157 inch. The prove-up thickness was 0.135 inch. Therefore, a repair was specified in this area.

Destructive testing found pitting and a minimum wall thickness of 0.164 inch. The remaining wall thickness was within the 20-mil range for pitting but thicker than expected for the prove-up testing (164 mils vs. 135 mils).

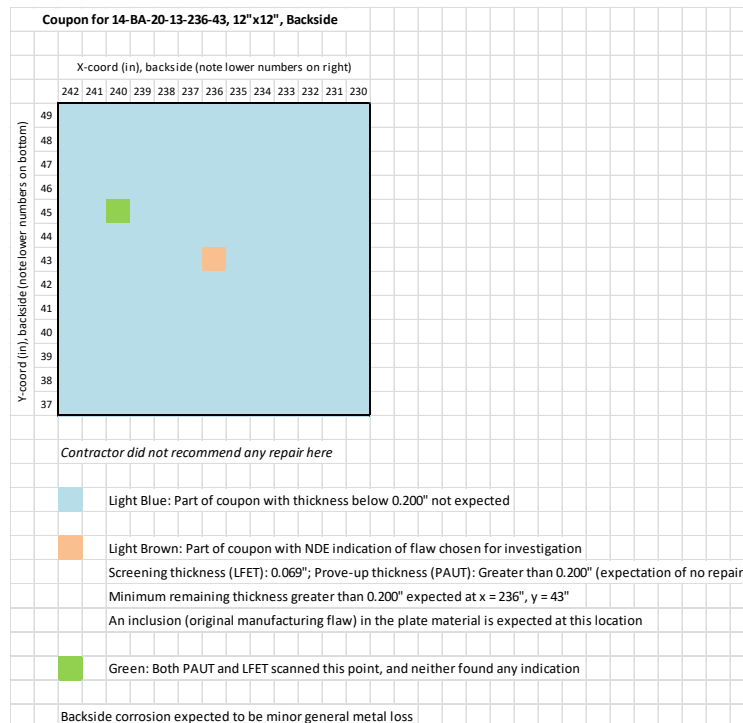
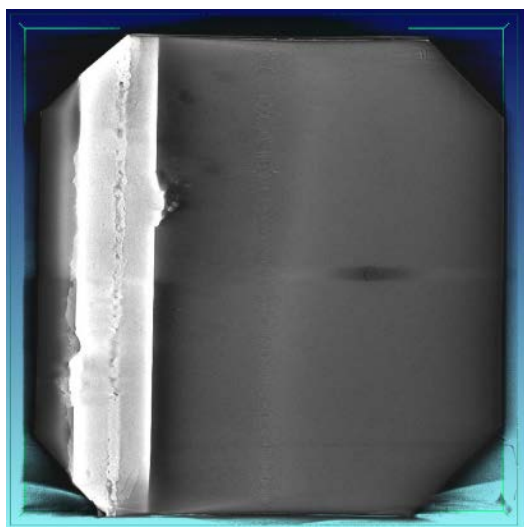
The LFET minimum screening thickness was 0.069 inch. The prove-up thickness was greater than 0.200 inch. Therefore, no repair was specified in this area.

Destructive testing found pitting and minimum wall thickness of 0.206 inch. Remaining wall thickness was as expected.
