SUBJECT: ADMINISTRATIVE ORDER ON CONSENT (AOC) STATEMENT OF WORK (SOW) SECTION 5 CORROSION AND METAL FATIGUE PRACTICES, DESTRUCTIVE TESTING RESULTS REPORT, RED HILL BULK FUEL STORAGE FACILITY (RED HILL), JOINT BASE PEARL HARBOR-HICKAM, OAHU, HAWAII

In 2018, ten coupons were removed from Tank 14, so that a metallurgical and corrosion analysis of the coupons could be undertaken, with the primary aim of validating non-destructive examination (NDE) results. The steel coupons, concrete powder samples, and corrosion product were submitted to a certified third-party laboratory to perform this analysis.

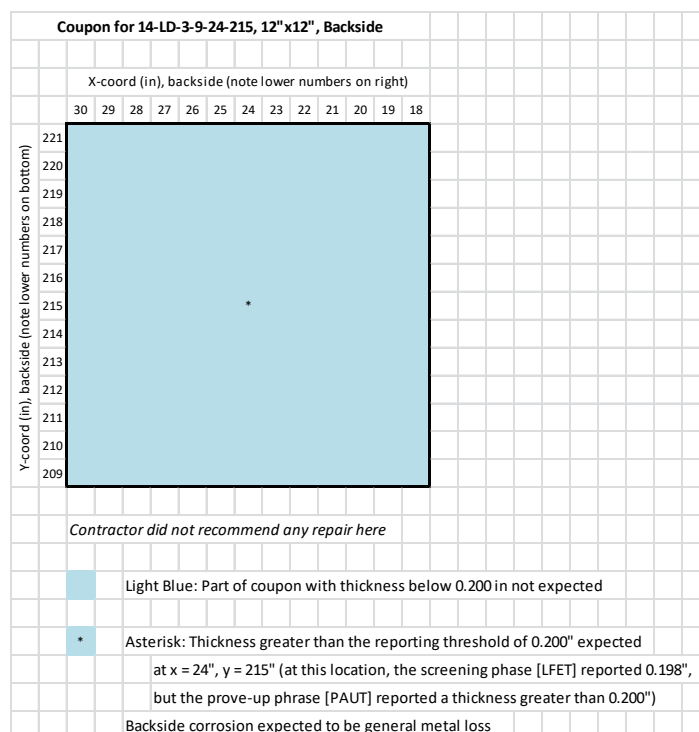
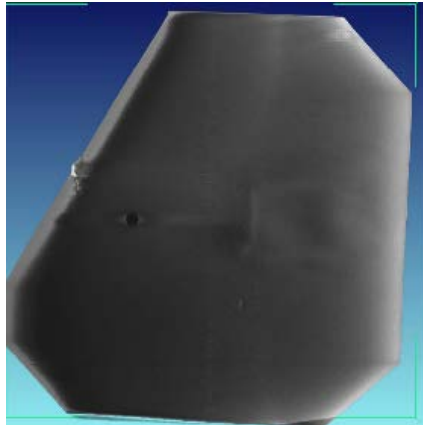
The LFET screening found no indications. Therefore, no repair was specified in this area.

Destructive testing found a minimum wall thickness of 0.242 inch. Remaining wall thickness was as expected.

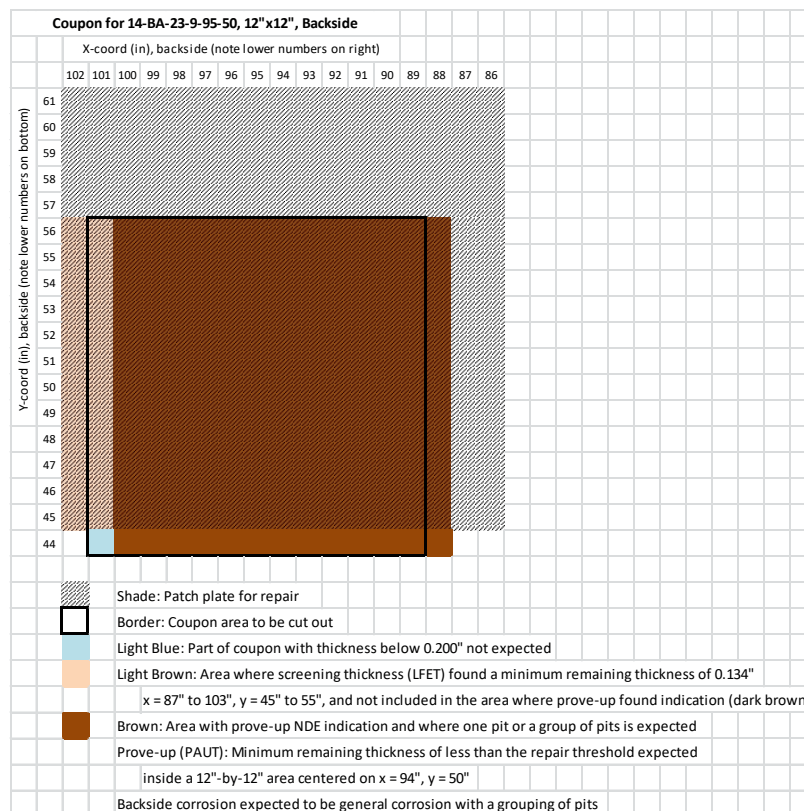
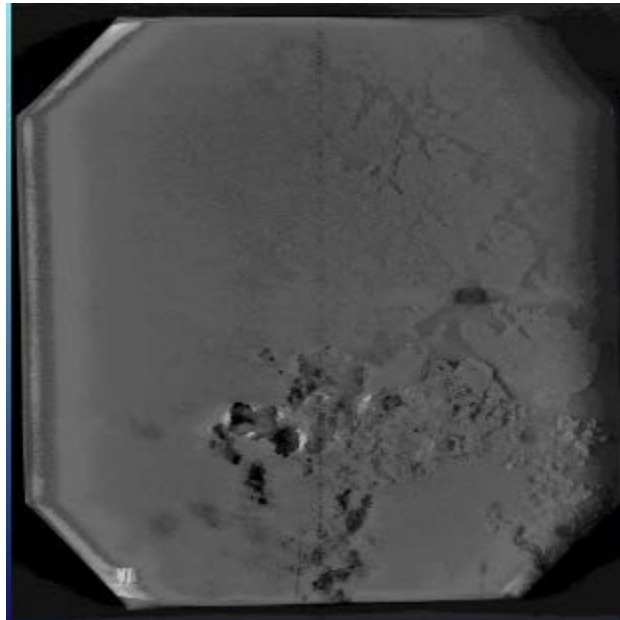
The LFET minimum screening thickness was 0.134 inch. No prove-up measurements were done in this location because a weld repair was indicated. A repair was specified in this area.

Destructive testing found pitting and minimum wall thickness of 0.122 inch. The remaining wall thickness was as expected. The LFET thickness fell within the 20-mil accuracy range.

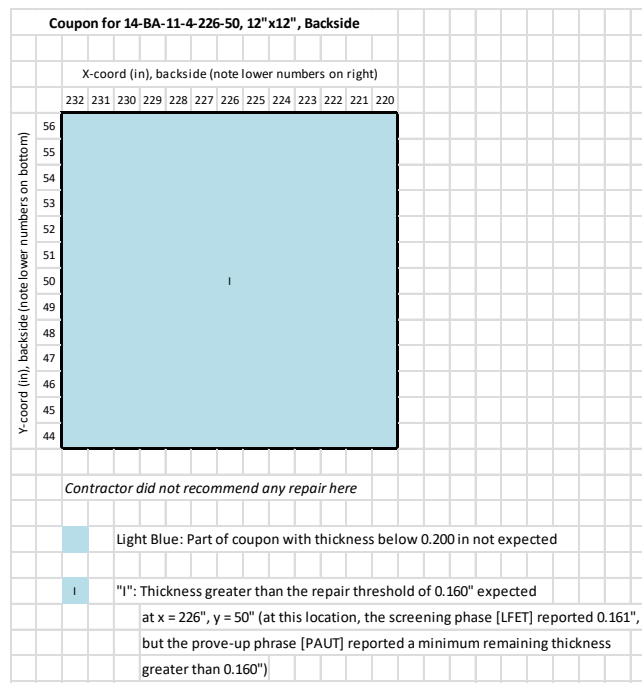
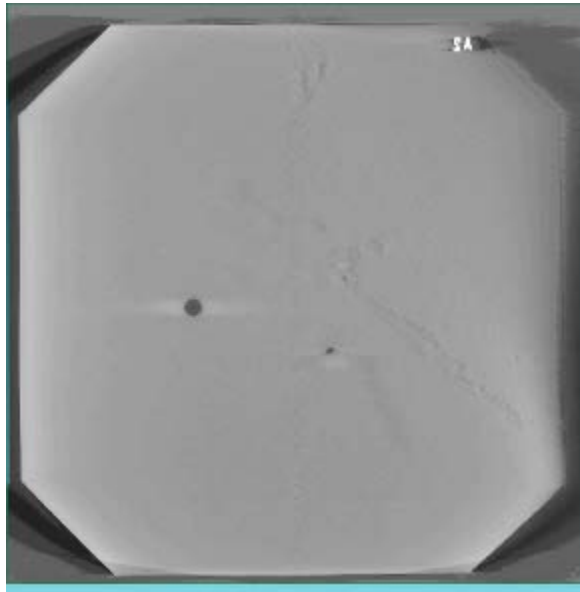
The LFET screening found no indications. Therefore, no repair was specified in this area.

Destructive testing found a minimum wall thickness of 0.248 inch. The remaining wall thickness was as expected.

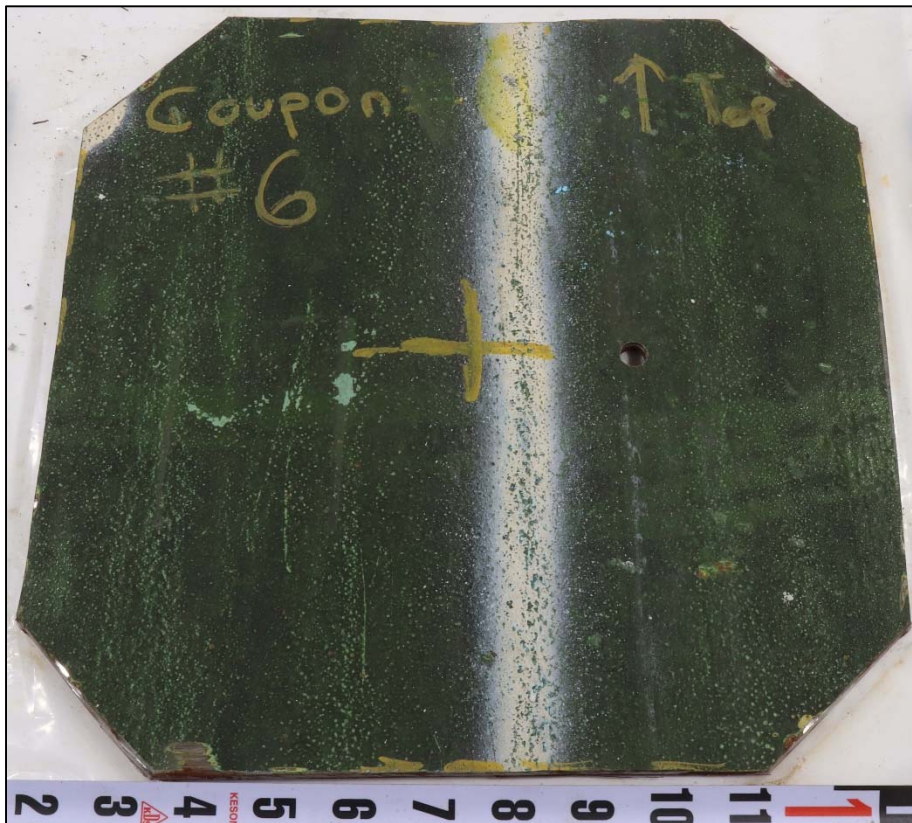
**Figure 14.** An image of the exterior surface of Coupon 6 in the as-received condition.

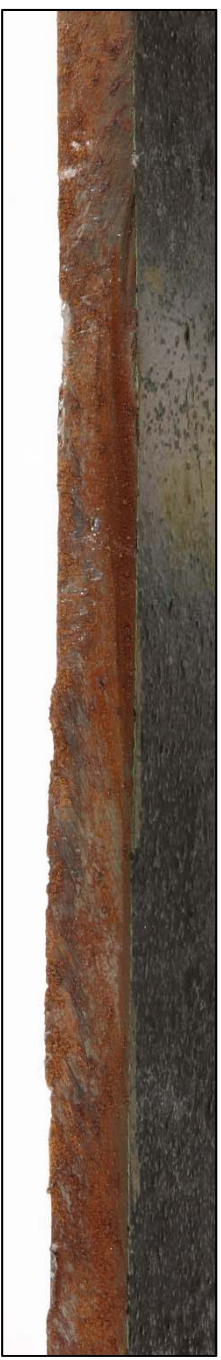
**Figure 15.** An image of a representative edge of Coupon 6 in the as-received condition.

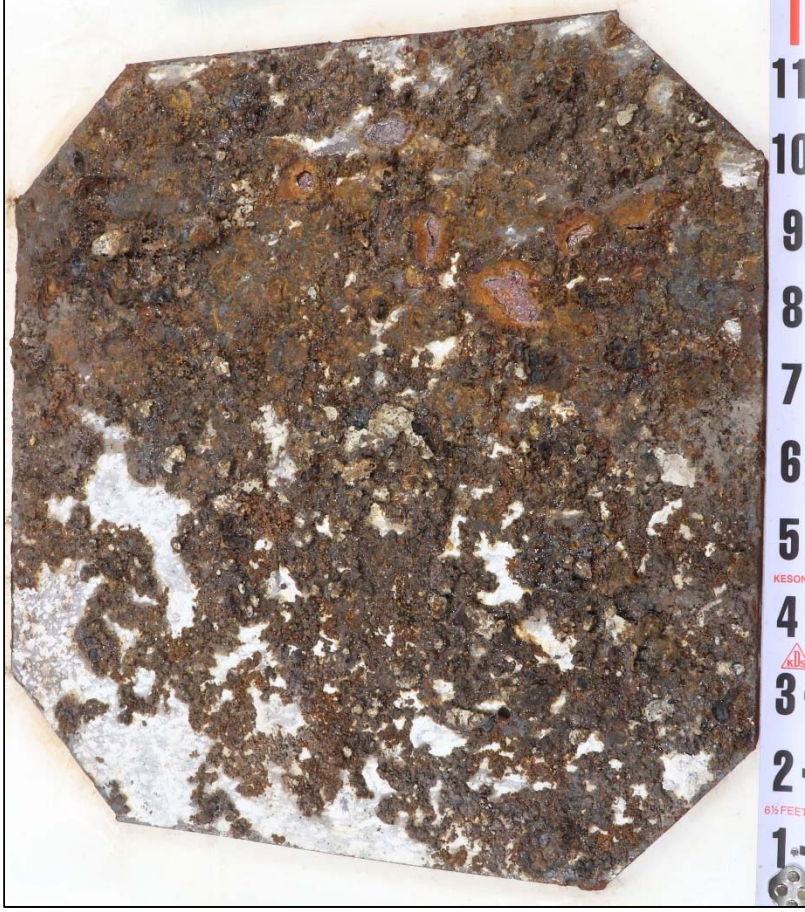
**Figure 16.** An image of the interior surface of Coupon 7 in the as-received condition.

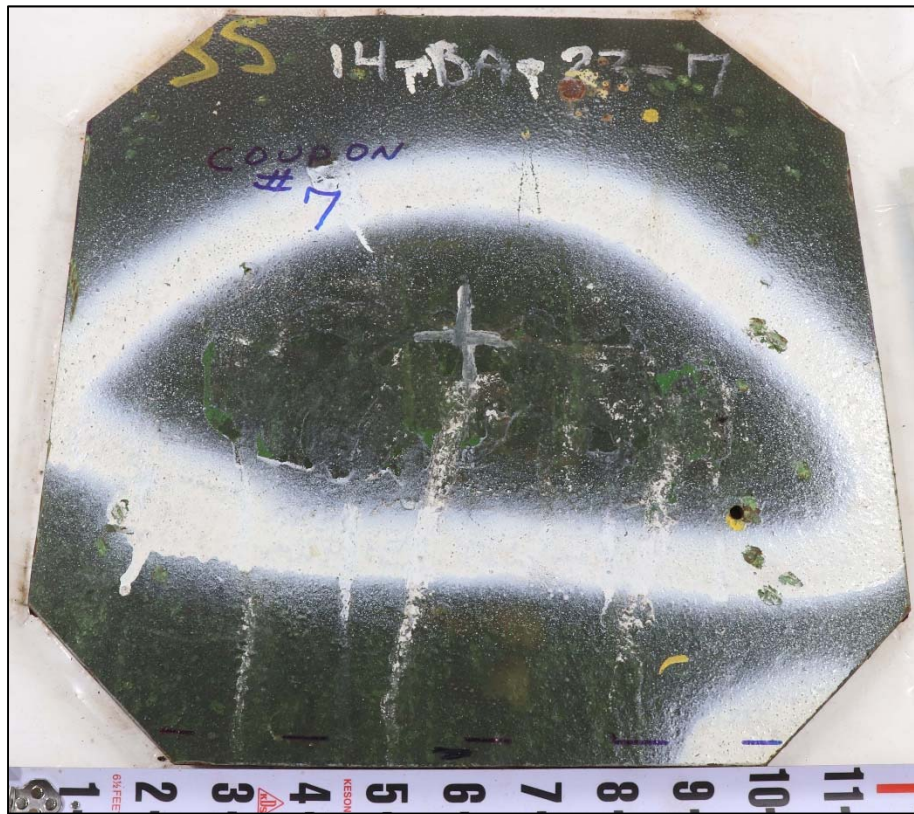
**Figure 17.** An image of the exterior surface of Coupon 7 in the as-received condition.

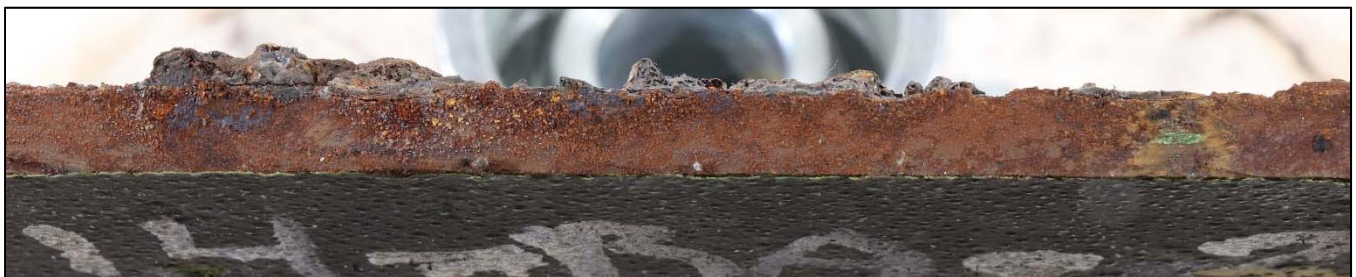
**Figure 18.** An image of a representative edge of Coupon 7 in the as-received condition.

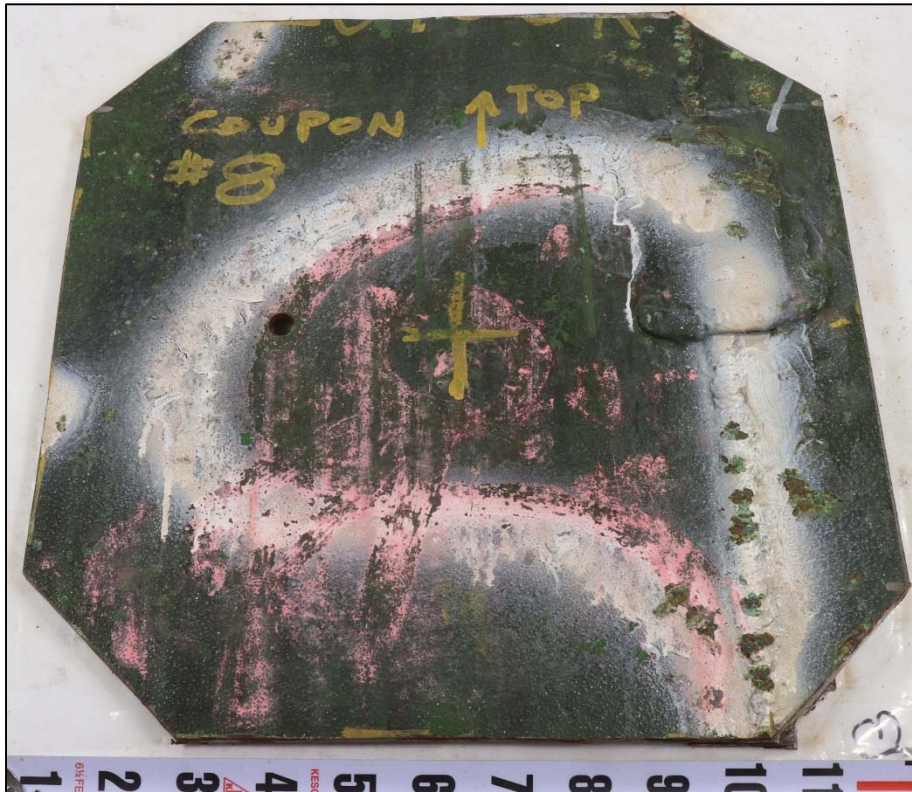
**Figure 20.** An image of the exterior surface of Coupon 8 in the as-received condition.

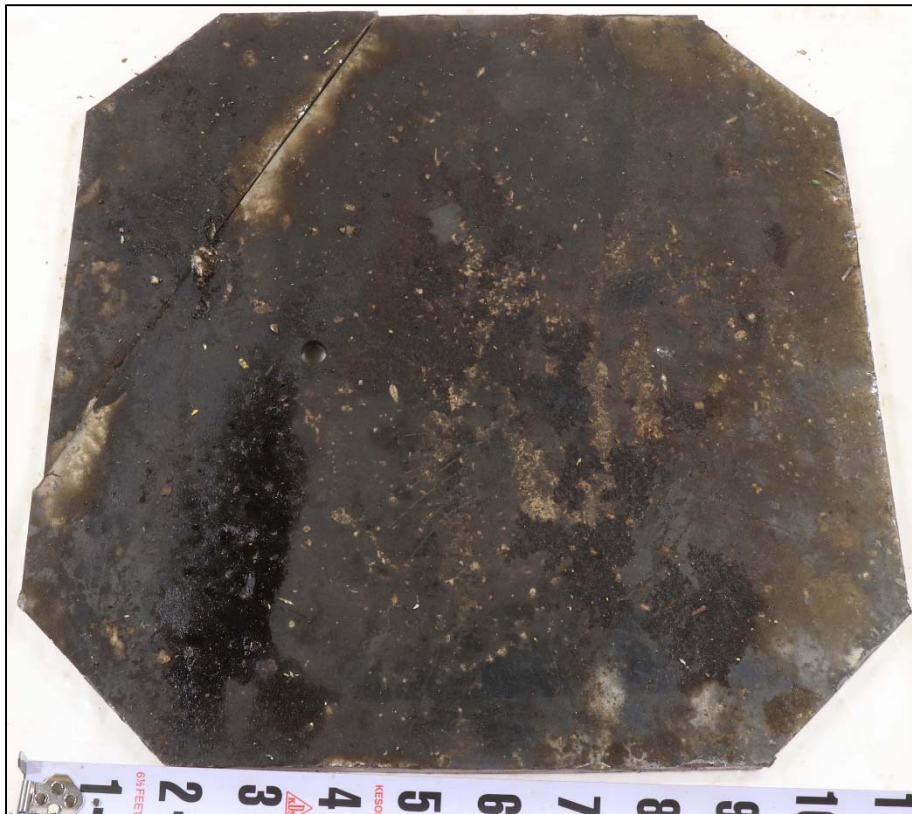
**Figure 22.** An image of the interior surface of Coupon 10 in the as-received condition.

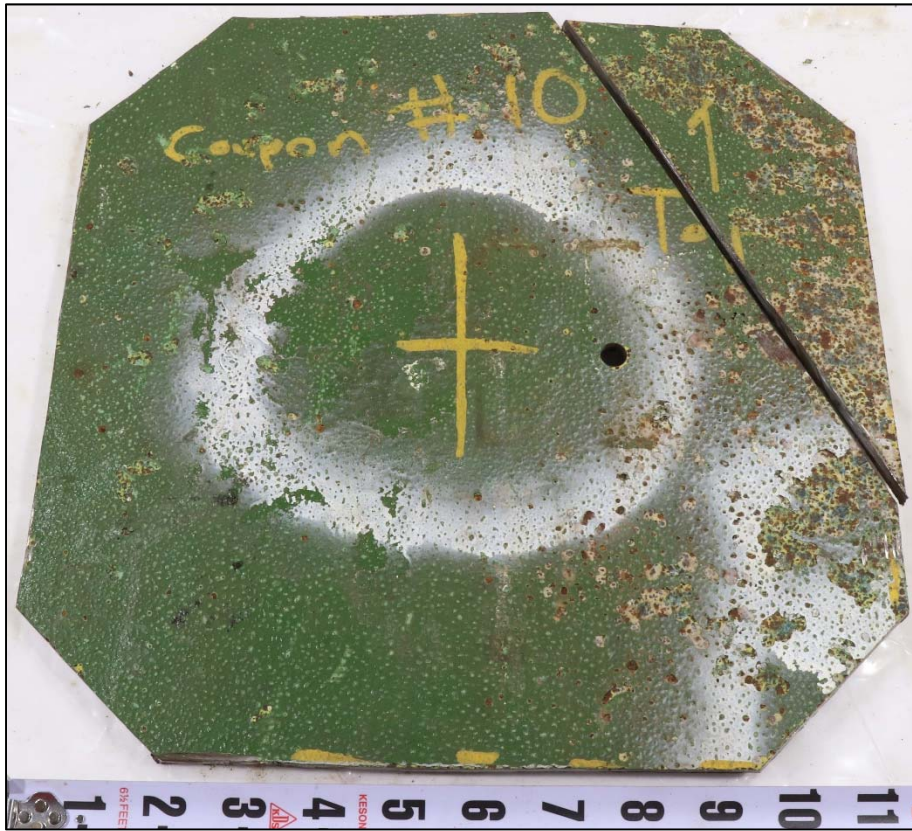
**Figure 23.** An image of the exterior surface of Coupon 10 in the as-received condition.

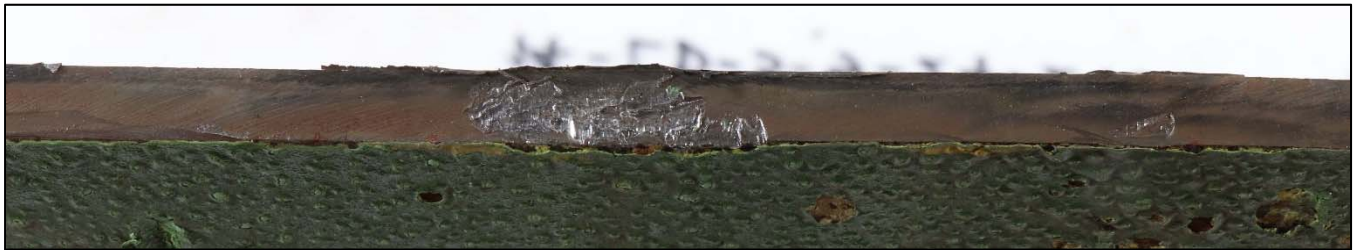
**Figure 24.** An image of a representative edge of Coupon 10 in the as-received condition.

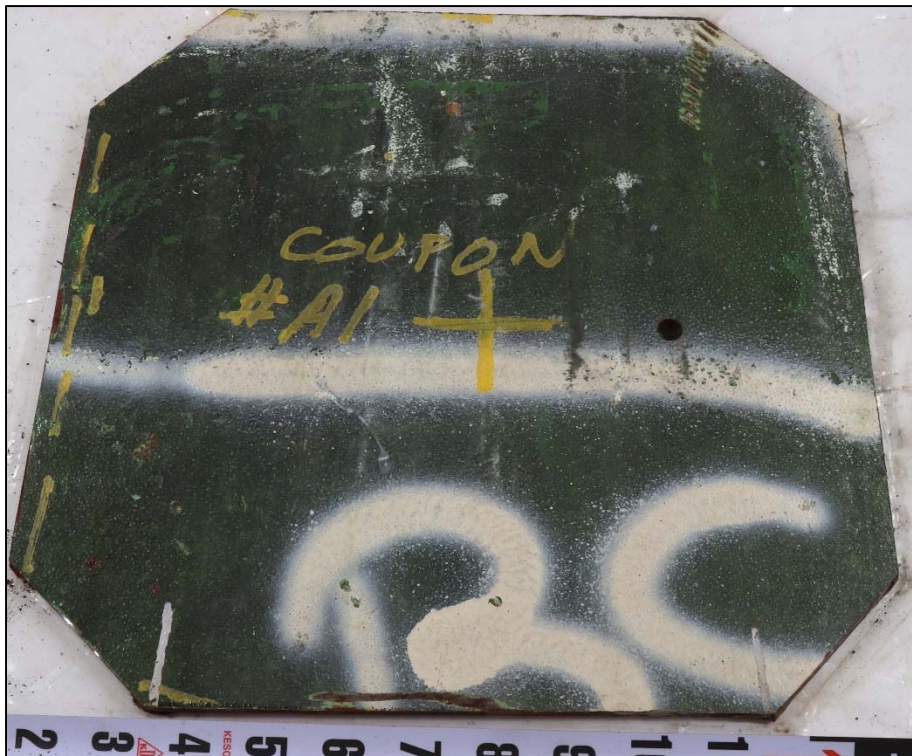
**Figure 26.** An image of the exterior surface of Coupon A1 in the as-received condition.

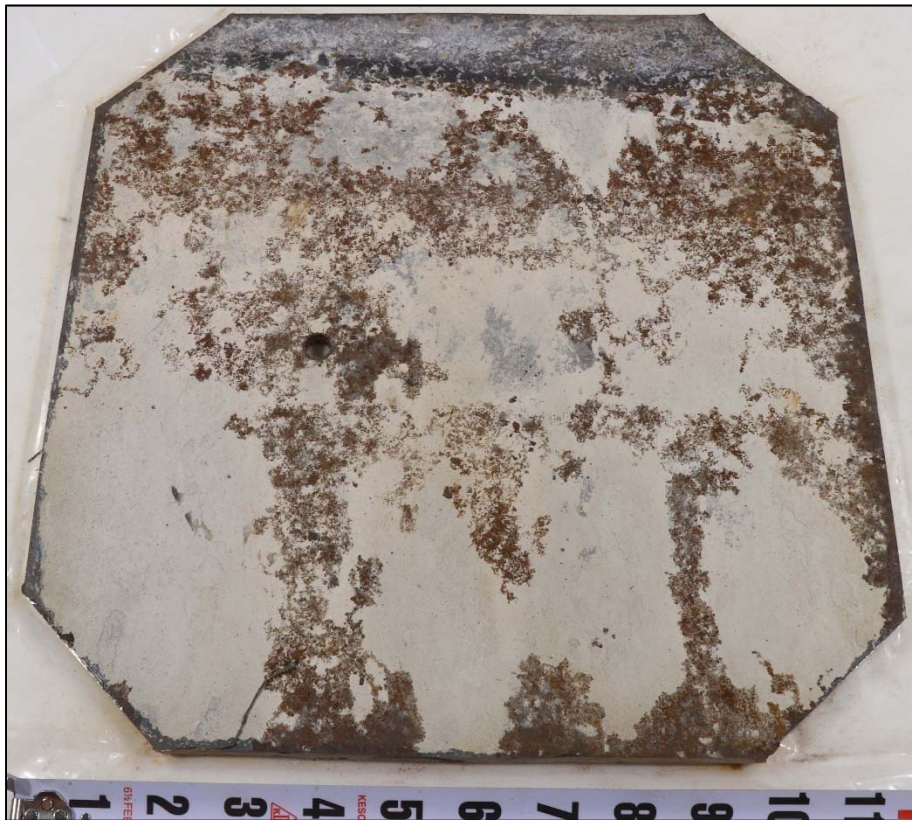
**Figure 28.** An image of the interior surface of Coupon A2 in the as-received condition.

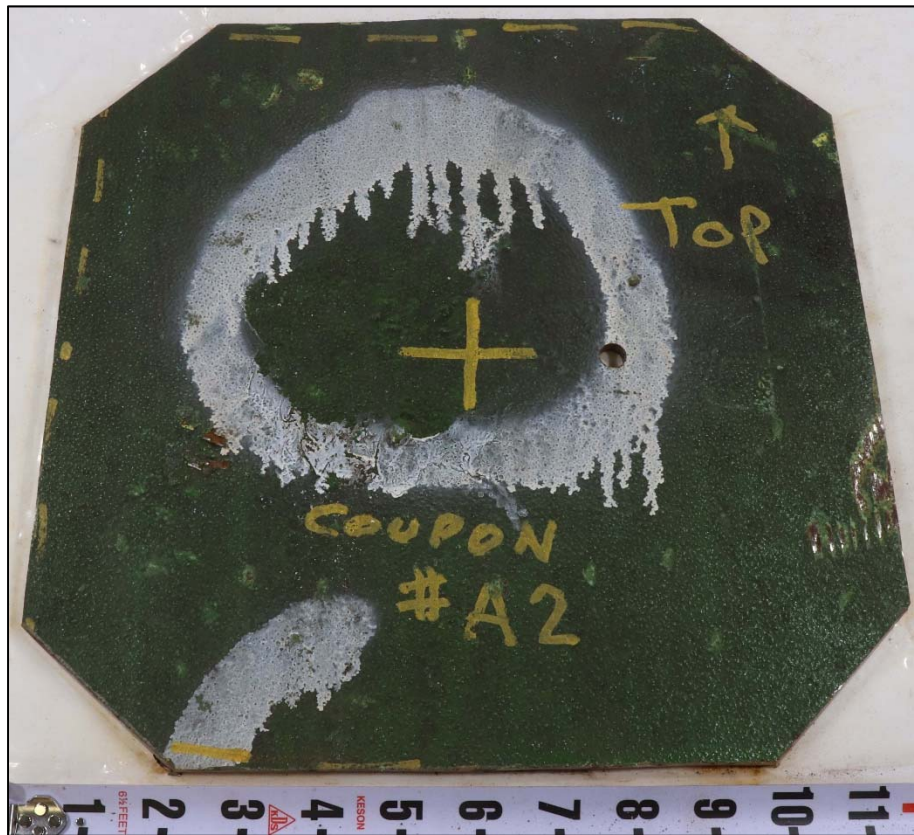
**Figure 29.** An image of the exterior surface of Coupon A2 in the as-received condition.

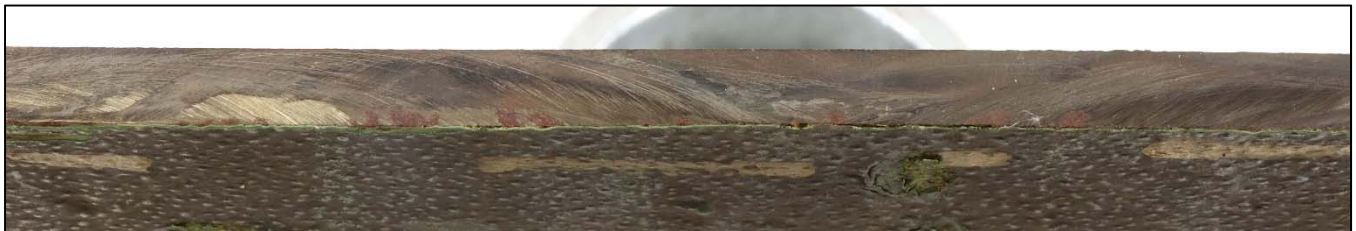
**Figure 30.** An image of a representative edge of Coupon A2 in the as-received condition.

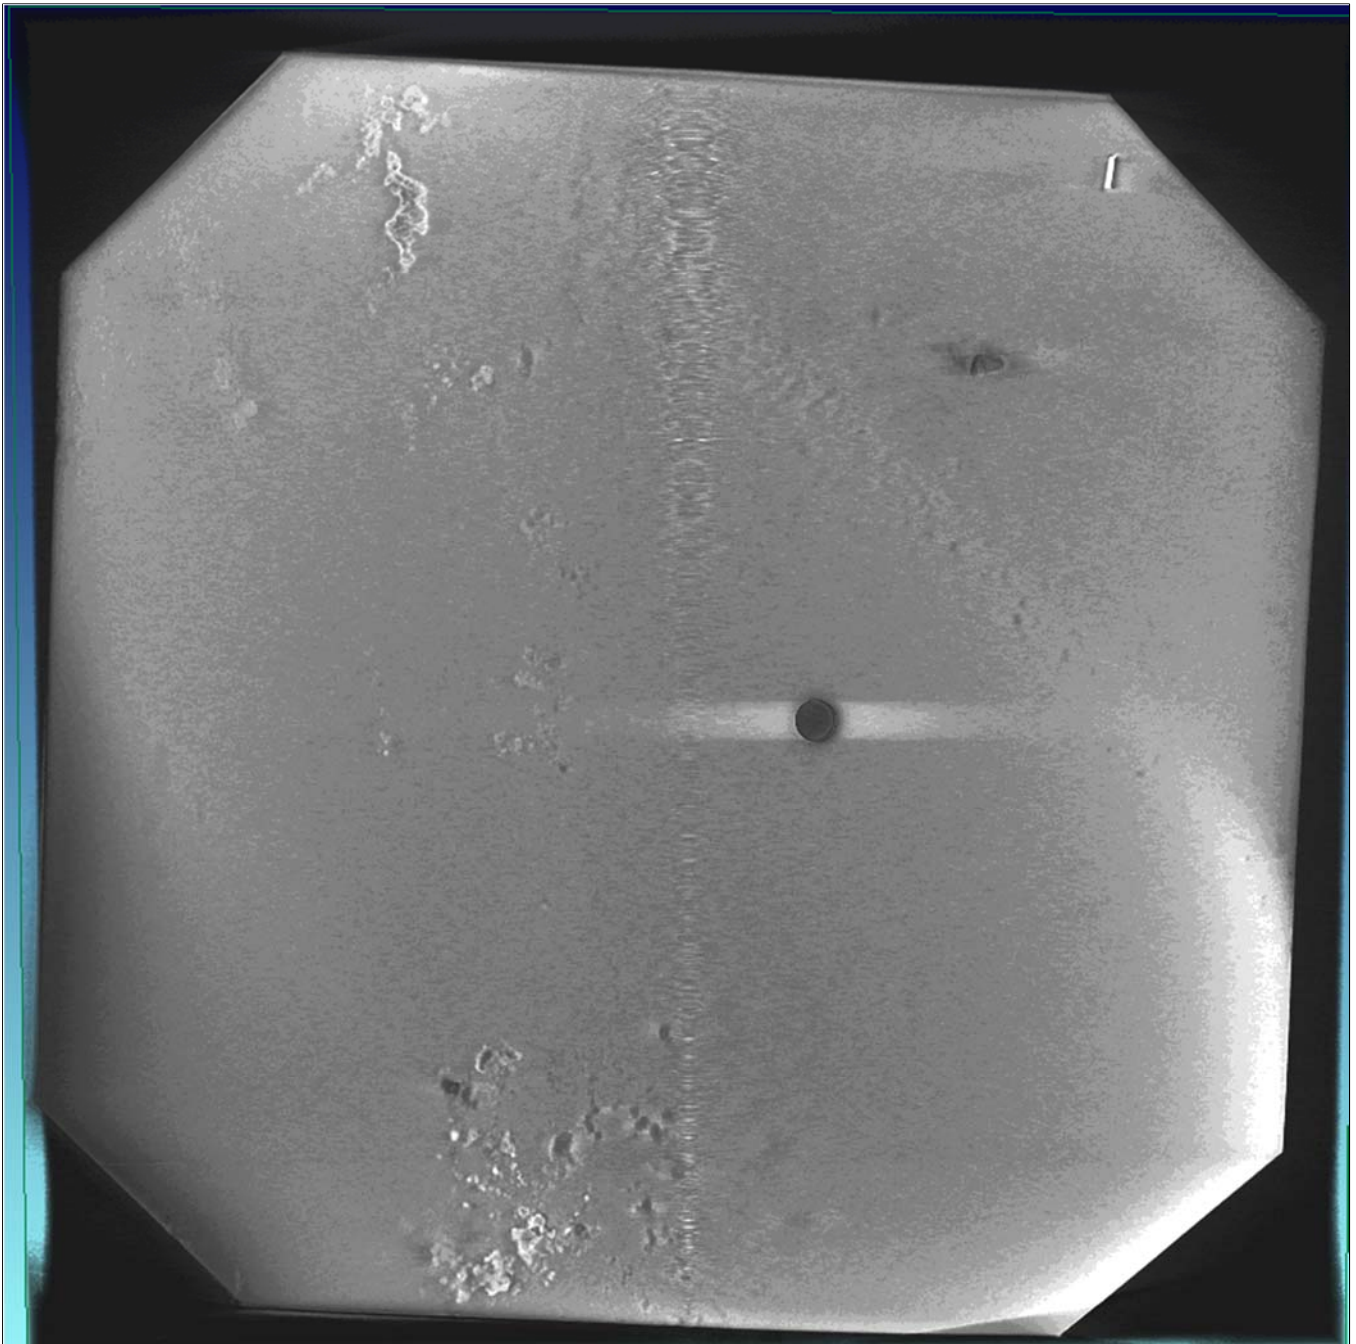
**Figure 31.** A representative screenshot of the CT scan performed on Coupon 1.

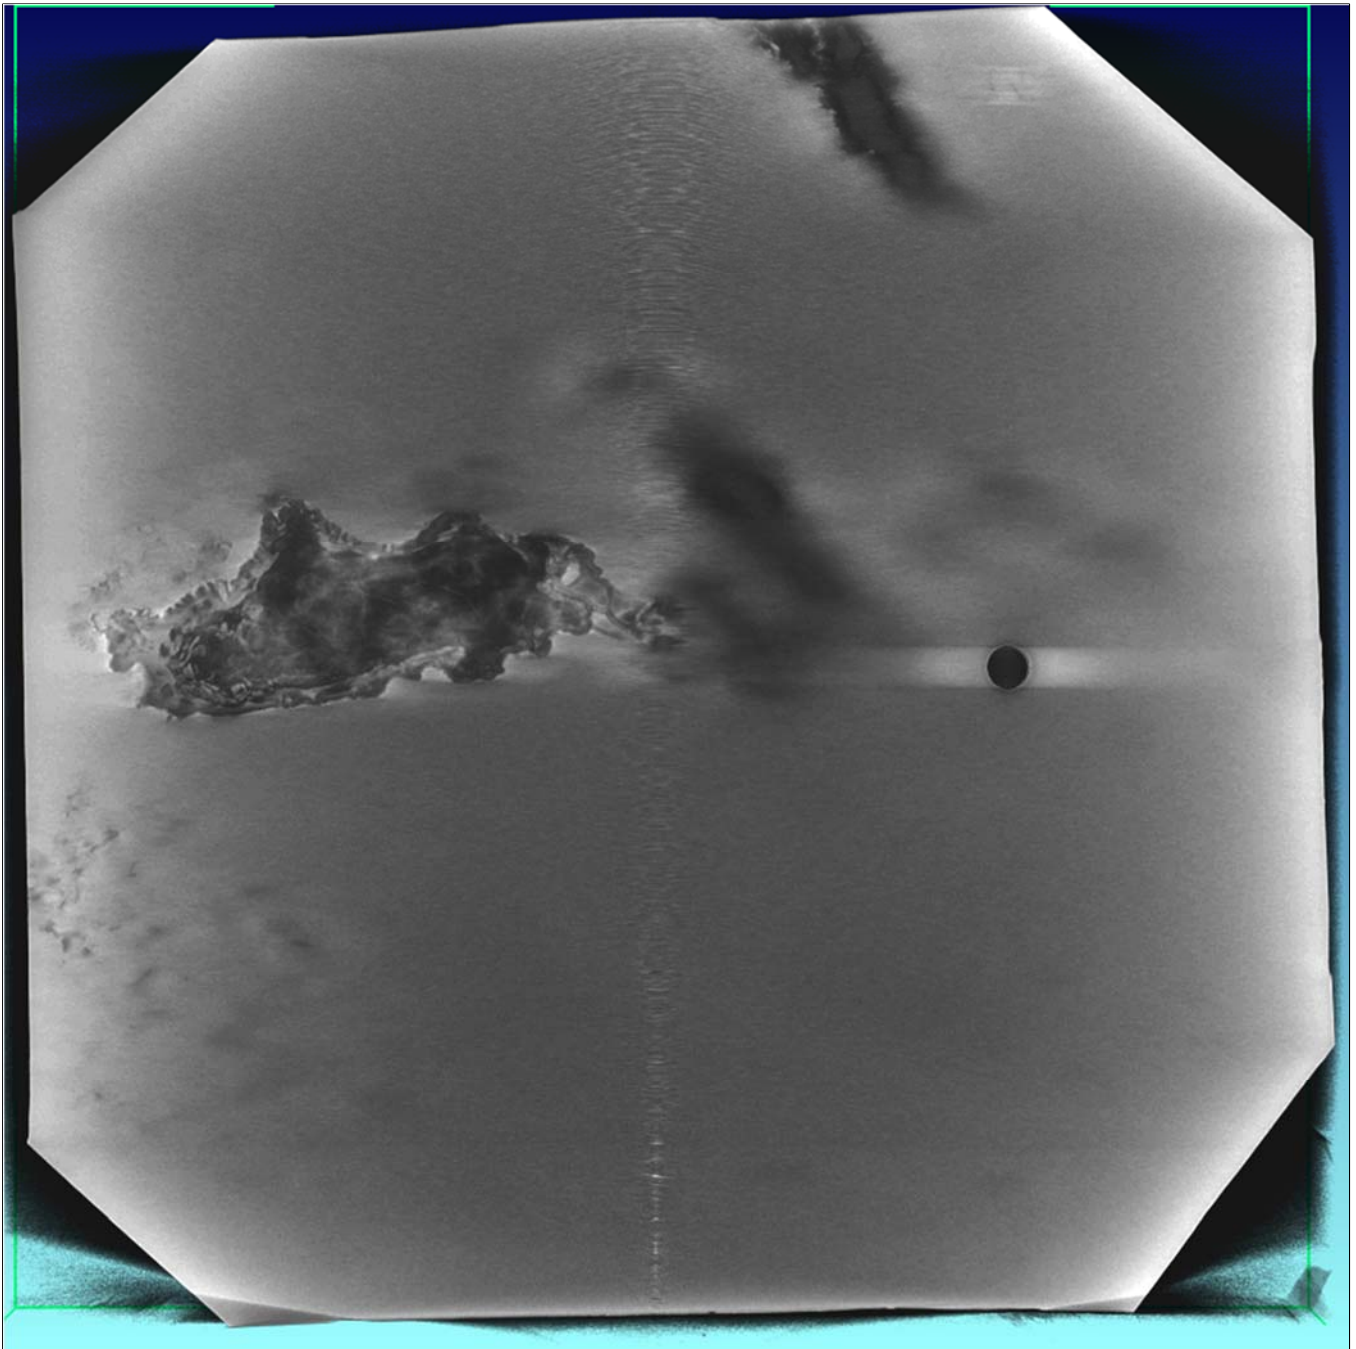
**Figure 32.** A representative screenshot of the CT scan performed on Coupon 2.

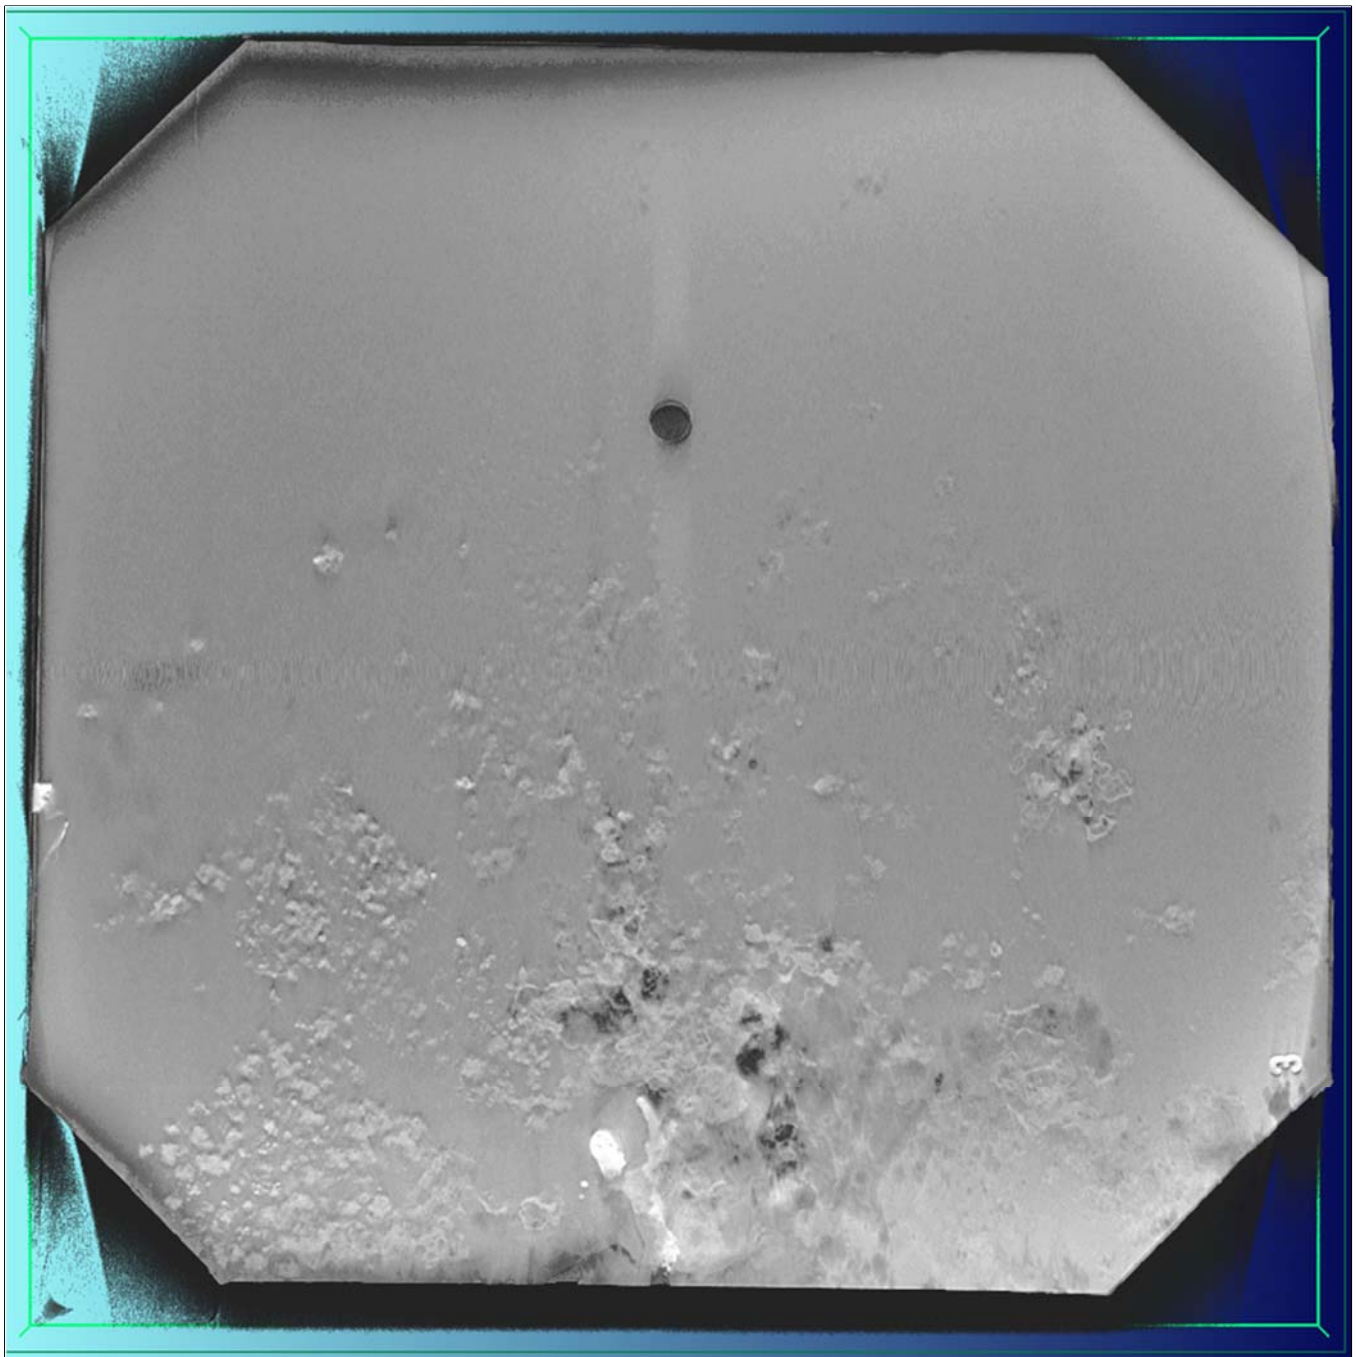
**Figure 33.** A representative screenshot of the CT scan performed on Coupon 3.

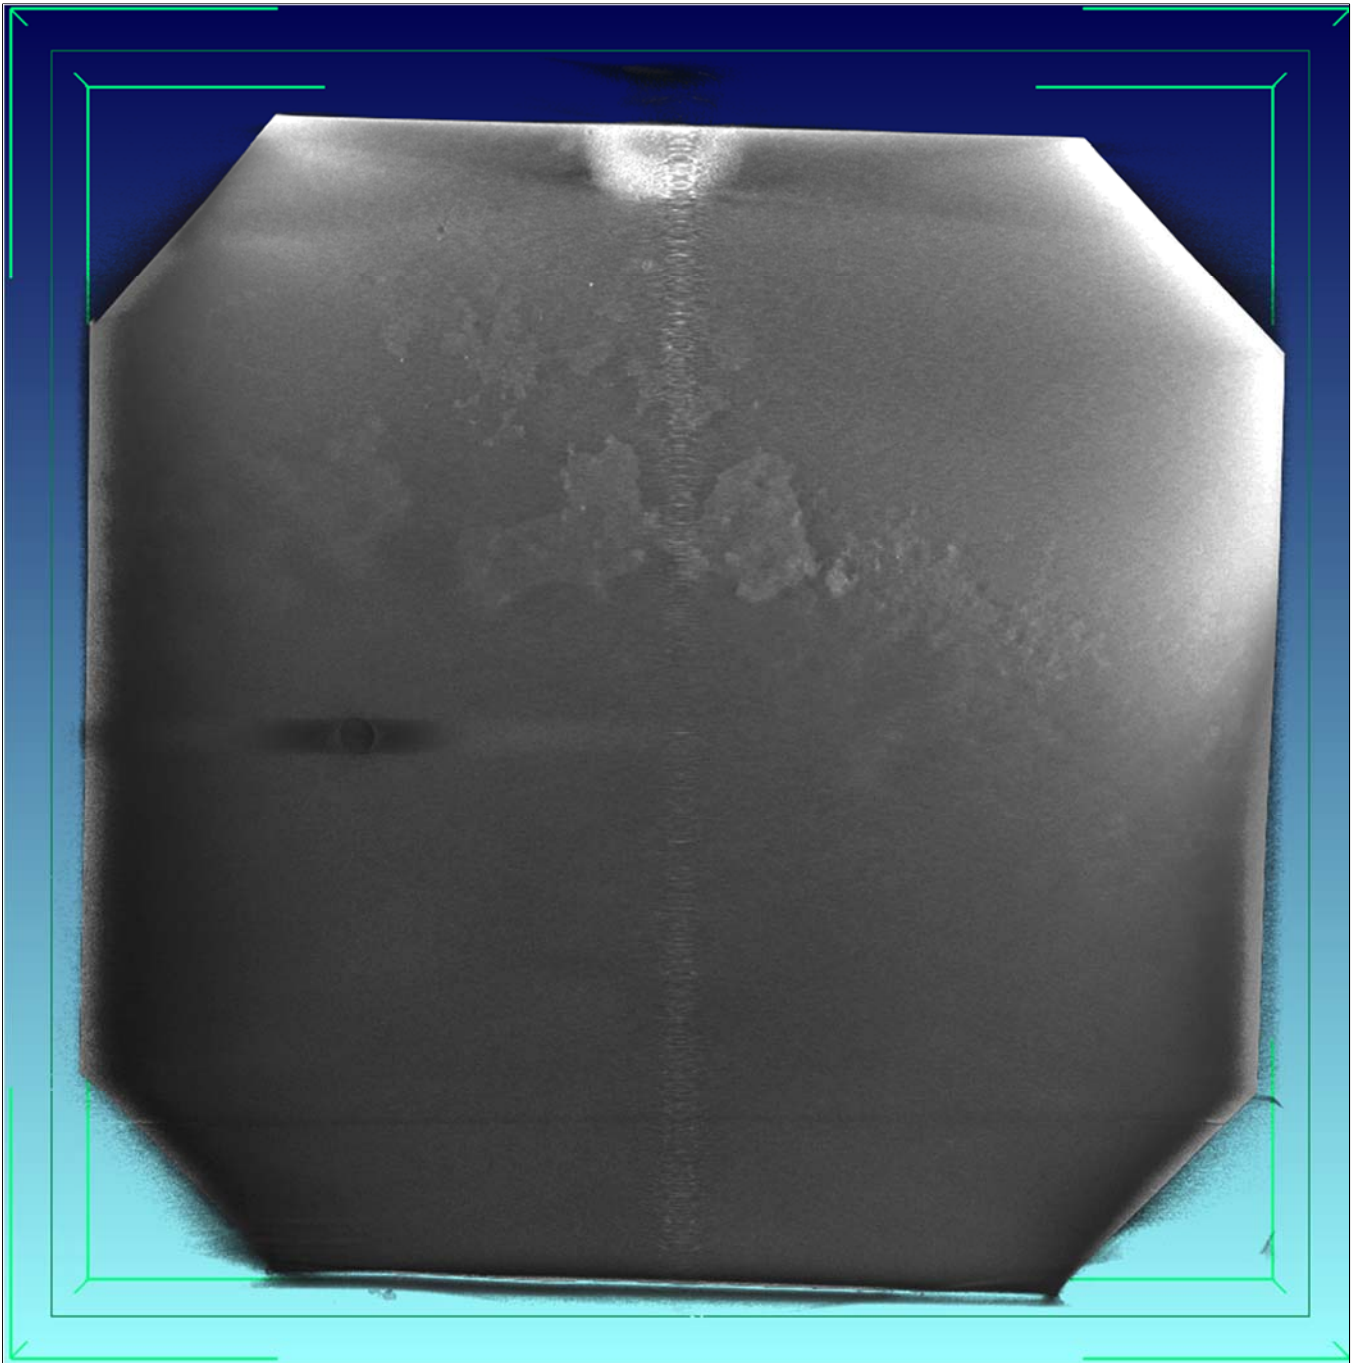
**Figure 34.** A representative screenshot of the CT scan performed on Coupon 5.

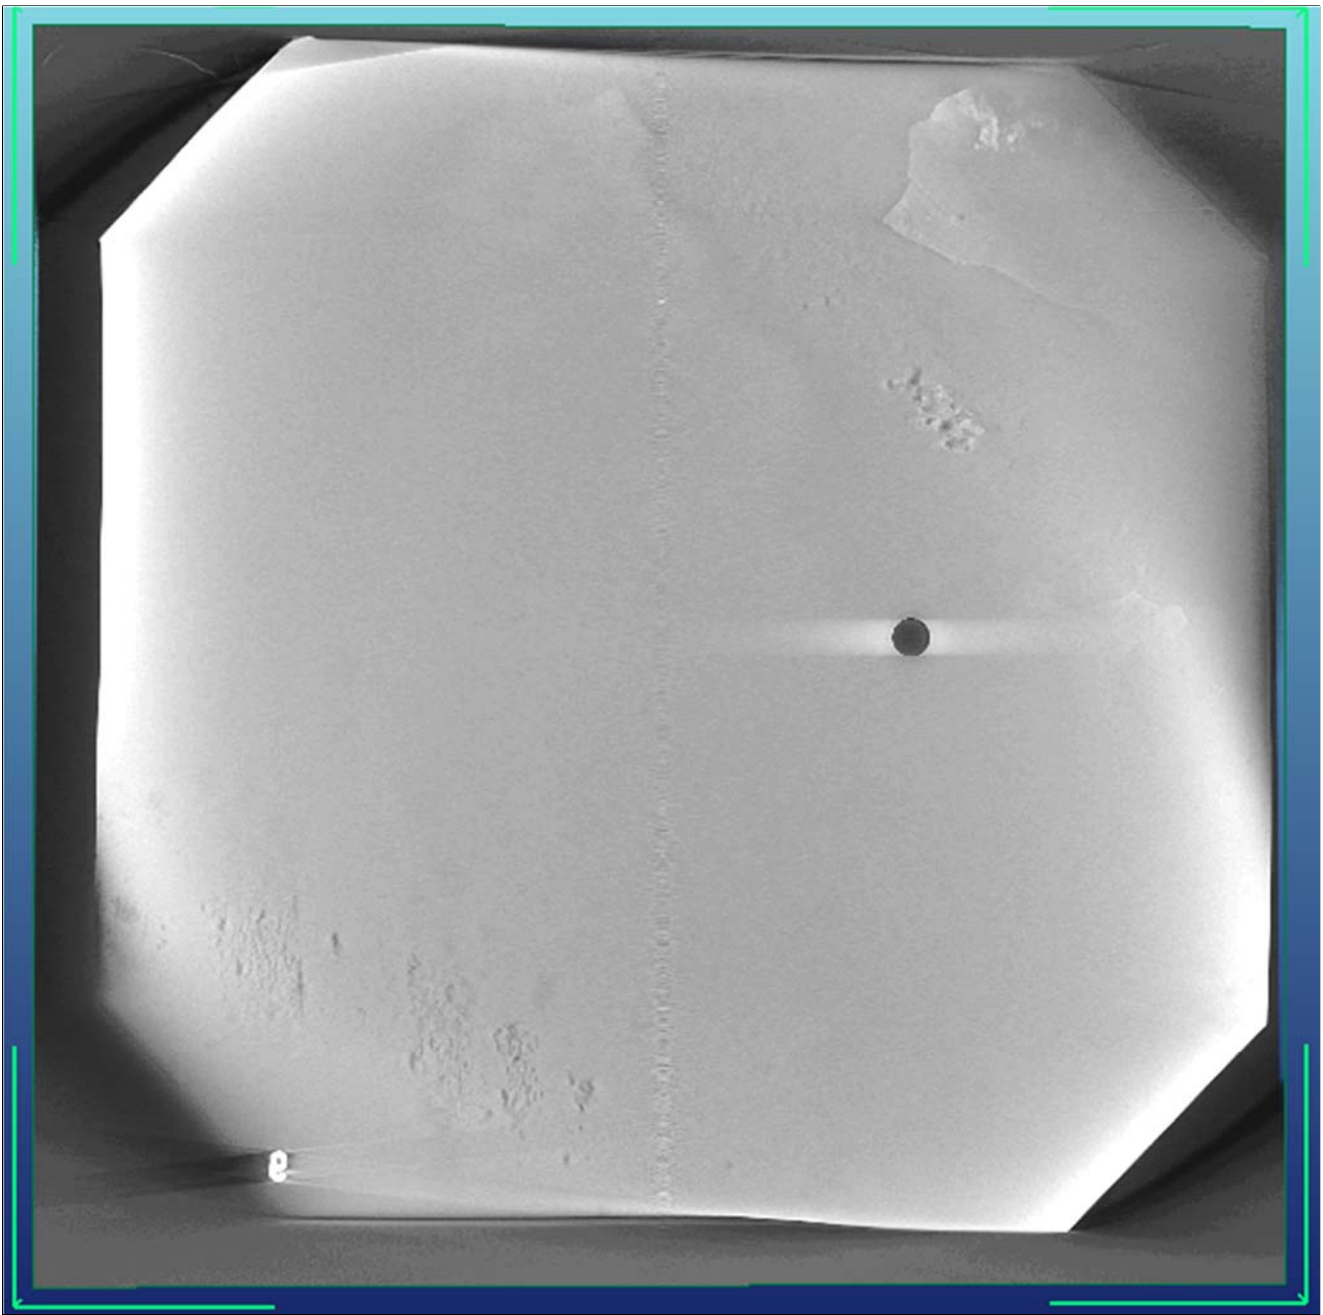
**Figure 35.** A representative screenshot of the CT scan performed on Coupon 6.

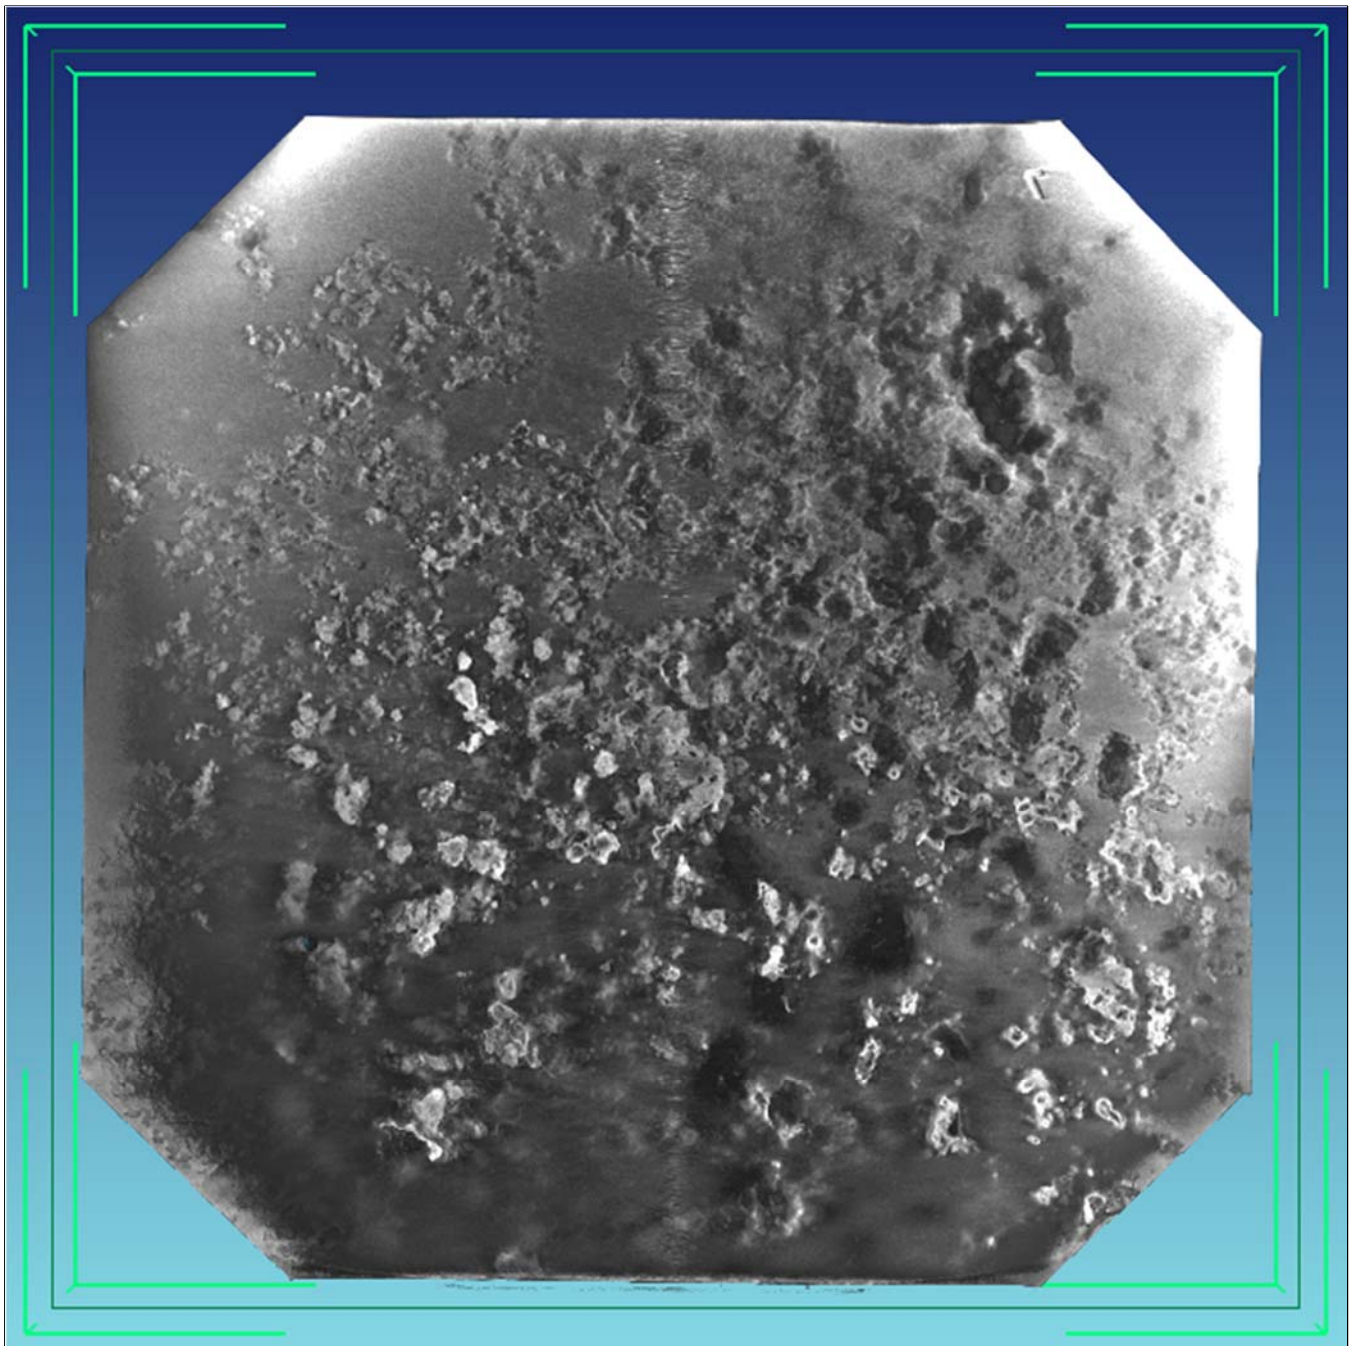
**Figure 36.** A representative screenshot of the CT scan performed on Coupon 7.
