SUBJECT: ADMINISTRATIVE ORDER ON CONSENT (AOC) STATEMENT OF WORK (SOW) SECTION 5 CORROSION AND METAL FATIGUE PRACTICES, DESTRUCTIVE TESTING RESULTS REPORT, RED HILL BULK FUEL STORAGE FACILITY (RED HILL), JOINT BASE PEARL HARBOR-HICKAM, OAHU, HAWAII

In 2018, ten coupons were removed from Tank 14, so that a metallurgical and corrosion analysis of the coupons could be undertaken, with the primary aim of validating non-destructive examination (NDE) results. The steel coupons, concrete powder samples, and corrosion product were submitted to a certified third-party laboratory to perform this analysis.

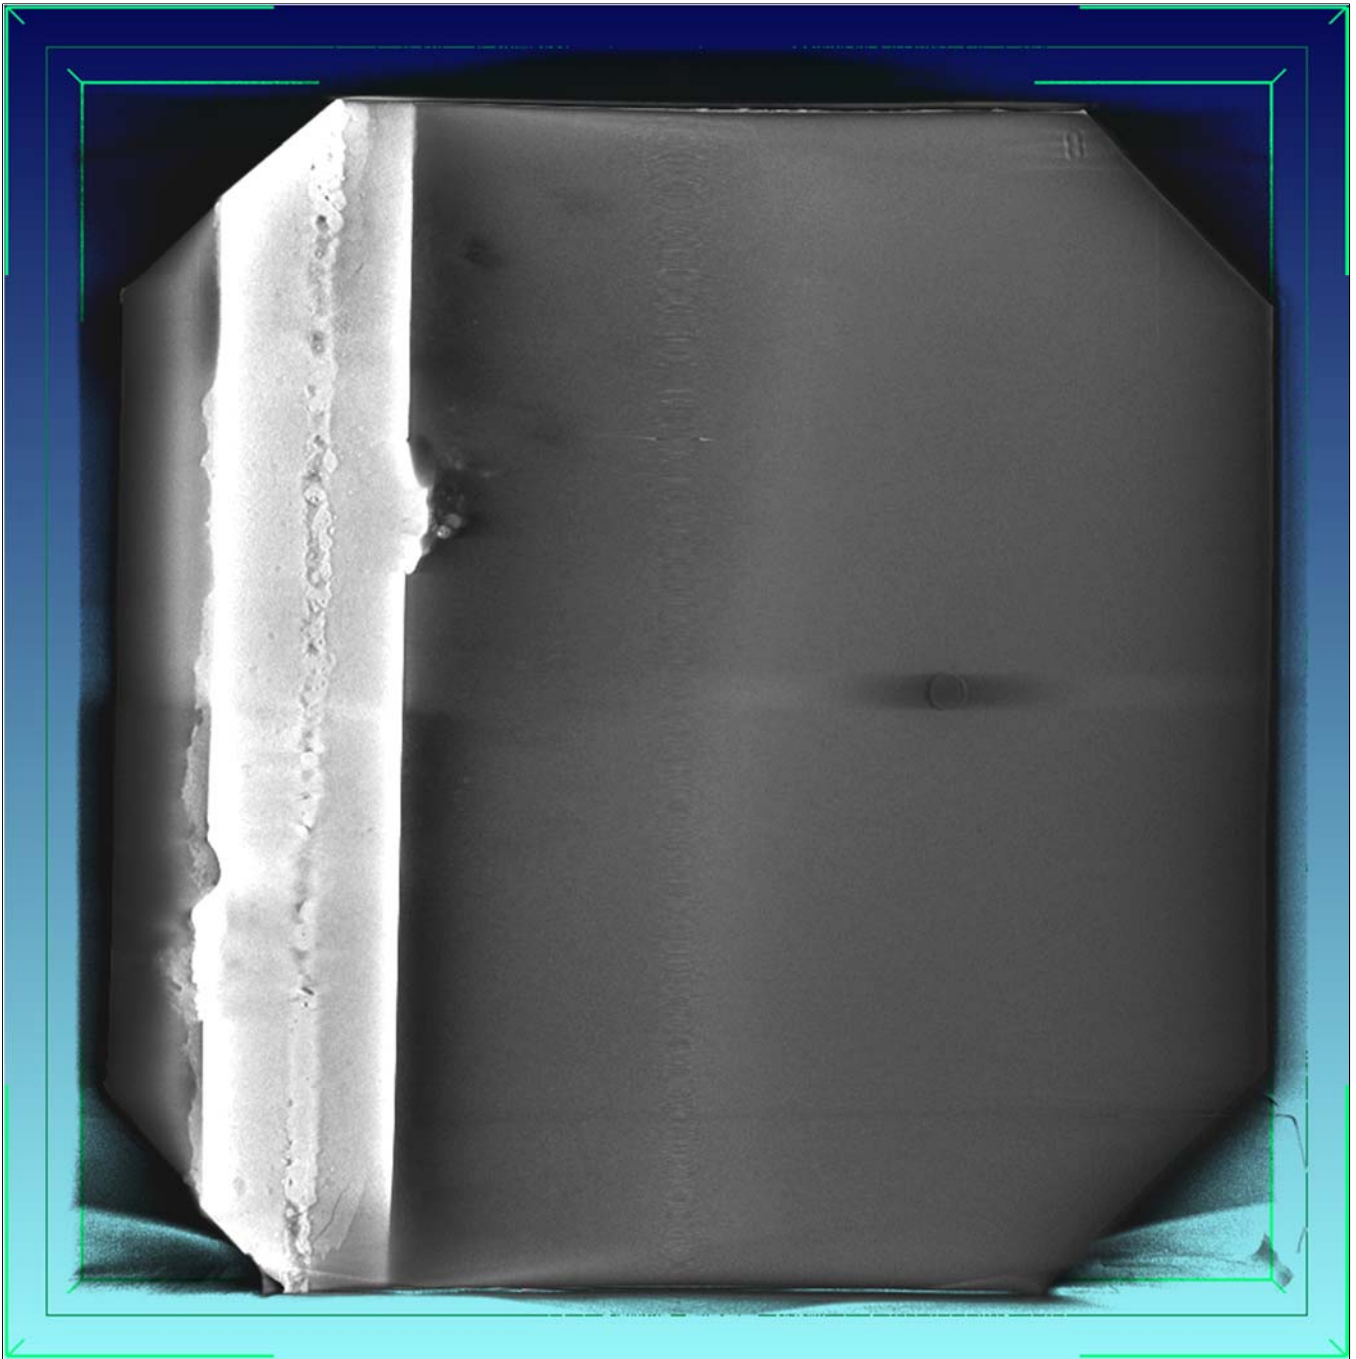
**Figure 37.** A representative screenshot of the CT scan performed on Coupon 8.

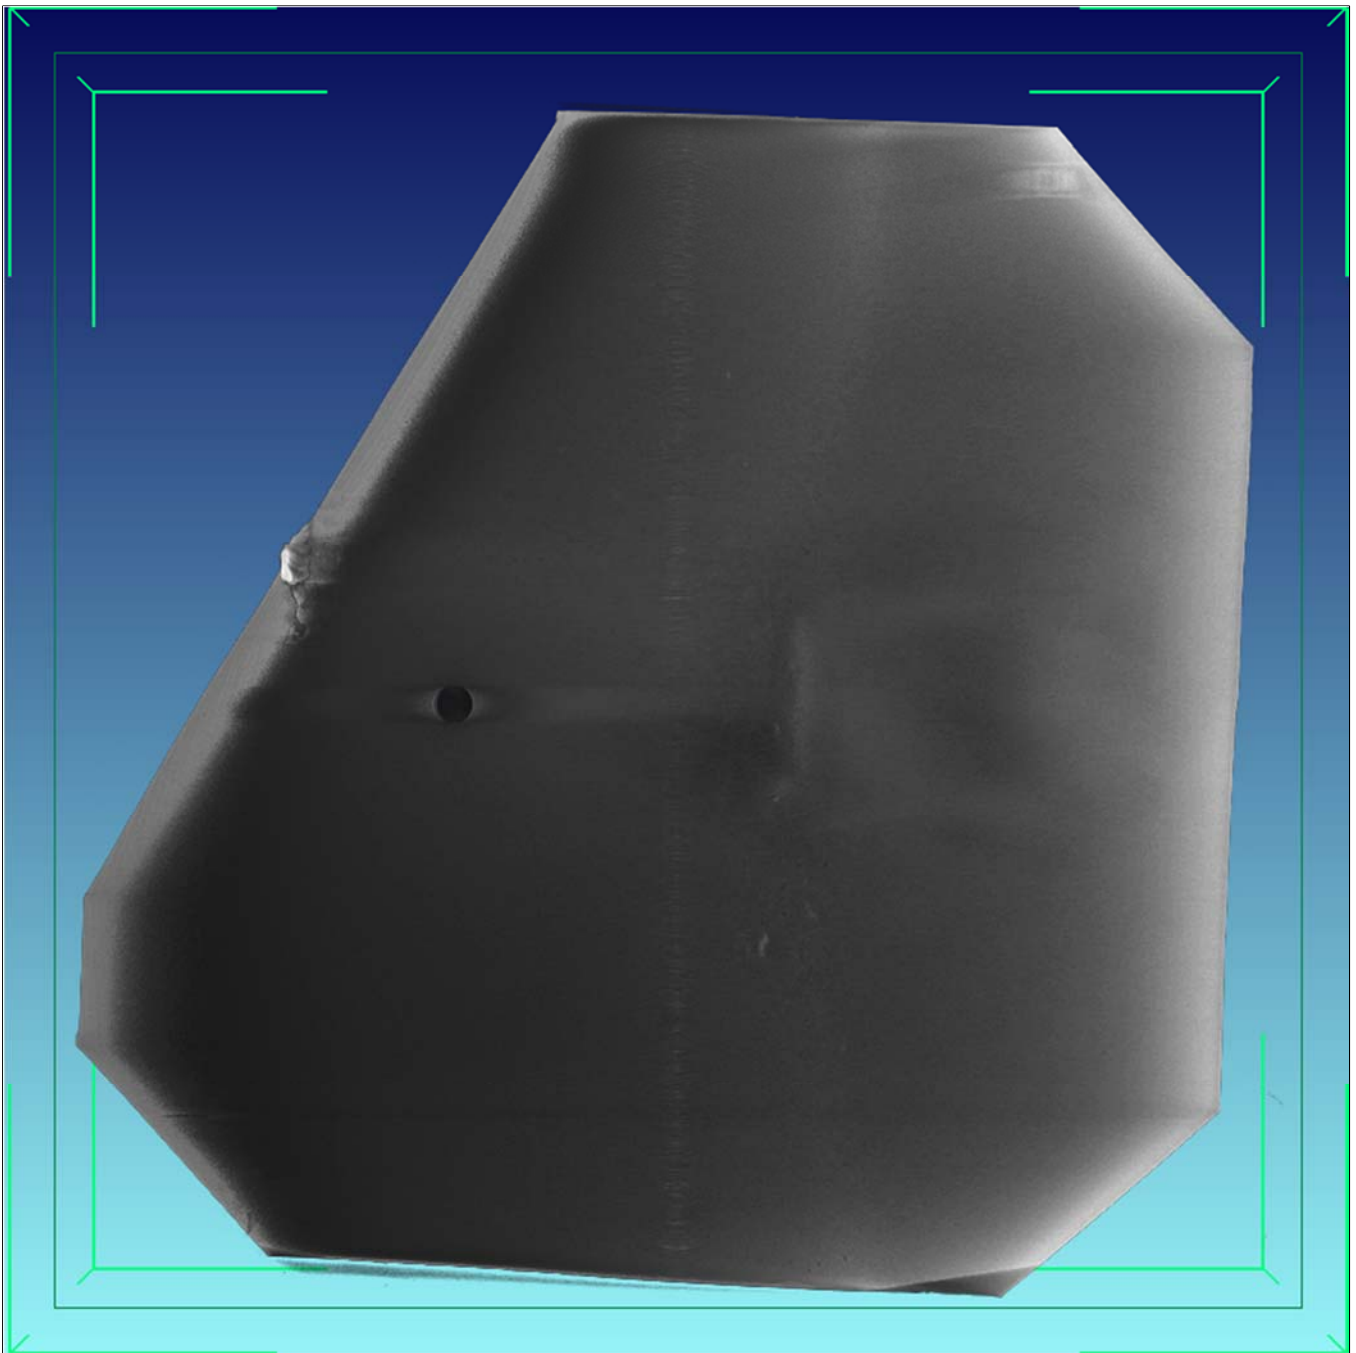
**Figure 38.** A representative screenshot of the CT scan performed on Coupon 10.

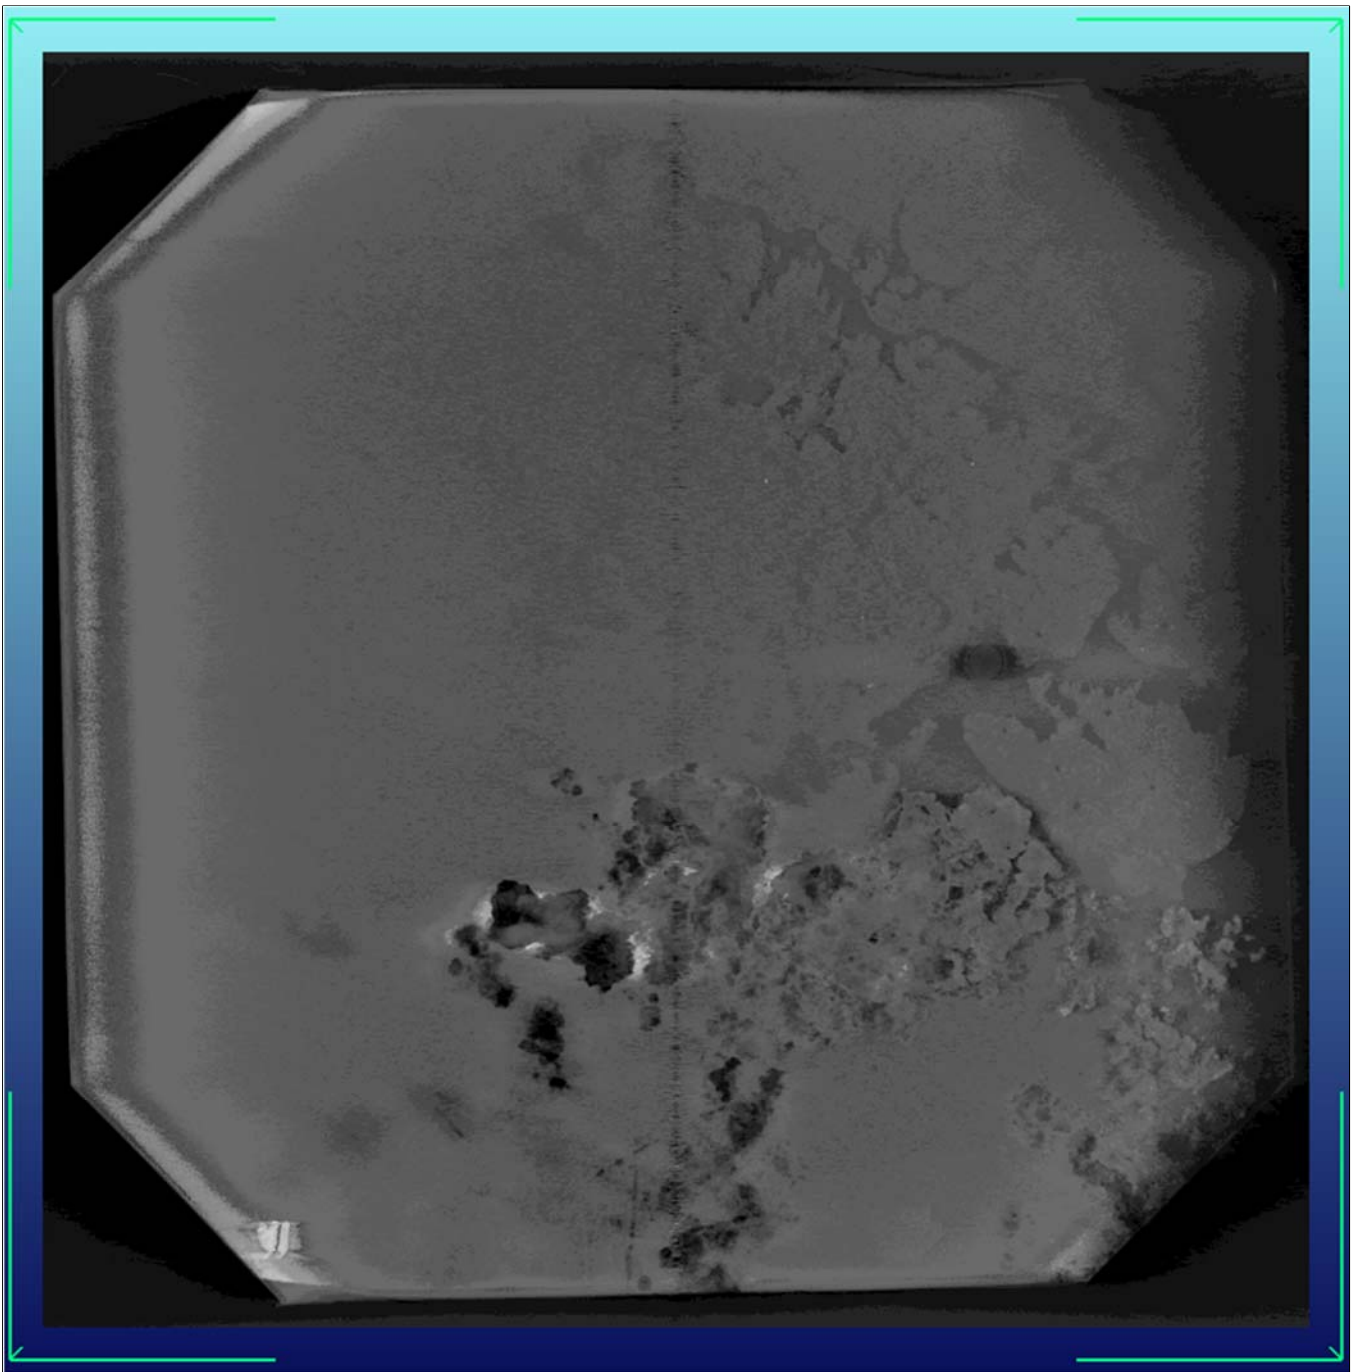
**Figure 39.** A representative screenshot of the CT scan performed on Coupon A1.

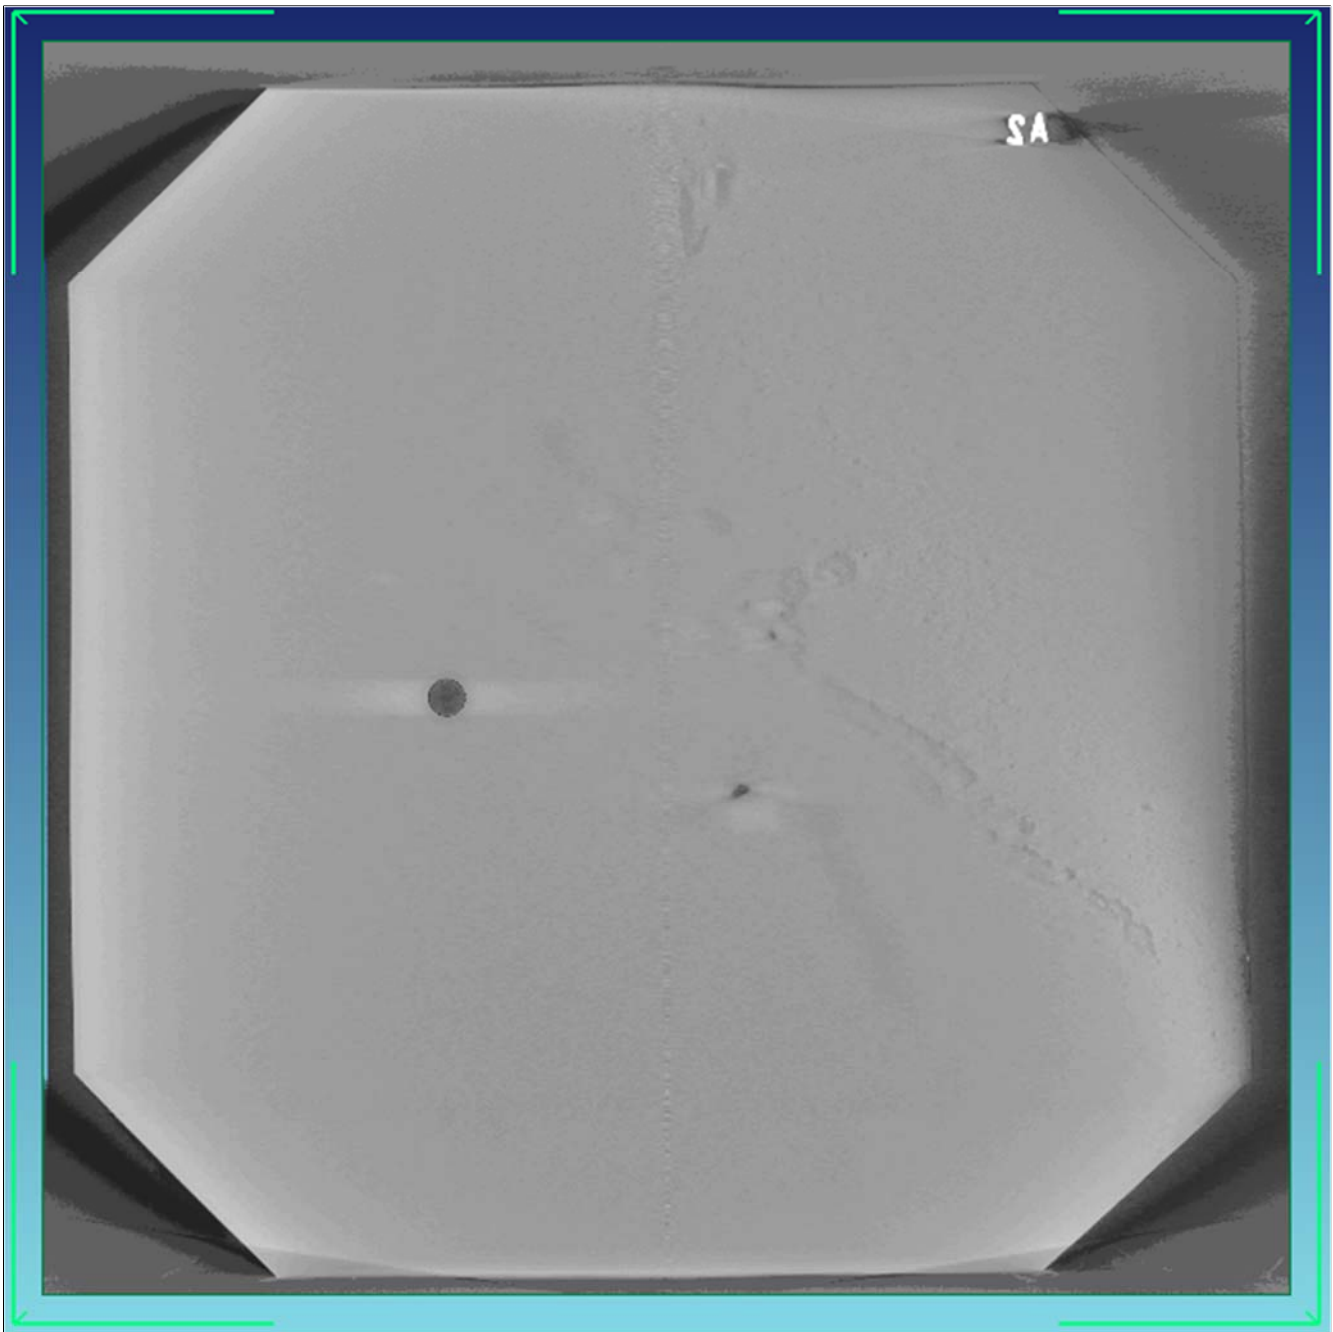
**Figure 40.** A representative screenshot of the CT scan performed on Coupon A2.

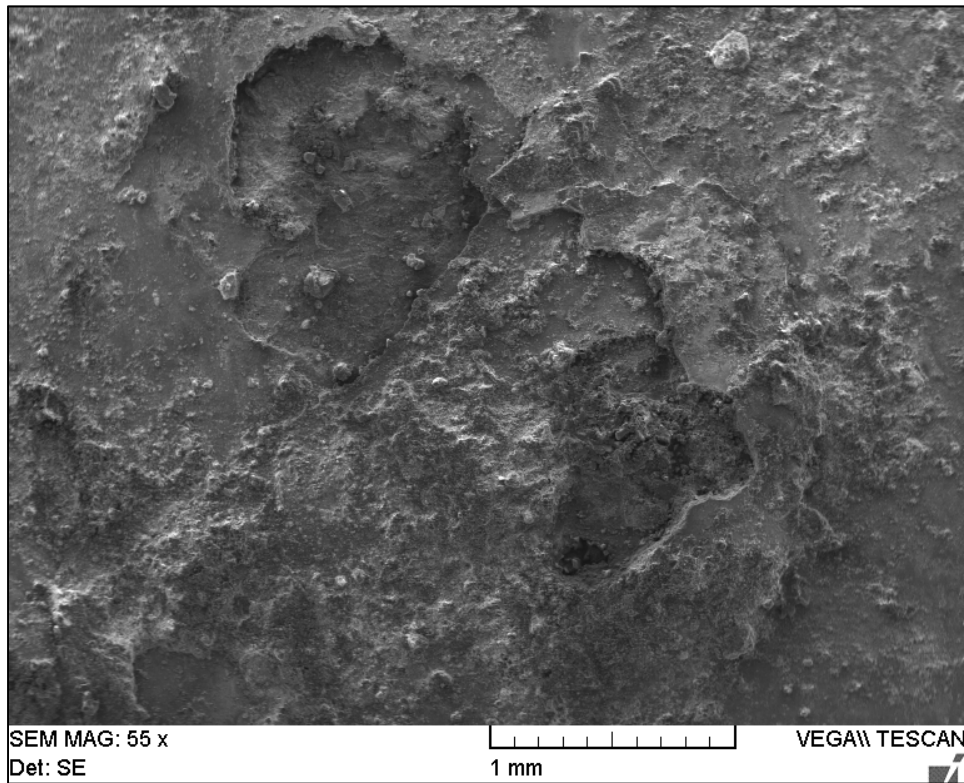
**Figure 41.** A representative SEM image of a pit on a specimen excised from Coupon 1 labeled as 1-1, prior to cleaning. (SEM, 32X)

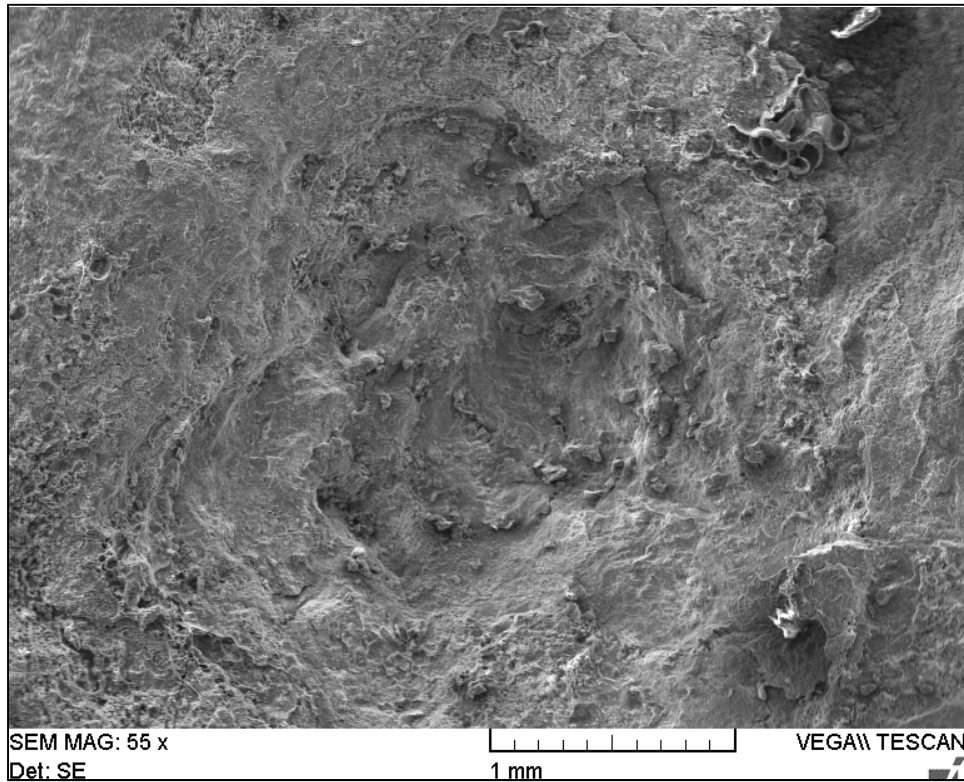
**Figure 42.** A representative SEM image of a pit on a specimen excised from Coupon 1 labeled as 1-2, prior to cleaning. (SEM, 32X)

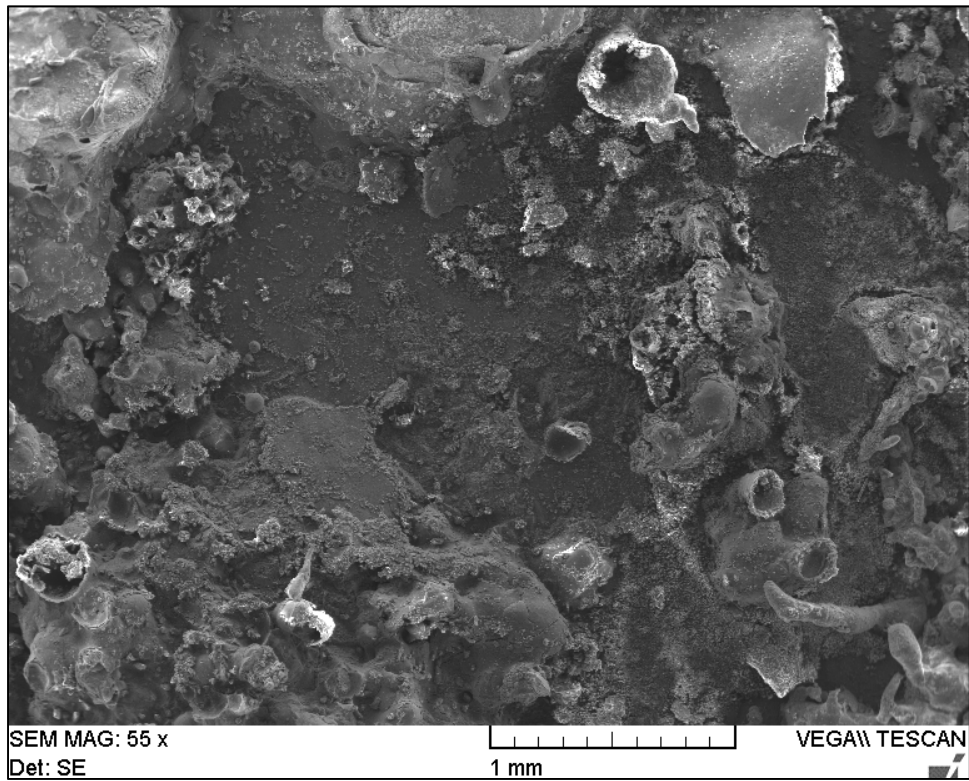
**Figure 43.** A representative SEM image of a pit on a specimen excised from Coupon 1 labeled as 1-3, prior to cleaning. (SEM, 32X)

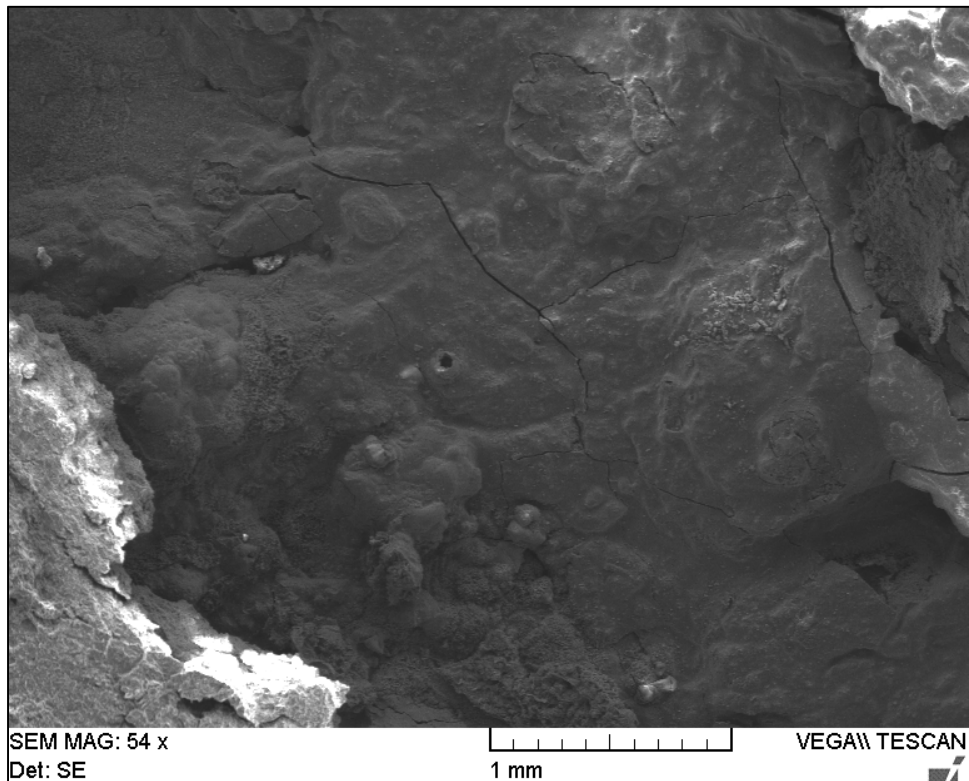
**Figure 44.** A representative SEM image of a pit on a specimen excised from Coupon 2 labeled as 2-1, prior to cleaning. (SEM, 32X)

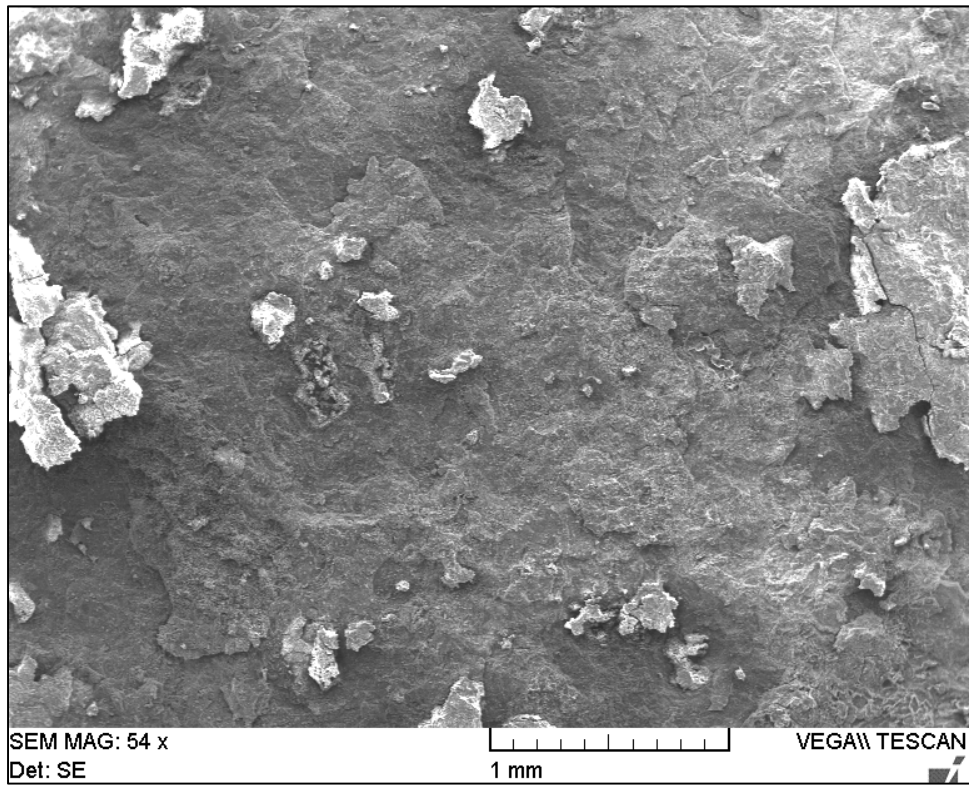
**Figure 45.** A representative SEM image of a pit on a specimen excised from Coupon 2 labeled as 2-2, prior to cleaning. (SEM, 32X)

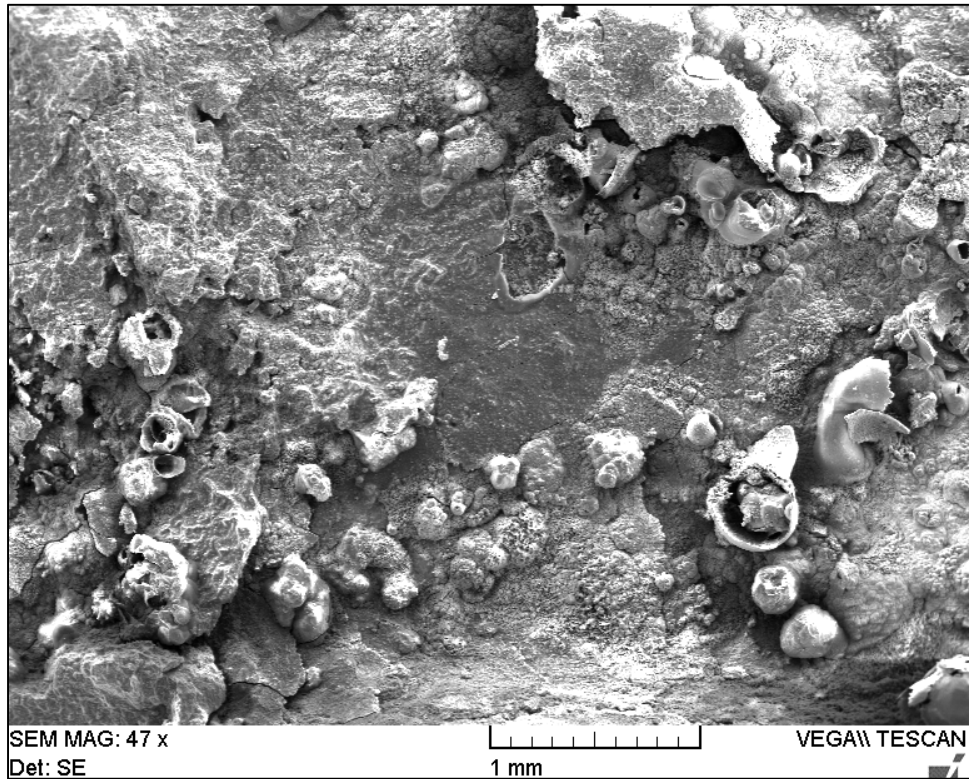
**Figure 46.** A representative SEM image of a pit on a specimen excised from Coupon 2 labeled as 2-3, prior to cleaning. (SEM, 28X)

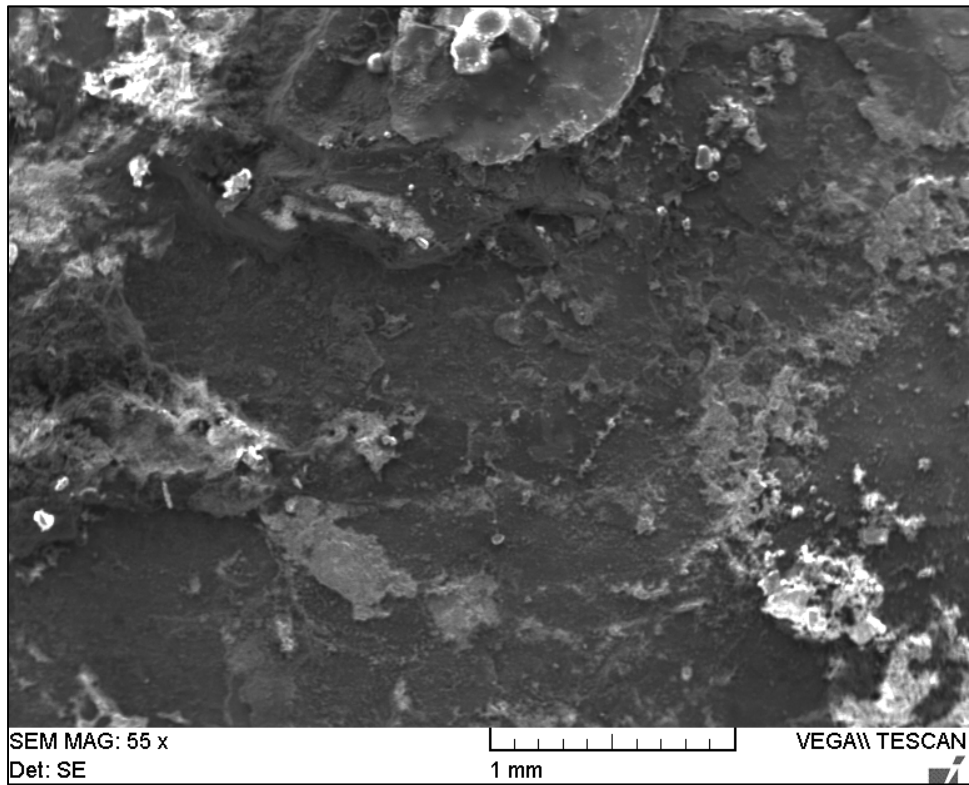
**Figure 47.** A representative SEM image of a pit on a specimen excised from Coupon 3 labeled as 3-1, prior to cleaning. (SEM, 32X)

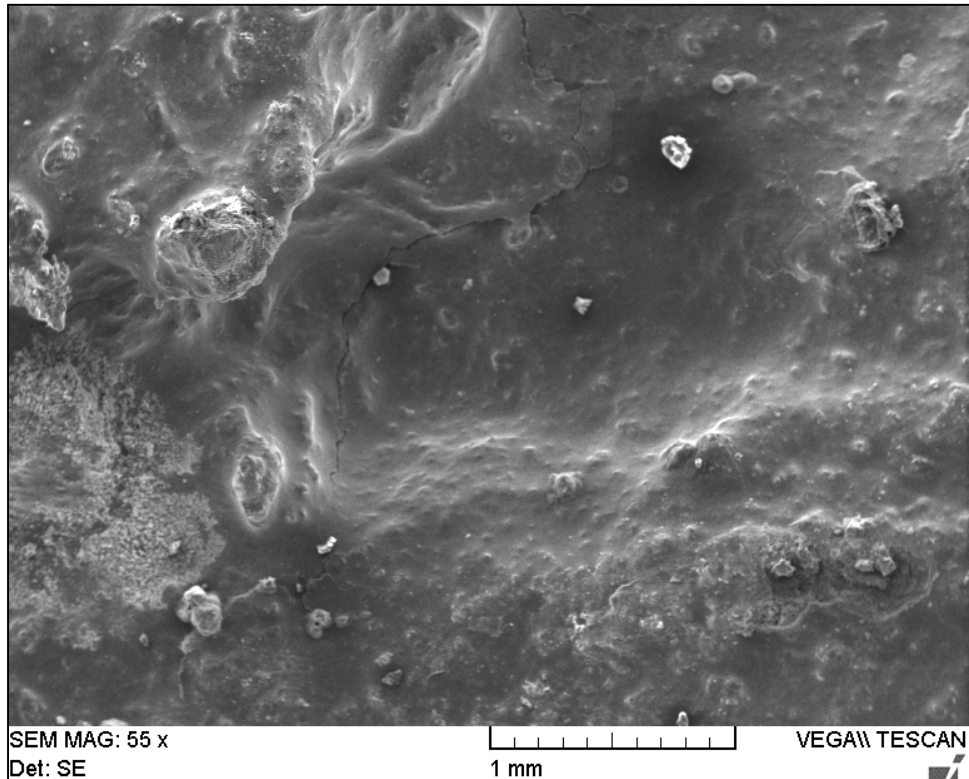
**Figure 48.** A representative SEM image of a pit on a specimen excised from Coupon 3 labeled as 3-2, prior to cleaning. (SEM, 32X)

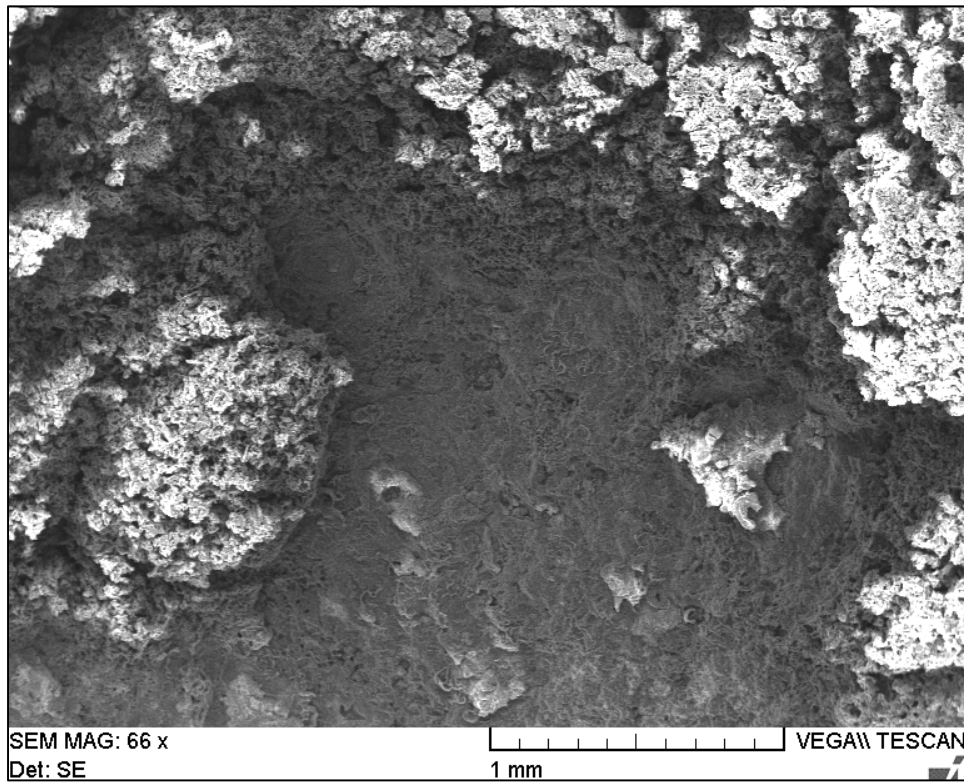
**Figure 49.** A representative SEM image of a pit on a specimen excised from Coupon 3 labeled as 3-3, prior to cleaning. (SEM, 39X)

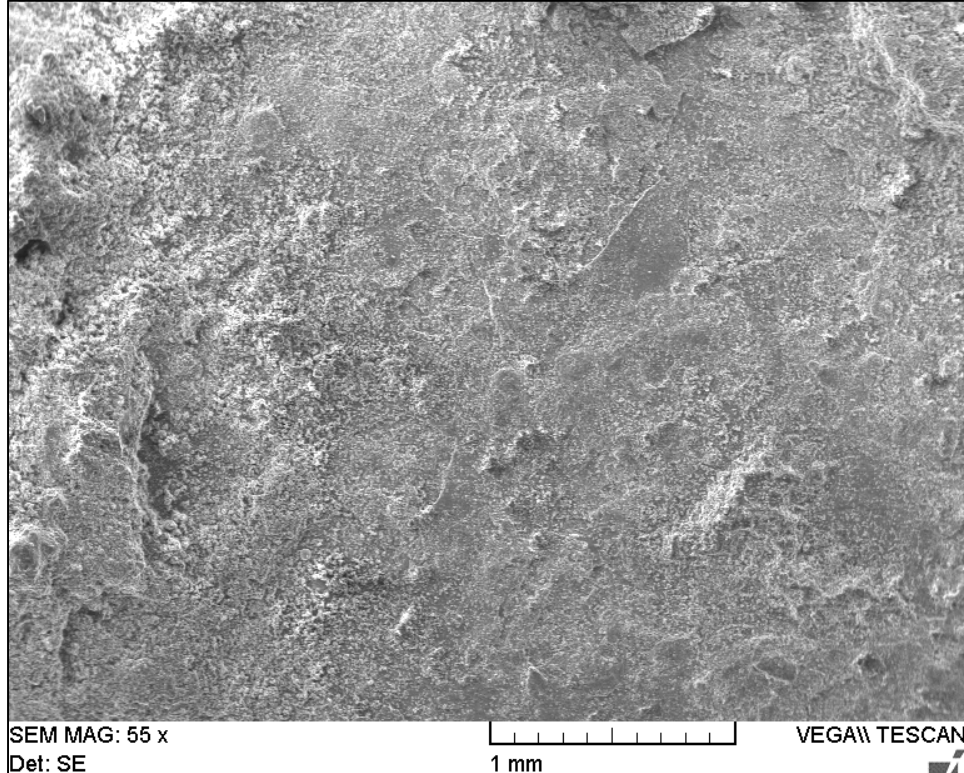
**Figure 52.** A representative SEM image of a pit on a specimen excised from Coupon 5 labeled as 5-3, prior to cleaning. (SEM, 32X)

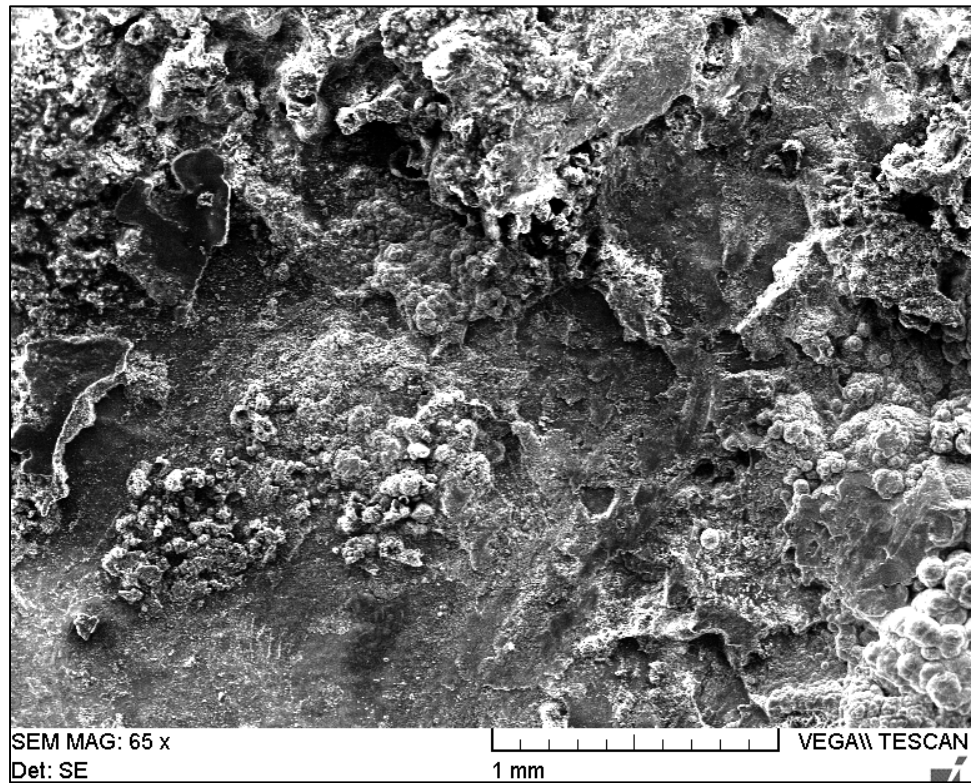
**Figure 53.** A representative SEM image of a pit on a specimen excised from Coupon 6 labeled as 6-1, prior to cleaning. (SEM, 38X)

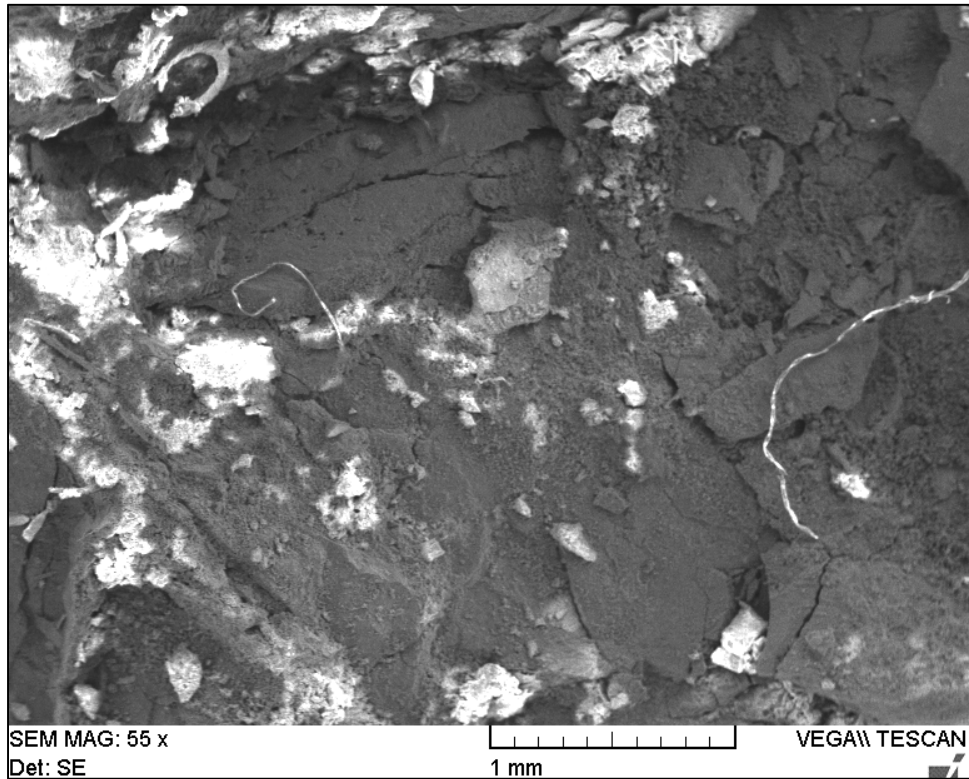
**Figure 56.** A representative SEM image of a pit on a specimen excised from Coupon 7 labeled as 7-1, prior to cleaning. (SEM, 32X)

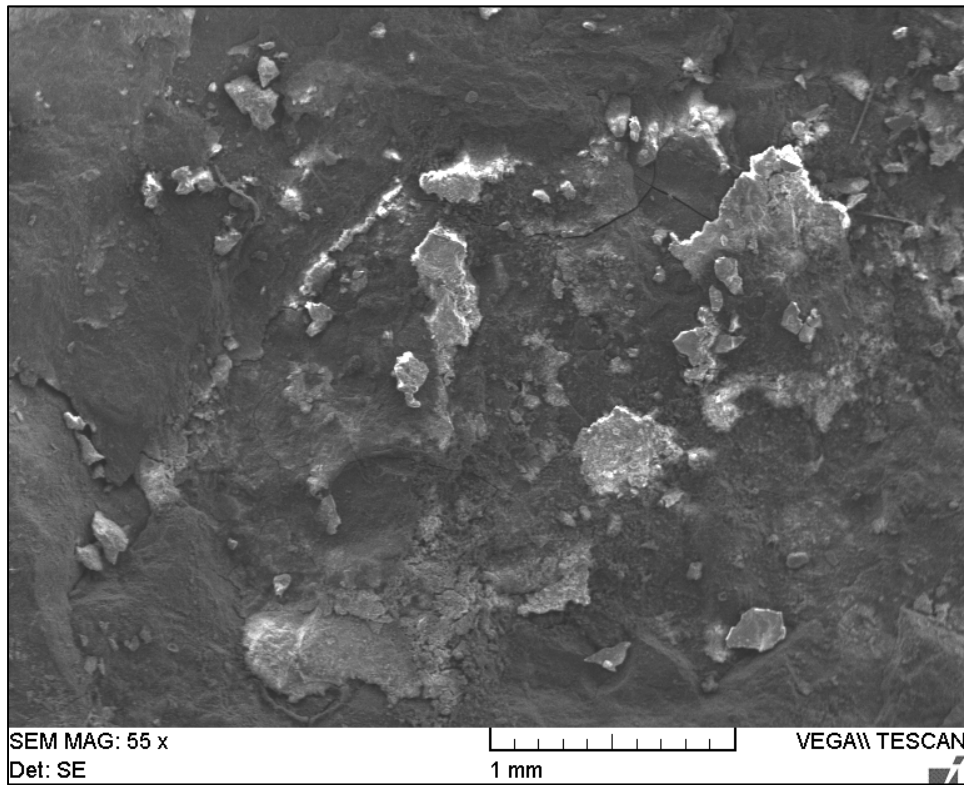
**Figure 57.** A representative SEM image of a pit on a specimen excised from Coupon 7 labeled as 7-2, prior to cleaning. (SEM, 32X)

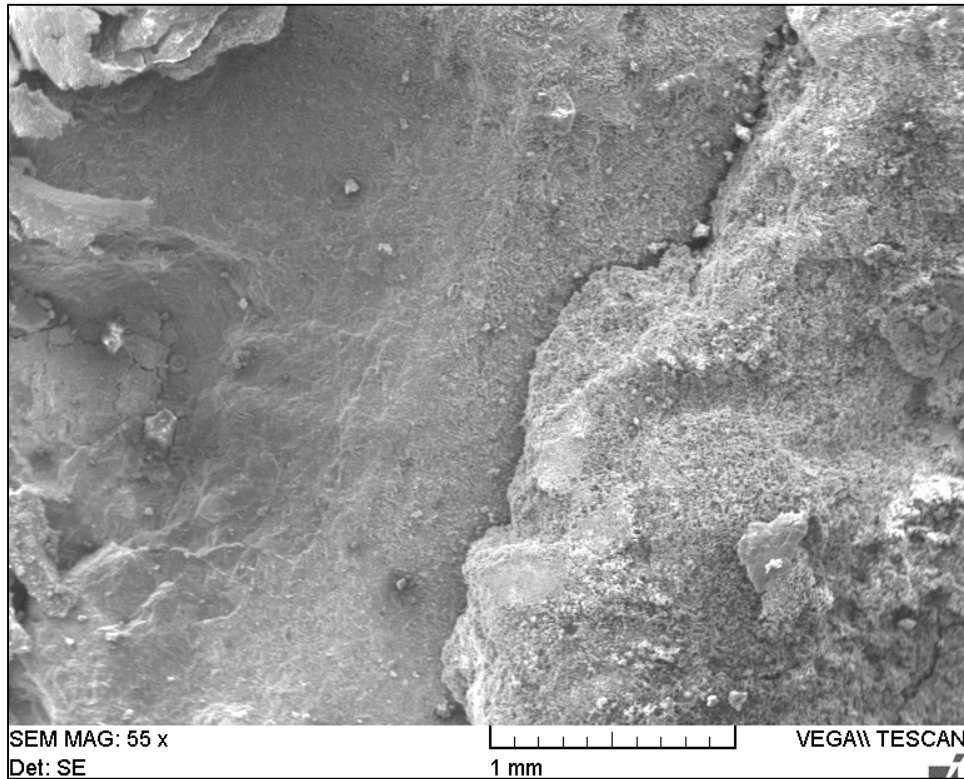
**Figure 58.** A representative SEM image of a pit on a specimen excised from Coupon 7 labeled as 7-3, prior to cleaning. (SEM, 32X)

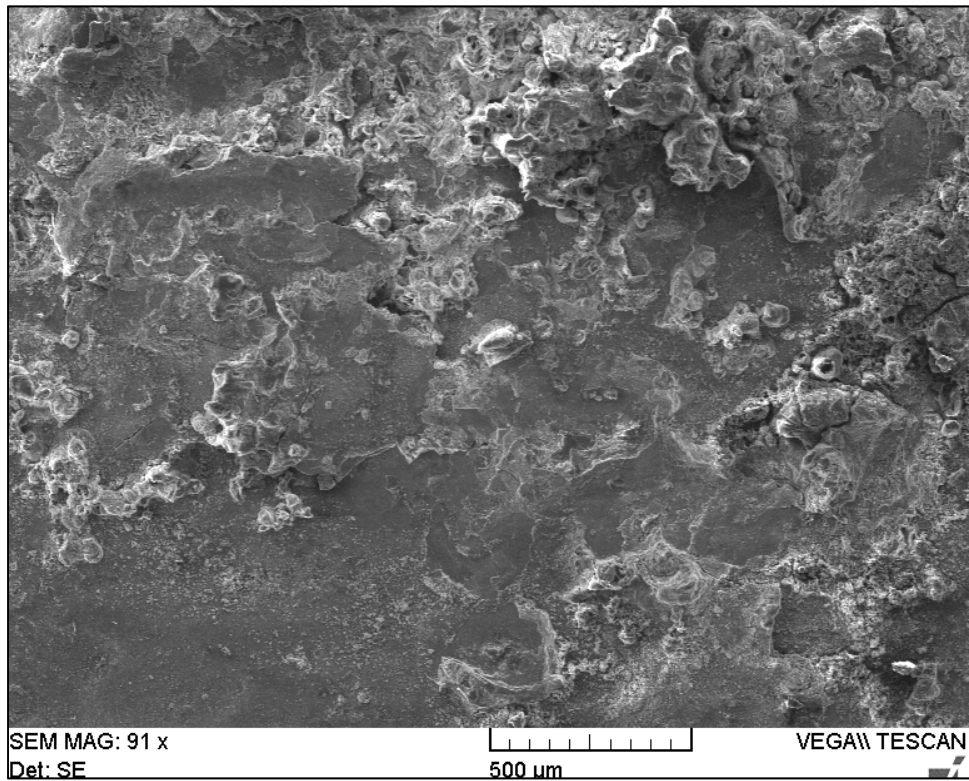
**Figure 59.** A representative SEM image of a pit on a specimen excised from Coupon 8 labeled as 8-1, prior to cleaning. (SEM, 53X)

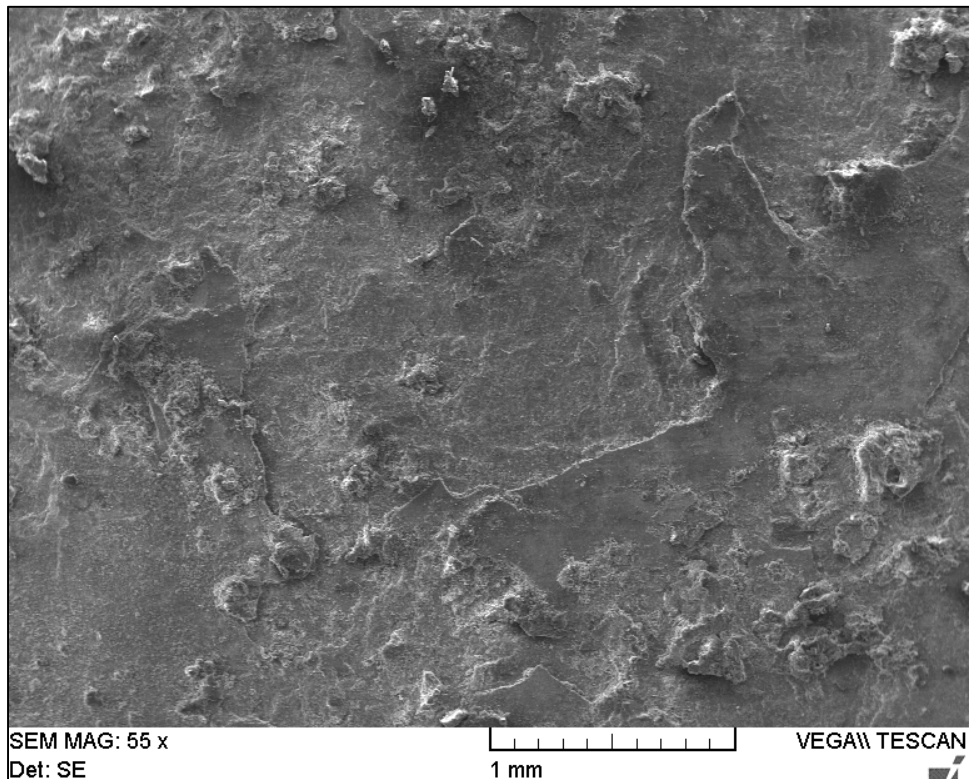
**Figure 60.** A representative SEM image of a pit on a specimen excised from Coupon 8 labeled as 8-2, prior to cleaning. (SEM, 33X)

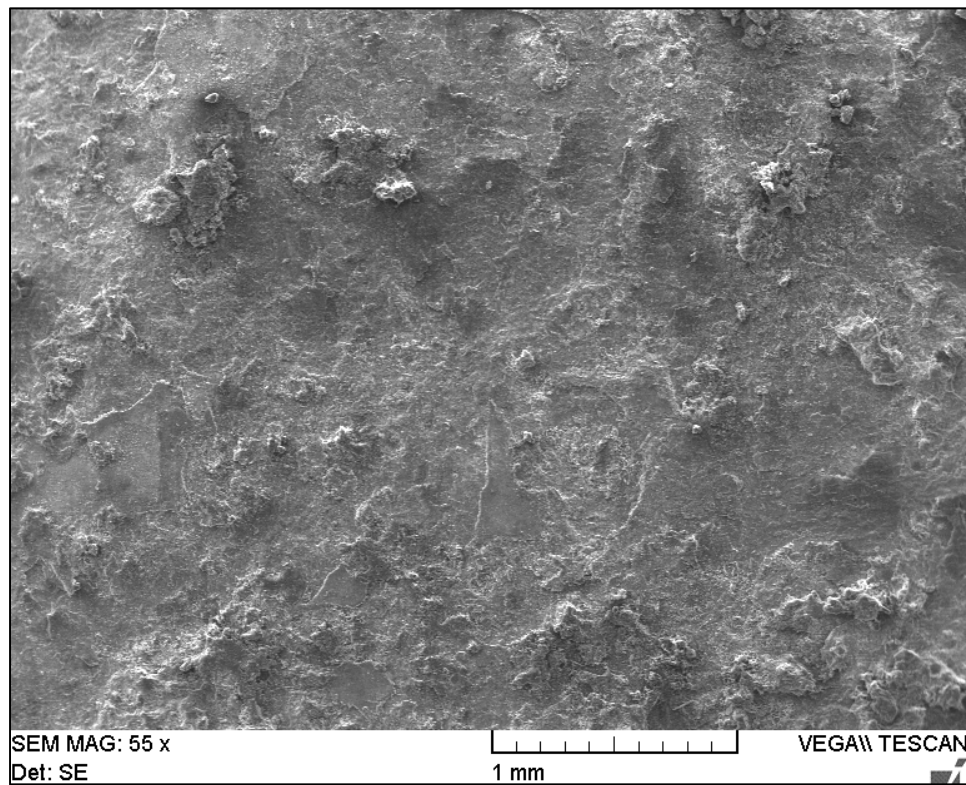
④ This is the weld-repaired plate section. Sample 8-3 exhibited a depression or pit on the painted surface.

**Figure 61.** A representative SEM image of a pit on a specimen excised from Coupon 8 labeled as 8-3, prior to cleaning. (SEM, 33X)

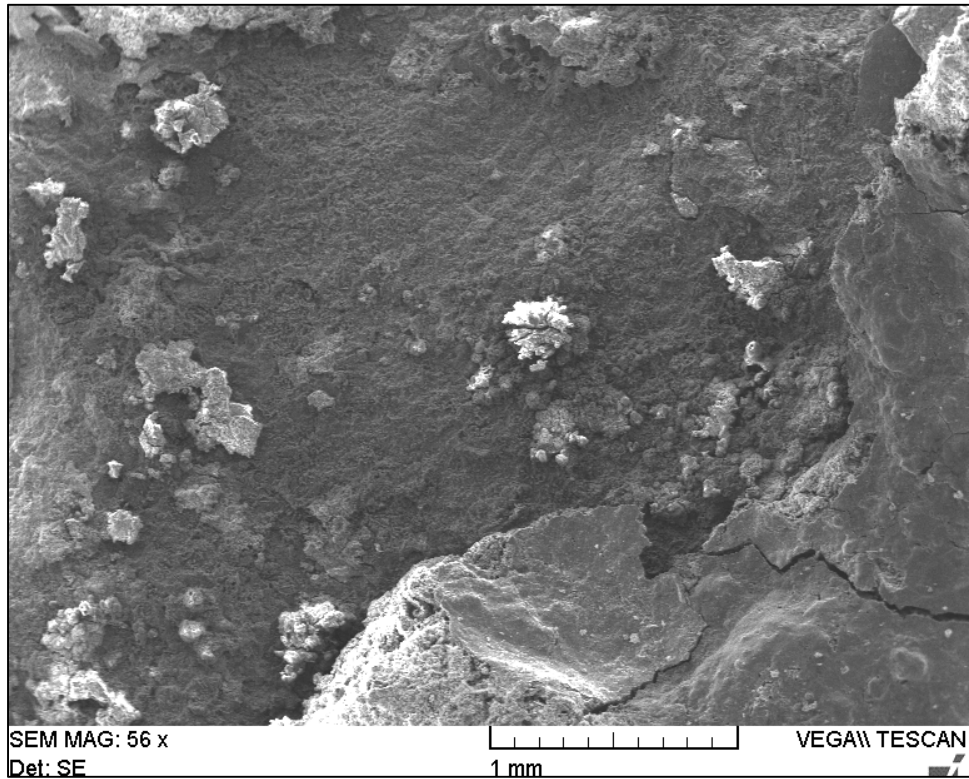
**Figure 66.** A representative SEM image of a pit on a specimen excised from Coupon A-1 labeled as A1-2, prior to cleaning. (SEM, 33X)

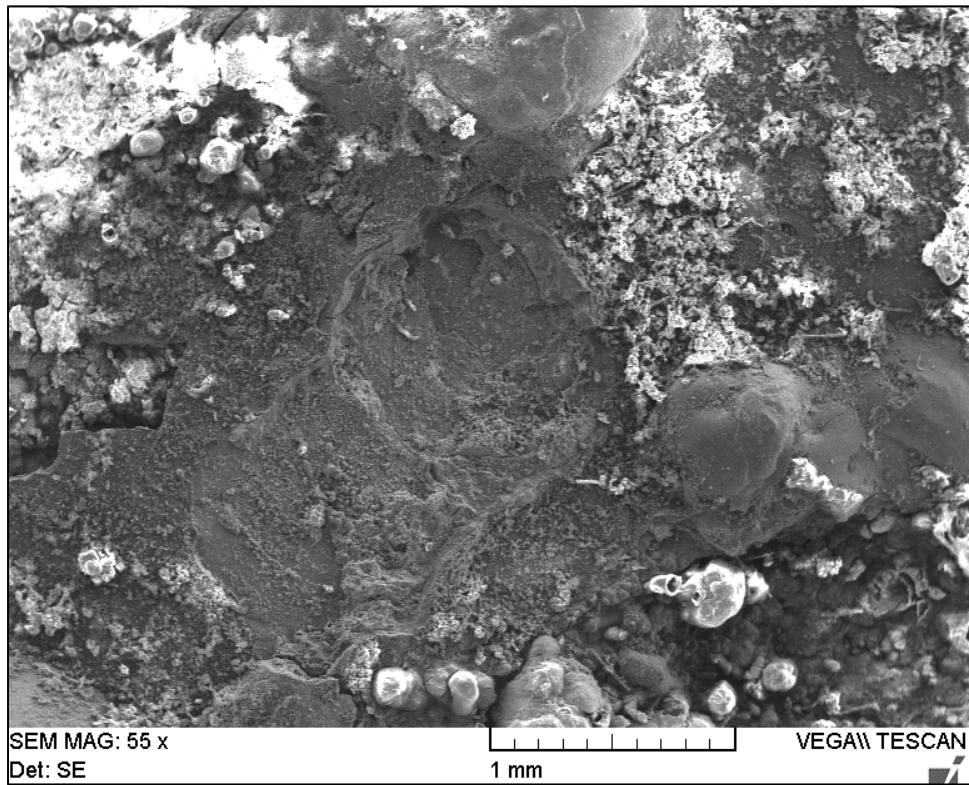
**Figure 67.** A representative SEM image of a pit on a specimen excised from Coupon A-1 labeled as A1-3, prior to cleaning. (SEM, 32X)
