SUBJECT: ADMINISTRATIVE ORDER ON CONSENT (AOC) STATEMENT OF WORK (SOW) SECTION 5 CORROSION AND METAL FATIGUE PRACTICES, DESTRUCTIVE TESTING RESULTS REPORT, RED HILL BULK FUEL STORAGE FACILITY (RED HILL), JOINT BASE PEARL HARBOR-HICKAM, OAHU, HAWAII

In 2018, ten coupons were removed from Tank 14, so that a metallurgical and corrosion analysis of the coupons could be undertaken, with the primary aim of validating non-destructive examination (NDE) results. The steel coupons, concrete powder samples, and corrosion product were submitted to a certified third-party laboratory to perform this analysis.

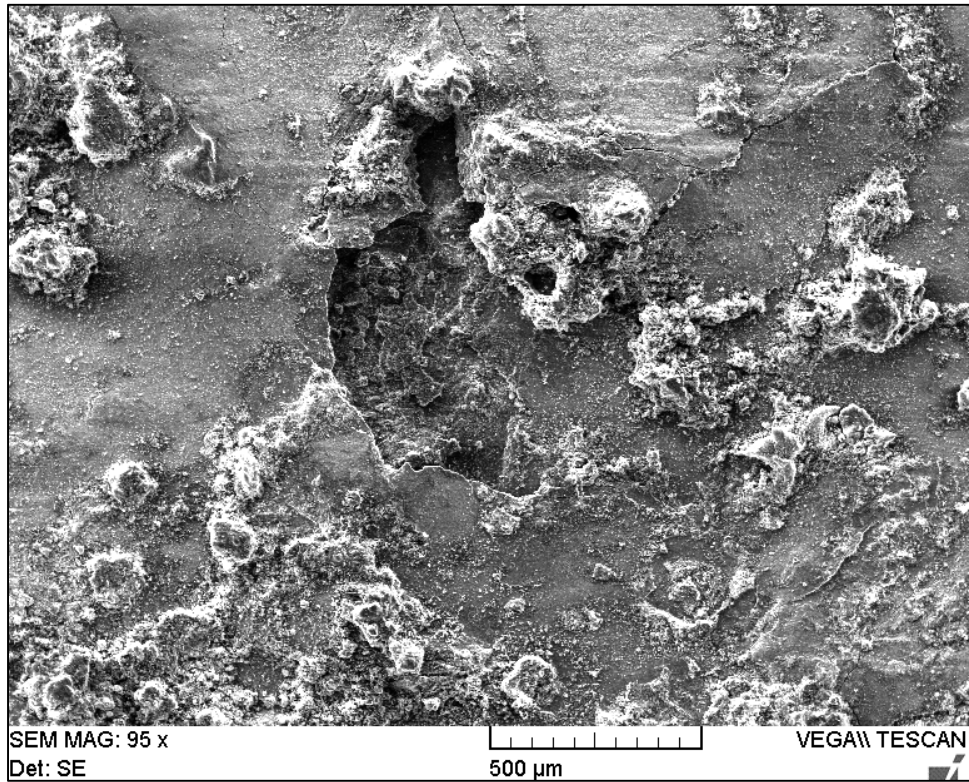
**Figure 68.** A representative SEM image of a pit on a specimen excised from Coupon A-2 labeled as A2-1, prior to cleaning. (SEM, 56X)

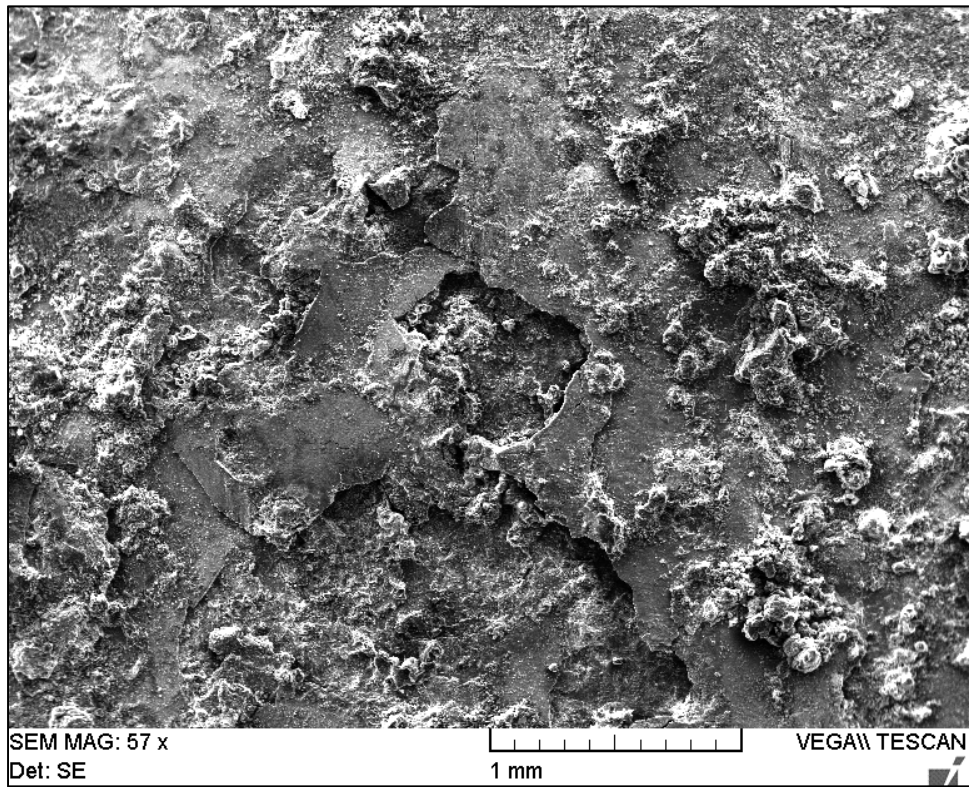
**Figure 69.** A representative SEM image of a possible pit on a specimen excised from Coupon A-2 labeled as A2-2, prior to cleaning. (SEM, 33X)

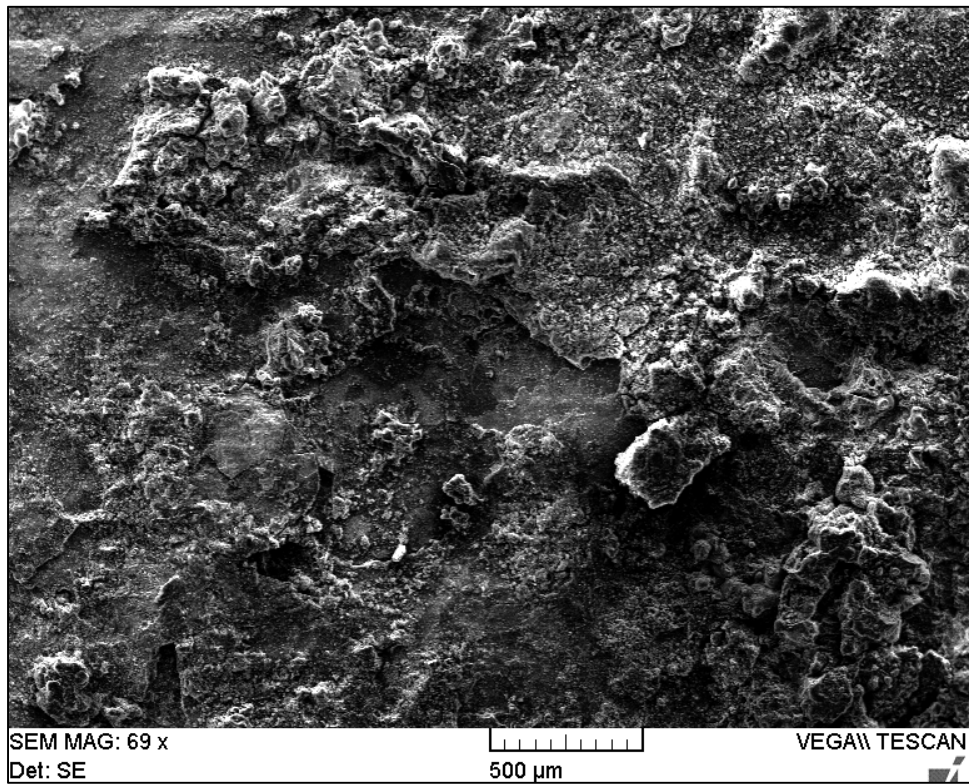
**Figure 70.** A representative SEM image of a possible pit on a specimen excised from Coupon A-2 labeled as A2-3, prior to cleaning. (SEM, 40X)

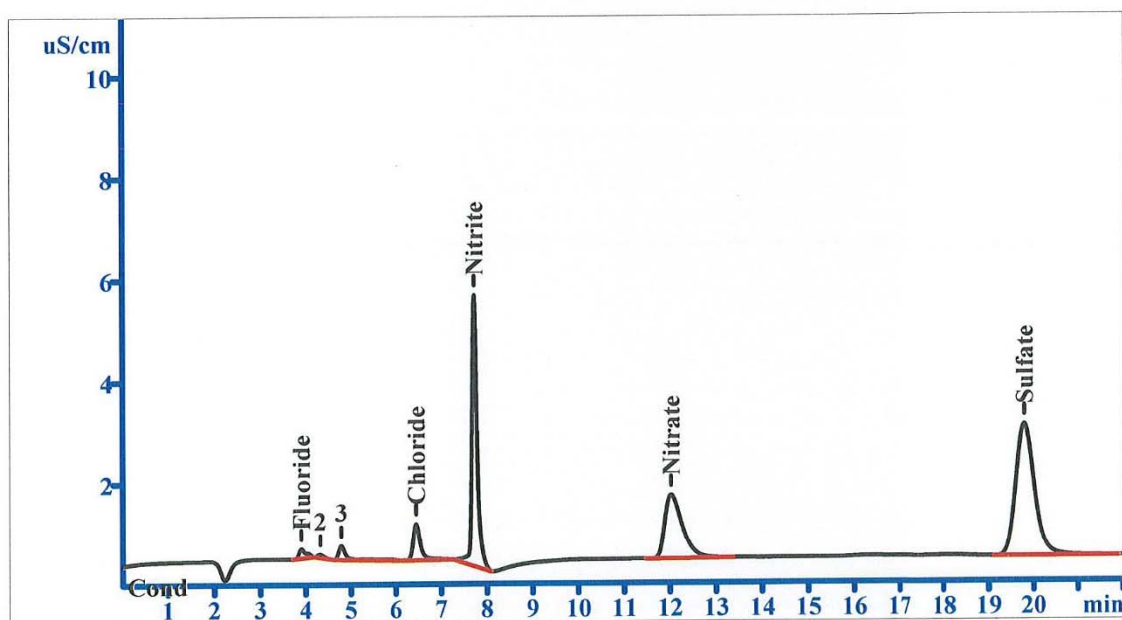
**Figure 101.** The ion chromatogram generated from a concrete sample removed from Coupon 1.

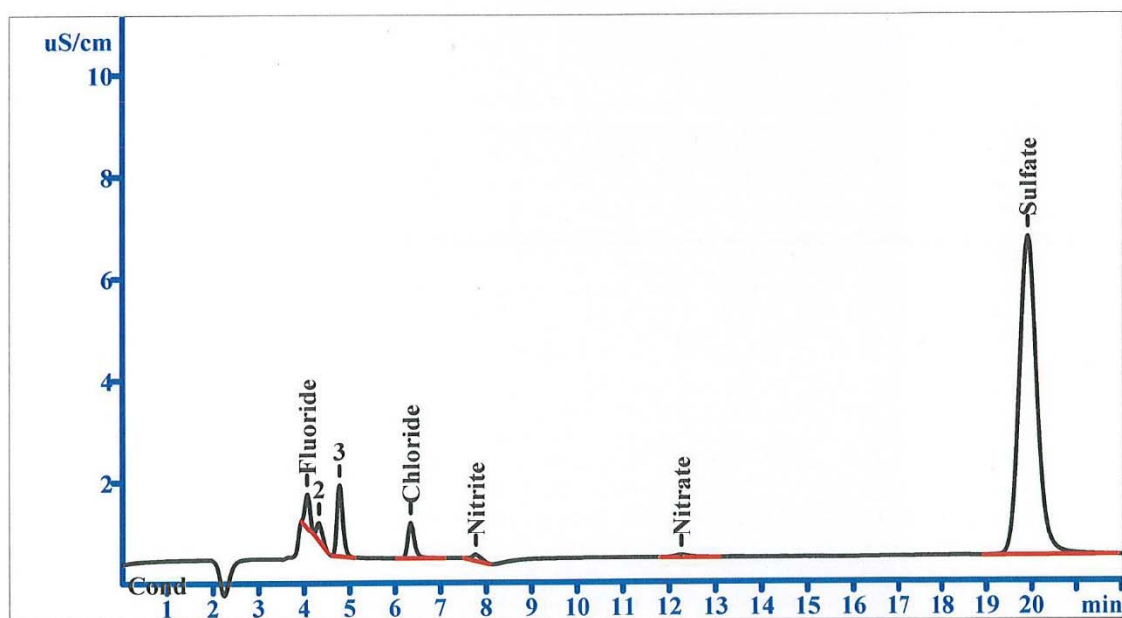
**Figure 102.** The ion chromatogram generated from a concrete sample removed from Coupon 2.

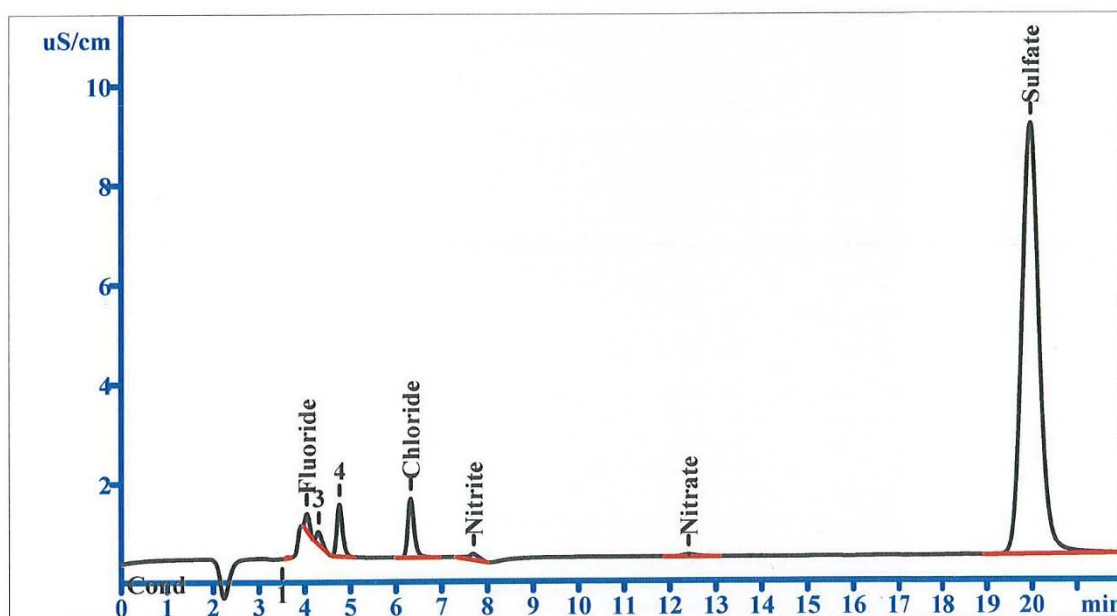
**Figure 103.** The ion chromatogram generated from a concrete sample removed from Coupon 3.

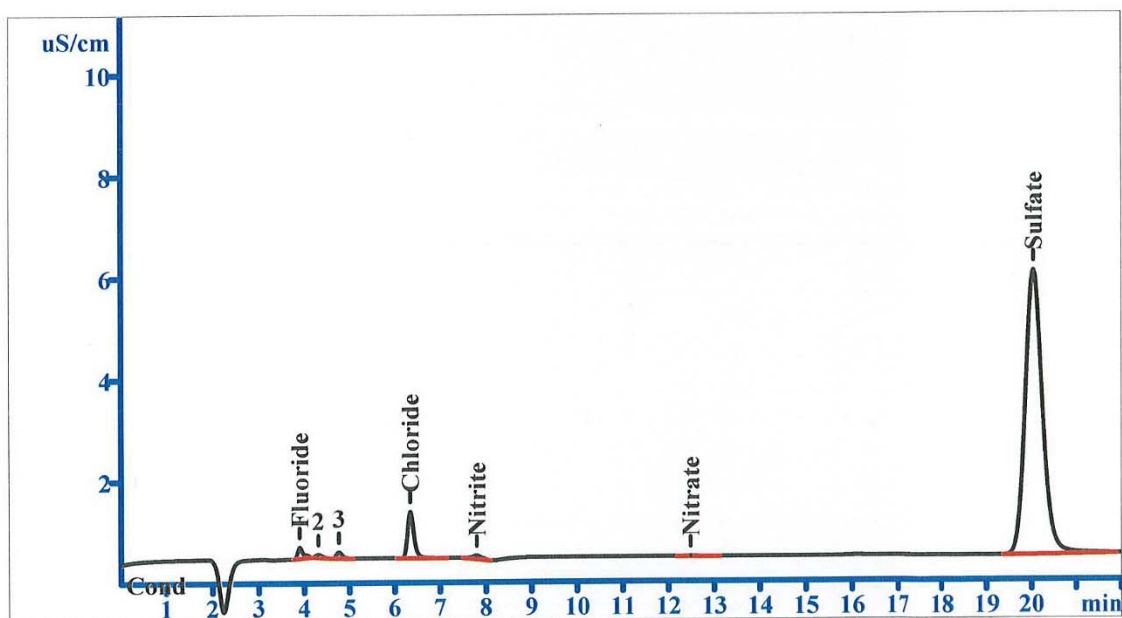
**Figure 104.** The ion chromatogram generated from a concrete sample removed from Coupon 5.

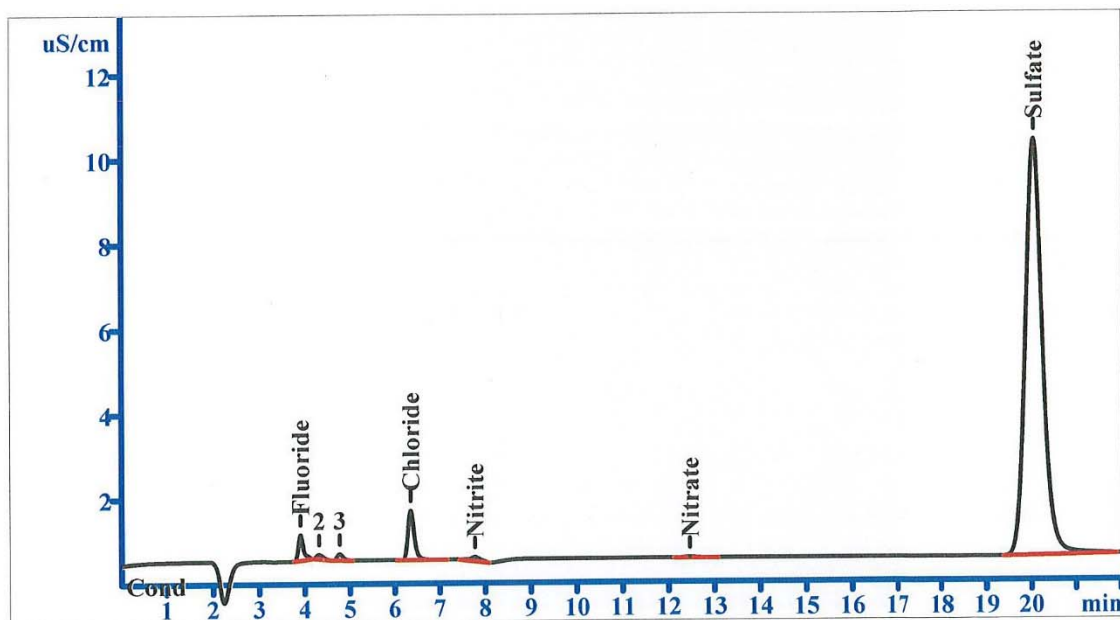
**Figure 105.** The ion chromatogram generated from a concrete sample removed from Coupon 6.

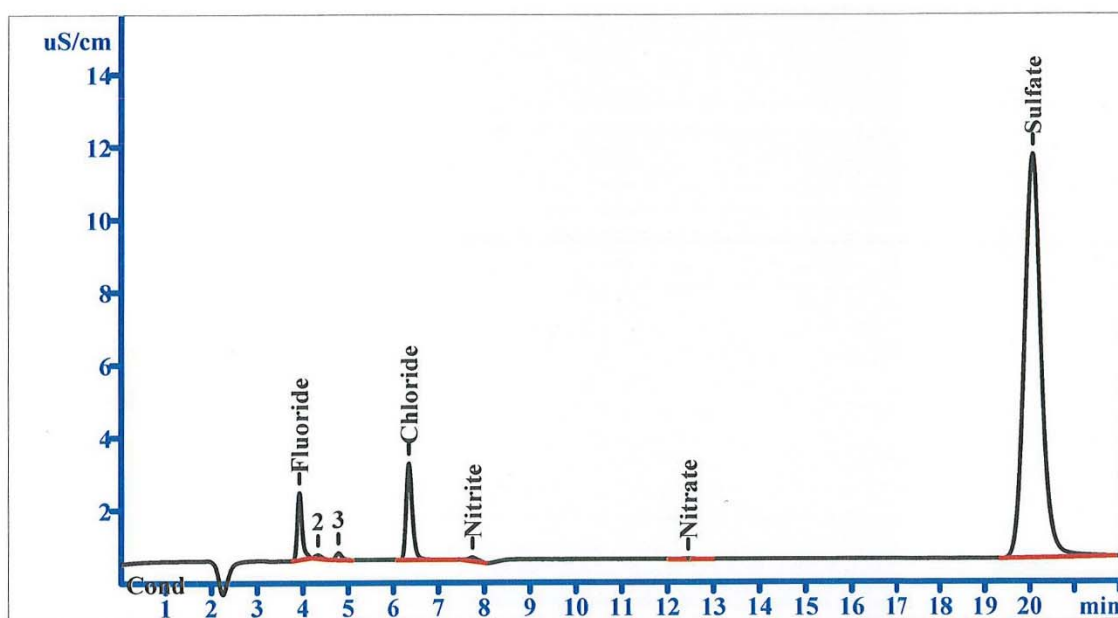
**Figure 106.** The ion chromatogram generated from a concrete sample removed from Coupon 7.

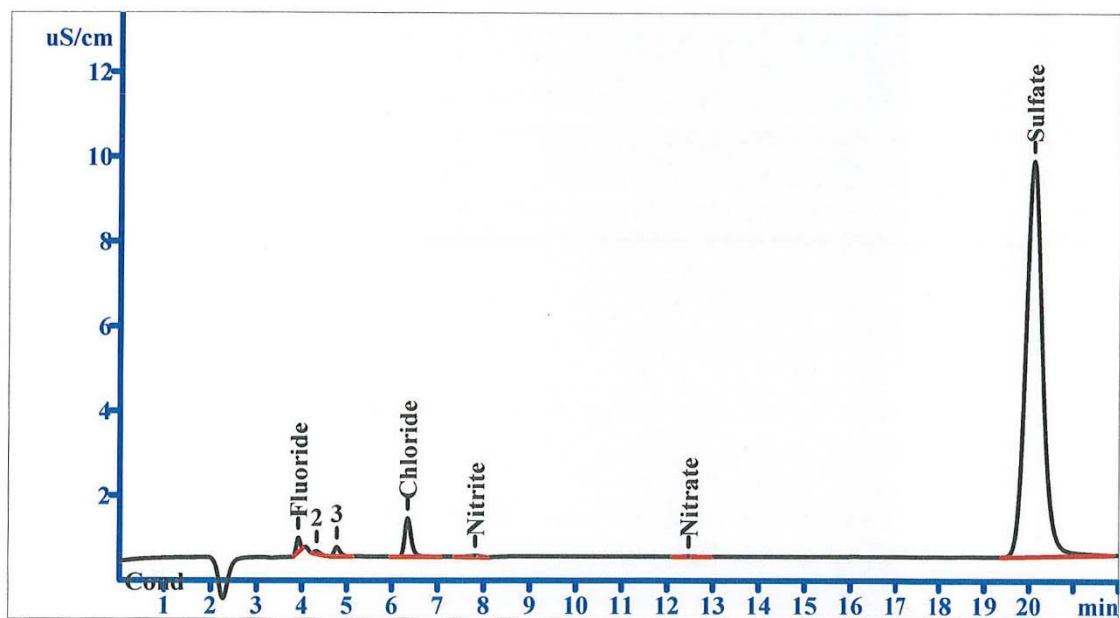
**Figure 107.** The ion chromatogram generated from a concrete sample removed from Coupon 8.

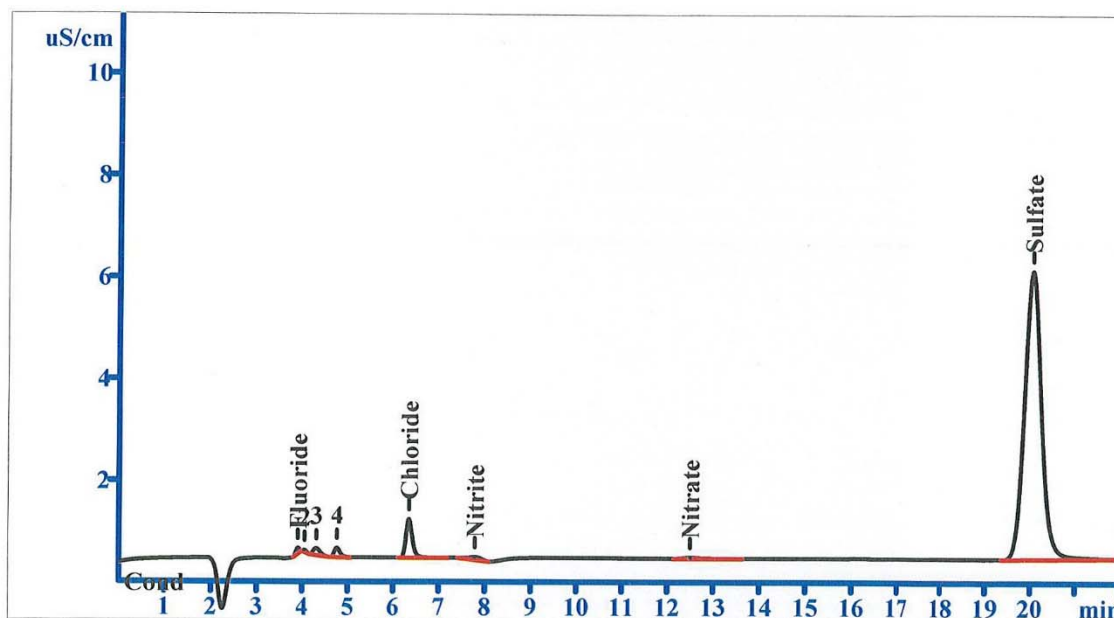
**Figure 108.** The ion chromatogram generated from a concrete sample removed from Coupon 10.

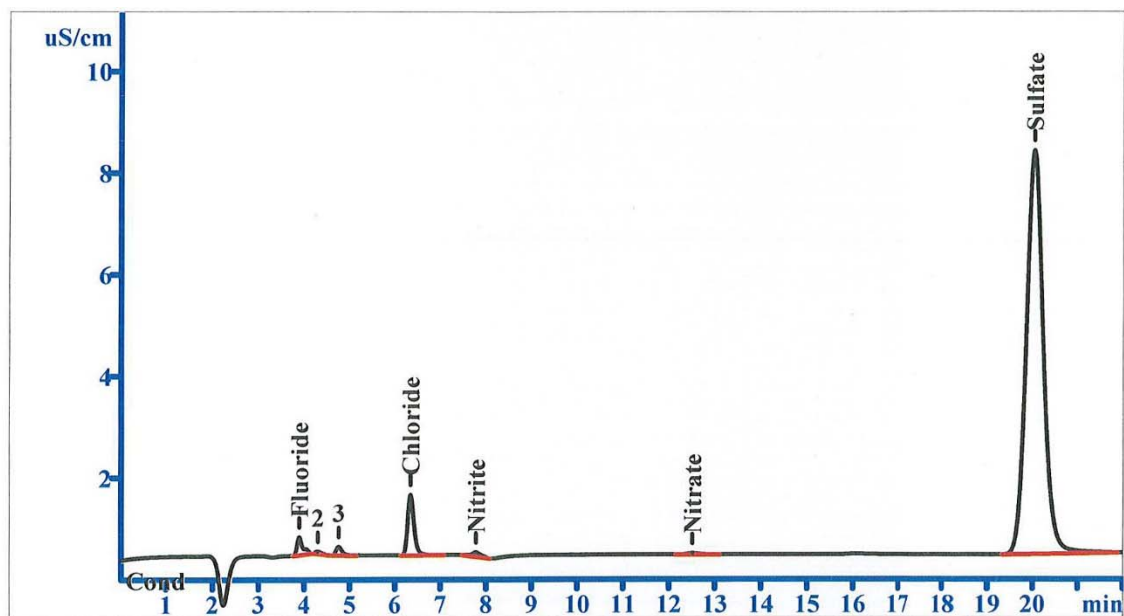
**Figure 109.** The ion chromatogram generated from a concrete sample removed from Coupon A1.

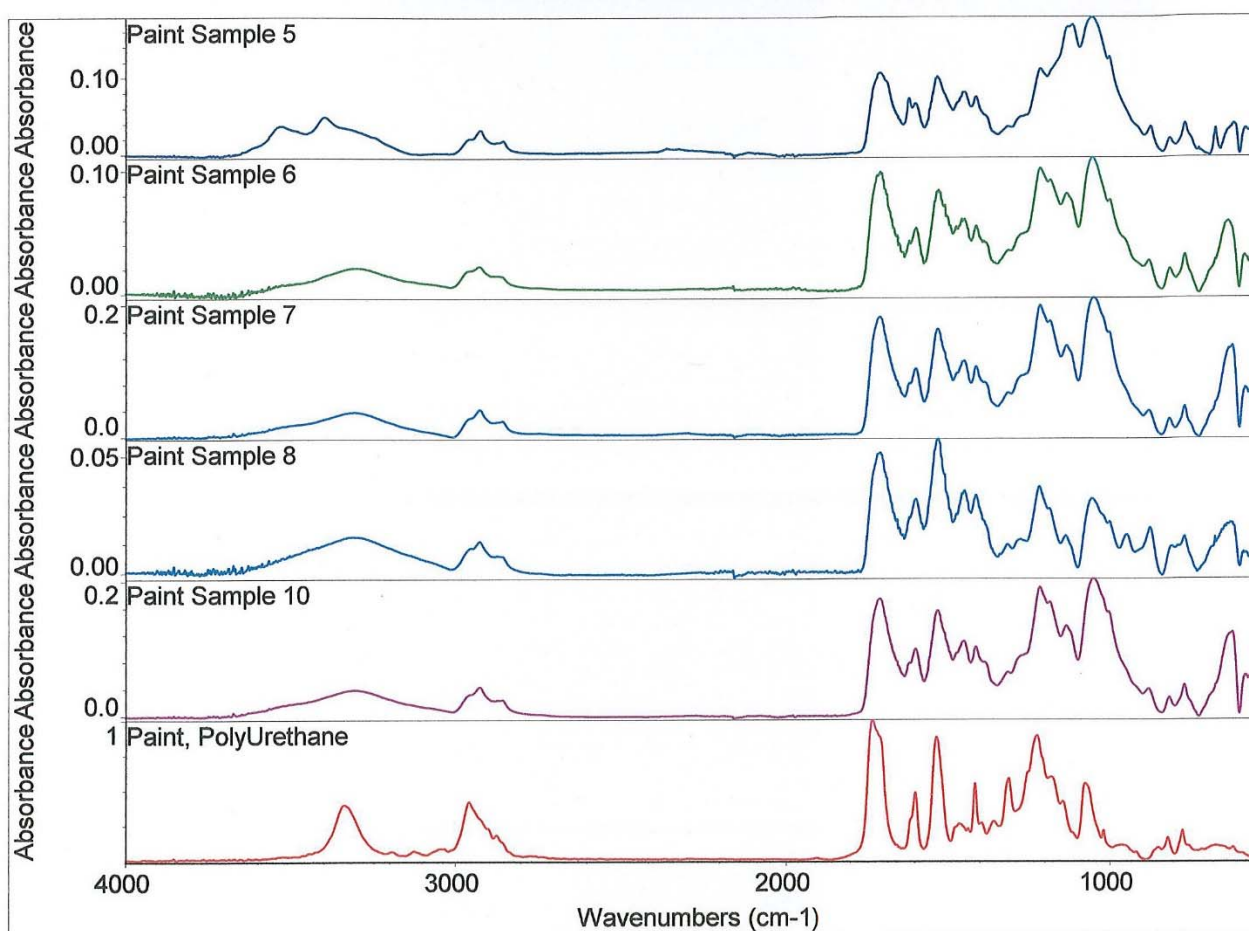
Fourier transform infrared (FTIR) spectroscopy was performed on paint samples removed from each coupon using Attenuated Total Reflectance (ATR) with a diamond crystal. All paint samples were identified as polyurethane enamel. The resulting FTIR spectra of the samples and the best matches from the spectral FTIR library of standards for polyurethane enamel are provided as Figures 111 and 112.

**Figure 111.** The FTIR spectra generated from a paint samples removed from the exterior surfaces of Coupons 1, A1, 2, A2 and 3 the best matches from the spectral FTIR library of standards for polyurethane enamel.

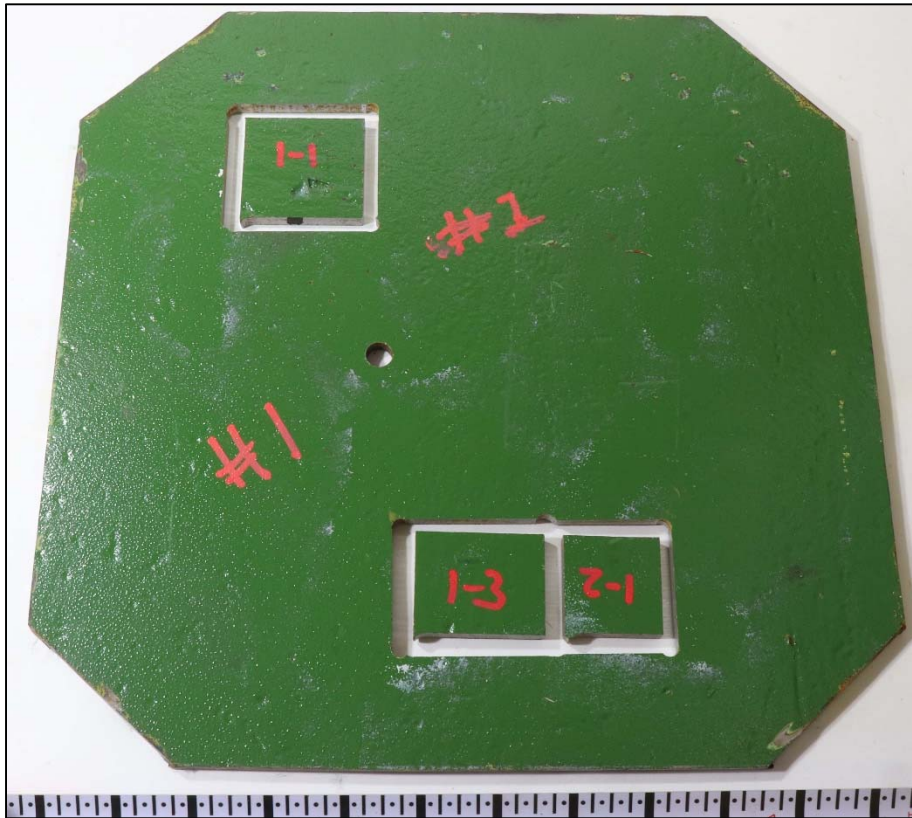
**Figure 130.** An image of the exterior surface of Coupon 1 after CO<sub>2</sub> blast cleaning.

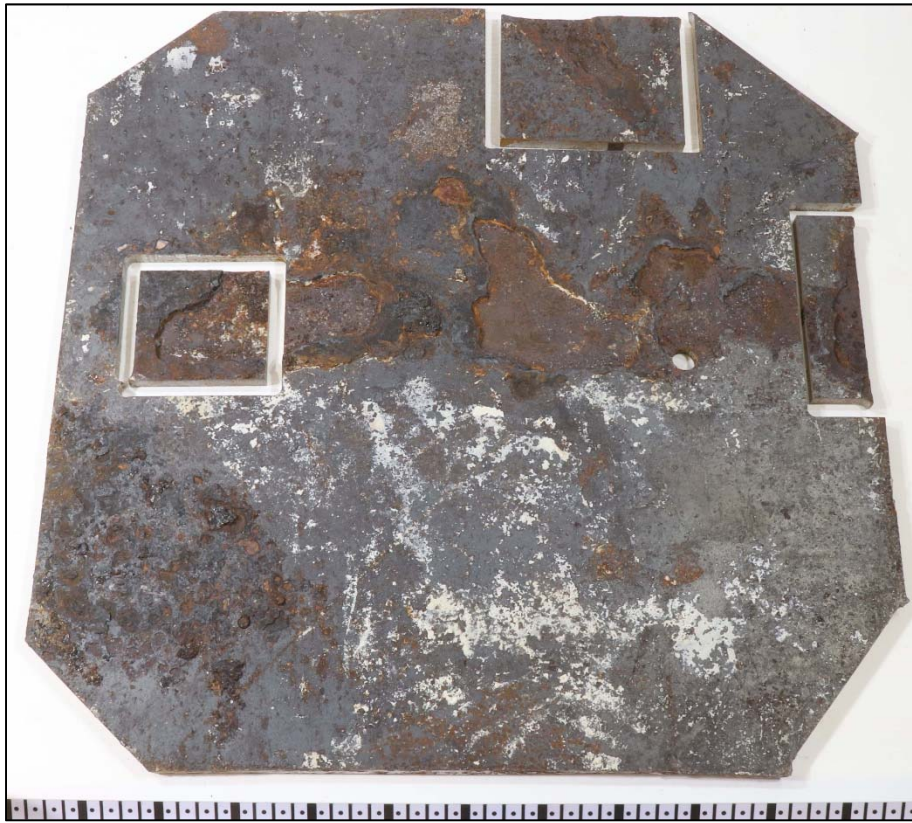
**Figure 131.** An image of the interior surface of Coupon 2 after CO<sub>2</sub> blast cleaning.

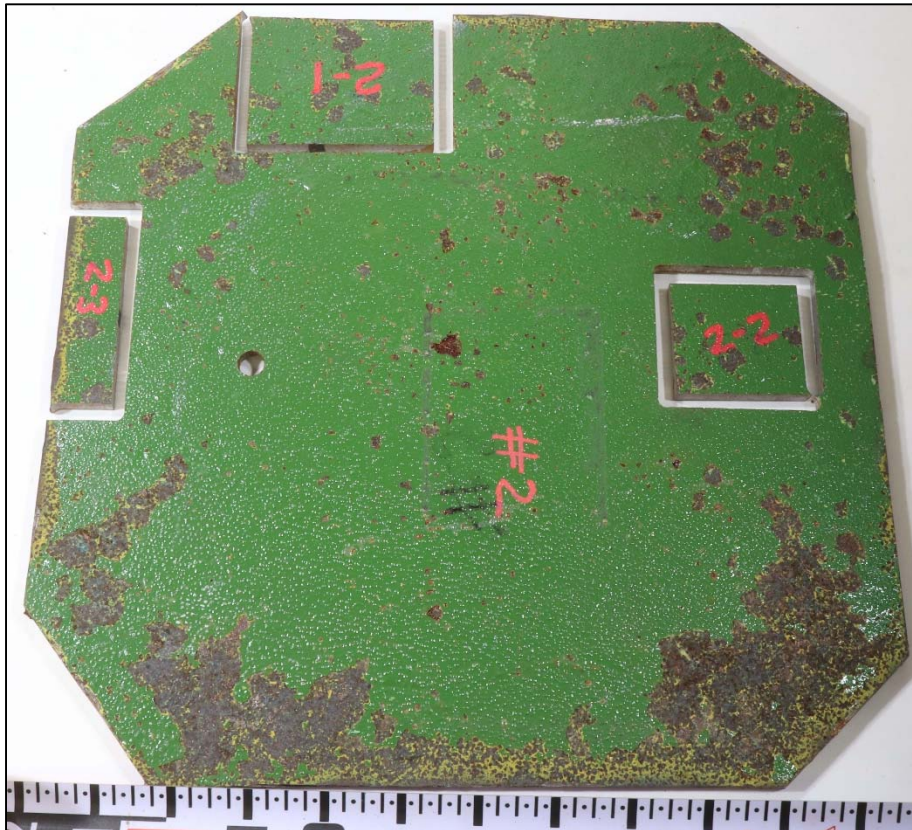
**Figure 132.** An image of the exterior surface of Coupon 2 after CO<sub>2</sub> blast cleaning.

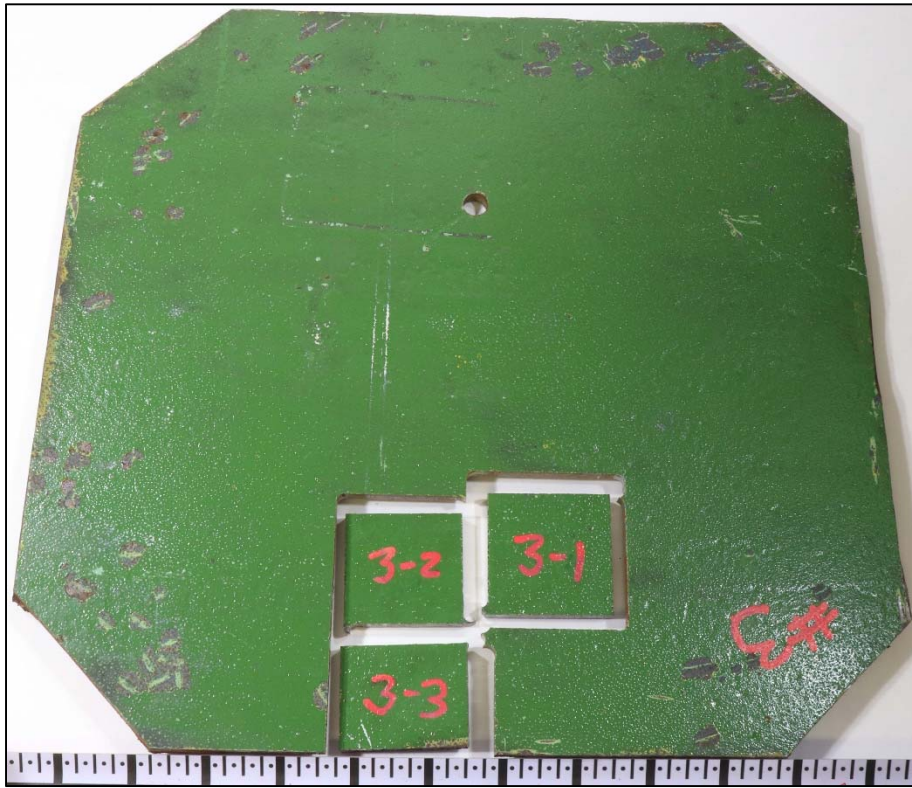
**Figure 134.** An image of the exterior surface of Coupon 3 after CO<sub>2</sub> blast cleaning.

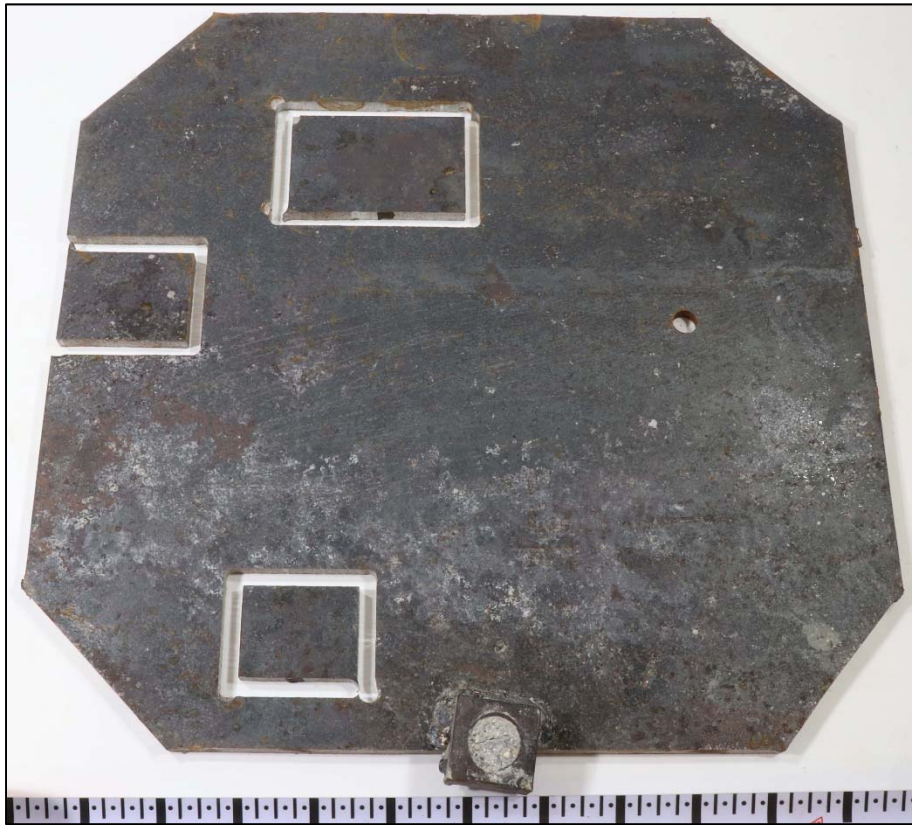
**Figure 135.** An image of the interior surface of Coupon 5 after CO<sub>2</sub> blast cleaning.

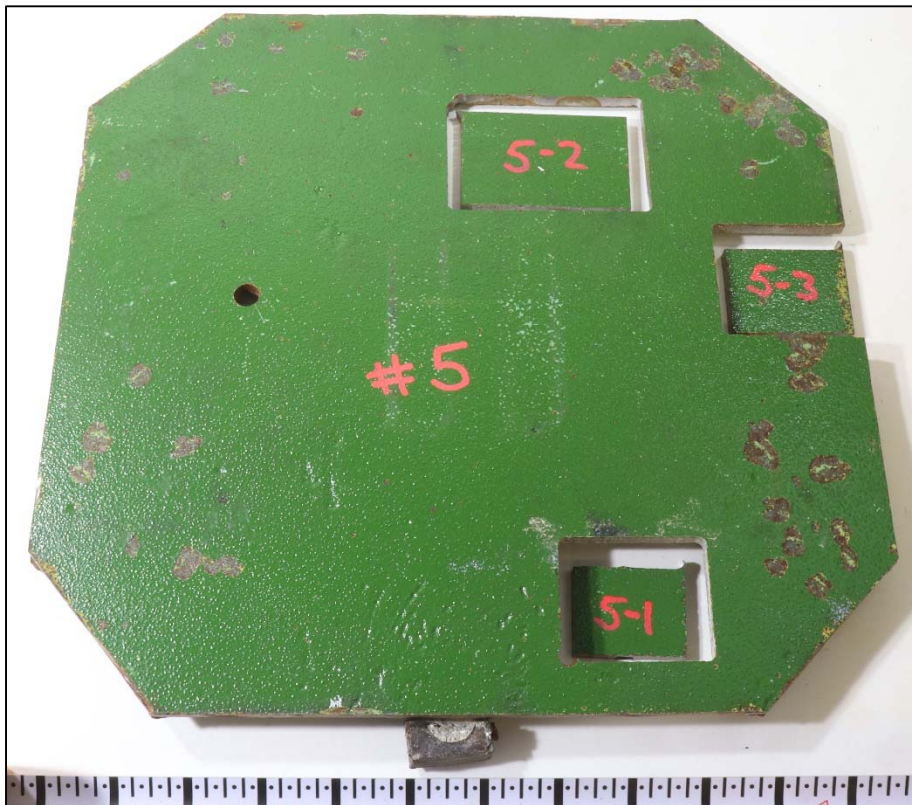
**Figure 136.** An image of the exterior surface of Coupon 5 after CO<sub>2</sub> blast cleaning.

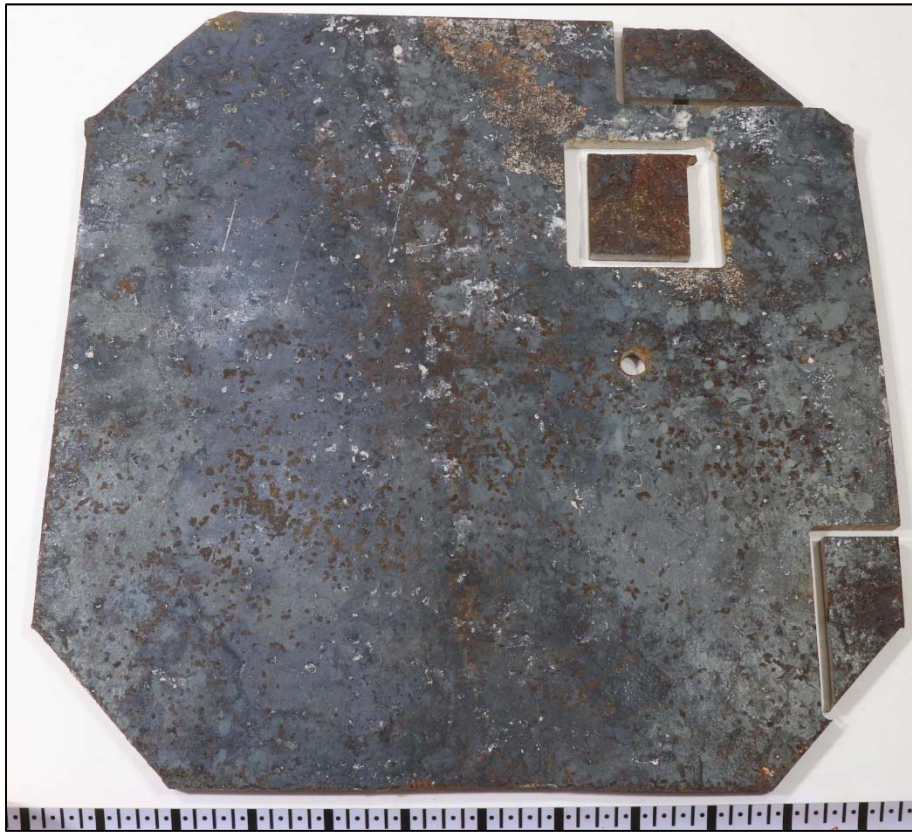
**Figure 137.** An image of the interior surface of Coupon 6 after CO<sub>2</sub> blast cleaning.

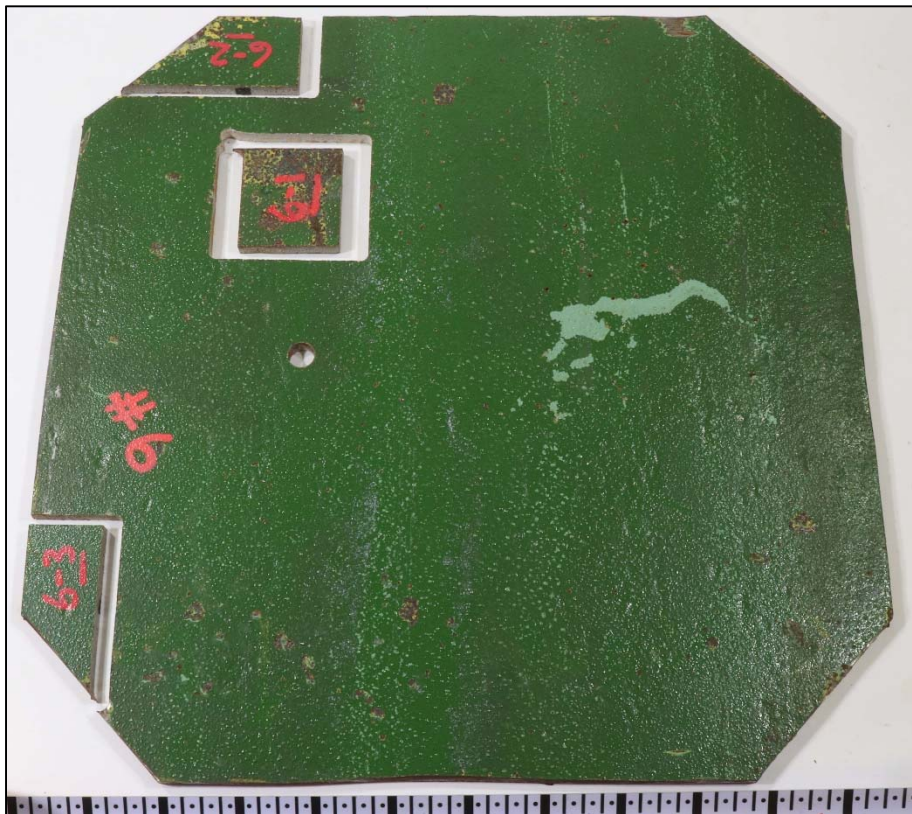
**Figure 138.** An image of the exterior surface of Coupon 6 after CO<sub>2</sub> blast cleaning.

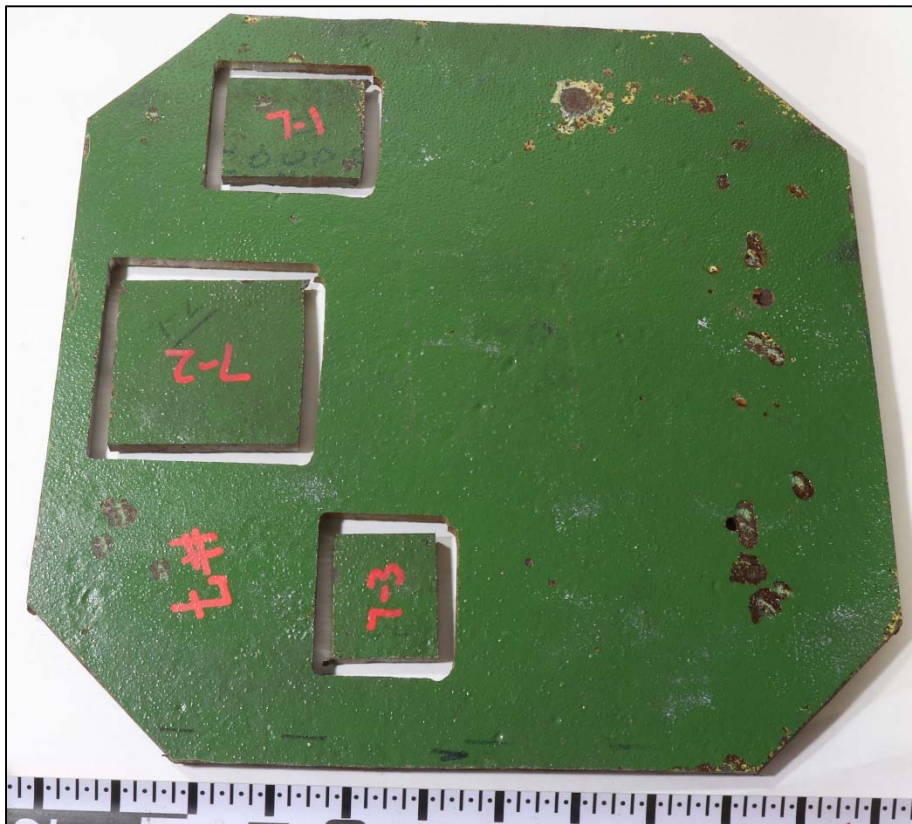
**Figure 140.** An image of the exterior surface of Coupon 7 after CO<sub>2</sub> blast cleaning.

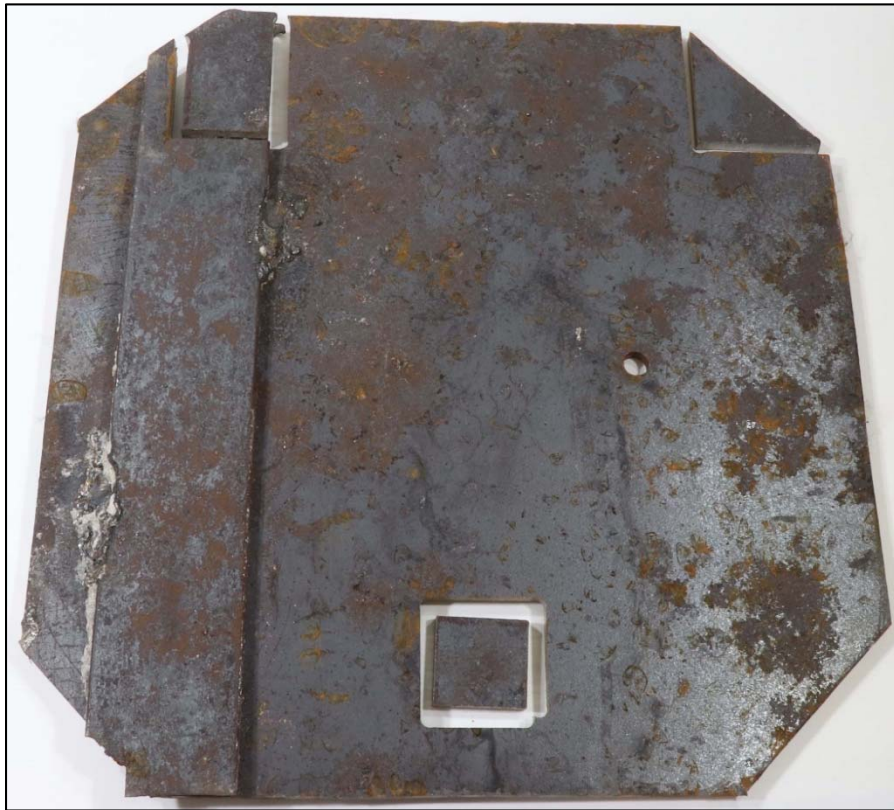
**Figure 141.** An image of the interior surface of Coupon 8 after CO<sub>2</sub> blast cleaning.

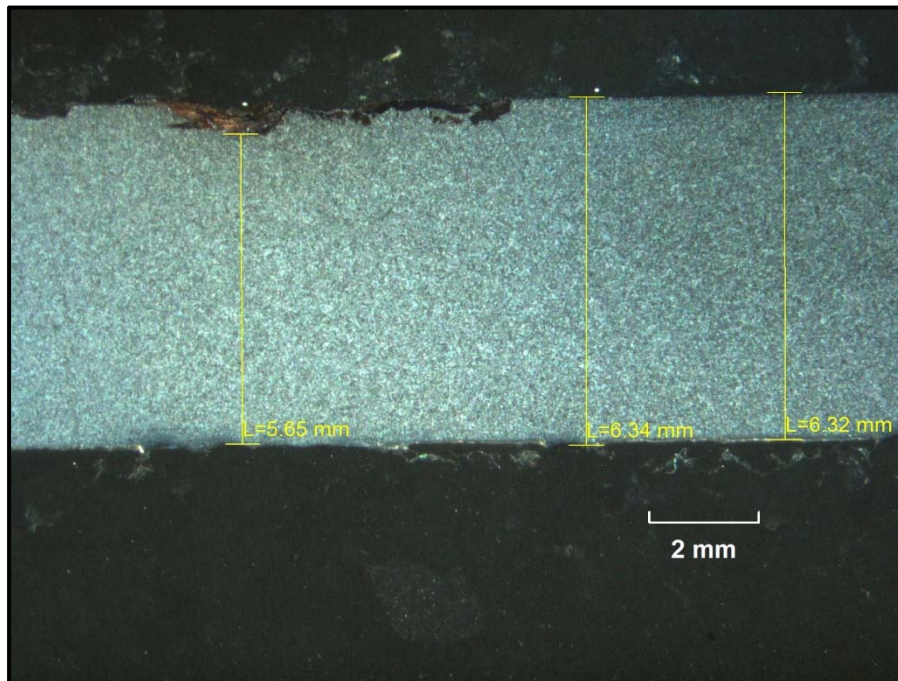
**Figure 180.** The prepared metallographic cross-section from Sample 1-2 is shown during examination with a stereomicroscope. The thickest location(s) are shown, as well as the thickness remaining underneath the deepest observed pit. (7X)

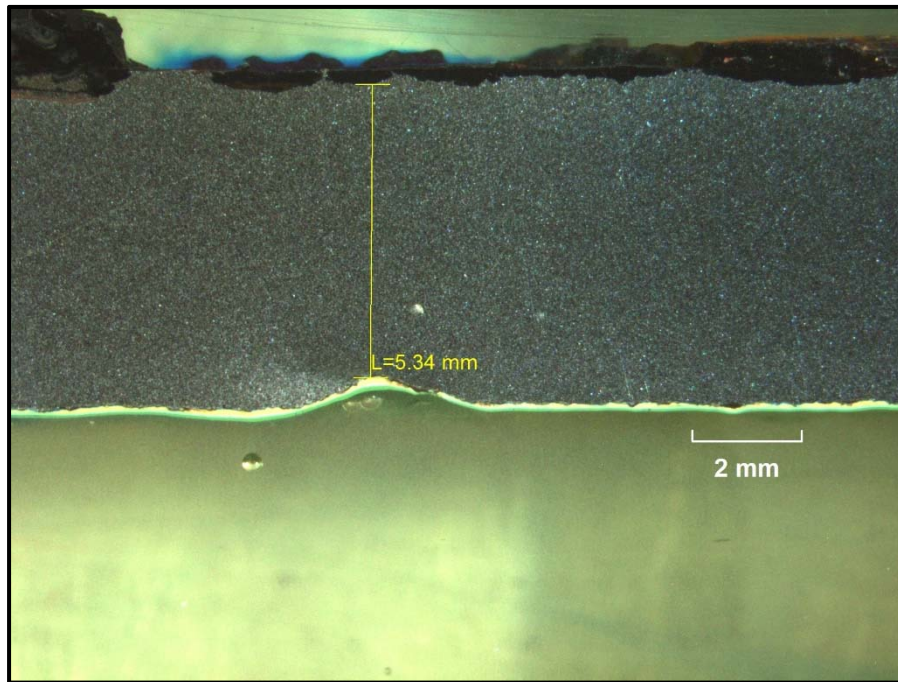
**Figure 181.** The prepared metallographic cross-section from Sample 1-3 is shown during examination with a stereomicroscope. The thickest remaining wall is shown. Note that the reduction in wall thickness was due to a depression on the painted face of the specimen. (7X)

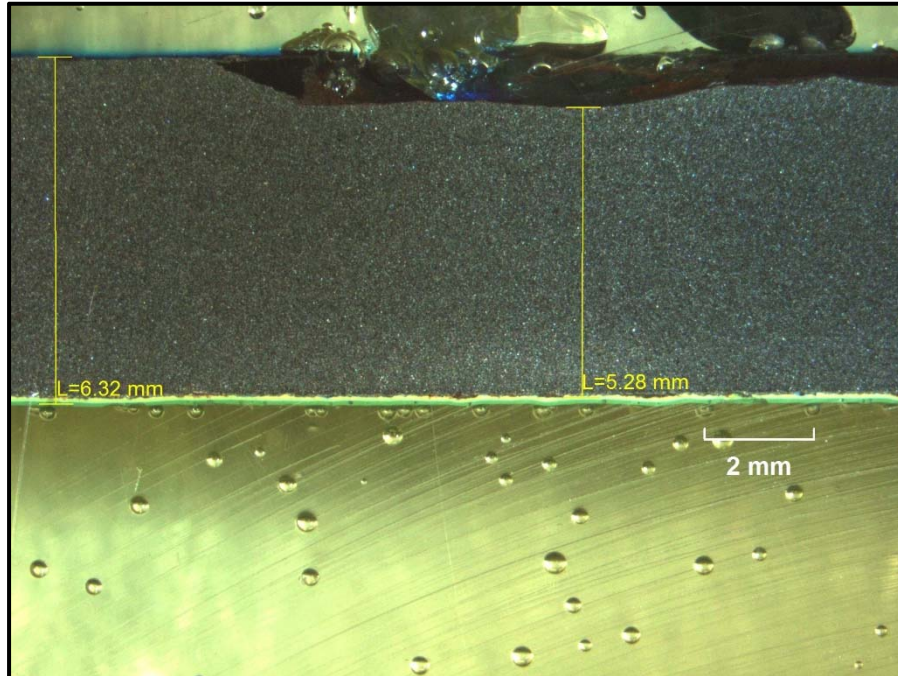
**Figure 182.** The prepared metallographic cross-section from Sample 1-4 is shown during examination with a stereomicroscope. The thickest location(s) are shown, as well as the thickness remaining underneath the deepest observed pit. (7X)

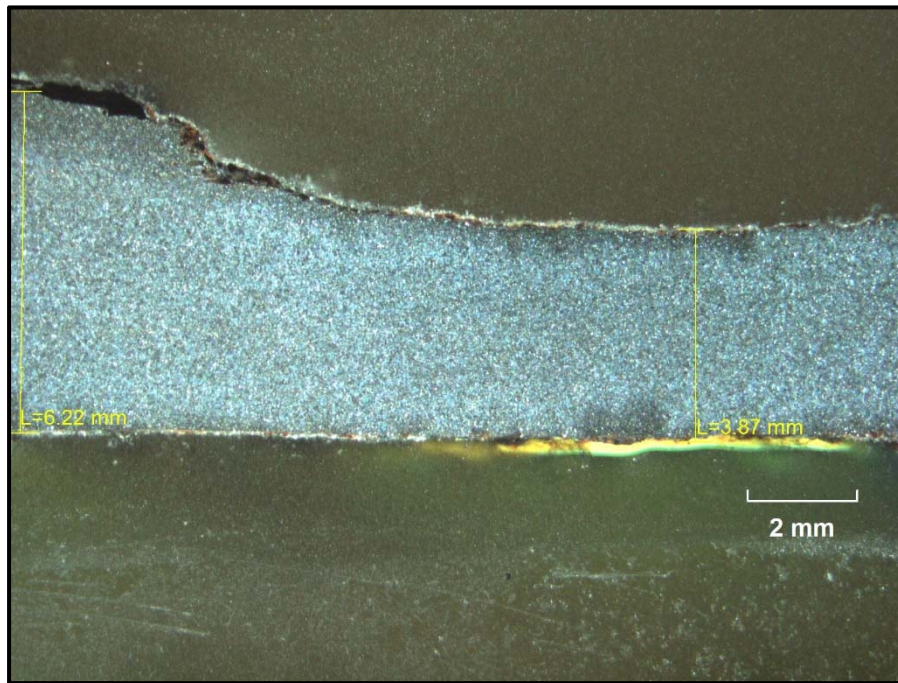
**Figure 183.** The prepared metallographic cross-section from Sample 2-1 is shown during examination with a stereomicroscope. The thickest location(s) are shown, as well as the thickness remaining underneath the deepest observed pit. (7X)

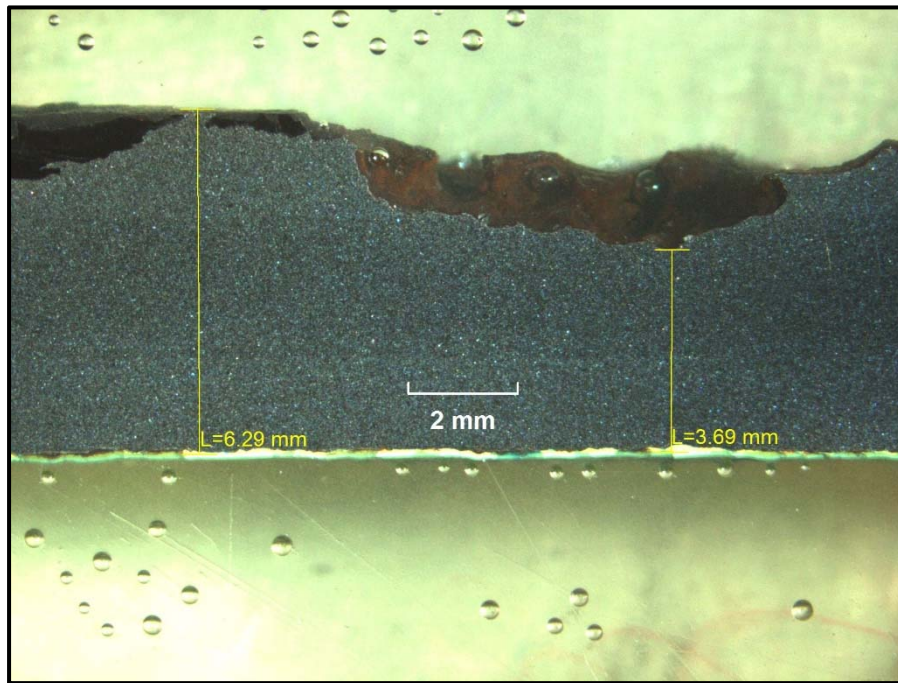
**Figure 187.** The prepared metallographic cross-section from Sample 3-2 is shown during examination with a stereomicroscope. The thickest location(s) are shown, as well as the thickness remaining underneath the deepest observed pit. (7X)

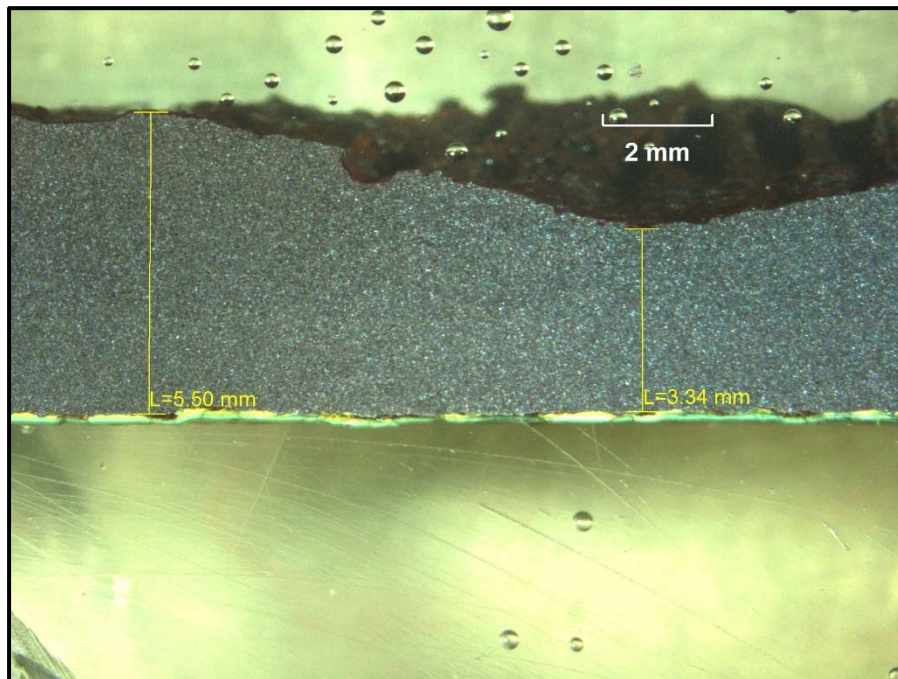
**Figure 188.** The prepared metallographic cross-section from Sample 3-3 is shown during examination with a stereomicroscope. The thickest location(s) are shown, as well as the thickness remaining underneath the deepest observed pit. (7X)

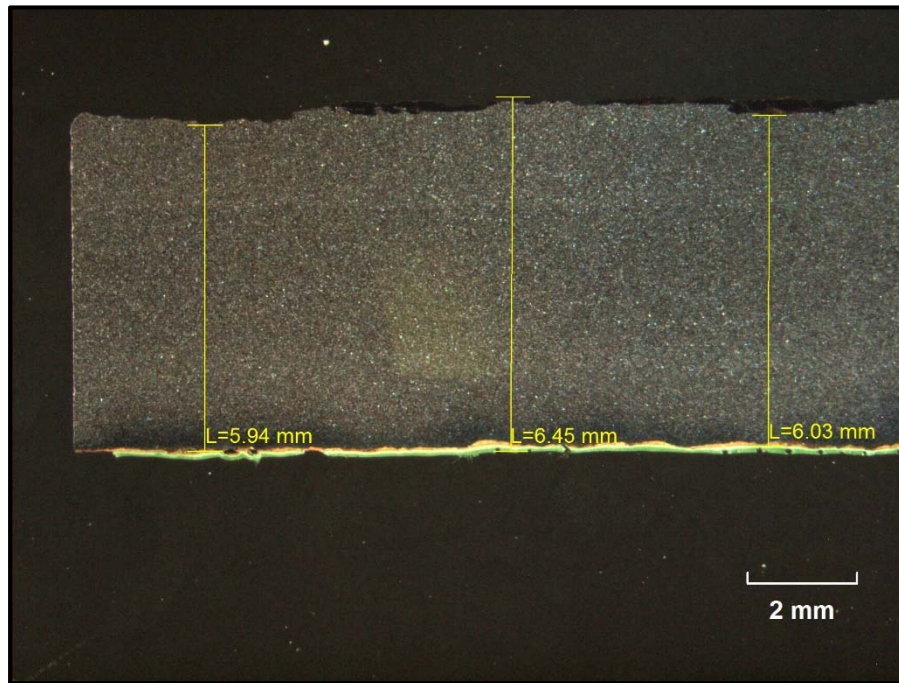
**Figure 189.** The prepared metallographic cross-section from Sample 3-4 is shown during examination with a stereomicroscope. The thickest location(s) are shown, as well as the thickness remaining underneath the deepest observed pit. (7X)
