SUBJECT: ADMINISTRATIVE ORDER ON CONSENT (AOC) STATEMENT OF WORK (SOW) SECTION 5 CORROSION AND METAL FATIGUE PRACTICES, DESTRUCTIVE TESTING RESULTS REPORT, RED HILL BULK FUEL STORAGE FACILITY (RED HILL), JOINT BASE PEARL HARBOR-HICKAM, OAHU, HAWAII

In 2018, ten coupons were removed from Tank 14, so that a metallurgical and corrosion analysis of the coupons could be undertaken, with the primary aim of validating non-destructive examination (NDE) results. The steel coupons, concrete powder samples, and corrosion product were submitted to a certified third-party laboratory to perform this analysis.

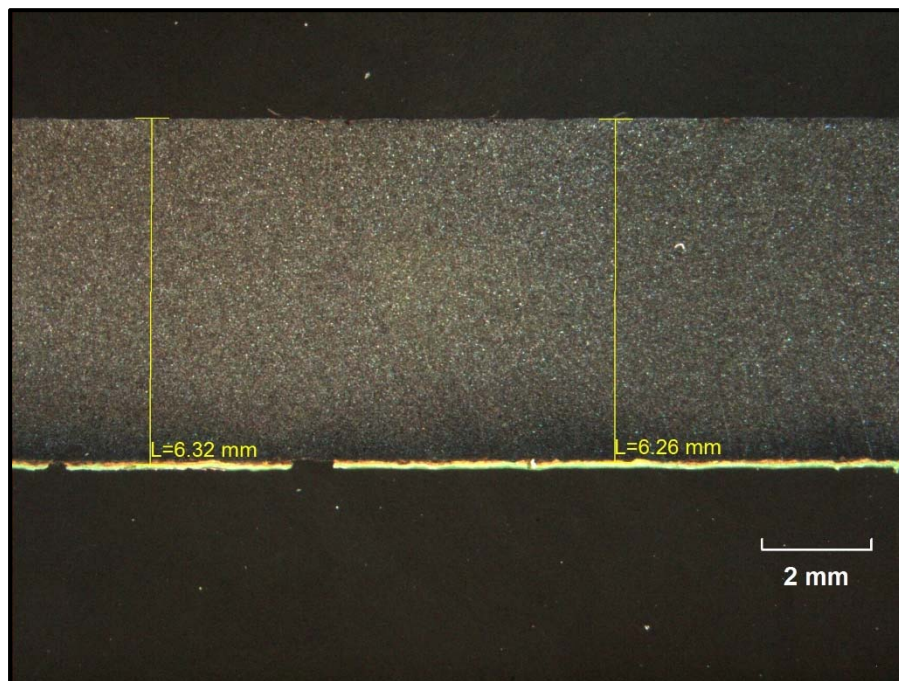
**Figure 190.** The prepared metallographic cross-section from Sample 5-1 is shown during examination with a stereomicroscope. No significant corrosion was observed. (7X)

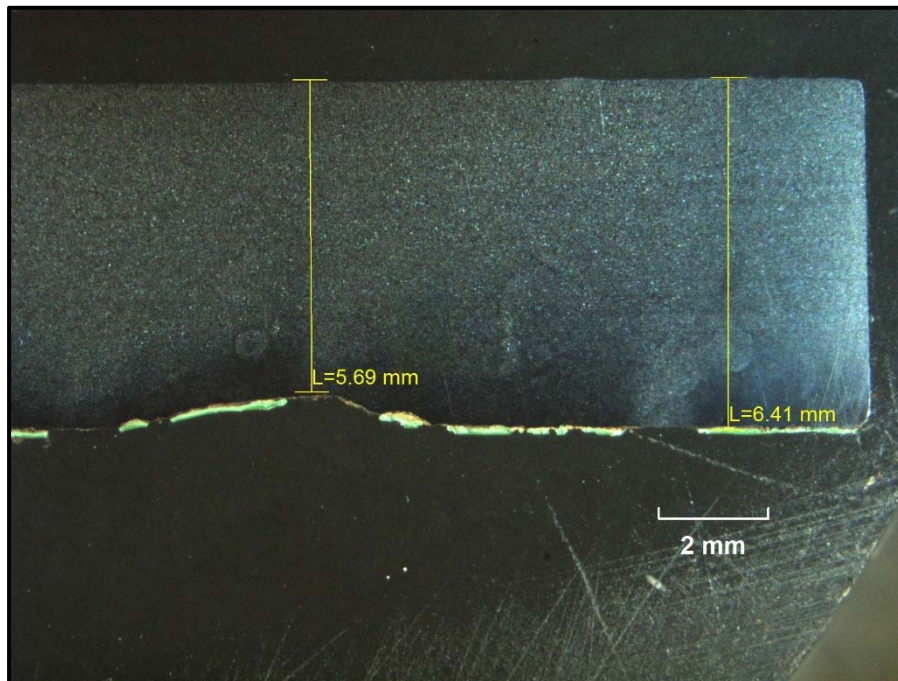
**Figure 192.** The prepared metallographic cross-section from Sample 5-5 is shown during examination with a stereomicroscope. The thickest remaining wall is shown. Note that the reduction in wall thickness was due to a depression on the painted face of the specimen. (7X)

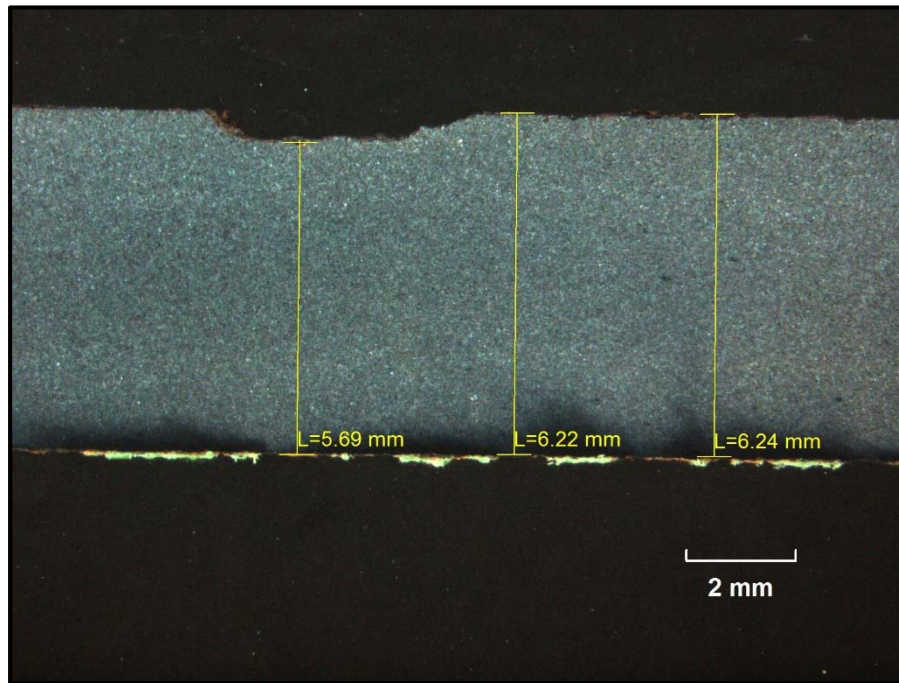
**Figure 195.** The prepared metallographic cross-section from Sample 6-3 is shown during examination with a stereomicroscope. The thickest location(s) are shown, as well as the thickness remaining underneath the deepest observed pit. (7X)

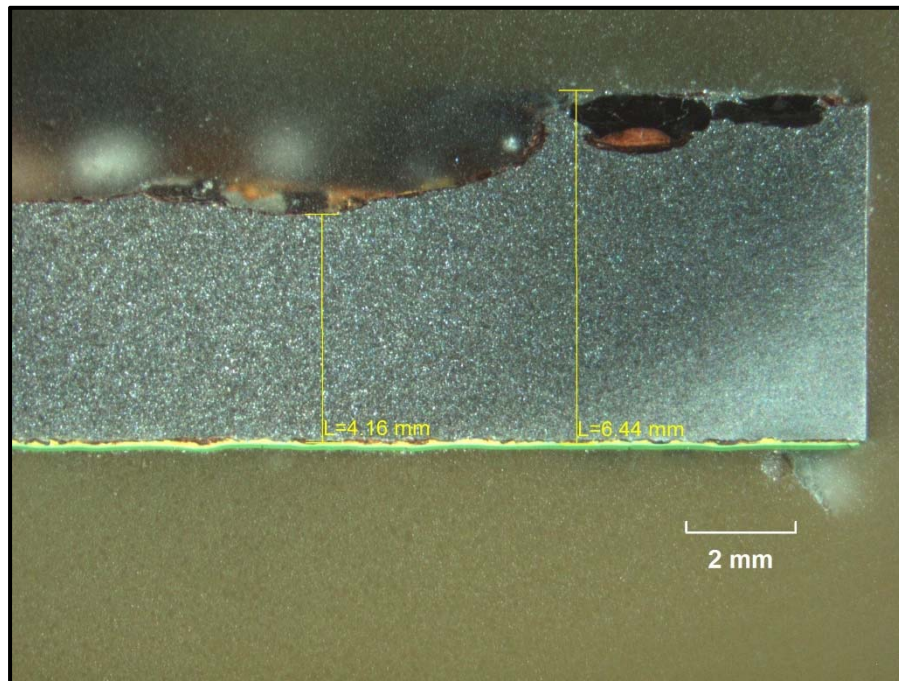
**Figure 196.** The prepared metallographic cross-section from Sample 7-1 is shown during examination with a stereomicroscope. The thickest location(s) are shown, as well as the thickness remaining underneath the deepest observed pit. (7X)

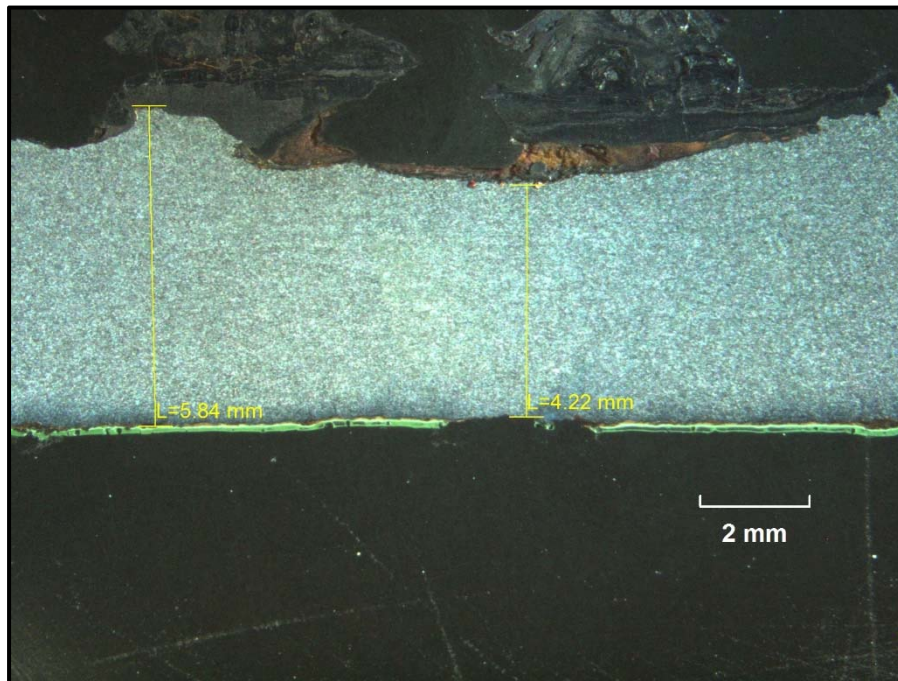
**Figure 198.** The prepared metallographic cross-section from Sample 7-4 is shown during examination with a stereomicroscope. The thickest location(s) are shown, as well as the thickness remaining underneath the deepest observed pit. (7X)

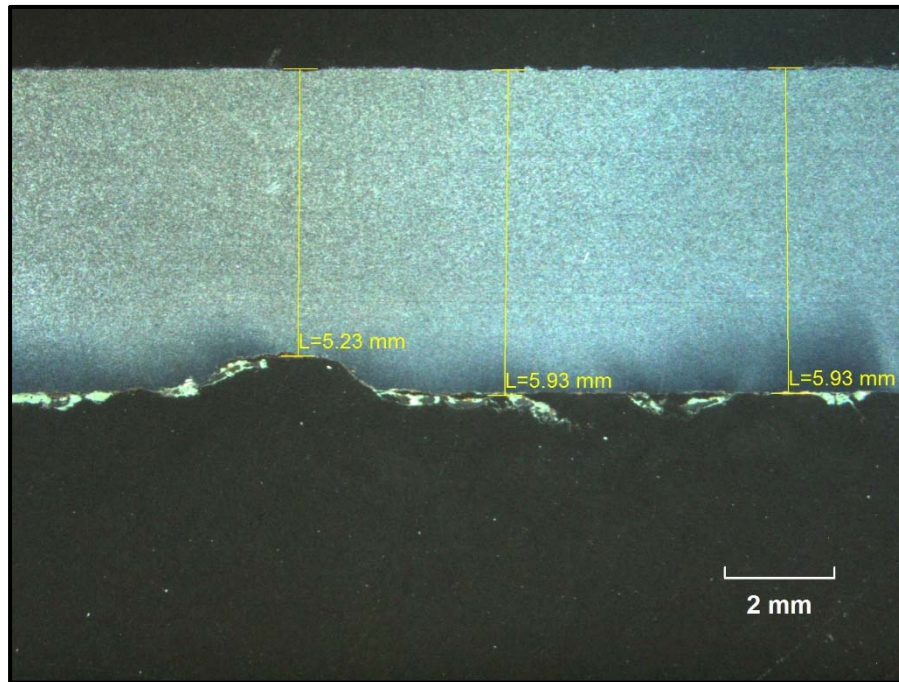
**Figure 199.** The prepared metallographic cross-section from Sample 8-3 is shown during examination with a stereomicroscope. The thickest remaining wall is shown. Note that the reduction in wall thickness was due to a depression on the painted face of the specimen. (7X)

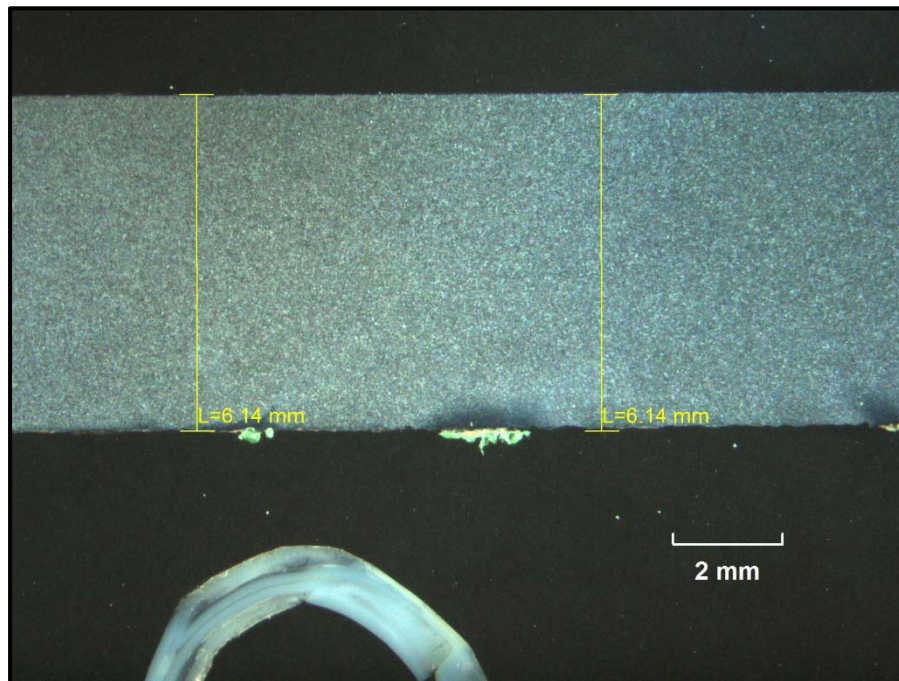
**Figure 200.** The prepared metallographic cross-section from Sample 10-1 is shown during examination with a stereomicroscope. The thickest location(s) are shown. No pitting was observed. (7X)

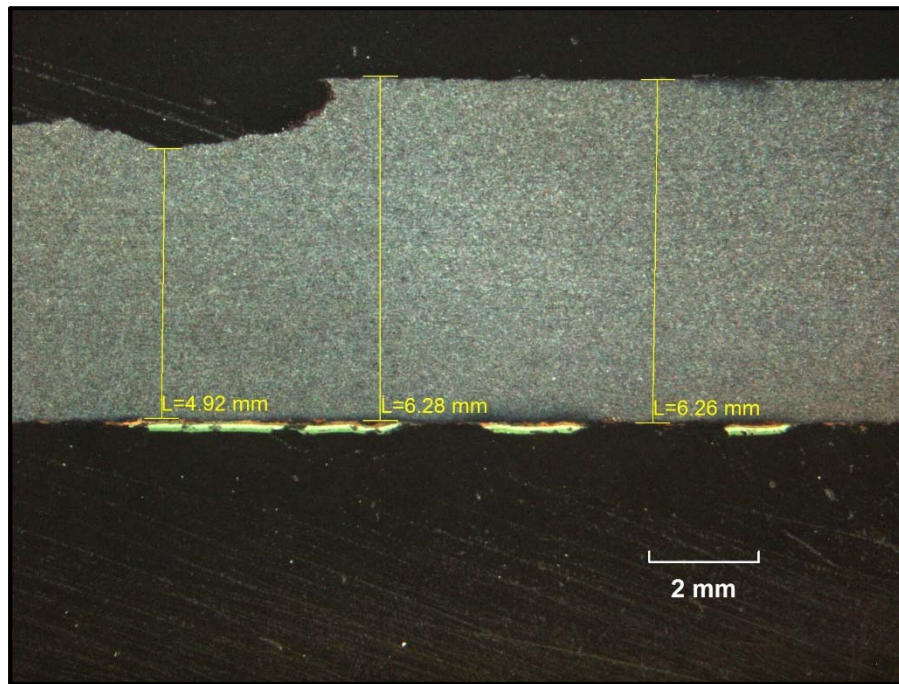
**Figure 203.** The prepared metallographic cross-section from Sample A1-1 is shown during examination with a stereomicroscope. The thickest location(s) are shown, as well as the thickness remaining underneath the deepest observed pit. (7X)

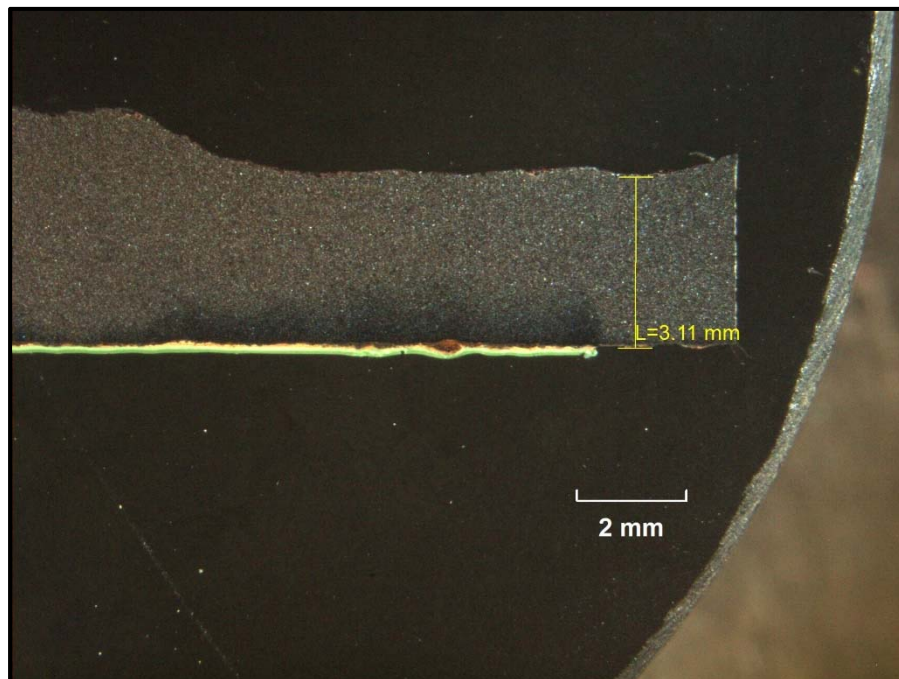
**Figure 204.** The prepared metallographic cross-section from Sample A1-4 is shown during examination with a stereomicroscope. The thickness remaining underneath the deepest observed pit is shown. (7X)

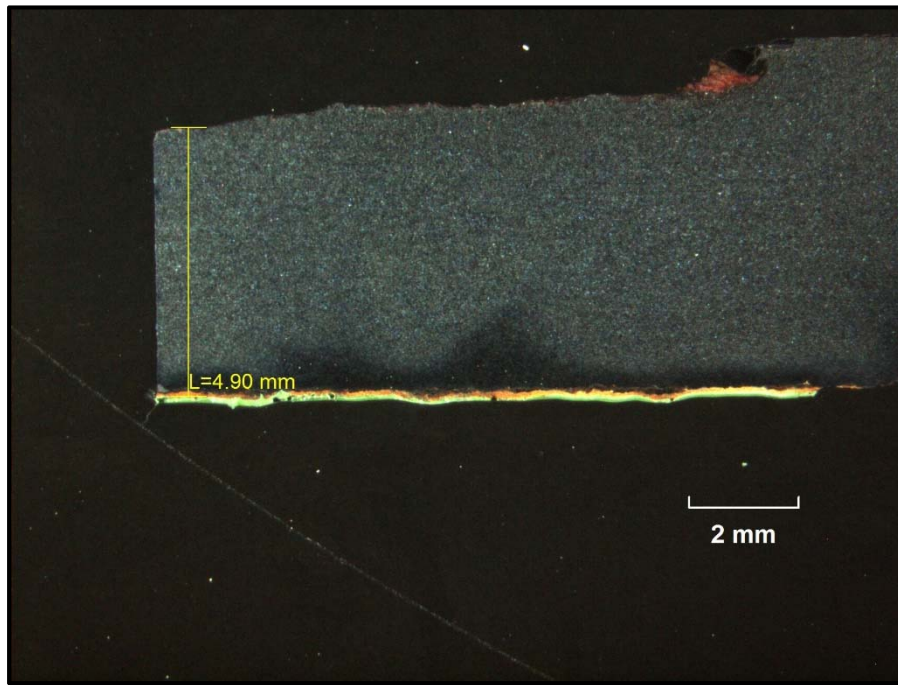
**Figure 205.** The prepared metallographic cross-section from Sample A1-5 is shown during examination with a stereomicroscope. The thickness remaining underneath the deepest observed pit is shown. (7X)

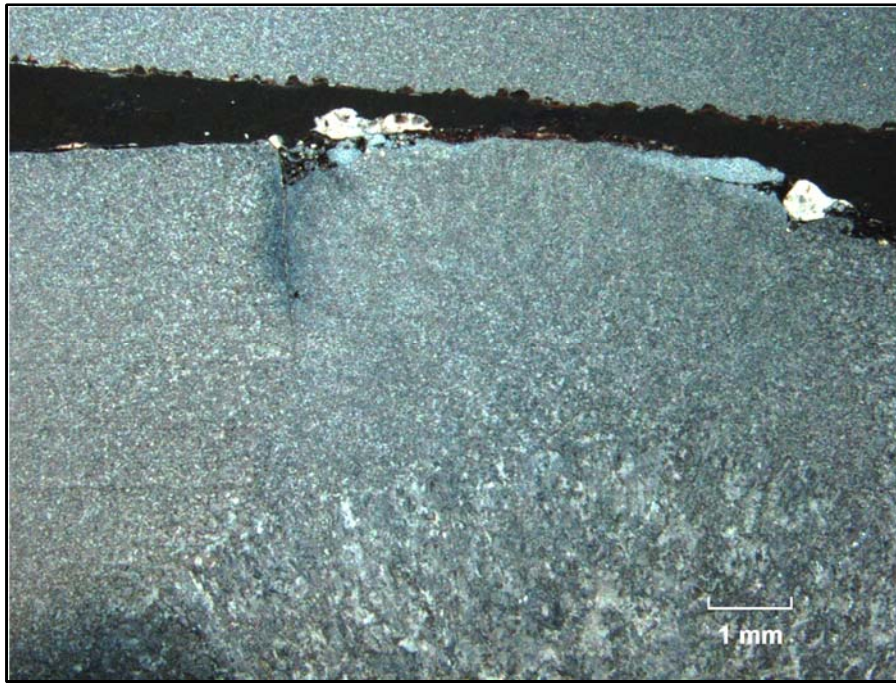
Coupon 8 exhibited what is presumed to be a prior weld repair and/or addition of a backing plate, where a patch was made on the tank wall. Representative images of the welds are presented as Figures 208 through 213. A full weld evaluation is outside the scope of this effort. The results are thus provided for information only.

**Figure 209.** The location identified in the previous figure is shown at higher magnification. The weld indication (arrow) appeared to be an area of incomplete fusion.

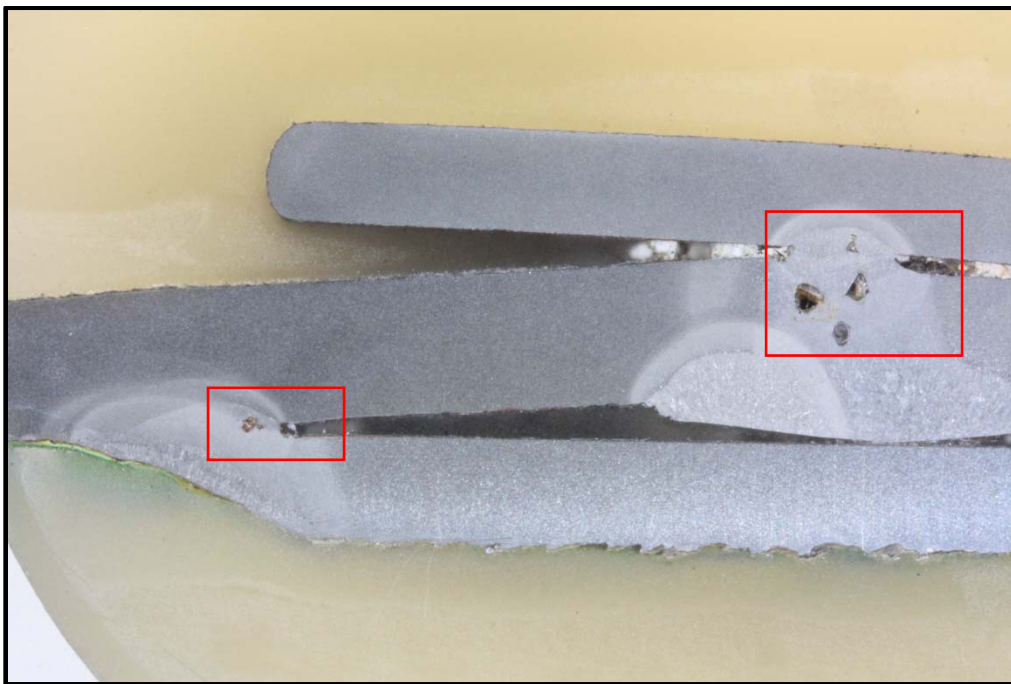
**Figure 210.** The prepared metallographic cross-section through welded sample 8-4 is shown in an overall view. The painted exterior surface is along the bottom section. The areas identified by the red boxes are shown in the next two figures at higher magnification.

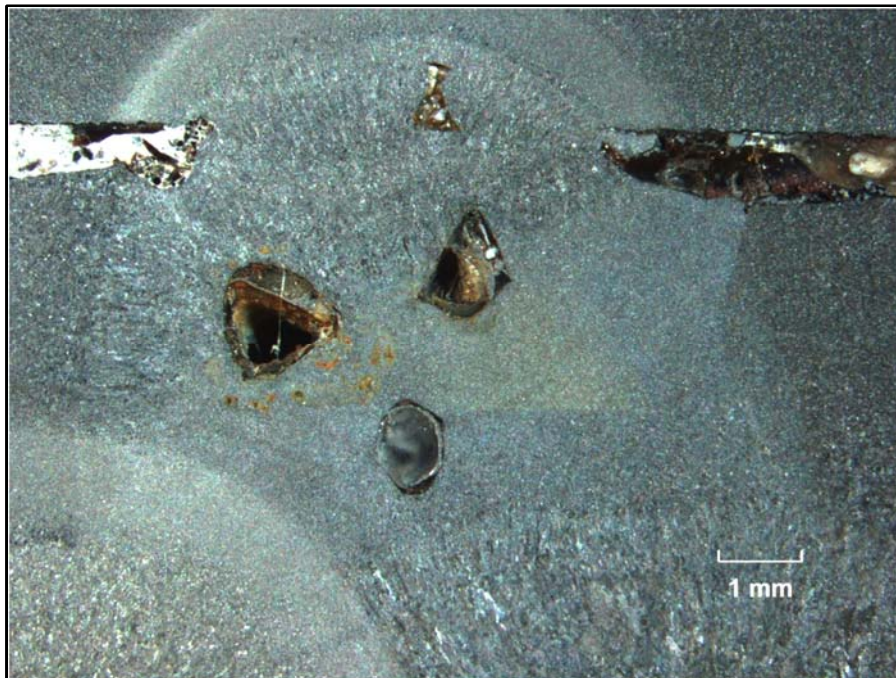
**Figure 212.** The right-hand feature in Figure 210 is shown at higher magnification. The weld indications appeared to be porosity.

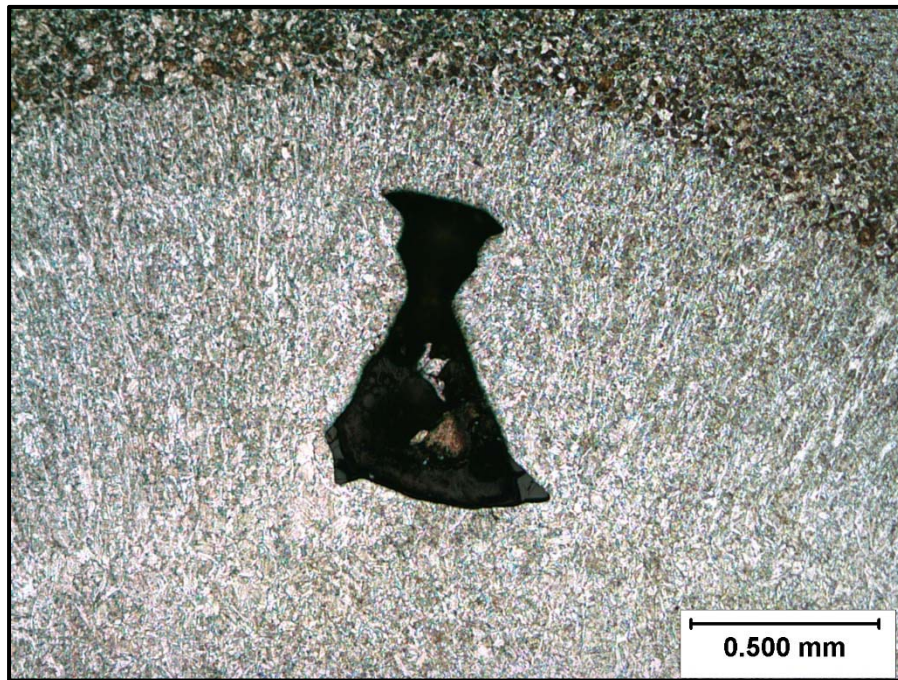
**Figure 213.** The one of the voids is shown at higher magnification. (2% Nital Etch, 50X)

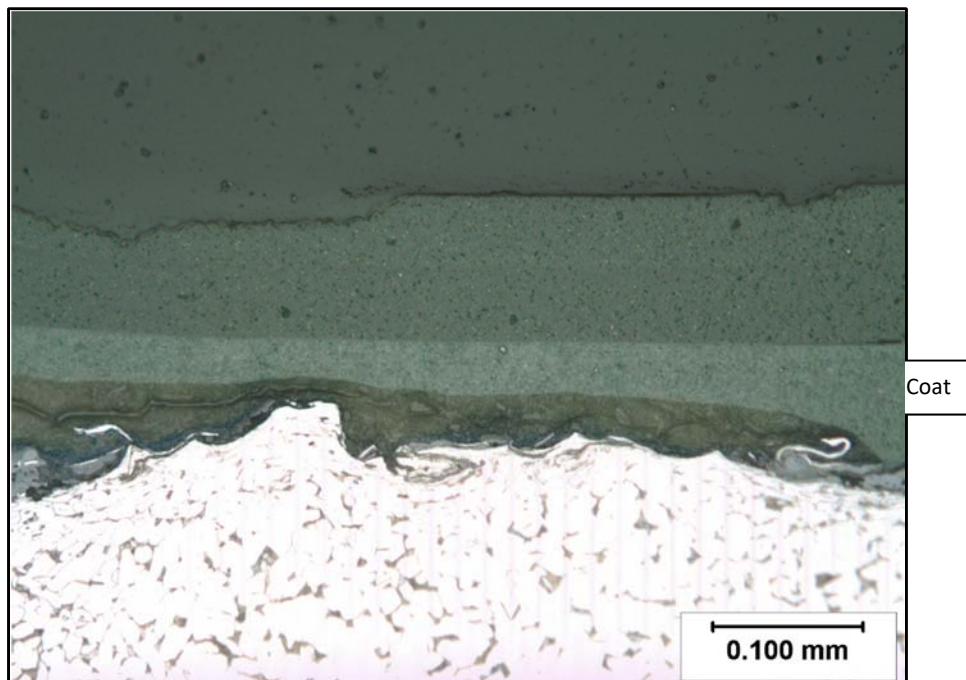
A typical paint layer was examined microscopically and was determined to consist of two layers, as shown in Figure 214. This indicates that the exterior tank wall exhibits a primer layer with a top coat. The scraped paint samples that were excised from each coupon previously for FTIR analysis would likely have captured some of both layers. The FTIR results presented previously were a good match for polyurethane, with no observable secondary component. Although this indicates that both the primer and top coat were polyurethane-based, it cannot be ruled out that the primer exhibited a different composition.

**Figure 214.** A typical paint layer is shown in cross-section, with key characteristics identified. (2% Nital Etch, 200X)

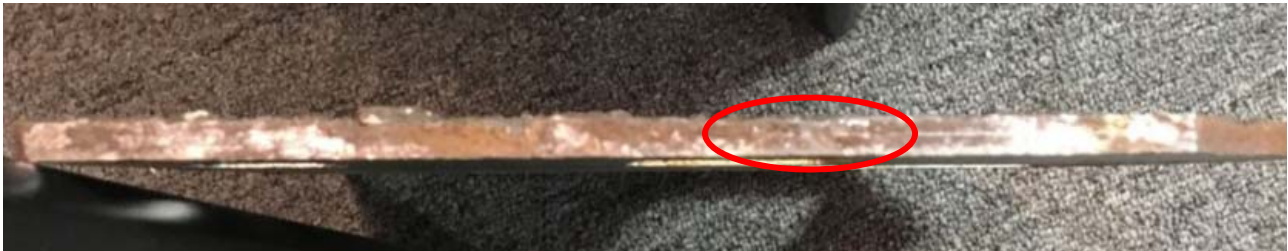
The area-of-concern was positively identified on the remains of Coupon #7 after the second photograph was provided by Mr. Jamond on March 20, 2019. Following the effects of the CO<sub>2</sub> cleaning, sectioning of test samples and subsequent storage, the edge did not exhibit a similar appearance to the provided photographs. After documenting the edge condition as of March 20, 2019, shown in Figure A-2, the edge was sand-blasted. No pitting was observed, as shown in Figures A-3 and A-4. It can be concluded that the rust-colored feature shown in the photographs provided to IMR on March 13, 2019 was a stain on the surface or some other artifact and not a deep pit.

**Figure A-2.** The same edge of Coupon #7 is shown on 3/20/19 after laboratory testing by IMR and subsequent storage. The red circle corresponds to the same area shown in Figure A-1. Note that the left ~1/4 of the coupon was consumed for mechanical testing, etc., but the area-of-concern remained intact.

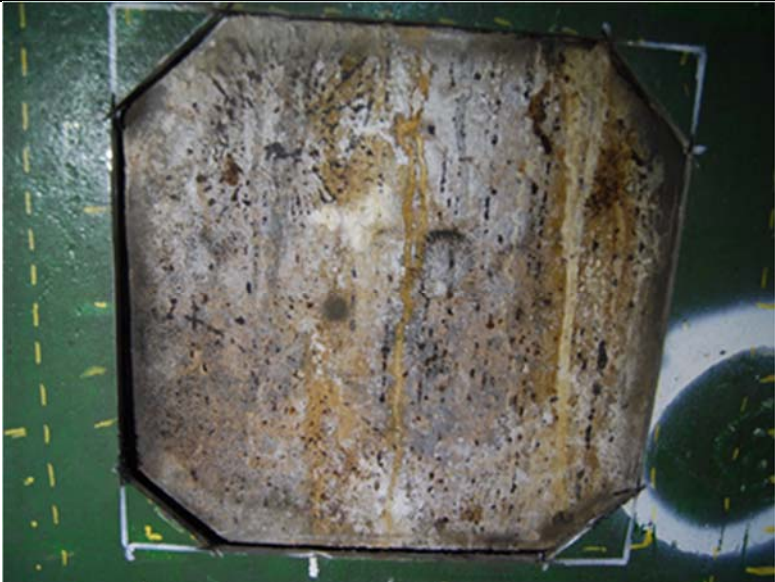
Checks	Observations	
	Exterior	Units
Void space between concrete and liner (if any)	1/8" Void on left side, no voids in all other areas	
Biological Materials	None	
Wet or Dry	Dry	
Smell	None	
Temperature	76.9	F
Surface pH	9 to 9.5	
Structure to Electrolyte	-0.252	Volts/CSE
Concrete Resistivity	26.4 Horizontal 31.1 Vertical	k-ohm-cm k-ohm-cm
General Condition	Excellent, sound concrete with some discoloration and no cracks and no delamination

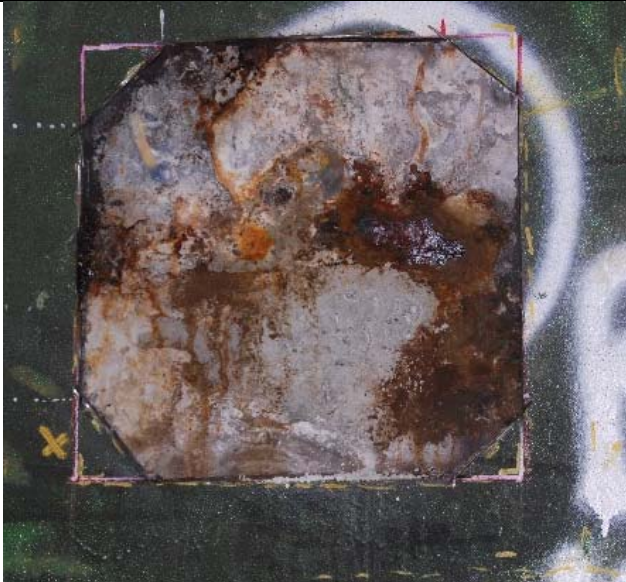
Checks	Observations	
	Exterior	Units
Void space between concrete and liner (if any)	1/8" void at upper left side. Otherwise no voids.	
Biological Materials	None	
Wet or Dry	Slightly damp	
Smell	Musty, no fuel	
Temperature	80.0	F
Surface pH	10-11 corroded area 11-12 non-corroded area	
Structure to Electrolyte	-0.380	Volts/CSE
Concrete Resistivity	19.0 Horizontal 17.5 Vertical	k-ohm-cm k-ohm-cm
General Condition	Good sound condition with some minor spalling and corrosion product. Coupon took some hammering to remove

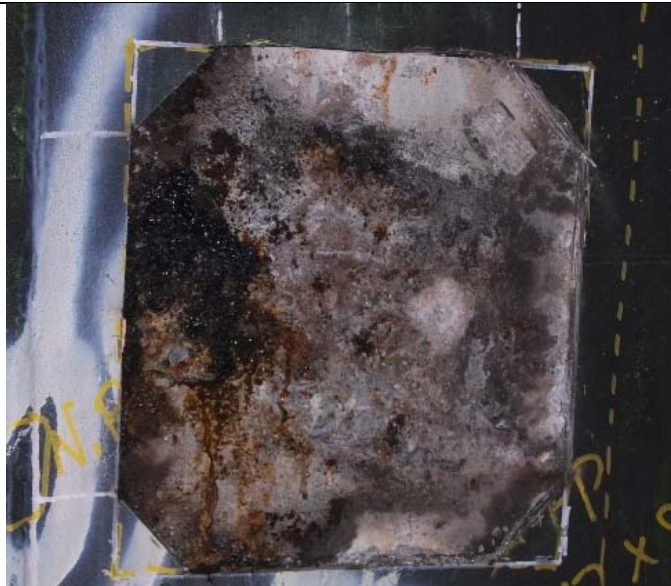
Checks	Observations	
	Exterior	Units
Void space between concrete and liner (if any)	On left side, uneven corrosion product and a 1/16-inch void. Otherwise, no voids.	
Biological Materials	None	
Wet or Dry	Mostly dry, with some damp spots	
Smell	None	
Temperature	79.3	F
Surface pH	11-12 dry areas, 7-8 in areas with corrosion product	
Structure to Electrolyte	-0.488	Volts/CSE
Concrete Resistivity	27.8 Horizontal 31.2 Vertical	K-Ohm-cm
General Condition	Good, with some corrosion products. Corrosion product was black on the left side, and brown in some other areas. Concrete was hard and difficult to drill for powder samples. Coupons required some hammering and prying to remove after cutting.

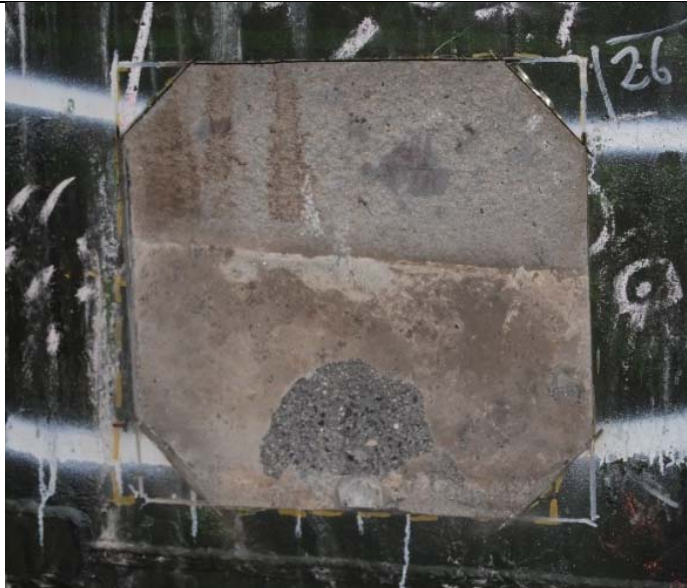
6/20/2018: 0800		
CONCRETE SAMPLE SPECIFICS		
Sample ID	5	5
Sample Location	14-DA-26-15-15-8	
Sample Dimensions	12X12 INCHES	
ON SITE VISUAL EXAMINATION		
Checks	Observations	
	Exterior	Units
Void space between concrete and liner (if any)	1/16" Void on top right side, no voids in all other areas	
Biological Materials	None	
Wet or Dry	Dry	
Smell	None	
Temperature	78.5	F
Surface pH	11-12	
Structure to Electrolyte	-0.220	Volts/CSE
Concrete Resistivity	19.1 Horizontal	k-ohm-cm
	22.0 Vertical	k-ohm-cm
General Condition	Excellent, sound concrete

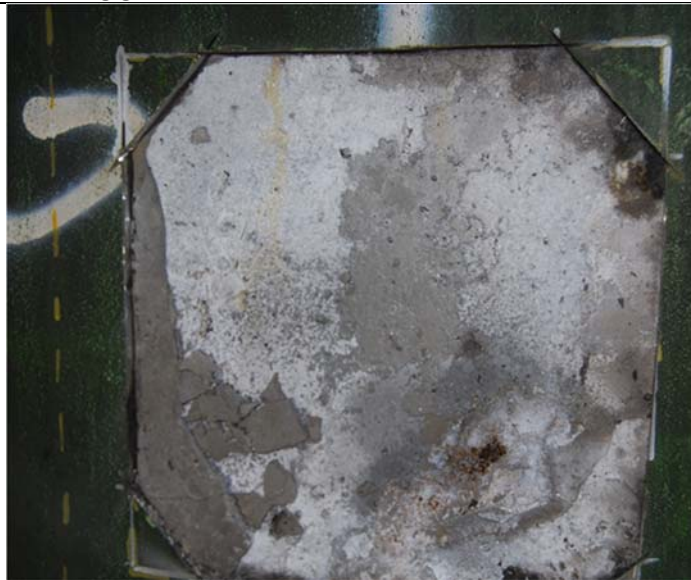
Checks	Observations	
	Exterior	Units
Void space between concrete and liner (if any)	None, however some loose adhering grout present	
Biological Materials	None	
Wet or Dry	Dry	
Smell	None	
Temperature	77.4F	F
Surface pH	12.5	
Structure to Electrolyte	-0.387	Volts/CSE
Concrete Resistivity	Horizontal = 387 Vertical = 359	k-ohm-cm k-ohm-cm
General Condition	Concrete is sound, no delamination. There is loose adhering grout on left side and middle

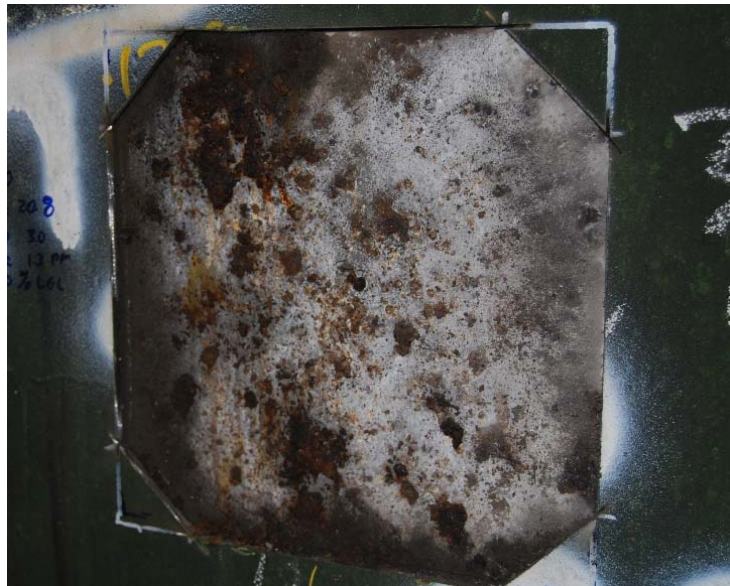
Checks	Observations	
	Exterior	Units
Void space between concrete and liner (if any)	3/8" void on left side. 1/16" void on top right otherwise no voids	
Biological Materials	None	
Wet or Dry		
Smell	none	
Temperature	77.5F	F
Surface pH	9- 10	
Structure to Electrolyte		Volts/CSE
Concrete Resistivity	Horizontal = 39.3 Vertical = 42.4	k-ohm-cm k-ohm-cm
General Condition	Concrete is sound with no delamination or cracks. Some brown and black corrosion products on concrete

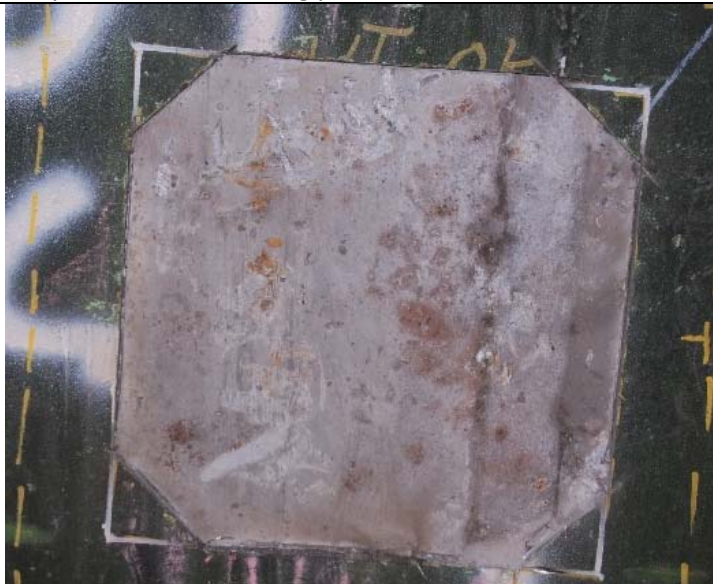
6/20/2018: 1400		
CONCRETE SAMPLE SPECIFICS		
Sample ID	8	8
Sample Location	14-BA-20-13-23-4	
Sample Dimensions	12X12 INCHES	
ON SITE VISUAL EXAMINATION		
Checks	Observations	
	Exterior	Units
Void space between concrete and liner (if any)	1/16" Void on left side, no voids in all other areas	
Biological Materials	None	
Wet or Dry	Dry	
Smell	None	
Temperature	80.0	F
Surface pH	11-12	
Structure to Electrolyte	-0.248	Volts/CSE
Concrete Resistivity	30.9 Horizontal 27.5 Vertical	k-ohm-cm k-ohm-cm
General Condition	Excellent, sound concrete with no cracks or delamination. Coupon had steel backing plate

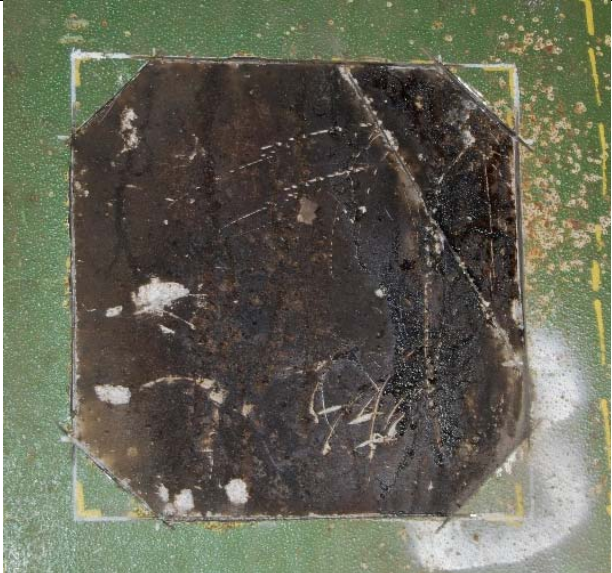
Checks	Observations	
	Exterior	Units
Void space between concrete and liner (if any)	None	
Biological Materials	None	
Wet or Dry	Dry	
Smell	Smells like coal tar	
Temperature	77.6	F
Surface pH	12-12.5	
Structure to Electrolyte	-0.181	Volts/CSE
Concrete Resistivity	27.3 Horizontal 38.1 Vertical	k-ohm-cm k-ohm-cm
General Condition	Excellent, sound concrete with no cracks or delamination. Coupon had to be cut into two pieces to remove. What appears to be coal tar coating present on backside of coupon and concrete.

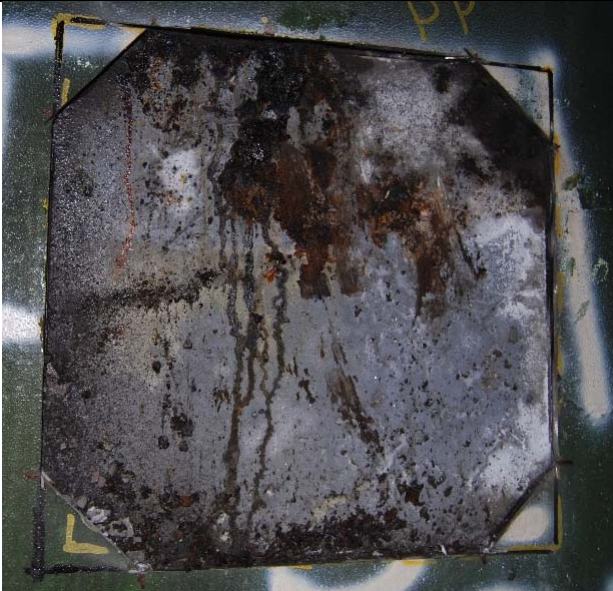
Checks	Observations	
	Exterior	Units
Void space between concrete and liner (if any)	1/8" Void on left side, no voids in all other areas	
Biological Materials	None	
Wet or Dry	Mostly dry with damp areas around corrosion product	
Smell	None	
Temperature	77.5	F
Surface pH	11-12 in dry areas, 7-8 in corroded area	
Structure to Electrolyte	-0.448 (dry area) -0.432 (damp area w. corrosion products)	Volts/CSE
Concrete Resistivity	32.9 Horizontal 37.0 Vertical	k-ohm-cm
General Condition	Good condition with sound concrete, no cracks or delamination. Corrosion products are present on concrete.

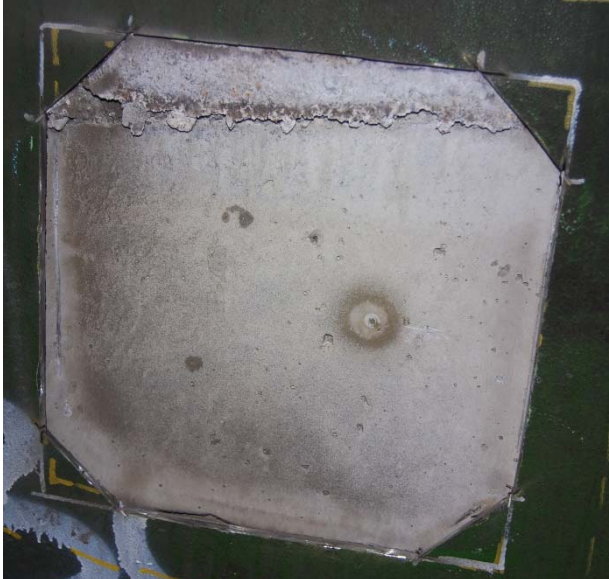
Table 2. On-Site Characterization of Steel Coupon

COUPON SPECIFICS		
Coupon ID #	14-UD-A-42-45-107	
Coupon Location		
Coupon Dimensions	12x12	
Coupon Thickness	1/4"	
Locations of Welds (If Any)	None	
ON-SITE VISUAL EXAMINATION		
Checks	Observations	
	In Exterior (Backs)	Exterior (Backs)
Deposits, Coatings, Debris	Coating + paint	Deposits
Scale	None	None
Observed biological Materials	None	None
Wet or Dry	Dry	Wet
Smell	Burnt	Damp, burnt
Presence of petroleum product between steel and concrete surface, and on or above the leg of the angle backer bar embedded in the concrete.	No	No
Provide a sketch of the coupon showing all indications. Provide ID#s for all indications on coupon and compare with NDE expected results sketch

Presence of corrosion	No	Yes
Isolated pitting	No	No
Isolated pitting within areas of general corrosion	No	No
Linked pitting within areas of general corrosion	No	No
Identify color of corrosion products	No	Brown
Identify if selective attack at welds	No	No

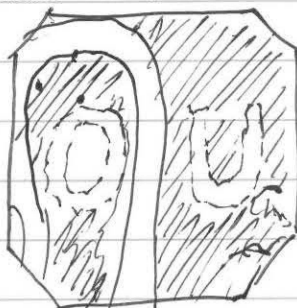
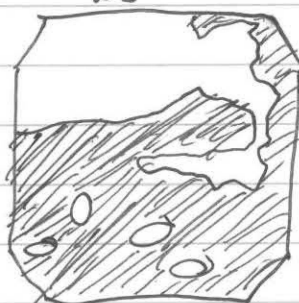
Sketch

Presence of corrosion

Yes

Corrosion product (powder) is black; likely FeO [iron(II) oxide]
