UNITED STATES ENVIRONMENTAL
PROTECTION AGENCY
REGION IX
75 Hawthorne Street
San Francisco, CA 94105

STATE OF HAWAII
DEPARTMENT OF HEALTH
P. O. BOX 3378
HONOLULU, HI 96801-3378

Re: Response to Corrosion and Metal Fatigue Practices, Destructive Testing Results Report, Red Hill Bulk Fuel Storage Facility (Red Hill), Joint Base Pearl Harbor-Hickam, Oahu, Hawaii

Corrosion Report on Red Hill Bulk Fuel Storage Facility

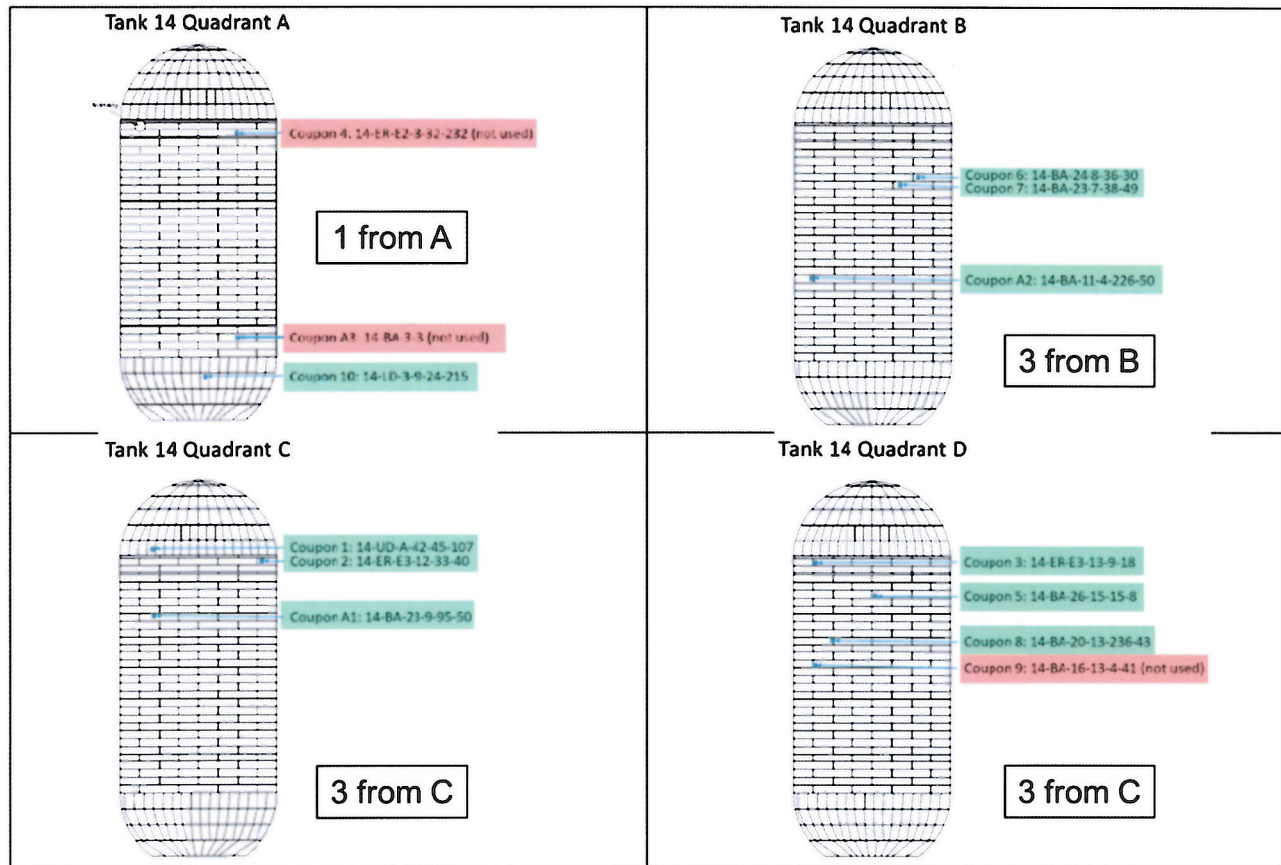
Figure 2-1 Schematic of Tank 14 Coupon Locations

The Navy, however, did not follow its commitment in the DT SOW and instead selected a much less diverse range of coupons that are unlikely to be representative of the potential conditions

within Tank 14 much less the conditions of all the tanks at the RHBFSF. Ultimately, the Navy extracted eight coupons from the tank barrel (i.e., the vertical walls), one from just inside the upper dome, and one from sloped section of the lower dome; shown below for the locations marked in green. The locations marked in red were identified as possible coupon locations but were not extracted. The BWS is not aware of any random locations selected based on the BFET scans specifically to assess the welds. The Navy's description of the NDE result at these coupon locations do not discuss the BFET result at all. Further, the BWS is not aware of any coupons extracted from the lower dome bottom plate.
