# Naval Audit Service

## Audit Report

### Department of the Navy Red Hill and Upper Tank Farm Fuel Storage Facilities

**N2010-0049**  
**16 August 2010**

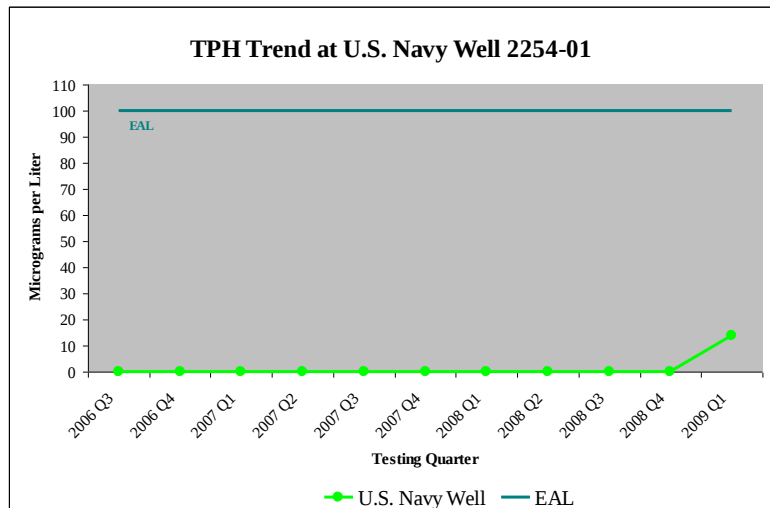
*U.S. Navy Well 2254-01*

In the 1<sup>st</sup> quarter of 2009, TPH contaminants were also detected at the Navy Well. Although the concentration that was detected was below the EAL,<sup>11</sup> this sampling event was the first time that TPH had been detected since the Navy began testing for the contaminant in 2006. As mentioned above, the recent detection of contaminants at the Navy Well may indicate migration

of fuel released from RH. The detection of contaminants at the Navy Well pumping station poses an immediate risk to the potable water sources in the RH area. If the Navy Well becomes contaminated beyond acceptable levels, the Navy and the island of Oahu could potentially lose an important source of drinking water. If this occurs, the Pearl Harbor Water System would be reduced by approximately 24 percent. Further, the Navy would be responsible for providing an alternate water source at the Navy Well as indicated in the GPP.
