**DEPARTMENT OF THE NAVY**

SUBJECT: ADMINISTRATIVE ORDER ON CONSENT (AOC) STATEMENT OF WORK (SOW) SECTION 5 CORROSION AND METAL FATIGUE PRACTICES, DESTRUCTIVE TESTING RESULTS REPORT, RED HILL BULK FUEL STORAGE FACILITY (RED HILL), JOINT BASE PEARL HARBOR-HICKAM, OAHU, HAWAII

In 2018, ten coupons were removed from Tank 14, so that a metallurgical and corrosion analysis of the coupons could be undertaken, with the primary aim of validating non-destructive examination (NDE) results. The steel coupons, concrete powder samples, and corrosion product were submitted to a certified third-party laboratory to perform this analysis.

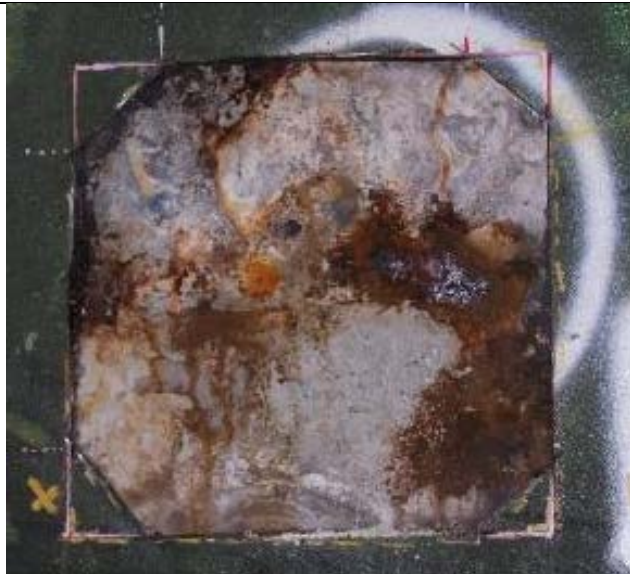
| 6/19/2018: 0930 | | |
|---|---|---|
| Concrete behind Coupon 2 | | |

| 6/19/2018: 0930 | | |
|---|---|---|
| General Condition | Good sound condition with some minor spalling and corrosion product. Coupon took some hammering to remove. | |

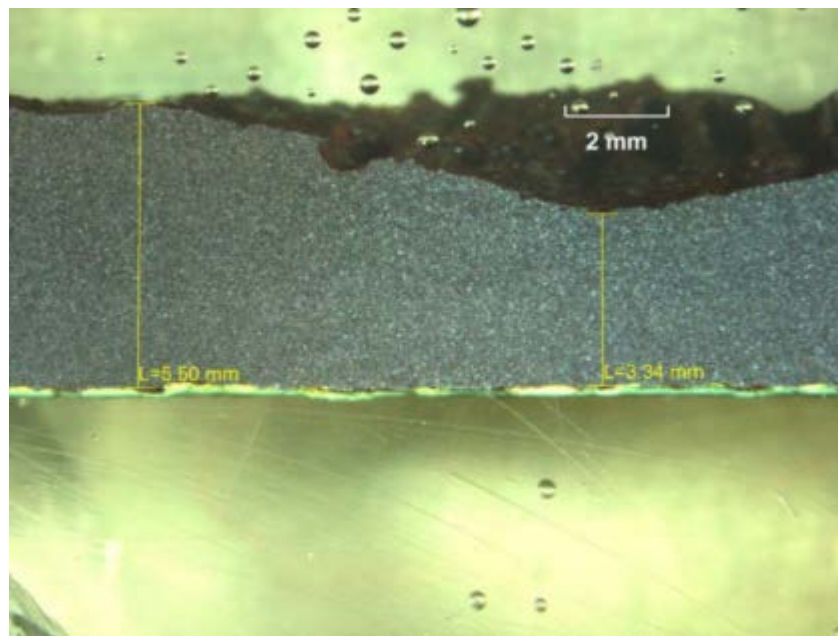
**Figure 3-4 Cross Section of Coupon 3 at Area of Maximum Wall Loss**

- Detailed results of the Destructive Testing Laboratory analysis of Coupon 3 are contained in Appendix A.
- The thinnest measured location was 131.5 mils (3.34 mm).
- Assuming a nominal wall thickness of 250 mils, the remaining wall thickness at the thinnest location was 52.6%.
- A cross-section view of Coupon 3 is shown in Figure 3-4.

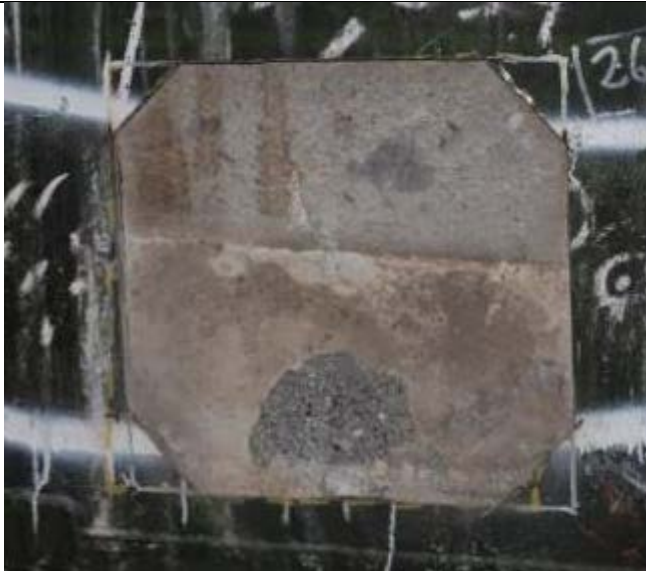
| 6/20/2018: 0800 | | |
|---|---|---|
| Concrete behind Coupon 5 | | |

| 6/20/2018: 0800 | | |
|---|---|---|
| General Condition | Excellent, sound concrete | |

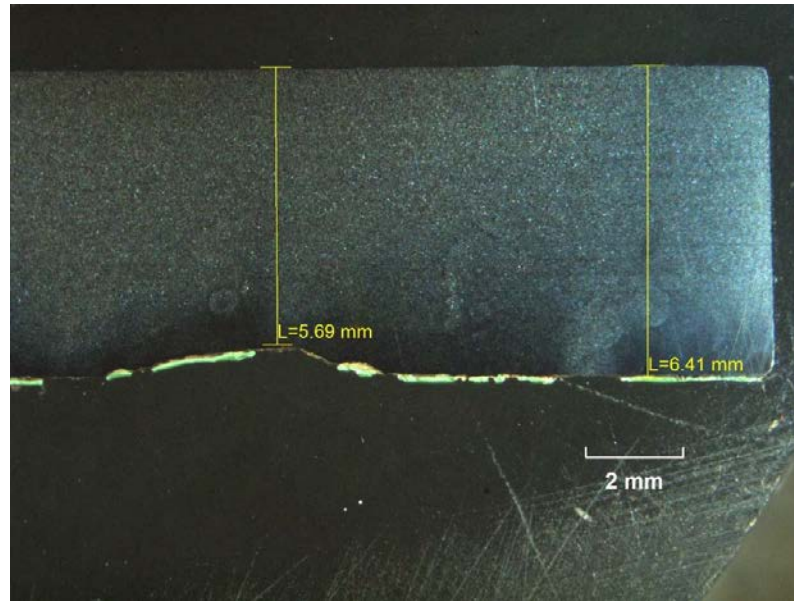
**Figure 3-5 Cross Section of Coupon 5 at Area of Maximum Wall Loss**

- Detailed results of the Destructive Testing Laboratory analysis of Coupon 5 are contained in Appendix A.
- The thinnest measured location was 224.0 mils (5.69 mm).
- Assuming a nominal wall thickness of 250 mils, the remaining wall thickness at the thinnest location was 89.6%.
- A cross-section view of Coupon 5 is shown in Figure 3-5.

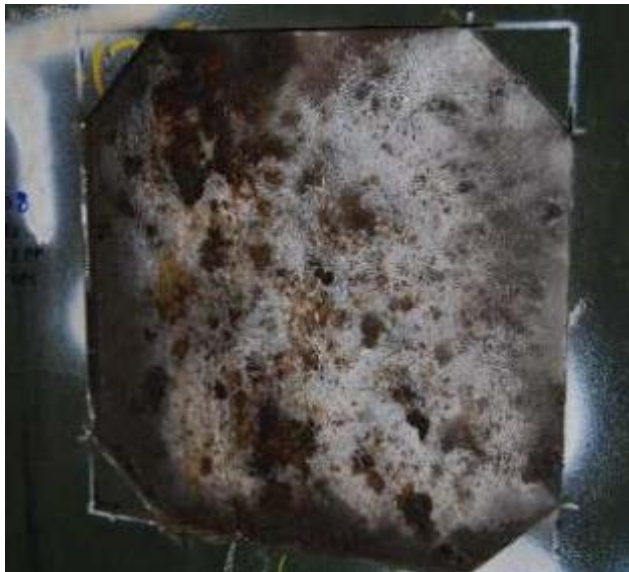
| 6/21/2018: 1030 | | |
|---|---|---|
| Concrete behind Coupon 7 | | |

| 6/21/2018: 1030 | | |
|---|---|---|
| General Condition | Concrete is sound with no delamination or cracks. Some brown and black corrosion products on concrete | |

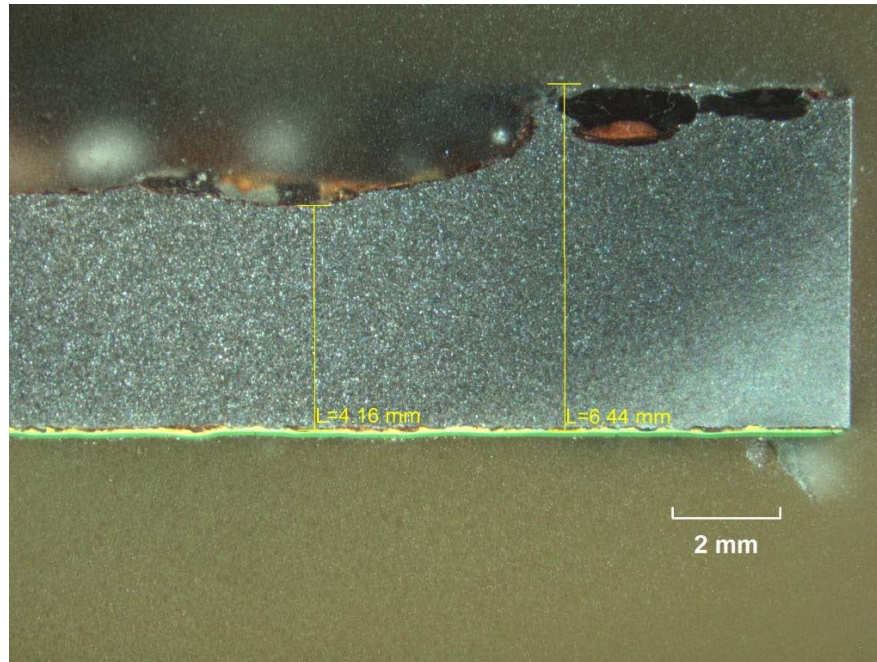
**Figure 3-7 Cross Section of Coupon 7 at Area of Maximum Wall Loss**

- Detailed results of the Destructive Testing Laboratory analysis of Coupon 7 are contained in Appendix A.
- The thinnest measured location was 163.8 mils (4.16 mm).
- Assuming a nominal wall thickness of 250 mils, the remaining wall thickness at the thinnest location was 66.5%.
- A cross-section view of Coupon 7 is shown in Figure 3-7.

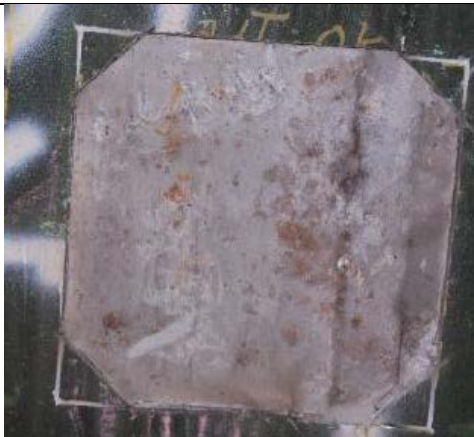
| 6/20/2018: 1400 | | |
|---|---|---|
| Concrete behind Coupon 8 | | |

| 6/20/2018: 1400 | | |
|---|---|---|
| General Condition | Excellent, sound concrete with no cracks or delamination. Coupon had steel backing plate | |

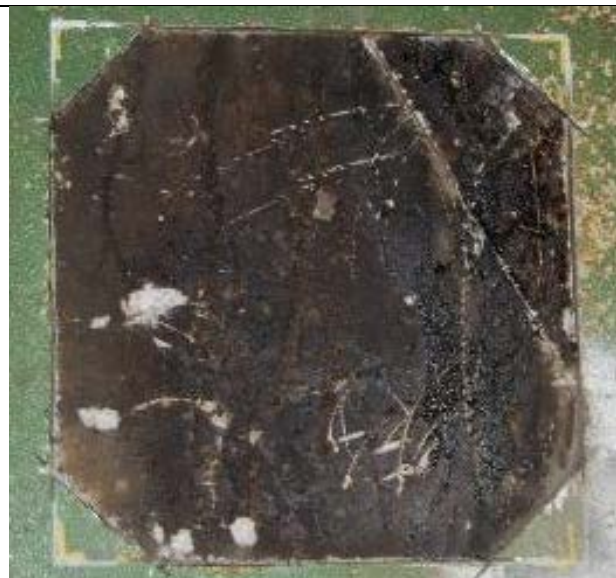
| 6/21/2018: 0930 | | |
|---|---|---|
| Concrete behind Coupon 10 | | |

| 6/21/2018: 0930 | | |
|---|---|---|
| General Condition | Excellent, sound concrete with no cracks or delamination. Coupon had to be cut into two pieces to remove. What appears to be coal tar coating present on backside of coupon and concrete. | |

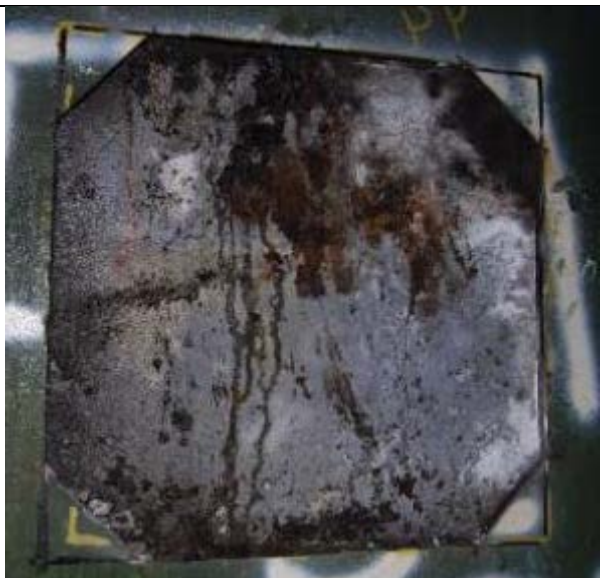
| 6/20/2018: 1100 | | |
|---|---|---|
| Concrete behind Coupon A1 | | |

| 6/20/2018: 1100 | | |
|---|---|---|
| General Condition | Good condition with sound concrete, no cracks or delamination. Corrosion products are present on concrete. | |

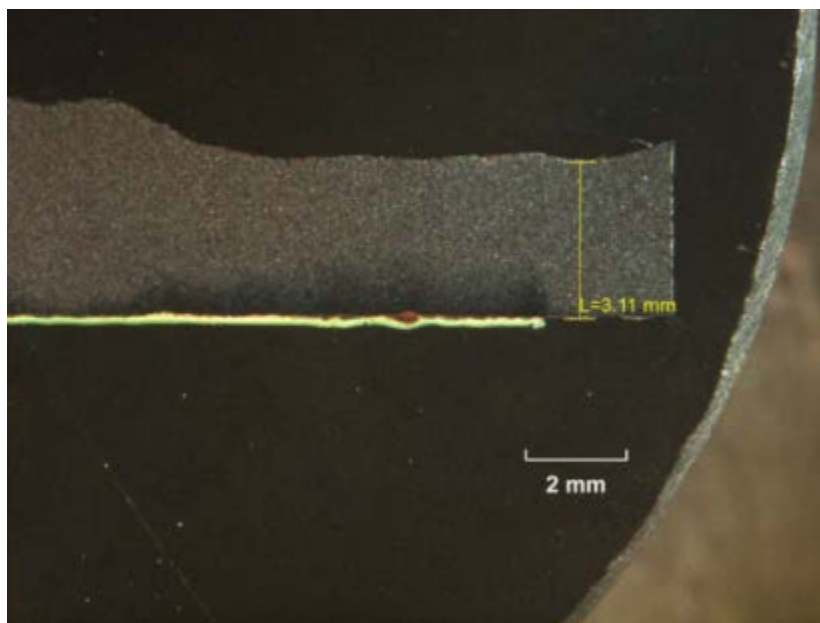
**Figure 3-10 Cross Section of Coupon A1 at Area of Maximum Wall Loss**

- Detailed results of the Destructive Testing Laboratory analysis of Coupon A1 are contained in Appendix A.
- The thinnest measured location 122.4 mils (3.11 mm).
- Assuming a nominal wall thickness of 250 mils, the remaining wall thickness at the thinnest location was 48.5%.
- A cross-section view of Coupon A1 is shown in Figure 3-10.

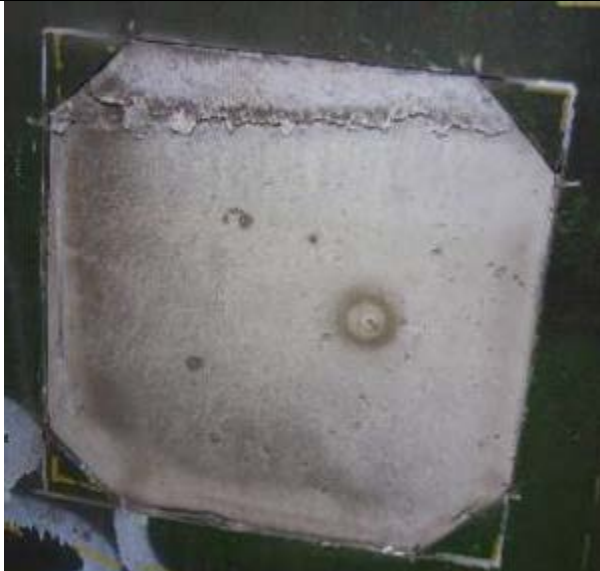
| 6/20/2018: 1530 | | |
|---|---|---|
| Concrete behind Coupon A2 | | |

| 6/20/2018: 1530 | | |
|---|---|---|
| General Condition | Good condition with sound concrete, no cracks or delamination. There is a layer of concrete that appears to have come off. Below that layer is sound concrete. | |

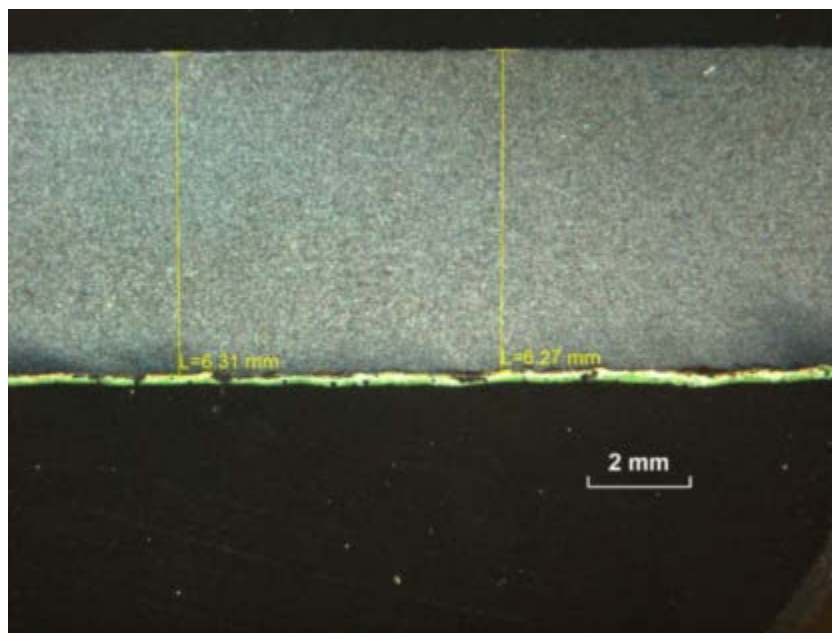
**Figure 3-11 Cross Section of Coupon A2 at Area of Maximum Wall Loss**

- Detailed results of the Destructive Testing Laboratory analysis of Coupon A2 are contained in Appendix A.
- The thinnest measured location was 247.6 mils (6.29 mm).
- Assuming a nominal wall thickness of 250 mils, the remaining wall thickness at the thinnest location was 97.5%.
- A cross-section view of Coupon A2 is shown in Figure 3-11.

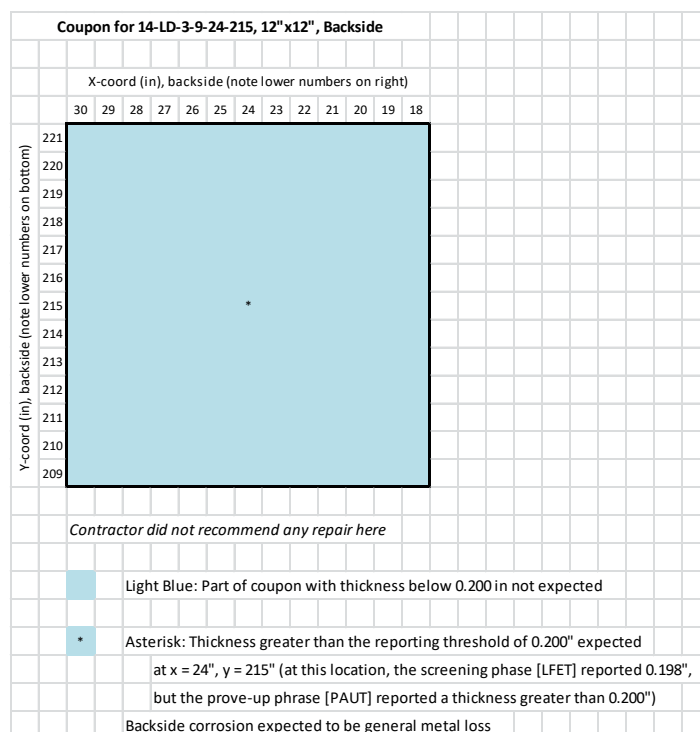
**Figure 4-17 Expected Results From NDE Spreadsheet Data, Coupon 10**

The LFET screening found no indications. Therefore, no repair was specified in this area.

Destructive testing found a minimum wall thickness of 0.242 inch. Remaining wall thickness was as expected.

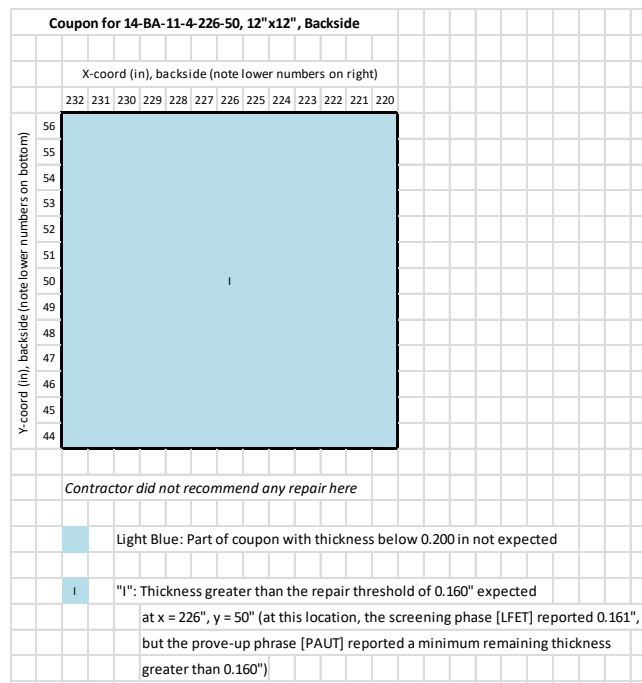
**Figure 4-21 Expected Results from NDE Spreadsheet Data, Coupon A2**

The LFET screening found no indications. Therefore, no repair was specified in this area.

Destructive testing found a minimum wall thickness of 0.248 inch. The remaining wall thickness was as expected.

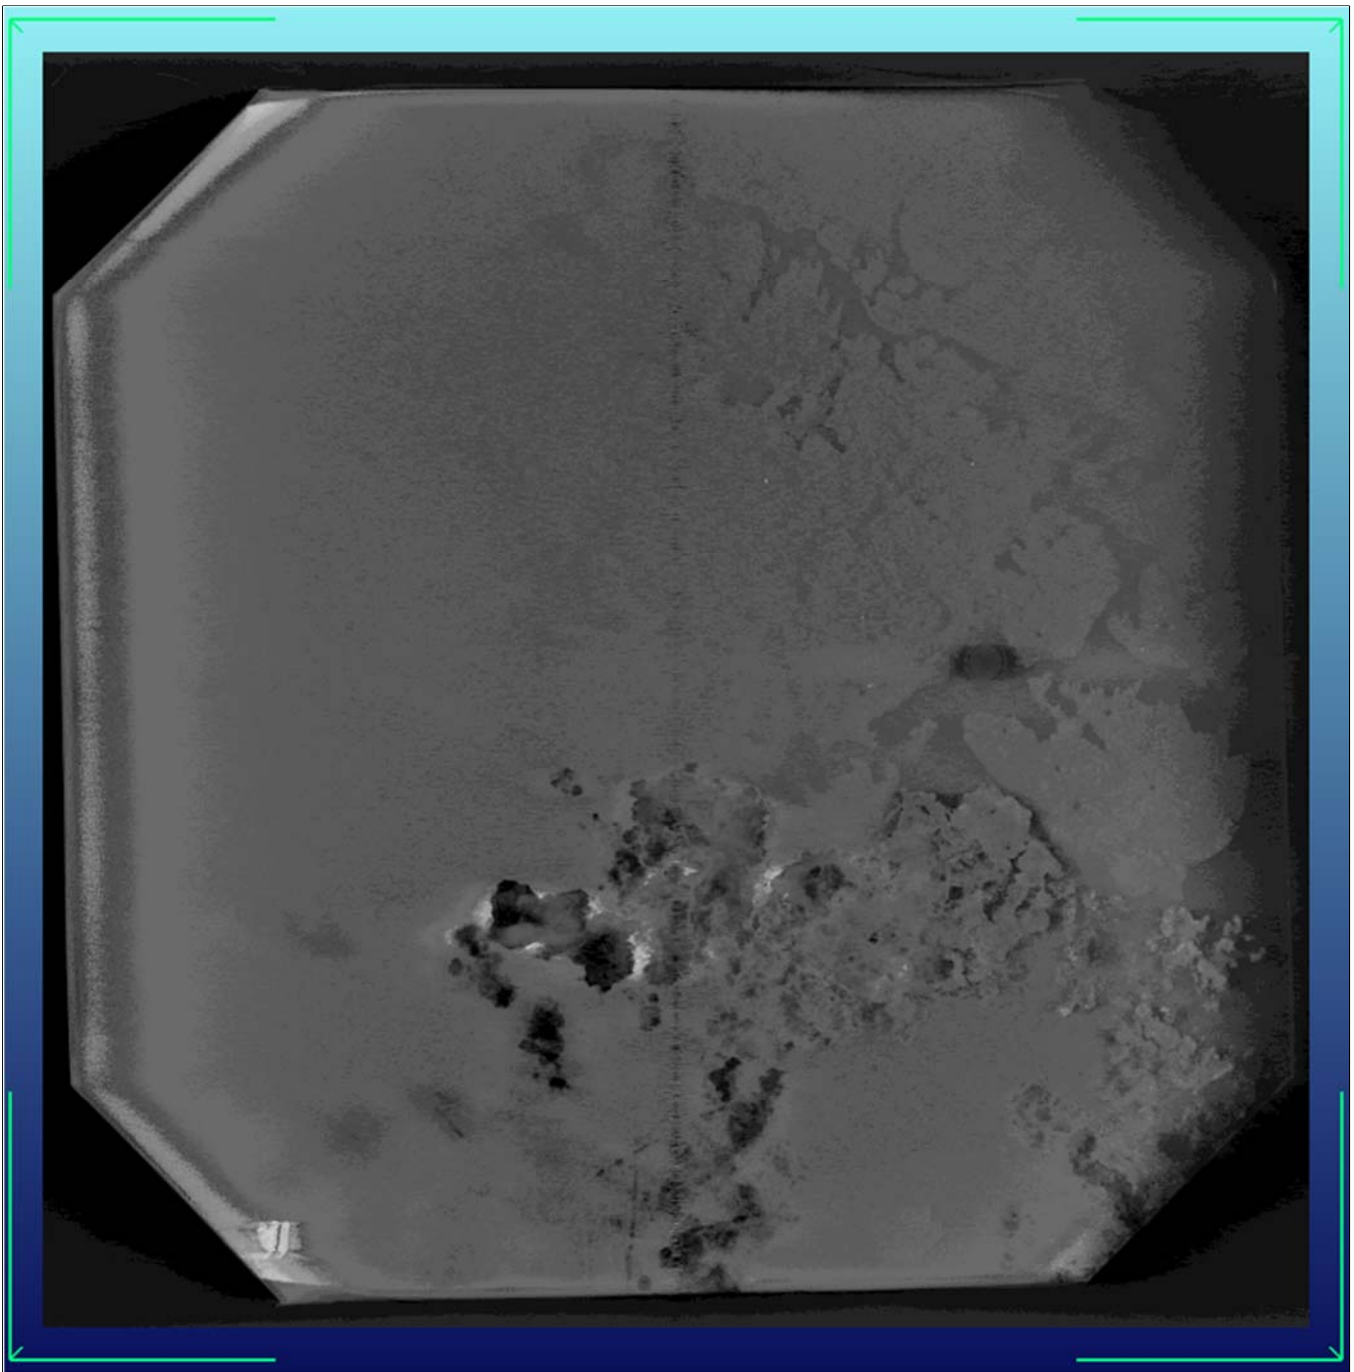
**Figure 39.** A representative screenshot of the CT scan performed on Coupon A1.

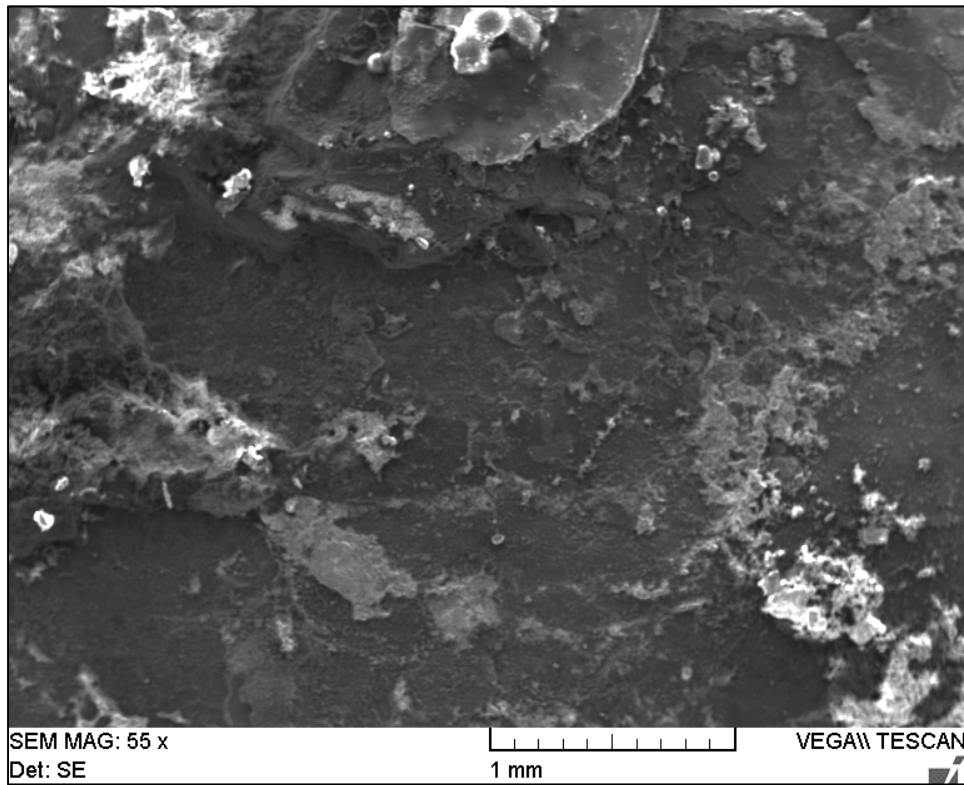
**Figure 47.** A representative SEM image of a pit on a specimen excised from Coupon 3 labeled as 3-1, prior to cleaning. (SEM, 32X)

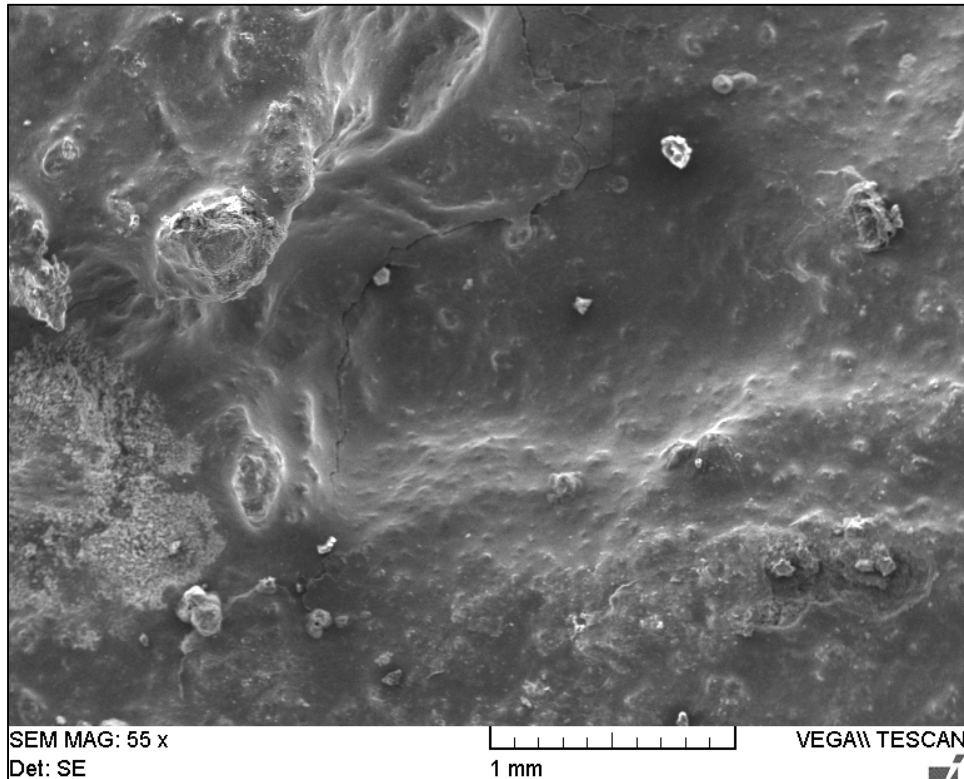
**Figure 48.** A representative SEM image of a pit on a specimen excised from Coupon 3 labeled as 3-2, prior to cleaning. (SEM, 32X)

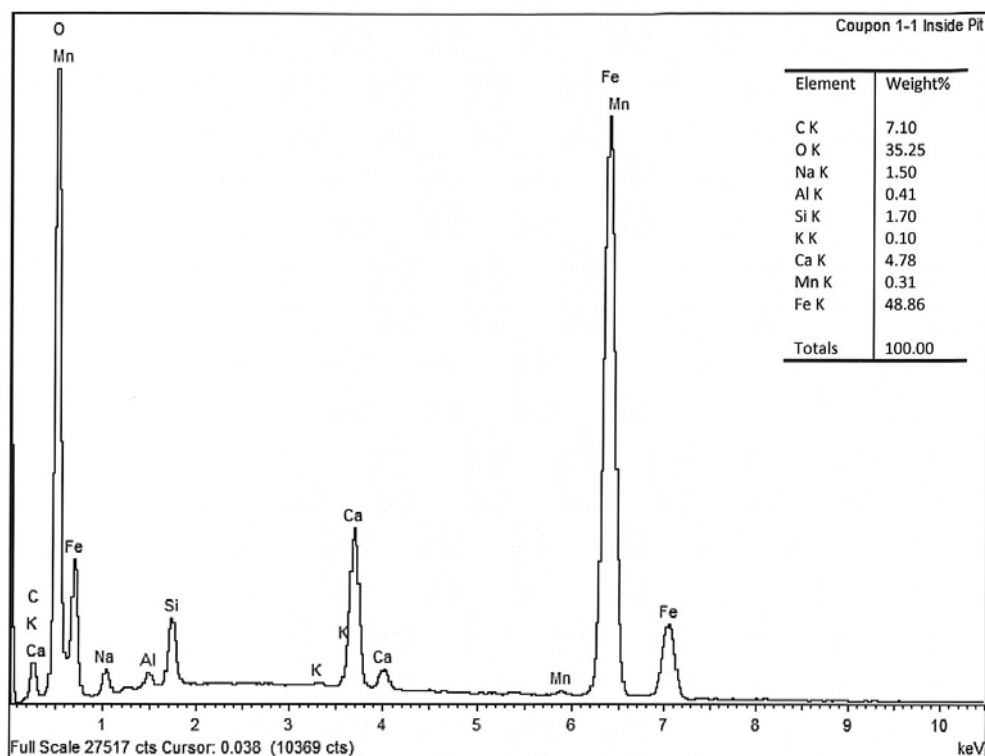
**Figure 71.** A representative EDS spectrum generated from of a pit on a specimen excised from Coupon 1 labeled as 1-1, prior to cleaning.

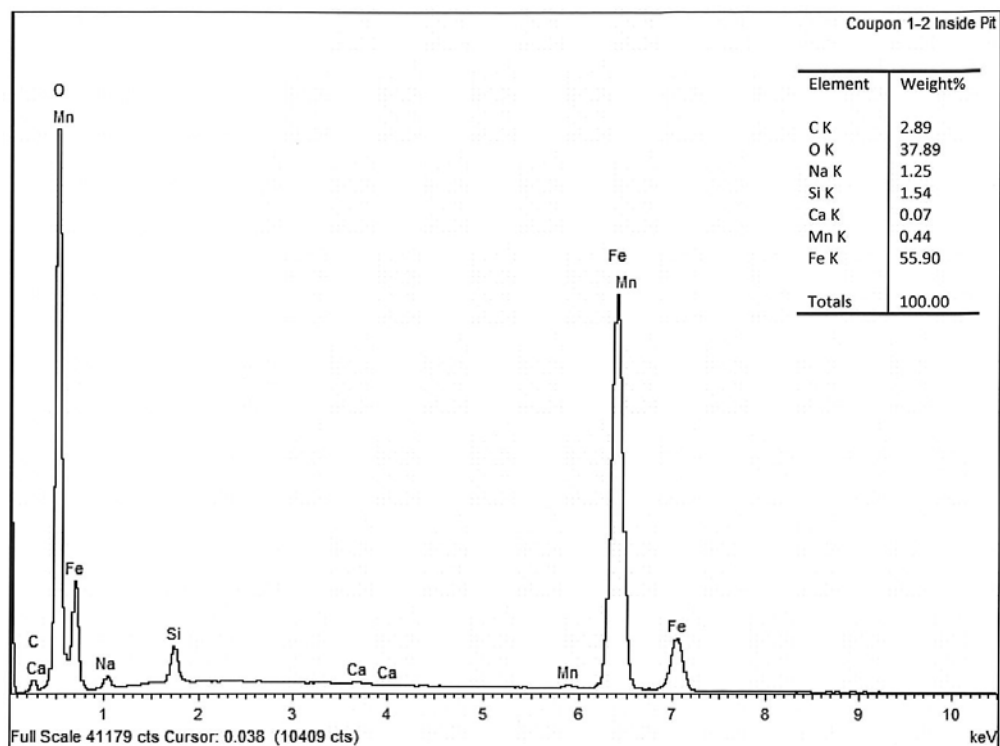
**Figure 72.** A representative EDS spectrum generated from of a pit on a specimen excised from Coupon 1 labeled as 1-2, prior to cleaning.

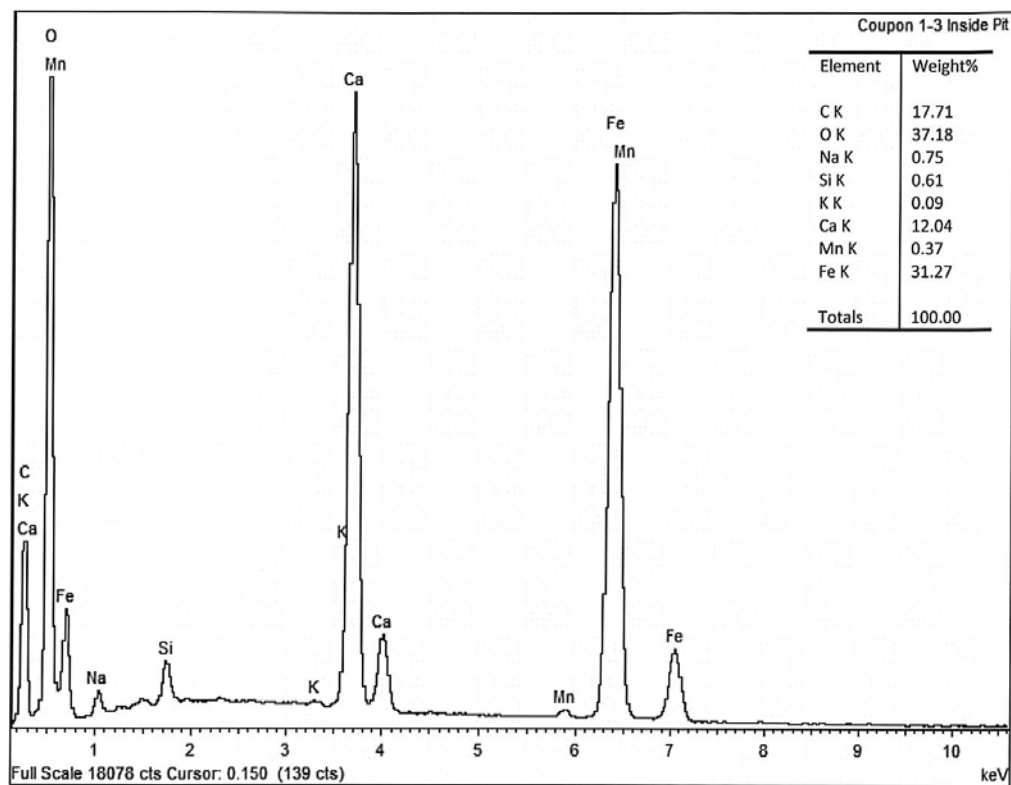
**Figure 73.** A representative EDS spectrum generated from of a pit on a specimen excised from Coupon 1 labeled as 1-3, prior to cleaning.

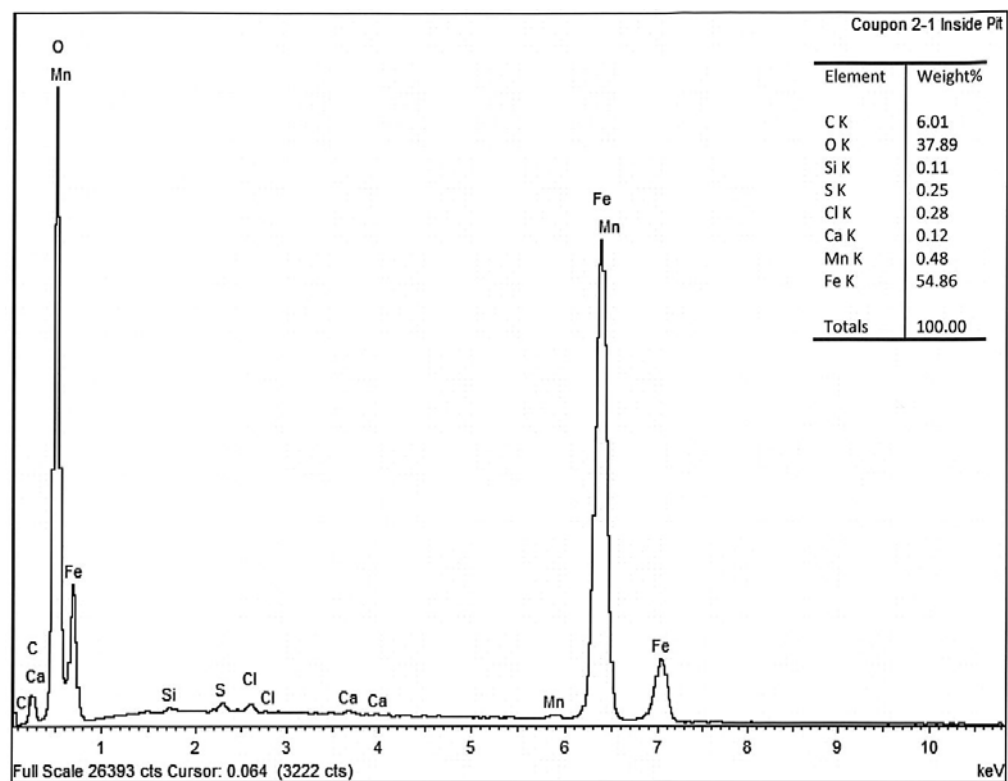
**Figure 74.** A representative EDS spectrum generated from of a pit on a specimen excised from Coupon 2 labeled as 2-1, prior to cleaning.

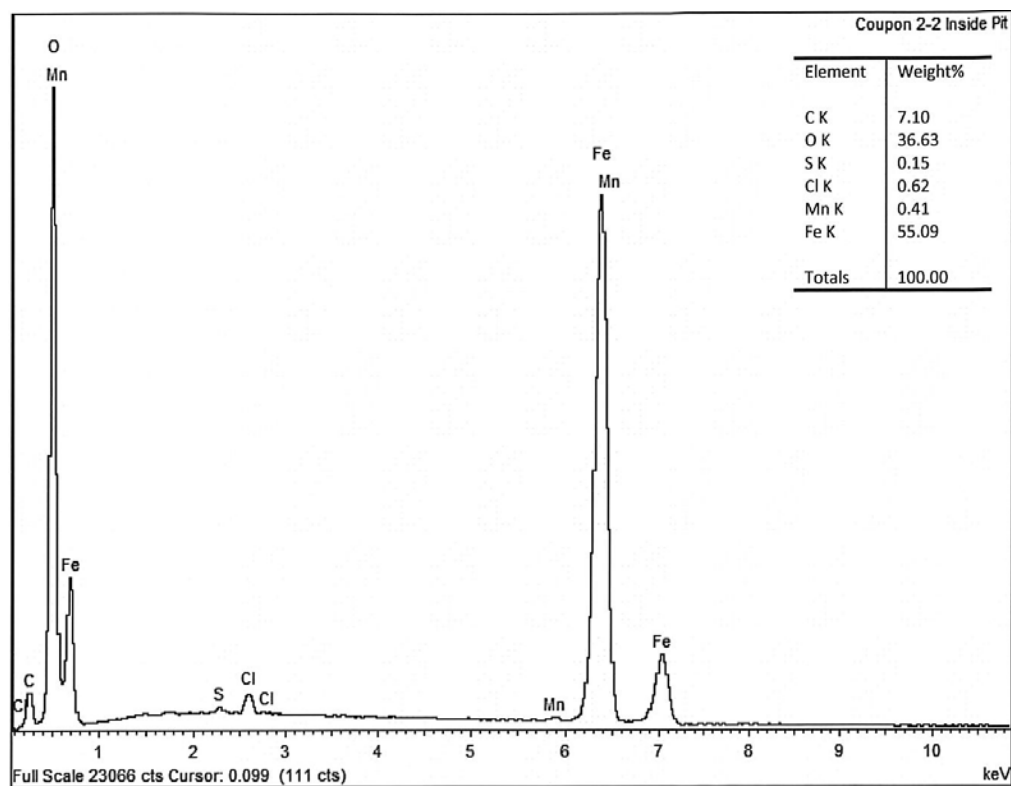
**Figure 75.** A representative EDS spectrum generated from of a pit on a specimen excised from Coupon 2 labeled as 2-2, prior to cleaning.

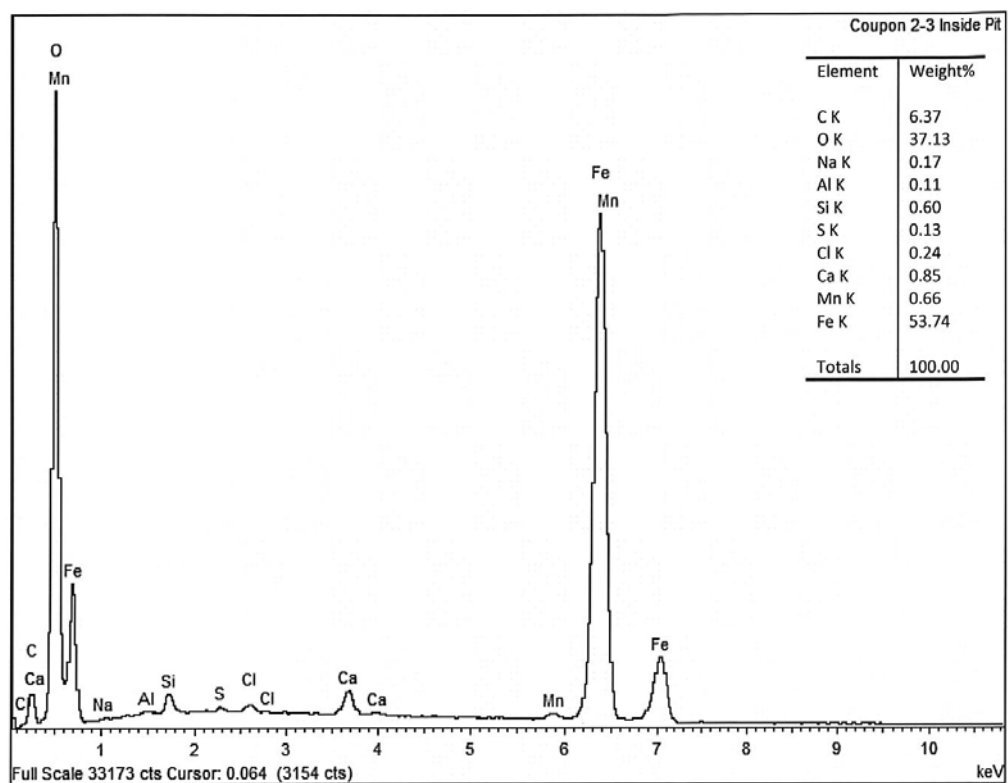
**Figure 76.** A representative EDS spectrum generated from of a pit on a specimen excised from Coupon 2 labeled as 2-3, prior to cleaning.

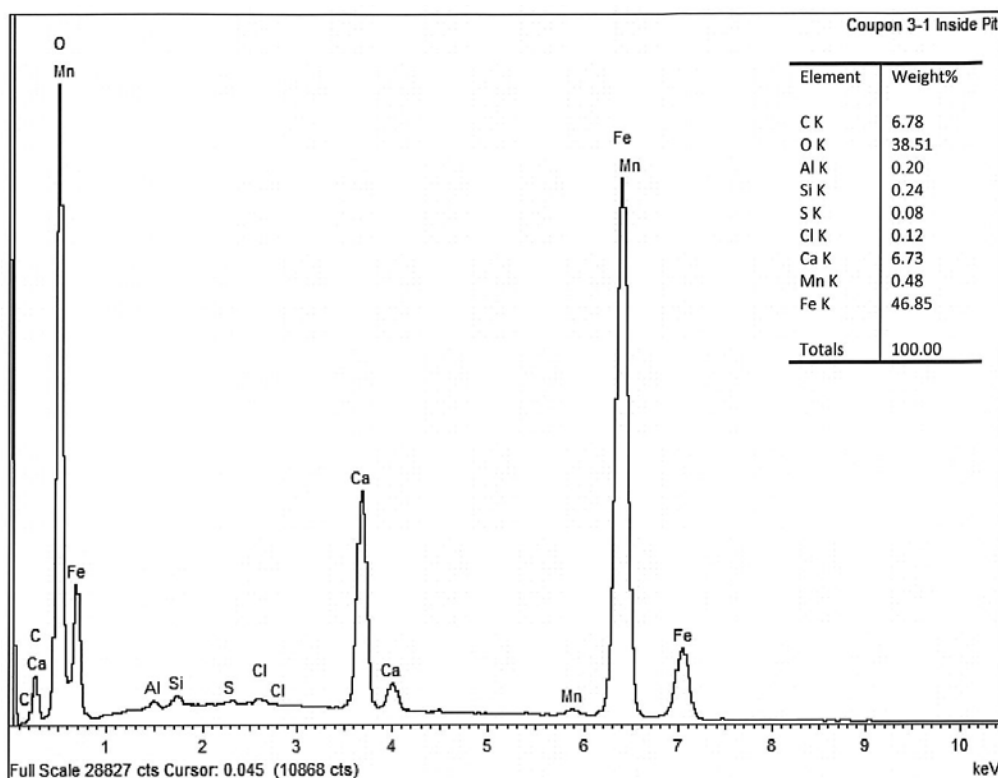
**Figure 77.** A representative EDS spectrum generated from of a pit on a specimen excised from Coupon 3 labeled as 3-1, prior to cleaning.

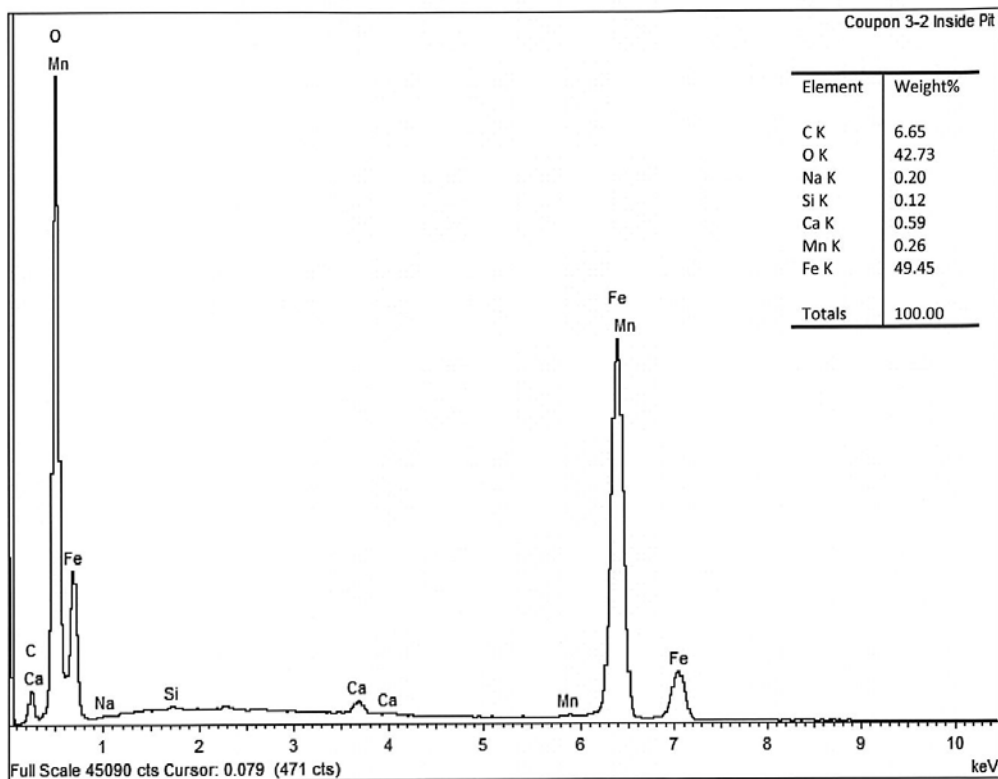
**Figure 78.** A representative EDS spectrum generated from of a pit on a specimen excised from Coupon 3 labeled as 3-2, prior to cleaning.

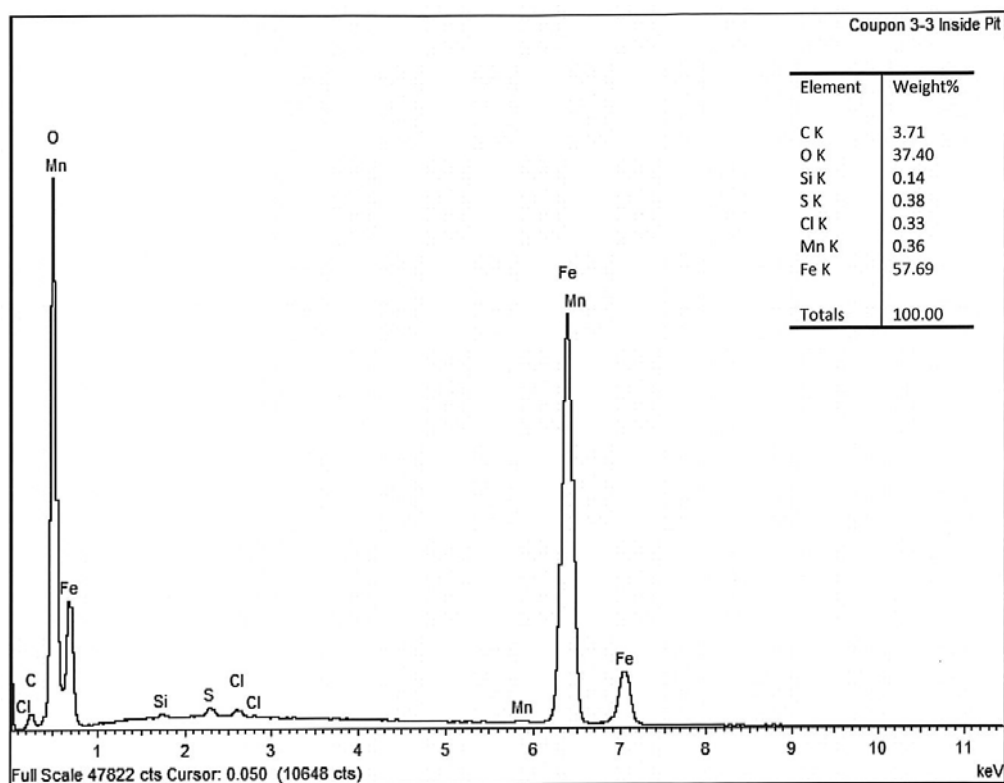
**Figure 79.** A representative EDS spectrum generated from of a pit on a specimen excised from Coupon 3 labeled as 3-3, prior to cleaning.

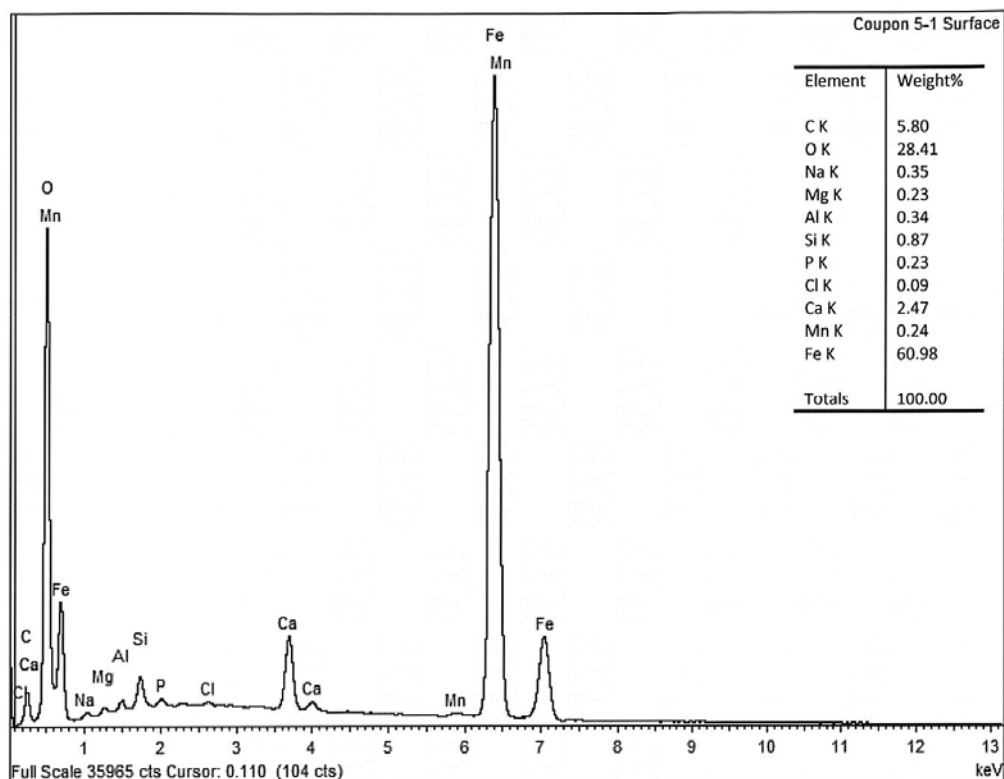
**Figure 80.** A representative EDS spectrum generated from the nominal surface of a specimen excised from Coupon 5 labeled as 5-1, prior to cleaning. No pit observed.

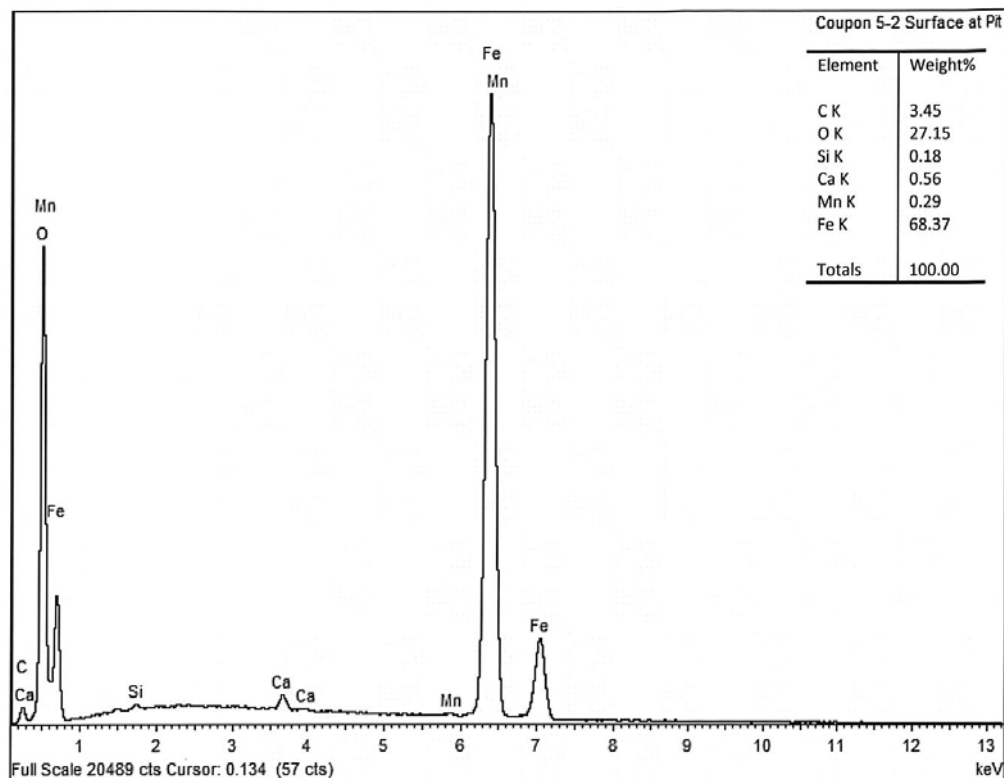
**Figure 81.** A representative EDS spectrum generated from the surface at a pit on a specimen excised from Coupon 5 labeled as 5-2, prior to cleaning.

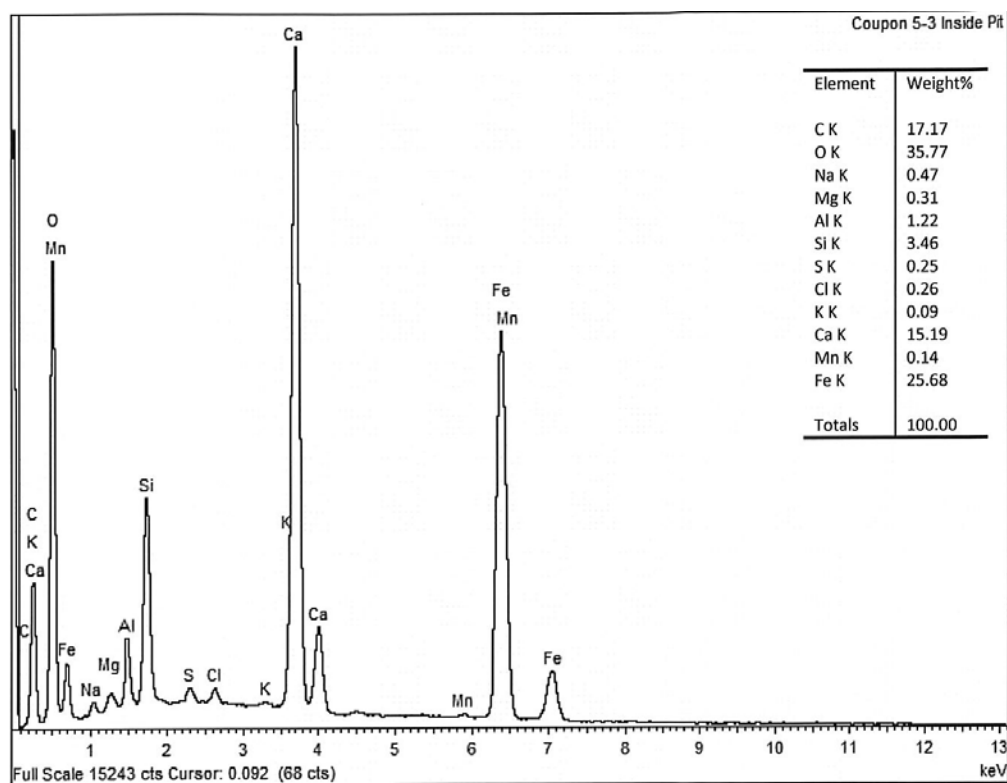
**Figure 82.** A representative EDS spectrum generated from of a pit on a specimen excised from Coupon 5 labeled as 5-3, prior to cleaning.

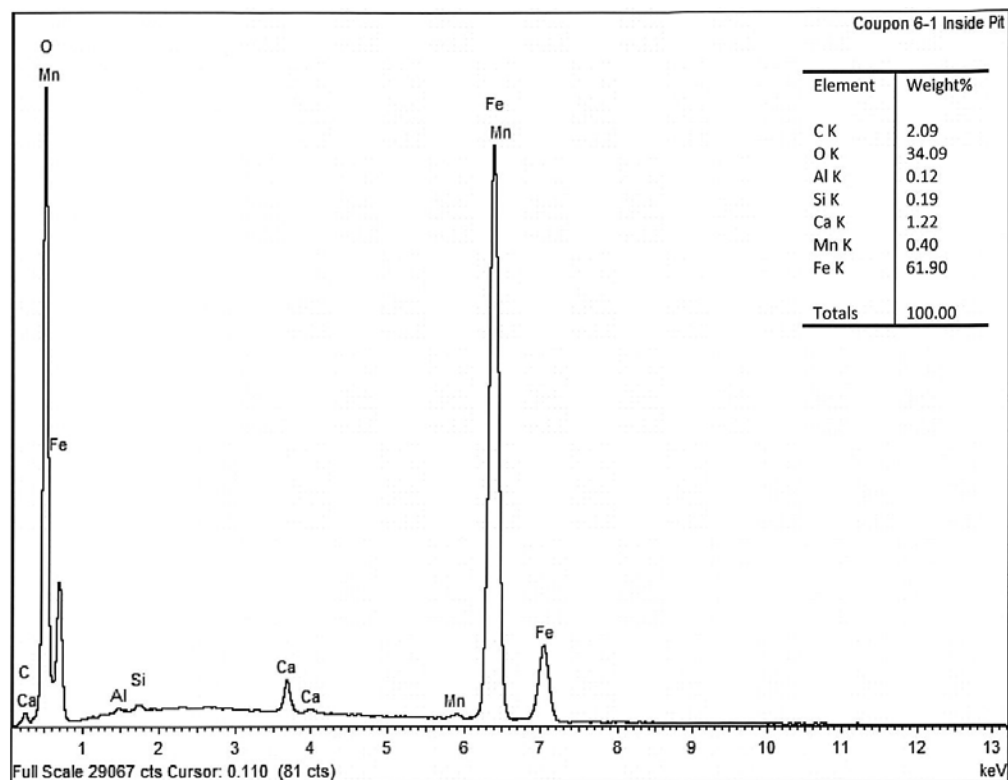
**Figure 83.** A representative EDS spectrum generated from of a pit on a specimen excised from Coupon 6 labeled as 6-1, prior to cleaning.

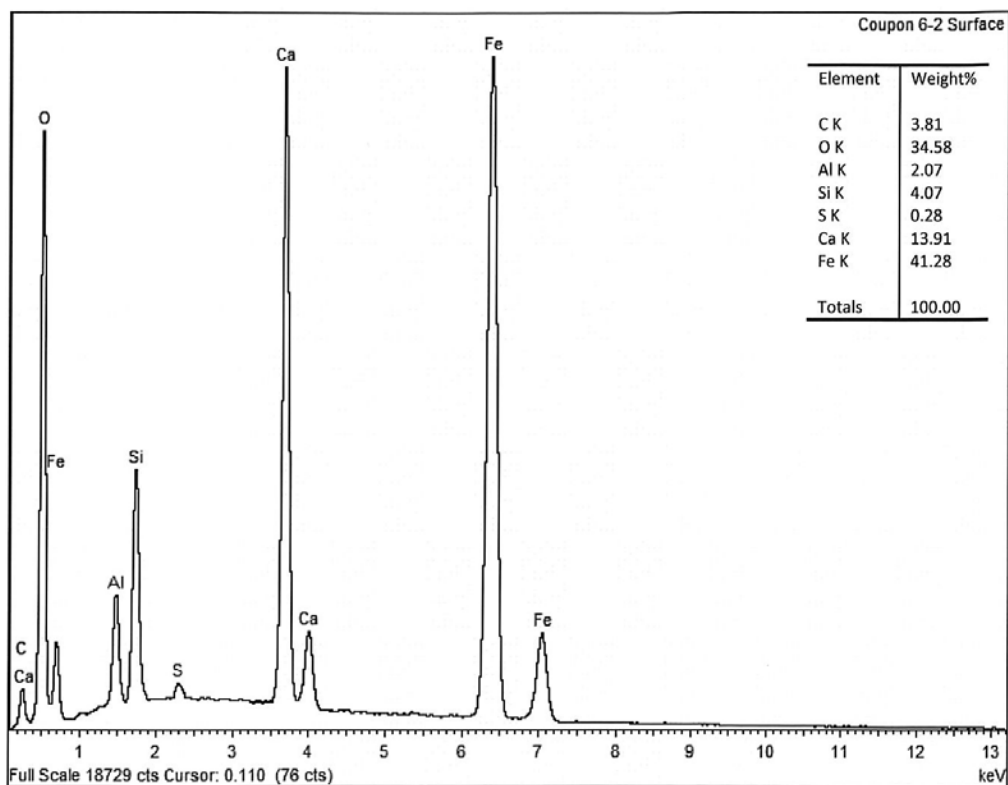
**Figure 84.** A representative EDS spectrum generated from the surface of a specimen excised from Coupon 6 labeled as 6-2, prior to cleaning.

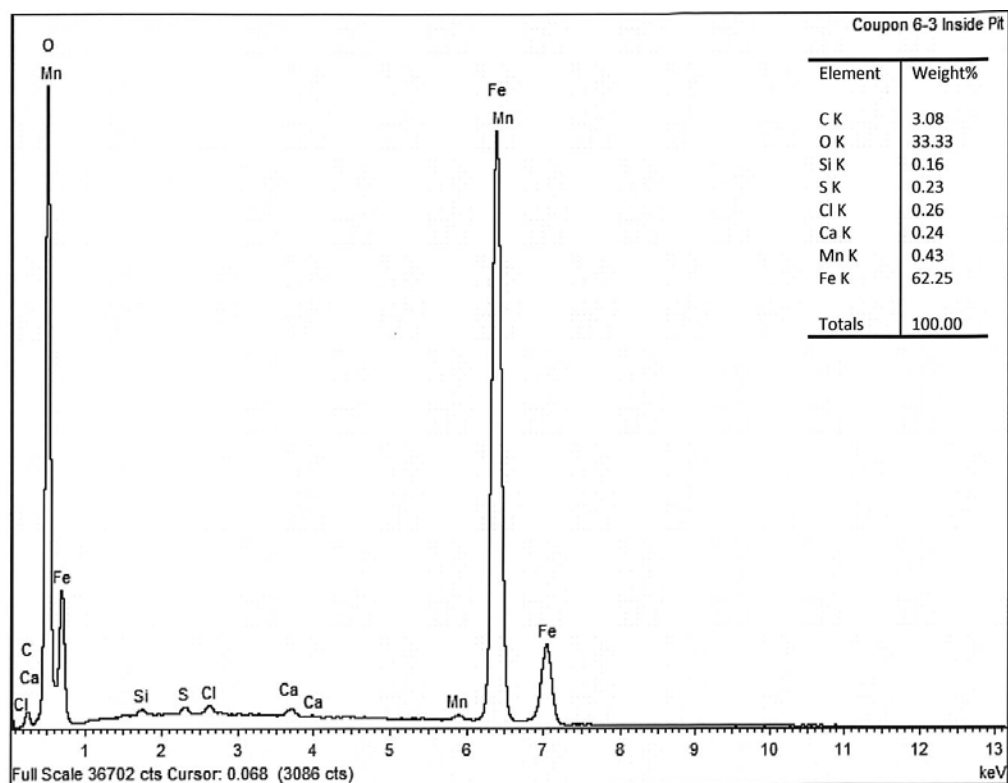
**Figure 85.** A representative EDS spectrum generated from of a pit on a specimen excised from Coupon 6 labeled as 6-3, prior to cleaning.
