**DEPARTMENT OF THE NAVY**

SUBJECT: ADMINISTRATIVE ORDER ON CONSENT (AOC) STATEMENT OF WORK (SOW) SECTION 5 CORROSION AND METAL FATIGUE PRACTICES, DESTRUCTIVE TESTING RESULTS REPORT, RED HILL BULK FUEL STORAGE FACILITY (RED HILL), JOINT BASE PEARL HARBOR-HICKAM, OAHU, HAWAII

In 2018, ten coupons were removed from Tank 14, so that a metallurgical and corrosion analysis of the coupons could be undertaken, with the primary aim of validating non-destructive examination (NDE) results. The steel coupons, concrete powder samples, and corrosion product were submitted to a certified third-party laboratory to perform this analysis.

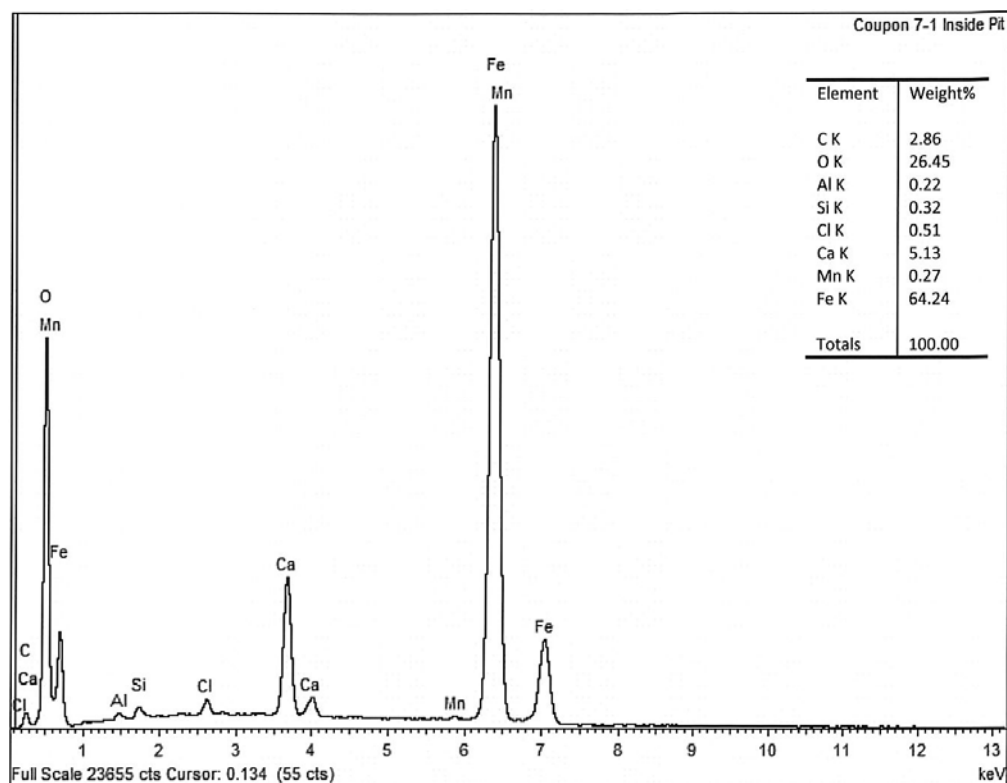
**Figure 86.** A representative EDS spectrum generated from of a pit on a specimen excised from Coupon 7 labeled as 7-1, prior to cleaning.

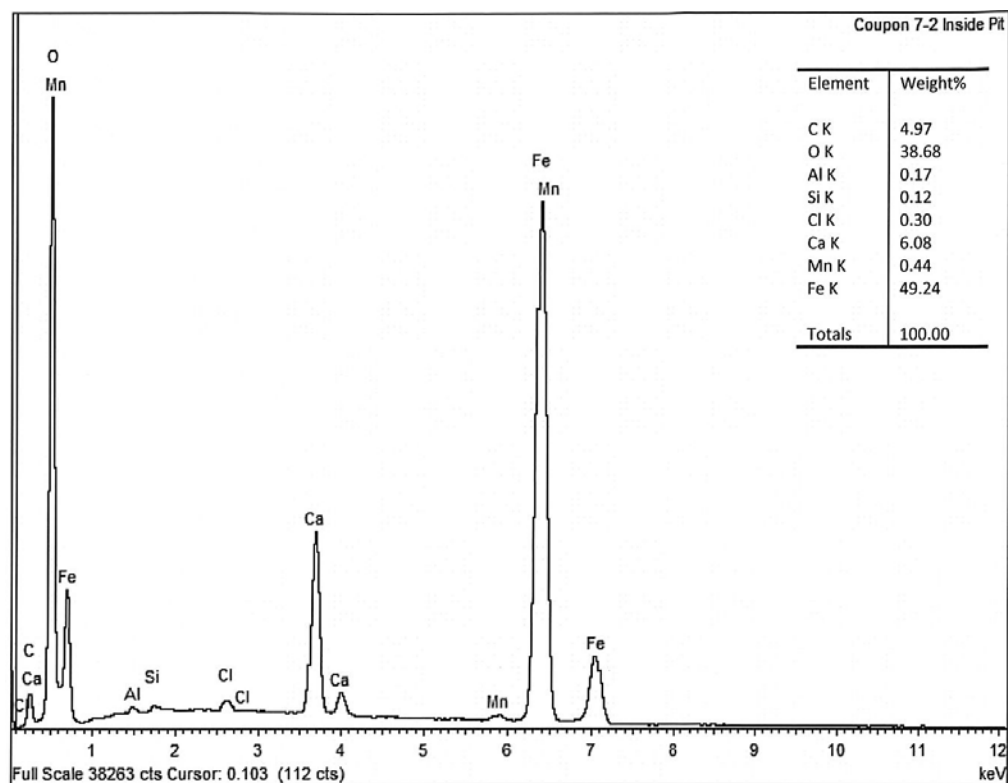
**Figure 87.** A representative EDS spectrum generated from of a pit on a specimen excised from Coupon 7 labeled as 7-2, prior to cleaning.

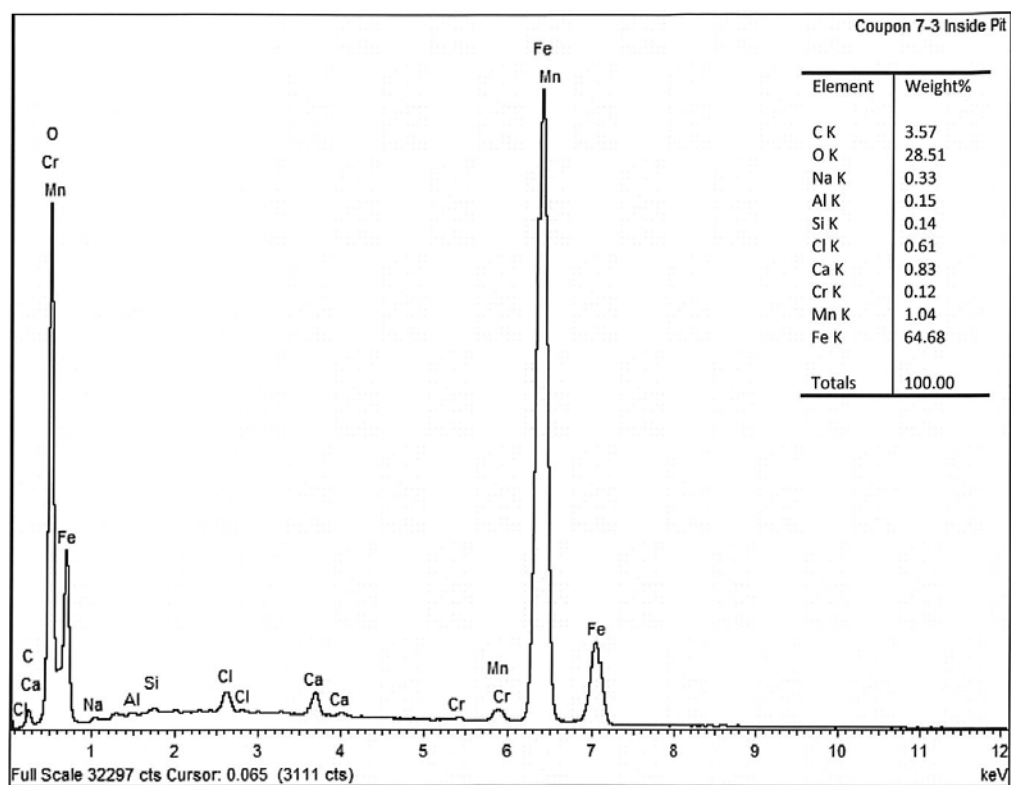
**Figure 88.** A representative EDS spectrum generated from of a pit on a specimen excised from Coupon 7 labeled as 7-3, prior to cleaning.

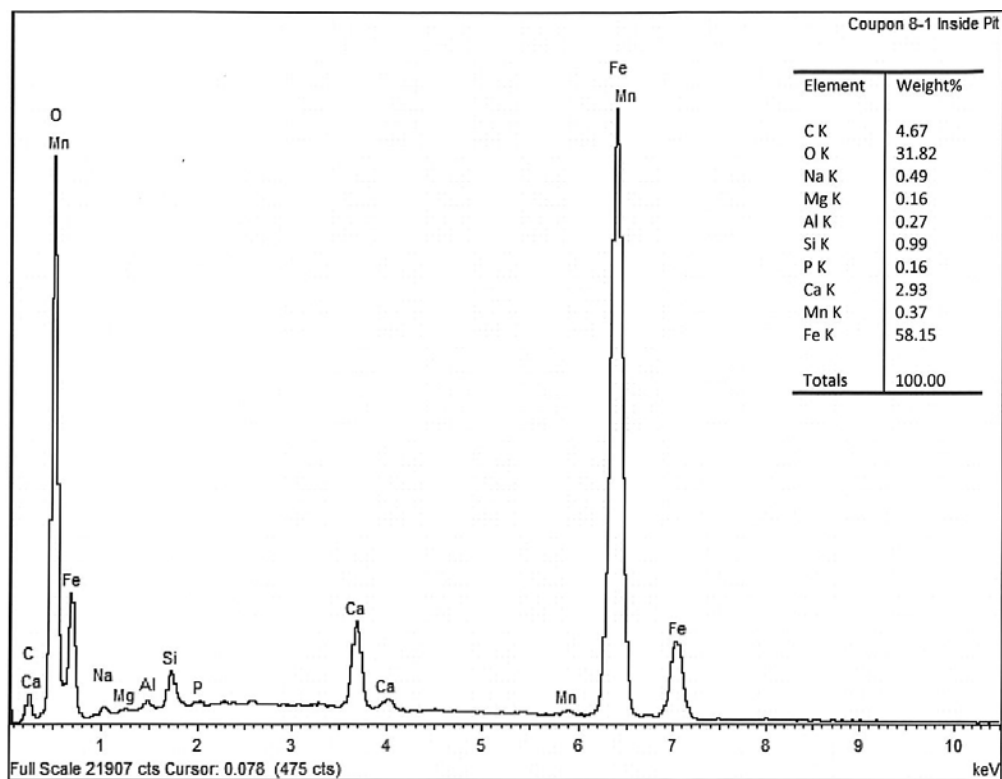
**Figure 89.** A representative EDS spectrum generated from of a pit on a specimen excised from Coupon 8 labeled as 8-1, prior to cleaning.

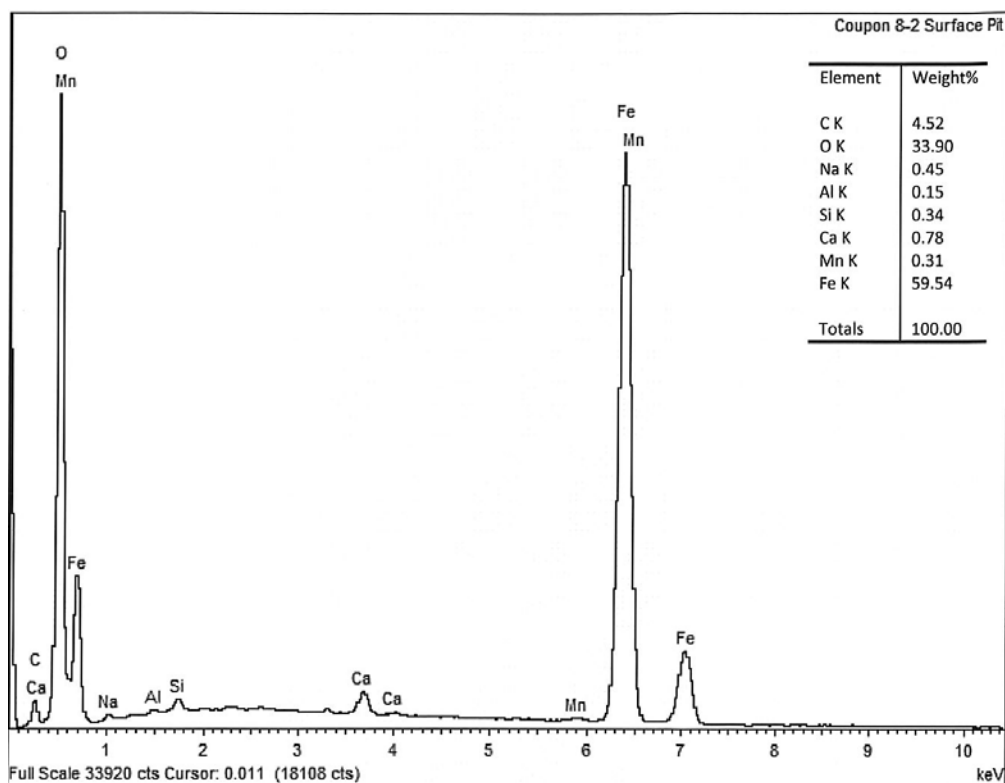
**Figure 90.** A representative EDS spectrum generated from the surface of a specimen excised from Coupon 8 labeled as 8-2, prior to cleaning.

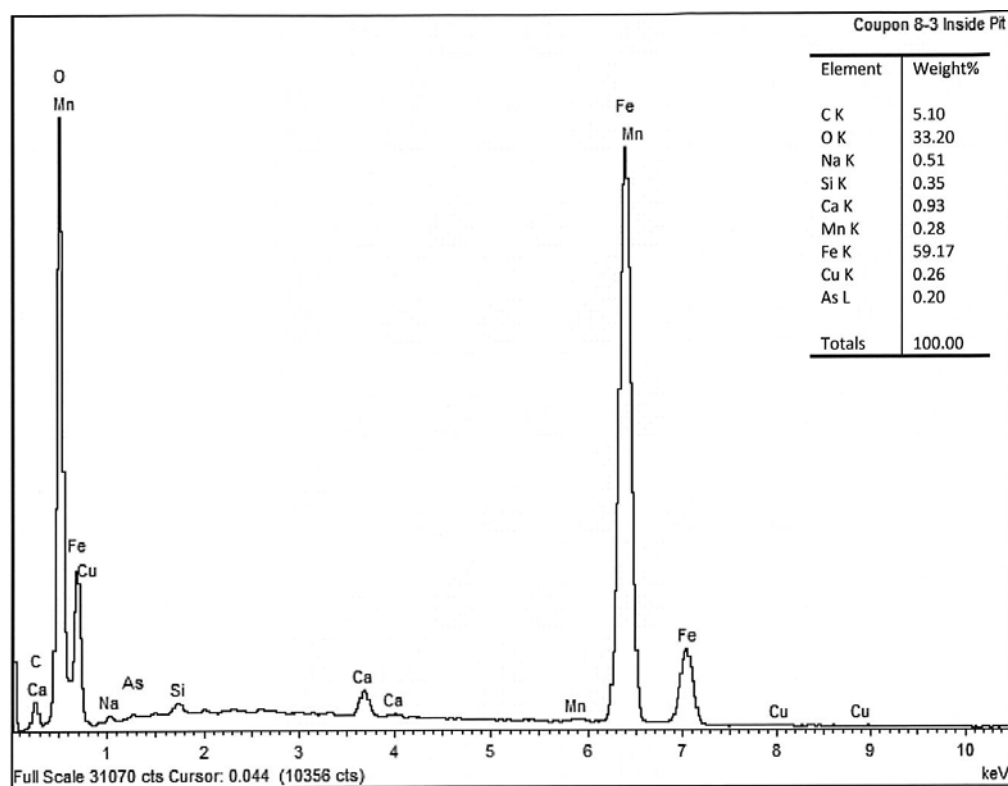
**Figure 91.** A representative EDS spectrum generated from of a pit on a specimen excised from Coupon 8 labeled as 8-3, prior to cleaning.

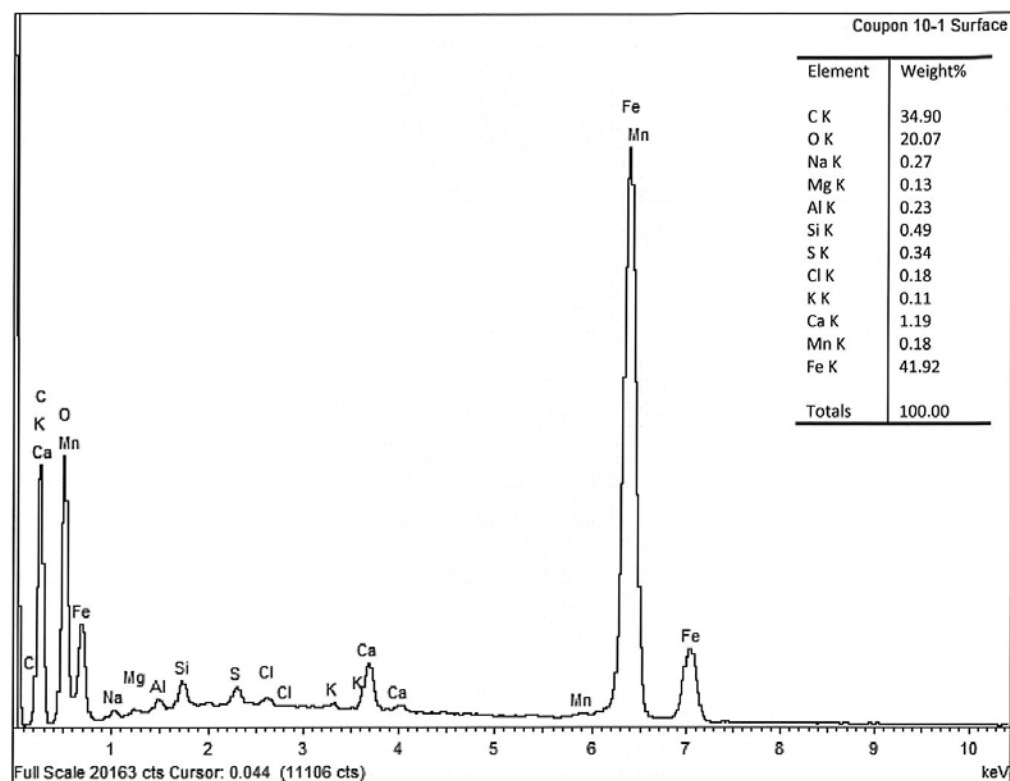
**Figure 92.** A representative EDS spectrum generated from the surface of a specimen excised from Coupon 10 labeled as 10-1, prior to cleaning.

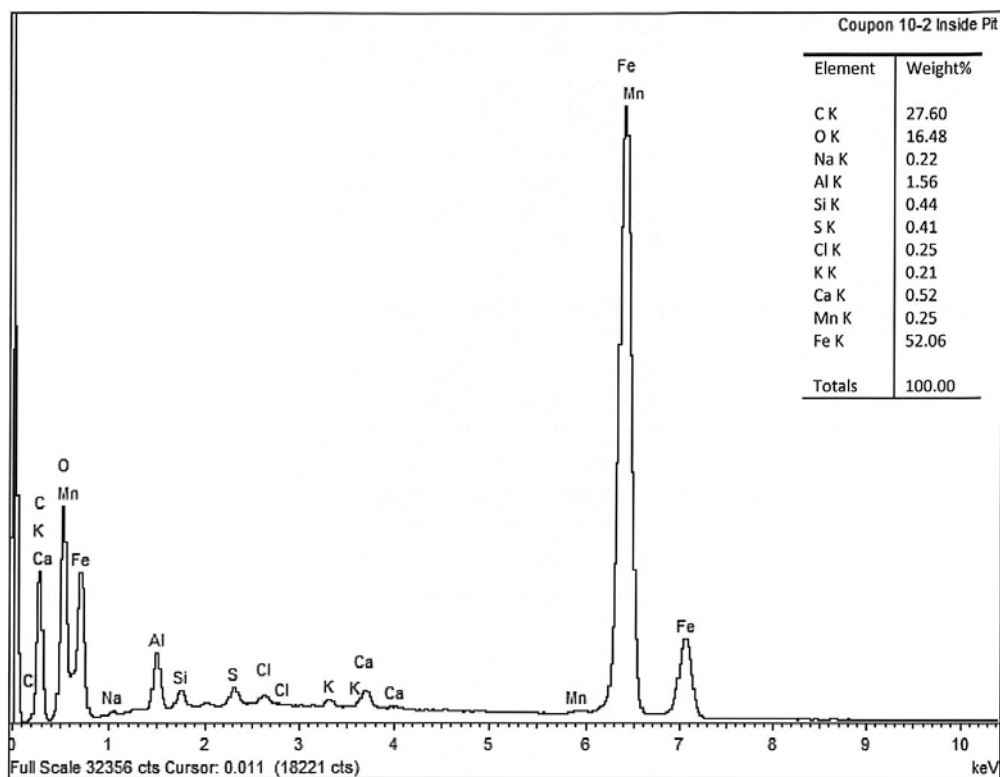
**Figure 93.** A representative EDS spectrum generated from of a pit on a specimen excised from Coupon 10 labeled as 10-2, prior to cleaning.

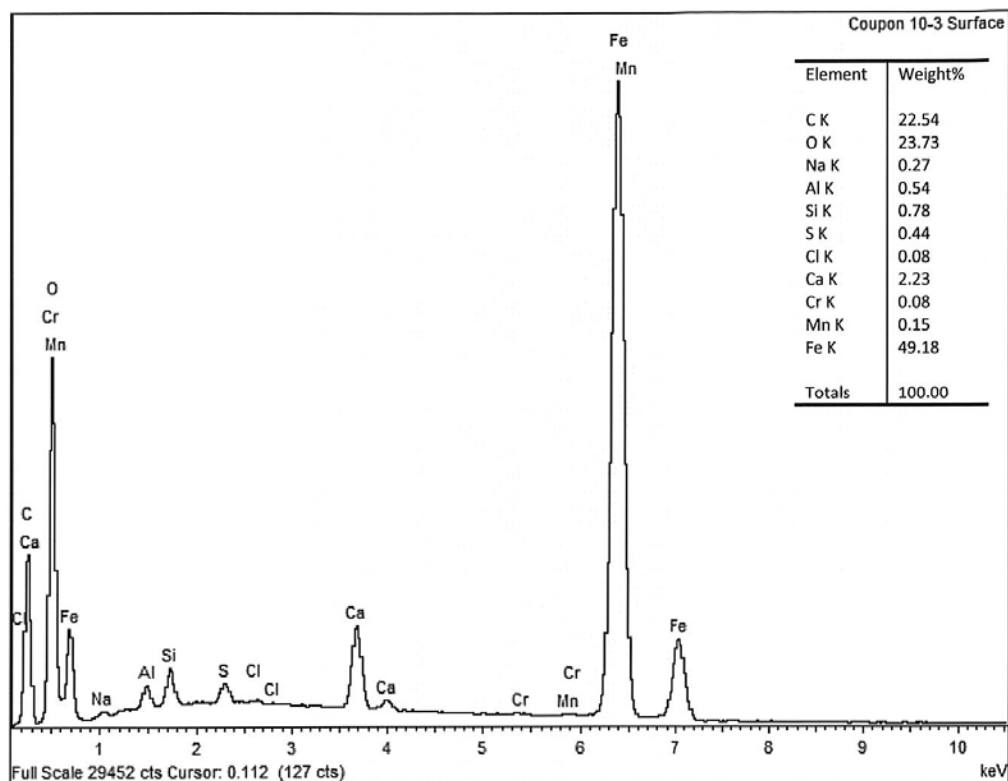
**Figure 94.** A representative EDS spectrum generated from the surface of a specimen excised from Coupon 10 labeled as 10-3, prior to cleaning.

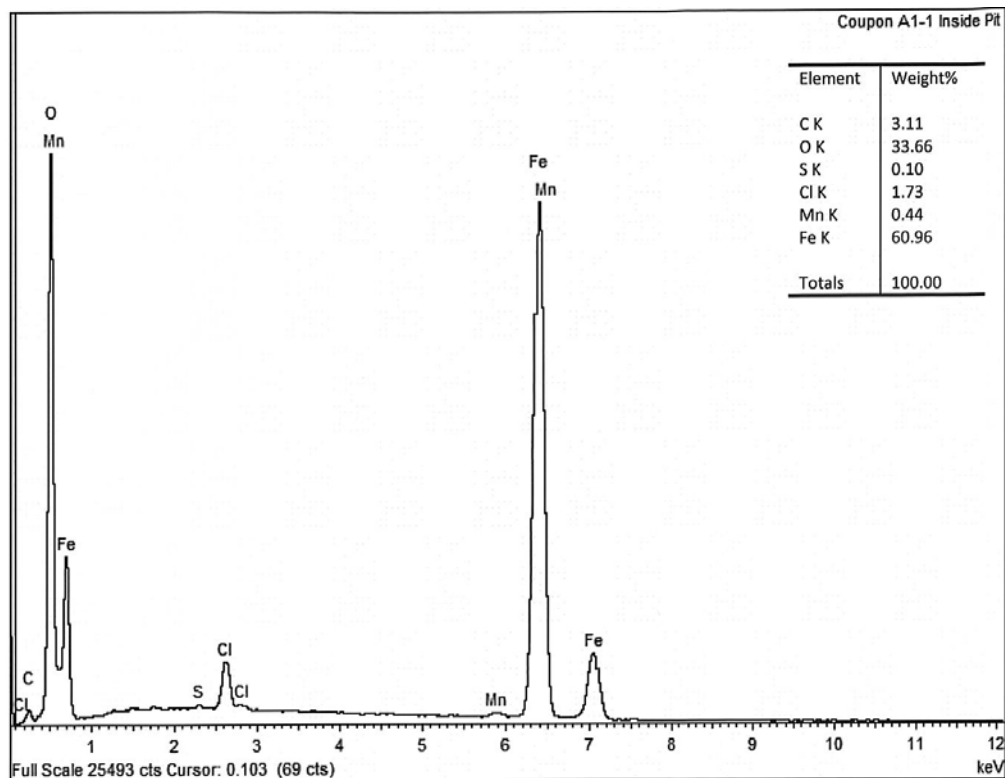
**Figure 95.** A representative EDS spectrum generated from of a pit on a specimen excised from Coupon A1 labeled as A1-1, prior to cleaning.

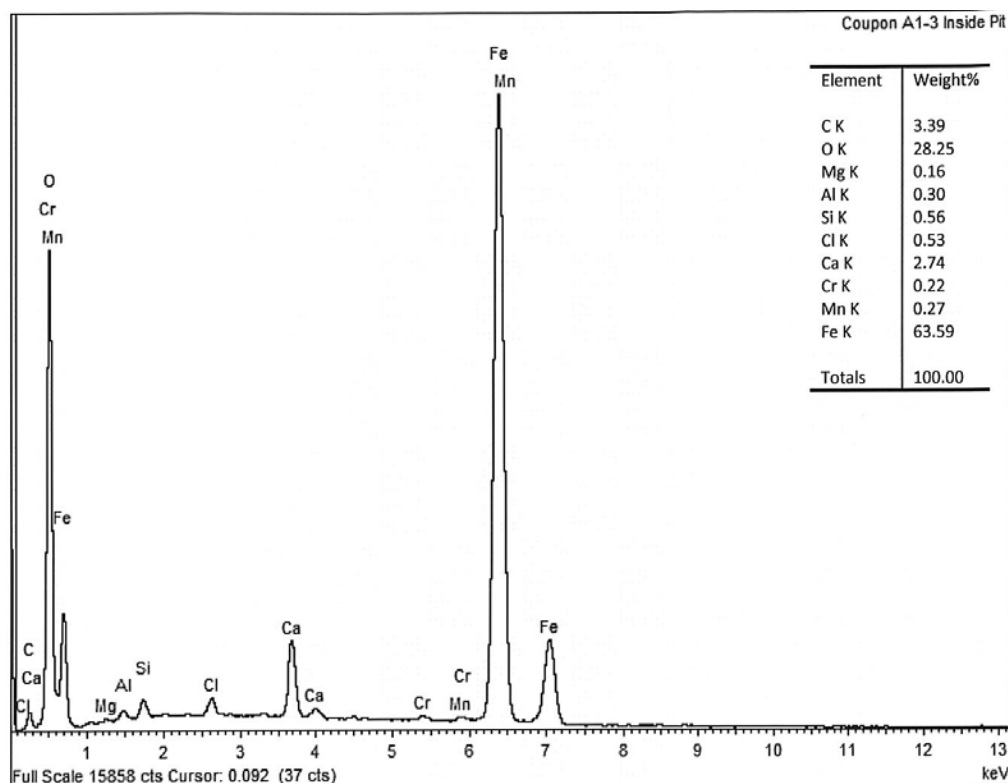
**Figure 97.** A representative EDS spectrum generated from of a pit on a specimen excised from Coupon A1 labeled as A1-3, prior to cleaning.

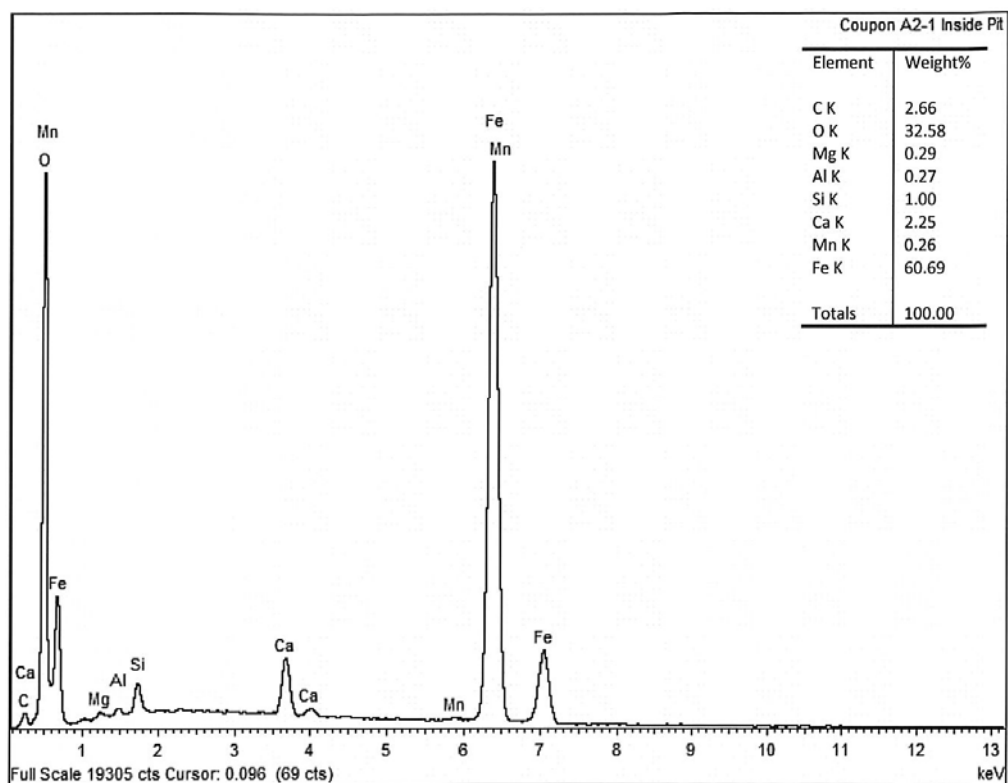
**Figure 98.** A representative EDS spectrum generated from of a pit on a specimen excised from Coupon A2 labeled as A2-1, prior to cleaning.

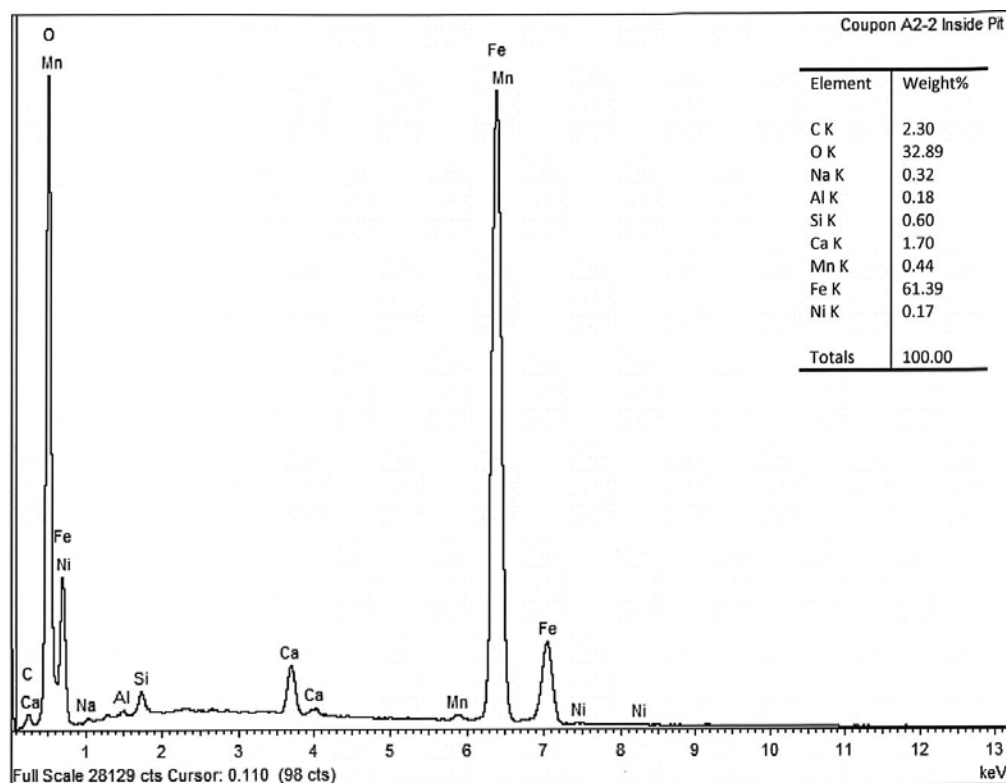
**Figure 99.** A representative EDS spectrum generated from of a pit on a specimen excised from Coupon A2 labeled as A2-2, prior to cleaning.

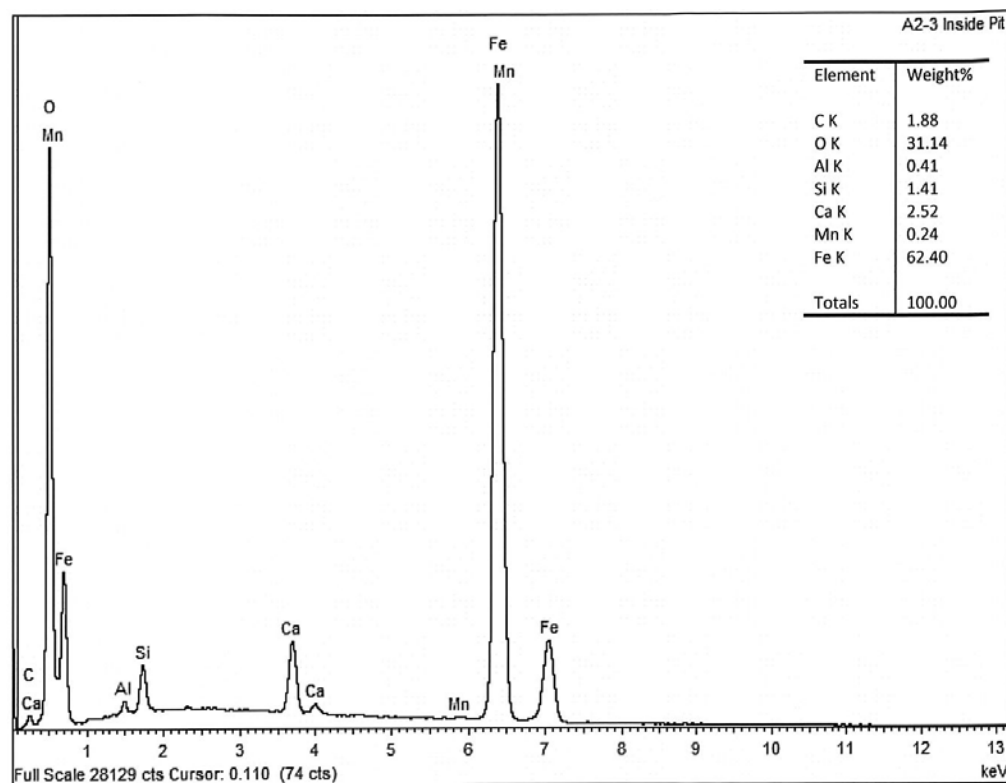
**Figure 100.** A representative EDS spectrum generated from of a pit on a specimen excised from Coupon A2 labeled as A2-3, prior to cleaning.

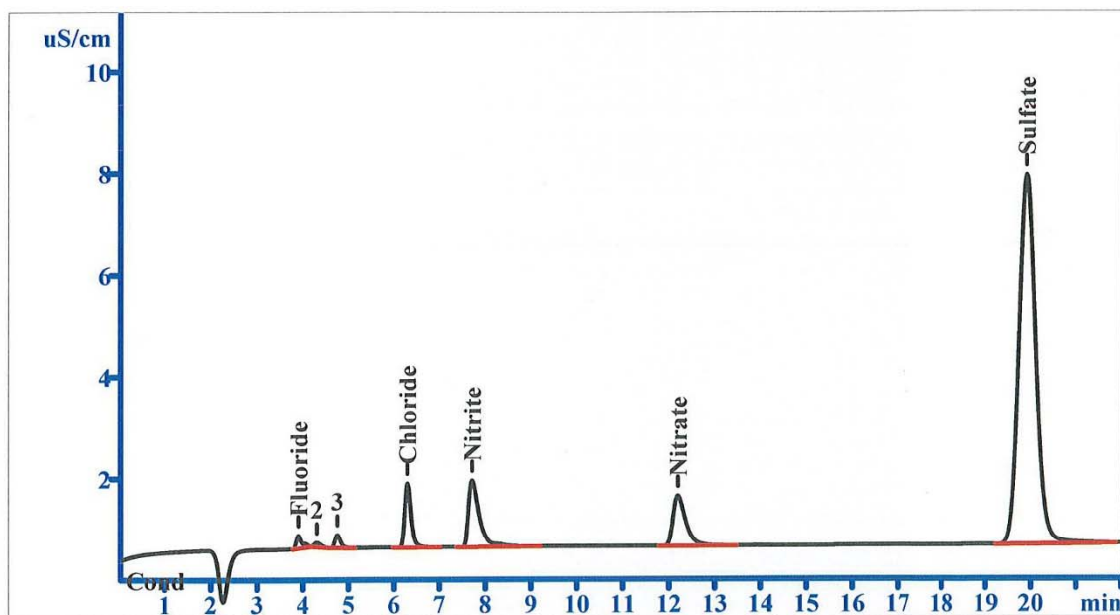
The concrete samples were analyzed by ion chromatography (IC) for common anions. Tables 15 and 16 summarize the ion chromatography results along with the pH values of the analyzed solution from the samples. The ion chromatograms generated are provided as Figures 101 through 110.

**Figure 101.** The ion chromatogram generated from a concrete sample removed from Coupon 1.

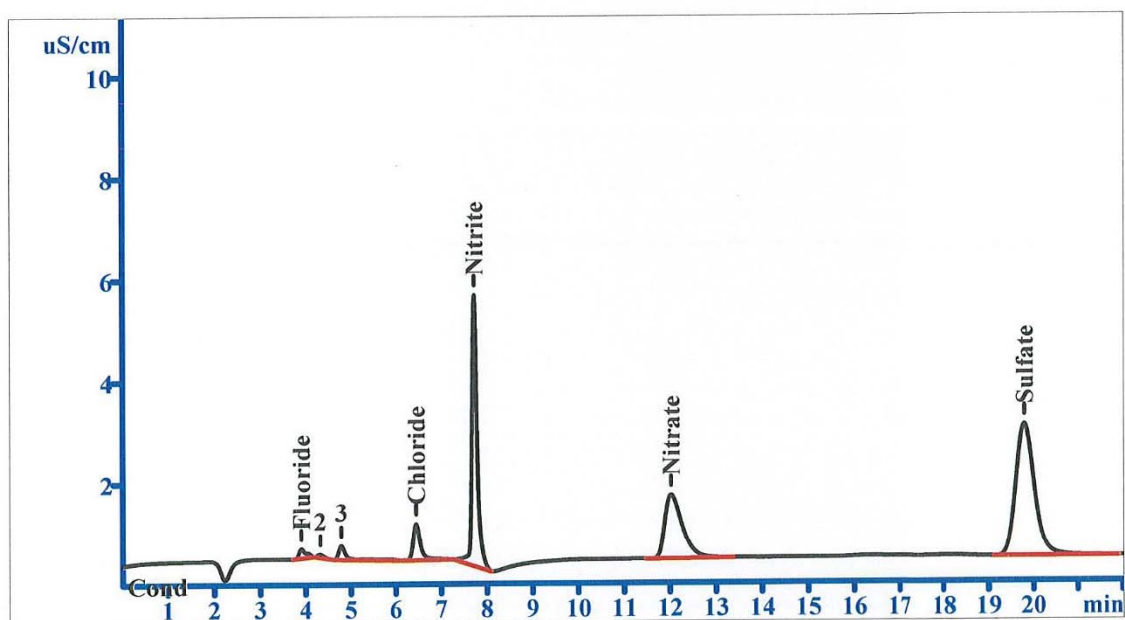
**Figure 102.** The ion chromatogram generated from a concrete sample removed from Coupon 2.

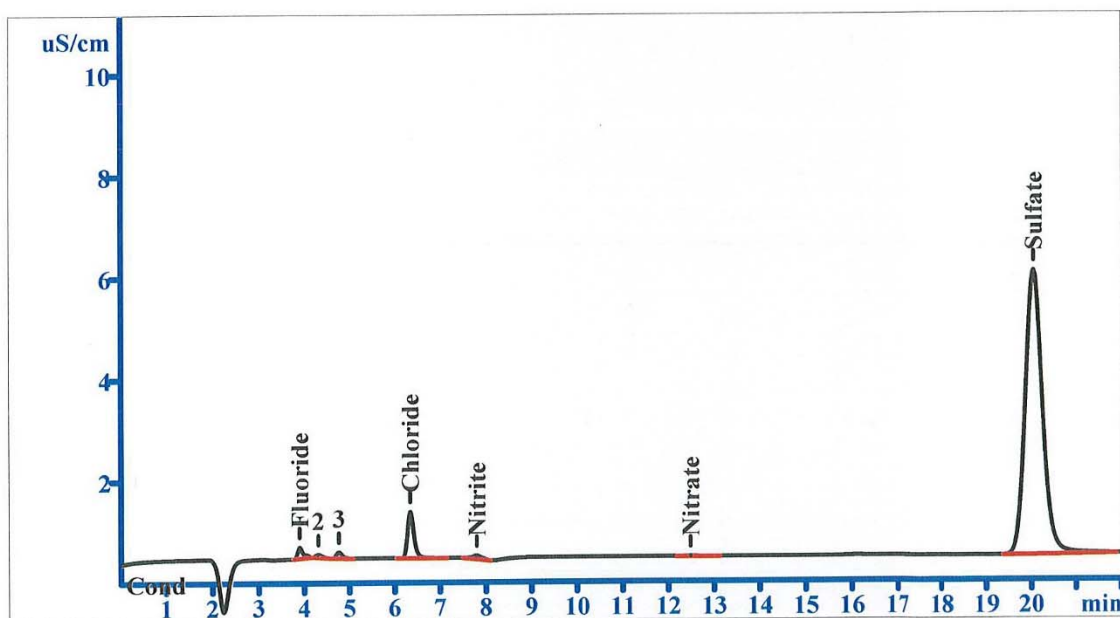
**Figure 105.** The ion chromatogram generated from a concrete sample removed from Coupon 6.

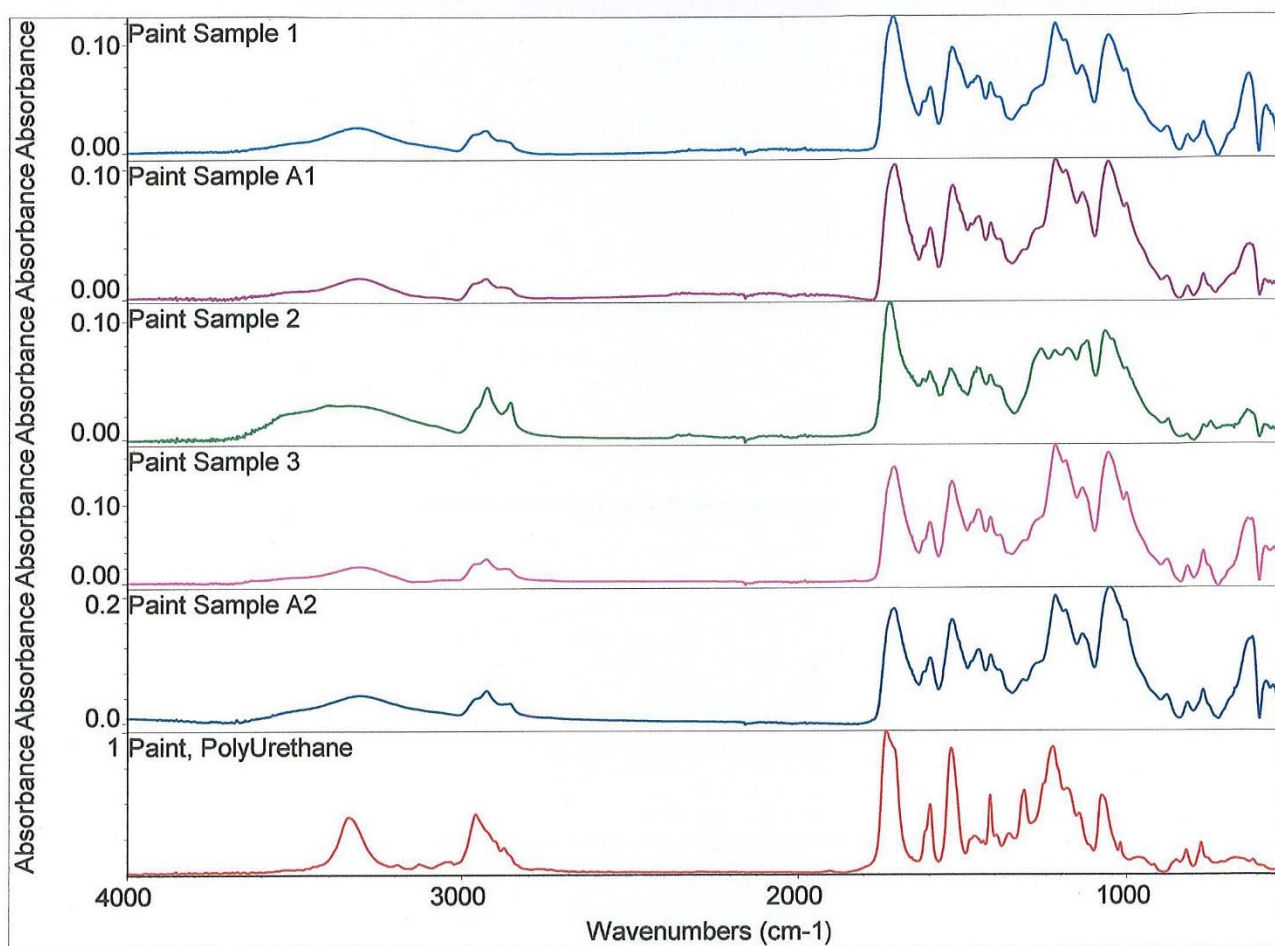
Fourier transform infrared (FTIR) spectroscopy was performed on paint samples removed from each coupon using Attenuated Total Reflectance (ATR) with a diamond crystal. All paint samples were identified as polyurethane enamel. The resulting FTIR spectra of the samples and the best matches from the spectral FTIR library of standards for polyurethane enamel are provided as Figures 111 and 112.

**Figure 111.** The FTIR spectra generated from a paint samples removed from the exterior surfaces of Coupons 1, A1, 2, A2 and 3 the best matches from the spectral FTIR library of standards for polyurethane enamel.

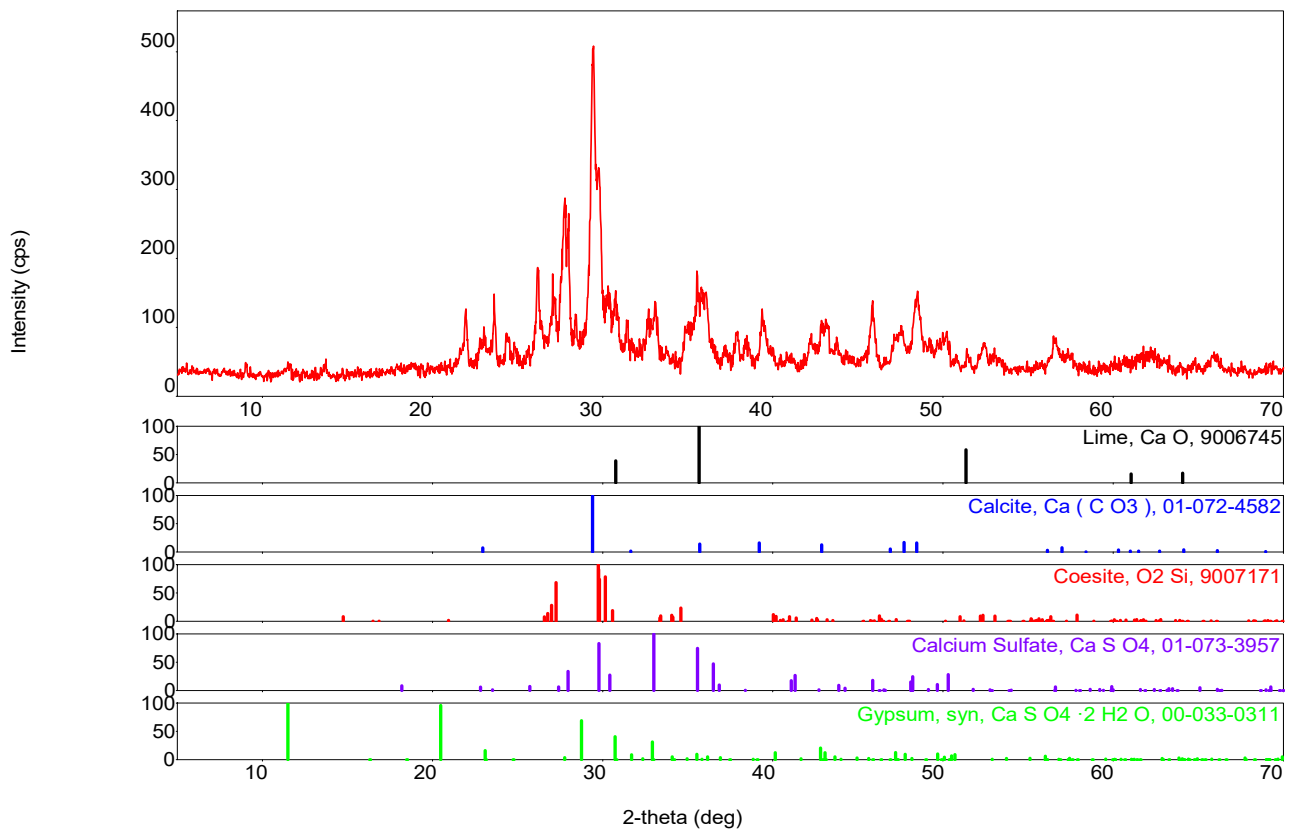
X-Ray Diffraction Spectroscopy (XRD) analysis of the concrete samples revealed the presence of the following crystalline phases: calcium oxide (lime); calcium carbonate (calcite); silicon dioxide (coesite); calcium sulfate; calcium sulfate hydrated (gypsum) and calcium hydroxide (portlandite). The results are summarized in Tables 17 and 18. The XRD diffractograms for the concrete samples are provided as Figures 113 through 122.

**Figure 113.** The XRD diffractogram generated from concrete removed Coupon 1.

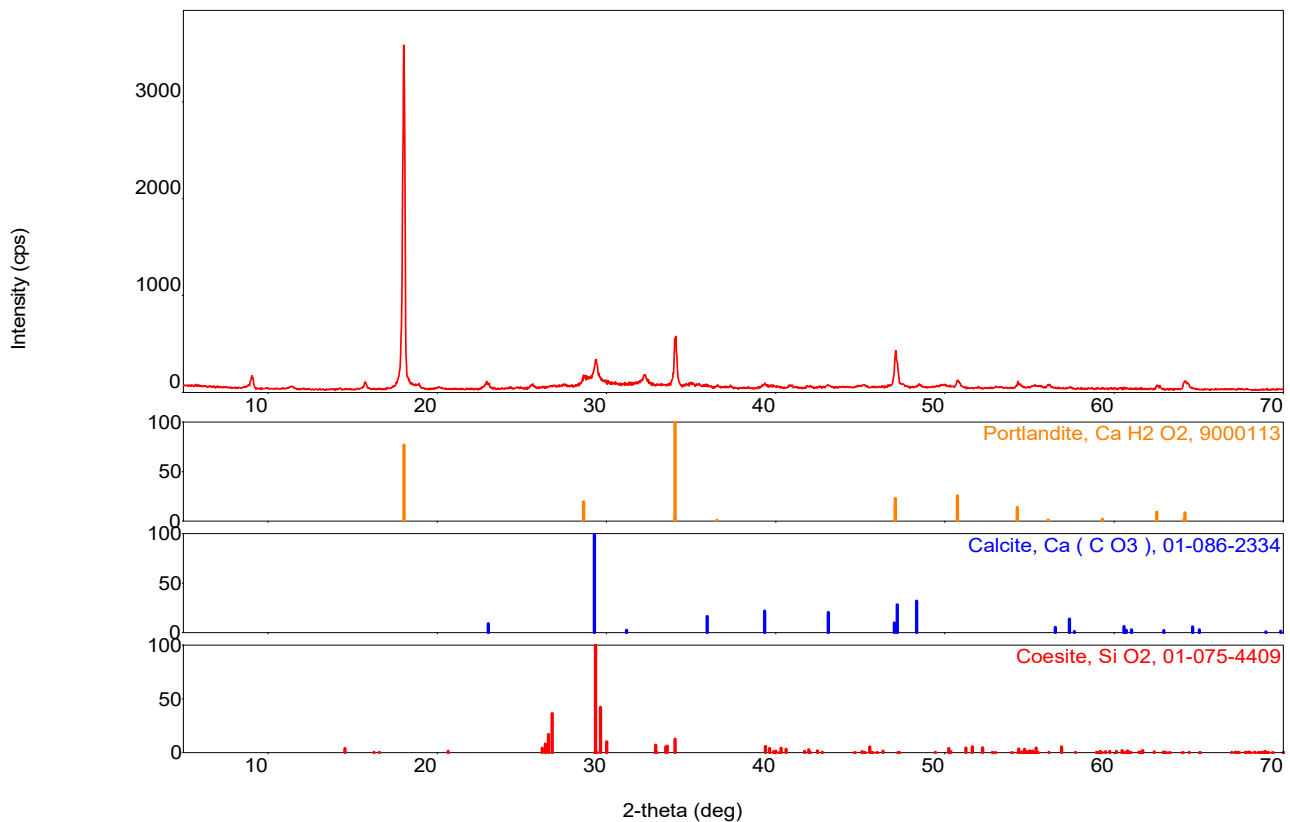
**Figure 114.** The XRD diffractogram generated from concrete removed Coupon 2.

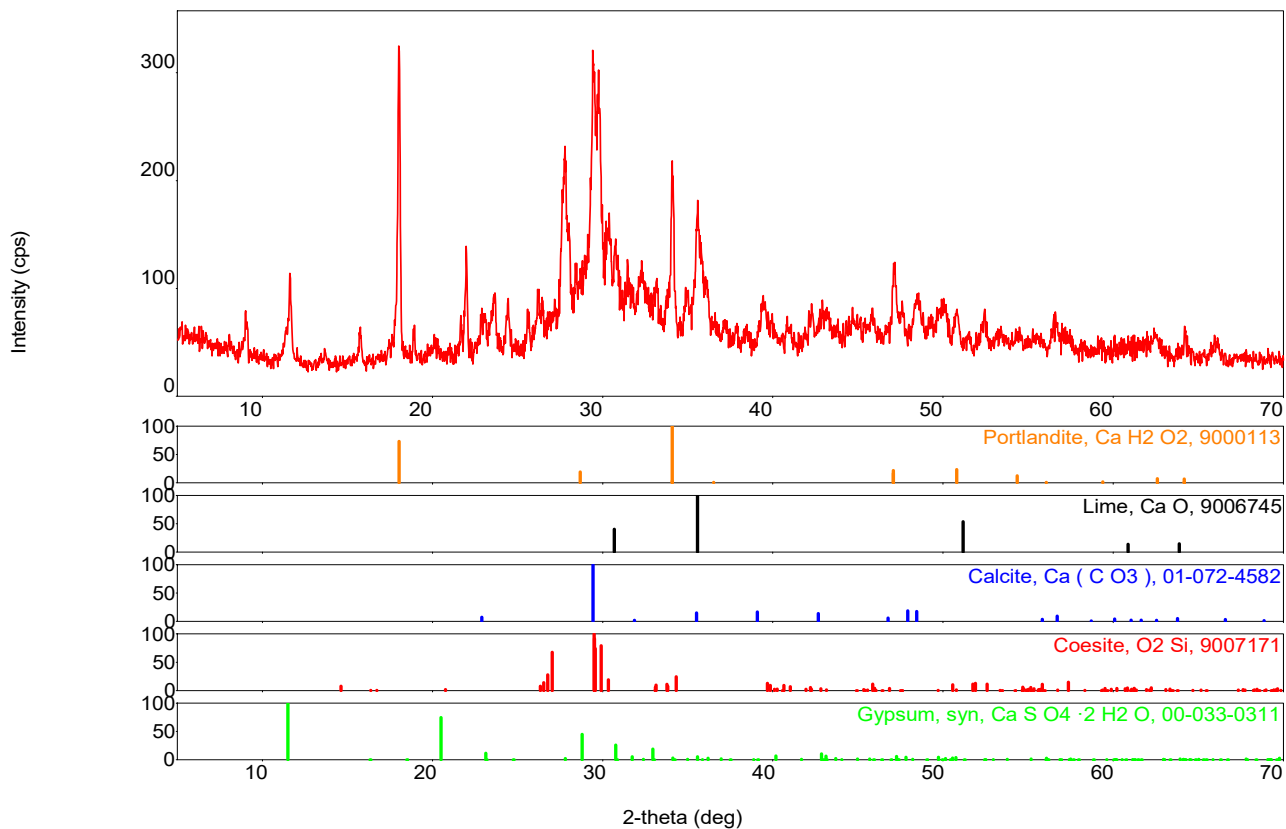
**Figure 115.** The XRD diffractogram generated from concrete removed Coupon 3.

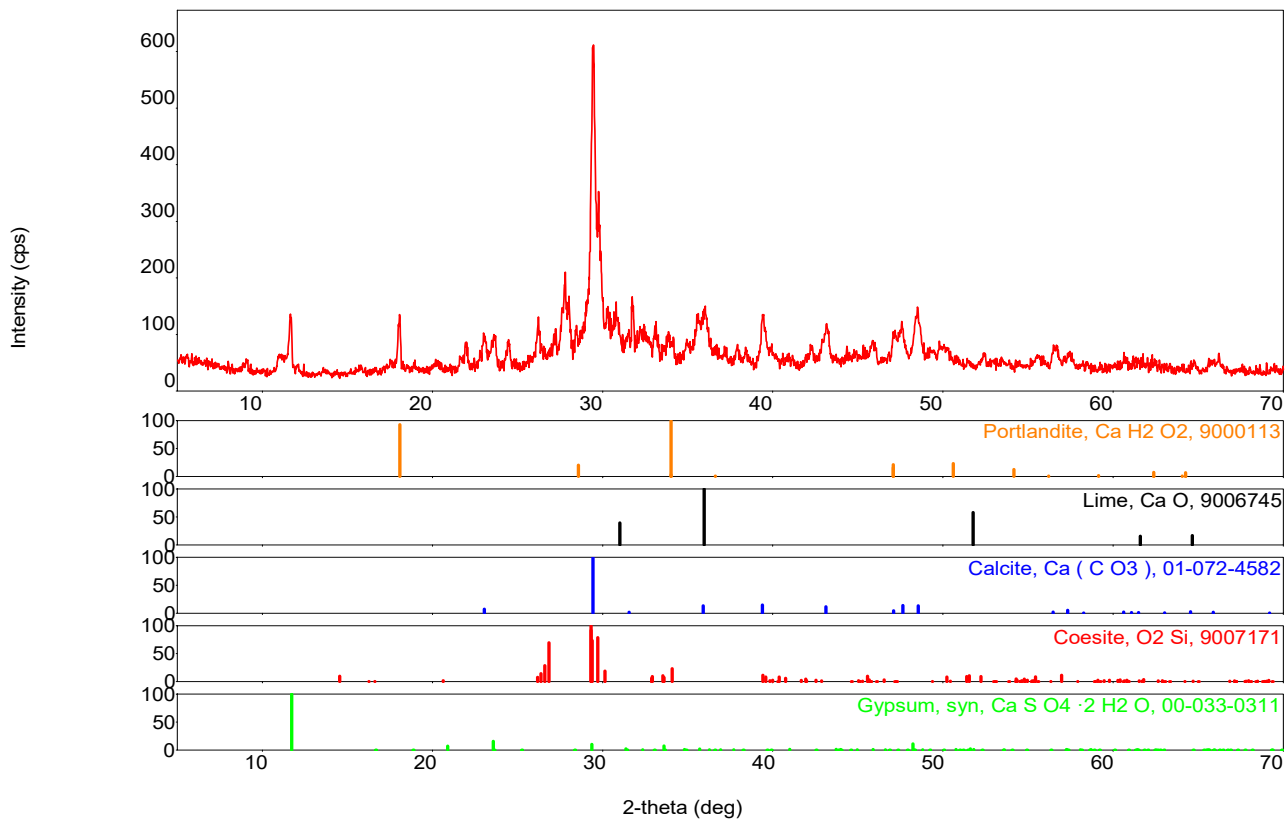
**Figure 116.** The XRD diffractogram generated from concrete removed Coupon 5.

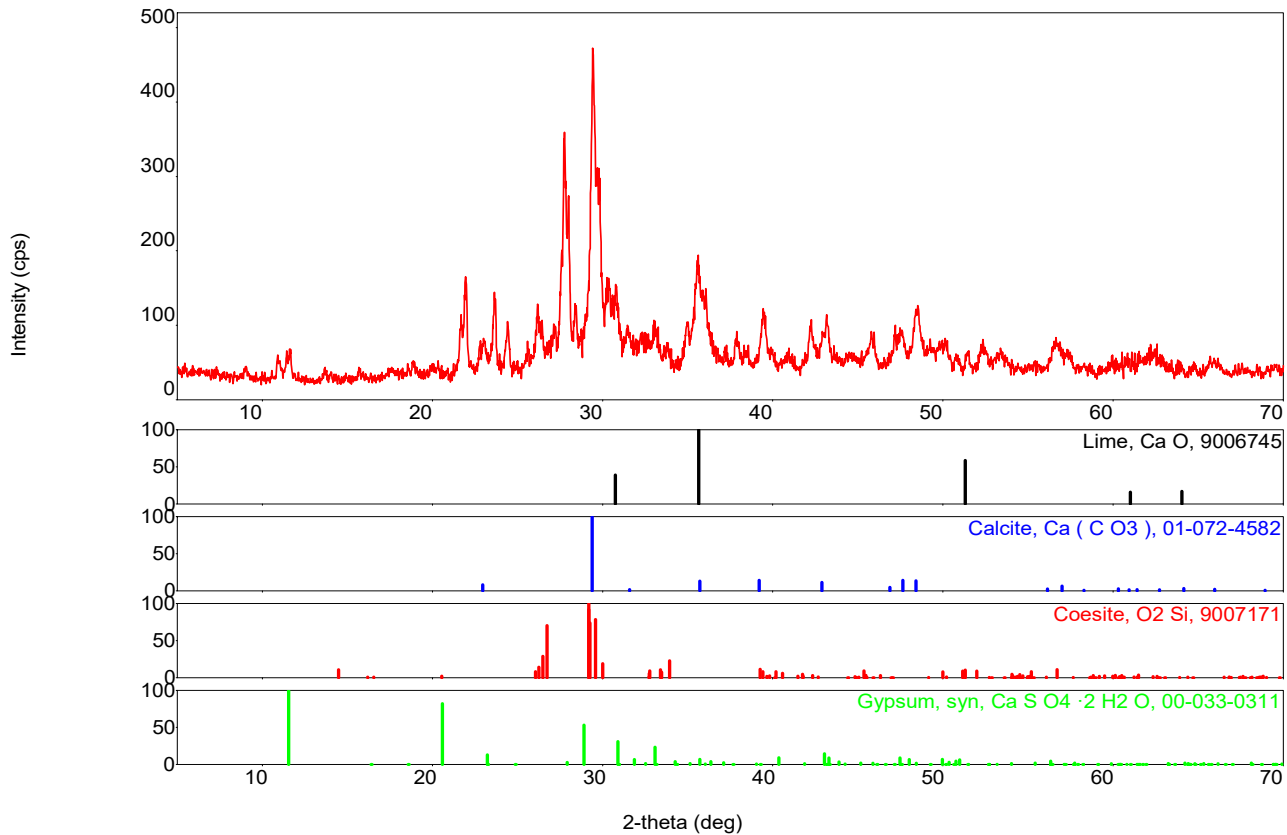
**Figure 117.** The XRD diffractogram generated from concrete removed Coupon 6.

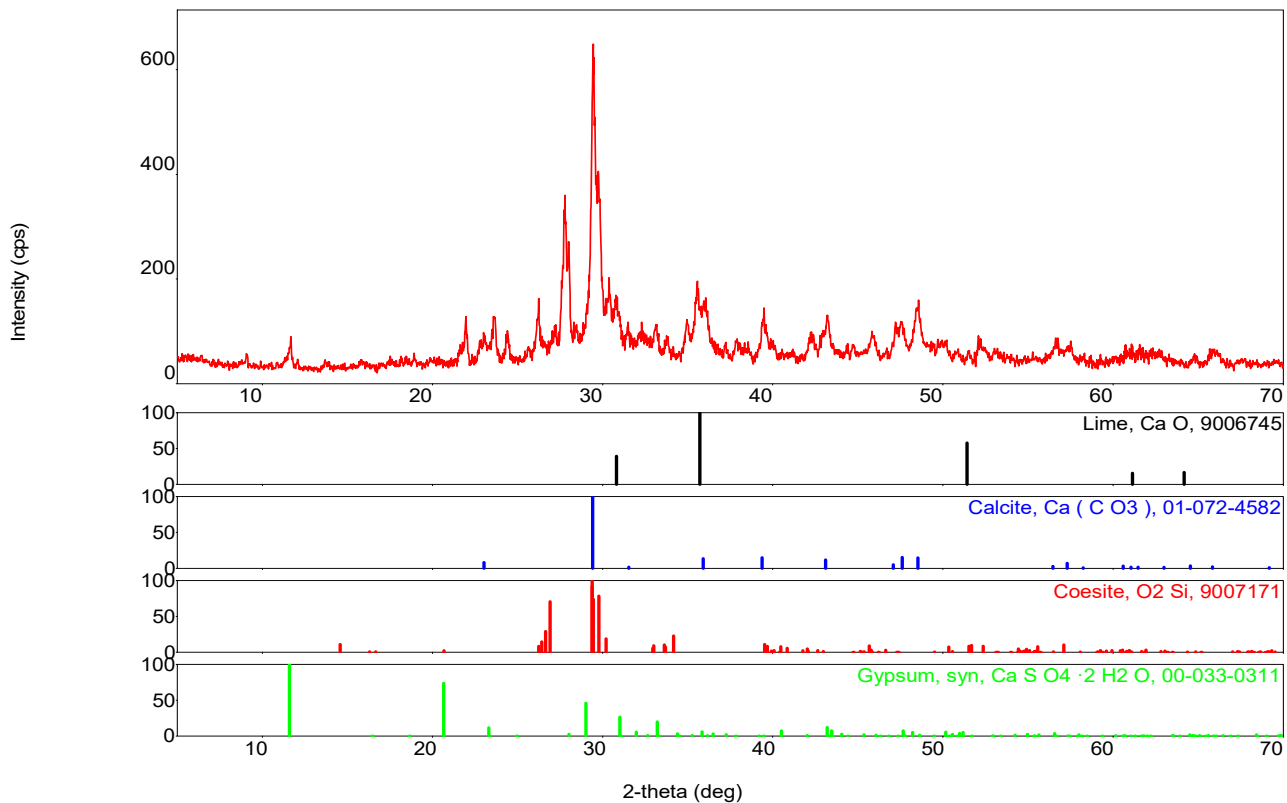
**Figure 118.** The XRD diffractogram generated from concrete removed Coupon 7.
