**DEPARTMENT OF THE NAVY**

SUBJECT: ADMINISTRATIVE ORDER ON CONSENT (AOC) STATEMENT OF WORK (SOW) SECTION 5 CORROSION AND METAL FATIGUE PRACTICES, DESTRUCTIVE TESTING RESULTS REPORT, RED HILL BULK FUEL STORAGE FACILITY (RED HILL), JOINT BASE PEARL HARBOR-HICKAM, OAHU, HAWAII

In 2018, ten coupons were removed from Tank 14, so that a metallurgical and corrosion analysis of the coupons could be undertaken, with the primary aim of validating non-destructive examination (NDE) results. The steel coupons, concrete powder samples, and corrosion product were submitted to a certified third-party laboratory to perform this analysis.

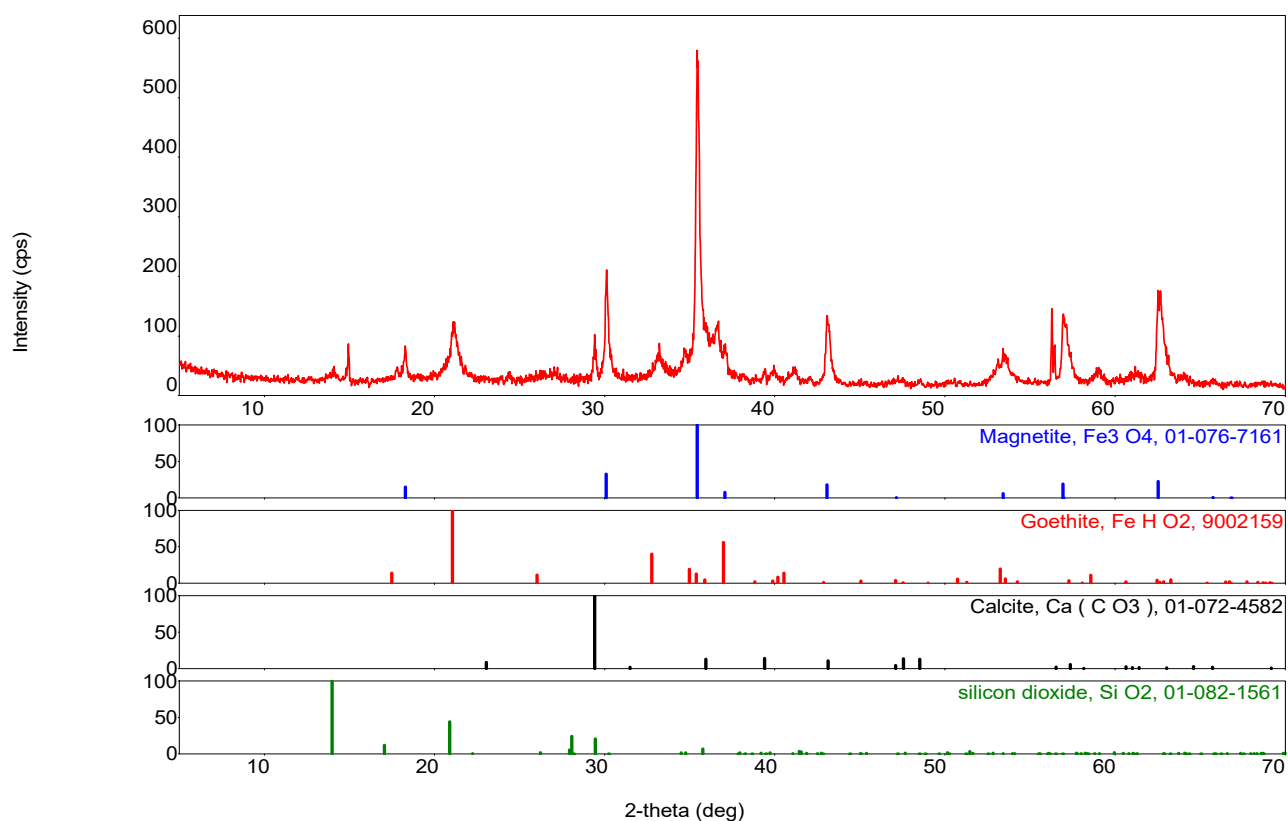
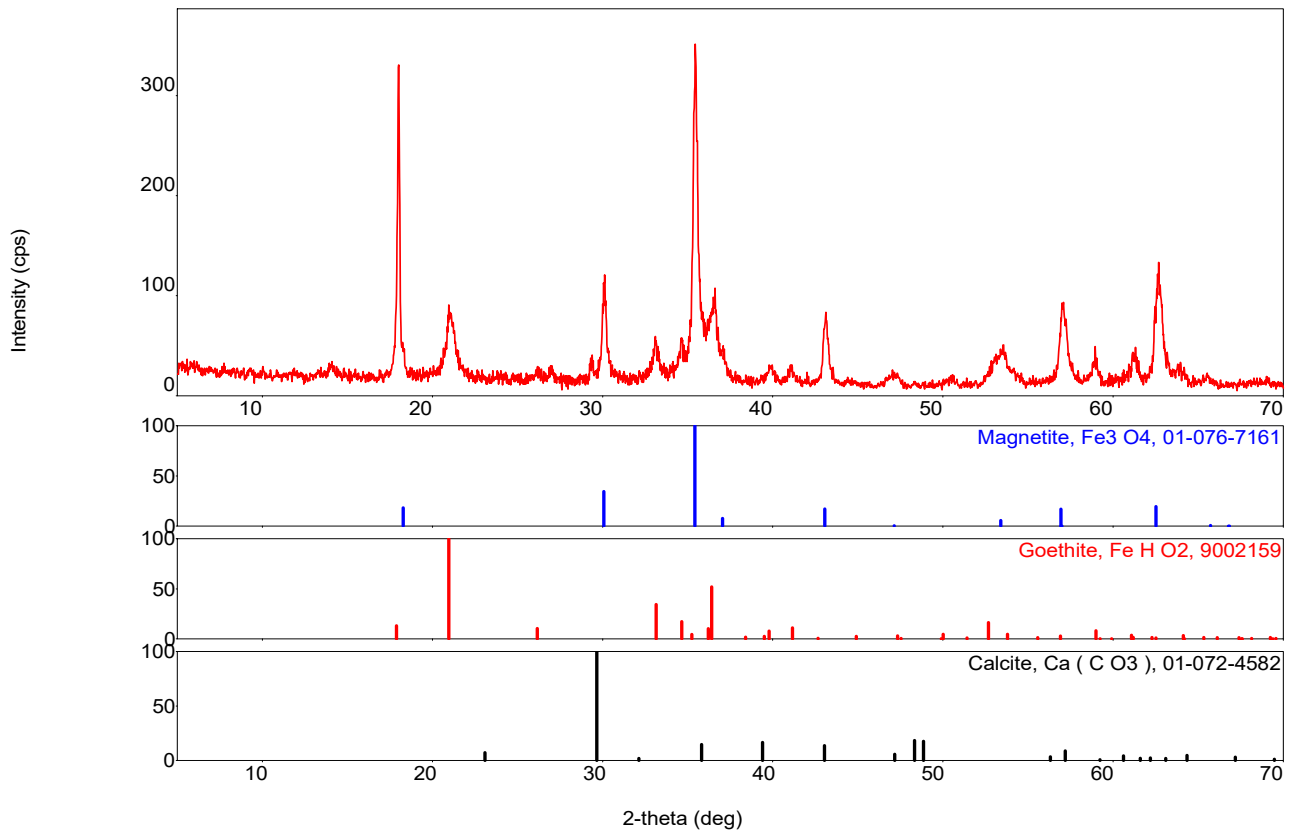
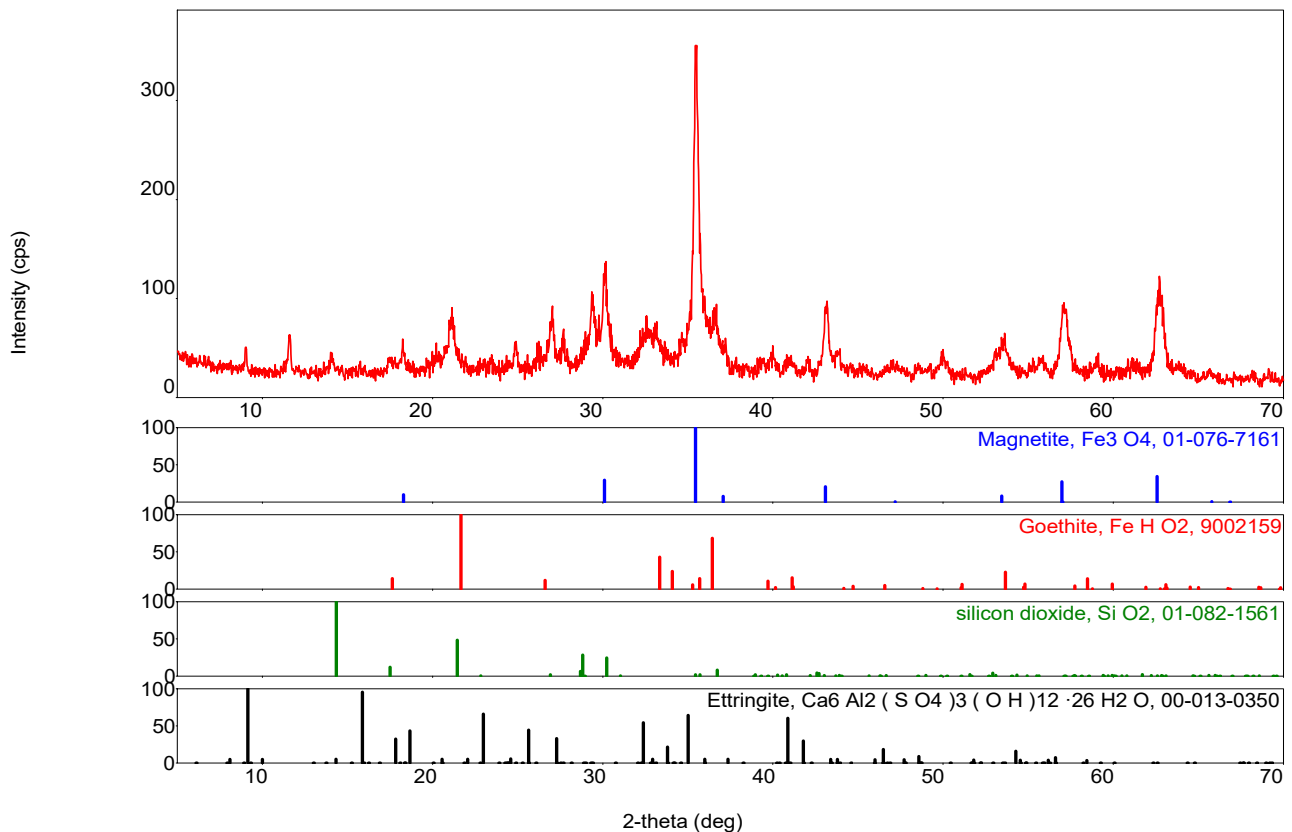
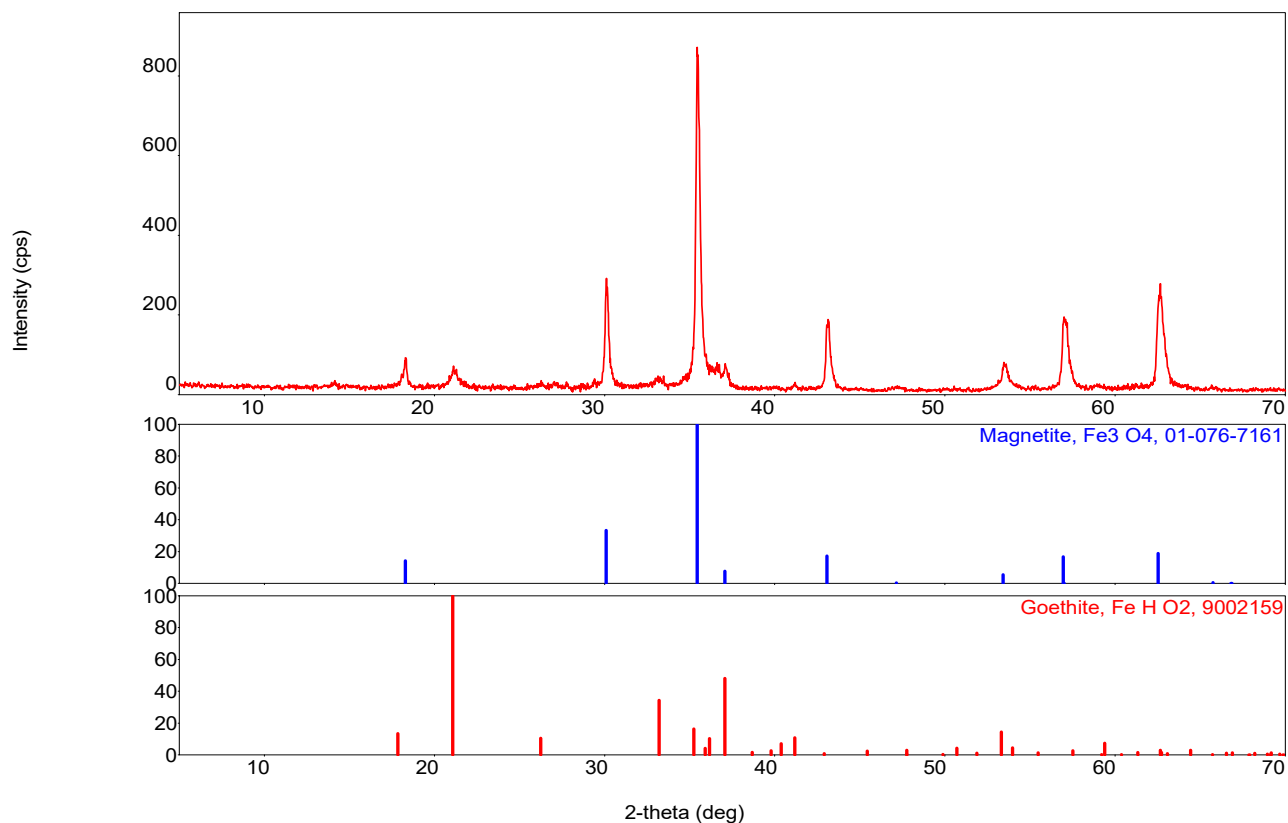
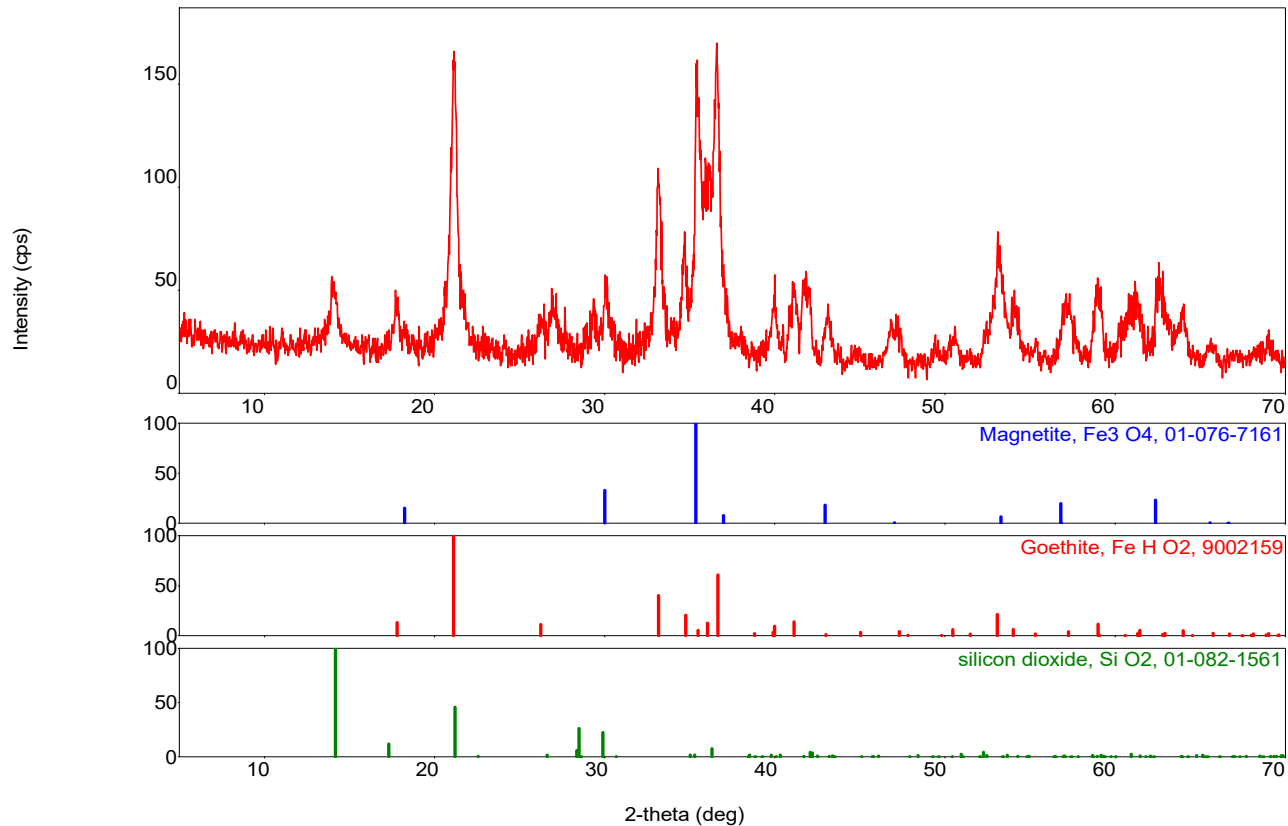
X-Ray Diffraction Spectroscopy (XRD) analysis of the corrosion product from the metal panels revealed the presence of the following crystalline phases: iron oxide (magnetite); iron hydroxide (goethite); calcium carbonate (calcite); silicon dioxide and hydrous calcium aluminum sulfate (ettringite). The results are summarized in Tables 19 and 20. The XRD diffractograms for the corrosion samples are provided as Figures 123 through 128.

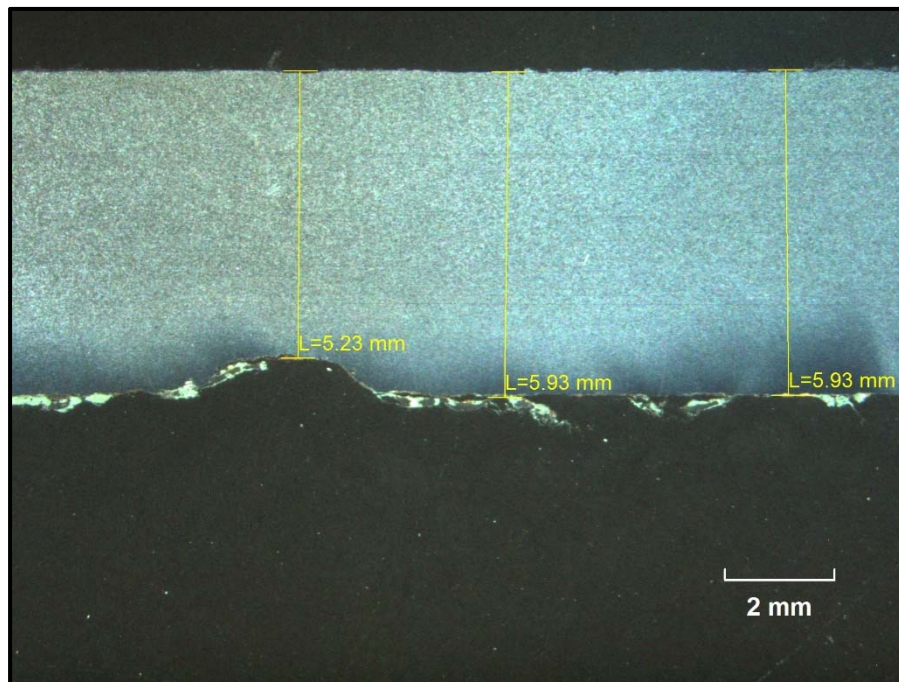
**Figure 198.** The prepared metallographic cross-section from Sample 7-4 is shown during examination with a stereomicroscope. The thickest location(s) are shown, as well as the thickness remaining underneath the deepest observed pit. (7X)

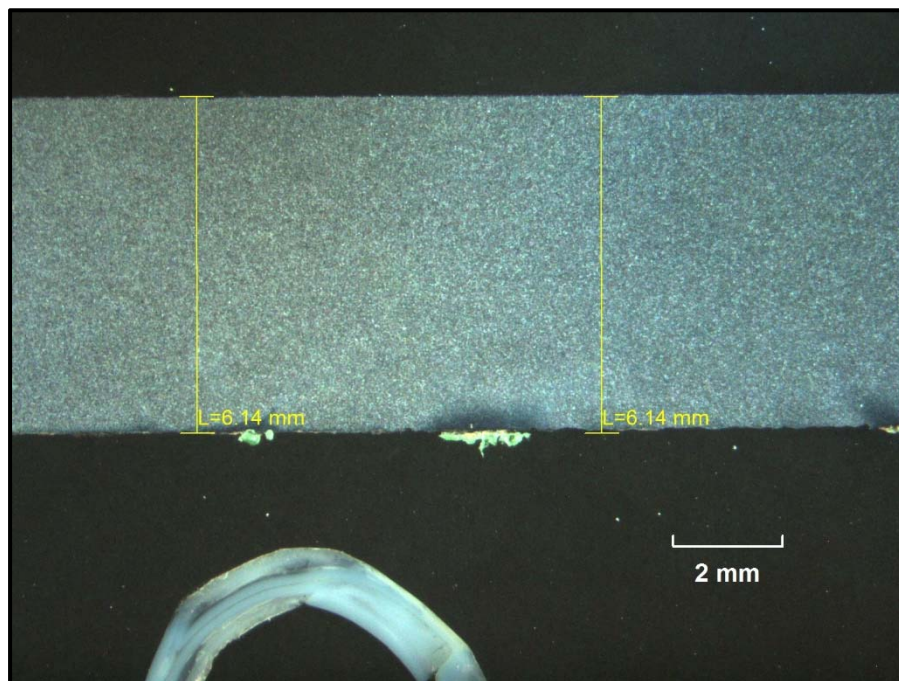
**Figure 199.** The prepared metallographic cross-section from Sample 8-3 is shown during examination with a stereomicroscope. The thickest remaining wall is shown. Note that the reduction in wall thickness was due to a depression on the painted face of the specimen. (7X)

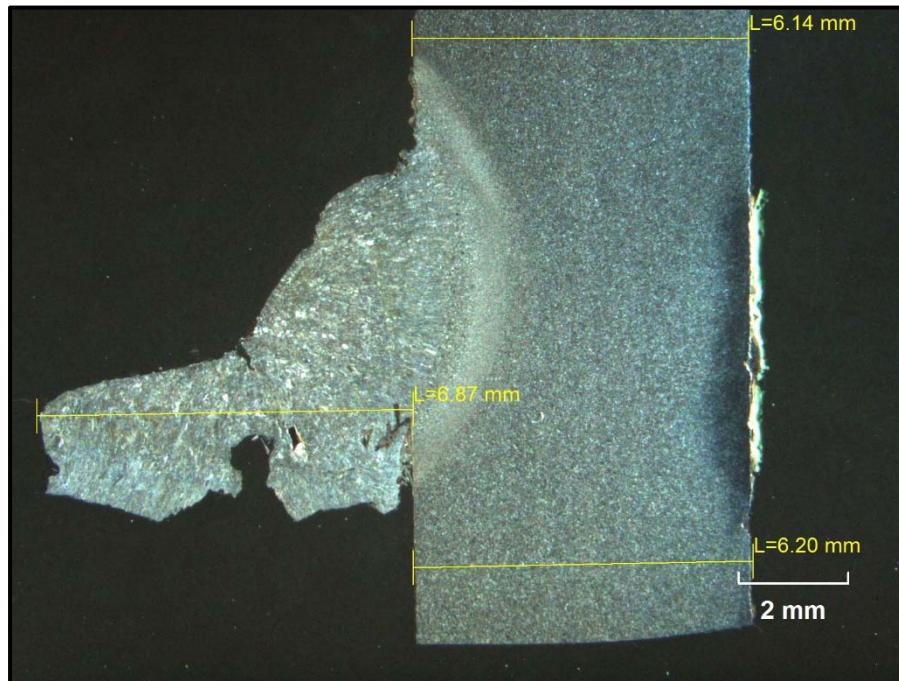
**Figure 201.** The prepared metallographic cross-section from Sample 10-2 is shown during examination with a stereomicroscope. The thickest location(s) are shown. No pitting was observed. (7X)

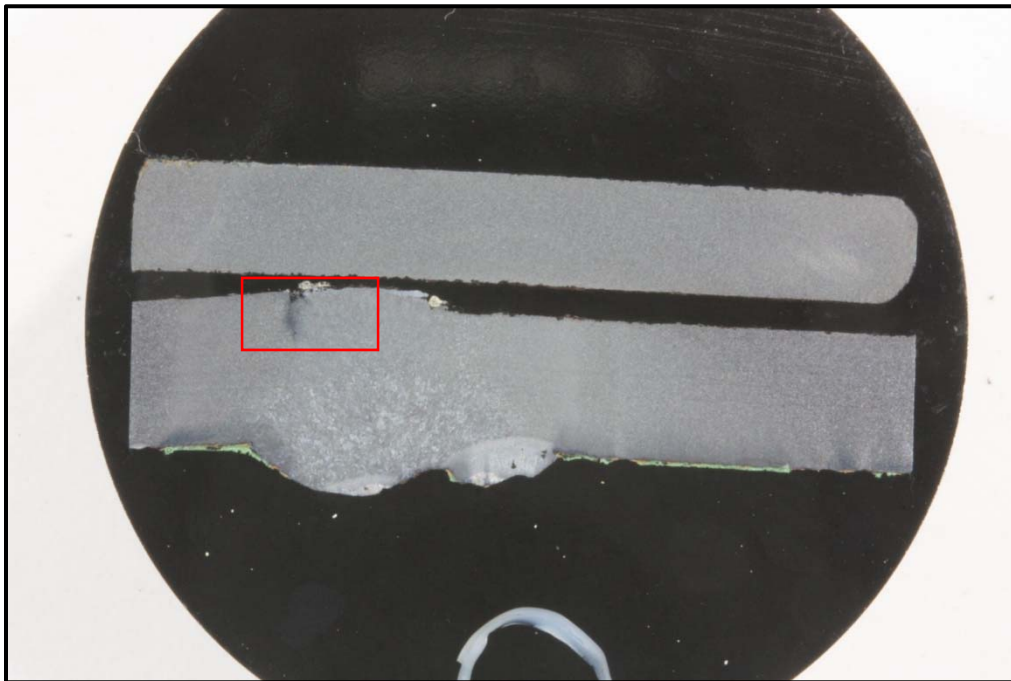
**Figure 207.** The prepared metallographic cross-section from Sample A2-4 is shown during examination with a stereomicroscope. The NDE indication was most likely locations of melting/re-solidification underneath the painted surface. No pitting was observed. (7X)

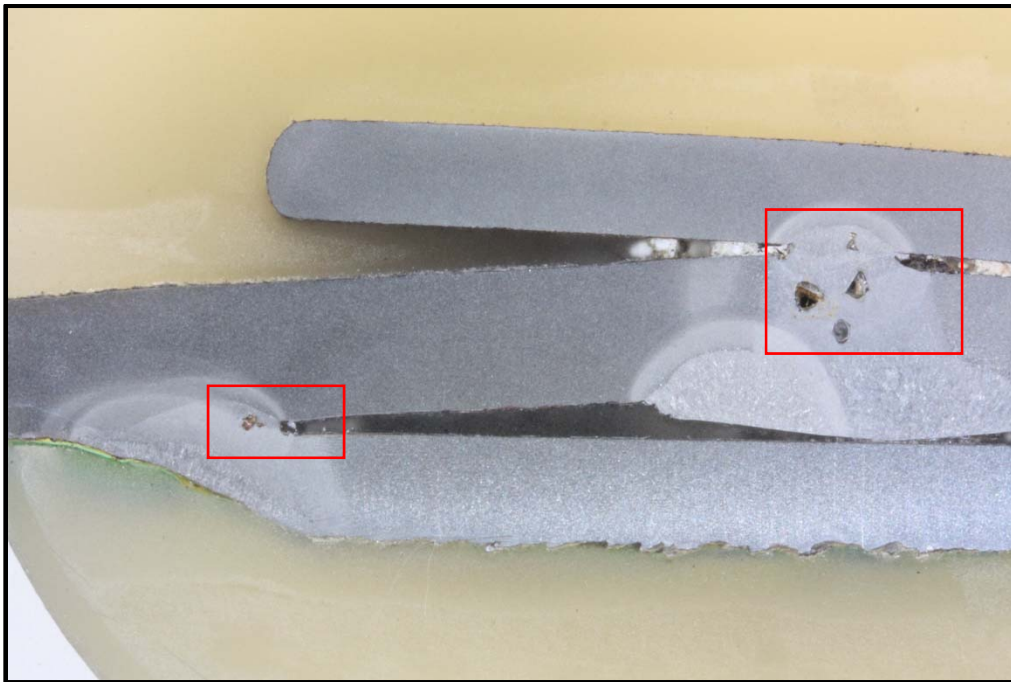
Coupon 8 exhibited what is presumed to be a prior weld repair and/or addition of a backing plate, where a patch was made on the tank wall. Representative images of the welds are presented as Figures 208 through 213. A full weld evaluation is outside the scope of this effort. The results are thus provided for information only.

**Figure 210.** The prepared metallographic cross-section through welded sample 8-4 is shown in an overall view. The painted exterior surface is along the bottom section. The areas identified by the red boxes are shown in the next two figures at higher magnification.
