Joint Task Force-Red Hill

Bi-Monthly Quality Validation Working Group Meeting

22 June 2023

Red Hill Bulk Fuel Storage Facility Defuel

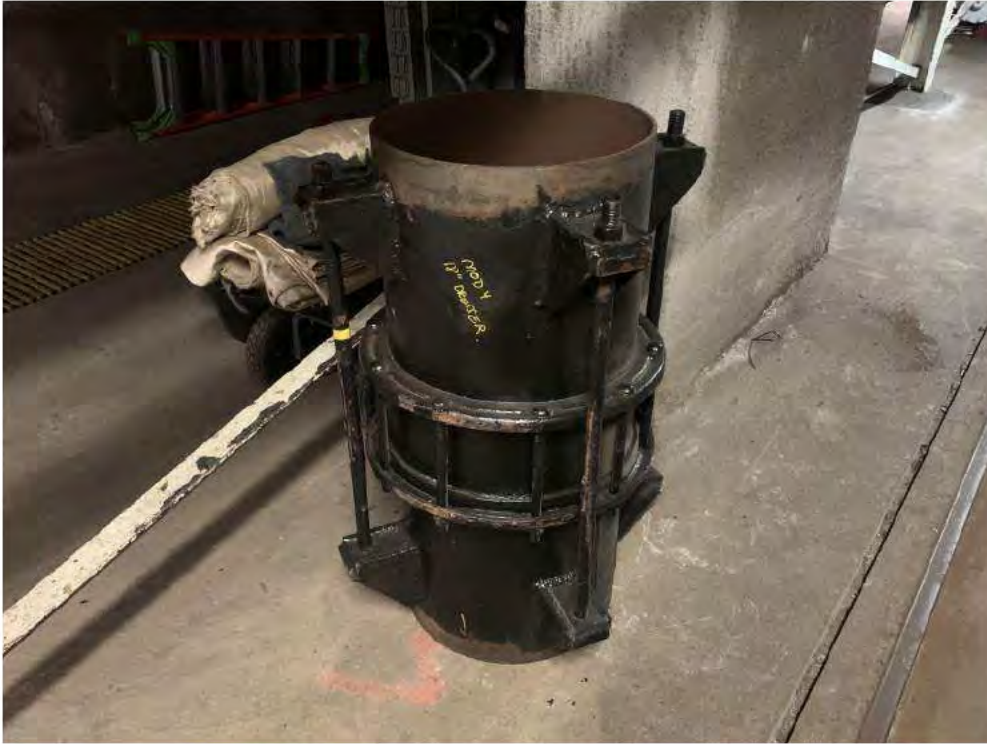
Mainline pipe compression sleeve coupling removed.

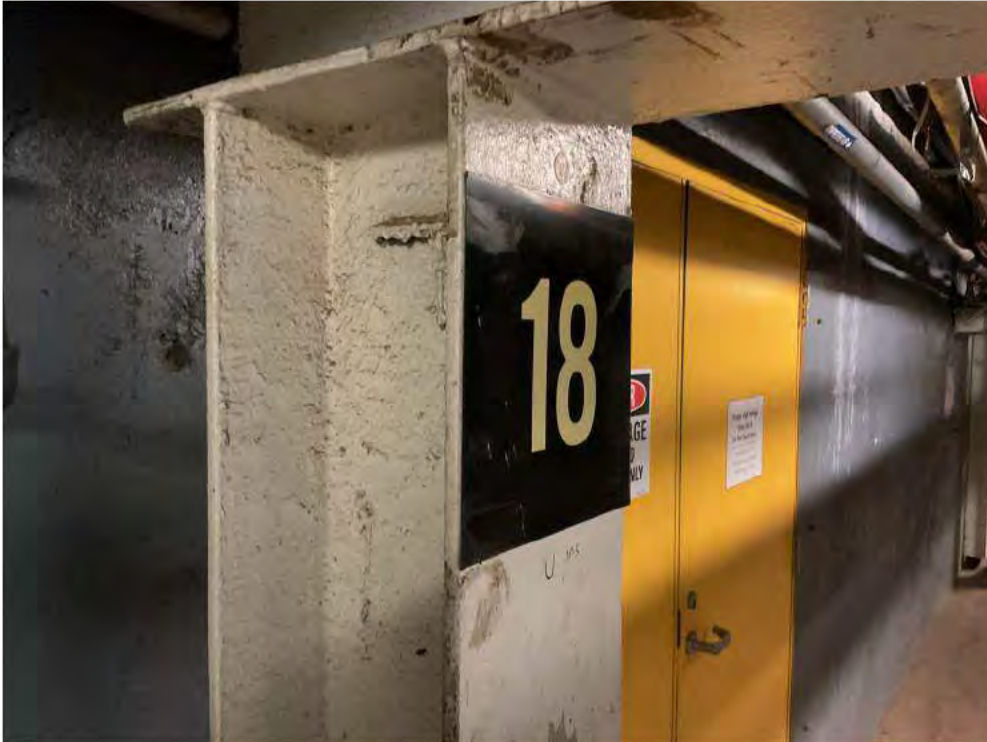
Existing Pipe Support 18.

10	Elevated pipe (JP-5, (b) (3) (A)) has limited or no lateral restraint. Provide lateral restraint to the existing pipe at PS 18, PS 19, PS 20, PS 45, PS 74, and PS 85.	21 Jun 23	(b) (3) (A)
11	Elevated pipe (b) (3) (A) has limited or no lateral restraint. Provide lateral stops as per (b) (4) retrofit concept drawings.	21 Jun 23	(b) (3) (A)

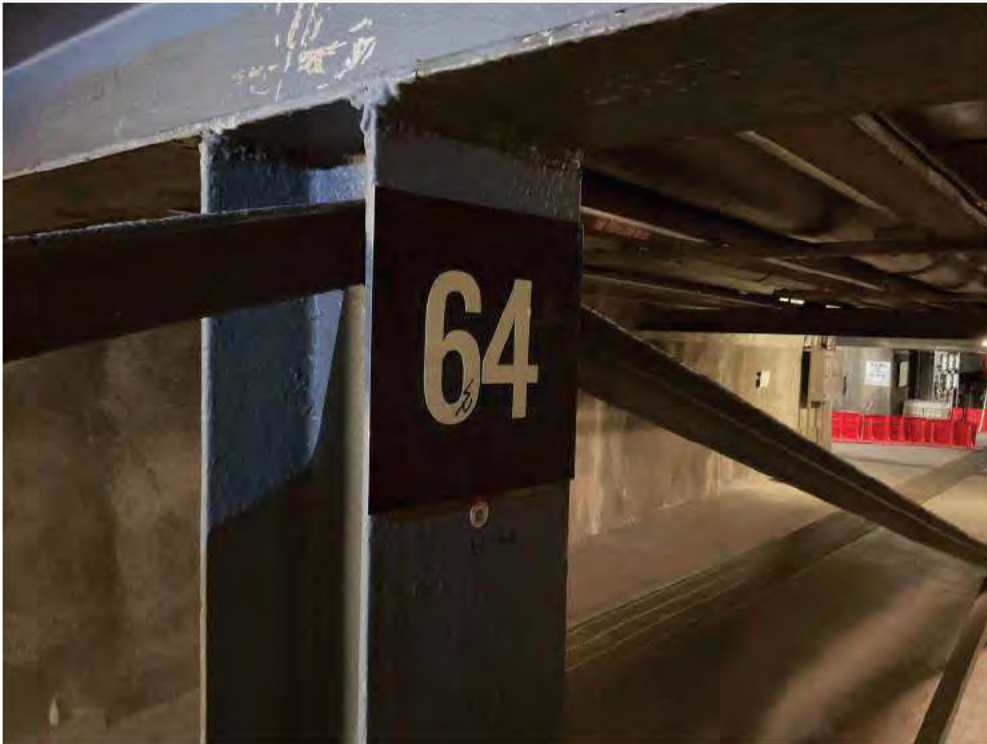
Existing Pipe Support 64.

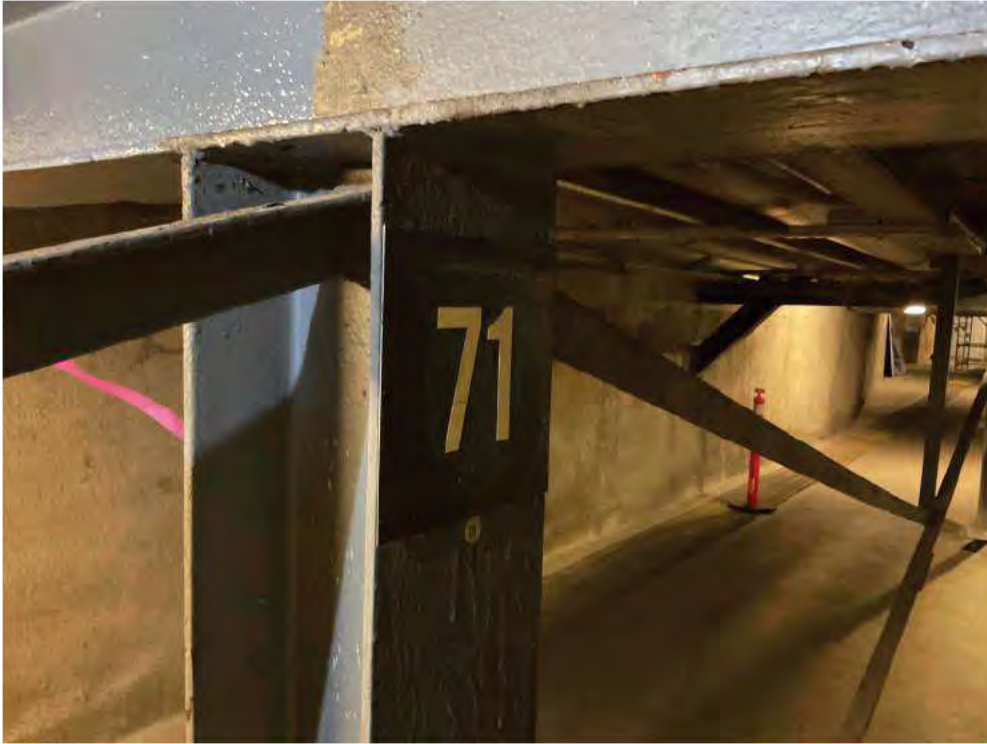
Existing Pipe Support 71.

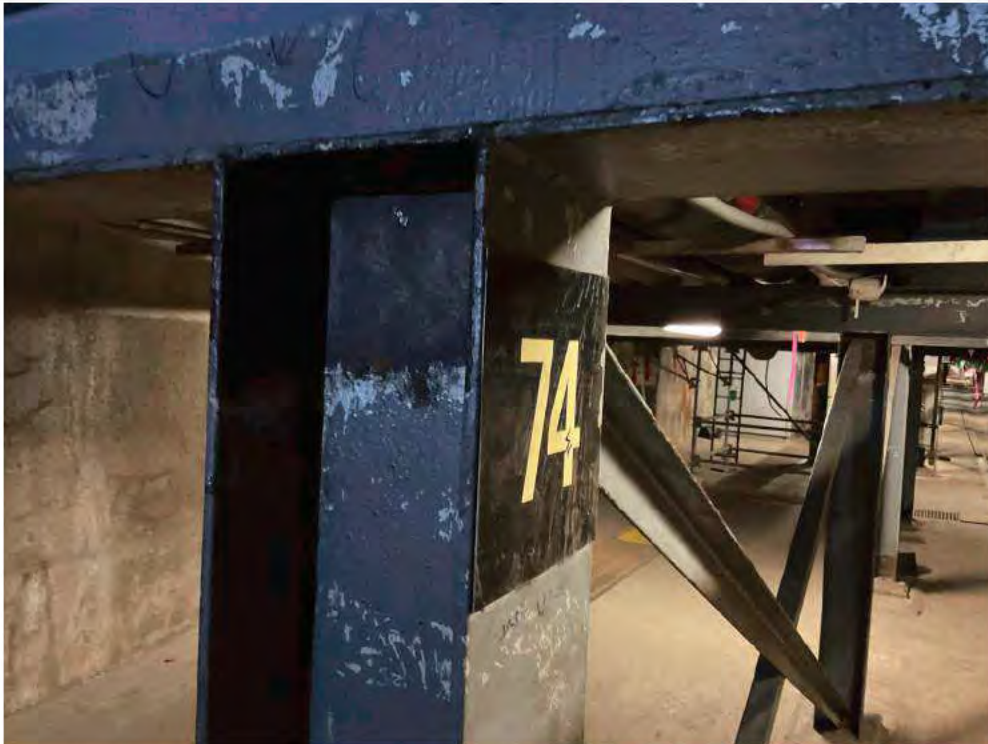
Existing Pipe Support 74.

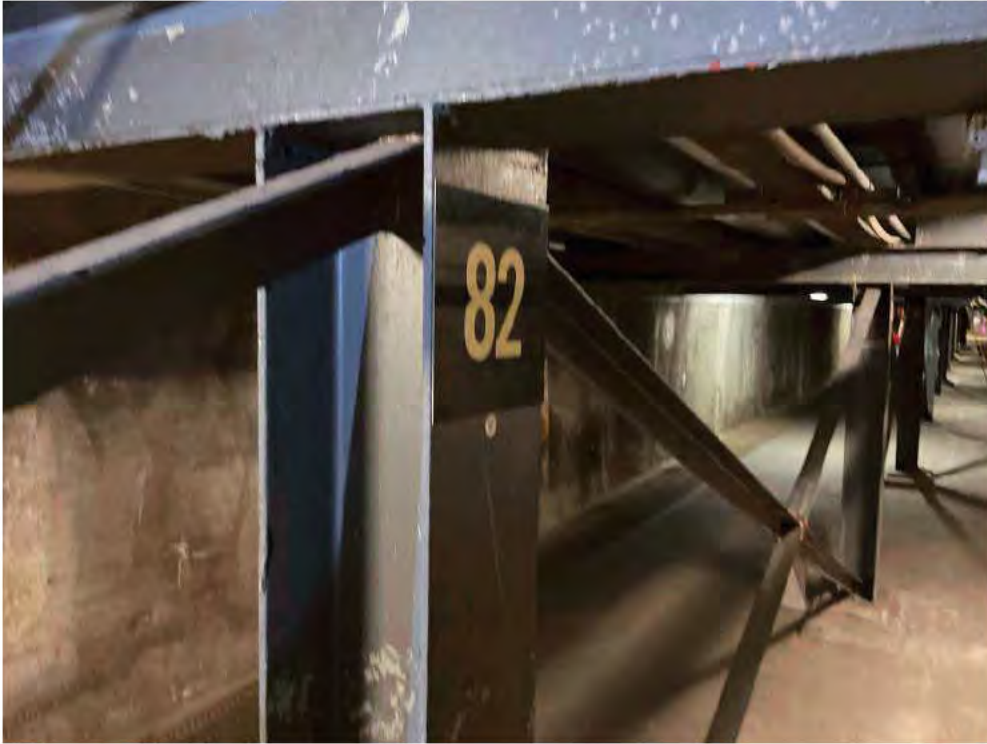
Existing Pipe Support 82.

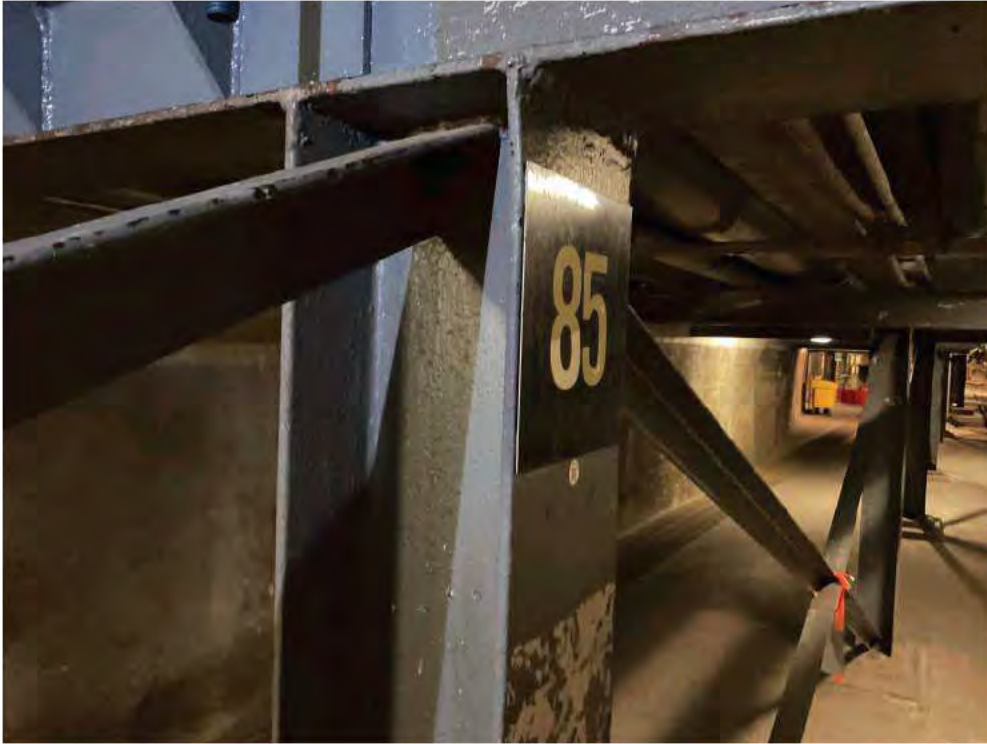
Existing Pipe Support 85.

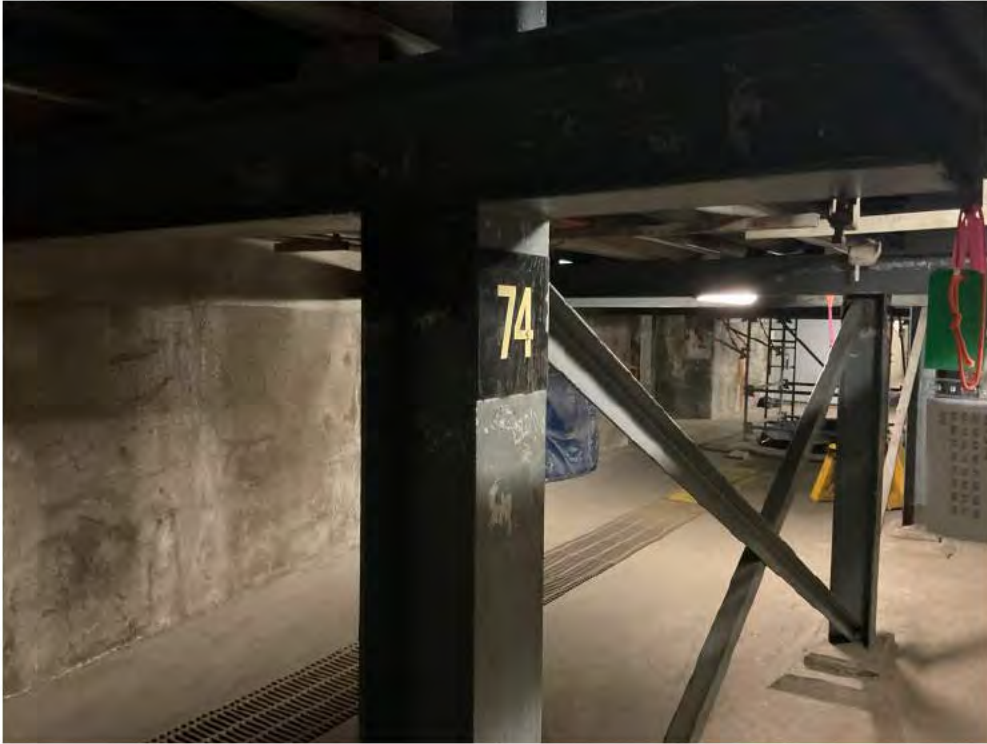
Source	PDF Page No.	Facility Geographic Area	Location Reference
(b) (4)	390	Tank Gallery	(b) (3) (A)
Repair Description	Elevated pipe (b) (3) (A) is not supported, cradle is missing. Provide missing cradle and lateral stops.		Source Contract Reference 47QSHA18D000Y W912DY21F0025 Service Order 662
Description of Contractor QC Method(s) Used	Methods outlined in detail in QCP.		Contractor QC Records Reviewed QCP and Daily Reports
Description of QA Validation and Observations	QA methods outlined in QASP. JTF-RH secondary QA and 3rd Party QV completed. JTF-RH QV visually inspected repair & reviewed contractor QC documentation. Final acceptance by government. Date: 05 JUN 2023		
Rework Needed		Photo Record Attached	Repair Work Validated as Complete
<input type="radio"/>	Yes	<input checked="" type="radio"/>	No
		See Page 2.	<input checked="" type="radio"/> Yes <input type="radio"/> No

Existing Pipe Support 74.

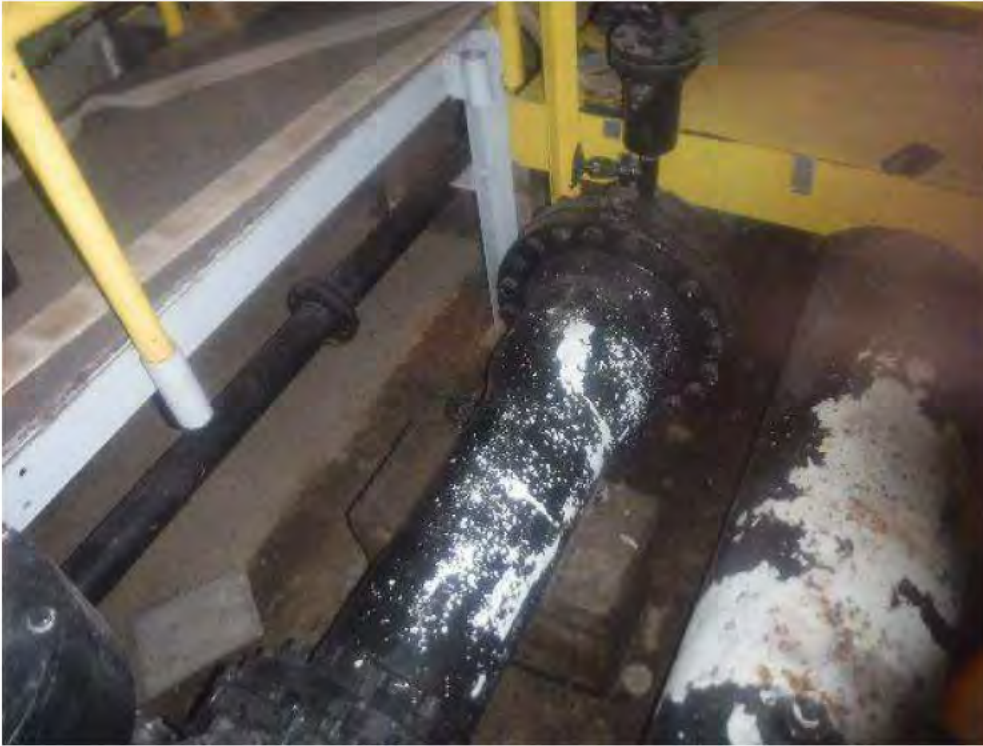
Existing threaded high point vent assembly at UGPH bulkhead.

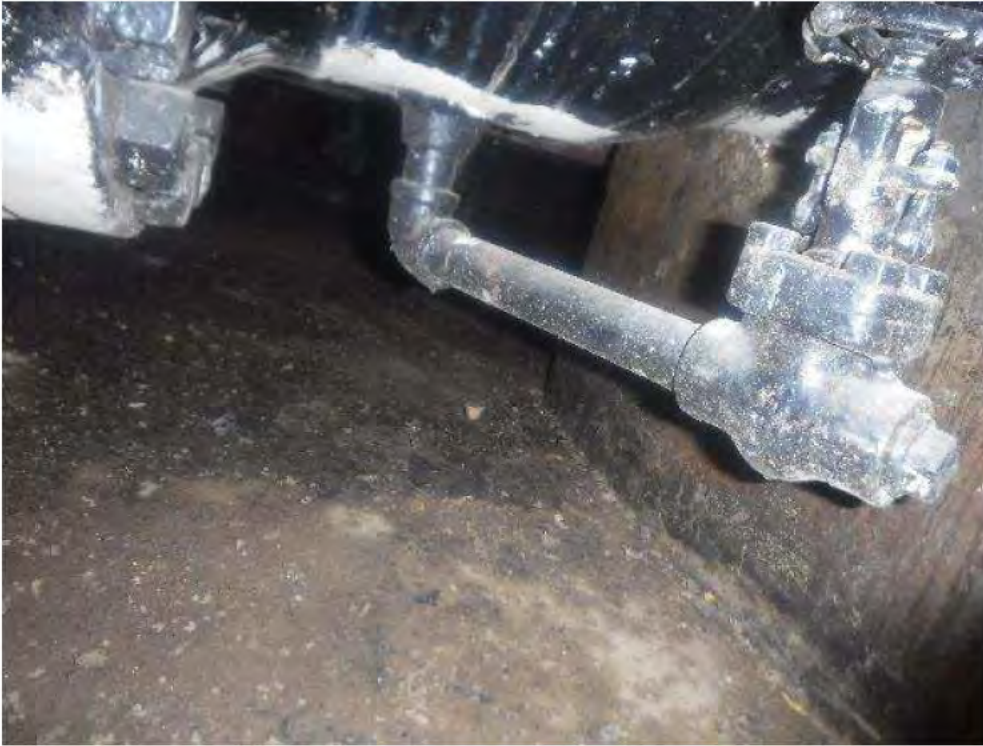
Existing threaded low point drain assembly at UGPH bulkhead.

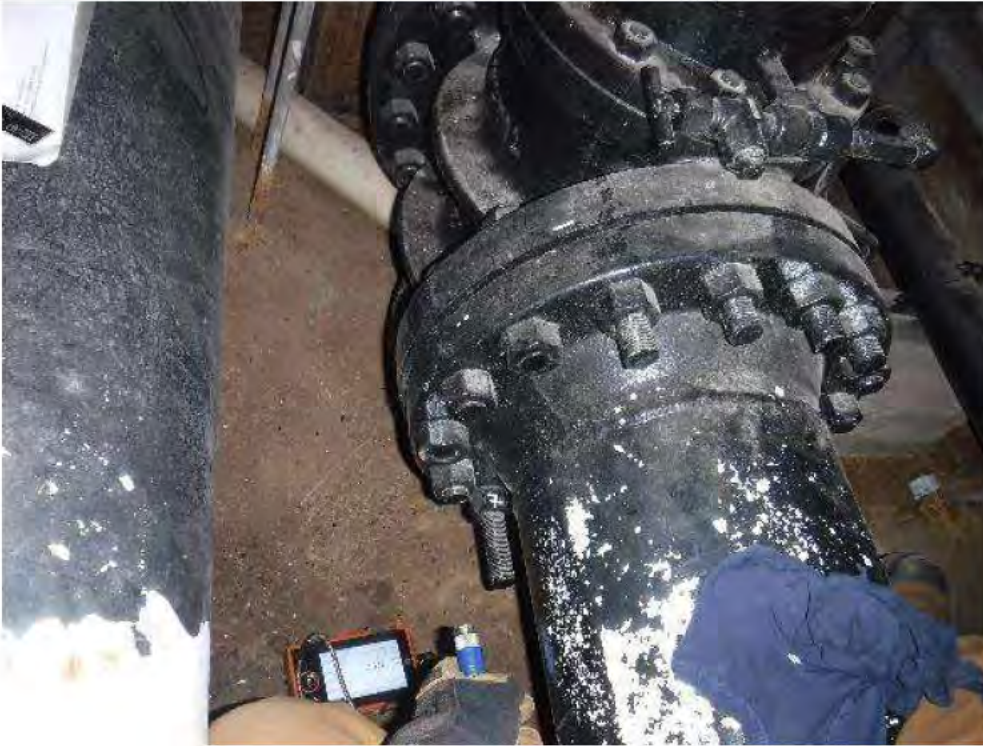
Existing fasteners at 16-inch flange not properly sized.

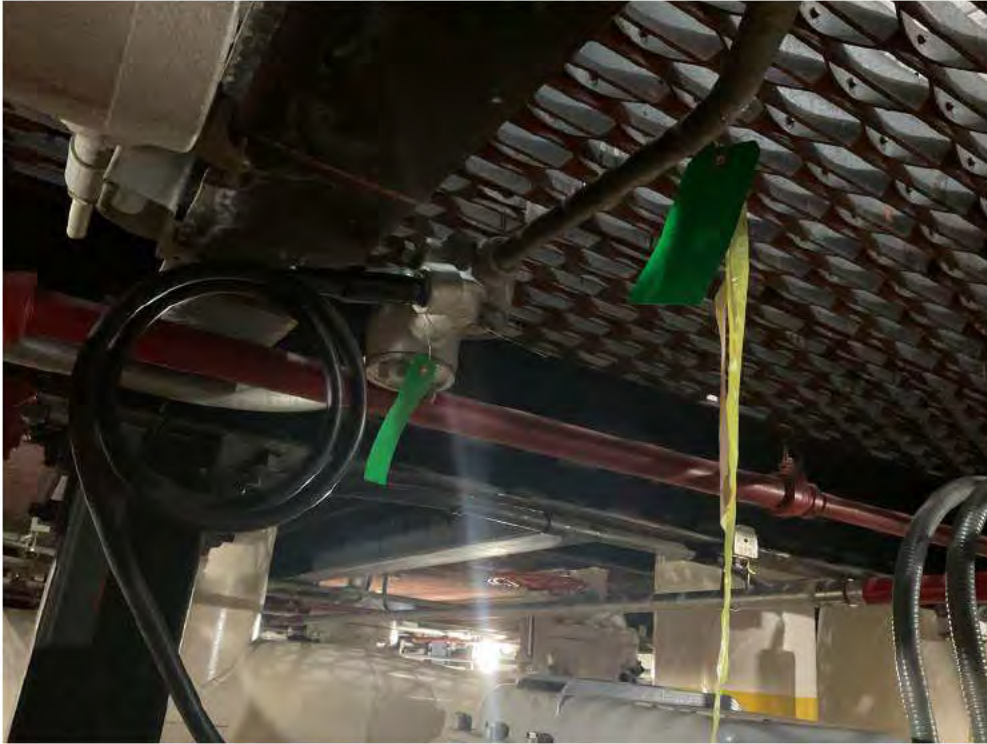
Source	PDF Page No.	Facility Geographic Area	Location Reference
NDAAs	61	Underground Pumphouse	Various
Repair Description	There are several open conduits, junction boxes, and unsealed electrical fittings throughout the UGPH that will not meet hazardous area ratings. Provide covers on electrical fittings.		Source Contract Reference 47QSHA18D000Y W912DY21F0025 Service Order 649
Description of Contractor QC Method(s) Used	Methods outlined in QASP. Visual examination of outlet cover installation, tagging each repair.		Contractor QC Records Reviewed QCP and Daily Reports.
Description of QA Validation and Observations	Methods outlined in QASP. JTF-RH secondary QA and 3rd Party QV completed. JTF-RH QV visually inspected repairs and reviewed contractor QC documentation (Work Plan, submittals, daily reports). Final acceptance by government. Date: 01 JUN 2023		
Rework Needed		Photo Record Attached	Repair Work Validated as Complete

Condulet GUA Cover installation (typical) with QA tags.

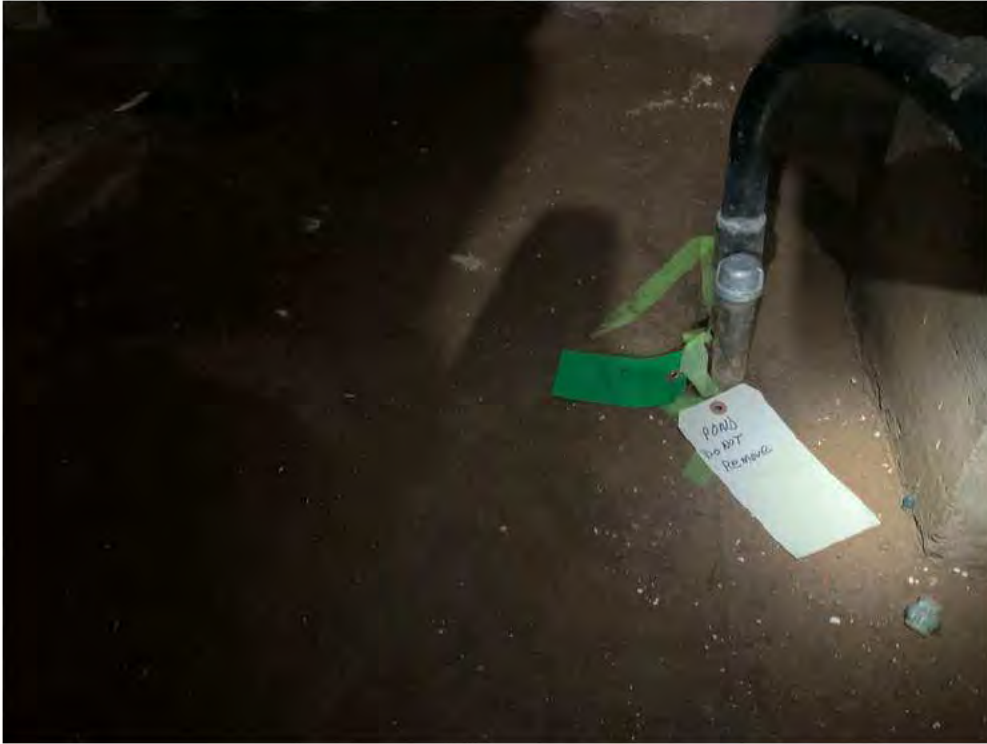
Source	PDF Page No.	Facility Geographic Area	Location Reference
NDAAs	62	Underground Pumphouse	Various
Repair Description	There are several locations throughout the UGPH where abandoned/open conduit penetrates the UGPH floor, potentially negating the secondary containment. Provide covers on open electrical conduits.		Source Contract Reference 47QSHA18D000Y W912DY21F0025 Service Order 649
Description of Contractor QC Method(s) Used	Methods outlined in QASP. Visual examination of threaded cap installation, tagging each repair.		Contractor QC Records Reviewed QCP and Daily Reports.
Description of QA Validation and Observations	Methods outlined in QASP. JTF-RH secondary QA and 3rd Party QV completed. JTF-RH QV visually inspected repairs and reviewed contractor QC documentation (Work Plan, submittals, daily reports). Final acceptance by government. Date: 01 JUN 2023		
Rework Needed		Photo Record Attached	Repair Work Validated as Complete

Cast iron round cap installation (typical) with QA tags.

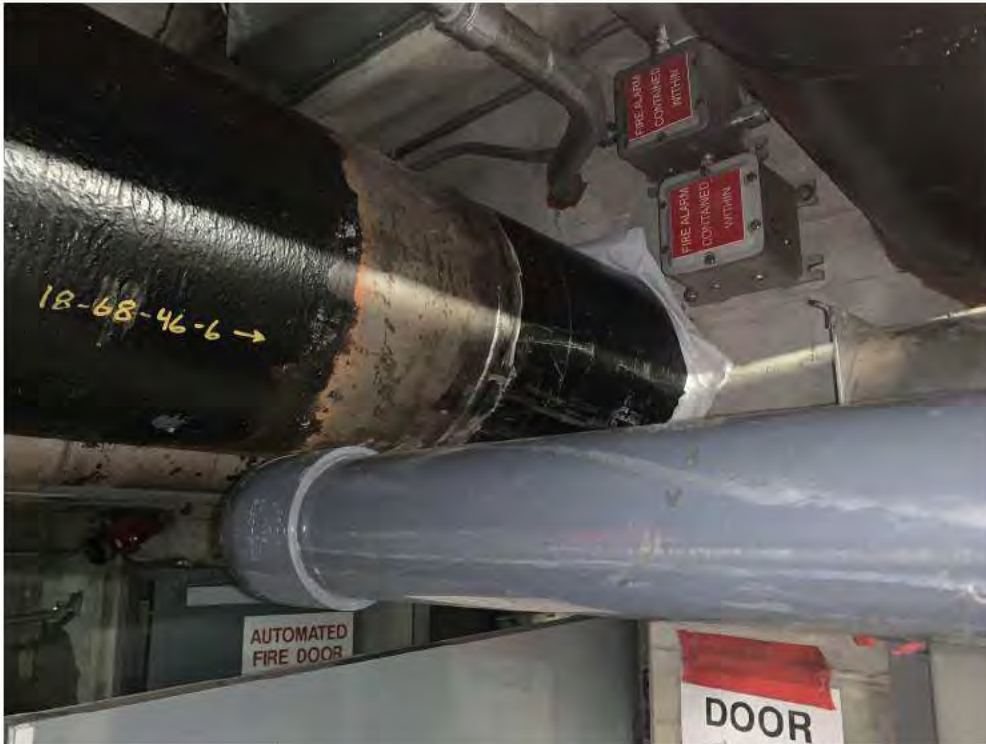
Uphill side of the Door 3 bulkhead penetration between PS 68 and 69; no existing photograph of bell connection available.
