KAIAKA BAY
WATERSHED-BASED PLAN

APPENDIX A:
GEOMORPHIC ASSESSMENT OF
POAMOHO STREAM

Geomorphic Assessment of Poamoho Stream

**Kaiaka Bay Watershed-Based Plan
Oahu, Hawaii**

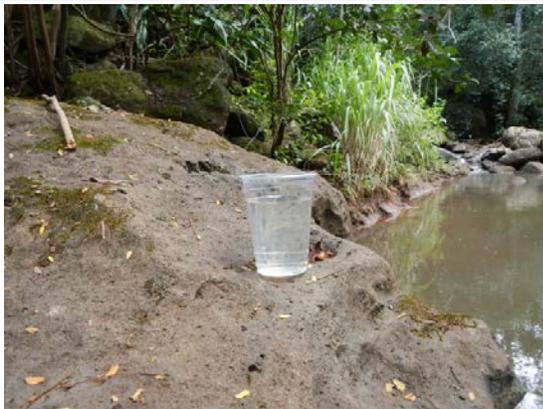
Day 2 – Near Dole Plantation

This sample is taken at the Striker Brigade crossing approximately 2,000-ft downstream of Kamehameha Highway crossing. The orange color suggests high suspended clay content. A visual inspection of the stream from the Kamehameha Highway bridge also found the flow to be orange.

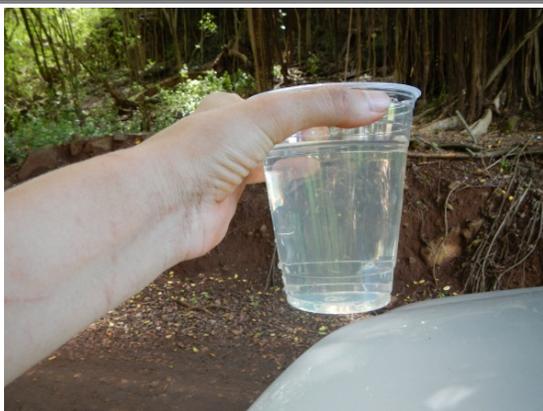
Day 2 – Upstream of Dole Plantation

This sample is taken from the Poamoho Stream approximately 2,000-ft upstream of the Kamehameha Highway crossing. This location is upstream of the high clay content flow source. As the overflow from Tanada Reservoir was also relatively clear, the potential sources of the high sediment content are: a localized slide, the tributary that drains the Whitmore Village and NCTAMS areas, or the residential area serviced by Nui Avenue.

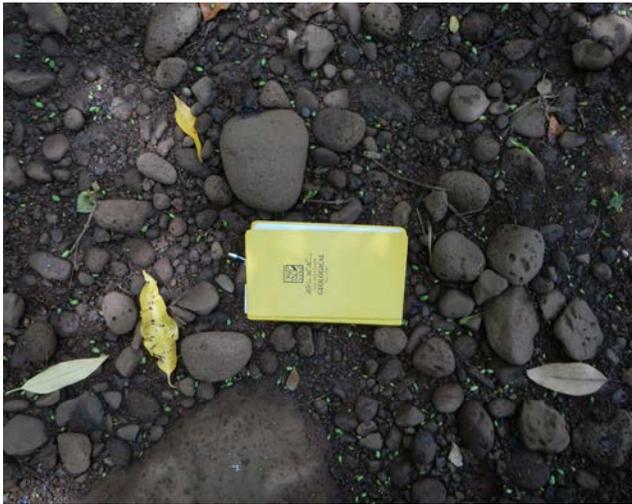
Day 1 – Lower Poamoho Stream

The bed material of Poamoho Stream was documented through photos. Based on the findings throughout the Day 1 visit it is suggested that the bed material throughout the lower reach is “bi-modal” in natural. This references two sources of material; local material input delivered from rock falls and bank erosion and transported finer material from the upper watershed. In the upper watershed the bed material also appears to be bi-modal. In the upper watershed, most of the material is coming from local sources as the extent of the watershed is near this location. The gravel sized material and smaller is very similar between the two locations. The larger material is more angular reflecting likely more recent introduction into the stream and limited downstream movement which tends to smooth the edges of the rocks. The photos below illustrate the type and size of bed material in the Poamoho Stream.

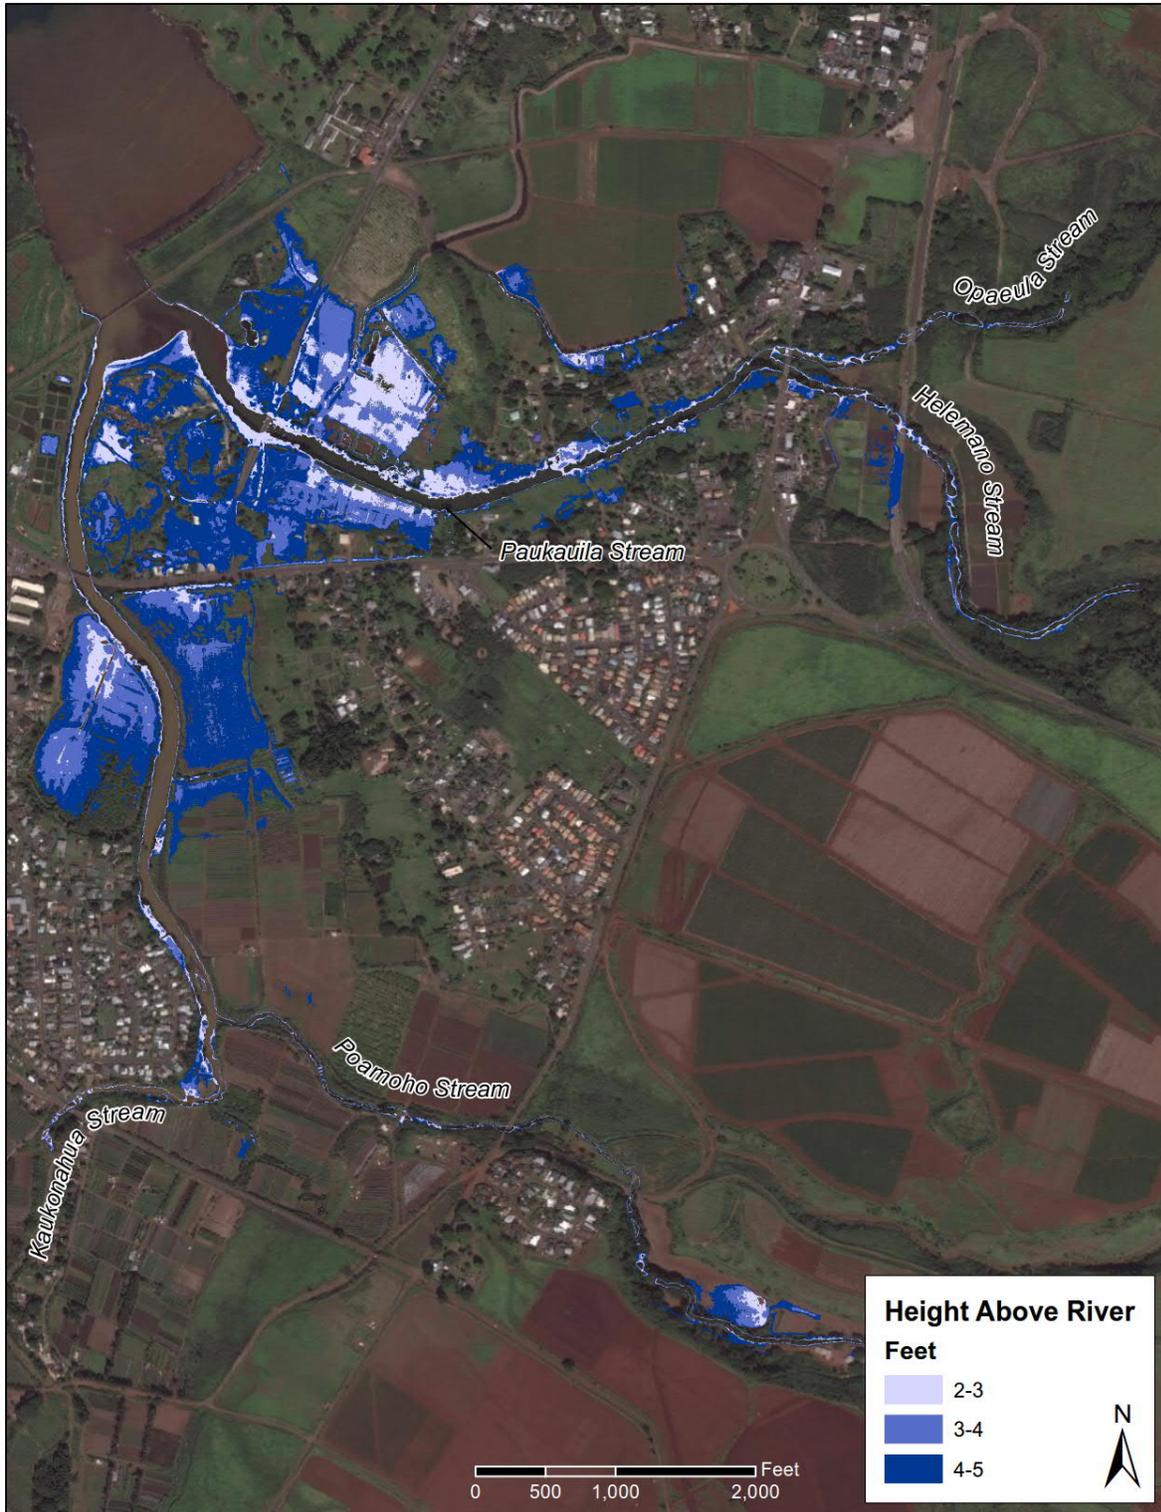
Figure 4-1 Potential Floodplain Function Restoration Areas near Haleiwa

The HAR analysis presented in Section 2.6 was refocused on the lower reaches of the Poamoho, Opaepa, and Kaukonahua streams to determine the spatial extent of potentially available floodplain as shown in Figure 4-1. The re-introduction of floodplain functions in the lower watershed will allow for transported sediment to be stored instead of discharging to the ocean.

Completed floodplain restoration projects have estimated an increase in sediment deposited on floodplains from 1.7 mm/yr to 11.3 mm/yr. Based on the potential inundation areas provided in Table 4-2 and the sediment deposition rate in the floodplain it is estimated that 234 tons (approximately 8,700 cubic yards) of sediment can be trapped on the floodplains per year. This reflects the amount of sediment not entering the Kaiaka Bay. As the sediment accumulates, the elevation of the floodplain increases, resulting in less potential storage opportunity. Removal of the deposited material on a regular schedule may provide for long term improvements of the water quality entering the bay.

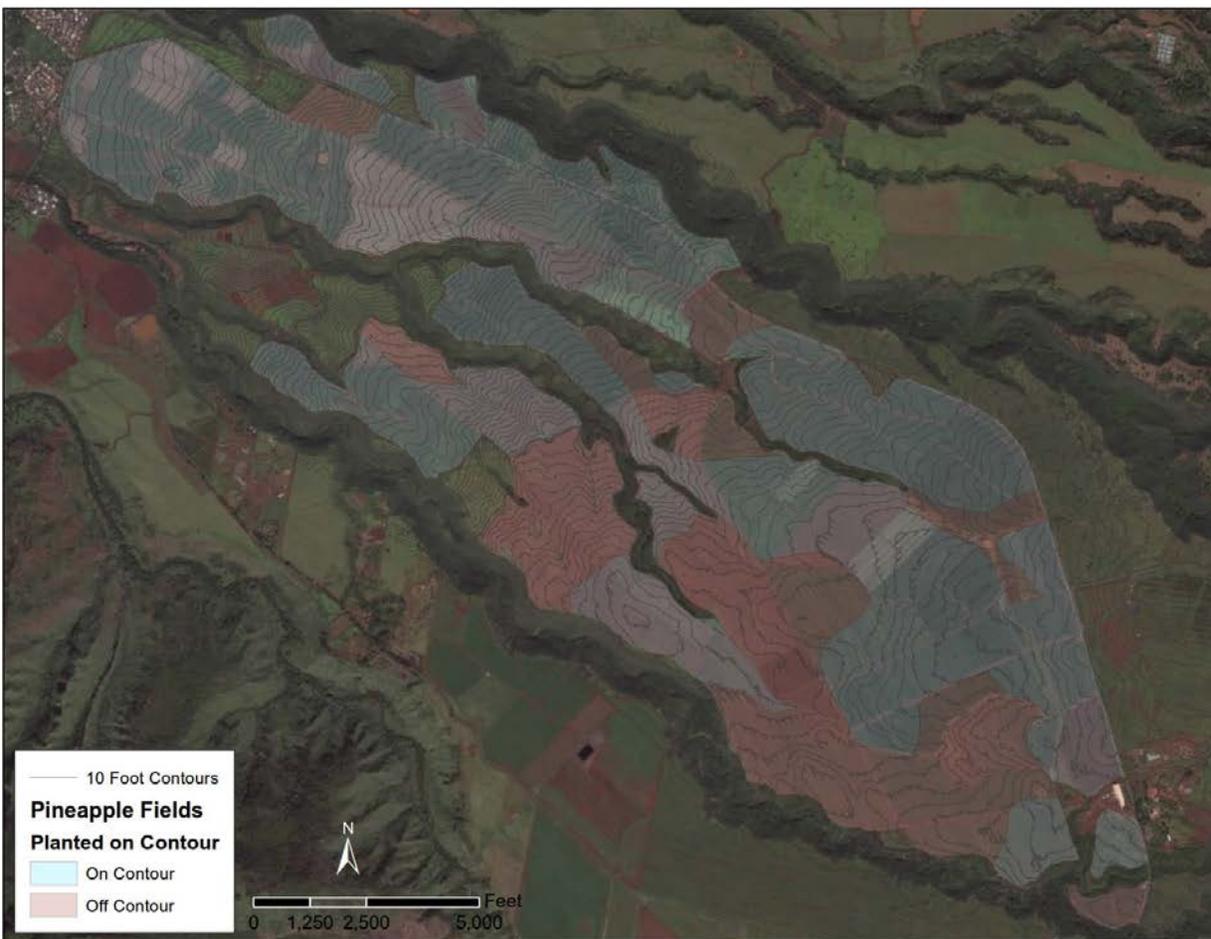
Figure 4-2. Estimated Pineapple Fields Planted on Contour

A second potential improvement would be the use of contour farming on Dole Plantation. Although the contribution of sediment to the stream system generated by pineapple operations appear to be limited, altering the orientation of the crop rows can be effective in reducing sediment transport during large rainfall events. Using contour lines developed from the LiDAR data along with aerial photography the spatial extent of pineapple crops planted on the contour were estimated. Figure 4-2 represents the initial results of the analysis. Regions of the pineapple fields with crop alignment estimated to be less the 45-degrees are represented as On Contour.

Based on the region assessed, approximately 2,660 acres are planted on the contour while 1,110 acres are not. Converting the crop alignment to follow the contour has the potential to reduce sediment wash-off by 50% while encouraging water storage and infiltration.

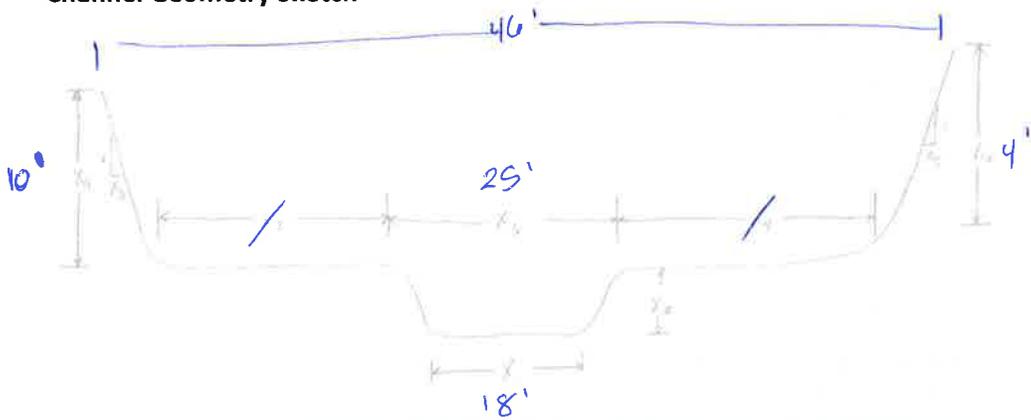
headcut reach
~15' ΔH
over 300' stream
no push up levees

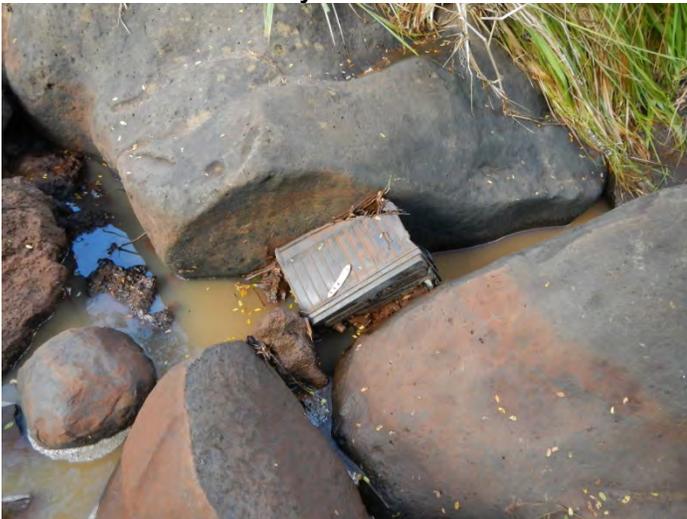
Photo #5795- Car battery in stream

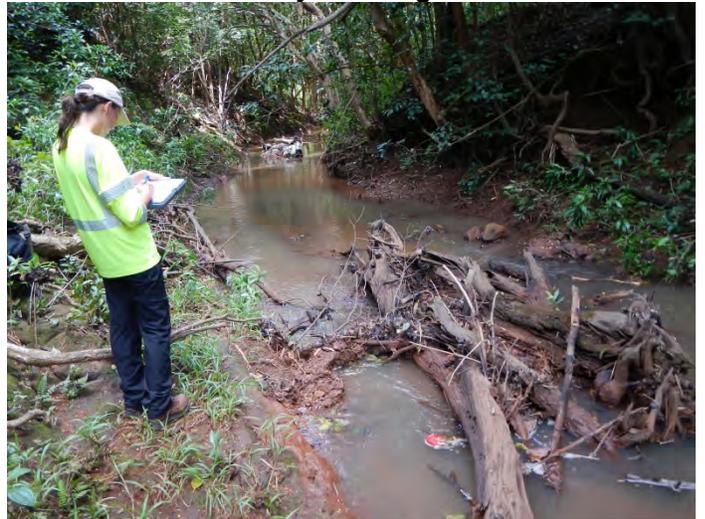
Photo #5826- Woody Debris/ gravel bar with Car
