Subject: Notice of Violation and Order
Docket No. 2025-CW-EO-44
Hawaii Water Pollution Rules and Regulations
Agricultural Road in Hanapepe
Hanapepe, Island of Kauai, Hawaii
File No. HIU010809

STATE OF HAWAII
DEPARTMENT OF HEALTH
NOTICE OF VIOLATION AND ORDER

Site Name: Hanapepe Unpermitted Grading
NGPC File No.: HIU010809

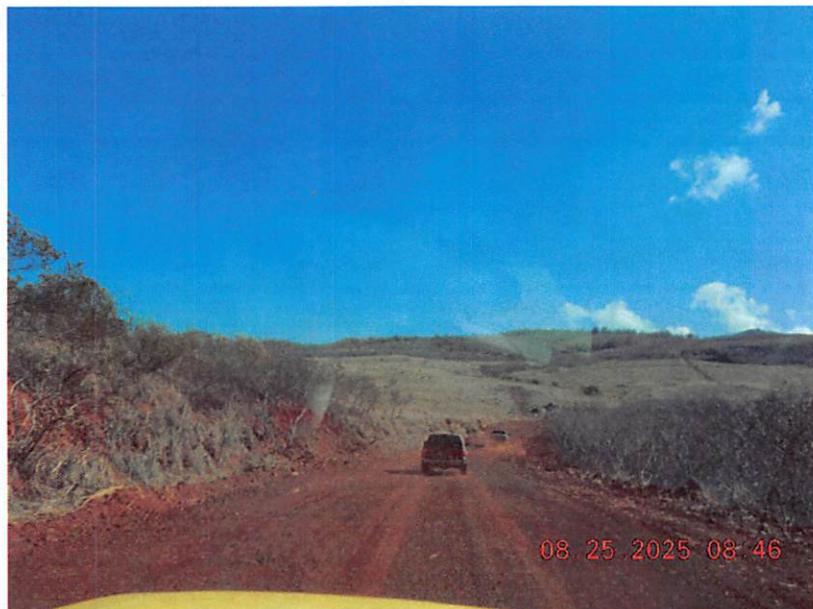
2. The inspection started at the northernmost point of Moi Road where there is an access to the Agricultural Road (Figure 1, Photograph 1). The Inspection Team entered the Agricultural Road (Photograph 2) and drove directly to the property leased by T. Brun (Brun Property). At the Brun Property, the Inspection Team observed work done on a short portion of the Agricultural Road and where the Bruns would like to lay down the soil from the DHHL project. The Inspection Team then continued back down the Agricultural Road to observe the grading work as well as a side road that extends southeast off the Agricultural Road. The inspection concluded with a visit to a short segment of the Agricultural Road south of the initial access at Moi Road; the segment meets with the DHHL Subdivision Project.

Description: View facing north of the access to the Agricultural Road off Moi Road.

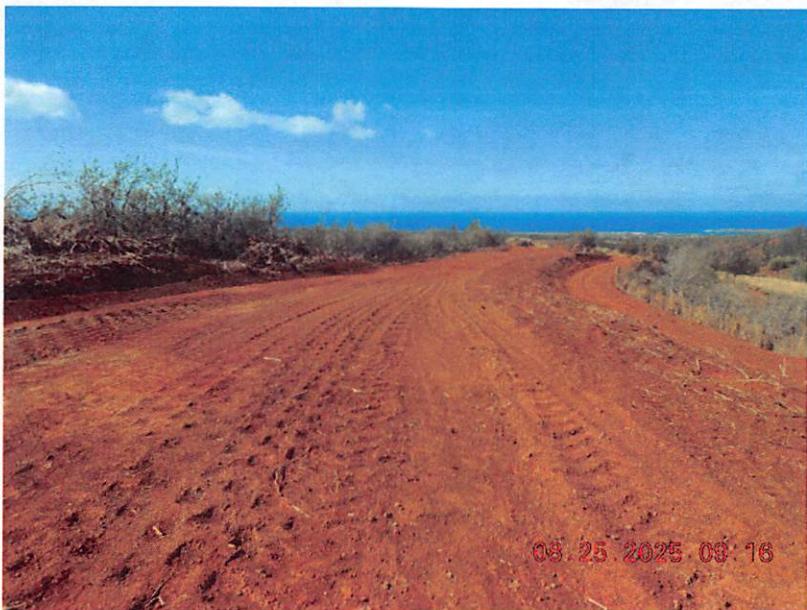
4. Within the Brun Property, we came to a gate that M. Contrades-Brun opened for us (Photograph 3). Just after entering the gate, I observed a bench adjacent and to the east of the Agricultural Road (Figure 2, Photographs 3-6).

Description: View facing north of a gate along the Agricultural Road leading into the Brun Property. A bench (yellow arrow) was present to the east of the Agricultural Road.

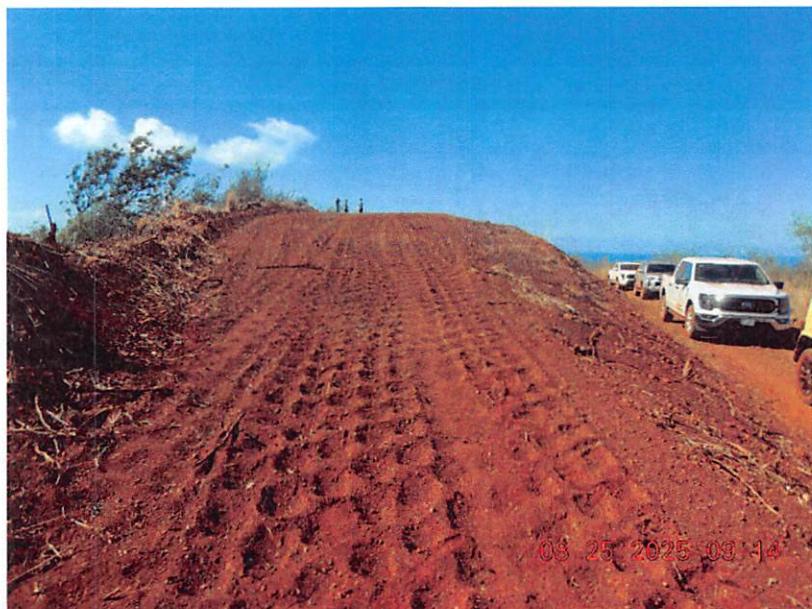
- a. B. Teixeira and I measured the width of the bench. The bench was at least thirty feet wide at some points and extended for at least 150 feet (Photograph 4). The bench appeared to reach over 12 feet high (Photograph 5-6). R. Coelho stated that HDCC had worked on the bench, but also that the bench was already existing and no material was brought in from off-site and used on the Agricultural Road or the bench. He indicated that the bench was graded to provide an additional lane that could be driven on.

Description: View facing south of the bench to the east of the Agricultural Road inside the Brun Property. Dirt and vegetation were pushed to the edges of the bench.

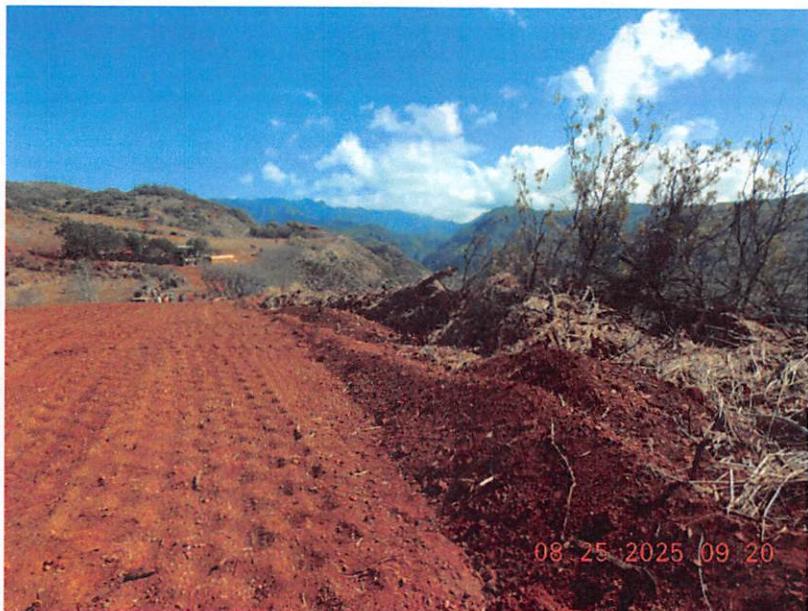
Description: View facing east of heavy equipment tracks in the bench. Some tracks were heavily compacted and shiny.

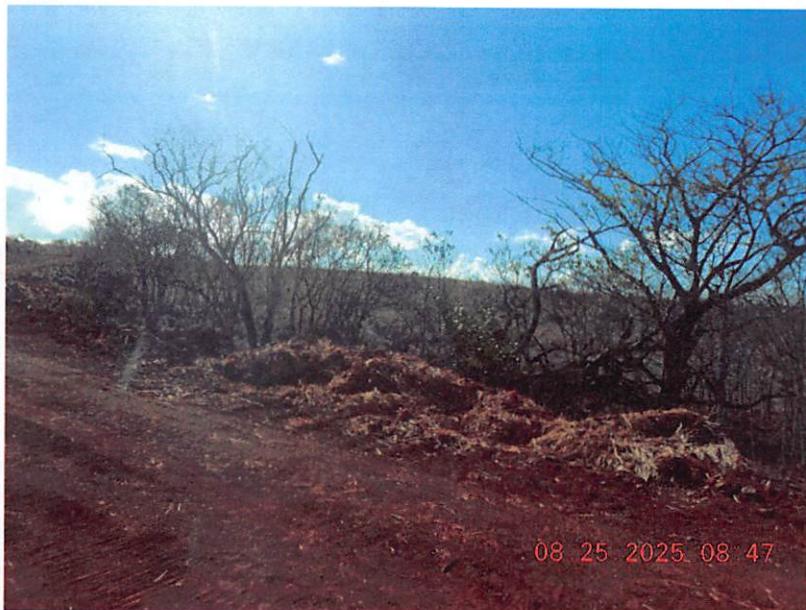
- b. In several locations, I observed areas of fresh red dirt on the side of the Agricultural Road that appeared to be turnouts or shoulders that would allow for trucks to pass as R. Coelho had previously explained (Photograph 14-15, 19-21).

Description: View facing northeast of the Agricultural Road where dirt and vegetation were pushed to the sides. The appeared to be a turnout area on the side of the road (yellow arrow).

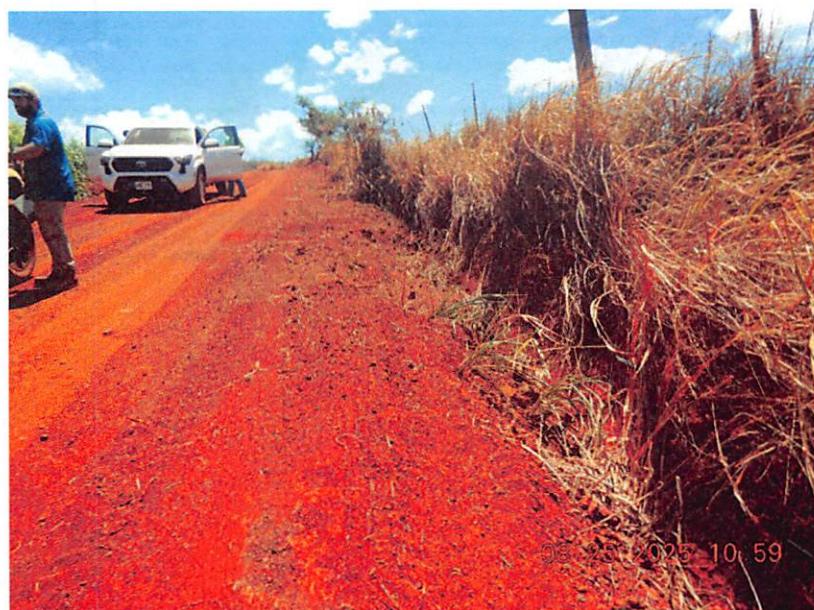
Description: View facing south of the Agricultural Road where dirt and vegetation were pushed to the side of the road and trees were pushed over.

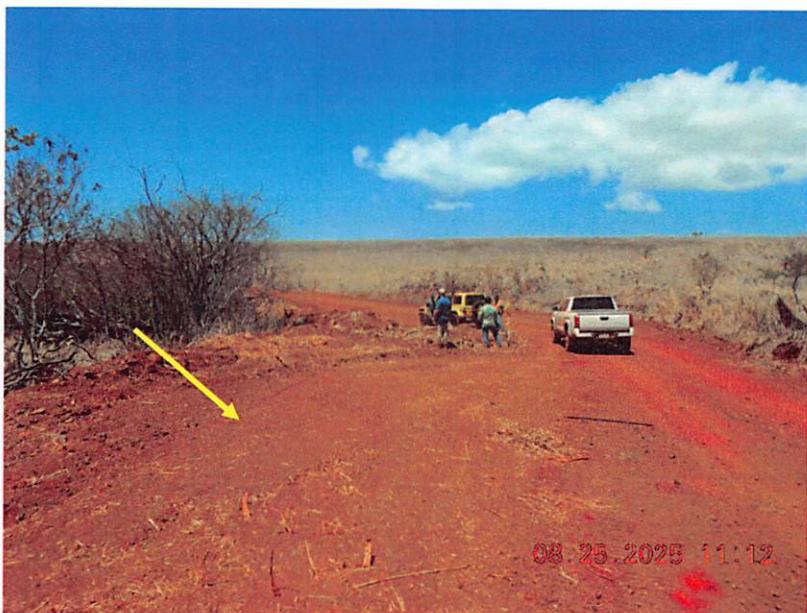
Description: View facing west of the Agricultural Road where there was a turnout area (yellow arrow). Gray rock and soil were present on a part of the road (white arrow).

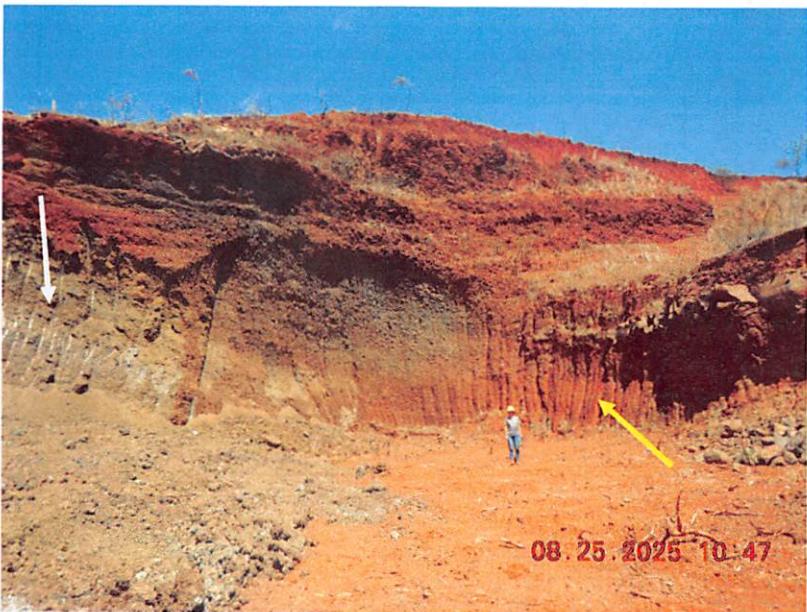
Description: Another view facing north of the quarried area along the Agricultural Road. No BMPs were implemented on the slopes or stockpiles to prevent erosion or capture sediment.

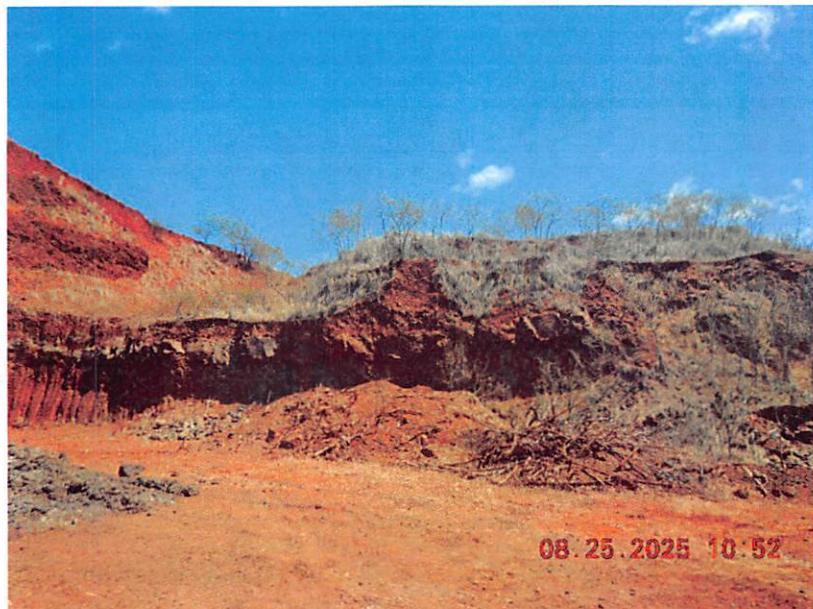
Description: View facing northwest of the quarried area along the Agricultural Road. Gray colored soil and rock were stockpiled at the foot of the quarried area.

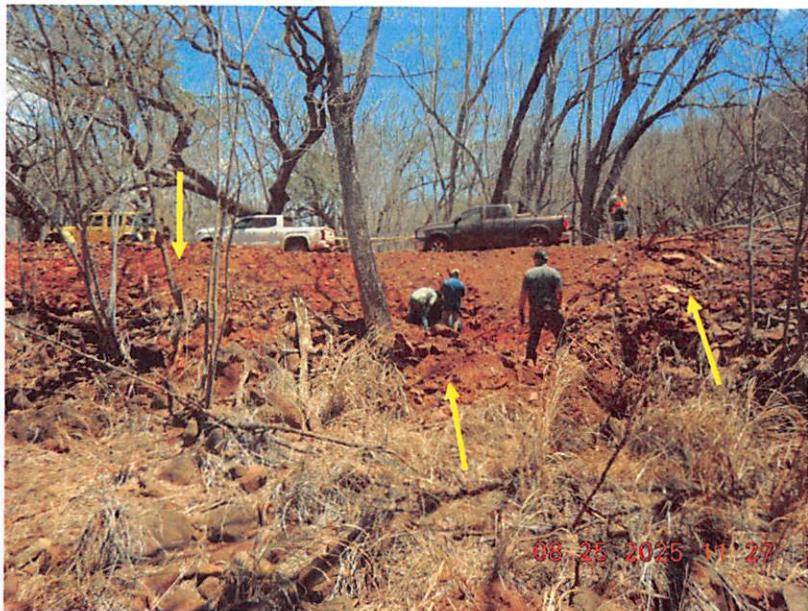
10. I observed red dirt, vegetation and rocks pushed into a gully identified as part of the Hanapepe River system (Figure 3, Photographs 28-30). The gully originated from the north (Photograph 31) and continued through a culvert that ran under the Agricultural Road (Photograph 28-29). The Hawaii Statewide GIS Program has a GIS map produced by the Department of Land and Natural Resources (DLNR), Division of Aquatic Resources (DAR), that identifies the gully as a tributary to the Hanapepe River system.

Description: View facing north of the gully that is a tributary to the Hanapepe River system (yellow arrow). This portion of the gully is upstream of the Agricultural Road.

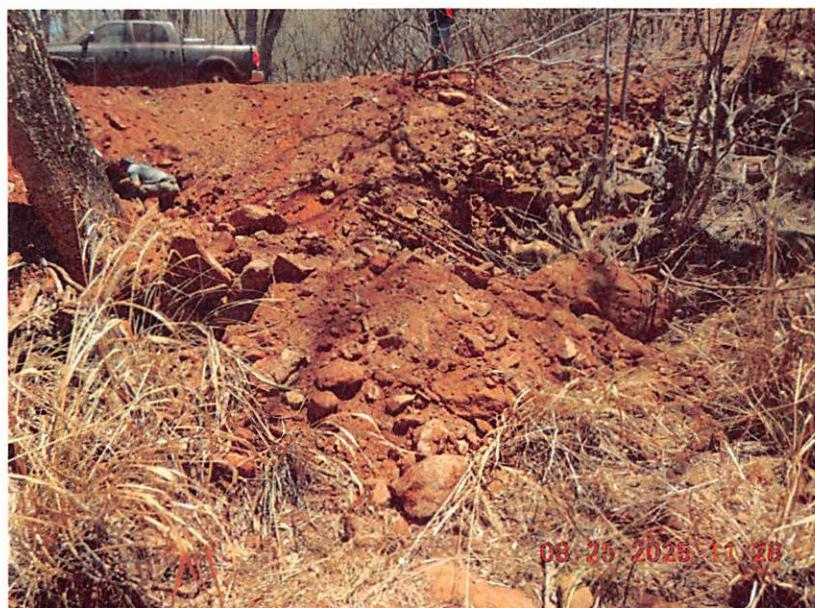
11. I observed red dirt, vegetation and rocks pushed into Kapahili Gulch (Photographs 32-37). The red dirt was loose and fluffy, and appeared to be a recent discharge. Further indicating a discharge into Kapahili Gulch, the dirt and rocks were red and contrasted against the lighter brown dirt and rocks at the gulch floor and in an upstream portion of the gulch.

Description: View facing east of red dirt and rocks pushed into Kapahili Gulch from the Agricultural Road.

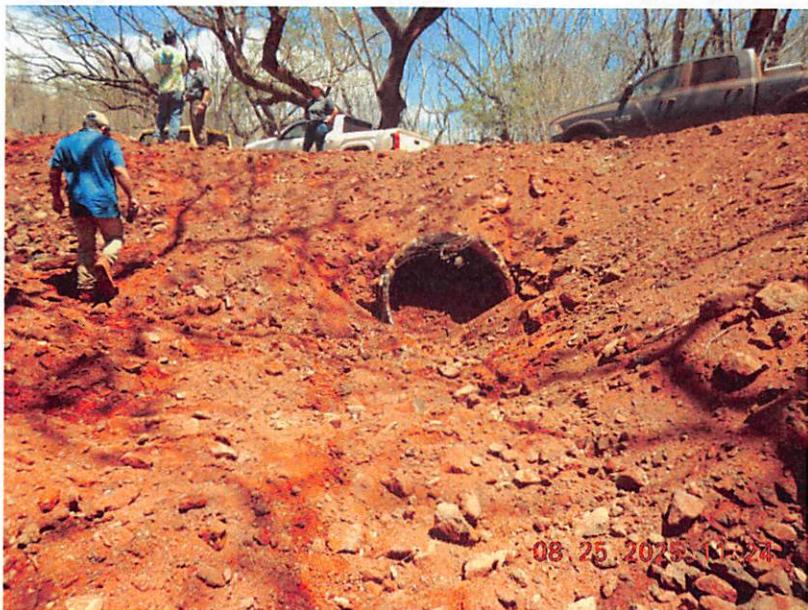
Description: Another view facing north of the red dirt, rocks, and vegetation (yellow arrow) pushed into Kapahili Gulch from the Agricultural Road. The material was red in color, contrasting with the brown rocks and vegetation (white arrow) in the gulch.

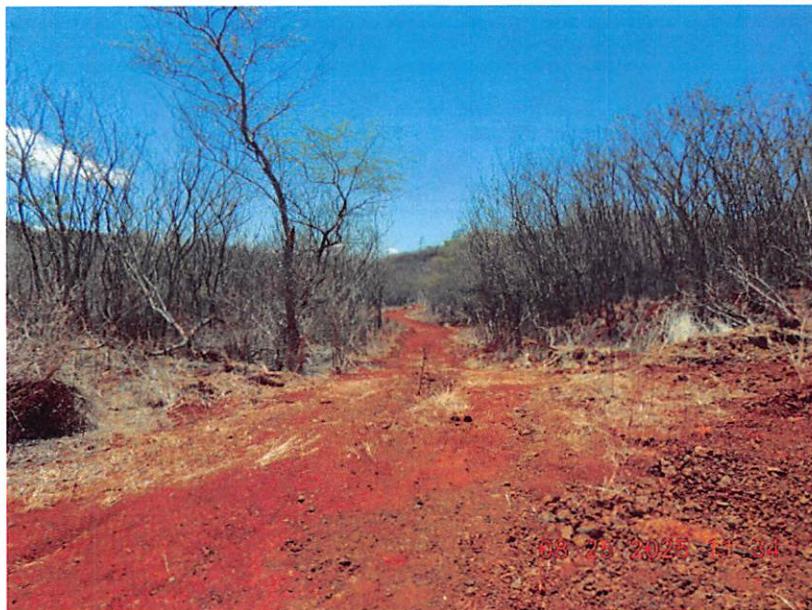
- c. R. Grenier and B. Teixeira measured the extent of the dirt and rocks pushed into the gulch (Photograph 37). The material extended approximately 24 feet into Kapahili Gulch from the Agricultural Road and was approximately 27 feet at its widest (Photographs 32 and 37).

Description: View of the Inspection Team measuring the extent of the red dirt, rocks, and vegetation pushed into Kapahili Gulch. Note the contrast in color between the red dirt and rocks of the discharge and the light brown rocks and yellow-brown vegetation in the gulch.

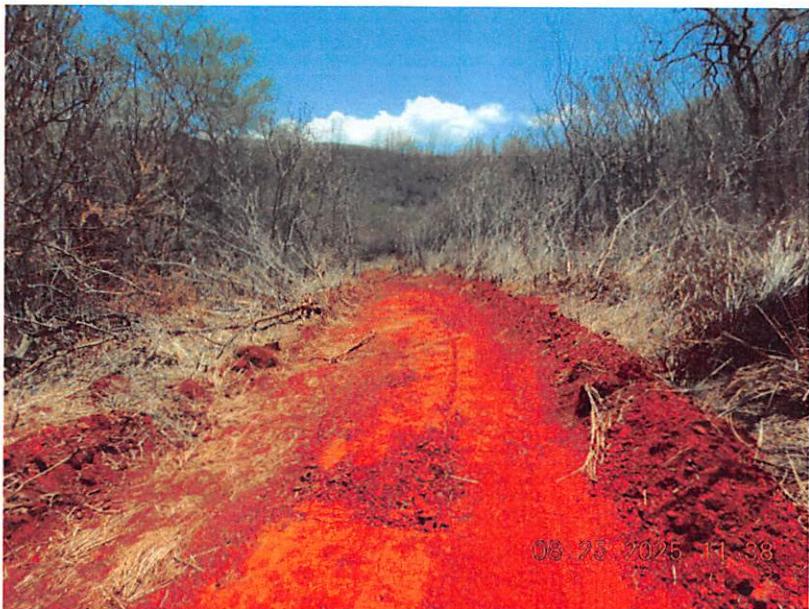
- a. The Inspection Team walked the length of the Side Road and R. Grenier took GPS points along the road. Based off the GPS points, the Side Road is approximately 1,375 feet in length. The Inspection Team measured the width of the Side Road at approximately eleven (11) feet and eight (8) inches wide. After the inspection, I calculated the area of the Side Road to be approximately 0.34 acres.
- b. I observed dirt, dried vegetation and tree branches pushed along the edges of the Side Road, indicating it had recently been disturbed and grubbed (Photographs 39-41).

Description: View facing north of the Side Road. Dirt is pushed to the sides of the road and vegetative debris was on the road. The Agricultural Road (yellow arrow) can be seen at the end of the Side Road.

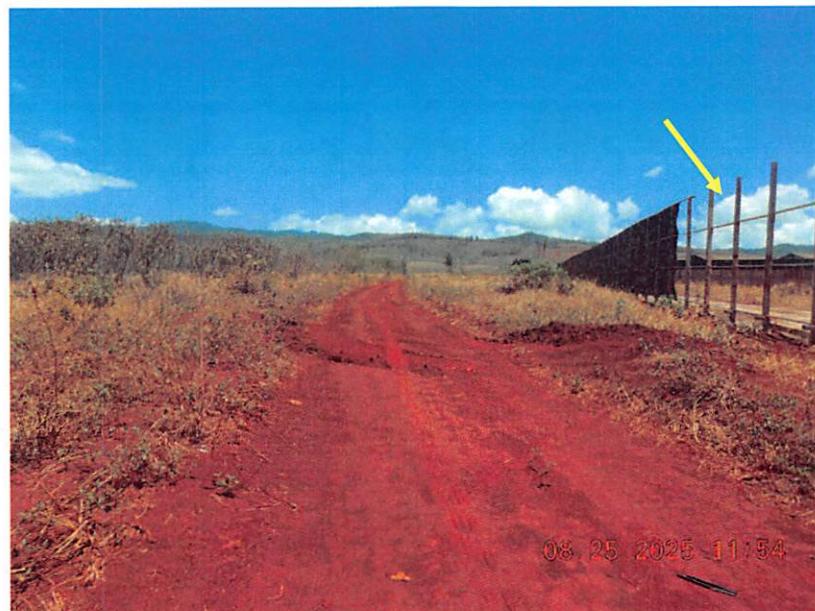
- c. The Side Road terminated at a dead end (Photograph 41). Near the terminus of the Side Road, I observed a few small stockpiles of dirt on the side of the road. I observed grubbed grass and trees on the sides of the road.
- d. I did not observe any BMPs along the Side Road or installed around stockpiles to prevent erosion and control sediment. However, the Side Road is generally flat, which helps to lower the potential for polluted storm water discharges.

Description: View facing south of the end of the Side Road. A few stockpiles of dirt (yellow arrows) were on the side of the road along with grubbed grass and trees.
