STATE OF HAWAII  
DEPARTMENT OF HEALTH  
P. O. BOX 3378  
HONOLULU, HI 96801-3378

**Subject: Notice of Violation and Order**  
**Docket No. 2021-CW-EO-47**  
**Hawaii Water Pollution Rules and Regulations**  
**Paradise Beverages, Inc.**  
**94-1450 Moaniani Street, Waipahu, Island of Oahu**  
**TMK: (1) 9-4-128:002**

**Complaint Investigation Report**  
**Figure Log**  
 Site Name: Paradise Beverage  
 Permit No.: HIU010639

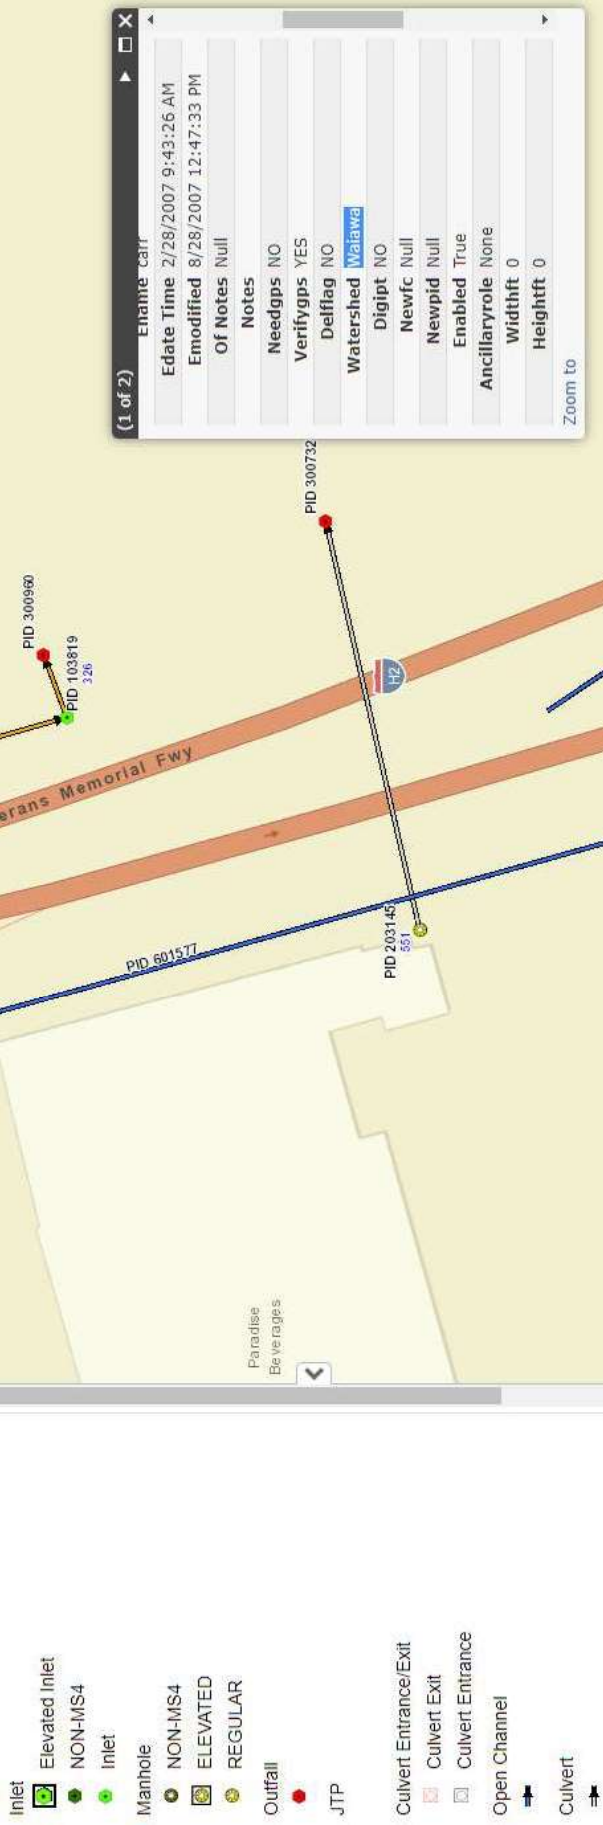
**Image 2:** Aerial view of the location of the City and County of Honolulu 84-inch reinforced concrete pipe. PID 300732 represents the Outfall, and PID 203145 defines the inlet where M. Dean was during the dye inspection on November 15, 2021. The image is from the Storm Water Asset Management System website of the State of Hawaii Department of Transportation, Highways Division, Oahu District.

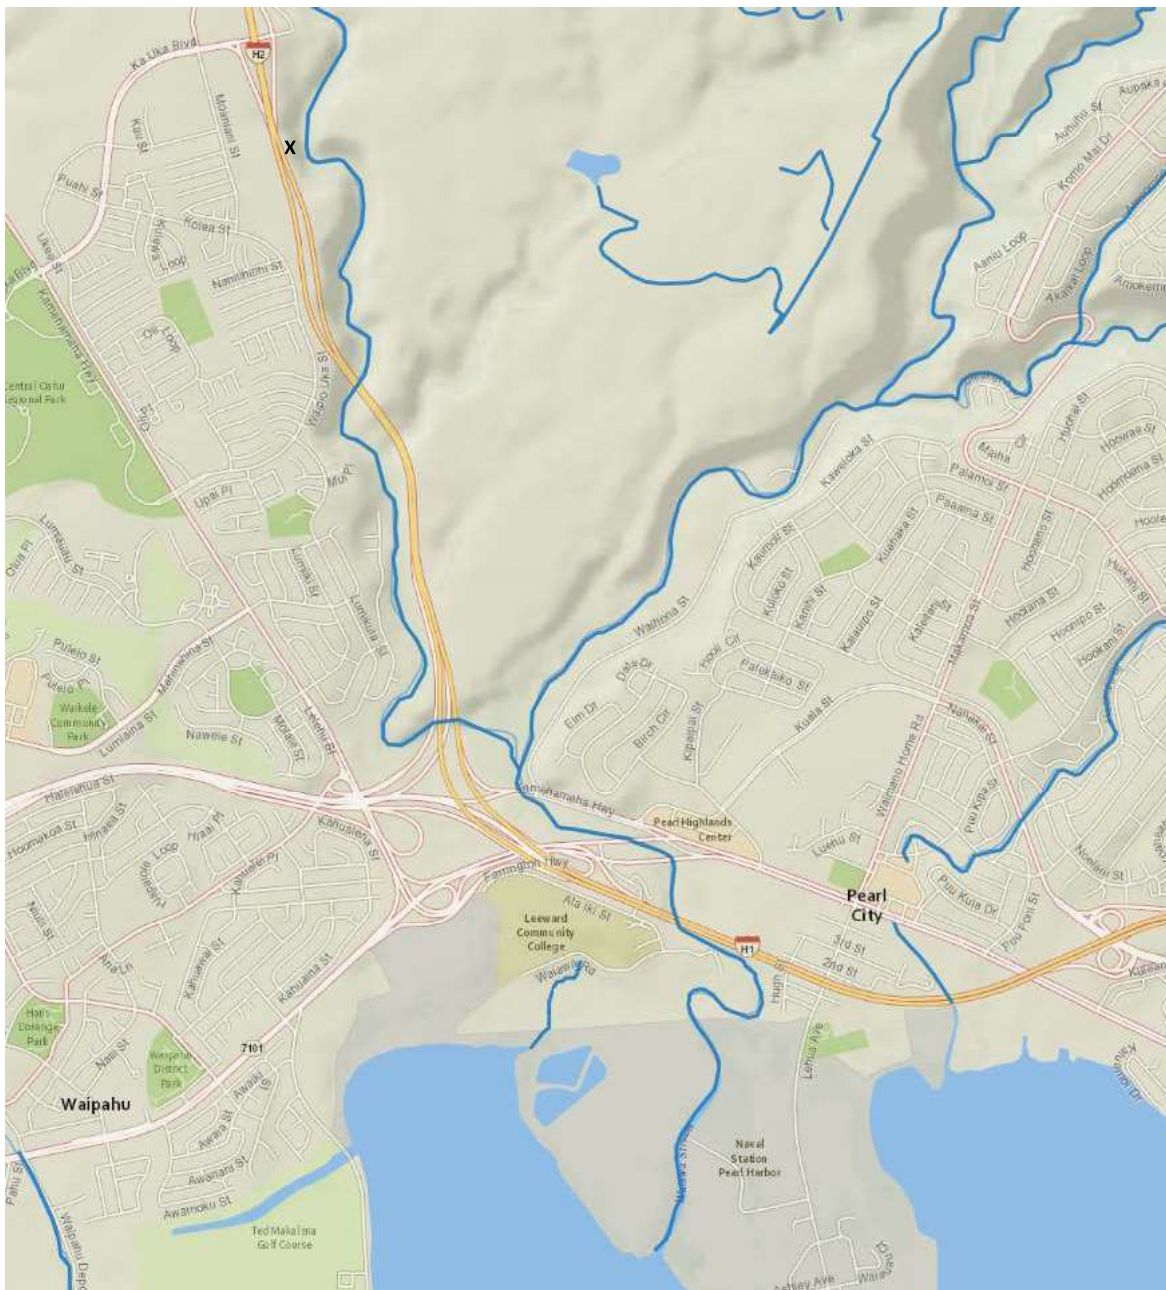
Waiawa Stream (refer to Image 3) is a Class 2 Inland State water. Discharges from the Outfall flow into Waiawa Stream.

**Image 3:** Aerial view of the Waiawa Stream Watershed. The image is from the Hawaii Statewide GIS Program – Streams Database. Note the X represents the approximate location of the Outfall.

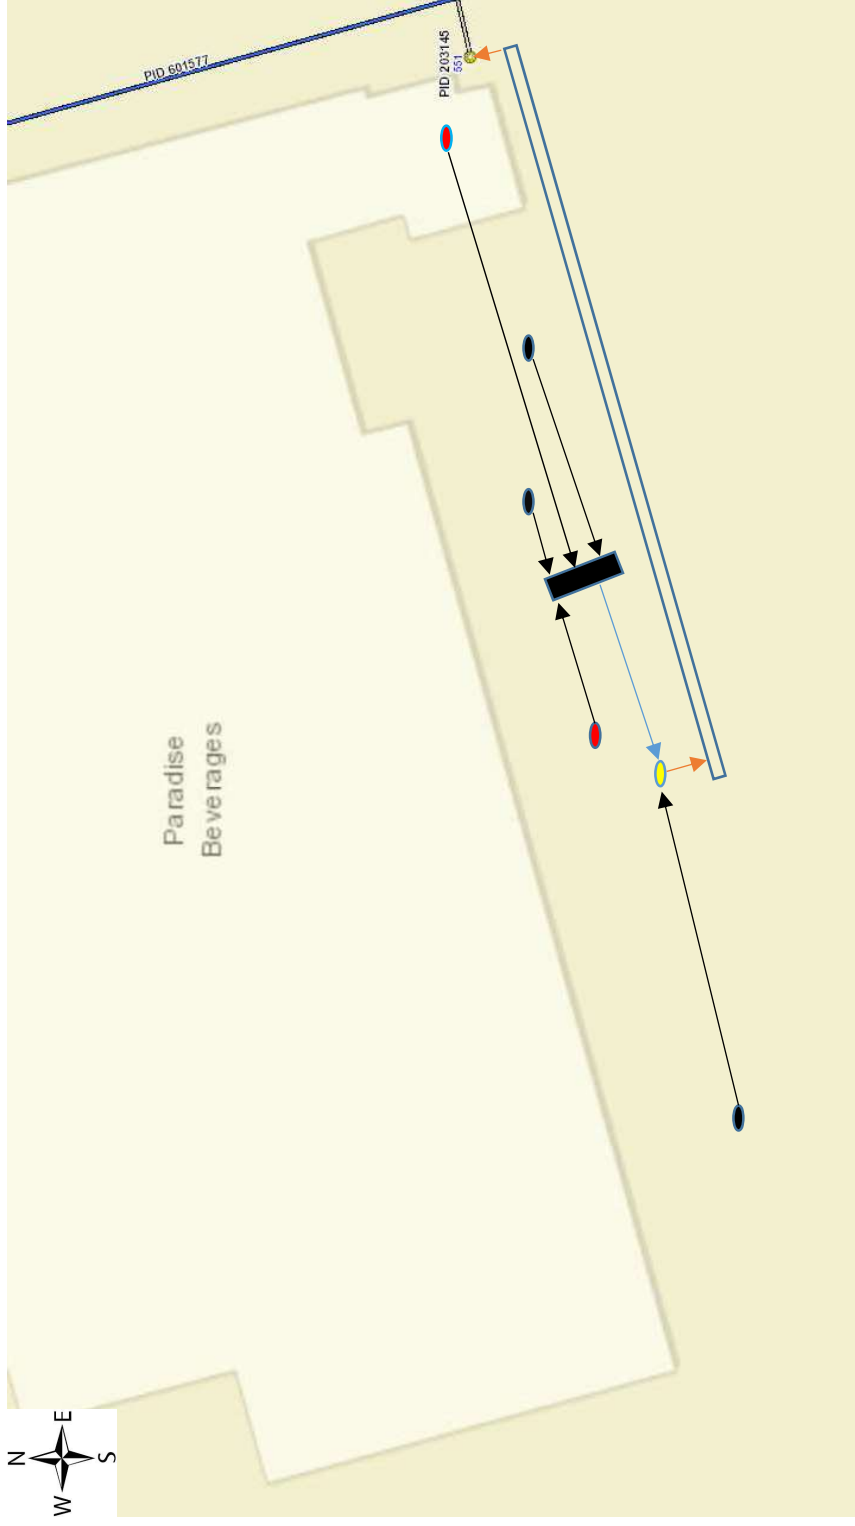
The dye tests confirmed that the drain inlets in the Facility's receiving area and maintenance bay connect to the Outfall located on the east side of Interstate H-2 (refer to Image 4). The investigation did not determine the sources of all connections entering into the Facility's drainage system junction box; however, dye tests confirmed that fluid in the Facility's storm drain system on the southeast side of the Facility is discharged through the Outfall.

**Image 4:** Aerial view of the Facility. The image shows the location and interconnection of the storm water drain inlets in the Facility's receiving area and maintenance bay. The black ovals represent three (3) drain inlets that were not dye tested; instead, we run water to confirm they all are discharged into the junction box. The red ovals represent two (2) drain inlets where fuchsia dye was poured. The junction box is represented with a yellow oval. The storm drain inlet on the west discharges through a pipe at the bottom of the junction box. The rest of the inlets (4) drain off through the same pipe after passing a valve system (black box).

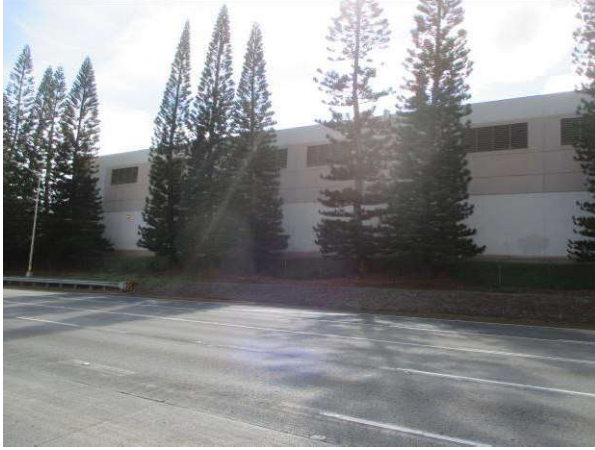
TMK: 9-4-128:002: View of parcel along Interstate Route H-2 (H-2) (State Road) facing west. (IMG\_001)

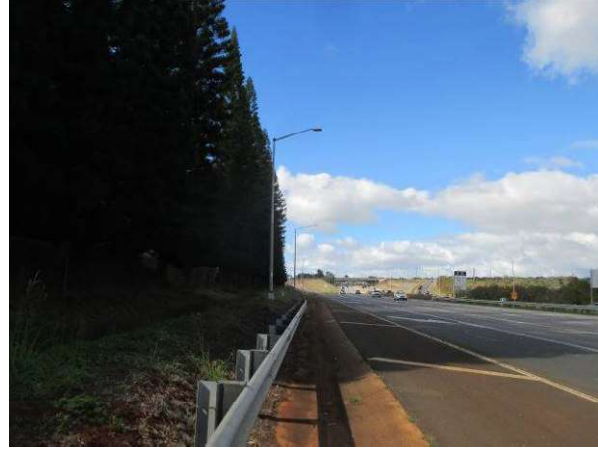
TMK: 9-4-128:002: View of H-2 adjacent to the parcel facing northwest, parcel to the left. (IMG\_002)

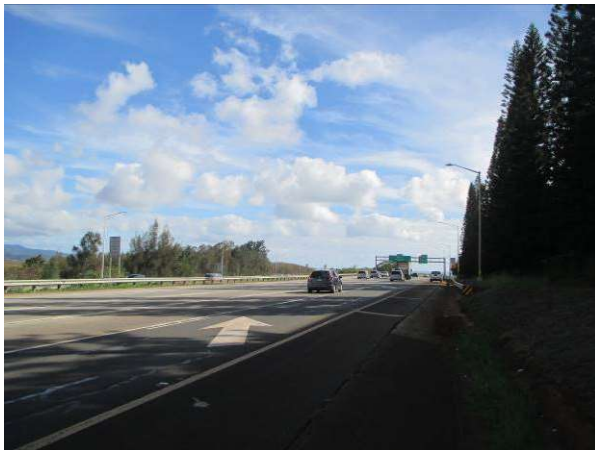
TMK: 9-4-128:002: View of H-2 adjacent to the parcel facing southeast, parcel to the right. (IMG\_003)

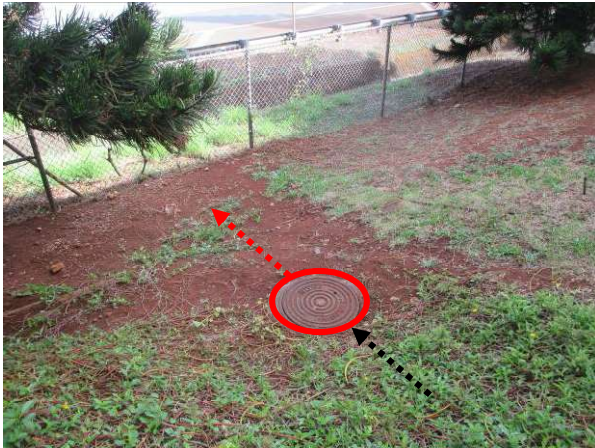
TMK: 9-4-128:002: State Highways Division storm drain manhole (SDMH) (PID 203145) located near the southeastern perimeter of the property with access to the CCH 84-inch RCP and a State Highways Division 84-inch corrugated metal pipe (CMP) culvert (PID 700670). (IMG\_009)
