SUBJECT: DESTRUCTIVE ANALYSIS OF 10 STEEL COUPONS REMOVED FROM RED HILL FUEL STORAGE TANK NO. 14, PURSUANT TO SECTION 5.3 OF THE ADMINISTRATIVE ORDER ON CONSENT STATEMENT OF WORK, RED HILL BULK FUEL STORAGE FACILITY, JOINT BASE PEARL HARBOR-HICKAM, OAHU, HAWAII

Destructive Analysis of 10 Steel Coupons Removed from Red Hill Fuel Storage Tank #14

REPORT No. 201801967

December 17, 2018

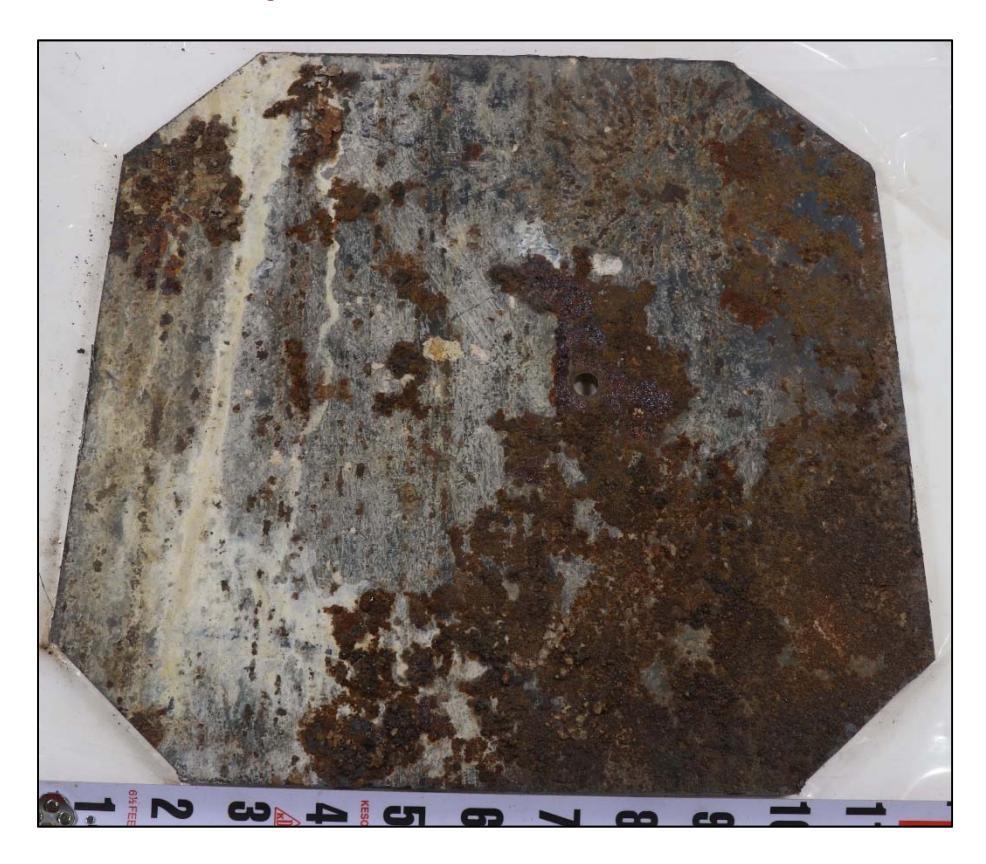
Figure 1. An image of the interior surface of Coupon 1 in the as-received condition.

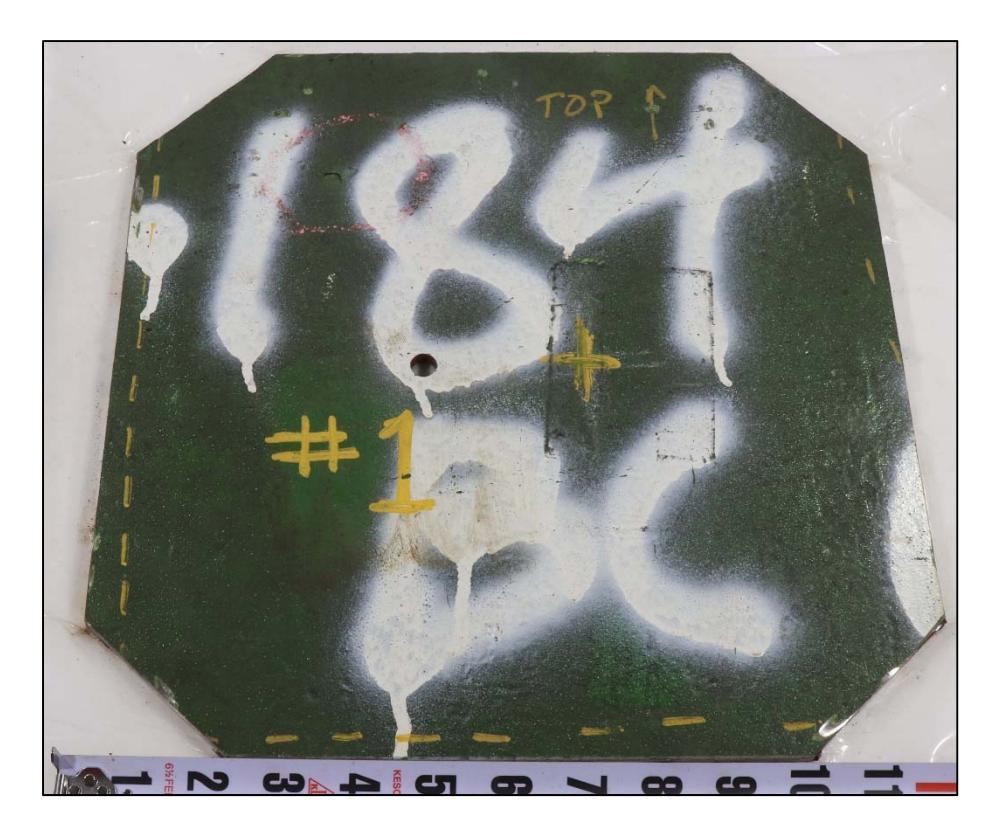
Figure 2. An image of the exterior surface of Coupon 1 in the as-received condition.

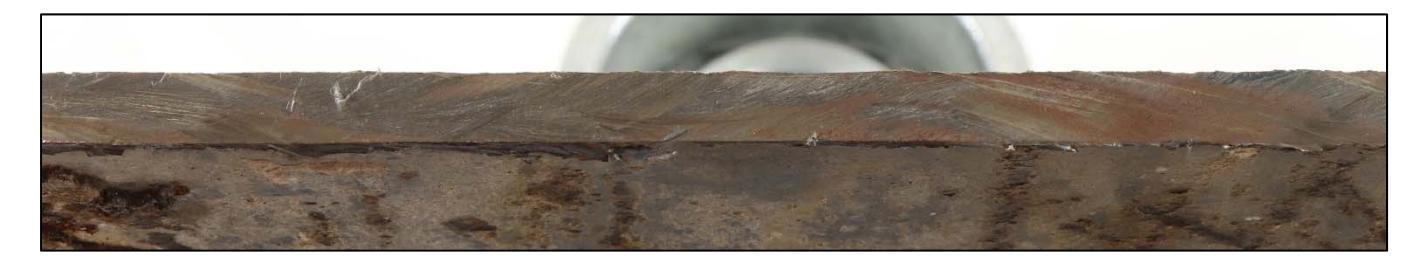
Figure 3. An image of a representative edge of Coupon 1 in the as-received condition.

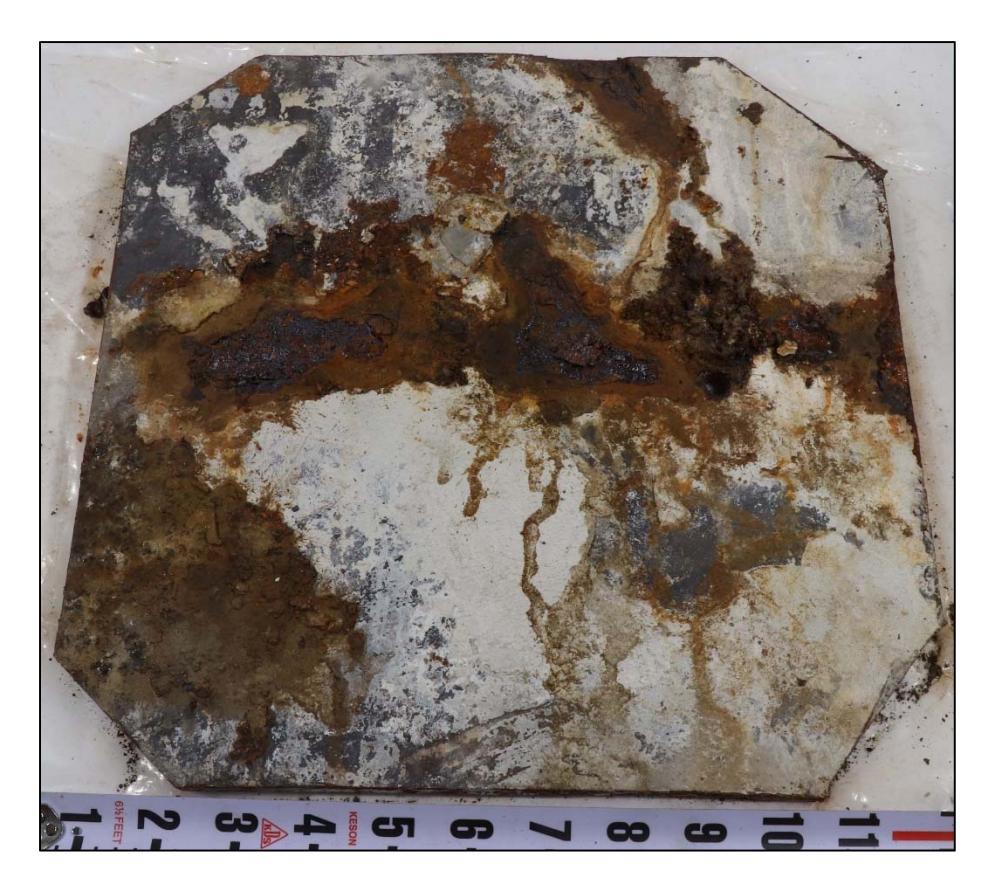
Figure 4. An image of the interior surface of Coupon 2 in the as-received condition.

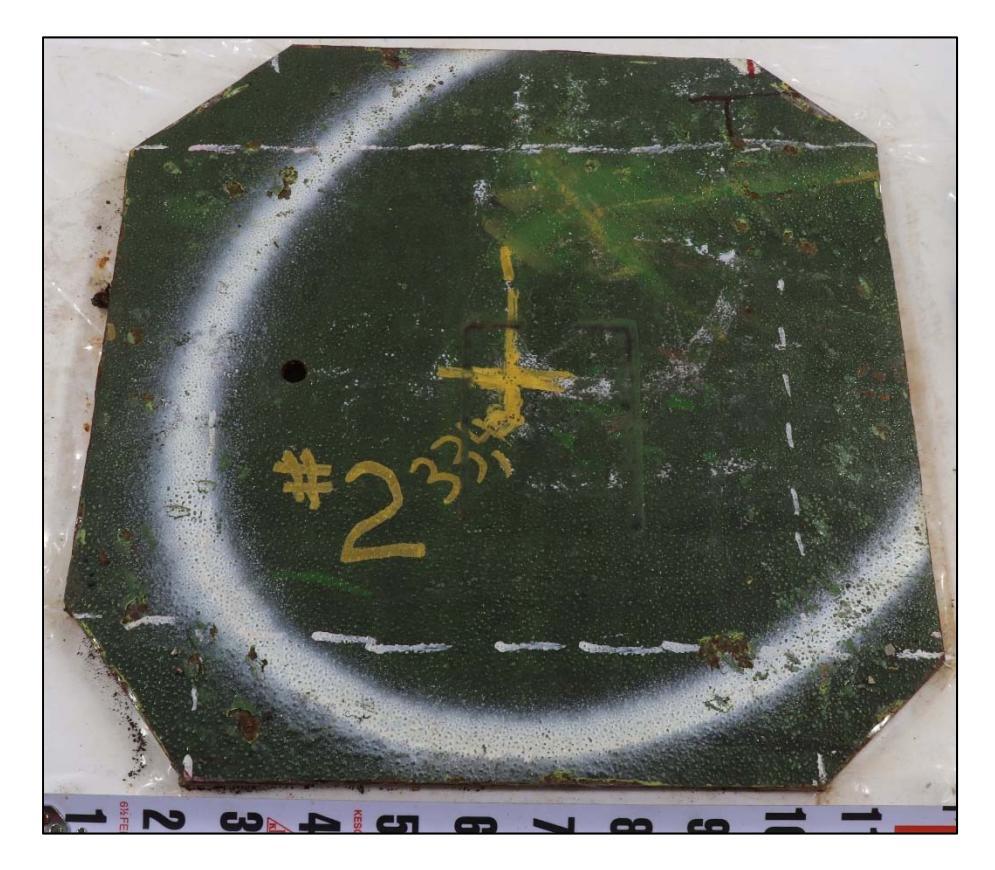
Figure 5. An image of the exterior surface of Coupon 2 in the as-received condition.

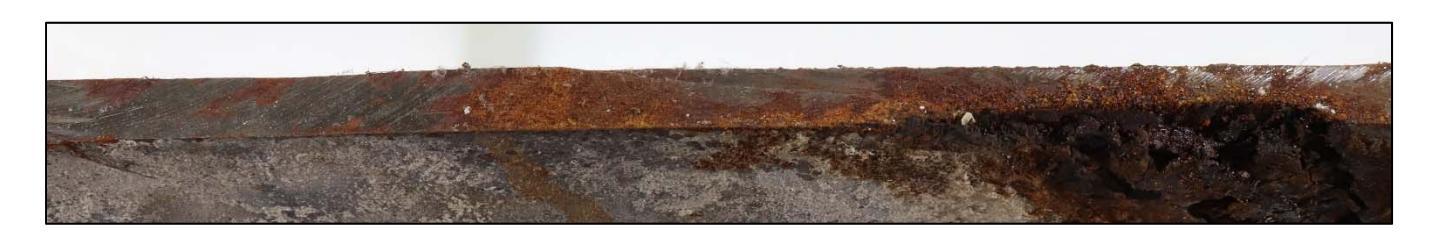
Figure 6. An image of a representative edge of Coupon 2 in the as-received condition.

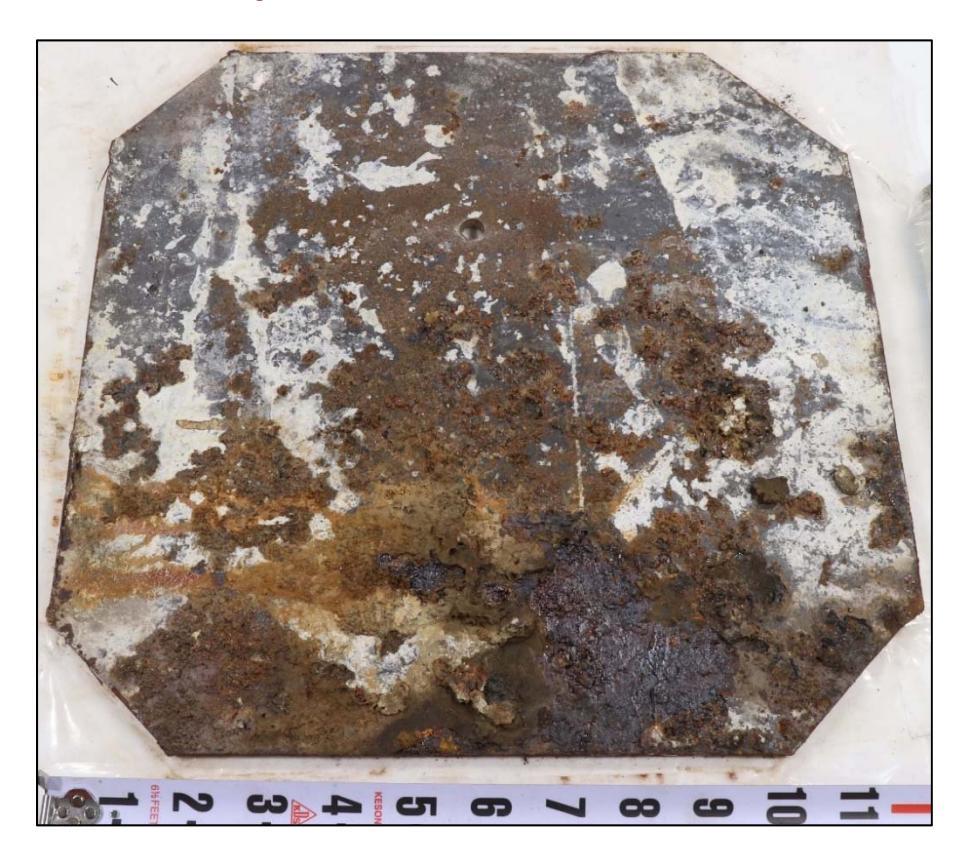
Figure 7. An image of the interior surface of Coupon 3 in the as-received condition.

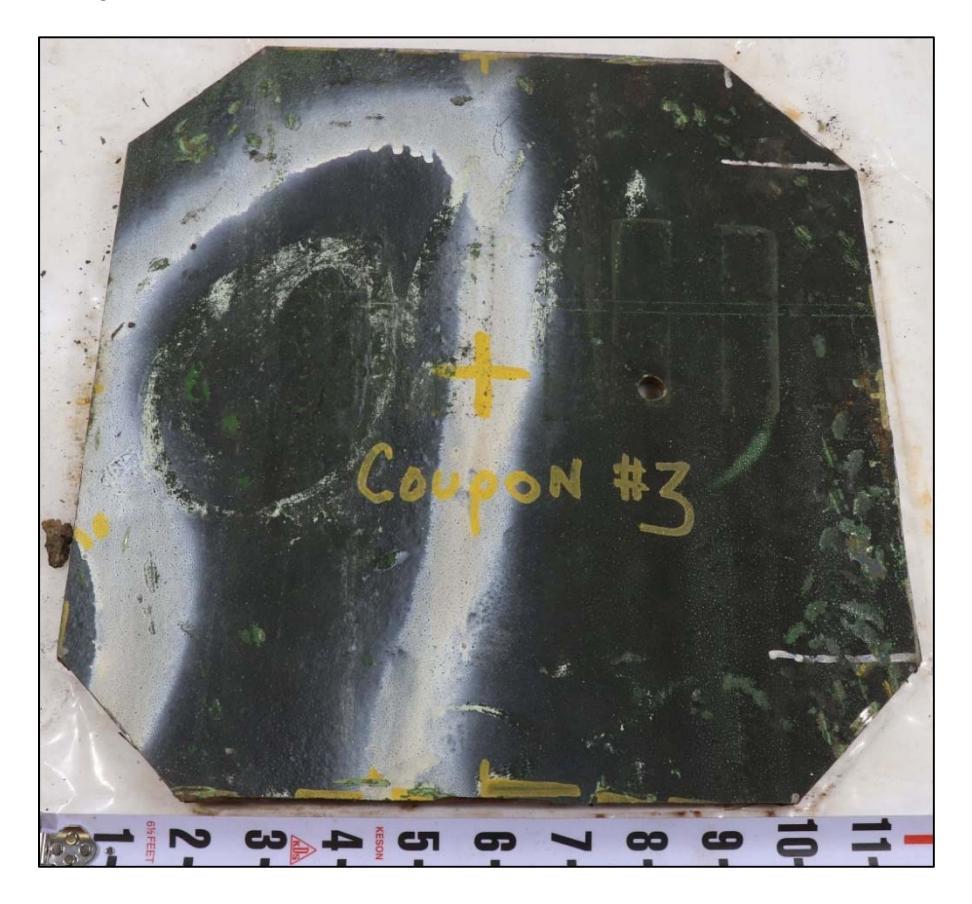
Figure 8. An image of the exterior surface of Coupon 3 in the as-received condition.

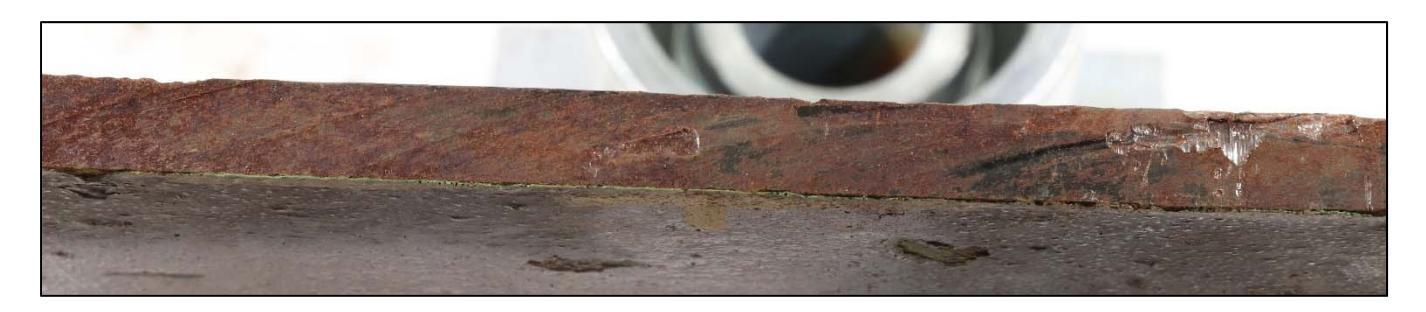
Figure 9. An image of a representative edge of Coupon 3 in the as-received condition.

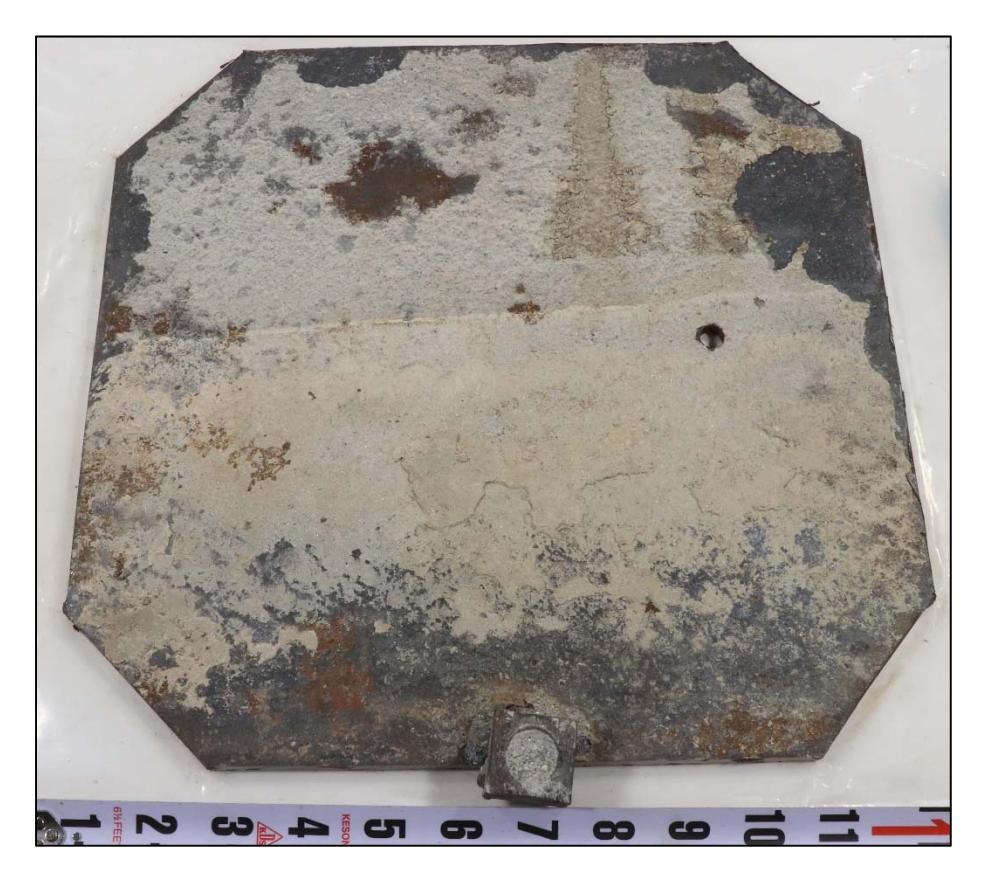
Figure 10. An image of the interior surface of Coupon 5 in the as-received condition.

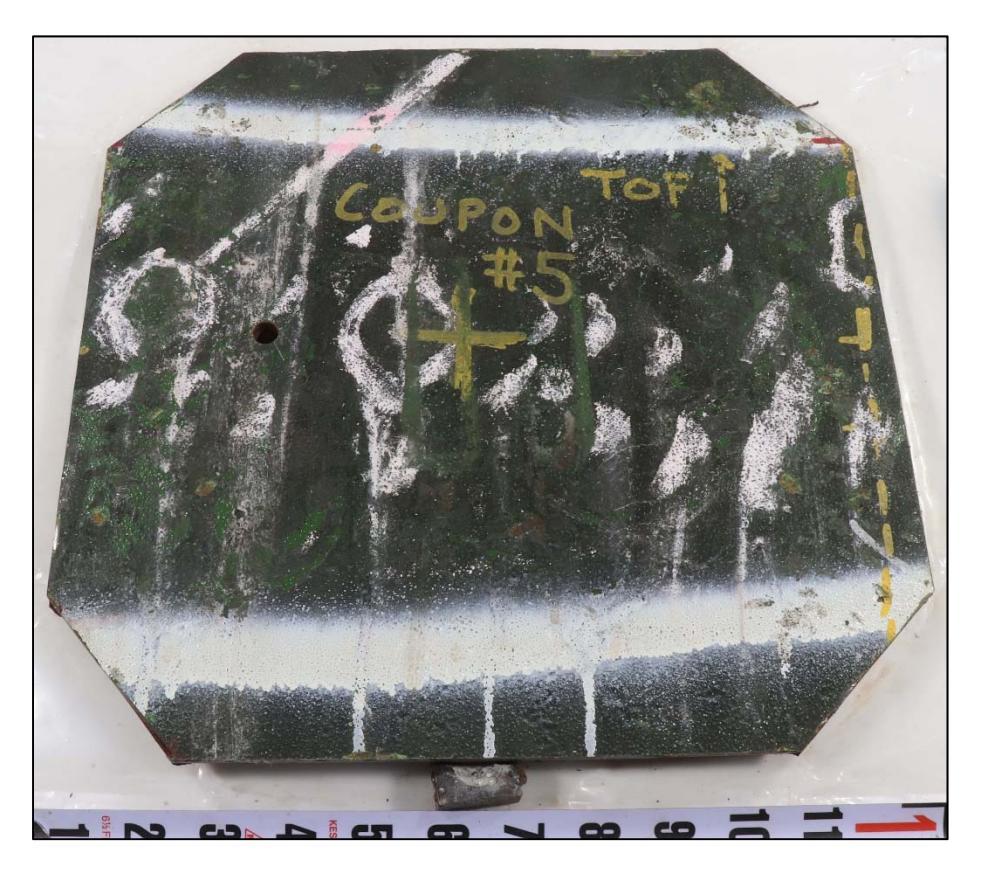
Figure 11. An image of the exterior surface of Coupon 5 in the as-received condition.

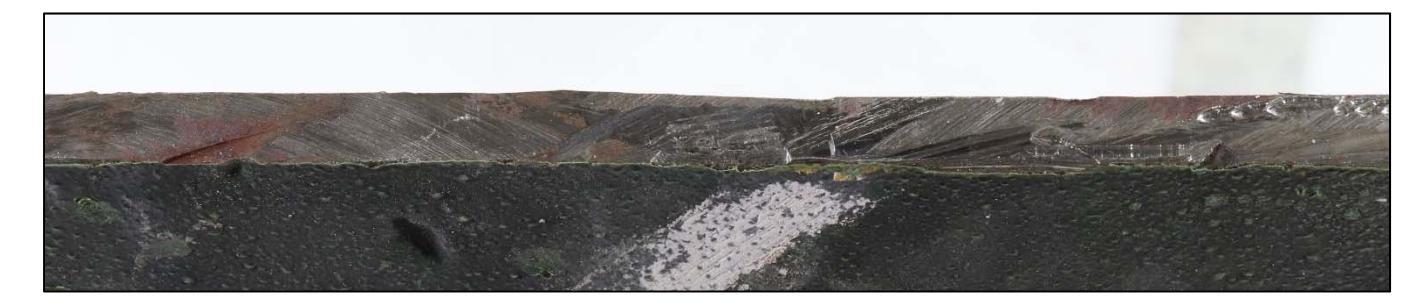
Figure 12. An image of a representative edge of Coupon 5 in the as-received condition.

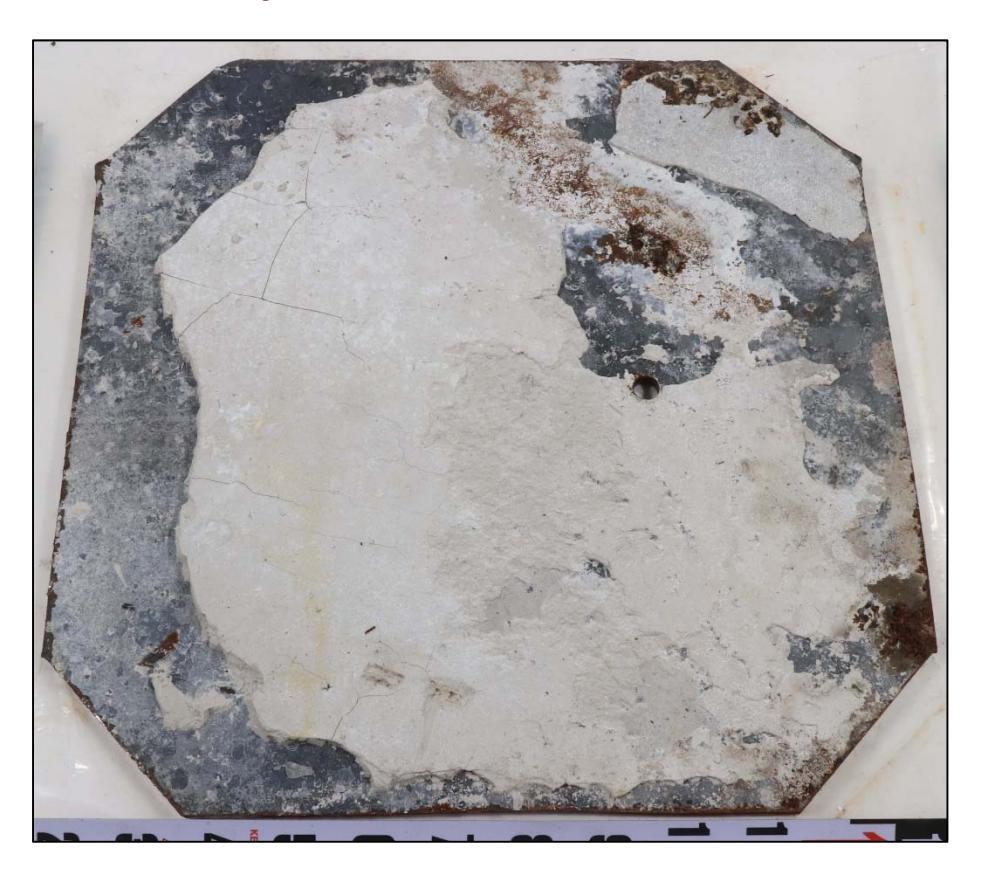
Figure 13. An image of the interior surface of Coupon 6 in the as-received condition.

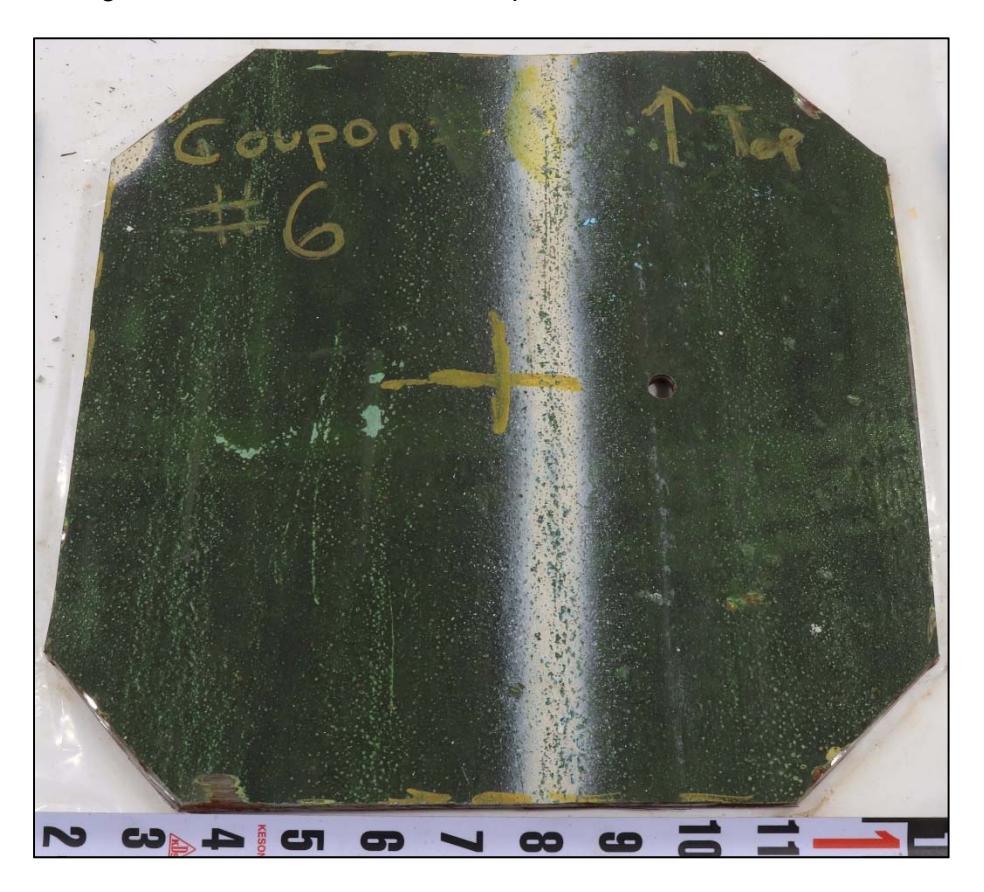
Figure 14. An image of the exterior surface of Coupon 6 in the as-received condition.

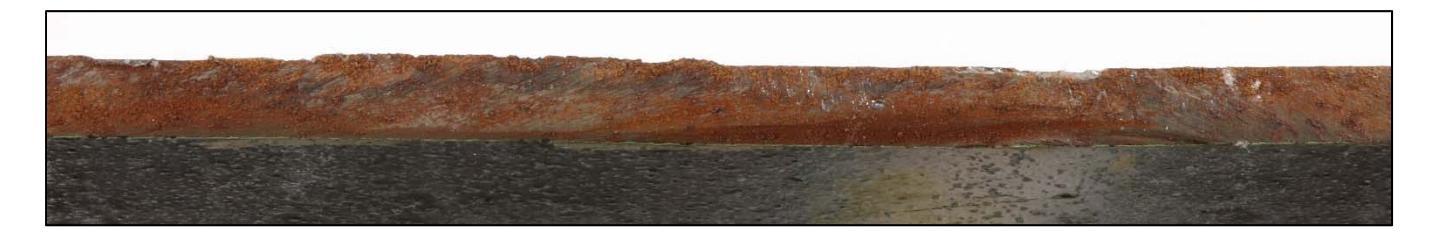
Figure 15. An image of a representative edge of Coupon 6 in the as-received condition.

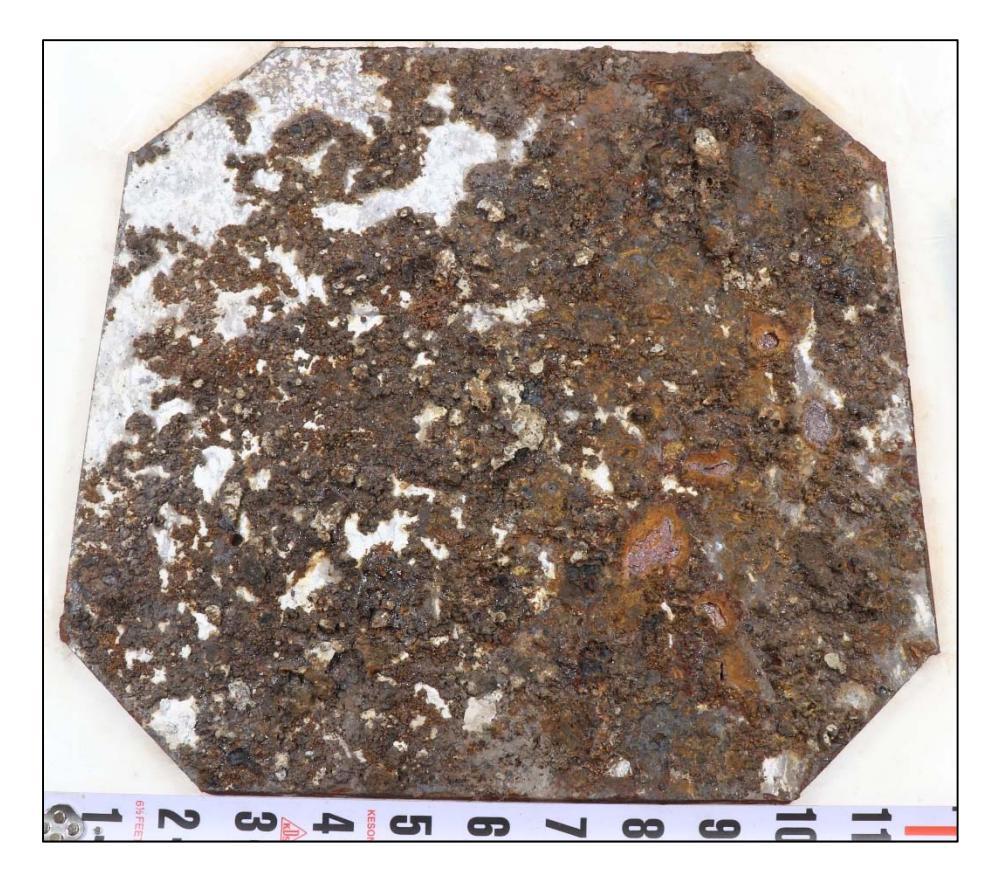
Figure 16. An image of the interior surface of Coupon 7 in the as-received condition.

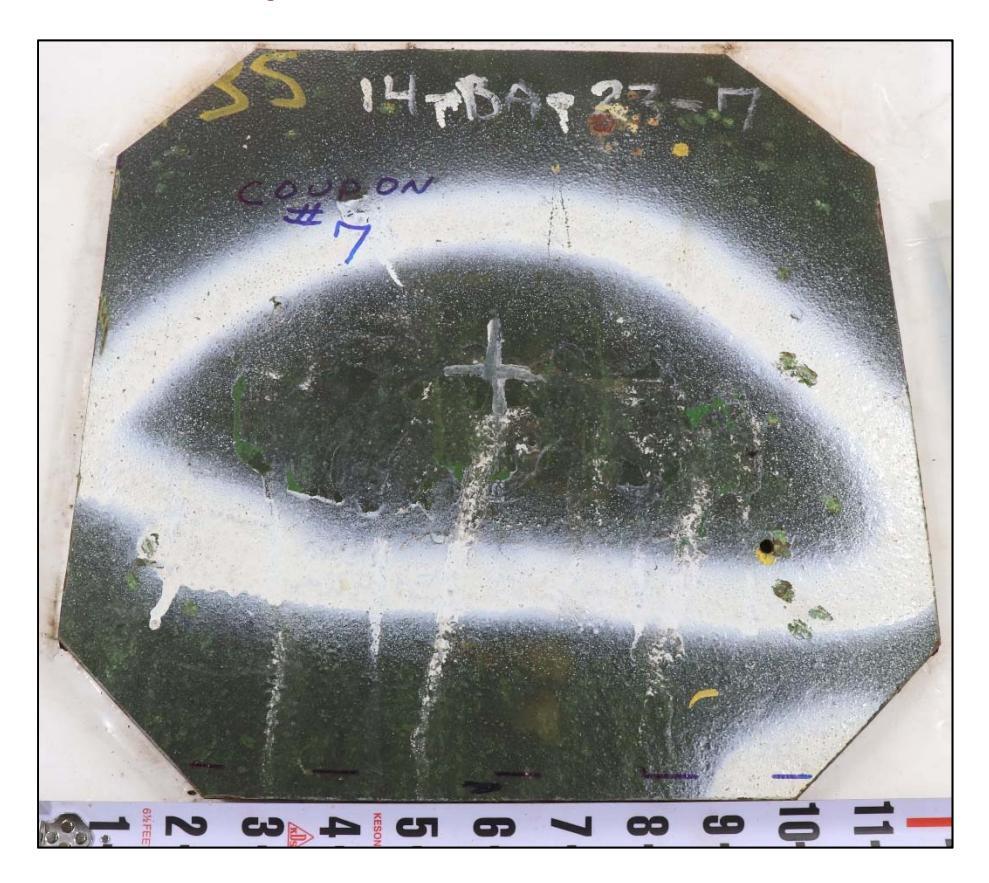
Figure 17. An image of the exterior surface of Coupon 7 in the as-received condition.

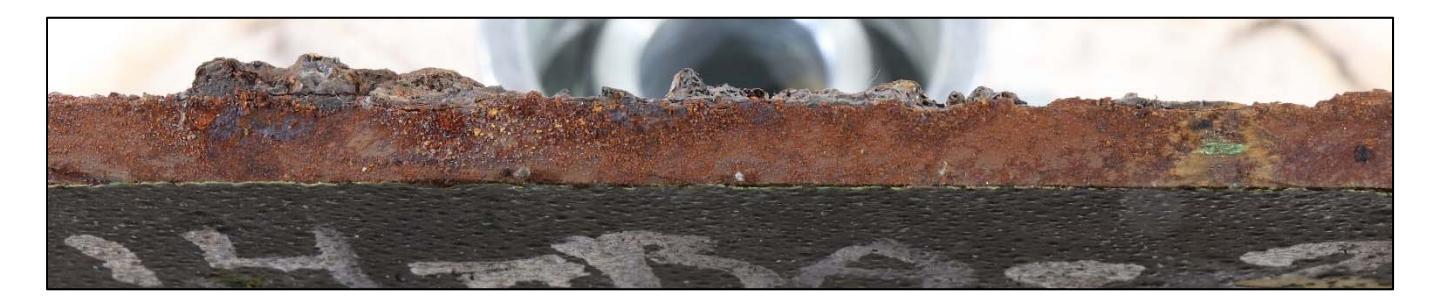
Figure 18. An image of a representative edge of Coupon 7 in the as-received condition.

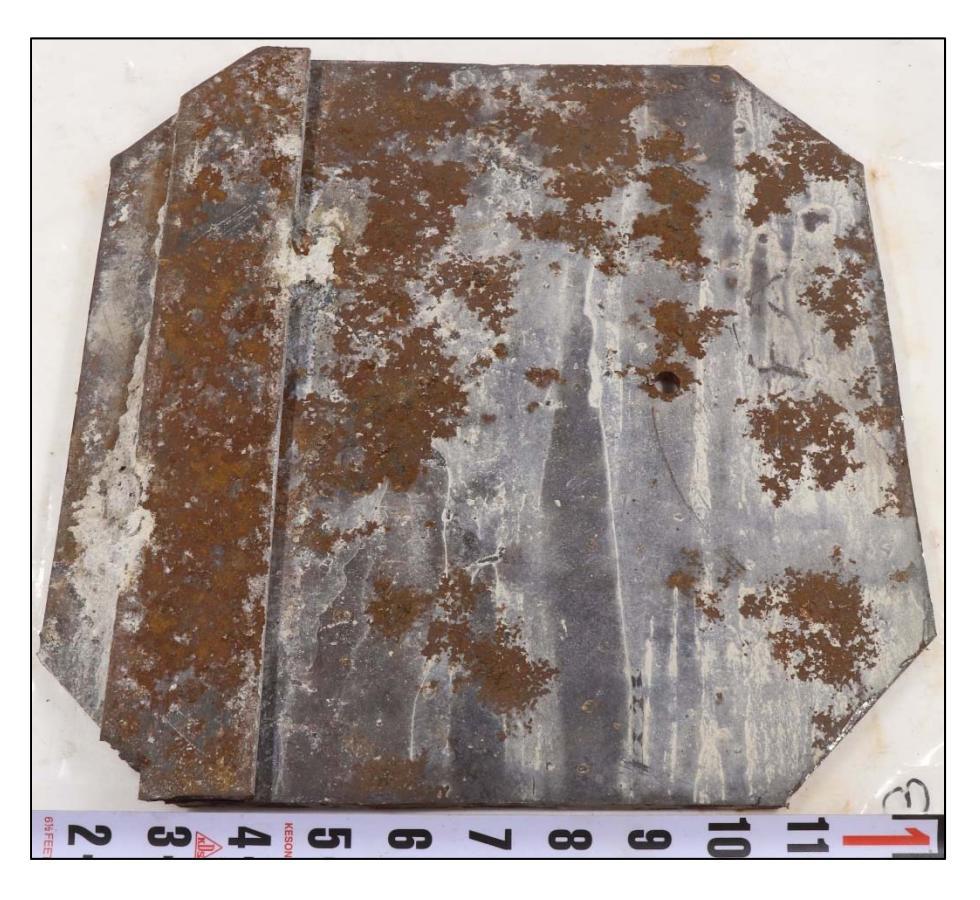
Coupon 8 exhibited what is presumed to be a prior weld repair and/or addition of a backing plate, where a patch was made on the tank wall. Representative images of the welds are presented as Figures 208 through 213. A full weld evaluation is outside the scope of this effort. The results are thus provided for information only.

Figure 19. An image of the interior surface of Coupon 8 in the as-received condition.

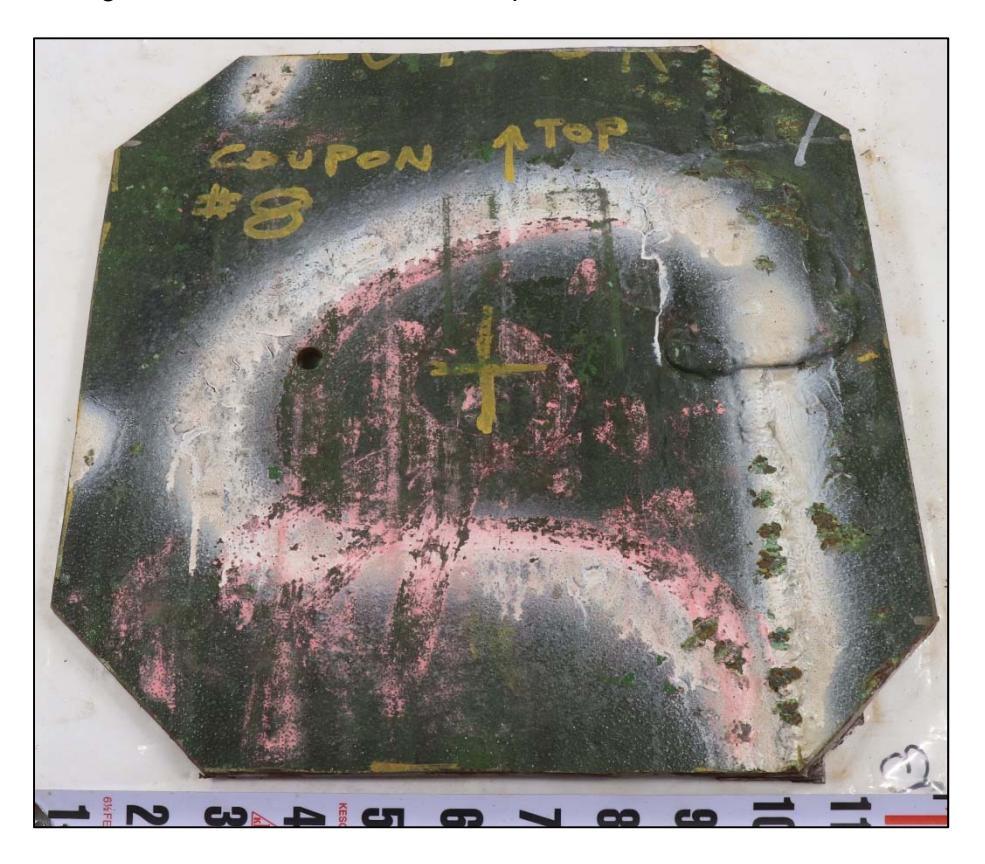
Figure 20. An image of the exterior surface of Coupon 8 in the as-received condition.

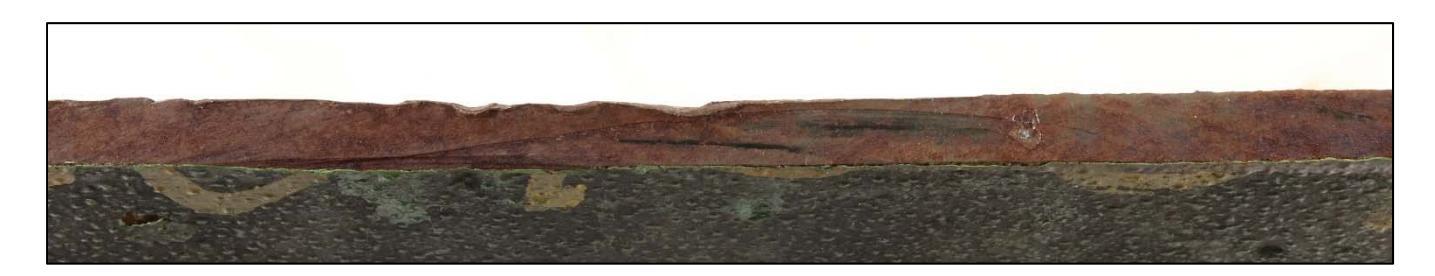
Figure 21. An image of a representative edge of Coupon 8 in the as-received condition.

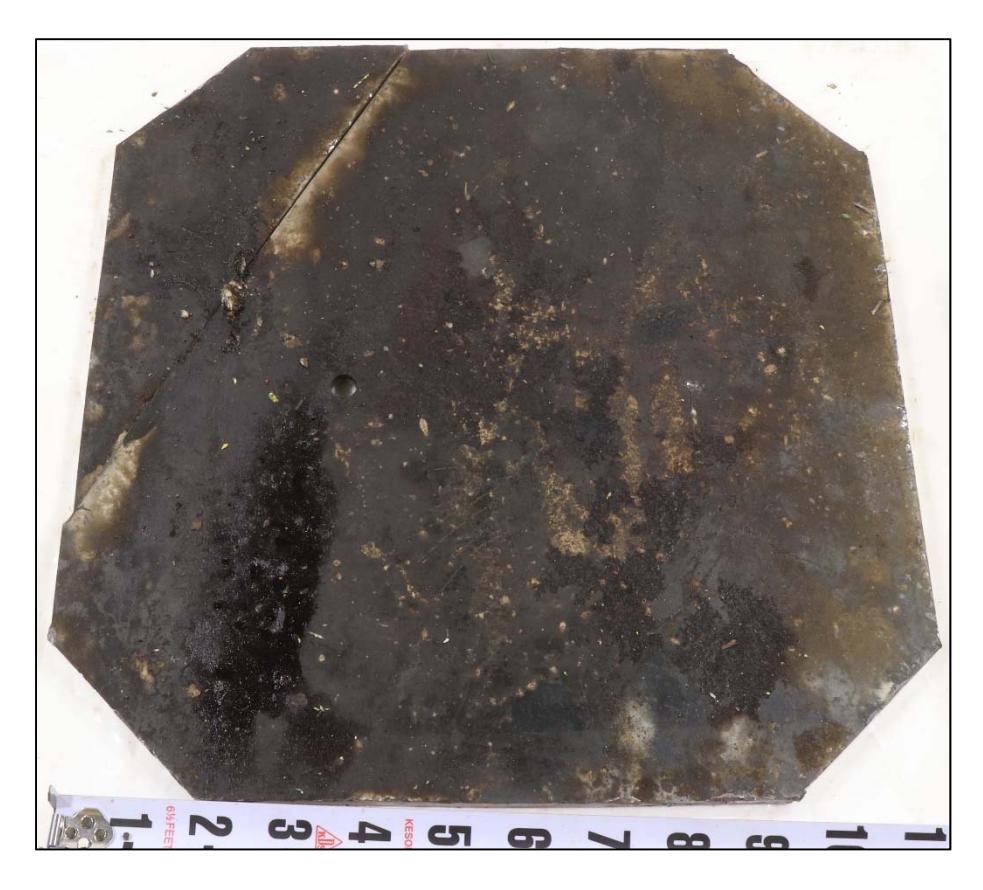
Figure 22. An image of the interior surface of Coupon 10 in the as-received condition.

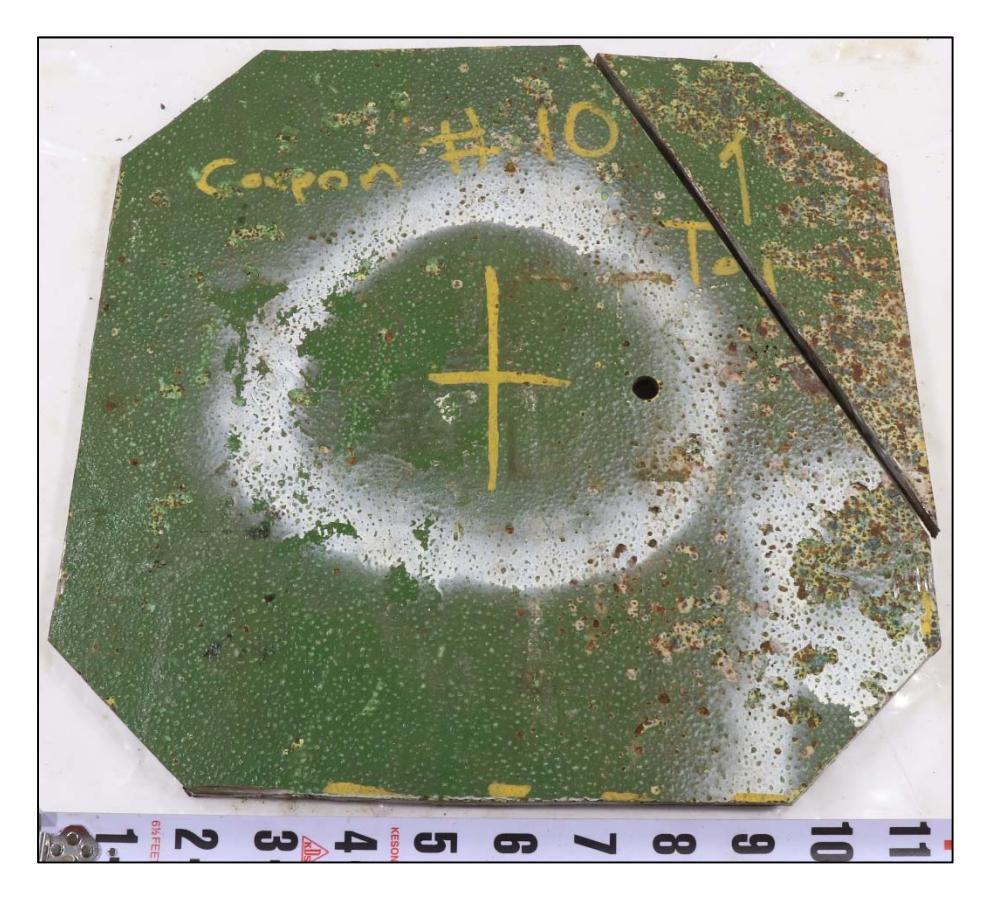
Figure 23. An image of the exterior surface of Coupon 10 in the as-received condition.

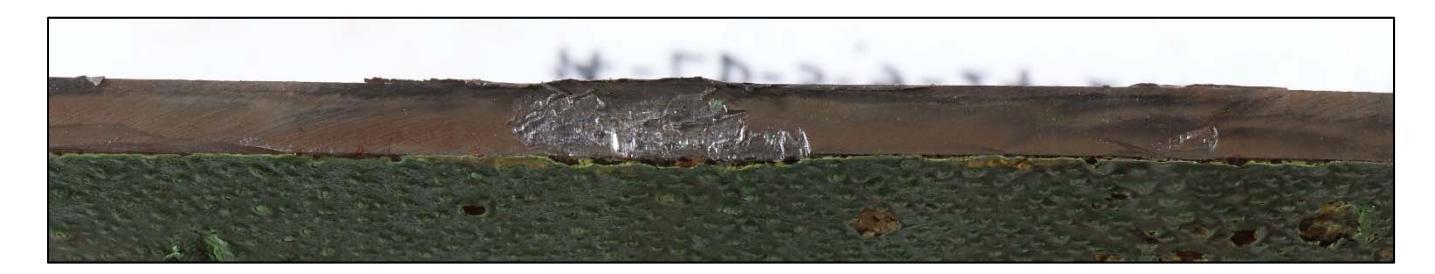
Figure 24. An image of a representative edge of Coupon 10 in the as-received condition.

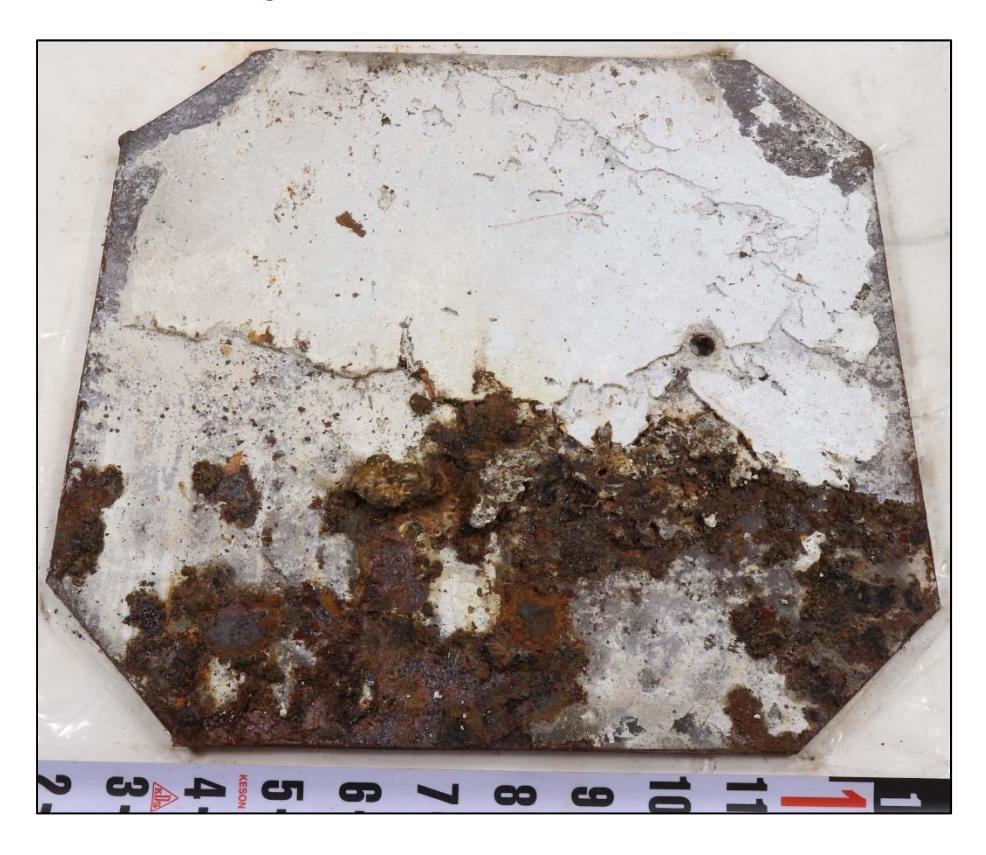
Figure 25. An image of the interior surface of Coupon A1 in the as-received condition.

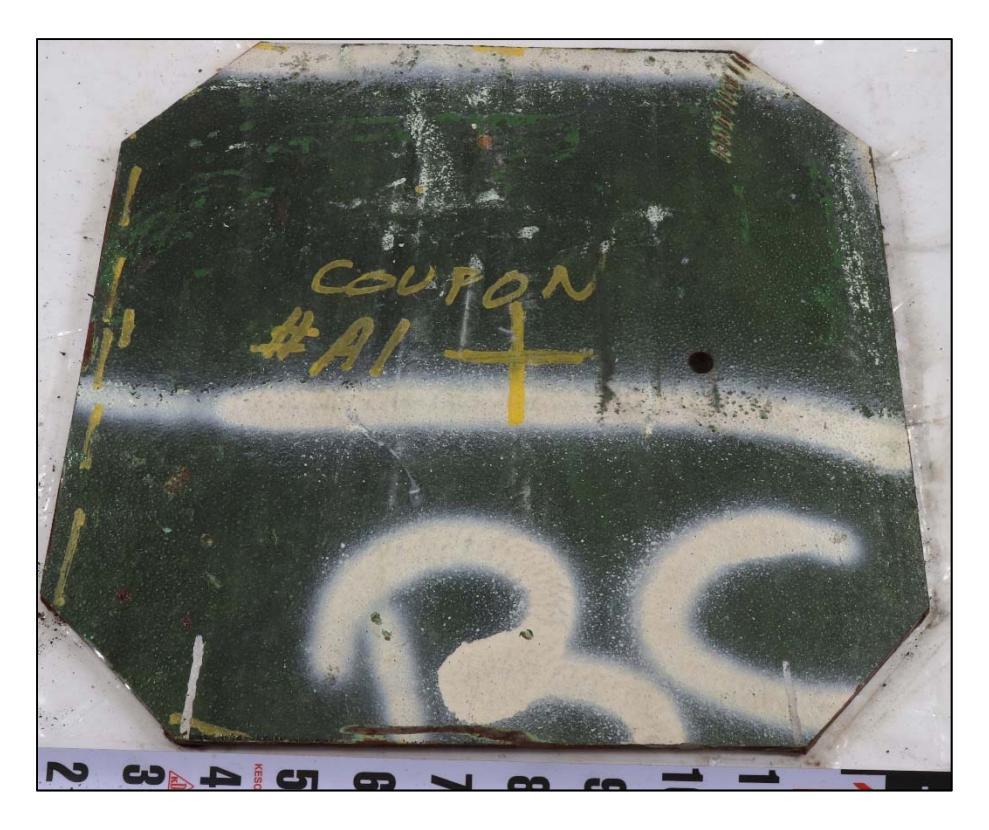
Figure 26. An image of the exterior surface of Coupon A1 in the as-received condition.

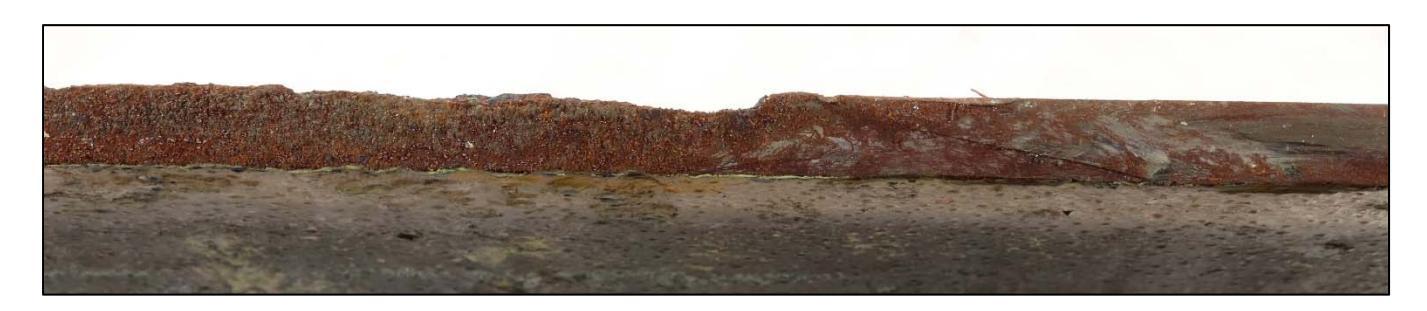
Figure 27. An image of a representative edge of Coupon A1 in the as-received condition.

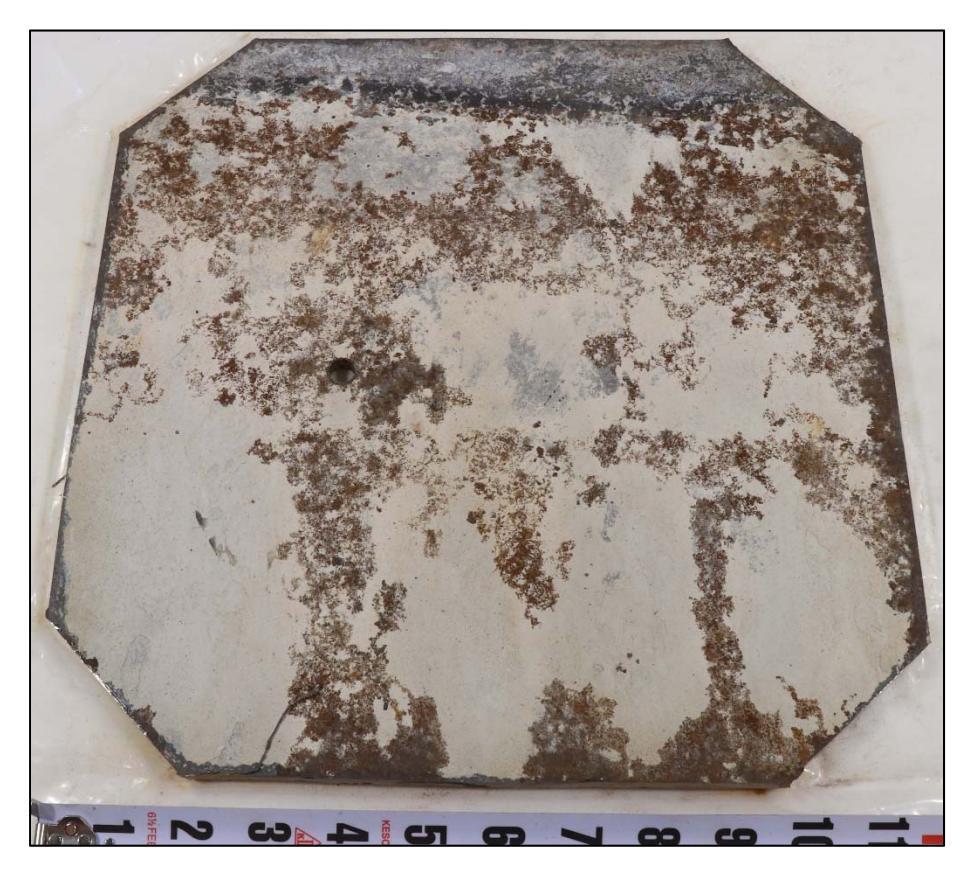
Figure 28. An image of the interior surface of Coupon A2 in the as-received condition.

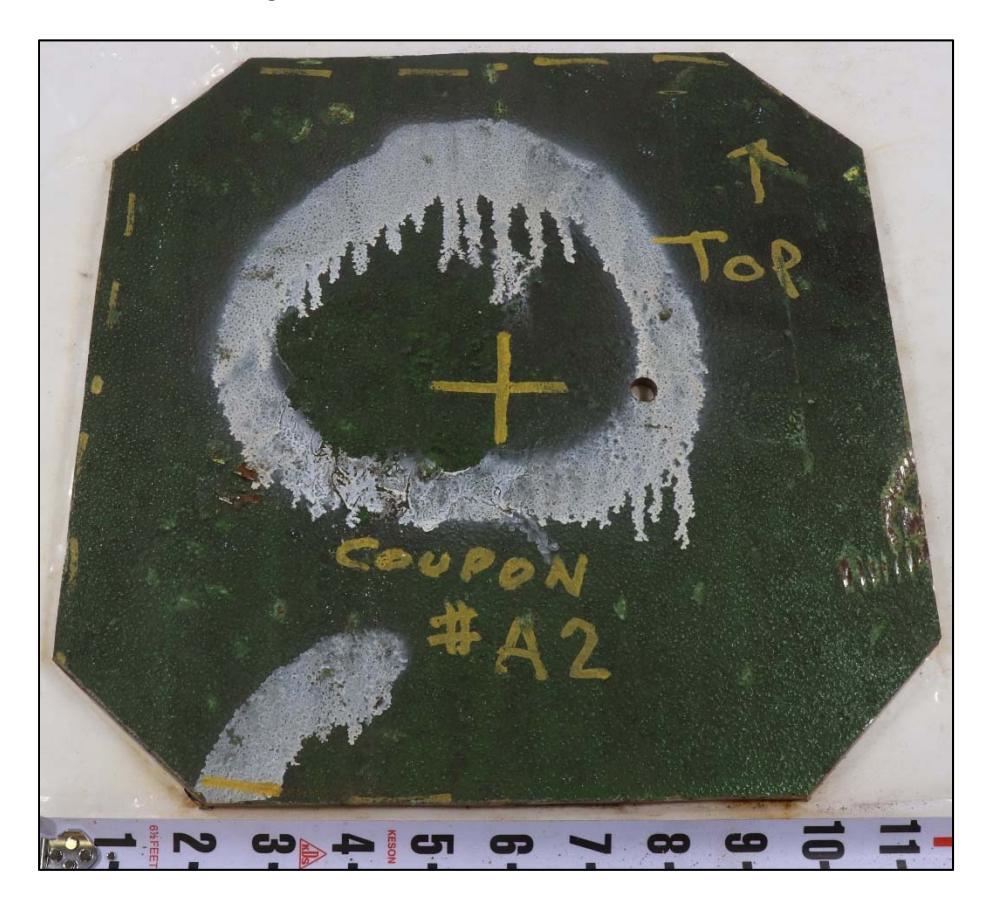
Figure 29. An image of the exterior surface of Coupon A2 in the as-received condition.

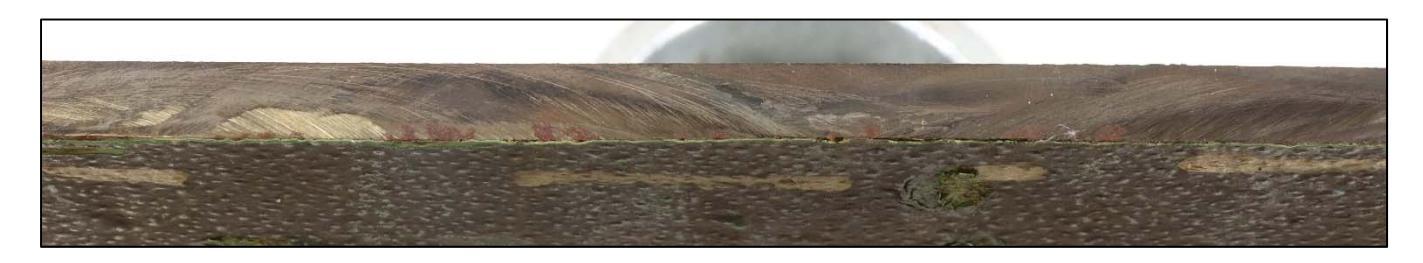
Figure 30. An image of a representative edge of Coupon A2 in the as-received condition.
