SUBJECT: DESTRUCTIVE ANALYSIS OF 10 STEEL COUPONS REMOVED FROM RED HILL FUEL STORAGE TANK NO. 14, PURSUANT TO SECTION 5.3 OF THE ADMINISTRATIVE ORDER ON CONSENT STATEMENT OF WORK, RED HILL BULK FUEL STORAGE FACILITY, JOINT BASE PEARL HARBOR-HICKAM, OAHU, HAWAII

Destructive Analysis of 10 Steel Coupons Removed from Red Hill Fuel Storage Tank #14

REPORT No. 201801967

December 17, 2018

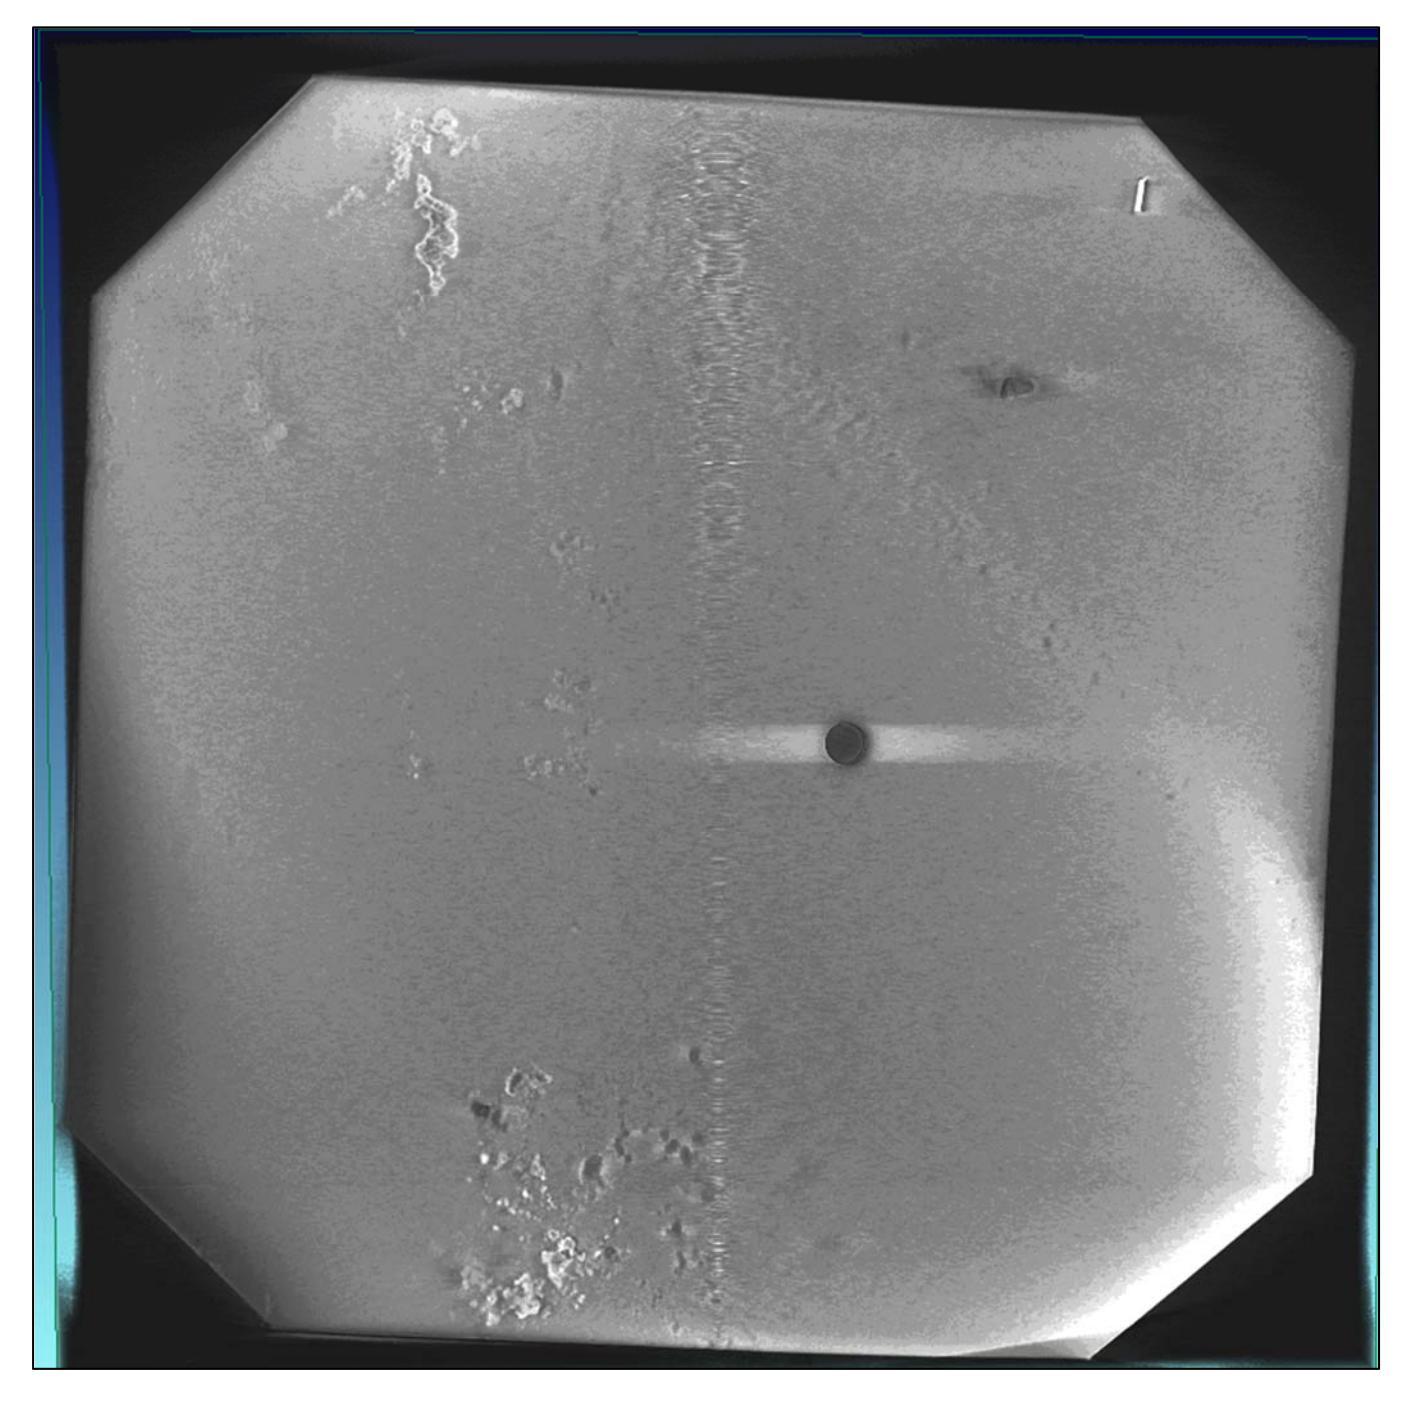
Computer Tomography (CT) scans were performed on each of the submitted coupons prior to cleaning or sectioning. This task was subcontracted to an accredited partner laboratory. Representative screenshots of the scans are provided in Figures 31 through 40. The full CT scan files and appropriate software will be provided to the customer on a separate disk. The CT scans were used to identify three regions on each coupon that exhibited the most severe wall thinning or any other density-based anomaly. The three regions of severe wall thinning identified were excised from the coupons for further analysis.

Figure 31. A representative screenshot of the CT scan performed on Coupon 1.

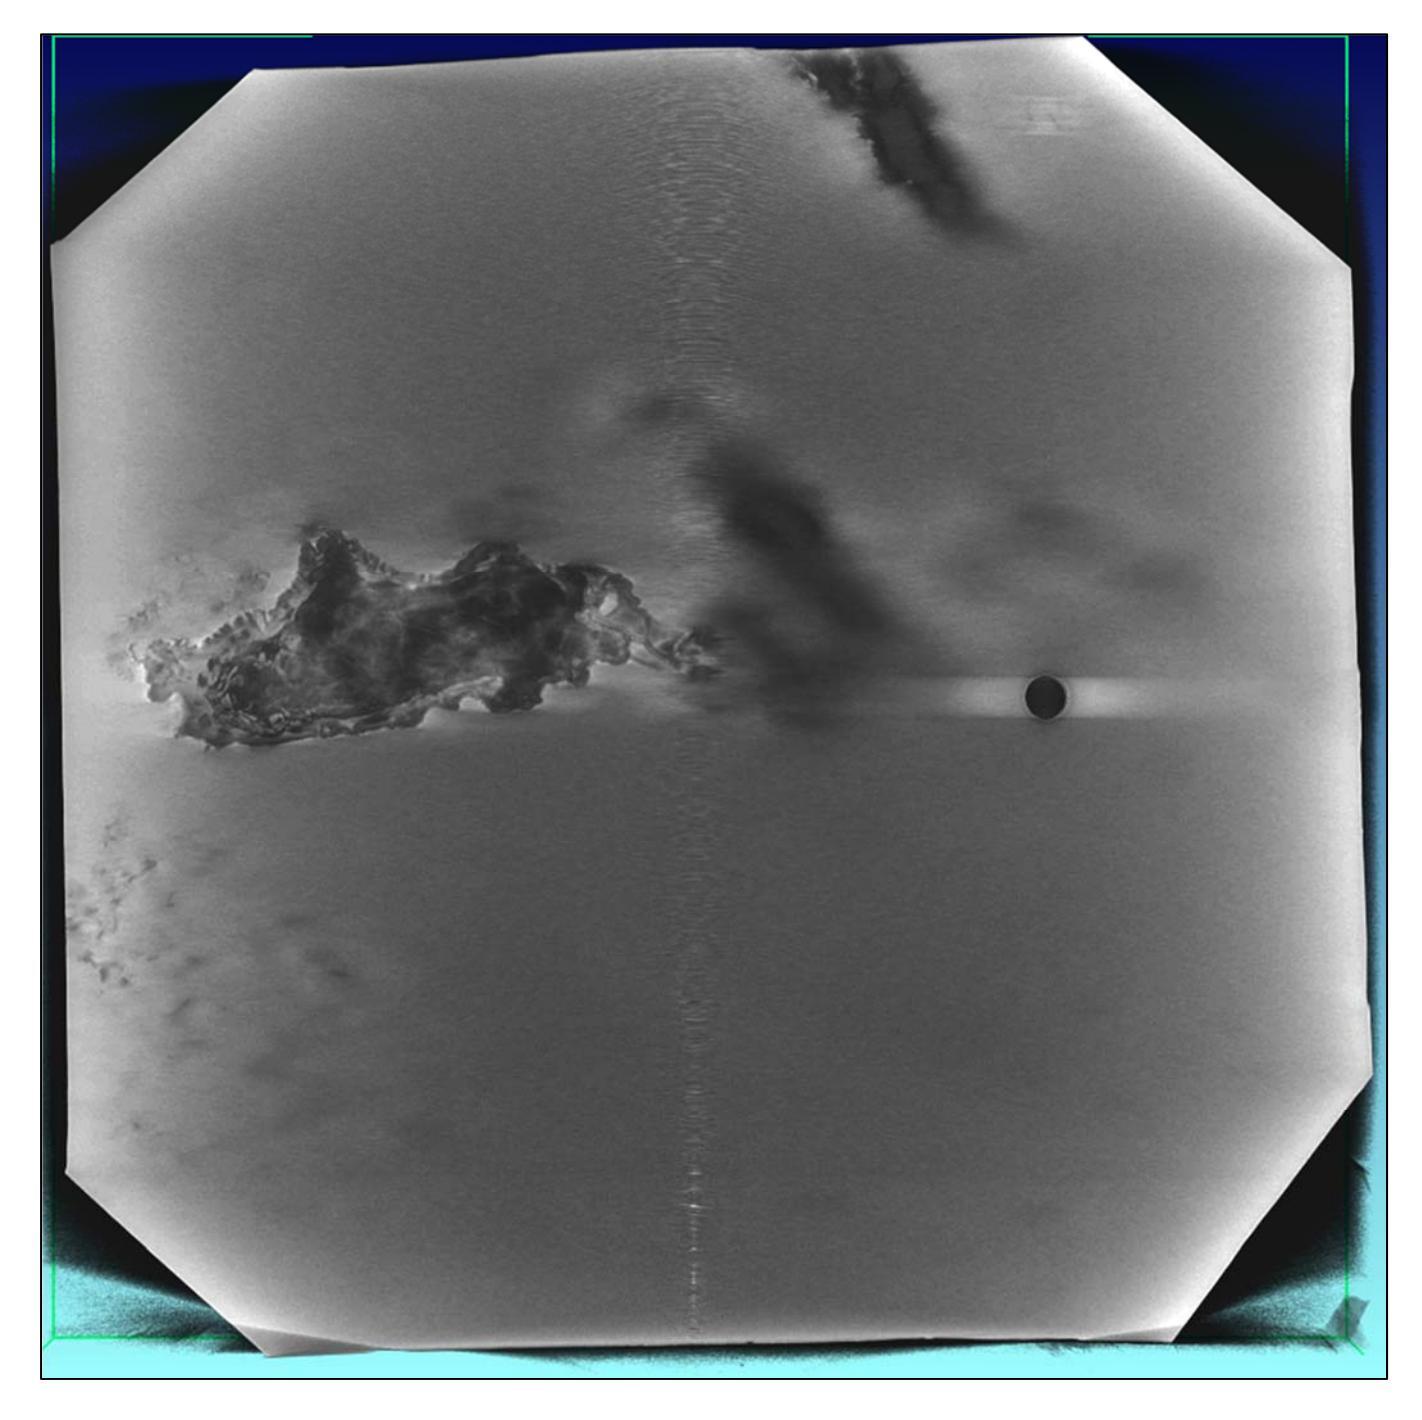
Figure 32. A representative screenshot of the CT scan performed on Coupon 2.

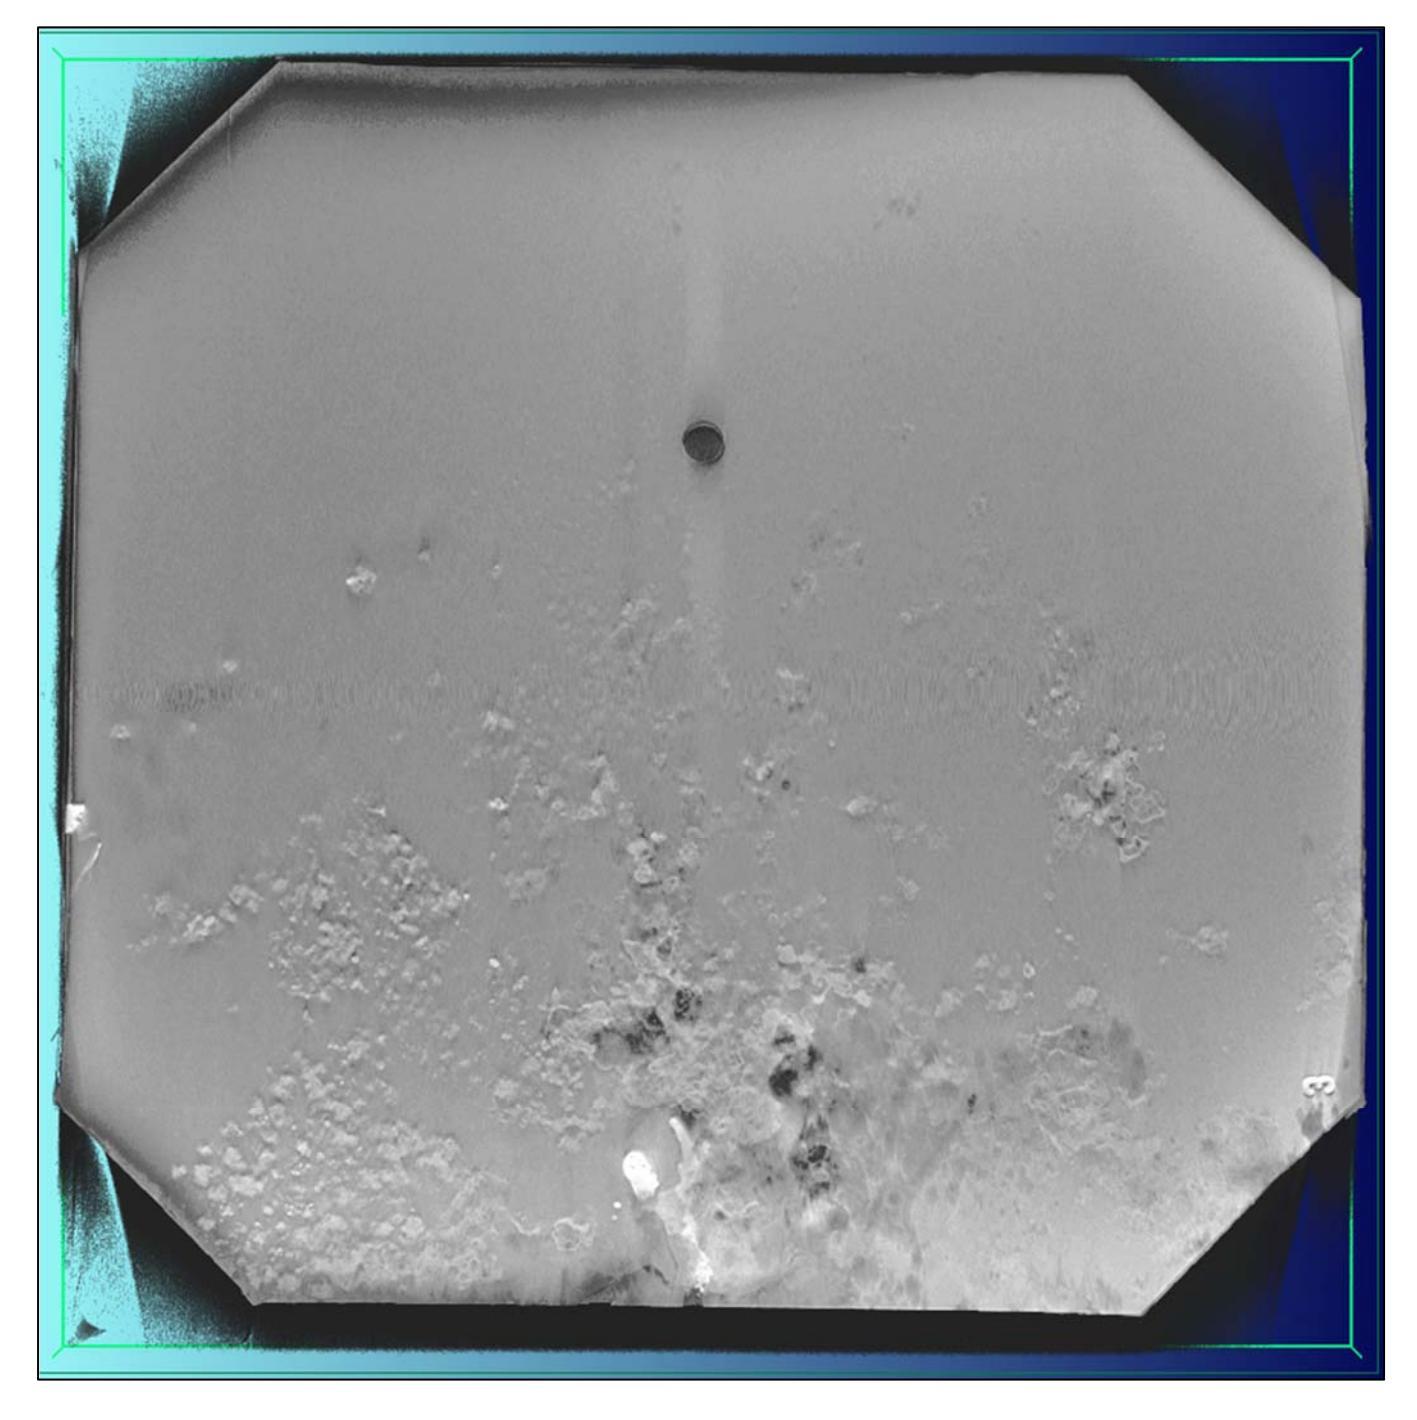
Figure 33. A representative screenshot of the CT scan performed on Coupon 3.

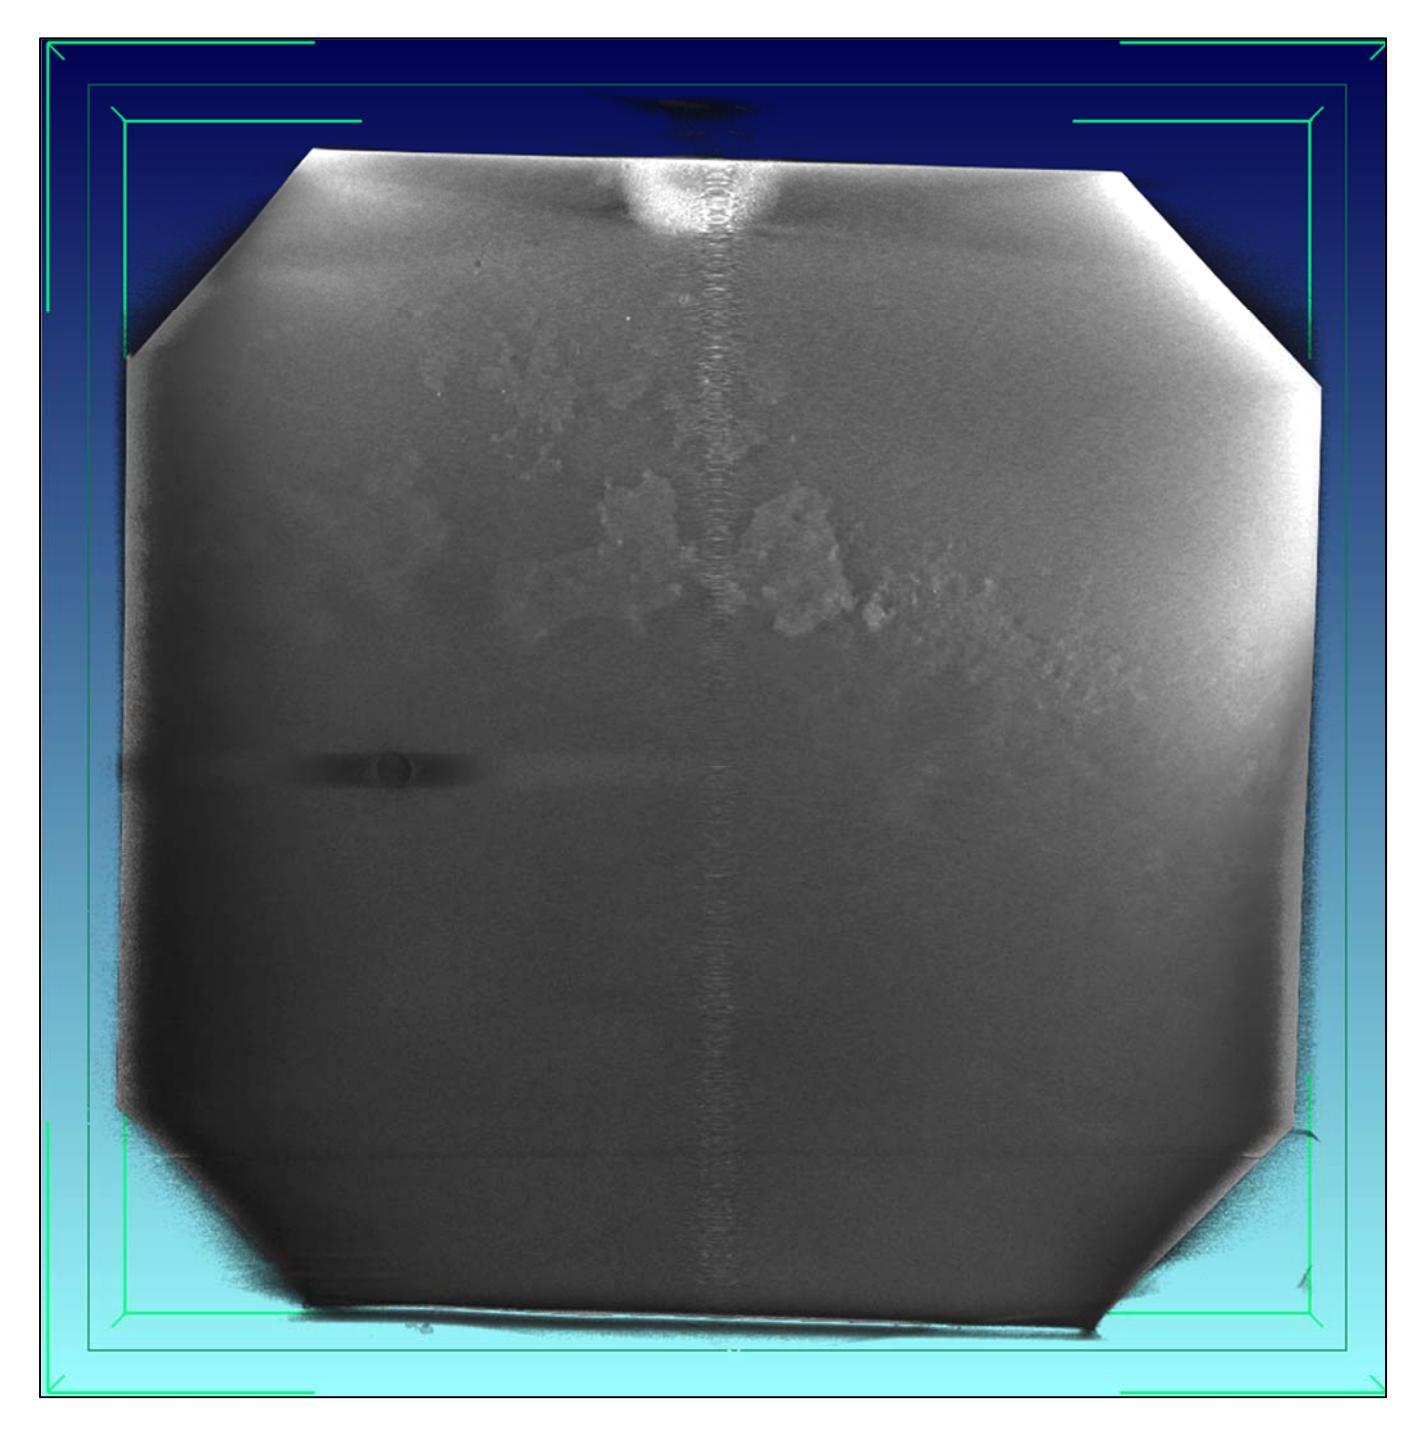
Figure 34. A representative screenshot of the CT scan performed on Coupon 5.

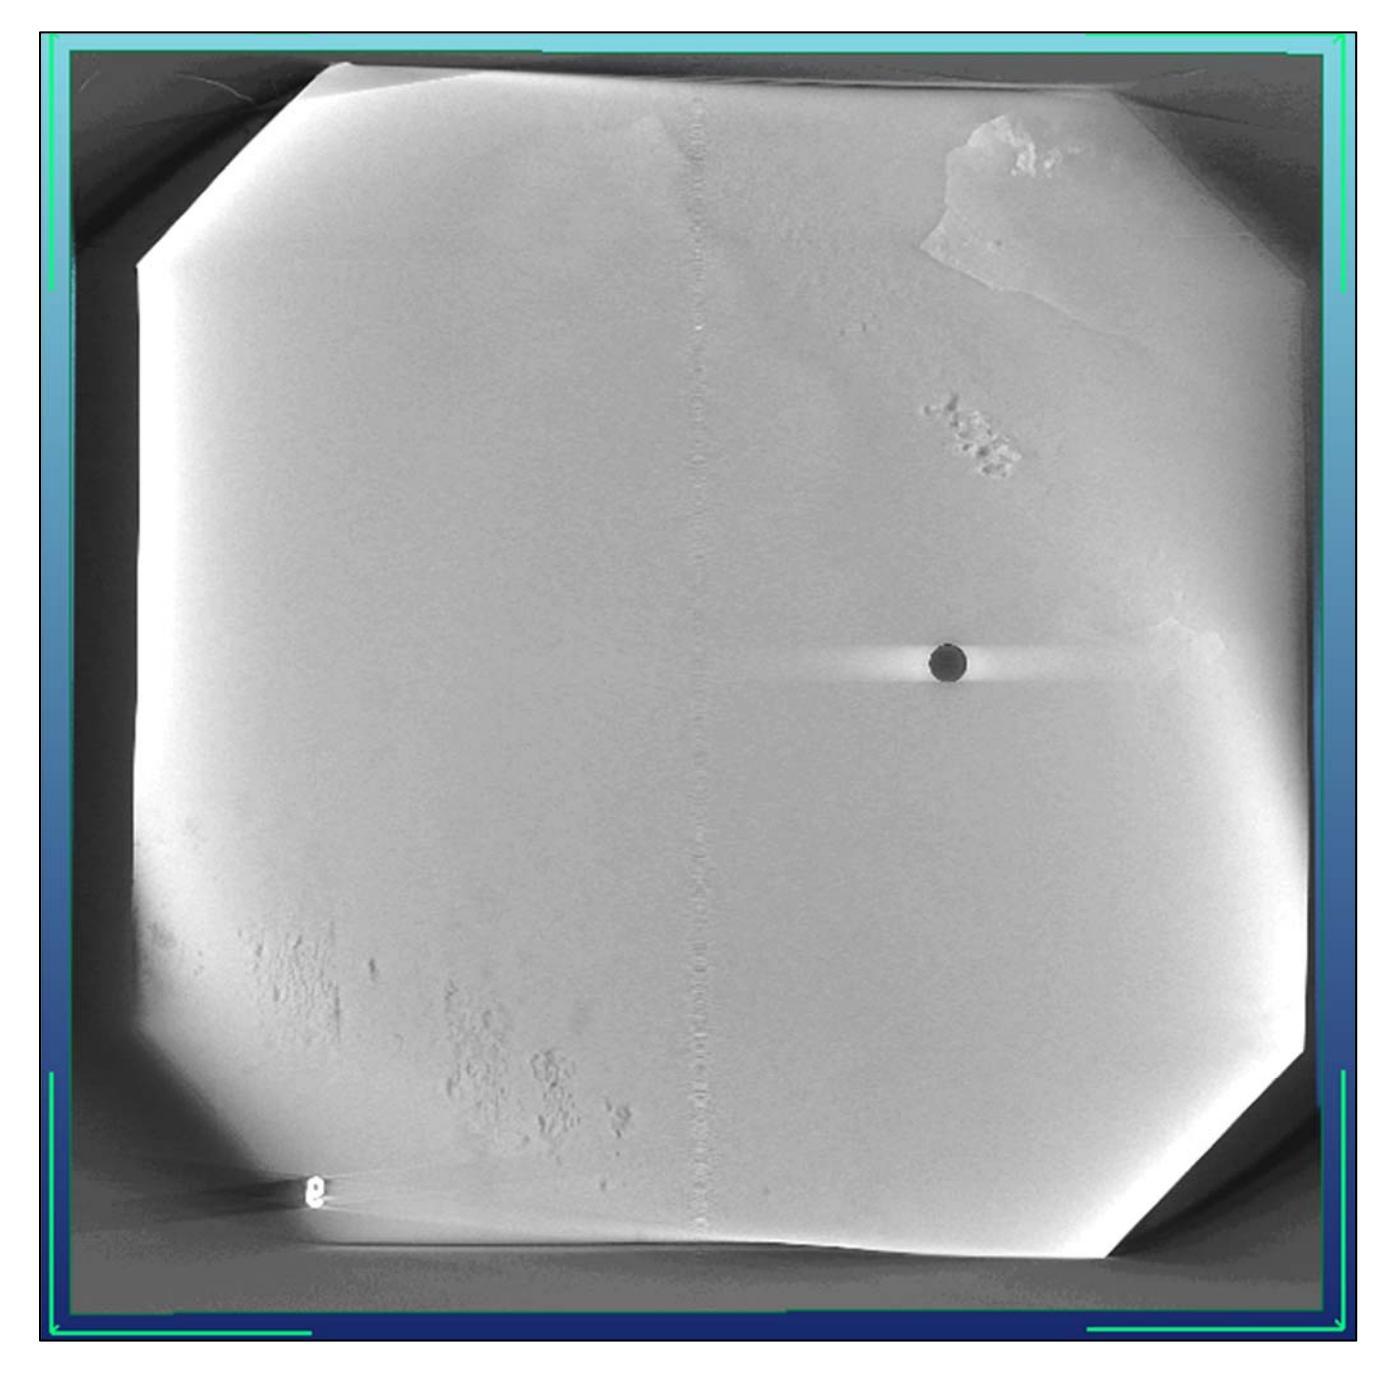
Figure 35. A representative screenshot of the CT scan performed on Coupon 6.

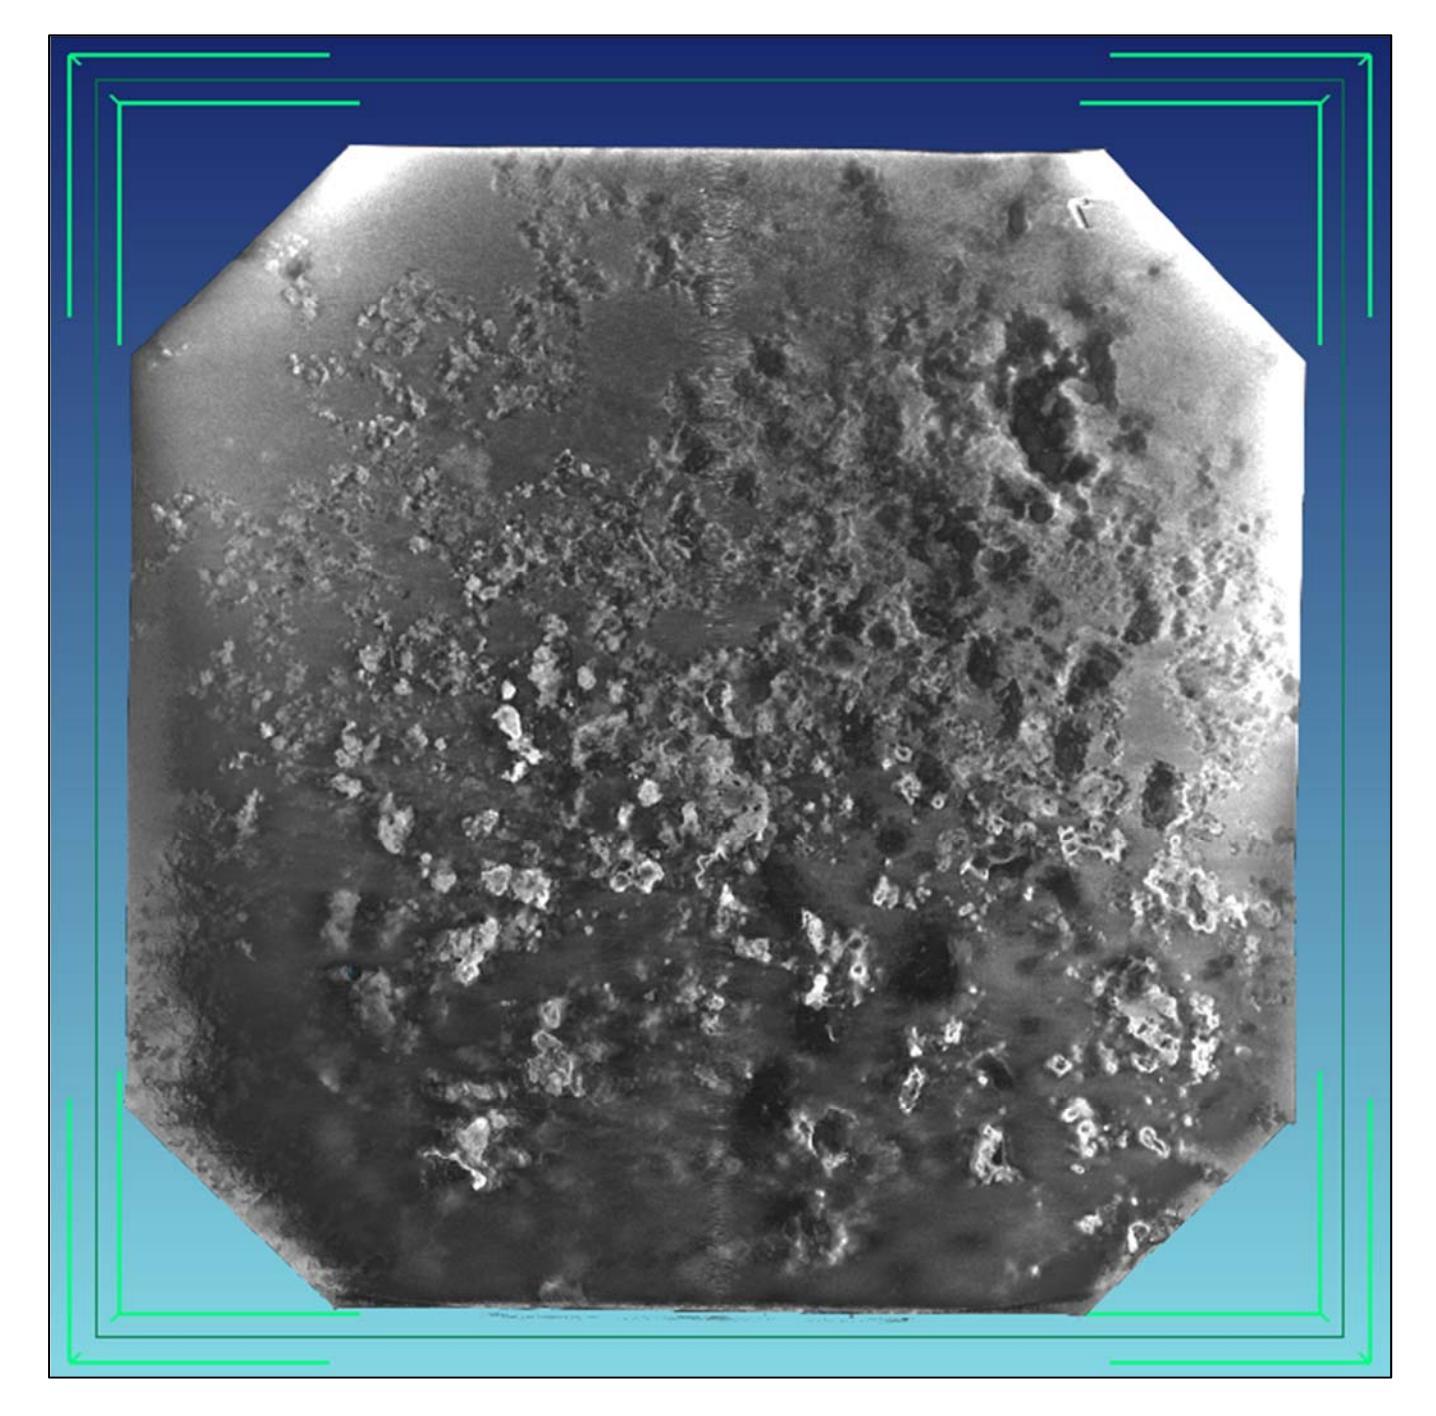
Figure 36. A representative screenshot of the CT scan performed on Coupon 7.

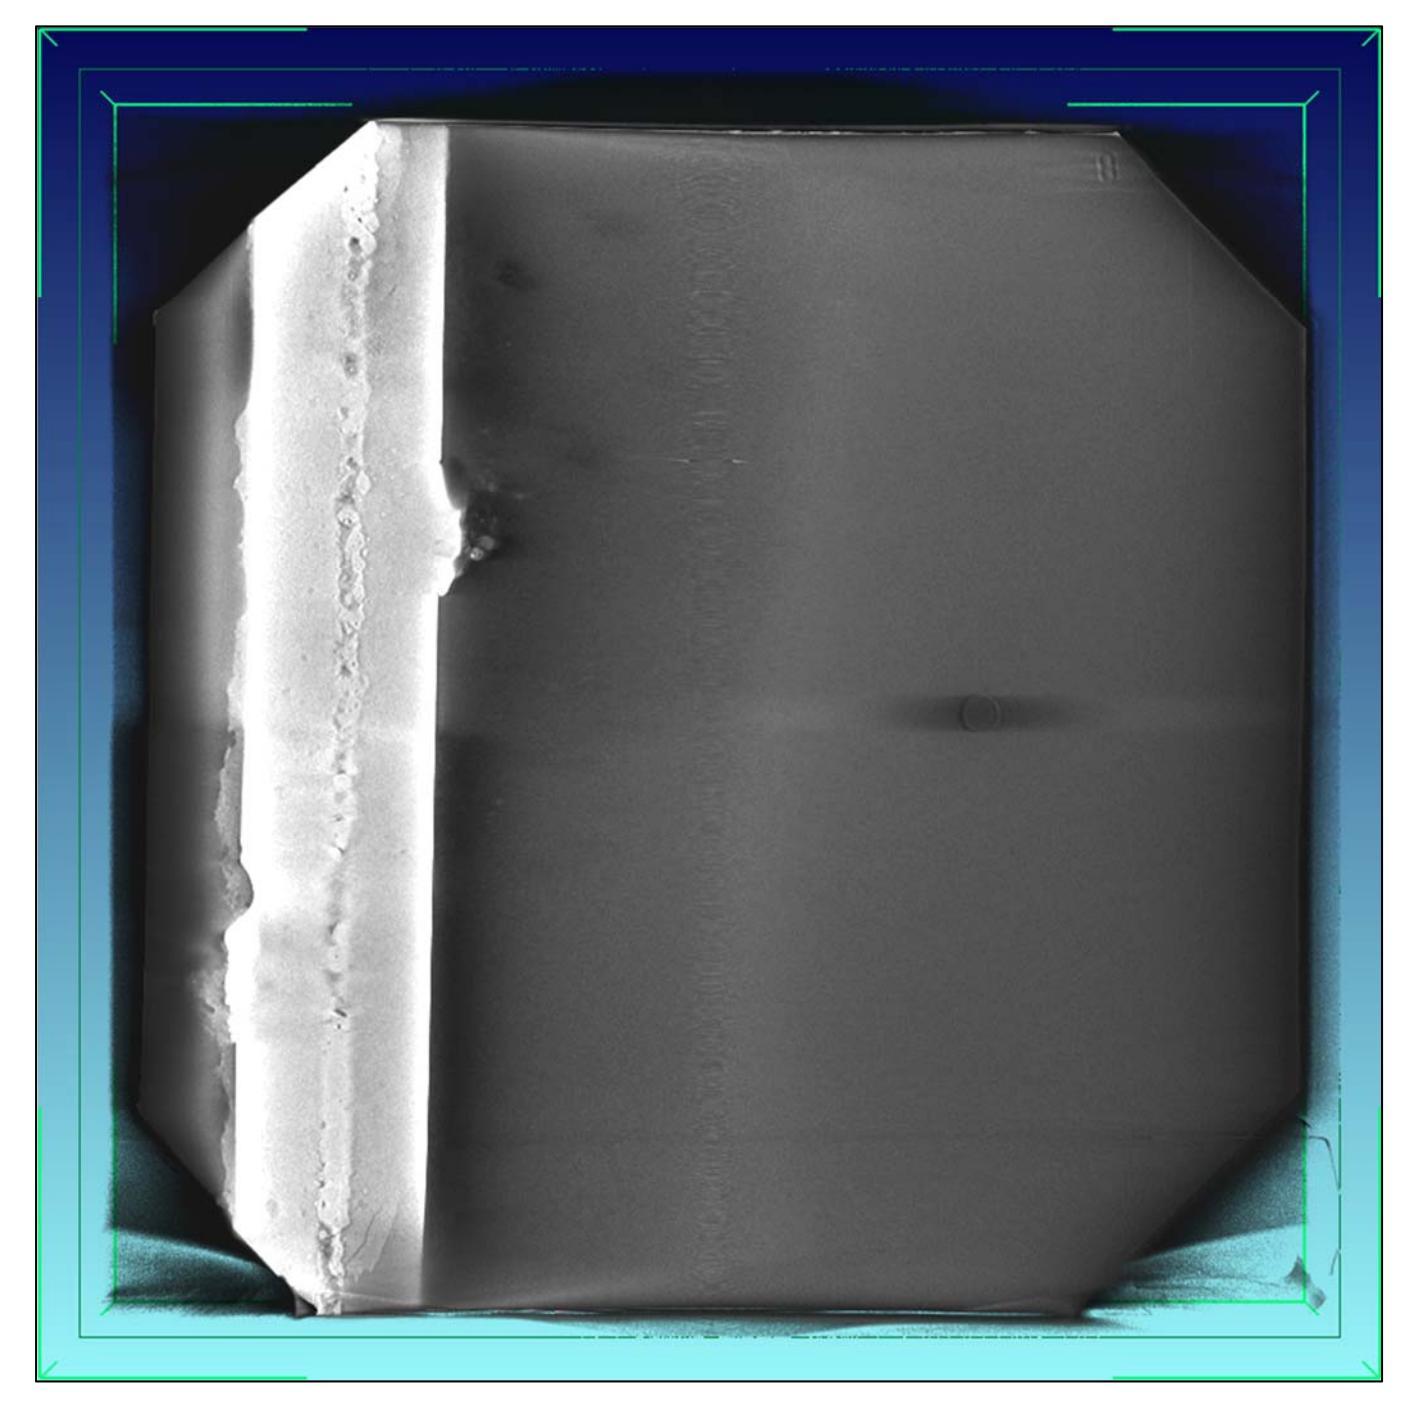
Figure 37. A representative screenshot of the CT scan performed on Coupon 8.

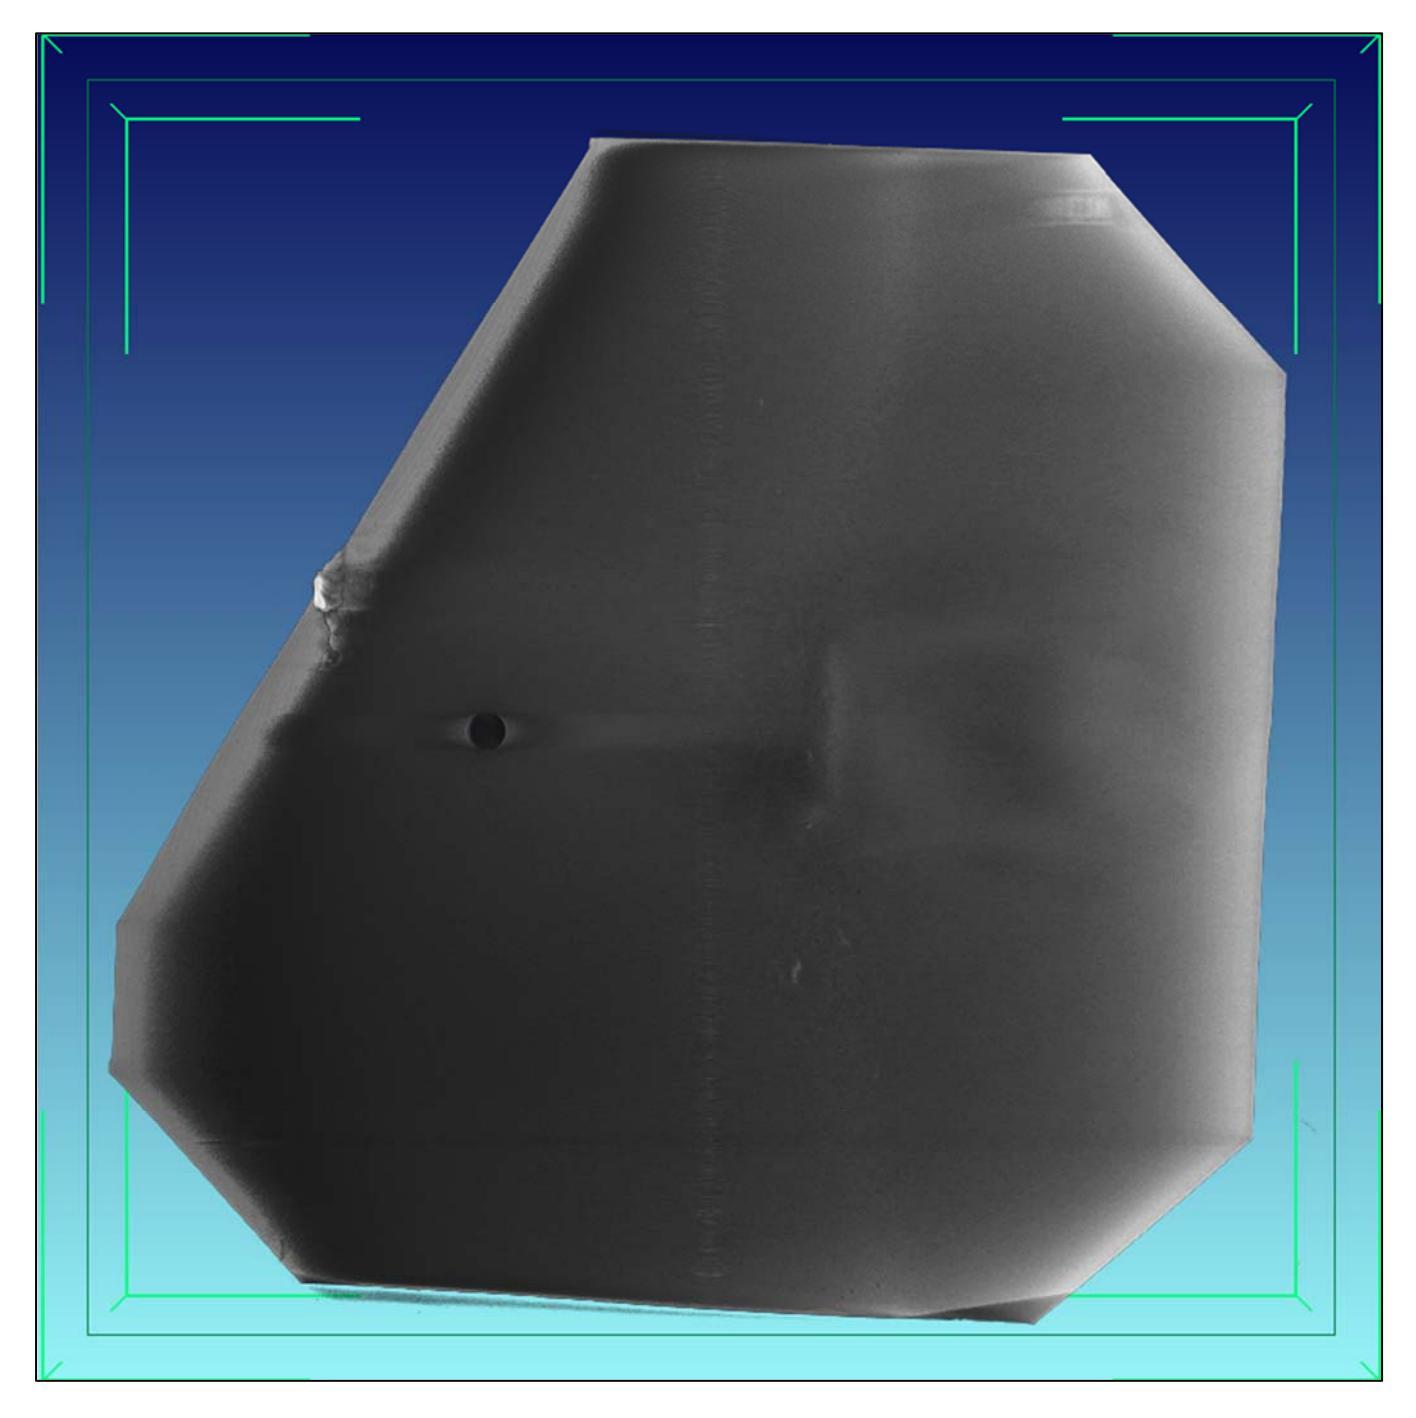
Figure 38. A representative screenshot of the CT scan performed on Coupon 10.

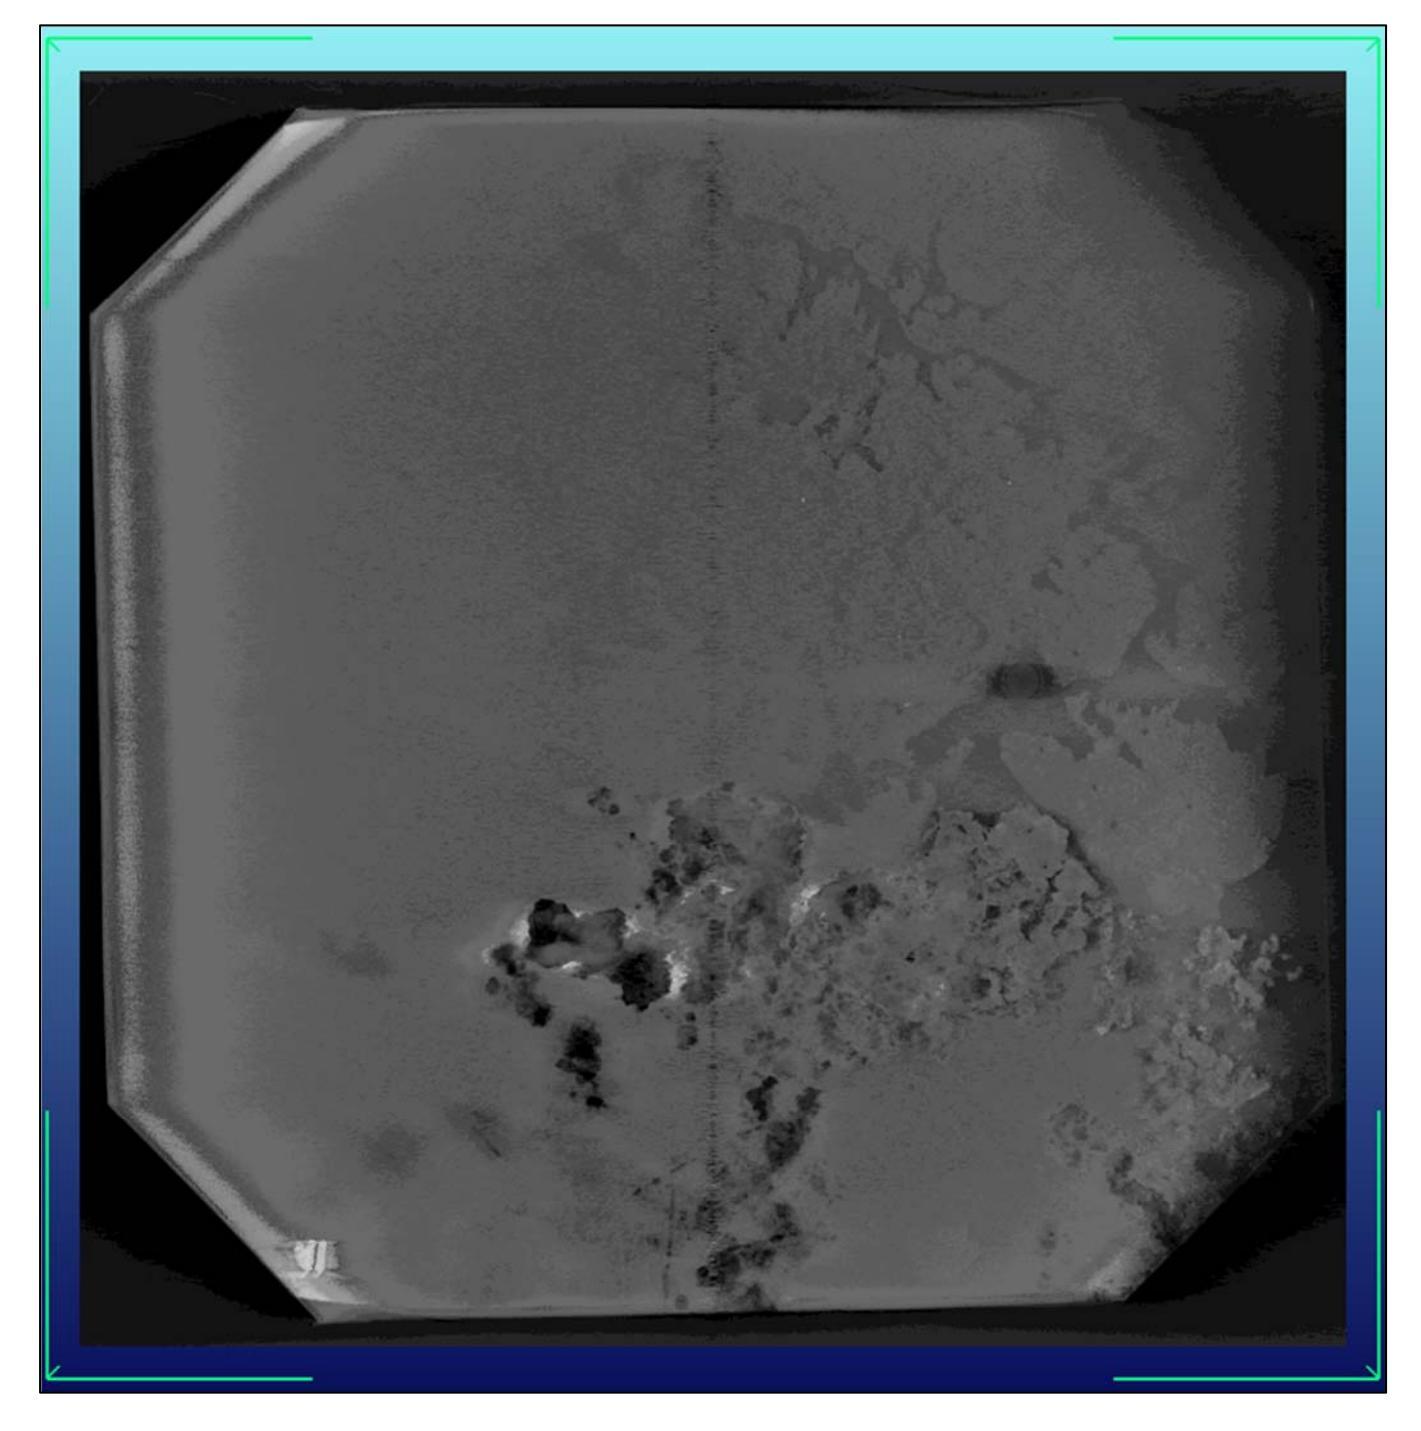
Figure 39. A representative screenshot of the CT scan performed on Coupon A1.

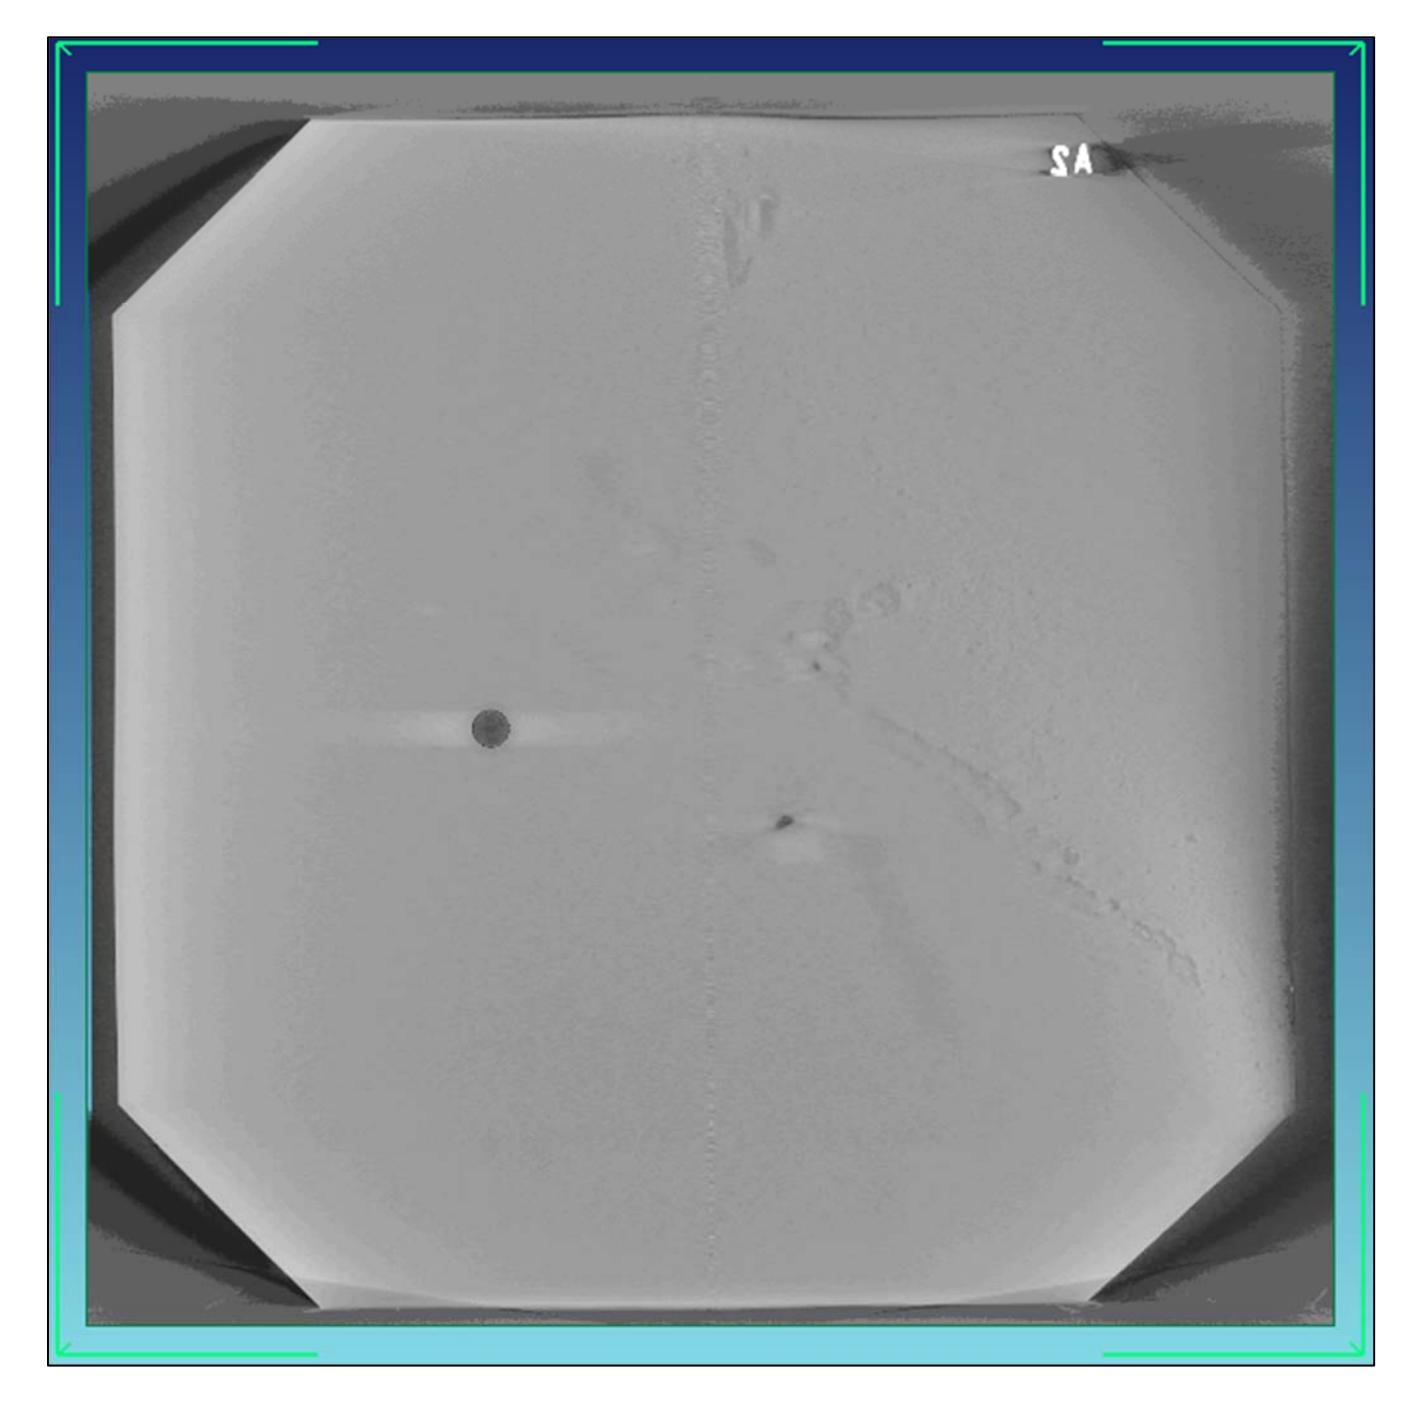
Figure 40. A representative screenshot of the CT scan performed on Coupon A2.

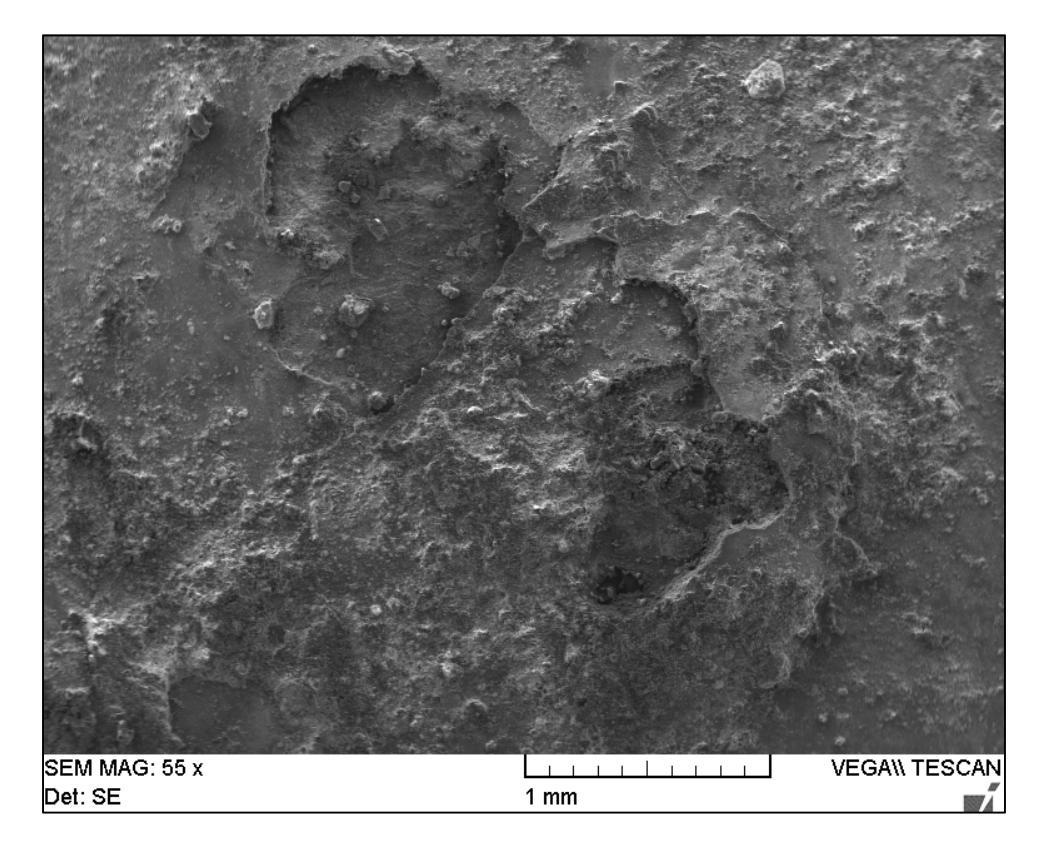
Figure 41. A representative SEM image of a pit on a specimen excised from Coupon 1 labeled as 1-1, prior to cleaning. (SEM, 32X)

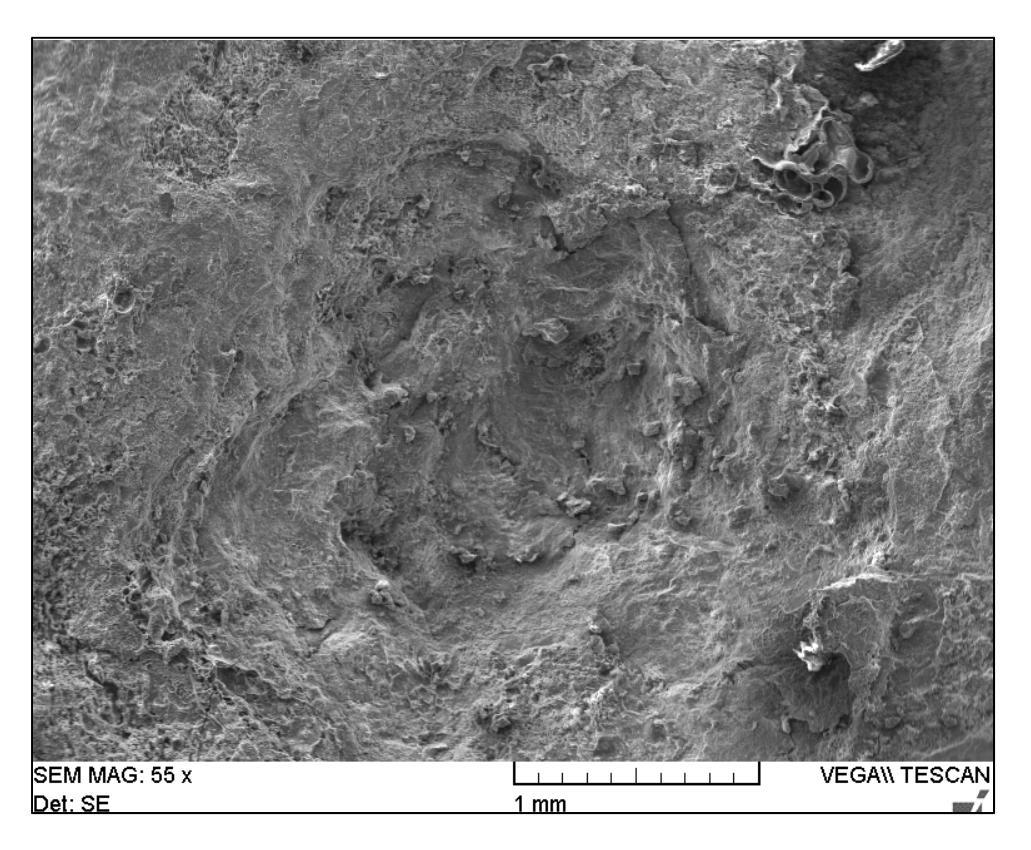
Figure 42. A representative SEM image of a pit on a specimen excised from Coupon 1 labeled as 1-2, prior to cleaning. (SEM, 32X)

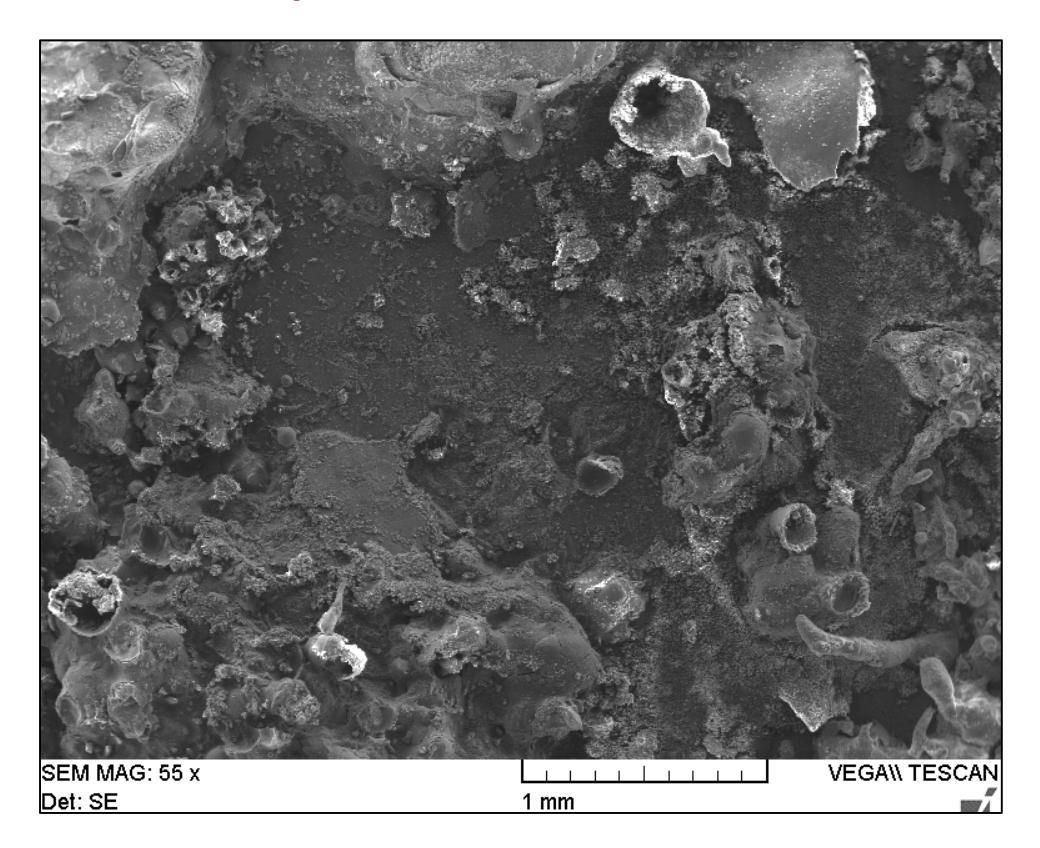
Figure 43. A representative SEM image of a pit on a specimen excised from Coupon 1 labeled as 1-3, prior to cleaning. (SEM, 32X)
