SUBJECT: DESTRUCTIVE ANALYSIS OF 10 STEEL COUPONS REMOVED FROM RED HILL FUEL STORAGE TANK NO. 14, PURSUANT TO SECTION 5.3 OF THE ADMINISTRATIVE ORDER ON CONSENT STATEMENT OF WORK, RED HILL BULK FUEL STORAGE FACILITY, JOINT BASE PEARL HARBOR-HICKAM, OAHU, HAWAII

Destructive Analysis of 10 Steel Coupons Removed from Red Hill Fuel Storage Tank #14

REPORT No. 201801967

December 17, 2018

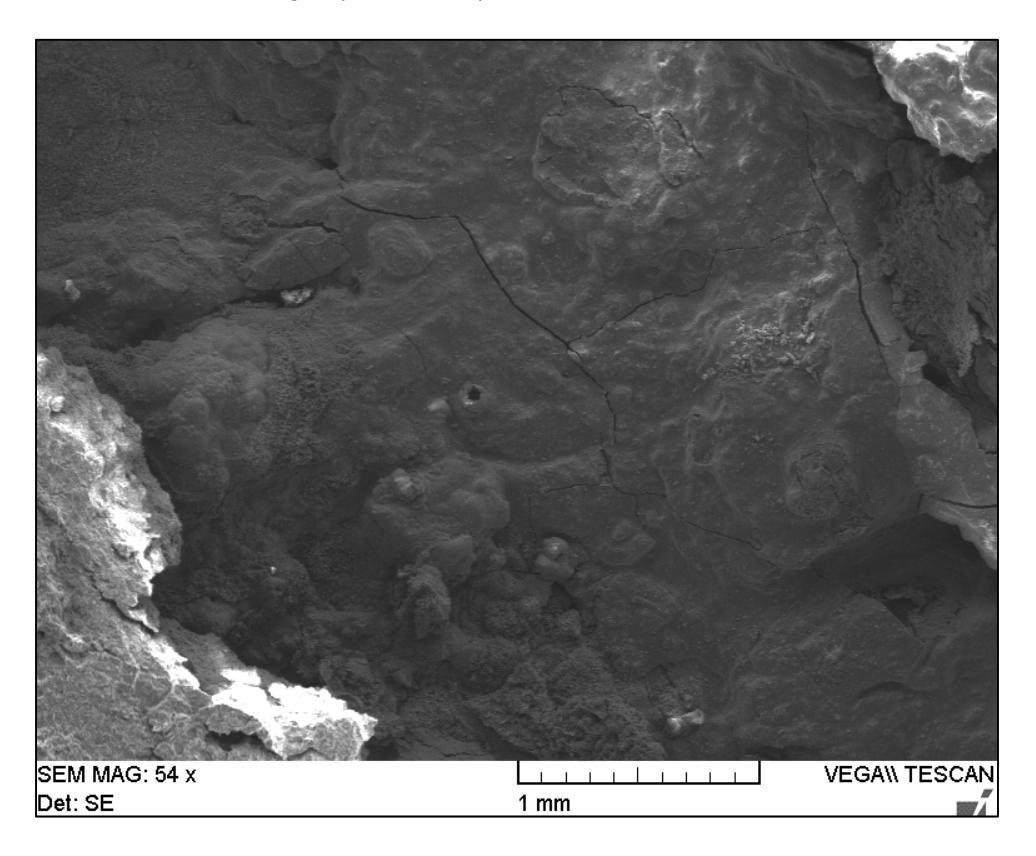
Figure 44. A representative SEM image of a pit on a specimen excised from Coupon 2 labeled as 2-1, prior to cleaning. (SEM, 32X)

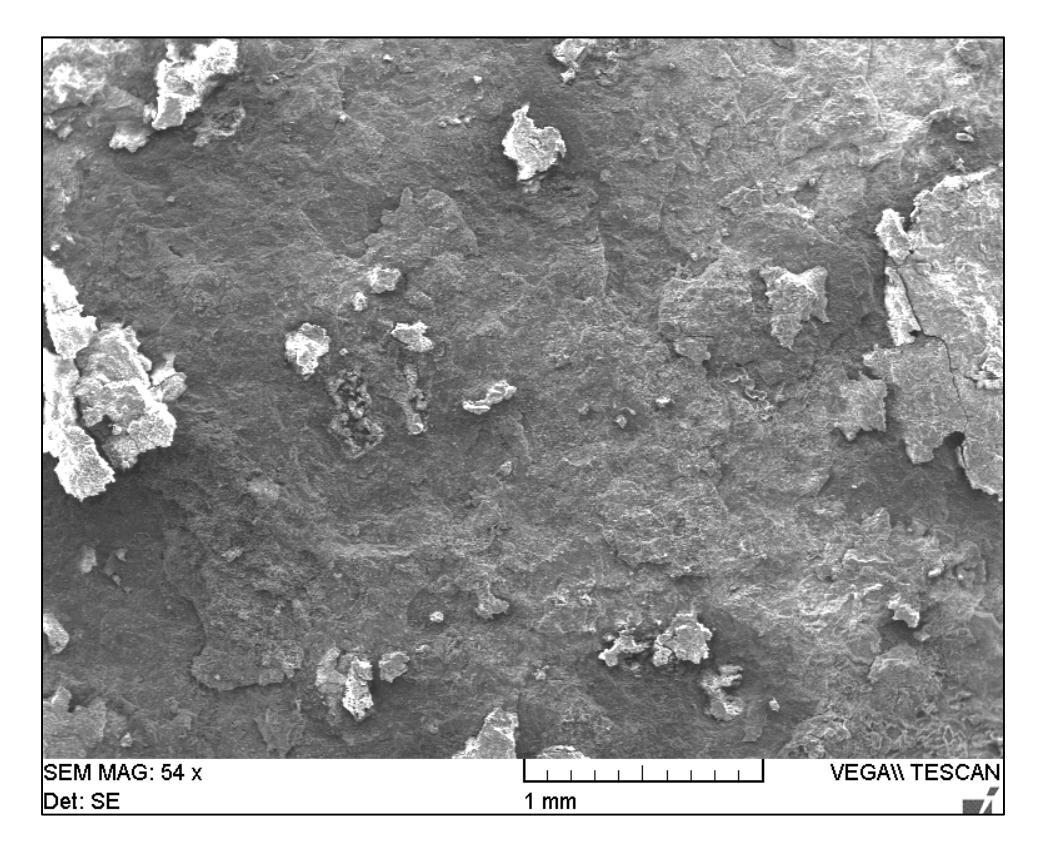
Figure 45. A representative SEM image of a pit on a specimen excised from Coupon 2 labeled as 2-2, prior to cleaning. (SEM, 32X)

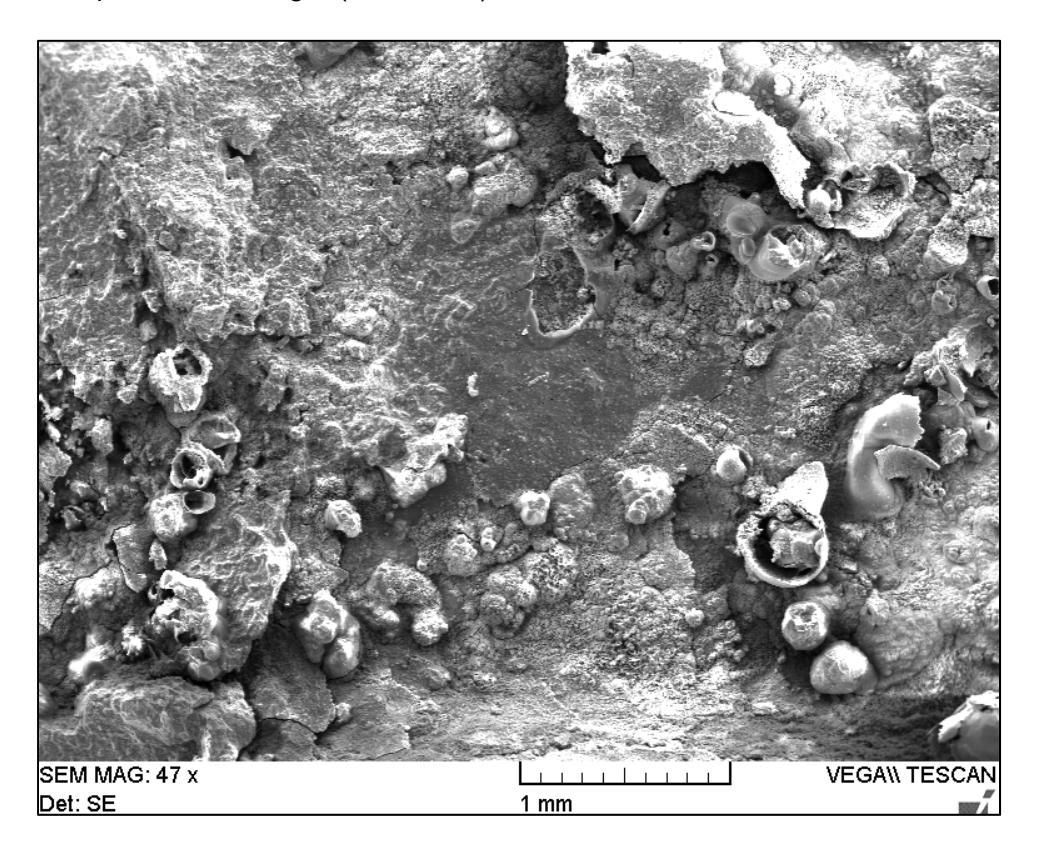
Figure 46. A representative SEM image of a pit on a specimen excised from Coupon 2 labeled as 2-3, prior to cleaning. (SEM, 28X)

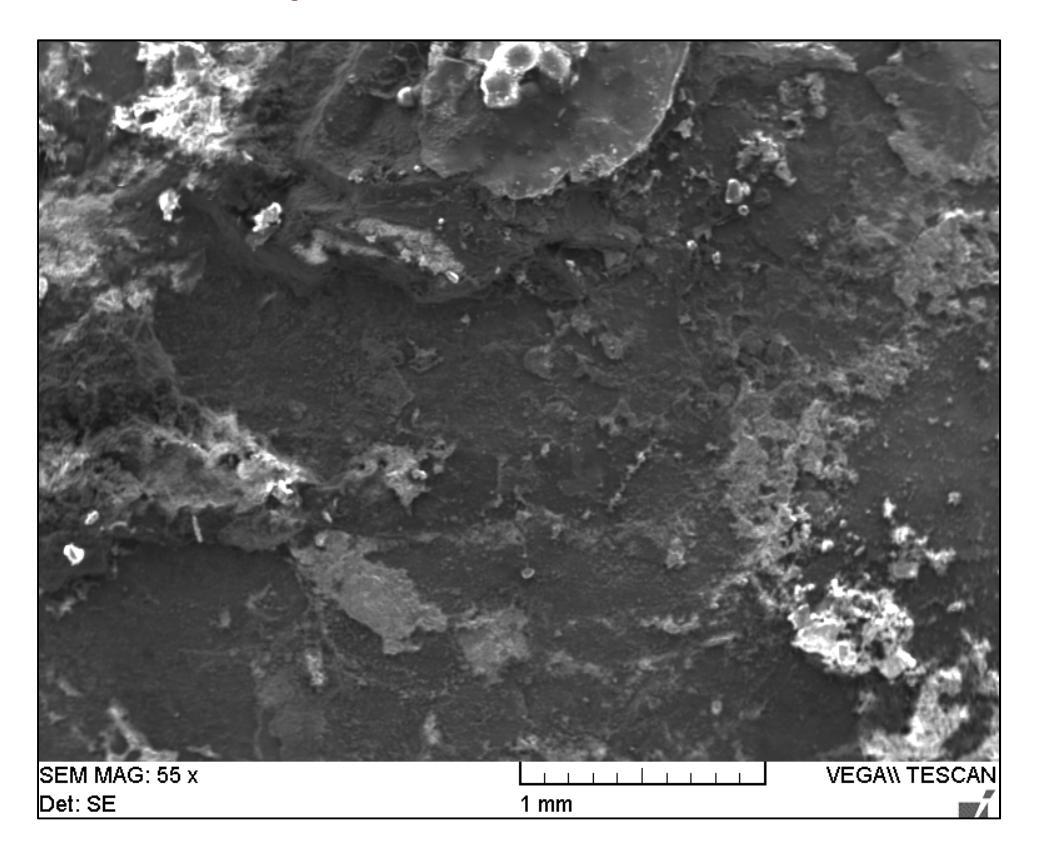
Figure 47. A representative SEM image of a pit on a specimen excised from Coupon 3 labeled as 3-1, prior to cleaning. (SEM, 32X)

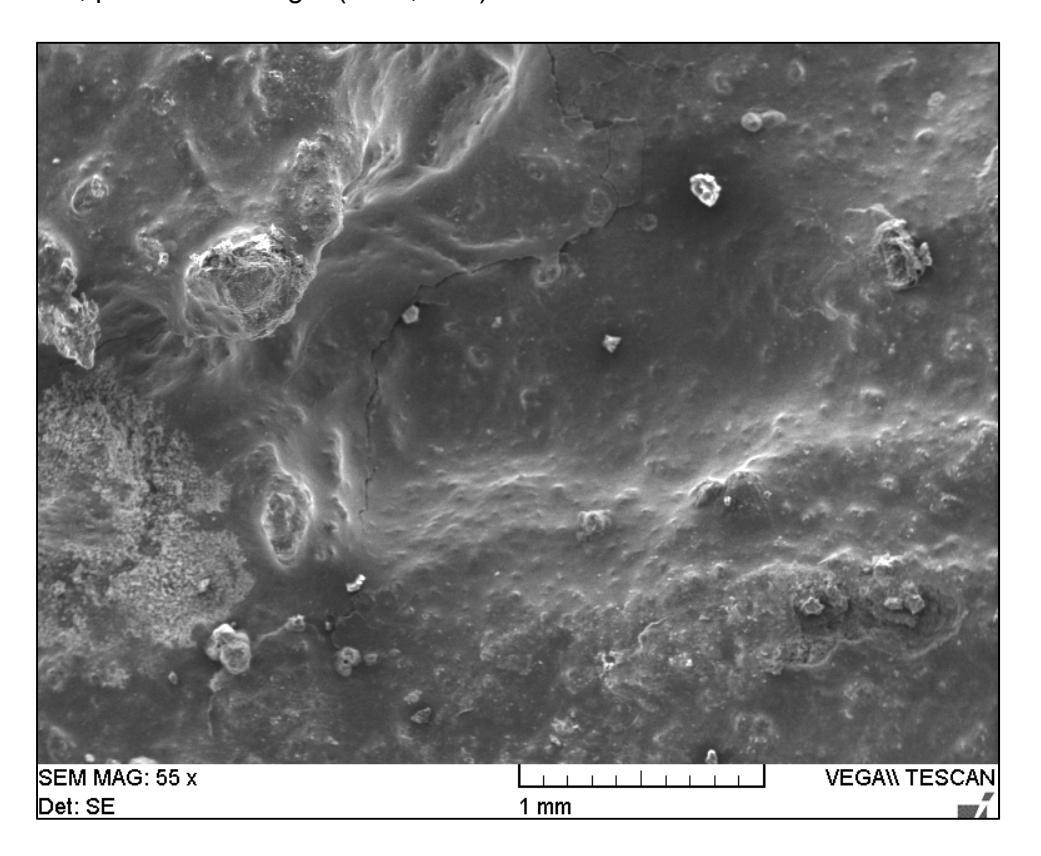
Figure 48. A representative SEM image of a pit on a specimen excised from Coupon 3 labeled as 3-2, prior to cleaning. (SEM, 32X)

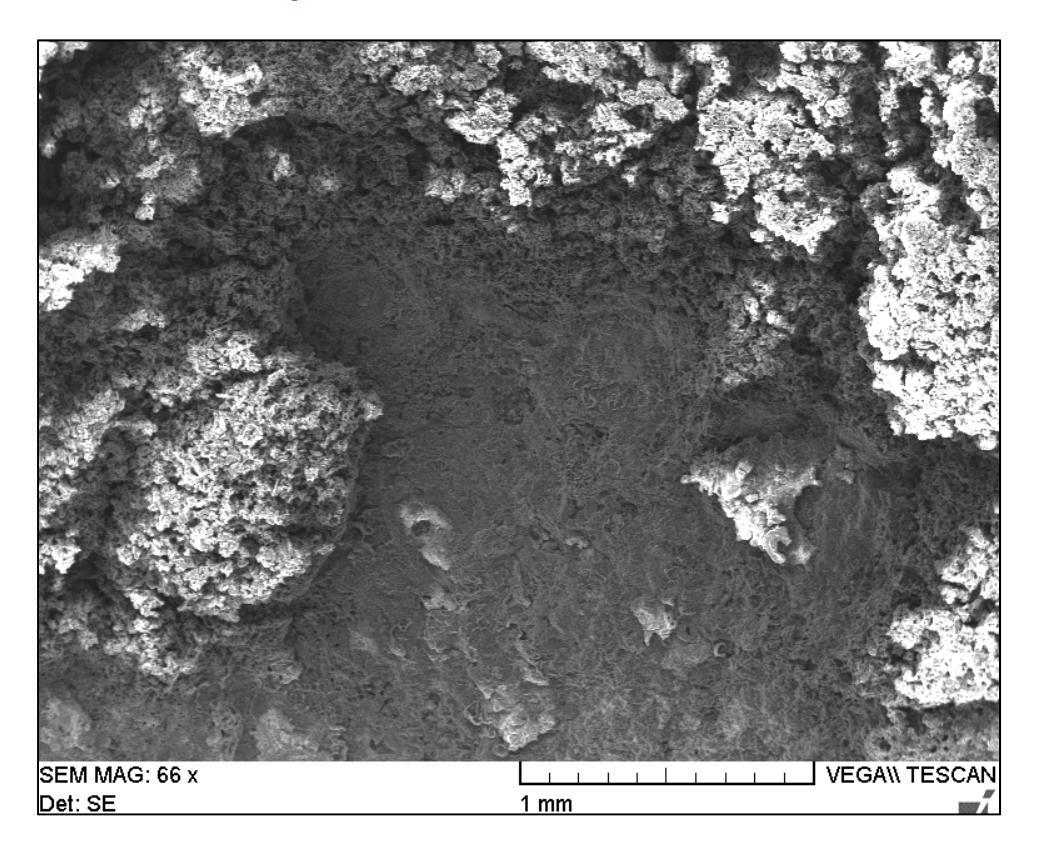
Figure 49. A representative SEM image of a pit on a specimen excised from Coupon 3 labeled as 3-3, prior to cleaning. (SEM, 39X)

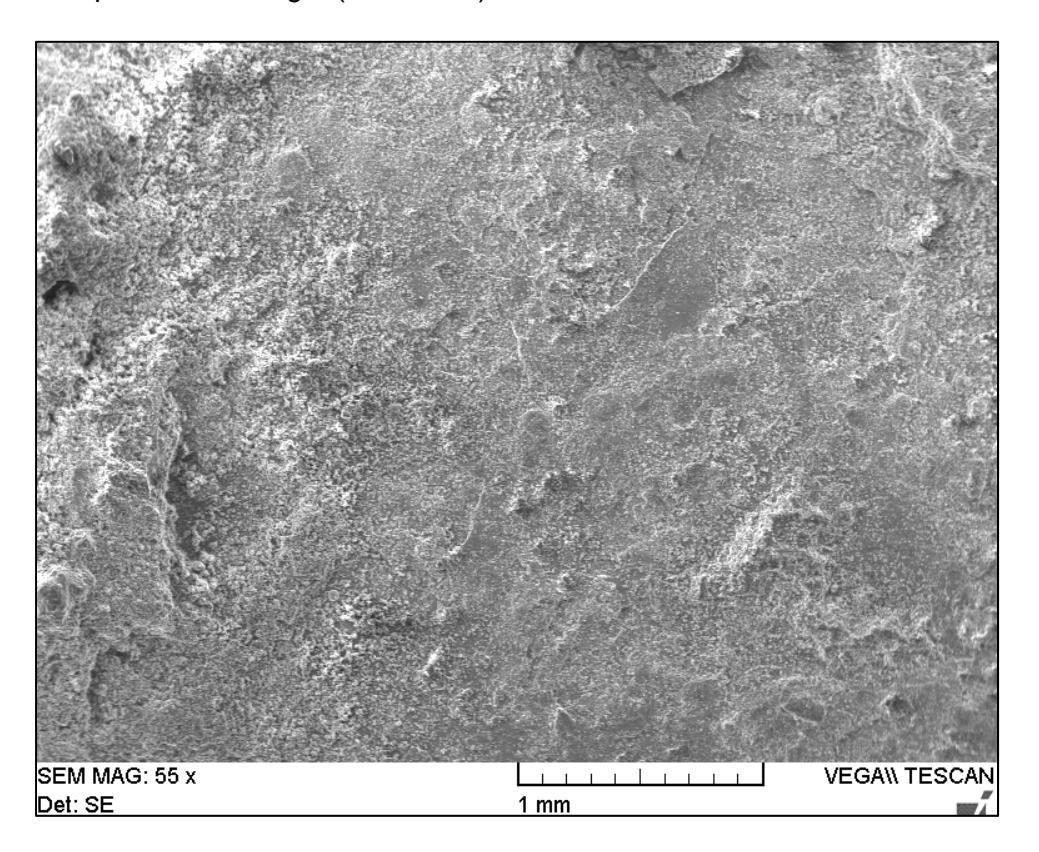
Figure 52. A representative SEM image of a pit on a specimen excised from Coupon 5 labeled as 5-3, prior to cleaning. (SEM, 32X)

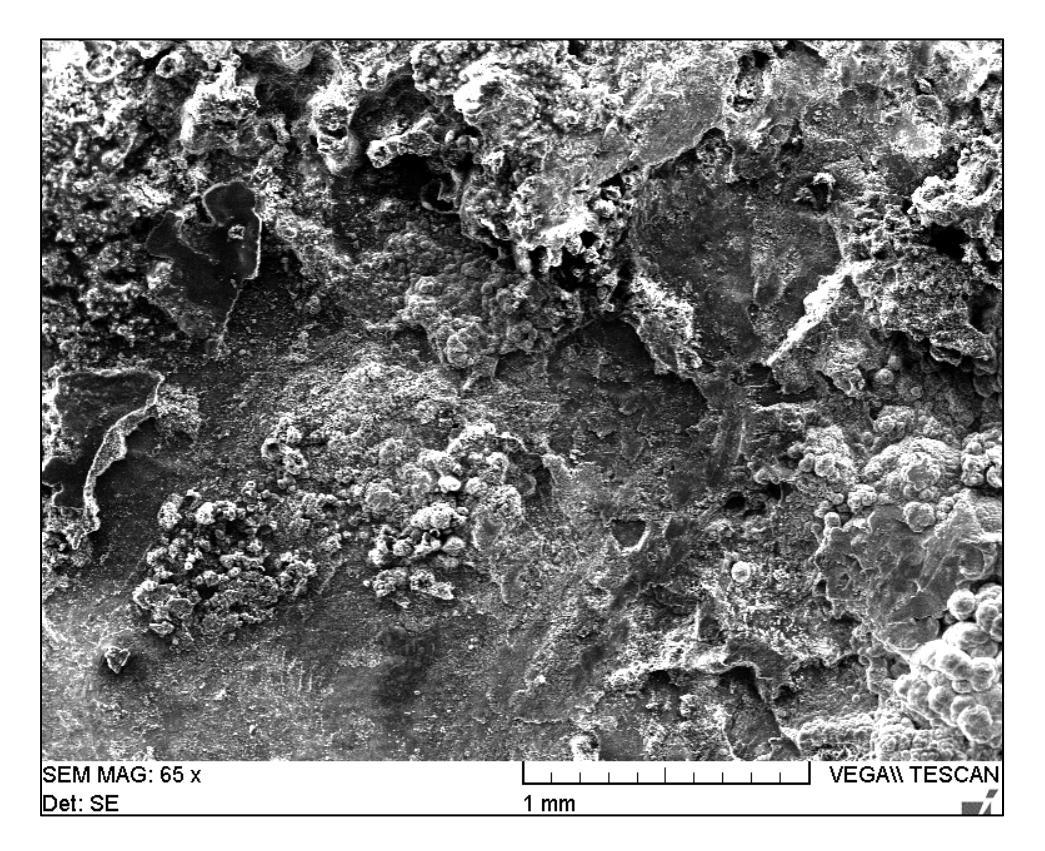
Figure 53. A representative SEM image of a pit on a specimen excised from Coupon 6 labeled as 6-1, prior to cleaning. (SEM, 38X)

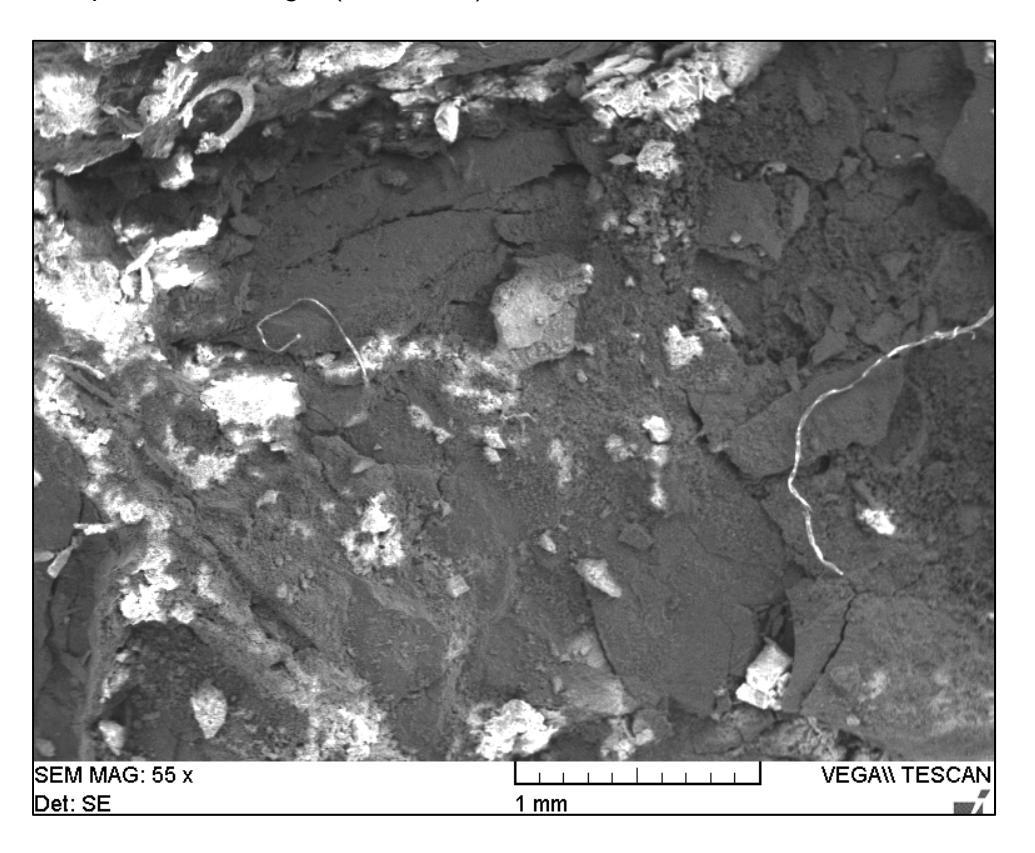
Figure 56. A representative SEM image of a pit on a specimen excised from Coupon 7 labeled as 7-1, prior to cleaning. (SEM, 32X)

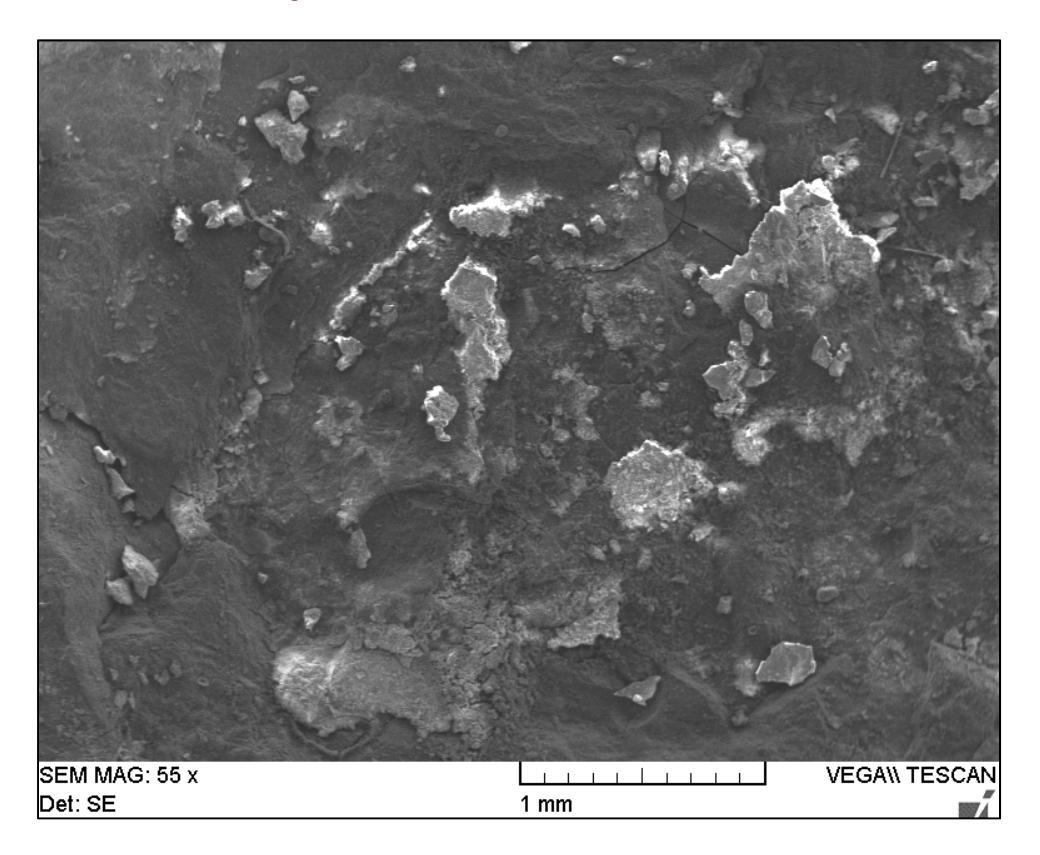
Figure 57. A representative SEM image of a pit on a specimen excised from Coupon 7 labeled as 7-2, prior to cleaning. (SEM, 32X)

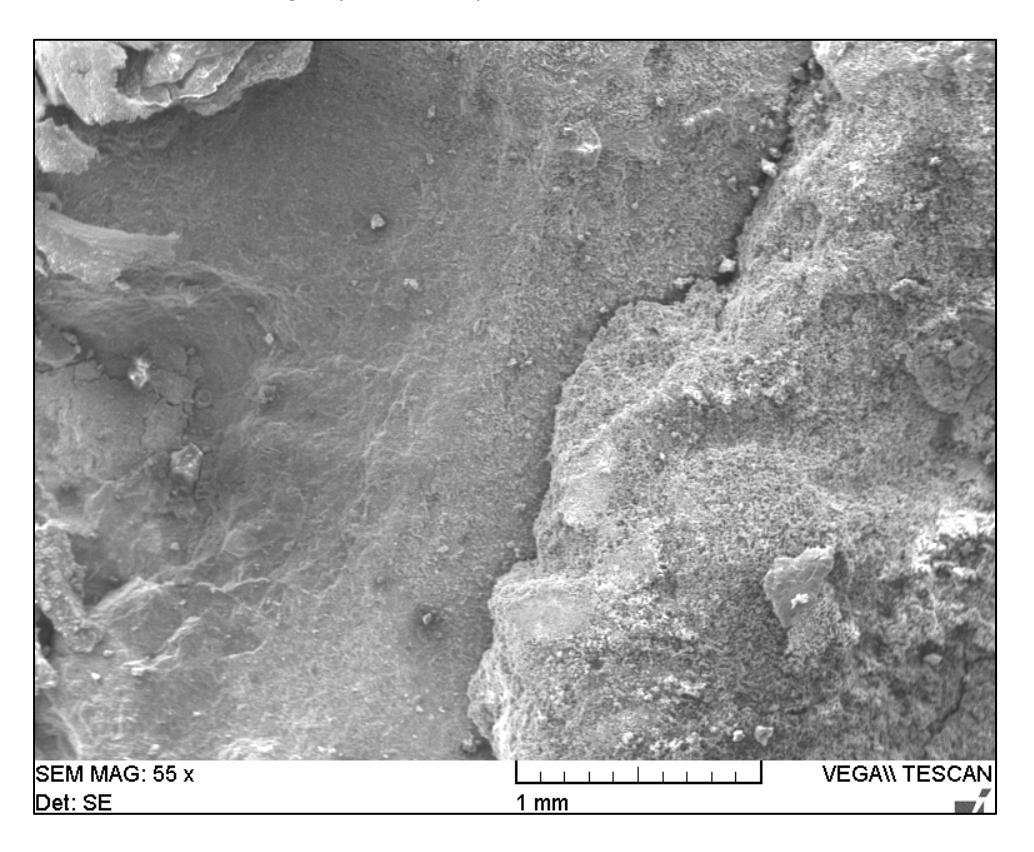
Figure 58. A representative SEM image of a pit on a specimen excised from Coupon 7 labeled as 7-3, prior to cleaning. (SEM, 32X)

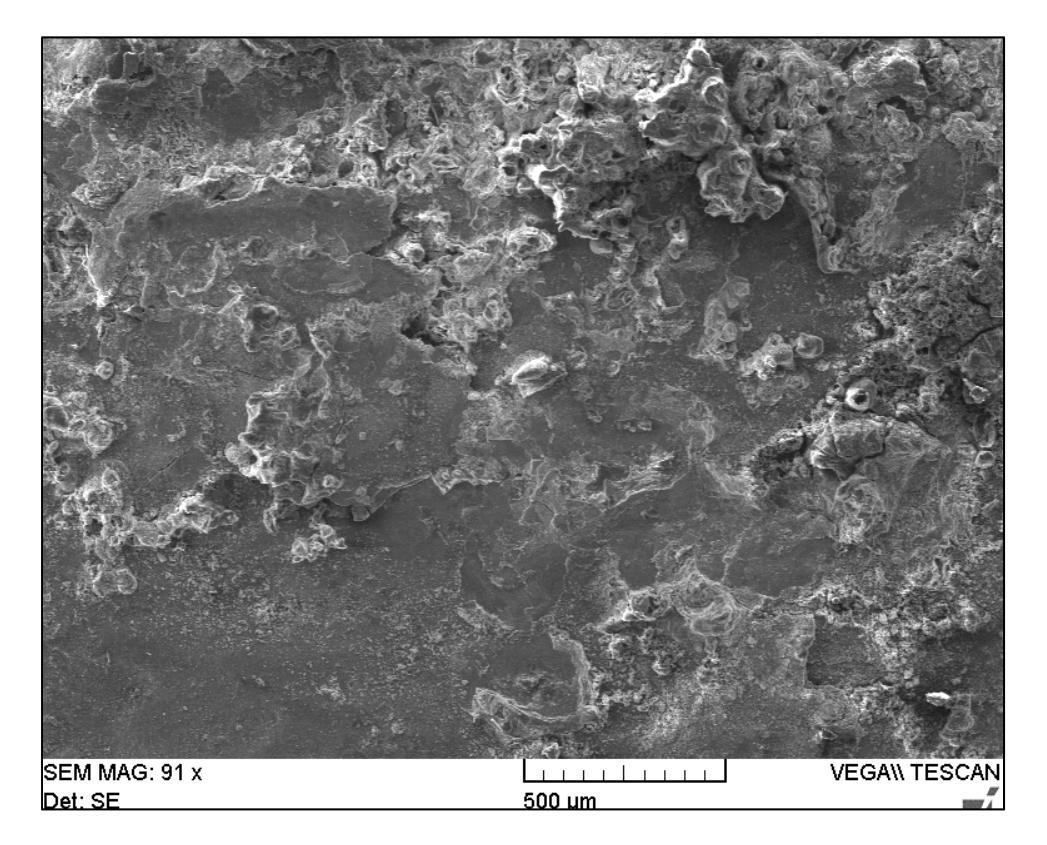
Figure 59. A representative SEM image of a pit on a specimen excised from Coupon 8 labeled as 8-1, prior to cleaning. (SEM, 53X)

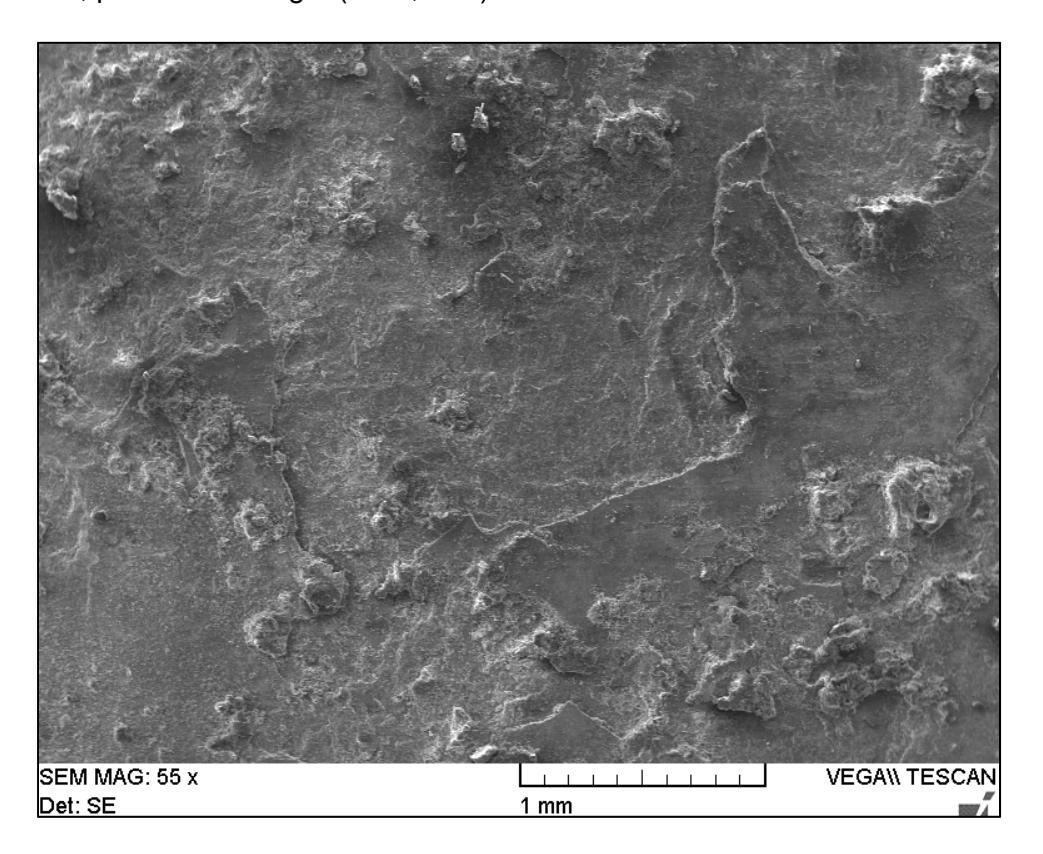
Figure 60. A representative SEM image of a pit on a specimen excised from Coupon 8 labeled as 8-2, prior to cleaning. (SEM, 33X)

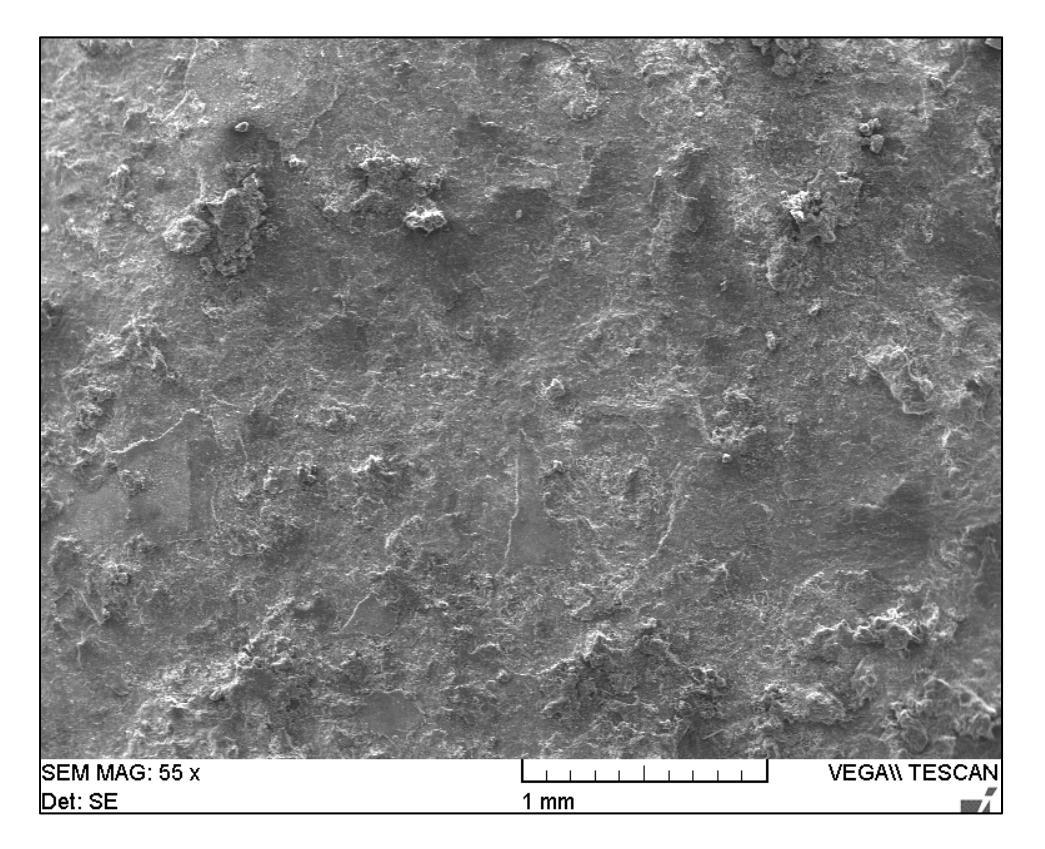
④ This is the weld-repaired plate section. Sample 8-3 exhibited a depression or pit on the painted surface.

Figure 61. A representative SEM image of a pit on a specimen excised from Coupon 8 labeled as 8-3, prior to cleaning. (SEM, 33X)

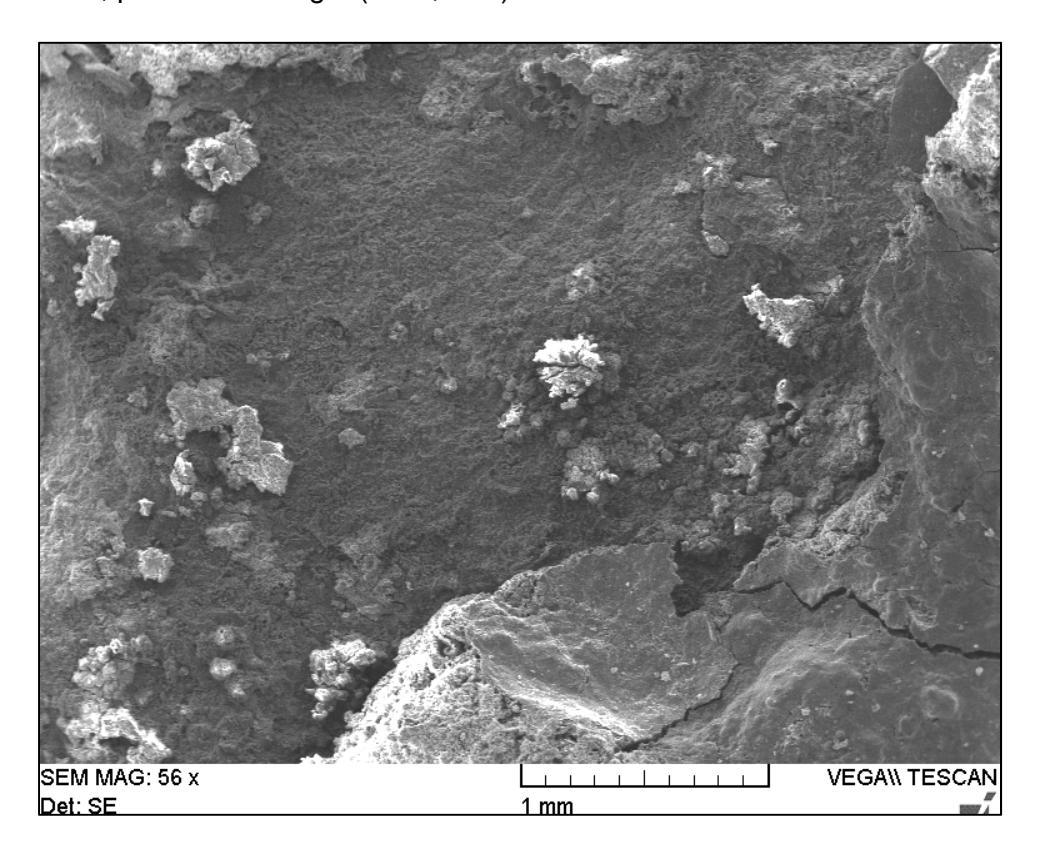
Figure 66. A representative SEM image of a pit on a specimen excised from Coupon A-1 labeled as A1-2, prior to cleaning. (SEM, 33X)

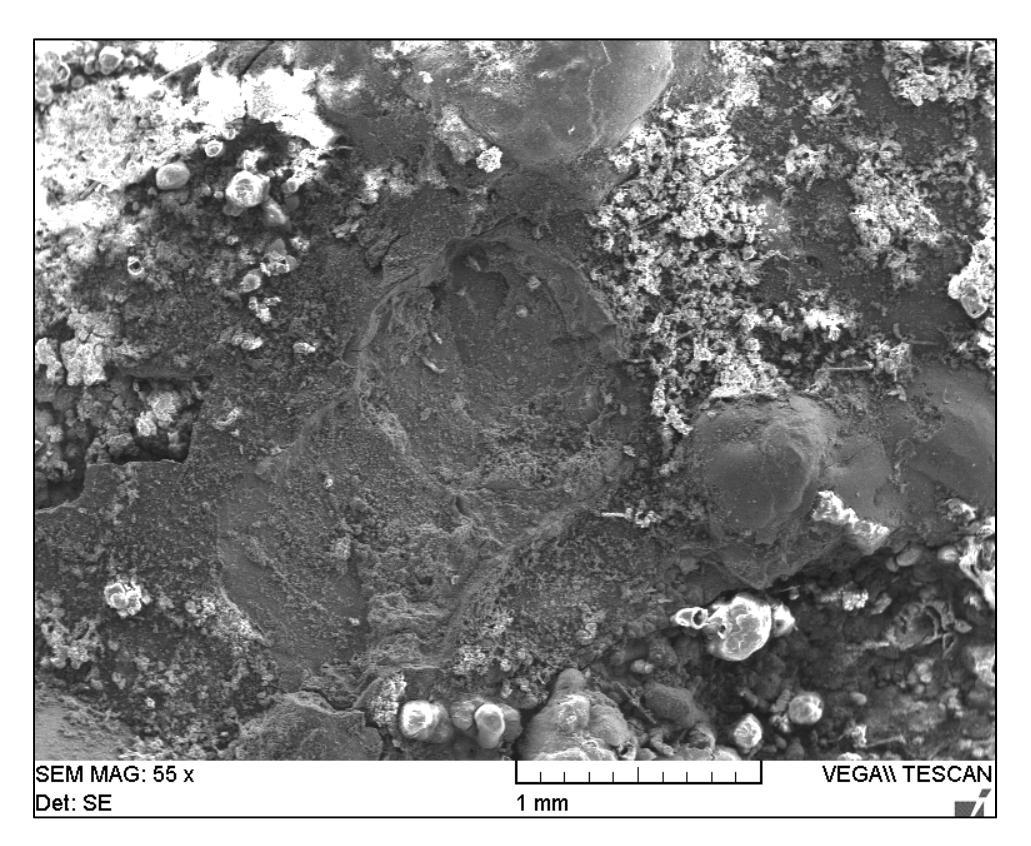
Figure 67. A representative SEM image of a pit on a specimen excised from Coupon A-1 labeled as A1-3, prior to cleaning. (SEM, 32X)

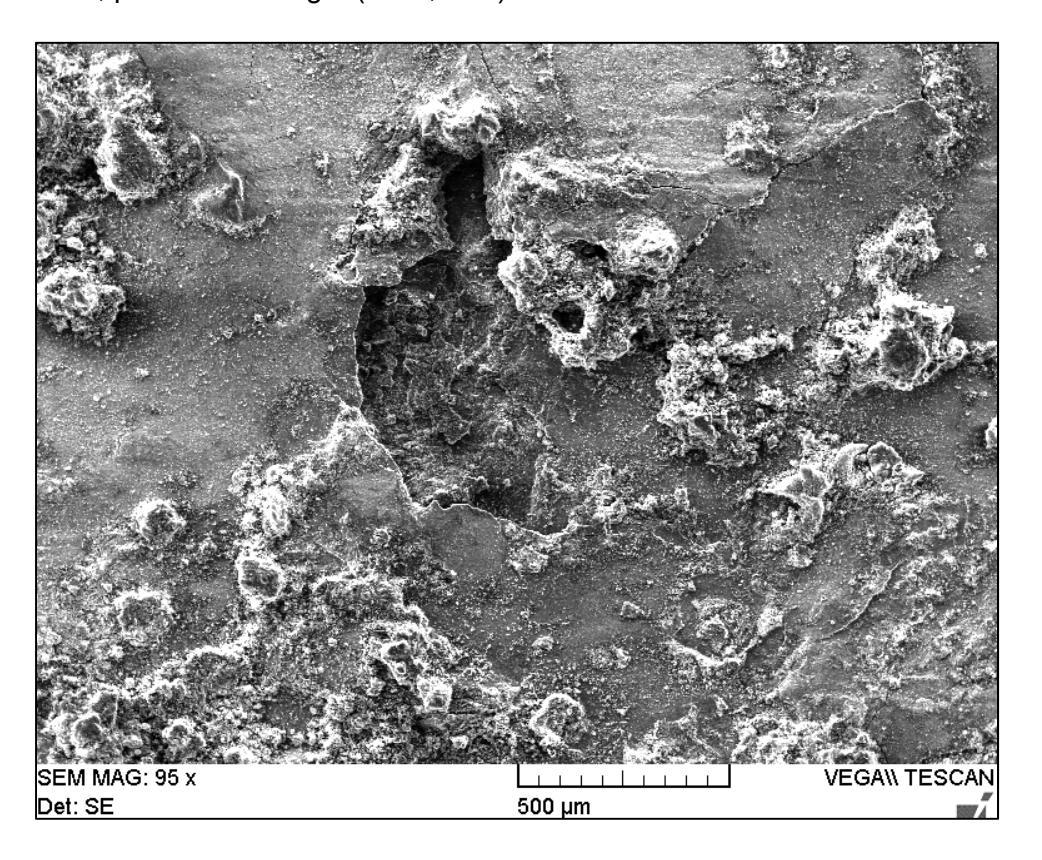
Figure 68. A representative SEM image of a pit on a specimen excised from Coupon A-2 labeled as A2-1, prior to cleaning. (SEM, 56X)

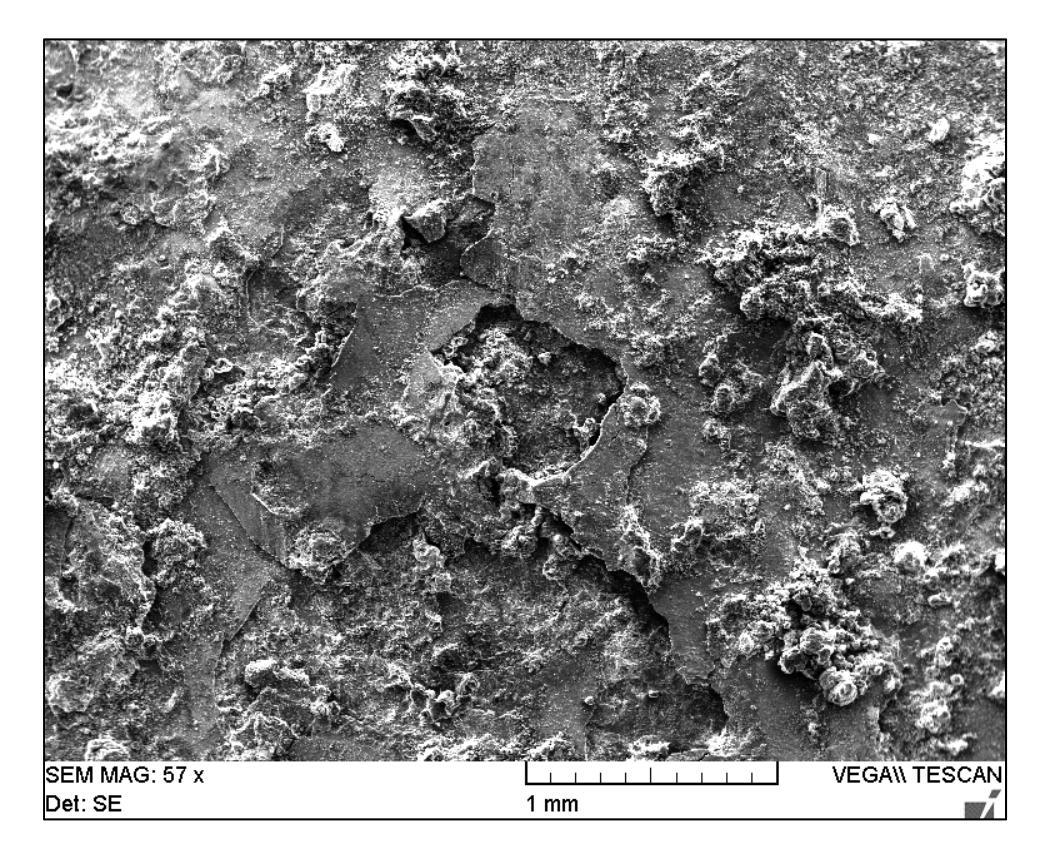
Figure 69. A representative SEM image of a possible pit on a specimen excised from Coupon A-2 labeled as A2-2, prior to cleaning. (SEM, 33X)

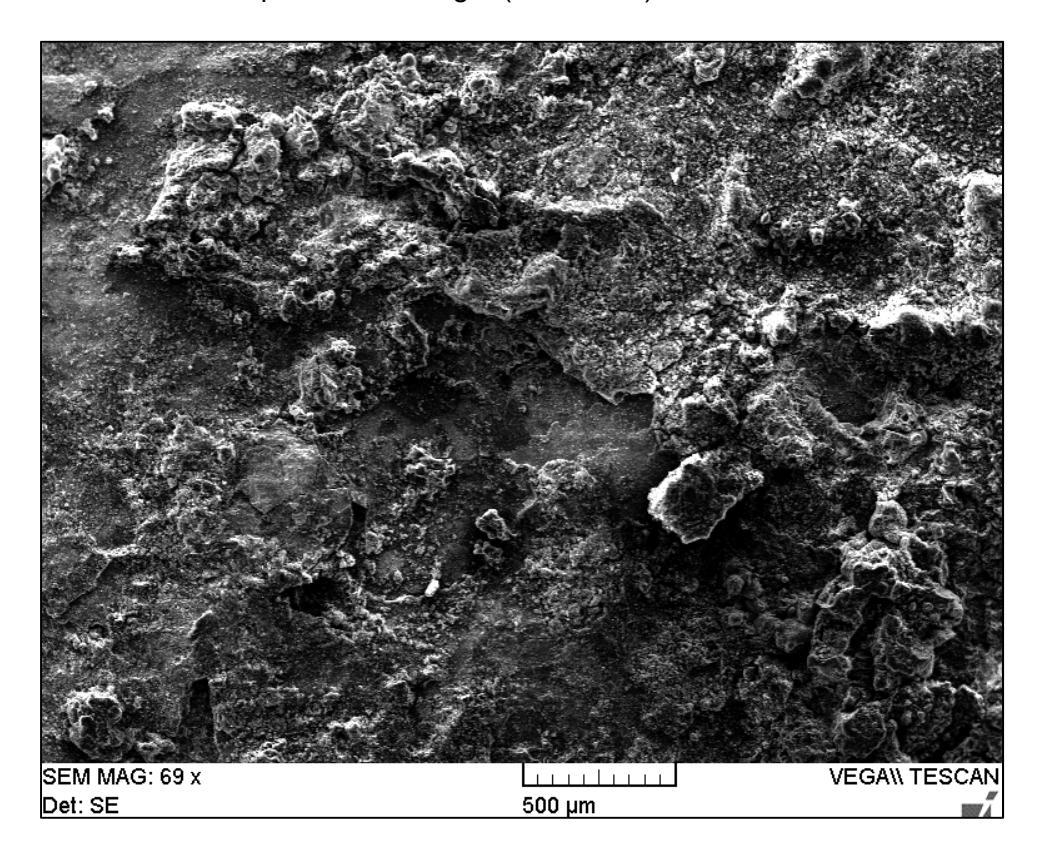
Figure 70. A representative SEM image of a possible pit on a specimen excised from Coupon A-2 labeled as A2-3, prior to cleaning. (SEM, 40X)

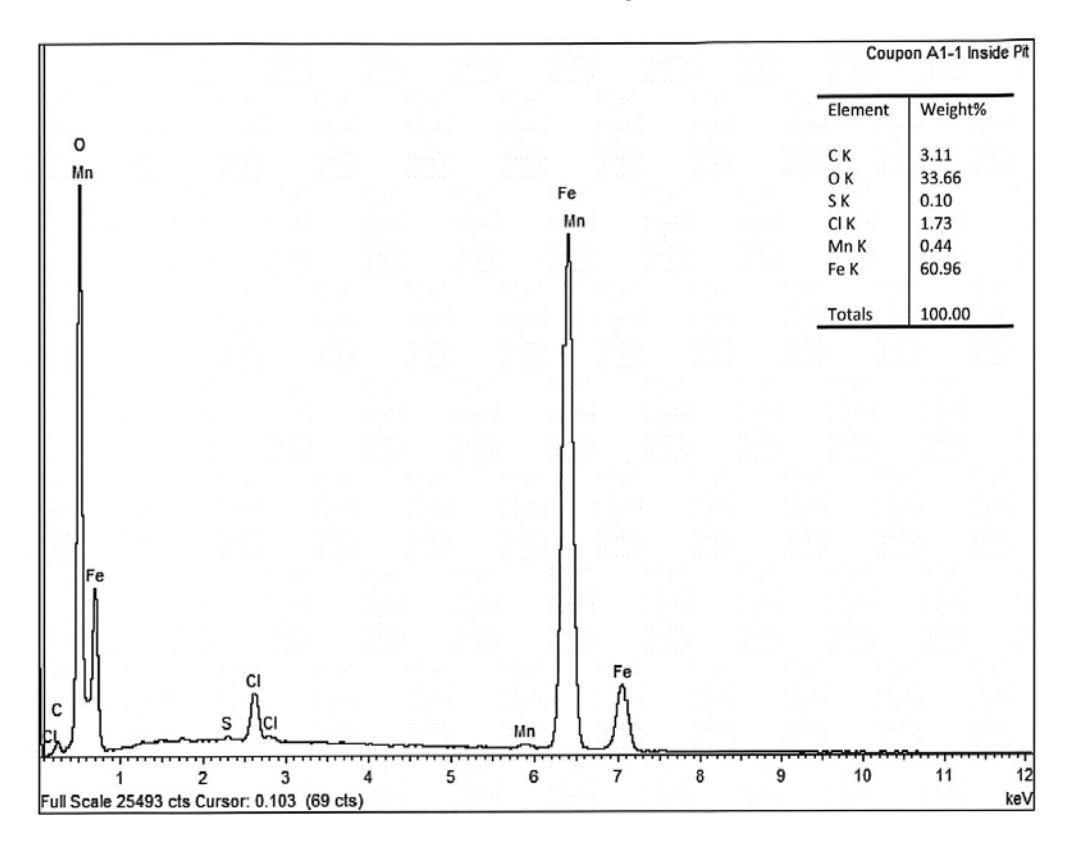
Figure 95. A representative EDS spectrum generated from of a pit on a specimen excised from Coupon A1 labeled as A1-1, prior to cleaning.

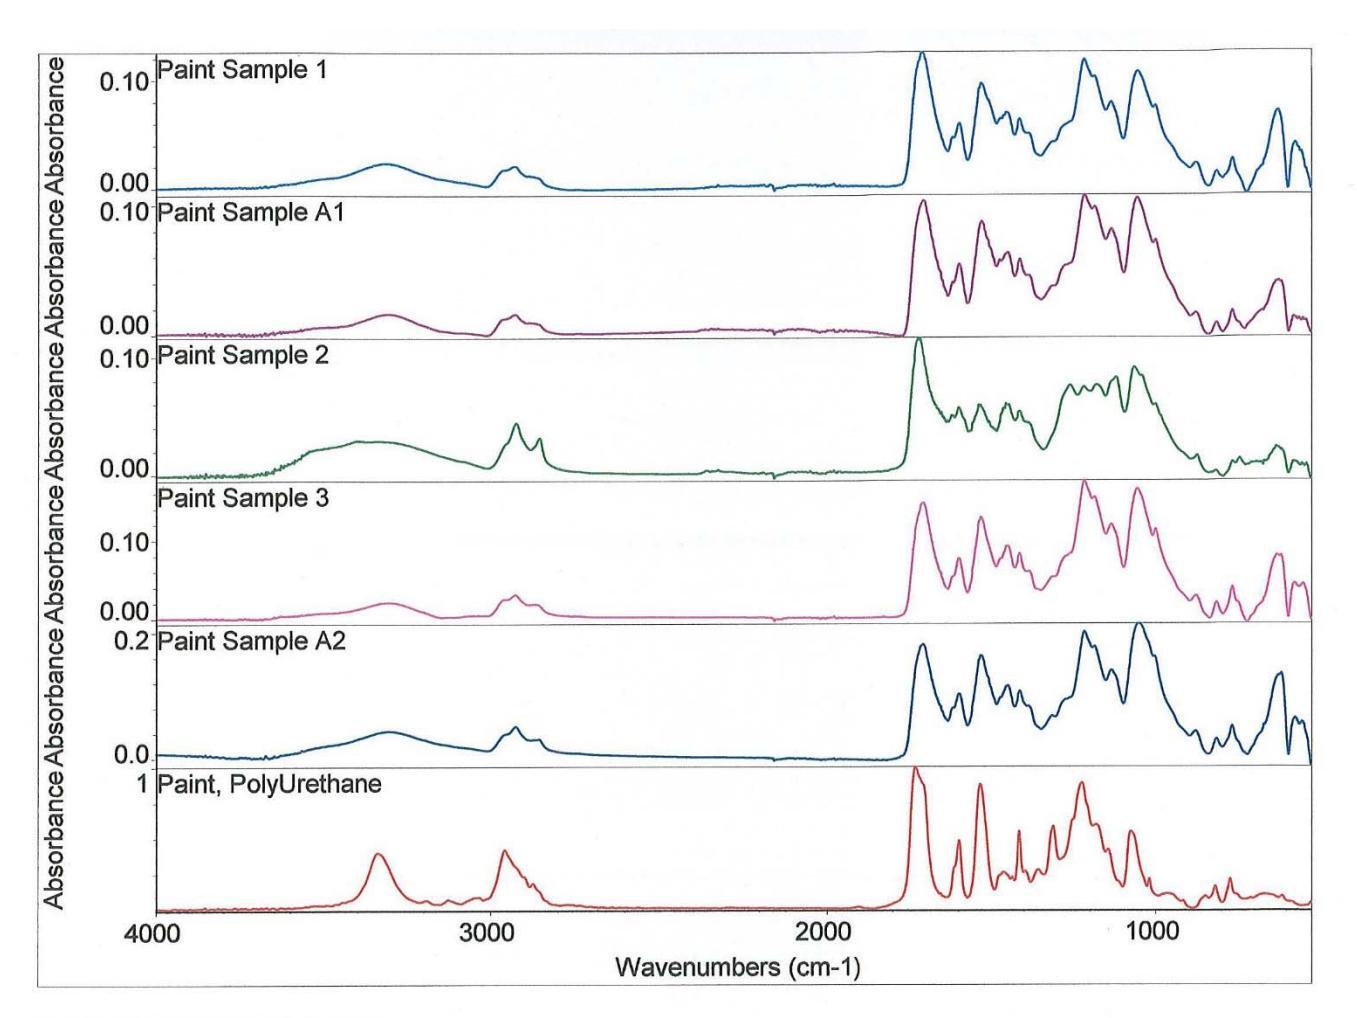
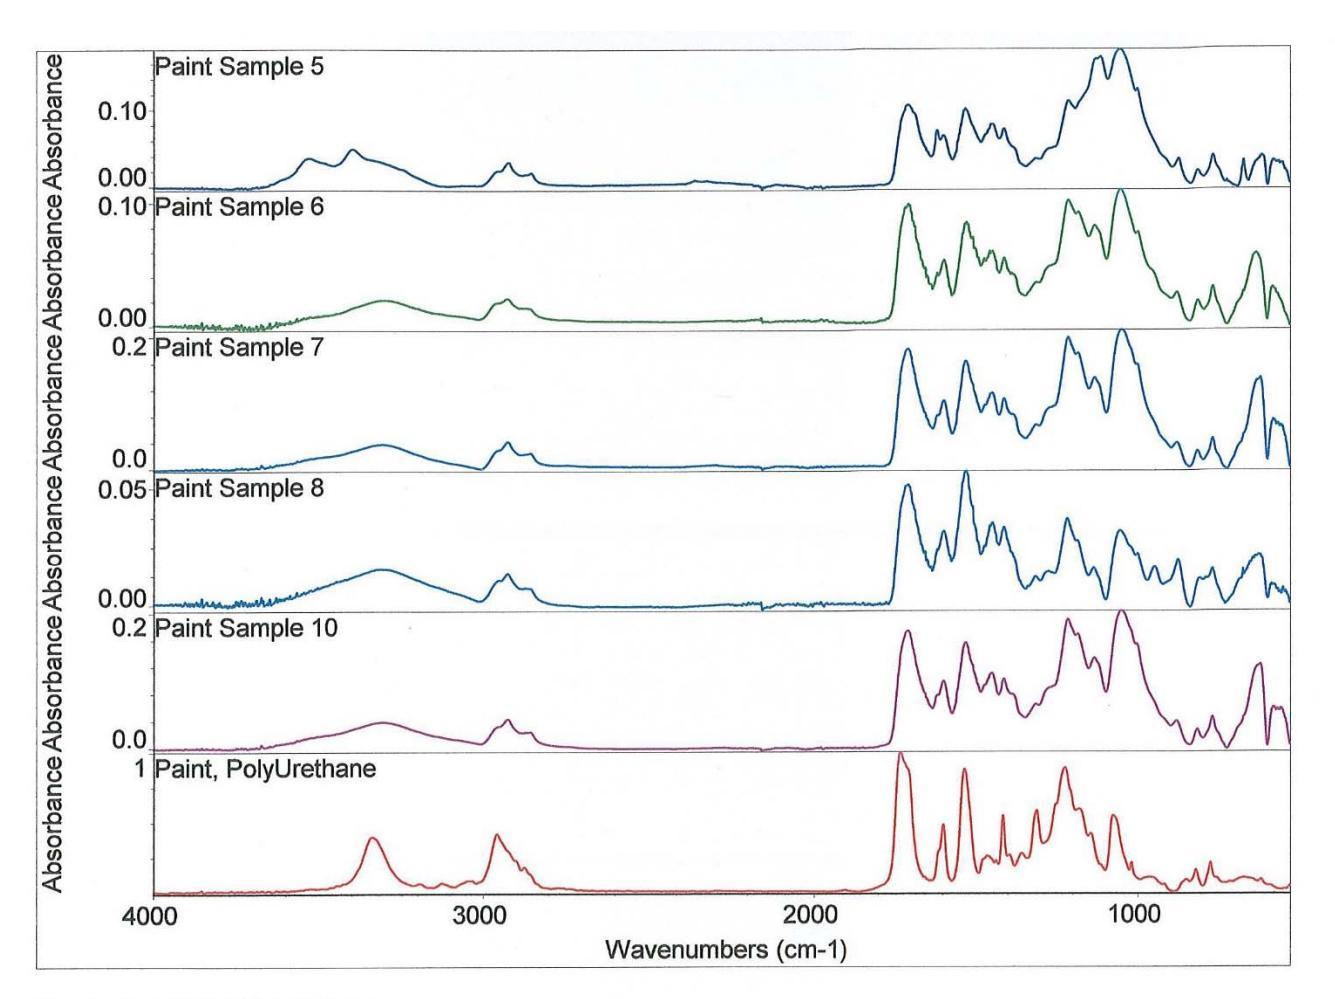
Fourier transform infrared (FTIR) spectroscopy was performed on paint samples removed from each coupon using Attenuated Total Reflectance (ATR) with a diamond crystal. All paint samples were identified as polyurethane enamel. The resulting FTIR spectra of the samples and the best matches from the spectral FTIR library of standards for polyurethane enamel are provided as Figures 111 and 112.
