SUBJECT: DESTRUCTIVE ANALYSIS OF 10 STEEL COUPONS REMOVED FROM RED HILL FUEL STORAGE TANK NO. 14, PURSUANT TO SECTION 5.3 OF THE ADMINISTRATIVE ORDER ON CONSENT STATEMENT OF WORK, RED HILL BULK FUEL STORAGE FACILITY, JOINT BASE PEARL HARBOR-HICKAM, OAHU, HAWAII

Destructive Analysis of 10 Steel Coupons Removed from Red Hill Fuel Storage Tank #14

REPORT No. 201801967

December 17, 2018

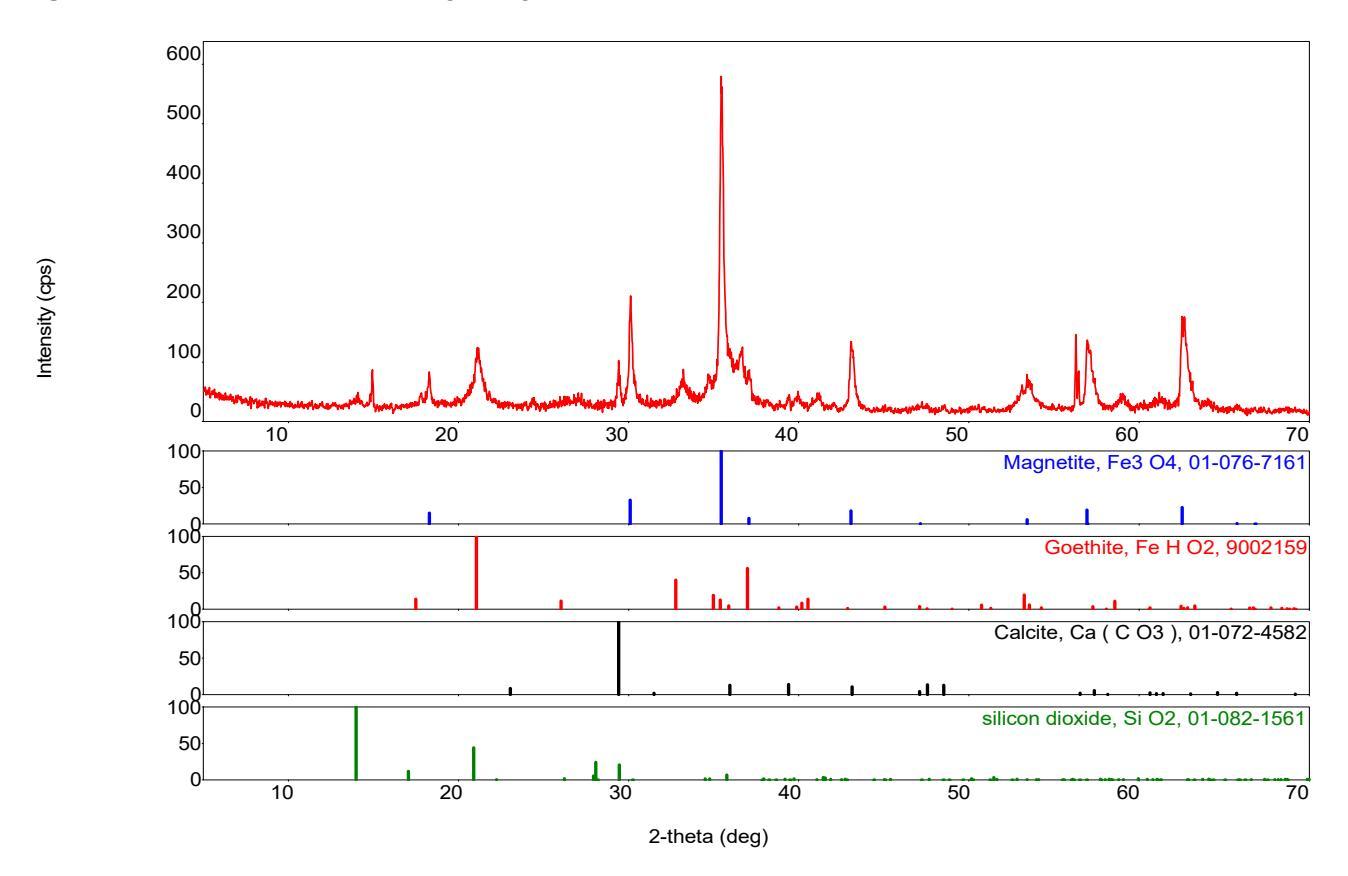
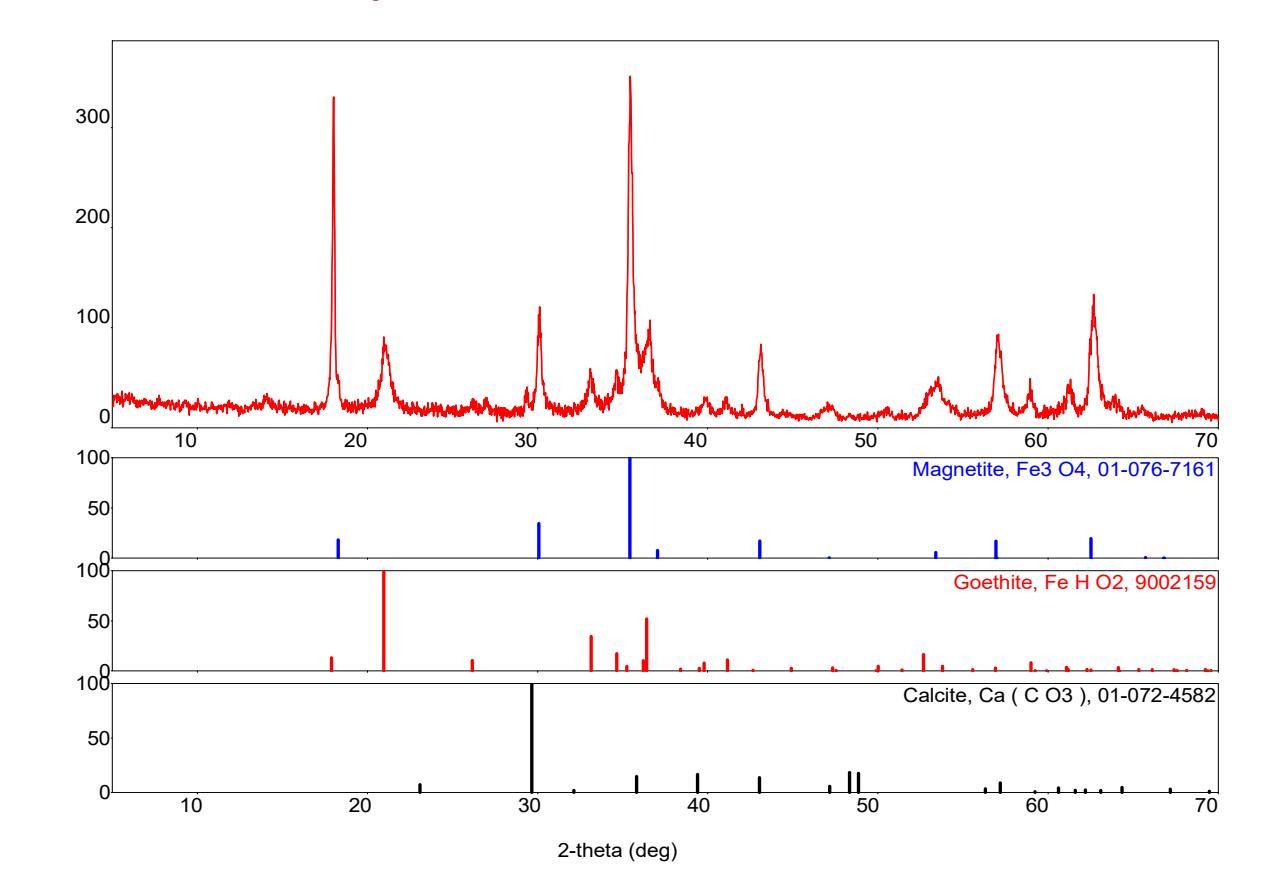
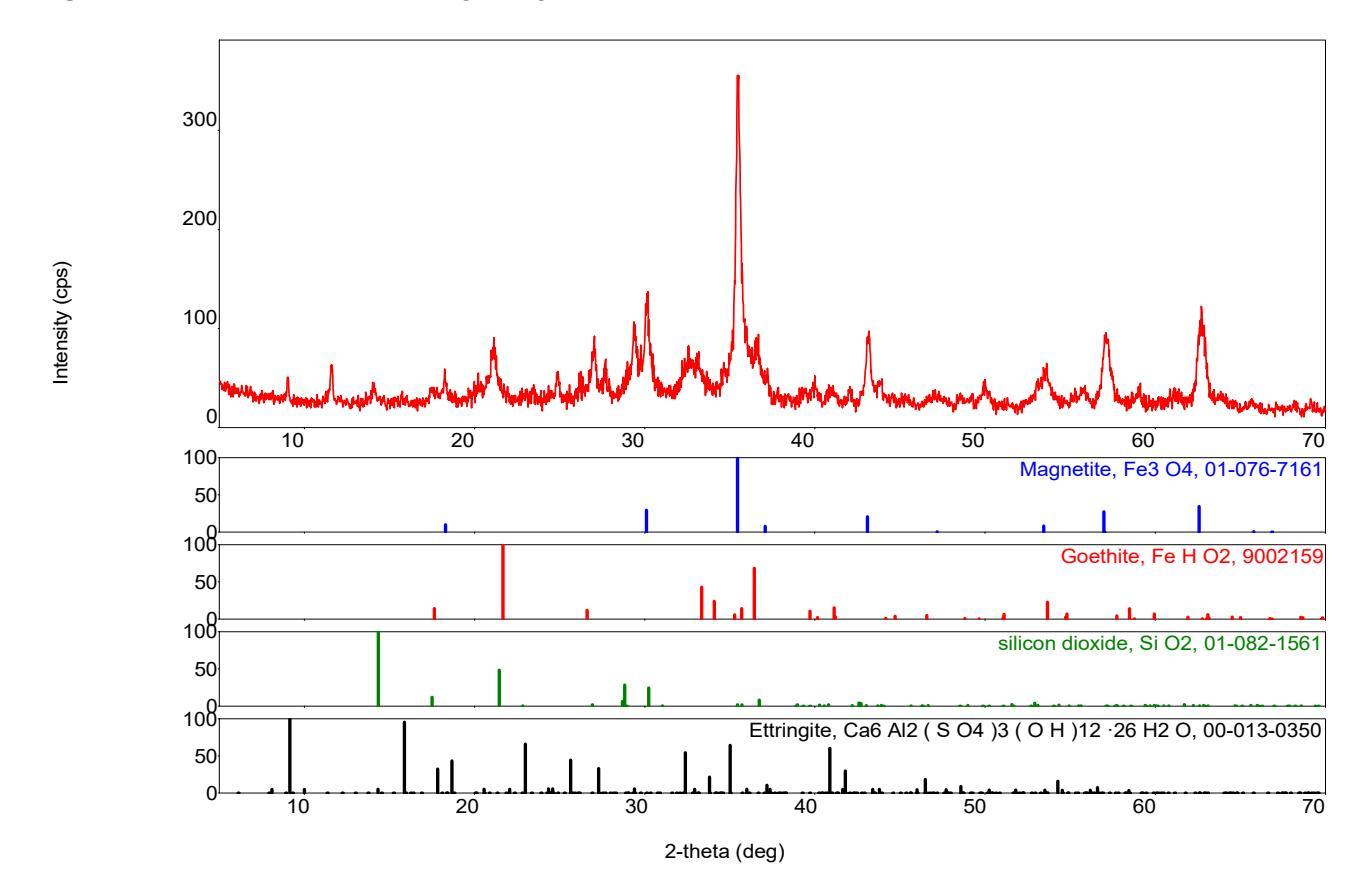
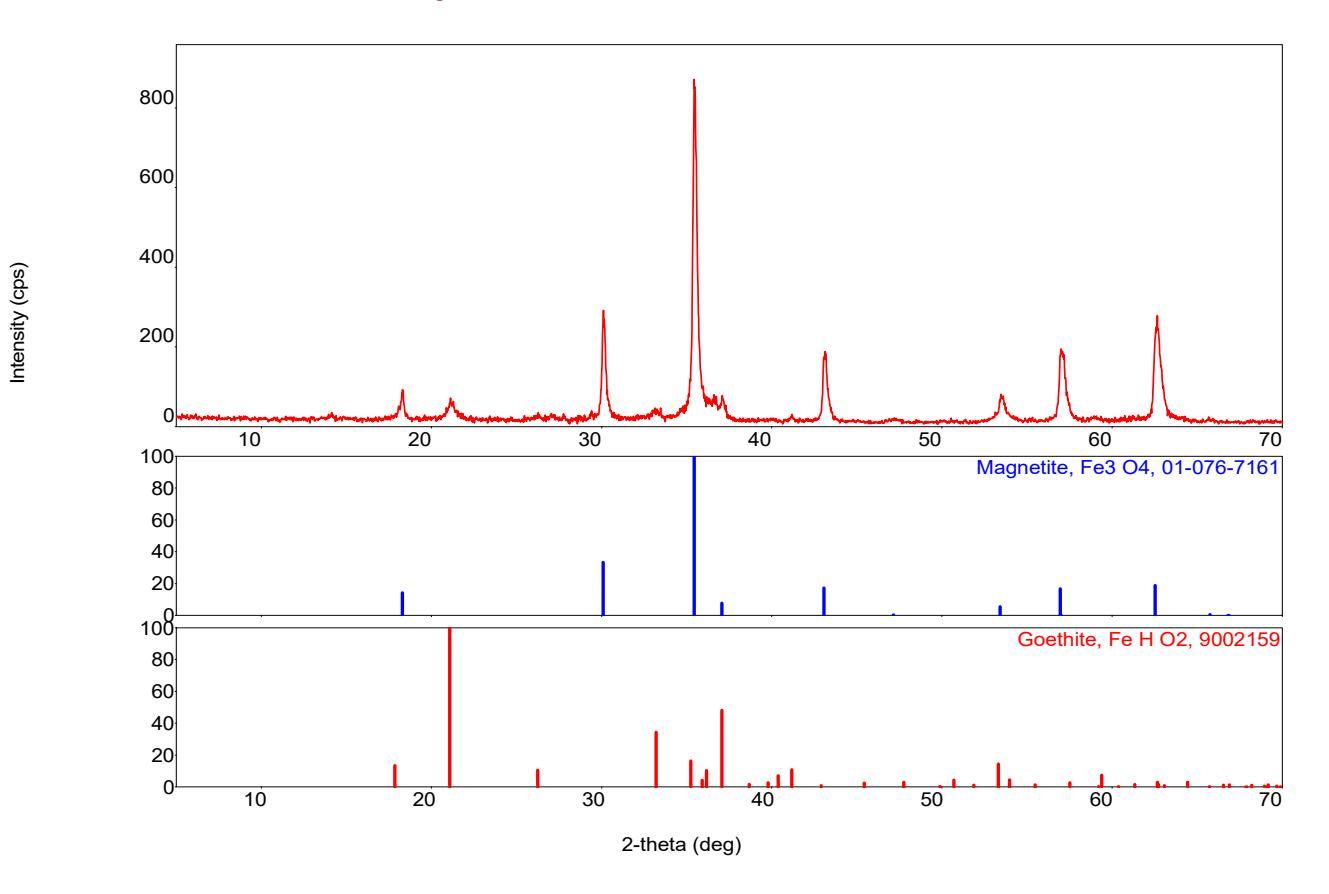
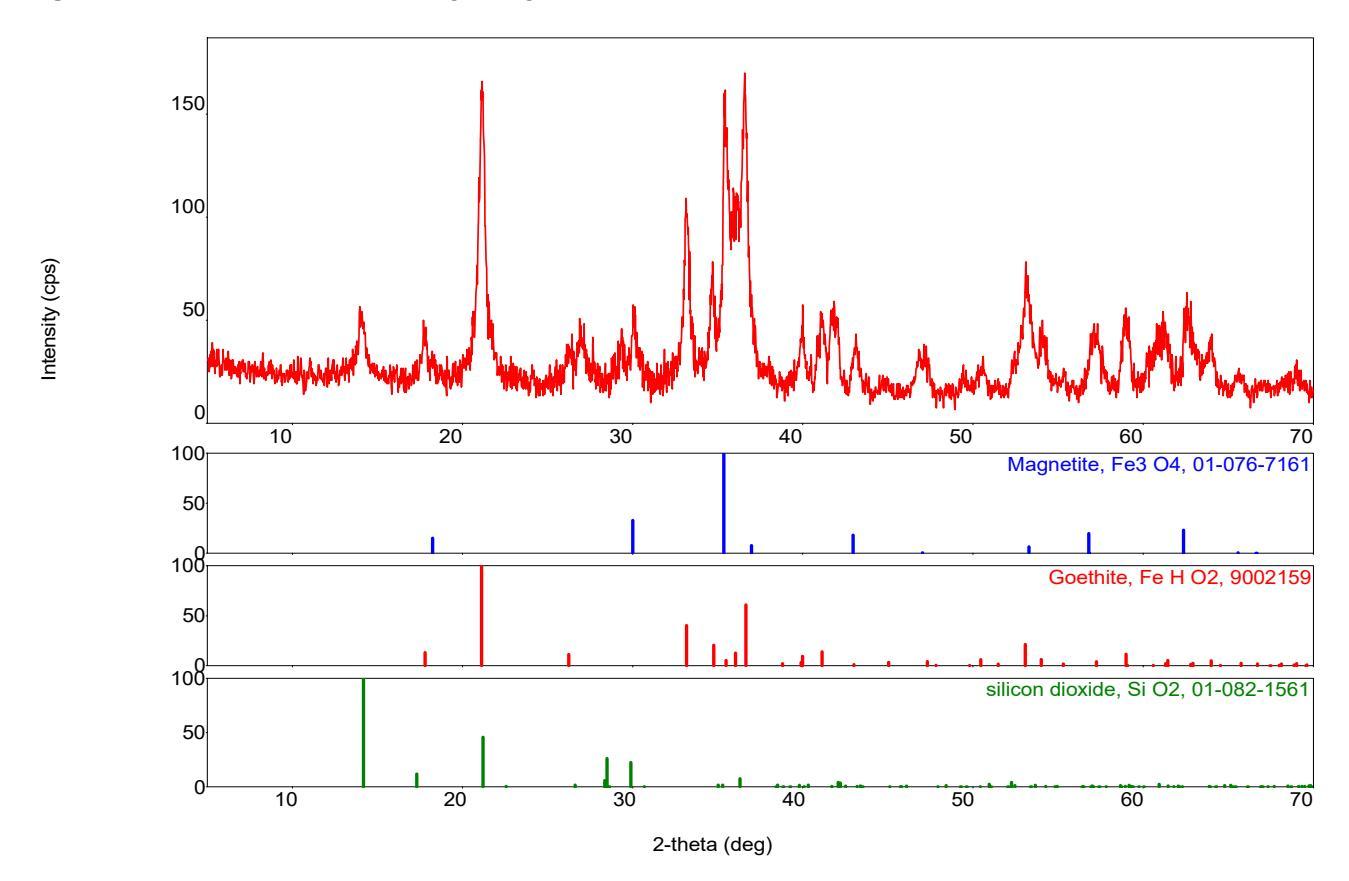
X-Ray Diffraction Spectroscopy (XRD) analysis of the corrosion product from the metal panels revealed the presence of the following crystalline phases: iron oxide (magnetite); iron hydroxide (goethite); calcium carbonate (calcite); silicon dioxide and hydrous calcium aluminum sulfate (ettringite). The results are summarized in Tables 19 and 20. The XRD diffractograms for the corrosion samples are provided as Figures 123 through 128.

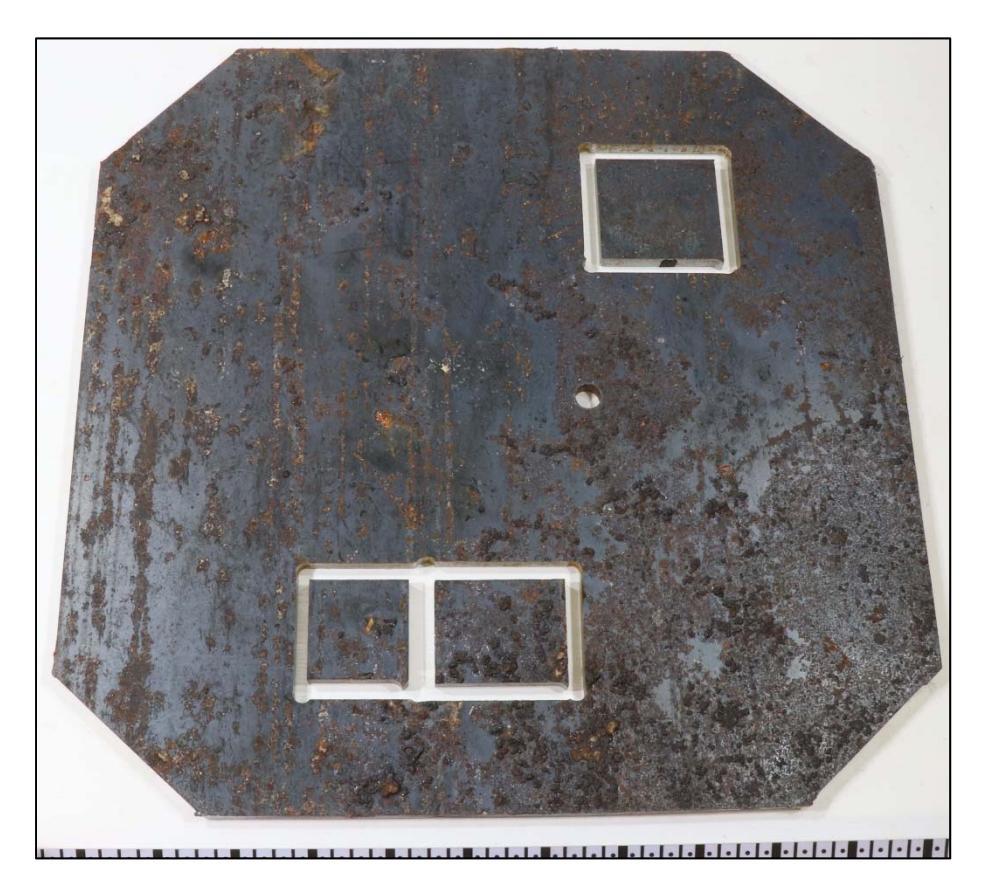
Figure 129. An image of the interior surface of Coupon 1 after CO₂ blast cleaning.

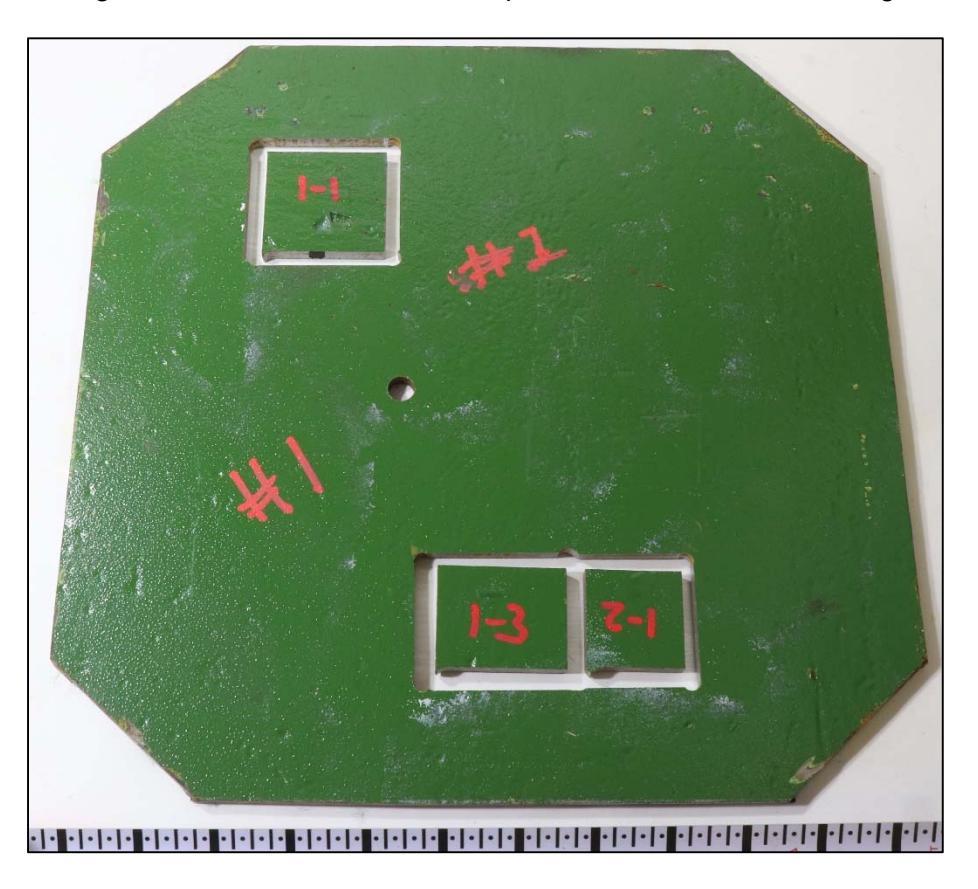
Figure 130. An image of the exterior surface of Coupon 1 after CO₂ blast cleaning.

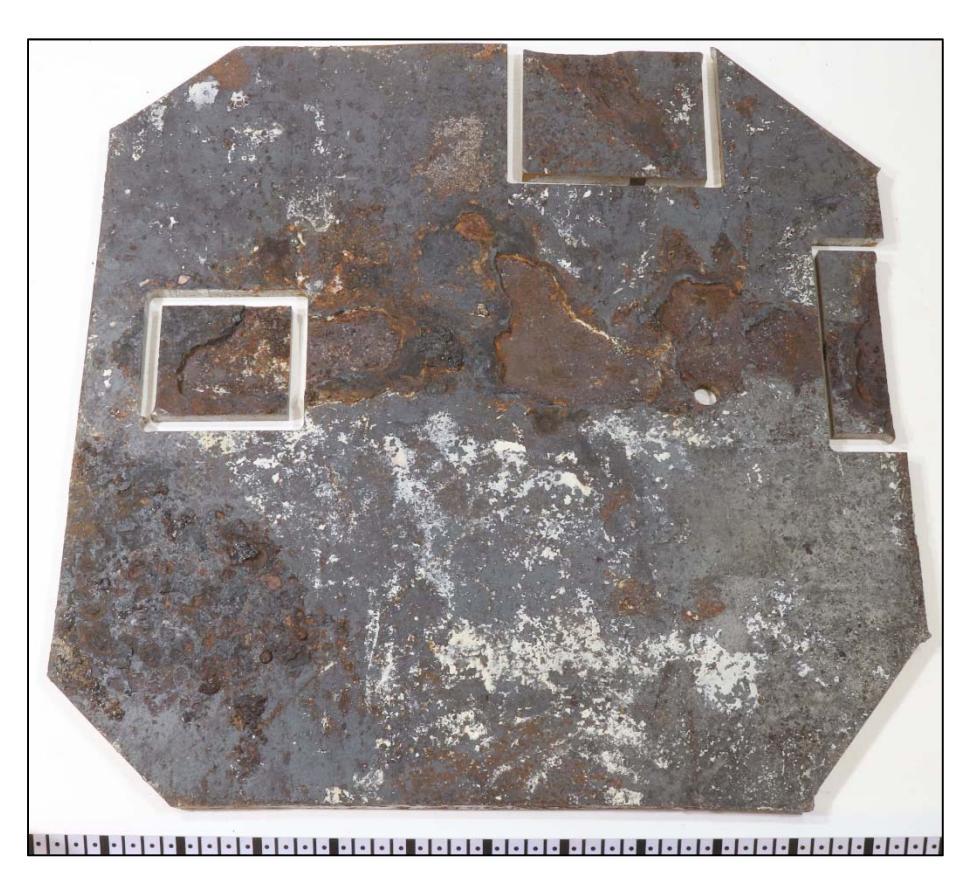
Figure 131. An image of the interior surface of Coupon 2 after CO₂ blast cleaning.

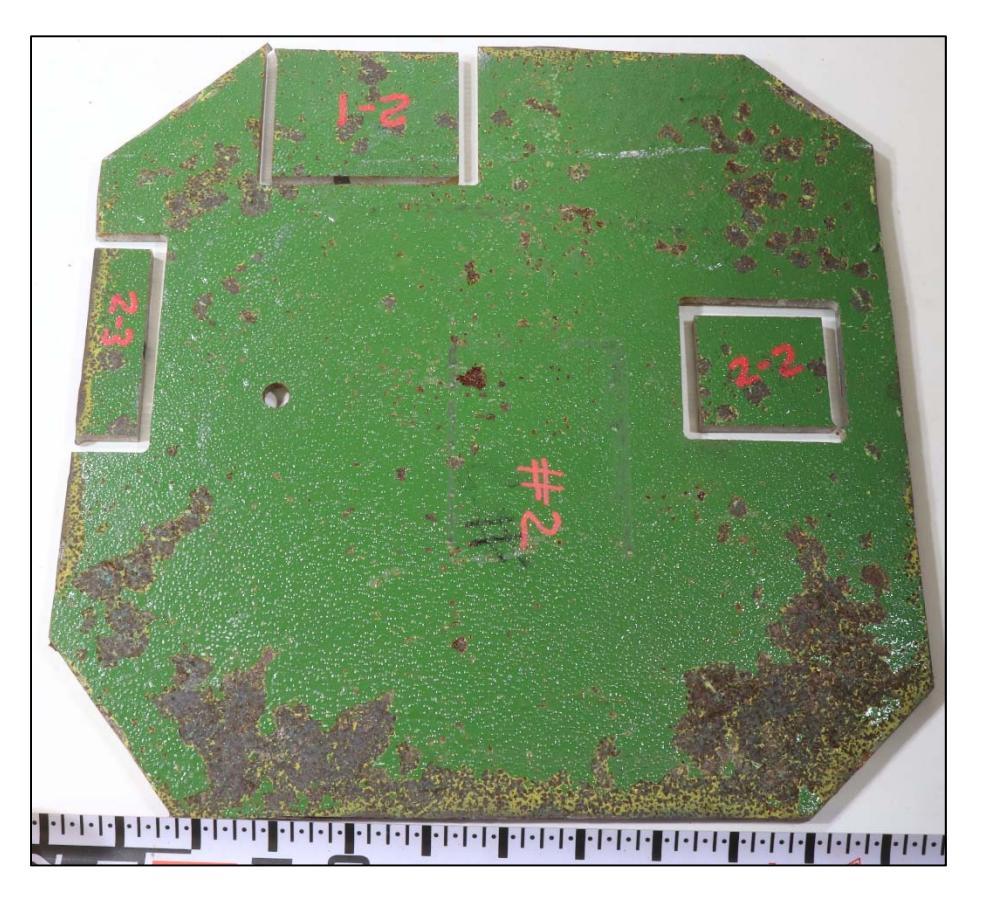
Figure 132. An image of the exterior surface of Coupon 2 after CO₂ blast cleaning.

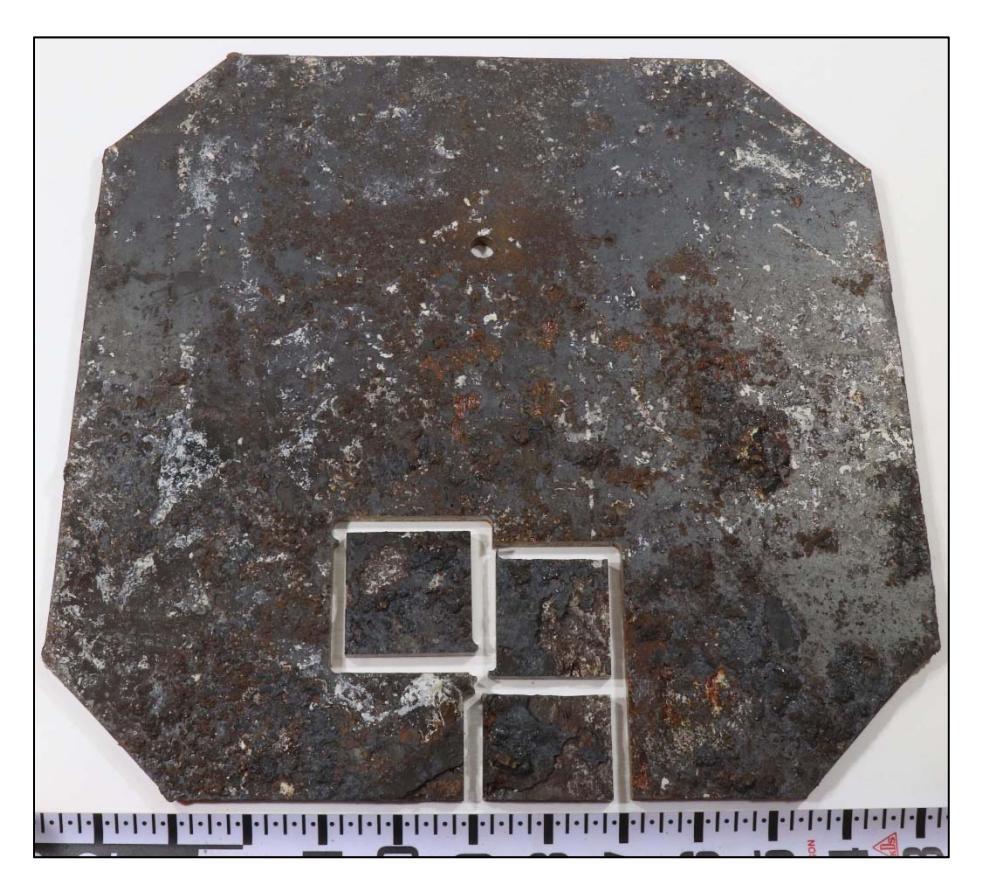
Figure 133. An image of the interior surface of Coupon 3 after CO₂ blast cleaning.

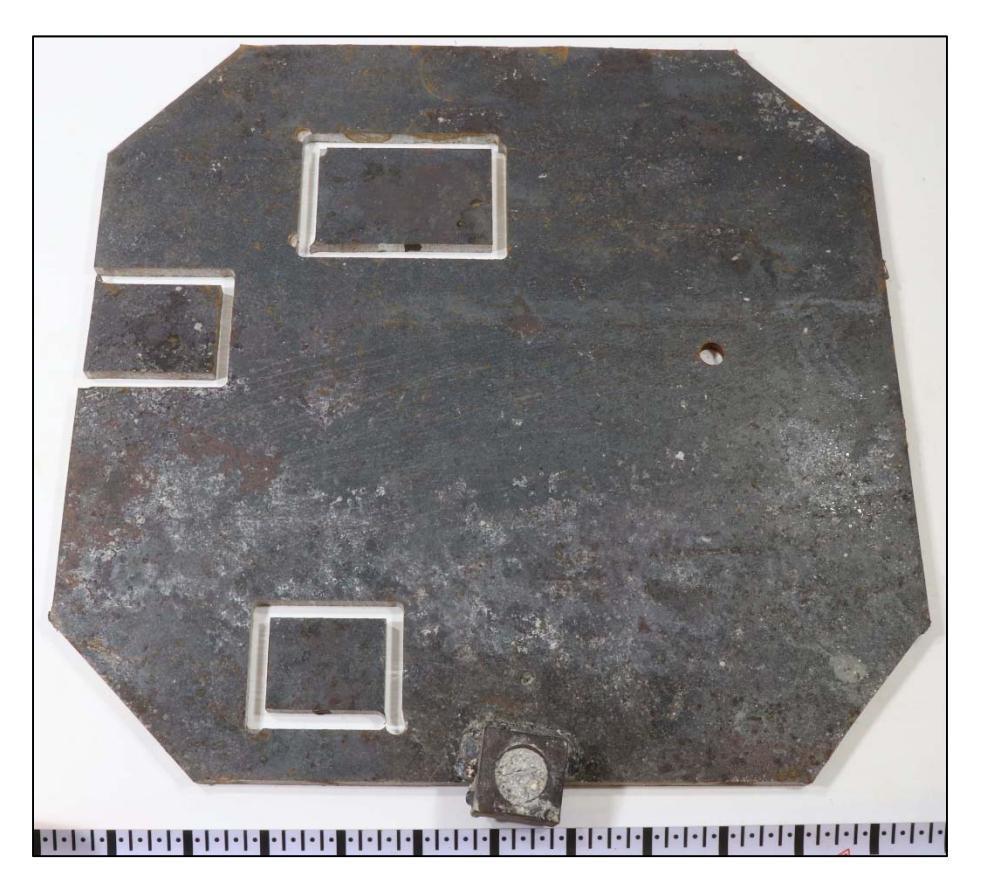
Figure 135. An image of the interior surface of Coupon 5 after CO₂ blast cleaning.

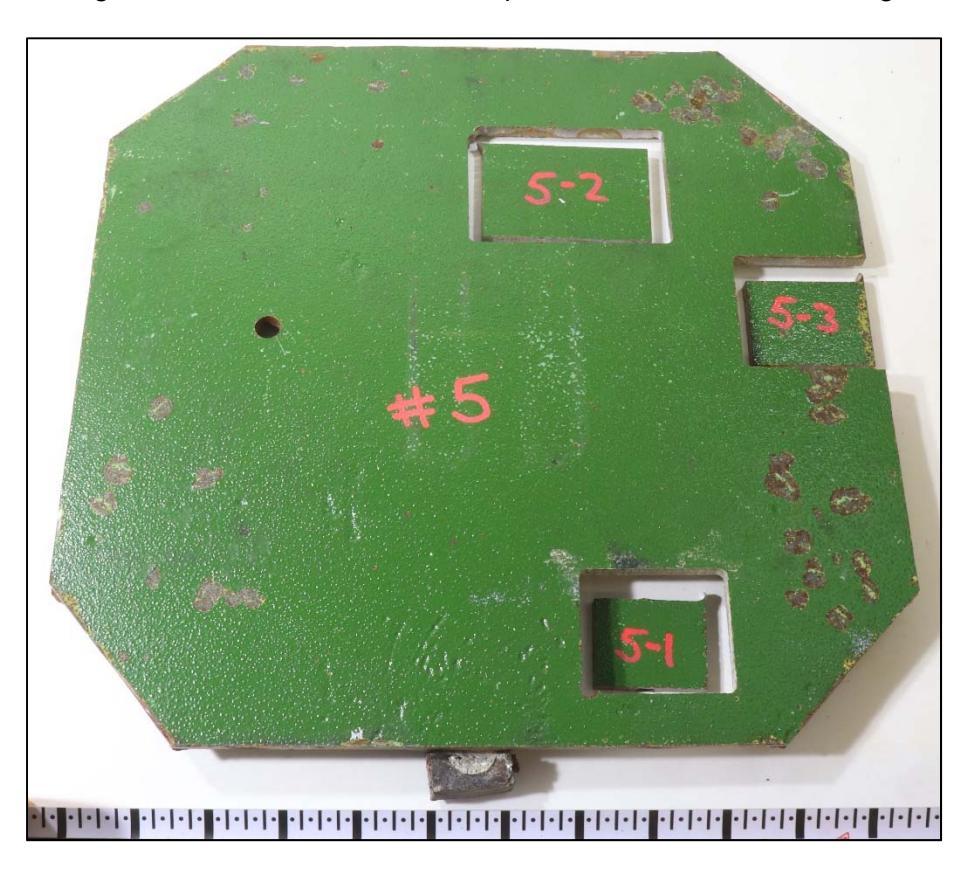
Figure 136. An image of the exterior surface of Coupon 5 after CO₂ blast cleaning.

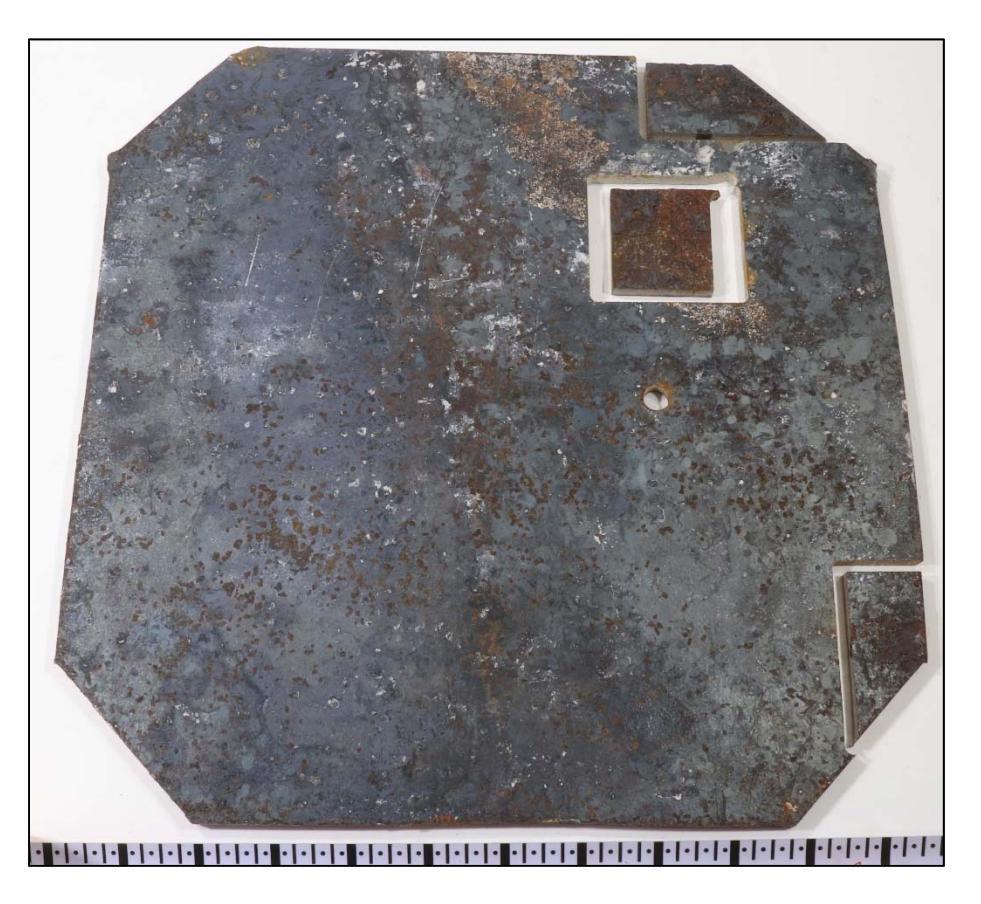
Figure 137. An image of the interior surface of Coupon 6 after CO₂ blast cleaning.

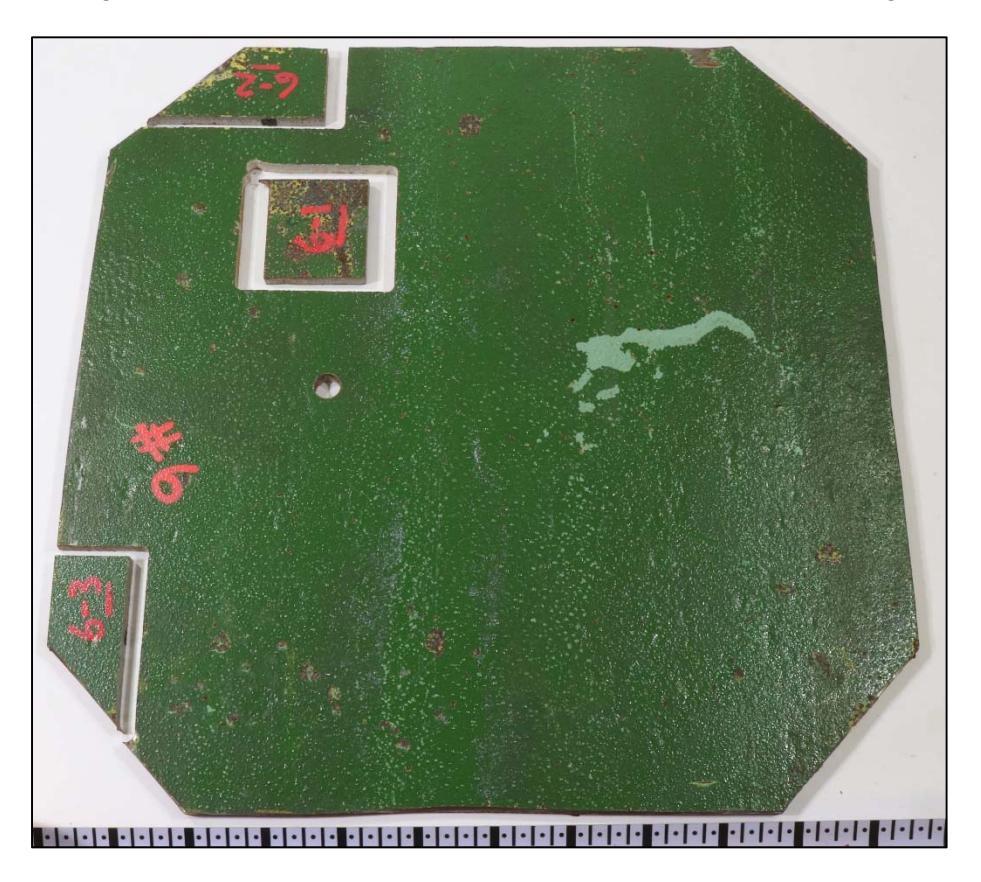
Figure 138. An image of the exterior surface of Coupon 6 after CO₂ blast cleaning.

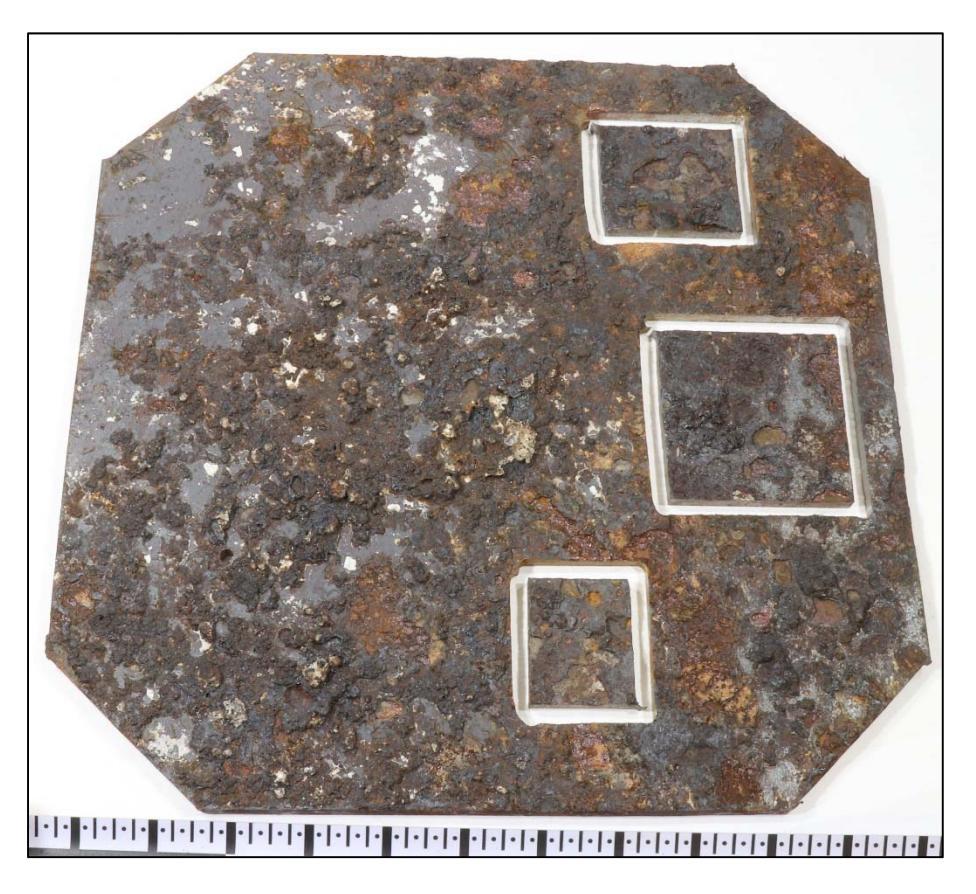
Figure 139. An image of the interior surface of Coupon 7 after CO₂ blast cleaning.

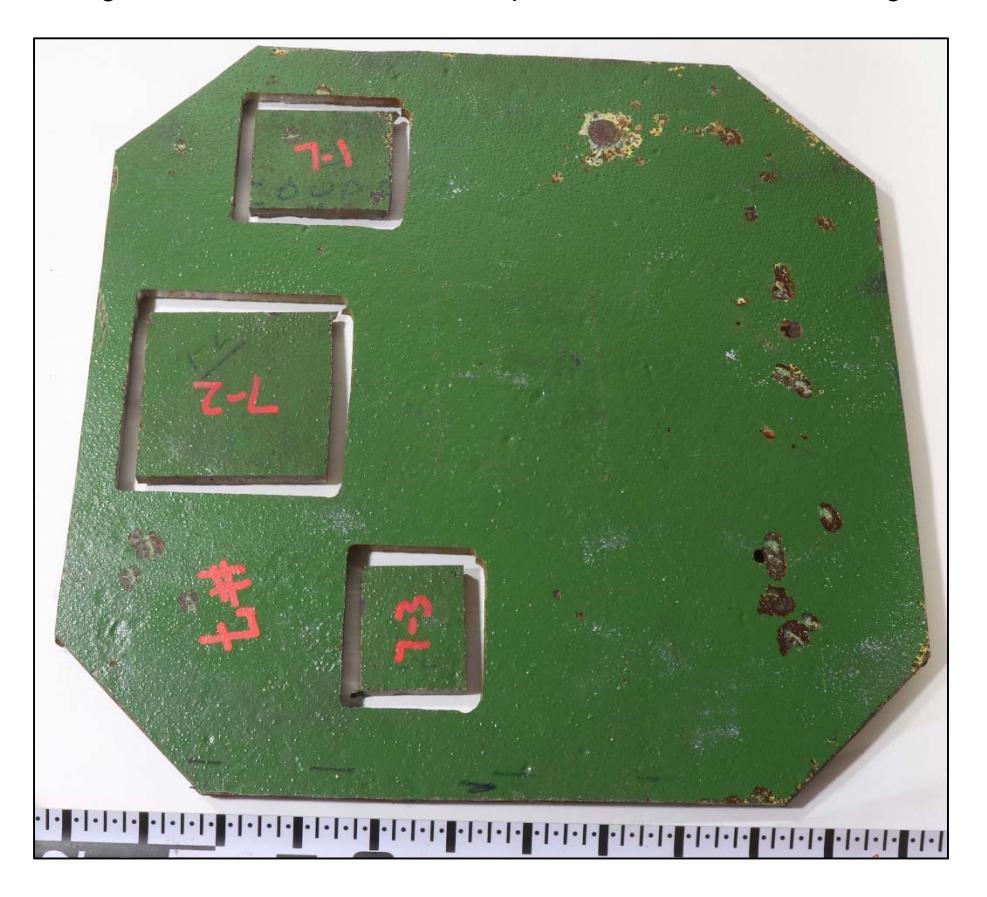
Figure 140. An image of the exterior surface of Coupon 7 after CO₂ blast cleaning.

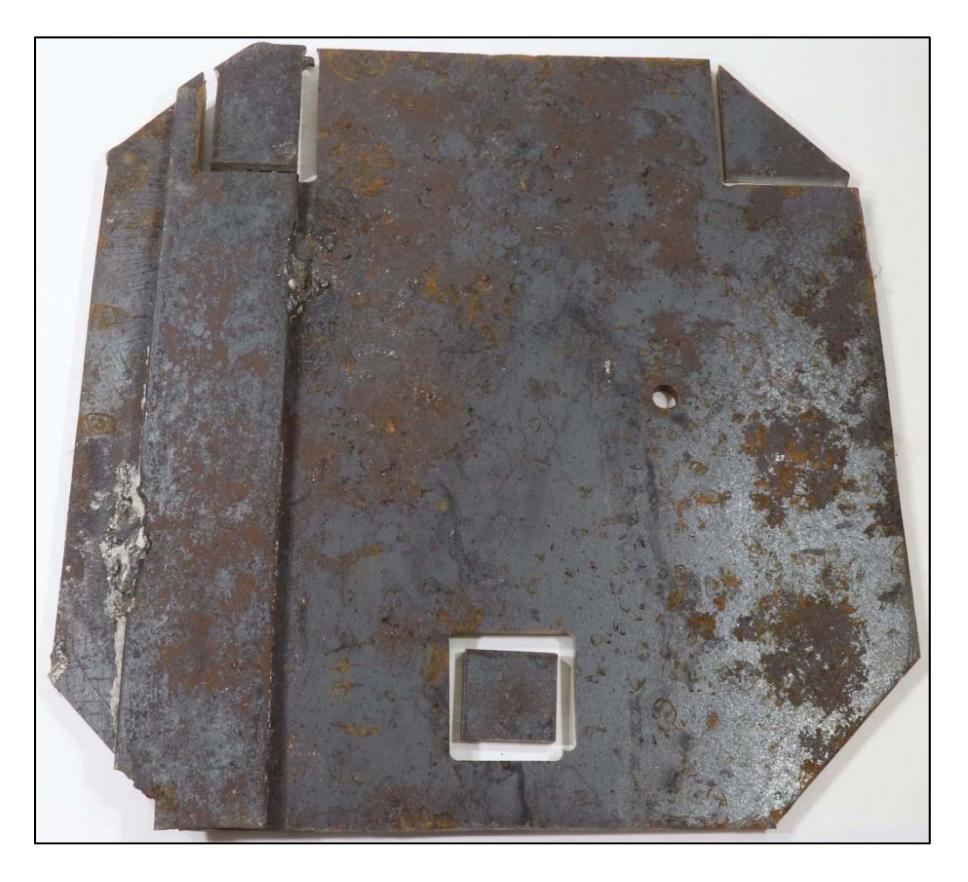
Figure 141. An image of the interior surface of Coupon 8 after CO₂ blast cleaning.

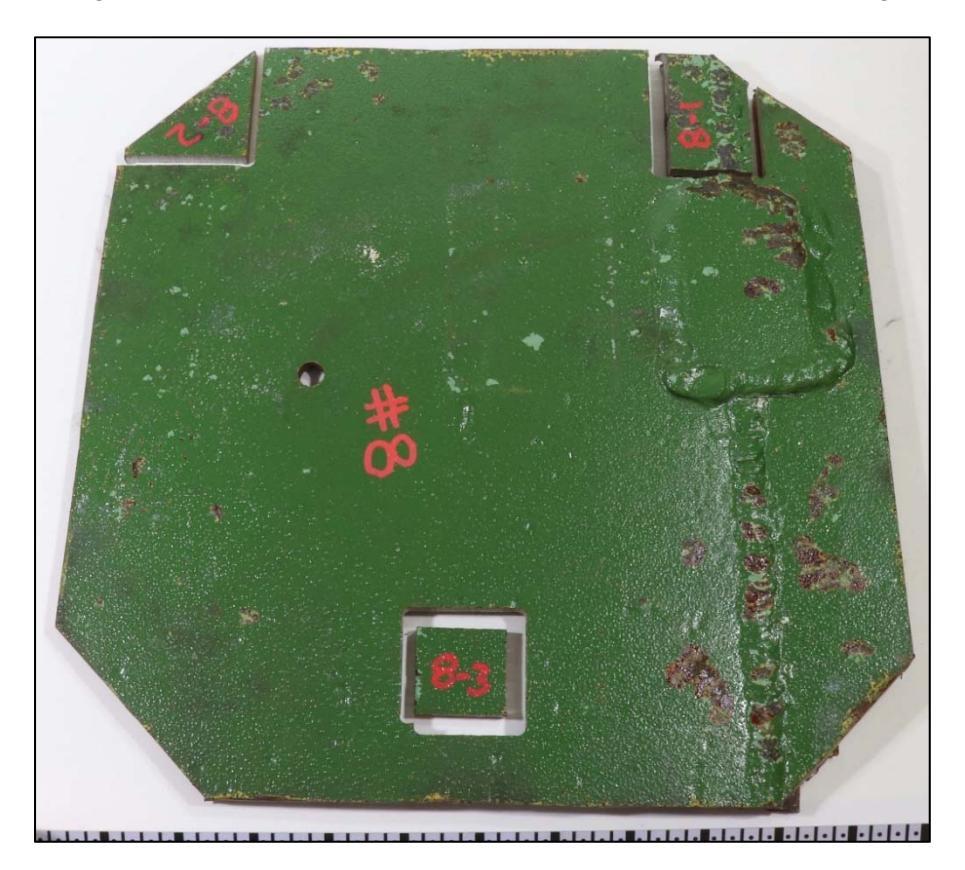
Figure 142. An image of the exterior surface of Coupon 8 after CO₂ blast cleaning.

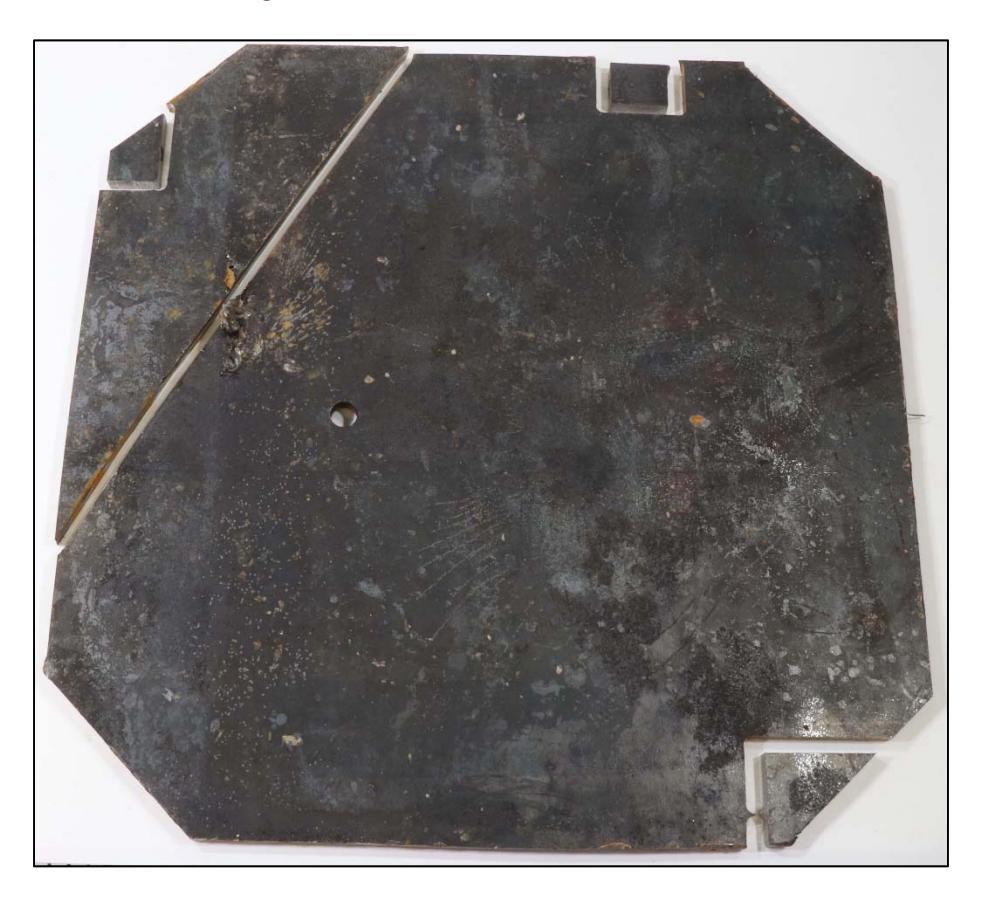
Figure 143. An image of the interior surface of Coupon 10 after CO₂ blast cleaning.

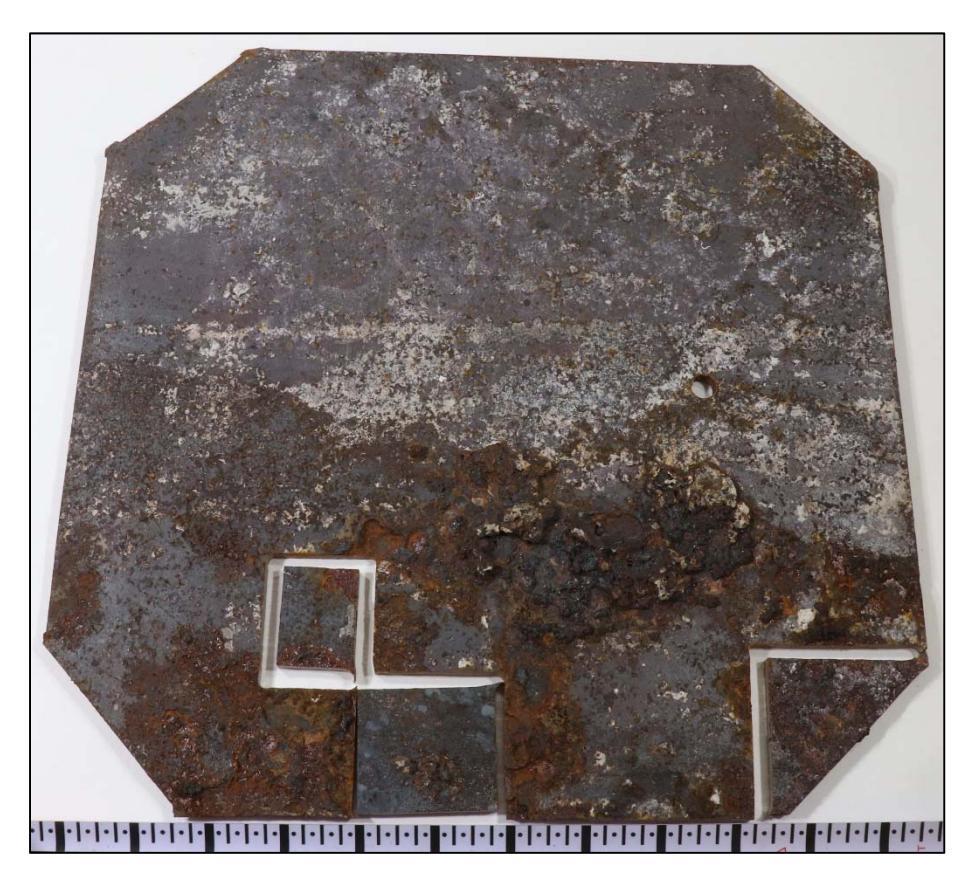
Figure 145. An image of the interior surface of Coupon A1 after CO₂ blast cleaning.

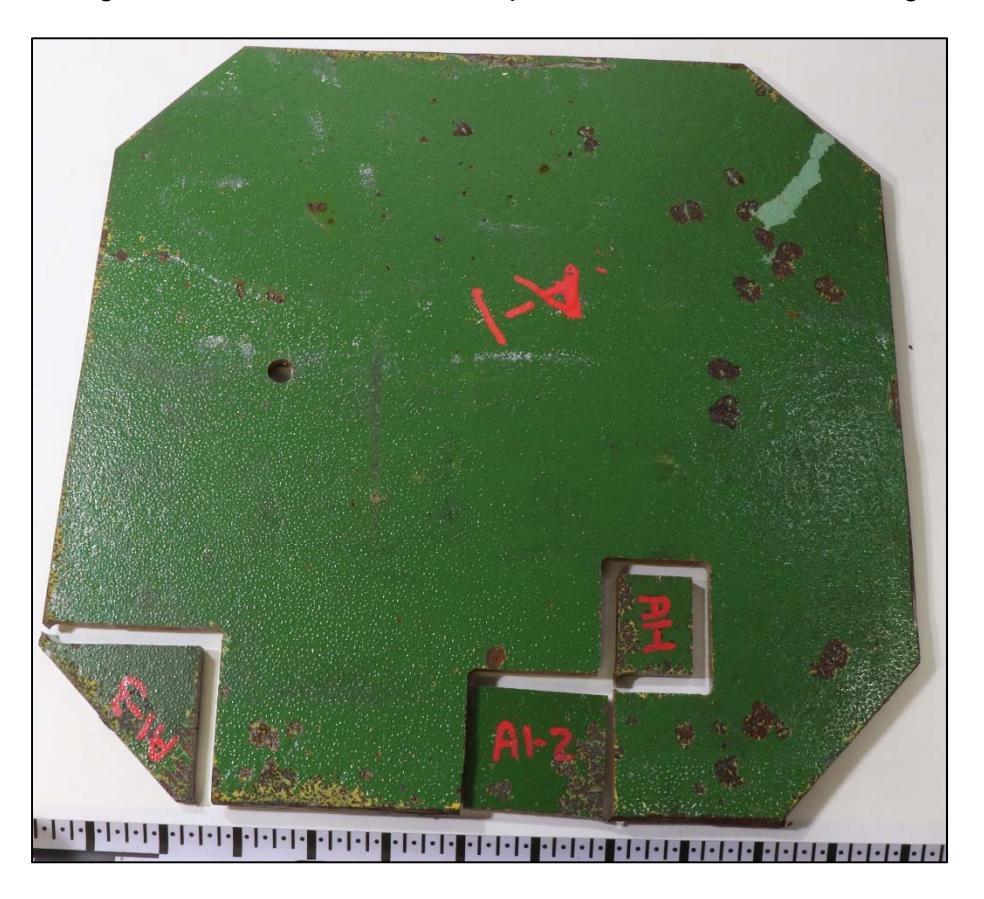
Figure 146. An image of the exterior surface of Coupon A1 after CO₂ blast cleaning.

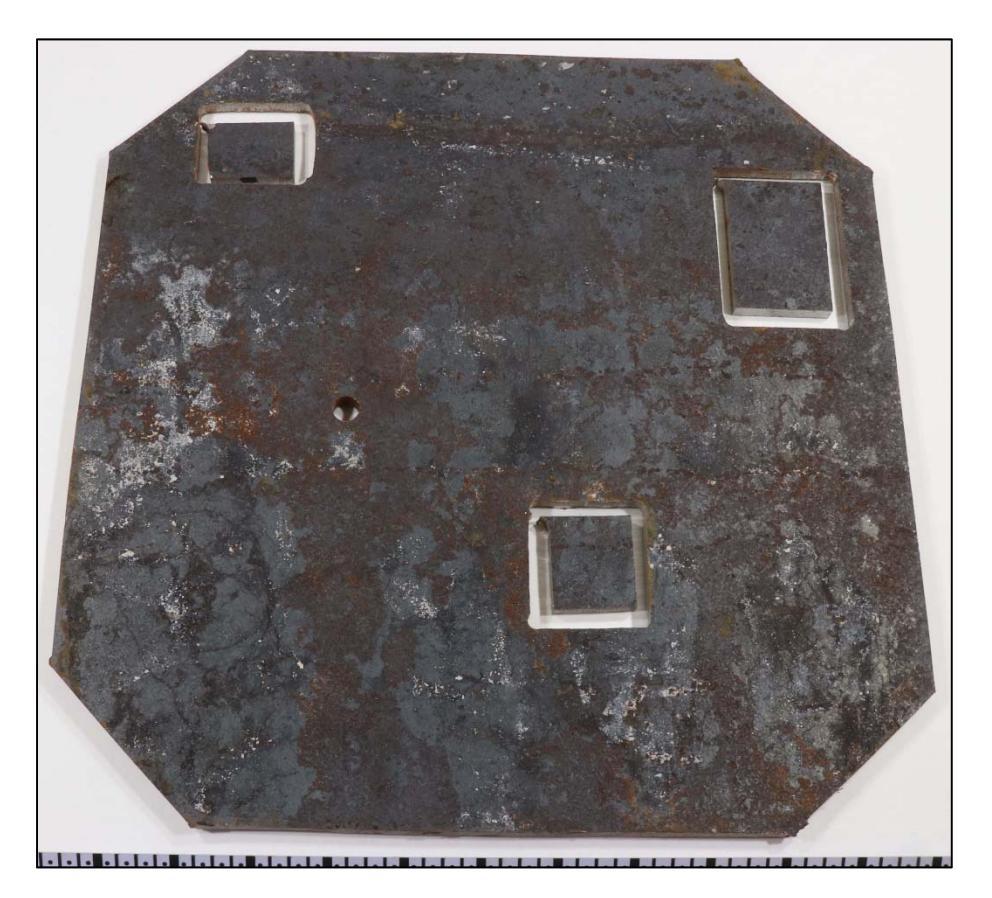
Figure 147. An image of the interior surface of Coupon A2 after CO₂ blast cleaning.

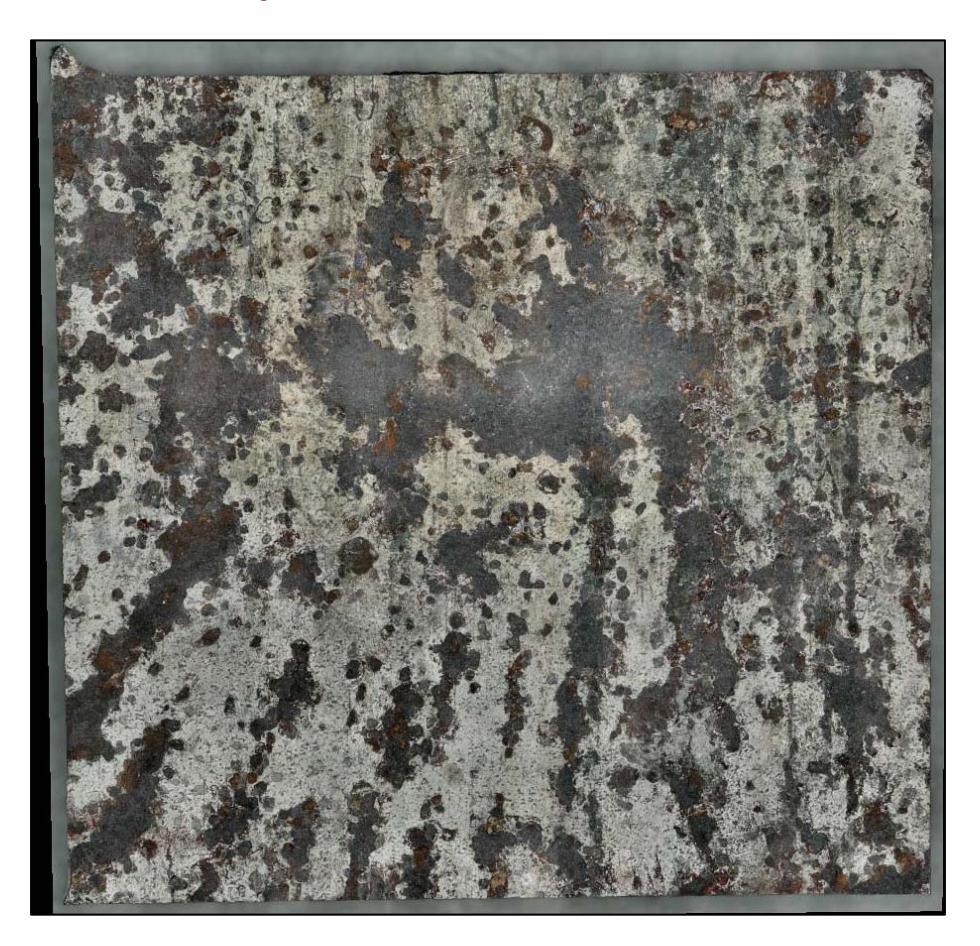
Figure 149. A screenshot of the 3D digital image of a specimen excised from Coupon 1 labeled as 1-1, after CO₂ blast cleaning

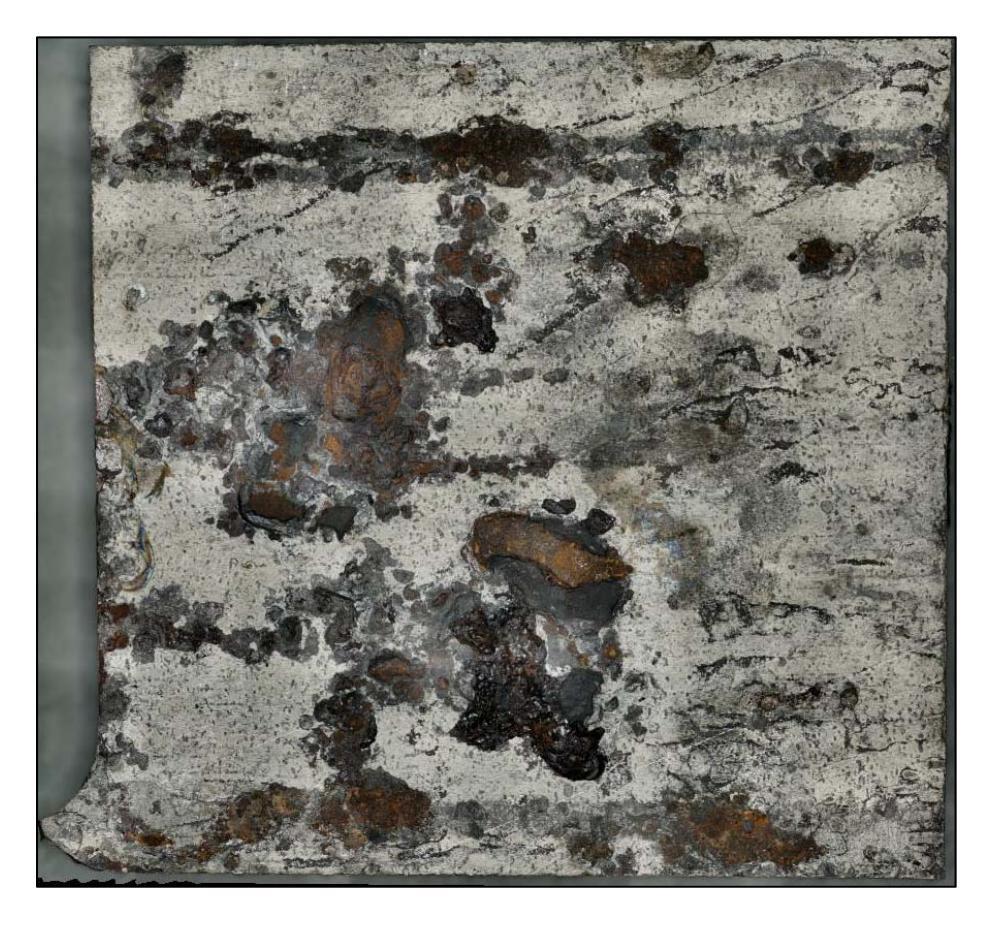
Figure 150. A screenshot of the 3D digital image of a specimen excised from Coupon 1 labeled as 1-2, after CO₂ blast cleaning
