SUBJECT: DESTRUCTIVE ANALYSIS OF 10 STEEL COUPONS REMOVED FROM RED HILL FUEL STORAGE TANK NO. 14, PURSUANT TO SECTION 5.3 OF THE ADMINISTRATIVE ORDER ON CONSENT STATEMENT OF WORK, RED HILL BULK FUEL STORAGE FACILITY, JOINT BASE PEARL HARBOR-HICKAM, OAHU, HAWAII

Destructive Analysis of 10 Steel Coupons Removed from Red Hill Fuel Storage Tank #14

REPORT No. 201801967

December 17, 2018

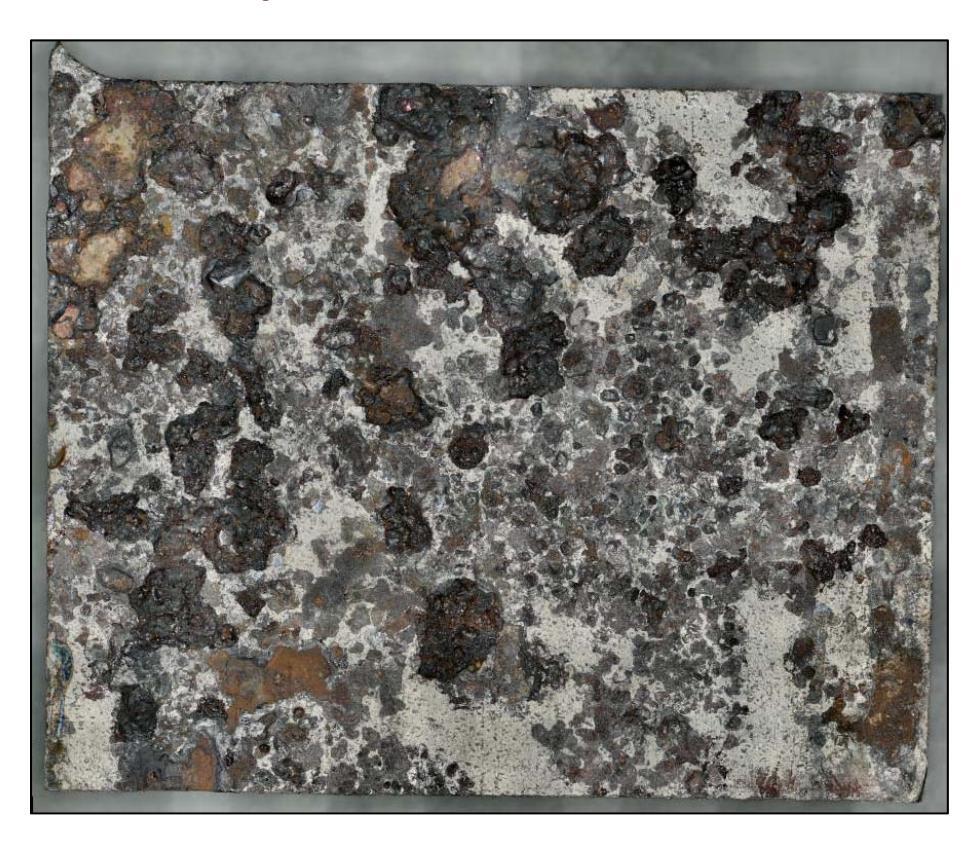
Figure 151. A screenshot of the 3D digital image of a specimen excised from Coupon 1 labeled as 1-3, after CO₂ blast cleaning

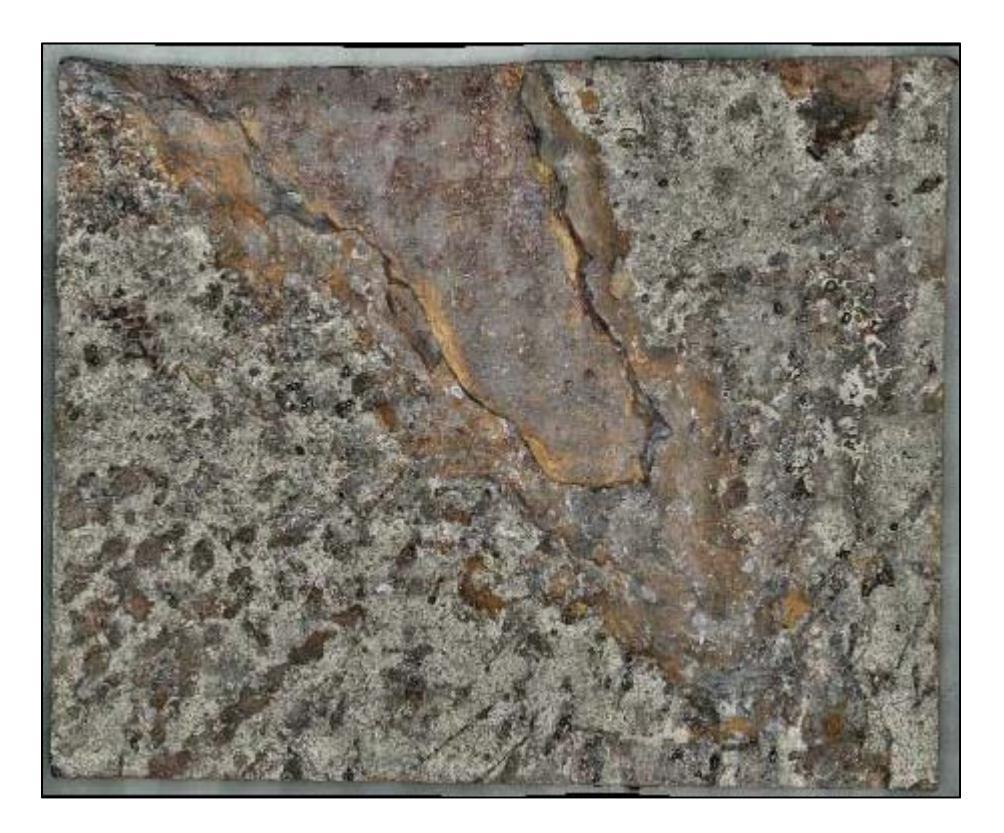
Figure 152. A screenshot of the 3D digital image of a specimen excised from Coupon 2 labeled as 2-1, after CO₂ blast cleaning

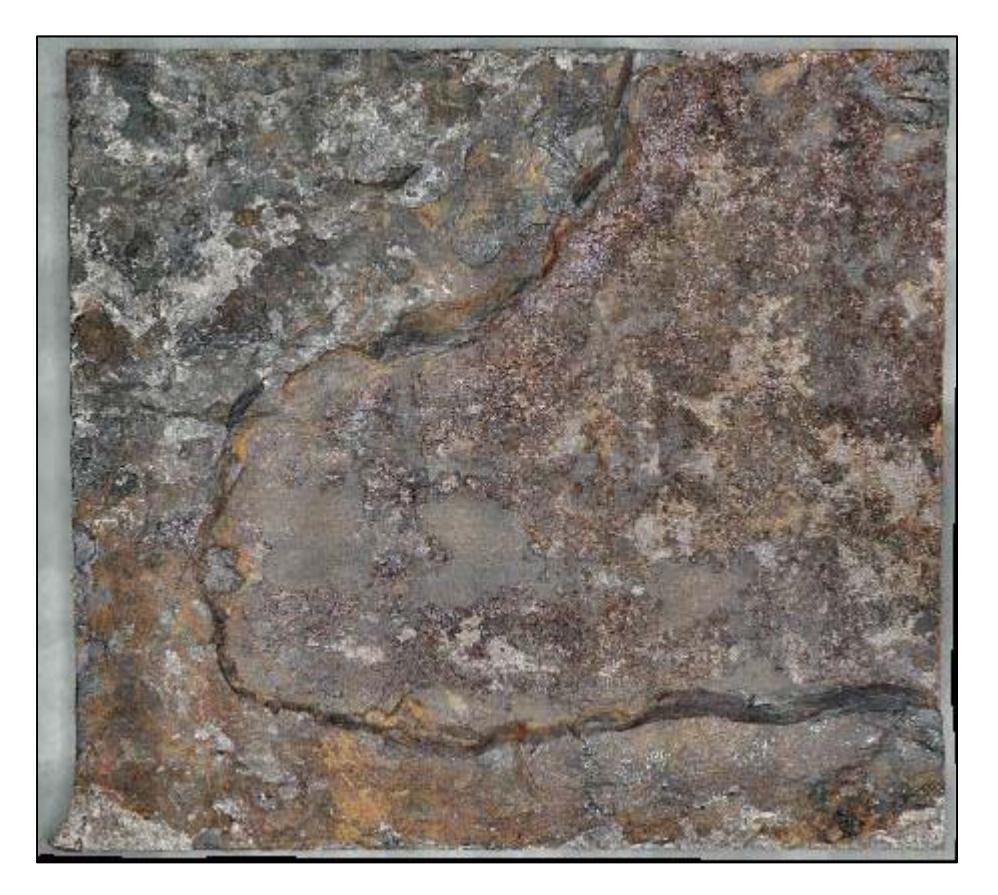
Figure 153. A screenshot of the 3D digital image of a specimen excised from Coupon 2 labeled as 2-2, after CO_2 blast cleaning

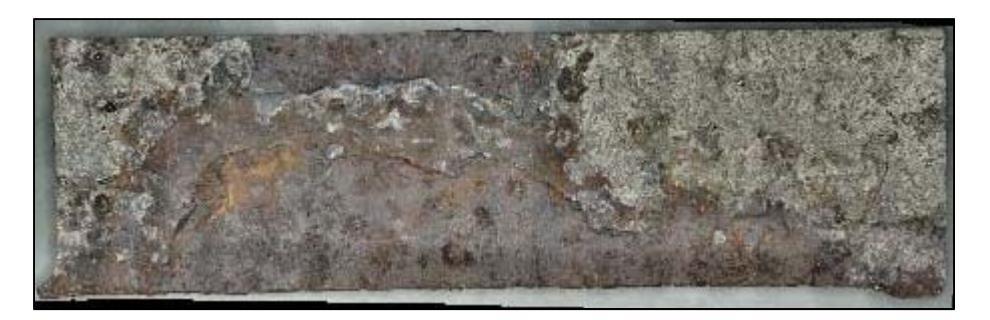
Figure 154. A screenshot of the 3D digital image of a specimen excised from Coupon 2 labeled as 2-3, after CO₂ blast cleaning

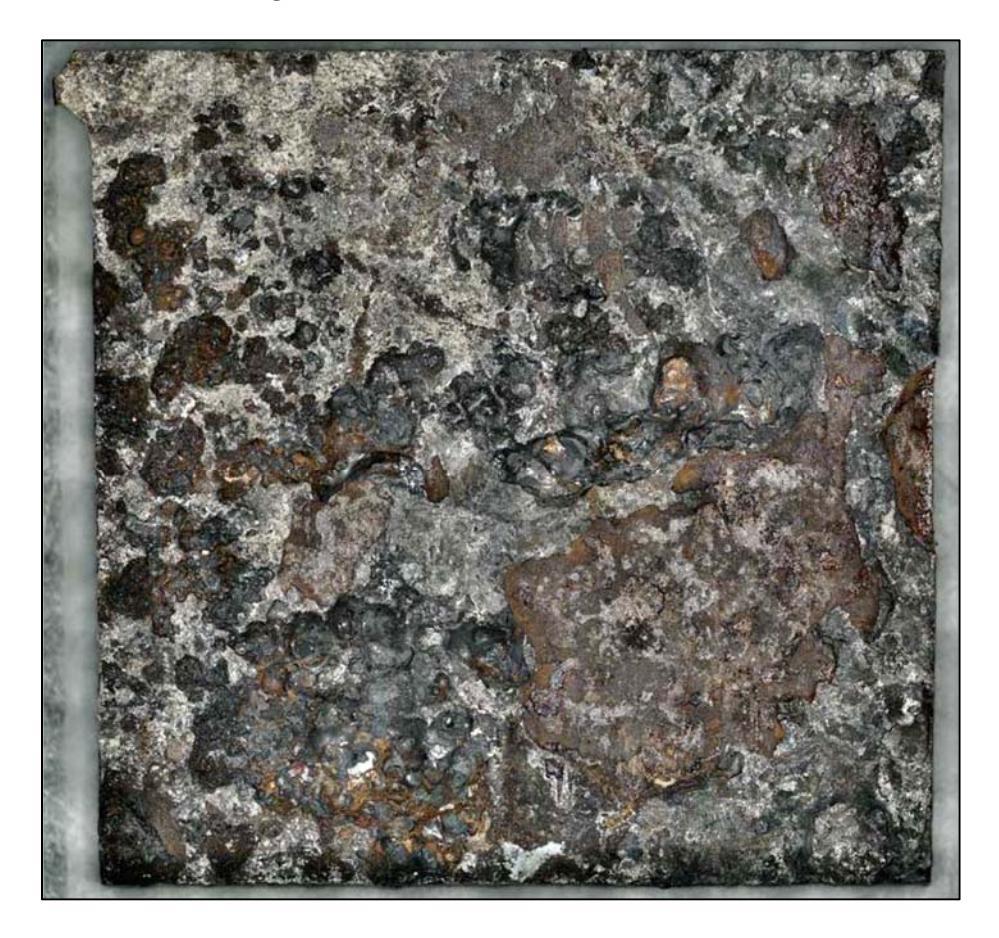
Figure 155. A screenshot of the 3D digital image of a specimen excised from Coupon 3 labeled as 3-1, after CO₂ blast cleaning

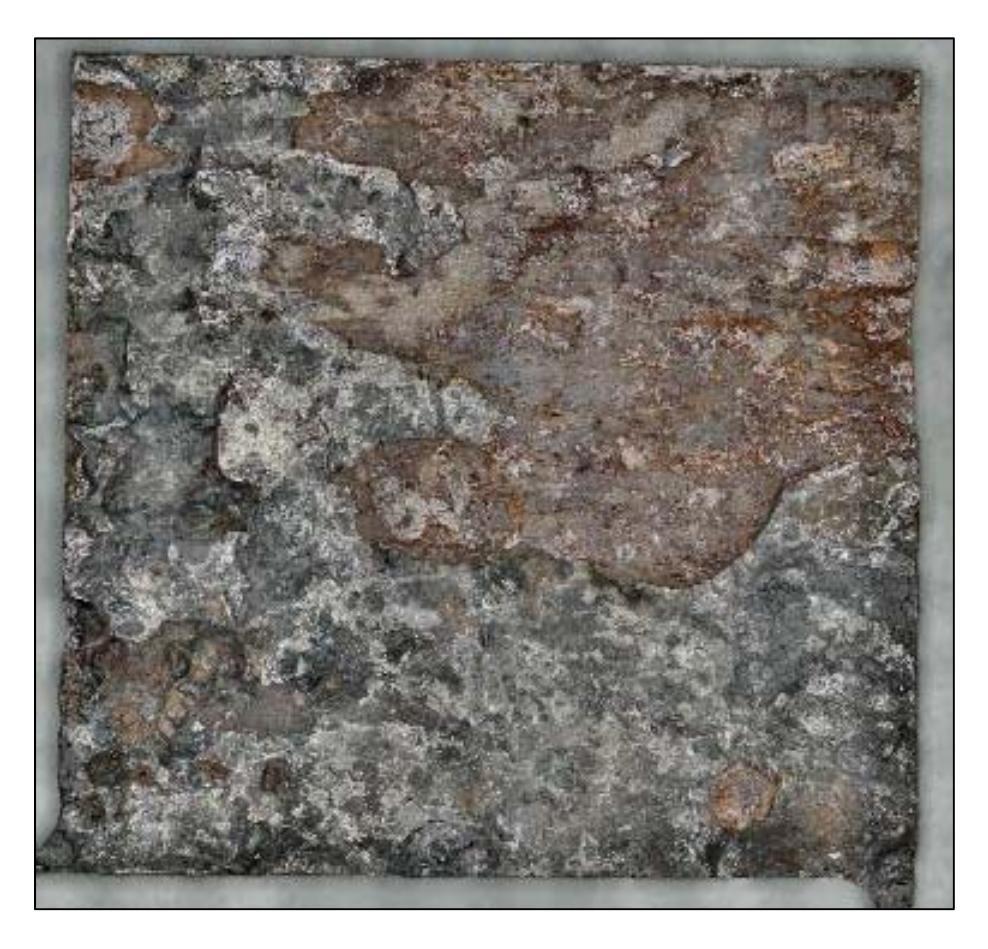
Figure 156. A screenshot of the 3D digital image of a specimen excised from Coupon 3 labeled as 3-2, after CO₂ blast cleaning

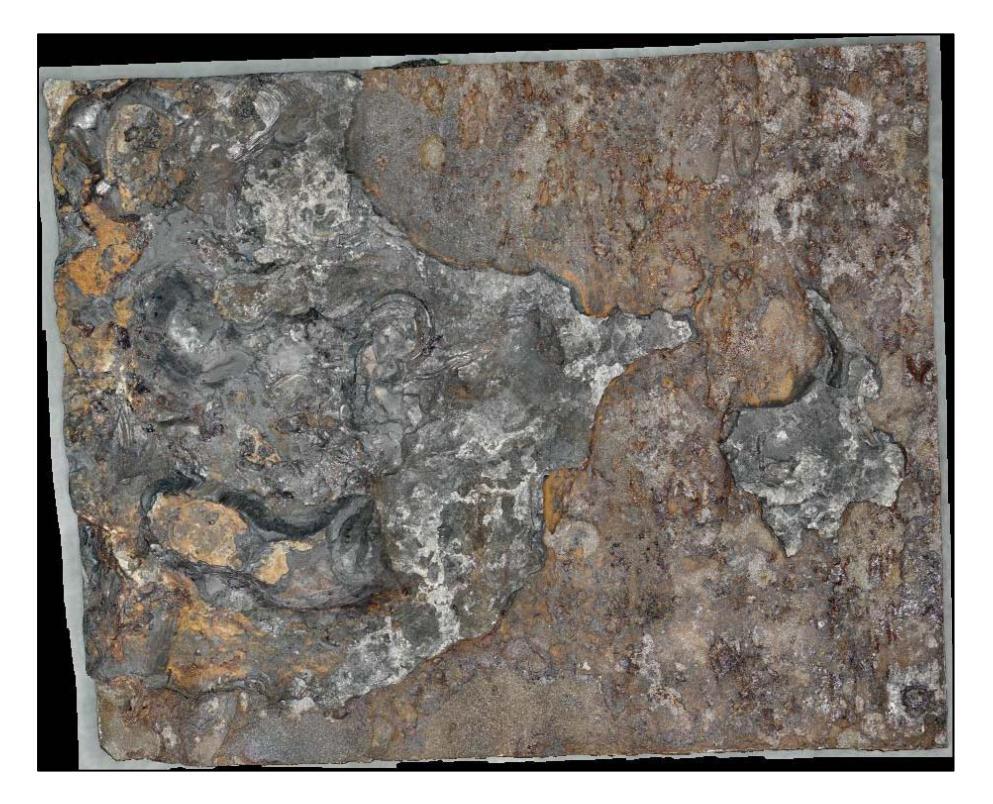
Figure 157. A screenshot of the 3D digital image of a specimen excised from Coupon 3 labeled as 3-3, after CO₂ blast cleaning

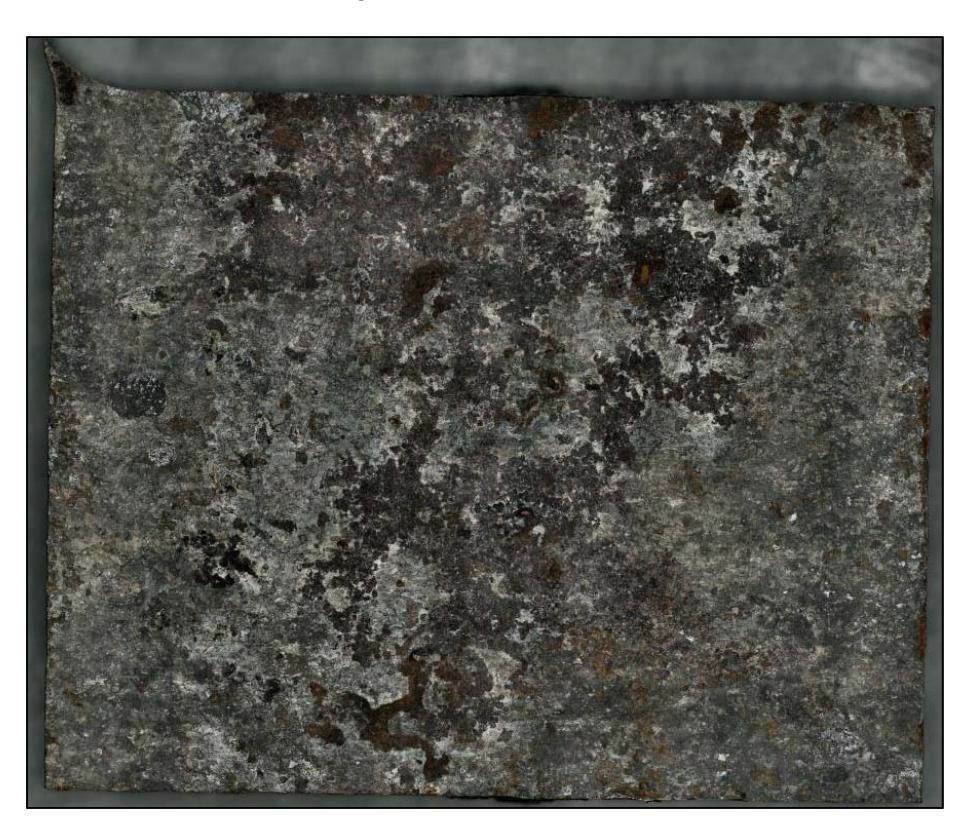
Figure 158. A screenshot of the 3D digital image of a specimen excised from Coupon 5 labeled as 5-1, after CO₂ blast cleaning

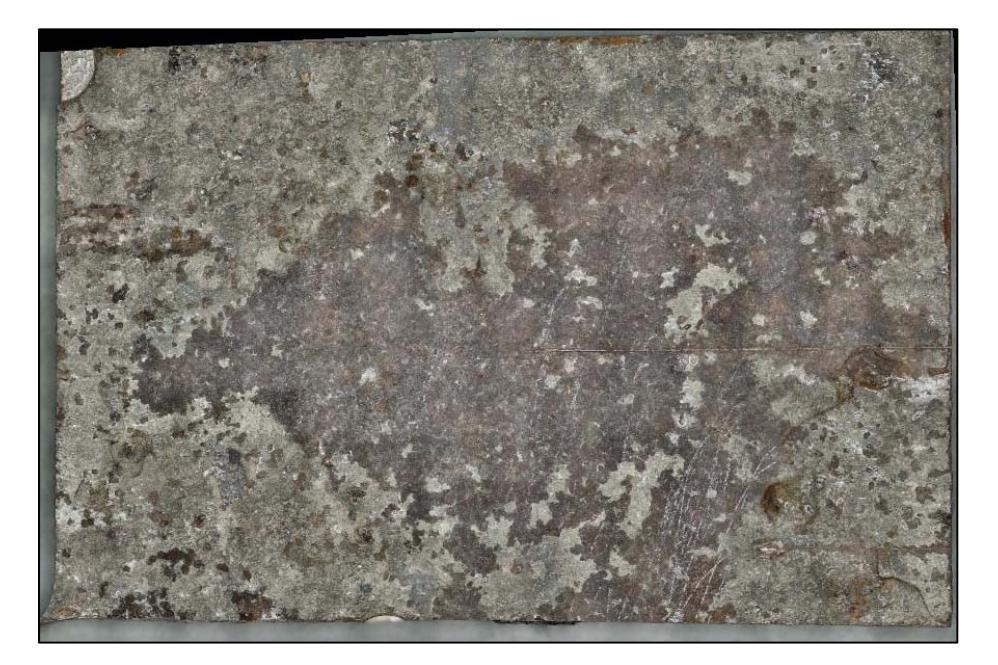
Figure 159. A screenshot of the 3D digital image of a specimen excised from Coupon 5 labeled as 5-2, after CO₂ blast cleaning

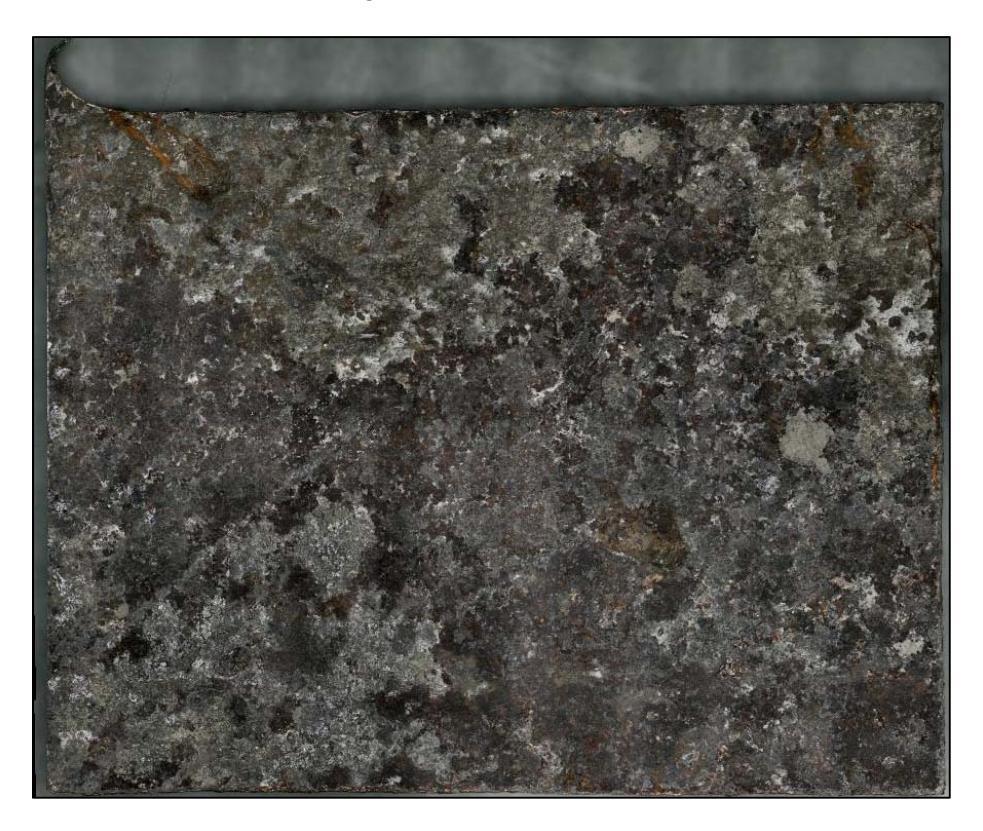
Figure 160. A screenshot of the 3D digital image of a specimen excised from Coupon 5 labeled as 5-3, after CO₂ blast cleaning

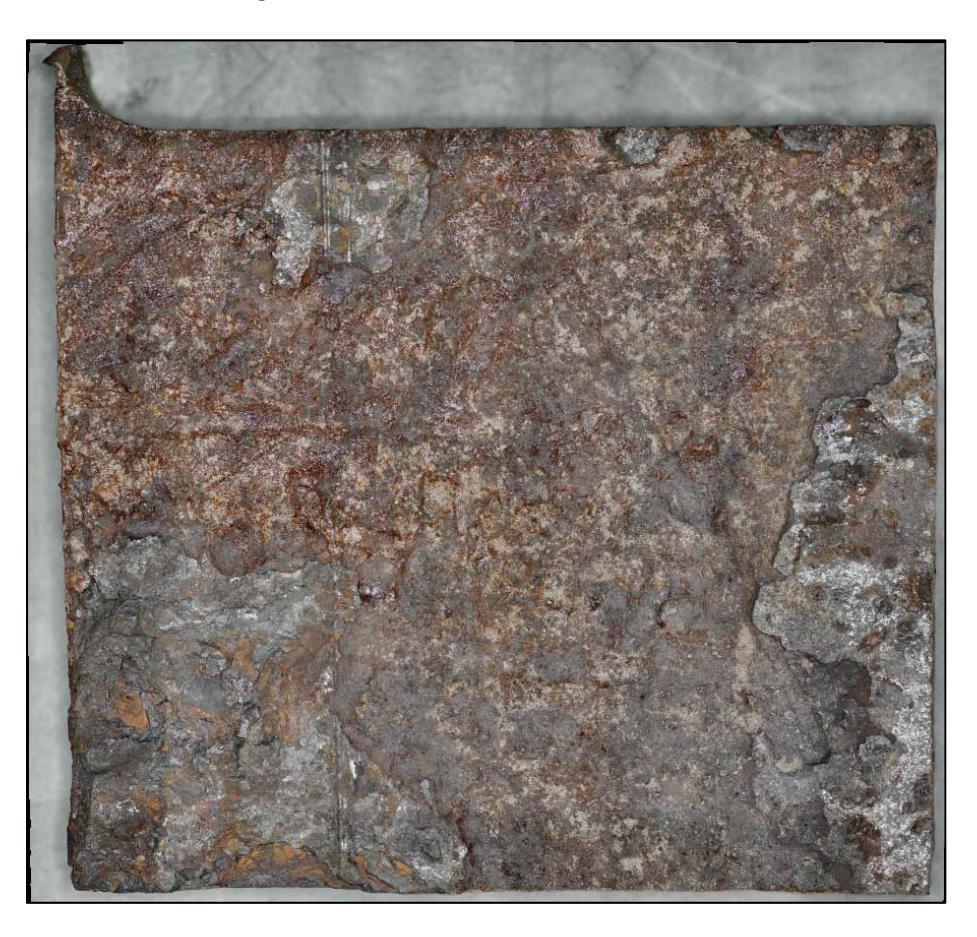
Figure 161. A screenshot of the 3D digital image of a specimen excised from Coupon 6 labeled as 6-1, after CO₂ blast cleaning

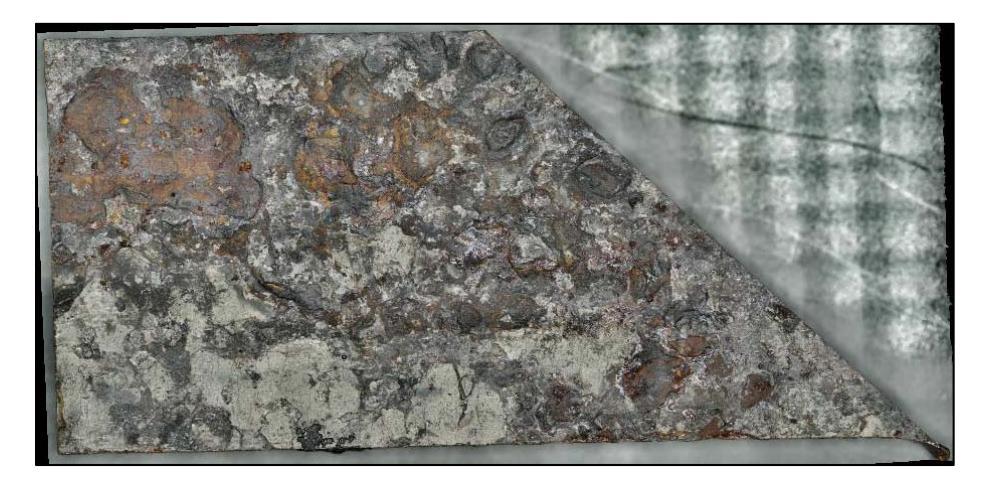
Figure 162. A screenshot of the 3D digital image of a specimen excised from Coupon 6 labeled as 6-2, after CO₂ blast cleaning

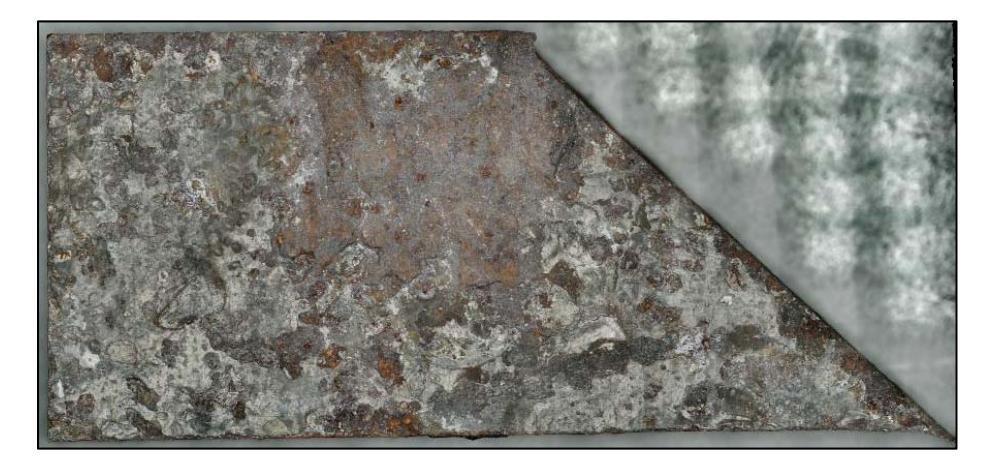
Figure 163. A screenshot of the 3D digital image of a specimen excised from Coupon 6 labeled as 6-3, after CO₂ blast cleaning

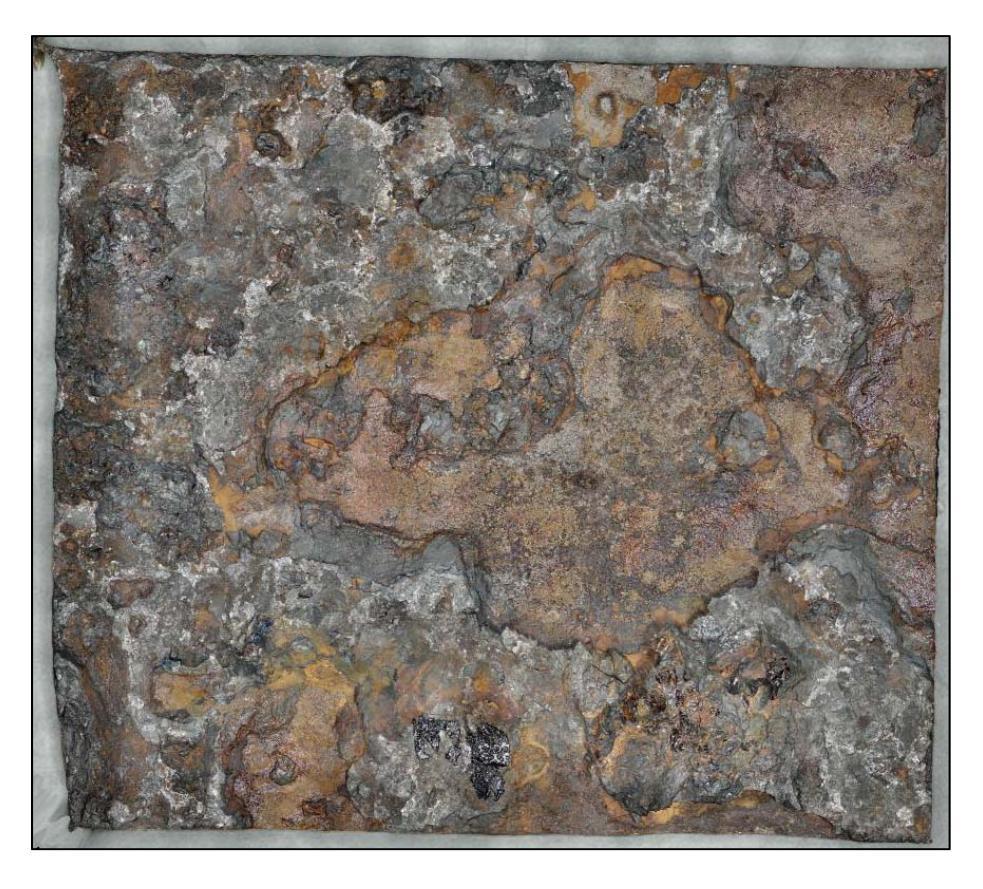
Figure 164. A screenshot of the 3D digital image of a specimen excised from Coupon 7 labeled as 7-1, after CO_2 blast cleaning

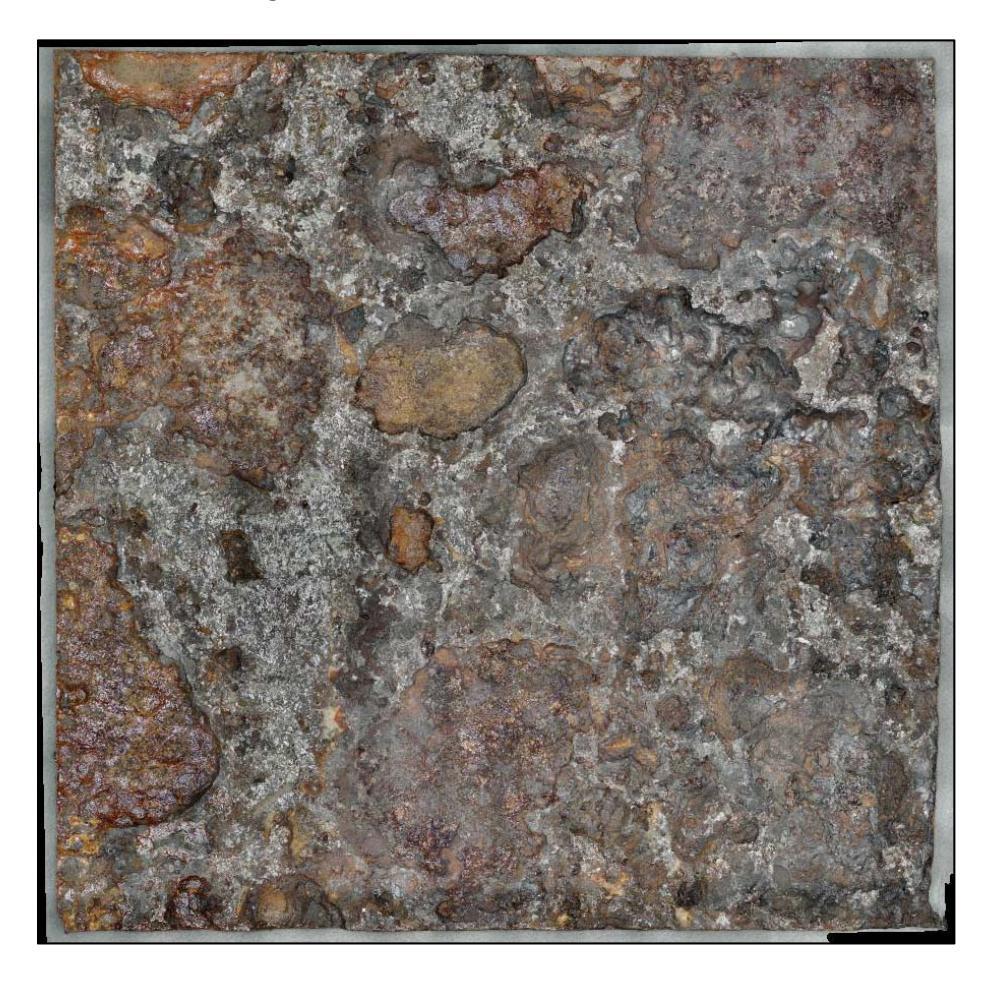
Figure 165. A screenshot of the 3D digital image of a specimen excised from Coupon 7 labeled as 7-2, after CO_2 blast cleaning.

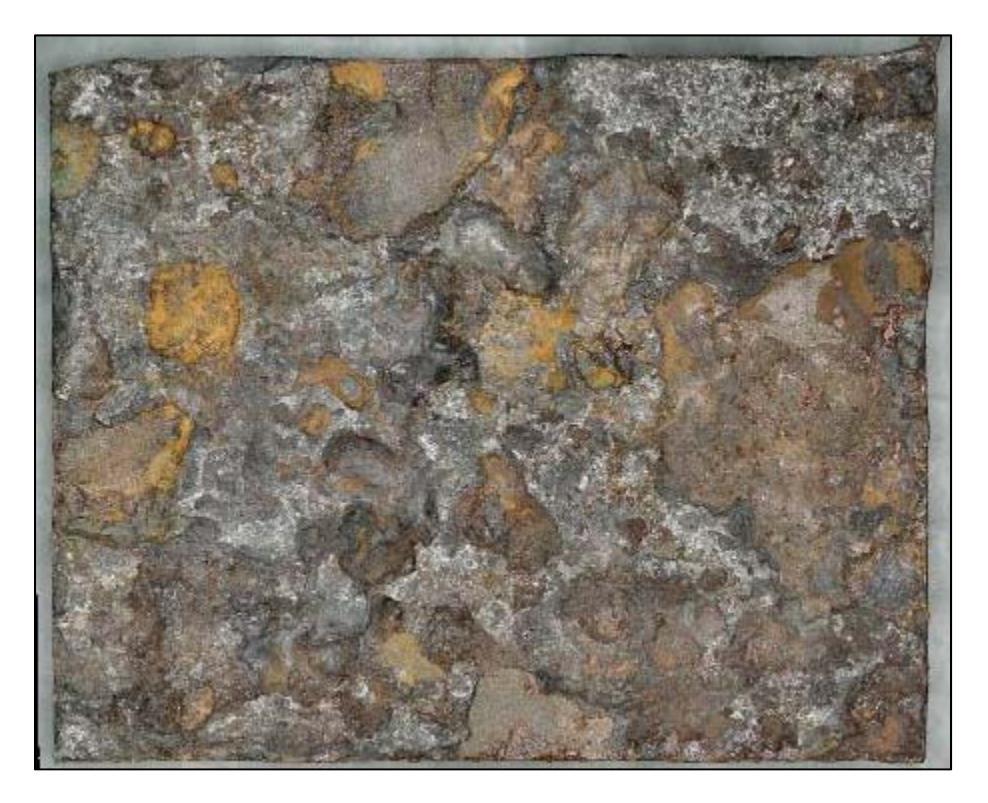
Figure 166. A screenshot of the 3D digital image of a specimen excised from Coupon 7 labeled as 7-3, after CO_2 blast cleaning

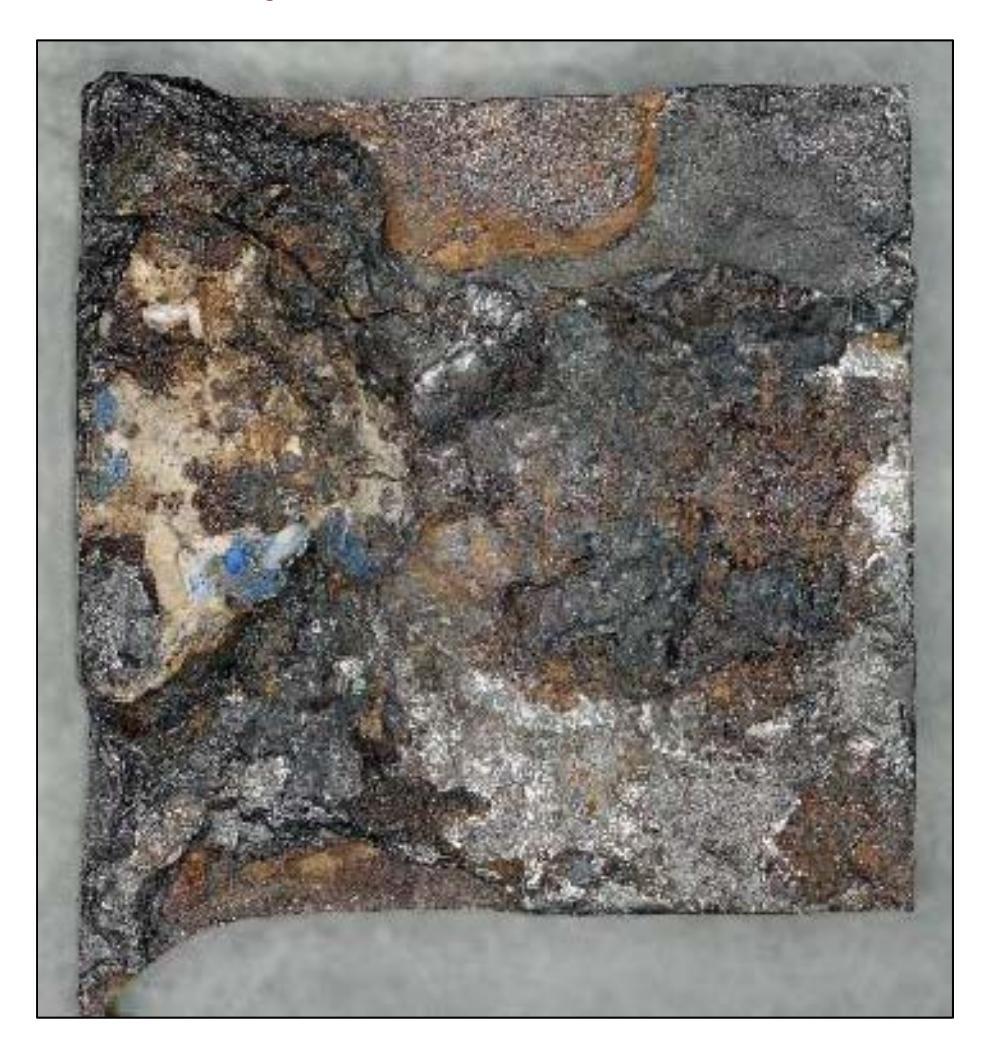
Figure 167. A screenshot of the 3D digital image of a specimen excised from Coupon 7 labeled as 7-4, after CO₂ blast cleaning

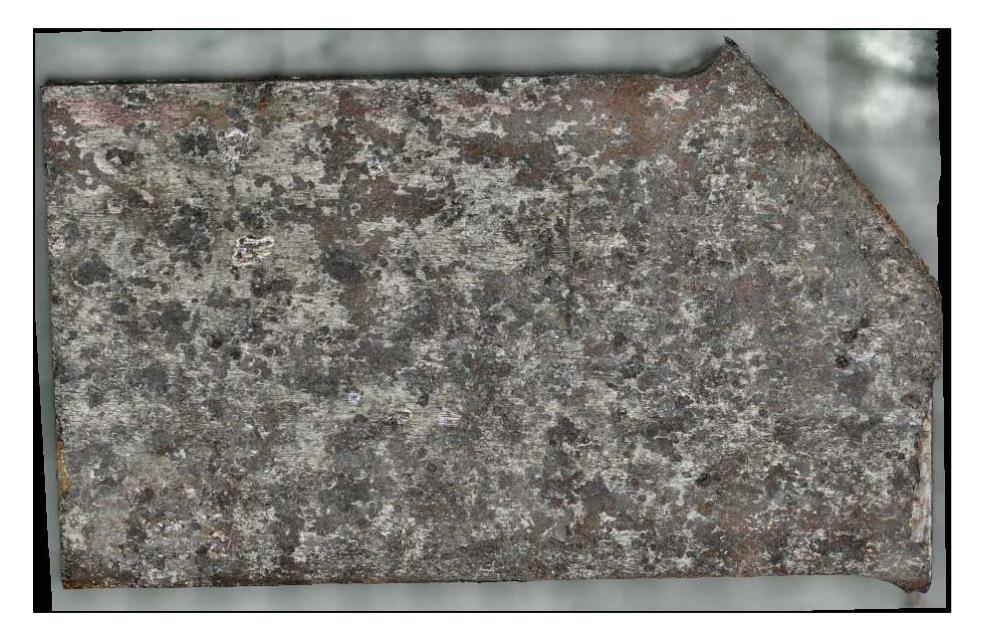
Figure 168. A screenshot of the 3D digital image of a specimen excised from Coupon 8 labeled as 8-1, after CO₂ blast cleaning

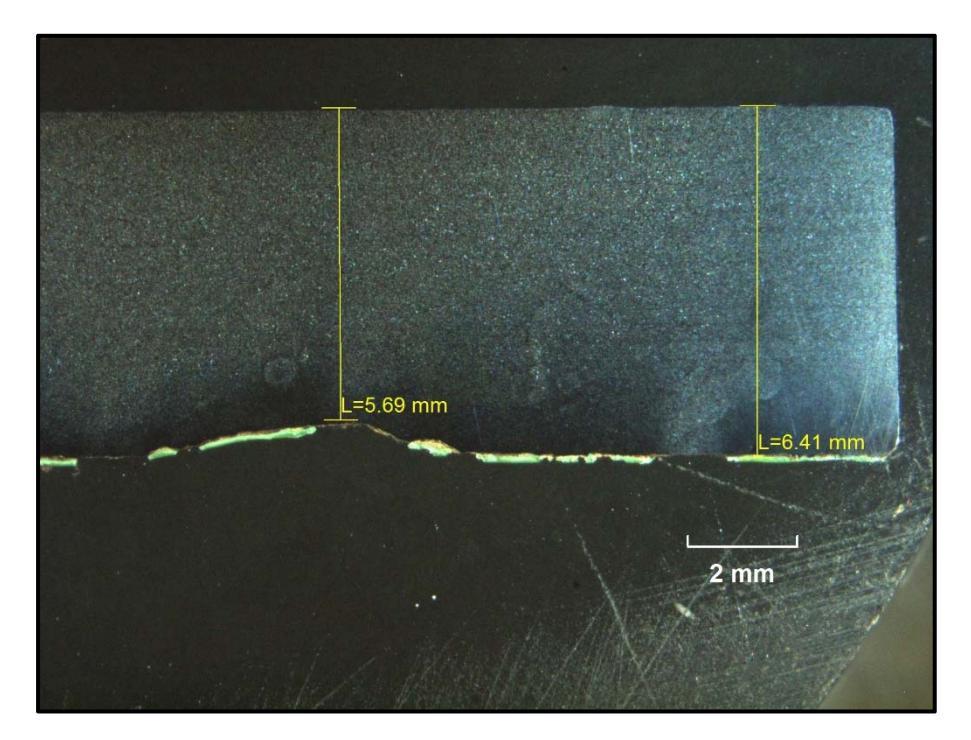
Figure 192. The prepared metallographic cross-section from Sample 5-5 is shown during examination with a stereomicroscope. The thickest remaining wall is shown. Note that the reduction in wall thickness was due to a depression on the painted face of the specimen. (7X)

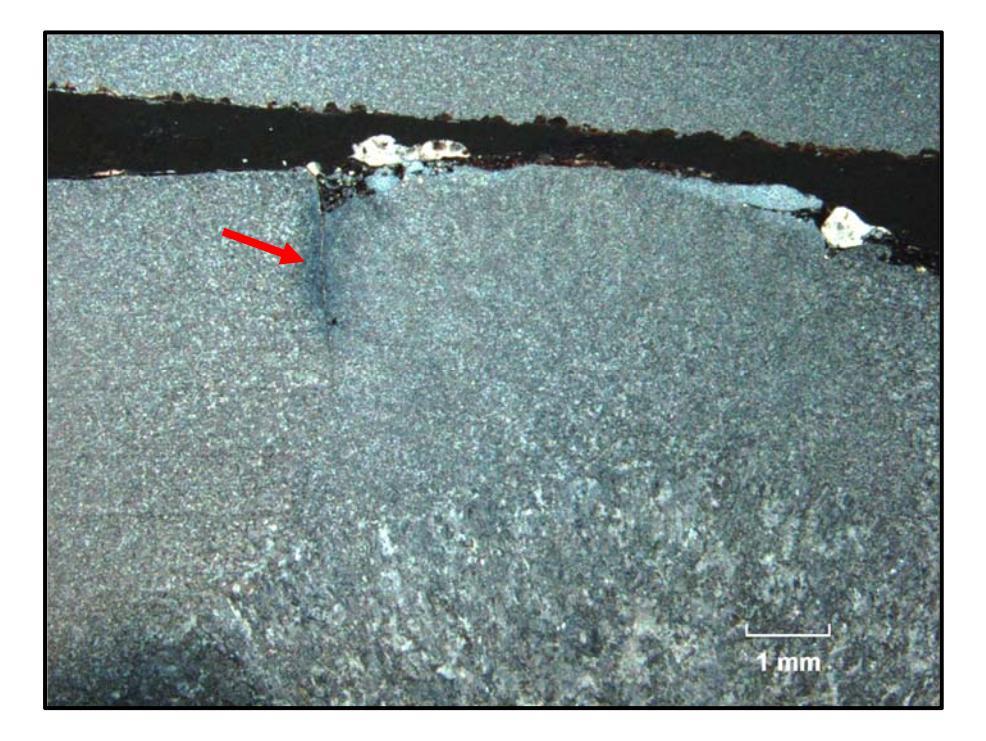
Coupon 8 exhibited what is presumed to be a prior weld repair and/or addition of a backing plate, where a patch was made on the tank wall. Representative images of the welds are presented as Figures 208 through 213. A full weld evaluation is outside the scope of this effort. The results are thus provided for information only.

Figure 209. The location identified in the previous figure is shown at higher magnification. The weld indication (arrow) appeared to be an area of incomplete fusion.

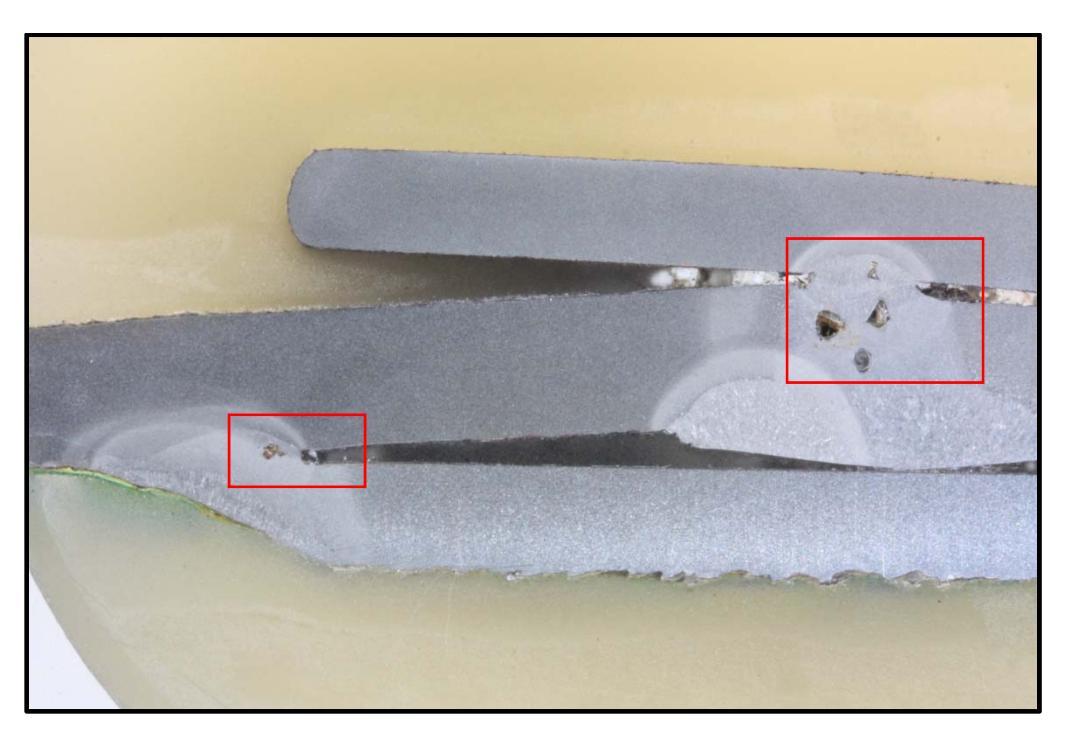
Figure 210. The prepared metallographic cross-section through welded sample 8-4 is shown in an overall view. The painted exterior surface is along the bottom section. The areas identified by the red boxes are shown in the next two figures at higher magnification.

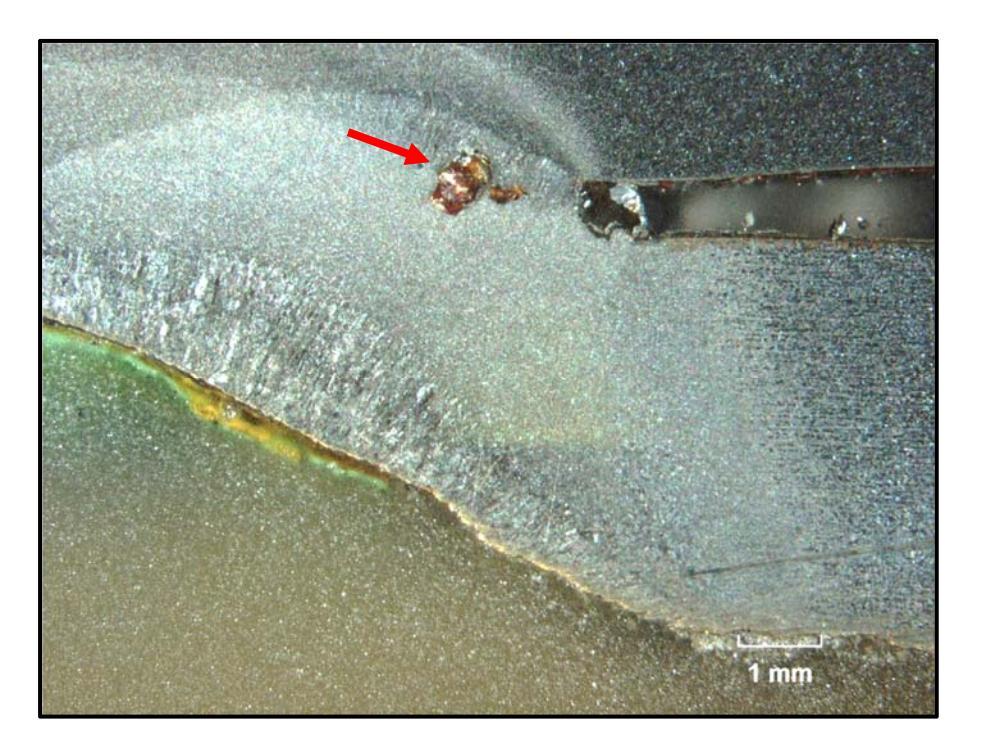
Figure 211. The left-hand feature in Figure 210 is shown at higher magnification. The weld indication (arrow) appeared to be an area of porosity.

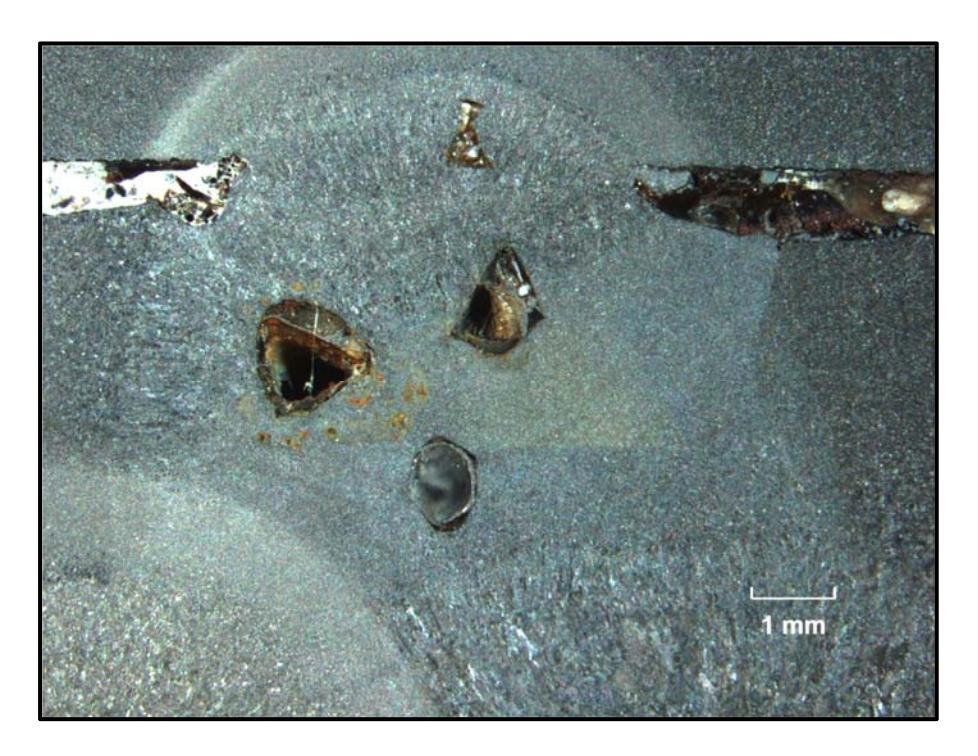
Figure 212. The right-hand feature in Figure 210 is shown at higher magnification. The weld indications appeared to be porosity.

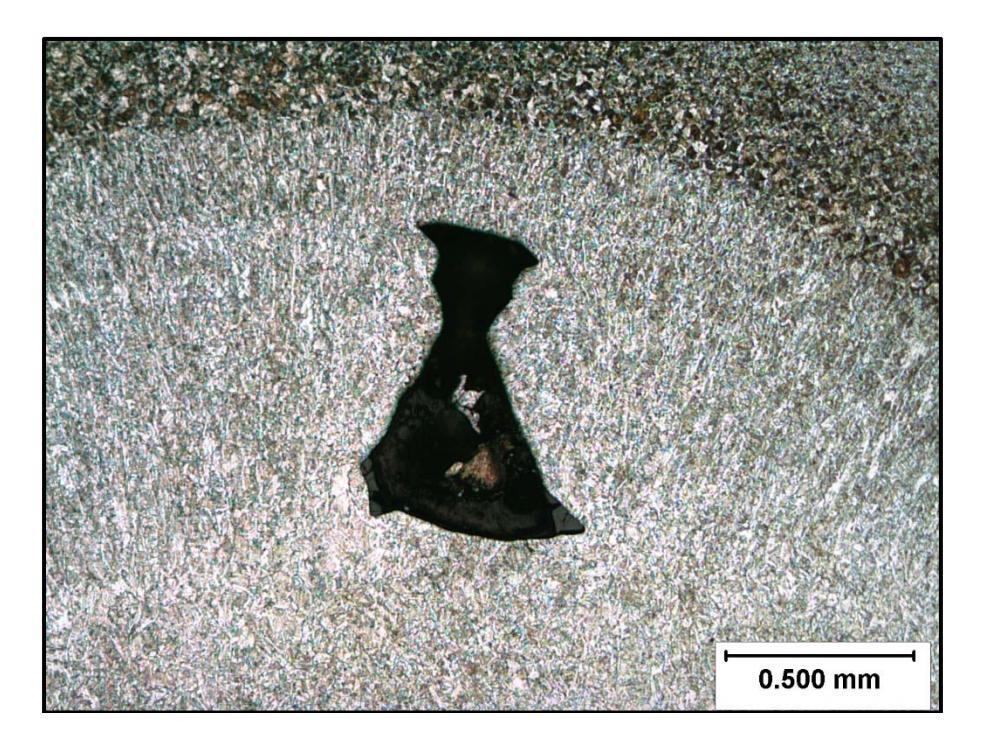
Figure 213. The one of the voids is shown at higher magnification. (2% Nital Etch, 50X)

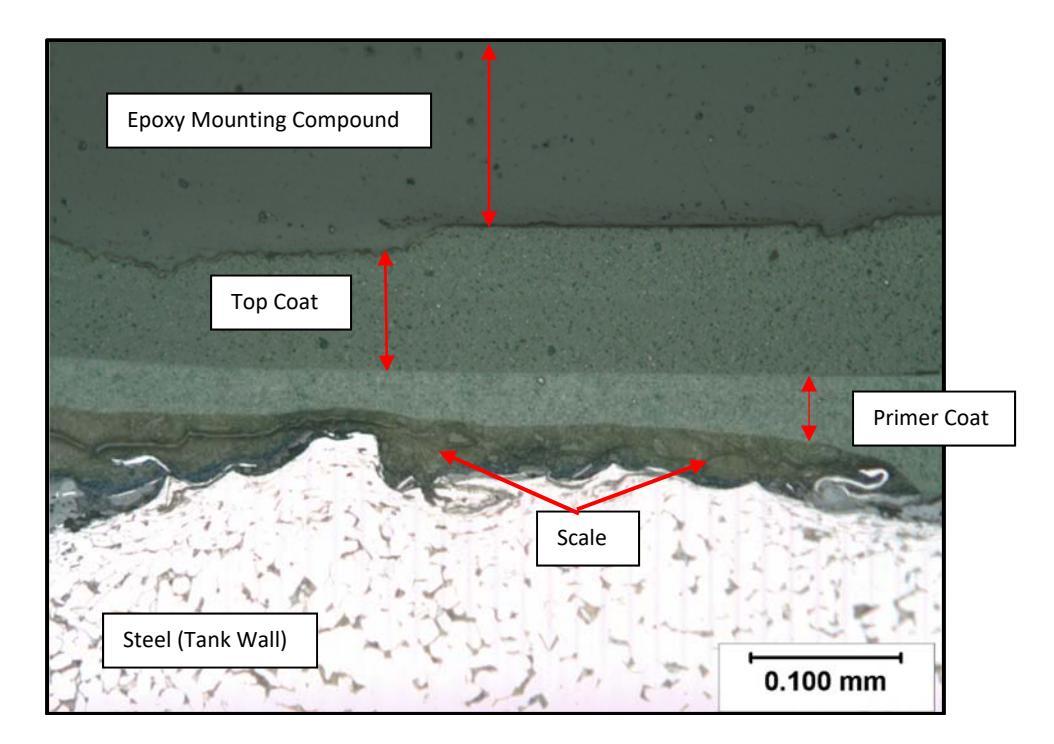
A typical paint layer was examined microscopically and was determined to consist of two layers, as shown in Figure 214. This indicates that the exterior tank wall exhibits a primer layer with a top coat. The scraped paint samples that were excised from each coupon previously for FTIR analysis would likely have captured some of both layers. The FTIR results presented previously were a good match for polyurethane, with no observable secondary component. Although this indicates that both the primer and top coat were polyurethane-based, it cannot be ruled out that the primer exhibited a different composition.

Figure 214. A typical paint layer is shown in cross-section, with key characteristics identified. (2% Nital Etch, 200X)
