RED HILL REPAIR TANKS OPTIONS STUDY

FISC Pearl Harbor, Hawaii

Final Report

September 2008

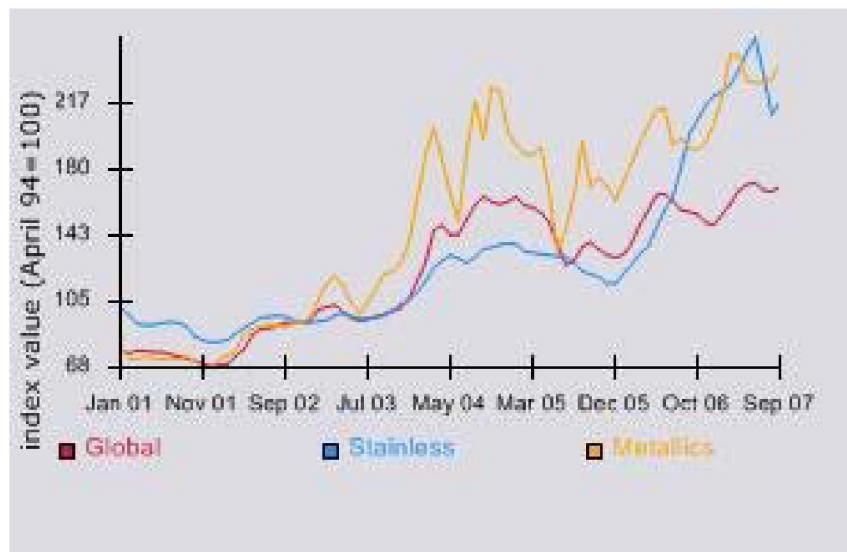
CRU data indicates an increase of over 300% in steel prices from 2001 to 2007.

The project cost may vary based on the cost of steel and fuel in the world marketplace. Several indices clearly demonstrate that the rise and trends of the steel market far exceed escalation as identified above.

A recent Wall Street Journal article dated July 16, 2007 states “The price of a ton of hot-rolled steel, a benchmark base product used in most finished steel, currently stands at around \$575 on the spot market--well above the \$175 the same ton of steel cost on the spot market back in 2001.” This equates to approximately 325% cost increase in six years.
