RED HILL BULK FUEL STORAGE FACILITY INVESTIGATION REPORT
VOLUME I OF III
(FINAL)

FOR
FLEET INDUSTRIAL SUPPLY CENTER
(FISC)
OAHU, HAWAII

RED HILL BULK FUEL STORAGE FACILITY INVESTIGATION REPORT (FINAL) FOR FLEET INDUSTRIAL SUPPLY CENTER (FISC) OAHU, HAWAII

AMEC Earth & Environmental, Inc.
4825 University Square, Suite 2
Huntsville, Alabama 35816

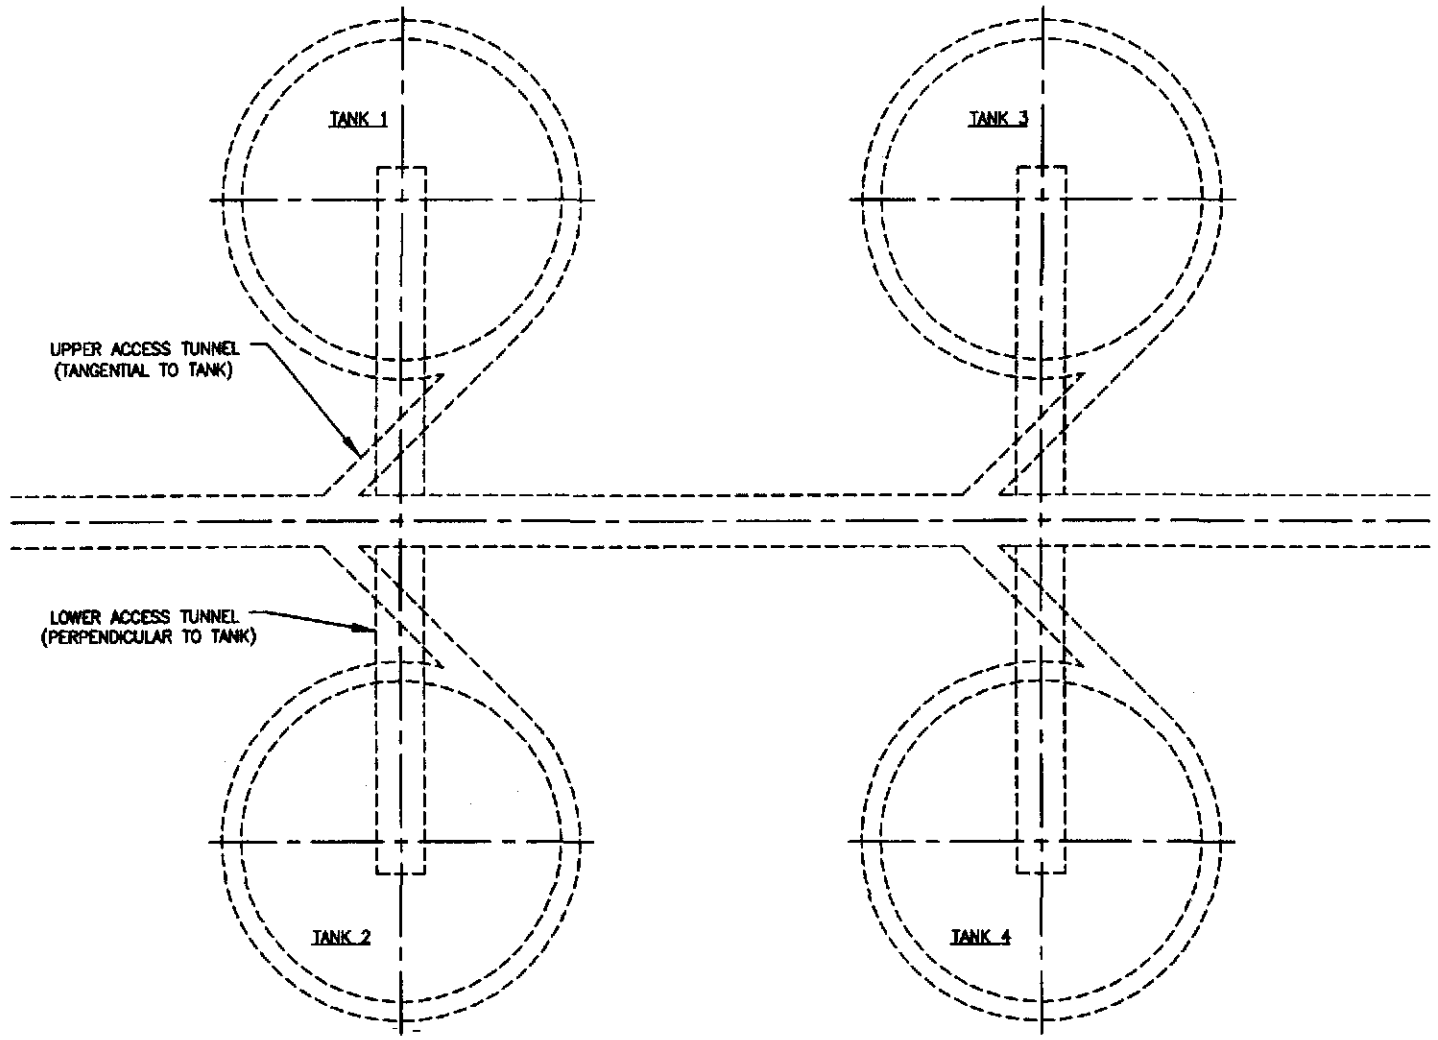
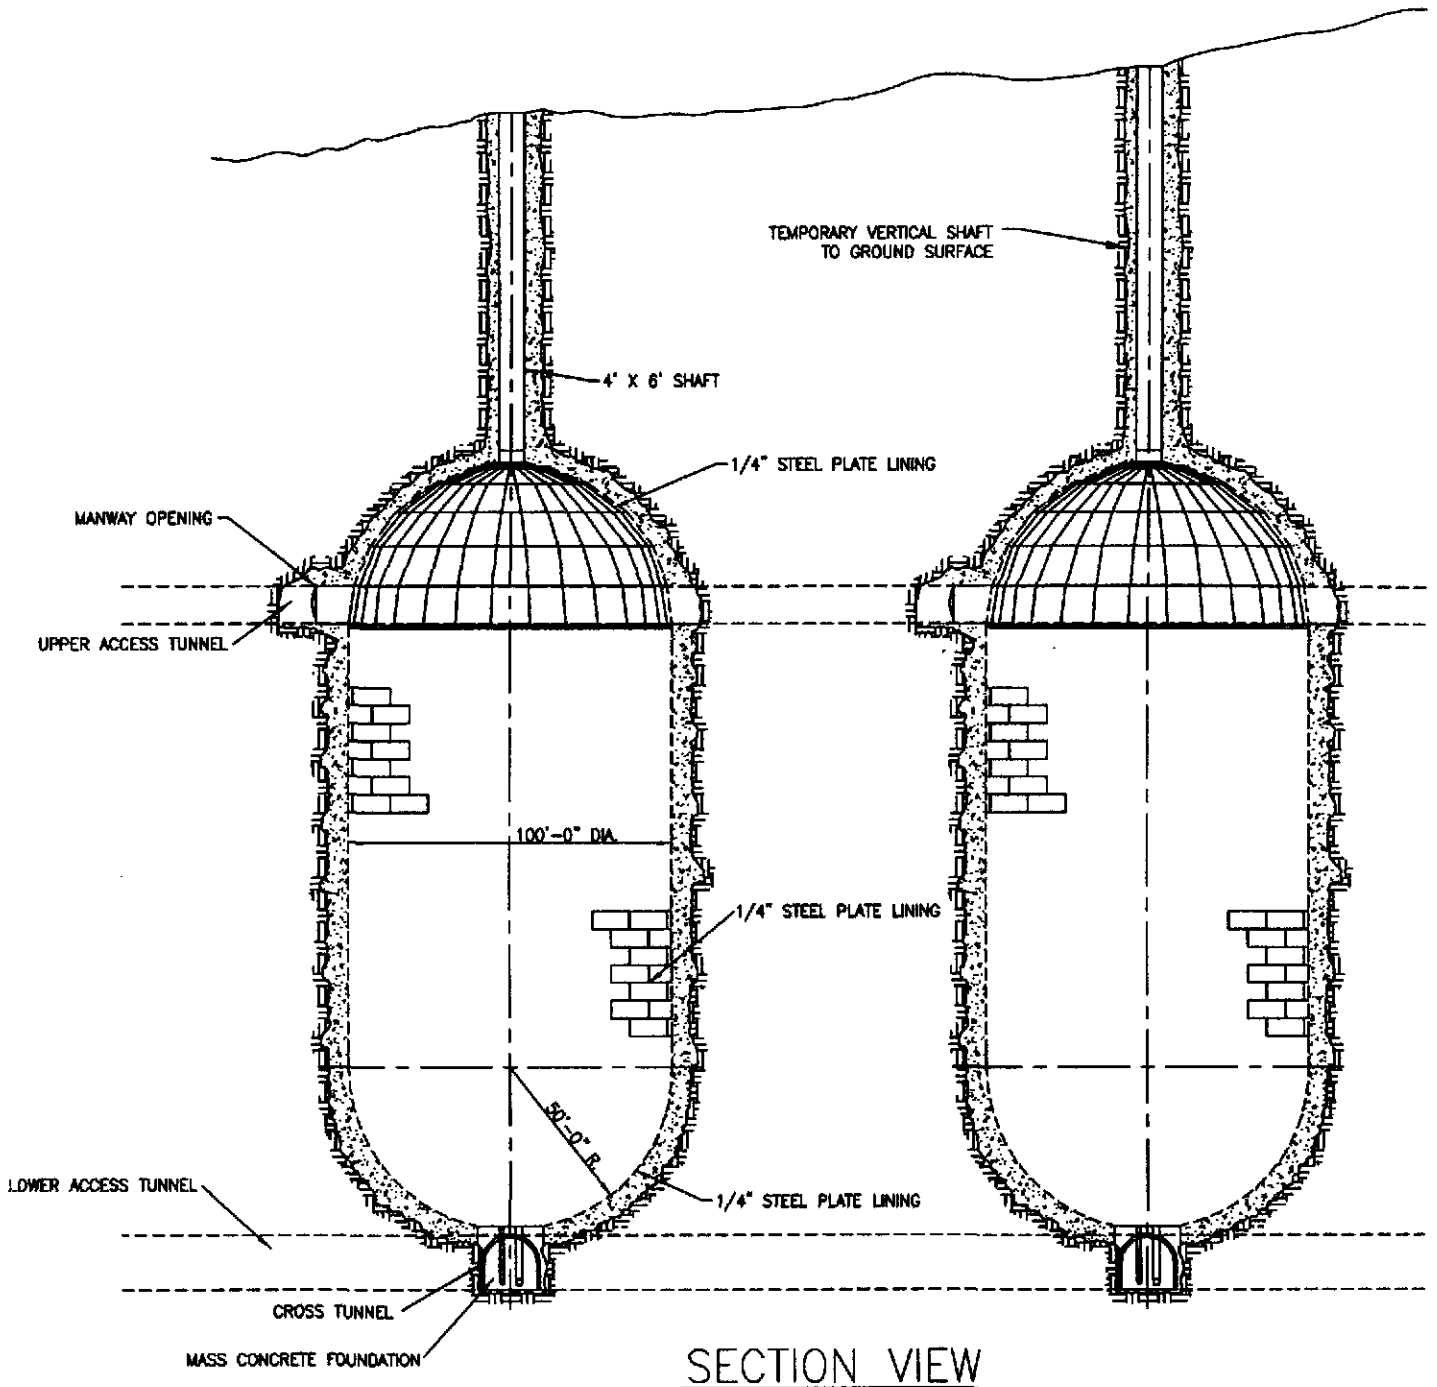
FIGURE 1-3	GENERAL TANK LAYOUT RED HILL BULK FUEL STORAGE FACILITY FLEET INDUSTRIAL SUPPLY CENTER
OGDEN	PROJ. NO. 1-1019-0229-0171 DRWN. BY MJD 8-17-99 CHKD. BY EGW 8-17-99

Construction of the bulk fuel farm began with the surface of Red Hill being removed to allow for vertical construction. Each tank pit was blasted from the basalt, utilizing a central vertical tunnel and radial blast tubes. Once the tank pits were opened, the steel tank segments were field constructed and placed into the pits in sections. The construction started with the lower dome being built in place. Once the lower dome was in place, the lowest portion was encased in a concrete bed. This method was generally followed for an entire tank as it progressed to the upper dome. Upon completion of the tank, small diameter holes were drilled in the sides of the tank and through the concrete bed. A 10 to 1 grout mixture was injected into the surrounding bedrock at approximately 300 pounds of pressure per square inch (psi). This method was utilized to close all possible seams and blasting fractures that may have been created during construction. (Please refer to Figure 1-3, General Tank Layout).

A leak monitoring system, referred to as 'tell-tale', was installed during tank construction. The tell-tale consists of a system of angle-iron ledges welded to the exterior diameter of each tank shell. The tank shell was generally constructed using 5 by 12 foot steel plates. The angle iron was welded over the 12-foot horizontal joint between

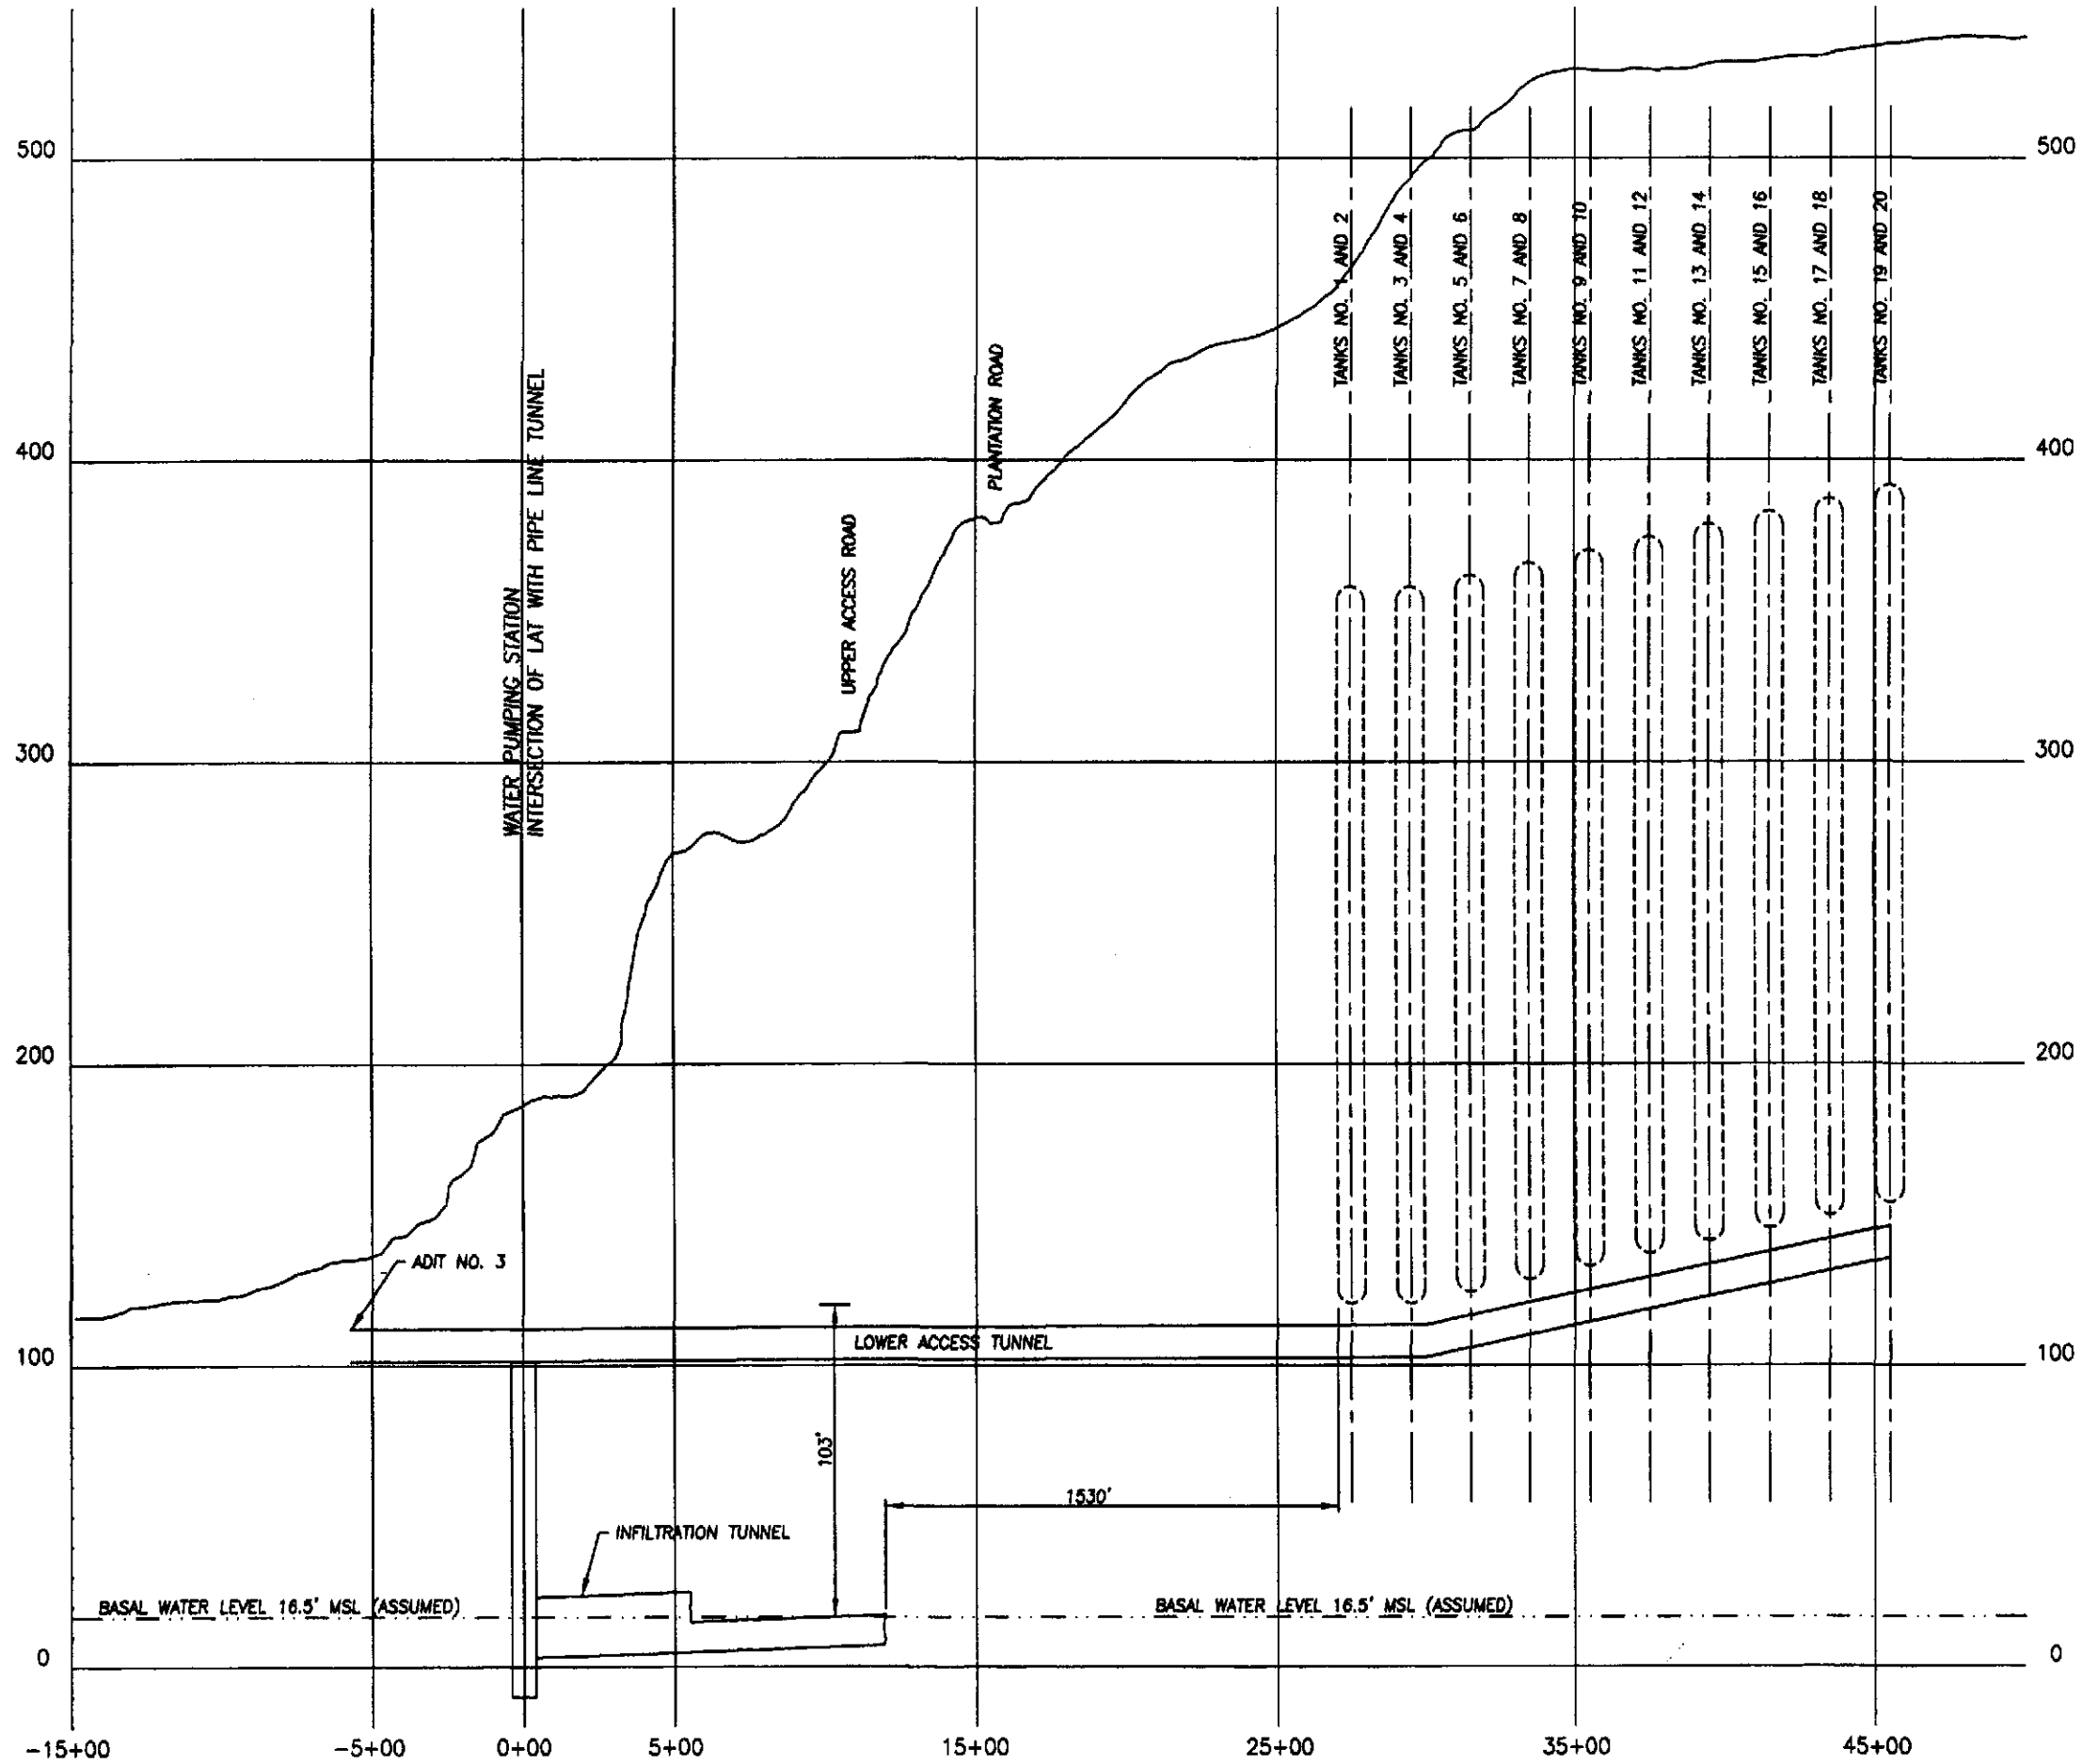
FIGURE 2-2

pump station covers Volatile Organic Compounds (VOCs) and other petroleum constituents of concern. No indication of petroleum contamination has been detected in basal aquifer water samples collected during periodic monitoring at the PWC pump station. Figure 2-2 provides a profile of the tanks and infiltration tunnel.

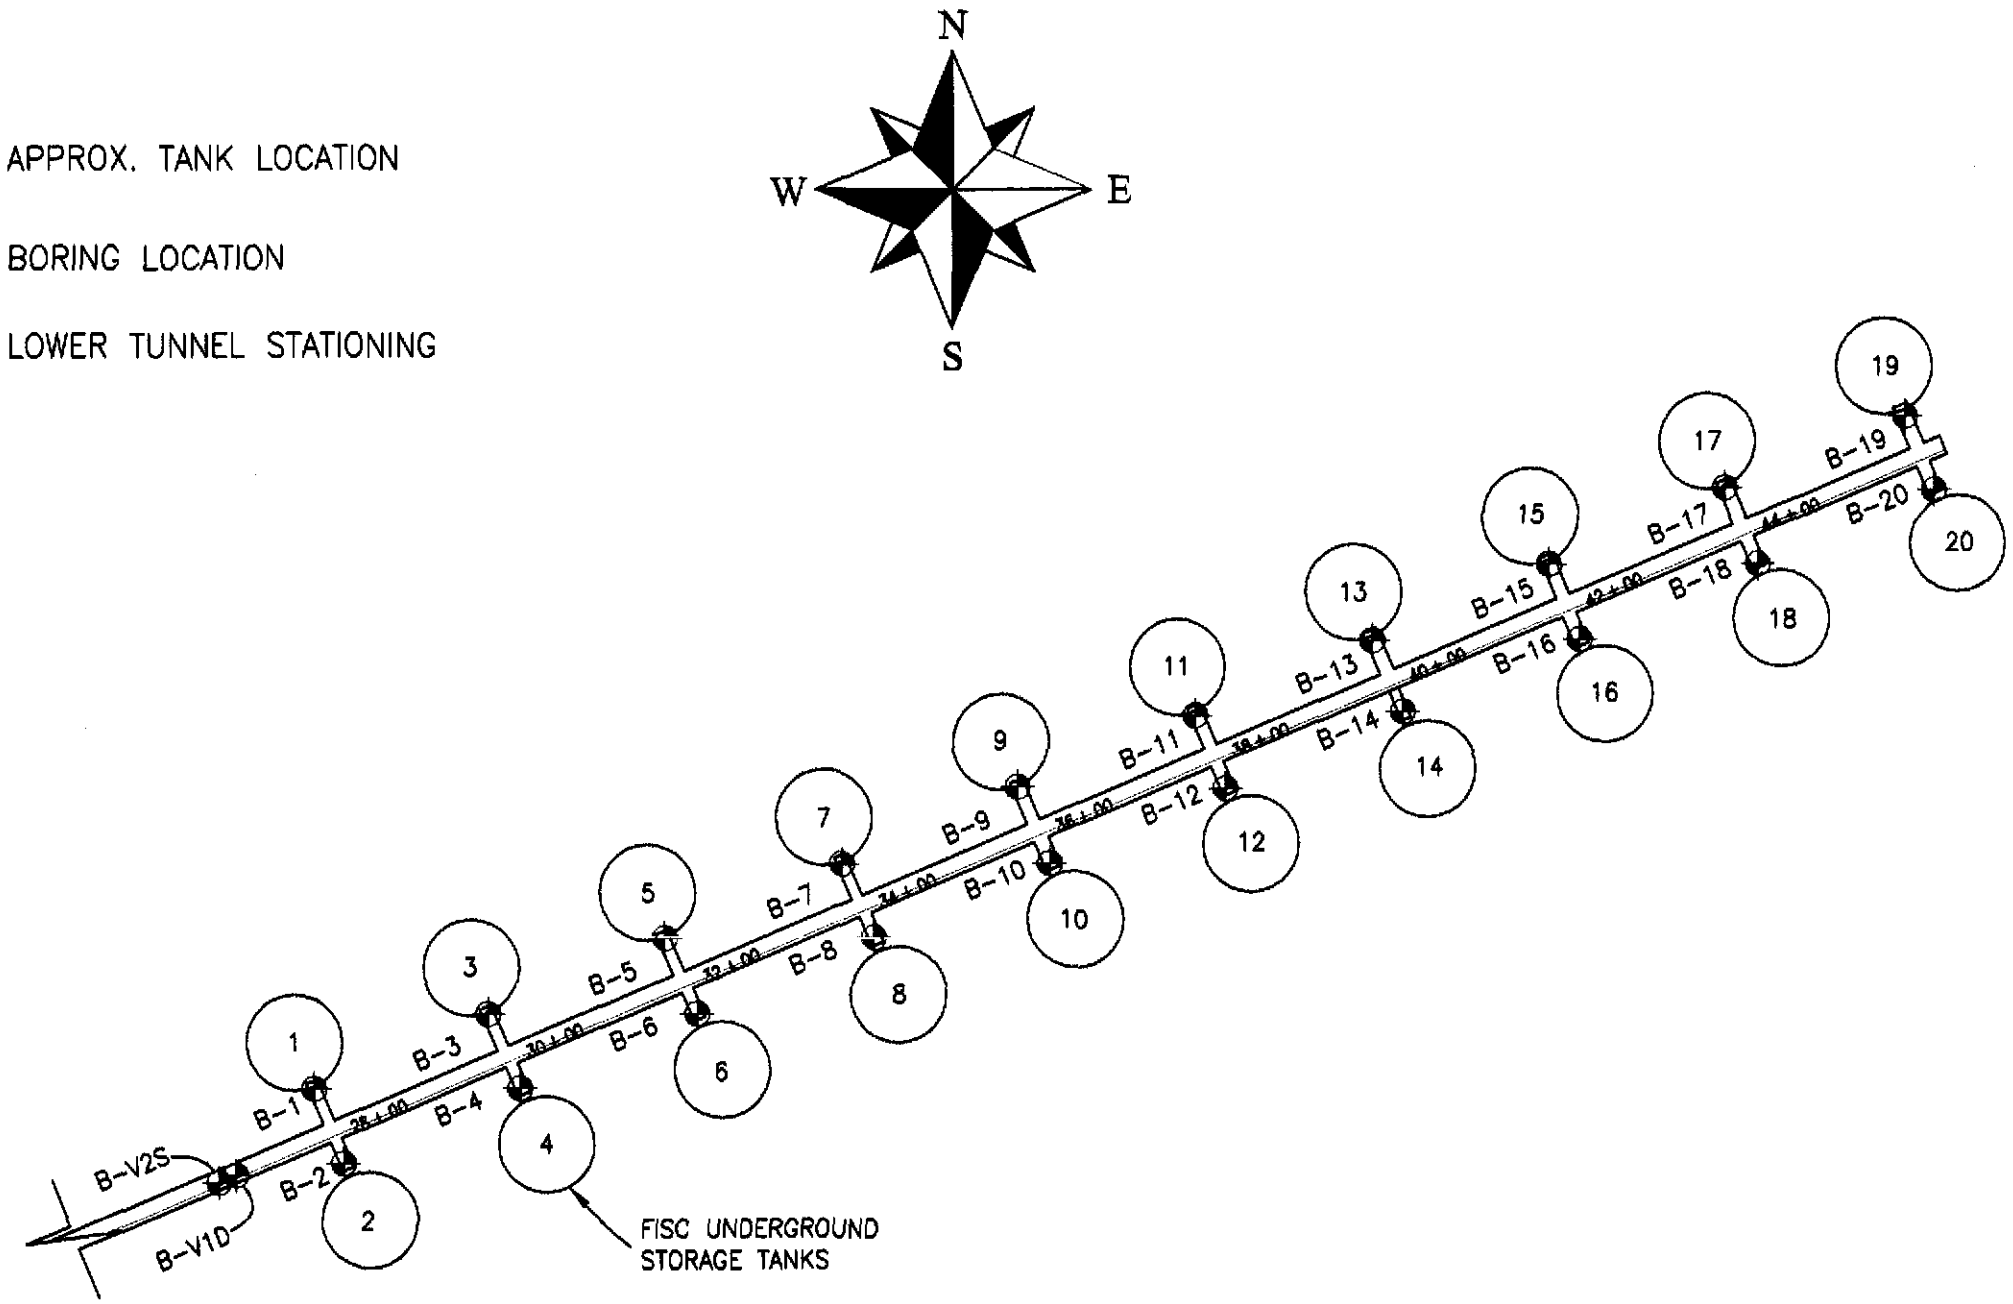
FIGURE 3-1	PLAN VIEW OF BORINGS RED HILL BULK FUEL STORAGE FACILITY FLEET INDUSTRIAL SUPPLY CENTER
OGDEN	PROJ. NO. 1-1019-0229 DRWN. BY APT 10/2/01 CHKD. BY _____ _____

No evidence of hydrocarbon impacts was noted at depth (greater than 2.0 feet bgs) in angle borings located at 4 of the 20 tanks (Tanks 8, 9, 10, and 15) and in the vertical borings (B-V1D and B-V2S). A hydrocarbon odor and elevated PID readings were observed at depth in the angle borings located at 15 of the 20 tanks (Tanks 1, 3, 4, 5, 6, 7, 11, 12, 13, 14, 16, 17, 18, 19, and 20).

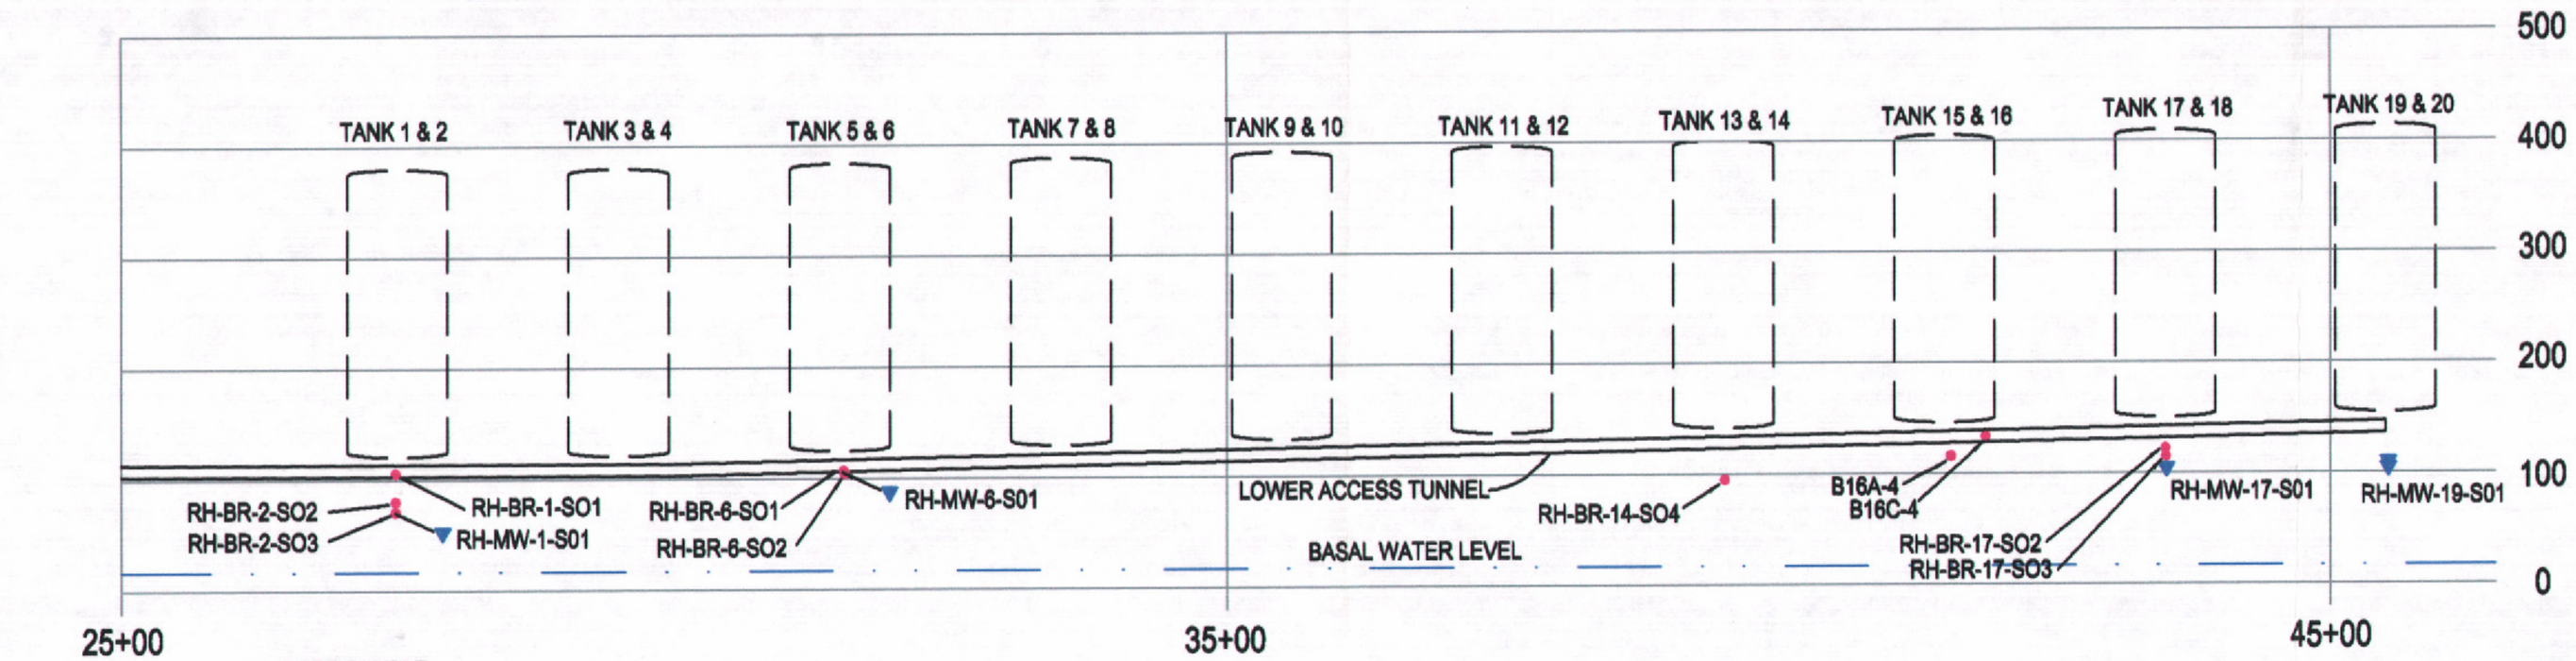
FIGURE 4-1	PLAN VIEW WITH CORE SAMPLE LOCATONS THAT EXCEED SOIL TIER I ACTION LEVELS
OGDEN	PROJ. NO. 1-1019-0229 DRWN. BY APT 10/2/01 CHKD. BY

Constituent exceedances of the Tier I soil action level values of the 87 core samples analyzed were noted in the angle borings located at Tanks 1, 2, 6, 14, 16 (B16A and B16C), and 17. Core samples analyzed from the vertical borings did not exceed the Tier I action levels. The constituents detected above the Tier I action levels are ethylbenzene, methylene chloride (a common laboratory contaminant), naphthalene, hydrocarbons (TPH C10-C28), and an unknown hydrocarbon. The sample location with exceedances for the soil Tier I action levels are depicted in Figure 4-1 and Figure 4-2.

SAMPLE ID	CONSTITUENTS WHICH EXCEED TIER I ACTION LEVELS	ANALYTICAL RESULTS (PPM)
RH-BR-1-S01	TPH (C10-C28)	25300
RH-BR-2-SO2	METHYLENE CHLORIDE	0.011
RH-BR-2-SO3	METHYLENE CHLORIDE	0.0127
RH-BR-6-S01	TPH (C10-C28)	10200
RH-BR-6-S02	TPH (C10-C28)	43100
RH-BR-14-S04	ETHYLBENZENE	1.55
	TPH (C10-C28)	26200
B16A-4	NAPHTHALENE	43
	UNKNOWN HYDROCARBON	11000
B16A-DUP	UNKNOWN HYDROCARBON	6600
B16C-4	NAPHTHALENE	47
	UNKNOWN HYDROCARBON	9400
RH-BR-17-SO2	METHYLENE CHLORIDE	0.0152
RH-BR-17-SO3	METHYLENE CHLORIDE	0.0108
