Documentation to Amend Drinking Water Health Advisory in Zone H2

Joint Base Pearl Harbor Hickam (JBPHH)
O‘ahu, Hawai‘i

Interagency Drinking Water System Team
Zone H2 Removal Action Report
March 2022

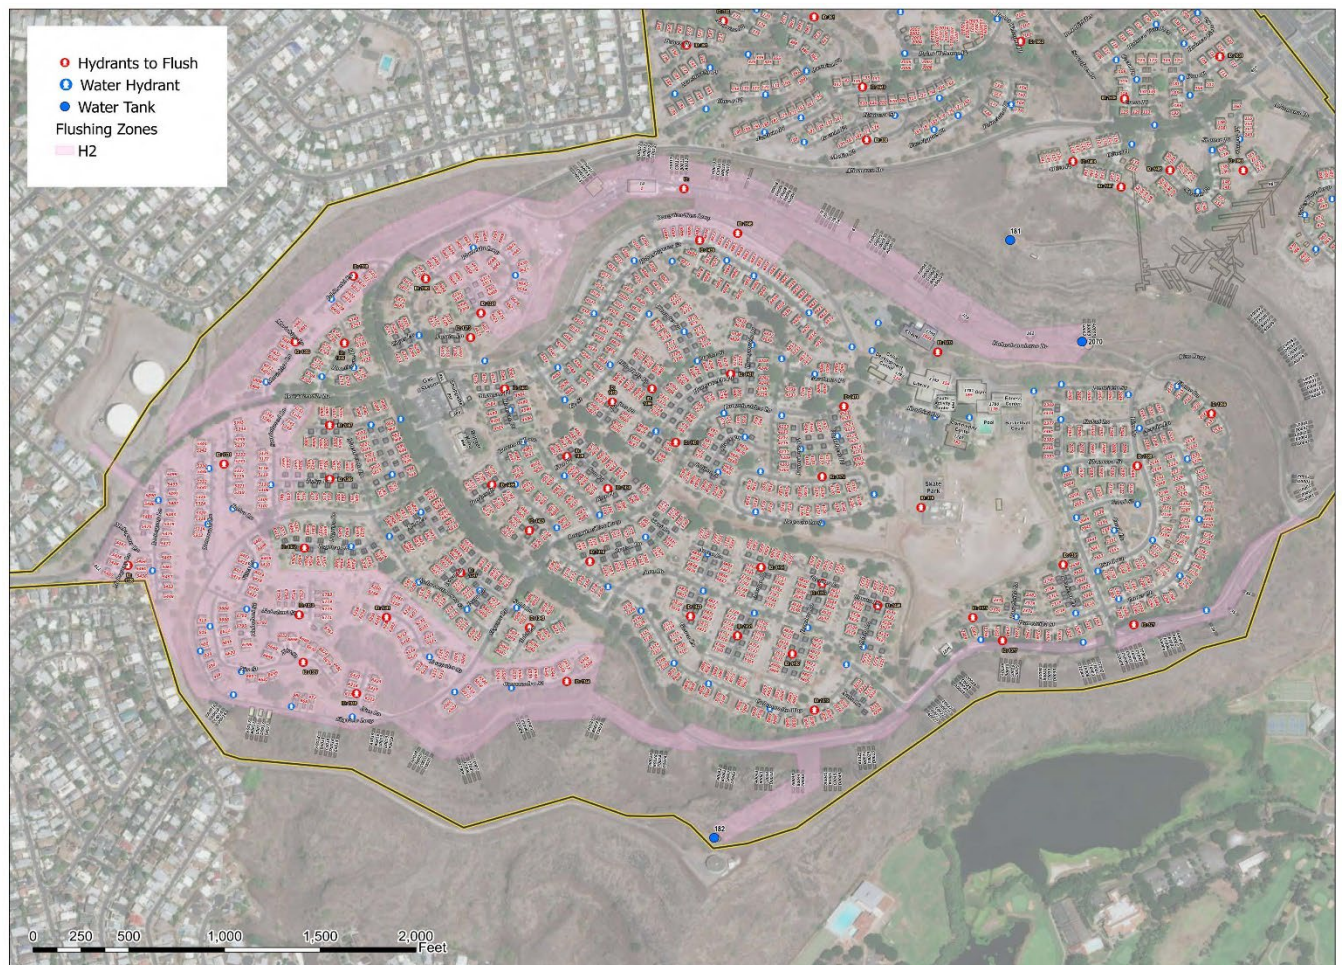
FIGURE 1: HYDRANTS FLUSHED ZONE H2

There are two flushing events for the distribution system in Zone H2. For distribution flushing the Flush 1 for Zone H2 occurred 22-25 December 2021. The distribution flushing for Flush 2 for Zone H2 occurred 6-9 January 2022.
