ALTERNATIVE WATERSHED-BASED PLAN FOR THE KAWELA WATERSHED,
MOLOKA'I, HAWAI'I

Prepared by
The Nature Conservancy of Hawai'i
and
the East Moloka'i Watershed Partnership
for
The State of Hawai'i Department of Health

December 2019

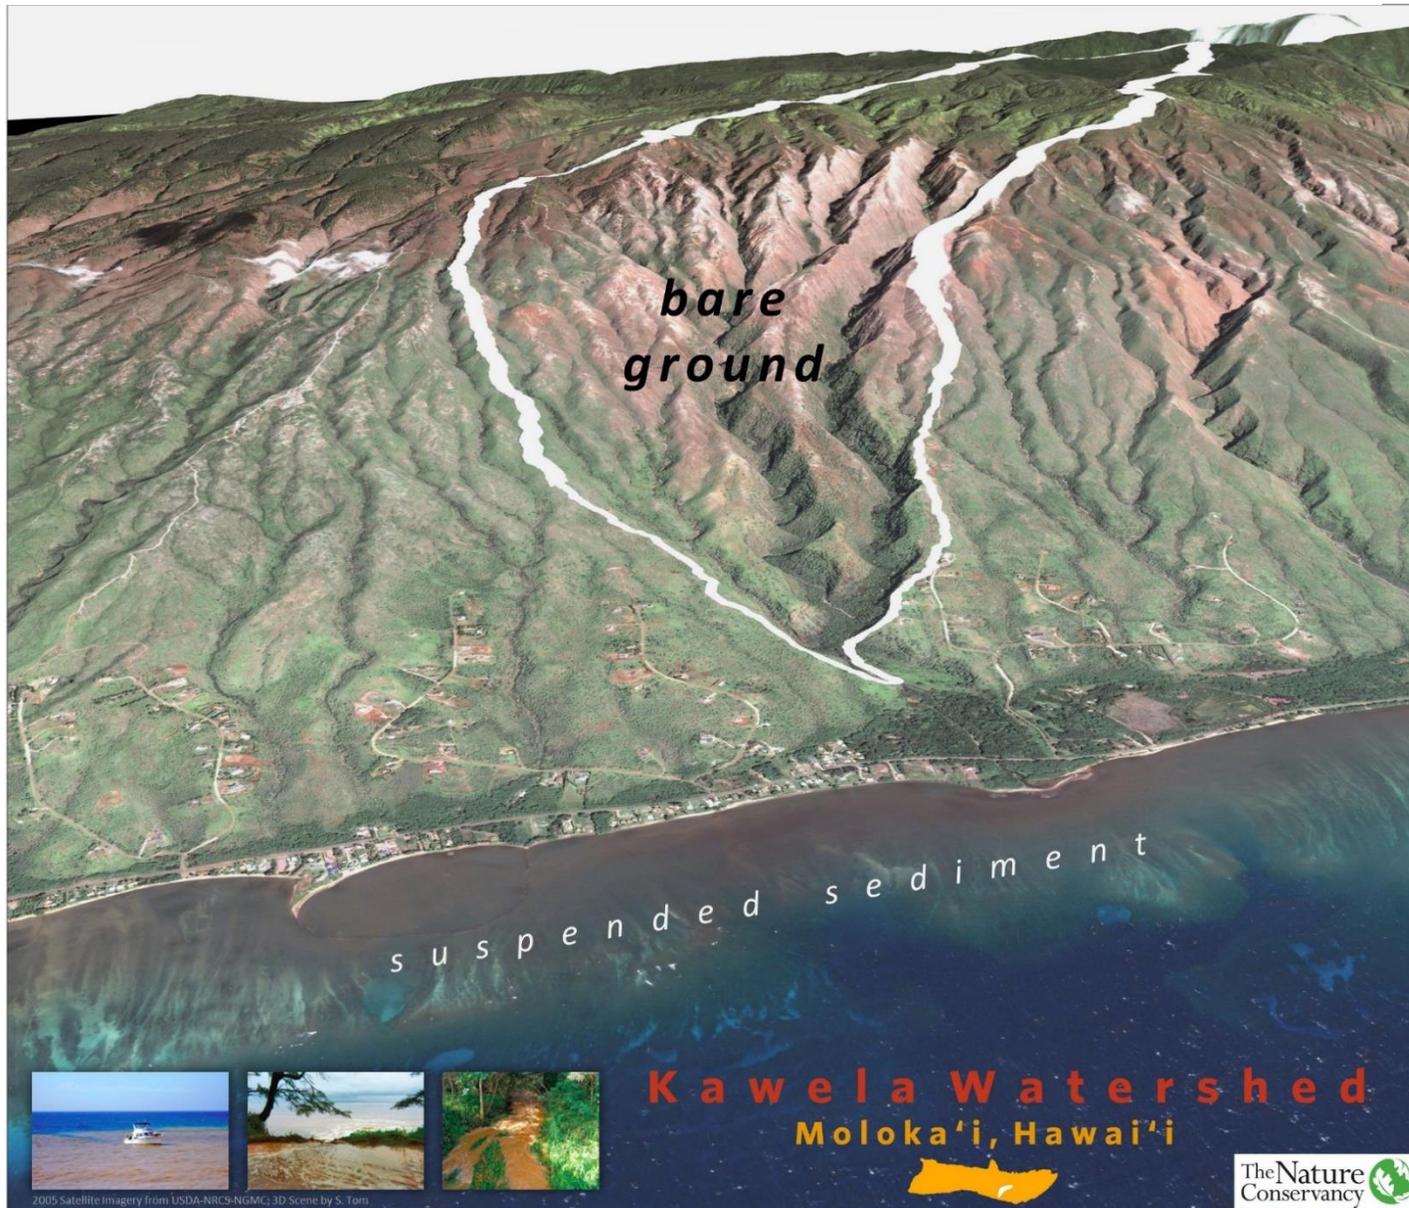
Figure 1. Satellite image of Kawela watershed (outlined in white) and neighboring areas (insets are images of the impacts of rain events to Kawela's nearshore environment).

As a result of centuries of feral ungulate impacts, Kawela is a barren landscape (FIG. 1 and 2). Beginning with cattle in the 1850's, ungulates have significantly impacted the native forest and shrubland ecosystems in the ahupua'a and are the primary reason why these vegetation types are

Goats roam in large numbers, are free from natural predators and inhabit the steepest terrain as their safe haven. Consequently, they strip the landscape of vegetation, which results in increased lowering rates and diminished infiltration capacity of the watershed (Stock et al. 2011, Jacobi and Stock 2013, 2017). Axis deer, while more elusive than goats, have seen population explosions on island over the last two decades with consequent and substantial impacts to natural areas due to browsing impacts. Feral pigs are found in all elevations and easily adapt to the wettest, highest elevations where they dig up understory vegetation exposing bare ground to runoff and invasive weed invasions. In Kawela, during dry, hot times of the year, goats and axis deer herds move to the upper montane mesic and wet forests where they graze on the forest edge or "browse line". The area below the browse line is a remnant dying forest, as evident by the mix of native dead tree stumps and invading alien grass. Below these dying forest grasslands, the landscape becomes a sea of alien vegetation, red dirt and gray rock (FIG. 1 and 2).

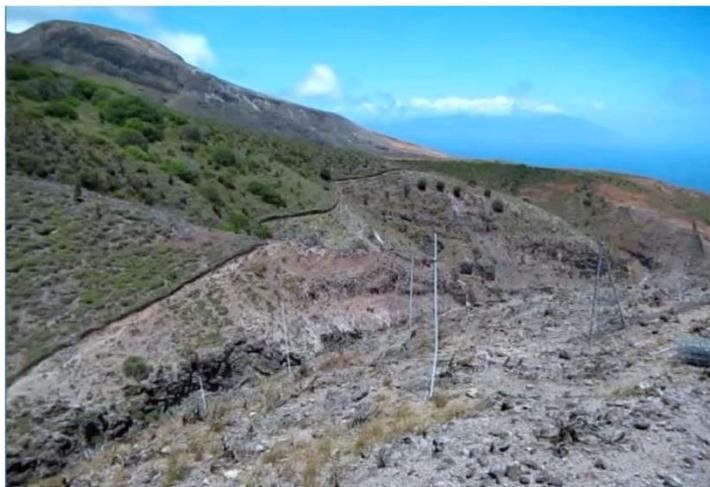
Figure 2. Fence effects inside and outside EMoWP watershed fencing in Kawela.

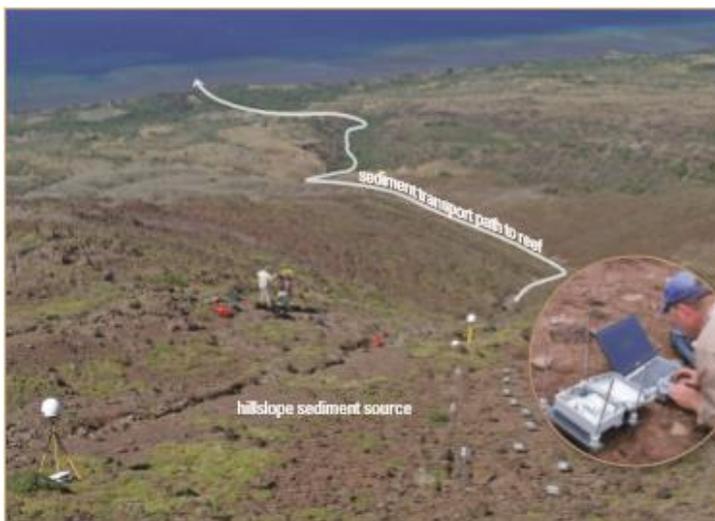
Figure 3. Taken from Stock et al. 2011 showing USGS Ridge to Reef study site in Kawela, Moloka'i.

0.4 inches/year of soil erosion for a period of five years, a 10-fold reduction in erosion rates was measured because of revegetation (FIG. 3; 2013).

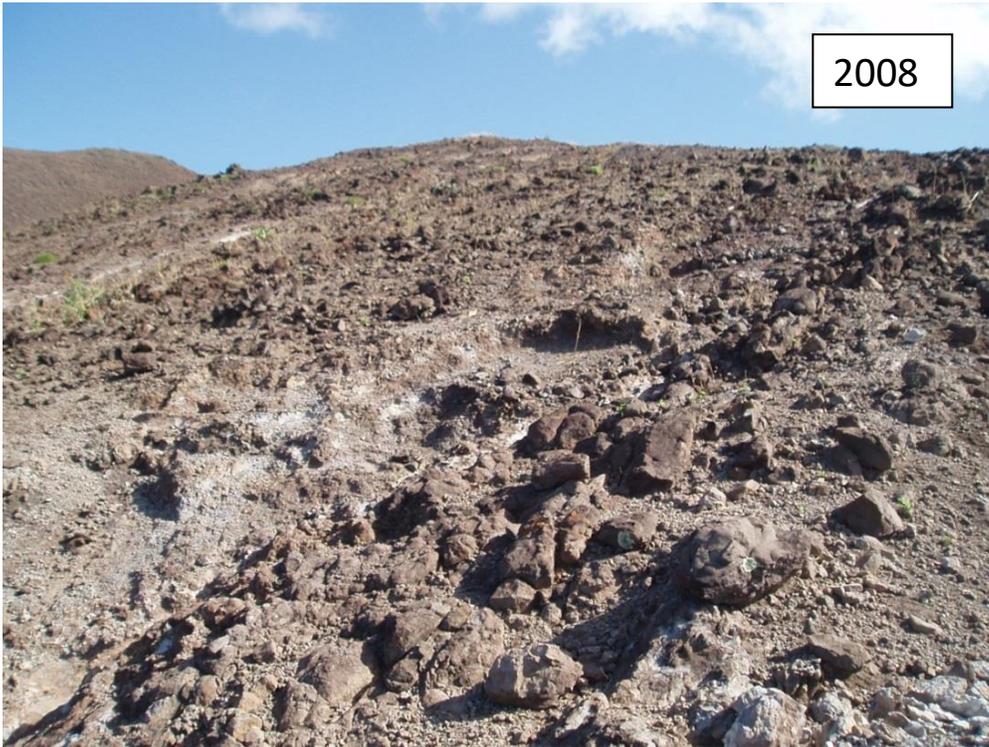
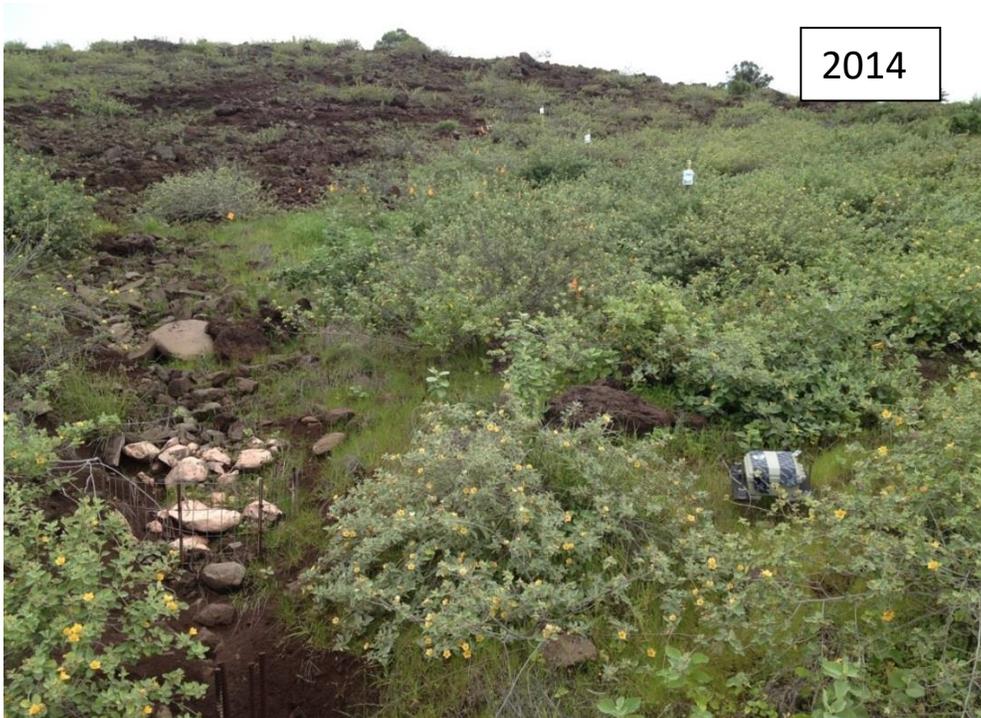
Figure 4. USGS Kawela ridge plot site in 2008 and 2014.

USGS research findings also show that these vegetation increases meant that hillside sites that were previously bare soil and supplied the watershed with fine silts and muds, were now covered with vegetation, litter and thin deposits effectively shutting down erosion as they revegetate (Jacobi and Stock 2013). At experimental study sites in Kawela where USGS had documented

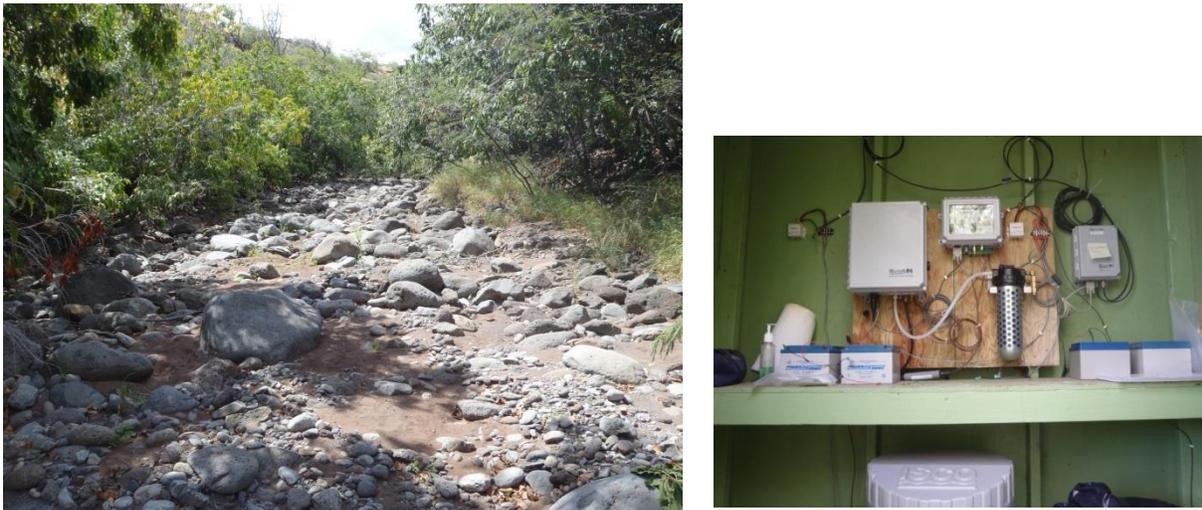
Figure 5. Kawela stream gauge with ISCO automated water sampler and pressure sensor.

Stream height and suspended sediment concentration will be monitored at USGS Kawela Stream Gauge site (Site number 164156000) using pressure sensors and automatic sediment samplers, located in the lower reaches of Kawela stream (MAP 3; FIG. 5). Historic ratings curves will be used to estimate stream discharge. Suspended sediment concentration curves will be used to

estimate suspended sediment concentration and loading. The site has been in operation since 2005, and is in current operation, with a total of nearly 4000 days of samples. However, between 2011 and 2015 the gauge was inactive. EMoWP worked with USGS and in 2016 received Maui County Department of Water Supply funding to pay operating costs. The station includes an ISCO automated water sampler, and a pressure sensor to measure water depth, as seen below.

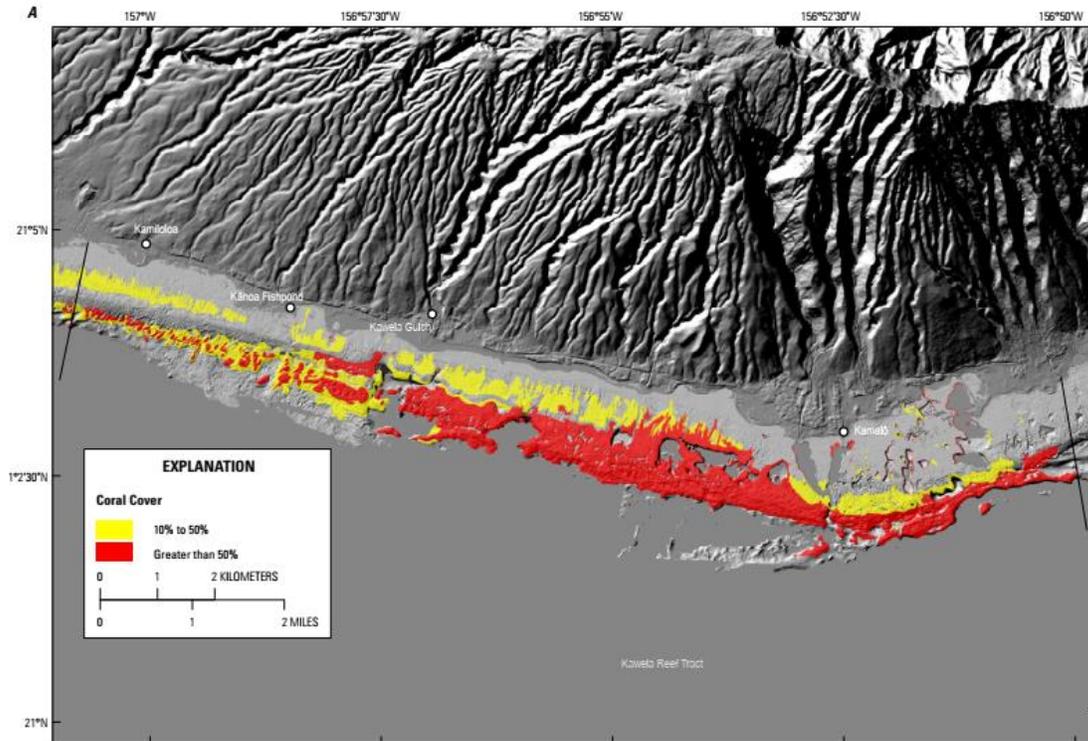
Figure 6. Figure from USGS (2019) showing major reef coral cover and transect lines (black) to the east and west of Kawela gulch.

Coral reef tract surveys were conducted last in 2007, at two transects east and west of Kawela in Kamiloloa and past Kamalō (Field et al. 2019). The last time the bathymetry was conducted in Kawela, the inner reef lagoon was less than 5m in many places. Future surveys, funded separately, would repeat the coral transects to the west and east of Kawela, and add an additional transect at the mouth of Kawela stream (see FIG. 6 below from Field et al. 2019, showing the two nearest transects). Benthic communities will be assessed by taking photographs of the benthos along the same transect lines previously conducted and analyzing those photographs for percent composition of the benthic community, including corals by species. Using external funds, additional monitoring could update the dataset, including coral health and fish surveys.
