MĀ‘ILĪ‘ILĪ WATERSHED MANAGEMENT PLAN

VOLUME I
Final Report
July 2014

Prepared for:
Hawai‘i State Department of Health
Clean Water Branch

TOWNSCAPE, INC.
Environmental & Community Planning

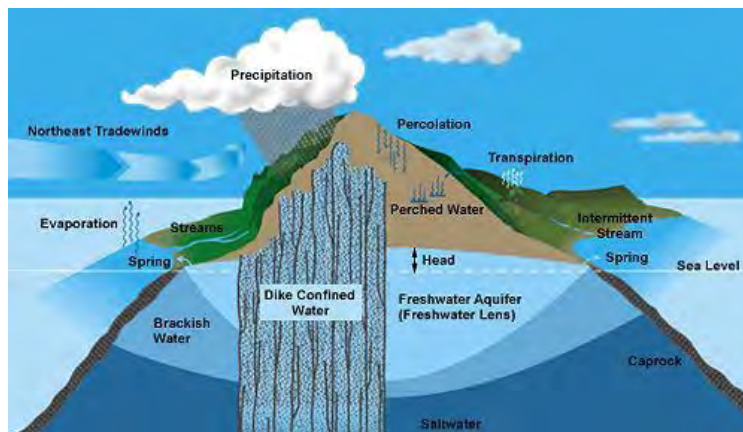
Figure 12. The Hydrologic Cycle. Source: BWS ⁽¹¹¹⁾

Hydrology is the science and study of the movement, quality, and distribution of water over a geographic area, e.g. a watershed. The hydrologic cycle (or “water cycle”) is the foundation for understanding both surface and groundwater hydrology. The hydrologic cycle is an ongoing process proceeding endlessly, regardless of the presence or absence of human beings. Rainfall and other precipitation falls onto the land, where it is taken up by trees and other vegetation. Some of it infiltrates the soil and re-charges groundwater, some of it evaporates back into the atmosphere, and the rest flows over land as runoff, enters streams and other water features and ultimately discharges into the ocean. The evaporation from the ocean and the land once again forms clouds and the cycle continues. Although the cycle is endless and not dependent on humans, human activity can significantly alter the hydrologic cycle. For example, changes in land use and vegetation and the creation of impervious surfaces can drastically change runoff patterns and infiltration rates (24).

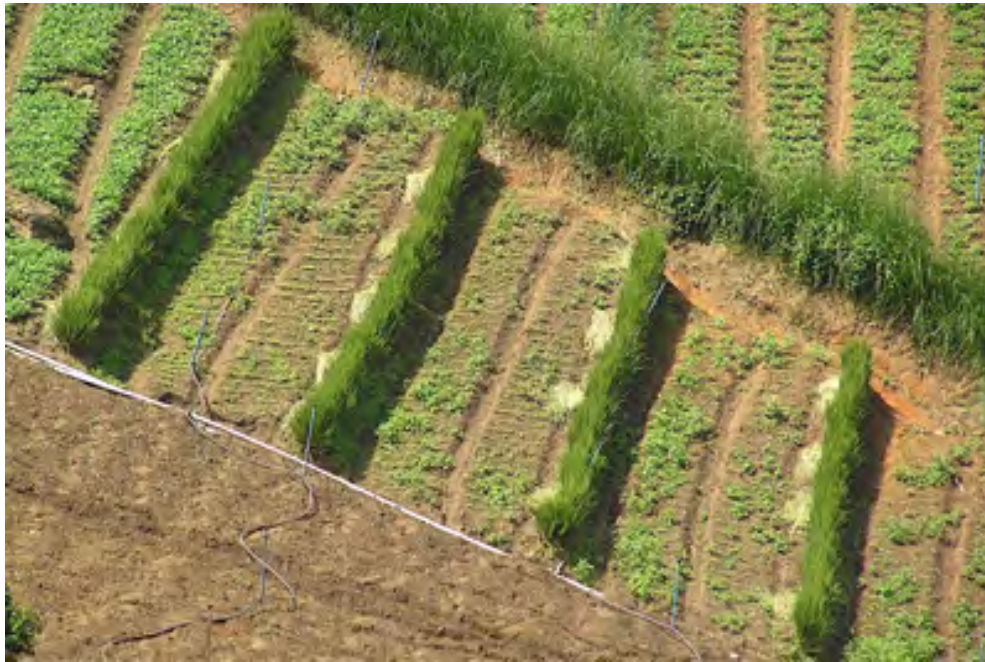
VEGETATIVE BARRIER (# 601) refers to permanent strips of stiff vegetation established along slope contours or across concentrated flow areas such as ephemeral gullies, which are typical for agricultural areas with tillage and irrigation. There are no large gullies that are observable via aerial imagery in this watershed, but any smaller concentrated flow erosion areas identified in the future can be addressed with this management practice. The NRCS FOTG specifically recommends vetiver grass due to its Vegetation Stiffness Index (VSI).

Hawaii Sunshine Vetiver can be used as a field border, filter strip or vegetative barrier, providing multiple benefits ⁽⁶⁶⁾

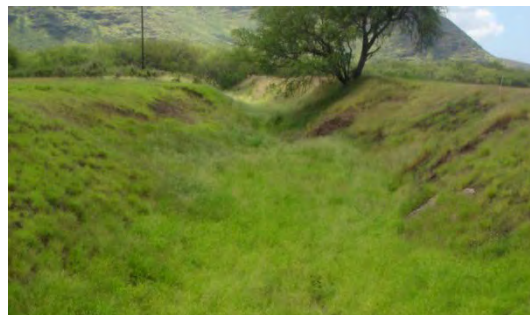
GRASSED WATERWAY (# 412) refers to shaped or graded stream channels with suitable vegetation (including grass) with the purpose of transporting runoff without causing erosion or flooding. This management practice is already in place at NRTF. Future maintenance or modifications may be necessary if additional pollutant loads are expected.

Existing grassed waterways at NRTF
