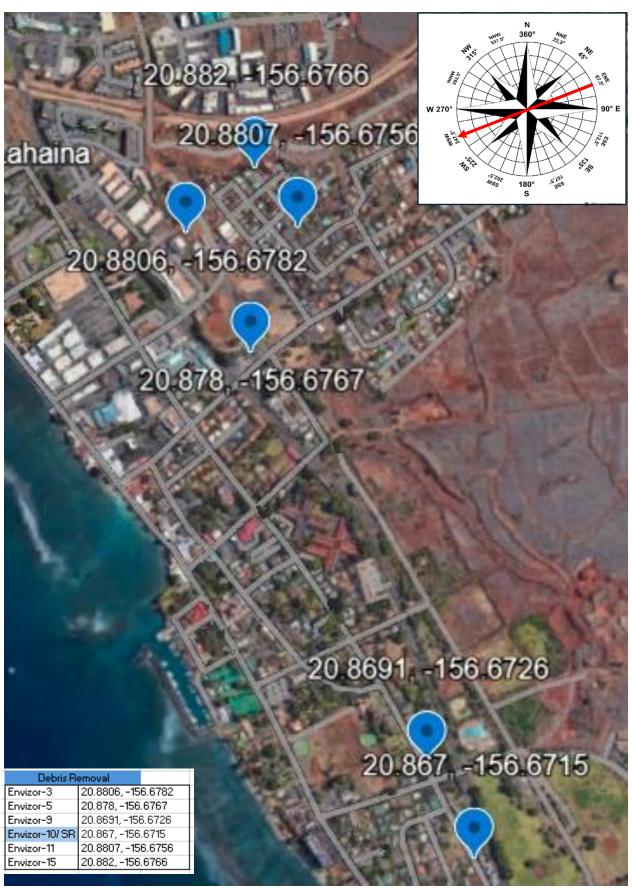
Station Location Summary:

Station 5, Station 5, Station 11, and Station 15 were set up around **301 Lahainaluna Rd.** for continued debris removal air monitoring.

Station 9 and Station 10 + Sensitive Receptor were set up around **439 Alio St.** for continued debris removal air monitoring.
