## Arsenic in Canec Ceilings and Wallboard in Hawai'i

This fact sheet provides homeowners, commercial building owners and operators, demolition and construction contractors, realtors, and others with an overview of the potential public health concerns associated with arsenic found in canec building materials, which were manufactured in Hawai'i from the early 1930s to the early 1960s. Additionally, this fact sheet discusses how to determine if canec is present, safe management practices during handling, demolition, and disposal, and provides resources for further information.

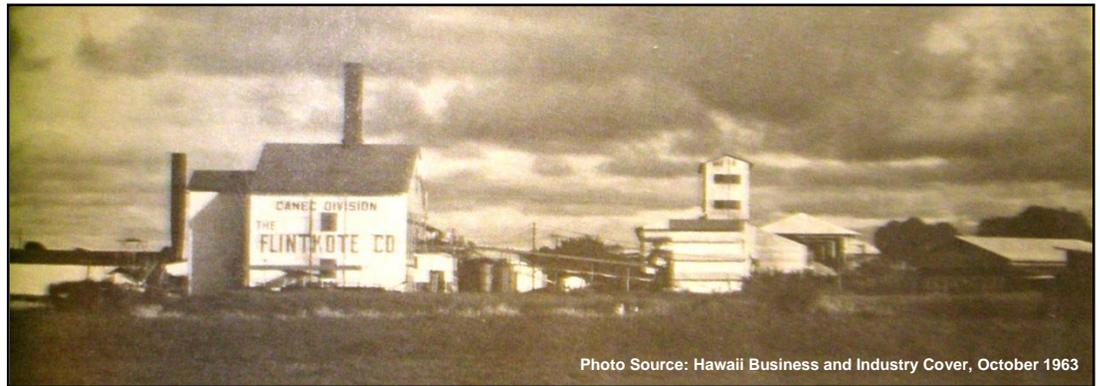
Photo Source: Hawaii Business and Industry Cover, October 1963

**ABOVE:** This is a historic photo of the canec plant formerly located in Hilo, Hawai'i. Flintkote Company owned and operated the plant from 1948 until about 1960.

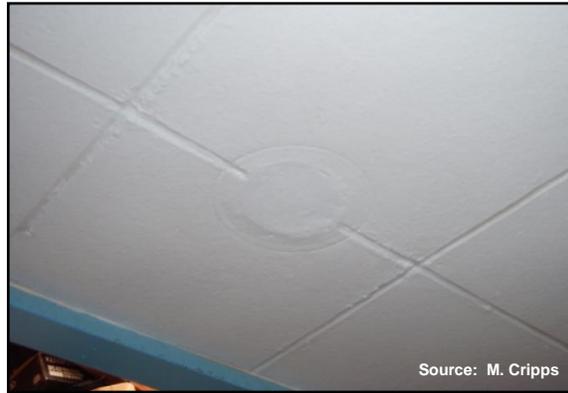
*Canec ceiling panels with characteristic V-shaped groove joints.*

Canec may be found in ceilings and/or interior walls as a tile or panel in buildings constructed prior to 1964. On ceilings, canec is often characterized with V-shaped groove joints that are arranged in linear patterns. The material itself is a fiberboard that is brownish-orange in color, though the exposed surface is typically finished smooth and painted, making it look similar to modern drywall. The individual fibers in canec building materials are fine and are not uniformly oriented. Canec is noticeably softer than drywall and can be dented with a firm press of a fingernail.

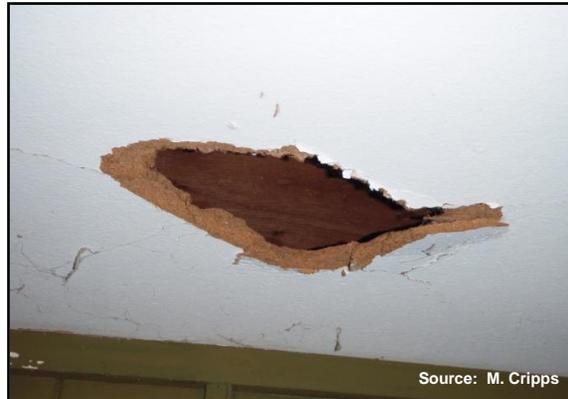
*A canec panel that is broken. Note the characteristic fibrous texture and brownish color.*
